**CITY OF PORTLAND, MAINE**  
Standing Committee on Sustainability and Transportation  
Councilor Andrew Zarro, District 4, Chair  
Councilor Roberto Rodriguez, At-Large  
Councilor Victoria Pelletier, District 2

Agenda  
May 10, 2023  
5:00 PM  
via Zoom

To: Councilor Zarro and members of the Sustainability and Transportation Committee  
Re: Stroudwater Dam recommendation  
Date: May 5, 2023

*Stroudwater Dam (MEMA Dam #441)  
2022 Visual Dam Safety Inspection Report*

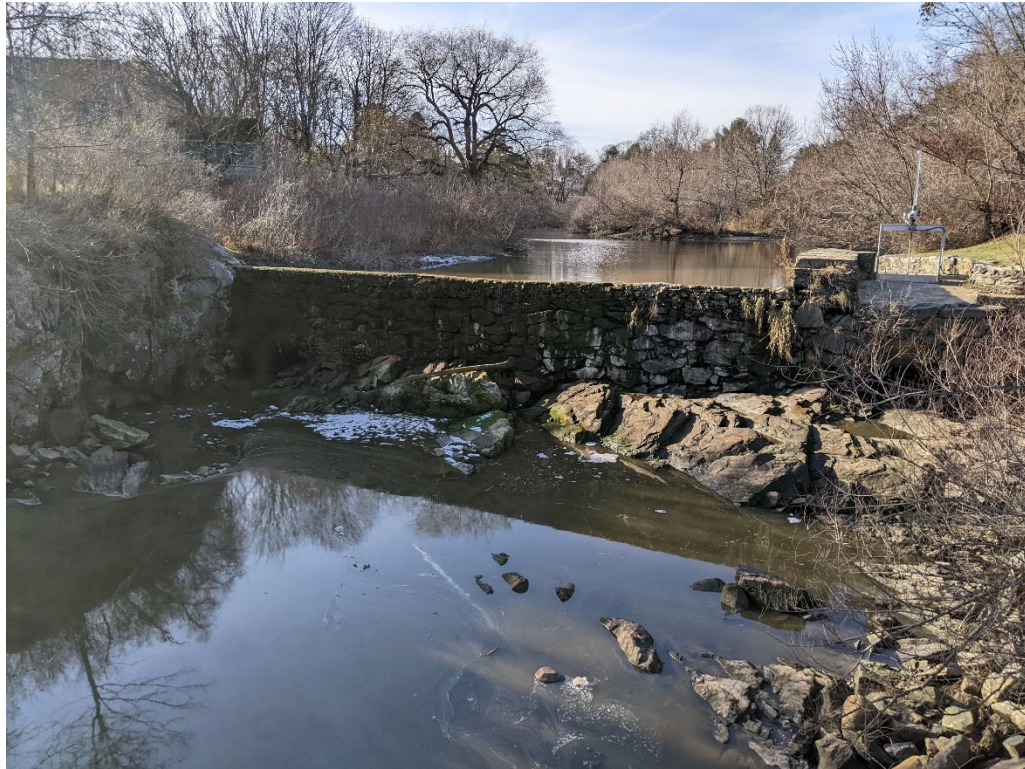
**Photo 1:** Downstream face of Stroudwater Dam from Westbrook Street Bridge (looking upstream)

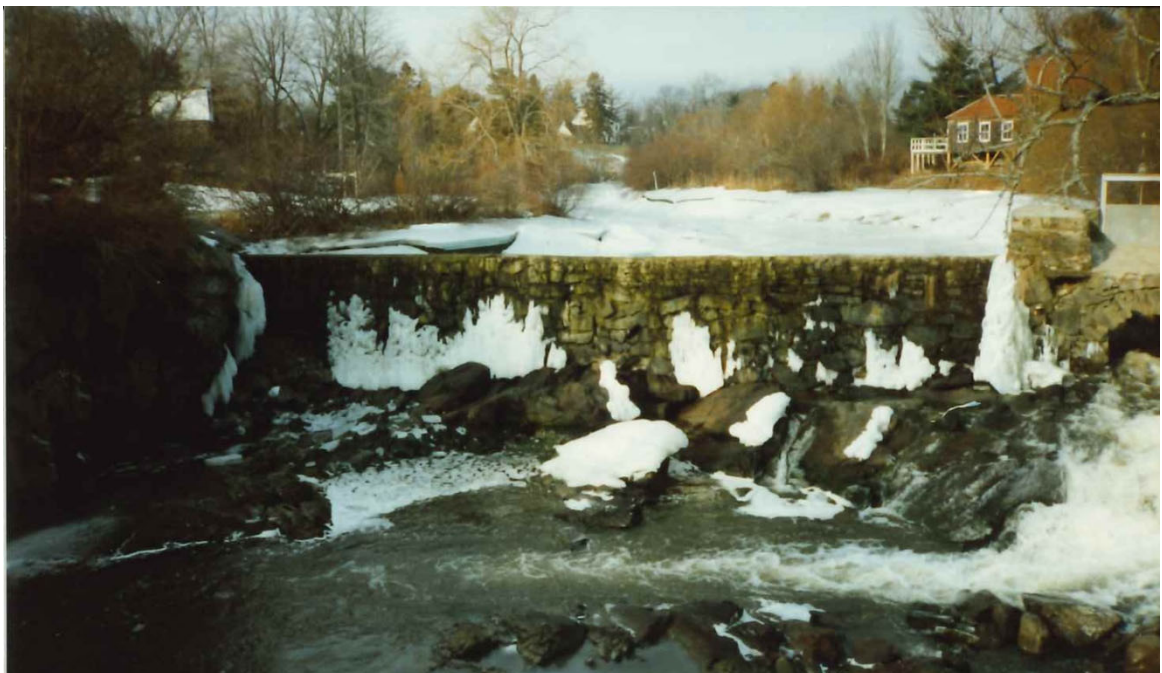
- Numerous longitudinal cracks were observed across the upstream face of the primary spillway (Photos 6 through 9); these cracks are a likely source of leakage that has been historically reported through the downstream dam face (Photo 4) at normal pool conditions;

**[Historic] Photo 4:** Leakage areas through dam on February 17, 1999 (delineated by ice formations)

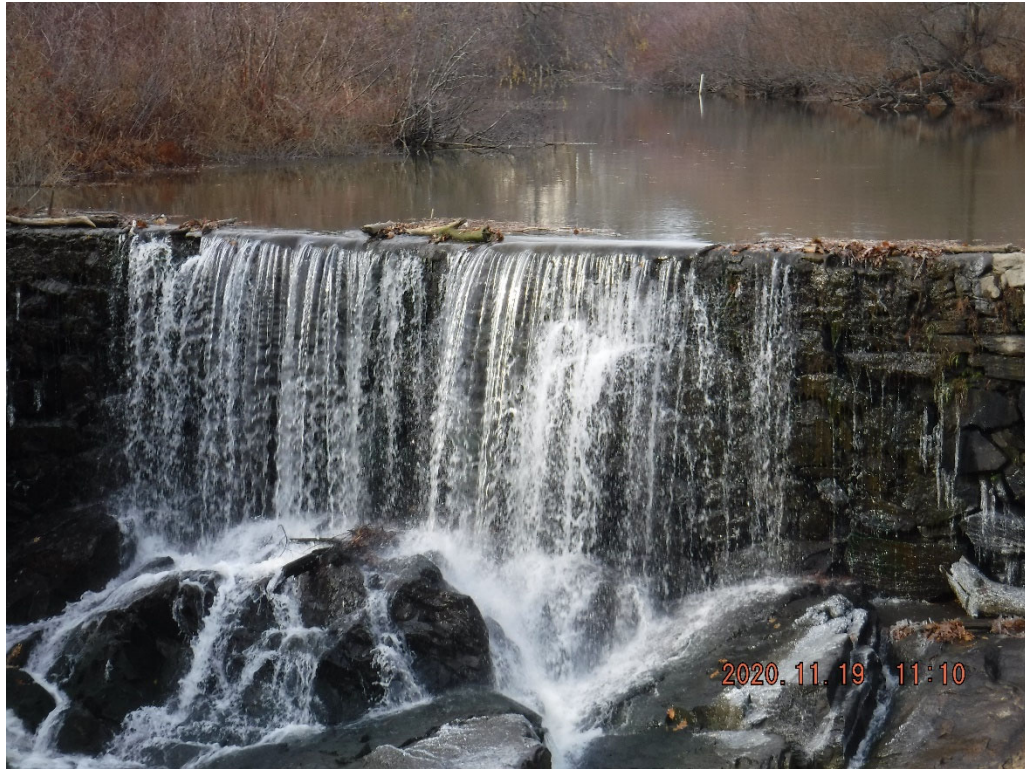
**[Historic] Photo 5:** Uneven spillway crest and spillage on November 19, 2020  
(NOTE center discharge only)

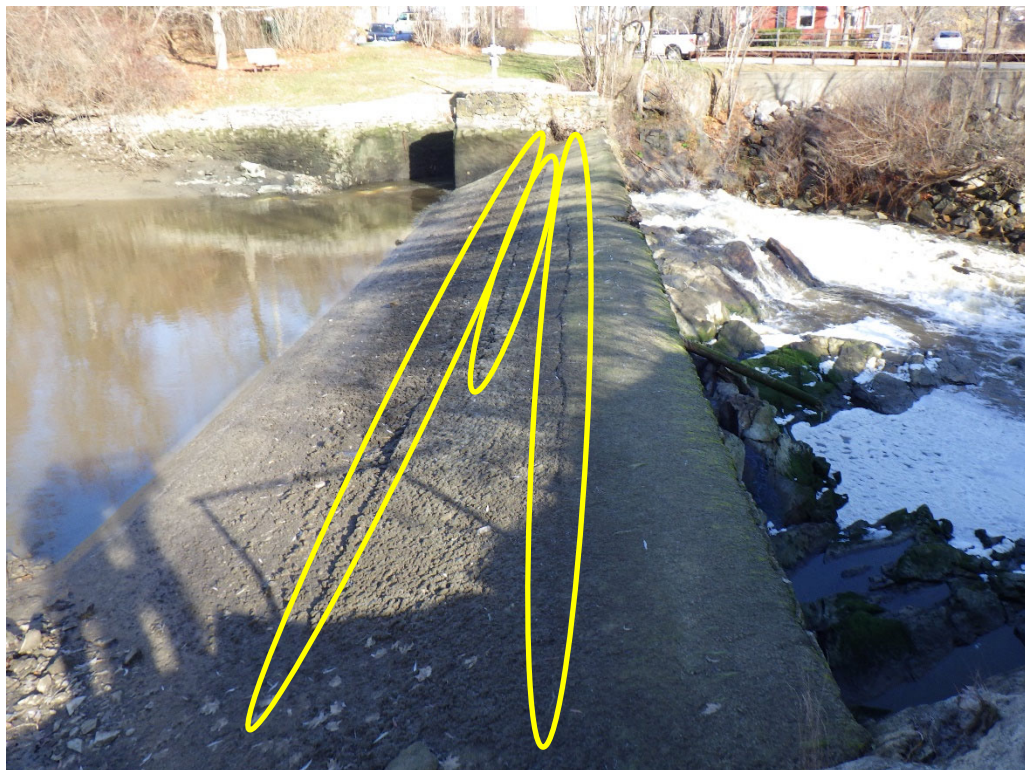
**Photo 6:** Primary Spillway concrete condition (NOTE longitudinal cracks)

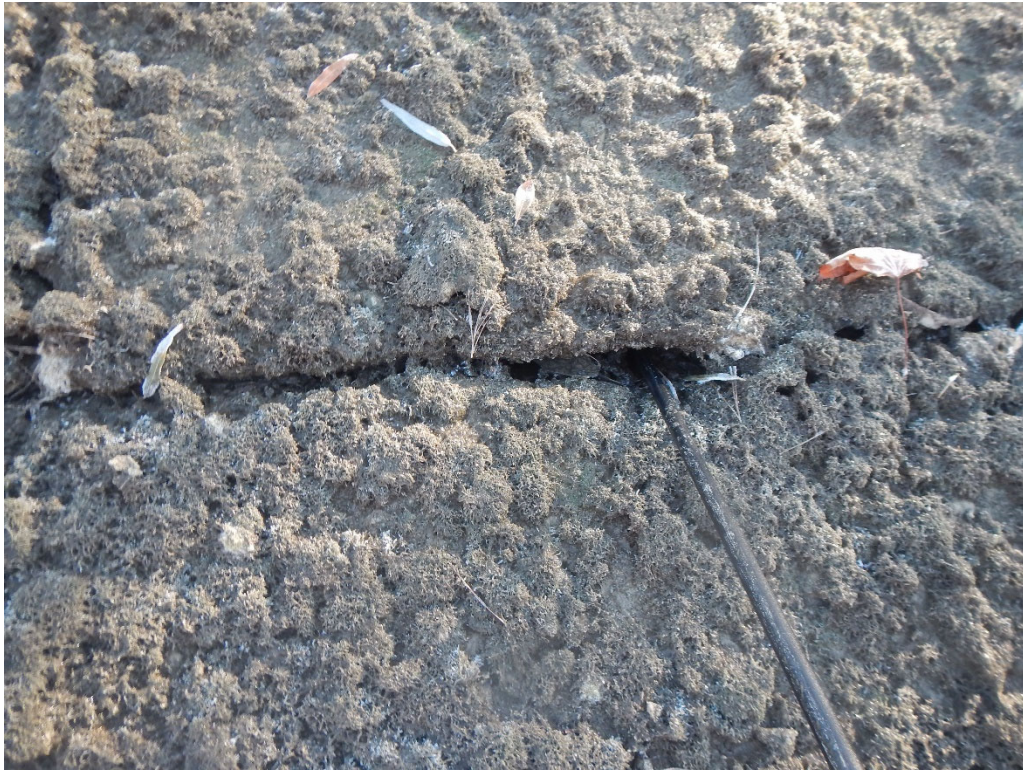
**Photo 7:** Deepest penetration (six inches) of longitudinal crack in Primary Spillway

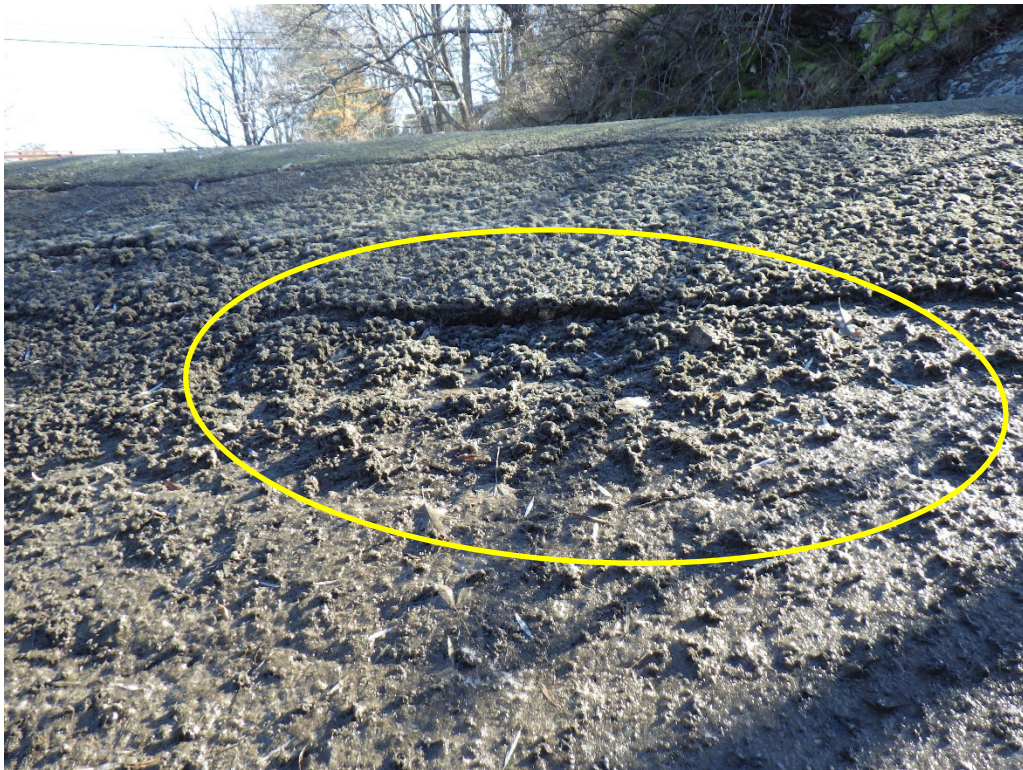
**Photo 8:** Depressed area of upstream face of Primary Spillway (similar condition as in 2012)

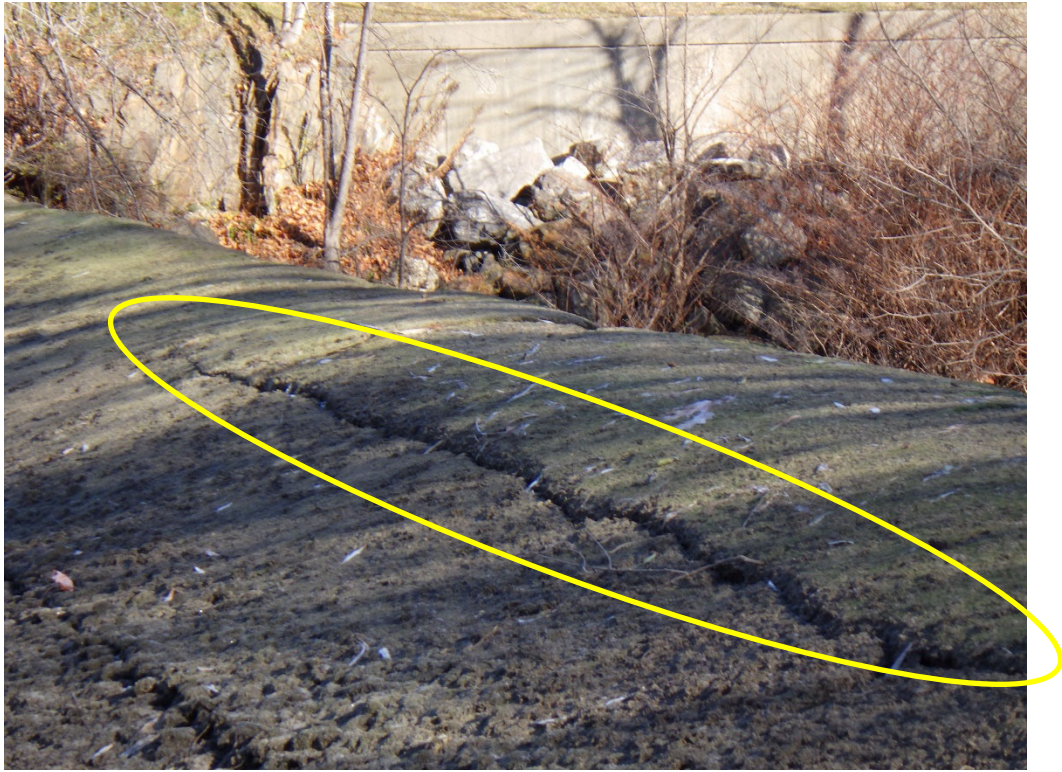
**Photo 9:** Upper concrete overlay crack and crest deformation on Primary Spillway

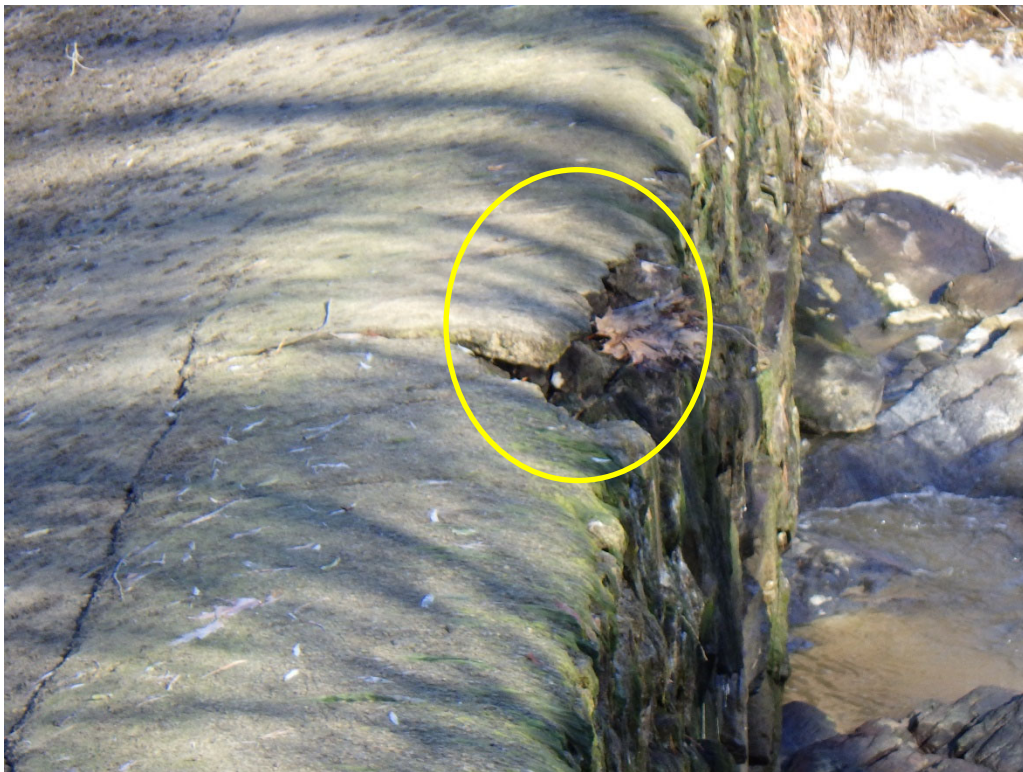
**Photo 10:** Damaged portion of spillway crest near center of Primary Spillway

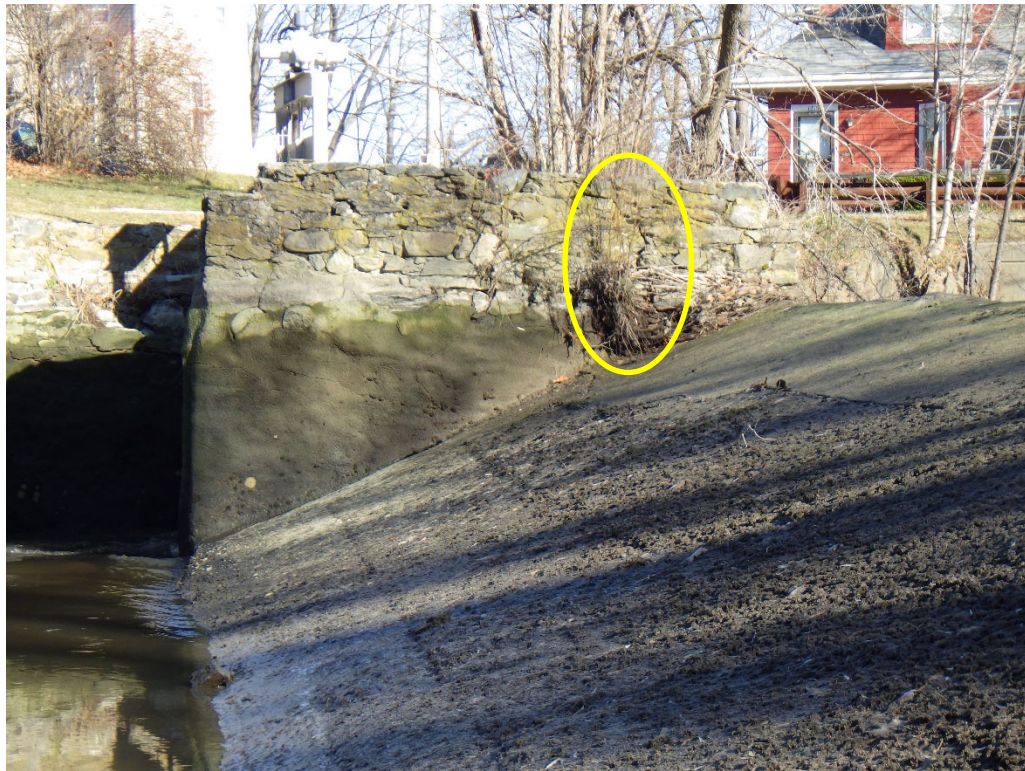
- Vegetation was observed growing from the dam at multiple locations. Continued tree growth (Photo 26 and 27) and joint vegetation (Photos 11, 12, 27, 28, 37, 38, 40 and 41) can lead to further stone dislodgement, destabilization of localized areas, and leakage pathways. This concern was particularly acute on the right (spillway) side of the divider pier where vegetation has expanded several masonry joints, displaced a few masonry stones, and likely propagated a vertical crack (Photos 12 and 13). Displaced concrete and masonry near the contact between the divider pier and the upper part of the spillway was suspected to be a source of leakage in Summit's 2012 inspection;

**Photo 11:** Divider pier with cracking and vegetation growth (potential leakage source)

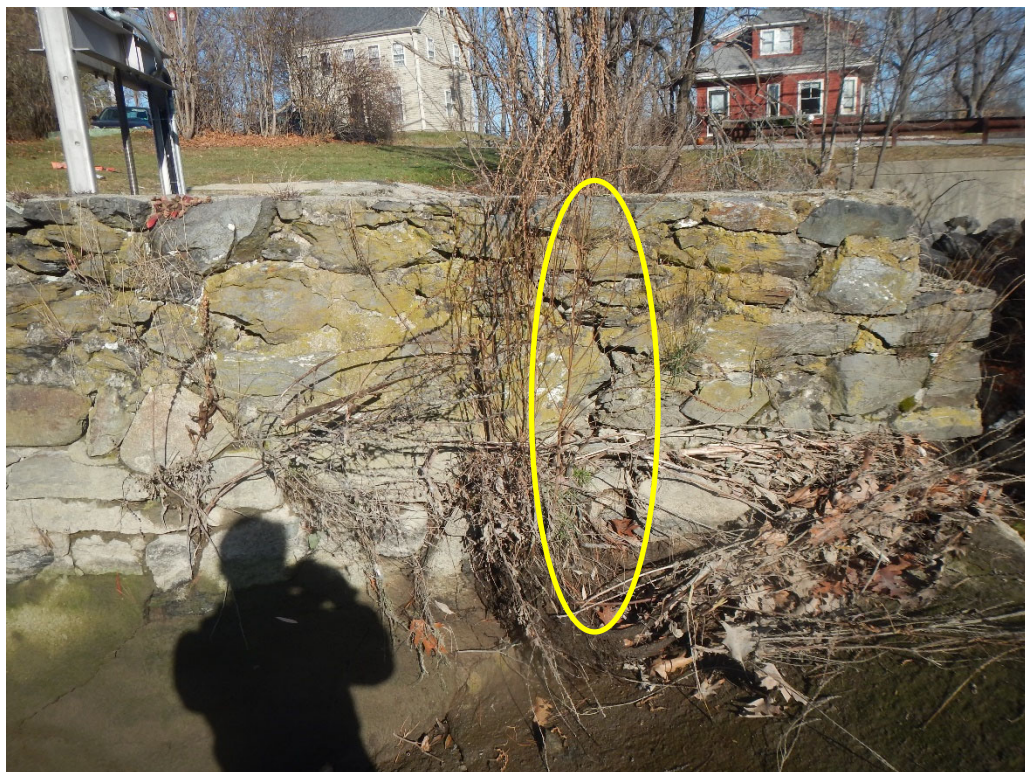
**Photo 12:** Divider pier cracking and vegetation growth (potential leakage source)

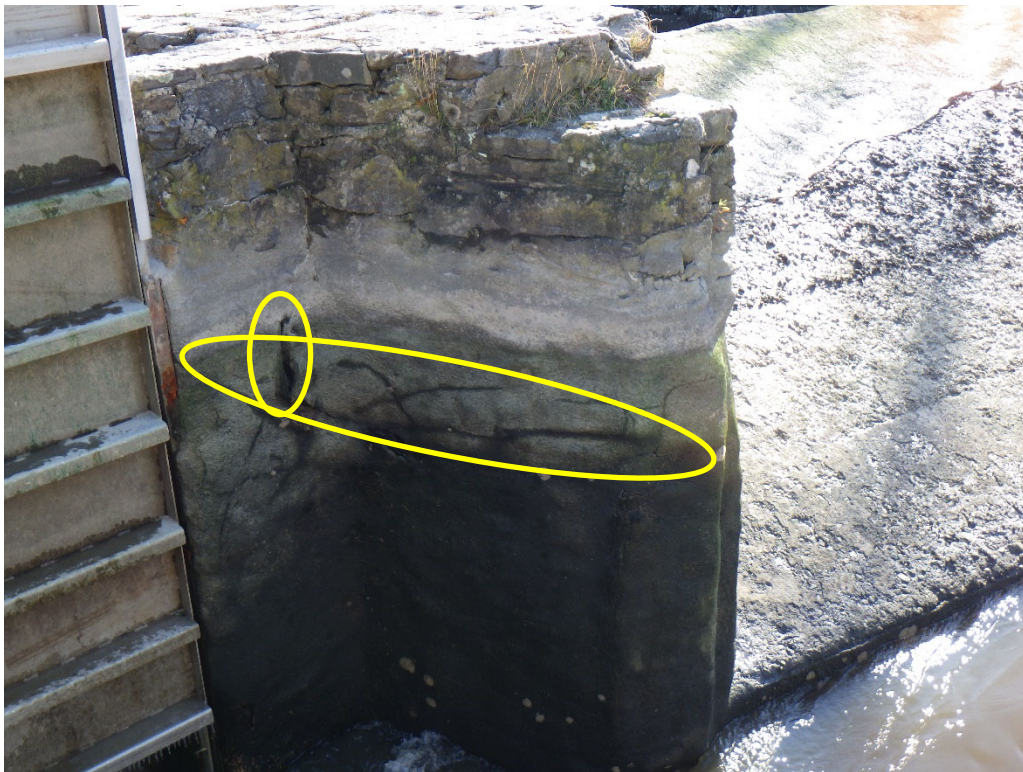
- Cracks were observed in the shotcrete overlay of the divider pier and headwall of the low-level outlet (Photo 14) and are a likely source of leakage;

**Photo 14:** Condition of upstream face of divider pier; NOTE cracks in shotcrete overlay

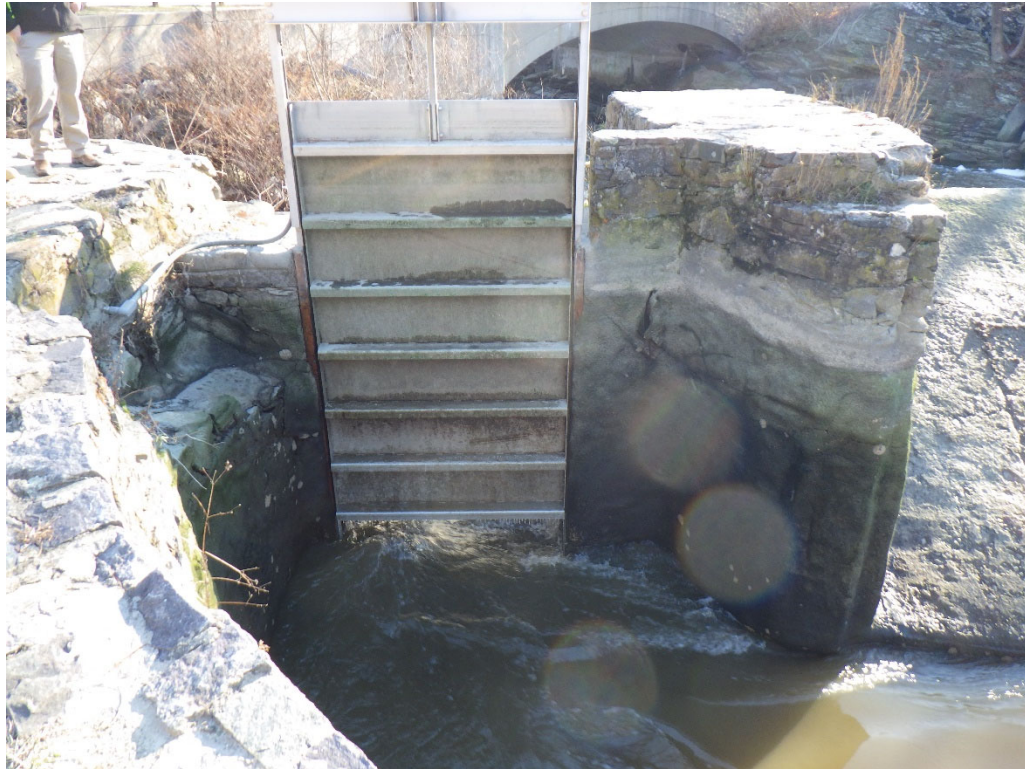
- The approach to the low-level outlet (Photos 15 and 19) was free of debris at the time of the inspection, although the City reported that debris has historically damaged the slide gate;

**Photo 15:** Aluminum Slide Gate (left side of dam) that controls discharge to Low-level Outlet

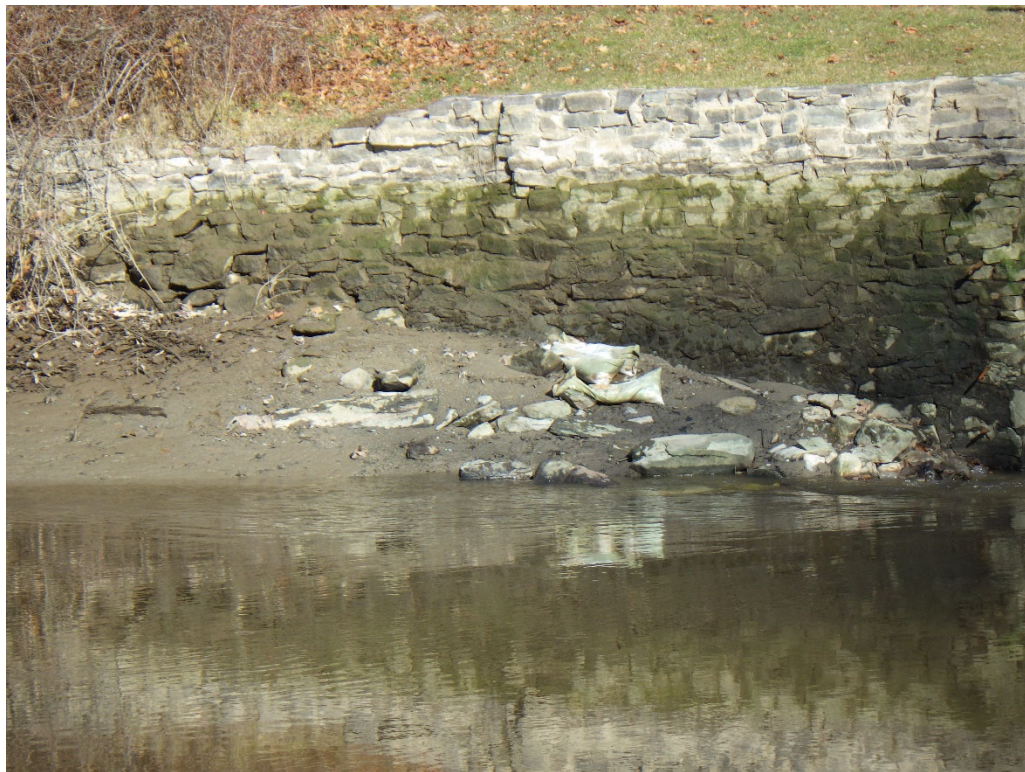
**Photo 18:** Upstream end of left abutment training wall with sediment accumulation

NOTE lack of shotcrete covering missing mortar in some joints

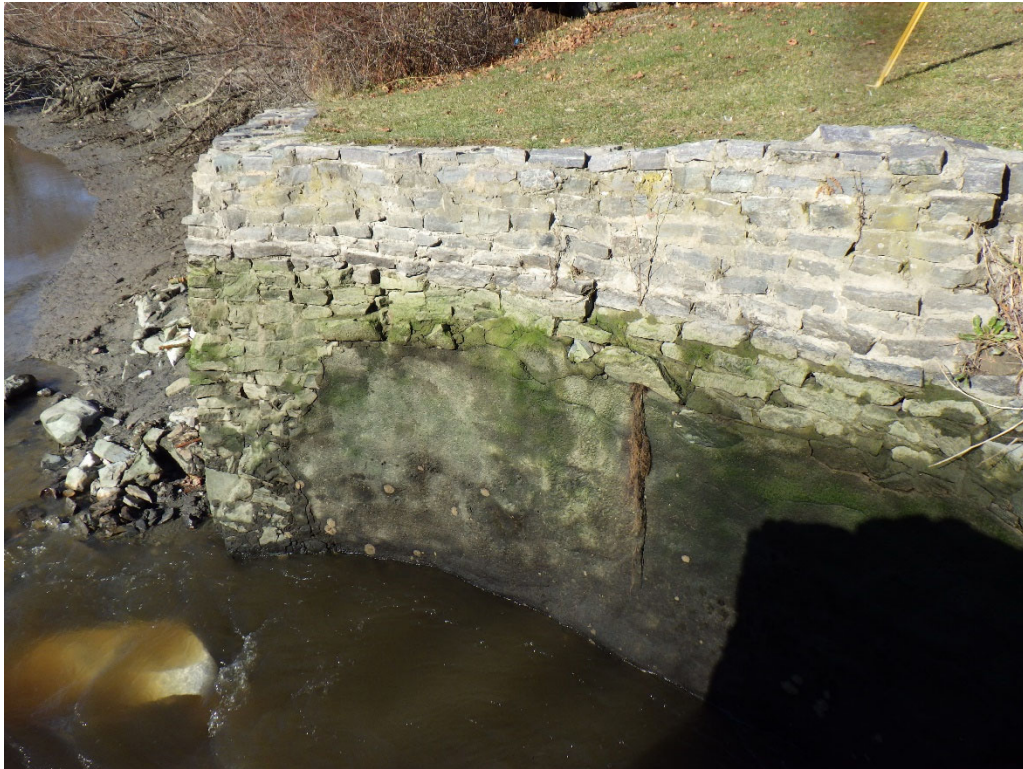
**Photo 19:** Upstream end of low-level outlet approach / upstream corner of left abutment training wall

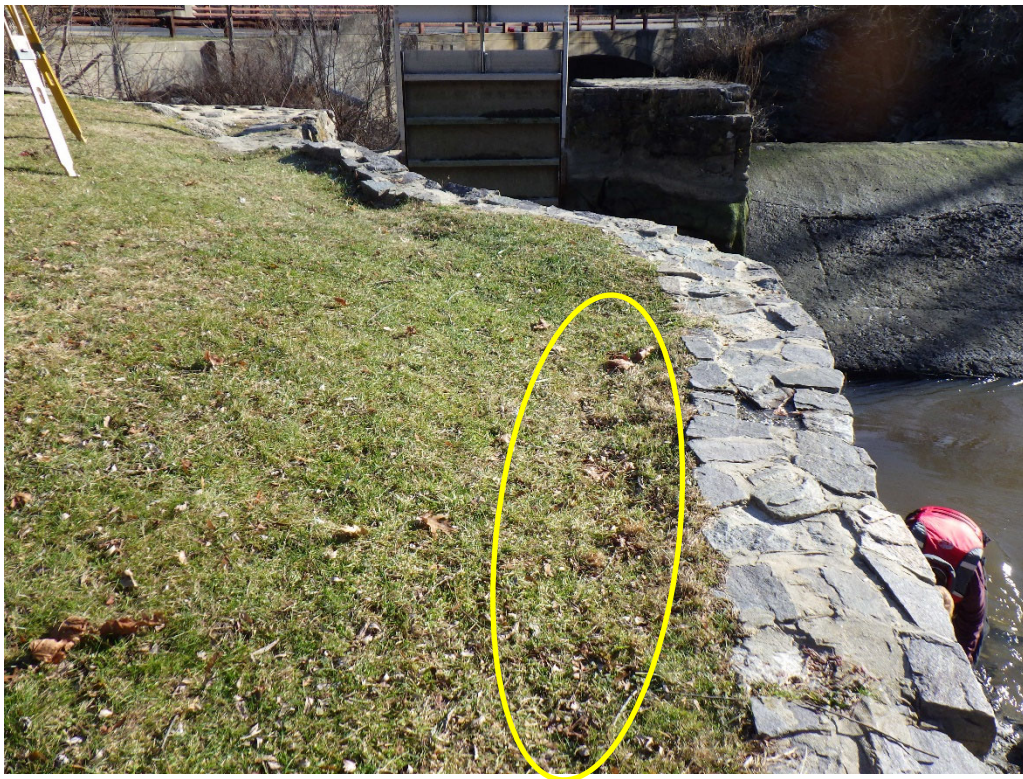
- Minor sinkholes and surface deformation were observed along the left abutment training wall (Photos 20 through 24). This area has a history of sinkhole development with various efforts to fill in these areas. These sinkholes are likely the result of water seeping through the masonry joints and shotcrete cracks of the left abutment training wall and into subsurface layers with sufficient velocity to erode soil materials along the seepage path through to the exit, causing soil piping;

**Photo 20:** Depressed surface behind left abutment training wall

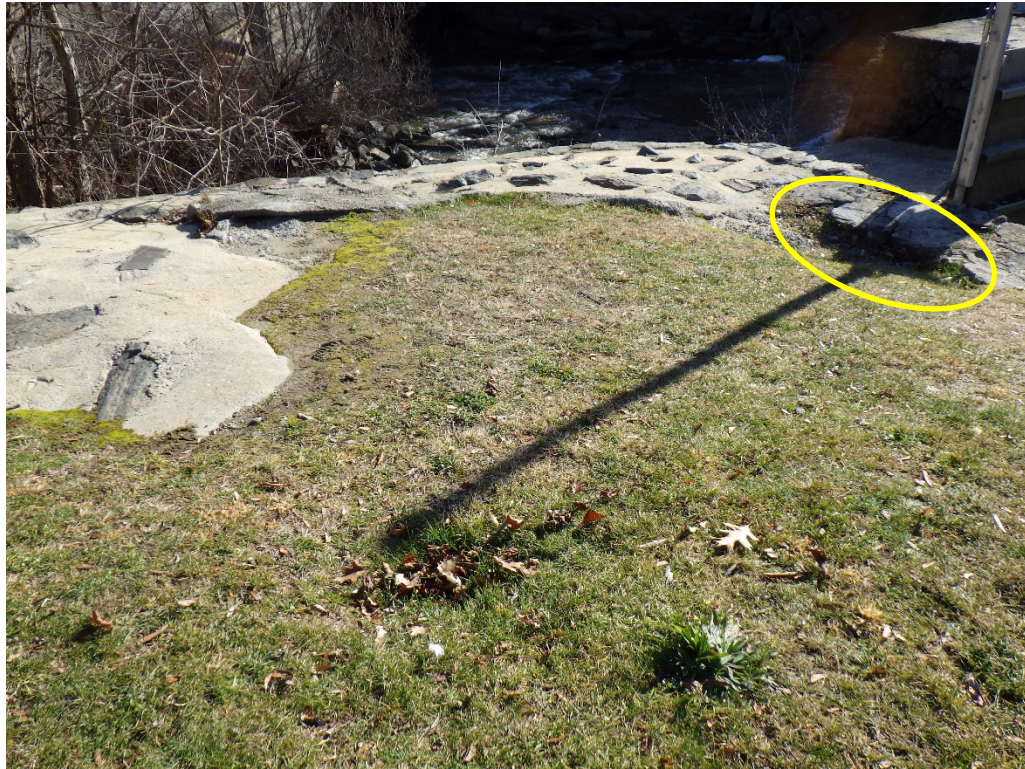
**Photo 21:** Localized sinkholes across Left Abutment

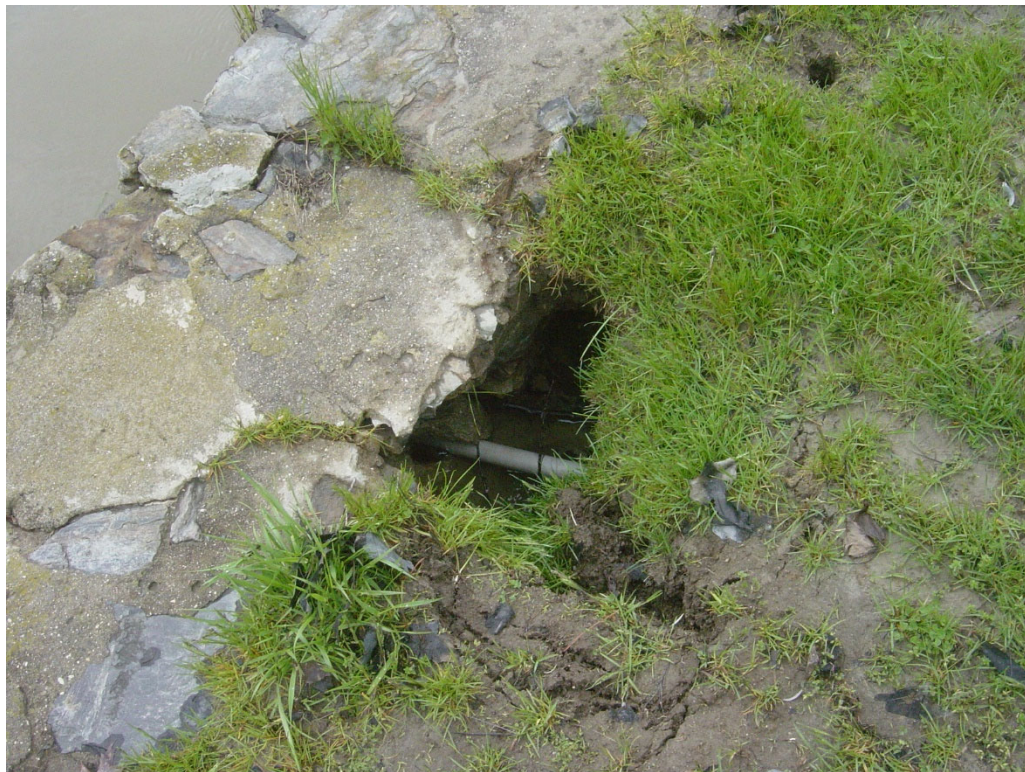
**[Historic] Photo 22:** Left Abutment sinkhole on May 16, 2006 (subsequently filled)

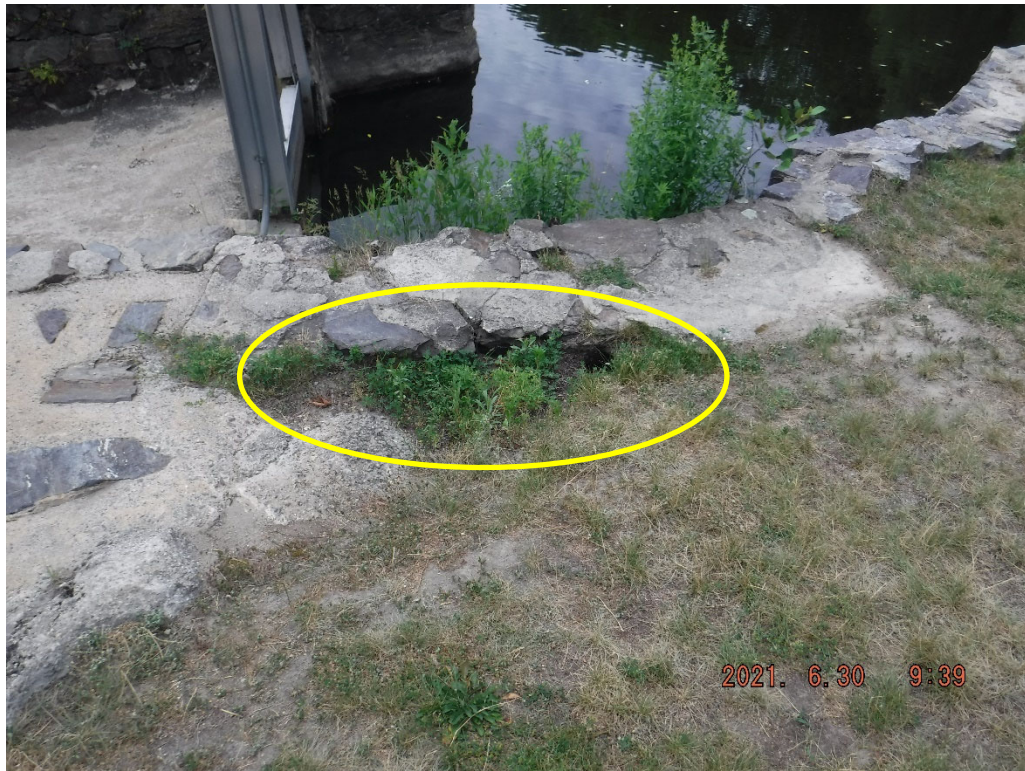
**[Historic] Photo 23:** Left Abutment sinkhole on 6/30/2021

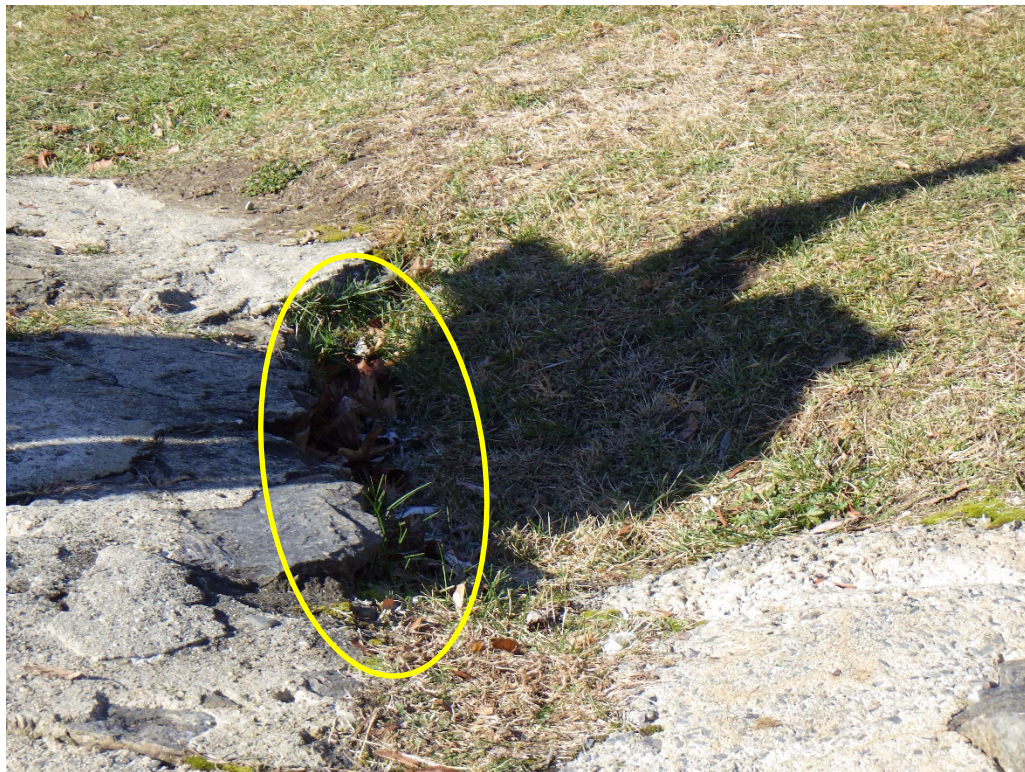
**Photo 24:** Sinkhole adjacent to left abutment training wall (in shaded portion of photograph)

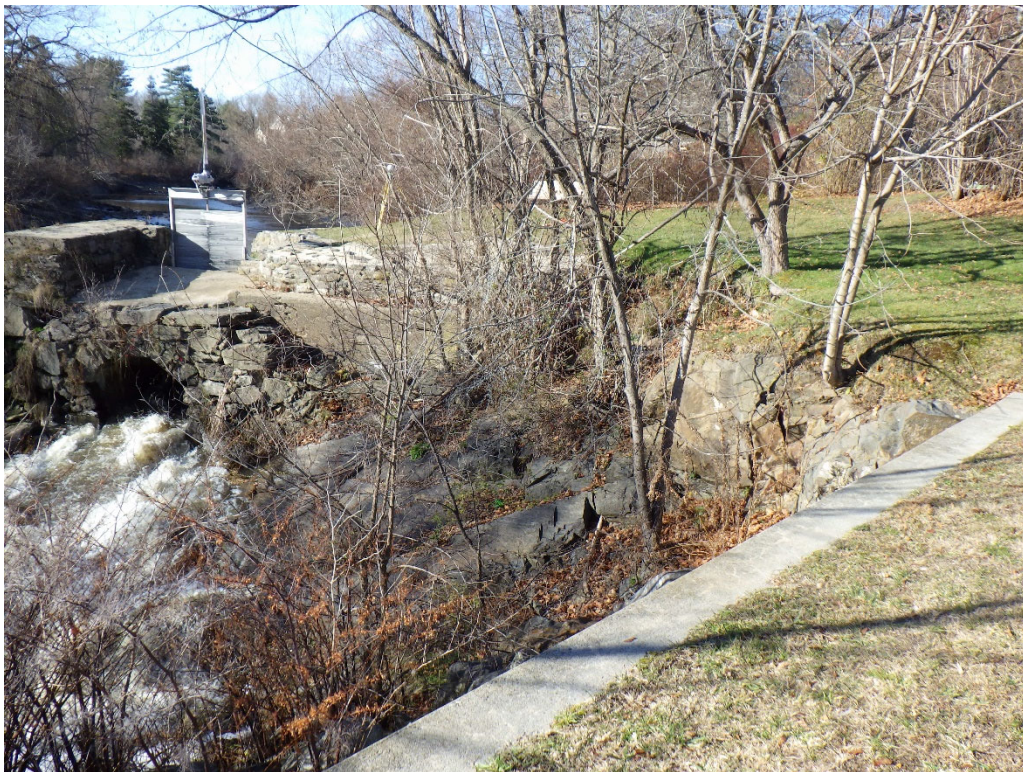
**Photo 26:** Tree growth on downstream side of Left Abutment

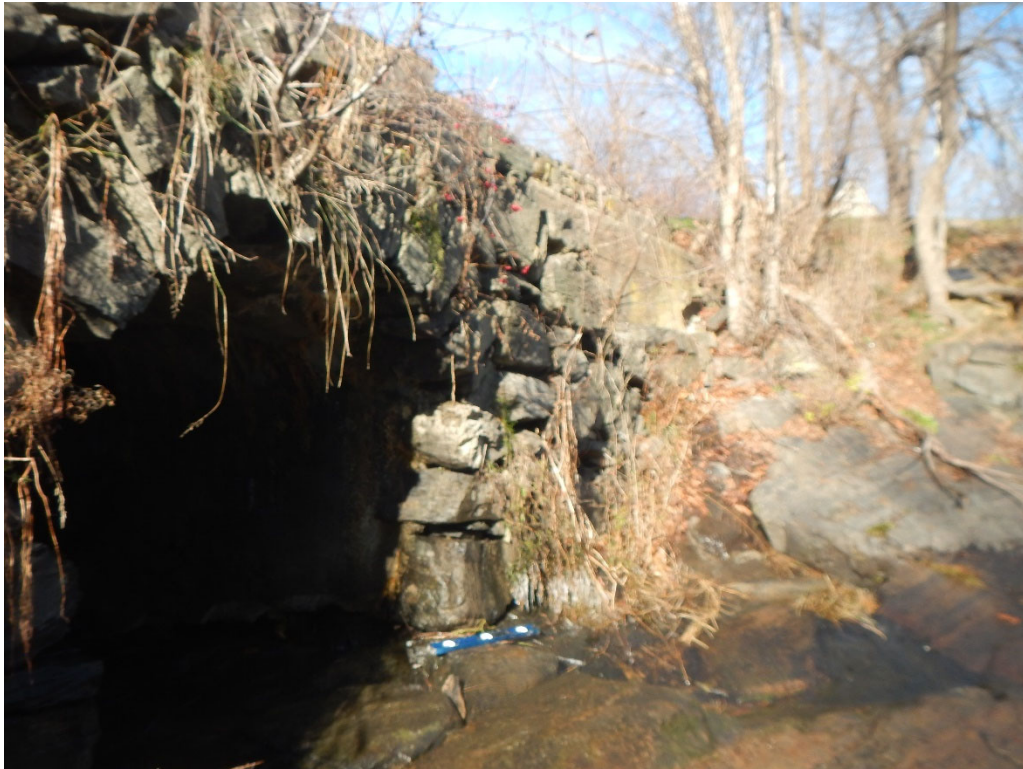
**Photo 27:** Tree growth and vegetation near Sluiceway outlet and downstream face of Left Abutment

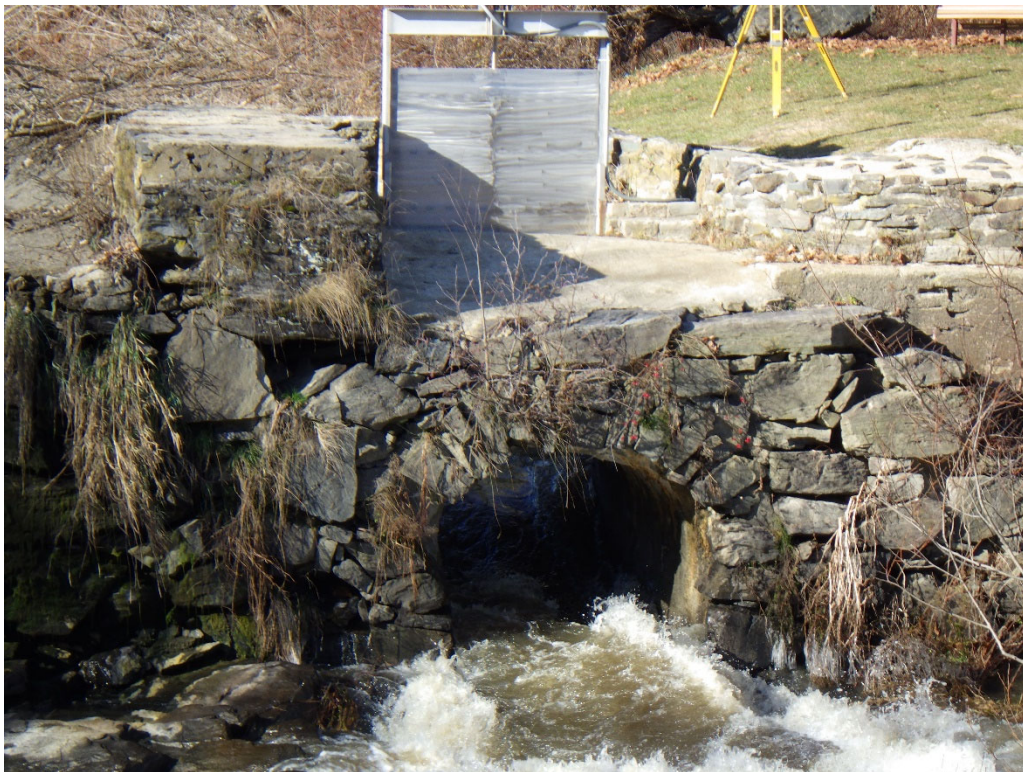
**Photo 28:** Sluiceway outlet at time of inspection

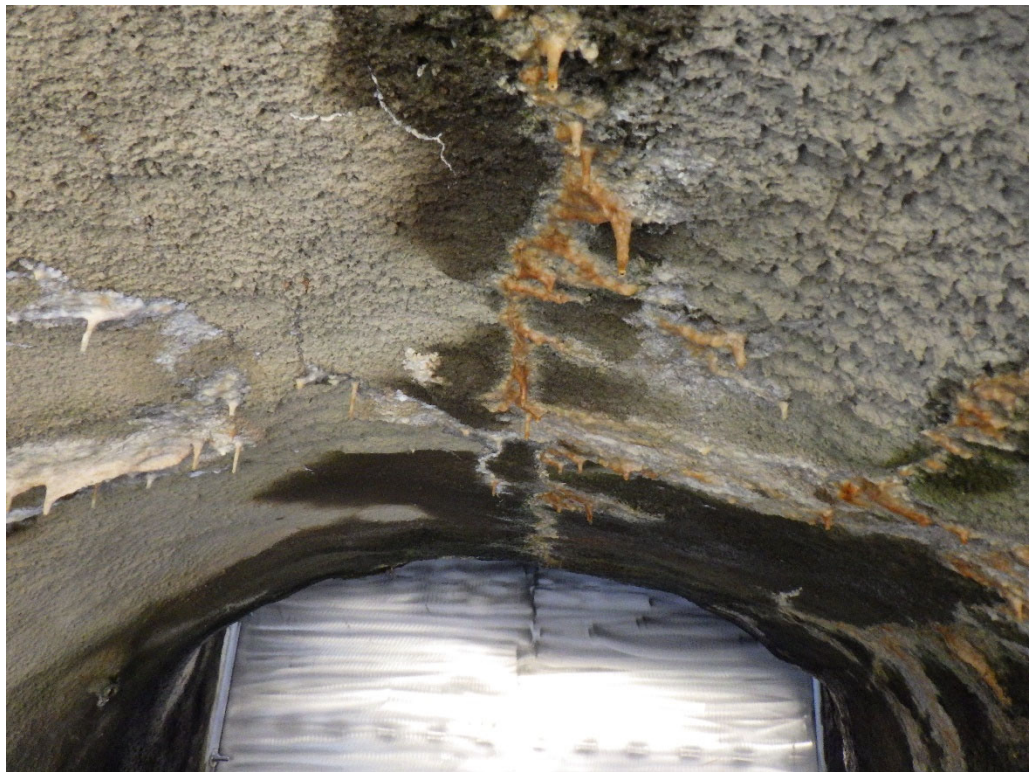
- The shotcrete overlay applied to the sluiceway in 1985 was in generally fair condition (Photo 30 and 31). However, the base of the overlay, at the interface with the bedrock, has been lost and some active flow could be observed entering the sluiceway through the missing sections of the overlay (Photos 32 through 36). Of note:

**Photo 30:** Condition of shotcrete overlay of Sluiceway ceiling

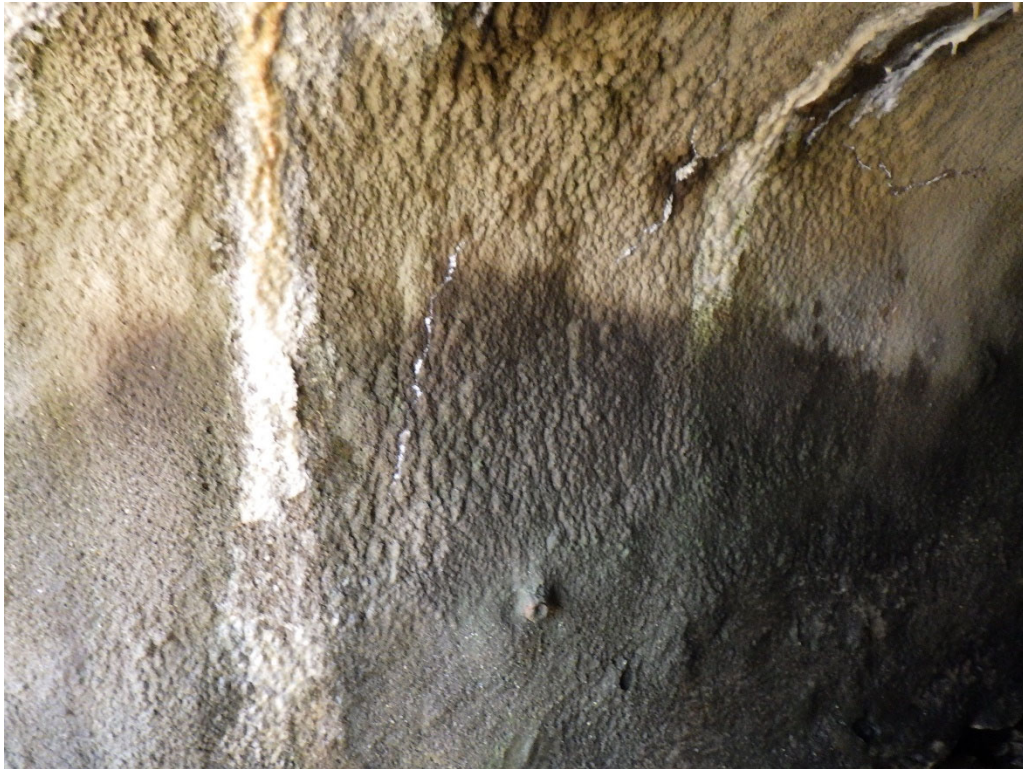
**Photo 31:** Condition of shotcrete overlay of Sluiceway left side

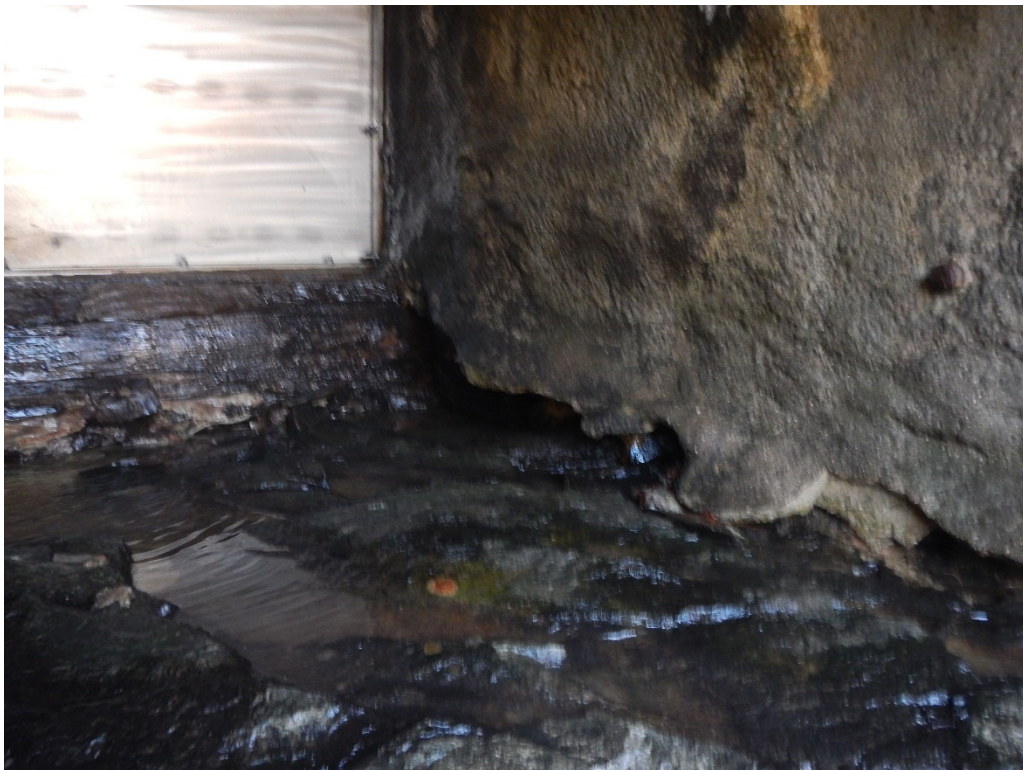
**Photo 32:** Interface between bedrock foundation and shotcrete overlay on left side of Sluiceway

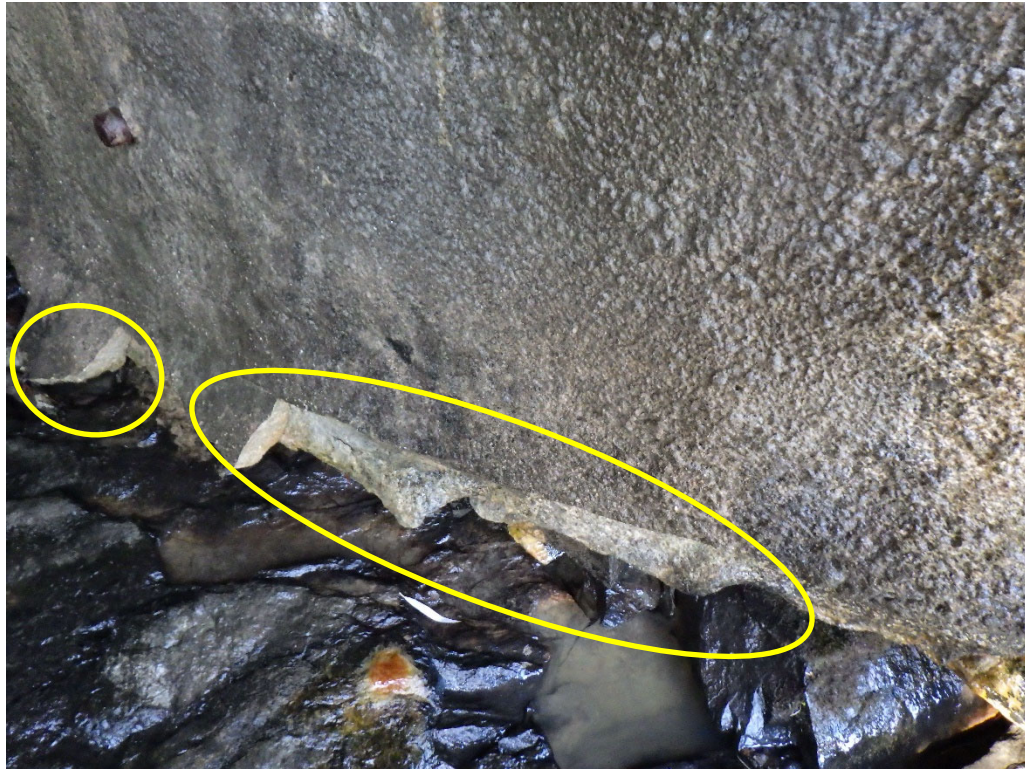
- The shotcrete overlay loss is active (Photo 33)
  - The loss of dam material and seal between the shotcrete overlay and foundation bedrock can provide an exit for seepage and leakage emanating from the left abutment and cracks in the shotcrete overlay of the low-level outlet headwall; and,

**Photo 33:** Interface between bedrock foundation and shotcrete overlay of Sluiceway

NOTE fresh break of overlap lip seen in discoloration

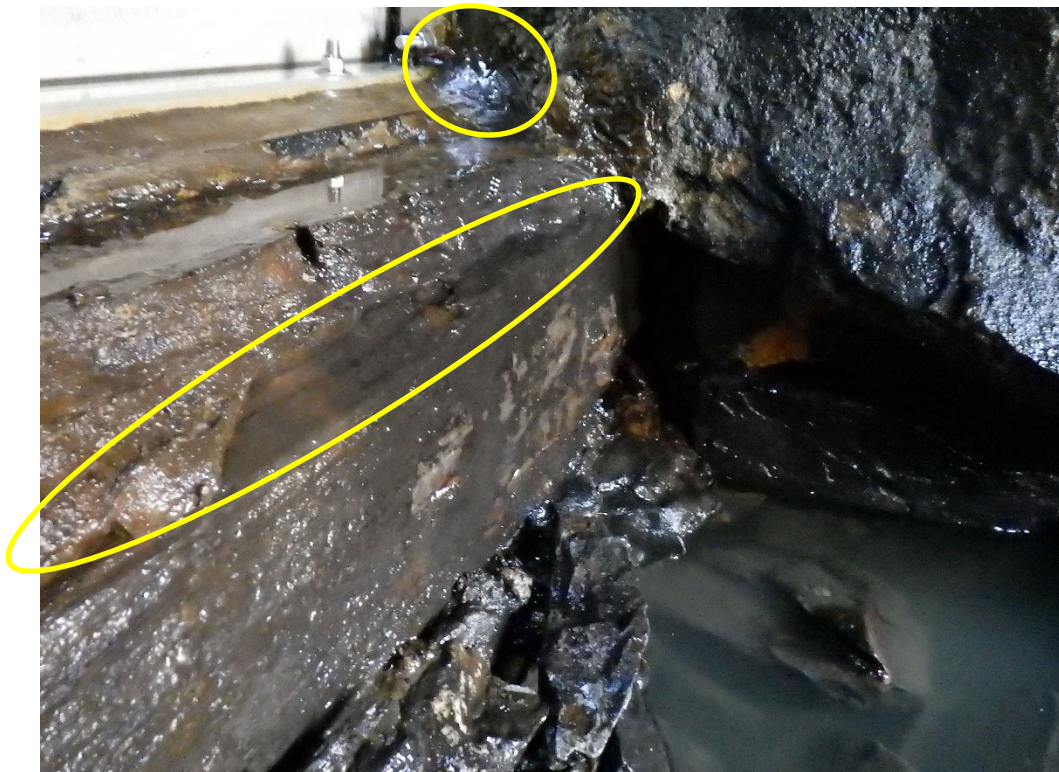
- Some leakage was observed between the wood beams composing the sill of the slide gate; minor leakage was also observed between the dam's masonry and the left side of the slide gate frame;

**Photo 34:** Interface between sill of Slide Gate, bedrock foundation, and shotcrete overlay of Sluiceway

NOTE leakage through sill and left side of Slide Gate frame
