**CITY OF PORTLAND, MAINE**  
Standing Committee on Sustainability and Transportation  
Councilor Andrew Zarro, District 4, Chair  
Councilor Roberto Rodriguez, At-Large  
Councilor Victoria Pelletier, District 2

Agenda  
May 10, 2023  
5:00 PM  
via Zoom

To: Councilor Zarro and members of the Sustainability and Transportation Committee  
Re: Stroudwater Dam recommendation  
Date: May 5, 2023

*Stroudwater Dam (MEMA Dam #441)  
2022 Visual Dam Safety Inspection Report*

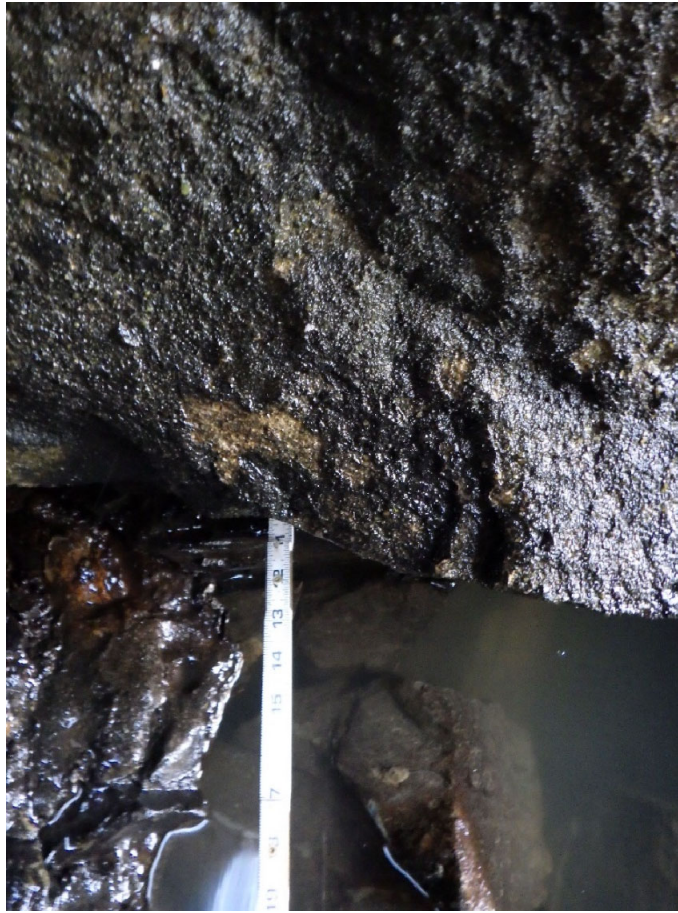
- Stone loss behind the shotcrete overlay has occurred (Photo 35) and may continue with seepage and leakage through the dam.
- The 1986 GEI report identified voids below the surface concrete fill placed atop the downstream face of the left abutment (Photo 25). The concrete fill was not significantly cracked or fractured indicating the void and associated material piping may have stabilized in this area;

**Photo 35:** Depth of void along left side of Sluiceway

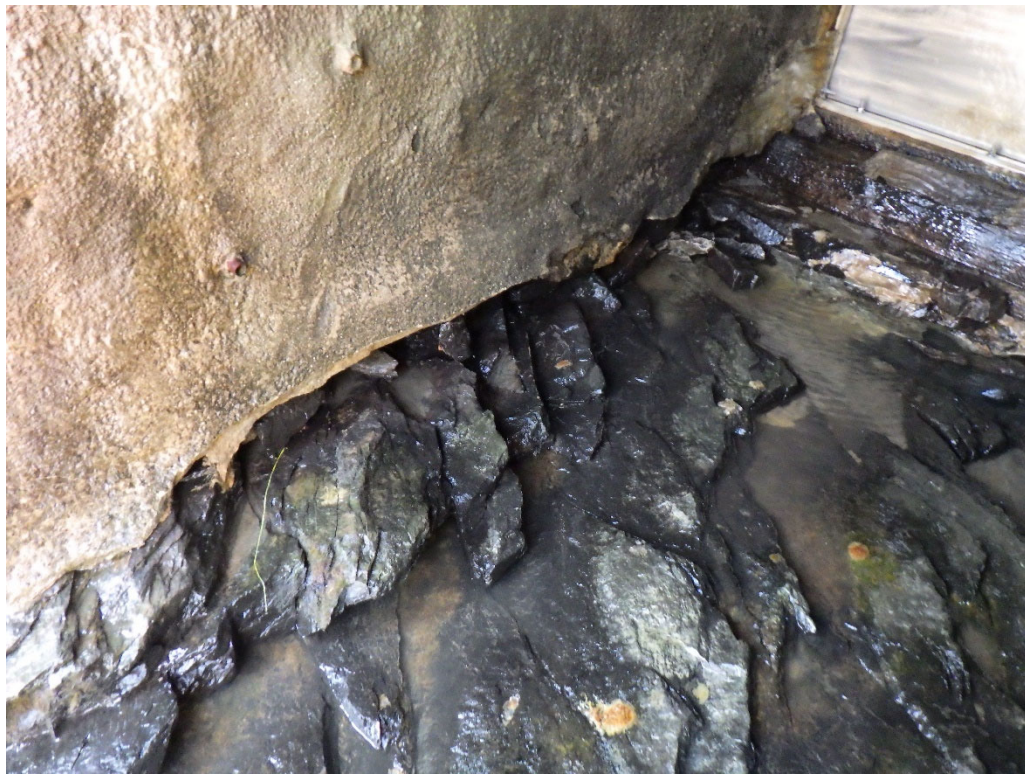
- The shotcrete overlay applied to the sluiceway in 1985 was in generally fair condition (Photo 30 and 31). However, the base of the overlay, at the interface with the bedrock, has been lost and some active flow could be observed entering the sluiceway through the missing sections of the overlay (Photos 32 through 36). Of note:

**Photo 36:** Interface between bedrock foundation and shotcrete overlay on right side of Sluiceway

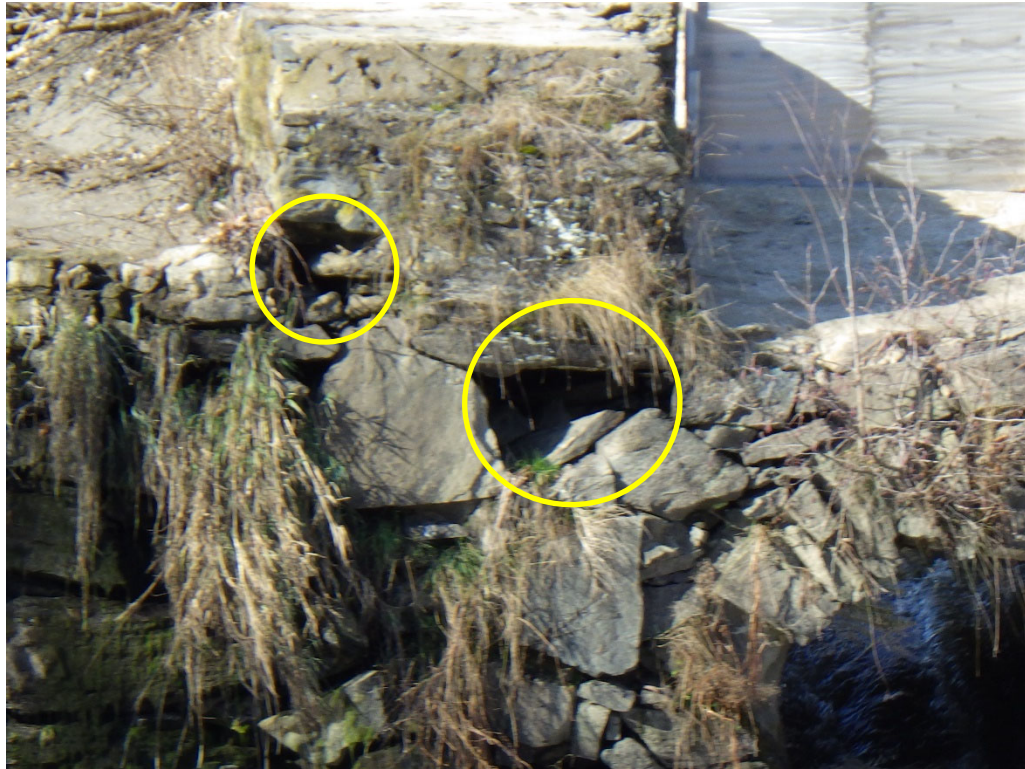
- Vegetation was observed growing from the dam at multiple locations. Continued tree growth (Photo 26 and 27) and joint vegetation (Photos 11, 12, 27, 28, 37, 38, 40 and 41) can lead to further stone dislodgement, destabilization of localized areas, and leakage pathways. This concern was particularly acute on the right (spillway) side of the divider pier where vegetation has expanded several masonry joints, displaced a few masonry stones, and likely propagated a vertical crack (Photos 12 and 13). Displaced concrete and masonry near the contact between the divider pier and the upper part of the spillway was suspected to be a source of leakage in Summit's 2012 inspection;

**Photo 37:** Stone loss and vegetation on downstream face of divider pier

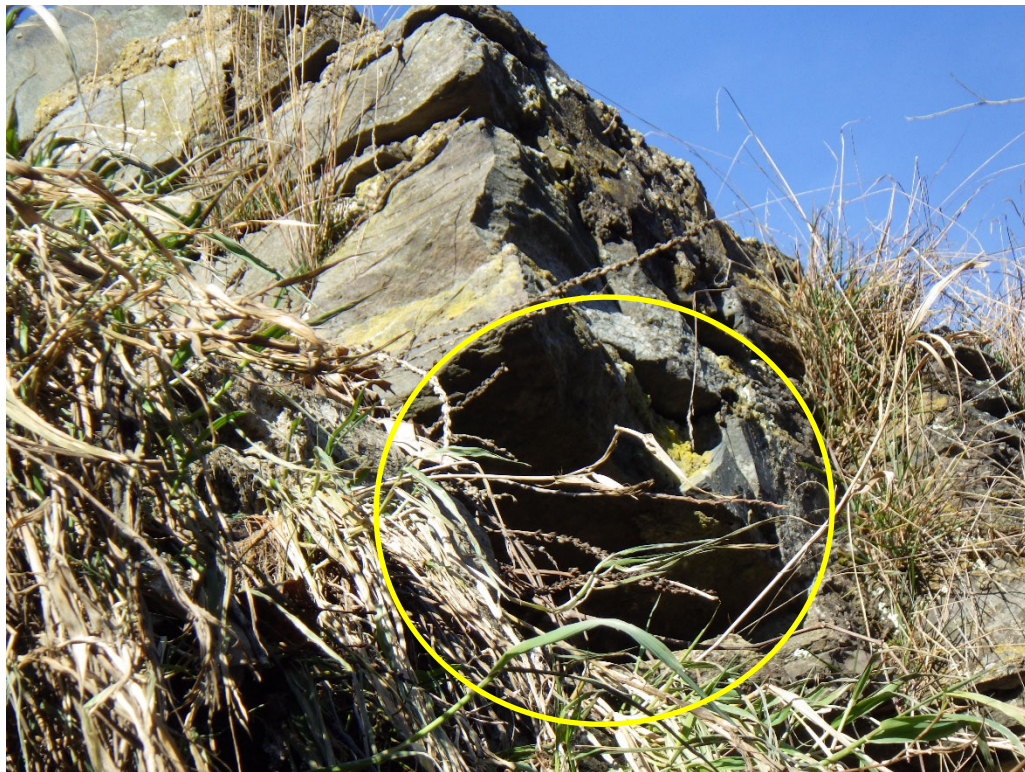
**Photo 38:** Stone loss along downstream face of divider pier

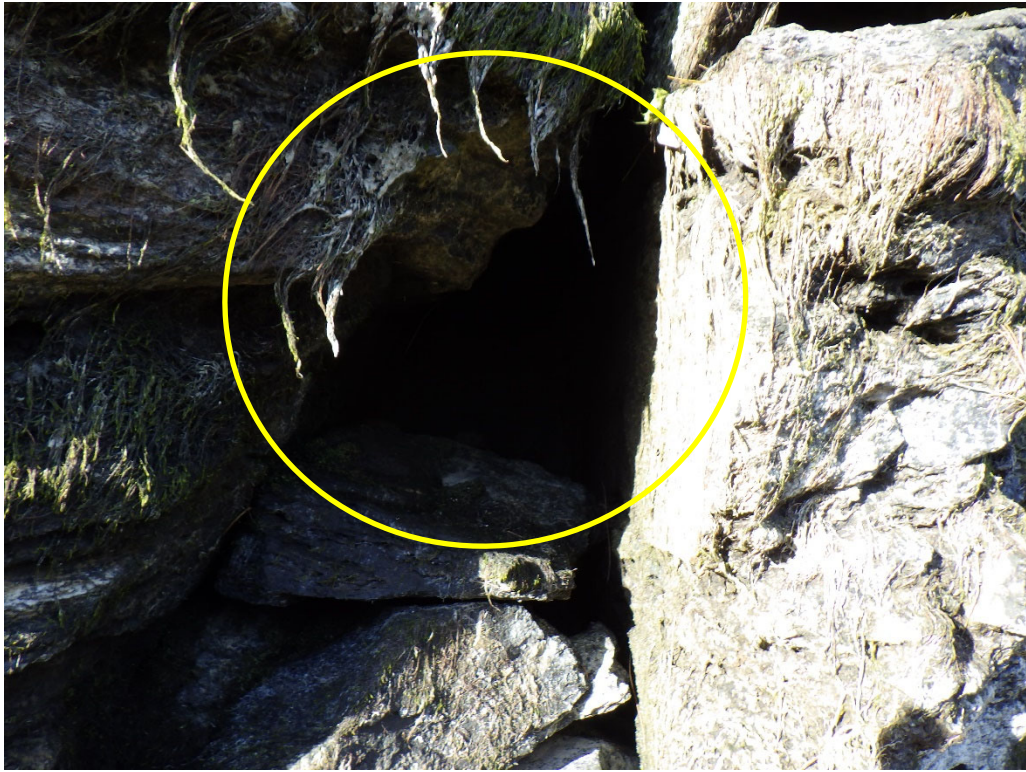
**Photo 39:** Stone loss near downstream face of divider pier

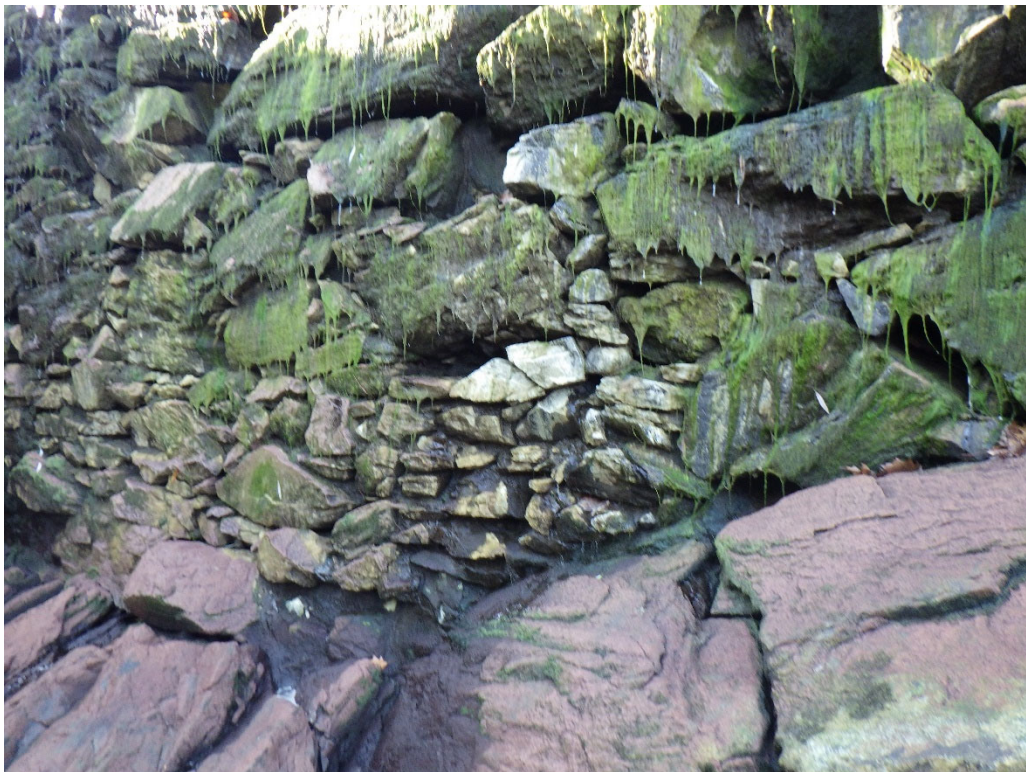
**Photo 40:** Sporadic stone movement and vegetation along downstream face of Primary Spillway

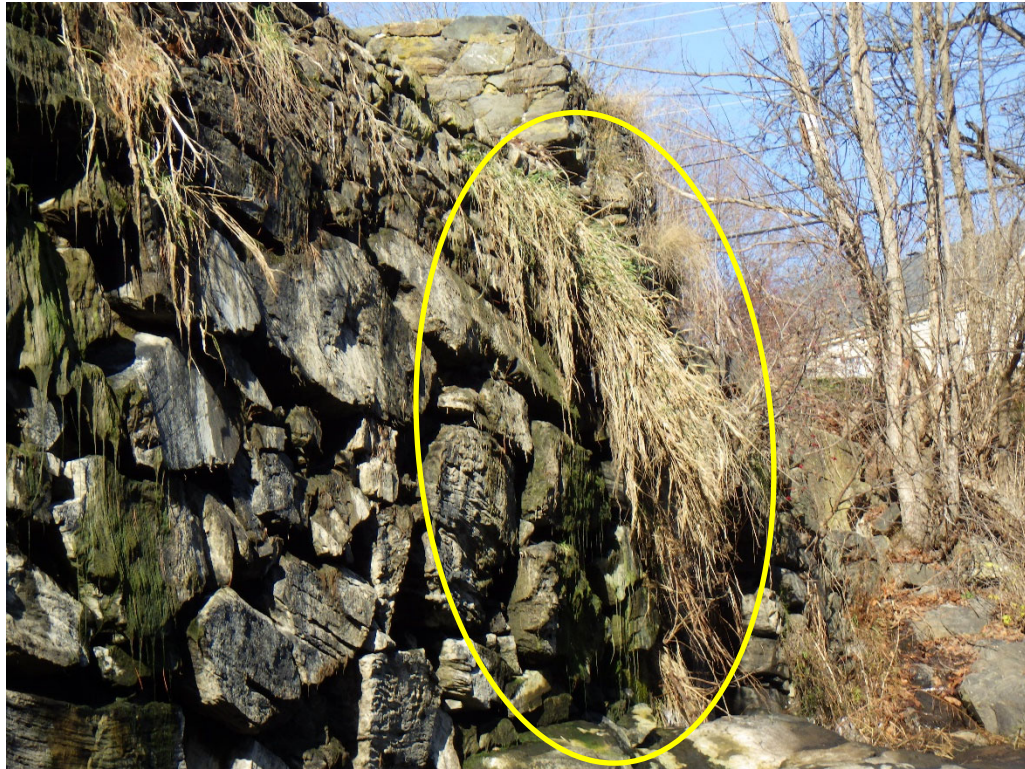
- A portion of the exposed downstream dam face, adjacent to the divider pier, has been displaced downstream with a “bulge” appearing in this area (Photo 41 and 42). This distressed area was also noted in the 2021 inspection. The movement indicates that a portion of the stone mass has been displaced (likely from freeze/thaw action from dam leakage) and destabilized the area; the area may be in a similar condition as preceded the 1998 failure of the downstream face of the dam near the right-most toe (Photo 44). Reduction of leakage into the area from the divider pier interface (Photo 12) and spillway overlay cracking (Photo 6) may reduce further movement. The area should be monitored during the spring season for movement and localized stone loss;

**Photo 41:** Bulged area of downstream face, near left contact of Primary Spillway and Divider Pier

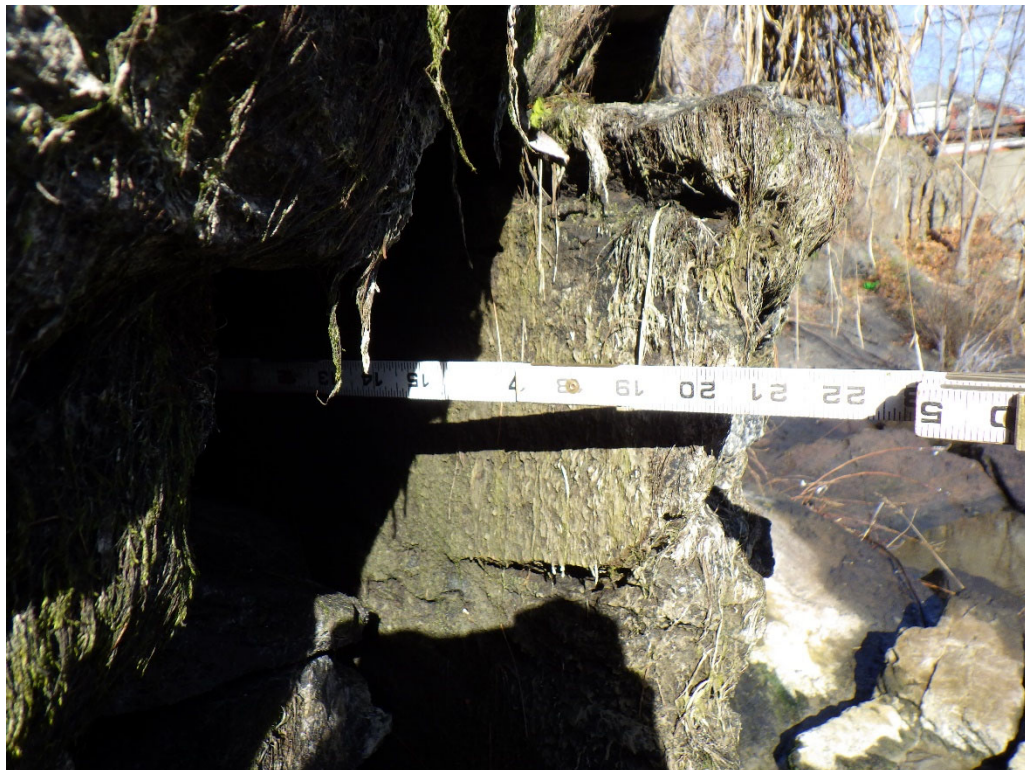
**Photo 42:** Stone movement and void depth at bulged area

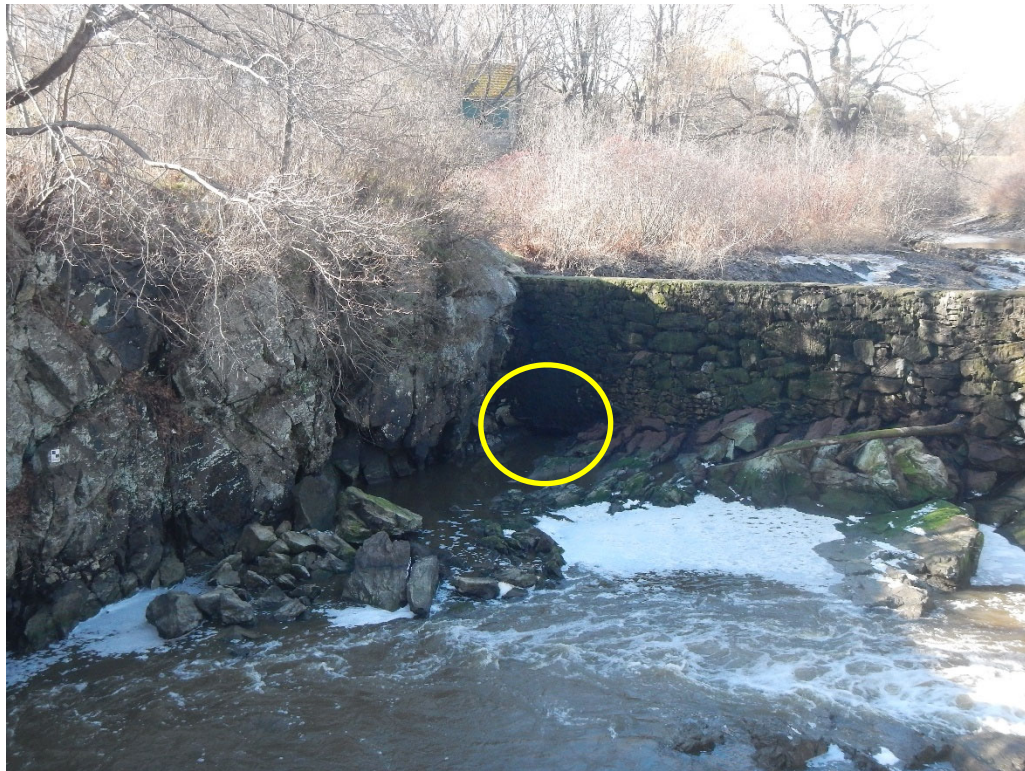
- A 60-inch wide by 30-inch high by 45-inch deep void was observed near the right toe of the downstream face of the dam, near the contact with the bedrock foundation and right bedrock abutment (Photos 43 and 47 through 49); this void was observed to be conveying leakage at the time of inspection. The void is located near the area of a 1998 repair (Photos 45 and 46) of a partial failure of the downstream face of the dam (Photo 44) and this repair may have partially failed or been undermined. This loss of material was noted in the 2012 inspection report but was partially obscured in inspection photos by high water. Untreated, the void may continue gradually expanding until a sudden, uncontrolled piping failure of the dam possibly occurs which would pose a public safety concern; and,

**Photo 43:** Interface between downstream face and right bedrock abutment  
(NOTE void at toe of downstream face at contact with abutment)

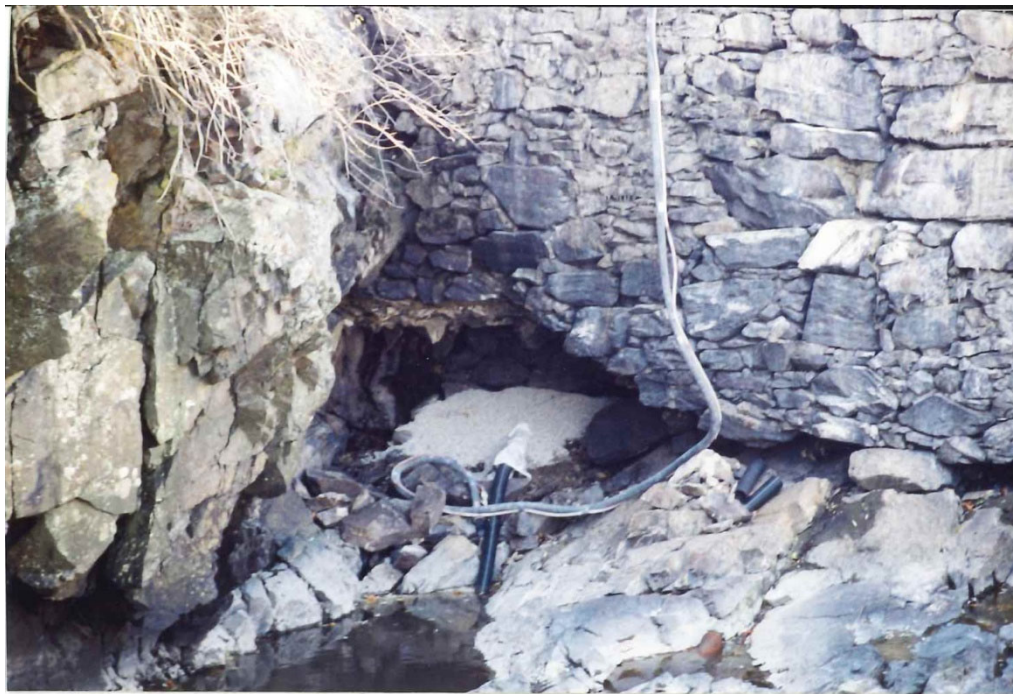
**[Historic] Photo 44:** 1998 partial failure of downstream face at current site of void

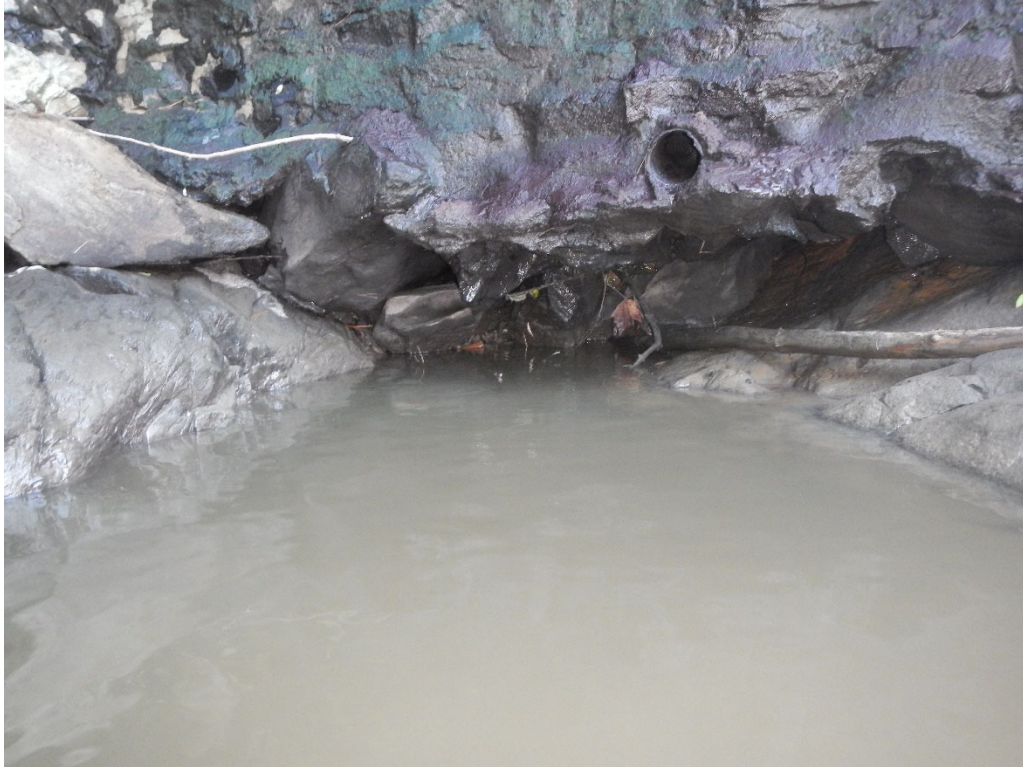
**Photo 47:** Void at interface of downstream face, right bedrock abutment, and bedrock foundation

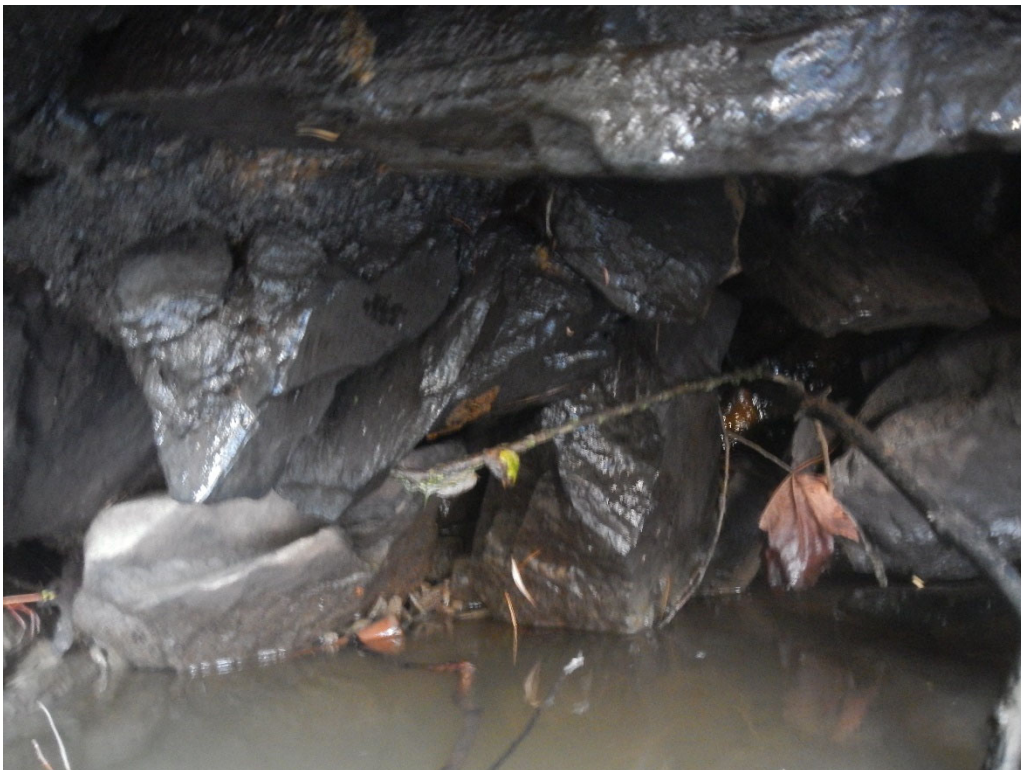
**Photo 48:** Detailed photo of right side of void

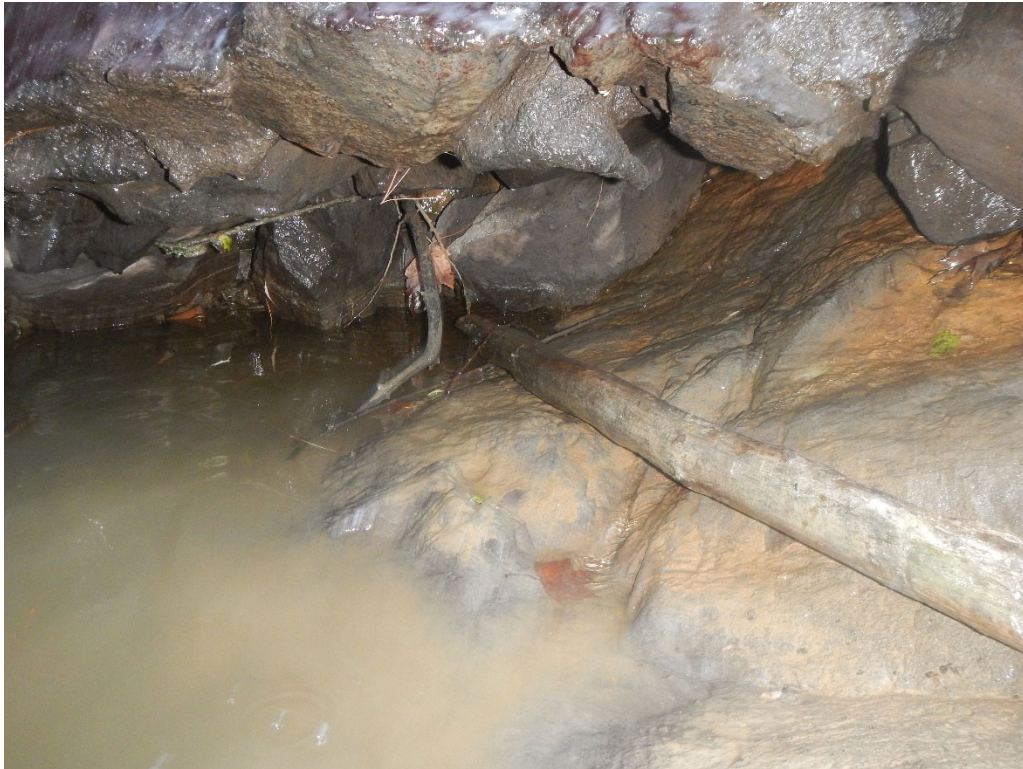
**Photo 49:** Detailed photo of left side of void

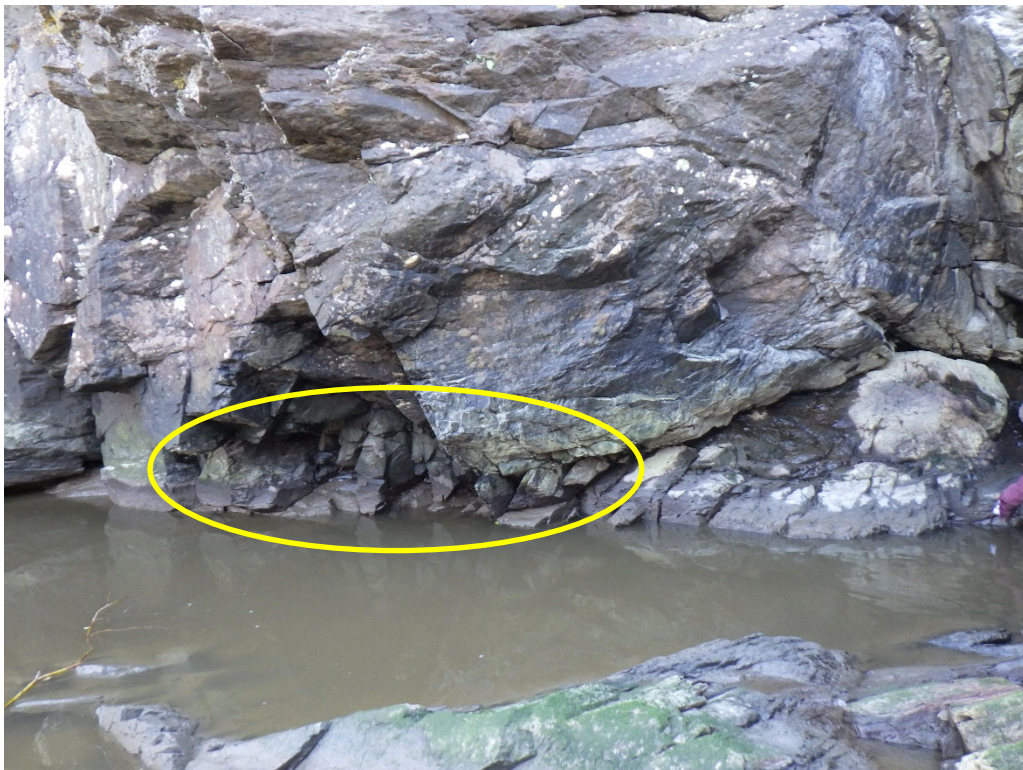
- Spalling was observed immediately downstream of the dam along the toe of the exposed bedrock comprising the right bedrock abutment (Photo 50); the spalling may be the result of freeze/thaw action, weathering, and/or erosion of the bedrock which may also be occurring along the contact between the dam and the right bedrock abutment.

**Photo 50:** Spalling along toe of right bedrock abutment, downstream of dam
