**PORTLAND FISH PIER AUTHORITY  
BOARD OF DIRECTORS  
October 14, 2021, 3:00 PM  
VIA ZOOM**

On 8 April 2021 TEC Associates concluded a multiday inspection of the Fish Pier structure above mean low water for the City of Portland, Maine. The purpose of this inspection was to determine the overall depreciation of the structure due to adverse conditions including weathering, cathodic action, and aging. Findings of this inspection include significant corrosion loss to the steel H-piles and bracing of the six finger piers, specifically in the high tide splash zone.

## PORTLAND FISH PIER STRUCTURAL INSPECTION

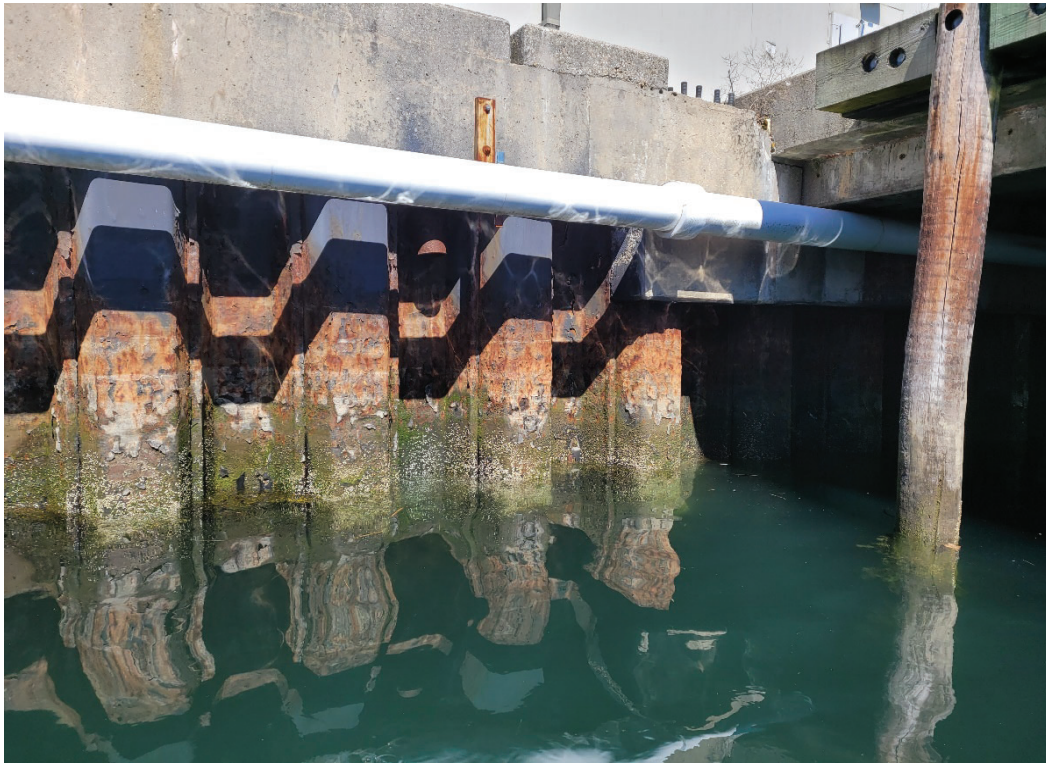
The sheet pile bulkhead steel is in good condition overall. Visible surface corrosion in the splash zone is generally 1/16" loss with some scale. Remaining section thickness was confirmed with electronic thickness gauge measurements along the full length of the sheet pile wall. Pile design thickness, based on original design plans, is 0.600". Measured thicknesses were all within tolerances and range between 0.611" and 0.483". Areas with loss averaged 0.554" remaining, for roughly 0.046" or 3/64" average loss.

Picture #5  
Typical sheet pile conditions between sorting piers

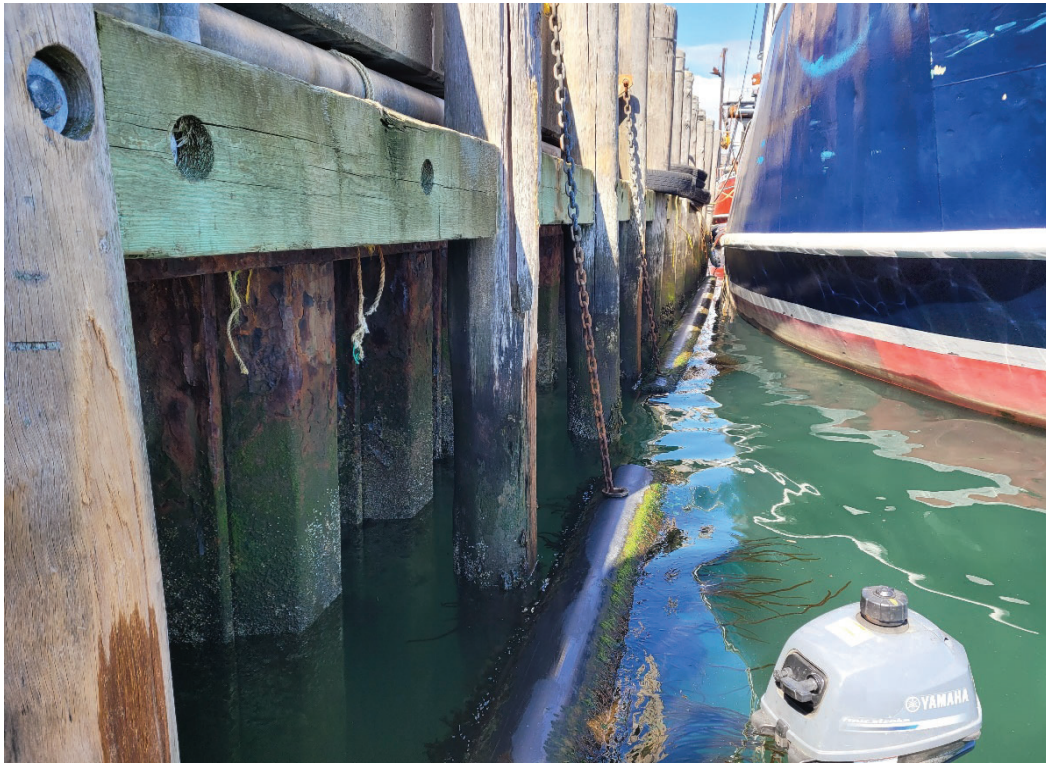
The fender system is in typical condition, with the exception of a few items of maintenance. Minor repairs to fender piles, chocking blocks, and ladders are called out on the attached Fish Pier plans. A detailed inspection of the Fender System was not provided, as routine repairs appear to be conducted on a frequent basis.

Picture #7  
Typical fender and sheet pile conditions

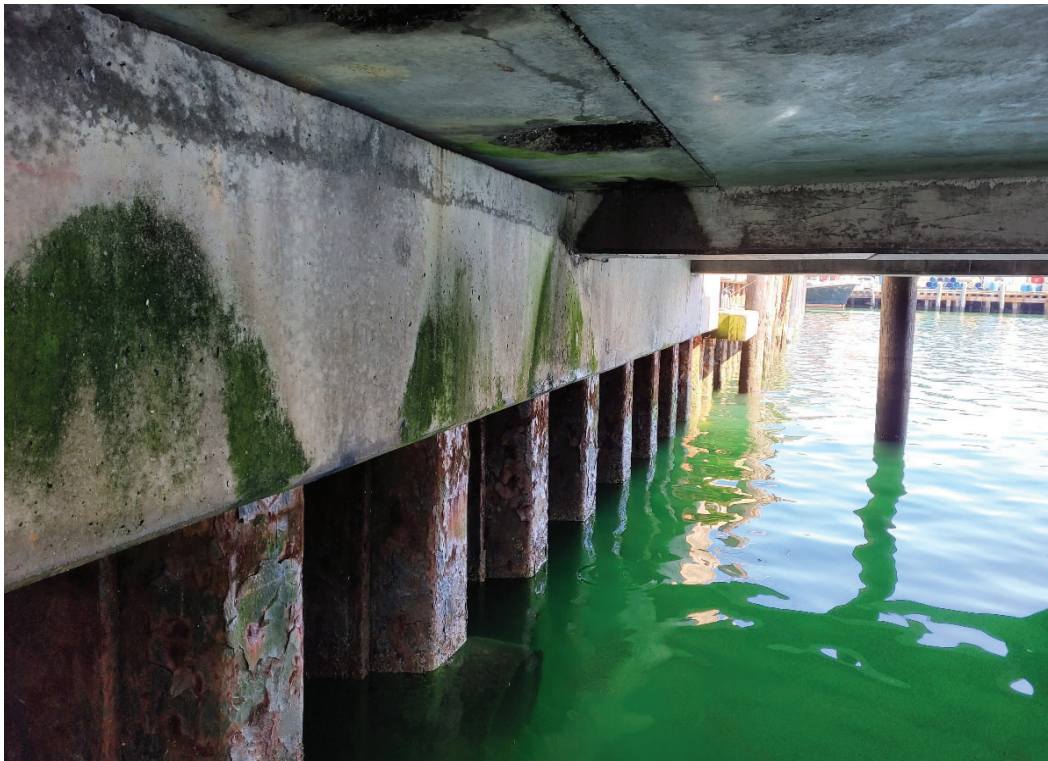
Picture #8  
Typical sheet pile conditions beneath sorting piers

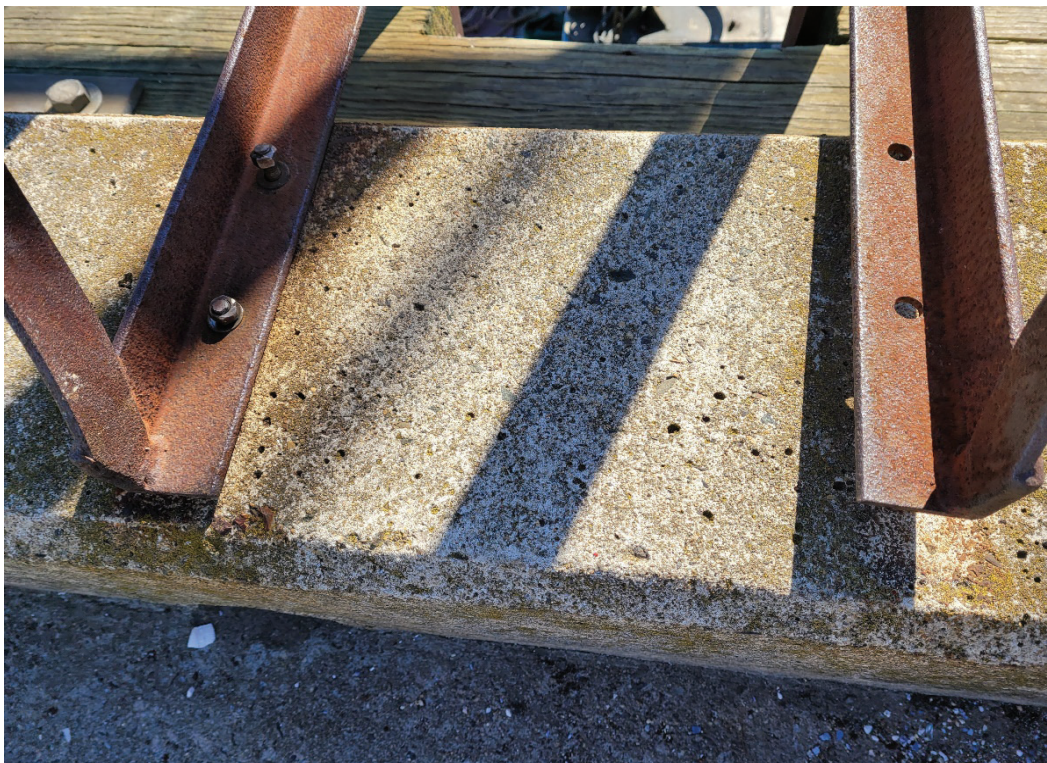
Picture #10  
Loose/missing ladder bolts at Sorting Pier 3 Extension

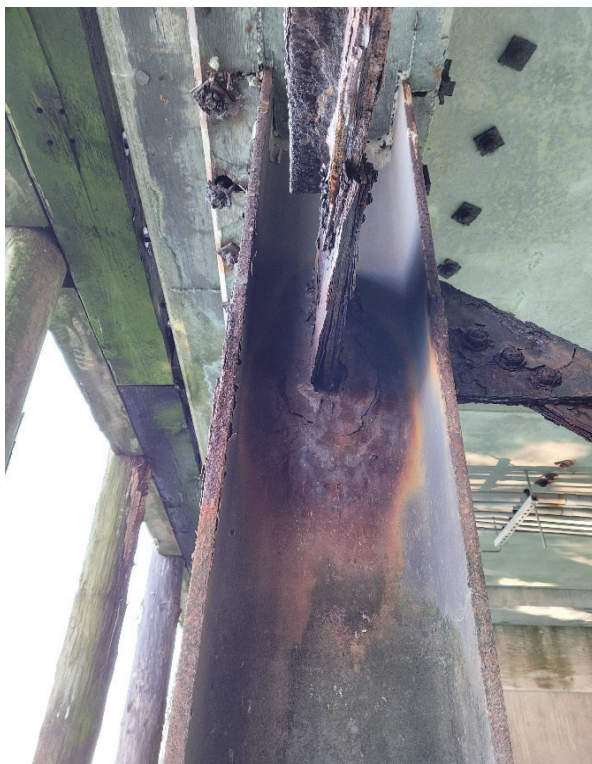
Picture #15  
Typical conditions (fair)

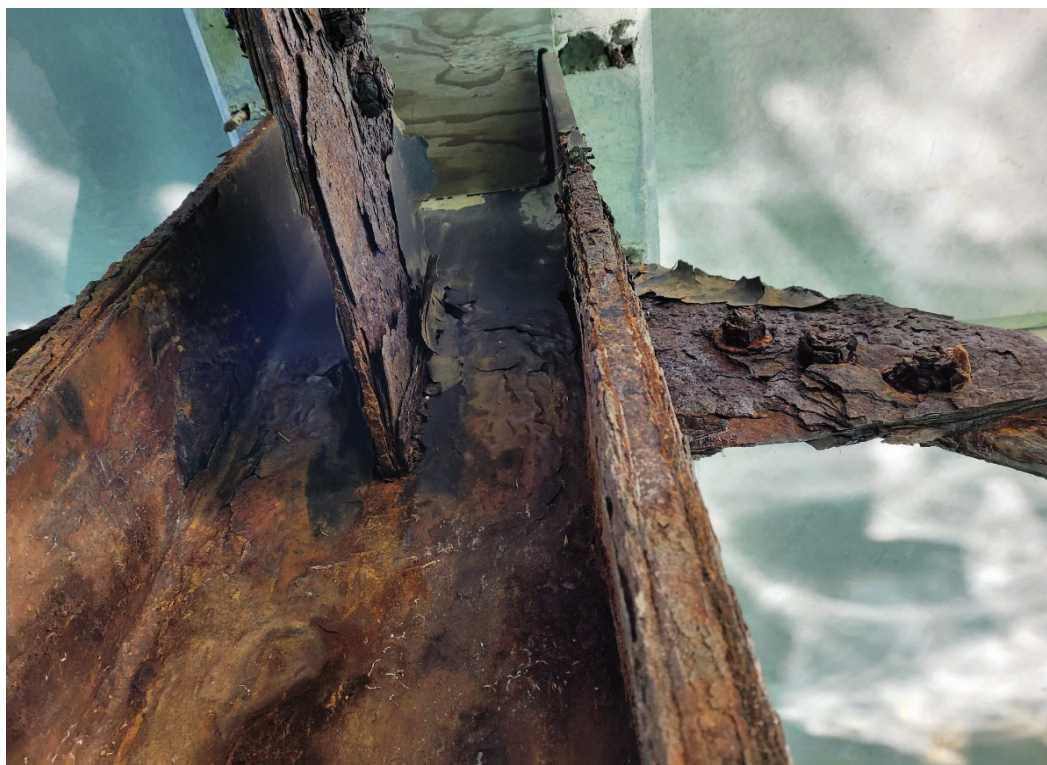
Picture #16  
Typical conditions (poor)

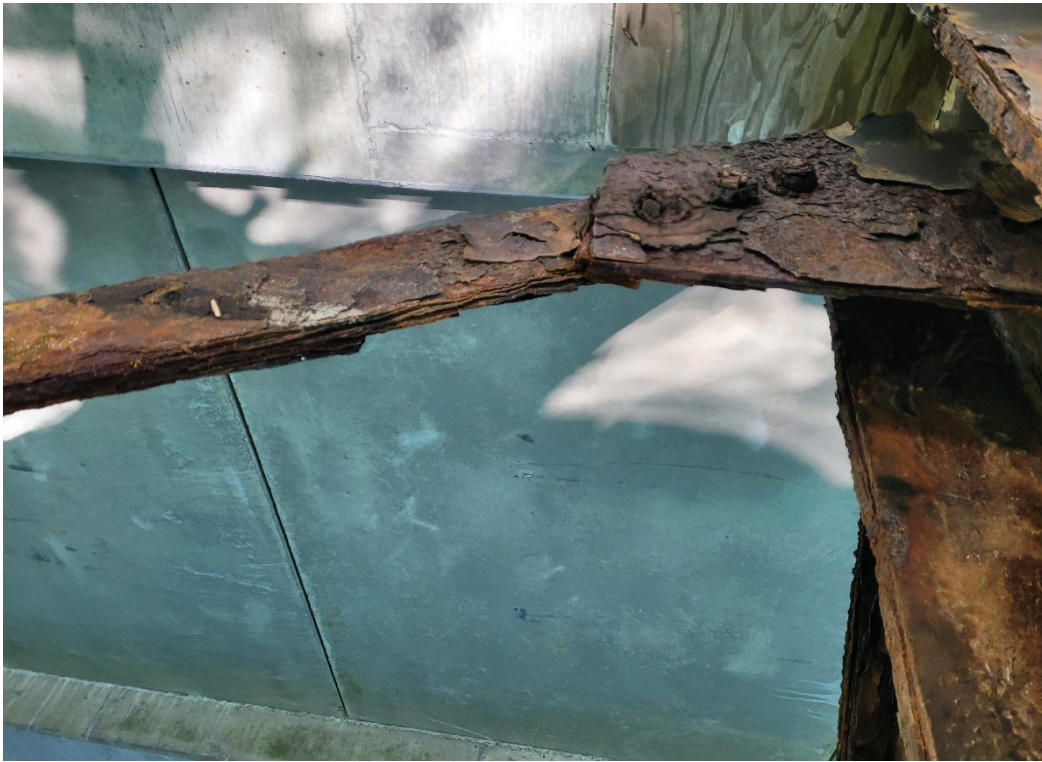
Steel diagonal bracing gussets and angles are in similar condition to the piles, with all top connections located in the area of heaviest corrosion. Corrosion of the bracing is uniform across the splash zone, with much of the diagonal lateral and longitudinal bracing corroded to between 25% to 50% or less of remaining net section. Conditions outside of this range are included with the pile details below.

Picture #17  
Typical heavy corrosion and scale to longitudinal diagonal bracing

Due to the intricate and costly nature of removing and reapplying the paint coating system, it had been previously recommended that allowing the steel bracing to rust out may be a feasible option. This was ultimately the route that has been taken, and the Fish Pier is now in need of widespread bracing replacement. One for one bracing replacement may not be advisable, and a reconfiguration of the bracing is worth investigation.

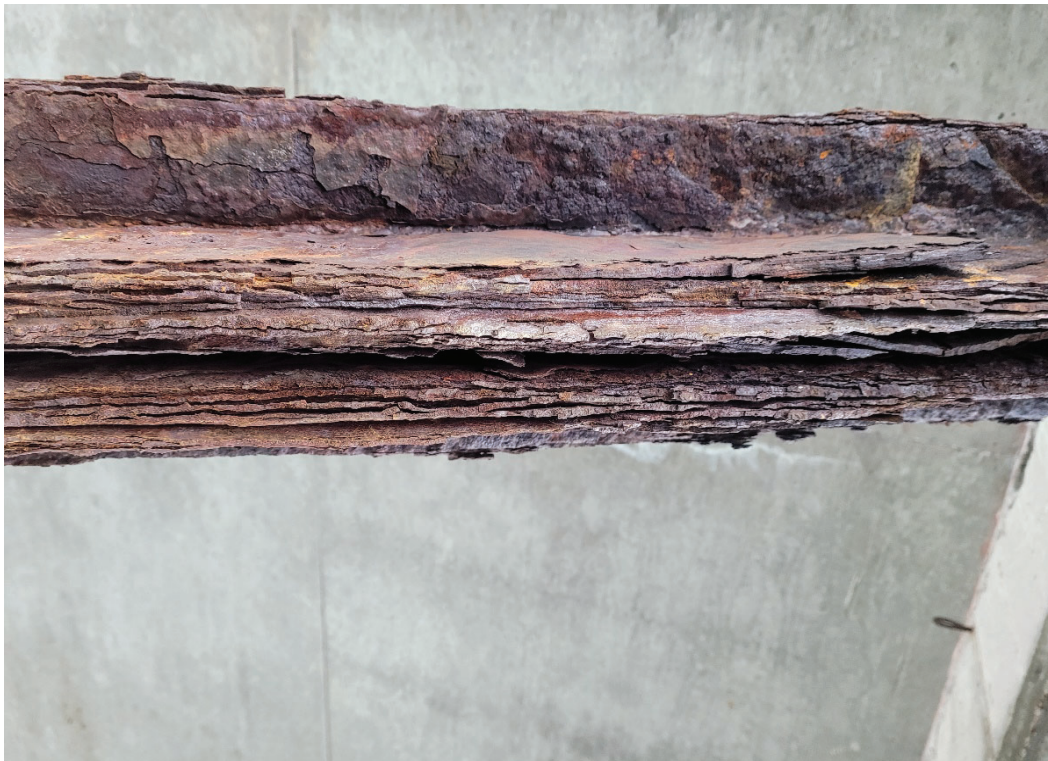
Picture #18  
Typical heavy corrosion and scale to lateral diagonal bracing

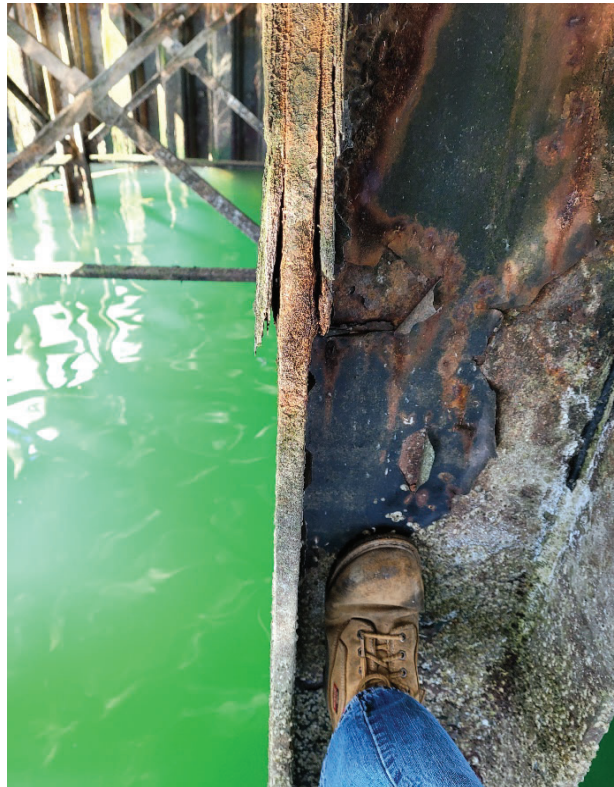
Picture #19  
Typical scale and corrosion at sorting piers

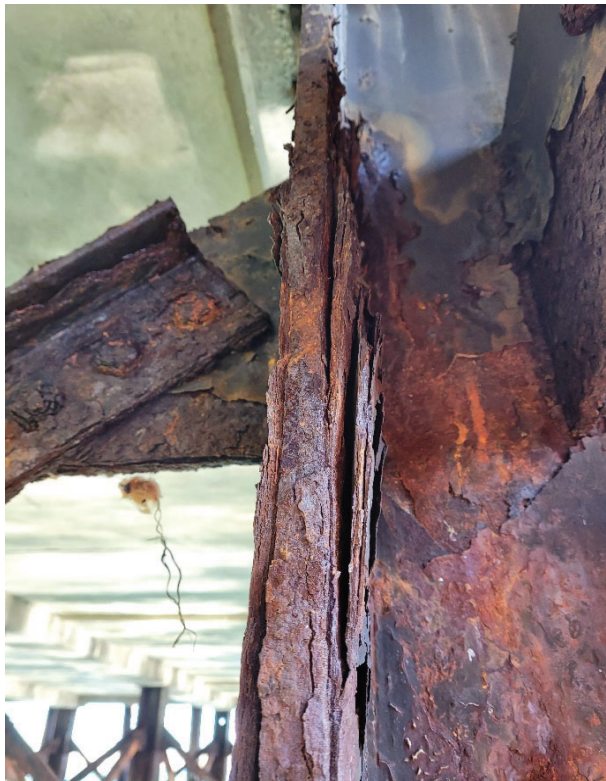
Picture #20  
Typical heavy scale and corrosion at sorting piers

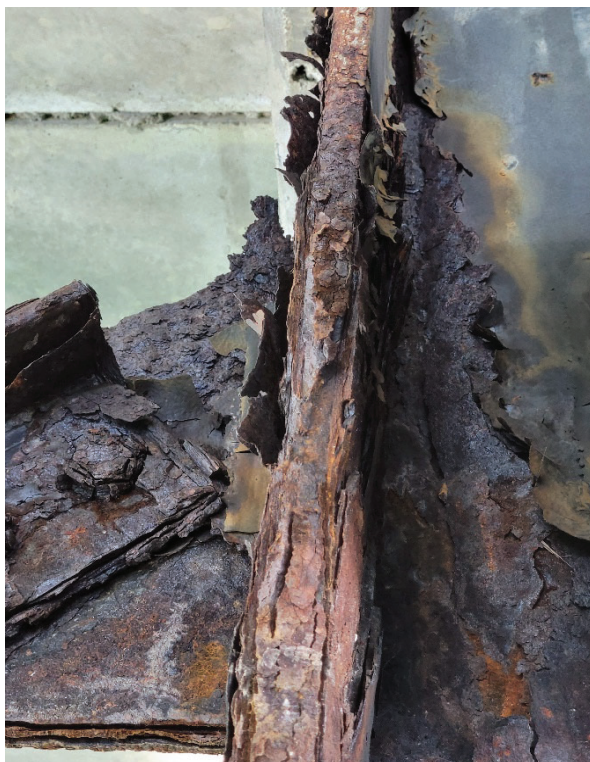
General conditions of 1/16" to 1/8" of corrosion loss exist across all piles in the splash zone. Isolated piles have up to 1/4" of corrosion loss, with a few near steel failure of the flange section. Specific conditions for each pile were recorded in the field and included later in this report.

Picture #21  
Heavy corrosion loss to H-pile flange

The H-piles have proven to be well protected below MLW by the cathodic protection system and original paint coating system. Some of this protection allows itself to the piles in the lower tidal range; however, the splash zone sees no benefit due to the lack of consistent submersion and the decline of the protective paint coating system. Targeted steel repairs to flanges of piles exceeding 3/8" loss or more would be prudent, followed by widespread jacketing or a reapplication of a protective paint coating system.

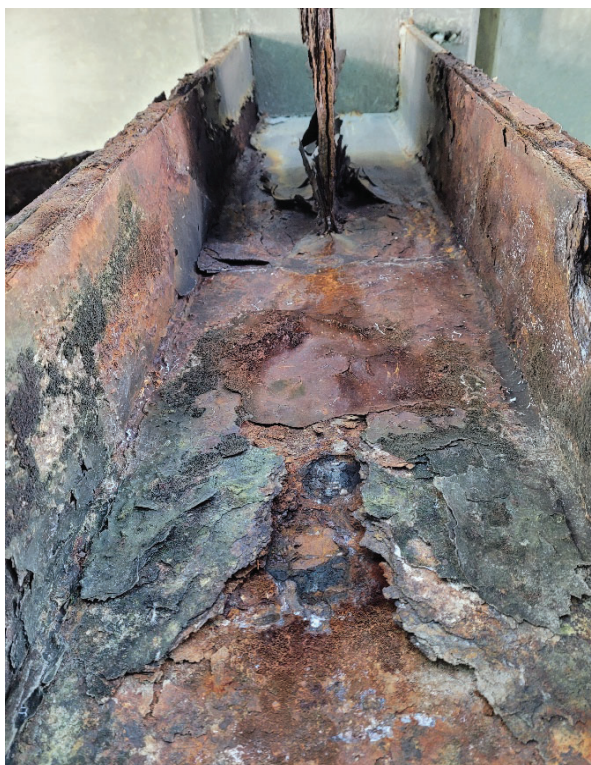
Picture #22  
Heavy scale and corrosion loss

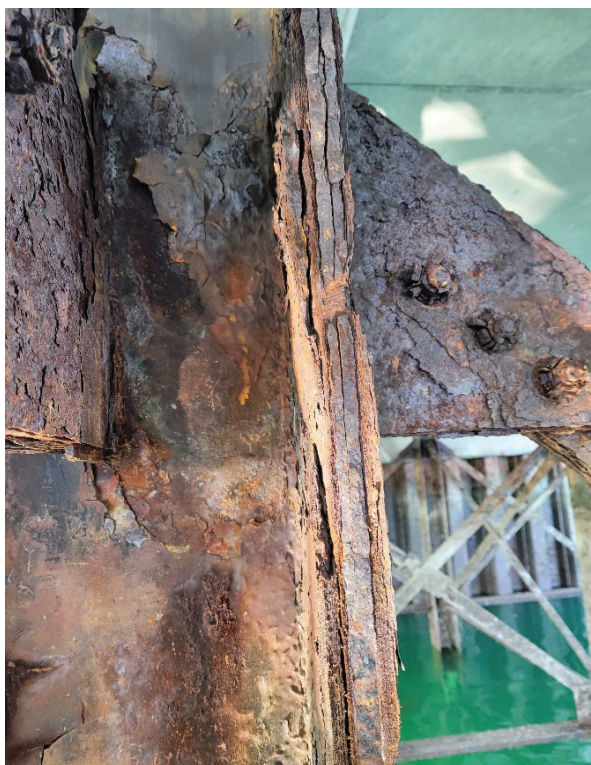
Picture #24  
Heavy scale and corrosion at Sorting Pier 3

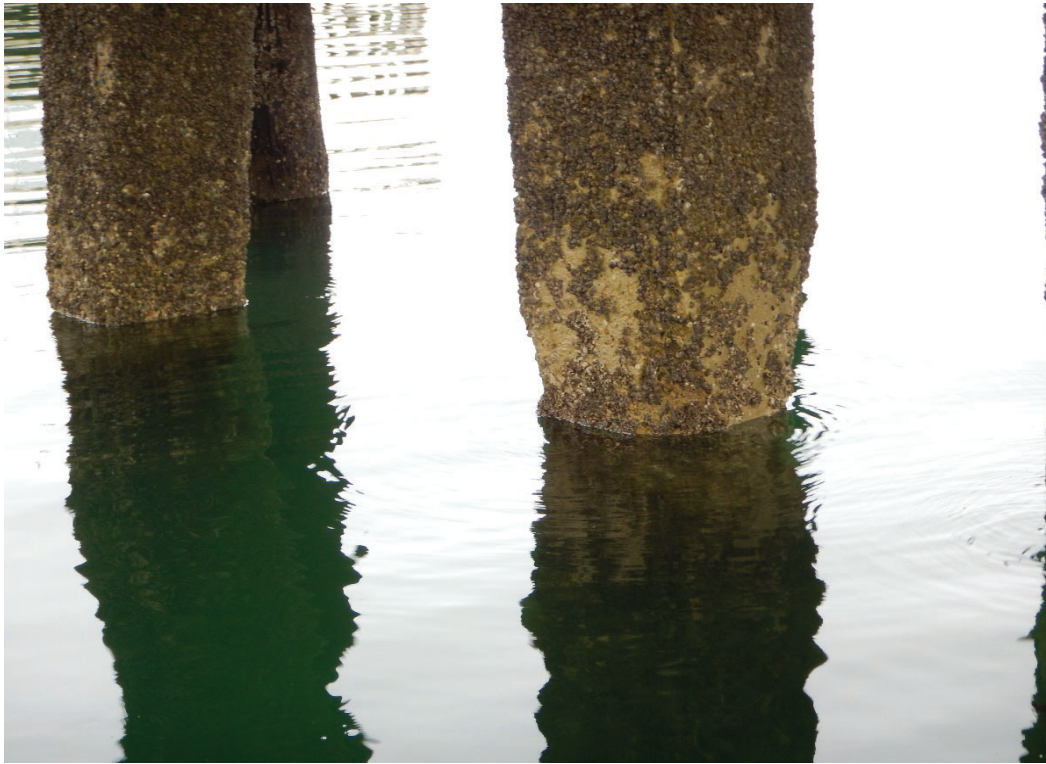
Picture #29  
Concrete pile section loss

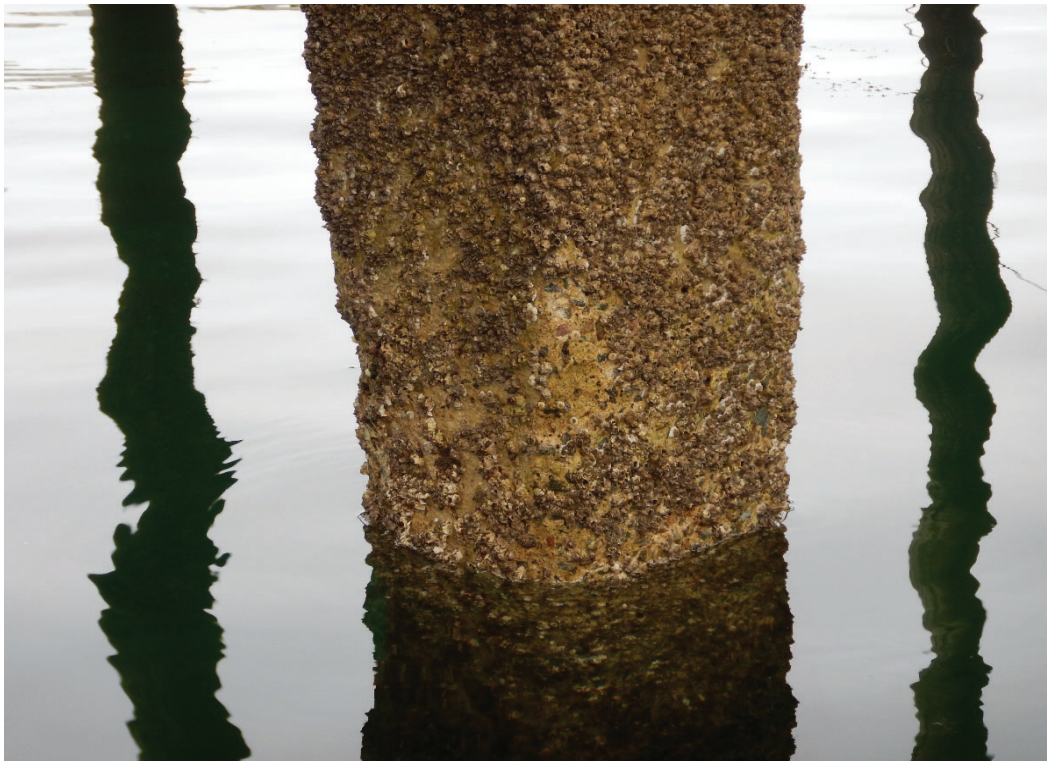
Picture #30  
Concrete pile section loss
