**PORTLAND FISH PIER AUTHORITY**  
**BOARD OF DIRECTORS**  
**November 8, 2021, 3:00 PM**  
Via Zoom Link Below

On 8 April 2021 TEC Associates concluded a multiday inspection of the Fish Pier structure above mean low water for the City of Portland, Maine. The purpose of this inspection was to determine the overall depreciation of the structure due to adverse conditions including weathering, cathodic action, and aging. Findings of this inspection include significant corrosion loss to the steel H-piles and bracing of the six finger piers, specifically in the high tide splash zone.

### PORTLAND FISH PIER STRUCTURAL INSPECTION

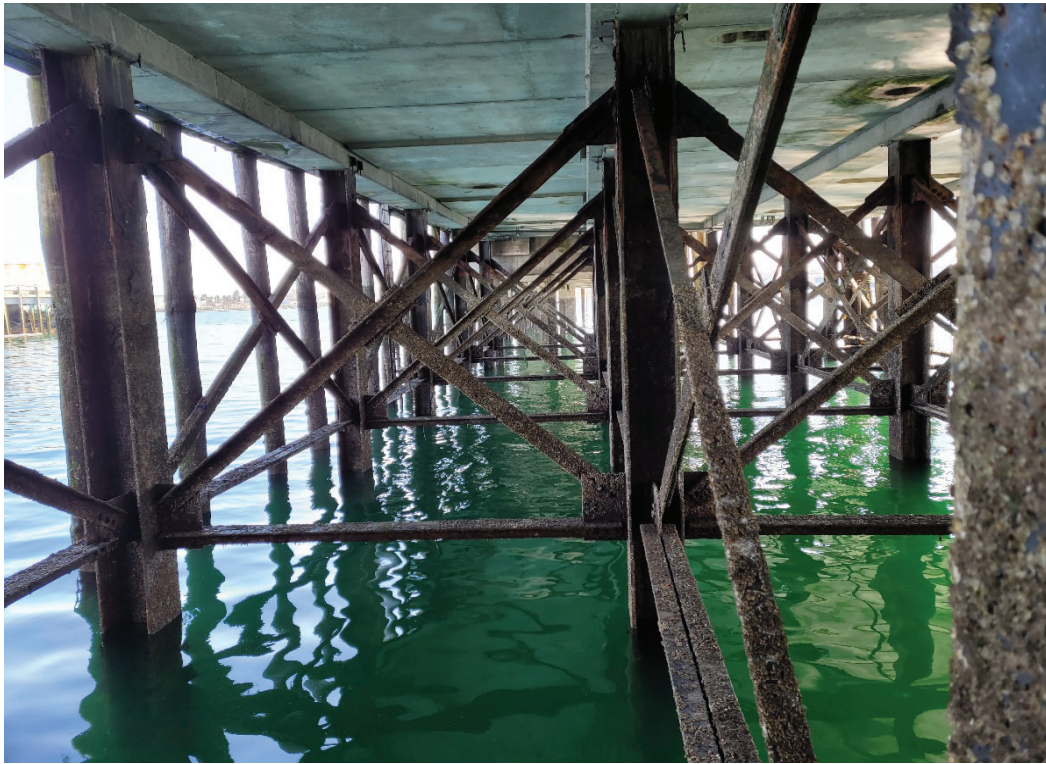
Picture #11  
Looking south at Sorting Pier 1 Bent 2

| <b>Bent 2</b> | P1 | 1/16" corrosion, up to 1/8" in places.<br>West lateral gusset to 25%, double angles both to 25%.<br>South longitudinal gusset to 0%, angle to 25%. |
| | P2 | 1/8" corrosion.<br>Both longitudinal gussets and east lateral gusset to 5%, angles all to 10%. |

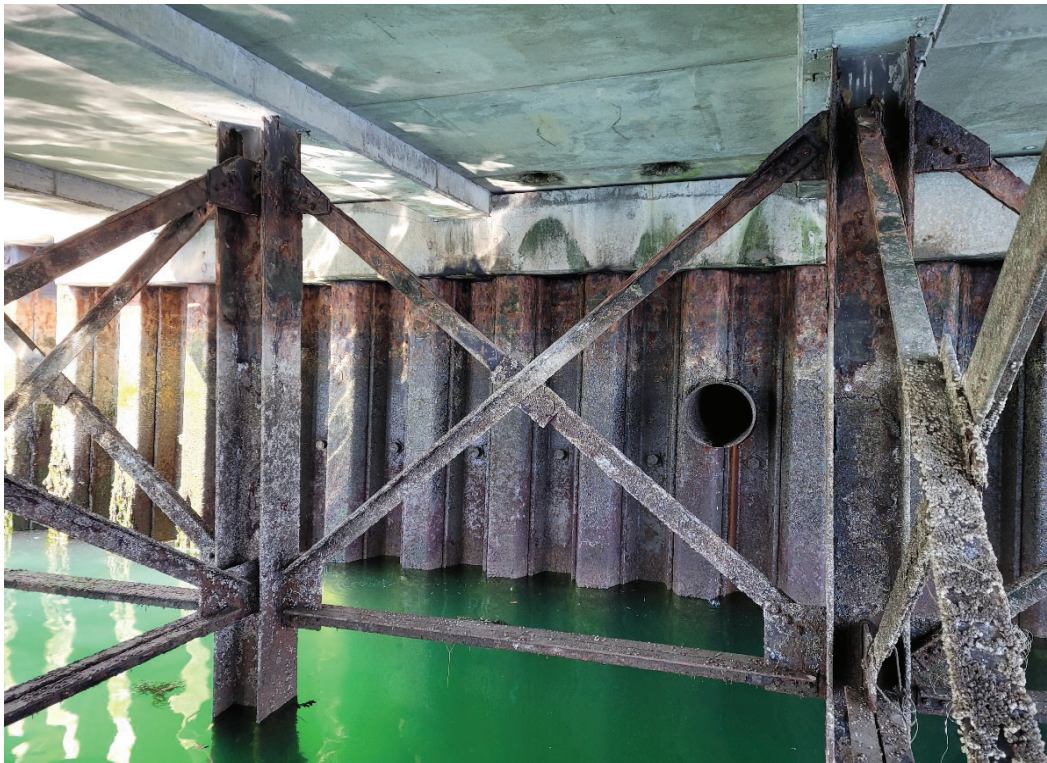
Picture #12  
Looking north at Sorting Pier 1 Bent 1 and sheet pile

| <b>Bent 1</b> | P1 | 1/8" corrosion.<br>South longitudinal bracing gusset to 0%, angle to 15%.<br>West lateral bracing gusset to 15%, double angles both to 15%.<br>Concrete beam cracked and breaking off around flanges inside. |
| | P2 | 1/16" corrosion.<br>South longitudinal bracing gusset to 5%, angle to 15%.<br>East lateral bracing gusset to 5%, angle to 10%.<br>Concrete beam cracked minor on bottom, runs from south pile flanges to west side. |

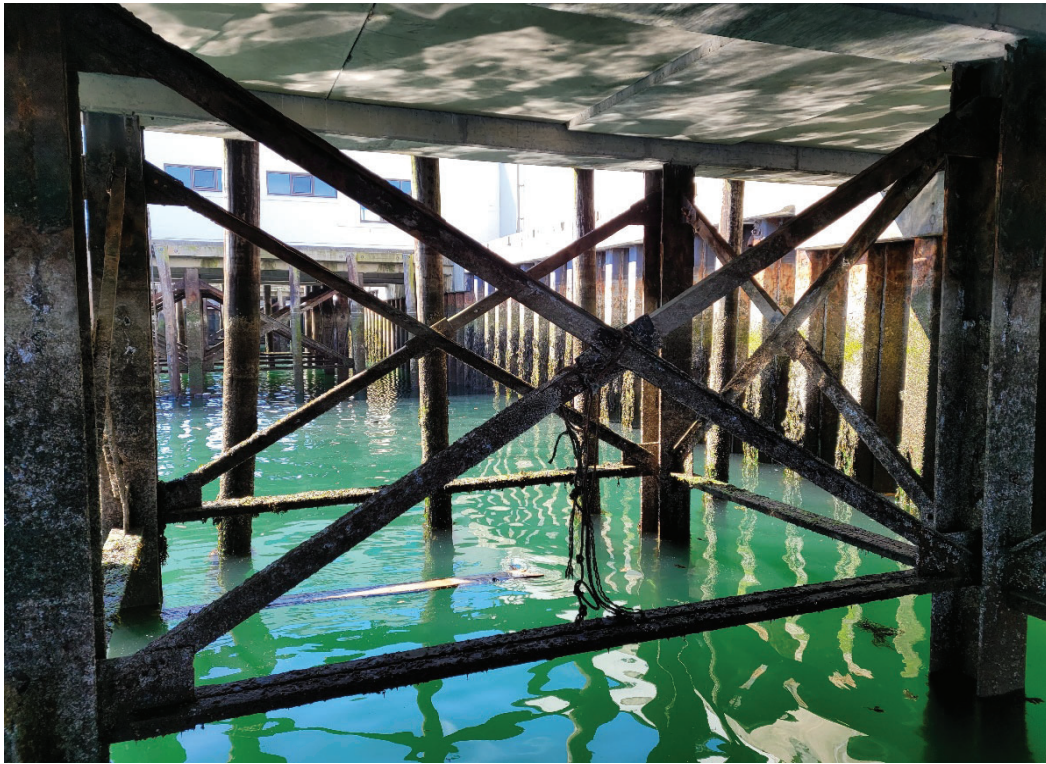
Picture #13  
Typical bracing

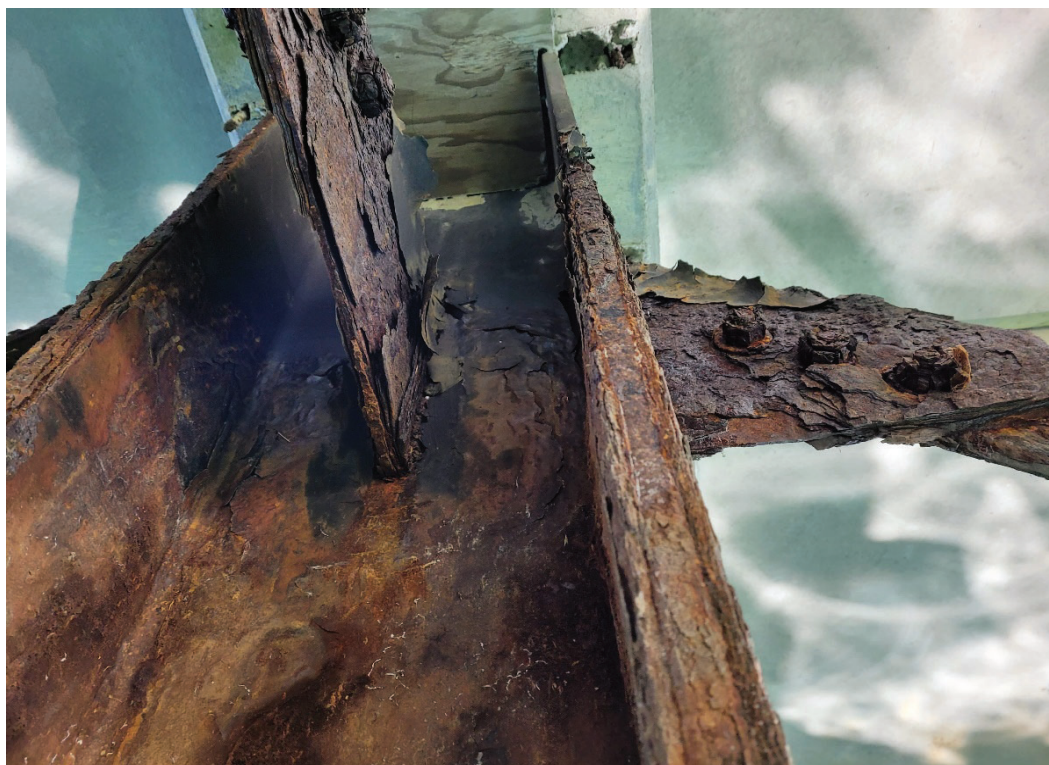
Picture #16  
Typical conditions (poor)
