- i. Presentation on Findings of Building Condition Report; PORTLAND COMPANY COMPLEX, 58 FORE STREET; Report prepared by Resurgence Engineering and Preservation for City of Portland Planning Department.

**RE:** April 1, 2015      WORKSHOP – Presentation on Findings of Building Condition Assessment of Portland Company Complex

# PORTLAND COMPANY COMPLEX GENERAL BUILDING CONDITION REPORT

PERFORMED FOR  
CITY OF PORTLAND, MAINE PLANNING DEPARTMENT  
389 CONGRESS STREET  
PORTLAND, ME 04101

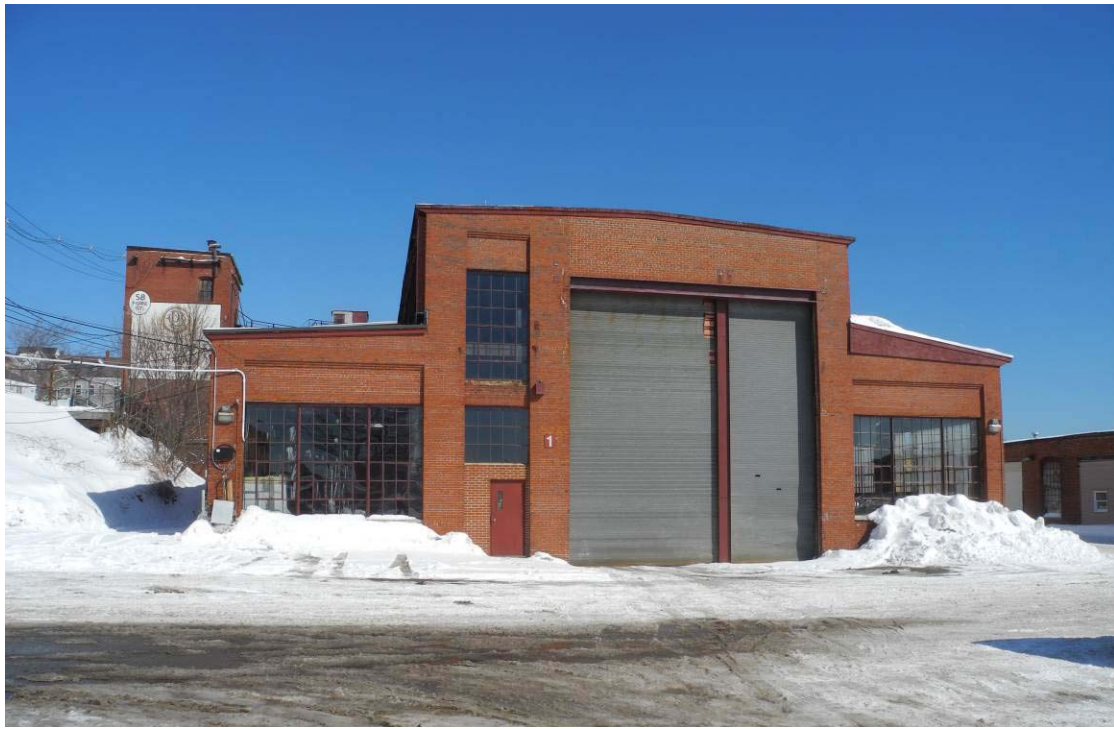
**PHOTO**  
**# 1.1**  
A 2 95.jpg

Building 1: View from west. Large, tall bay door has replaced original smaller overhead door and symmetrical high windows. Increased roof pitch at right side of photo appears to have been in place since late 1930s.

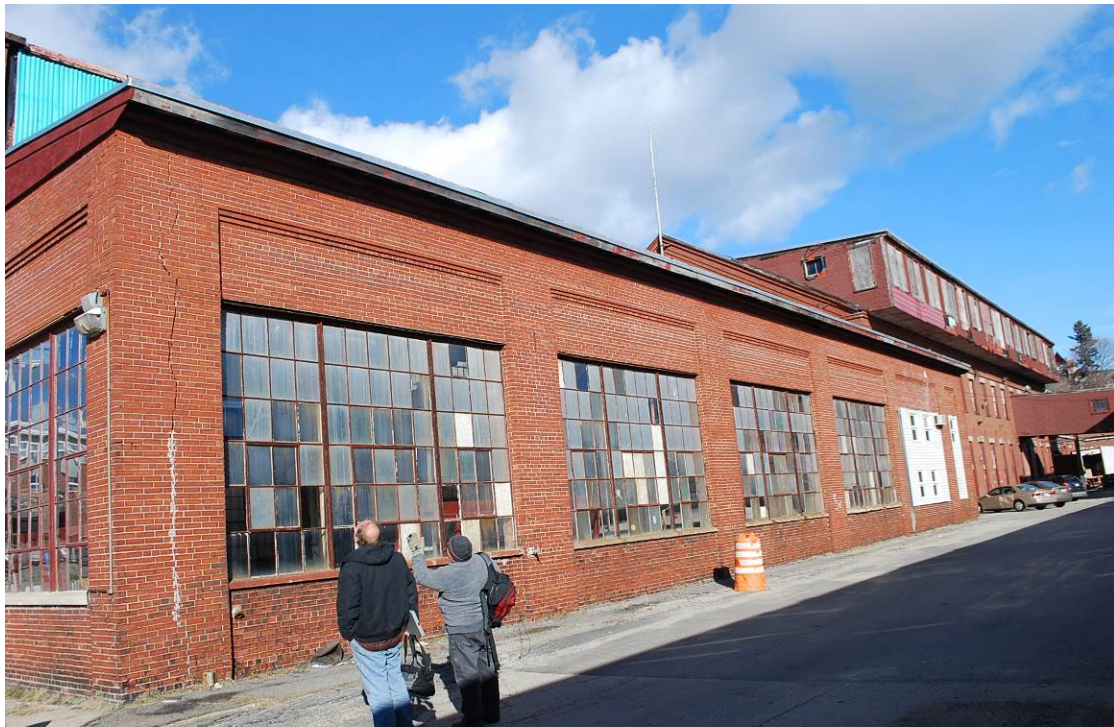
**PHOTO**  
**# 1.2**  
R 07.jpg

Building 1: View along south elevation looking toward Building 2, showing five bays of steel-framed windows and a small bay near Building 2. Note large crack at left, near joint with west wall.

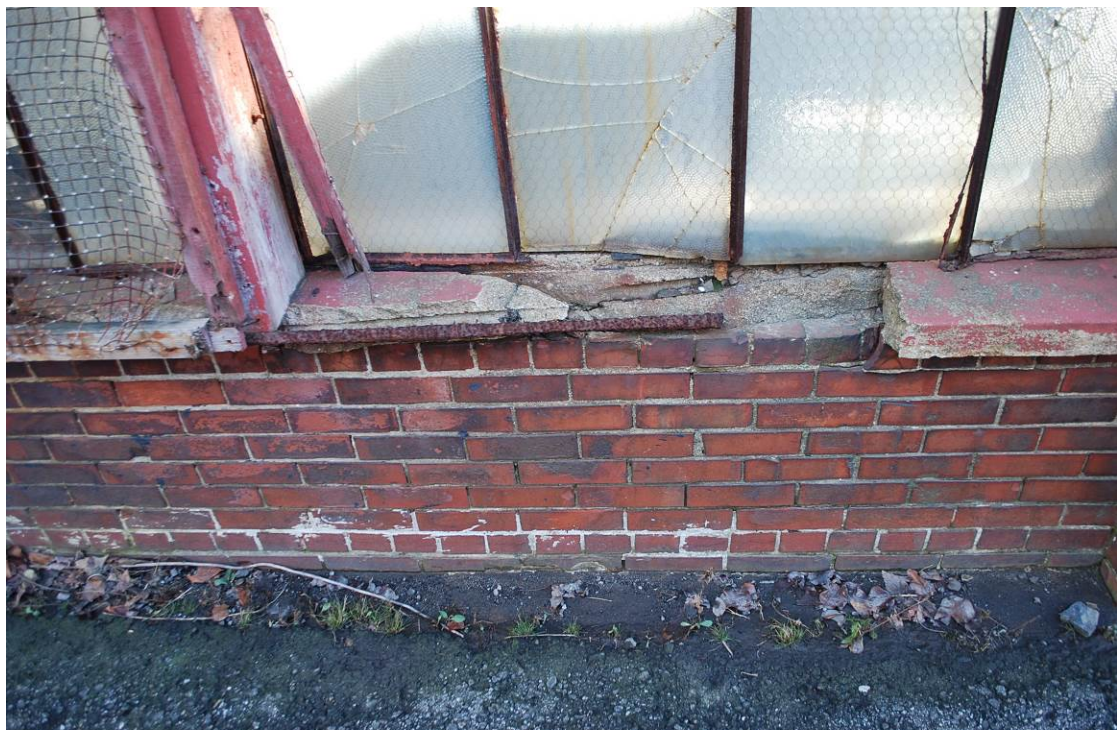
**PHOTO**  
**#1.6**  
R 32.jpg

Building 1: Rising damp at perimeter wall base, failed concrete sills, and significantly damaged steel-framed windows.

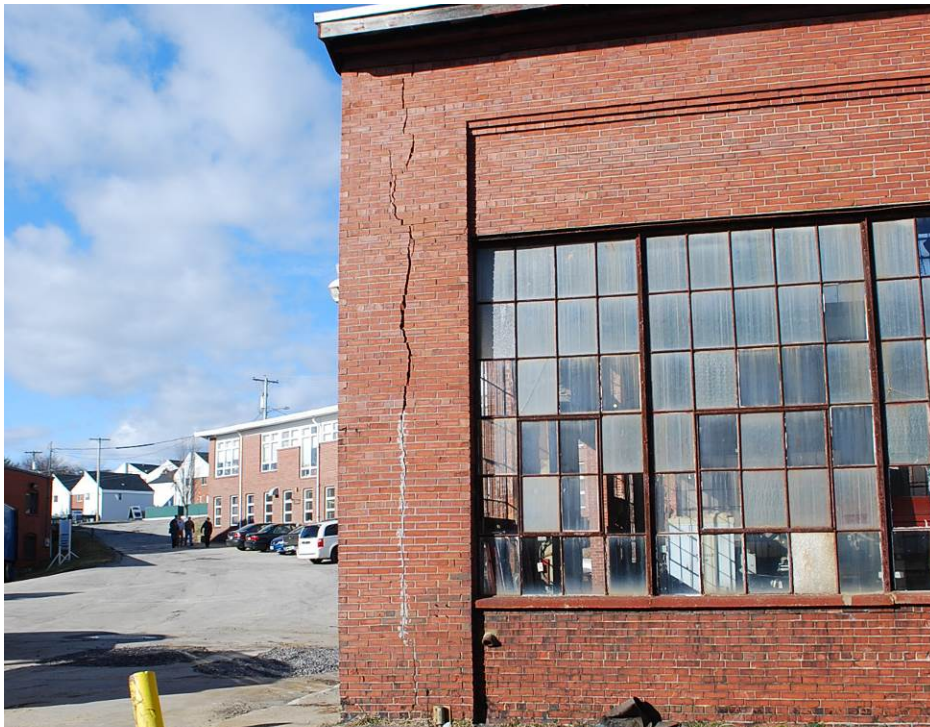
**PHOTO**  
**#1.7**  
R 06.jpg

Building 1: Brick masonry crack, northwest corner of building. Rebuilding the west wall of the building and performing other masonry repairs can improve lateral stability of the building. .

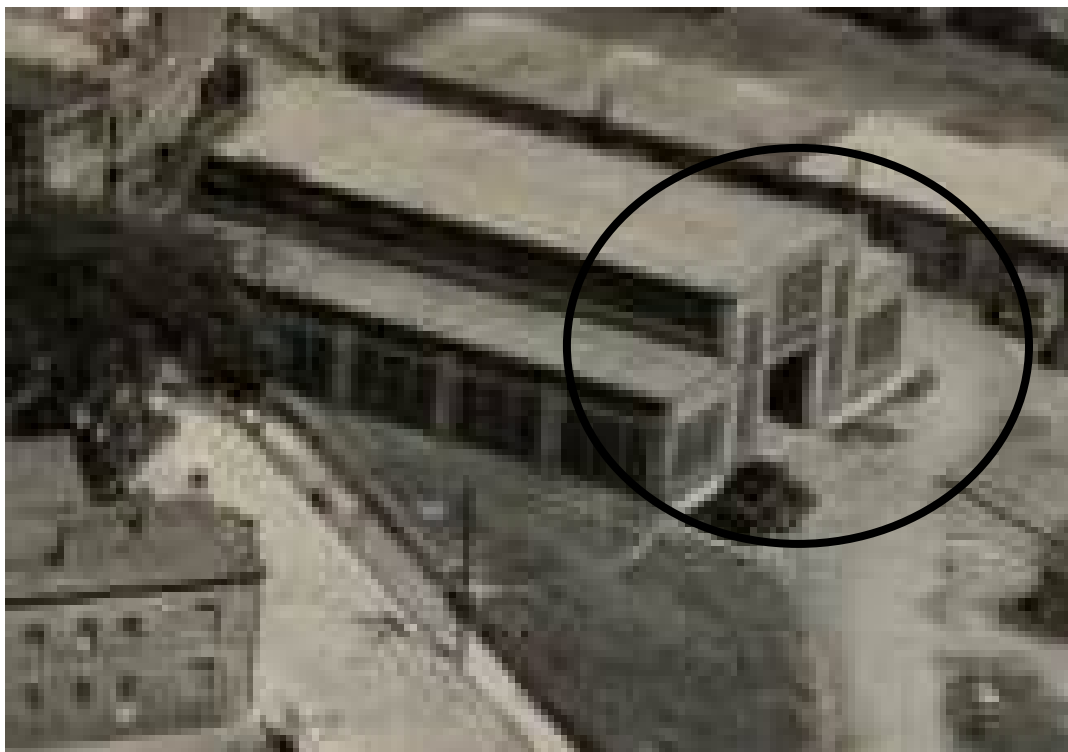
**PHOTO**  
**#1.8**  
maine memory  
nhwk

Building 1: 1938 aerial photo shows smaller-scale door opening and symmetrical windows. Rebuilding west wall to a similar configuration could strengthen wall and return elevation to its period of significance.

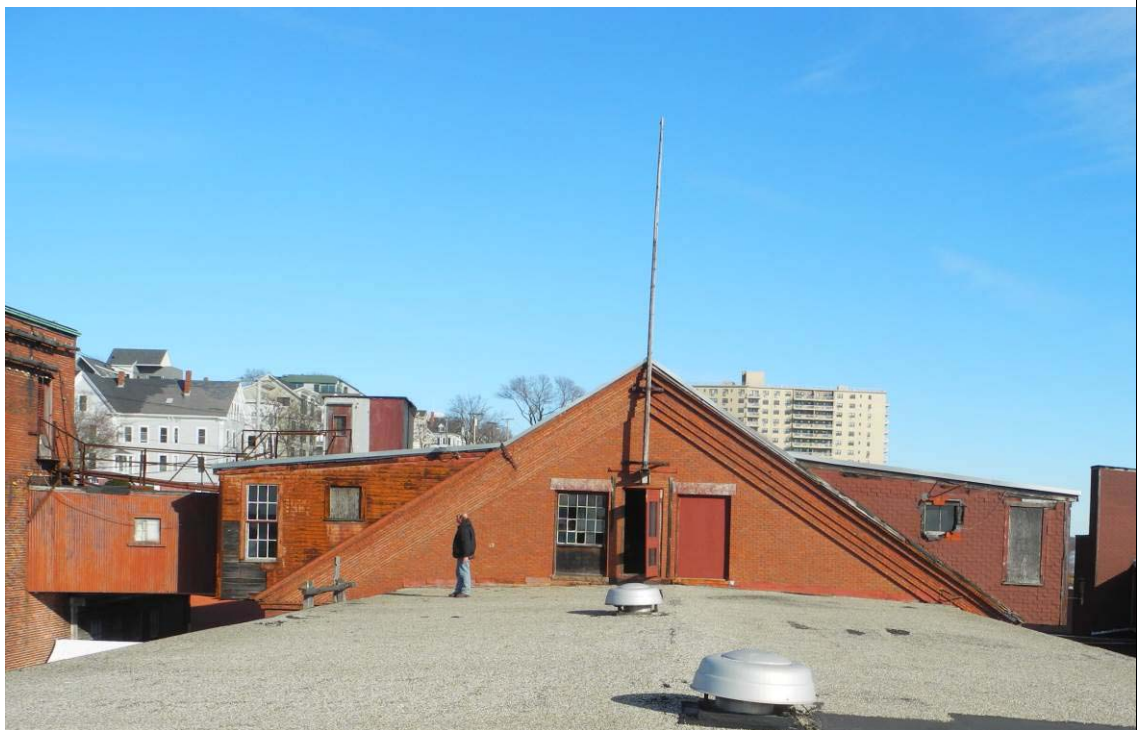
**PHOTO  
#2.6**  
A 30 86.jpg

Building 2: West gable viewed from West end of Building 1. Third floor dormers extending from each side of gable require strengthening to ensure integrity of cantilevered structure. Note different dormer cladding materials.

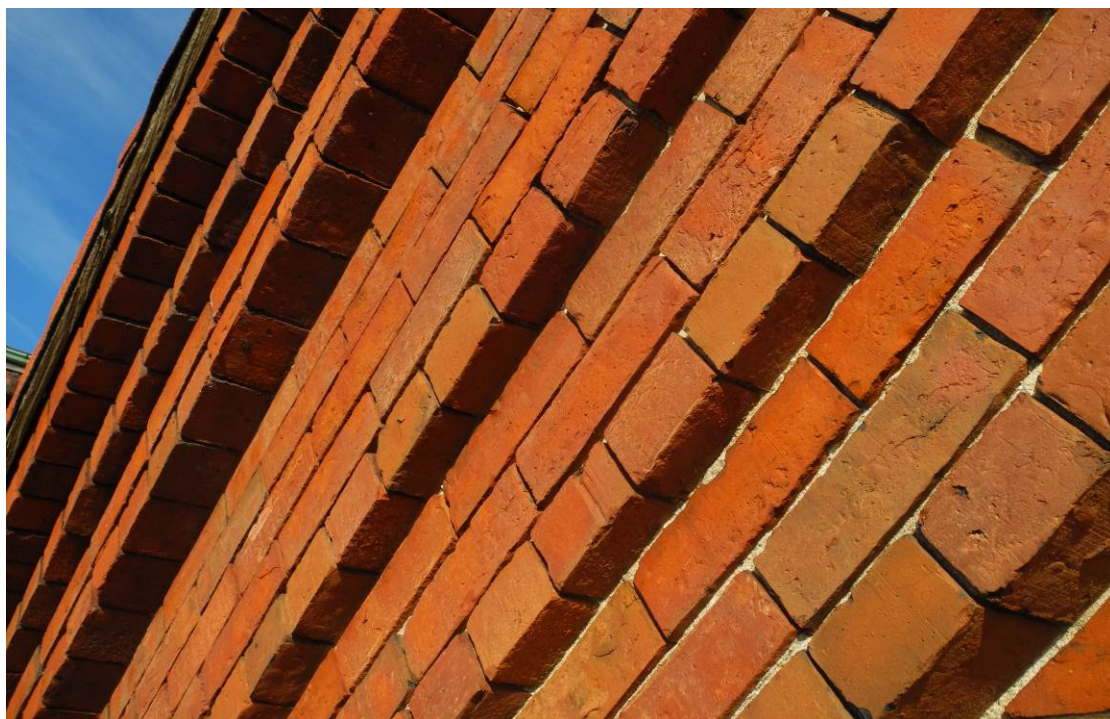
**PHOTO**  
**#2.8**  
A 30 68.jpg

Building 2: West Gable end rake (detail) comprised of 15 courses of brick masonry corbelling out over one foot beyond outside face of primary gable end wall. Repointing required, but otherwise in good condition.

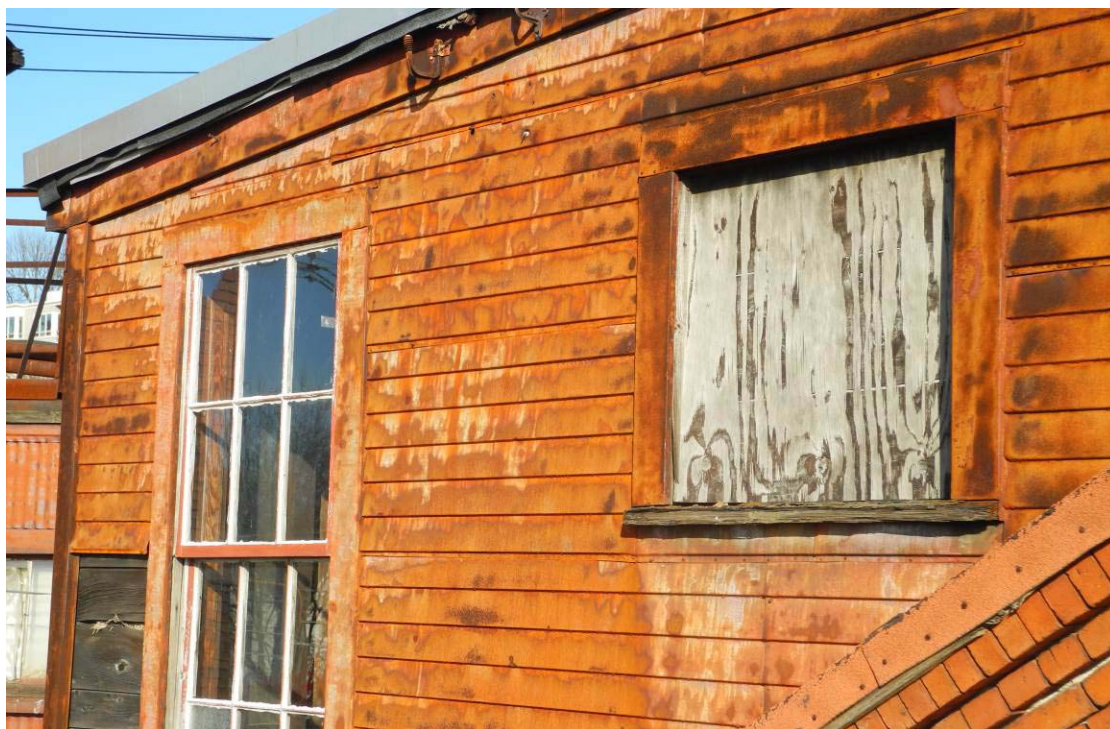
**PHOTO  
#2.9**  
A 30 95.jpg

Building 2: West end of north-facing third-floor dormer. Note corroded metal siding and missing siding. 6/6 window sash is likely original.

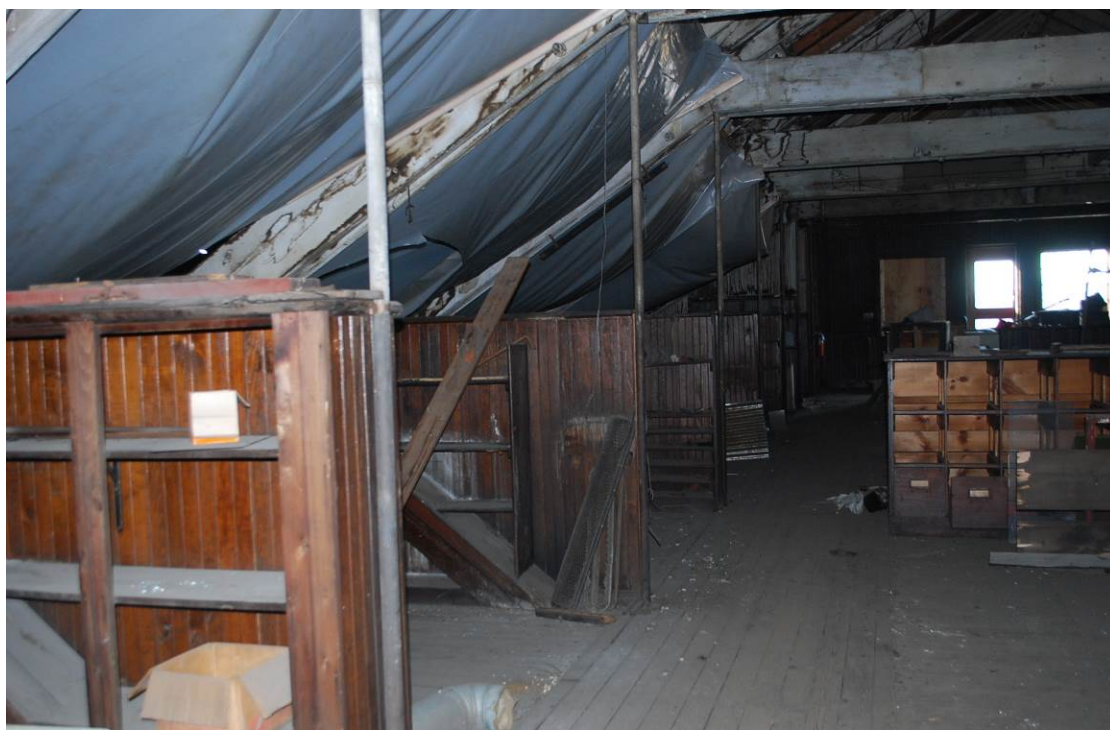
**PHOTO  
#2.10**  
R 169.jpg

Building 2: View from east end of third floor. Plastic sheeting has been used throughout to prevent roof leaks from reaching the assembly space below.

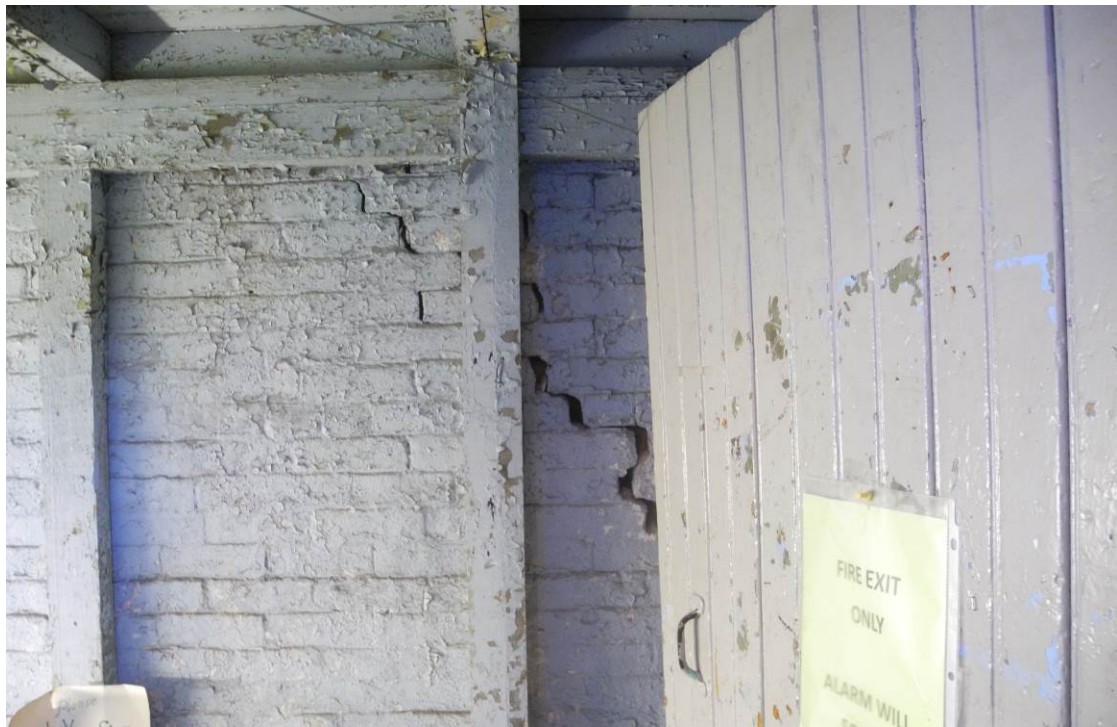
**PHOTO  
#2.16**  
A 3 37.jpg

Building 2: Common wall with Building 3: Extensive masonry crack near second floor south door.

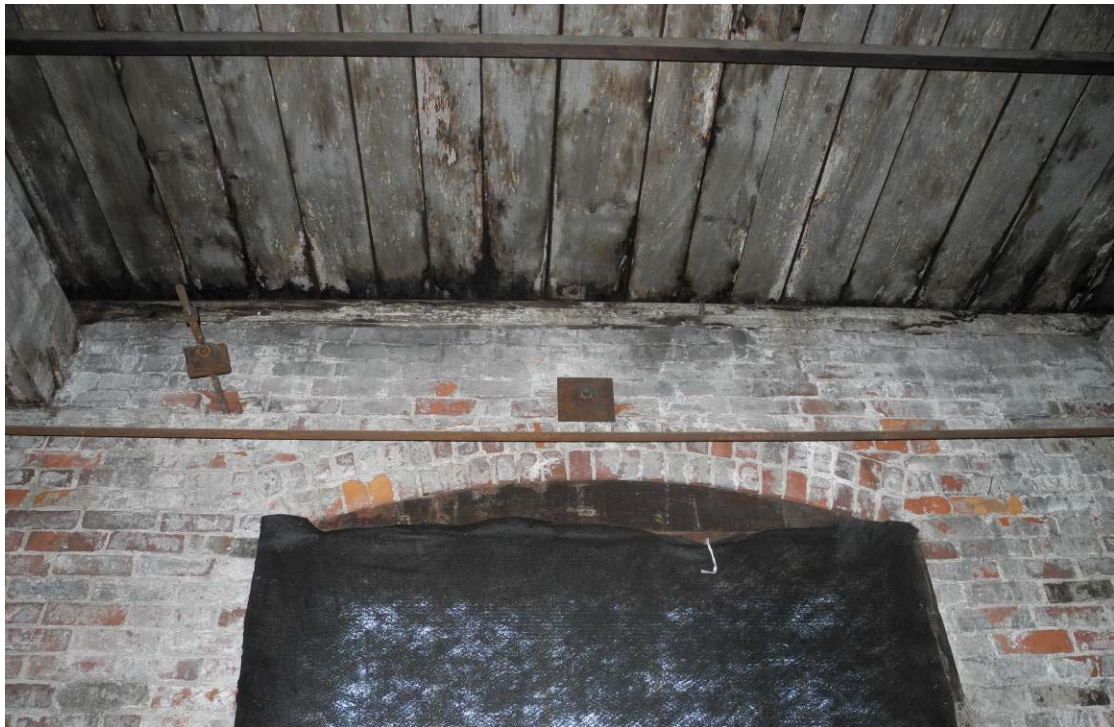
**PHOTO**  
**#3.8**  
A 3 31.jpg

Building 3: Potentially rotted sheathing at south eave. Closely examine ends of sheathing and eave plates for rot. Additional sheathing may be needed to create sufficient diaphragm action between roof edges and wall.

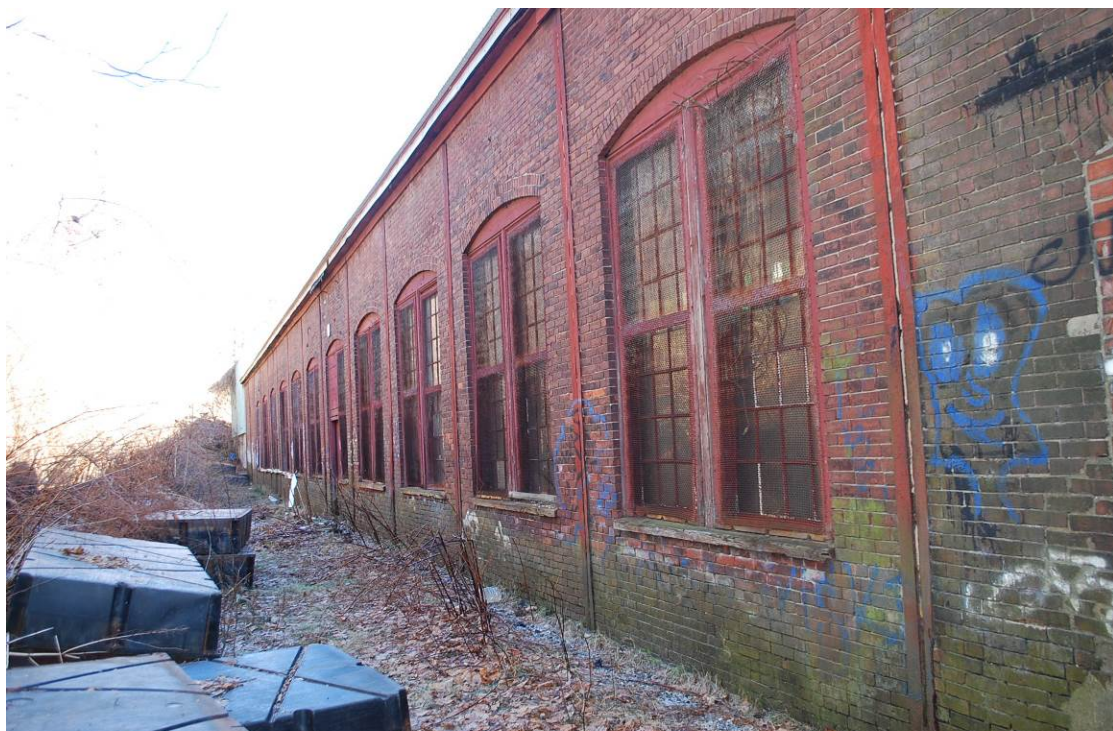
**PHOTO**  
**#4.1**  
R 61.jpg

Building 4: View from northwest, looking along north elevation. Hill descending from left drains substantial water toward the Building 4 foundation, and plant growth limits available sunlight in summer months.

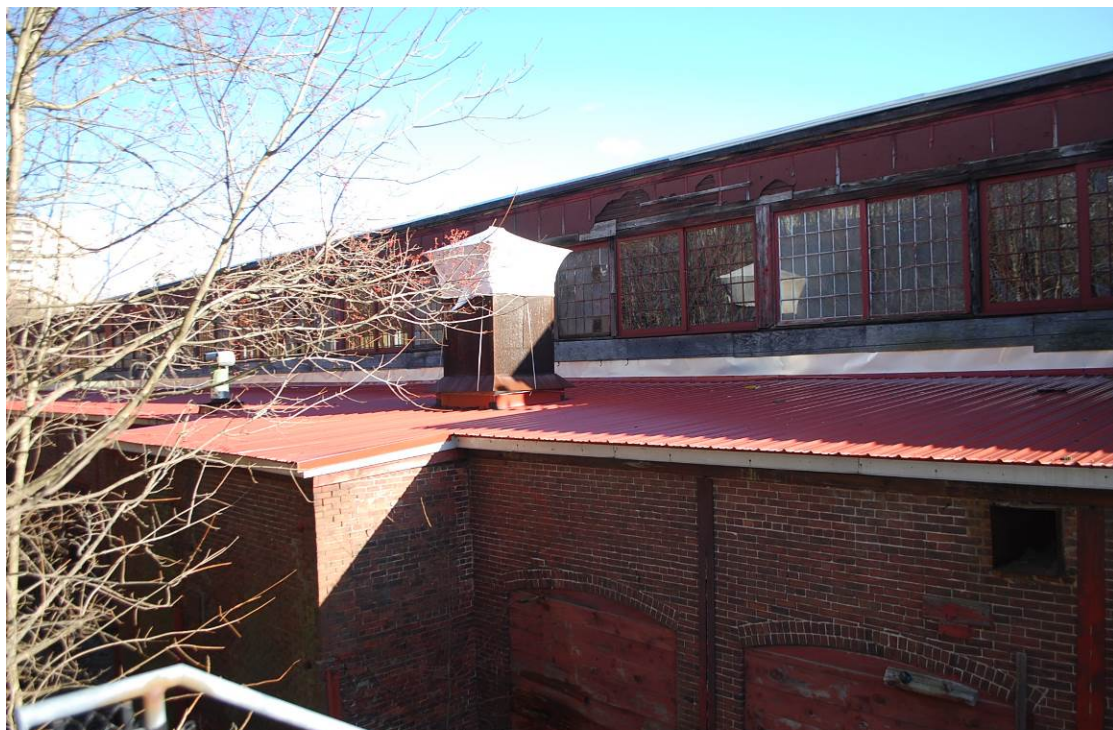
**PHOTO**  
**#4.2**  
R 65.jpg

Building 4: View looking east shows 30-light clerestory windows. As a foundry building, snow loads likely never accumulated on the roof while the foundry was operational. Since closing, snow loads can accumulate on roof.

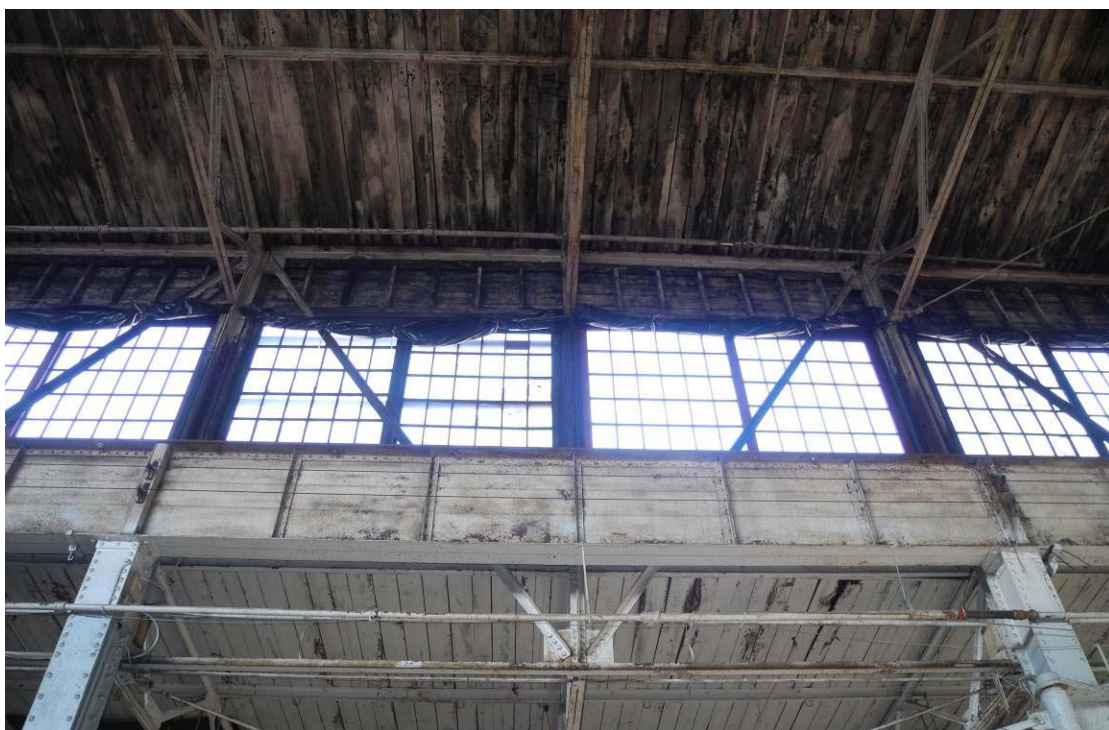
**PHOTO**  
**#4.8**  
A 30 109.jpg

Building 4: South-facing upper wall and clerestory roof, with significant wood staining and possible rot. Continuous crane rail is visible in the foreground.

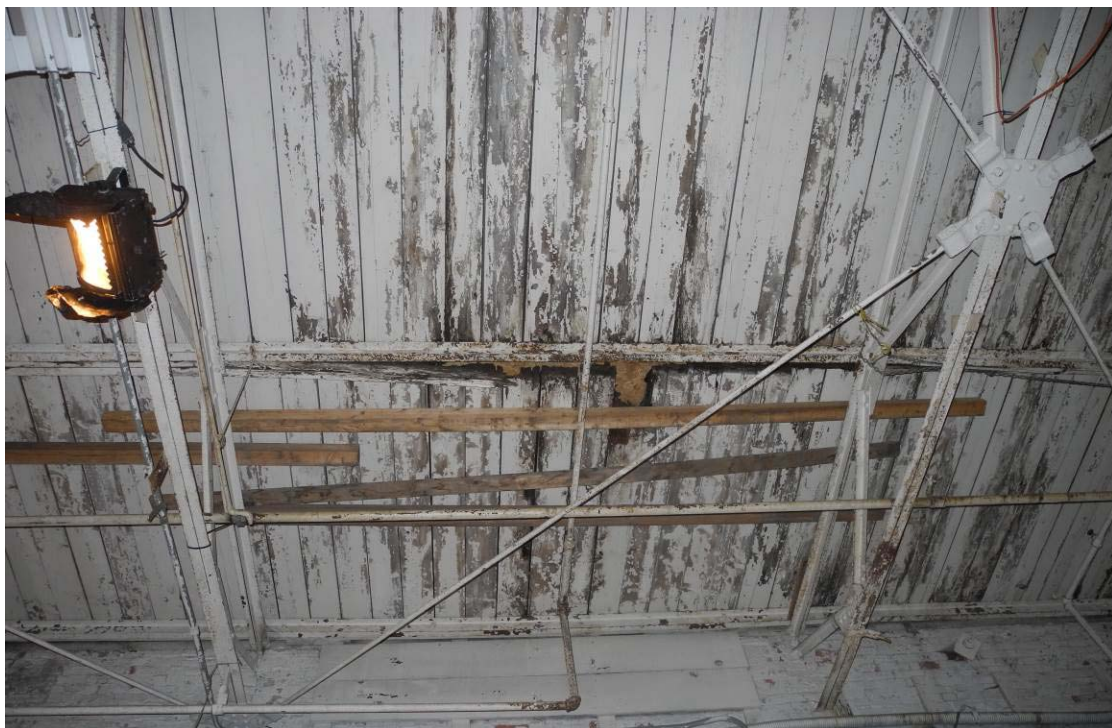
**PHOTO**  
**#4.10**  
A 3 40.jpg

Building 4: North bay roof decking: Local roof sheathing rot supported by multiple 2x framing members spanning between trusses.

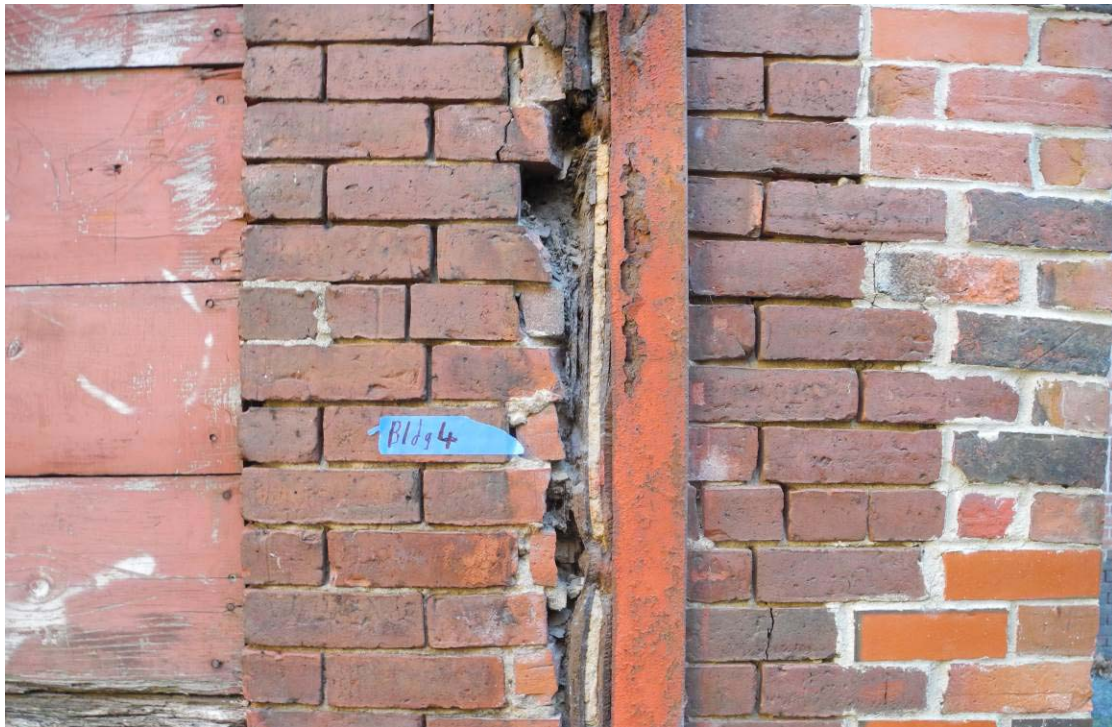
**PHOTO**  
**#4.11**  
A 29 49.jpg

Building 4: Significantly deteriorated built-up angle column. Constant exposure to a shoreline environment, along with inherent construction flaw, caused failure of these columns for several feet above the base.

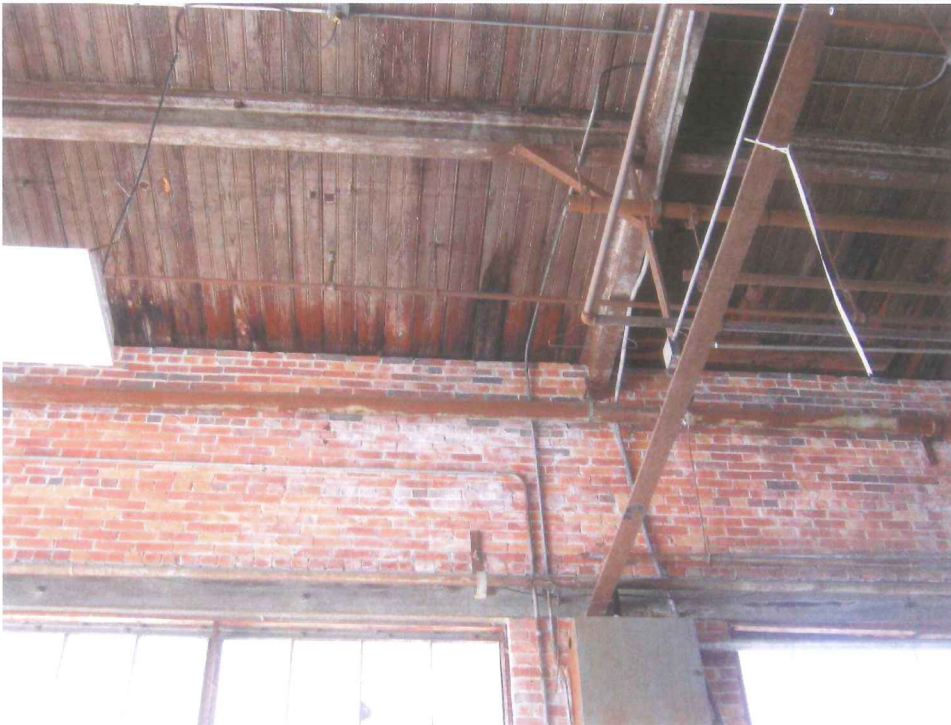
Photo 1-2: Wood deck condition at eave.

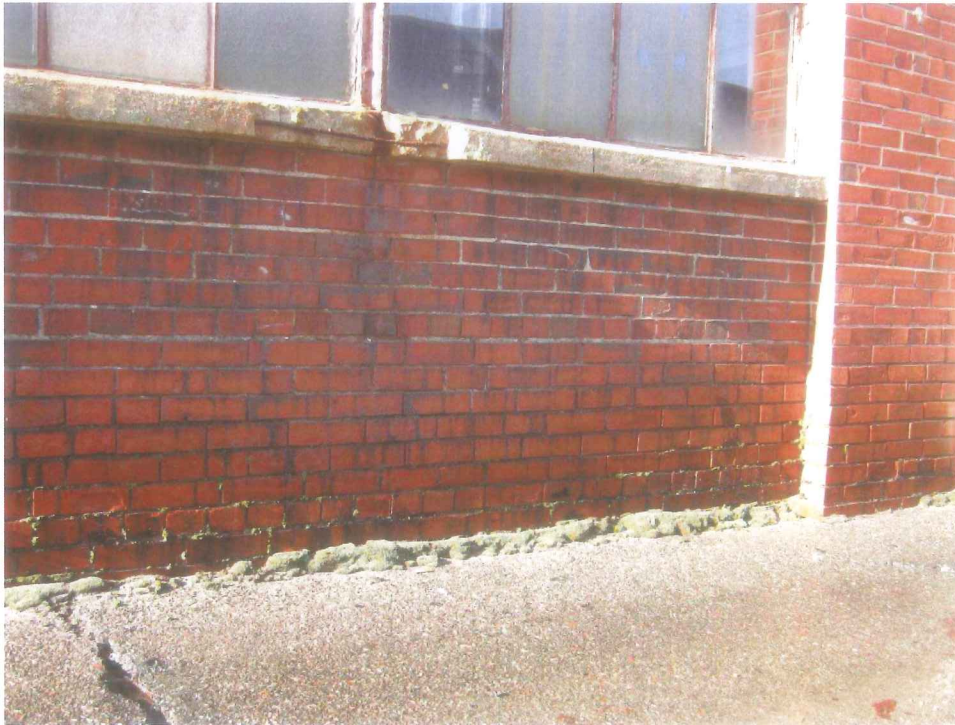
Photo 1-3: Building 1 at eave drip line. Note sill condition, window condition, moss and missing mortar.

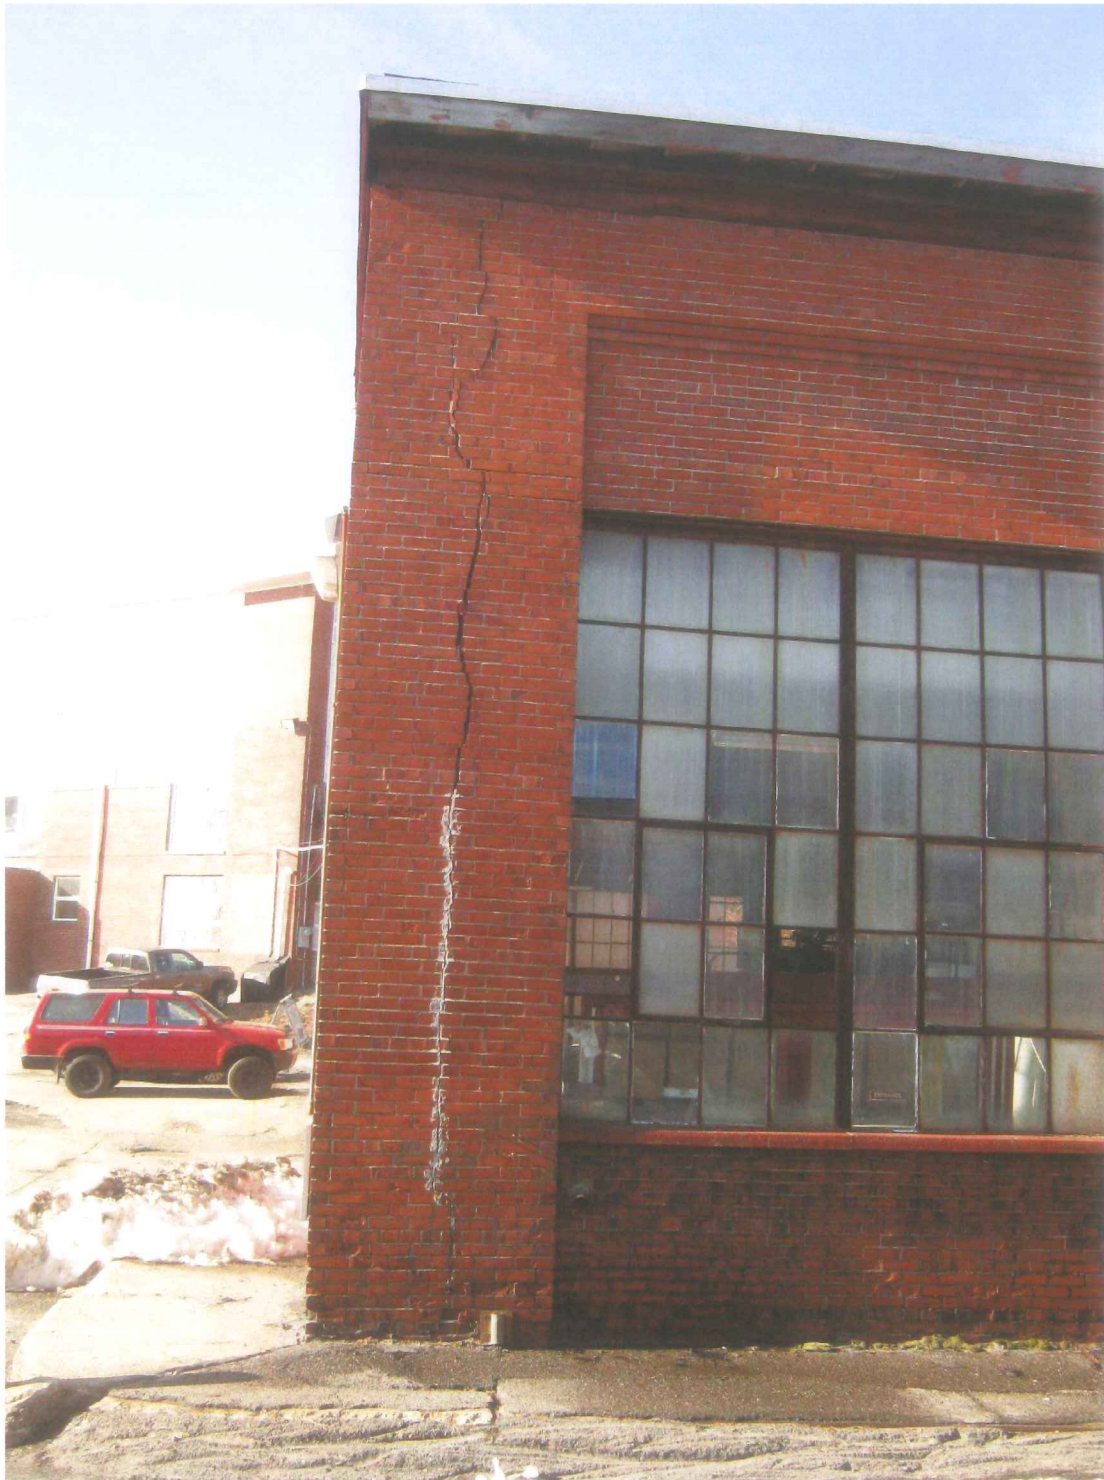
Photo 1-4: Vertical brick masonry crack at southwest pilaster.

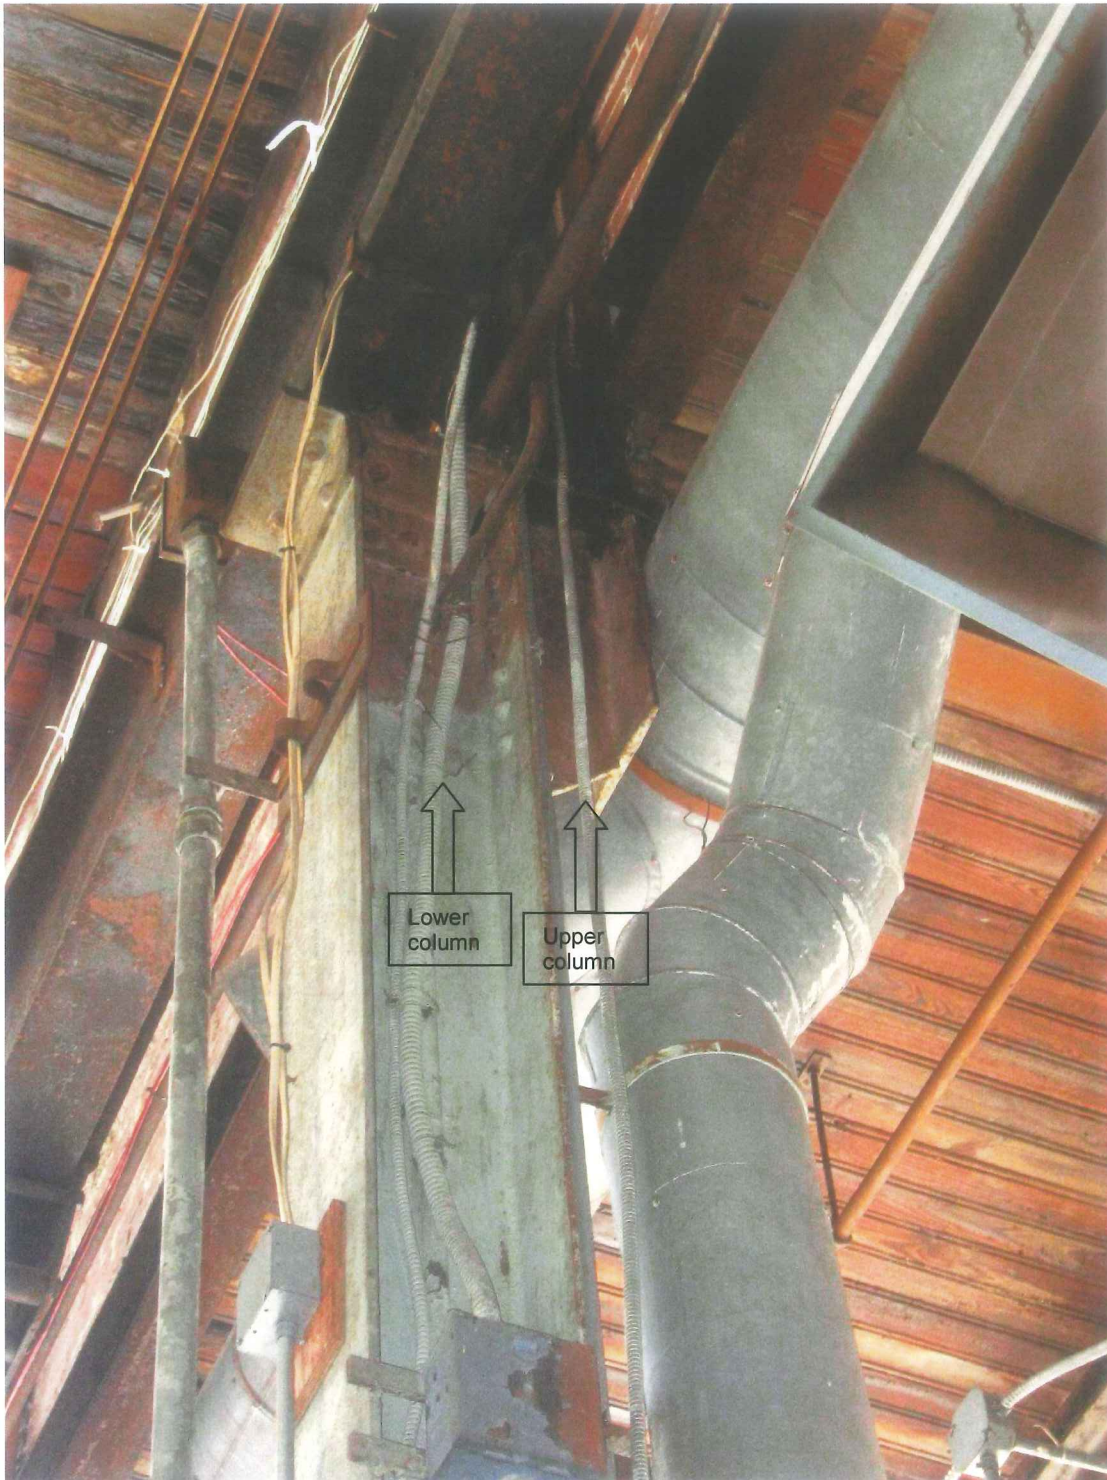
Photo 1-5: Column discontinuity at low-high roof condition.

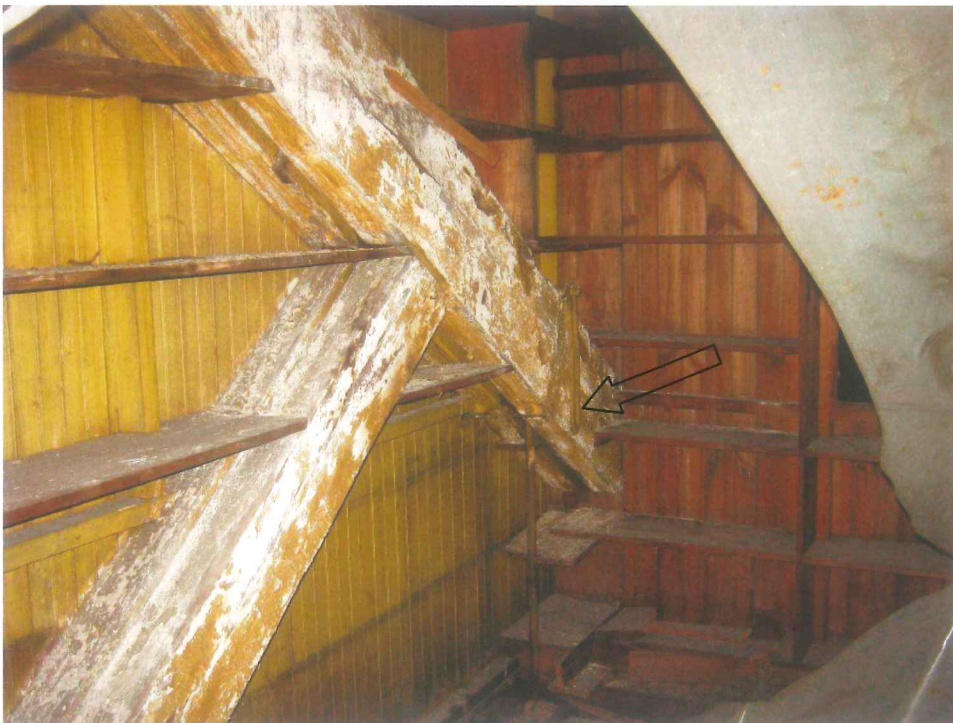
Photo 2-4: Broken truss hanger saddle hanger.

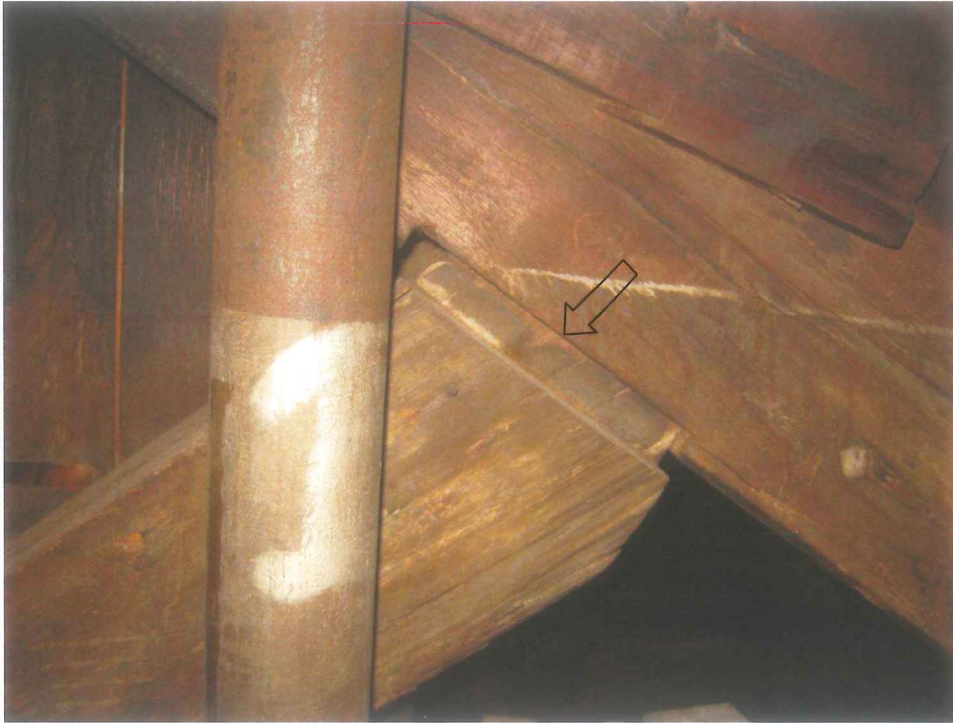
Photo 2-5: Timber truss joint separation.

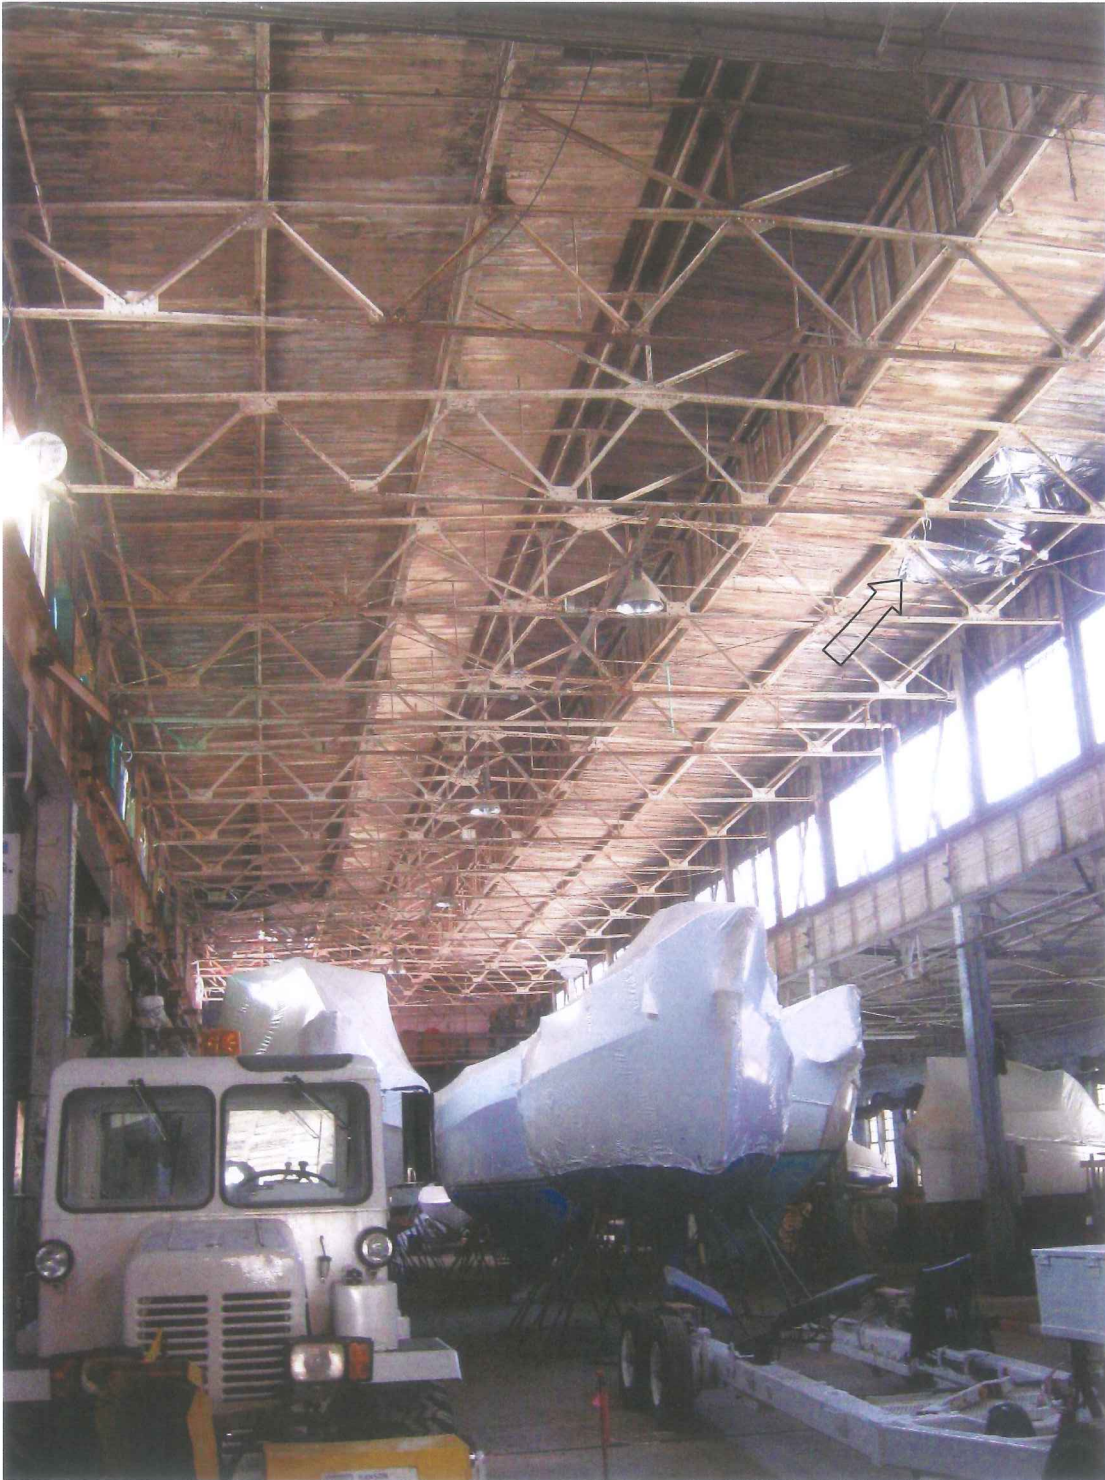
Photo 4-3: View of Building 4 interior looking east. Note plastic leak catch.
