- i. Presentation on Findings of Building Condition Report; PORTLAND COMPANY COMPLEX, 58 FORE STREET; Report prepared by Resurgence Engineering and Preservation for City of Portland Planning Department.

**RE:** April 1, 2015      WORKSHOP – Presentation on Findings of Building Condition Assessment of Portland Company Complex

# PORTLAND COMPANY COMPLEX GENERAL BUILDING CONDITION REPORT

PERFORMED FOR  
CITY OF PORTLAND, MAINE PLANNING DEPARTMENT  
389 CONGRESS STREET  
PORTLAND, ME 04101

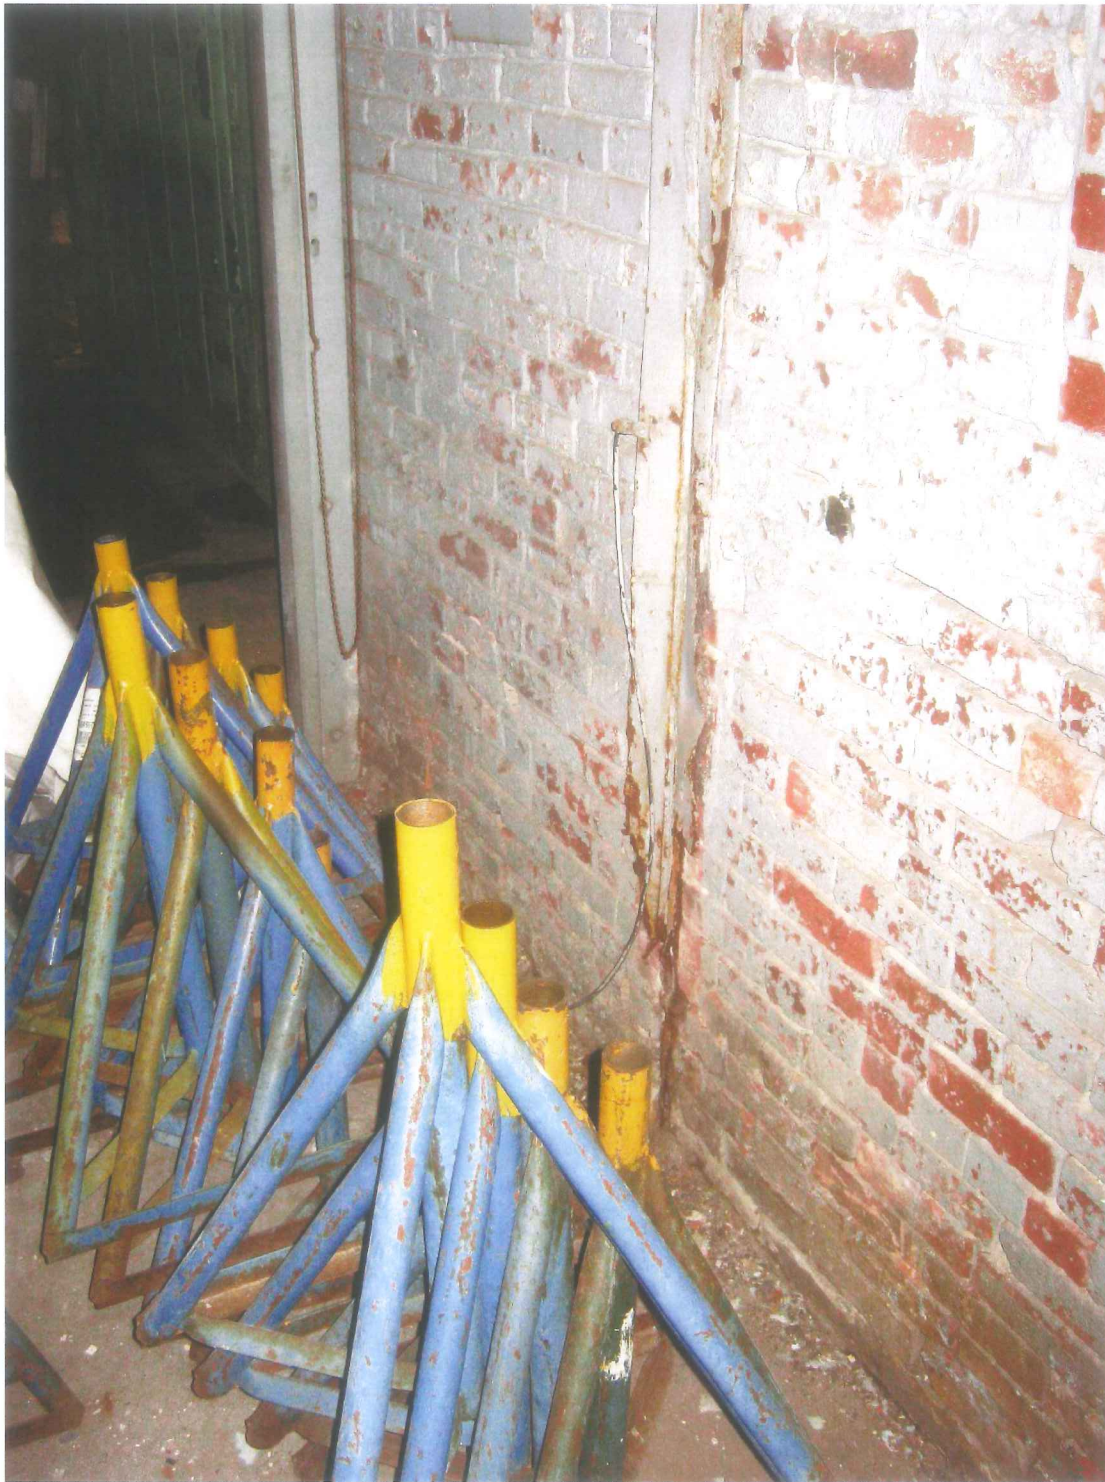
Photo 4-4: Column at exterior wall embedded in masonry. Note column section completely deteriorated.

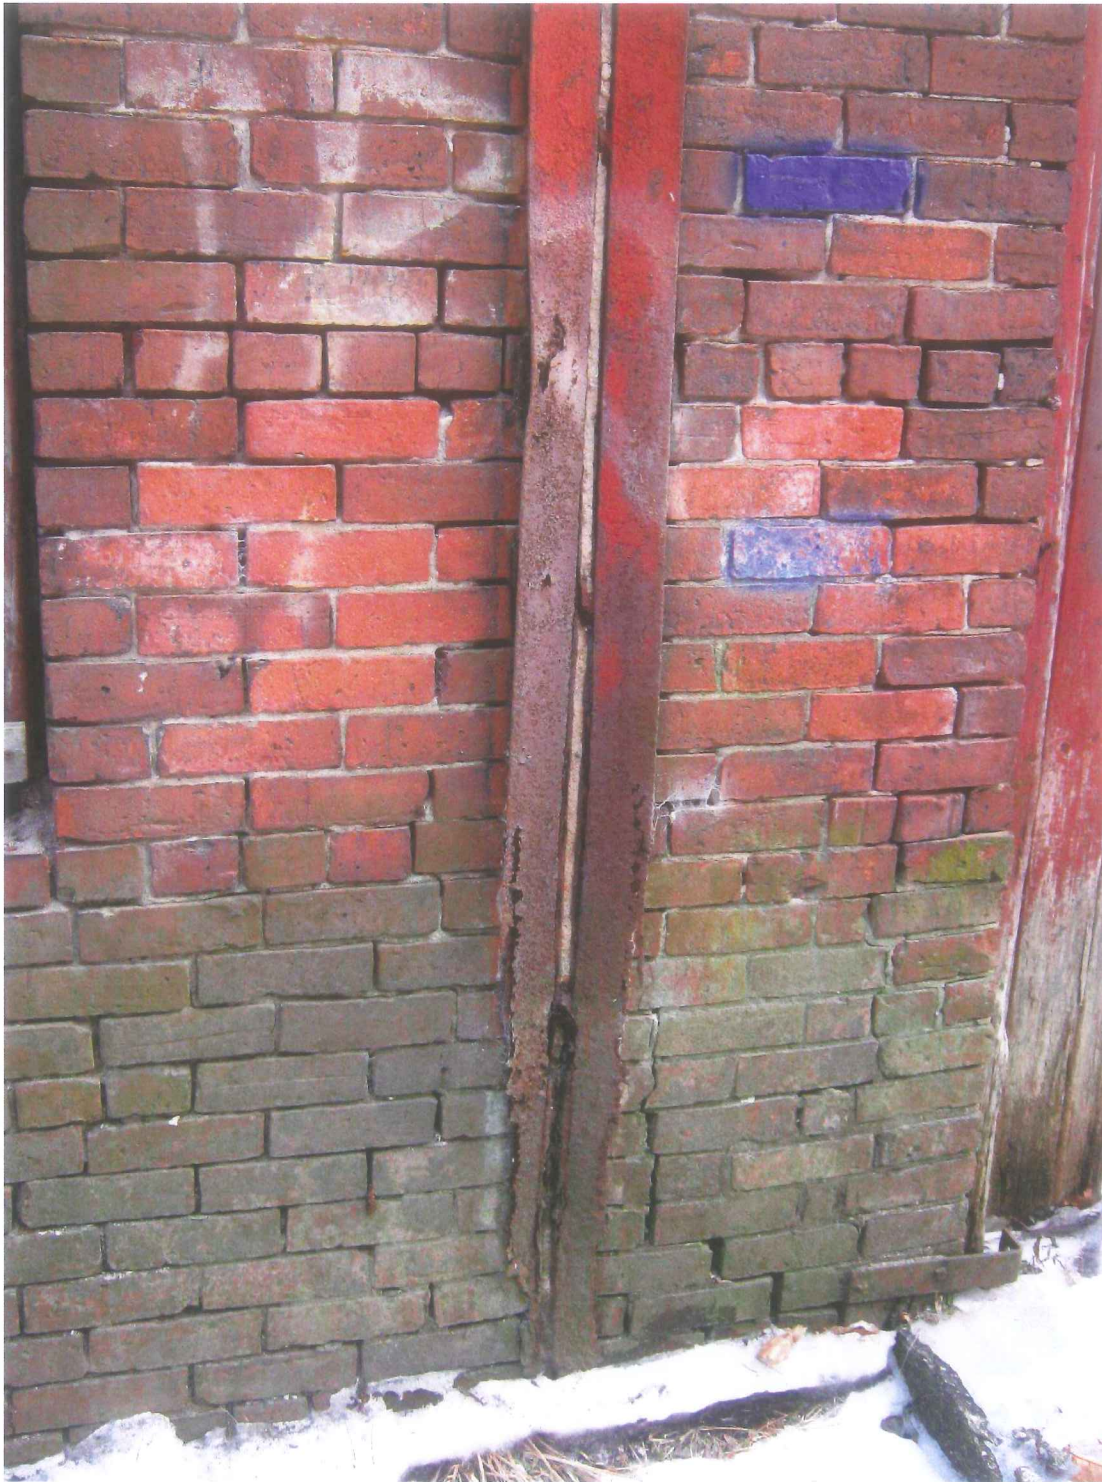
Photo 4-5: Column at exterior wall embedded in masonry. Note column section completely deteriorated. Also note open masonry joints, cracked bricks.

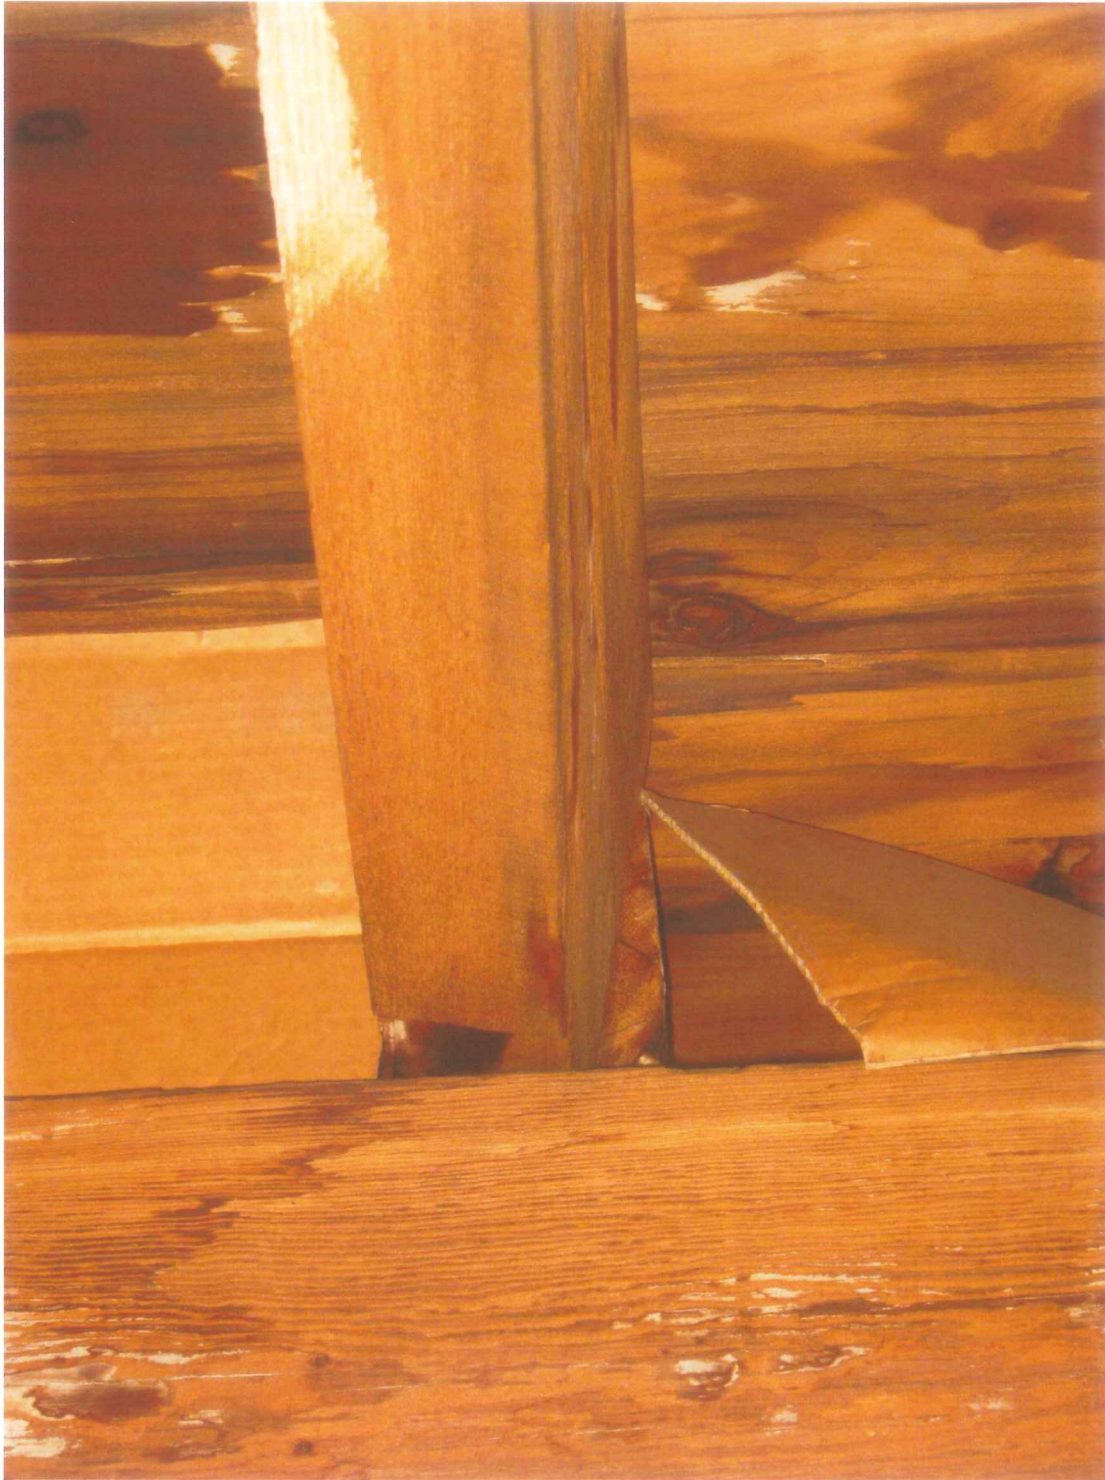
Photo 6A-5: Rotated roof rafter and evidence of prior leaking.

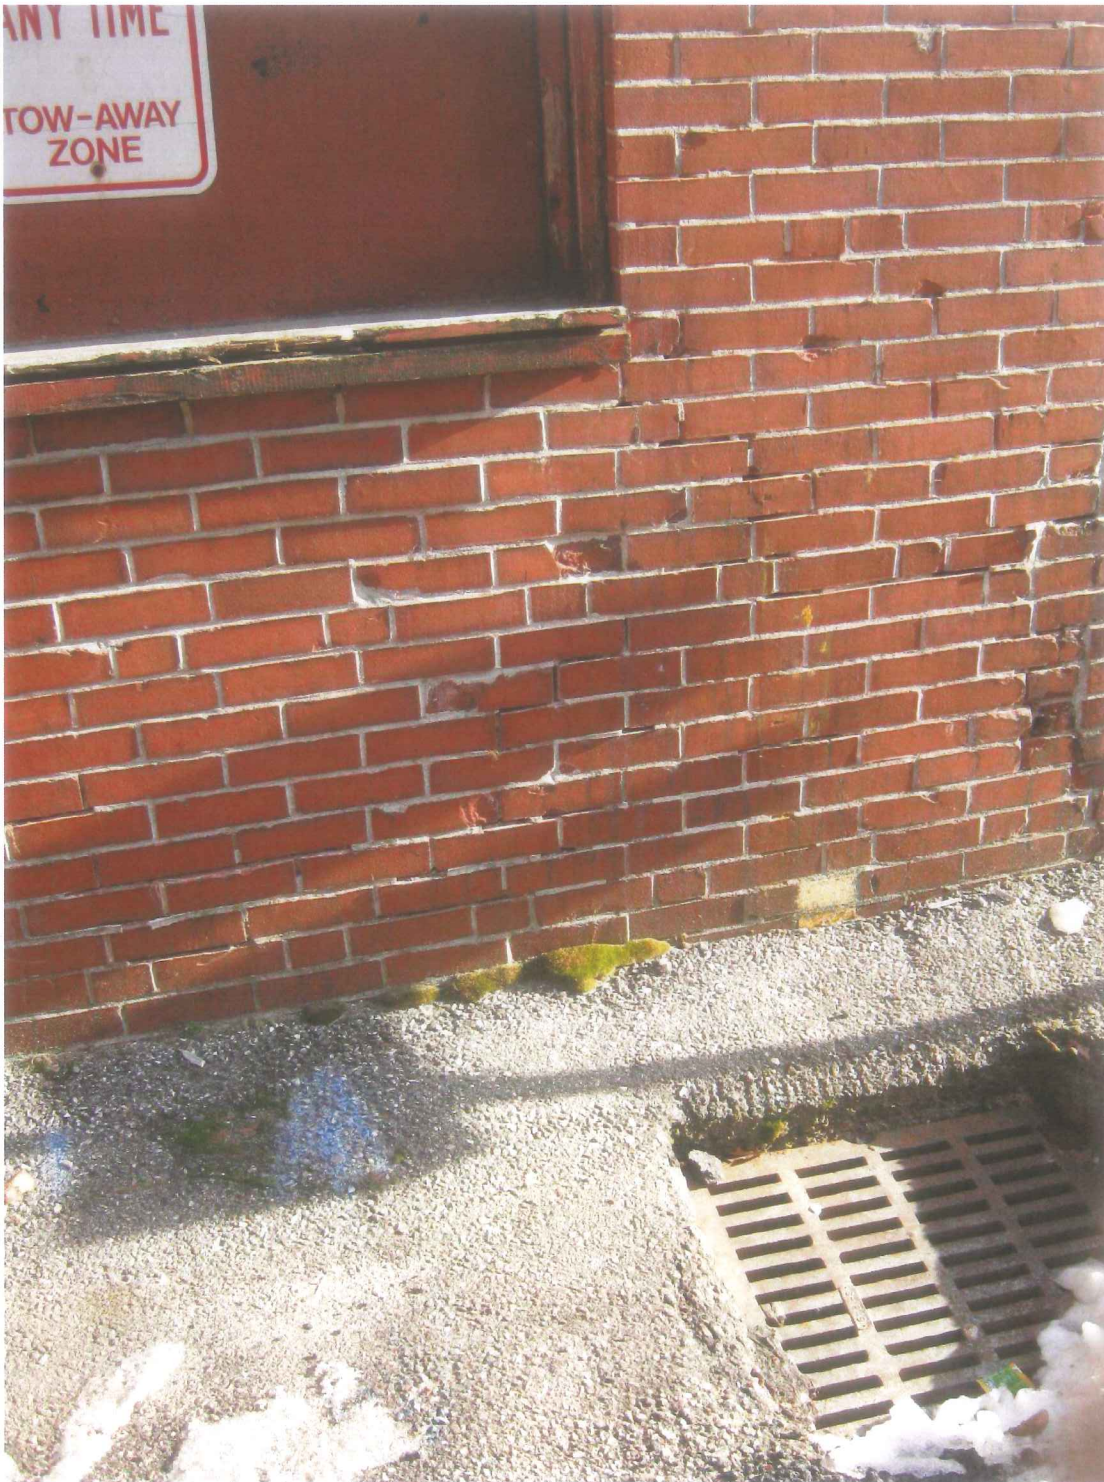
Photo 6A-6: Moss, spalled bricks, open masonry joints and rotting wood sill at Building 6A.

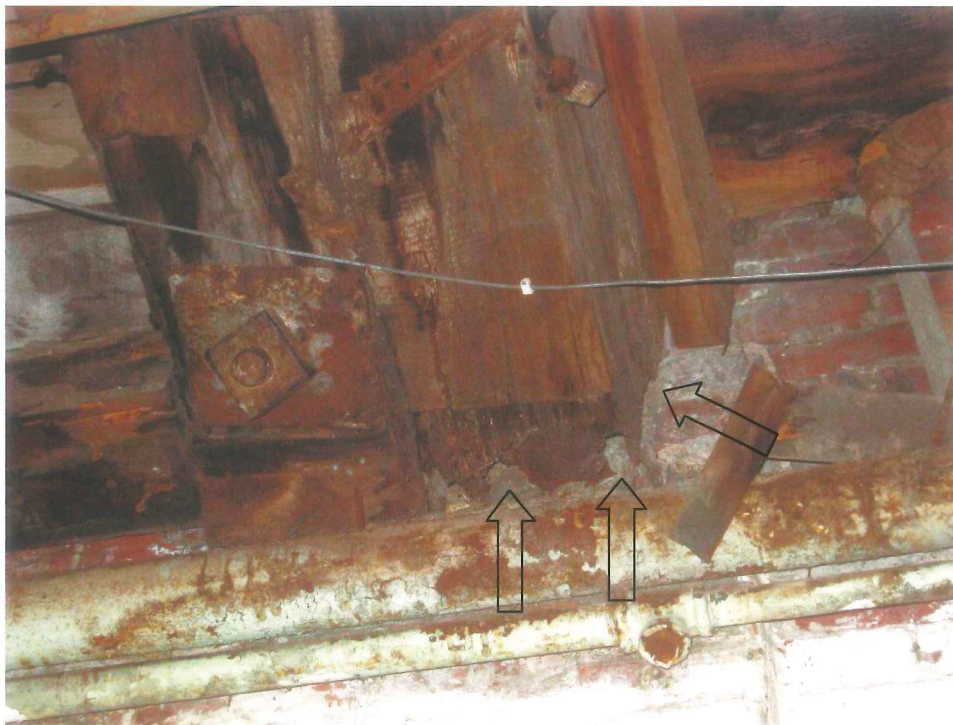
Photo 6B-2: Failed (deteriorated) end of timber truss supporting exterior wall of Building 6A.

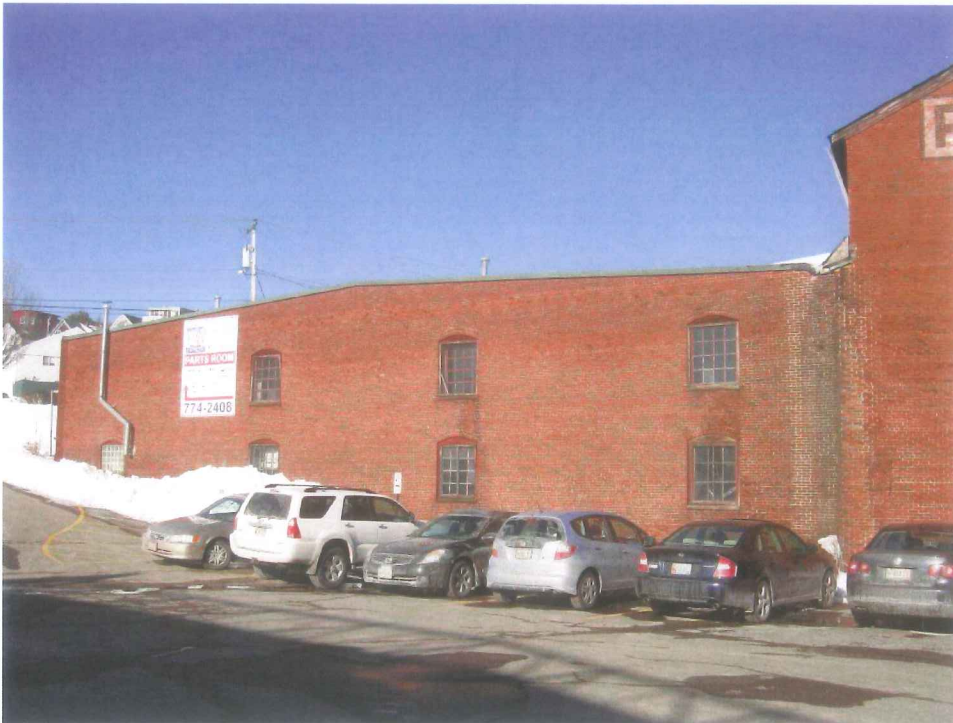
Photo 11-2: West elevation of Building 11. Note drainage condition where building 11 meets building 12.

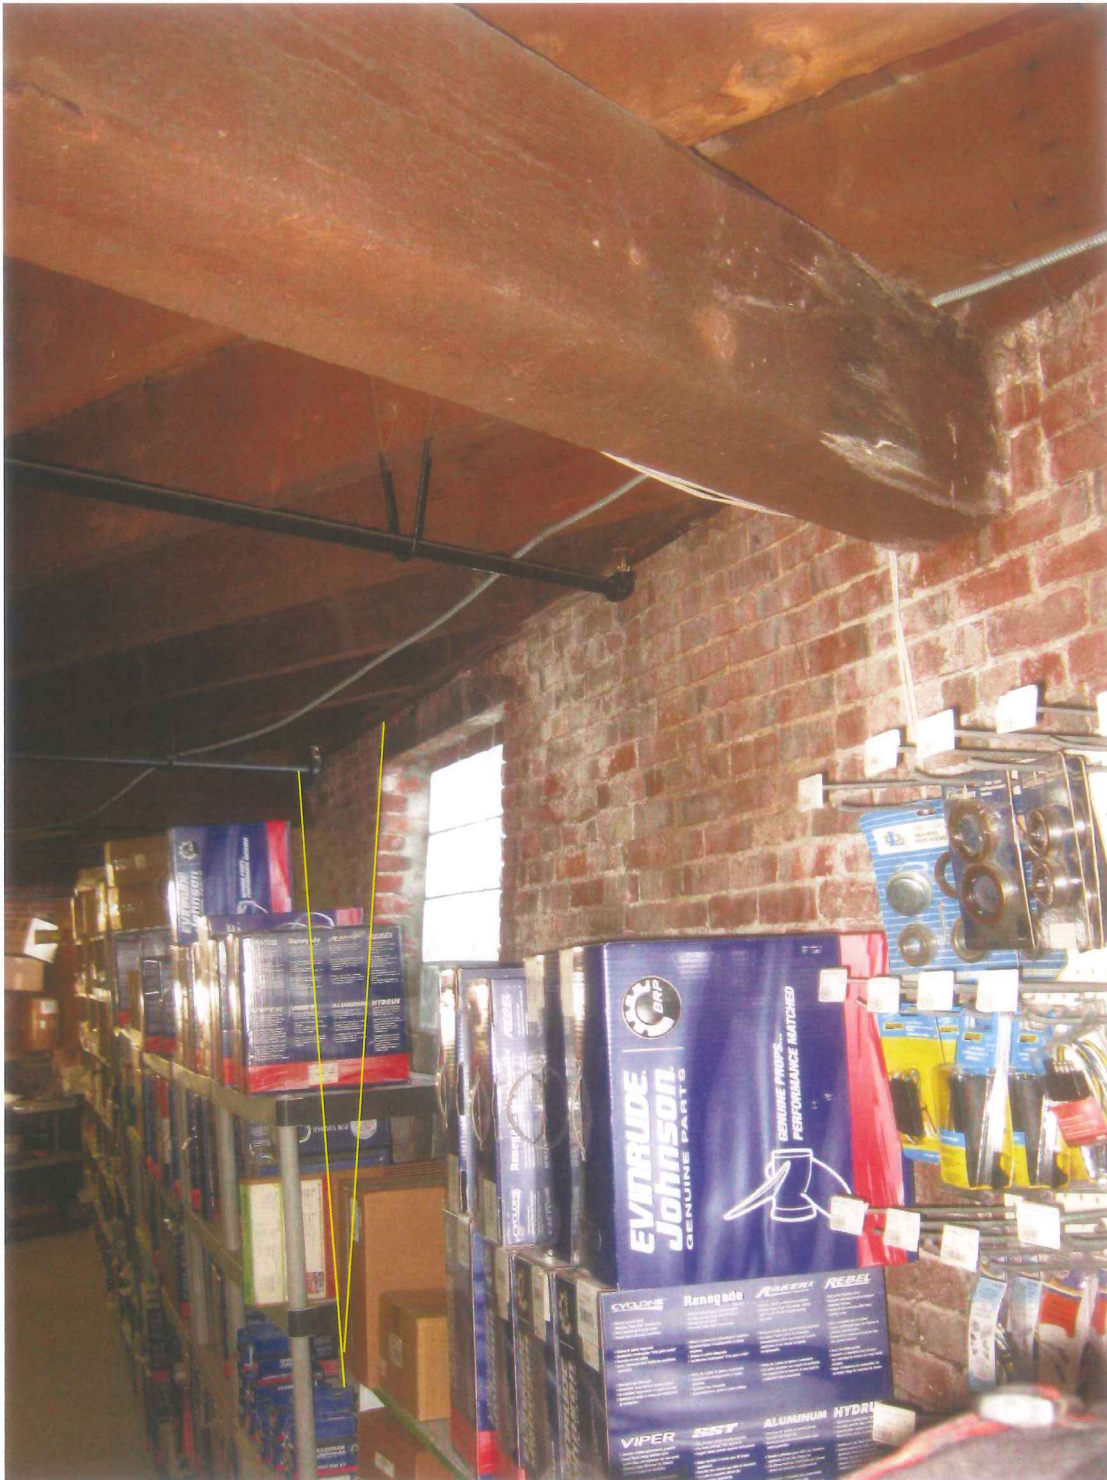
Photo 11-3: Bowed north wall retaining embankment (lines added for emphasis).

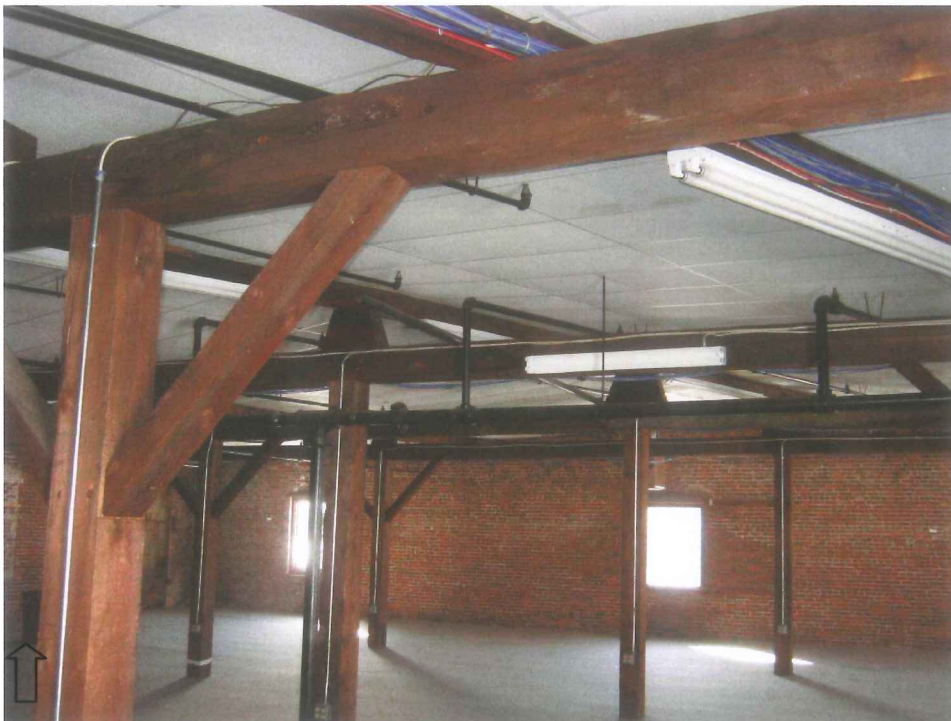
Photo 11-5: Stacked framing system for Building 11 roof. Note leak catch bucket behind column.

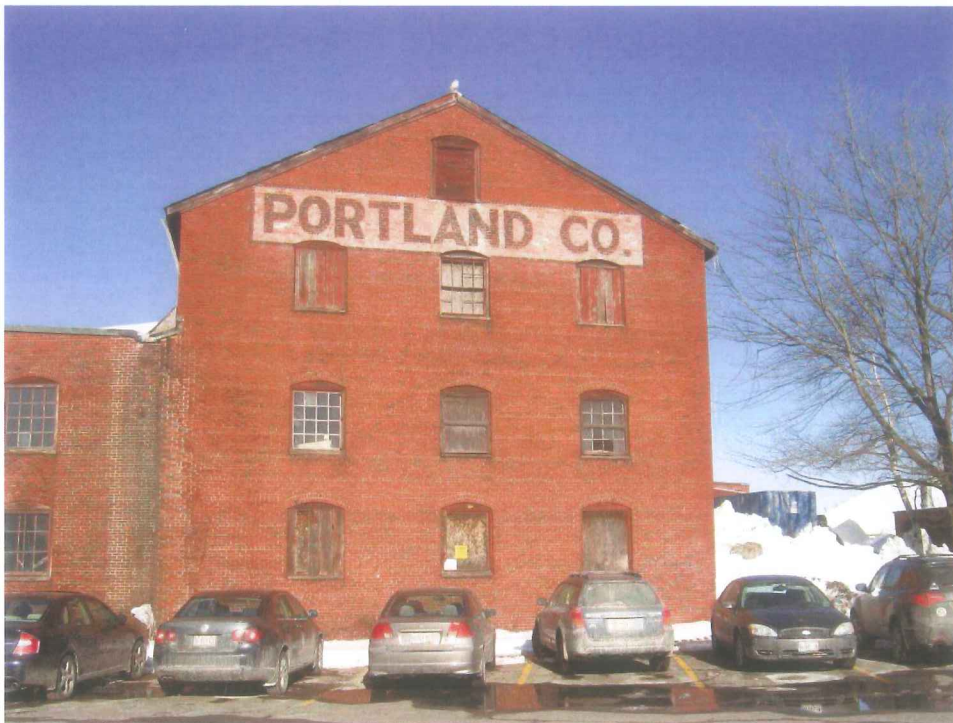
Rating Justification: The roof of building 12 is in poor condition and has been letting water into the building for an extended duration. Roof, upper floor and columns of building will require repairs or reconstruction. Masonry damage is significant and portions of masonry walls will need to be rebuilt. Building is located at a low point on the site and drainage condition at crawlspace will need to be resolved. Despite issues, structural “bones” of building are substantial and it was well constructed in its day.

Photo 12-1: West elevation of building 12. Note windows with missing and broken panes, loose slates at eaves.

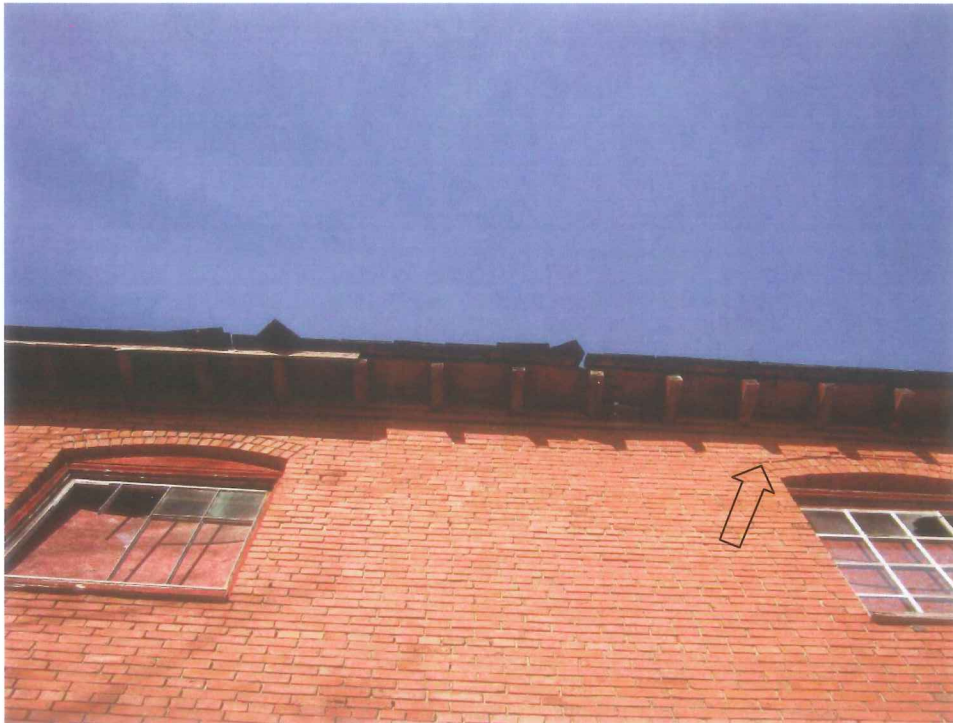
Photo 12-2: Eave with loose slates, missing eave trim, masonry cracking and broken windows.

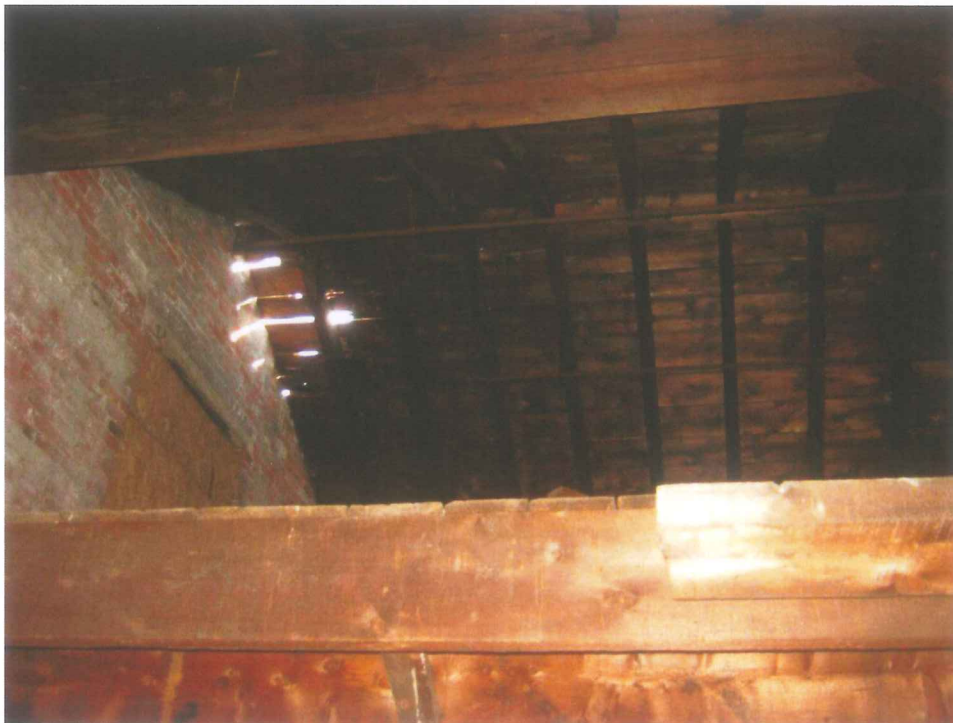
Photo 12-3: Daylight visible at through roof sheathing. Condition is at both ends of roof.

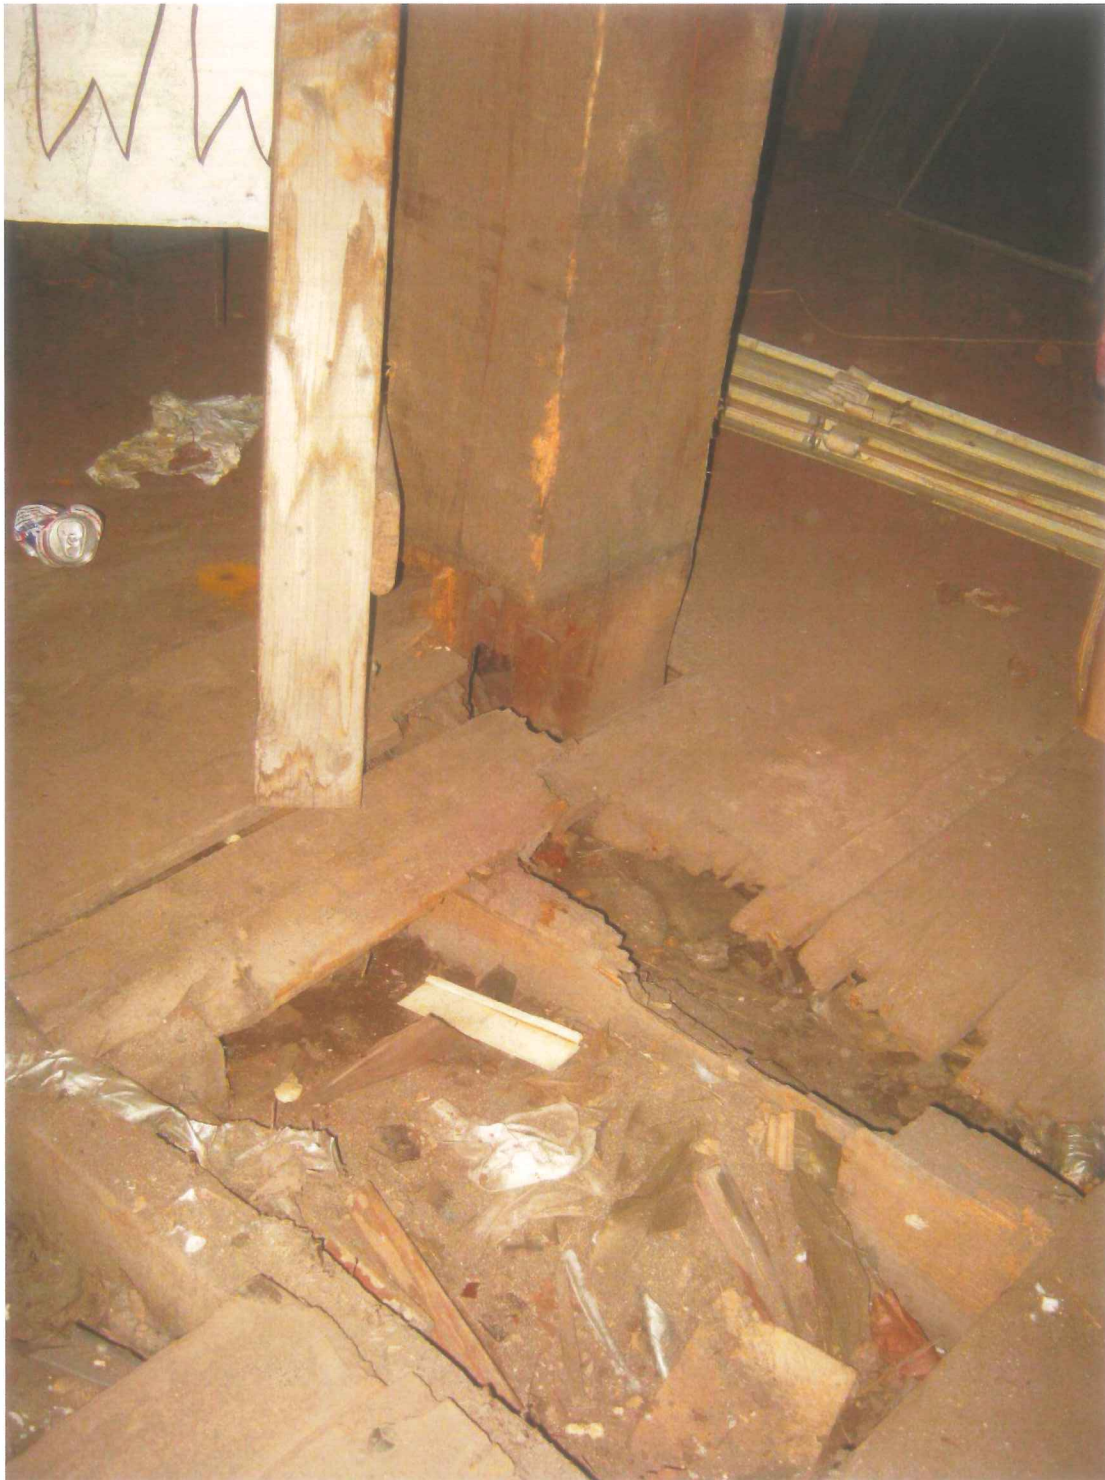
Photo 12-4: Rotting column bottom, floor joists and sills at ground floor.

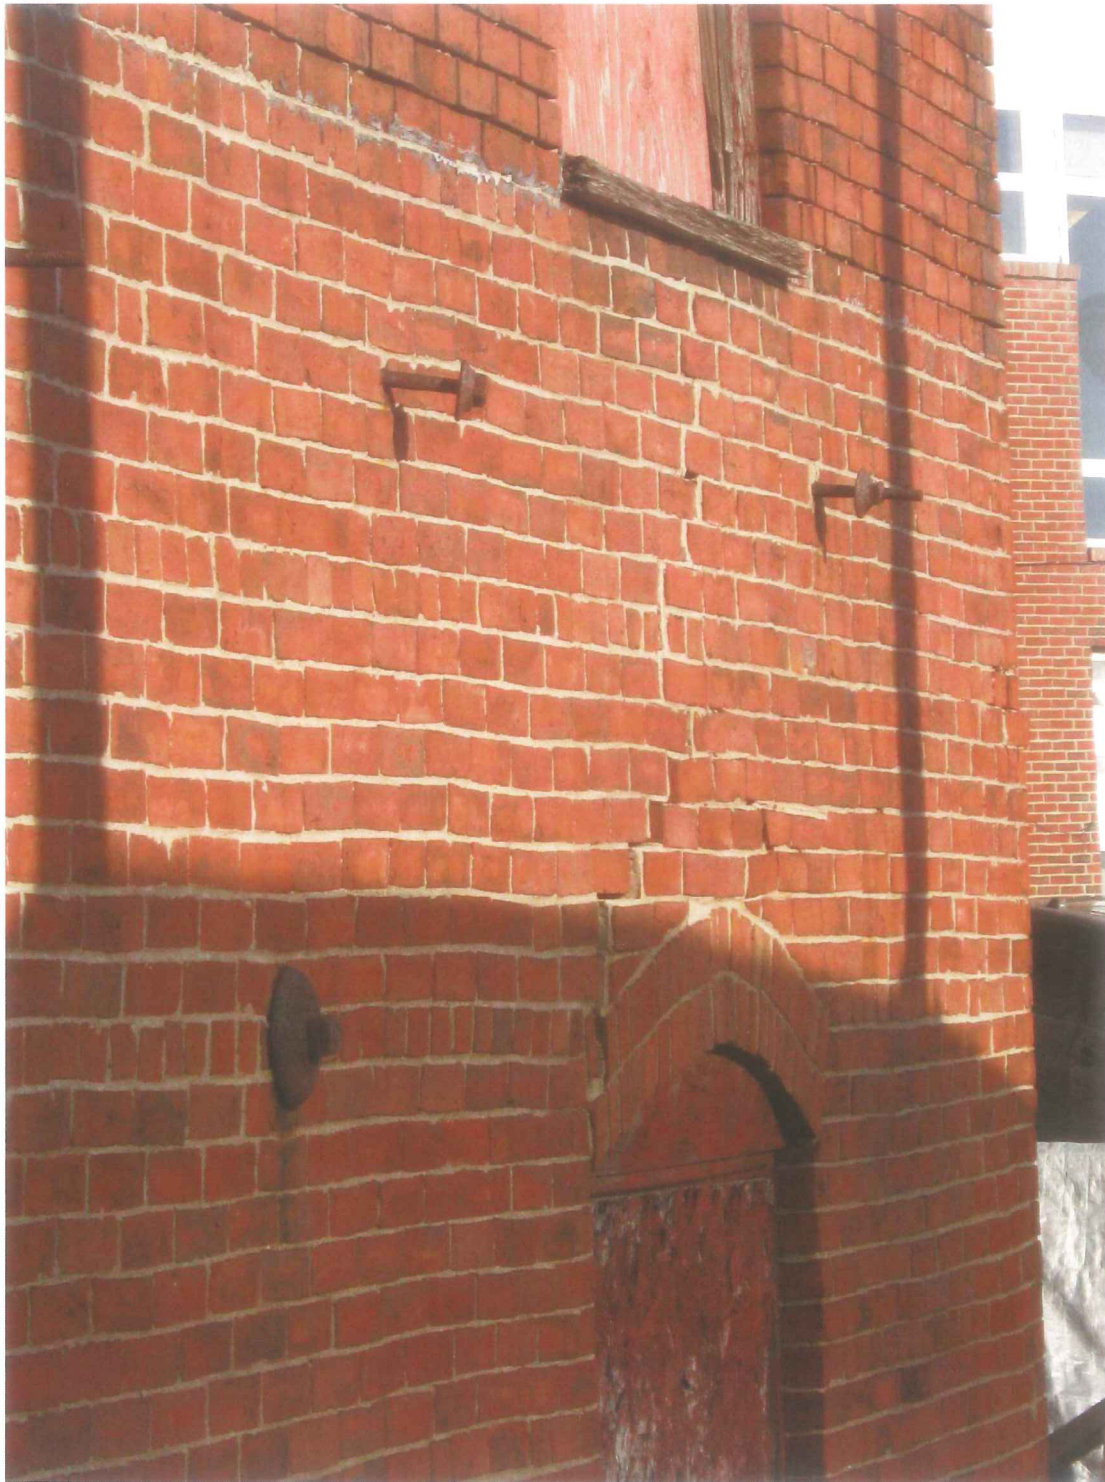
Photo 12-5: Diagonal masonry cracking over window opening, open joints, rotting window sill.

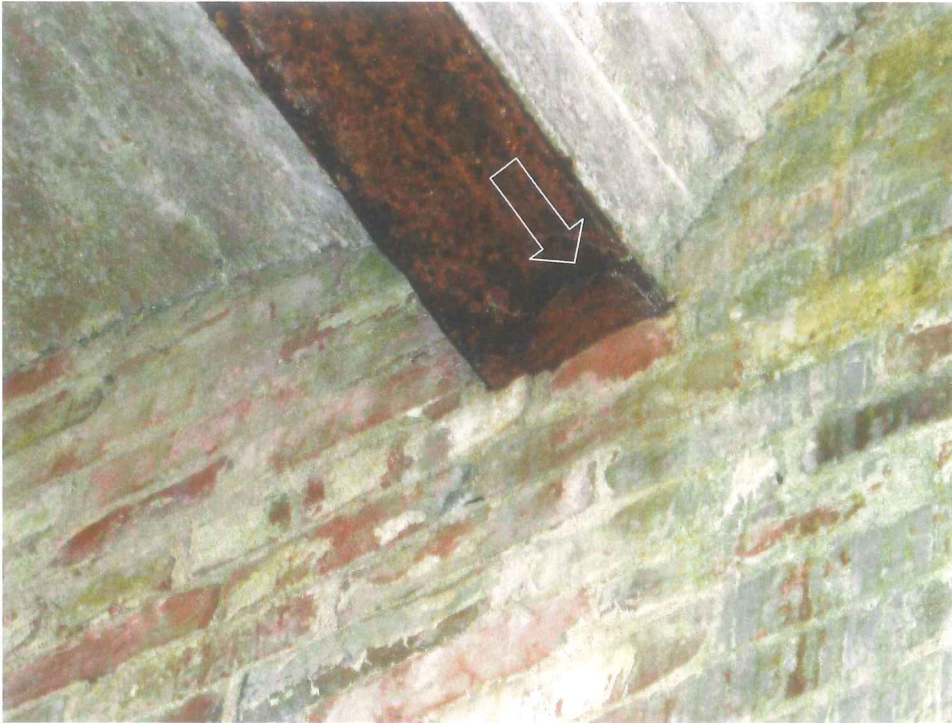
Photo 58-3: Beam end condition with flaking rust.

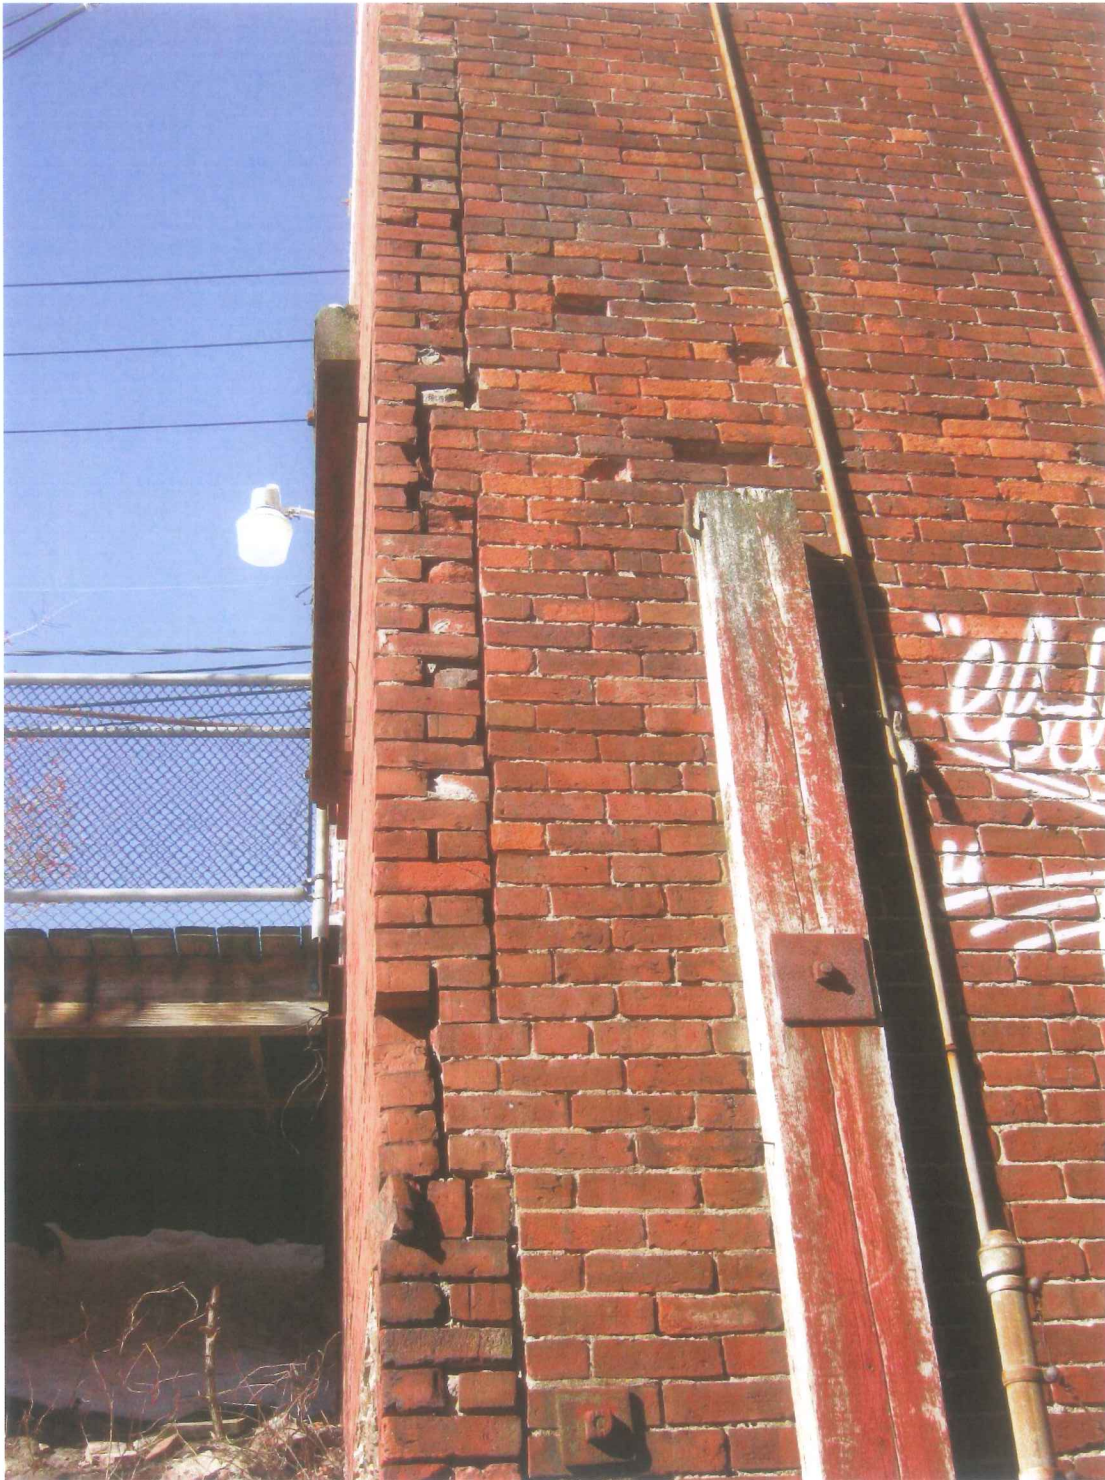
Photo 58-4: Open joints and missing bricks at the corner of the vault/tower.

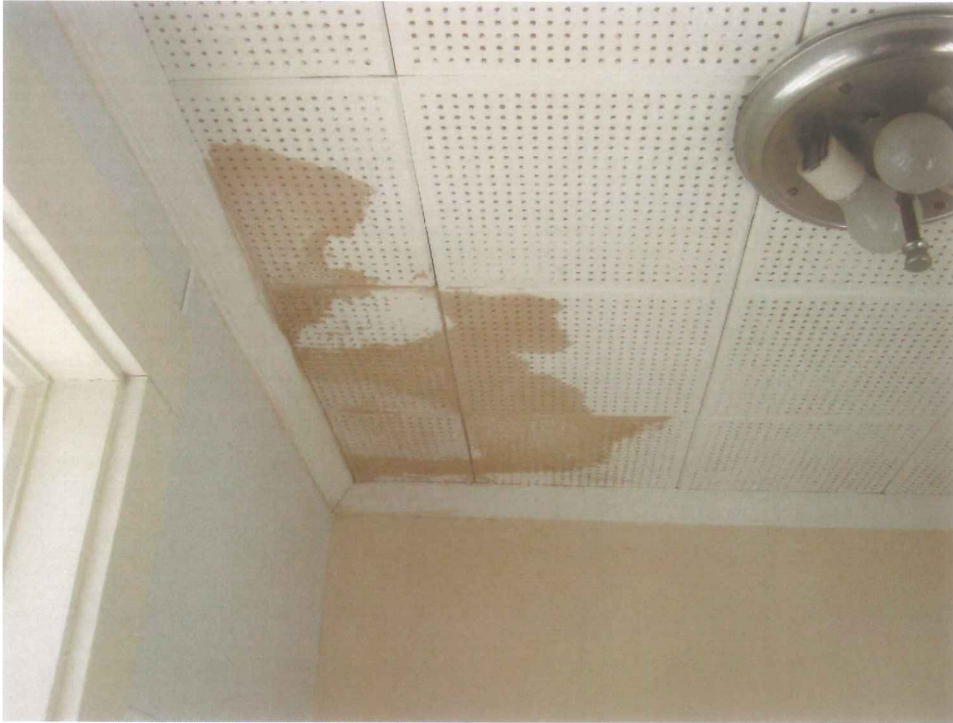
Photo 30-3: Leaking noted at ceiling adjacent to southwest wall.

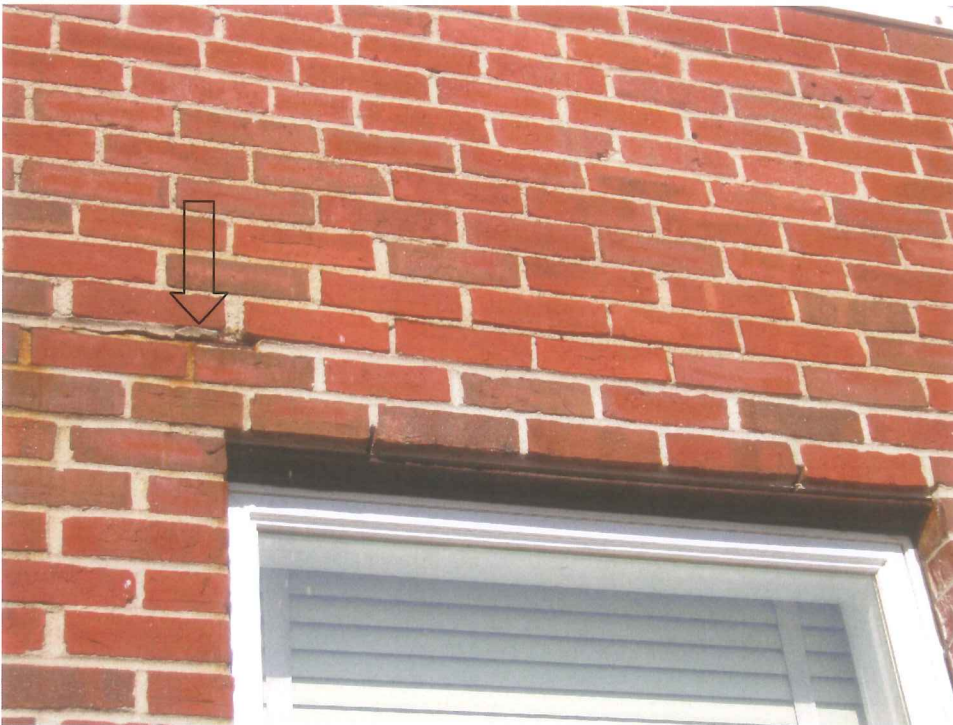
Photo 30-4: Mortar falling from joint with steel protruding; corroded steel lintel and broken mortar adhesion.
