## Historic Preservation Board

Wednesday, January 18, 2023 at 5:00 PM  
Via Zoom

Replacement of a Tool House  
at the  
Western Cemetery  
Portland, Maine

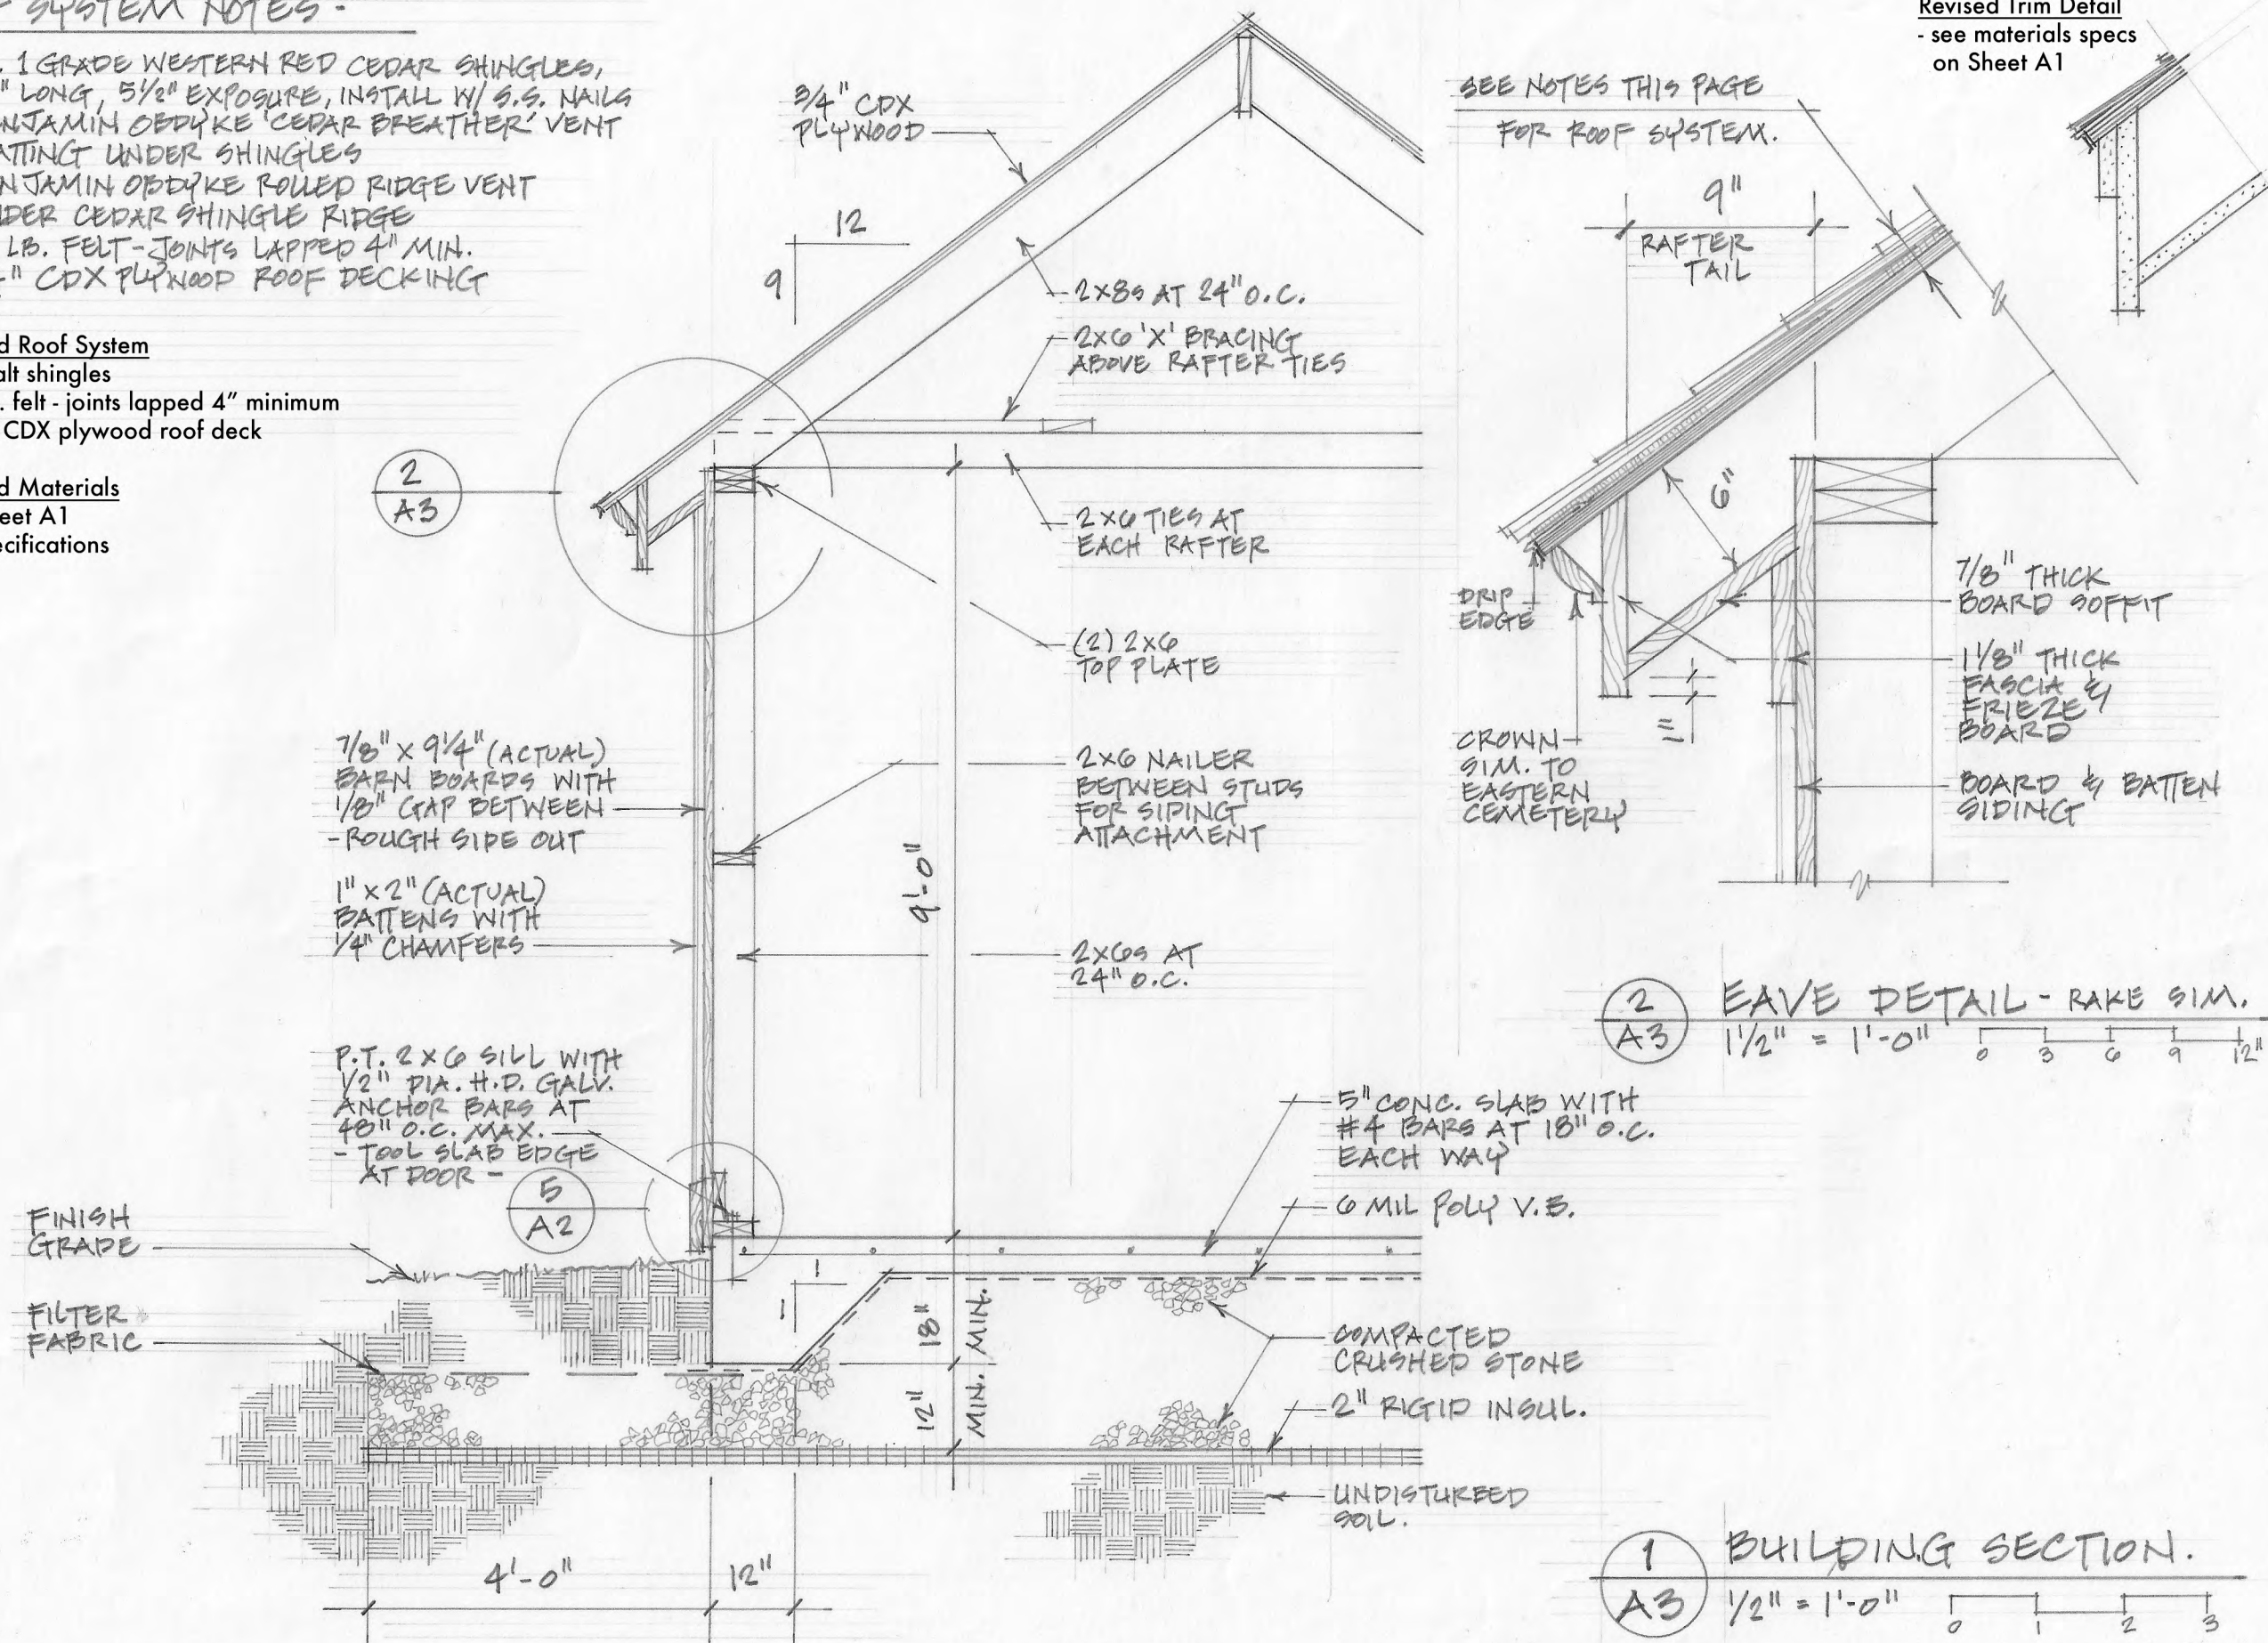
Revised Trim Detail  
- see materials specs  
on Sheet A1

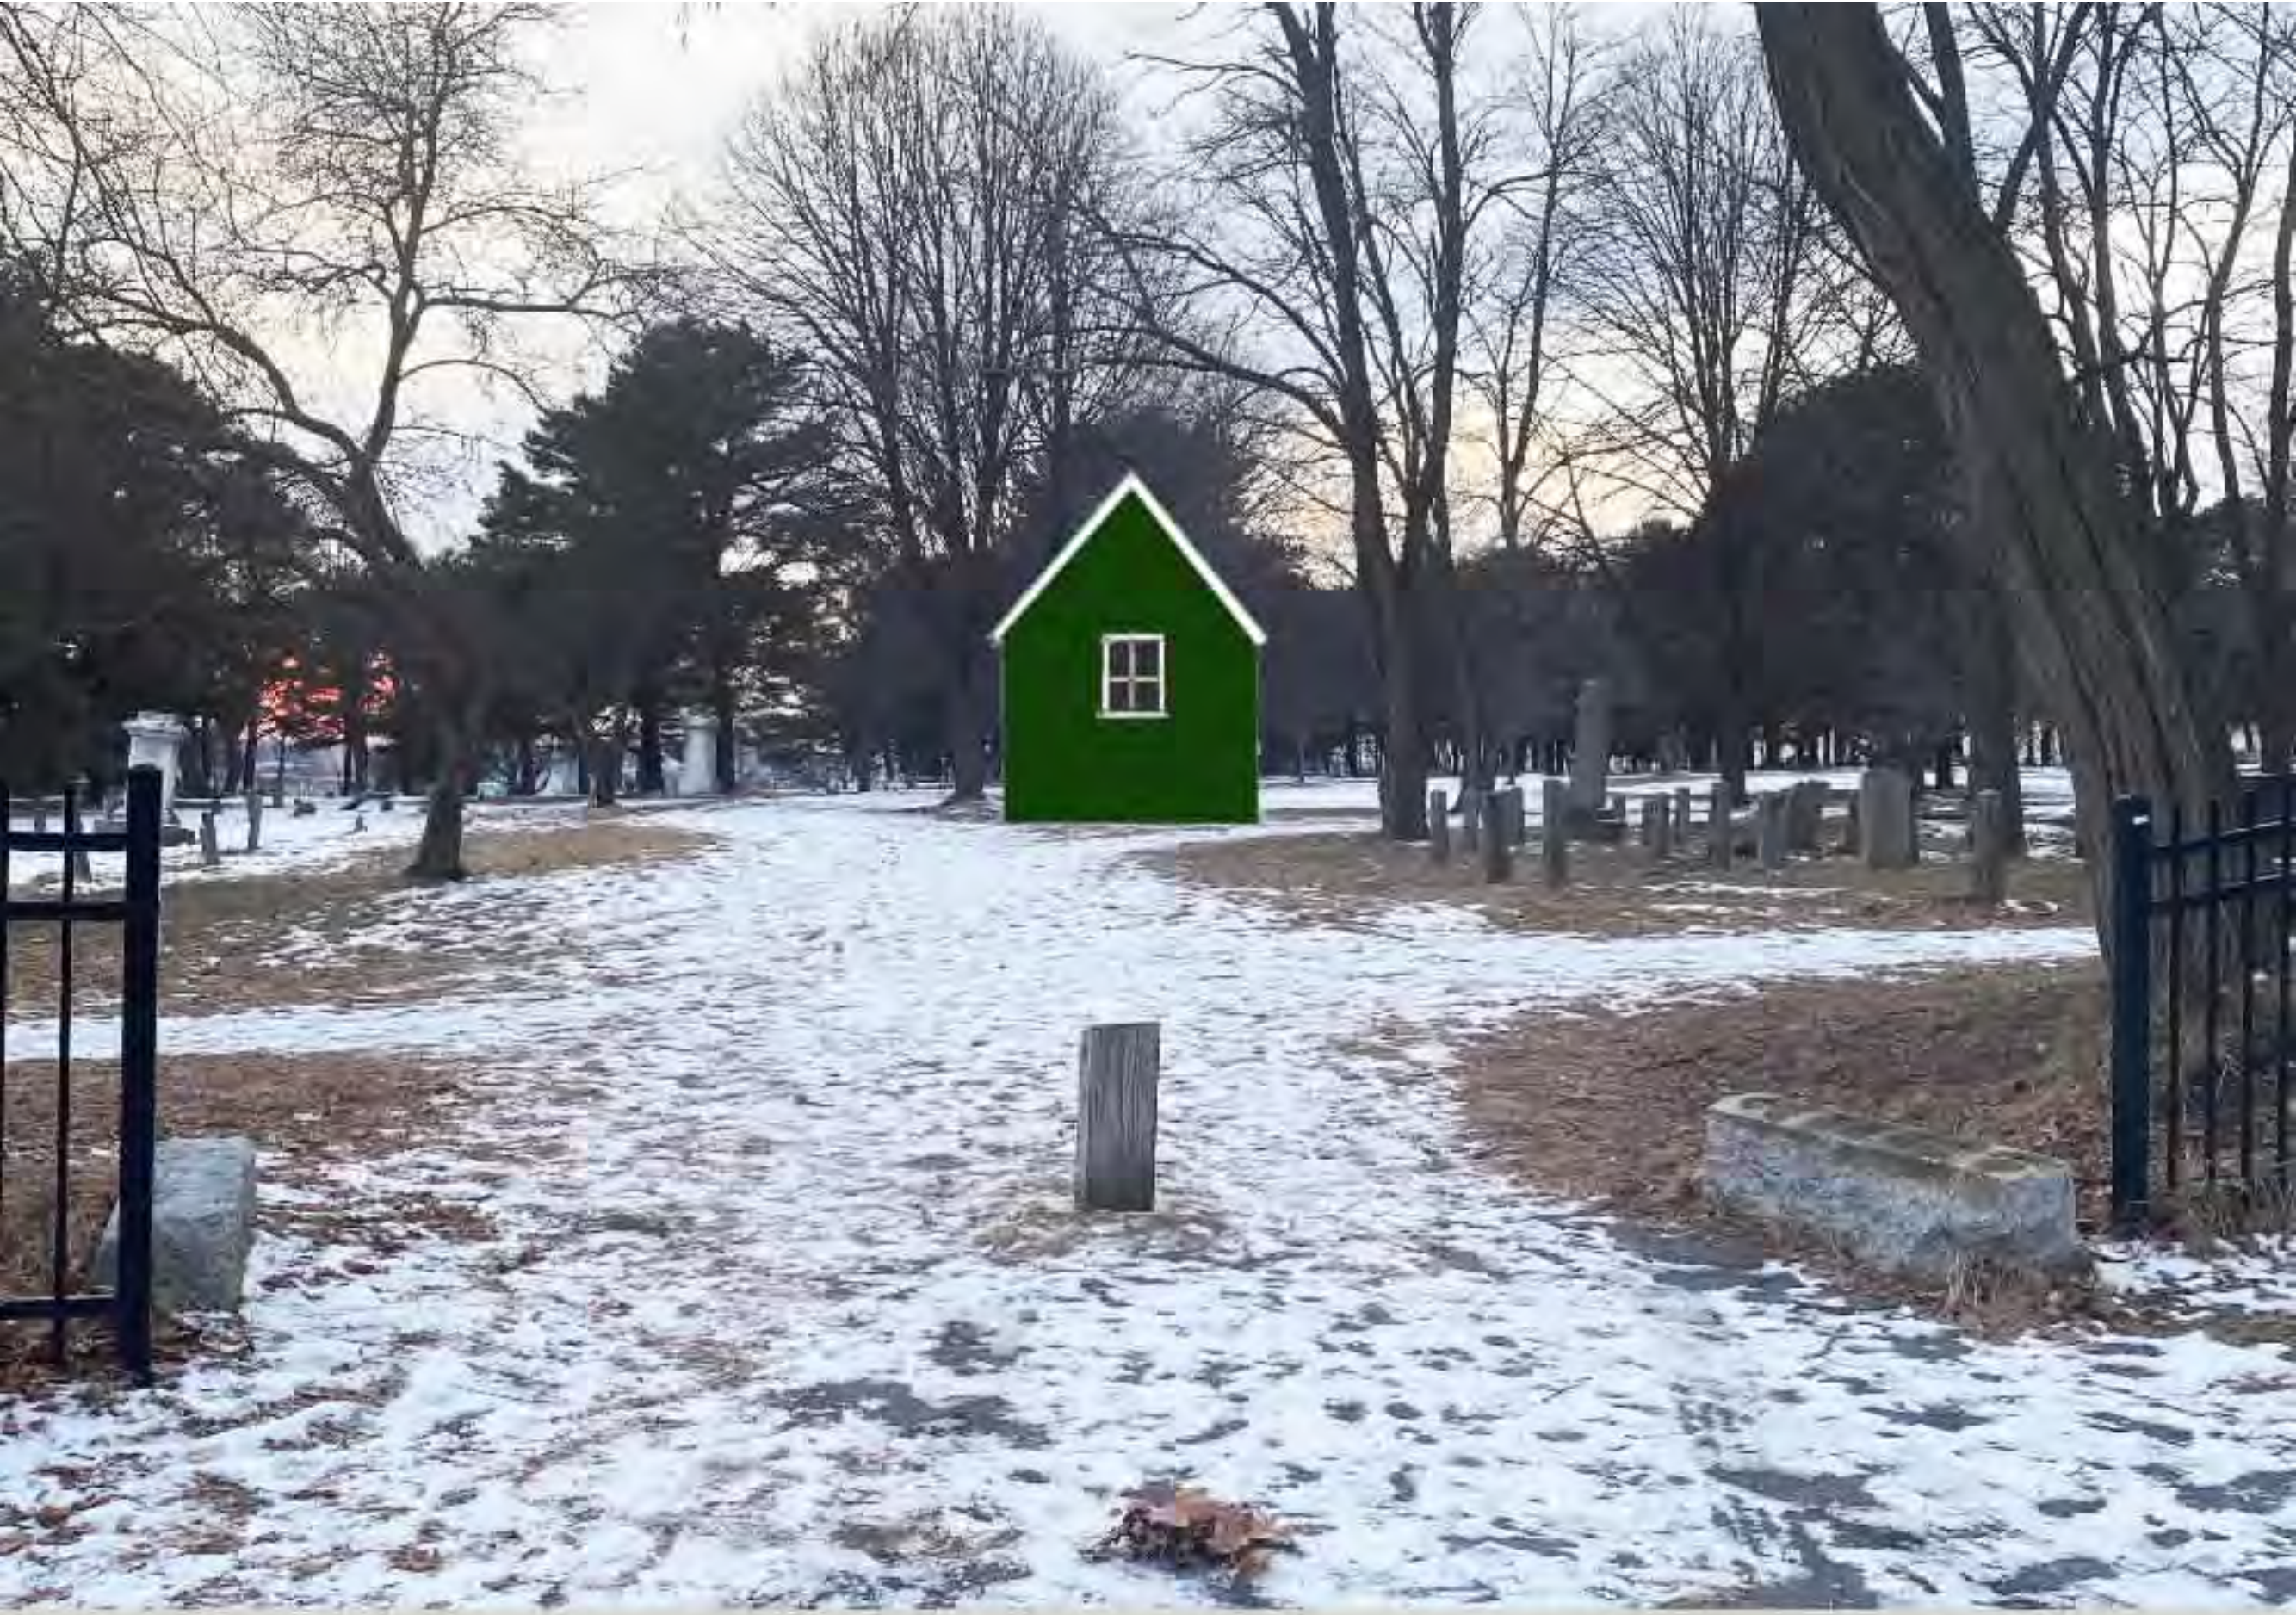
*View from the maintenance entry with a scaled version of the proposed tool house at front edge of Woodbine Grove.*

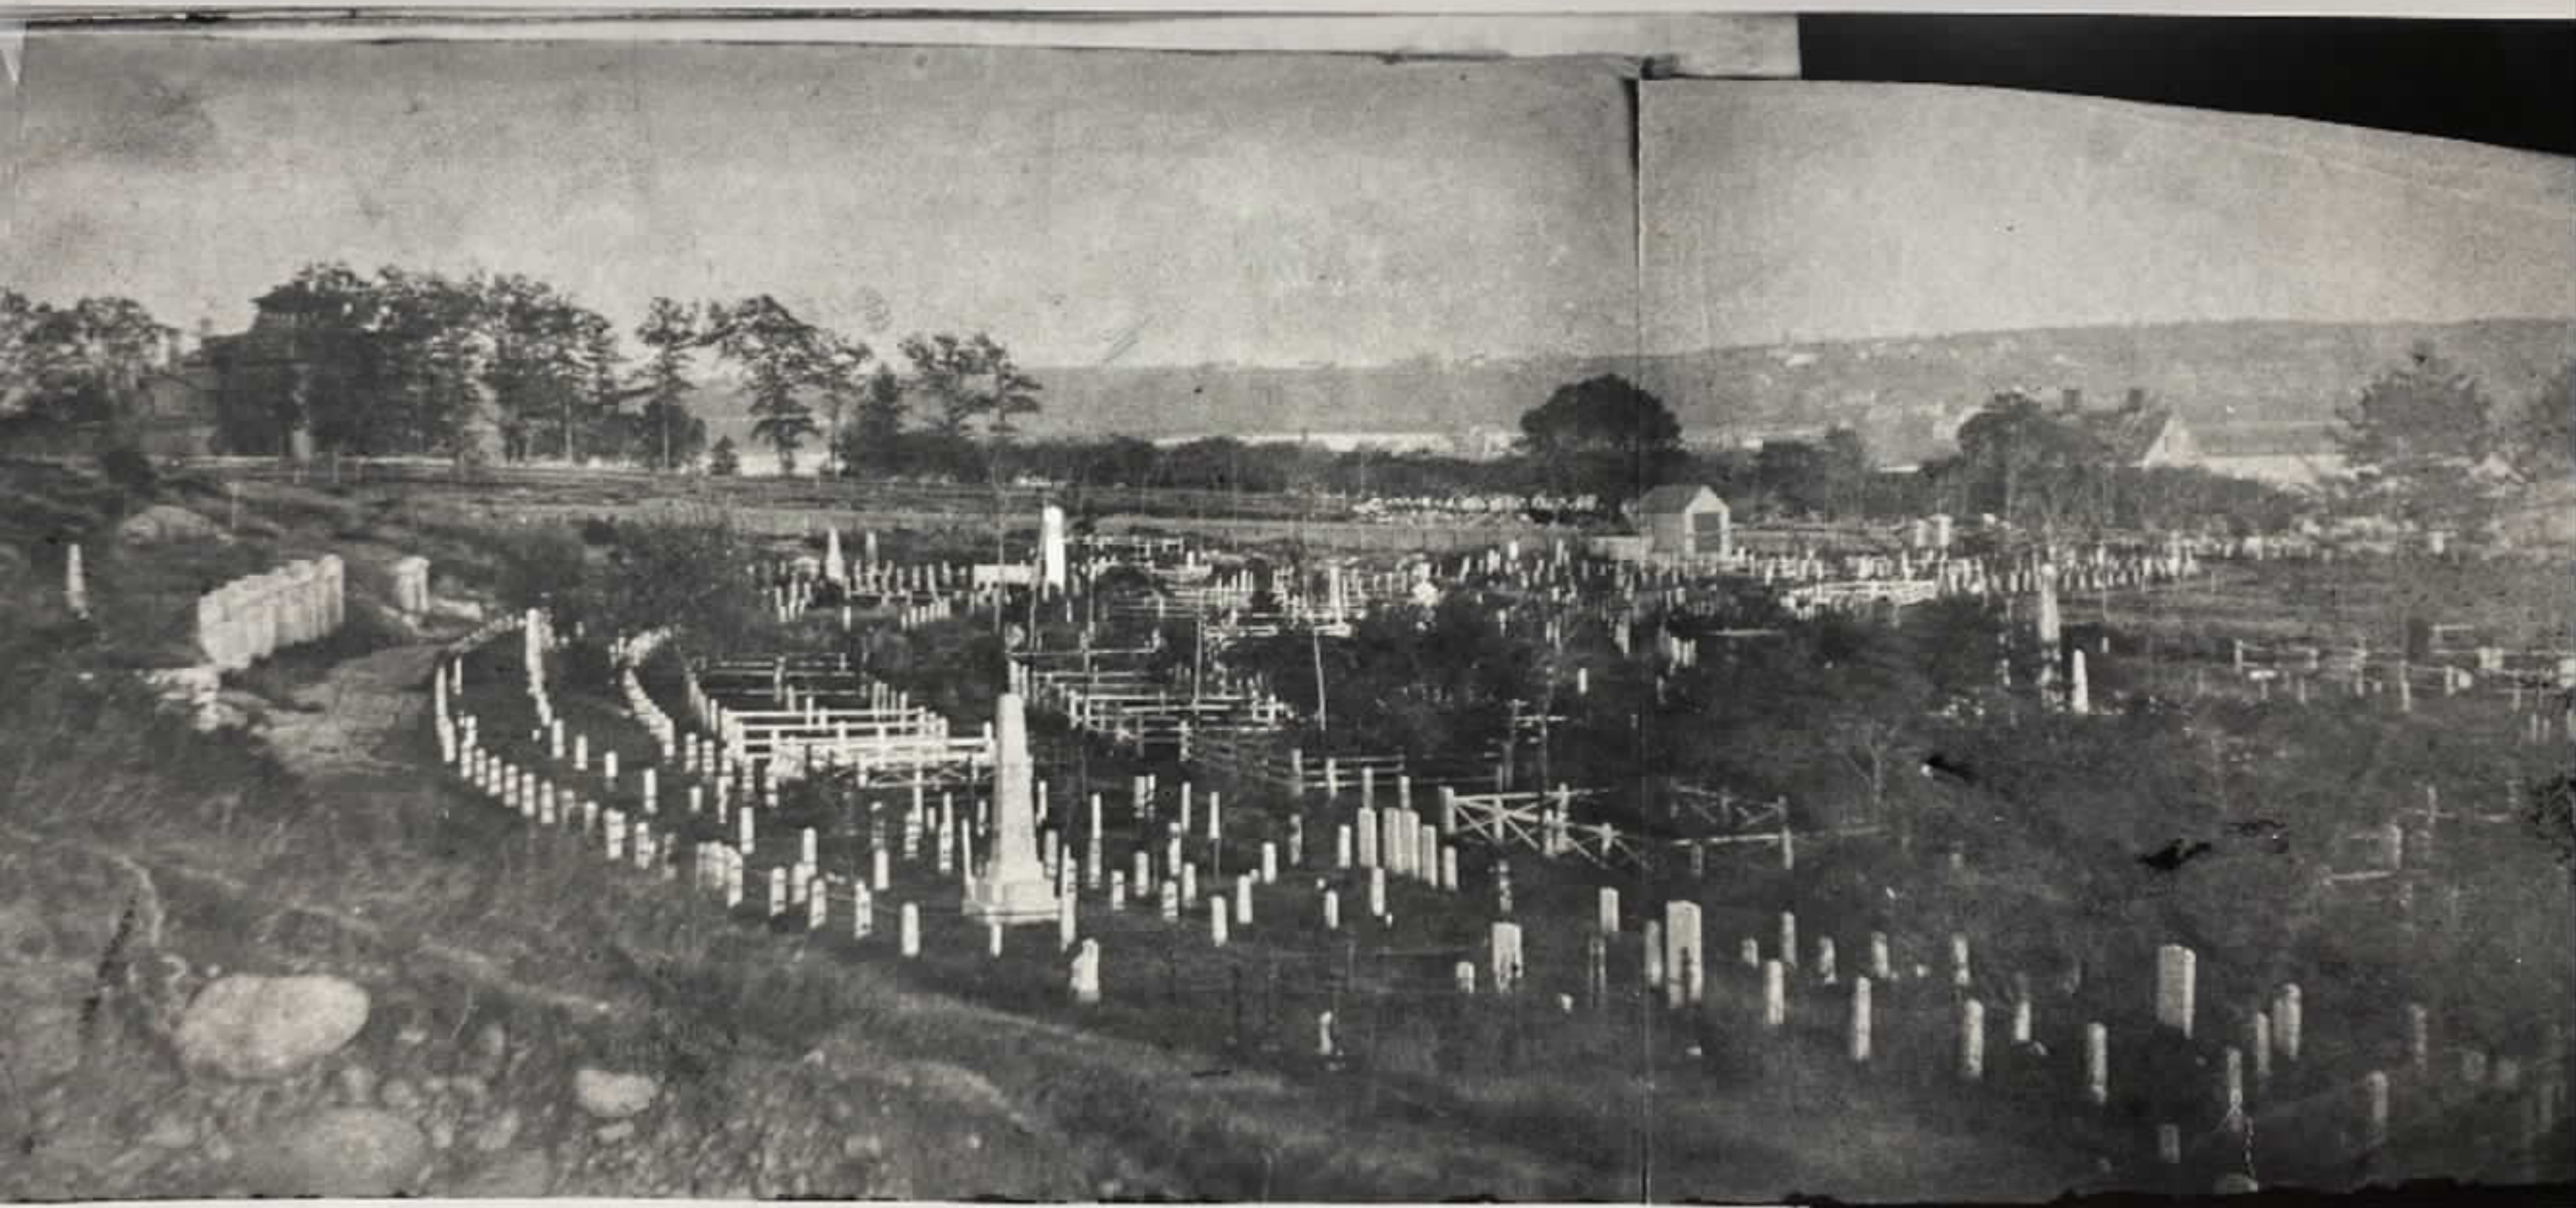
*An 1857 photograph taken from the Western Promenade side of Western Cemetery shows a utility building near the Vaughan Street maintenance entry.*

As noted in the Stewards' project description (see Attachment 1,) a small building is visible in the 1857 photograph of the cemetery, close to the Vaughan Street fence and a pedestrian entrance. The 1889 plan by City Engineer William Goodwin shows a similarly sized building some distance into the cemetery, roughly where the current proposed site is for the new tool house "...at the eastern tip of Woodbine Grove." No explicit documentation exists on the use of these buildings, but there is no evidence that they were constructed like the Eastern Cemetery's Dead House, with space for temporary, subterranean storage of bodies.

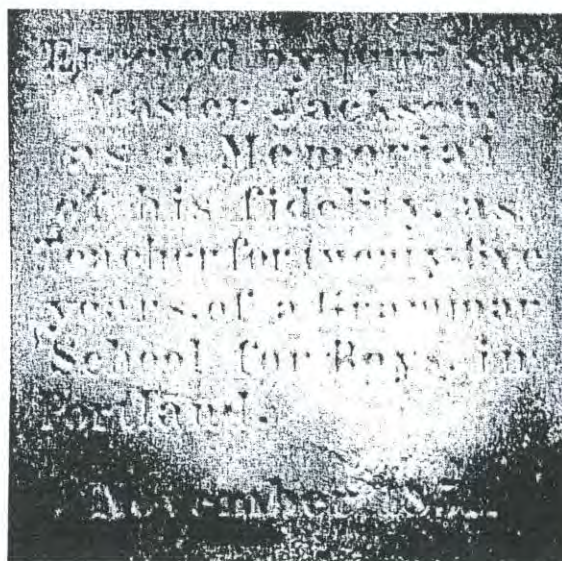
*Eroding inscription on Jackson monument*

The stones that show the most extensive deterioration and are the most at risk are the marble markers. Calcium carbonate is particularly susceptible to deterioration from acidic deposition [acid rain] and other atmospheric pollutants. About 1,000 of the marble markers [over 60% of the total markers] have eroded surfaces varying from slight to severe. Lichen, moss, mildew, fungi grow on many of the marble, sandstone and even granite markers. The markers in the best condition are the slate tablets and granite markers. While all of the slates have clear inscriptions and very little splitting or spalling, many are tilted and need to be reset to preserve their stability.

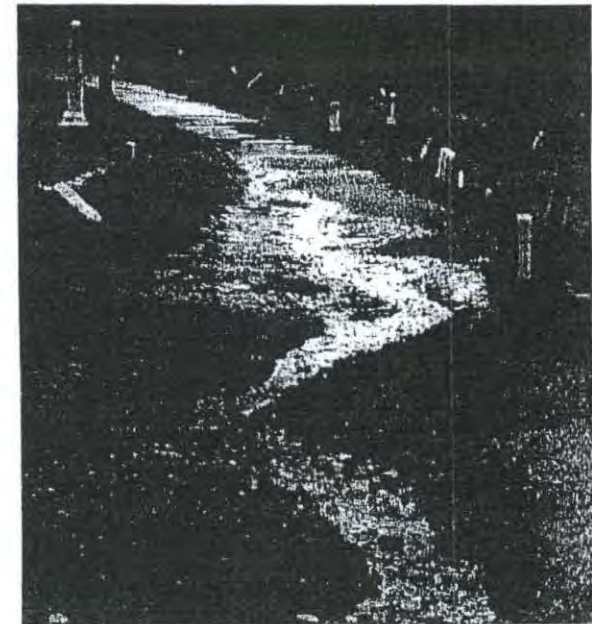
*Erosion on southwest perimeter avenue*

The Fir Avenue on the north side, from the high point near the Longfellow tomb, carries a concentrated flow toward Vaughan Street and then turns toward the central oval, Woodbine Grove, near the Daveis Memorial Gate where it runs over burial plots in an eroded area. It appears that earth fill has been added [it has a different color and texture than surrounding materials] inside the Daveis gate diverting surface drainage from following Fir Avenue adjacent to Vaughan Street. Water flows along Cypress Avenue adjacent to Woodbine Grove to the main vehicular gate and then down Fir Avenue parallel to Vaughan Street. At the southeast corner of the cemetery, water leaves the avenue and flows overland toward Western Promenade.

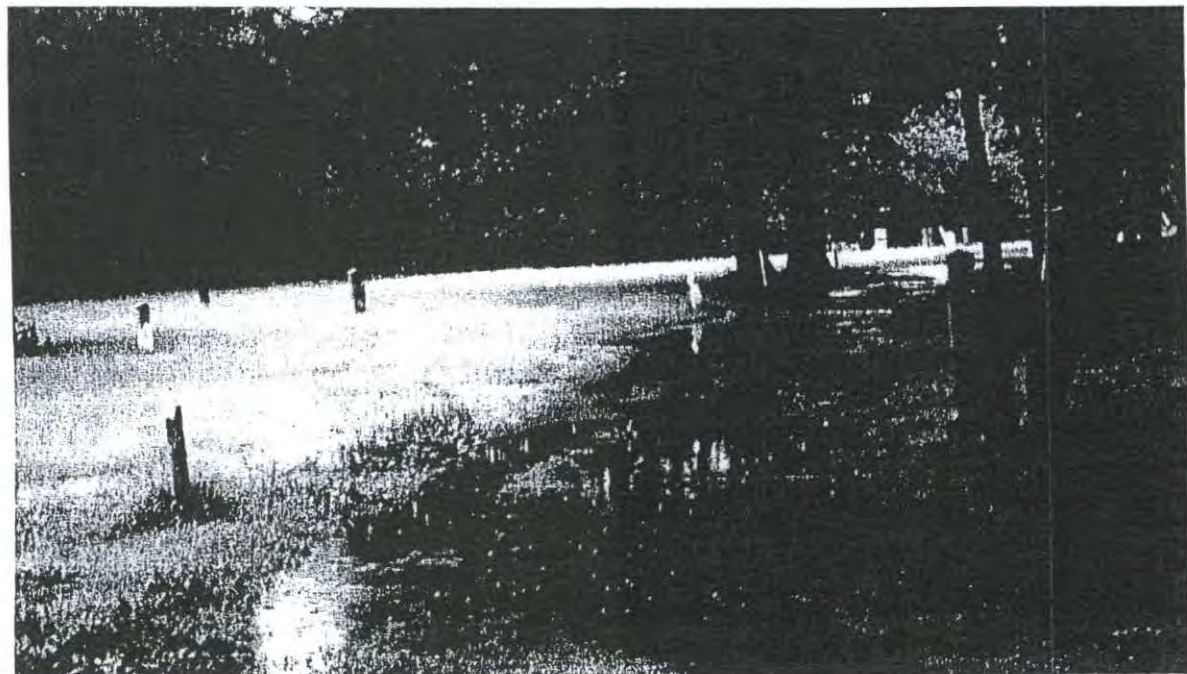
*Ponding on southeast perimeter avenue*

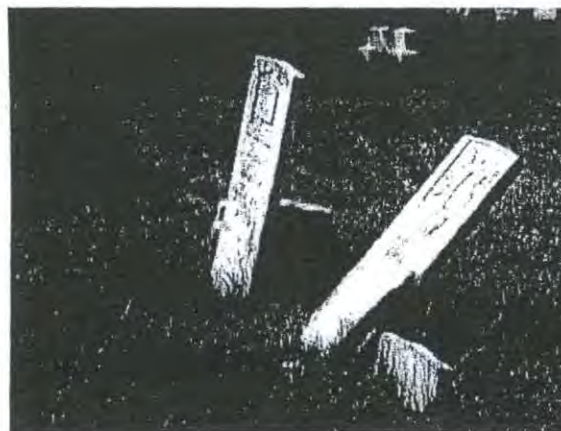
*Leaning marble markers*

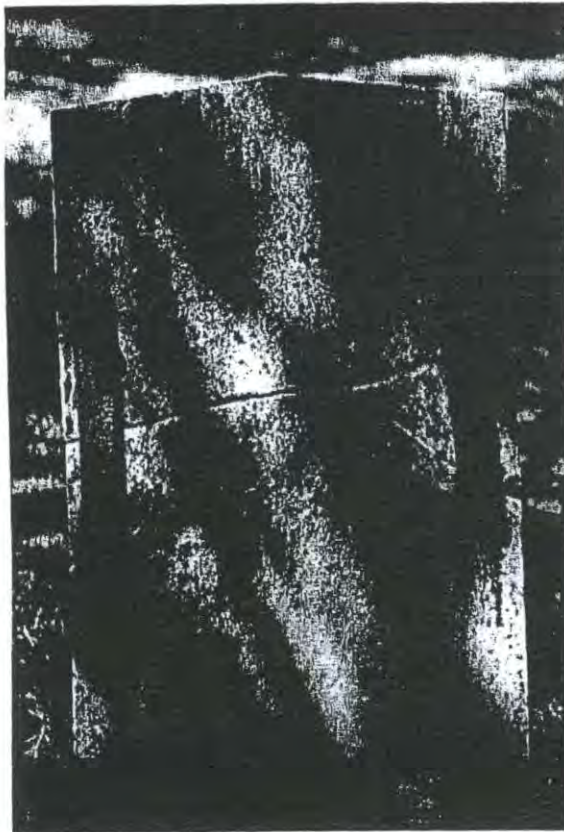
*Marble marker with iron strap repair*

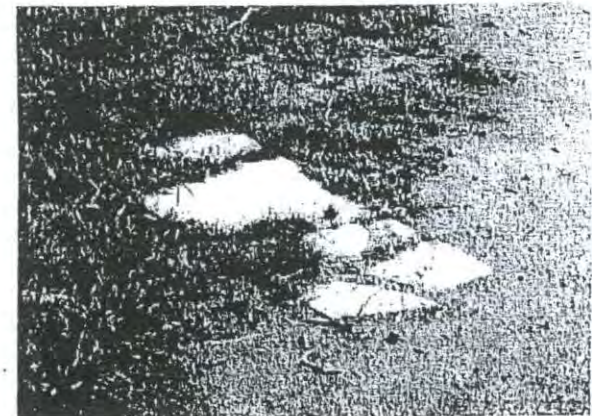
*Broken marble marker*

Mounting truncated stones and fragments requires the development of clips to attach them to "blanks", new stones cut to support fragments. This method is proposed for use if ready made clips can be found or custom clips can be fabricated according to a conservator's specifications.

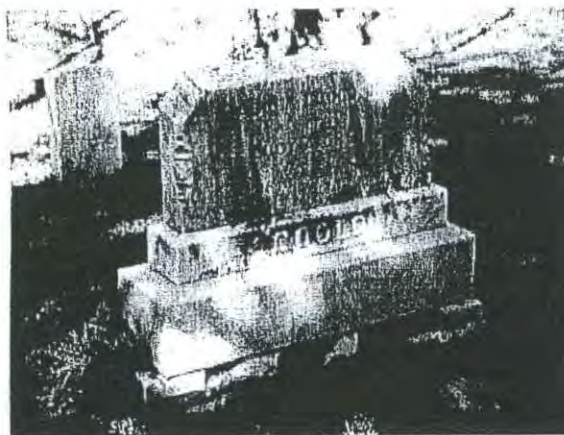
*Marble marker with exposed foundation*

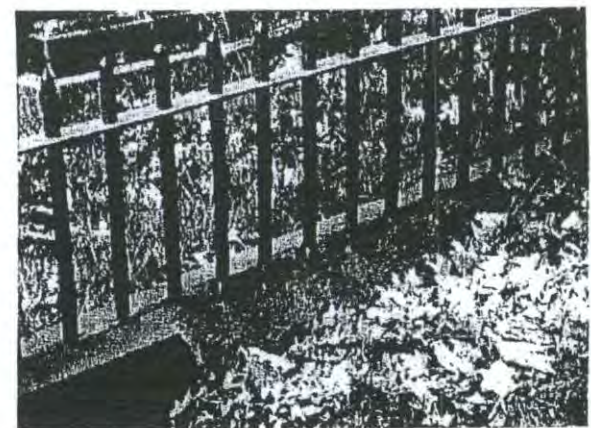
*Rust jacking damage at family plot edging*

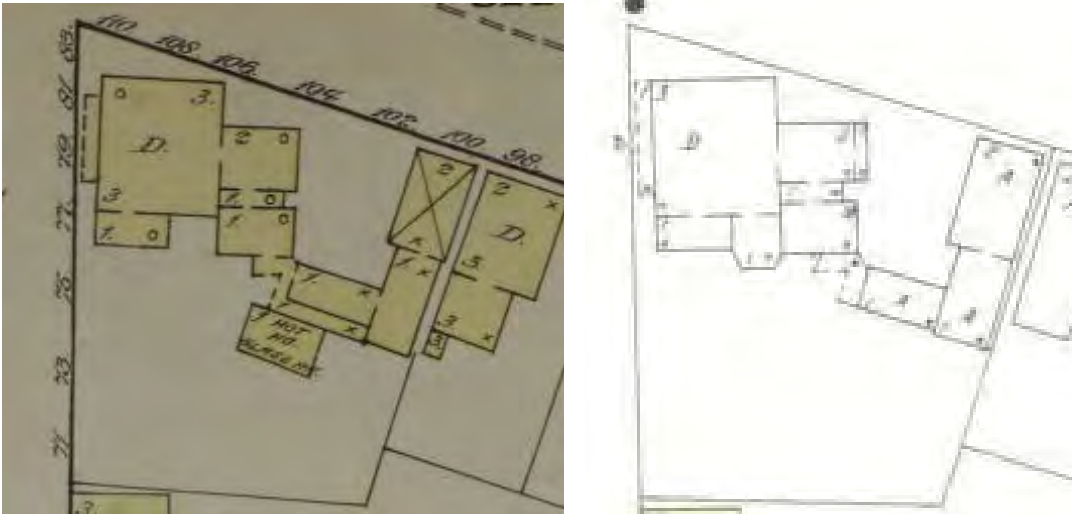
Figure 2: Sanborn Fire Insurance maps from 1886 (left) and 1954 (right) showing 71-79 High Street and 100 Pleasant Street still connected by a rambling assemblage of 1 story additions.

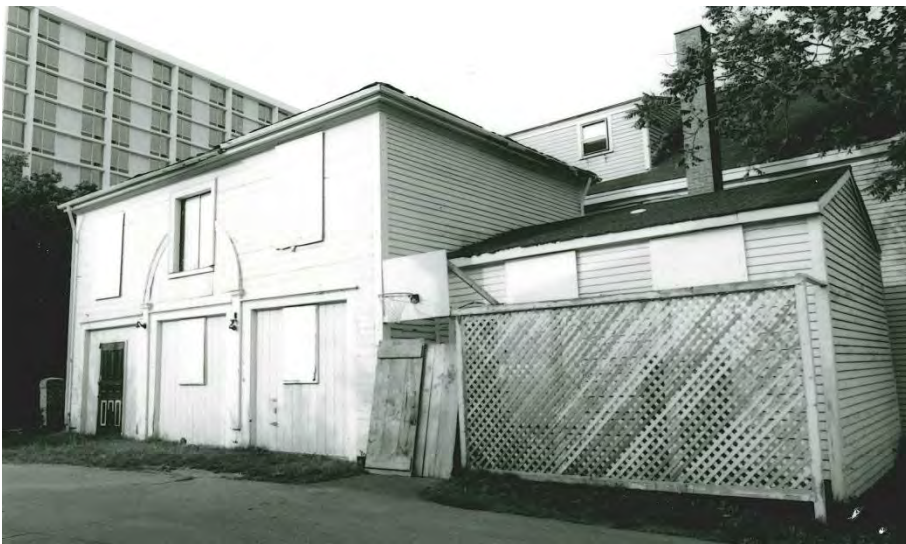
Figure 5: 1990 Historic survey photo showing 100 Pleasant Street much as it appears today, though in a less deteriorated condition. Note that the rear el is already shortened as most of it was torn down in the 1980s.

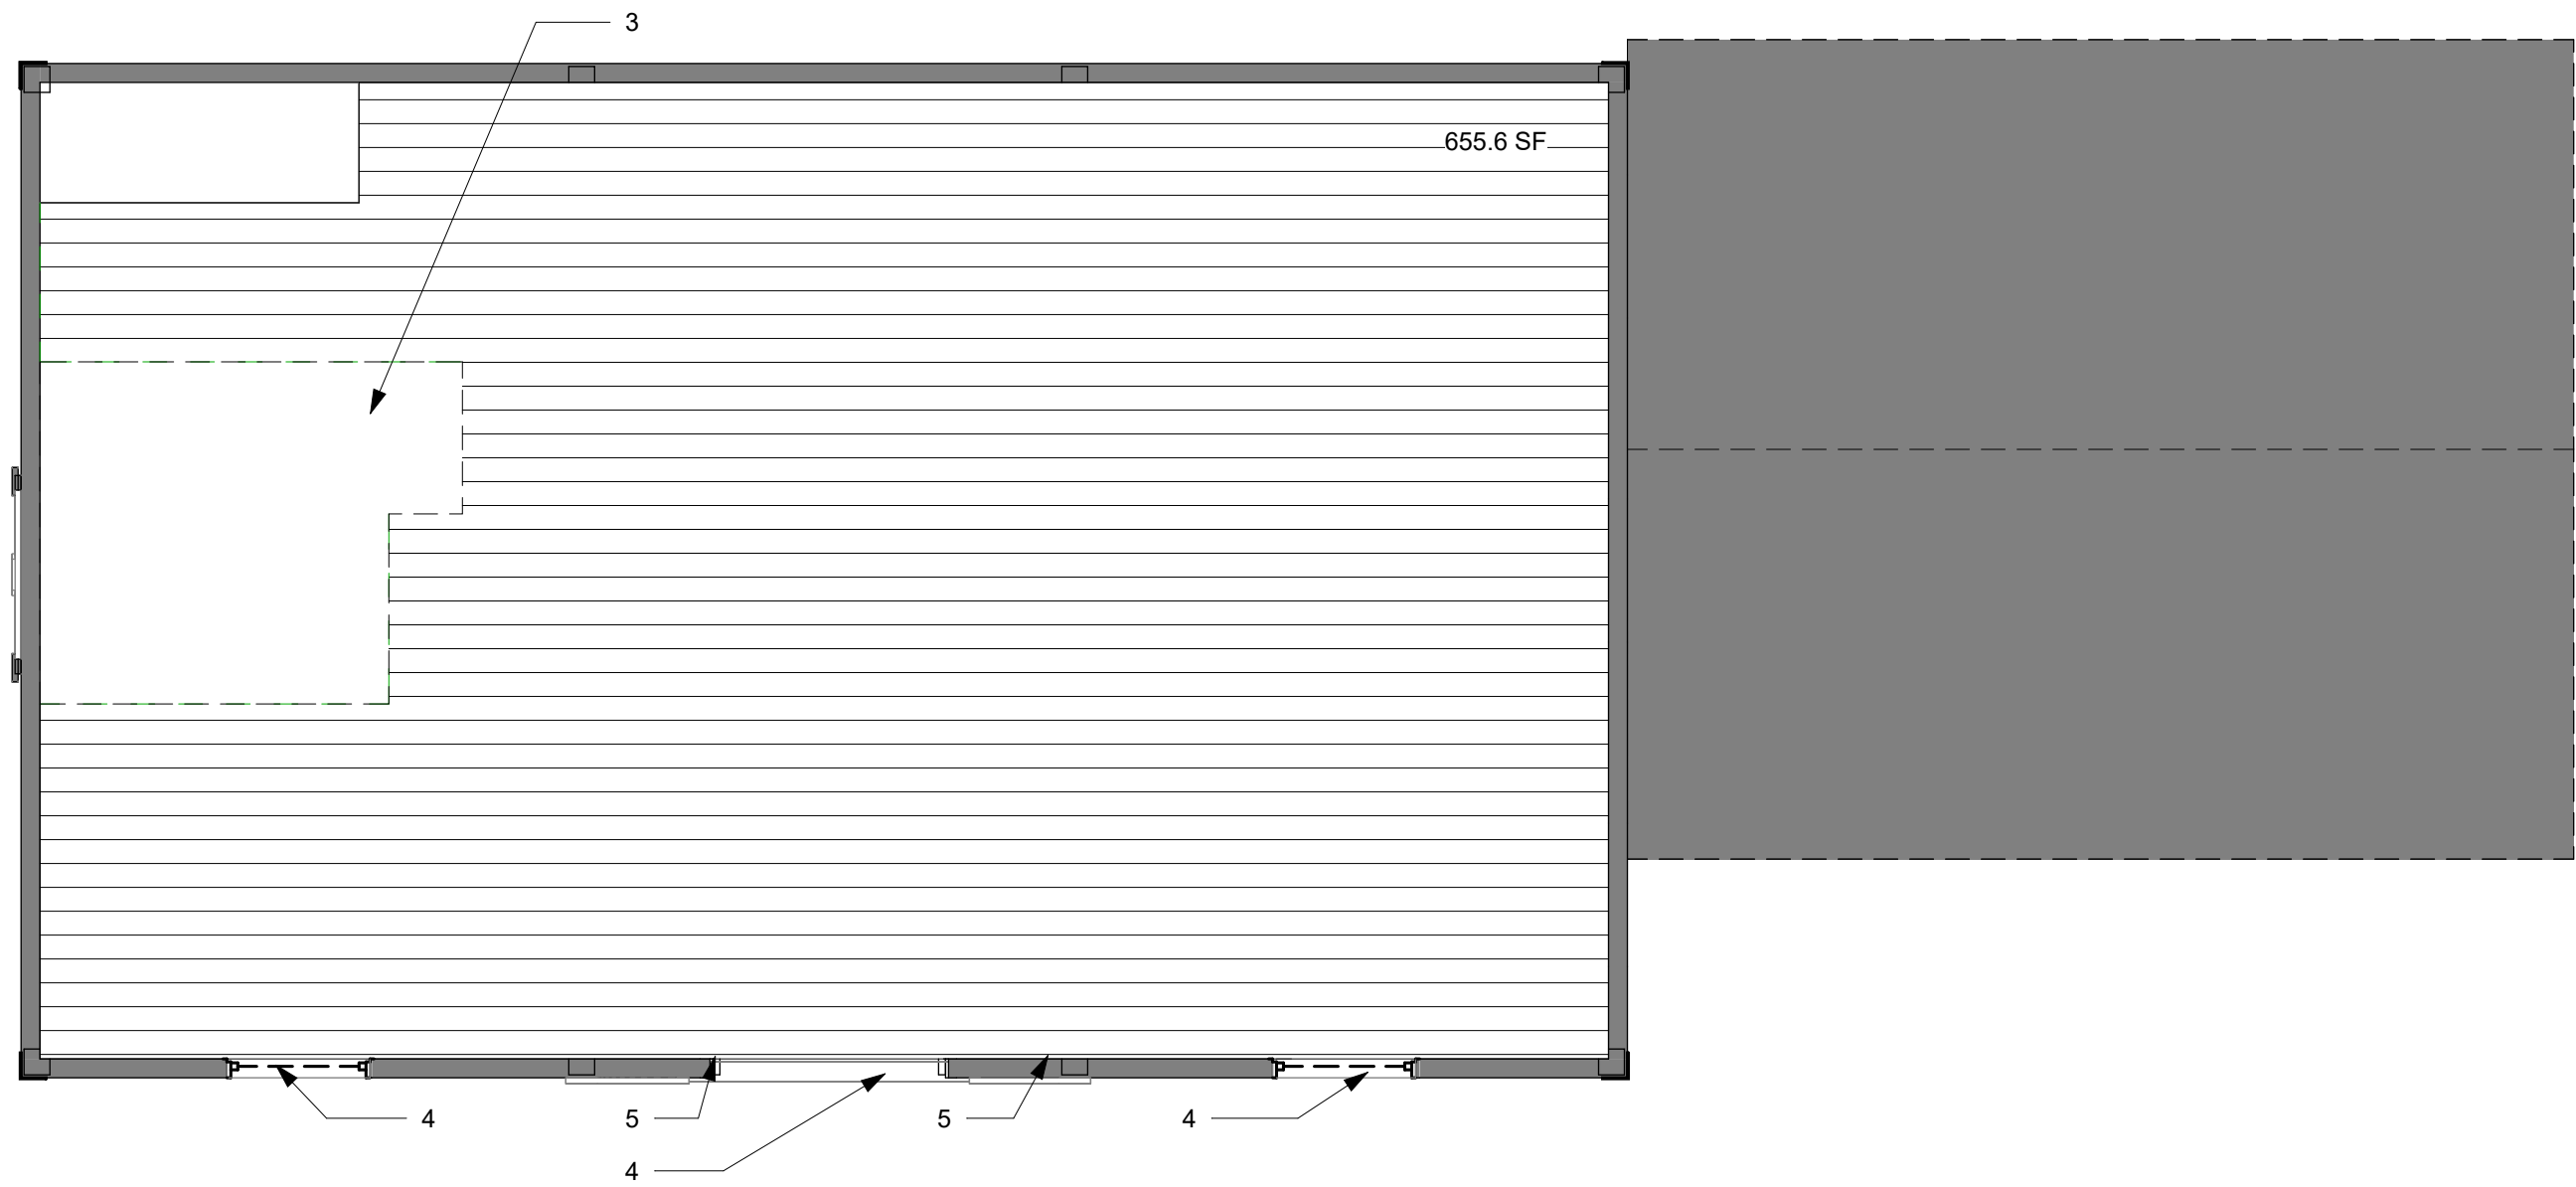
④ SECOND FLOOR - DEMO  
1/4" = 1'-0"

- 1 REMOVE EXISTING PARTITIONS / DOORS (TYP)
- 2 REMOVE BACK BUILDING ENTIRELY INCLUDING FOUNDATION
- 3 REMOVE EXISTING FLOORING FOR FUTURE STAIR
- 4 REMOVE EXISTING WINDOW
- 5 SALVAGE WINDOW SLIDING SHUTTERS
- 6 REMOVE EXISTING FRONT DOOR
- 7 REMOVE EXISTING PANELS IN ORIGINAL OPENINGS
- 8 SALVAGE CEILING ABOVE

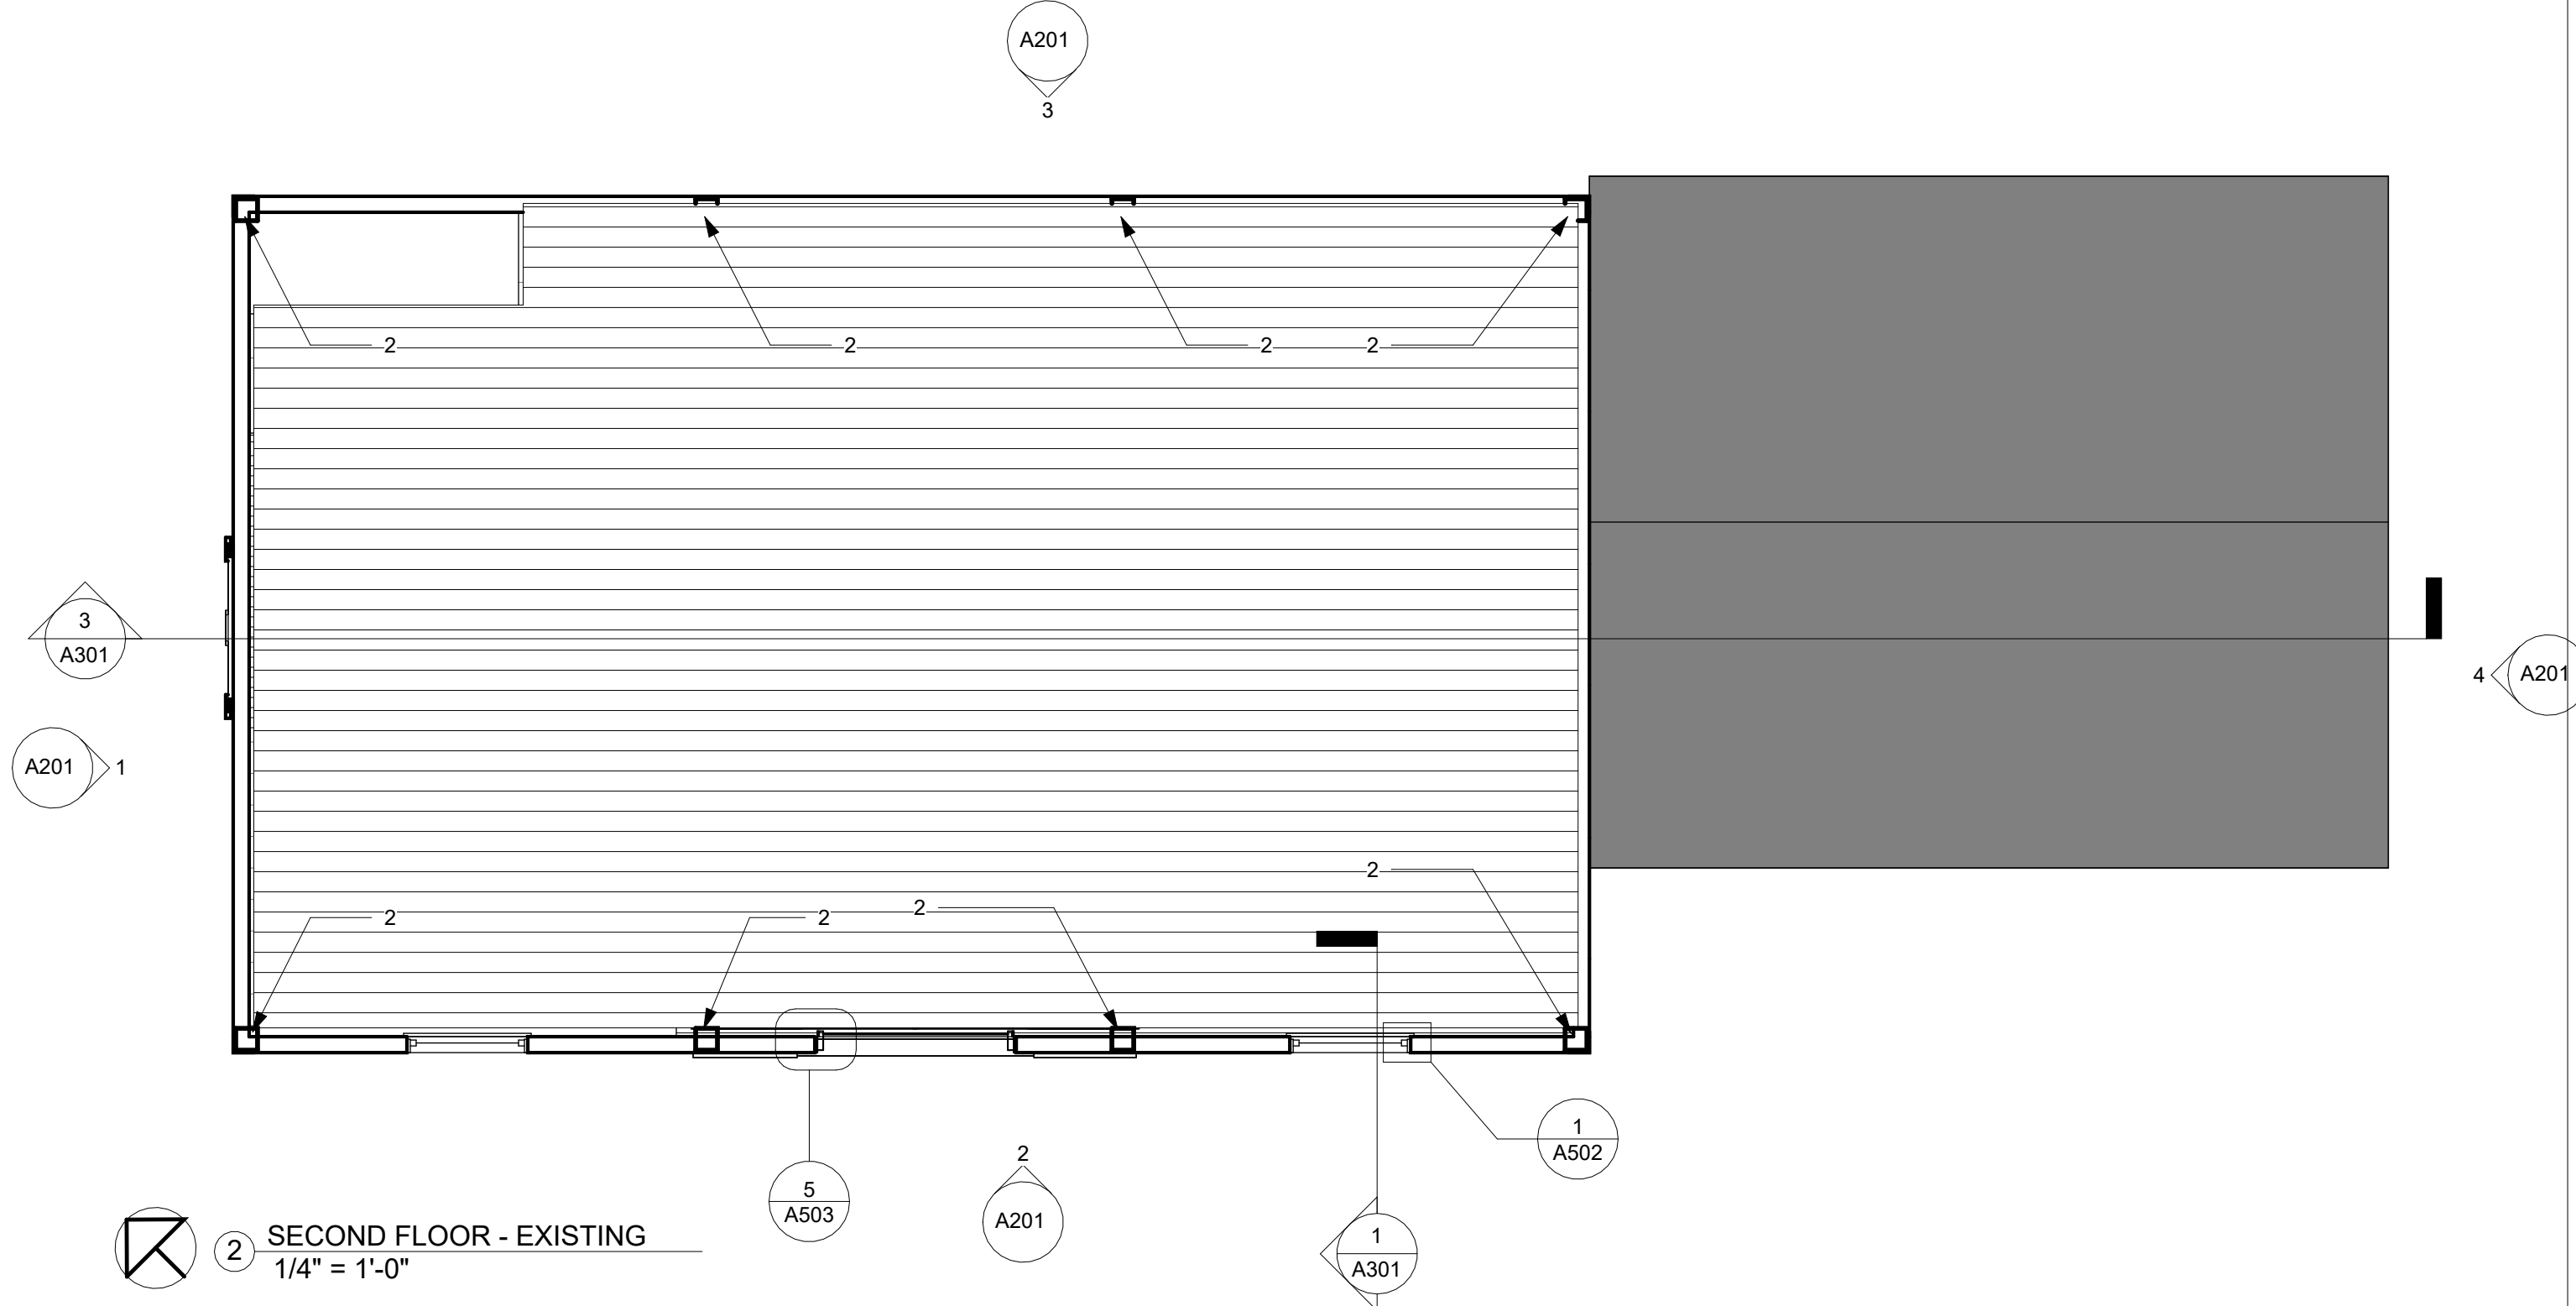
② SECOND FLOOR - EXISTING  
1/4" = 1'-0"

- 1 WOOD BEAMS
- 2 WOOD COLUMNS (TYP)
- 3 BOXED COLUMN (TYP)
- 4 BASEBOARDS
- 5 BEADBOARD WALL COVERING
