## Historic Preservation Board

Wednesday, November 20, 2024 at 5:00  
PM Room 24 (Ground Level of City Hall)  
and Zoom

## **AGENDA:**

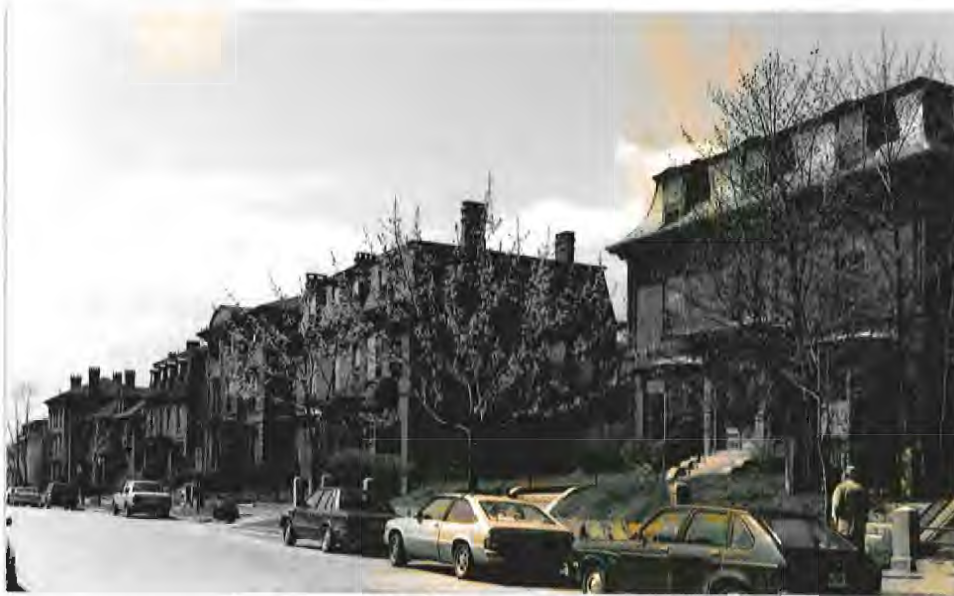
*The Deering Street Historic District is distinguished by its remarkable homogeneity. This group of houses lining the north side of Deering Street share a uniformity in their setback, scale, building height, and materials, although differences in house type and stylistic details add interest to the streetscape.*

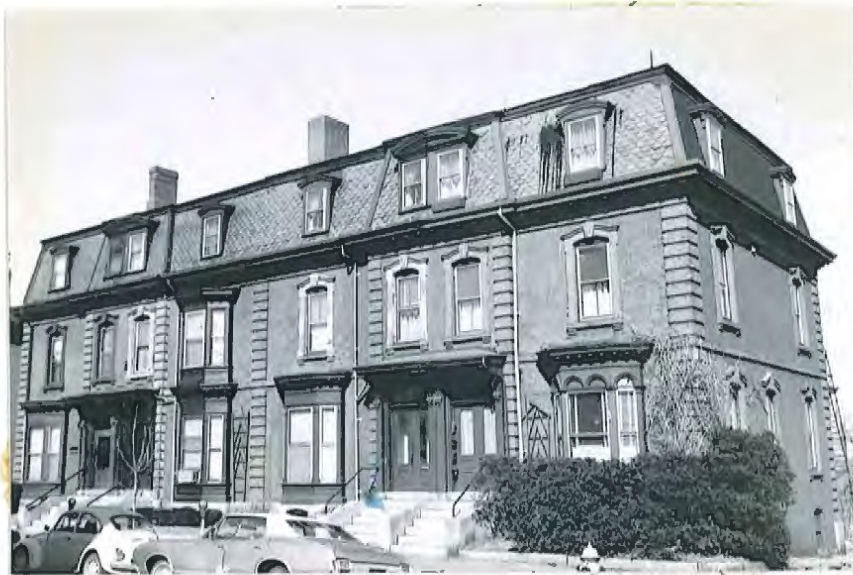
*One of several house types found in this district is the rowhouse. 33-39 Deering Street was built as four adjoining homes separated by party walls with individual entrances for each family. Its symmetrical design, height and materials are similar to that of neighboring homes of single family and duplex types.*

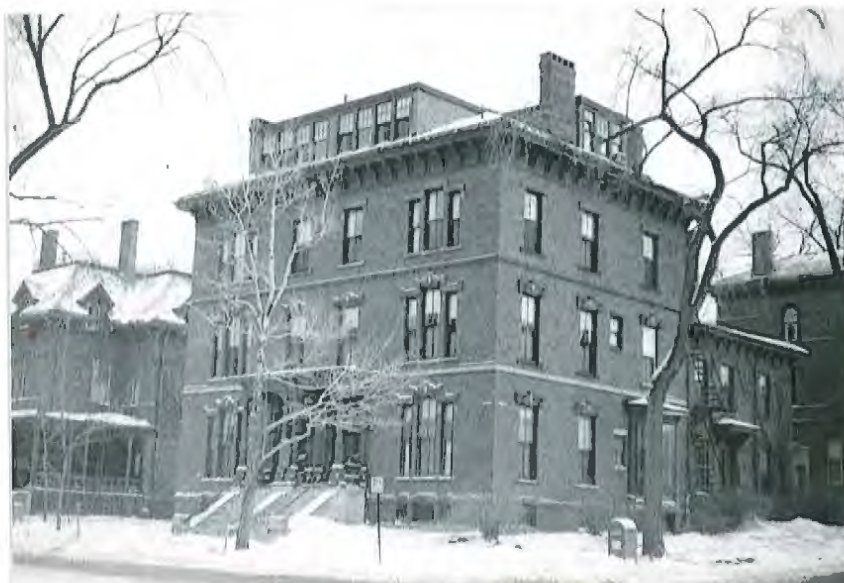
*A National Historic Landmark, the Thomas Brackett Reed House at 32 Deering Street is significant as the home of Reed, a U.S. Congressman and Speaker of the House. It is also a distinguished example of the Italianate style. Designed by Francis Fassett in 1875, the double house features Fassett's trademark sawtooth brickwork and extensive decoration.*

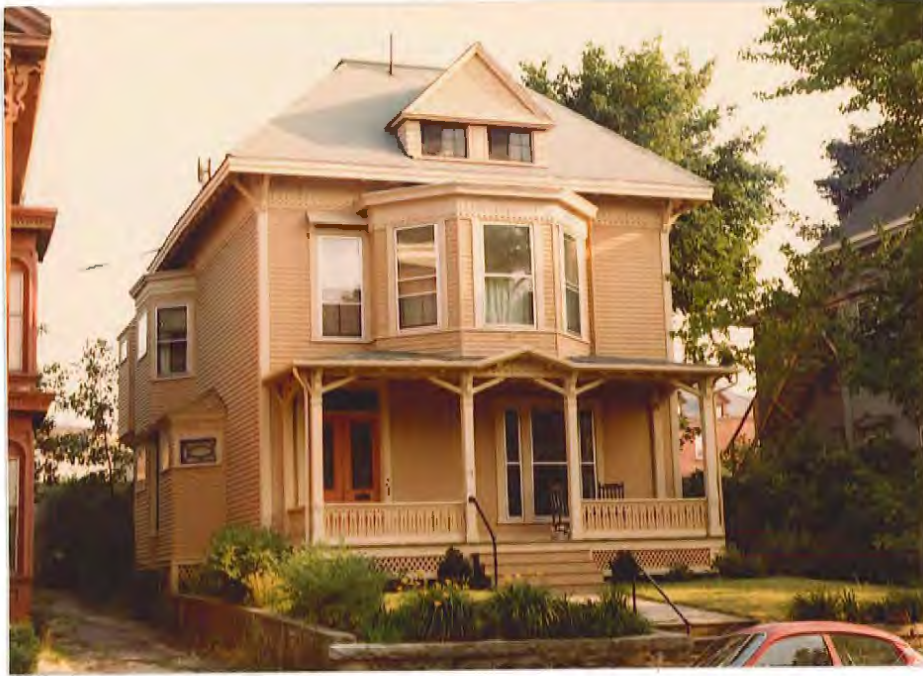
*The Harrison T. Whipple House at 40 Deering Street is one of the few buildings in the district to break the typical setback and choice of masonry construction. However, its scale and the degree and quality of its ornamentation serve to make it compatible with the predominant building pattern.*

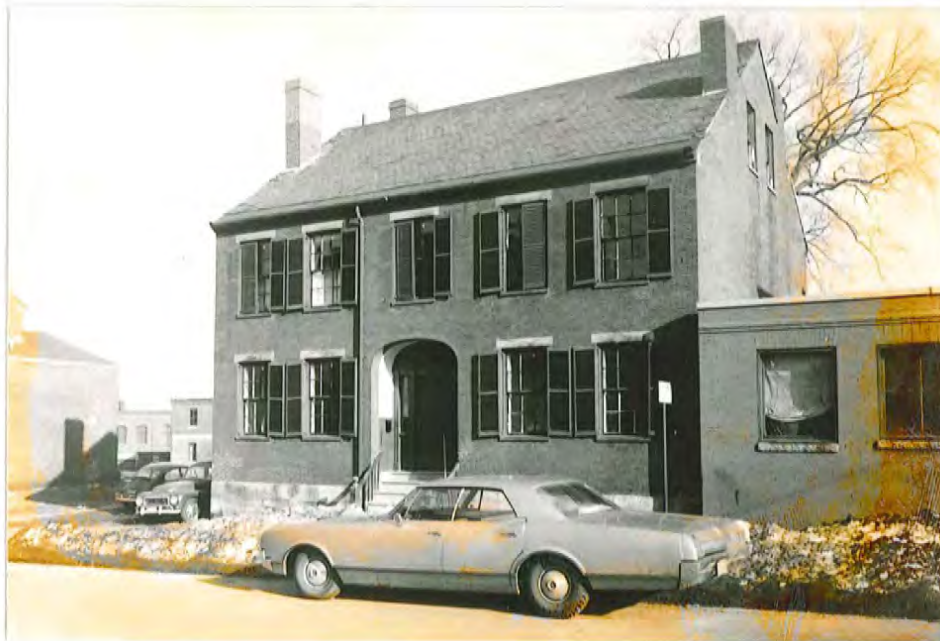
*The John How House, 40 Pleasant Street, built in 1817 as a wedding gift from Daniel to his son John. Basically similar in style to the earlier house, this one appears more compact because of the broad, recessed entrance way.*

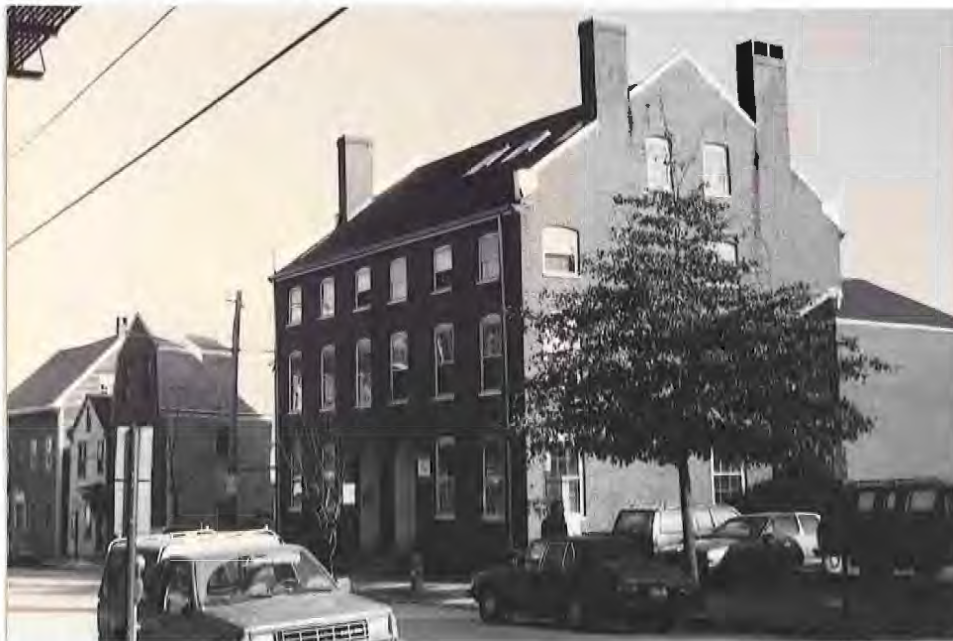
*The Joseph How House, 30-32 Pleasant Street, built in 1818 by Daniel's brother as a two family structure. The tradition of constructing duplexes was to continue throughout the nineteenth century in Portland. Like the other two How Houses, this structure has four chimneys on outside walls, but the window tops are elliptical and the elevation is three and one-half storeys. This enclave of late Federal red brick dwellings is coherent in general form in material and in details.*

plan is that of a double house for two families. It is also taller than the other two houses, having three-and-a-half stories under a gable roof phrased by end chimneys. Its double entrances are arched recesses following the model of the fan and sidelights of the John How House, and its brickwork is common bond.

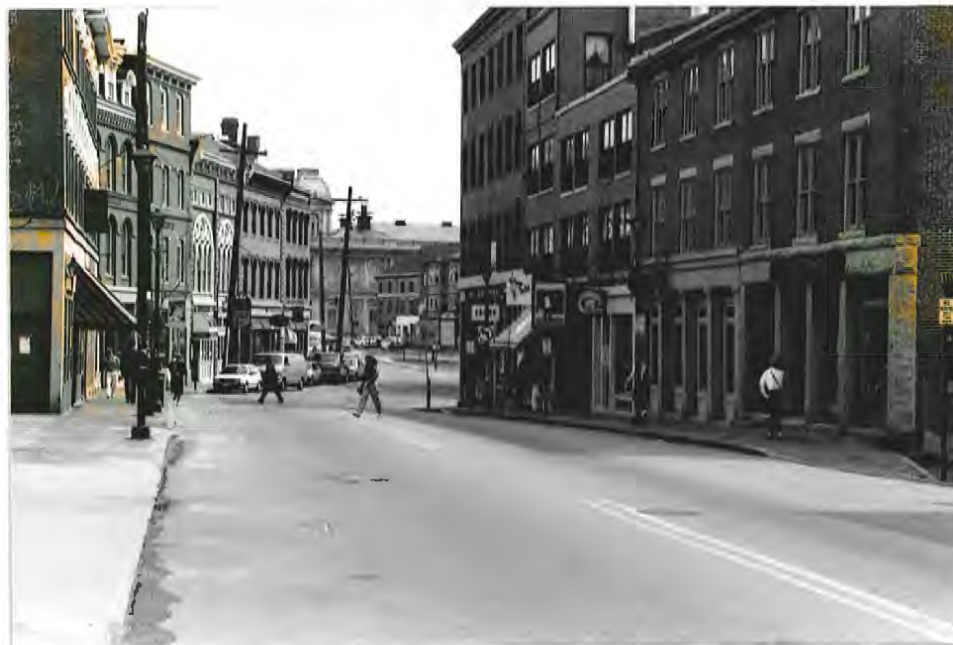
*Fore Street retains its meandering character from the days it was the city's Waterfront and is lined, still, with three and four storey brick buildings which maintain a scale compatible with the narrow street.*

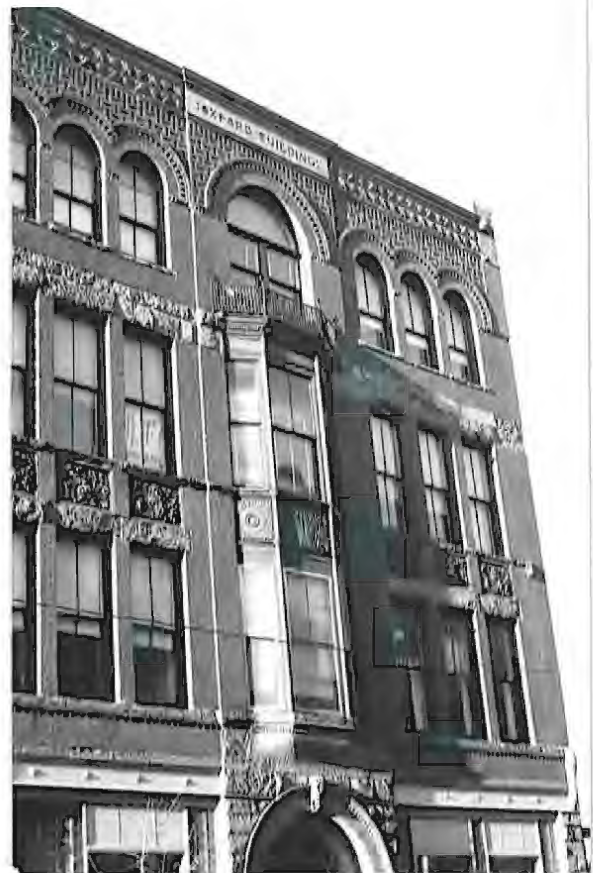
*The Oxford Block, 183-187 Middle Street. John Calvin Stevens I's Romanesque Revival business block built in 1886-87.*

*Decorative brickwork, terra cotta panels, carved stone and metal balcony extend the richness of the arched openings and projecting bay. Whether articulated in this later Romanesque style or in earlier styles, this richness of detail is characteristic of much of the architecture of the waterfront district.*

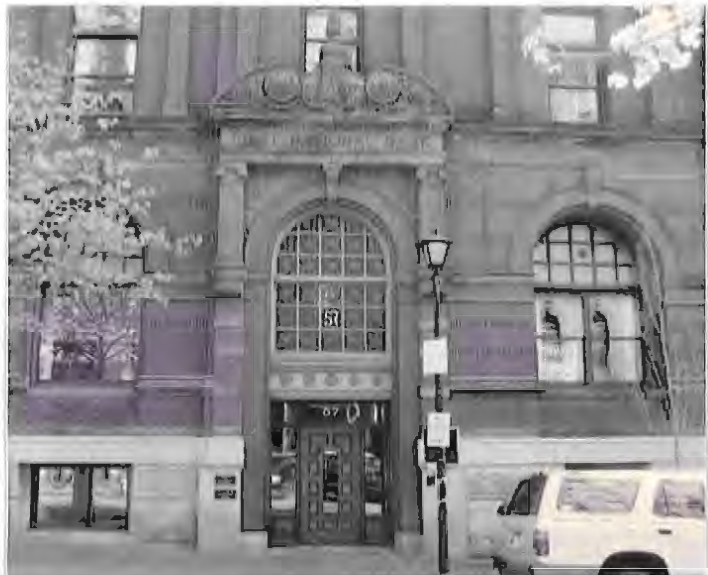
*The First National Bank Block, 57 Exchange Street. A detail above the entrance door of the 1883-4 Queen Anne style building emphasizes the richness of the asymmetrical design which culminates in a corner tower. Henry van Brunt and Frank Howe of Boston, architects.*

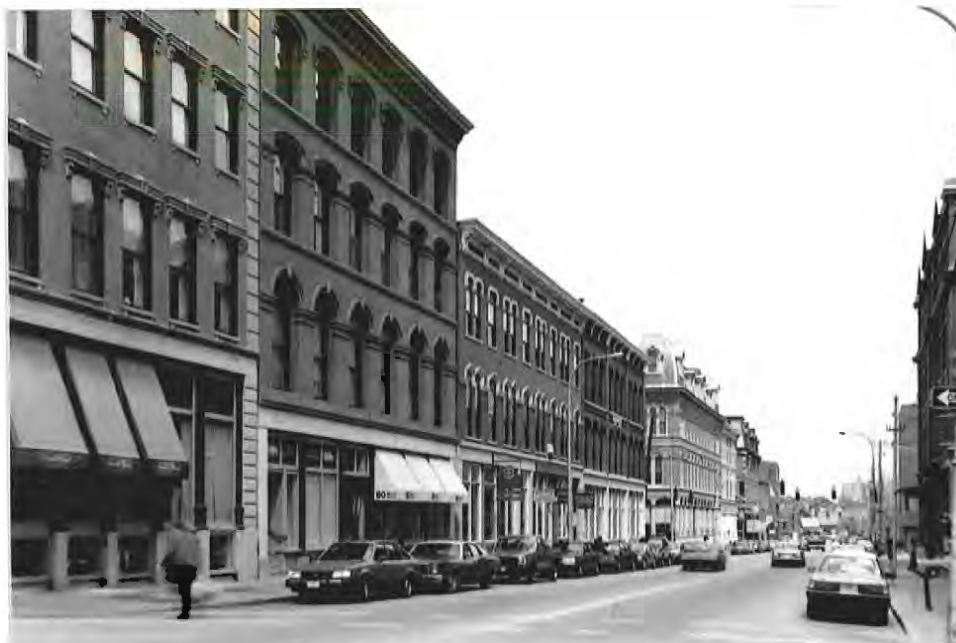
*Middle Street. The Woodman, Thompson and Rackleff blocks are visible on the lower left. The importance of the first storey definition is apparent as is the rhythmic repetition of vertical window openings. The depth of the windows and the projection of the moldings are important design elements which provide relief and richness of detail.*

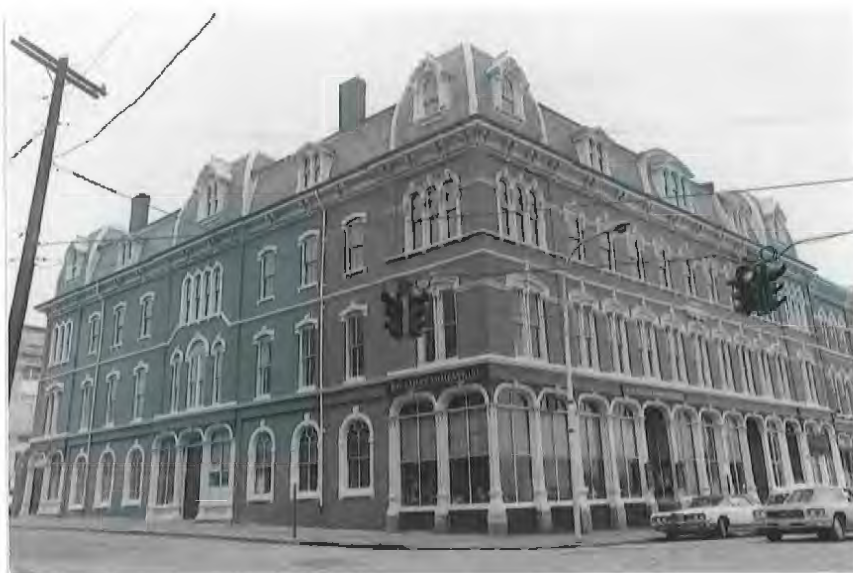
*Woodman Building, 133-141 Middle Street. The tall cast iron columns, the elliptical arches, the prominent belt courses, and window hoods enliven and break into smaller components an otherwise massive building. Noteworthy are the groupings of windows which define the corners and the centers of the two facades.*

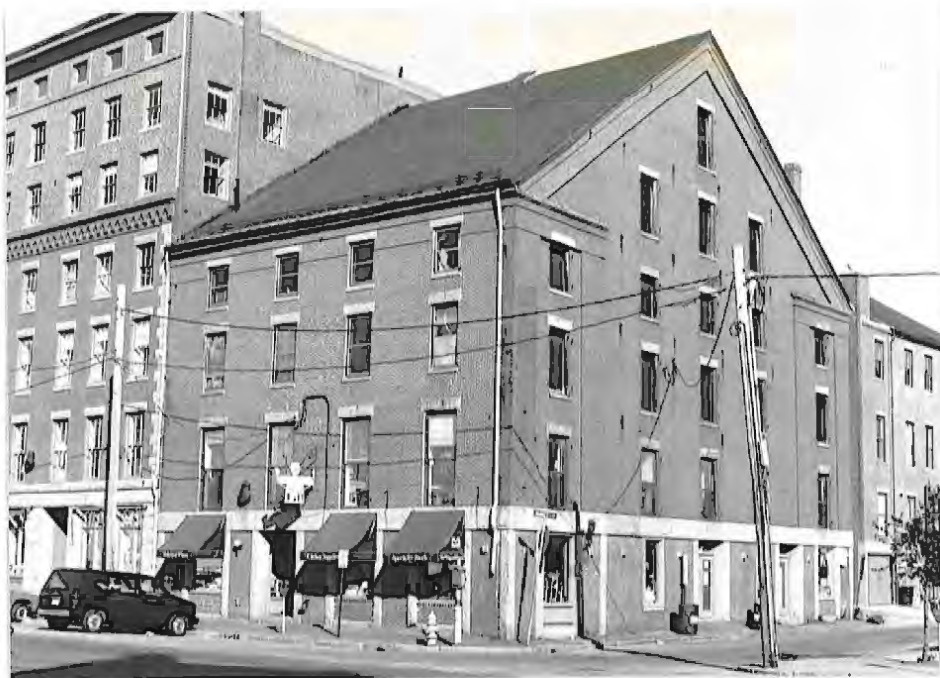
*William Moulton Block, 157-163 Commercial Street. In 1851 it was one of the first blocks built on Commercial Street. The Greek Revival stylistic features are the wide granite lintel which separates the first story from the upper floors and the heavy granite lintels over each window. Noteworthy on the side elevation is the deep return of the gable which is supported on each side by brick pilasters.*

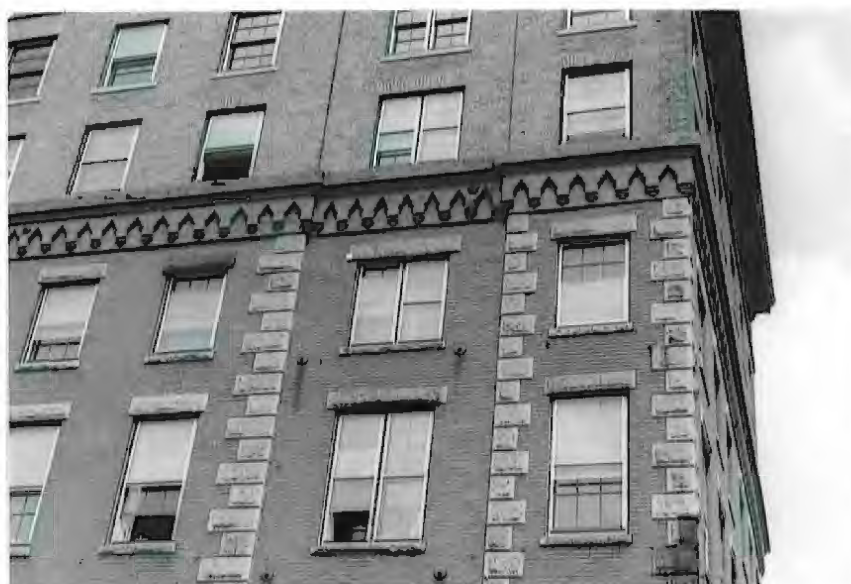
*William Moulton Block, 165-169 Commercial Street. Two years later Moulton had the neighboring building, partially visible in upper photograph, built (the three upper floors are a later addition). This builder added quoins and a corbelled cornice, architectural features of the Italianate style. In both buildings the first floor is set off by a heavy granite cornice and granite piers. This delineation of the first floor unifies the buildings in the waterfront district.*

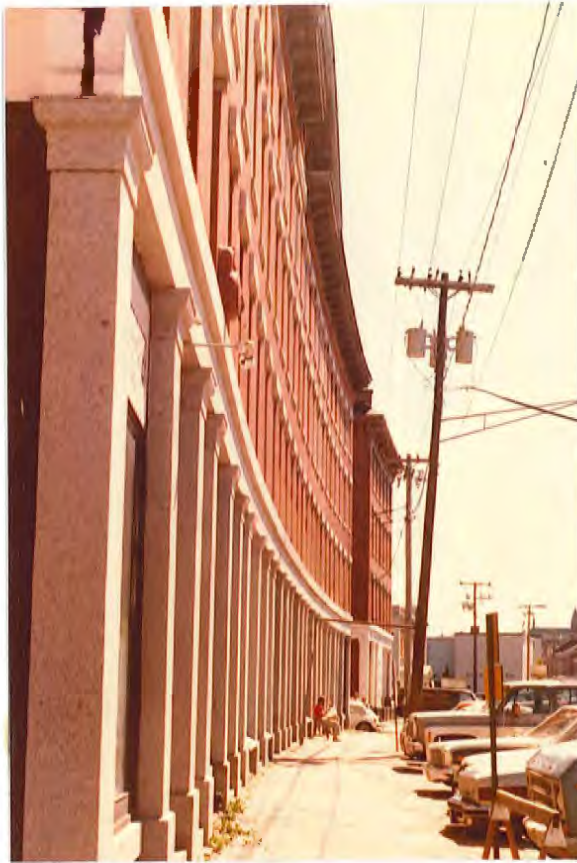
*The Elias Thomas Block, 102-132 Commercial Street. Built in 1860, this granite and brick Greek Revival block is unusually long and was designed to reflect the curve of the street.*

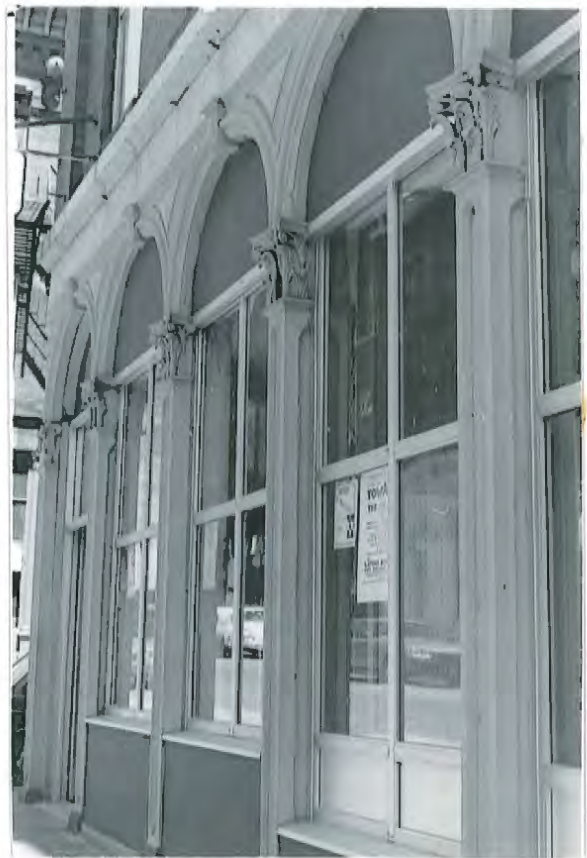
*Ocean Insurance Company Exchange Street Block. Completed in 1867, the year following the Great Fire. The first story arcade is cast iron, an affordable material for such fine details as the corinthian capitals on the pilasters. Many commercial buildings in the waterfront district feature cast iron storefronts.*

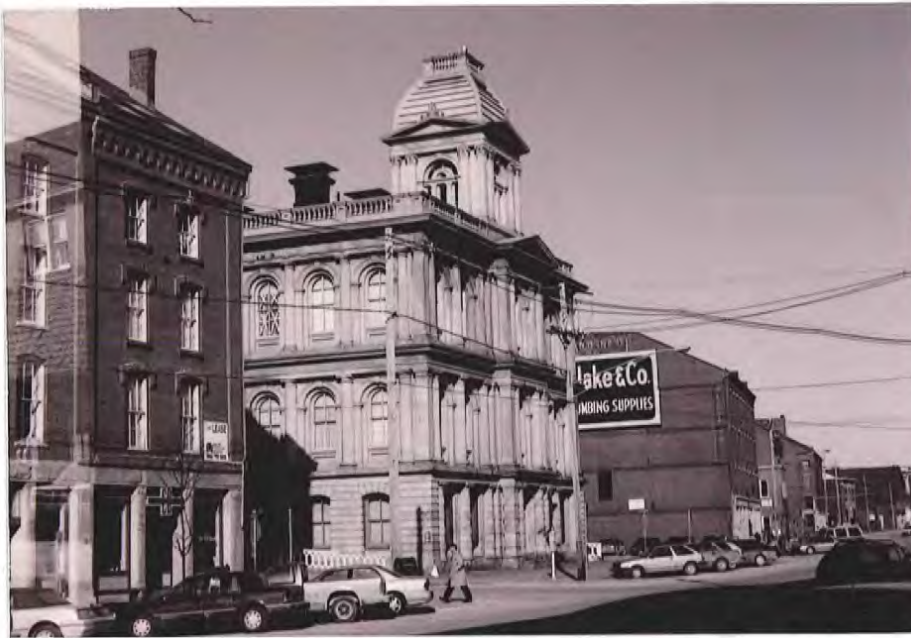
*The Customhouse on Fore Street replaced a structure lost in the 1866 fire, and was finished in 1871 from designs by architect, Alfred B. Mullett. It is an outstanding example of the Second Empire Style. Here grey granite is used to create strong light-dark contrasts in the projecting columns, the recessed windows, fine roofline, balustrade and surrounding fence. A building of this scale and richness needs generous views -- this was designed to be seen from four sides.*

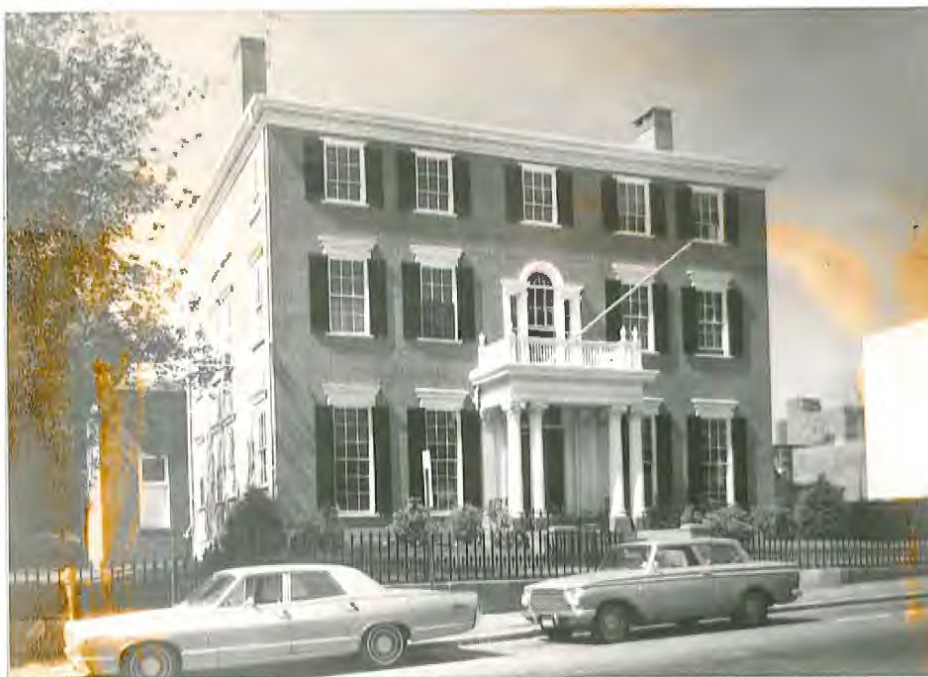
*Unlike the Deering Street and Western Promenade historic districts which were settled after 1850 and thus exhibit later Victorian-era architecture, the Spring Street area's earlier development is revealed in its numerous early nineteenth century buildings. Indeed, most of Portland's surviving Federal period buildings are located in the Spring Street historic district. The Stephen McLellan House (1800), 116 High Street is a reminder of Portland's post Revolutionary War prosperity and resulting building boom. One of the more finely detailed surviving examples of this style, the house was designed and built by John Kimball, Sr. Like many other homes of the period, the five bay structure is three stories in height, with windows that diminish in length on each succeeding story. The house is distinguished by the decorative crowns of first and second story windows, the classic Palladian window, the elegant square entrance portico supported by four Corinthian columns and four Corinthian pilasters and surrounded by its delicate balustrade.*

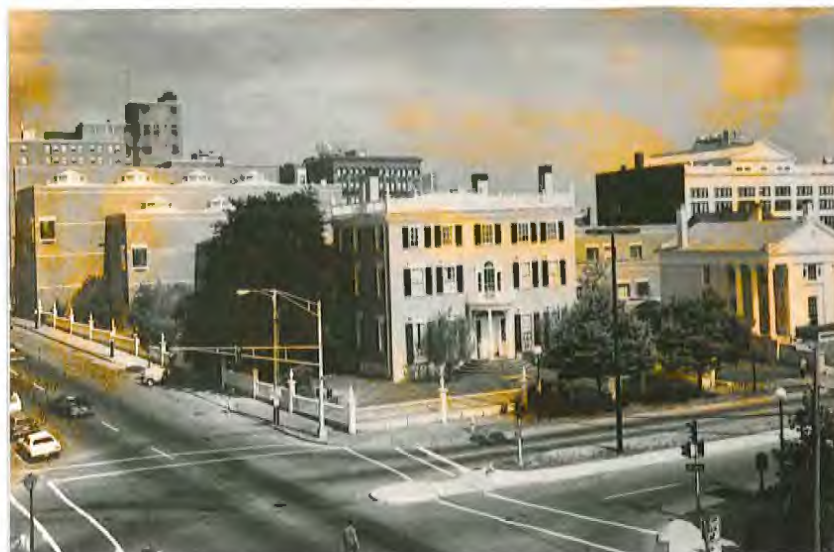
*At the prominent corner of Spring and High Streets, the McLellan-Sweat House (1800), owned by the Portland Museum of Art, is situated across High Street from the similar Stephen McLellan house (see photo above) and was designed by the same architect. Also visible in the photograph is the 1983 Payson wing of the Museum to the left and the Charles Quincy Clapp house (1832), now part of the Portland School of Art, to the right. Nowhere else in the city are there four landmark quality buildings in such close proximity. The award winning Payson wing, which steps up from one to four stories along its High Street elevation complements its historic neighbors yet makes its own strong contemporary design statement.*

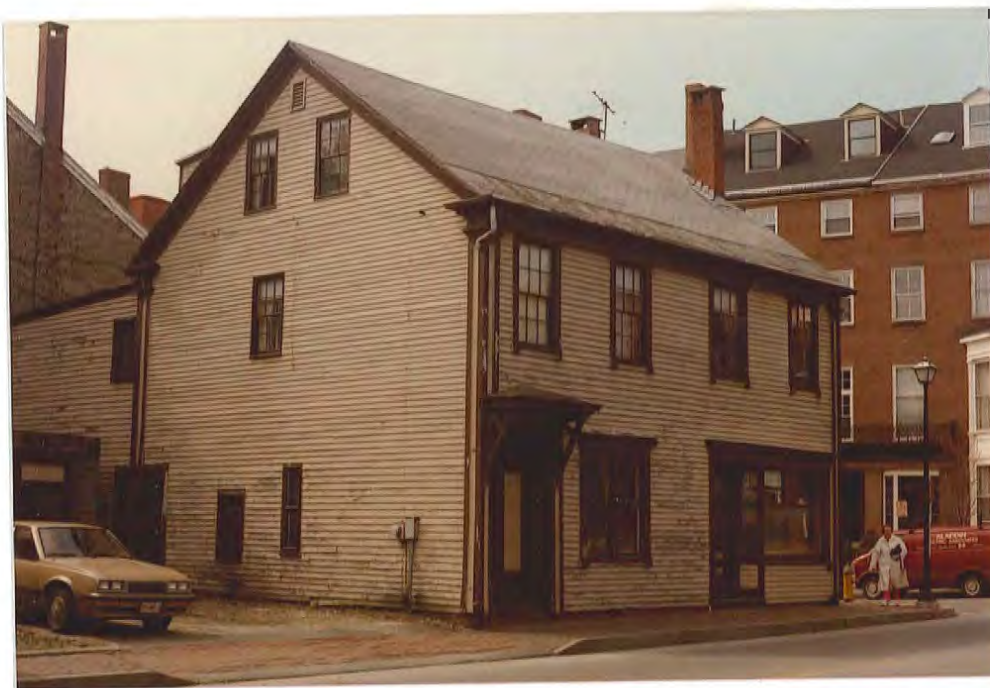
*The simple Hiram Beal House and Store (by 1858) at 132-134 Spring Street and the Spring Street Fire House (1837) are two of the numerous surviving Greek Revival style structures in the district. Although these two buildings are situated almost opposite each other, there is great variety in the architectural styles of neighboring structures, marking the neighborhood's longevity as a popular residential address.*

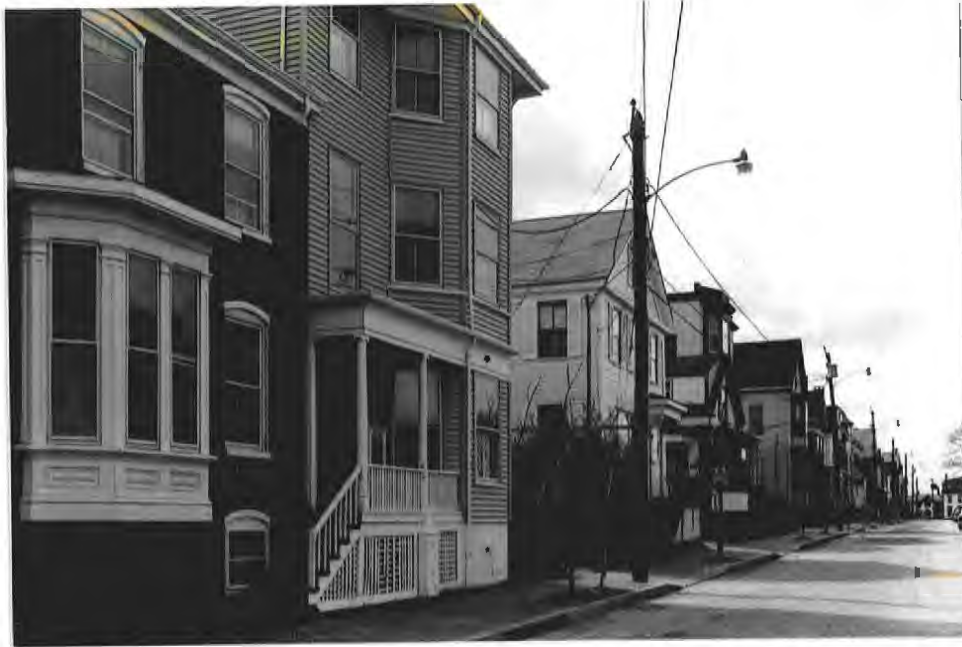
*The area comprising Brackett and Winter Streets was once part of Anthony Brackett's farm and was subdivided in the 1840's and 50's following his widow's death. Winter Street, shown above, includes both brick and frame structures, predominately in the Greek Revival and Italianate styles. Most structures in this section of the district were built by local carpenter/builders in vernacular adaptations of the fashionable architectural styles of the day. The vernacular houses tend to exhibit less elaborate trim details and materials than their high style counterparts.*

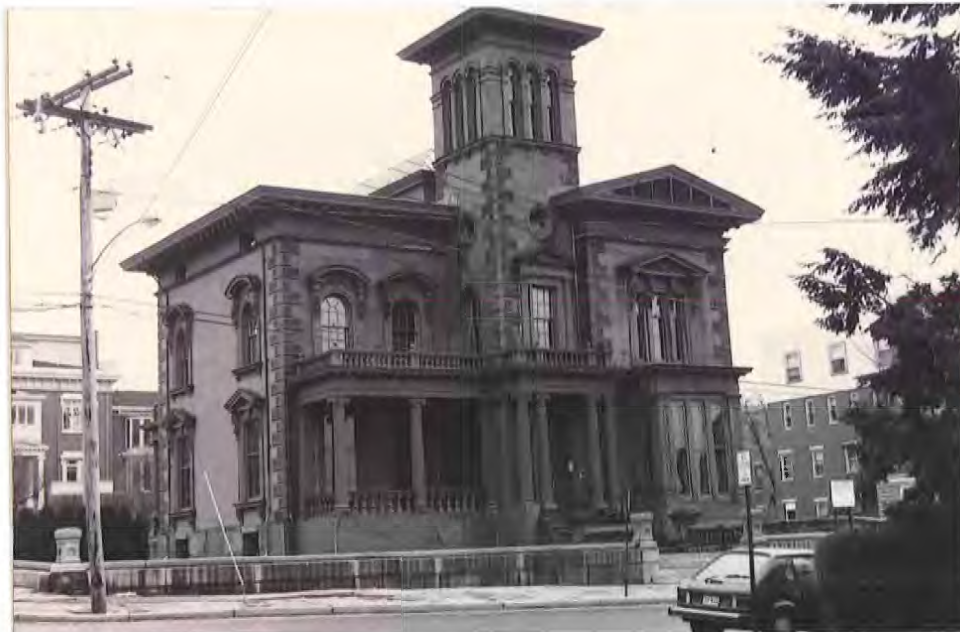
*The Morse-Libby (Victoria) Mansion was designed by New Haven architect Henry Austin and built from 1859-1863. As a National Historic Landmark the house is considered to be one of the finest examples of the Italian Villa style in America. Forthrightly asymmetrical in its massing, the house is incredibly rich in detailing on both its exterior and its interior. The opulent interior with its frescoes and trompe l'oeil wall paintings, original furniture, lighting features and elaborately carved woodwork make it one of Portland's most popular attractions. Probably the most lavish building in Portland, it stands as a striking counterpoint to its more restrained Federal and Greek Revival neighbors.*

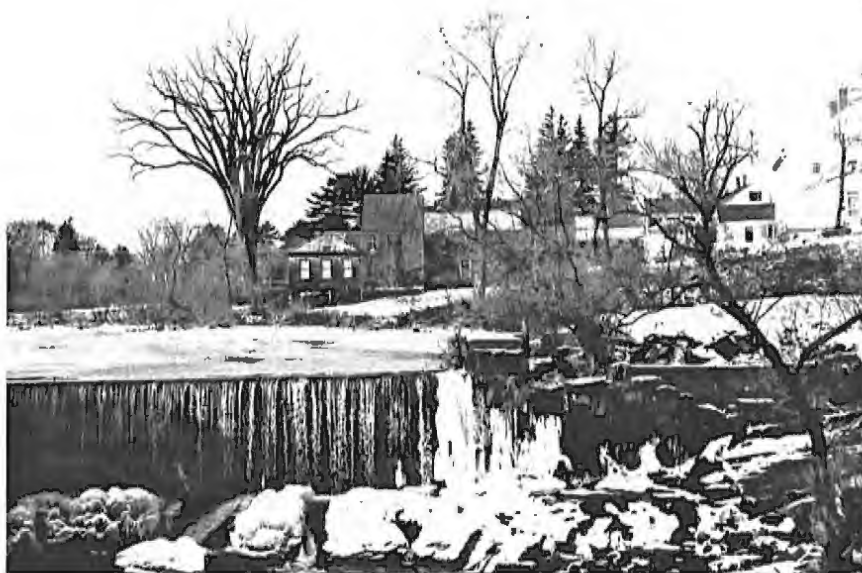
*Stroudwater Dam, built in 1845 and found on the river which flows behind the Tate and Hawes houses.*

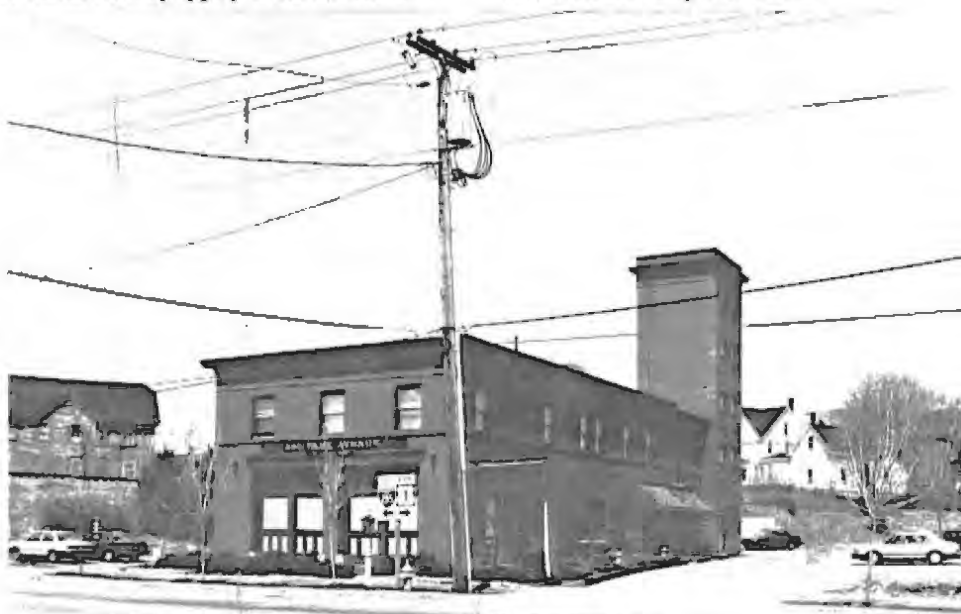
*The conversion of the 295 Park Avenue Fire Station to medical offices was done in such a way that necessitated only minimal exterior alterations. The station's form and key features now, as before, communicate its early use. The original doors and hose towers were retained and a new entrance was created on a secondary facade.*

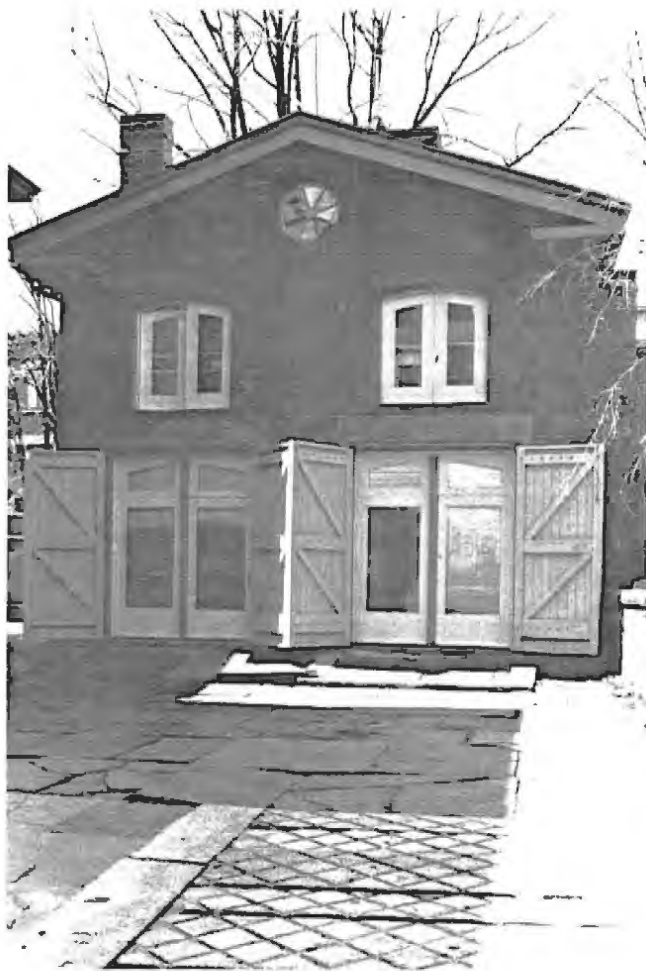
*When the carriage house at the Victoria Mansion was adapted to become an architect's office, the original doors were fixed in an open position and new glass panelled doors were inserted in the openings. A second means of egress was located on the side elevation, not visible from the street. The new use was accommodated successfully without obscuring original key exterior features.*

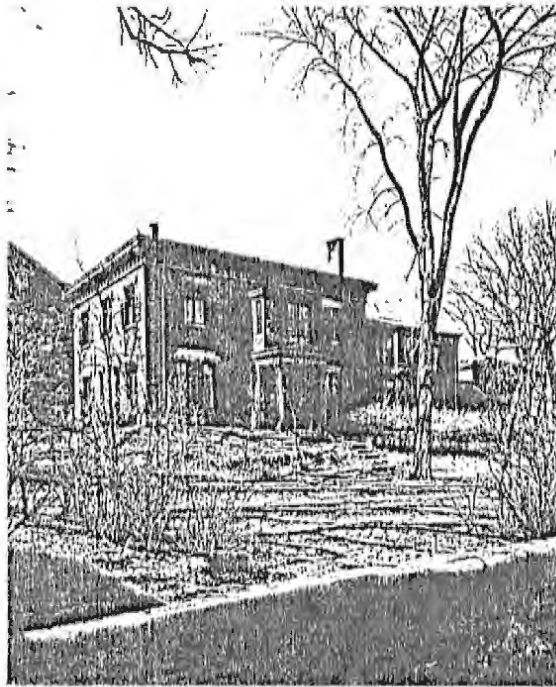
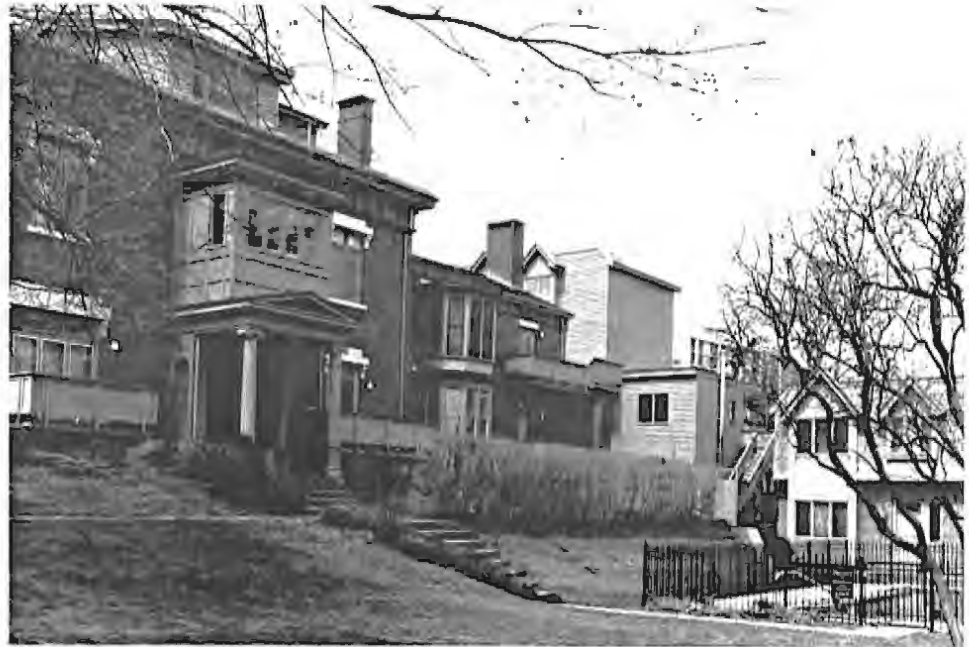
*The relationship between a historic building and its site helps to define its historic character. In planning and adaptive reuse projects, this relationship should be preserved. In the pre-renovation view of this former mansion, the grandeur of the open, terraced grounds provided evidence of the building's original importance. When the property was converted for residential condominium use, the carriage house behind the main building was remodelled and doubled in height and its terraced grounds were developed with a swimming pool and additional living units. As a consequence, the prominence of the mansion relative to its site has been significantly altered. By reconsidering the placement or character of some of the additions and site alterations, the original sense of this unique property could have been preserved.*

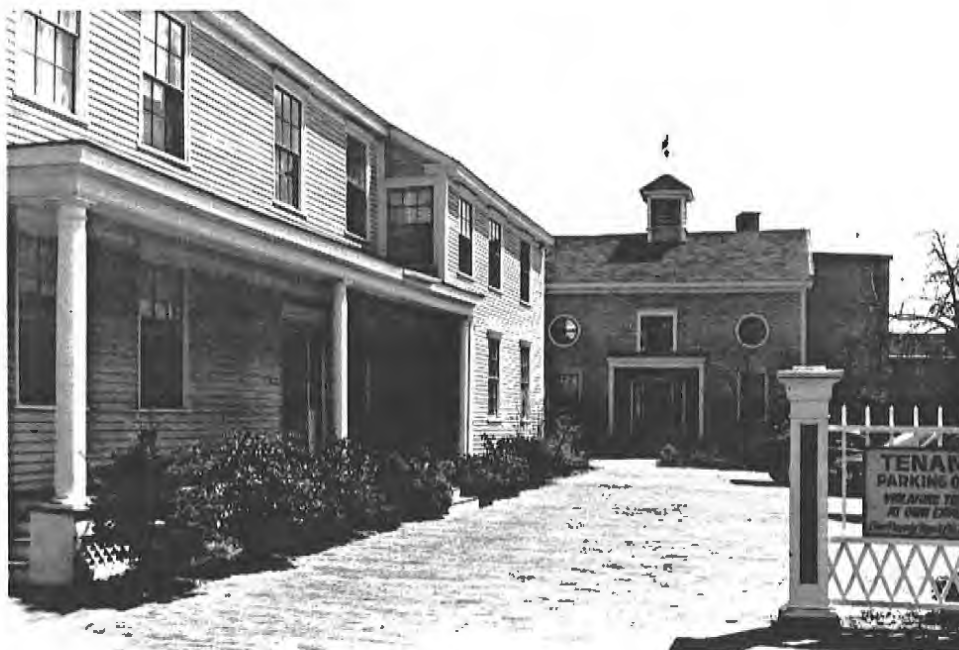
*Here, although there has been an intensification of use, changes to the building and the site are not readily apparent from the street. Additions have been made off the sides and rear of the building and parking has been limited to an area obscured by the fence. The sense of an open courtyard leading up to a carriage house has been retained.*

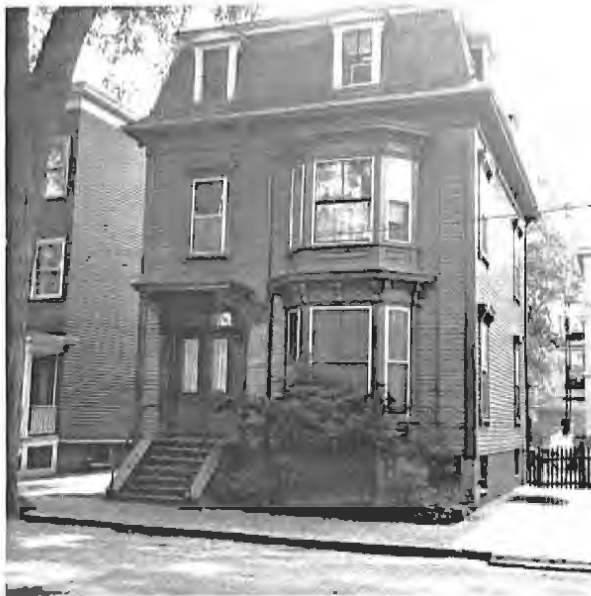
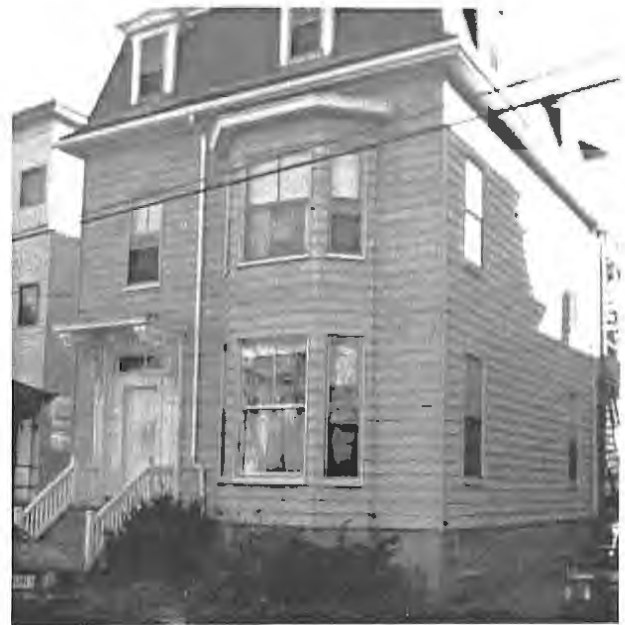
*This property, which was photographed in 1967 (left) and again in 1989 (right), illustrates the dramatic effect incremental changes can have on a historic property. When synthetic siding was applied, the trim over windows, at the corners and cornice and over the bays was removed. The original double doors, which are typical of Second Empire style buildings, were replaced with a single, smaller door. While individual alterations or replacements may seem to be minor, the cumulative effect of the changes can rob a building of its architectural character.*

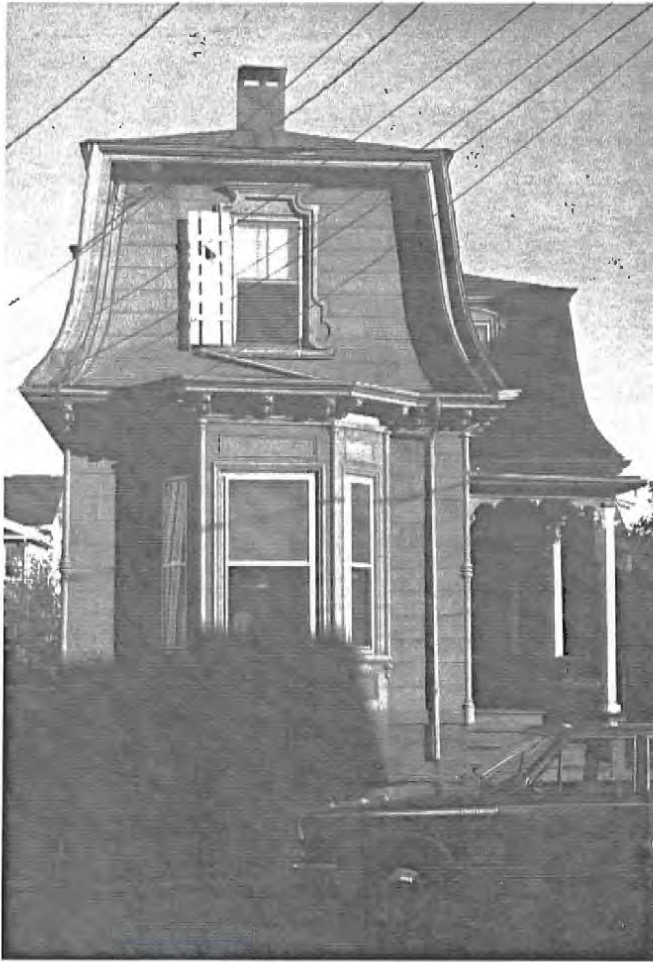
c. 1975

*Another example where removal of decorative trim results in the loss of architectural interest.*

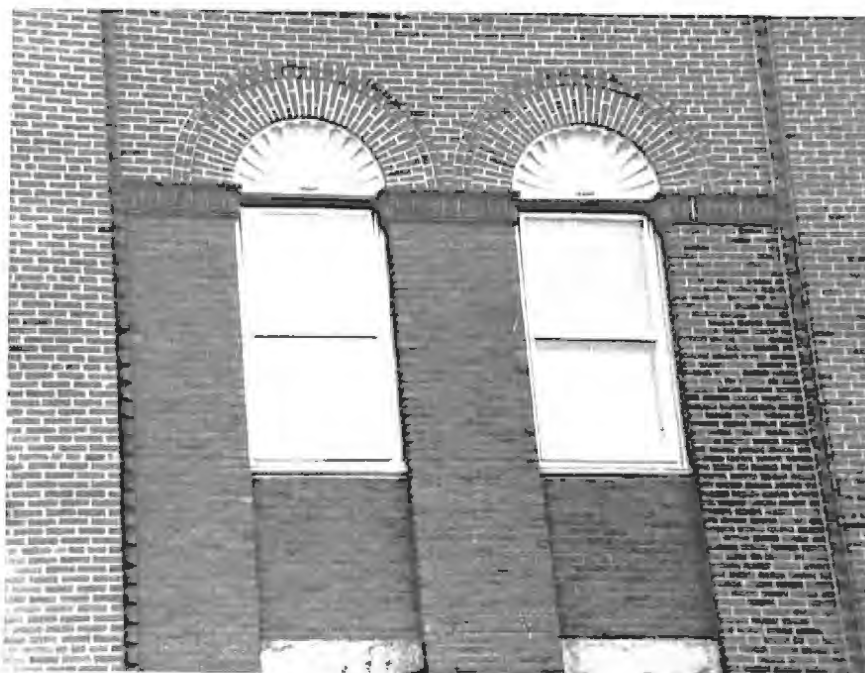
*Unlike earlier buildings, late 19th-century brick buildings featured thin, deeply recessed mortar joints. This gave the appearance of a smooth, seamless wall of masonry. This type of brickwork is not only indicative of advances in masonry technology from that of earlier eras, it is also part of the original design intent. Repointing with white mortar and wide joints will destroy the original character of the building by creating much more pronounced joint patterns than were originally intended.*

*Key: 1)original character 2)repointed portion of wall*

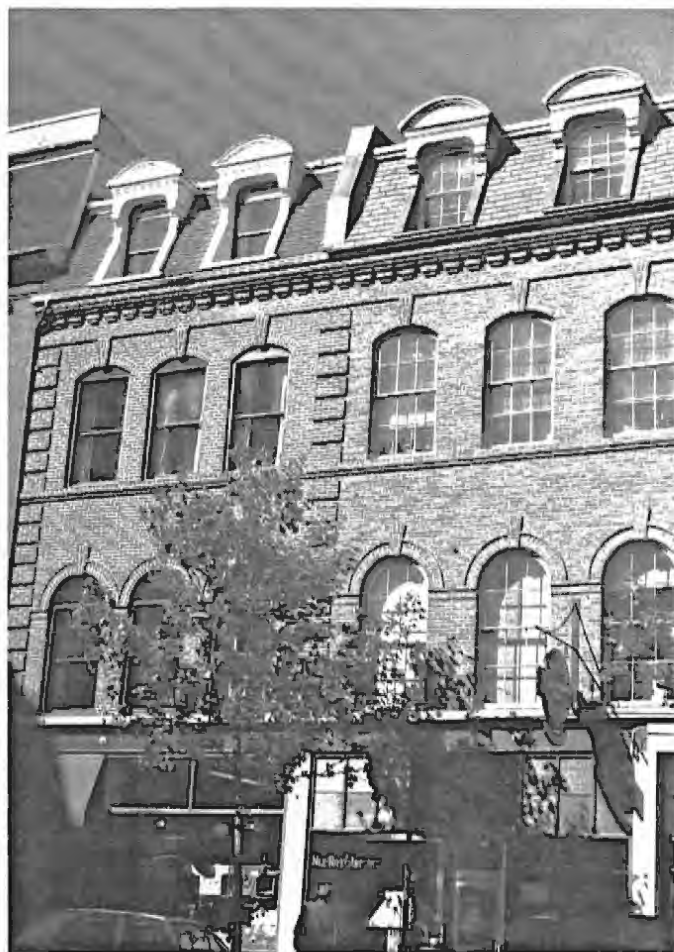
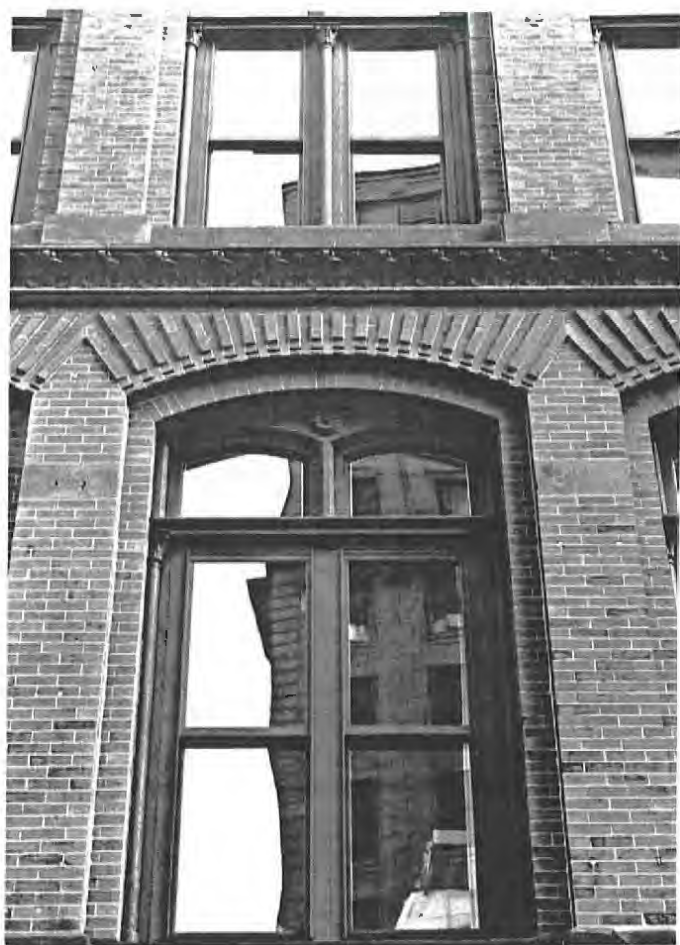
*When the original windows on this building had to be replaced due to deterioration, care was taken to duplicate the original window configuration and to retain the trim pieces which give the window their visual interest.*

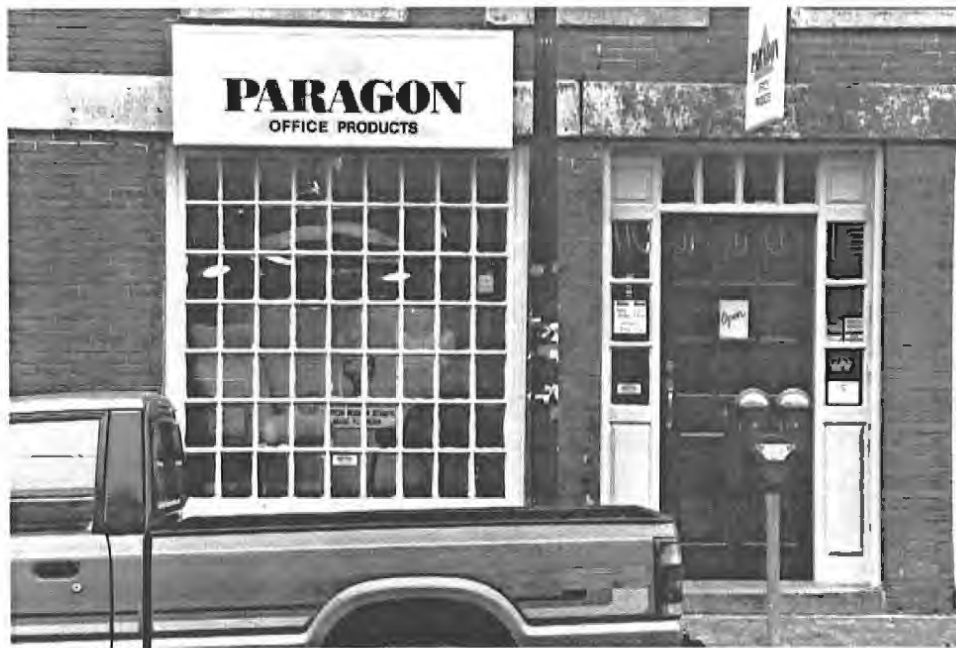
*Small-pane storefront windows and residential entrances were not used historically in commercial buildings. Simpler window and door designs would complement the straightforward Federal lines of this building.*
