## Historic Preservation Board

Wednesday, November 20, 2024 at 5:00  
PM Room 24 (Ground Level of City Hall)  
and Zoom

## **AGENDA:**

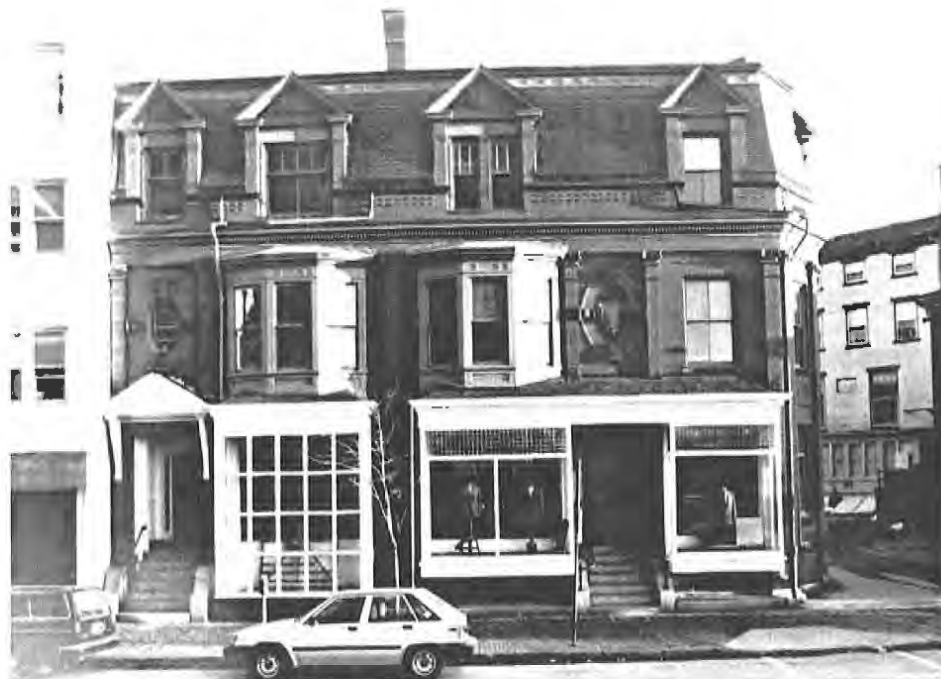
*Several years after this Queen Anne style residence was built on Congress Street, storefronts were added to accommodate a commercial use. These modifications, which are of high quality in their own right, reveal the fact that upper Congress evolved from a primarily residential neighborhood to a commercial corridor. Although this is a major change to the structure, it does not overwhelm or obscure the original building.*

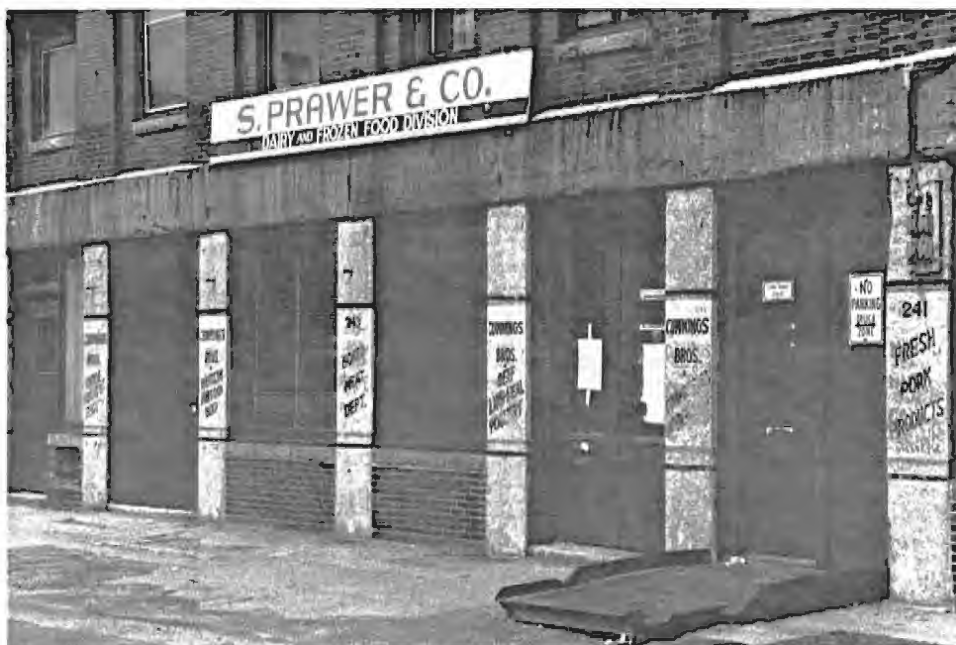
*Signs have been painted on the granite piers of this Commercial Street warehouse which describe the products sold within. Retaining this signage is encouraged, even if the use of the building should change, for it reveals the building's long history as a wholesale food warehouse in a bustling waterfront commercial district.*

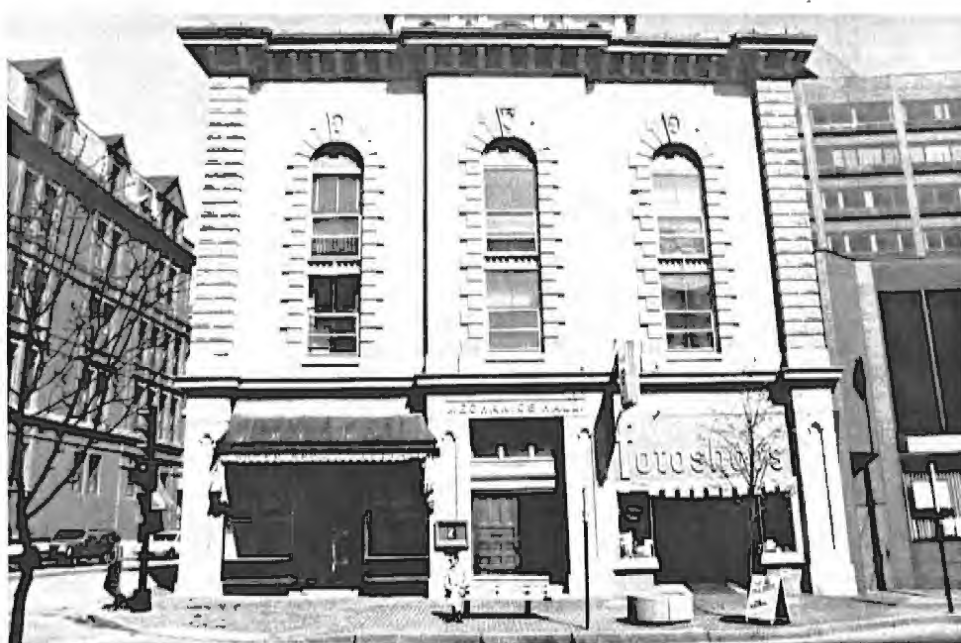
*To acquire significance of its own, an altered storefront must be of high quality and an excellent example of its own design period. Also, it should generally be compatible with the rest of the building. Although it was constructed of good quality materials, the storefront on the right has not acquired significance because it is not an outstanding example of its own design period nor is it compatible with the original design of the building. In this case, the left storefront might serve as a template for a future redesign of the right storefront.*

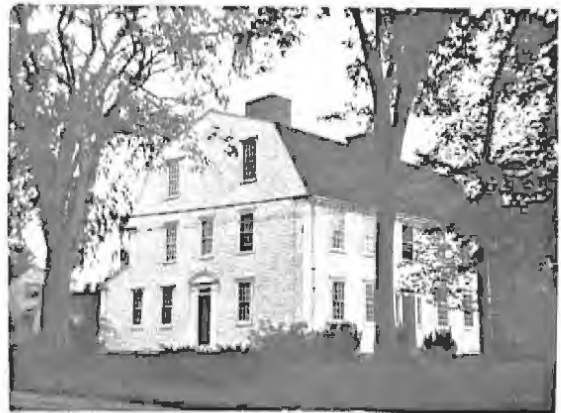
*One of the clues for identifying this building as a Colonial-era structure is its multi-pane sash with heaving muntins. Were these replaced with simpler windows, an important stylistic feature would be lost.*

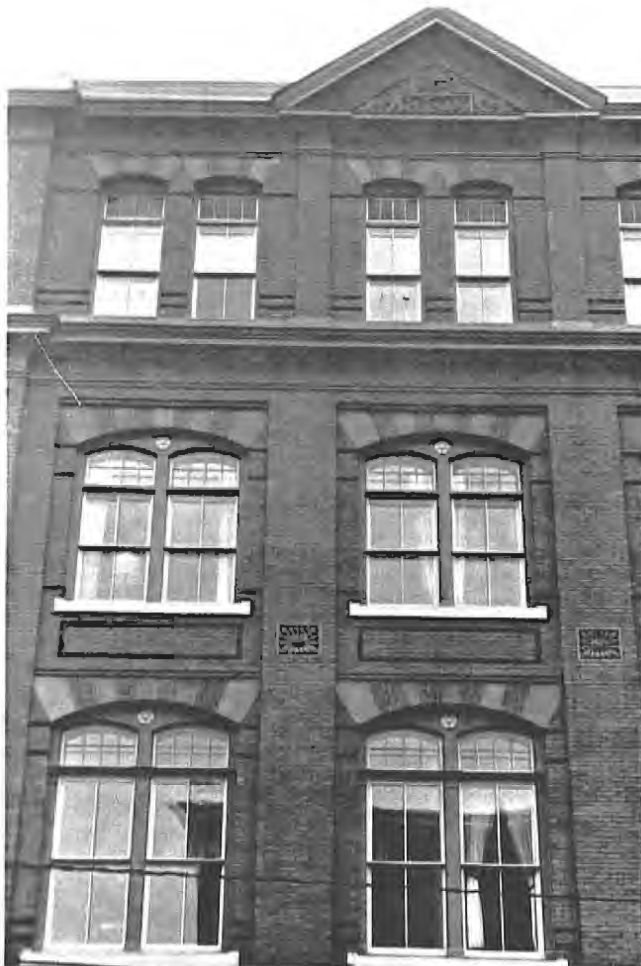
*The terracotta panels, patterned brickwork, decorative lintels over the windows and composite window sash are all features associated with the Queen Anne style. As part of a sensitive rehabilitation effort each of these features was repaired, ensuring that the richness and complexity of this style was retained.*

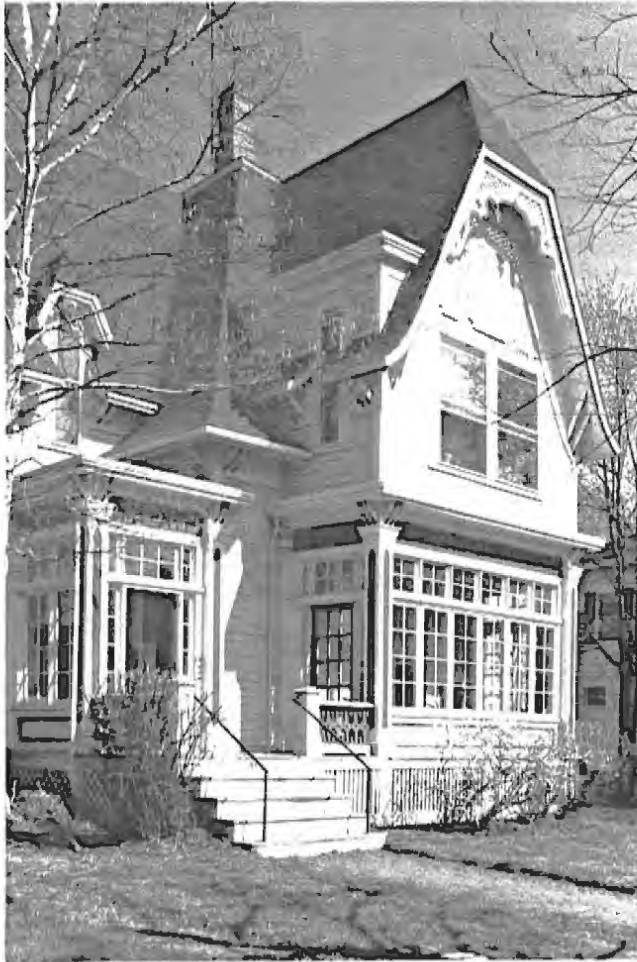
*The skilled craftsmanship displayed in this Swiss style house is evident in many of its features. Its complex massing and roofline, its pierced vergeboard and gable panels, its sawn balusters, its multi-part windows, and its polychromatic paint scheme all help to define its historic character.*

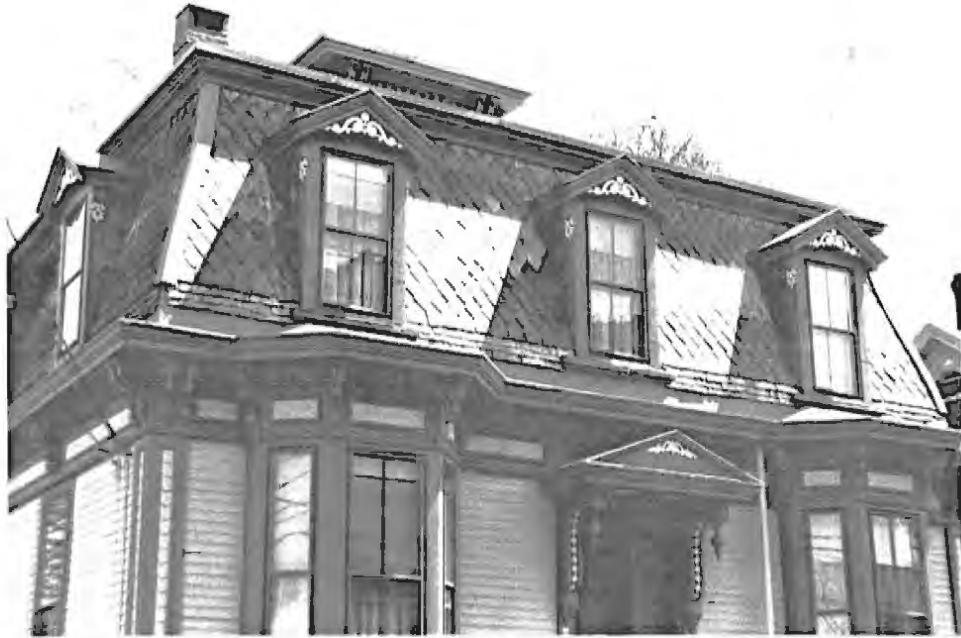
*Polychromatic slate roofs are a tell-tale feature of the Second Empire style. On this small residence, the texture and color of the mansard is important in the overall architectural design. Were this reshingled in a material which does not approximate the appearance of slate, an important character-defining feature would be lost.*

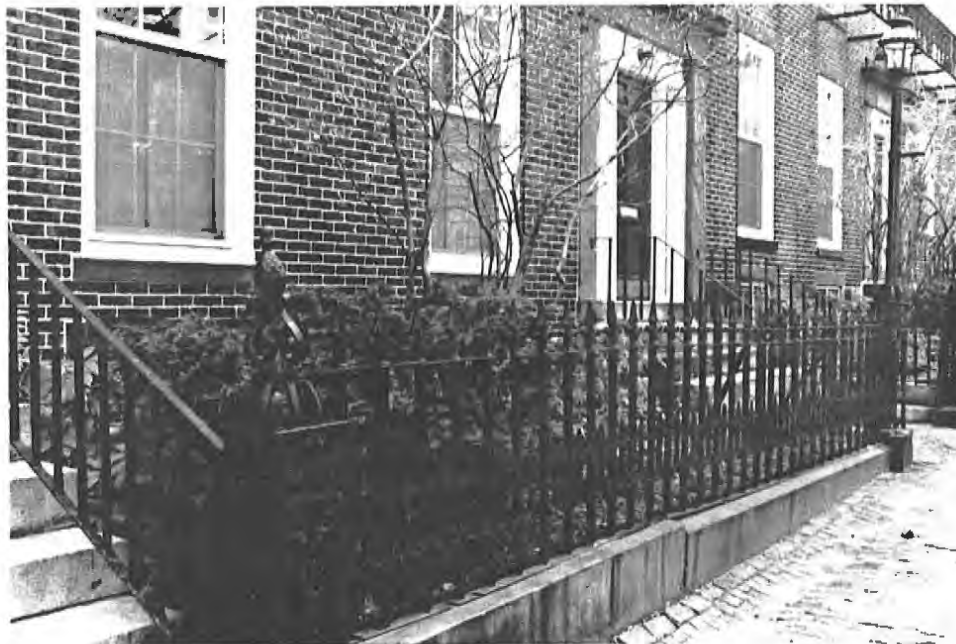
*Site features, such as this elaborate cast iron fence, deserve the same careful preservation as the buildings they enhance.*

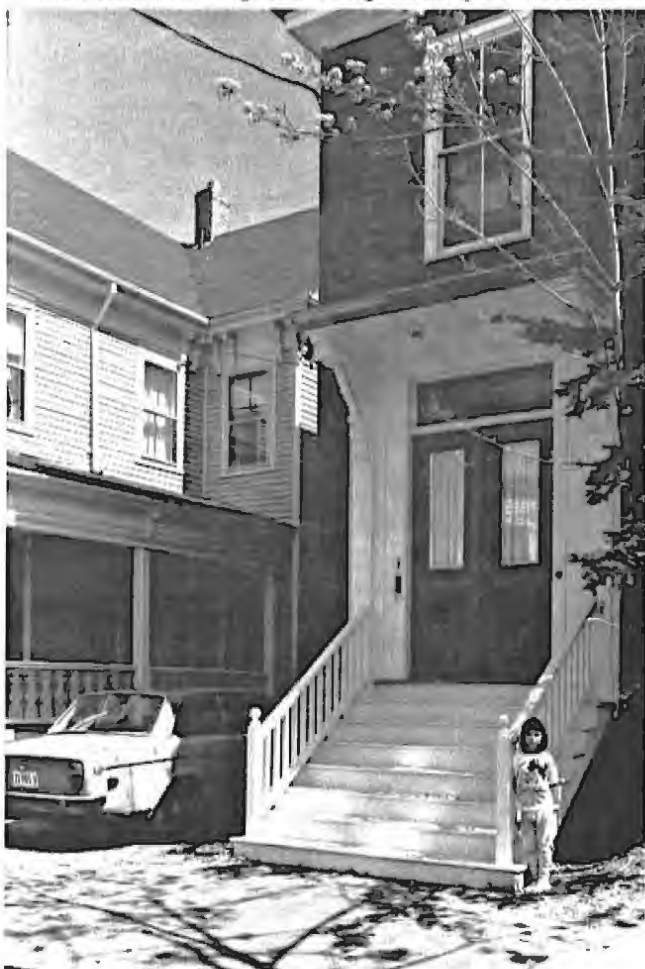
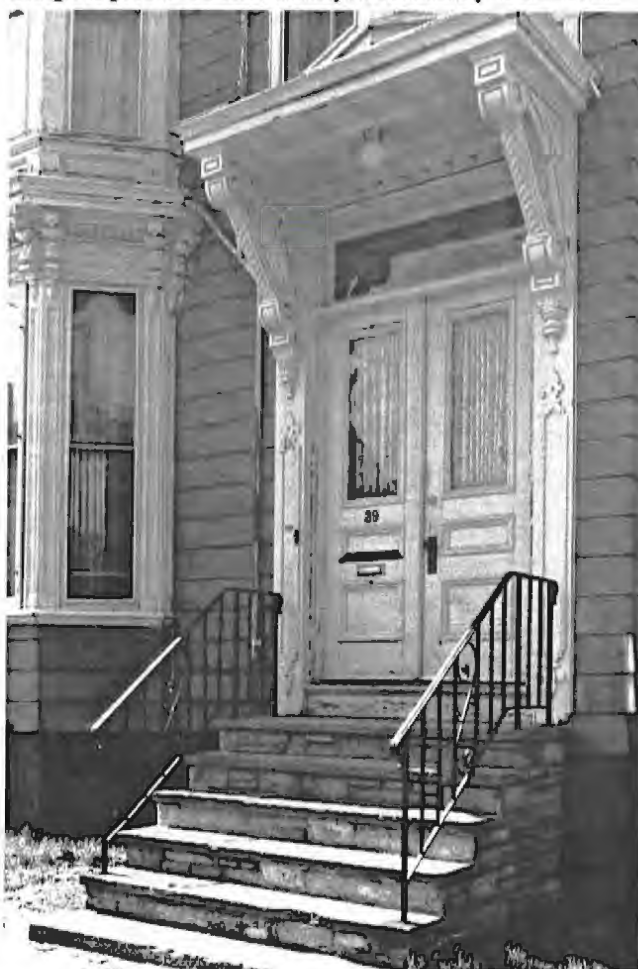
*It is important to use similar materials when replacement of a deteriorated architectural feature is necessary. Here, two sets of steps have been replaced on wood frame Italianate style buildings. The wooden steps and railings on the left resemble the original feature both in material and style. The artificial stone steps and wrought iron railings on the right have no historical basis.*

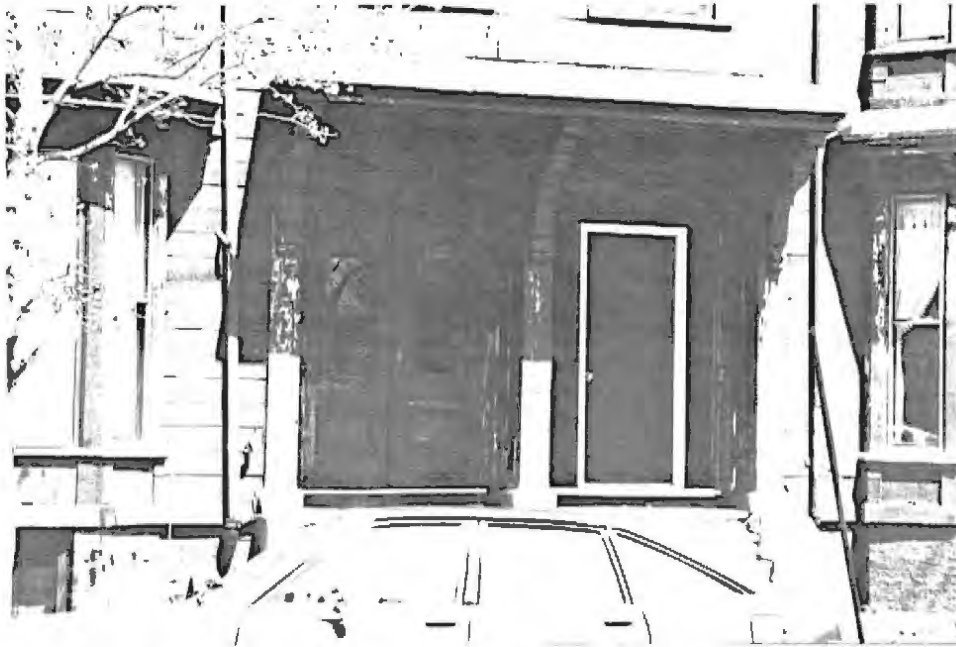
*The replacement of the original double doors with a solid steel door and infill panels (on the right) destroys the historic integrity of this entrance. Salvage doors of the same type as those on the left or new replication of the original doors would be a more compatible solution.*

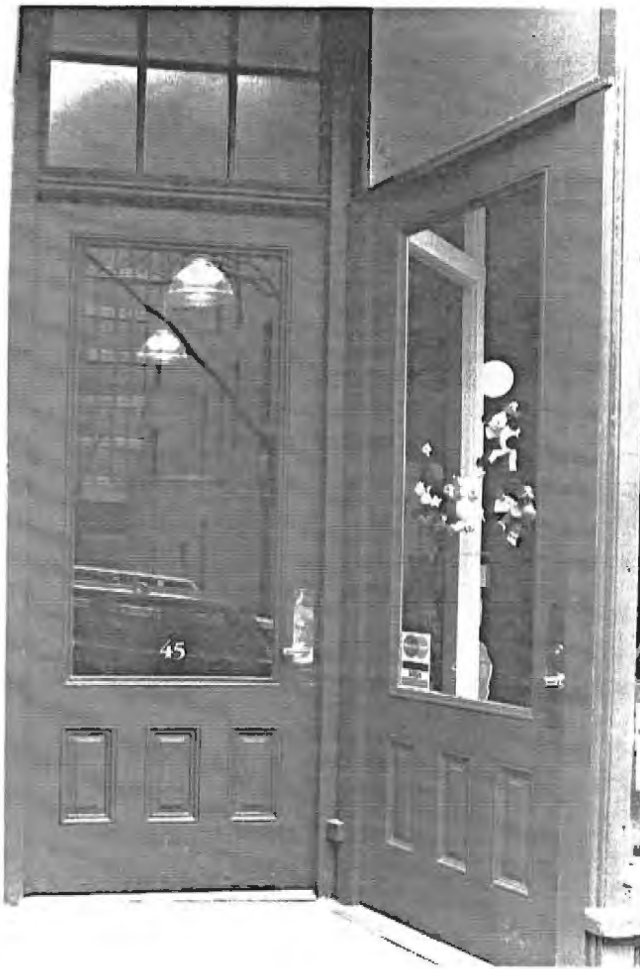
*Design for replacement of a character-defining feature may be based upon an existing feature. When a second entrance was created in this storefront, a new door was built which duplicated the existing door on the left.*

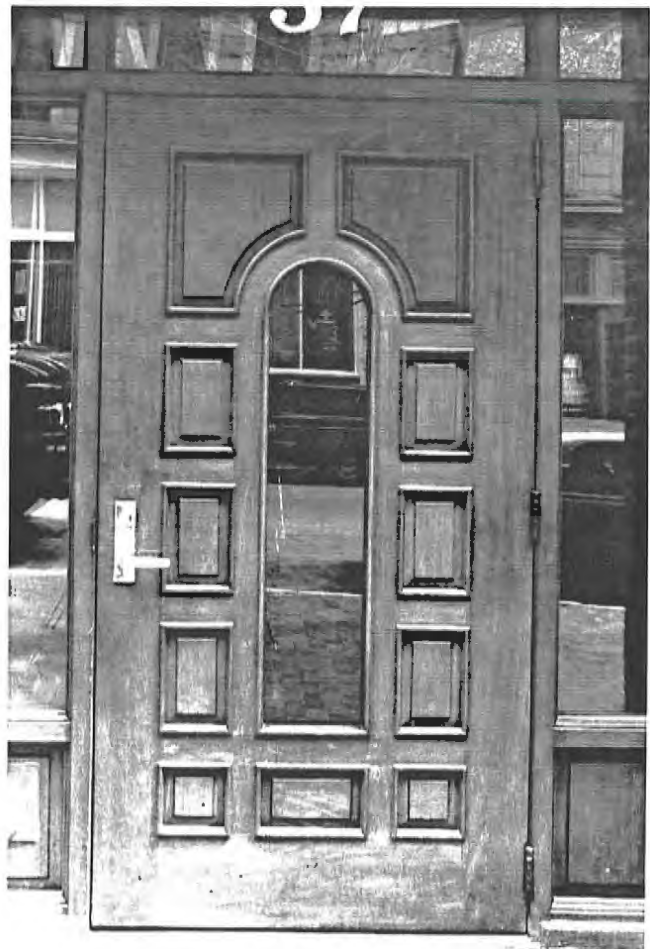
*The design for this door, on a nearby building of similar style, has no historical basis. Historic, physical, or pictorial evidence could have been used to replicate the earlier door.*

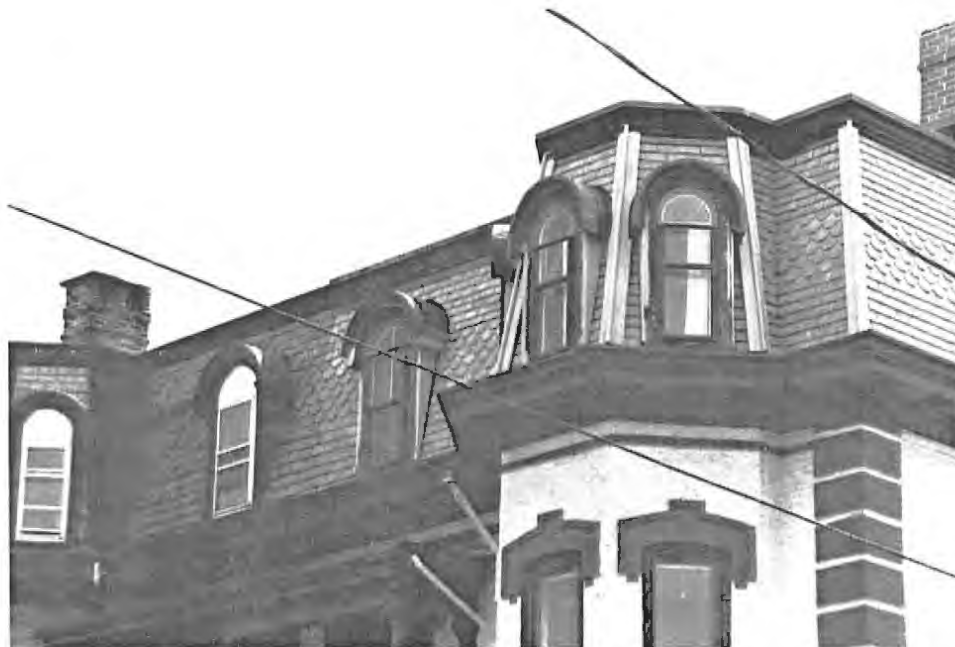
*Sometimes a substitute material may be used to replace a deteriorated feature. The mansard roof on this double house retains its original slate on the left side while that on the right side has been replaced with "Supra-Slate", a mineral fiber-shingle product. This new material matches closely the design, color, and texture of the original slate.*

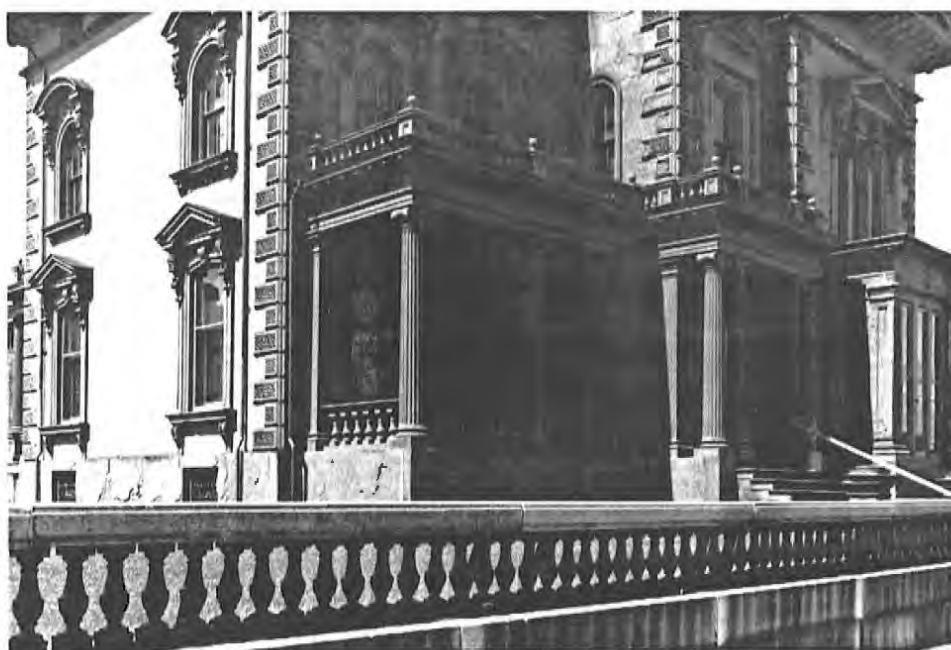
*When an original material is difficult or too costly to match, alternative treatments may be used if they match the appearance and general properties of the historic material. A good replacement stone has not been found for the Victoria Mansion's deteriorating brownstone. When the porch in the left foreground needed to be replaced, wood with a sand painted finish was used as an acceptable substitute.*

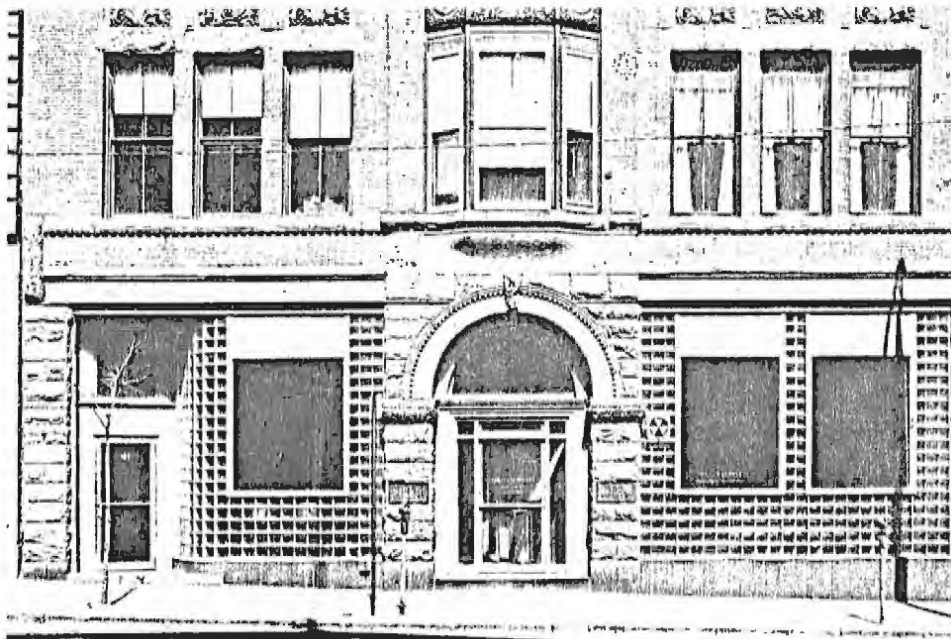
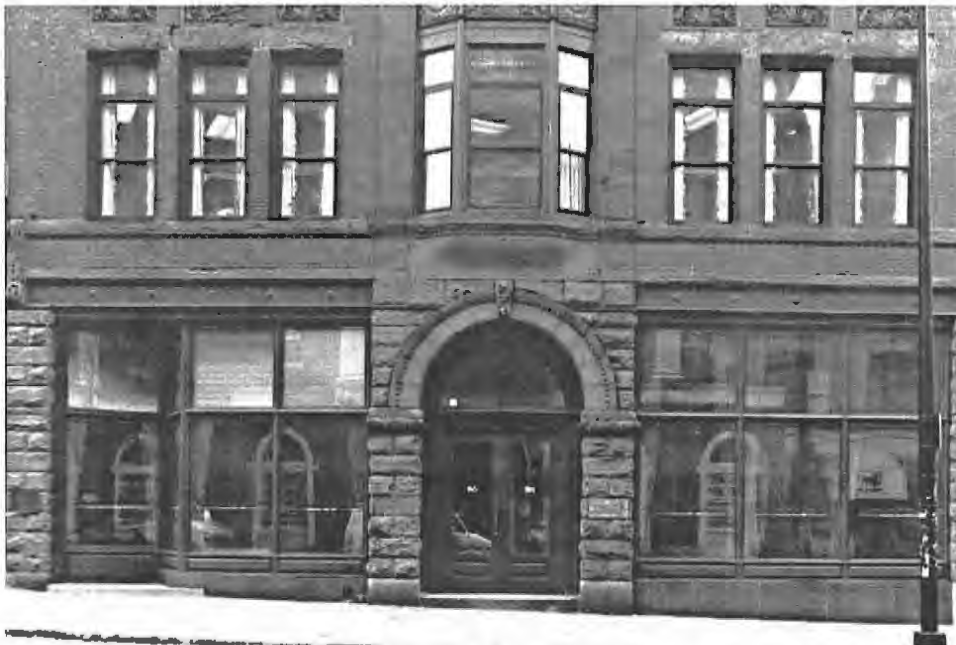
*If a historic feature was removed in a previous renovation project, it may be possible to replicate the original feature through the use of early photographs or other documentation. In a 1950's renovation of the Oxford Block storefront (top photo), much of its historic fabric was removed. A more recent rehabilitation project included a contemporary interpretation of the original storefronts and central entry (bottom photo), which was based on traditional principles of storefront design.*

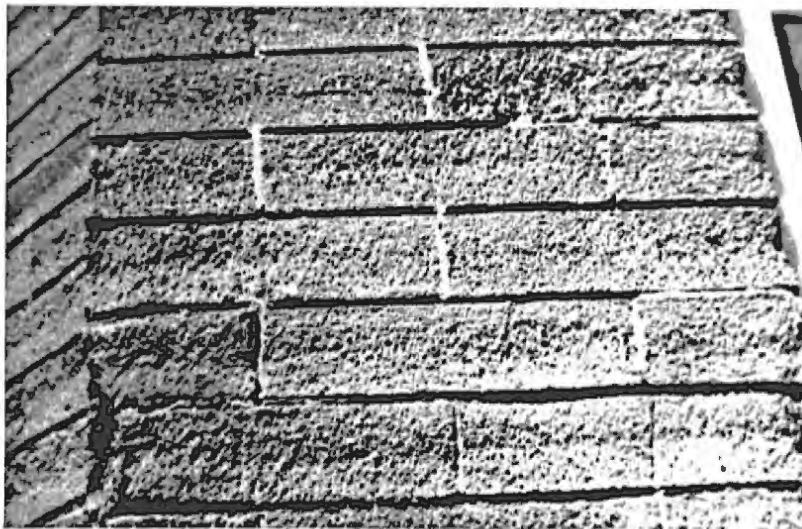
*Bricks must be cleaned by the gentlest means possible. Sandblasting to remove paint or dirt can cause sever erosion, as illustrated in this photograph. Even when sandblasting is skillfully performed, the protective outer surface of the brick is partially removed and increased porosity will result. This will accelerate deterioration. Other methods of cleaning by water and chemicals should be tested and the least harsh method chosen.*

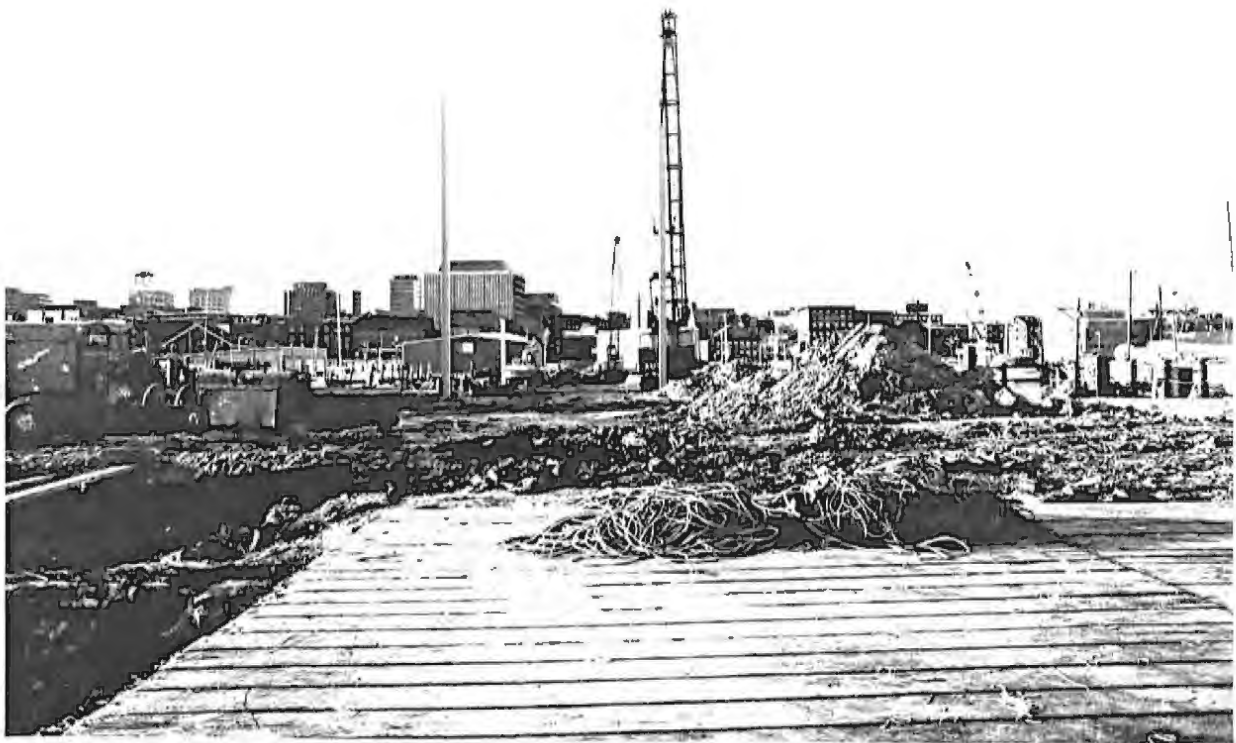
*Trained archeologists should conduct a survey of any site suspected to contain material evidence of previous cultures. Development plans should accommodate the need to protect or at least document these resources.*

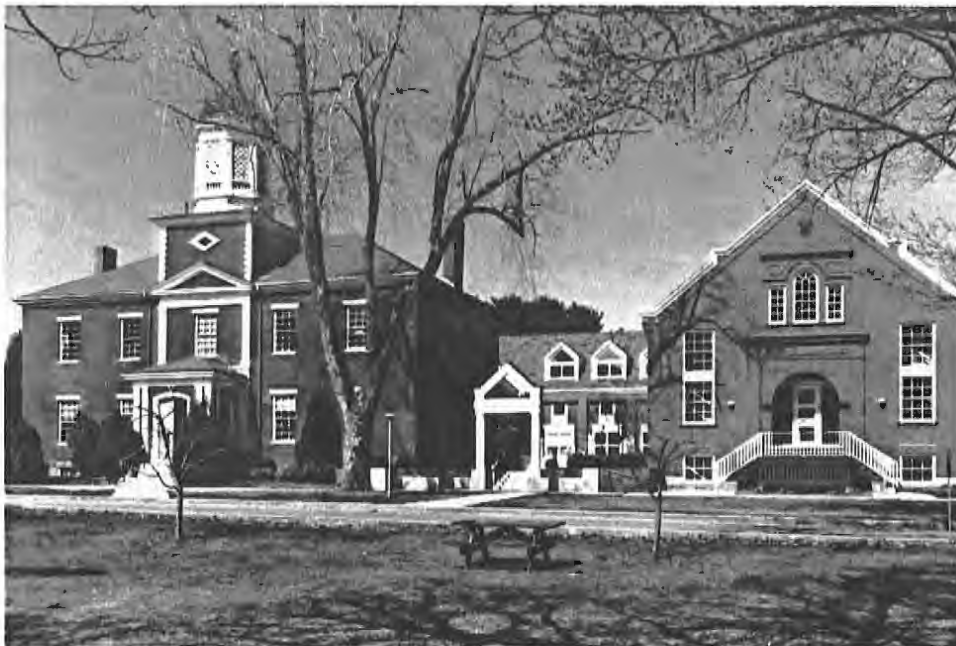
*Contemporary additions or alterations to historic buildings should generally be made on a side or rear elevation, not on the primary facade. The scale and materials should be compatible with the historic fabric, as illustrated in this addition to the Josephine S. Abplanalp Library at Westbrook College. It is important to note, however, that compatibility need not and should not mean exact replication. There should be a clear differentiation between the new and old, through detailing or materials, so the addition will not appear to be a part of the original building. Here, the addition respects the scale and designs of the two buildings it connects and at the same time makes its own contemporary design statement.*

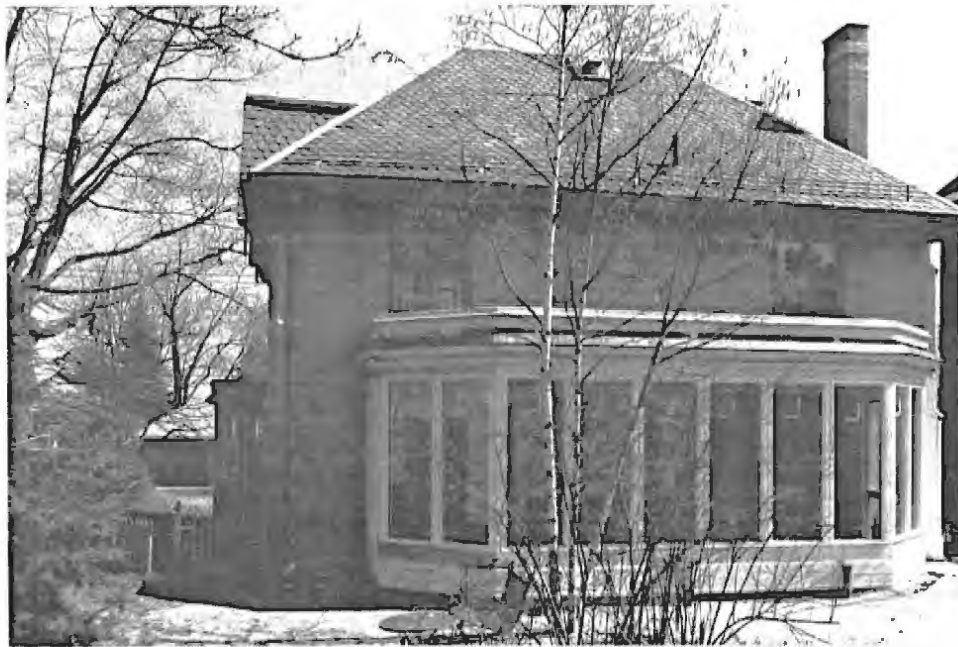
*To be compatible with a historic building, a contemporary addition may echo some of the building's original features or details. The kitchen addition on the rear of this house resembles the original bay on the left in its five-sided shape, its window proportions, and its flat roof surmounted by a rail. Nevertheless, it "reads" as contemporary.*

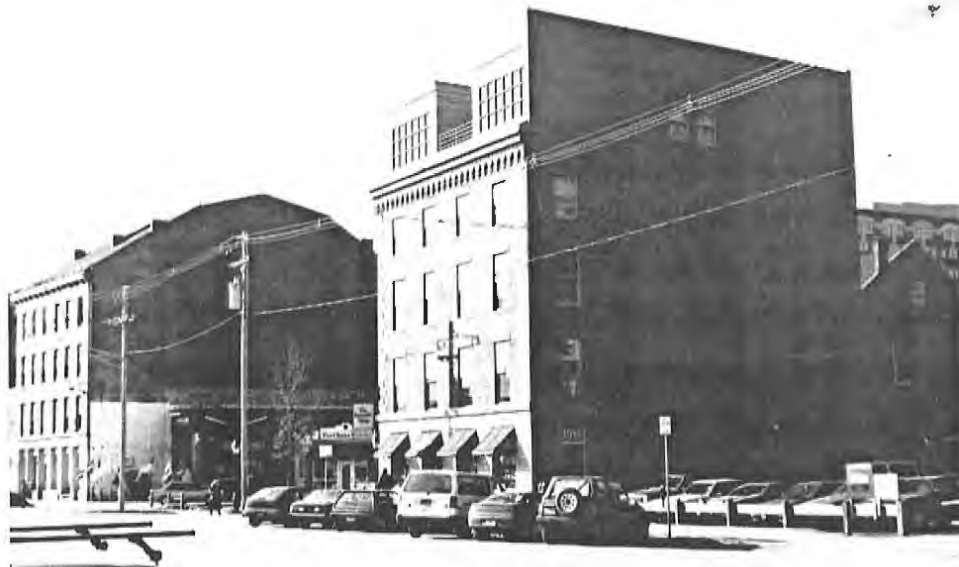
*The roofline is often an important character defining feature that should be respected. Here, the once prominent gambrel roof, typical of warehouses in the waterfront district, has been irreversibly altered by this rooftop addition which sits flush with the plane of the perimeter walls. The change is brick on the extended side wall is the only indication of the original roofline. Were the addition pulled back from the perimeter walls and integrated within the gambrel roof form, a more successful solution would have resulted.*

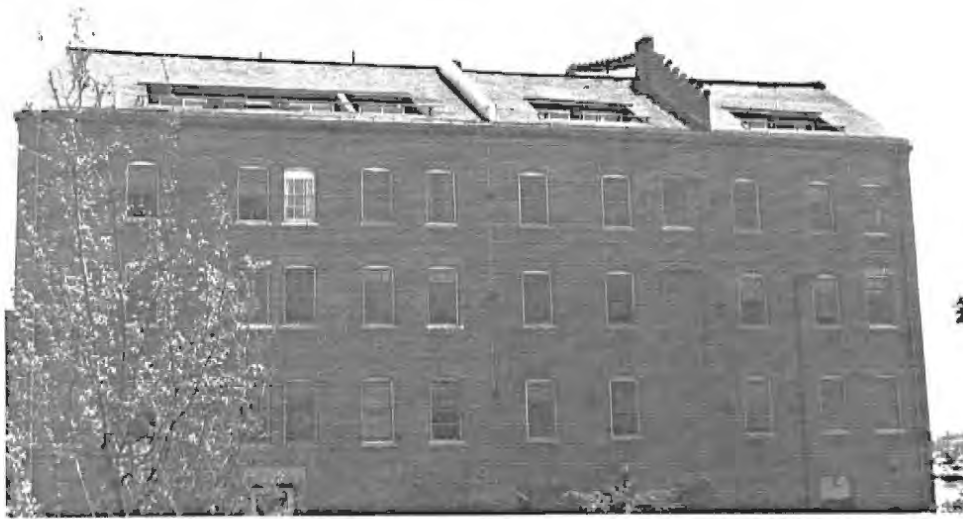
*By constructing inverted dormers in this gambrel roof, the developers gained usable space in the former attic. The shape of the roof, a distinctive architectural feature, has been retained and conveys a sense of the building's original character.*

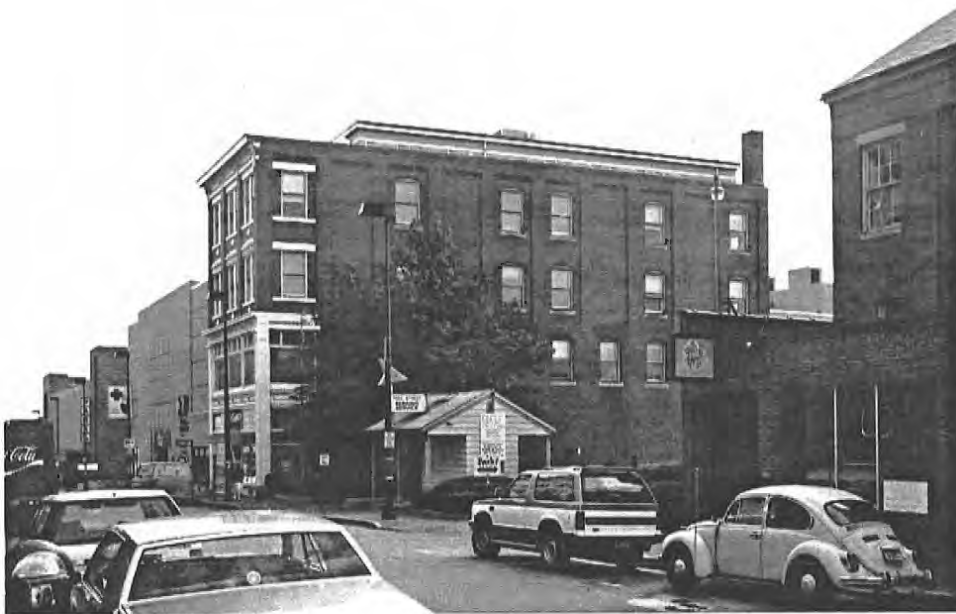
*By locating the rooftop addition back from the streetwall, the original architectural integrity of the building is retained.*

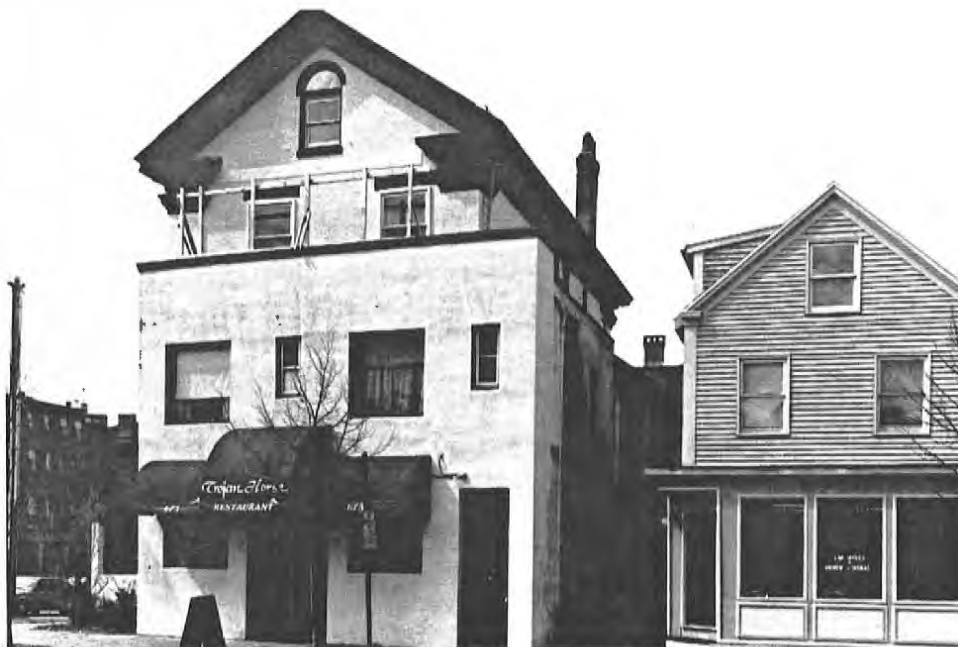
*When a major addition was made to the facade of this building, the original facade was destroyed, making the possibility of future reversal inordinately expensive.*

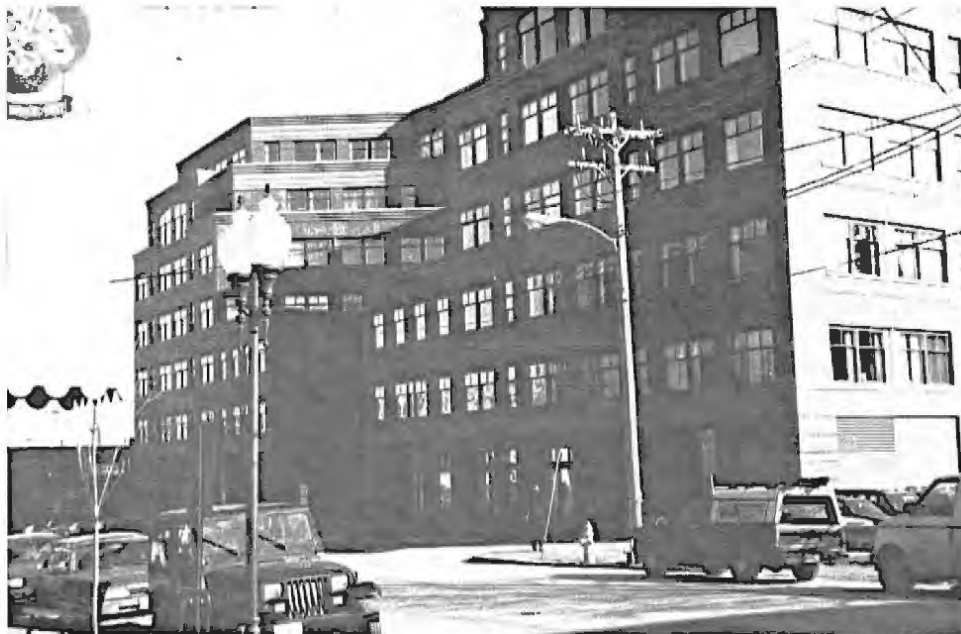
*New office buildings at 100 Middle Street are at least two stories higher than any adjacent historic buildings; yet they have a comfortable presence on Middle Street due to their set backs and angled facets. In addition, the strongly-detailed first floor creates a base that anchors the building to the street. Breaking the height of the building into horizontal bands can reduce the perceived height of a large building.*

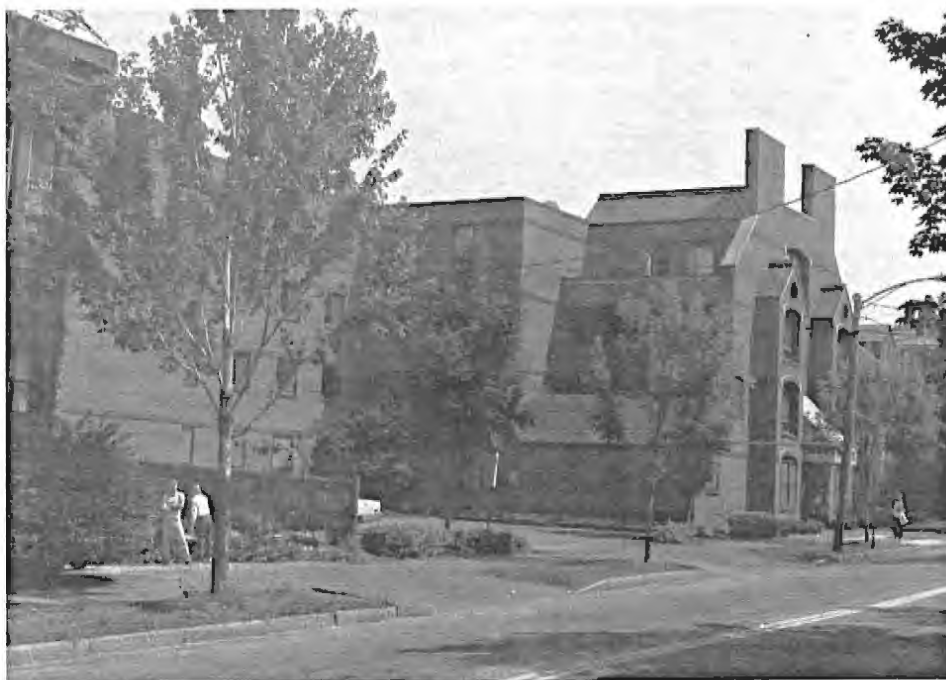
*The four story height of this Cumberland Park Place apartment complex is reduced at the sides and front of the building by pitched roofs, projecting banks of windows, and other details that attract the eye to lower parts of the building. The composition of the facade can be broken into subgroupings, some of which are of the same scale as the adjacent houses.*

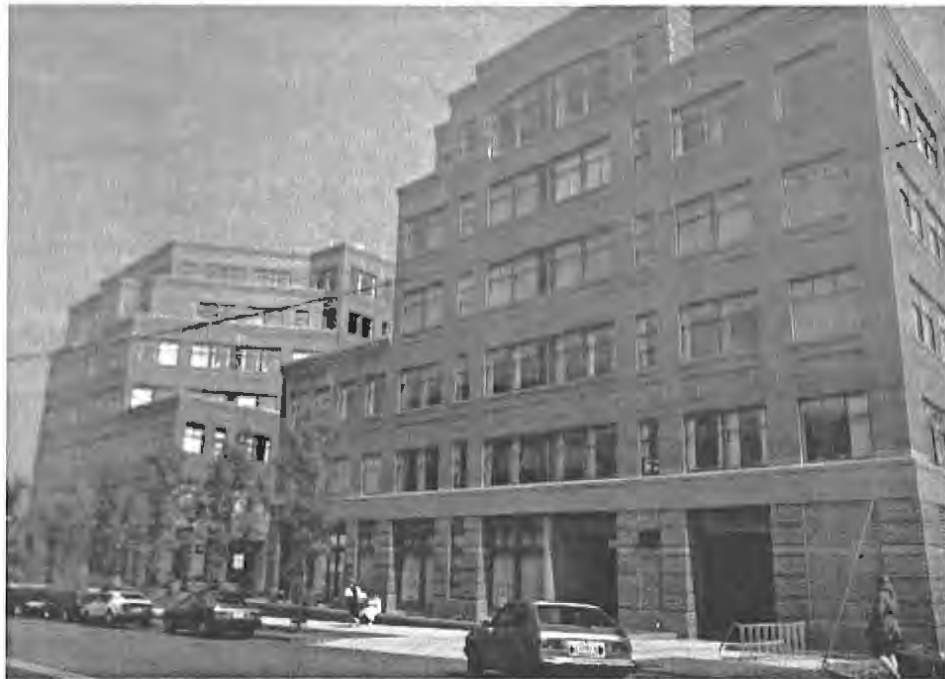
*The bulk of 100 Middle Street would have been oppressive and incompatible with nearby historic buildings on the street had it not been broken down into two towers. In addition, the multi-faceted, stepped facades and recessed courtyard help to reduce the apparent width of the building. When viewed from a distance, it appears there are two separate buildings, which are each similar in width to the significant older buildings across the street.*

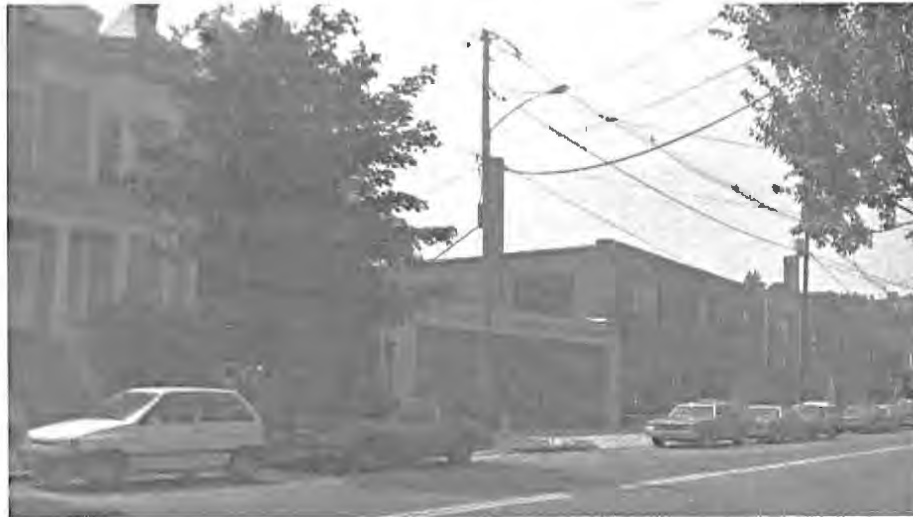
*This commercial building on Cumberland Avenue inserted into a neighborhood of older houses changes the scale of the streetscape due to its uninterrupted width. Elements such as projecting or receding entrances, pilasters or piers on the facades, or occasional setbacks, could have been used to break up the facade into segments that correspond with the width of adjacent residences.*

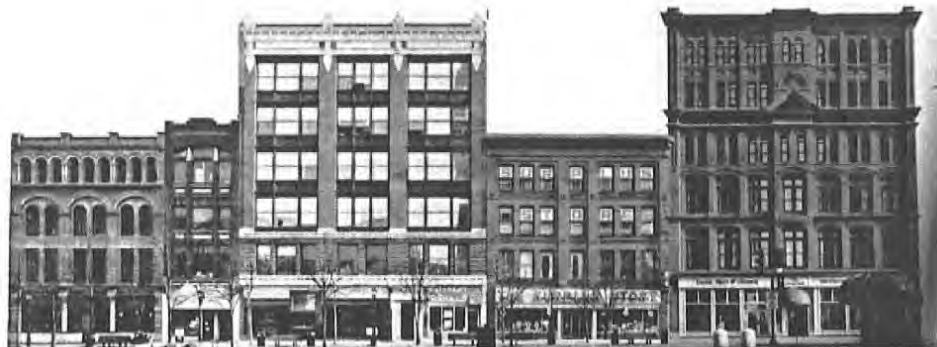
*This group of commercial buildings on Monument Square shows the variety of width and height that can be accommodated within a historic setting. Even though width and height (and thus scale) vary considerably from building to building, there are many similarities including storefront proportions, level of detail, strength of upper and lower cornices, etc.*

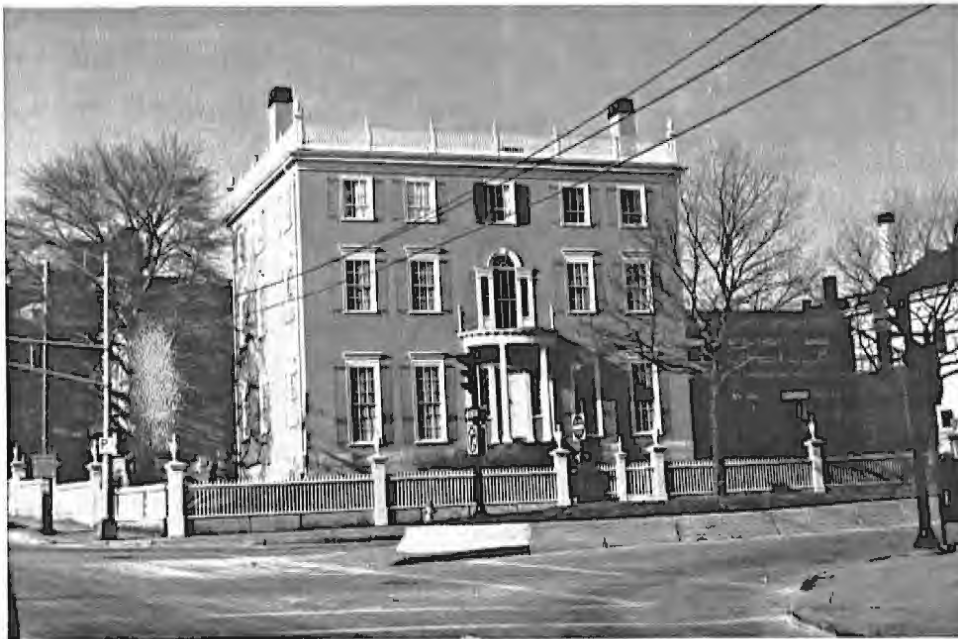
*The proportions of Federal-style houses contribute to their elegance. The ratio of width to height of the entire facade and of windows and doors within the facade of the McLellan-Swett House was based on ancient principals going back to the Romans. These proportions were standardized to a degree by the builders of the day, and can be seen in the large Federal houses along State and High Streets and on Danforth Street.*

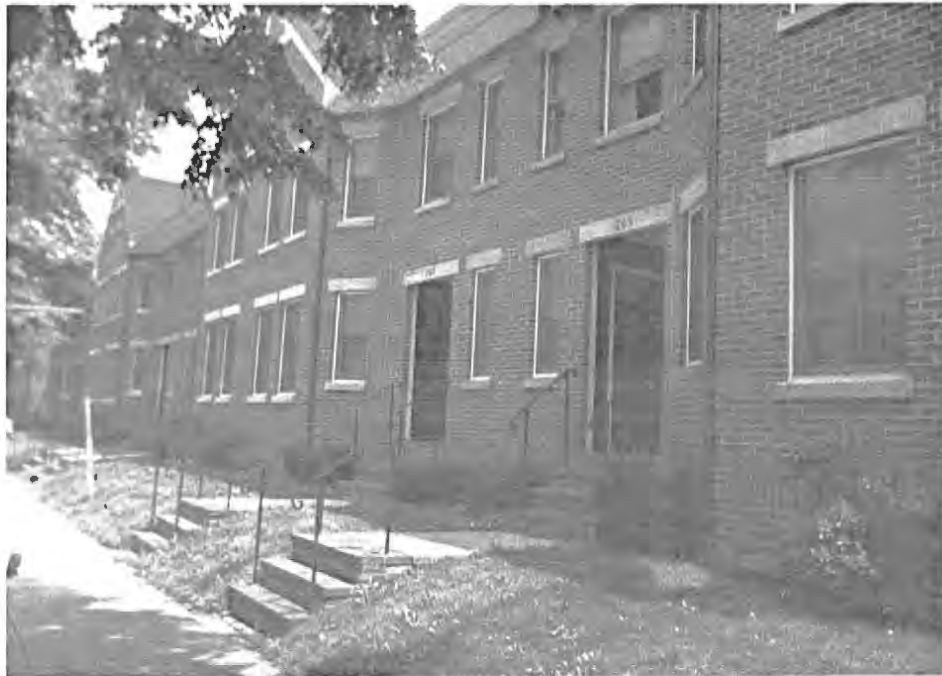
*The ratio of width to height of the projecting and recessed portions of this facade are carefully related to each other and to the width and height of neighboring houses in the West End.*

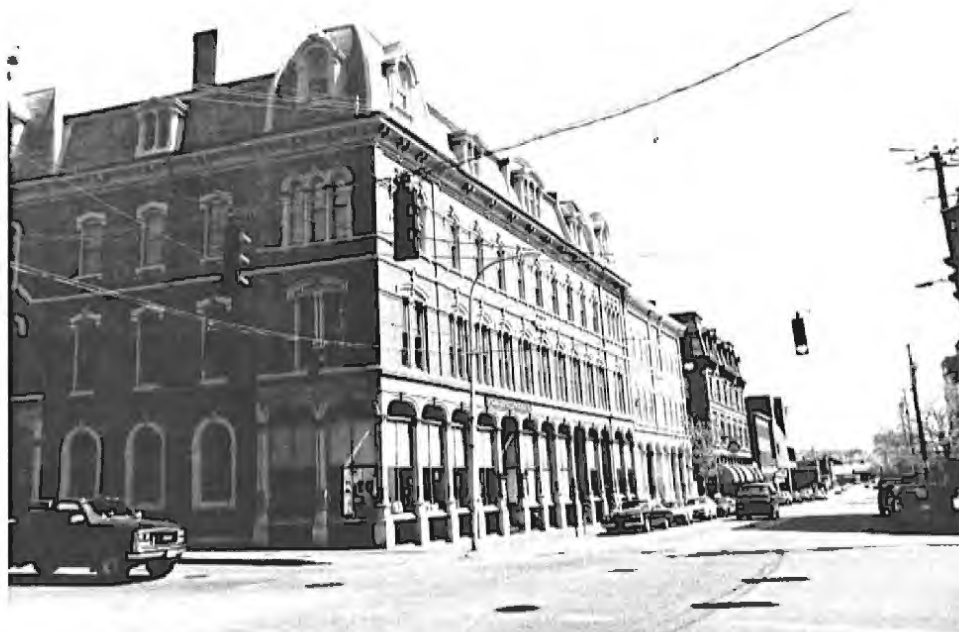
*The proportion of Victorian commercial buildings was set by many factors resulting from land use and sale patterns, limitations of building technology, etc. This view of commercial blocks on Middle Street shows a remarkable row of large three-story buildings that are very similar in scale and proportion. Such a strong pattern should be a design determinant for any new construction proposed for adjacent sites.*
