## Historic Preservation Board

Wednesday, November 20, 2024 at 5:00  
PM Room 24 (Ground Level of City Hall)  
and Zoom

## **AGENDA:**

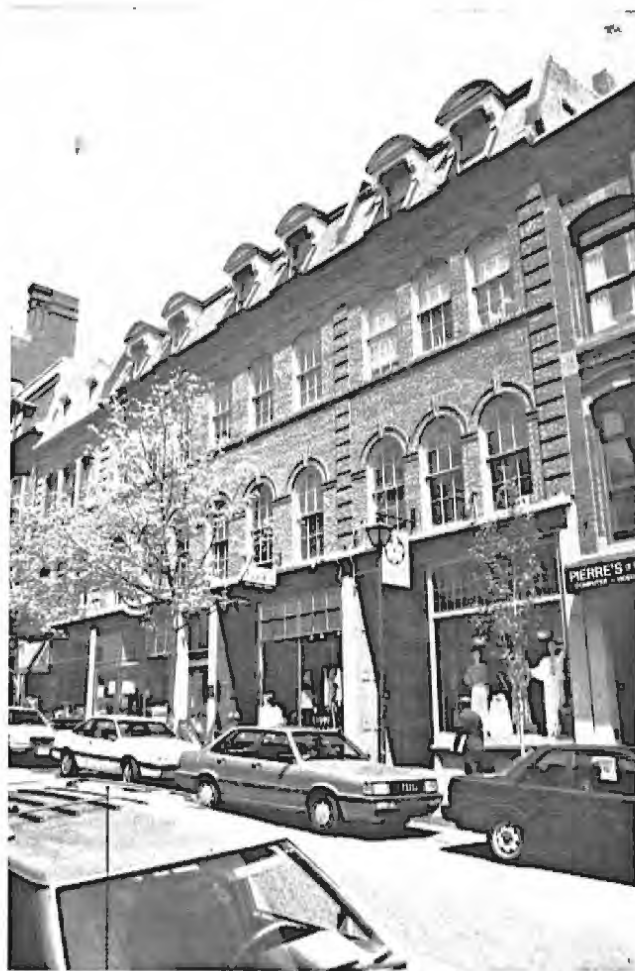
*The same is true for many smaller buildings in the Old Port. In this photograph a large commercial building is divided into typical storefront bays by storefront piers, upper story pilasters, and roof parapets to correspond with the more common single-bay structures along Exchange Street.*

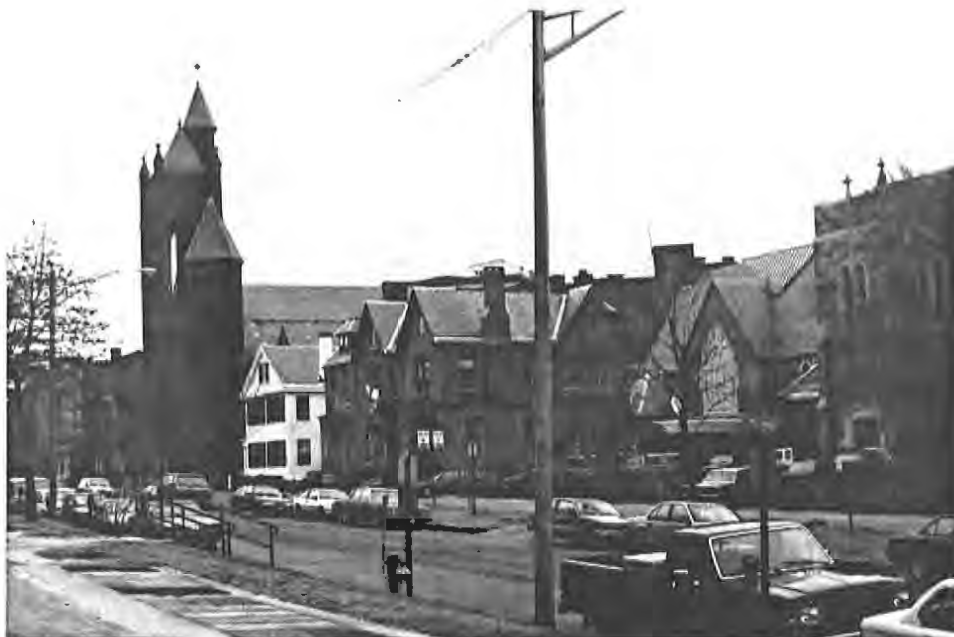
*The substantial structures along State Street represent a diversity that can allow a great degree of freedom of design for infill construction. The many towers, turrets, dormers and cupolas set a precedent for any number of roof designs. As important in this case is the overall scale of these buildings, overall proportion of width to height, and the substantial amount of open space in front of and between each building.*

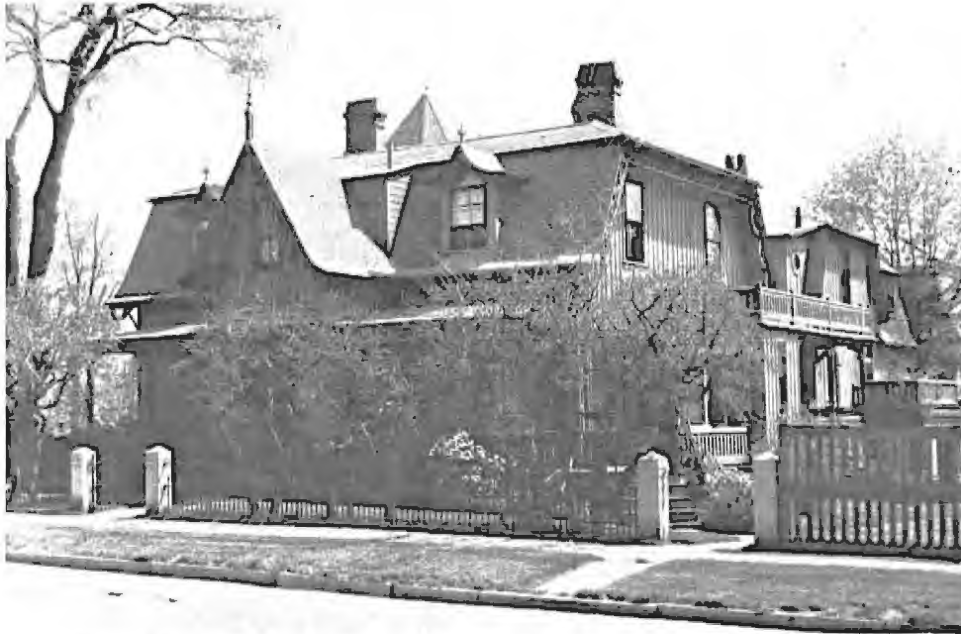
*This Western Promenade example shows how diverse roof shapes and features along Bowdoin Street can be found in an area of compatible buildings. Here the juxtaposition of an elaborate Gothic roofline with simpler, later rooflines provides a counterpoint to the similar scale and siting of all houses in the area.*

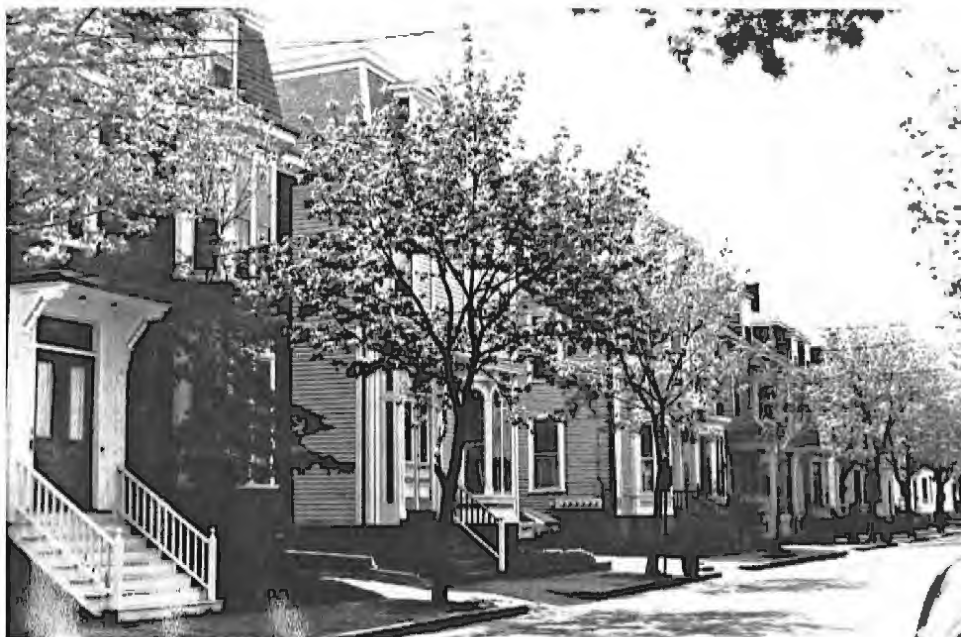
*The detached townhouses of Cushman Street represent a case where rooflines are so uniform that a new building inserted into this streetscape would be likely to have a mansard roof with the ridge perpendicular to the street. While a dramatically different roofline would not be ruled out, such a design would need to be carefully considered and justified as to its compatibility.*

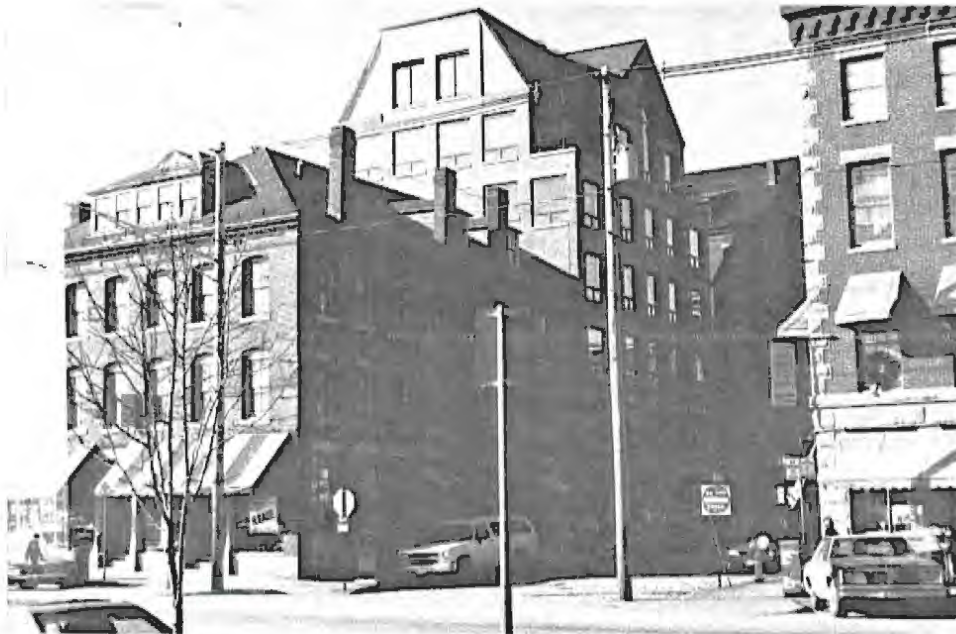
*This new commercial building in the Old Port is located on a crowded site on Moulton Street, but is perhaps most visible from Commercial Street. The multi-faceted roofline is successfully used to reduce the apparent height of the building and to harmonize with the gable, hip and gambrel roofs of its neighbors on Fore Street and Commercial Street.*

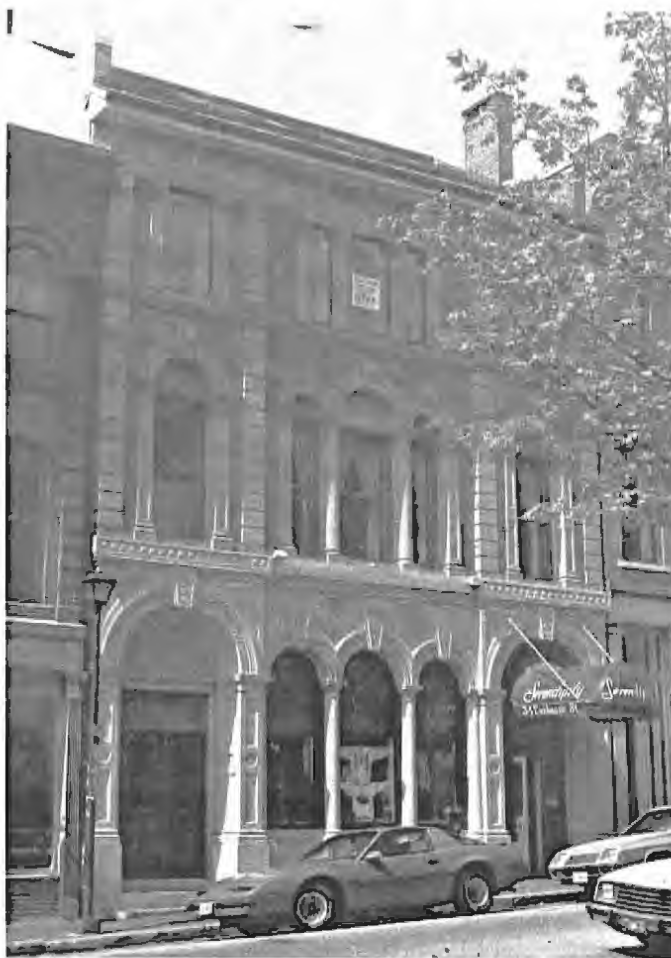
*This Old Port commercial building demonstrates the classic three-part facade composition of base, middle and top. Windows and doors are another important compositional element of commercial buildings. Storefronts and upper story windows set the pattern of a building facade. In a commercial setting, these patterns, though they can be decorated differently, are usually consistent. This building on Exchange Street has unique window and door decoration that sets it apart from its neighbors. But the window and door sizes and the rhythm they establish are similar to others in the area, and the way the windows and door are divided are likewise related to patterns found throughout the Old Port. Although upper story windows are, of necessity, different in proportion from the storefront windows and doors, the rhythm of upper and lower stories is related.*

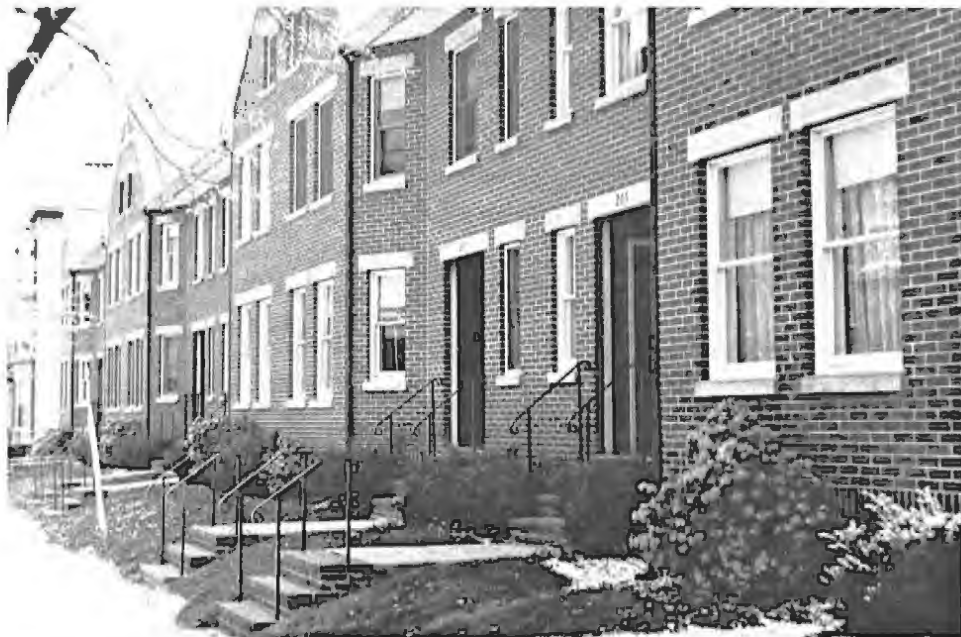
*In this condominium townhouse development on Vaughan Street, windows with stone heads and sills, together with recessed entrances, have proportions like those of neighboring historic residences. In addition, the rhythm established by the pattern of the windows and the location of the doors is in common with that of other houses in the district.*

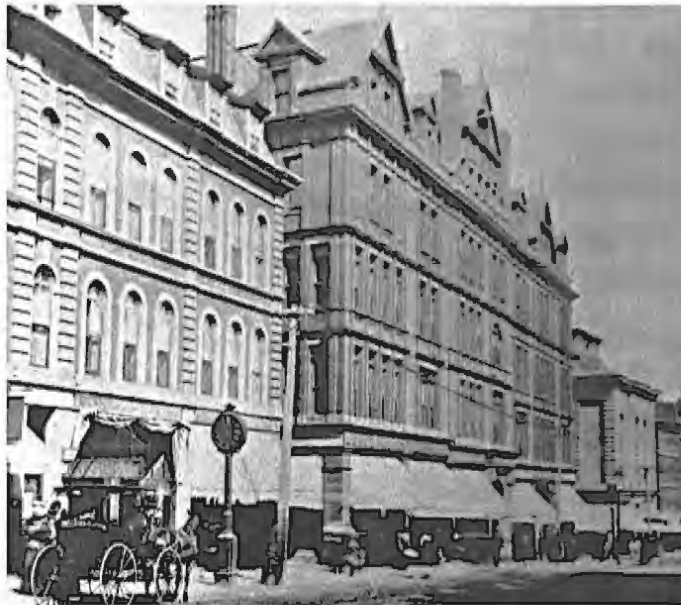
*Many commercial storefronts featured projecting awnings and recessed entries. Current code requirements dictate recessed doorways on new buildings located at the sidewalk. These awnings and recesses in this historic view along Congress Street play a major part in the composition of storefronts, and can set up a rhythm at the streetscape that is attractive in its own right. These elements play a role similar to that of porches on houses, in that they welcome the pedestrian and provide shelter from wind, rain and sun.*

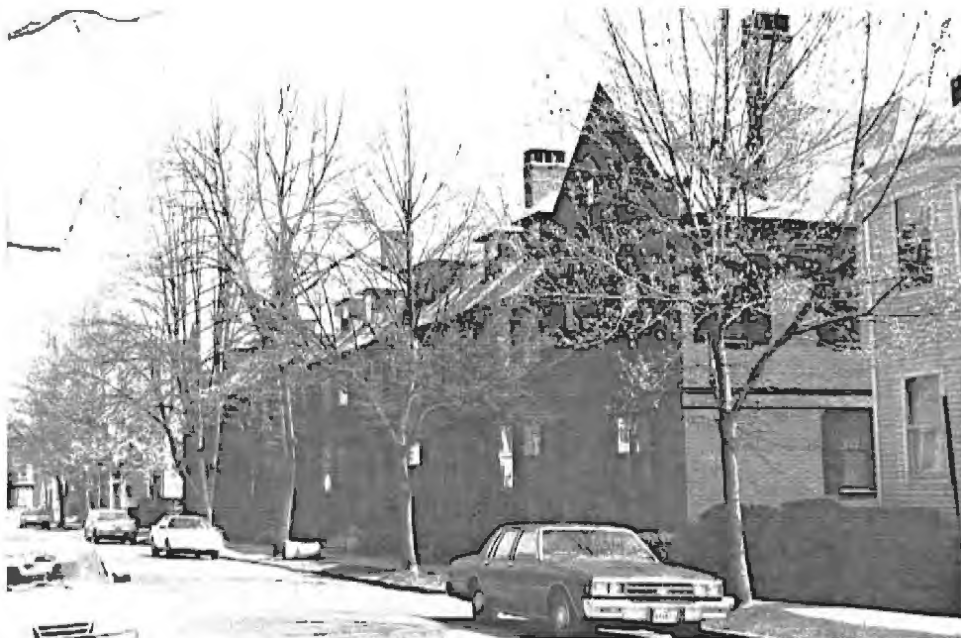
*The projecting front porches, bay windows and dormers of these Neal Street rowhouses establish a wonderful rhythm that relates the width of each house to the sidewalk and the passerby. Thus even though the houses are attached, a pattern similar to that of single-family houses is perceived.*

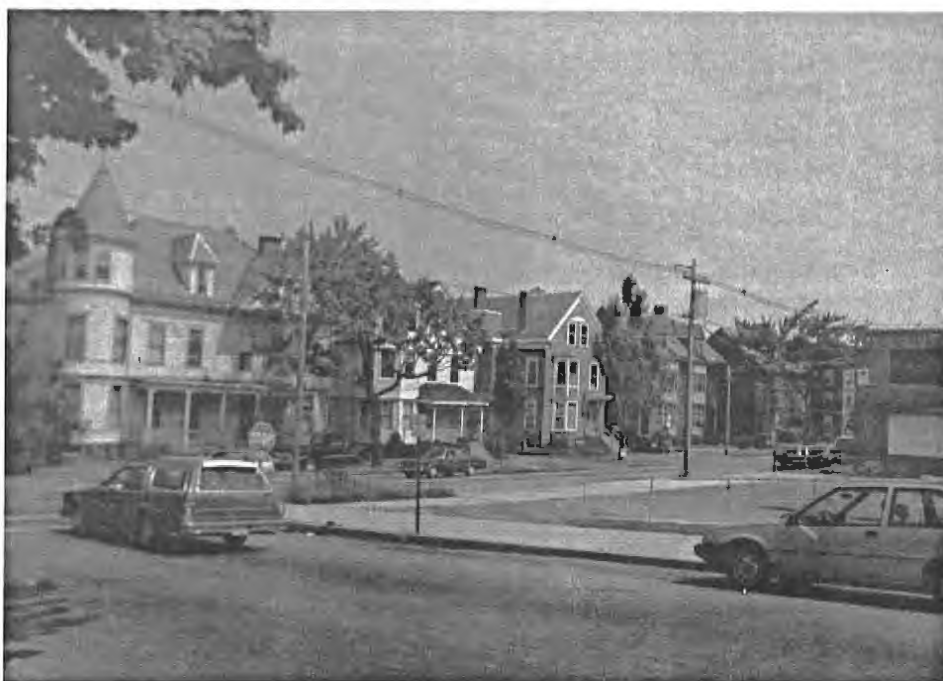
*In this photograph, detached houses on Cumberland Avenue are characterized by porches. Even though of varying sizes and degree of detail, they unify the streetscape by their presence in each facade composition and by their human scale.*

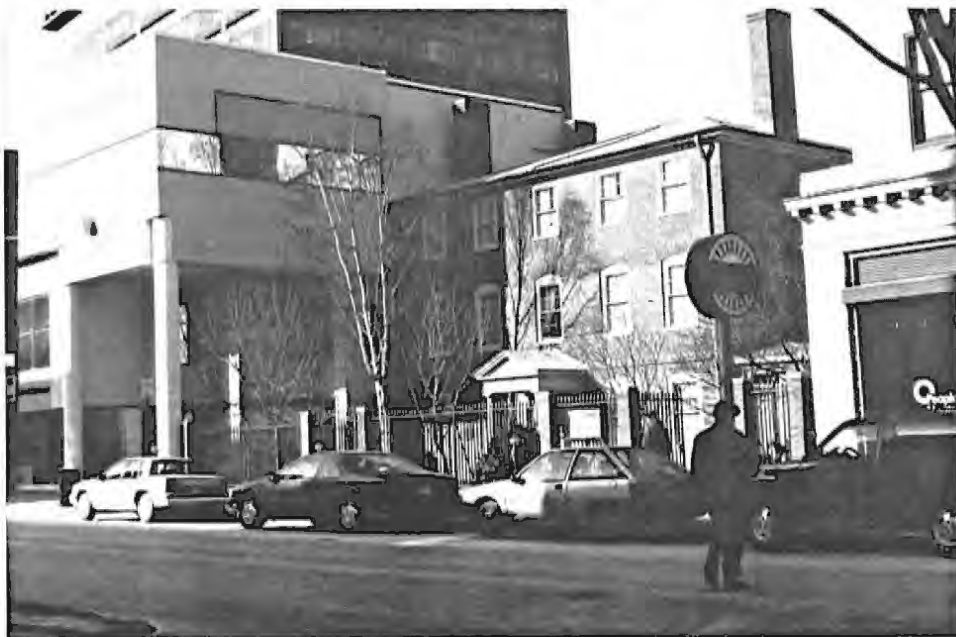
*While the use of modern building materials in historic districts is not discouraged, their compatibility with their immediate context should be carefully considered. Here, at 489 Congress Street, both the materials themselves and their coloration stand in sharp contrast to those of the Wadsworth-Longfellow House and serve to overwhelm the more restrained landmark building.*

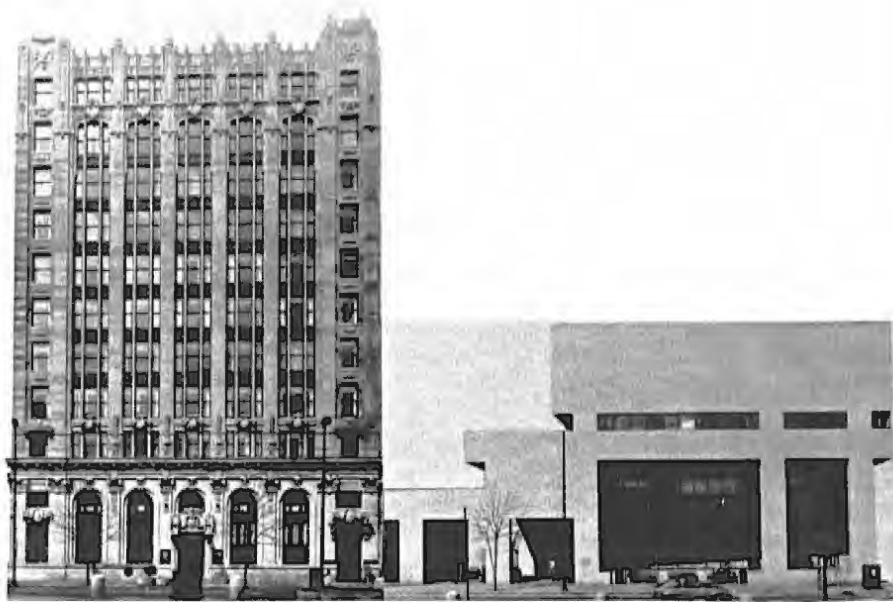
*The Portland Public Library is a fine example of a radically modern building maintaining the streetwall that is traditionally provided by storefronts along a commercial street within a historic context. Even though its entrance is deeply recessed, the building has a variety of elements which serve to enliven its sidewalk presence. The huge piers, iron entrance gate, and sloped greenhouse glazing all serve to reinforce its "storefront" while allowing a dramatic overhang at upper levels.*

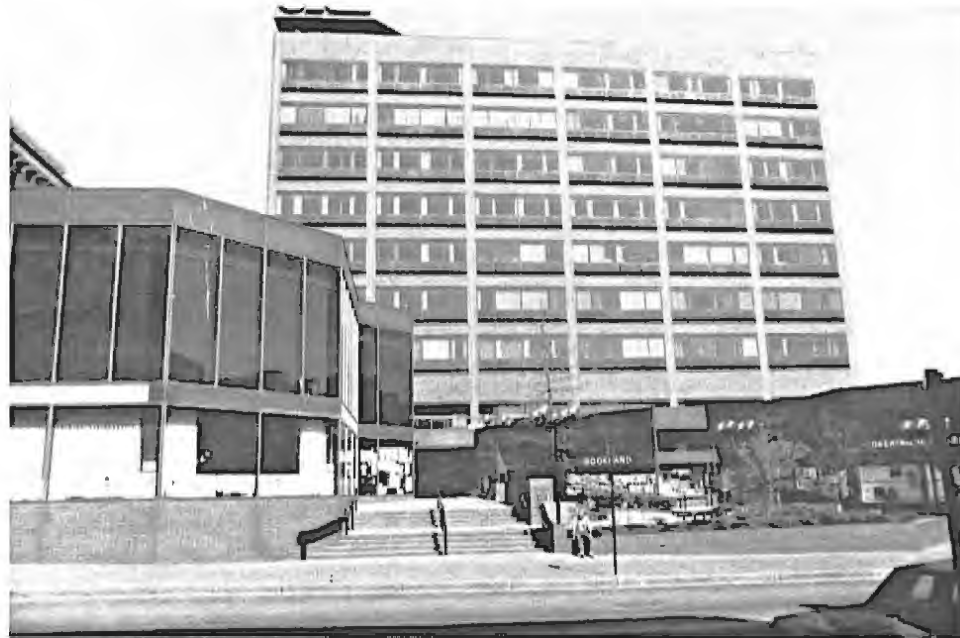
*The Maine Savings Bank is another example of a successful integration of a modern design with traditional commercial buildings. The austere main tower is set back from the street, with an approach plaza defined by two story wings that reach out to the sidewalk. Their faceted sides serve to draw the eye gradually to the main tower entrance. The impact of the tower on the sidewalk is lessened, and a public space is provided. Even though the wall of continuity is broken, the gap is not perceived because of the presence of the building at the sidewalk at either edge of the site, and the walls of the plaza at the street line. Although many such breaks in the street wall would damage the strong sense of enclosure that defines Congress Street, they can be successfully used at a few strategic points to create public spaces for significant new construction projects.*

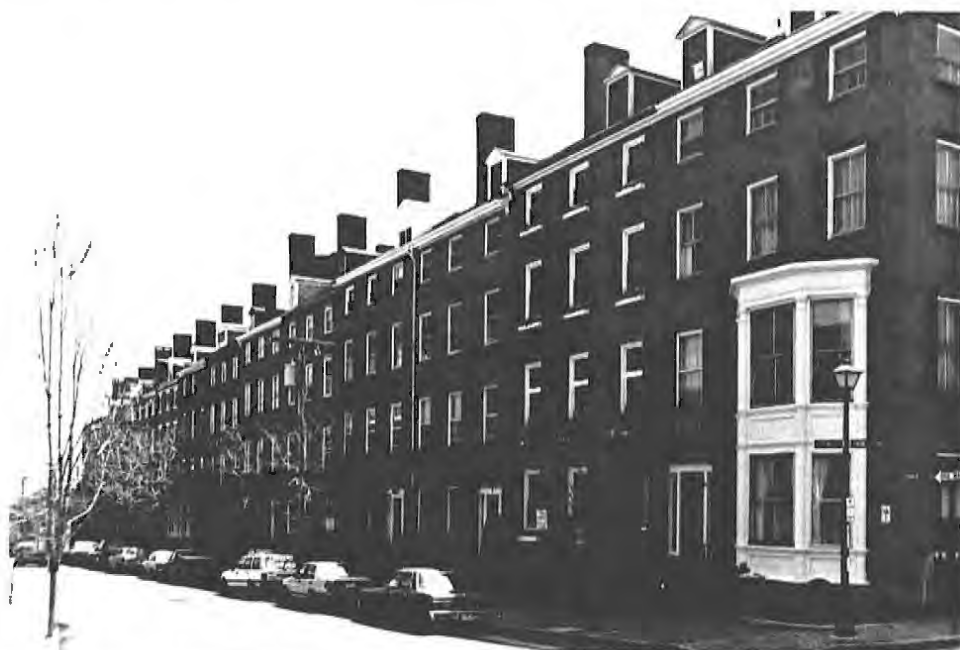
*The Park Street Row creates an attractive street wall, one that should not be broken. The continuity is emphasized by the rhythm of windows and doors, of chimneys and dormers, of porches and steps and railings. Fences and granite curbs add to the consistency of the block. This is an example of where scale, composition and relation to the street all come together to create a cohesive whole that is universe.*

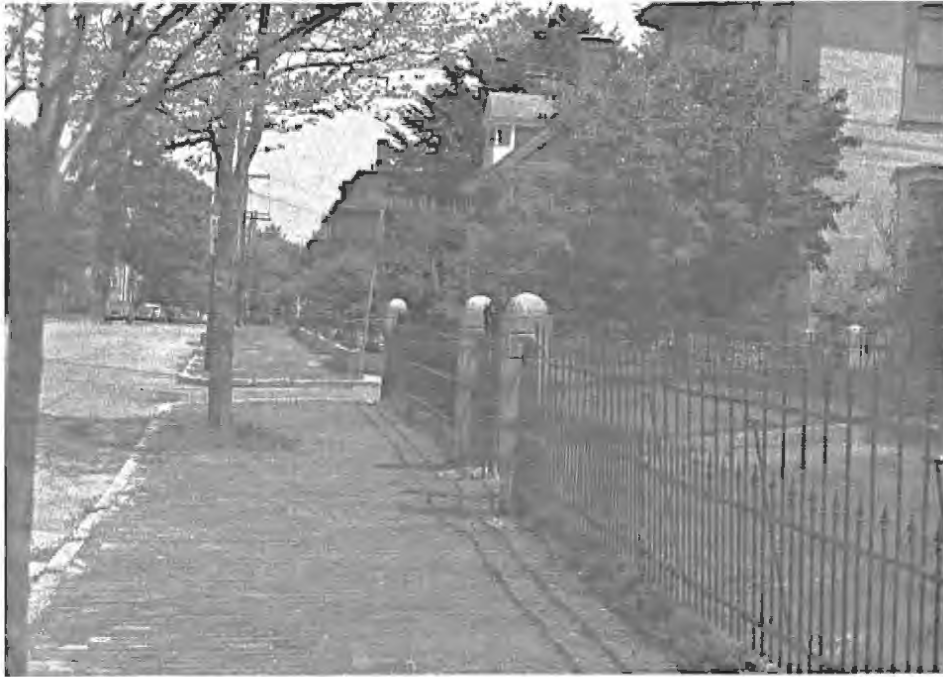
*Fences and walls create important walls of continuity, and serve to stake out important visual boundaries amidst open space. Granite curbs add an important design note. In a neighborhood where fences are commonly used at the sidewalk such as along Spring Street, an infill design can contribute to the area with a contemporary interpretation of nearby fences and curbs.*

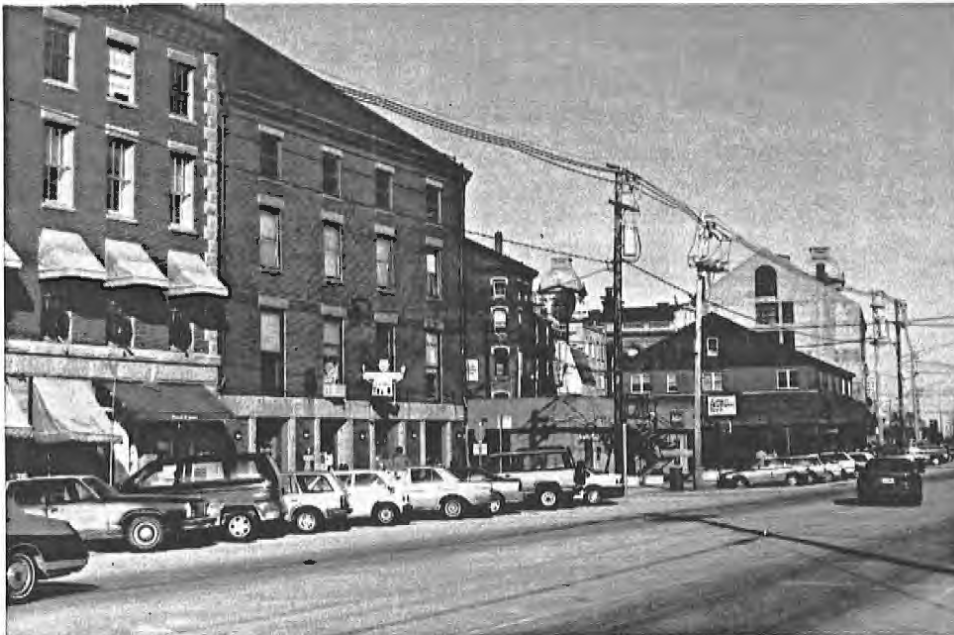
*In contrast, this photograph shows how the street wall along Commercial Street is broken down by a building that does not maintain the height and width that is typical of the pattern. Here the typical feeling of enclosure is lost and the character of the area is diffused and directionless. This is an example of where the site should have more building on it than it does at present. It is an opportunity to improve on the street wall while increasing utilization of an important site.*

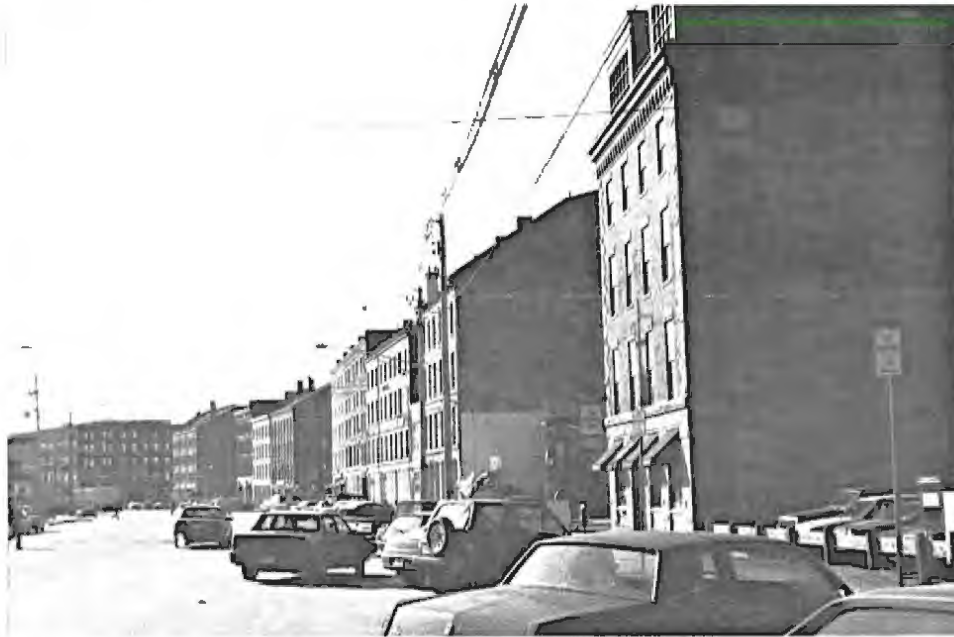
*One of Portland's finest commercial "walls" is along Commercial Street. Here, commercial buildings of remarkably consistent character form the sides of the street for a number of blocks. Buildings of various sizes are grouped together in the traditional fashion to create the solid street facade out of many parts. The result is a sense of place and enclosure that is a uniquely urban and plays a major role in the "feel" of the Old Port.*

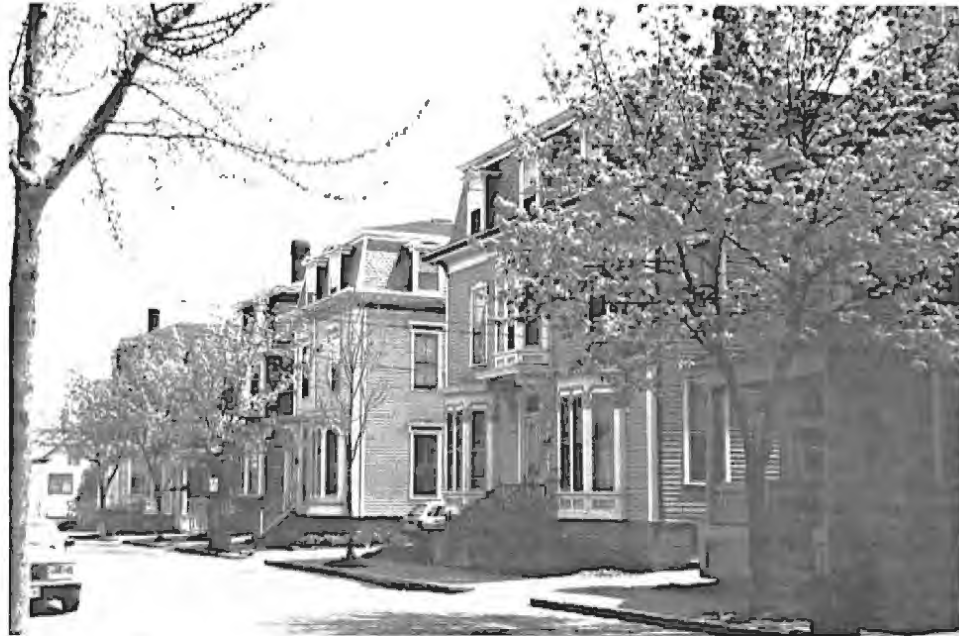
*The spacing of these detached houses on Cushman Street is consistent for the entire block. Even though the sideyards are minimal, they create a very different rhythm from that of a block of rowhouses, one that is important historically and architecturally.*

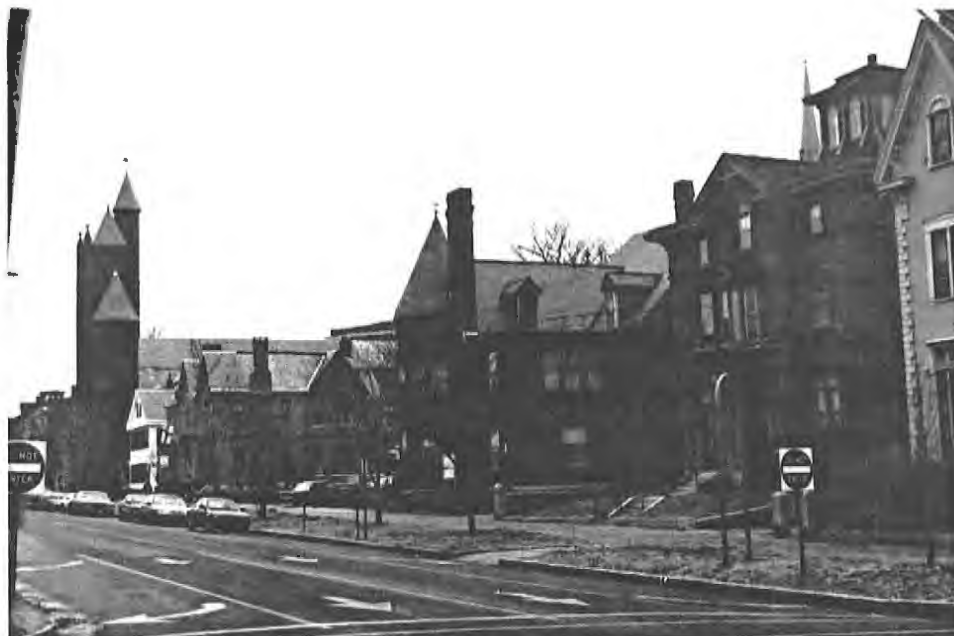
*This photograph shows larger, more distinguished houses with larger front and side yards along State Street. In this case, the residences have traditionally had more "breathing space" around them that allows all of the details of at least three sides of the houses to show. The spaciousness of these lots is a critical component of this streetscape and plays a major part in differentiating this street from Cushman Street, architecturally and historically.*

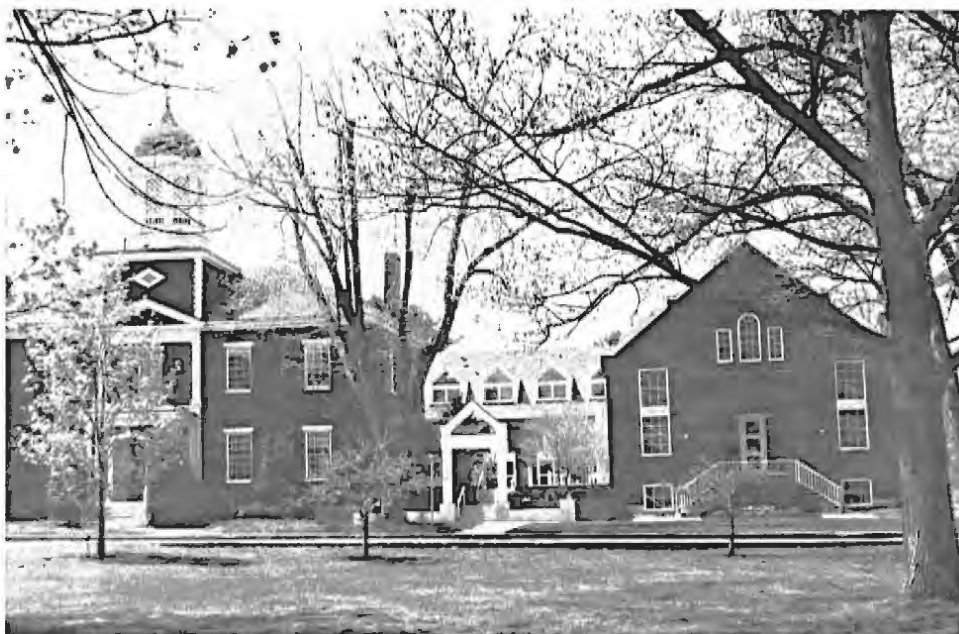
*At Westbrook College, a new building connects two historic buildings. While new construction could conceivably have been brought out to the street, in this case the contemporary structure has been recessed to allow the historic rhythm and spacing between facades at the street to continue to be the dominant characteristic of the overall composition. The two older buildings continue to be the focal points, while the new addition can have its own identity on a different plane.*

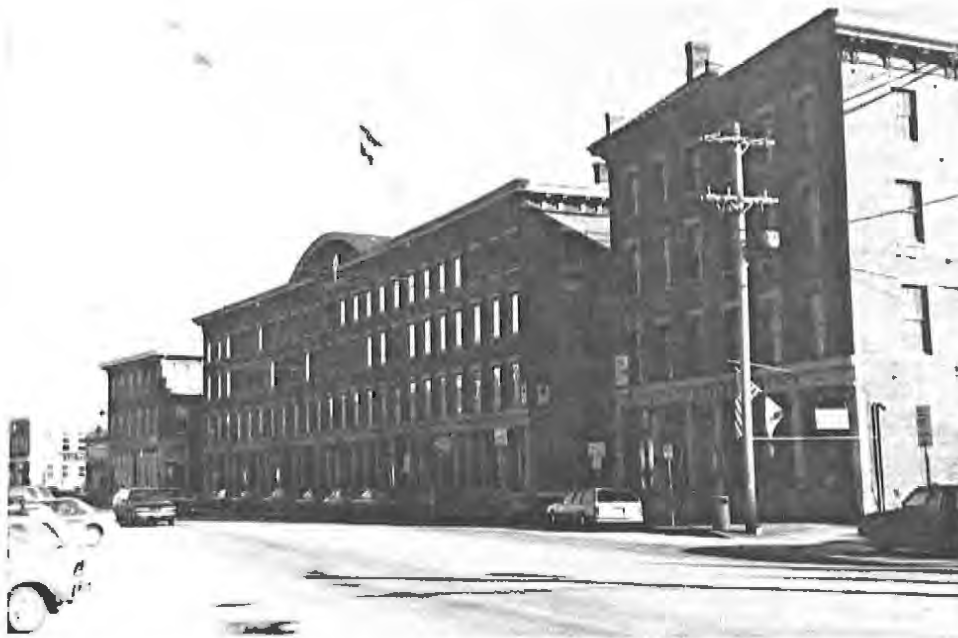
*In spite of the rhythm of windows, doors and granite piers, the Thomas Block is an emphatically horizontal building when viewed from any distance away. Although most of the buildings on Commercial Street have a similar orientation, that of the Thomas Block is exaggerated by its length.*

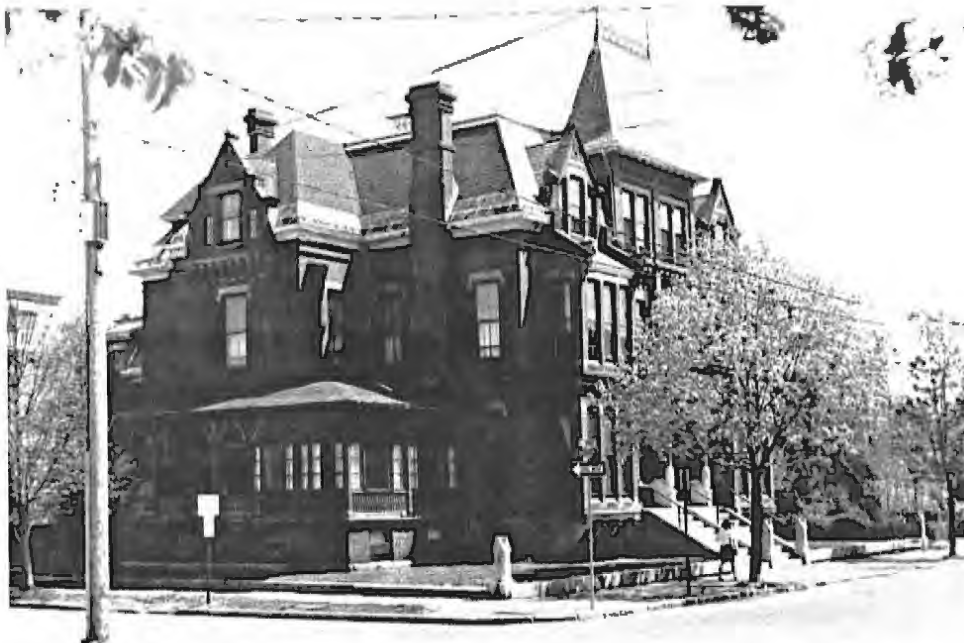
*The Francis Fassett house at 117-119 Pine Street is a dramatically vertical house. The bay windows and center tower topped with ornamental ironwork draw the eye upward from all viewing angles. This degree of vertical orientation is somewhat unusual for a free-standing house on spacious grounds. Its prominent setting at a multi-angled street intersection may have led its designer to make a monumental statement in a highly ornamental style of the day.*

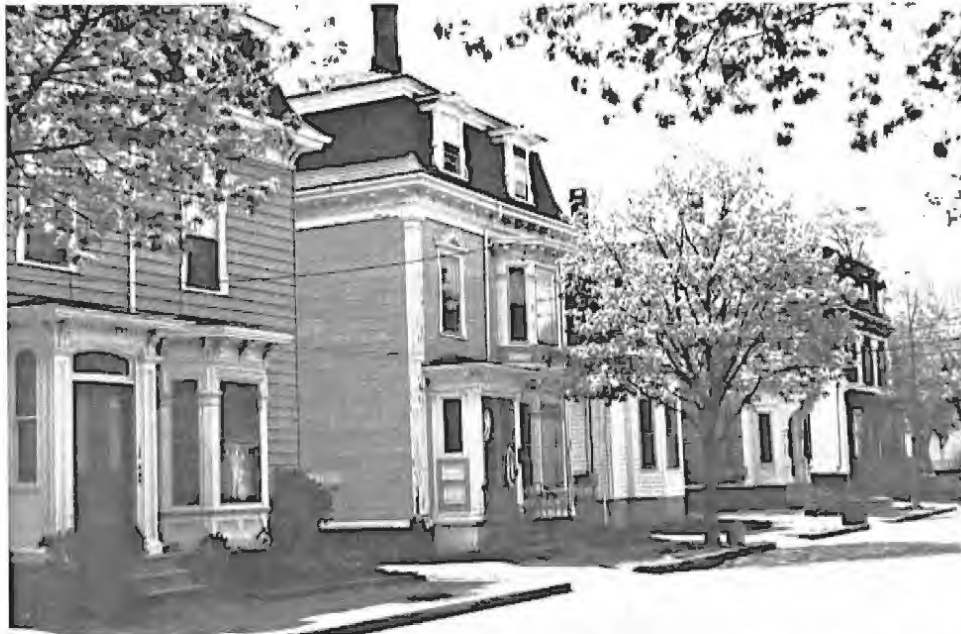
*These detached Second Empire houses on Cushman Street are likewise vertically oriented, though in a more subtle manner. The bay windows and Mansard roofs emphasize the verticality of the narrow three-story structures.*

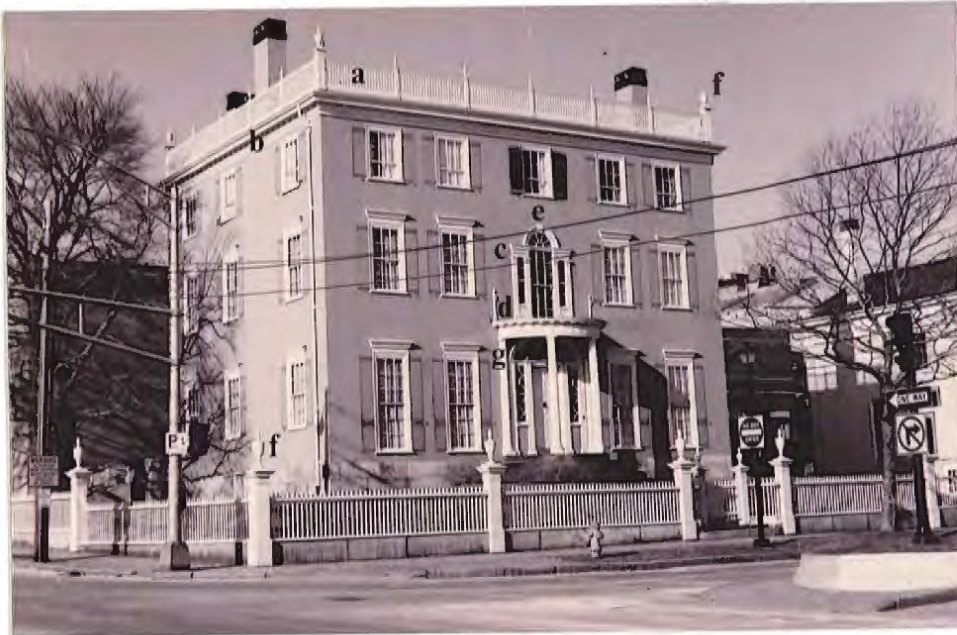
*Federal Style*

*Hugh McLellan House, 103 Spring Street, designed and built by John Kimball, Sr. in 1800*  
*a) balustrade; b) cornice; c) Palladian window; d) portico; e) keystone; f) urn; g) elliptical fanlight*

The Federal Style coincides with the post Revolutionary emergence of this nation. The forms differ from colonial in proportion - the Federal is more attenuated and often delicate - and features such as Palladian

windows and balustrades are used in the "High Style" examples. The basic form, as in colonial architecture is a rectangular box with window and door openings symmetrically placed.

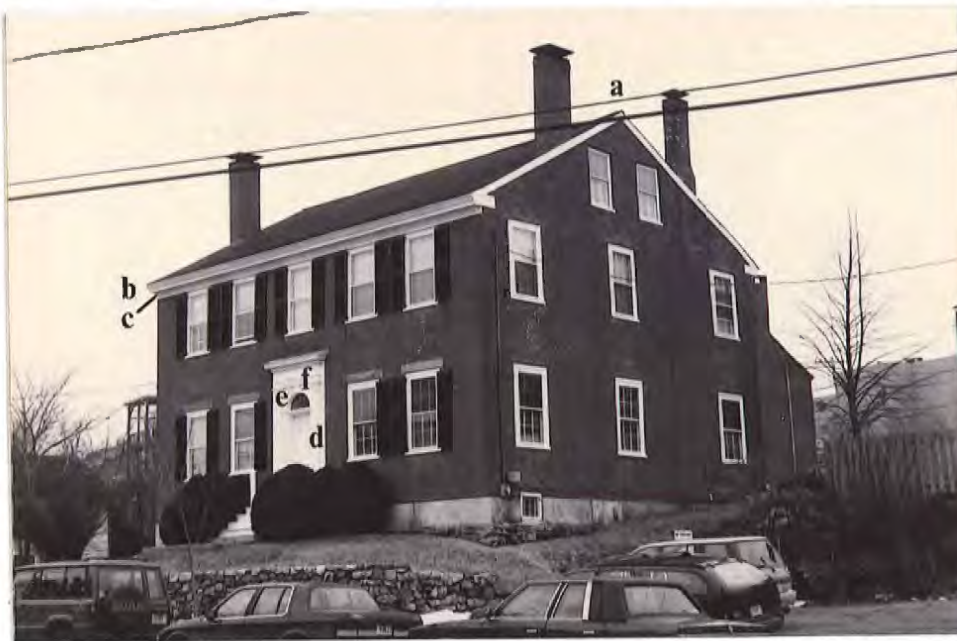
*Federal Style*

*Daniel How House, 23 Danforth Street, built 1799*  
*a) gable; b) cornice; c) entablature; d) pilasters; e) fanlight; f) keystone*

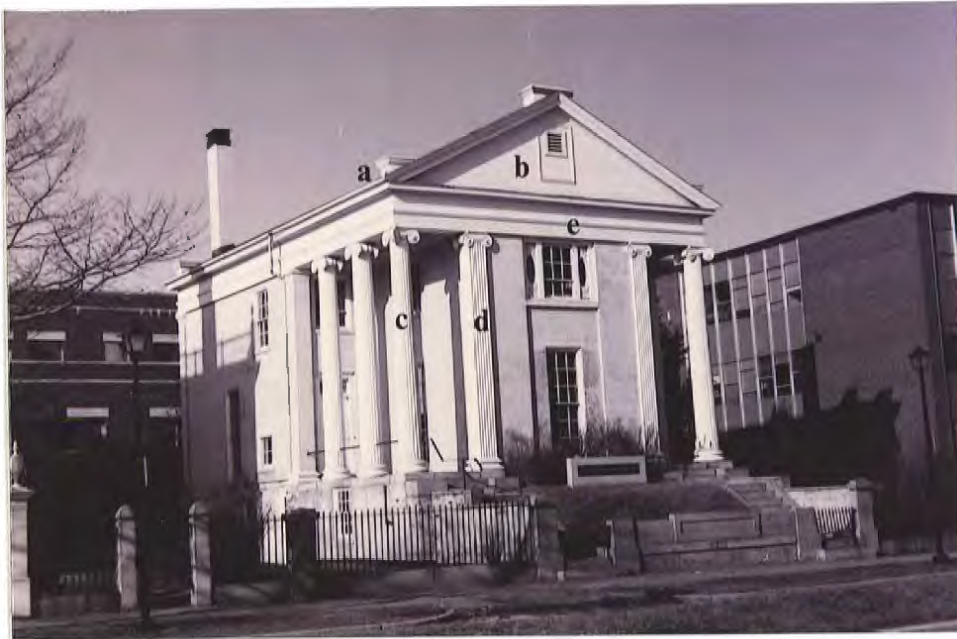
*Greek Revival Style*

*Charles Q. Clapp House, 97 Spring Street, built 1832, designed by Charles Q. Clapp  
a) low pitched gable roof; b) pediment; c) Ionic column; d) Ionic pilaster; e) entablature*

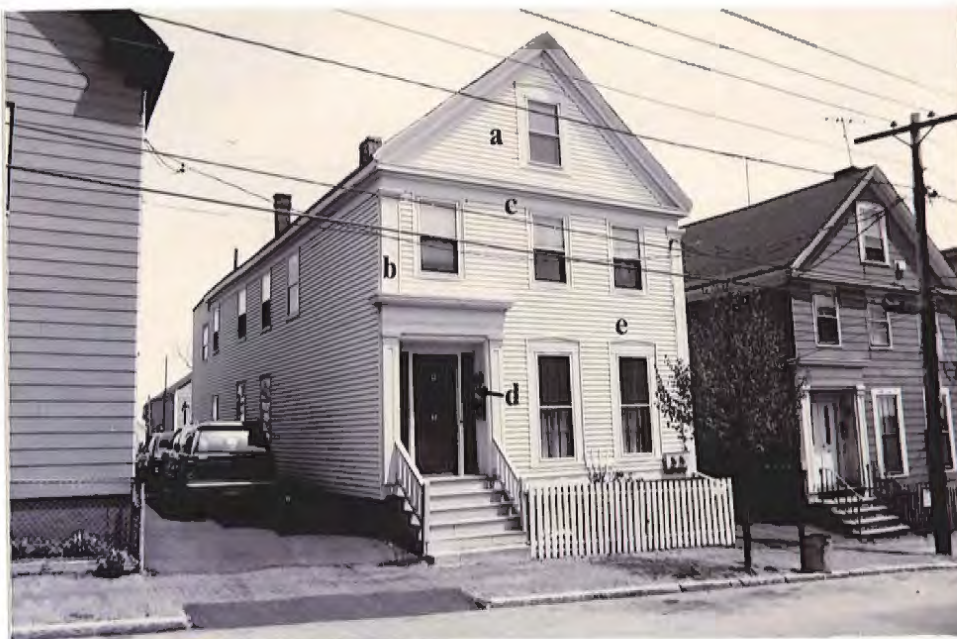
*Greek Revival Style*

*47 Brackett Street, built c. 1850*

The frame vernacular Greek Revival style dwelling, at 47 Brackett Street, retains the temple aspect of the high style examples by facing the gable to the street and enclosing it to form a full pediment, supported by the corner pilasters. Other features of this style are the entranceway and the window surrounds. A full, deep entablature supported by panelled pilasters marks the recessed door while the first and attic story windows have broad flat moldings and are capped by shallow pediments. Originally all windows were glazed in a six over six configuration and the door was panelled with no light.

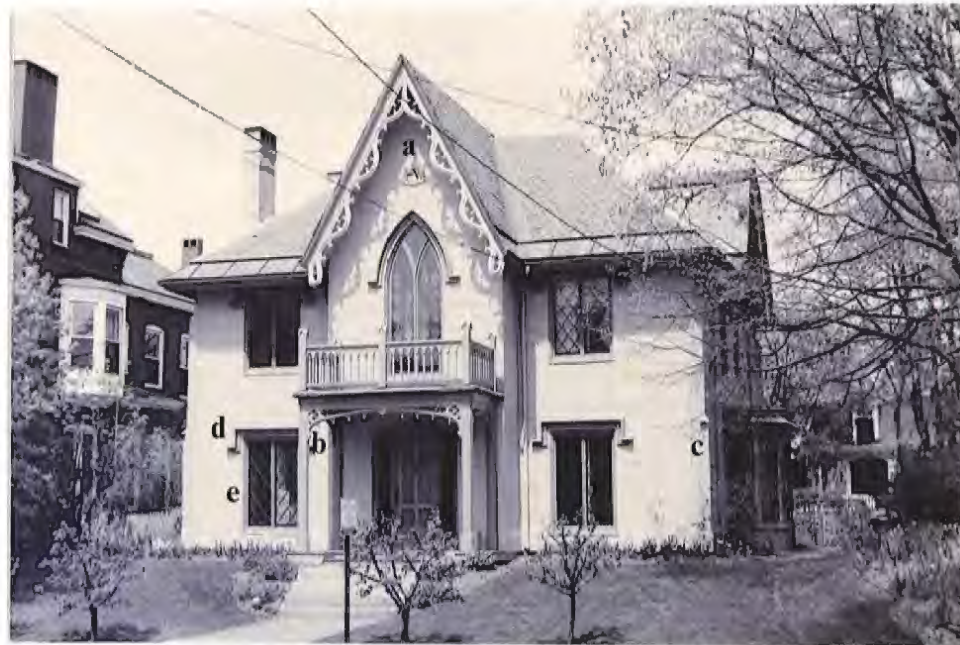
*Gothic Revival Style*  
*John J. Brown House, 387 Spring Street, built 1845, designed by Henry Rowe*  
*a) gable; b) portico; c) pier buttress; d) drip molding; e) leaded panes*

buildings. Verticality is emphasized by the corner pier buttresses, the slender portico supports and the bargeboards in the gables. Tall paired windows have romantic medieval diamond shaped leaded panes, while the central window terminates in a pointed arch outlines by a drip molding.

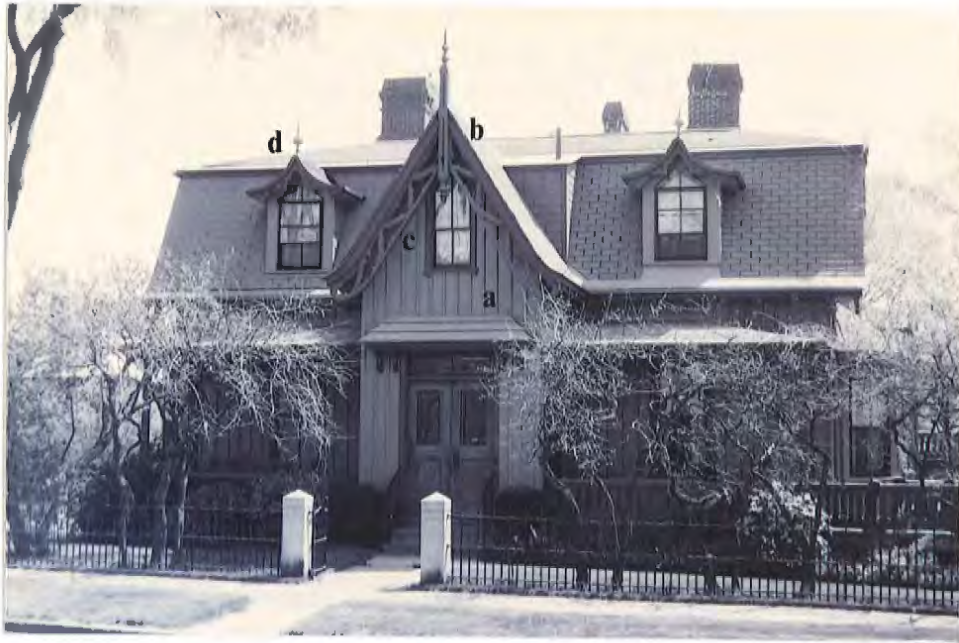
*Gothic Revival Style*  
*William Goodwin House, 75 Vaughan Street, built 1859*  
*a) board and batten; b) gable; c) bargeboards; d) finial*

This example of a Gothic Revival style, the William Goodwin House, is clad with board and batten, thus giving more emphasis to the vertical. The steep pointed gable with its decorating bargeboards and finial is characteristic as is the deceptive cottage scale of the facade. The house, in fact, extends toward the east and provides much interior space.

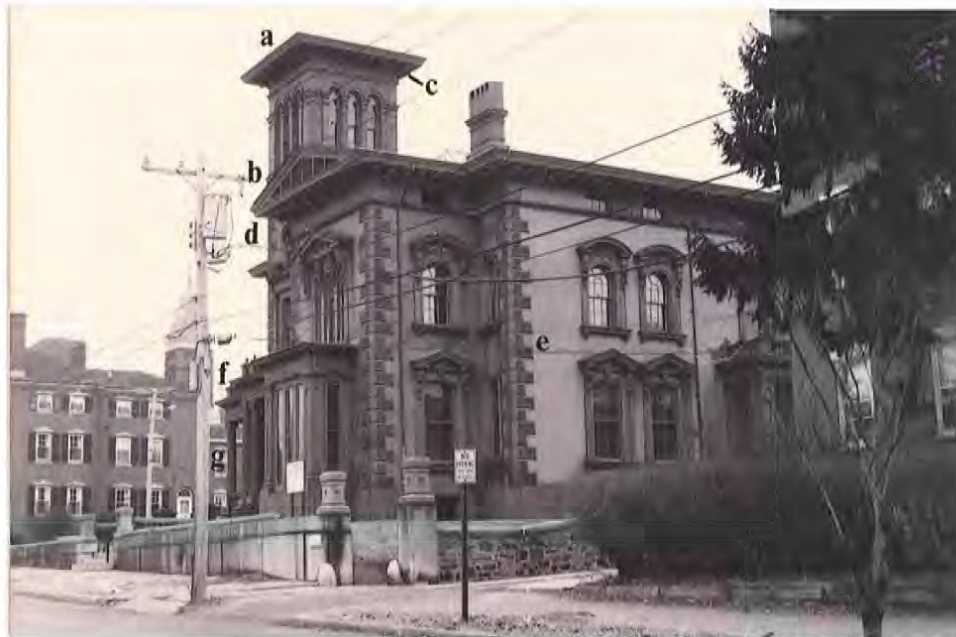
*Italianate Style*

*Morse-Libby House, 109 Danforth Street, built 1858-1860, architect Henry Vaughan*  
a) tower; b) pediment; c) modillions; d) deep overhang; e) quoins; f) balustrade; g) columns

The Morse-Libby House, also known as the Victoria Mansion, is widely recognized as the premier example of the Italian Villa style in the country. In addition to the features outlined, elaborate working of the brownstone in the columns, quoins and brackets.

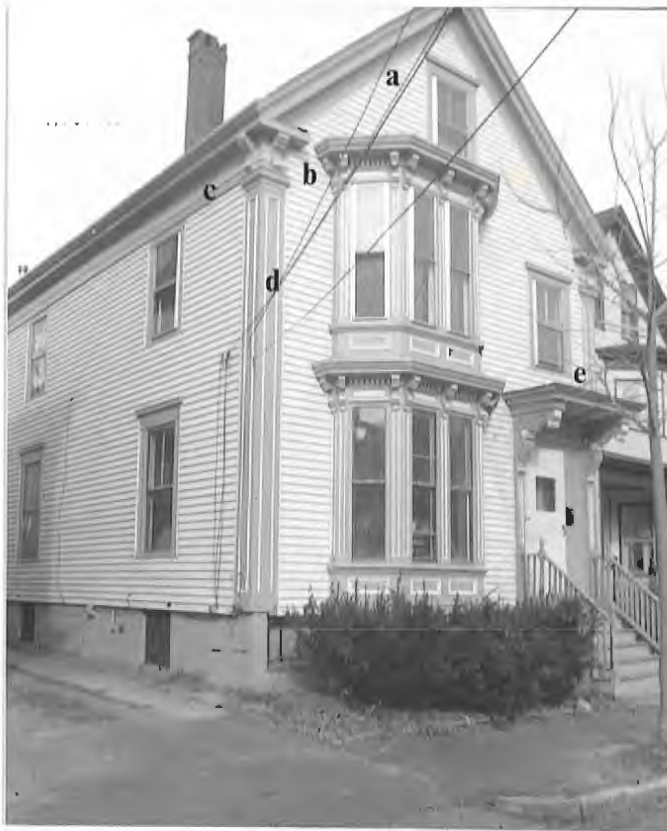
*Italianate Style*  
*Elihu Hasty House, 53 Spruce Street, built 1874*  
*a) gable; b) brackets; c) entablature; d) corner boards; e) hood*

In this typical Portland Italianate frame dwelling, the Elihu Hasty House, the gable facing the street has a rather steep pitch. Panelled corner boards (which derive from the Greek Revival), replace the quoins exhibited in the high style version. Brackets are abundant, window tops are made important with an entablature and the entrance hood is a prominent feature. Unfortunately the original double door has been replaced with a single leaf with a subsequent loss of breadth and glass.
