## Historic Preservation Board

Wednesday, November 20, 2024 at 5:00  
PM Room 24 (Ground Level of City Hall)  
and Zoom

## **AGENDA:**

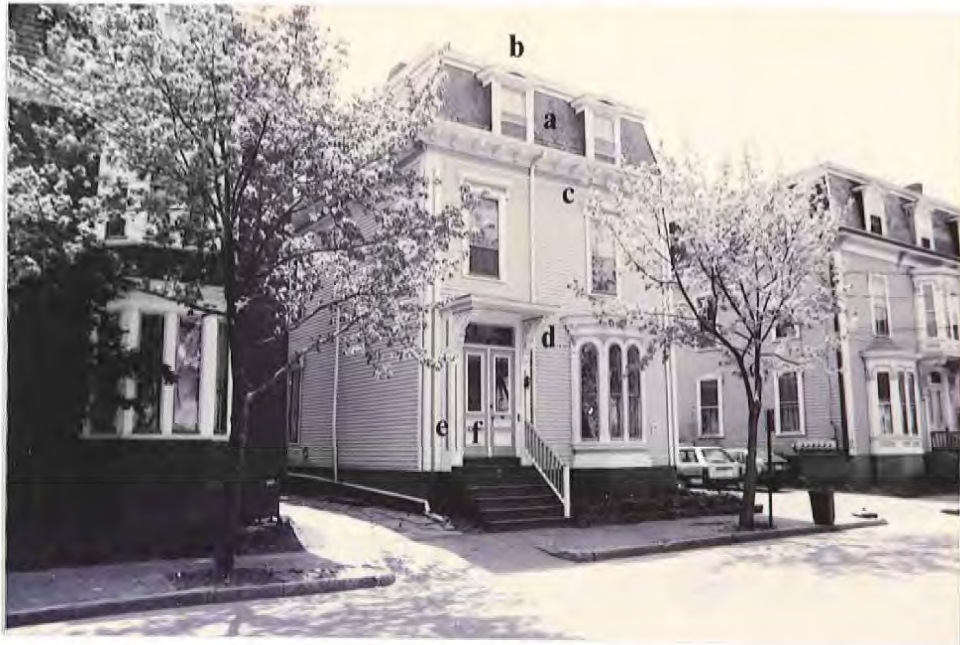
*Second Empire Style*  
*Stephen R. Small House, I, 18 Cushman Street, built 1870*  
*a) mansard roof; b) pediment; c) cornice; d) brackets; e) corner boards; f) double leaf entrance*

In the frame vernacular example, the Stephen R. Small House, the resemblance to Italianate forms is a clear reminder that these styles influenced each other. In common are the corners articulated by panelled corner boards, the strongly projecting cornice and entrance hood, both supported on brackets. Windows, too, have bracketted cornices or, on the dormers, triangular pediments. The mansard roof form, however, is the distinctive mark of the Second Empire style, and since the steep pitch is so visible, decorative patterns of slate form an important part of the design.

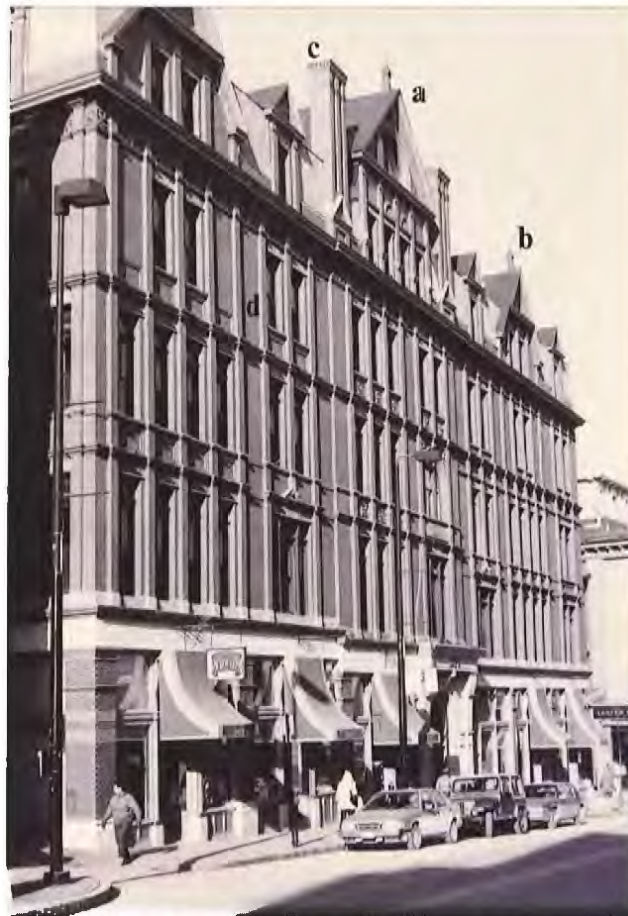
*Queen Anne Style*  
*John B. Brown Memorial Building, 1882-1883, 523-543 Congress Street, designed by Francis H. Fassett*

*a) gable; b) finial; c) chimney stack; d) pilaster*

the several pointed gables surmounted by finials. The terra cotta panels which line up below the roofline add textural richness and the gables and chimneys create a picturesque, open skyline.

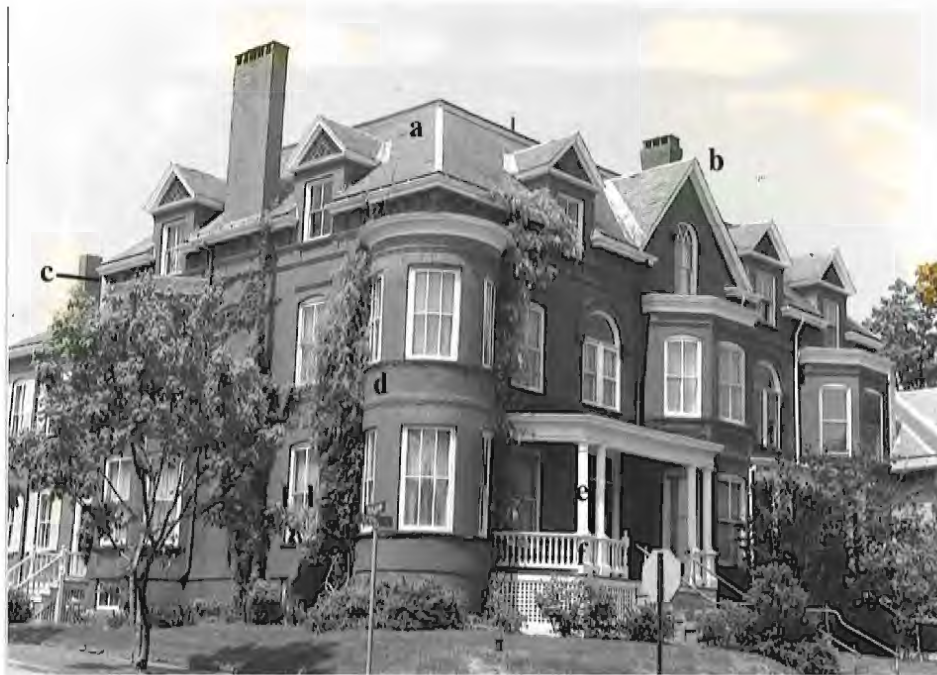
*Queen Anne Style*

*Willis A. Cates House, 398 Spring Street, built 1897*

This double house, the Willis A. Cates House, - a favorite Portland dwelling form - shares a number of characteristics with the John B. Brown building. The most obvious is its basically blocky shape which is enlivened by various projecting elements. The steep hipped roof is pierced by a gable, gabled dormers and tall chimney stacks. The walls are enlivened by a corner tower and three sided bay windows, decorative brickwork - brackets along the eaves, panels and string course. Round and elliptical topped windows and deep porches supported on slender columns add to the sculptural character of the structure.

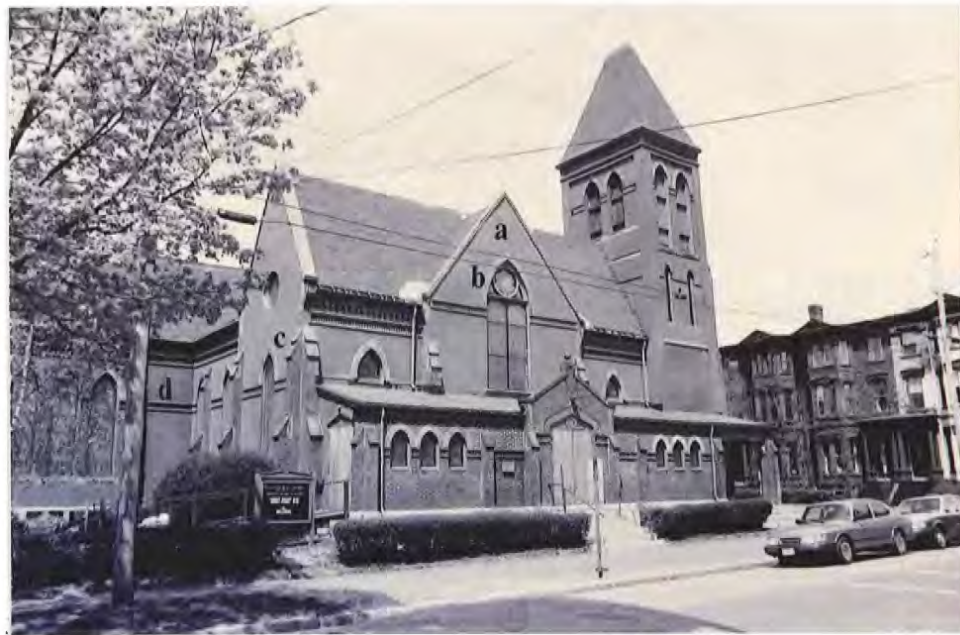
*High Victorian Gothic Style*  
*Williston Congregational Church, 32 Thomas Street, built 1877, designed by Francis Fassett*  
*a) gable; b) pointed window; c) pier buttress; d) string course*

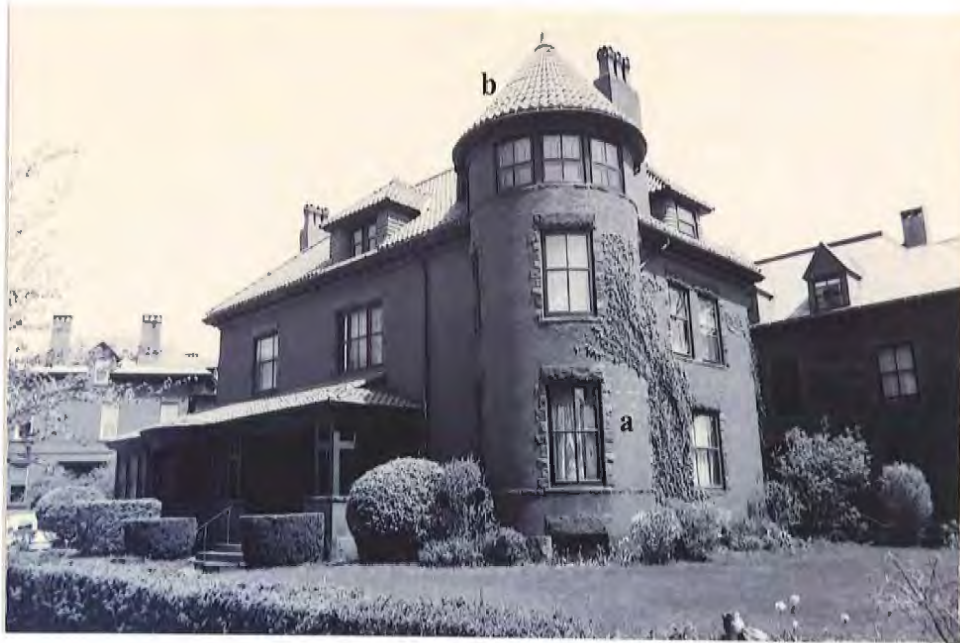
*High Victorian Gothic Style*  
*Harry Butler House, 1 Thomas Street, built 1892-1894, designed by John Calvin Stevens, I*  
*a) molding; b) conical roof*

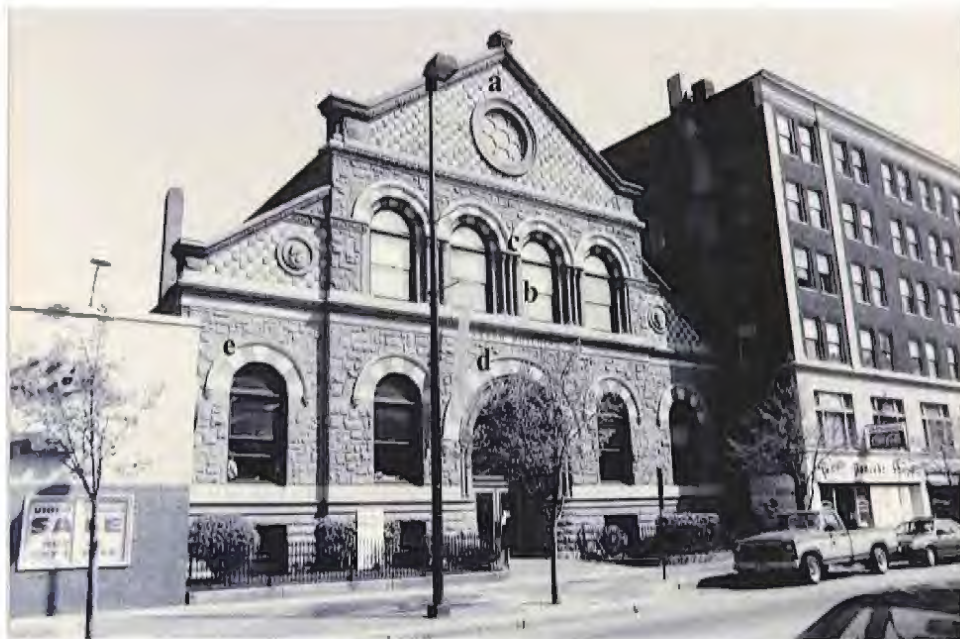
*Romanesque Revival Style*  
*Baxter Building, Congress Street, built 1888, designed by Francis H. Fassett*  
*a) gable; b) colonette; c) capitals; d) "nave"; e) "side aisles"*

The model for the Baxter Building, Portland's former Public Library is a Romanesque church facade with its indication of nave and side aisles. Deeply recessed arched openings are outlined by alternating colors of stone. The entrance adds colonettes with carved capitals leading up to a richly carved inner arch. Some stone is left rough and there are portrait panels on either side. Larger window panes became common by the last quarter of the century. Spacing of windows during this period varies, as seen here with wide spaces below and a tighter rhythm above.

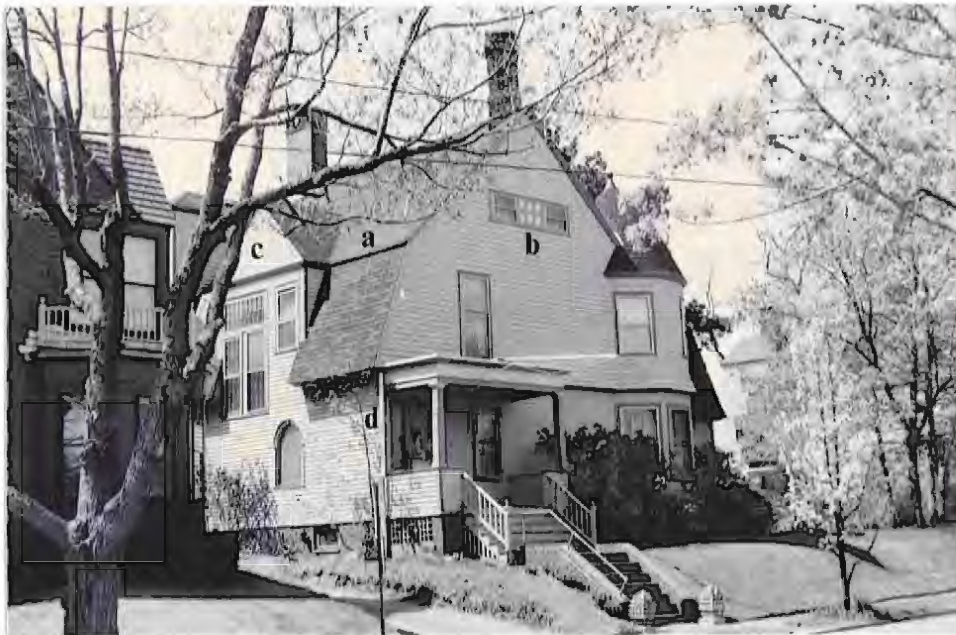
*Shingle Style*

*Montgomery S. Gibson House, 44 Bowdoin Street, built 1885-86, designed by John Calvin Stevens, I  
a) gambrel gable; b) decorative panel; c) dormer; d) overhang*

asymmetrical front gambrel gables, the low corner tower, large dormers on the flank and tall, panelled chimney stacks. The smooth shingle surface of the gambrel gable wraps itself around the tower; at the peak of the facade the shingles make a wave pattern just above the panelled window strip.

Although the house is large, the insistent horizontality of the overhang and the depth of the eaves create an informal cottage scale which is quite different from the strong verticality of the Queen Anne, Second Empire and Italianate styles.

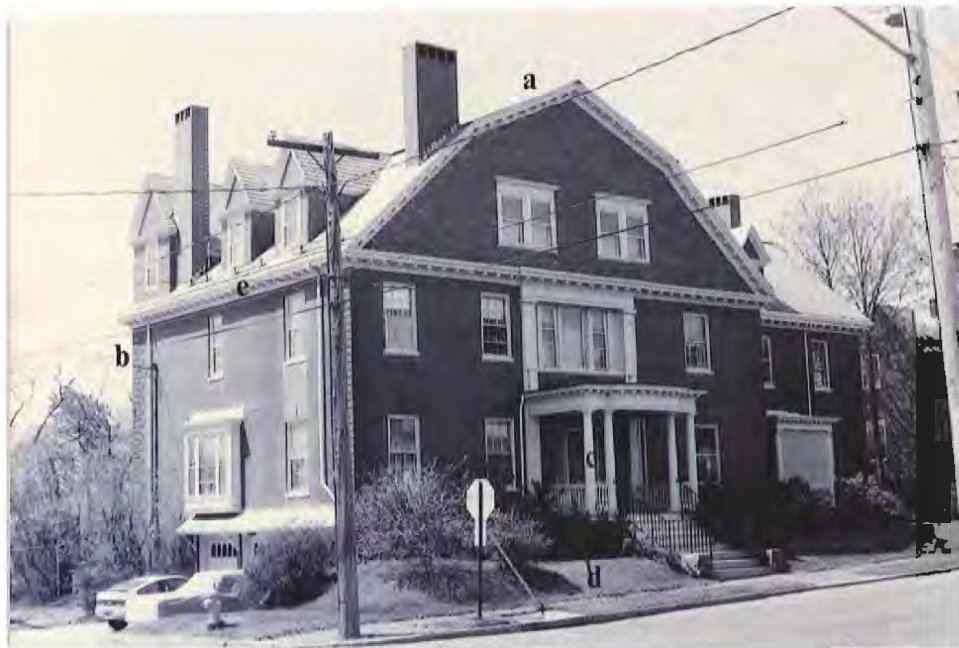
*Colonial Revival Style*  
*Franklin C. Payson House, 28 Bowdoin Street, built 1901, designed by John Calvin Stevens, I*  
*a) gambrel; b) quoins; c) column; d) balustrade; e) modillions*

elliptical fan lighted door, columns, balustrades, and roofline modillions are eighteenth century details freshly used. The depth and substantiality of the portico, the attic paired windows, and the principal entrance in the gable end are Revival traits.

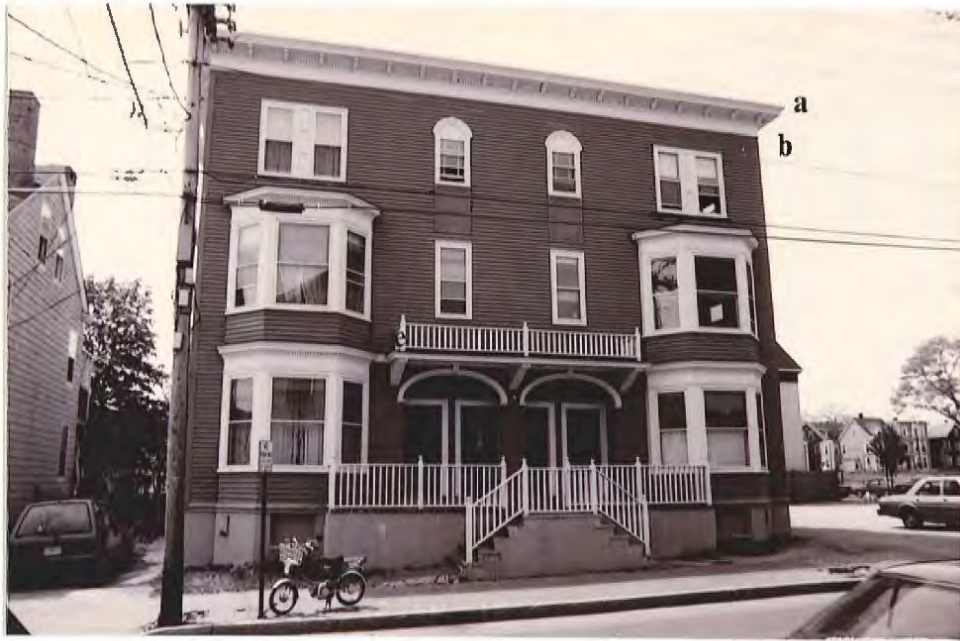
*Colonial Revival Style*  
*122-124 Brackett Street, built around 1897*  
*a) cornice; b) modillions; c) elliptical arch; d) keystone; e) balustrade*

In a vernacular structure, like 122-124 Brackett Street, the blocky shape needed for an apartment building is most evident, yet style characteristics are important for articulating the mass. Modillions under the cornice, the semi-circular "fans" on the center third floor windows, the elliptical arches with keystones over the entrances, and the balustrades identify this building as Colonial Revival.

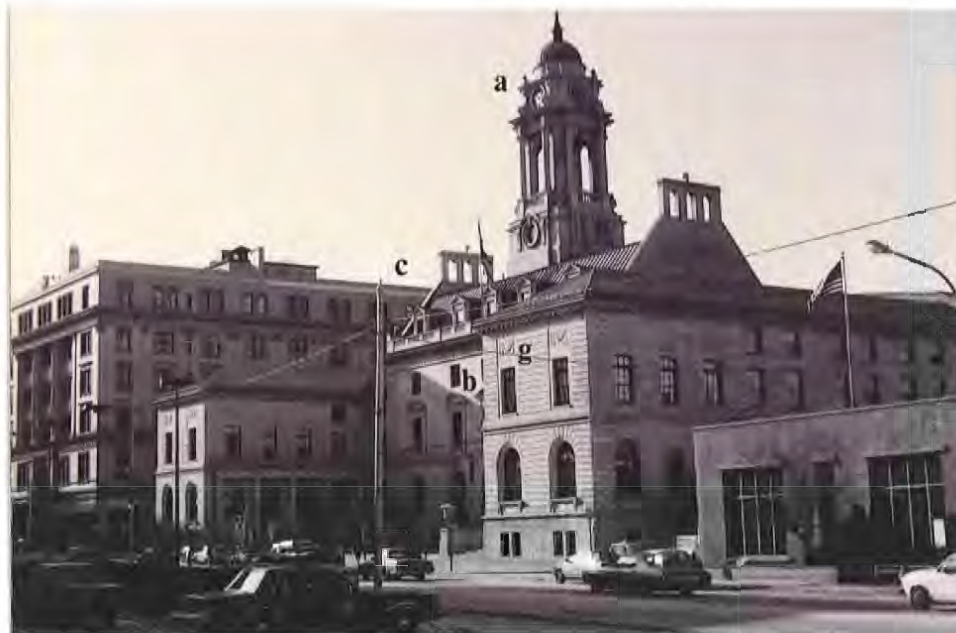
*Classical Revival Style*  
*Portland City Hall, built 1902-12, designed by Carrere and Hastings; John Calvin and John Howard Stevens, local associates*  
*a) cupola; b) pediment; c) balustrade; d) column; e) pilaster; f) console; g) panel*

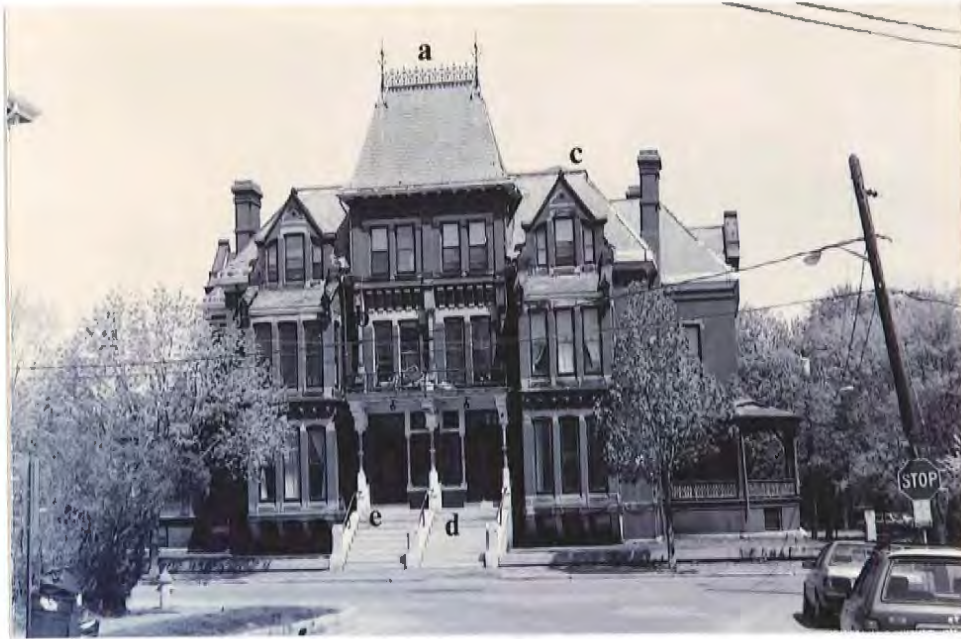
*Classical Revival Style*

*Francis H. Fassett Residences, 117-119 Pine Street, built 1876, designed by Francis H. Fassett*  
*a) cresting; b) brackets; c) gables; d) portico; e) colonette; f) string course*

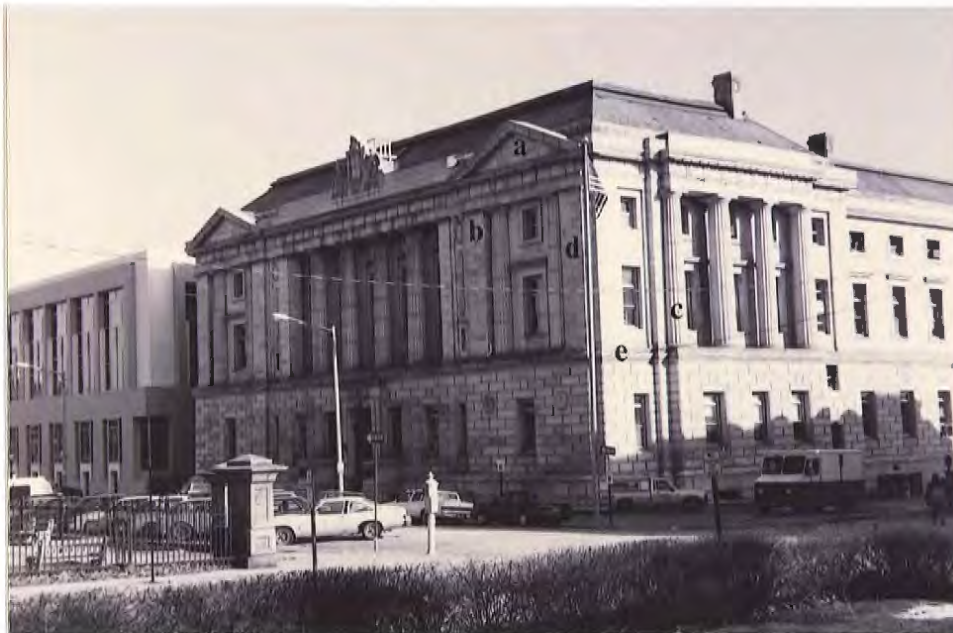
*Classical Revival Style*

*Cumberland County Courthouse, built 1906-1910, designed by George Burnham and Guy Lowell*  
*a) pediment; b) entablature; c) Doric columns; d) pavillions; e) horizontal molding*

The Cumberland County Courthouse appears as a more massive and compact building because the collaborating architects (Burnham of Portland, Lowell of Boston) make the first floor serve as a solid base surmounted by a horizontal projecting molding, and unify the second and third stories by monumental Doric columns. The ends of the principal facade are articulated by projecting pedimented pavillions, while the connecting colonnade stands in relief against the recessed window area. A fully developed entablature rests on the columns of the side elevation as well.

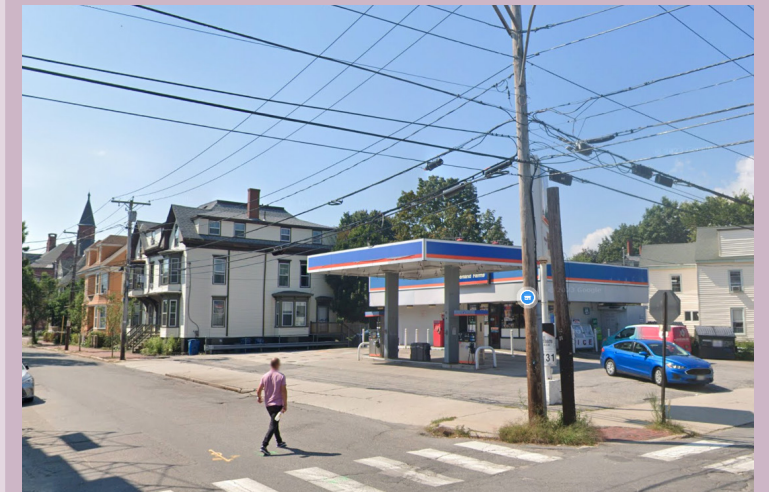
49 Pine Str (UD) REDO.png

This gas station was constructed sometime in the later half of the 20th century, after most of the buildings in the West End Historic District. Its date of construction make it noncontributing.

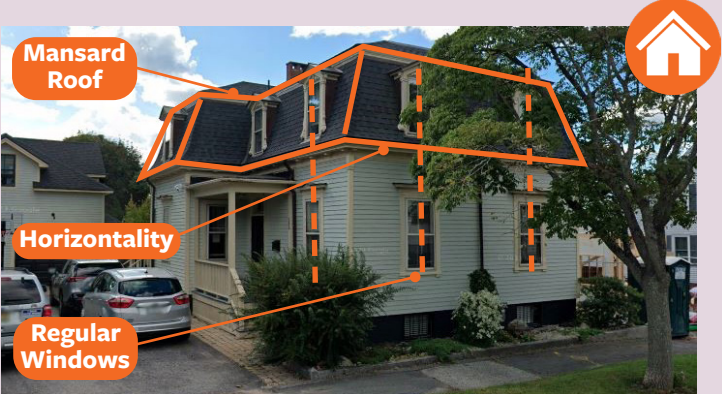
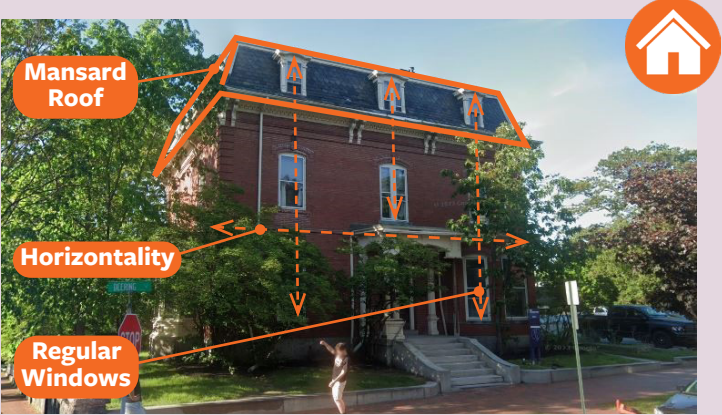
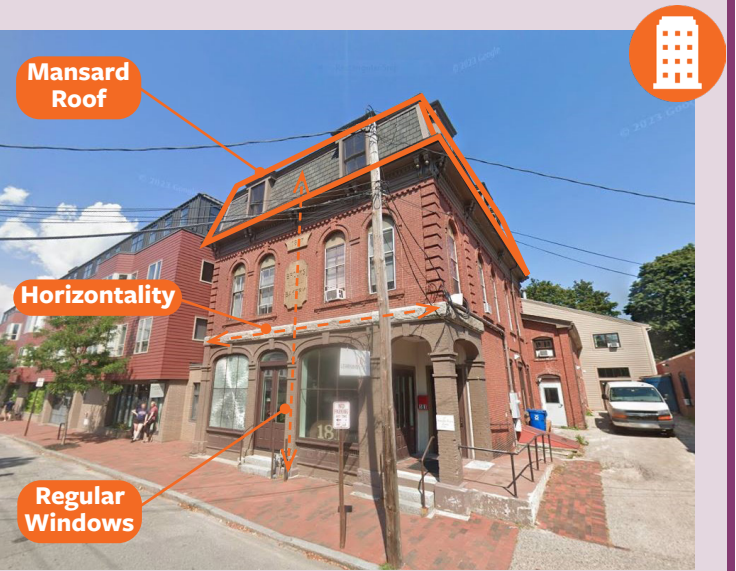
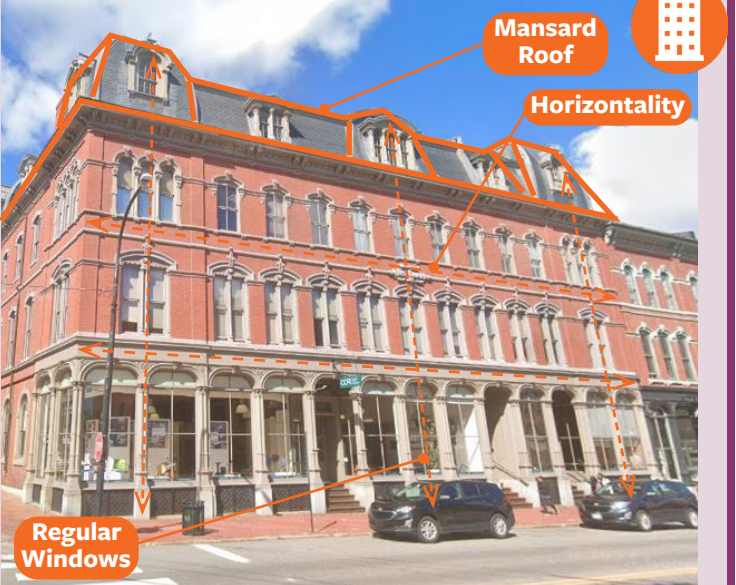
Even buildings of the same style can have dramatically differing scales that define the character of each. Below are four examples of Second Empire style buildings. Residential examples can vary from modest wood frame construction (top left) to very grand brick version edifices (bottom left). The same variety can also exist within commercial/mixed-use buildings (right). All four examples feature the characteristic mansard roof, strong horizontality, and regularly or symetrically arranged windows that define the style.

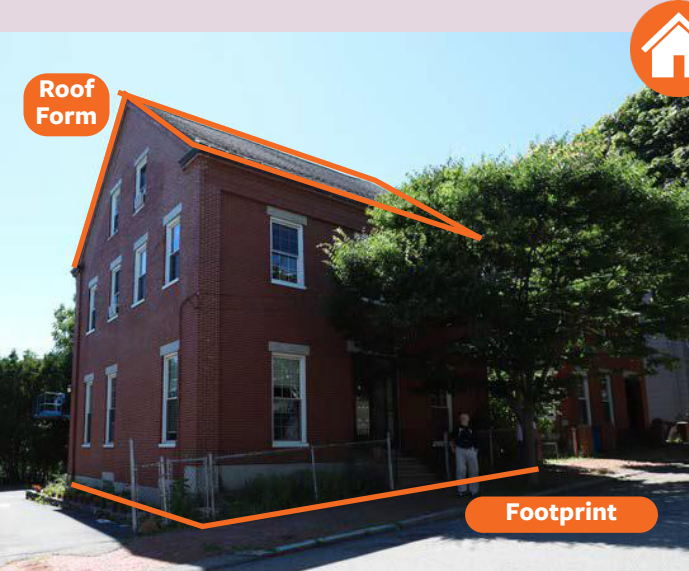
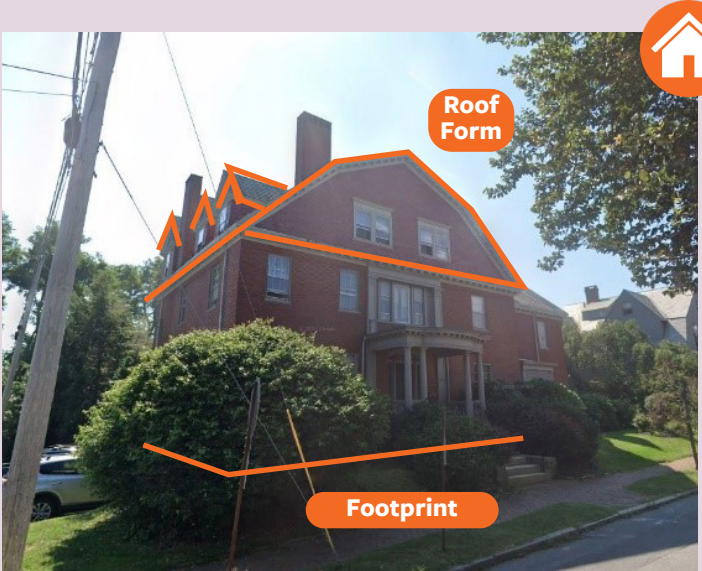
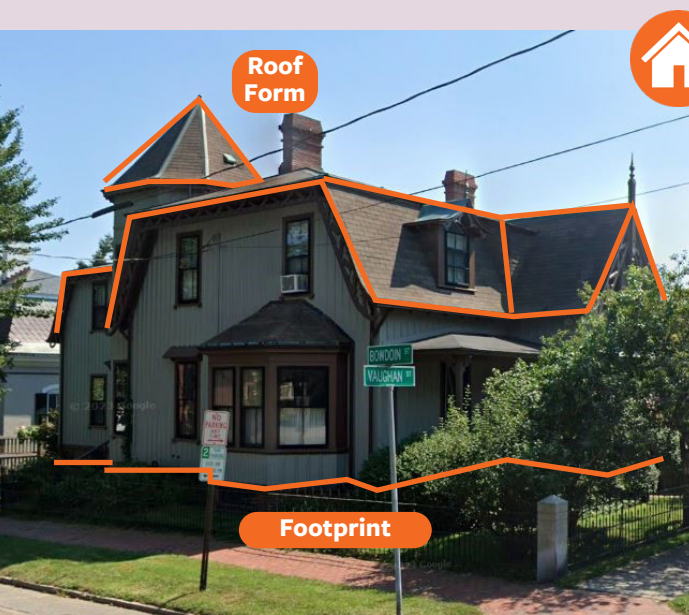
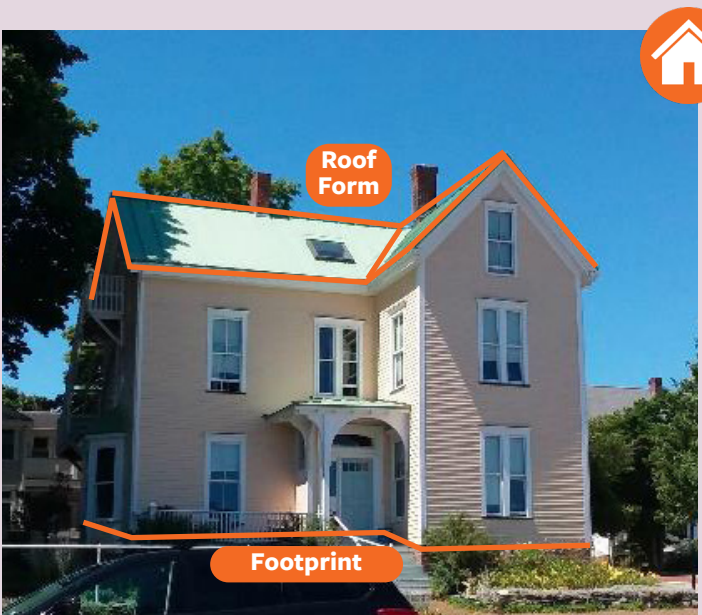
The form of a building is typically comprised of its footprint (1), roof shape (2), and how they interrelate. These elements can both be simple with a rectangular footprint and gable roof (top left), or both can be complex with shifts in wall plane, porches, bays, and canopies, all capped by a variety of roofs (bottom left). Many buildings fall somewhere between these extremes, perhaps showing a simple plan topped by a complex roof (top right) or an irregular plan with a straightforward roof (bottom right).

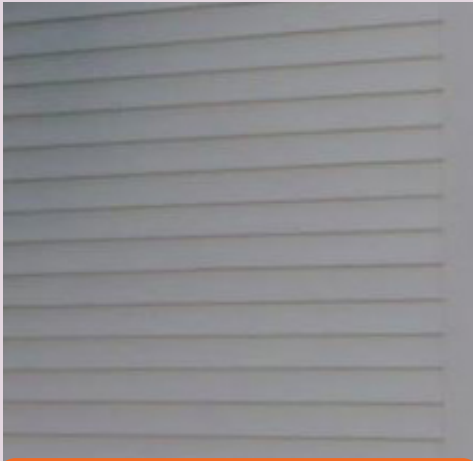
Clapboards

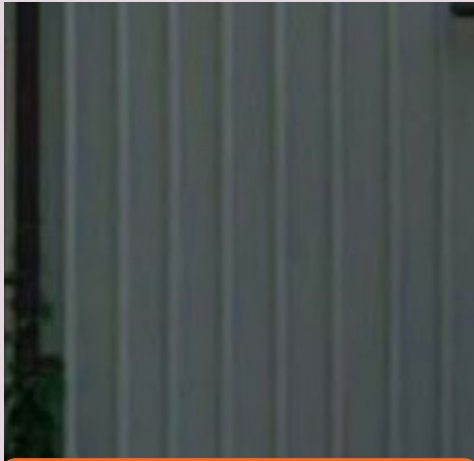
Vertical board and batten

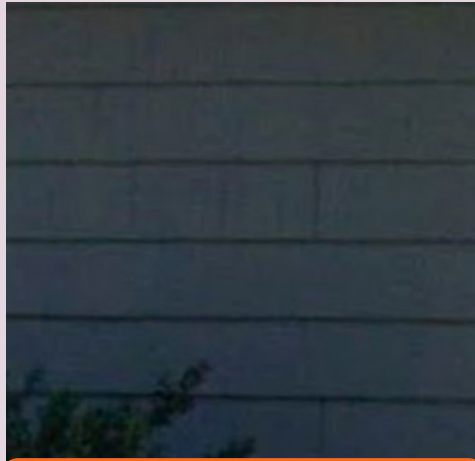
Shingles

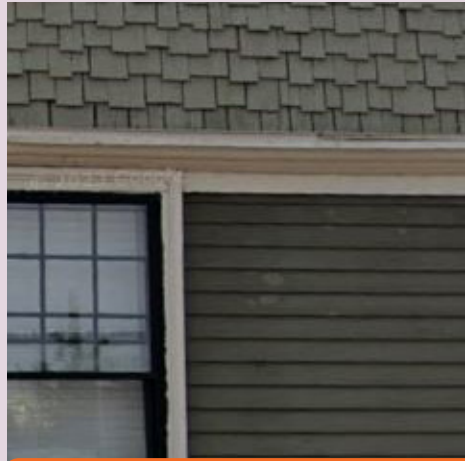
Clapboards and staggered shingles

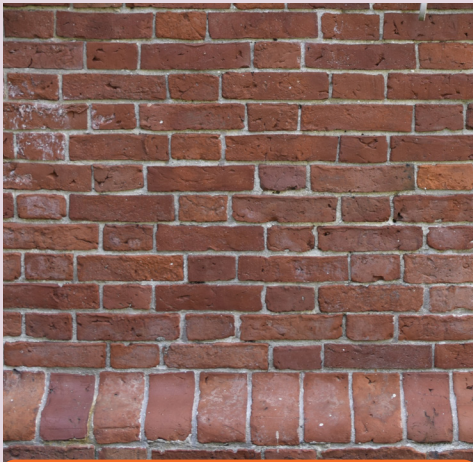
Red brick in a flemish bond

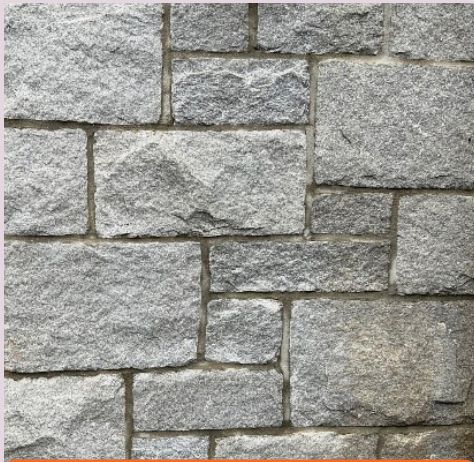
Rough-faced irregular ashlar granite

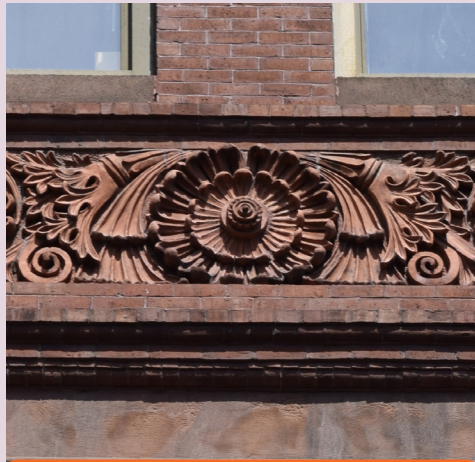
Unglazed terracotta

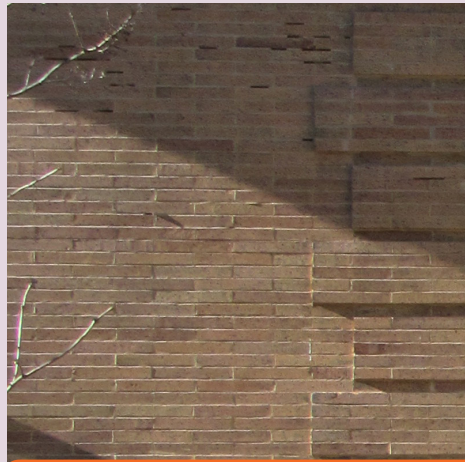
Buff-colored roman brick

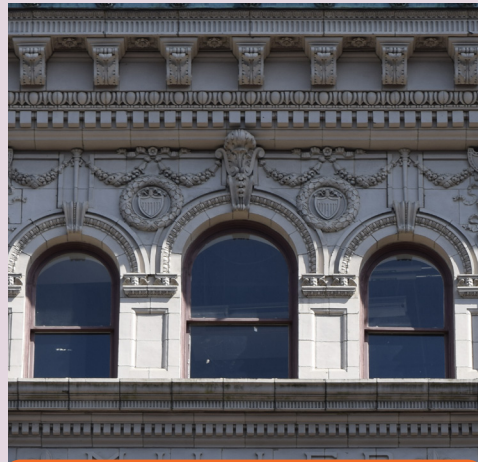
Glazed terracotta

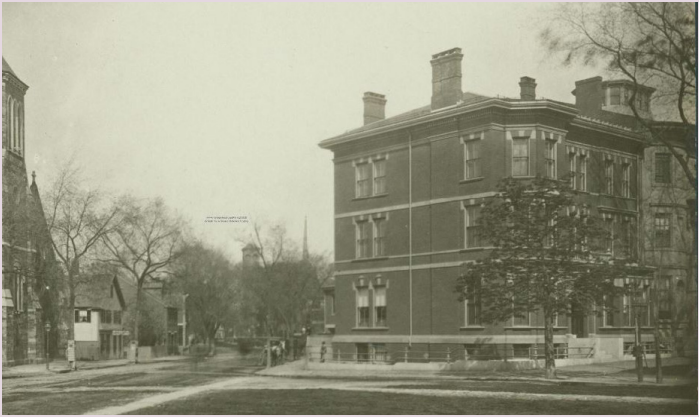
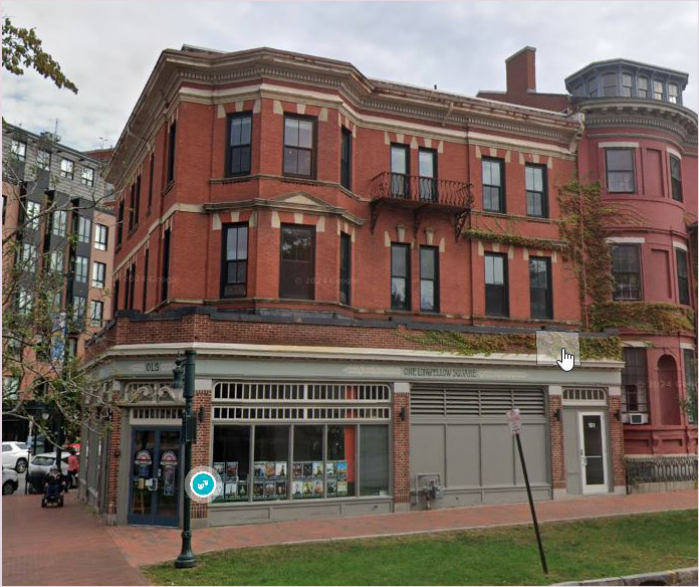
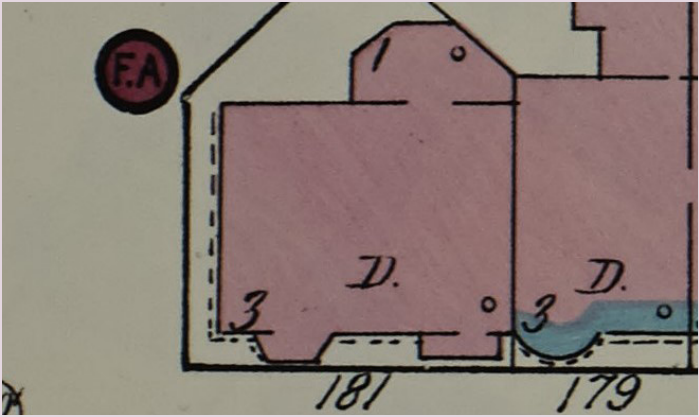
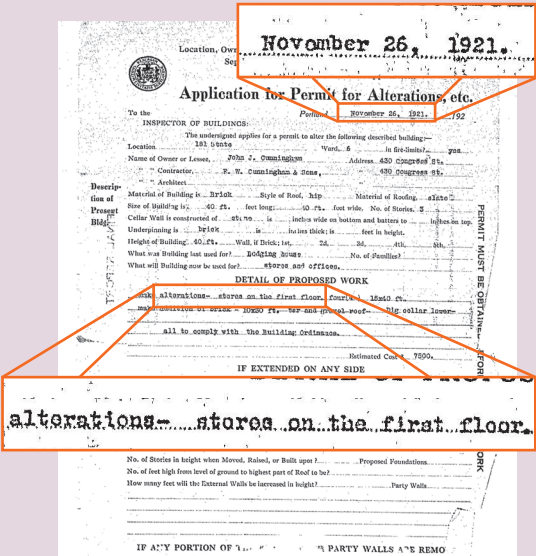
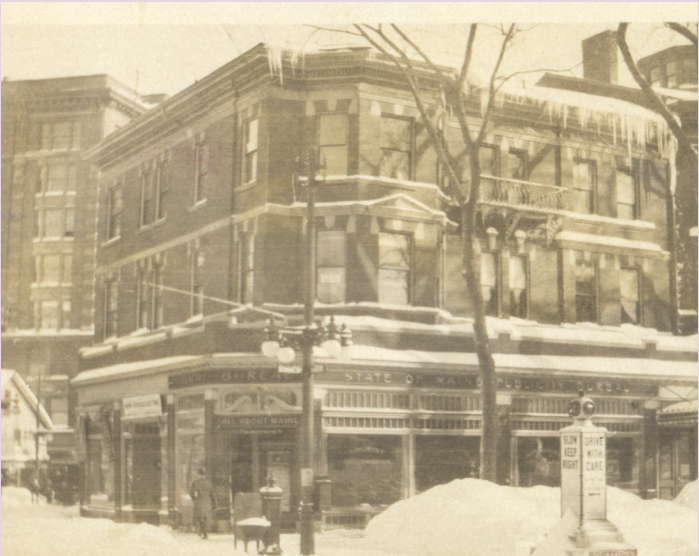
181-183 State Street is an example of a building which experienced modifications after its construction. While the first floor storefronts were thoughtfull designed, the change in color of the associated masonry and the colonial revival style of its details hint that the storefront was a later addition. A rare 1880s photo of Longfellow Square and the 1896 Sanborn fire insurance map provides evidence that the building was originally constructed as a grand, single family residence.

A 1909 Sanborn Fire Insurance map shows that the building remained a single family residence until at least that year, while the 1924 Tax Photo clearly shows the storefront addition. A 1921 building permit application confirms that the date of the alteration, setting it within the historical period of the Congress Street Historic District.

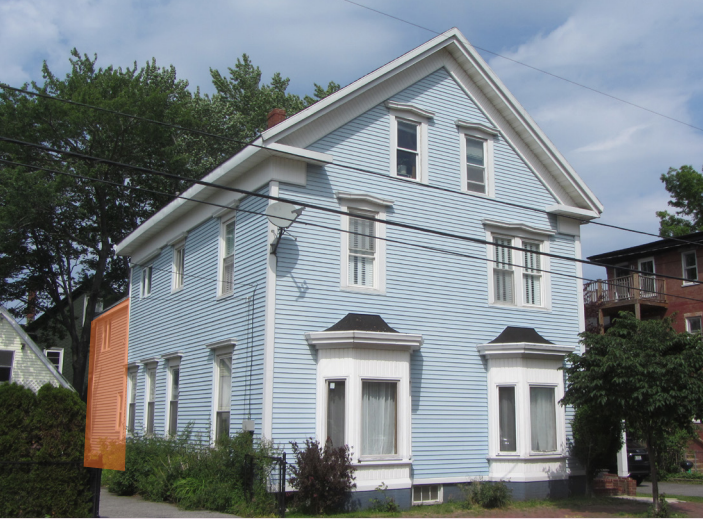
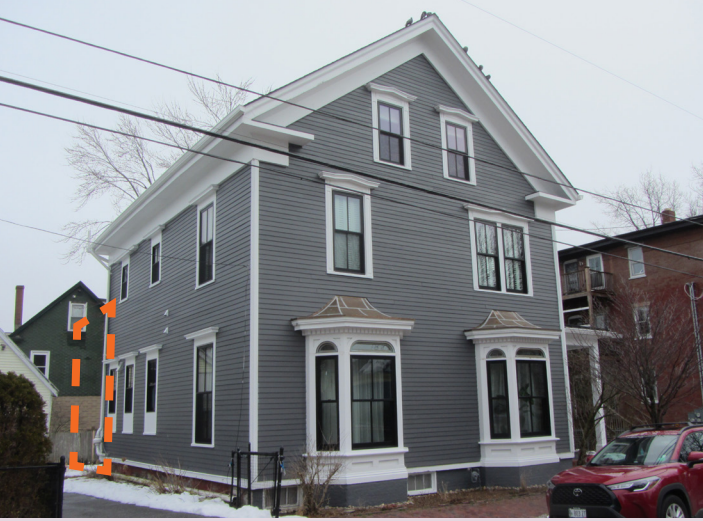
At 59 Atlantic Street, the applicants successfully argued that a rear el, which had been present on the building for some time, lacked architectural character and historic integrity. In this case, the Historic Preservation Board approved the removal of the el as part of an overall scheme of rehabilitation.

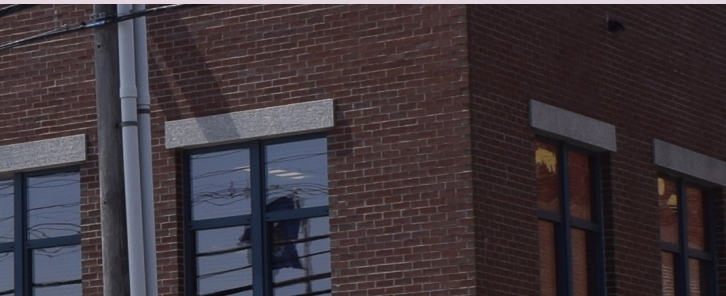
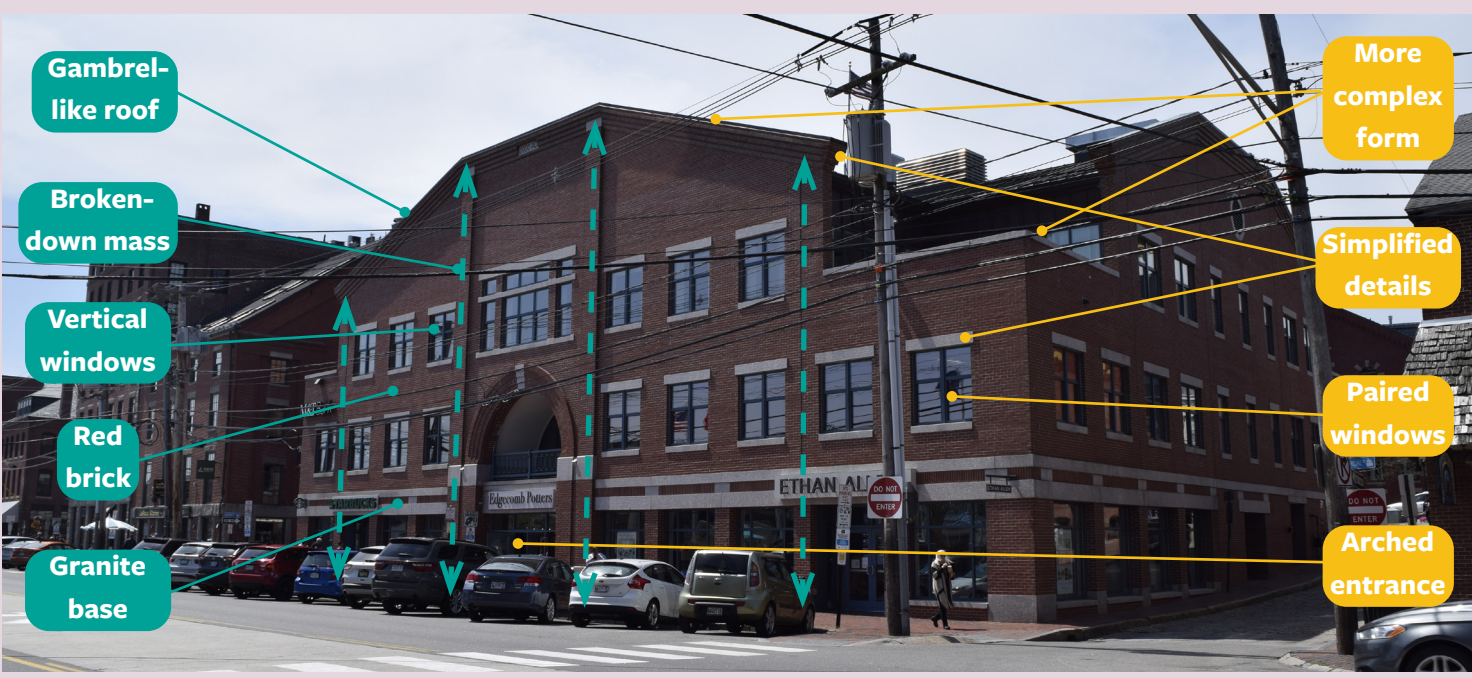
### 145 COMMERCIAL STREET (2000) DIFFERENTIATED TRADITIONAL

When a traditional aesthetic is desired, it can be straightforward to take cues from the context and develop a compatible design; however the challenge then becomes achieving differentiation. This can be done subtly with simplified details, or more boldly with changes in material or scale.

This project achieves compatibility through primary building materials of red brick and granite that strongly reference the surrounding context. A granite base, roof that references nearby gambrel roofs, and broken down massing relate this larger building to nearby buildings. Vertically oriented windows with traditional headers and sills also relat to nearby historic buildings.

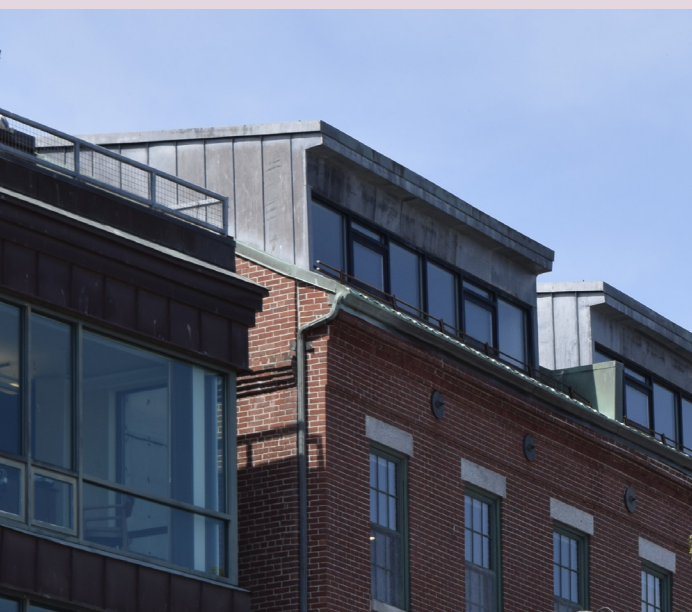
### 300 FORE/93 COMMERCIAL STREET (2007) COMPATIBLE CONTEMPORARY

When a contemporary aesthetic is desired, the challenge can be in creating a compatible relationship. This can be achieved by mimicking forms, establishing alignments, utilizing contextual materials in a contemporary way, or contemporary materials in a contextual way.

This project achieves compatibility through alignment of floors and cornices with adjacent buildings, a compatible width, an abstracted roof form, and the use of granite as a contextual matrial close to the sidewalk. While the windows are banded, they are generally broken down into vertically-oriented units. The color of the fiber-cement board paneling is also a play on the adjacent US Custom House.

This design is strikingly modern and differentiated using primarily contemporary materials such as as metal, curtain wall windows, and fiber-cement panelling. The curved roof, while a reference to nearby gambrels, is distinct from them, and bands of vertical windows depart from punched openings.
