## Historic Preservation Board

Wednesday, May 21, 2025 at 5:00 PM  
Room 24 (Ground Level of City Hall) and  
Zoom

- i. Preliminary review of proposed updates to the CITY OF PORTLAND HISTORIC RESOURCES DESIGN MANUAL. City of Portland, Applicant. The Historic Preservation Board will hold a hybrid workshop to review draft updates to the City of Portland Historic Resources Design Manual. The current Historic Resources Design Manual can be found here: <https://www.portlandmaine.gov/496/Additional-Resources>.

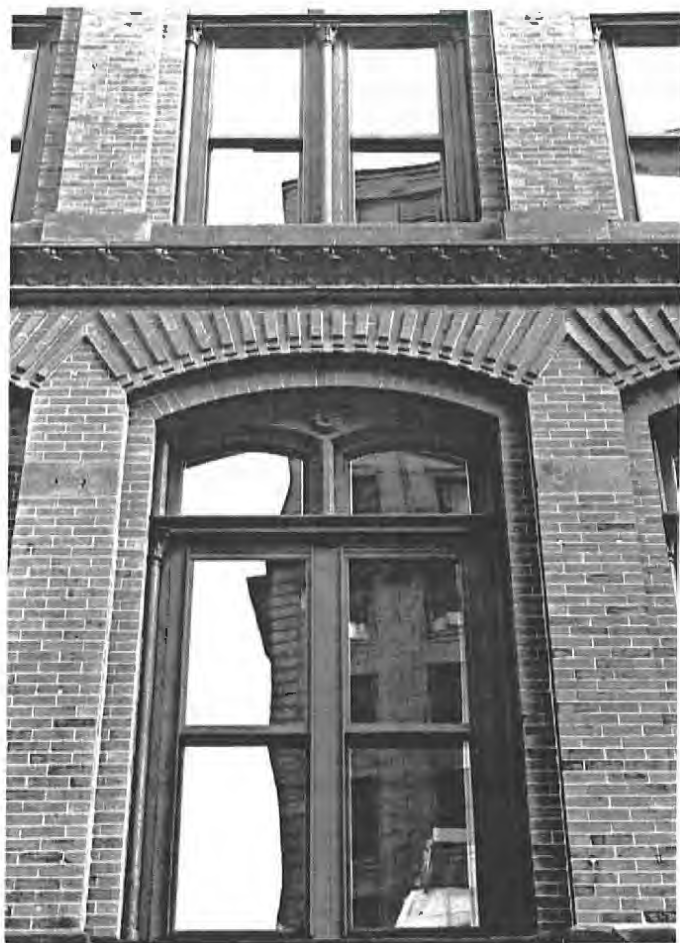
*When the original windows on this building had to be replaced due to deterioration, care was taken to duplicate the original window configuration and to retain the trim pieces which give the window their visual interest.*

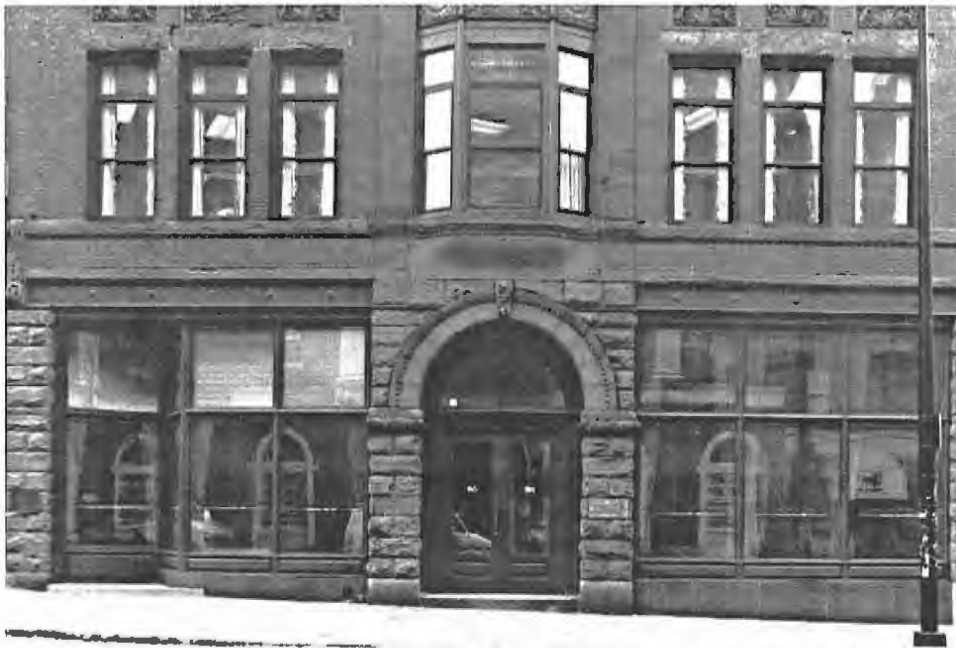
*If a historic feature was removed in a previous renovation project, it may be possible to replicate the original feature through the use of early photographs or other documentation. In a 1950's renovation of the Oxford Block storefront (top photo), much of its historic fabric was removed. A more recent rehabilitation project included a contemporary interpretation of the original storefronts and central entry (bottom photo), which was based on traditional principles of storefront design.*

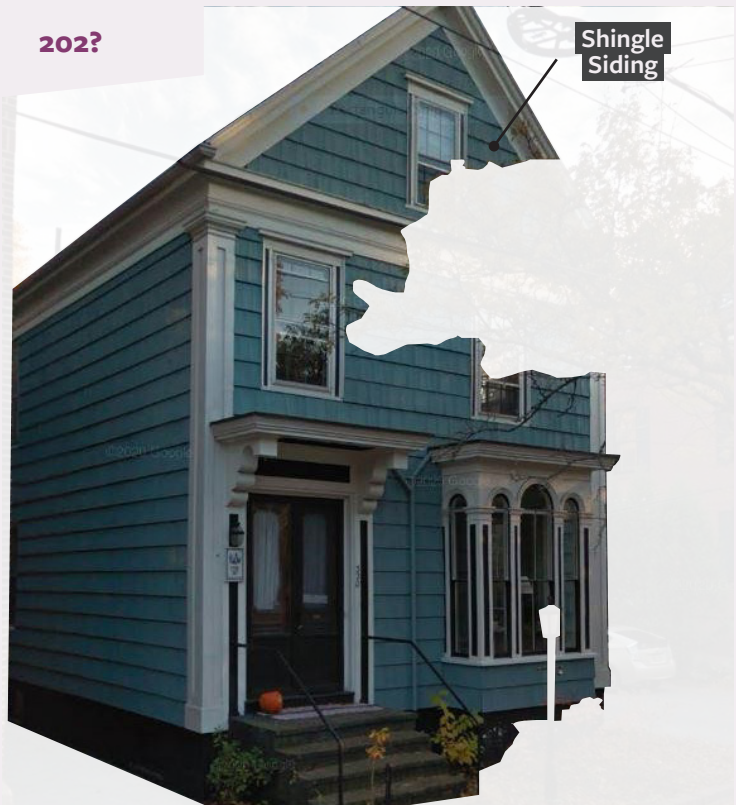
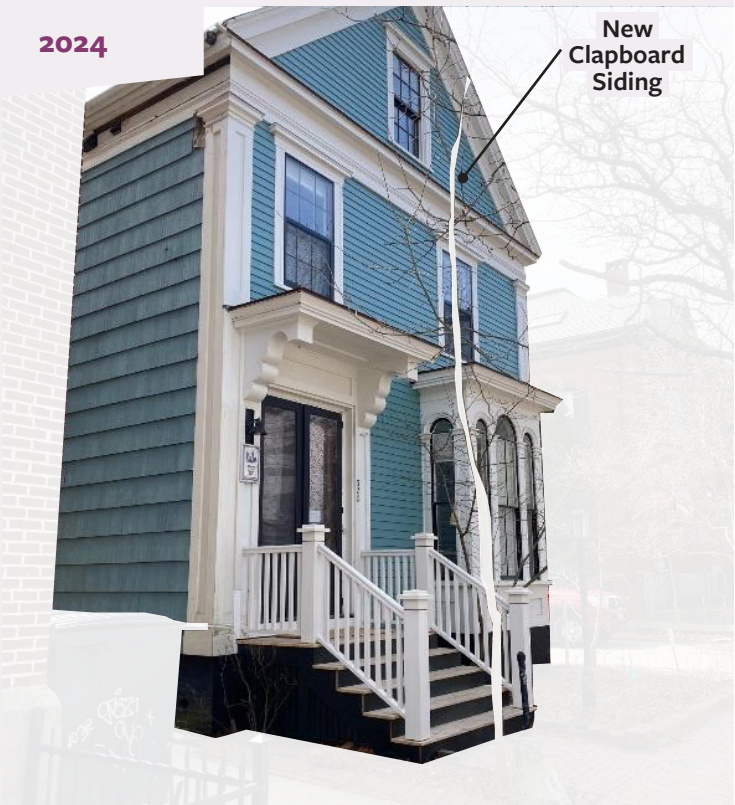
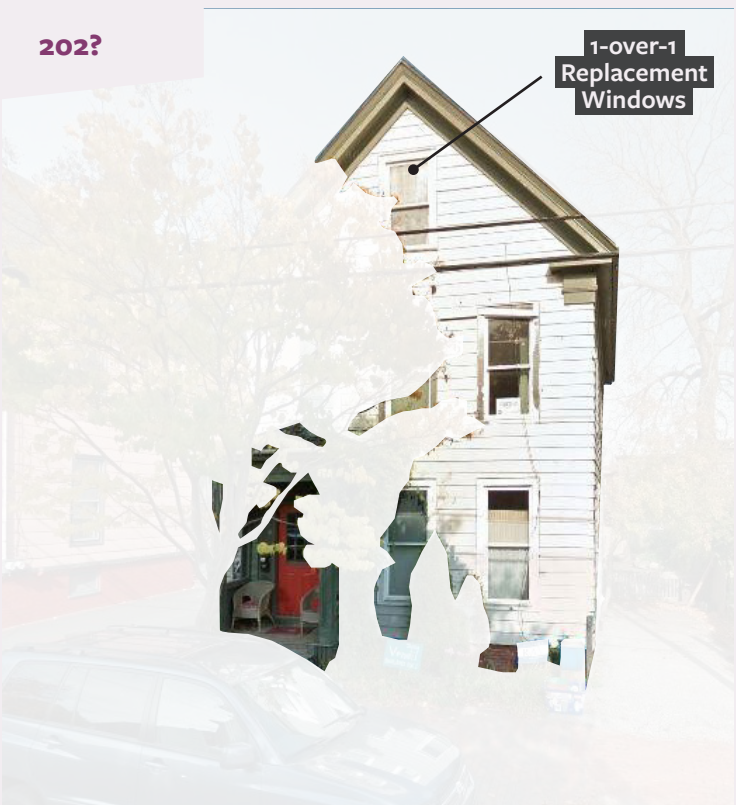
Tt the Richard L. Jordan House (1851, 73 Atlantic Street), all of the building’s historic windows had been replaced with simplified one-over-one windows prior to the designation of the Munjoy Hill Historic District. After the replacement windows started to fail the owner wanted to bring back some of the building’s historic character. While neighboring buildings have a variety of window styles, the owner reviewed the 1924 tax photo to identify two-over-one windows as the historically accurate design for the new replacement windows.

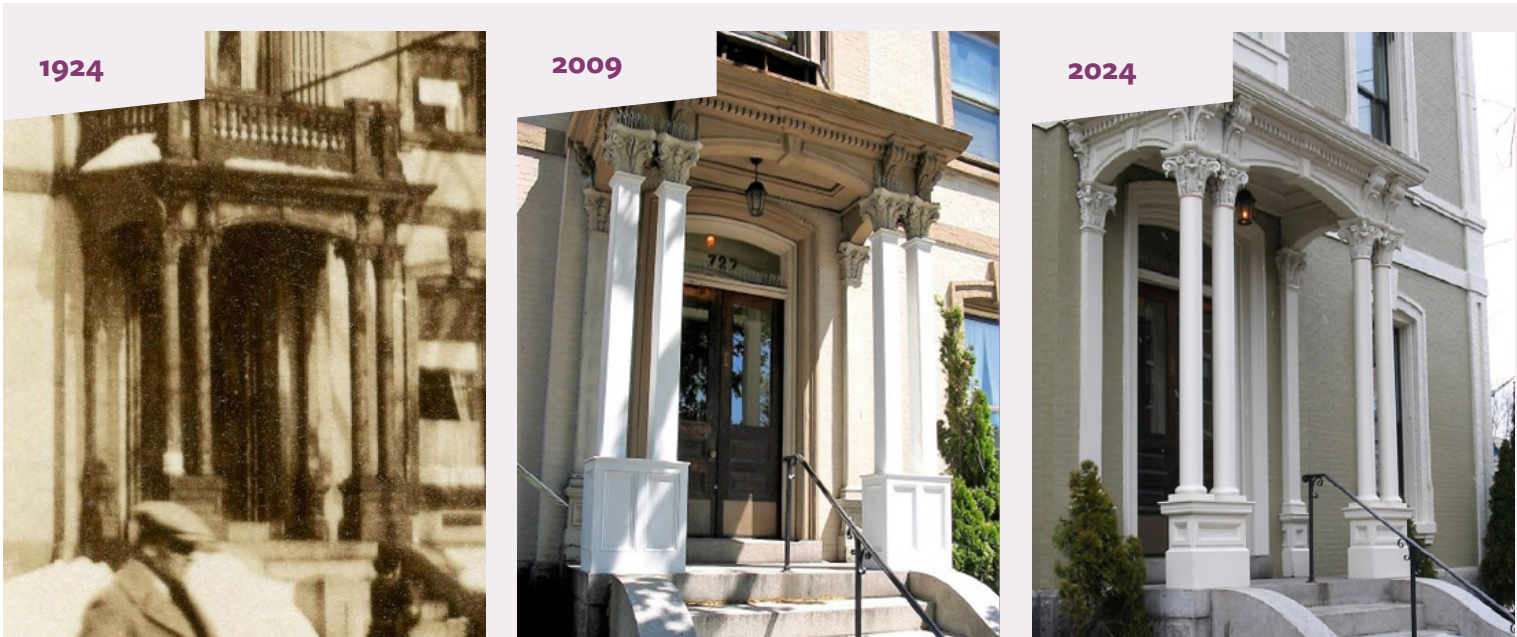
The entry porch of the Woodbury Davis House (1870, 729 Congress Street) was altered with the installation of poorly matched replacement columns at some point prior to the designation of the Deering Street Historic District (Center). Based on historic photos (left) and careful study of the existing pilasters, the original columns were recreated, restoring much of the porch's character. While the owners chose to recreate the historic columns, they were not required to restore the missing balustrade as they had long been missing from the porch.

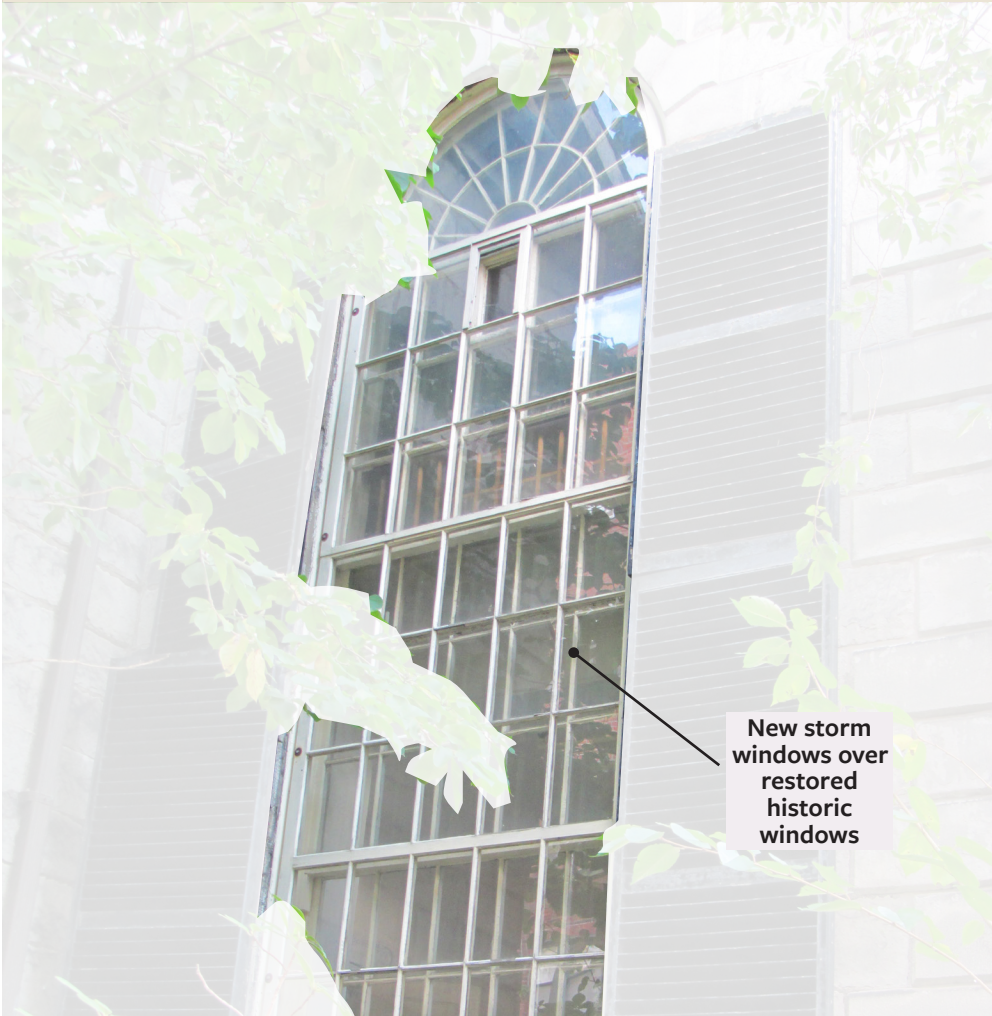
- B Character-defining windows have been retained
- E Distinctive windows have been retained
- F Historic windows have been repaired and protected using new storm windows

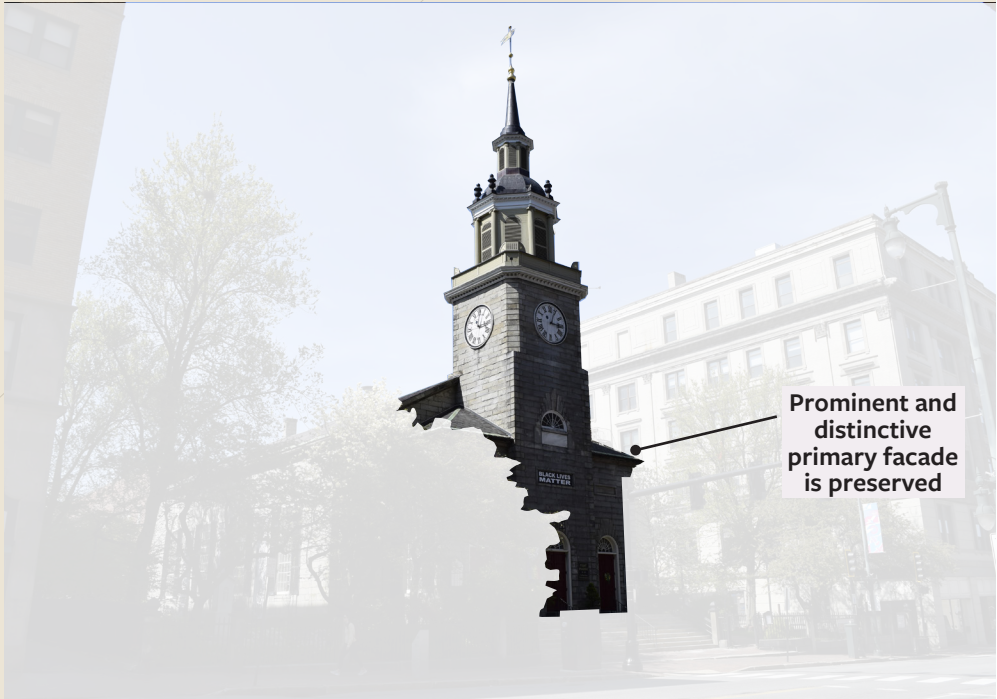
- E The distinctive primary elevation of the church was preserved
- I Necessary additions were made at the rear to avoid destroying prominent features
