## Historic Preservation Board

Topic: Historic Preservation Workshop and Public Hearing 11-19-2025

- i. Preliminary Review of Proposed Updates to the City of Portland Historic Resources Design Manual; City of Portland, Applicant. The Historic Preservation Board will hold a hybrid workshop to review draft updates to the City of Portland Historic Resources Design Manual. The current Historic Resources Design Manual can be found here: <https://www.portlandmaine.gov/496/Additional-Resources>

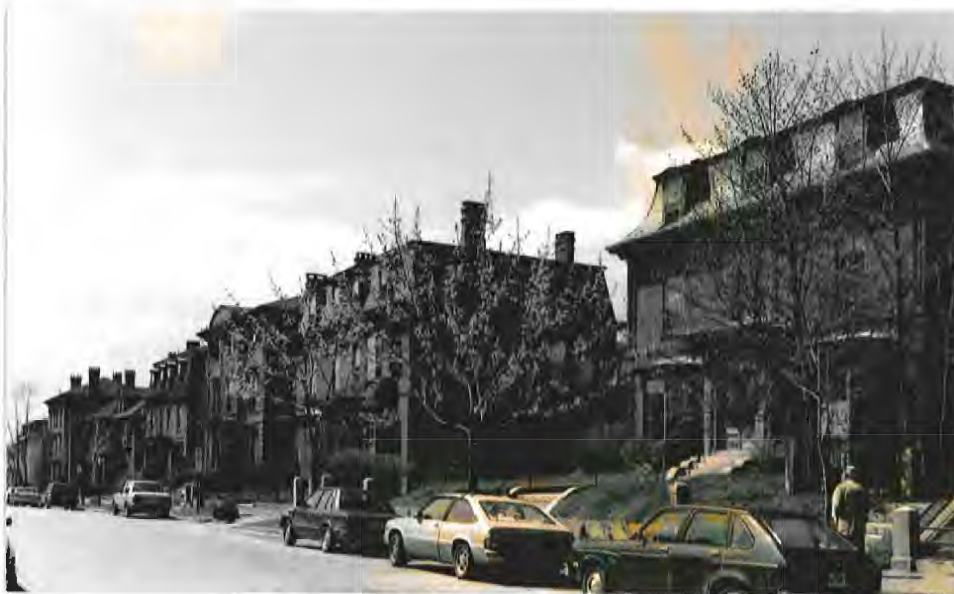
*The Deering Street Historic District is distinguished by its remarkable homogeneity. This group of houses lining the north side of Deering Street share a uniformity in their setback, scale, building height, and materials, although differences in house type and stylistic details add interest to the streetscape.*

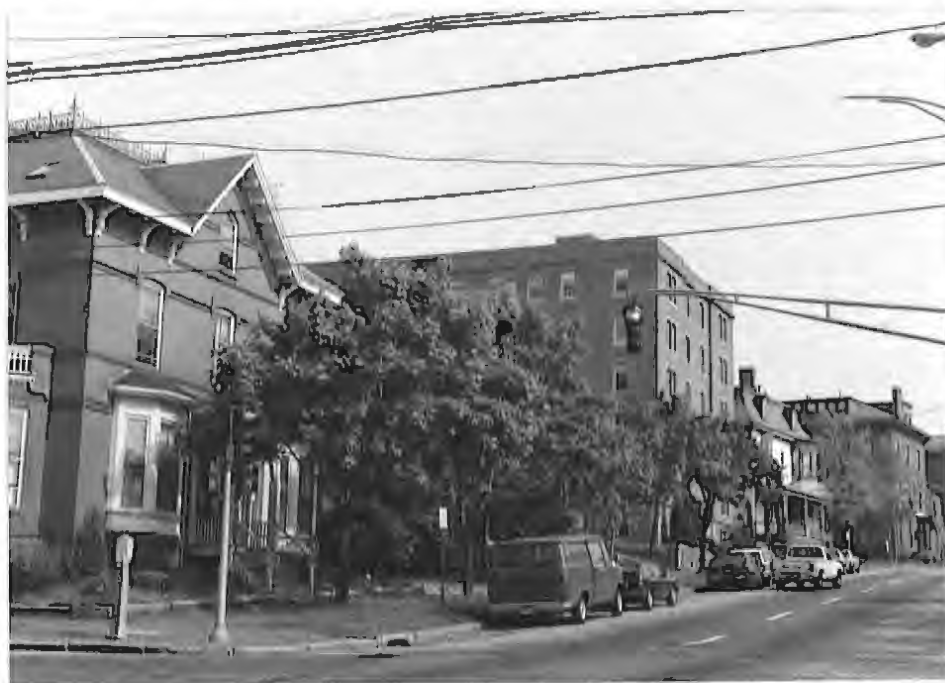
*State Street features the most diverse collection of building types and styles in the district. Here one finds early 20th century apartment buildings, duplexes and single family residences. Architectural styles range from Victorian Gothic to Italianate to Colonial Revival. With few exceptions, buildings face State Street, rather than the intersecting streets. Again, the relative uniformity of scale and the sophistication of the architecture itself serve to unify the street. As this corridor is a key gateway into the inner city, changes should be carefully considered.*

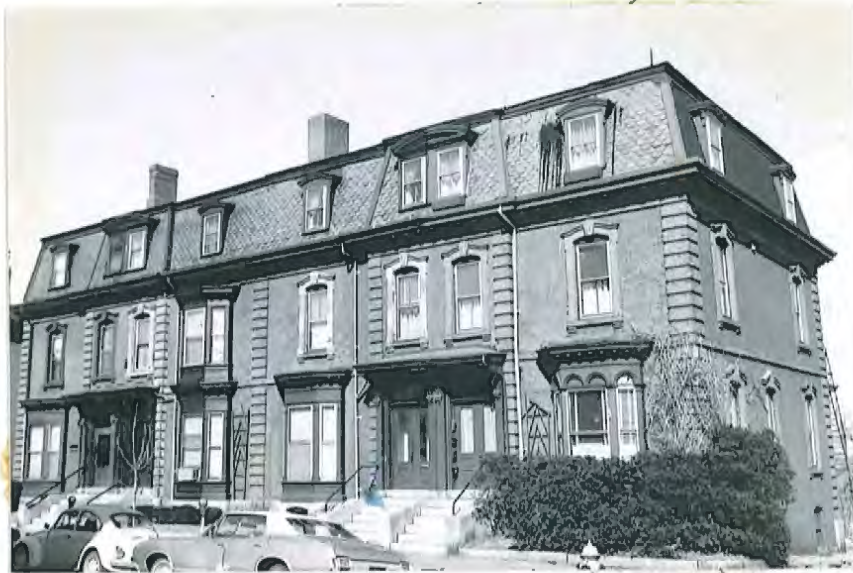
*One of several house types found in this district is the rowhouse. 33-39 Deering Street was built as four adjoining homes separated by party walls with individual entrances for each family. Its symmetrical design, height and materials are similar to that of neighboring homes of single family and duplex types.*

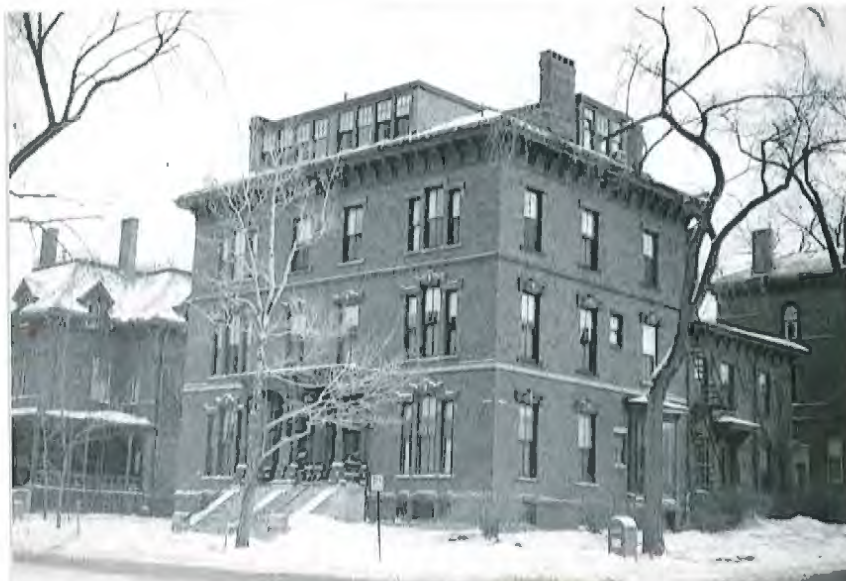
*A National Historic Landmark, the Thomas Brackett Reed House at 32 Deering Street is significant as the home of Reed, a U.S. Congressman and Speaker of the House. It is also a distinguished example of the Italianate style. Designed by Francis Fassett in 1875, the double house features Fassett's trademark sawtooth brickwork and extensive decoration.*

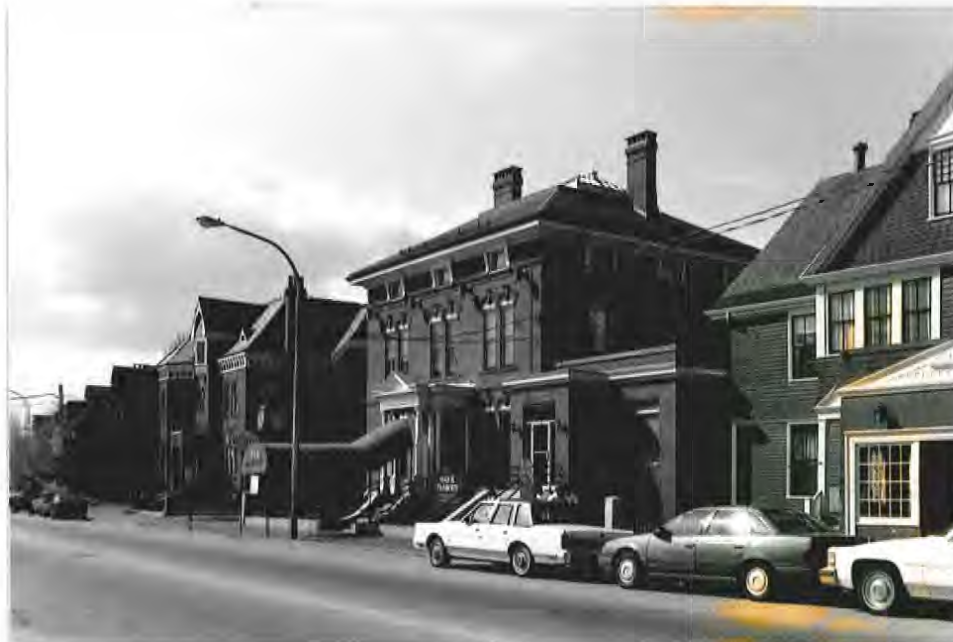
*Several architectural styles and building materials are displayed in this group of Congress Street converted houses. Nevertheless, the shingle and clapboard Queen Anne style Samuel T. Pickard House on the right is similar in setback, scale and building height to the brick Italianate house in the center and to the brick Queen Anne style house on the left.*

Shifting from brick to clapboards and shingles, Stevens designed the Samuel T. Pickard House (1884) at 743 Congress Street in the Queen Anne style. The house features an asymmetrical plan and an exploitation of the various ways in which wood can be worked: clapboards on the first story, shingles on the second story and the gable ends, and carved wood reliefs in the pediment above the entrance and between the windows in the gable.

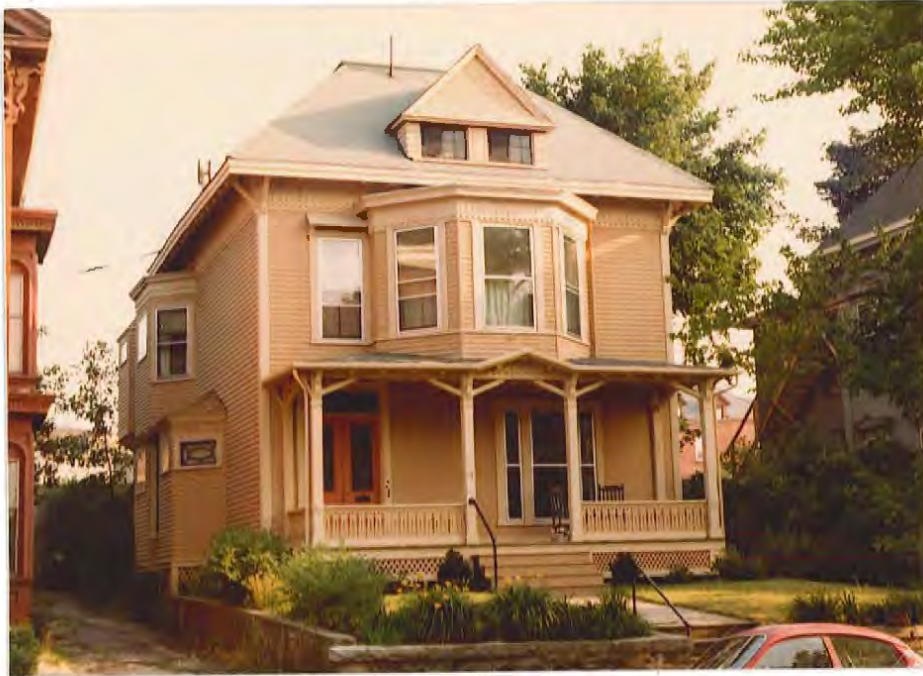
*The Harrison T. Whipple House at 40 Deering Street is one of the few buildings in the district to break the typical setback and choice of masonry construction. However, its scale and the degree and quality of its ornamentation serve to make it compatible with the predominant building pattern.*

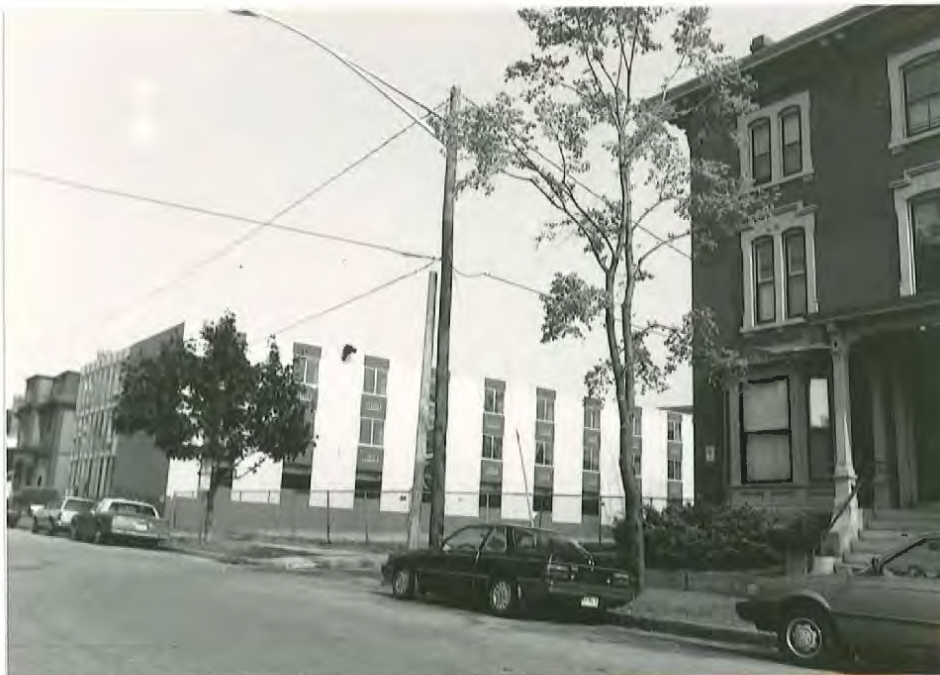
*Few intrusions are present in the Deering Street Historic District. Any new construction in this district should respect the prevailing qualities of the existing buildings to avoid the jarring effect created by the former hotel annex. Here, while the height and scale is similar to that of its neighbors, the flatness of the facade and the lack of ornamentation makes this a poor solution for its infill site.*

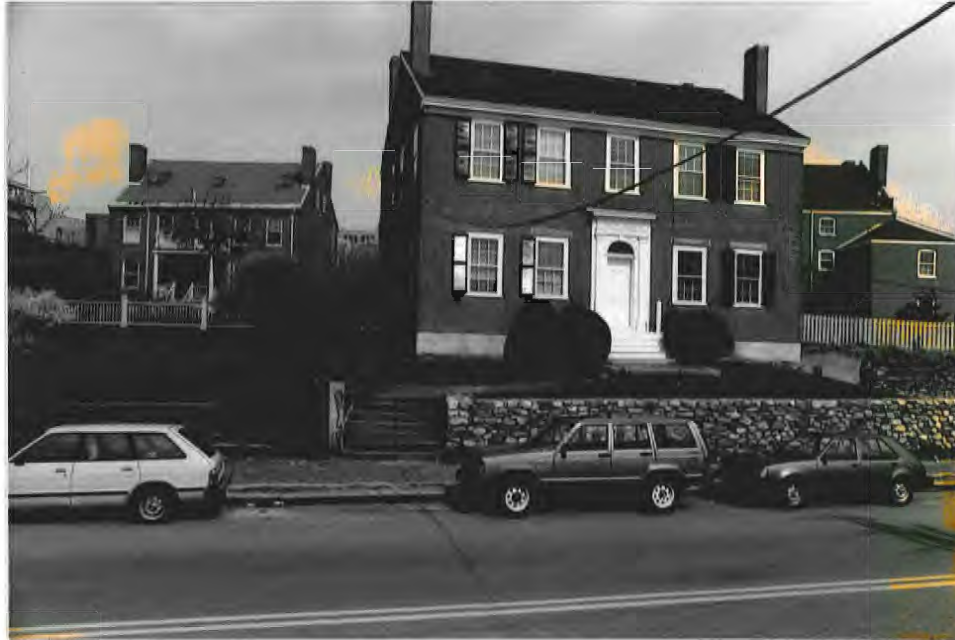
*The Daniel How House, 23 Danforth Street, was built in 1799 in the post Revolutionary War expansion of Portland economy. The dwelling is, in style, conservative late Federal. The outstanding feature is the entrance surmounted by entablature and cornice supported on Doric pilasters. To the right and left in the background are the two other How Houses.*

The Daniel How House at 23 Danforth Street was built in 1799 as one of the first Federal-style houses in Portland. A two-and-a-half story brick house with end chimneys, gable roof, and granite trim, its symmetrical facade reveals a four-room and central hallway plan. The brick of the front is laid in Flemish bond, another characteristic of high-style aspirations, and the entrance surround nearly doubles the height of the actual doorway. Phrased with Doric detailing and a semicircular

fanlight, the entrance serves to elevate the house above the level of simple vernacular building and it also responds sensitively to the raised site that once overlooked the harbor.

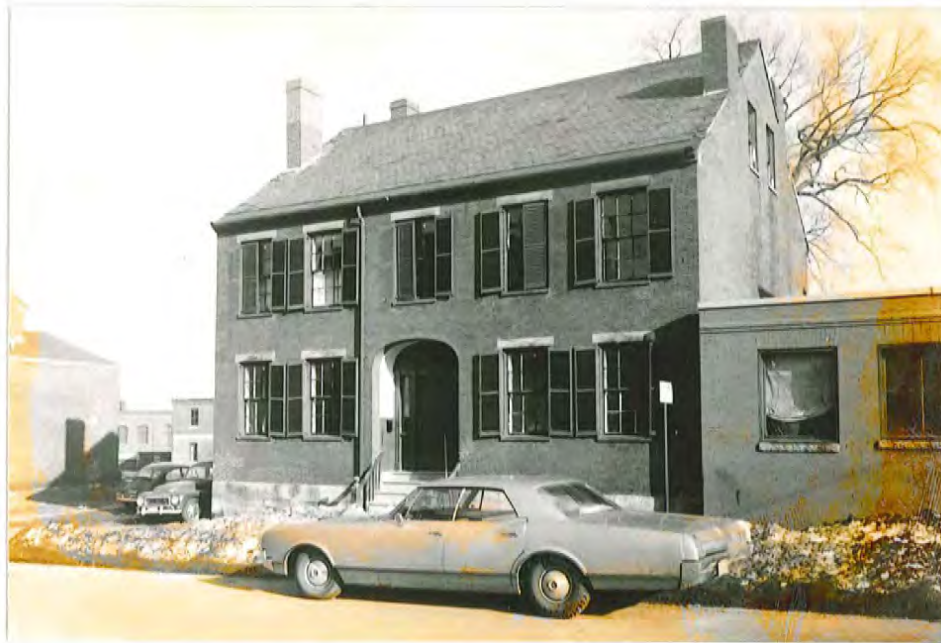
*The John How House, 40 Pleasant Street, built in 1817 as a wedding gift from Daniel to his son John. Basically similar in style to the earlier house, this one appears more compact because of the broad, recessed entrance way.*

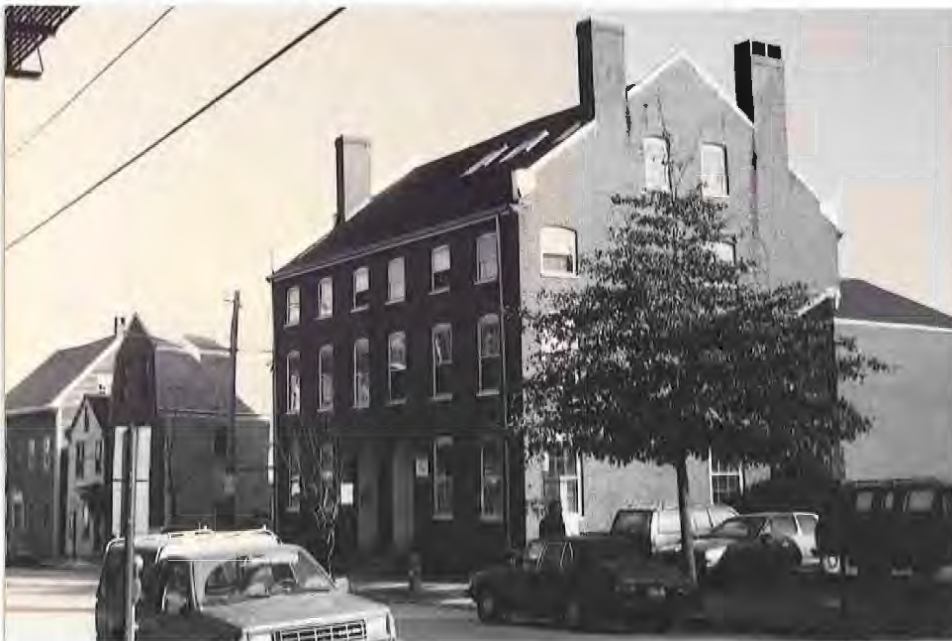
*The Joseph How House, 30-32 Pleasant Street, built in 1818 by Daniel's brother as a two family structure. The tradition of constructing duplexes was to continue throughout the nineteenth century in Portland. Like the other two How Houses, this structure has four chimneys on outside walls, but the window tops are elliptical and the elevation is three and one-half storeys. This enclave of late Federal red brick dwellings is coherent in general form in material and in details.*

plan is that of a double house for two families. It is also taller than the other two houses, having three-and-a-half stories under a gable roof phrased by end chimneys. Its double entrances are arched recesses following the model of the fan and sidelights of the John How House, and its brickwork is common bond.

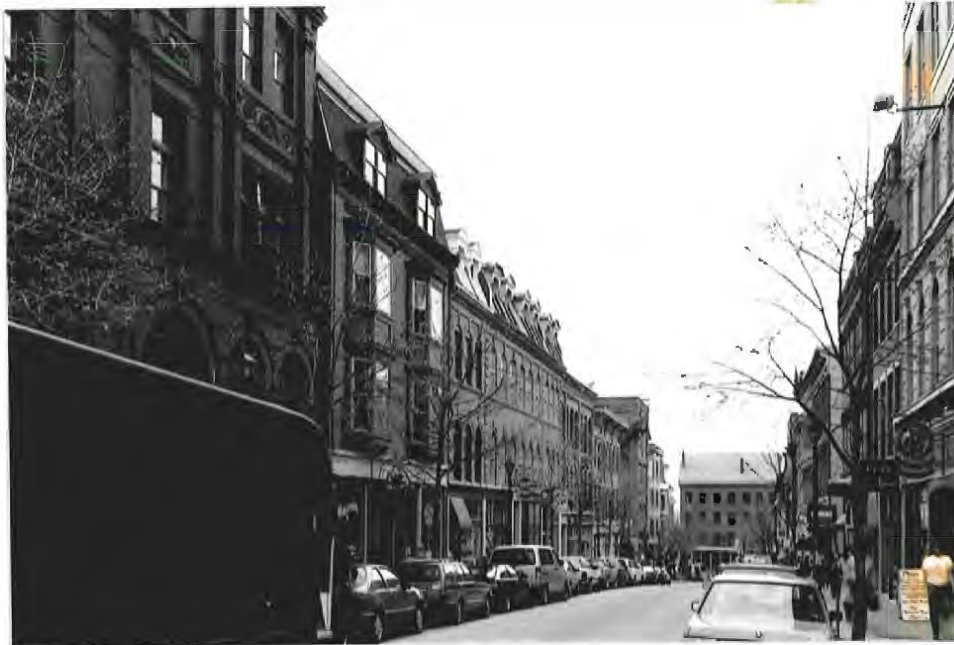
*Exchange Street is narrow and steep. The Chadwick-Duran Block at the base of Exchange survived the fire of 1866 and in its architectural severity contrasts with the more elaborate dormers, bay windows and cornices of the post-Fire Victorian buildings. Building heights are distinctly uniform and all buildings are organized in a 3-part composition -- 1st floor base, upper floors broken by vertical window openings and strong cornices. Exchange Street more than any other street in the city, provides an uninterrupted nineteenth century view.*

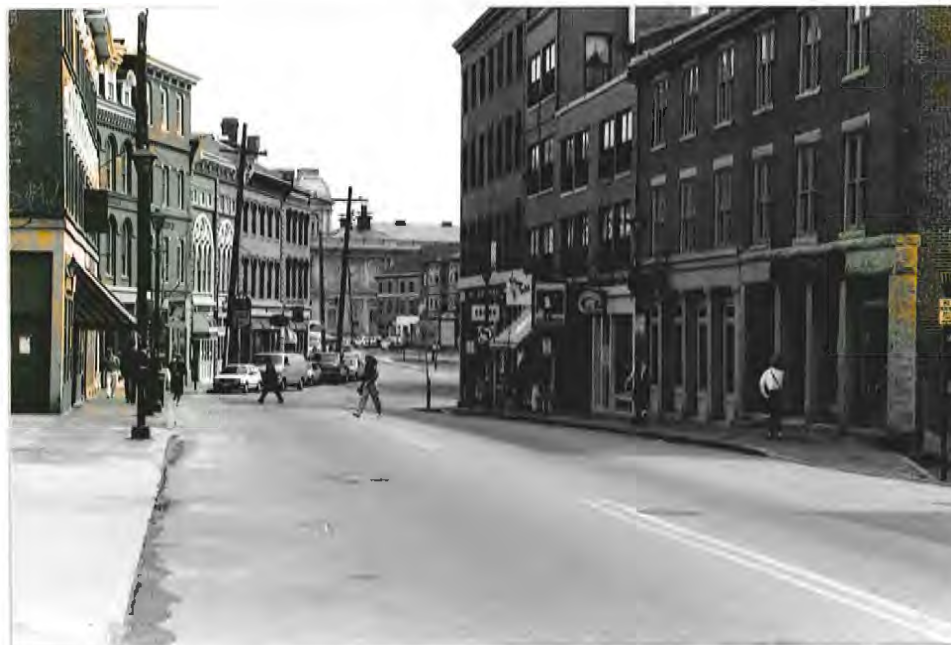
*Fore Street retains its meandering character from the days it was the city's Waterfront and is lined, still, with three and four storey brick buildings which maintain a scale compatible with the narrow street.*

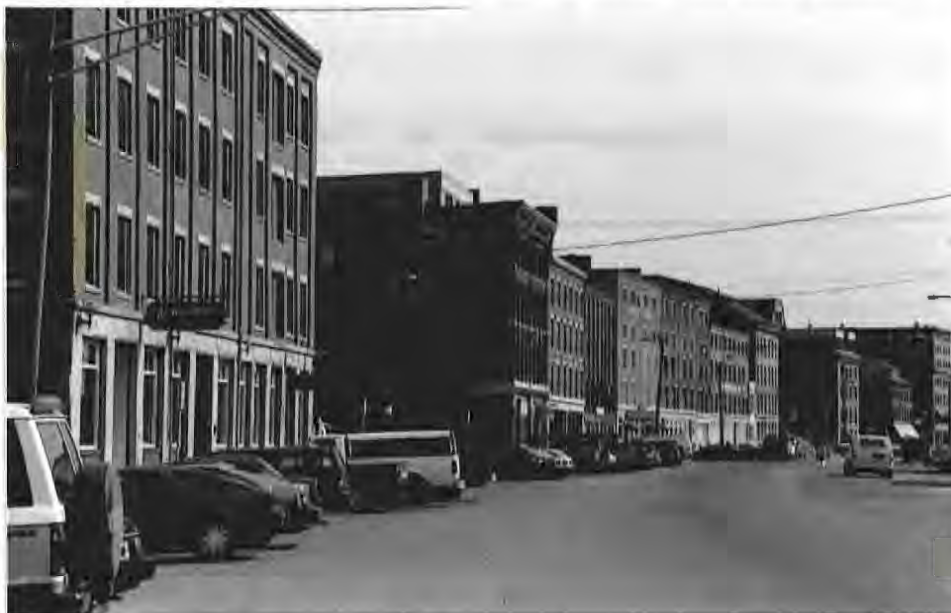
*Commercial Street is flat and unusually broad. Wide blocks of four and five storeys balance the breadth of the street. First floor facades and strong cornice lines are important unifying features in this wall of buildings. Because of the breadth of the street, changes to rooflines are especially noticeable. Some of the recent rooftop additions have broken the consistency of the street.*

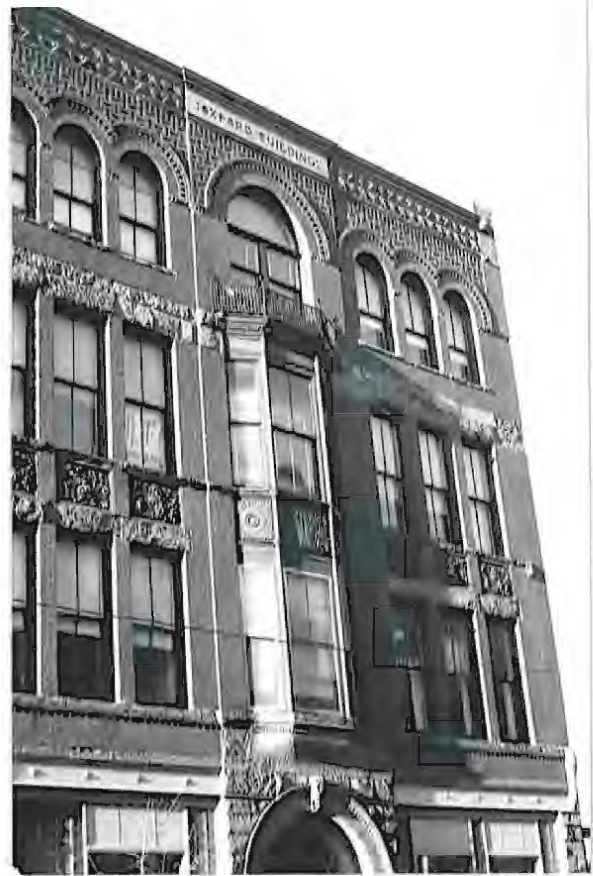
*The Oxford Block, 183-187 Middle Street. John Calvin Stevens I's Romanesque Revival business block built in 1886-87. Decorative brickwork, terra cotta panels, carved stone and metal balcony extend the richness of the arched openings and projecting bay. Whether articulated in this later Romanesque style or in earlier styles, this richness of detail is characteristic of much of the architecture of the waterfront district.*

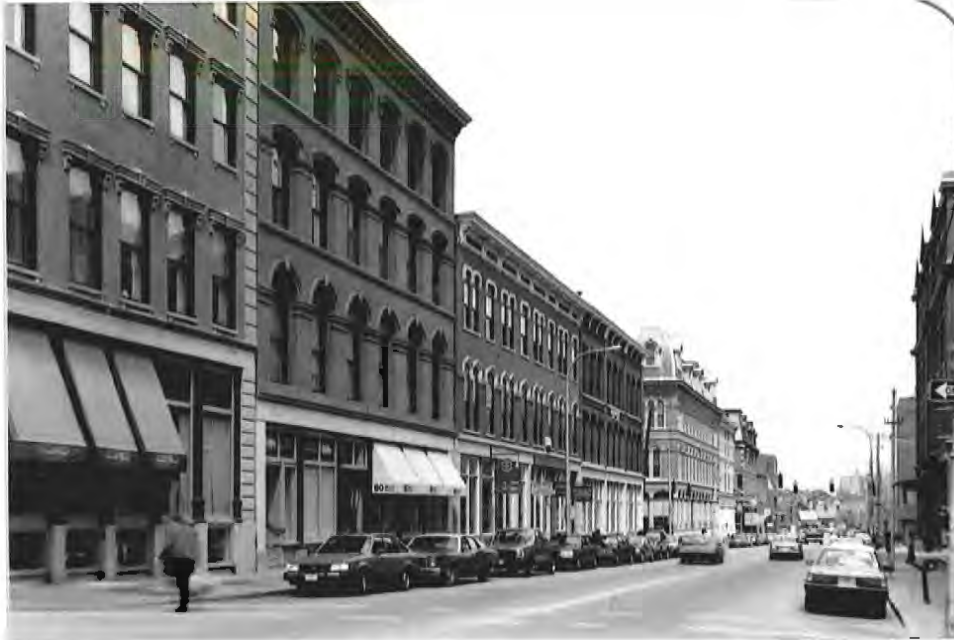
*Middle Street. The Woodman, Thompson and Rackleff blocks are visible on the lower left. The importance of the first storey definition is apparent as is the rhythmic repetition of vertical window openings. The depth of the windows and the projection of the moldings are important design elements which provide relief and richness of detail.*

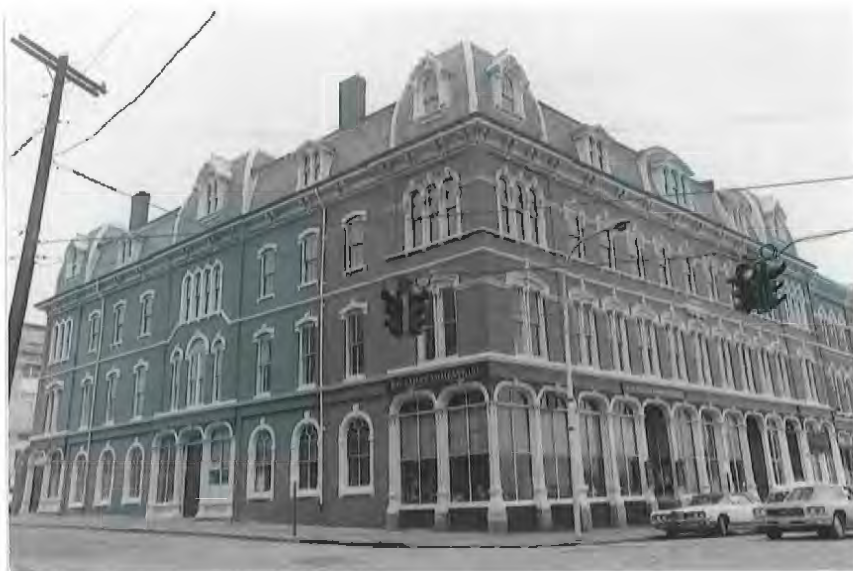
*Woodman Building, 133-141 Middle Street. The tall cast iron columns, the elliptical arches, the prominent belt courses, and window hoods enliven and break into smaller components an otherwise massive building. Noteworthy are the groupings of windows which define the corners and the centers of the two facades.*

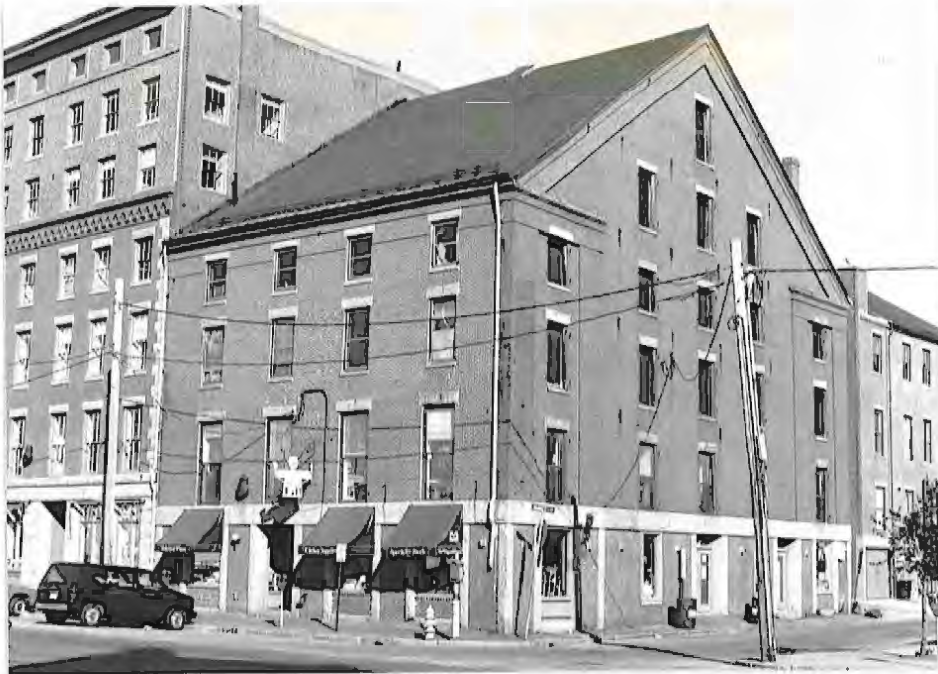
*William Moulton Block, 157-163 Commercial Street. In 1851 it was one of the first blocks built on Commercial Street. The Greek Revival stylistic features are the wide granite lintel which separates the first story from the upper floors and the heavy granite lintels over each window. Noteworthy on the side elevation is the deep return of the gable which is supported on each side by brick pilasters.*

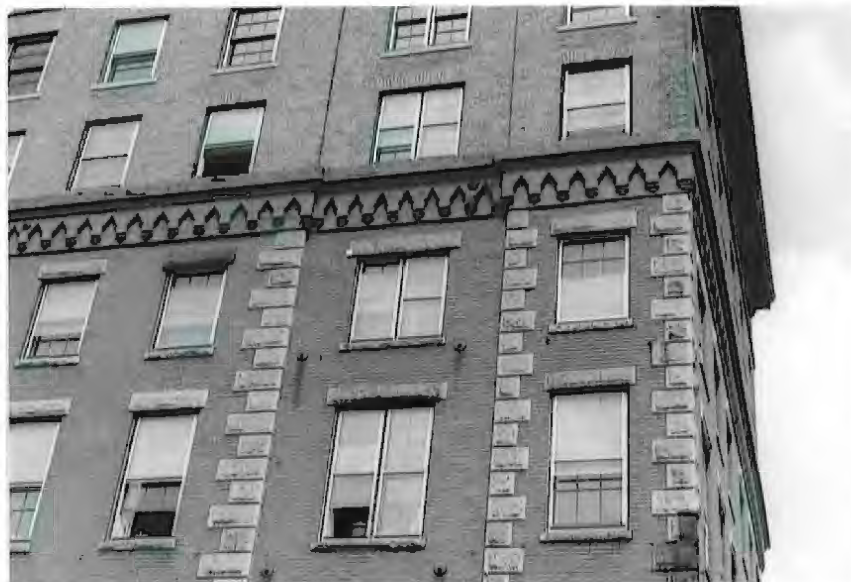
*William Moulton Block, 165-169 Commercial Street. Two years later Moulton had the neighboring building, partially visible in upper photograph, built (the three upper floors are a later addition). This builder added quoins and a corbelled cornice, architectural features of the Italianate style. In both buildings the first floor is set off by a heavy granite cornice and granite piers. This delineation of the first floor unifies the buildings in the waterfront district.*

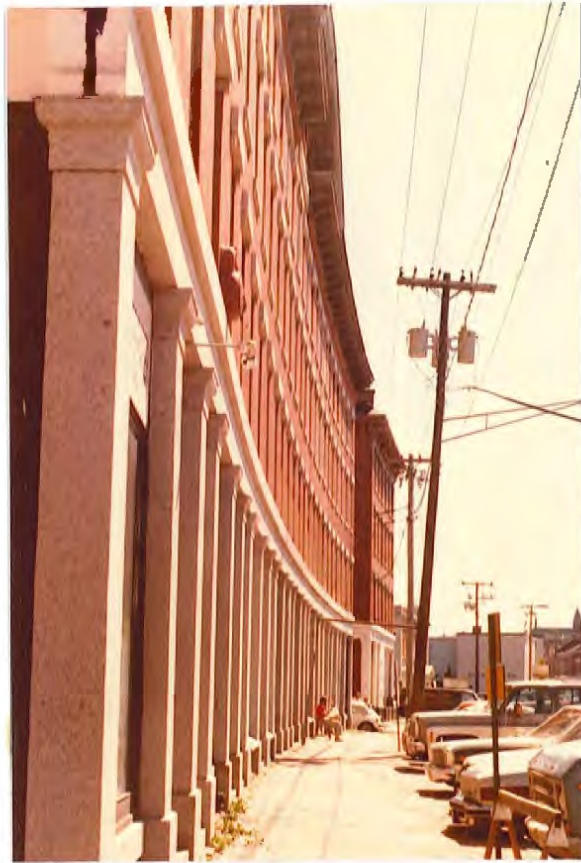
*The Elias Thomas Block, 102-132 Commercial Street. Built in 1860, this granite and brick Greek Revival block is unusually long and was designed to reflect the curve of the street.*

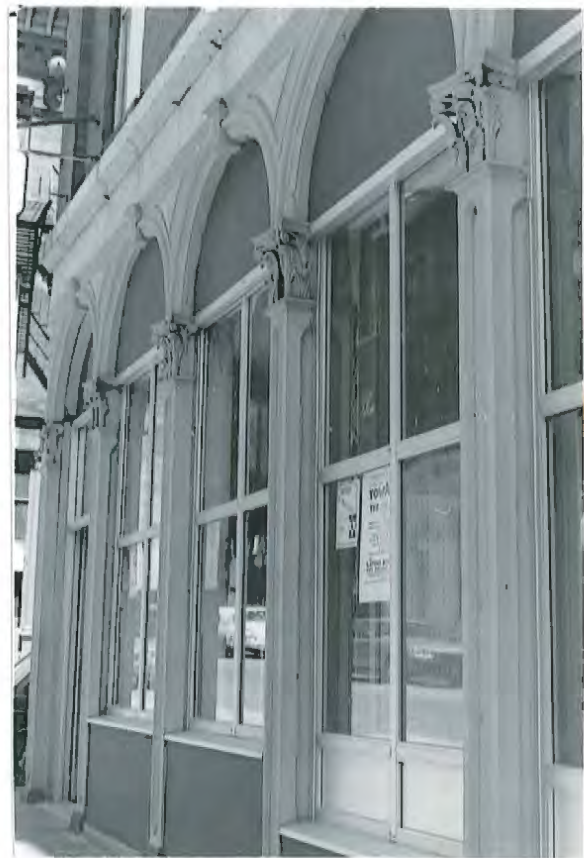
*Ocean Insurance Company Exchange Street Block. Completed in 1867, the year following the Great Fire. The first story arcade is cast iron, an affordable material for such fine details as the corinthian capitals on the pilasters. Many commercial buildings in the waterfront district feature cast iron storefronts.*

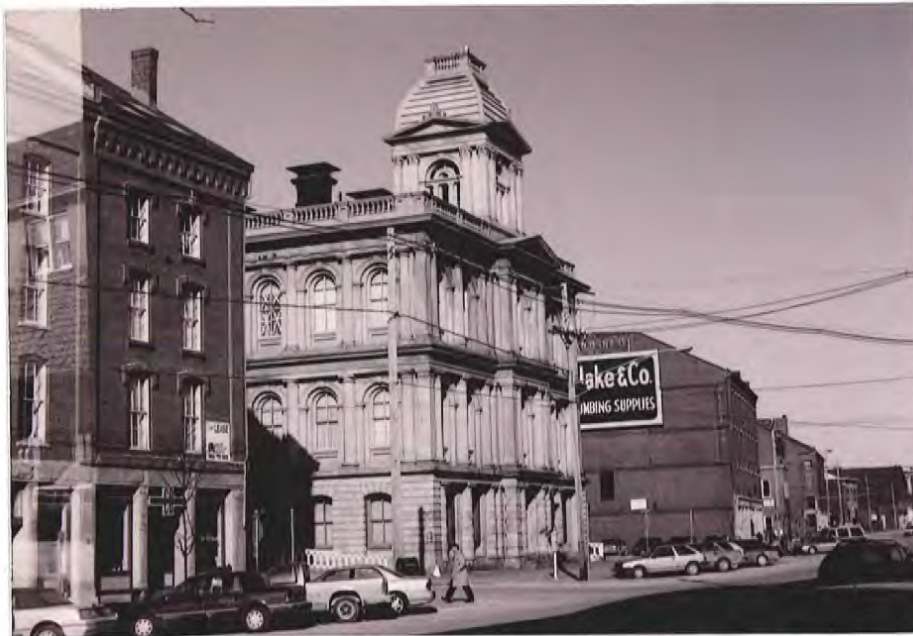
*The Customhouse on Fore Street replaced a structure lost in the 1866 fire, and was finished in 1871 from designs by architect, Alfred B. Mullett. It is an outstanding example of the Second Empire Style. Here grey granite is used to create strong light-dark contrasts in the projecting columns, the recessed windows, fine roofline, balustrade and surrounding fence. A building of this scale and richness needs generous views -- this was designed to be seen from four sides.*

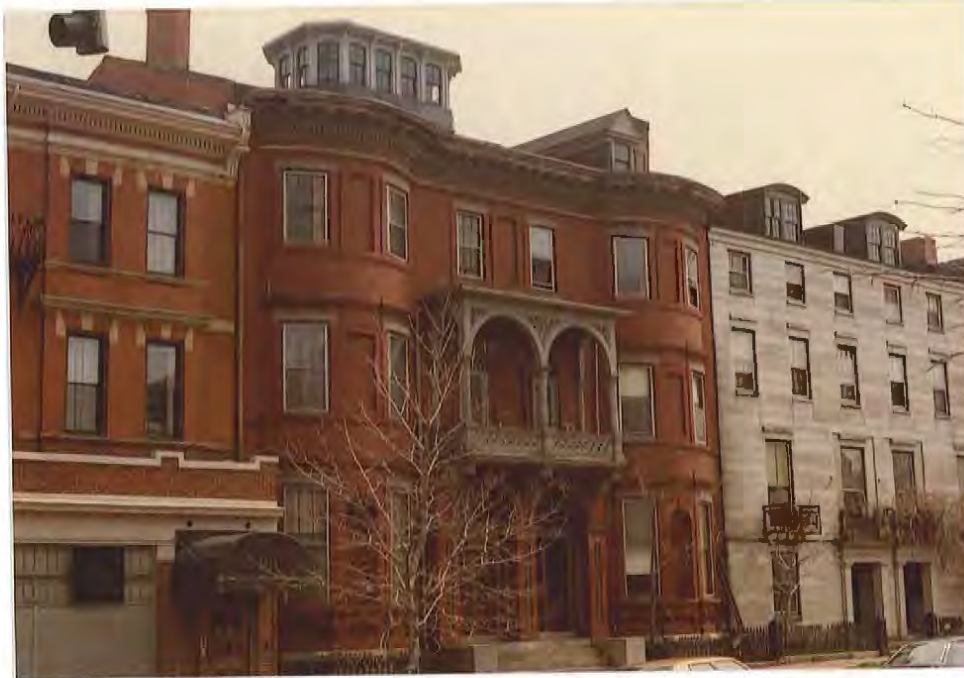
*Building types represented in the district include many variants on the double house. Two quite different examples of this type, the Fitch-Swan House (1859) and the John Neal Block (1836) are located on State Street near Longfellow Square. The Greek Revival granite Neal Block seems almost severe next to the undulating bays and pierced wood balcony of the Italianate painted brick Fitch-Swan house. Although the buildings share a similar height, width, and setback, the marked differences in their ornamentation and detailing makes for a visually stimulating streetscape.*

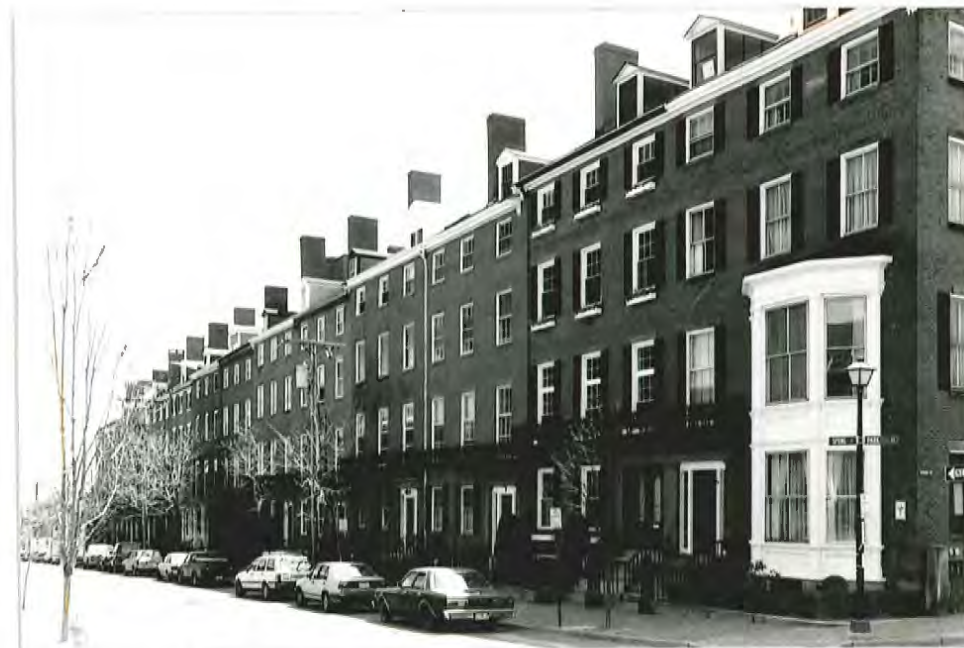
*Park Street Row was built between 1835 and 1838 by a group of investors, the Park Street Proprietary. This group of rowhouses offered an alternative to the single and double house. Twenty houses were built on Spring, Park, and Gray Streets and sold unfinished to individual owners. Although the three units on Gray Street have been demolished, the row remains the largest project of its type ever built in Maine. Some changes have been made to doorways and windows; some bays and dormers have been added. Nevertheless, the low pitched gable roof, the regular fenestration, the brownstone sills and lintels, the post and lintel entrances, the ironwork of both the delicate balconies and fences remain as character defining features.*

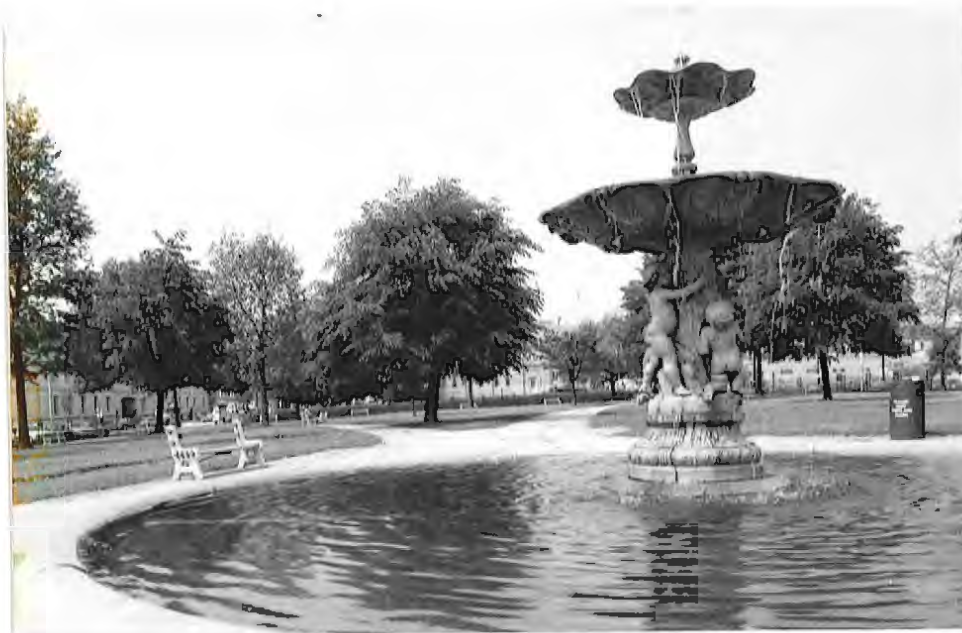
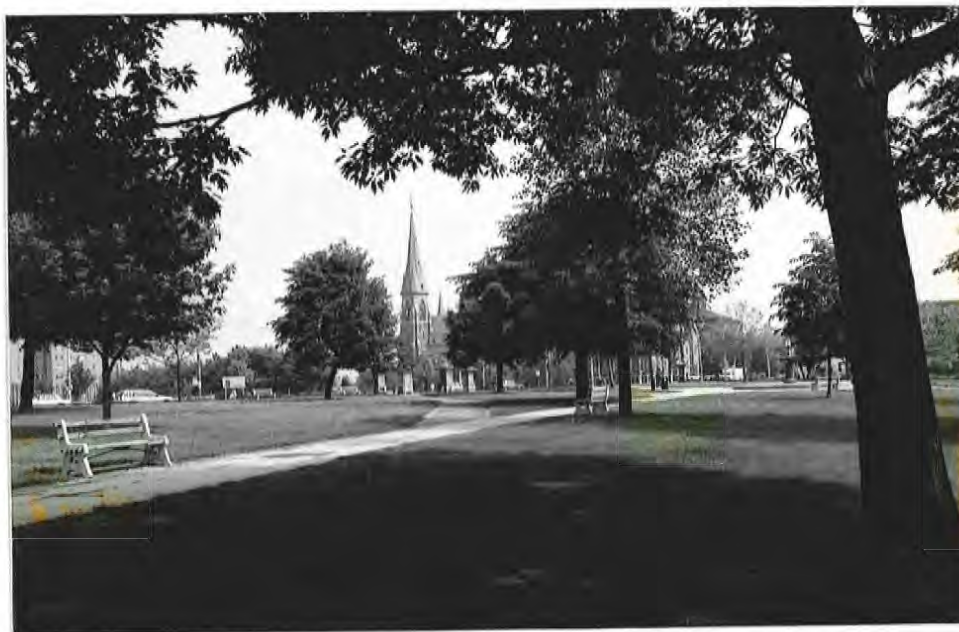
# Historic Plan of Lincoln Park

The eastern end of the park was lost in 1970 with the widening of Franklin Street. However, the granite posts and iron fence were carefully relocated such that it continues to define the eastern boundary. Although the park is in a deteriorated condition, its major architectural and landscape design elements survive. Despite years of deferred maintenance and limited city budgets, Lincoln Park retains its integrity and there is renewed interest in maintaining its historic character.

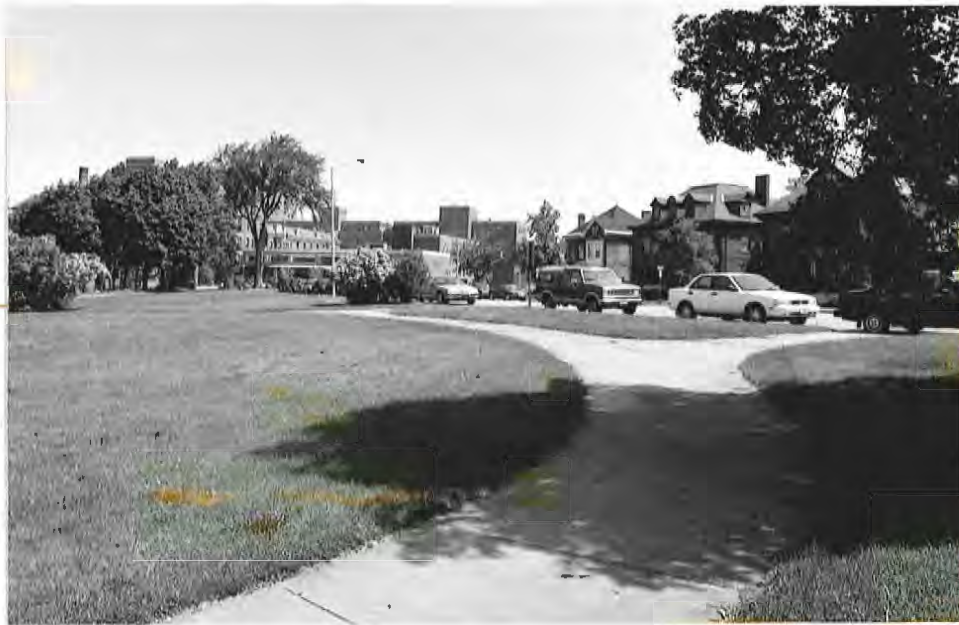
# Historic Western Promenade Plan

The Western Promenade remains significant today by providing visitors and residents of Portland with a publicly-owned and maintained site from which to take in the magnificent views of the countryside and the White Mountains. Although increased development has changed the view immediately to the west, the Promenade retains the purpose and intent for which it was initially developed and preserved.

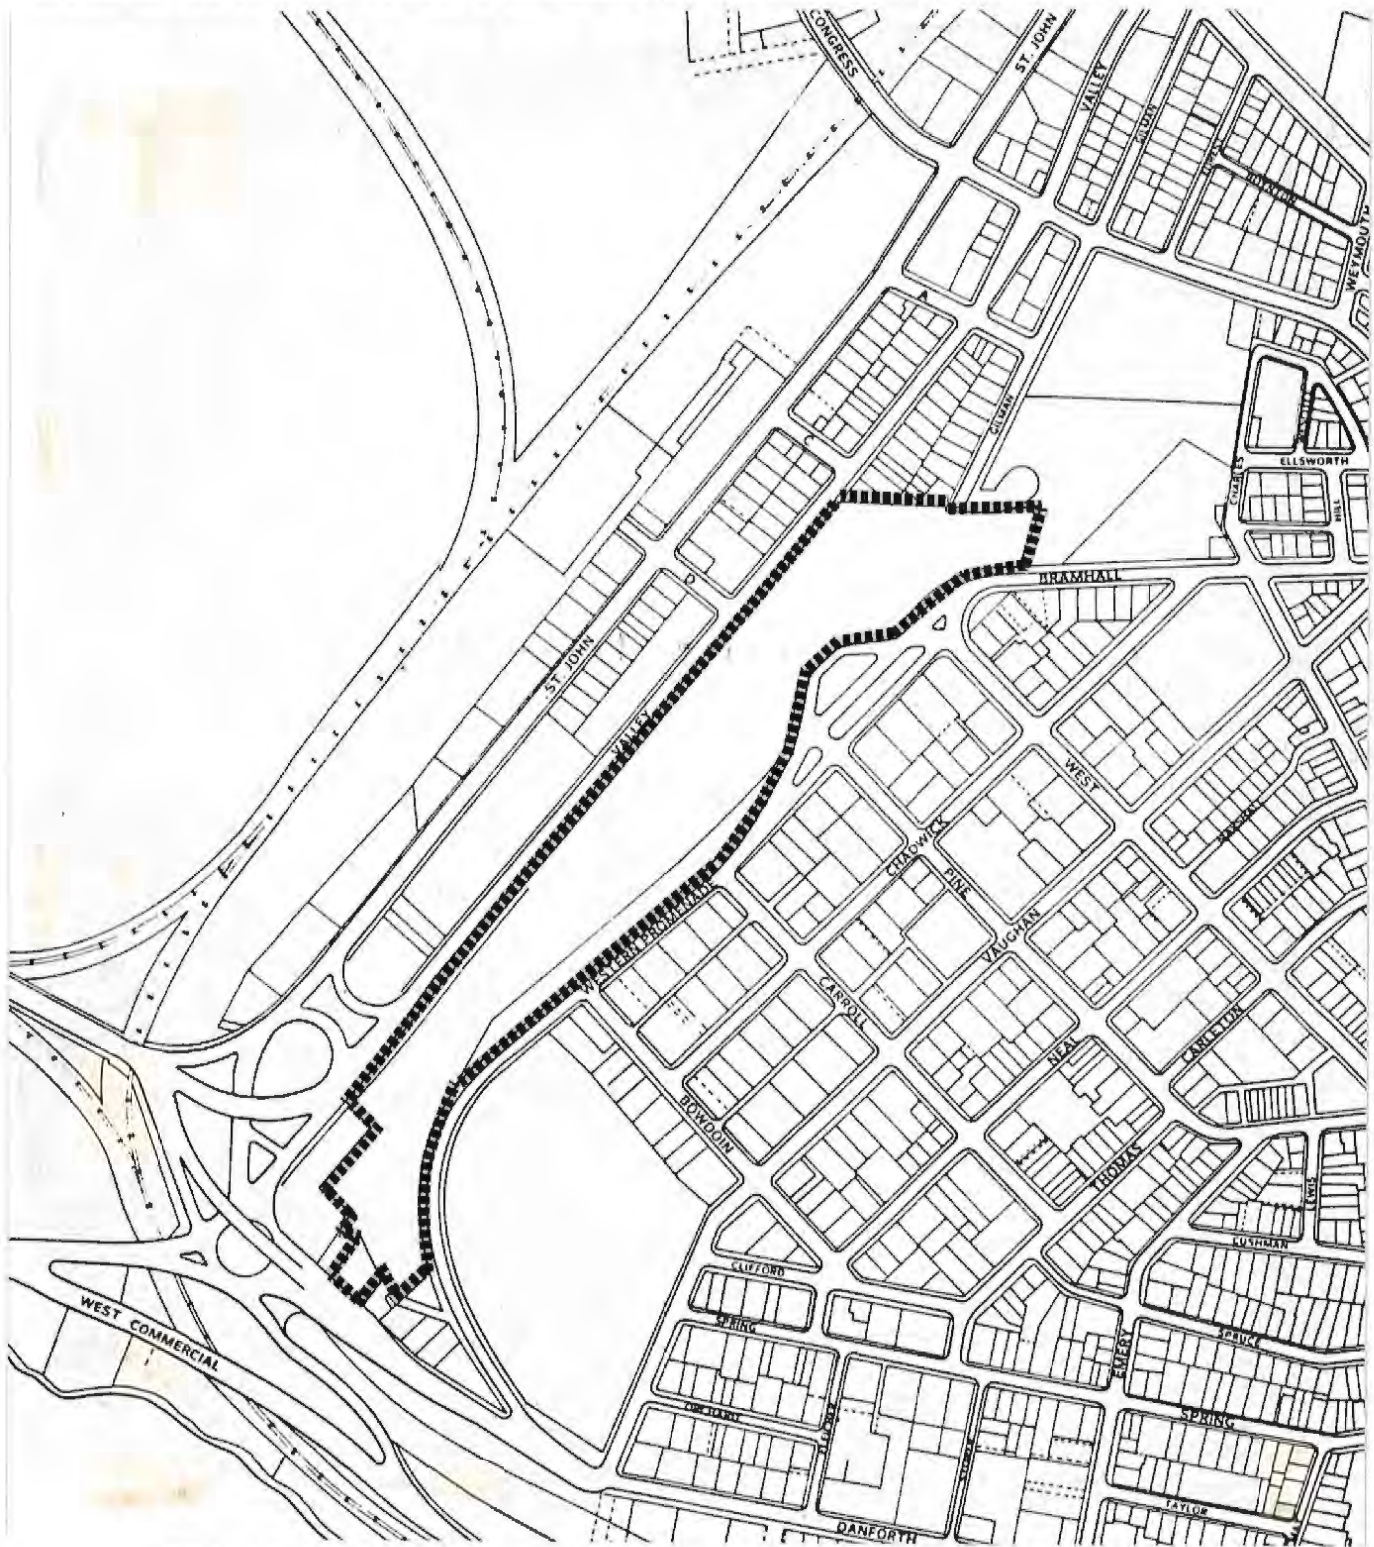
## Boundaries of the Western Promenade Historic Landscape District

*The boundary embraces the entire parcel of land historically associated with the Western Promenade.*

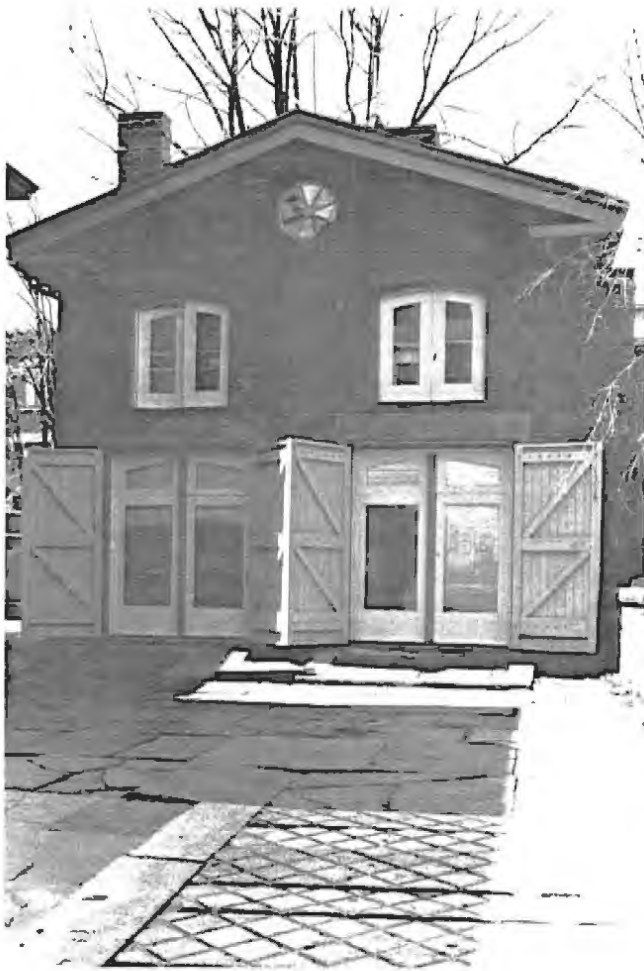
*When the carriage house at the Victoria Mansion was adapted to become an architect's office, the original doors were fixed in an open position and new glass panelled doors were inserted in the openings. A second means of egress was located on the side elevation, not visible from the street. The new use was accommodated successfully without obscuring original key exterior features.*

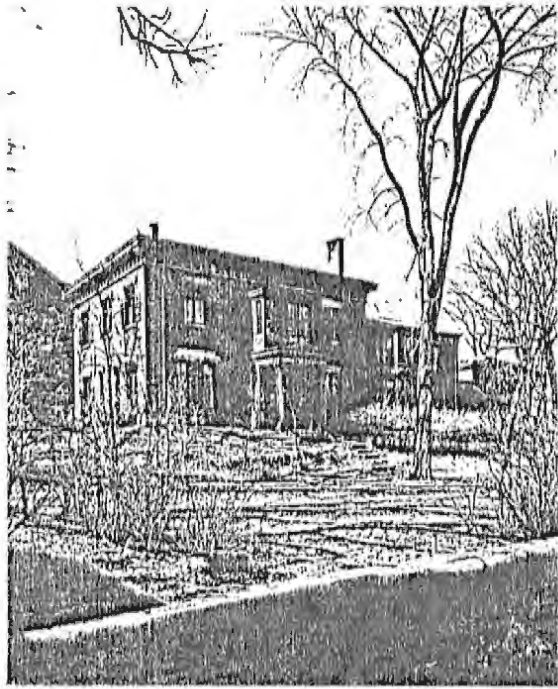
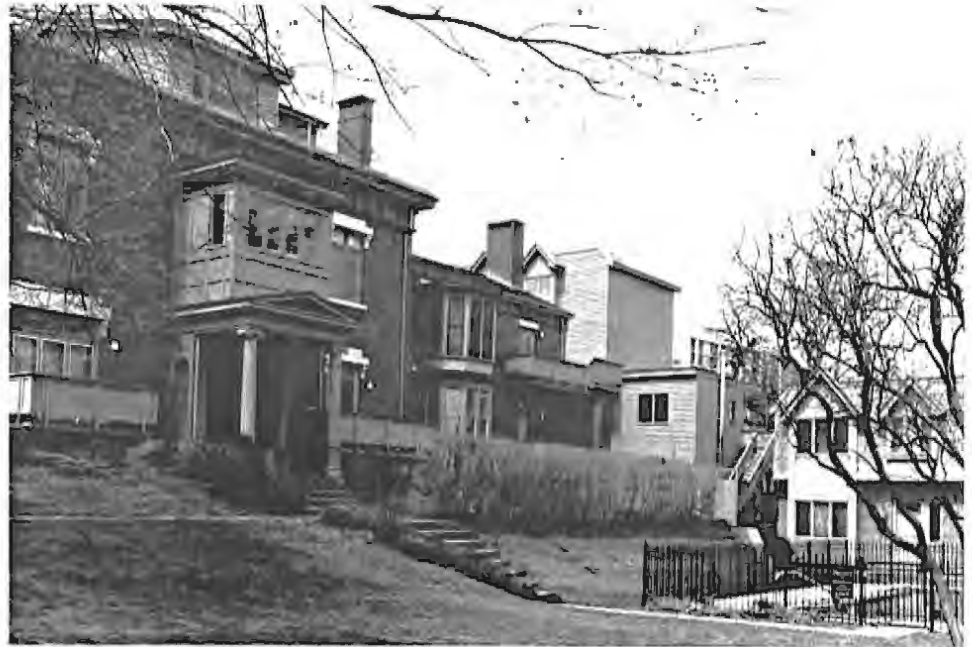
*The relationship between a historic building and its site helps to define its historic character. In planning and adaptive reuse projects, this relationship should be preserved. In the pre-renovation view of this former mansion, the grandeur of the open, terraced grounds provided evidence of the building's original importance. When the property was converted for residential condominium use, the carriage house behind the main building was remodelled and doubled in height and its terraced grounds were developed with a swimming pool and additional living units. As a consequence, the prominence of the mansion relative to its site has been significantly altered. By reconsidering the placement or character of some of the additions and site alterations, the original sense of this unique property could have been preserved.*
