## Historic Preservation Board

Topic: Historic Preservation Workshop and Public Hearing 11-19-2025

- i. Preliminary Review of Proposed Updates to the City of Portland Historic Resources Design Manual; City of Portland, Applicant. The Historic Preservation Board will hold a hybrid workshop to review draft updates to the City of Portland Historic Resources Design Manual. The current Historic Resources Design Manual can be found here: <https://www.portlandmaine.gov/496/Additional-Resources>

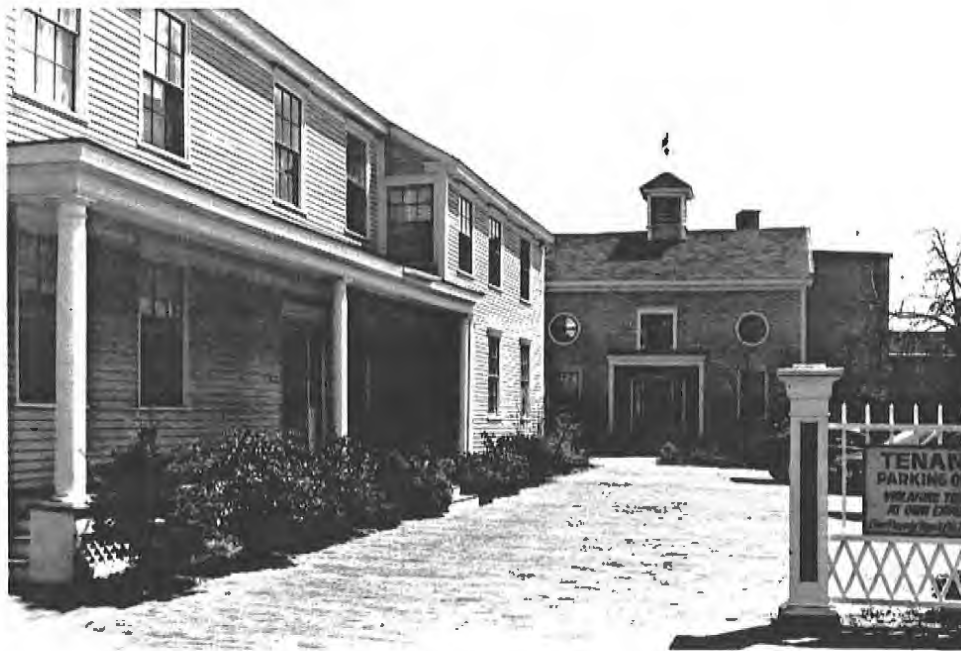
*Here, although there has been an intensification of use, changes to the building and the site are not readily apparent from the street. Additions have been made off the sides and rear of the building and parking has been limited to an area obscured by the fence. The sense of an open courtyard leading up to a carriage house has been retained.*

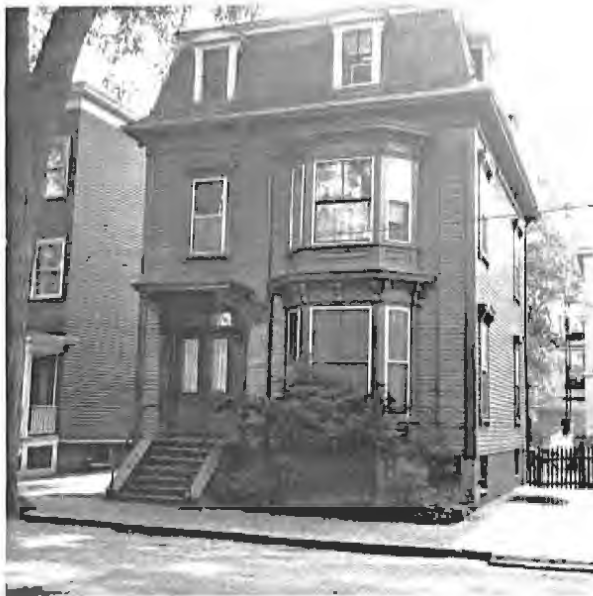
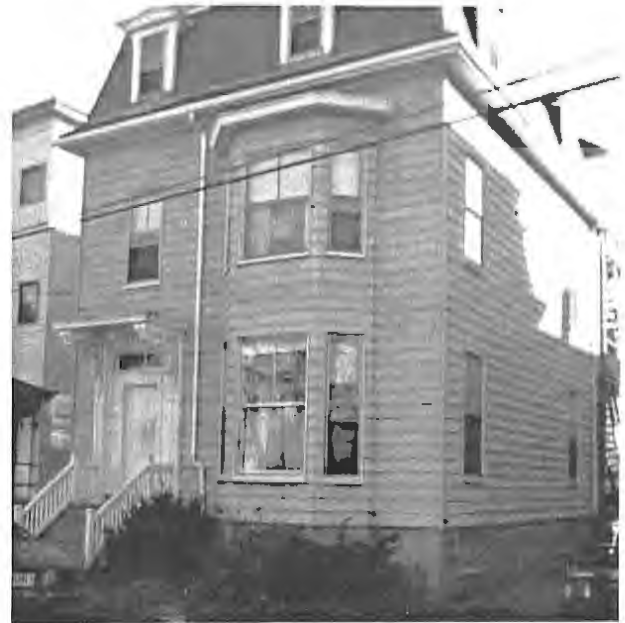
*This property, which was photographed in 1967 (left) and again in 1989 (right), illustrates the dramatic effect incremental changes can have on a historic property. When synthetic siding was applied, the trim over windows, at the corners and cornice and over the bays was removed. The original double doors, which are typical of Second Empire style buildings, were replaced with a single, smaller door. While individual alterations or replacements may seem to be minor, the cumulative effect of the changes can rob a building of its architectural character.*

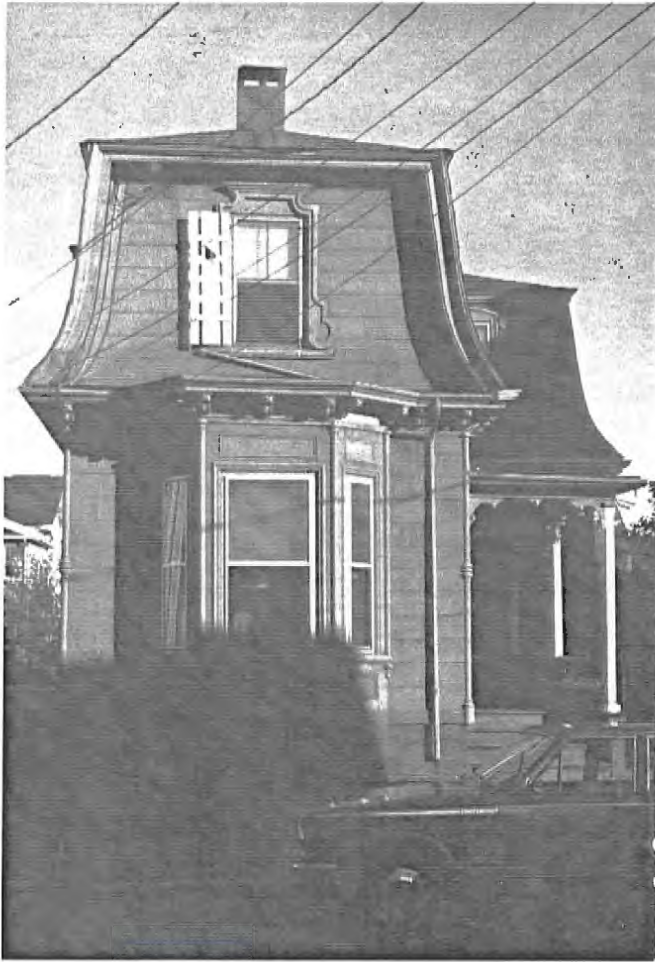
c. 1975

*Another example where removal of decorative trim results in the loss of architectural interest.*

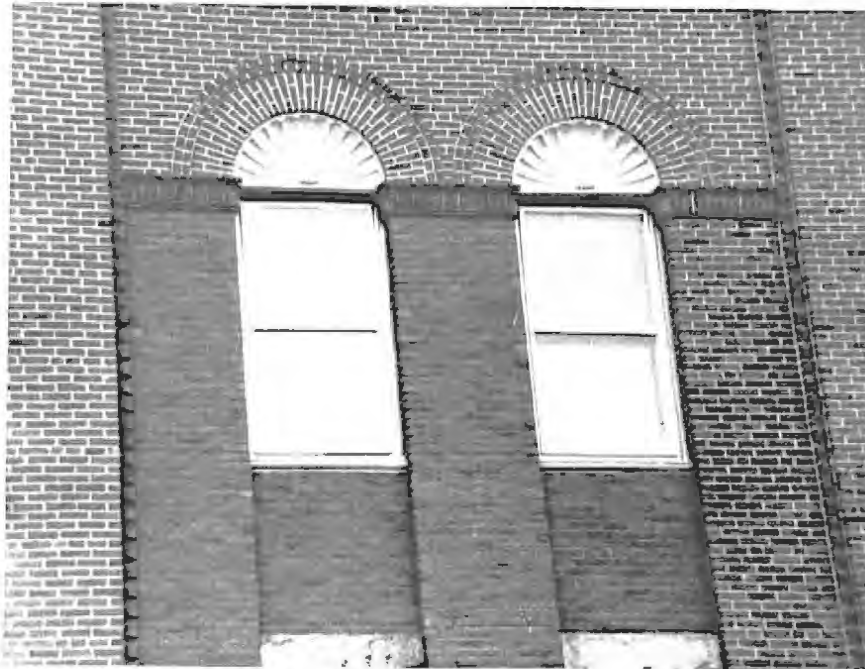
*Unlike earlier buildings, late 19th-century brick buildings featured thin, deeply recessed mortar joints. This gave the appearance of a smooth, seamless wall of masonry. This type of brickwork is not only indicative of advances in masonry technology from that of earlier eras, it is also part of the original design intent. Repointing with white mortar and wide joints will destroy the original character of the building by creating much more pronounced joint patterns than were originally intended.*

*Key: 1)original character 2)repointed portion of wall*

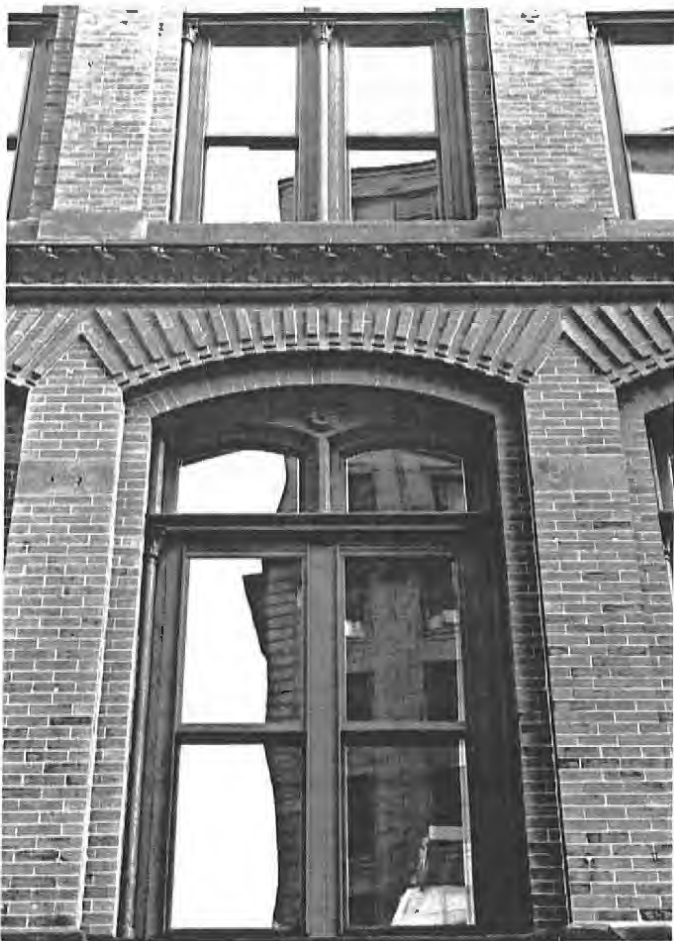
*When the original windows on this building had to be replaced due to deterioration, care was taken to duplicate the original window configuration and to retain the trim pieces which give the window their visual interest.*

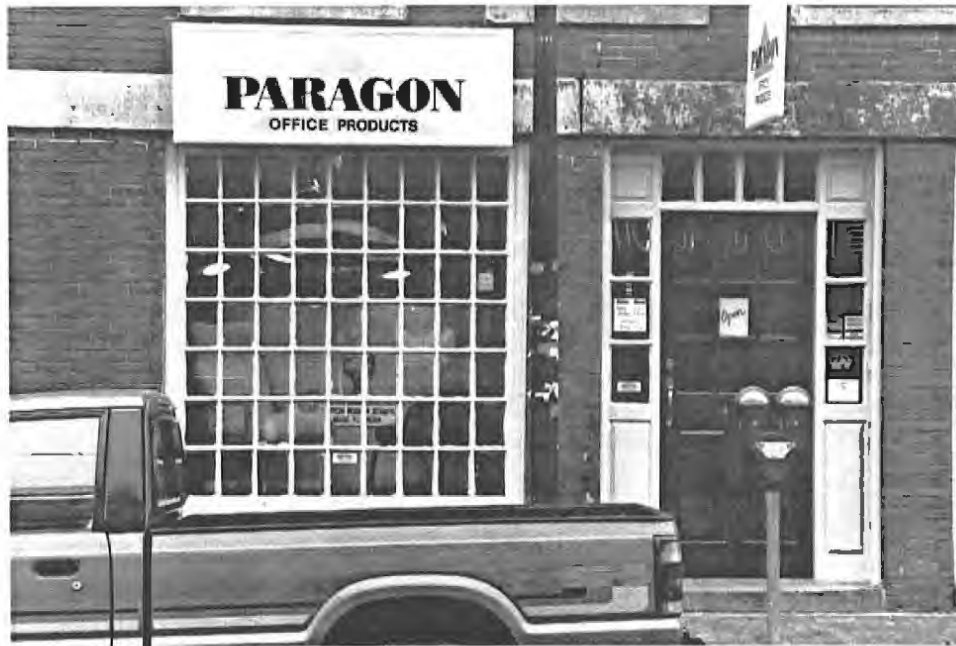
*Small-pane storefront windows and residential entrances were not used historically in commercial buildings. Simpler window and door designs would complement the straightforward Federal lines of this building.*

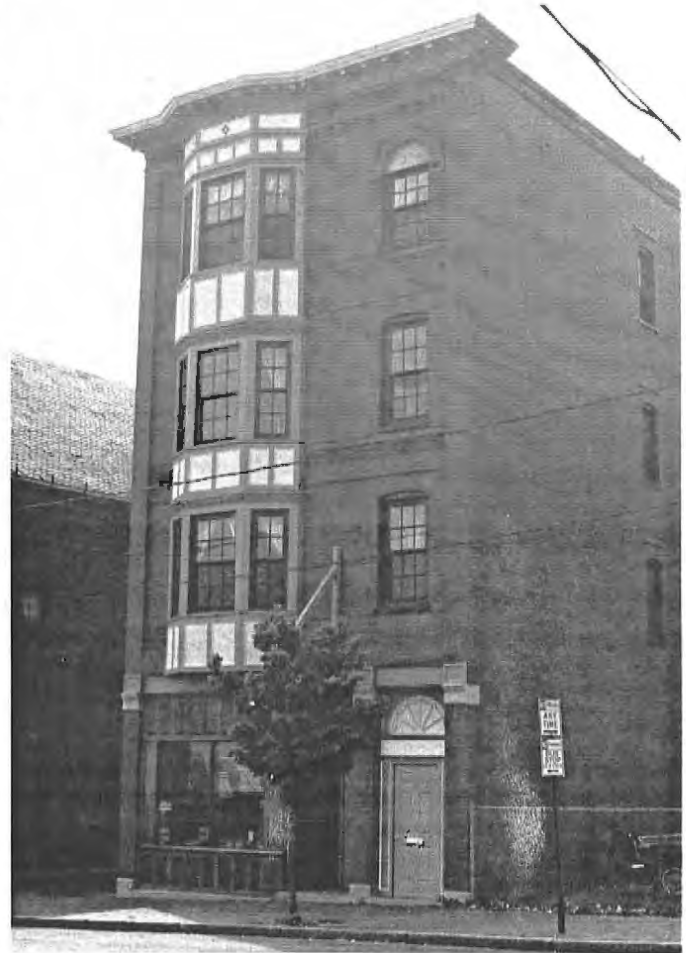
*When this late Victorian (circa 1890) building was renovated its windows and front entrance were replaced with features more appropriate for an early 19th century structure. The storefront has no historical basis, but was designed solely on conjecture.*

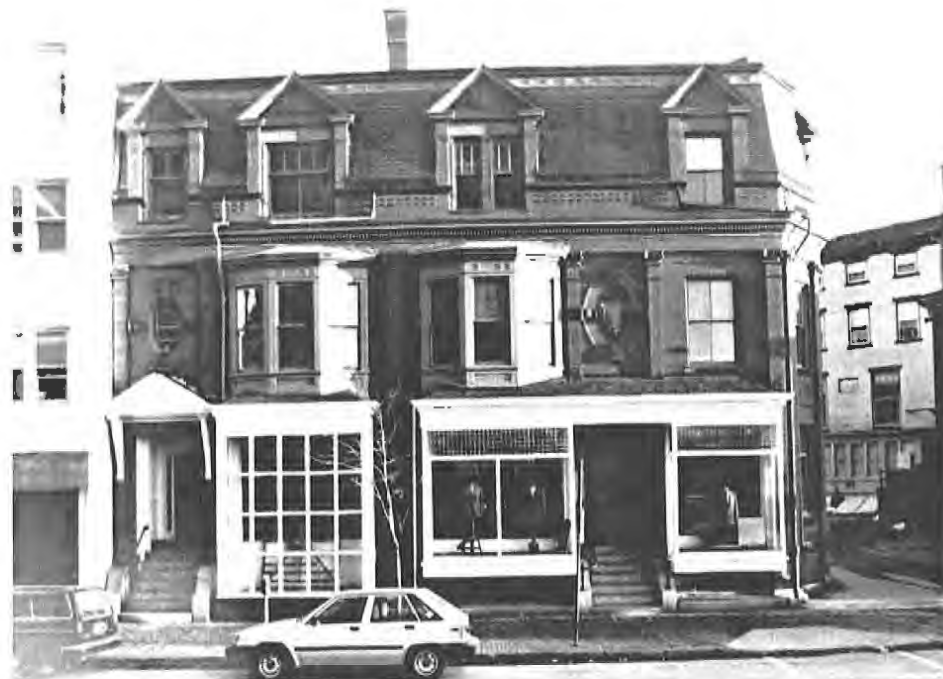
*Several years after this Queen Anne style residence was built on Congress Street, storefronts were added to accommodate a commercial use. These modifications, which are of high quality in their own right, reveal the fact that upper Congress evolved from a primarily residential neighborhood to a commercial corridor. Although this is a major change to the structure, it does not overwhelm or obscure the original building.*

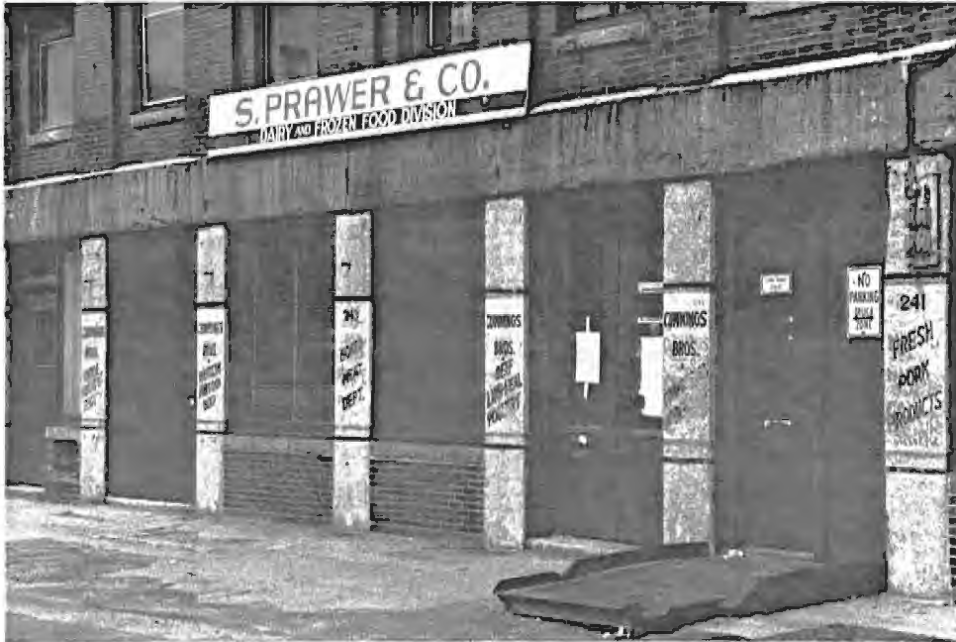
*Signs have been painted on the granite piers of this Commercial Street warehouse which describe the products sold within. Retaining this signage is encouraged, even if the use of the building should change, for it reveals the building's long history as a wholesale food warehouse in a bustling waterfront commercial district.*

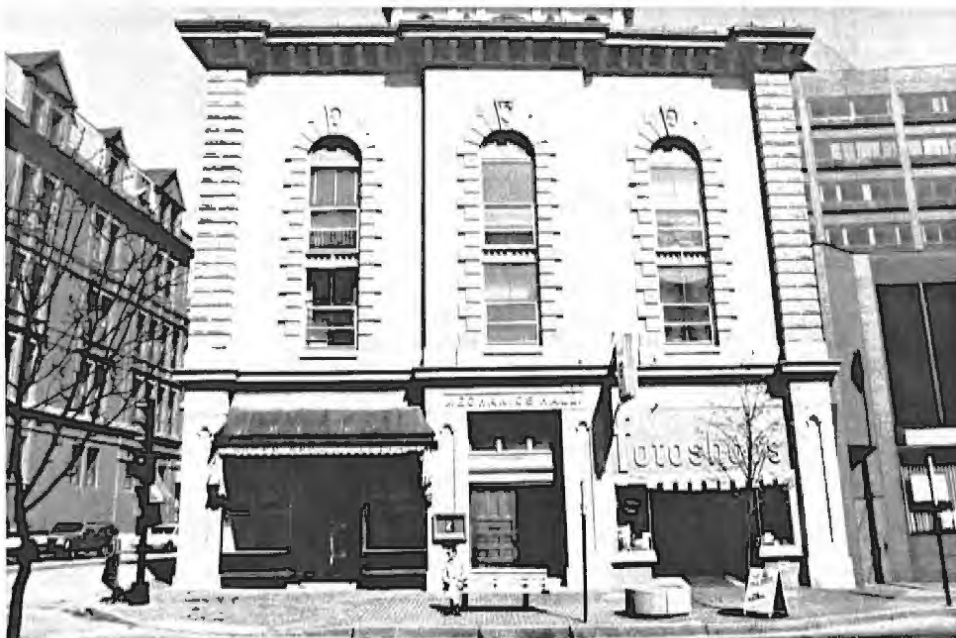
*To acquire significance of its own, an altered storefront must be of high quality and an excellent example of its own design period. Also, it should generally be compatible with the rest of the building. Although it was constructed of good quality materials, the storefront on the right has not acquired significance because it is not an outstanding example of its own design period nor is it compatible with the original design of the building. In this case, the left storefront might serve as a template for a future redesign of the right storefront.*

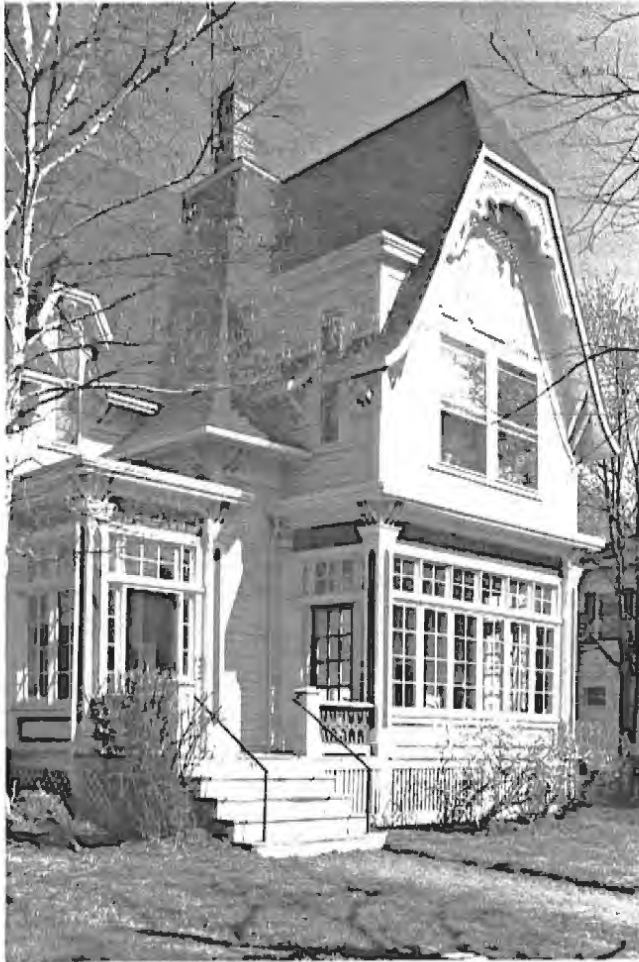
*The skilled craftsmanship displayed in this Swiss style house is evident in many of its features. Its complex massing and roofline, its pierced vergeboard and gable panels, its sawn balusters, its multi-part windows, and its polychromatic paint scheme all help to define its historic character.*

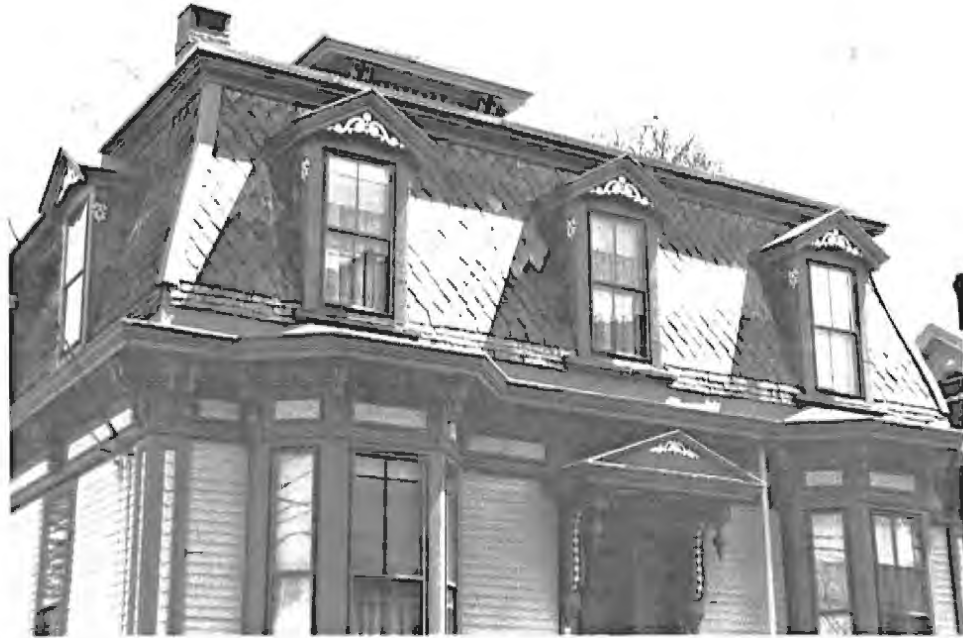
*Polychromatic slate roofs are a tell-tale feature of the Second Empire style. On this small residence, the texture and color of the mansard is important in the overall architectural design. Were this reshingled in a material which does not approximate the appearance of slate, an important character-defining feature would be lost.*

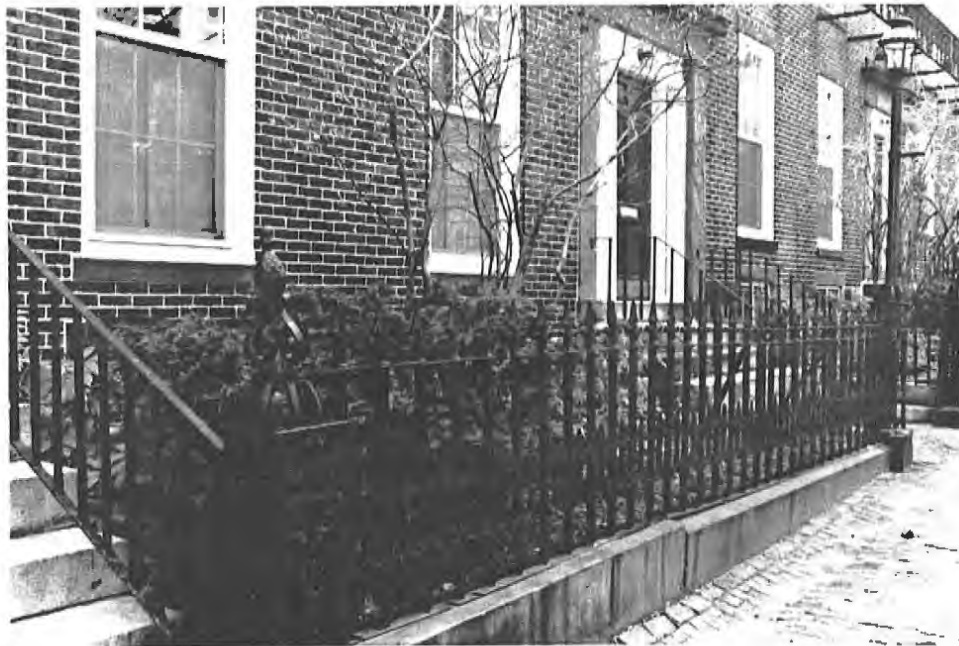
*Site features, such as this elaborate cast iron fence, deserve the same careful preservation as the buildings they enhance.*

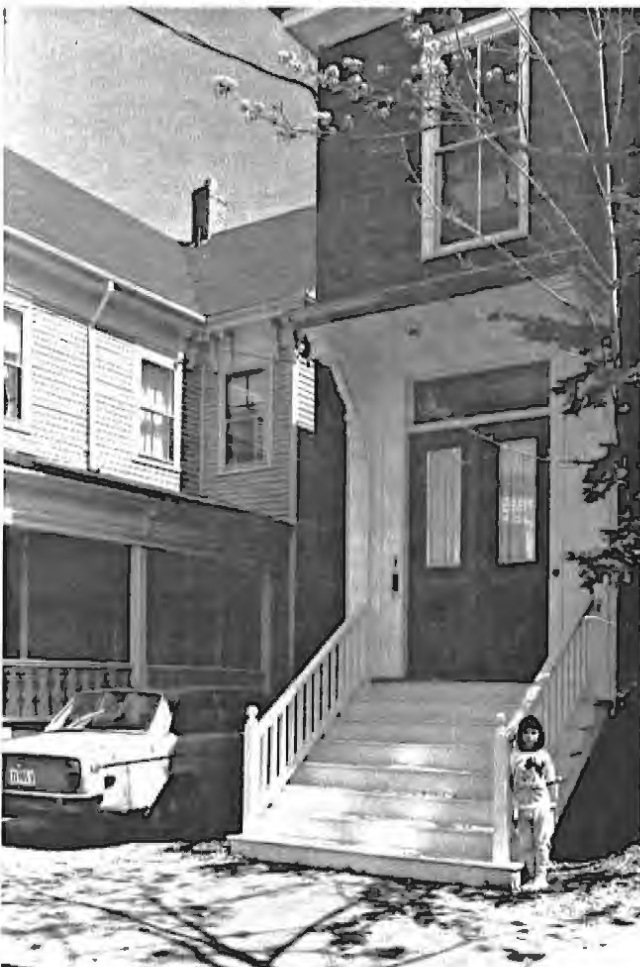
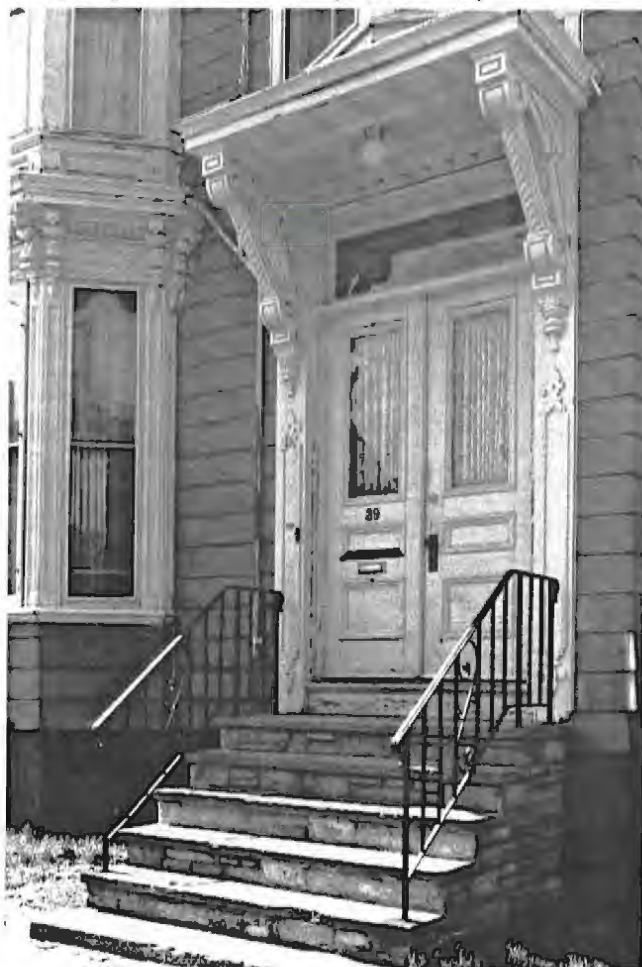
*It is important to use similar materials when replacement of a deteriorated architectural feature is necessary. Here, two sets of steps have been replaced on wood frame Italianate style buildings. The wooden steps and railings on the left resemble the original feature both in material and style. The artificial stone steps and wrought iron railings on the right have no historical basis.*

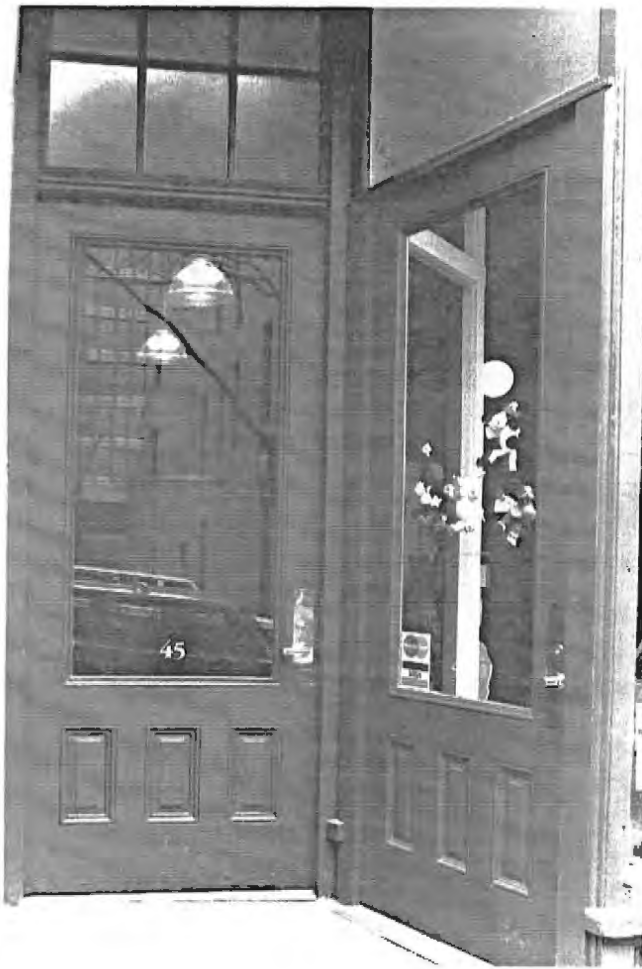
*Design for replacement of a character-defining feature may be based upon an existing feature. When a second entrance was created in this storefront, a new door was built which duplicated the existing door on the left.*

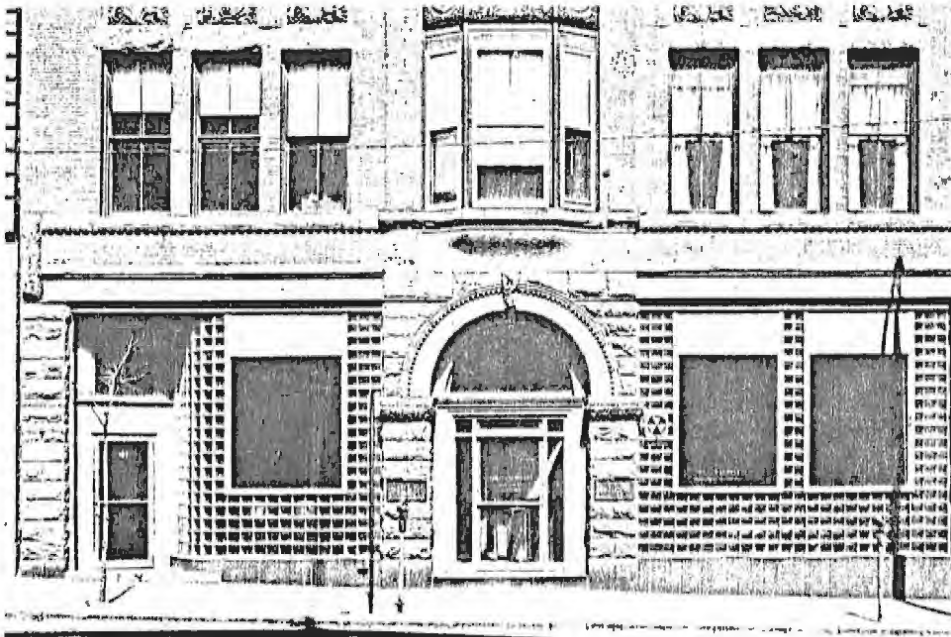
*If a historic feature was removed in a previous renovation project, it may be possible to replicate the original feature through the use of early photographs or other documentation. In a 1950's renovation of the Oxford Block storefront (top photo), much of its historic fabric was removed. A more recent rehabilitation project included a contemporary interpretation of the original storefronts and central entry (bottom photo), which was based on traditional principles of storefront design.*

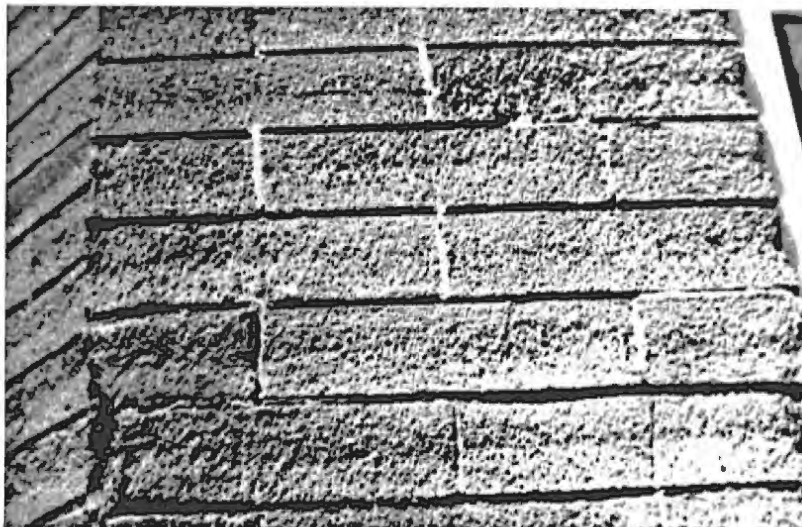
*Bricks must be cleaned by the gentlest means possible. Sandblasting to remove paint or dirt can cause sever erosion, as illustrated in this photograph. Even when sandblasting is skillfully performed, the protective outer surface of the brick is partially removed and increased porosity will result. This will accelerate deterioration. Other methods of cleaning by water and chemicals should be tested and the least harsh method chosen.*

Some cleaning methods can physically be very destructive. Sandblasting of brick, for example, removes the outer glazed surface exposing the soft inner core to the elements. Masonry surfaces may also be harmed with chemical cleaners that are too harsh and not correctly applied. In developing a cleaning plan, it is best to start with the mildest, least destructive method in order to determine what will accomplish the job without damaging the historic material.

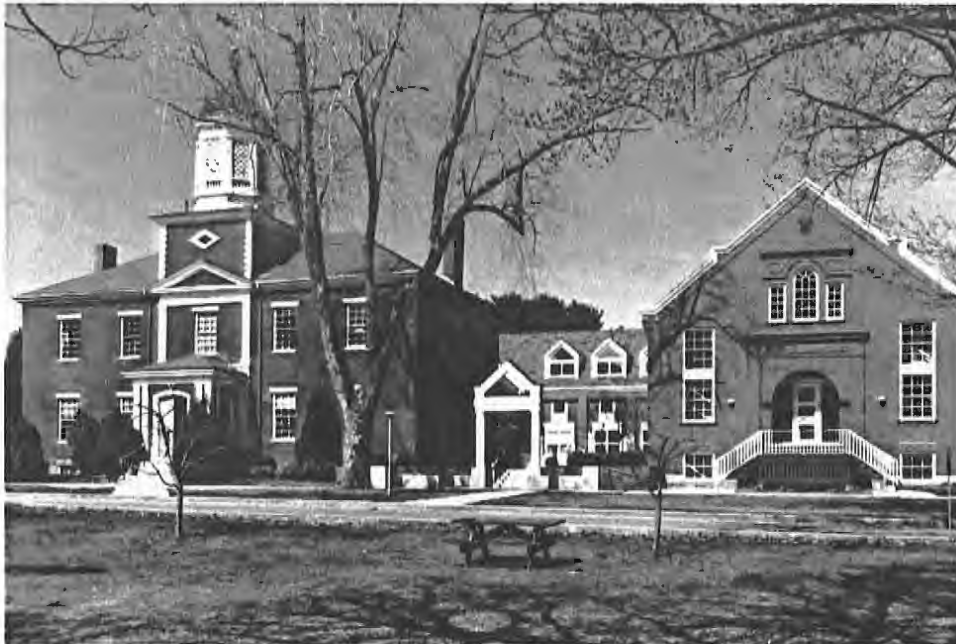
*Contemporary additions or alterations to historic buildings should generally be made on a side or rear elevation, not on the primary facade. The scale and materials should be compatible with the historic fabric, as illustrated in this addition to the Josephine S. Abplanalp Library at Westbrook College. It is important to note, however, that compatibility need not and should not mean exact replication. There should be a clear differentiation between the new and old, through detailing or materials, so the addition will not appear to be a part of the original building. Here, the addition respects the scale and designs of the two buildings it connects and at the same time makes its own contemporary design statement.*

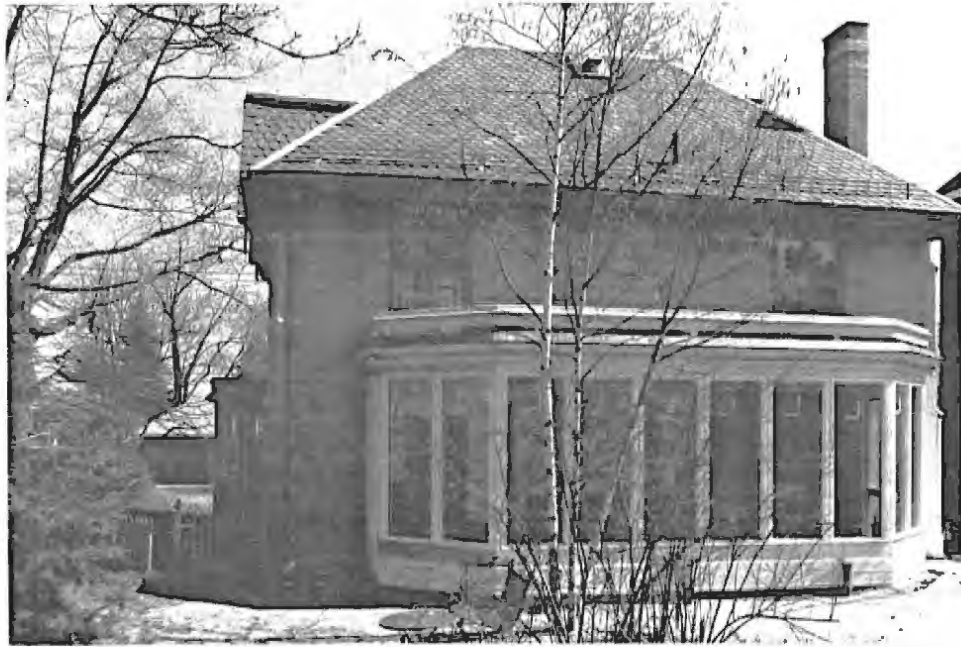
*To be compatible with a historic building, a contemporary addition may echo some of the building's original features or details. The kitchen addition on the rear of this house resembles the original bay on the left in its five-sided shape, its window proportions, and its flat roof surmounted by a rail. Nevertheless, it "reads" as contemporary.*

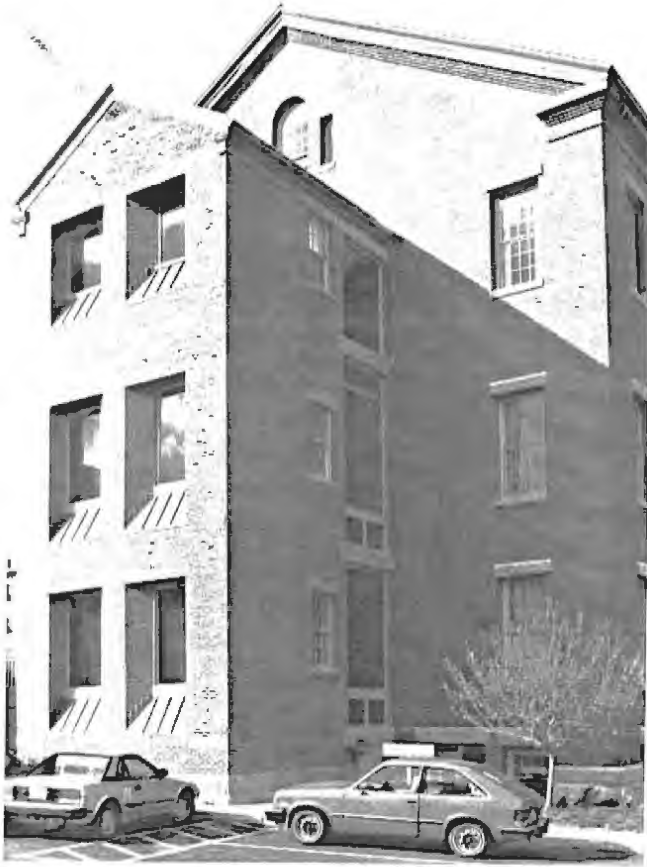
*When a second stairway or an elevator cannot be accommodated within a historic building, a contemporary addition may be built for this purpose. Here the roofline, mass and fenestration pattern of the new Staples School stair tower compliments that of the main building. The point of connection where the addition meets the original building is clearly defined by an almost continuous wall of glass.*

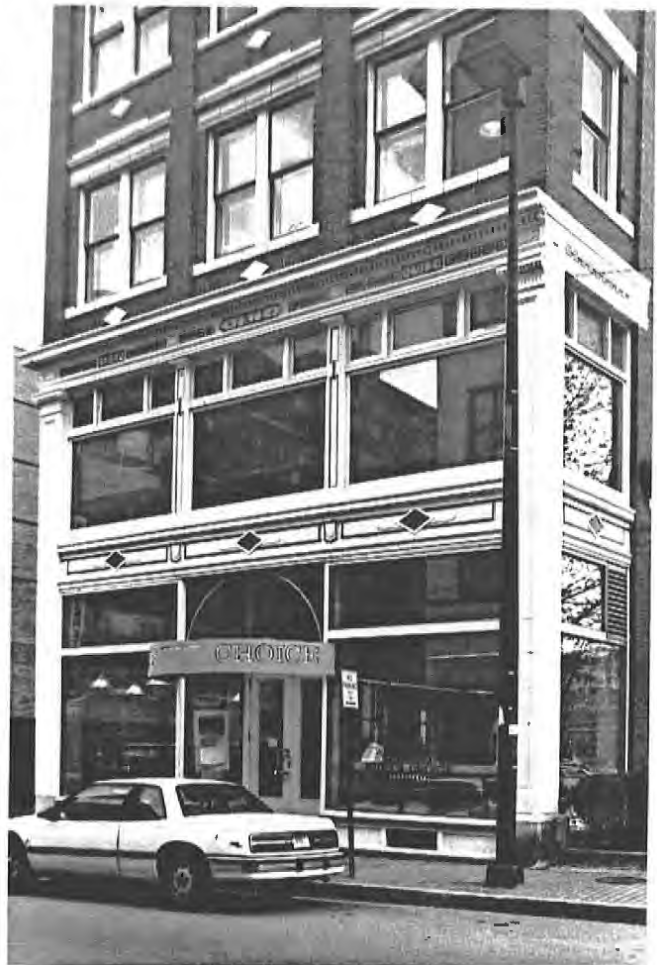
*A contemporary design for a storefront in a historic building will be compatible if it follows the spatial organization of traditional storefront design. The proportions of the new storefront at the Frye Building were determined by the existing lower cornice and the vertical divisions in the upper stories.*

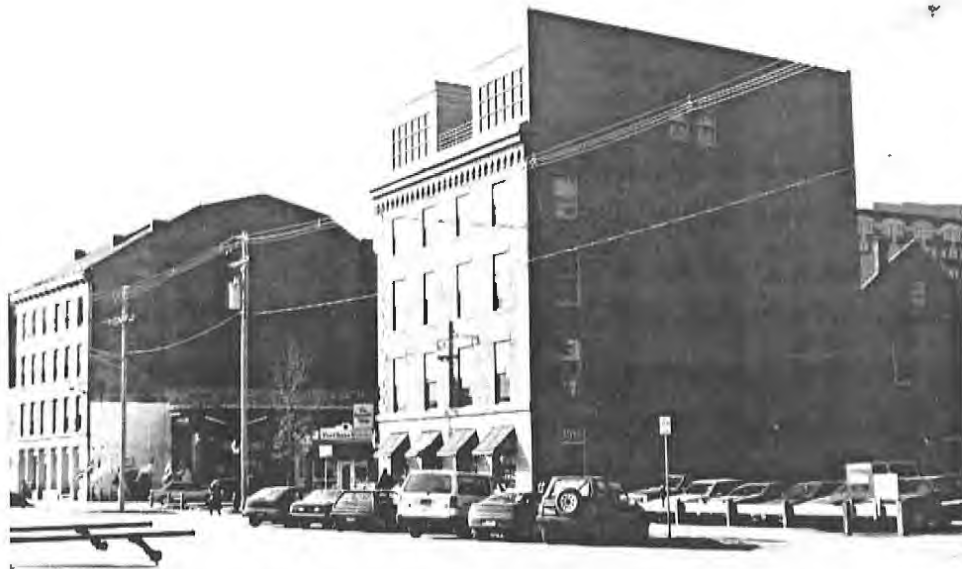
*The roofline is often an important character defining feature that should be respected. Here, the once prominent gambrel roof, typical of warehouses in the waterfront district, has been irreversibly altered by this rooftop addition which sits flush with the plane of the perimeter walls. The change is brick on the extended side wall is the only indication of the original roofline. Were the addition pulled back from the perimeter walls and integrated within the gambrel roof form, a more successful solution would have resulted.*

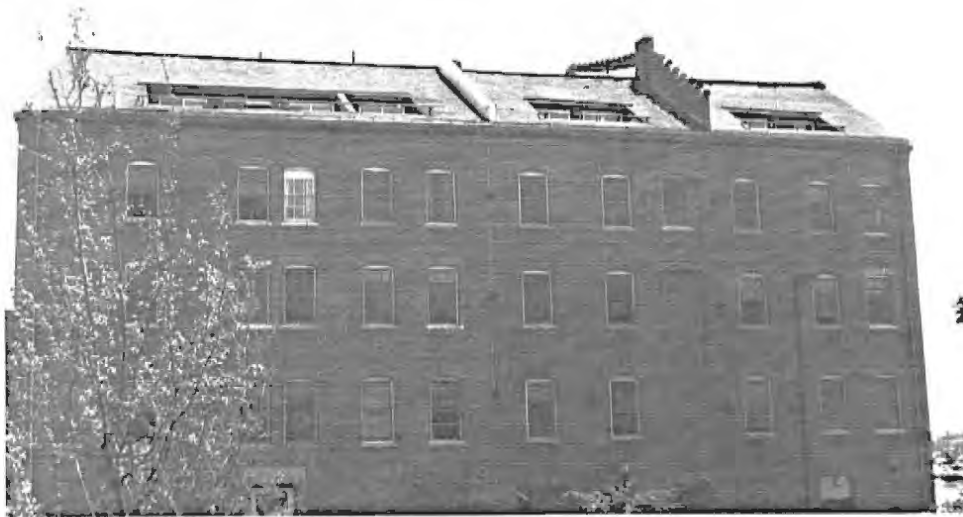
*By constructing inverted dormers in this gambrel roof, the developers gained usable space in the former attic. The shape of the roof, a distinctive architectural feature, has been retained and conveys a sense of the building's original character.*

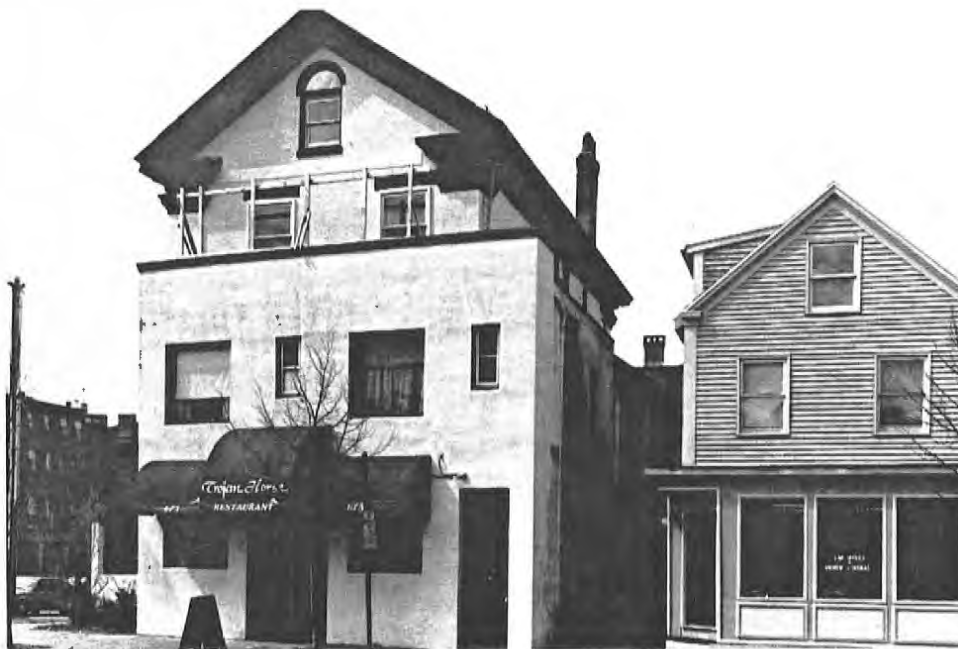
*When a major addition was made to the facade of this building, the original facade was destroyed, making the possibility of future reversal inordinately expensive.*

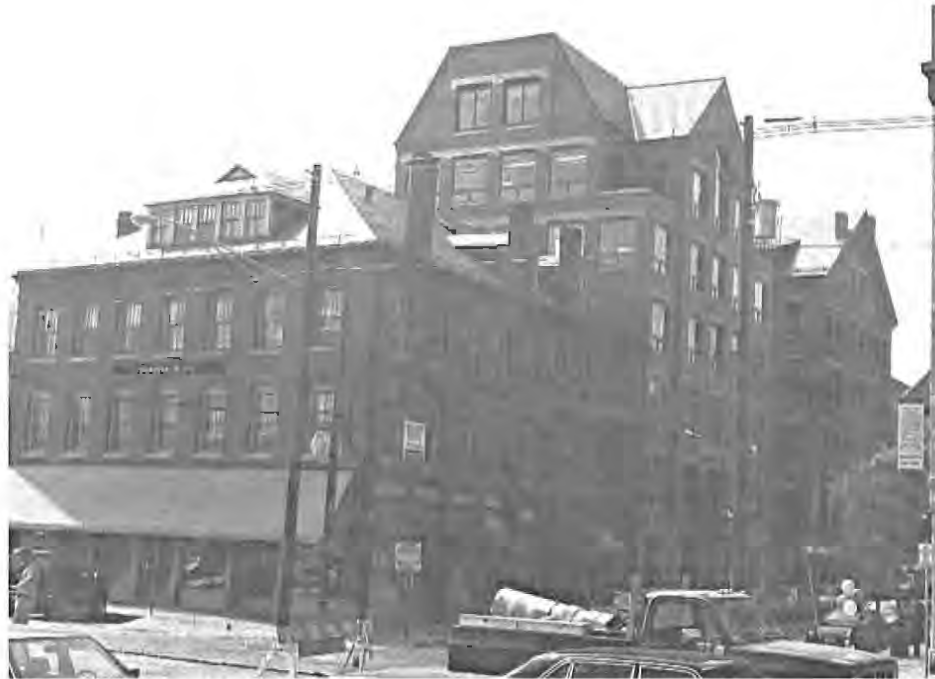
*Ten Moulton Street illustrates how the height of infill construction can serve as a bridge between the heights of surrounding structures. While the infill building is taller than its immediate neighbor on Commercial Street, it is roughly the same height as the adjacent building that fronts on Fore Street. The roof also contributes to the impression of proper scale relative to its neighbors by echoing the dormer shape of the building in the foreground and the gable shape of the building behind it. Details, such as the cut-out balconies, also help to reduce its apparent height, especially from the street.*

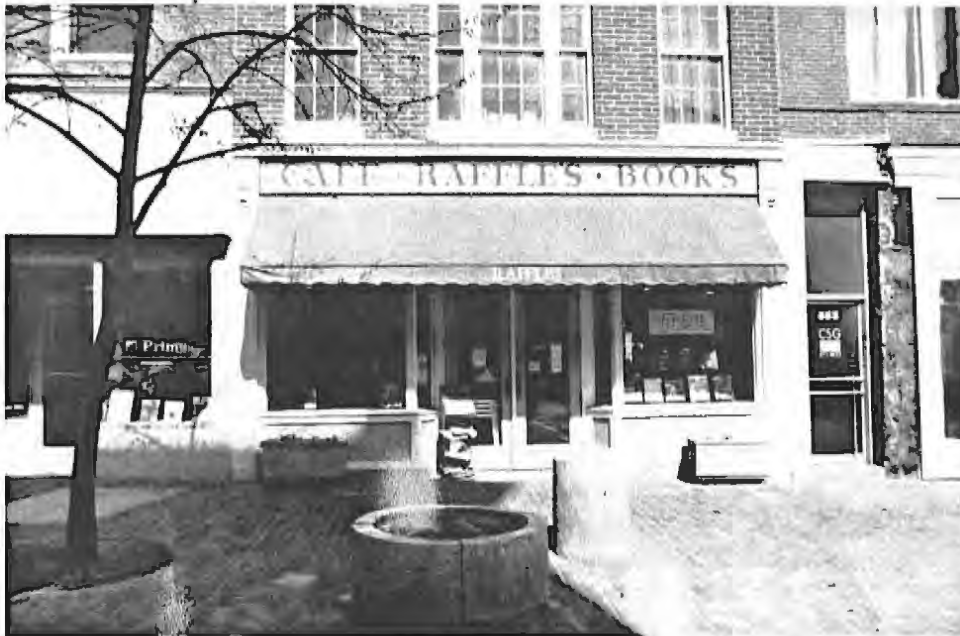
*This close-up of a commercial facade at 565 Congress Street shows how an individual storefront relates to the pedestrian. The width of the storefront, the size of the door, the height of the display windows, even the placement of the door within the storefront represent traditional design patterns that humans relate to from years of use and familiarity. This is a new storefront, built with modern and traditional materials, that adheres to traditional storefront design patterns while presenting a clean contemporary look.*

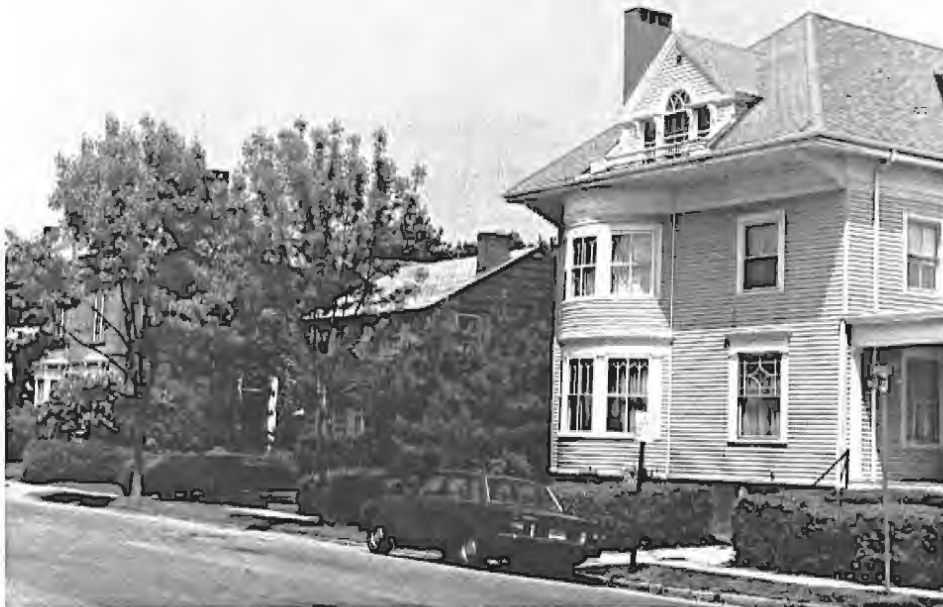
*Just as new buildings can be too large for their context, too small a structure can also break the continuity of an established district. The garrison colonial style residence on Vaughan Street in the center of this photograph is significantly smaller than its historic neighbors, not only in terms of its height, but also in its width, overall scale and mass.*

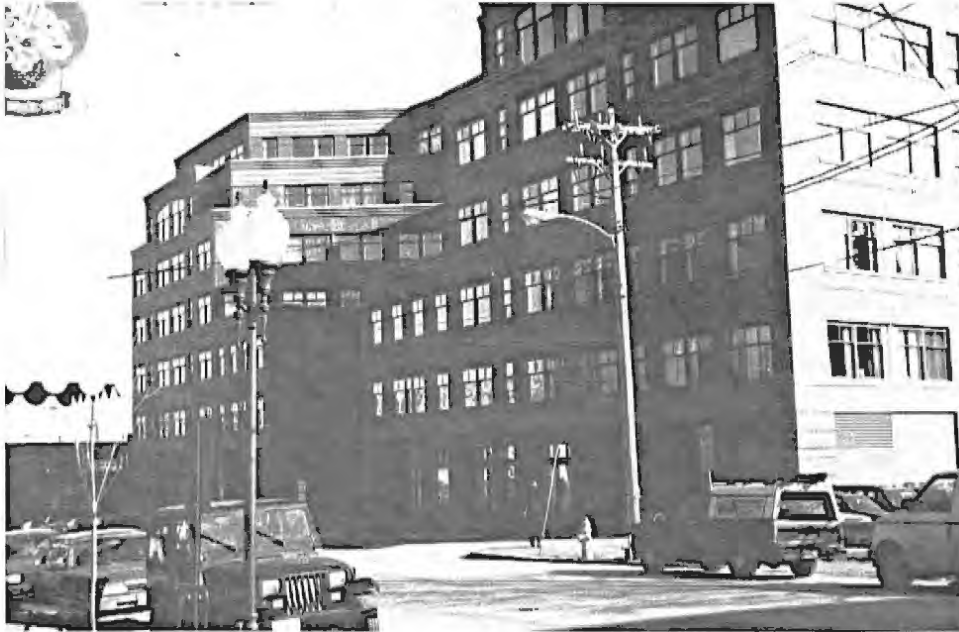
*New office buildings at 100 Middle Street are at least two stories higher than any adjacent historic buildings; yet they have a comfortable presence on Middle Street due to their set backs and angled facets. In addition, the strongly-detailed first floor creates a base that anchors the building to the street. Breaking the height of the building into horizontal bands can reduce the perceived height of a large building.*

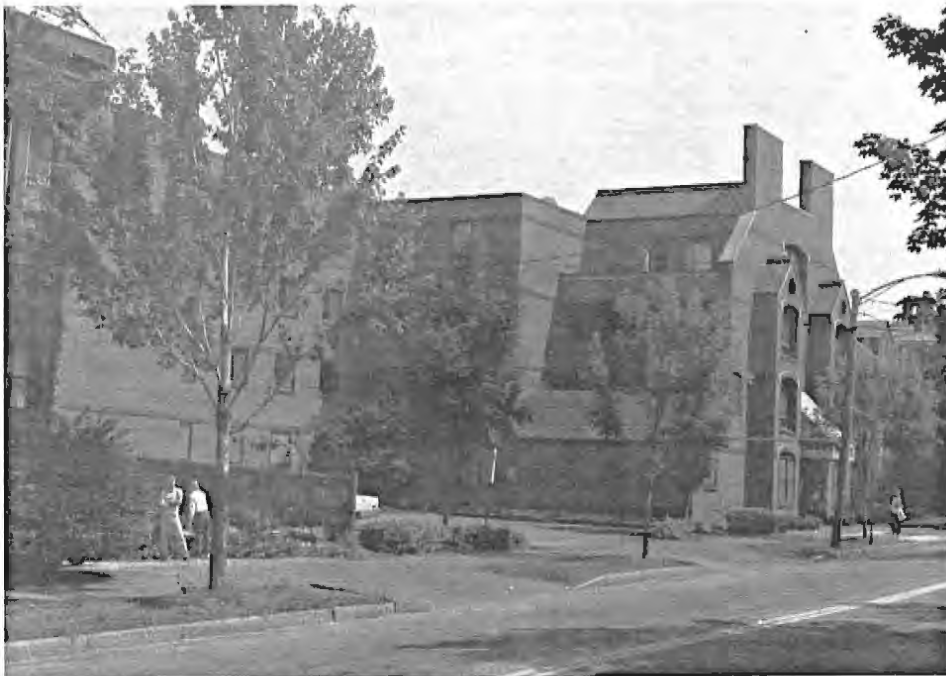
*The four story height of this Cumberland Park Place apartment complex is reduced at the sides and front of the building by pitched roofs, projecting banks of windows, and other details that attract the eye to lower parts of the building. The composition of the facade can be broken into subgroupings, some of which are of the same scale as the adjacent houses.*

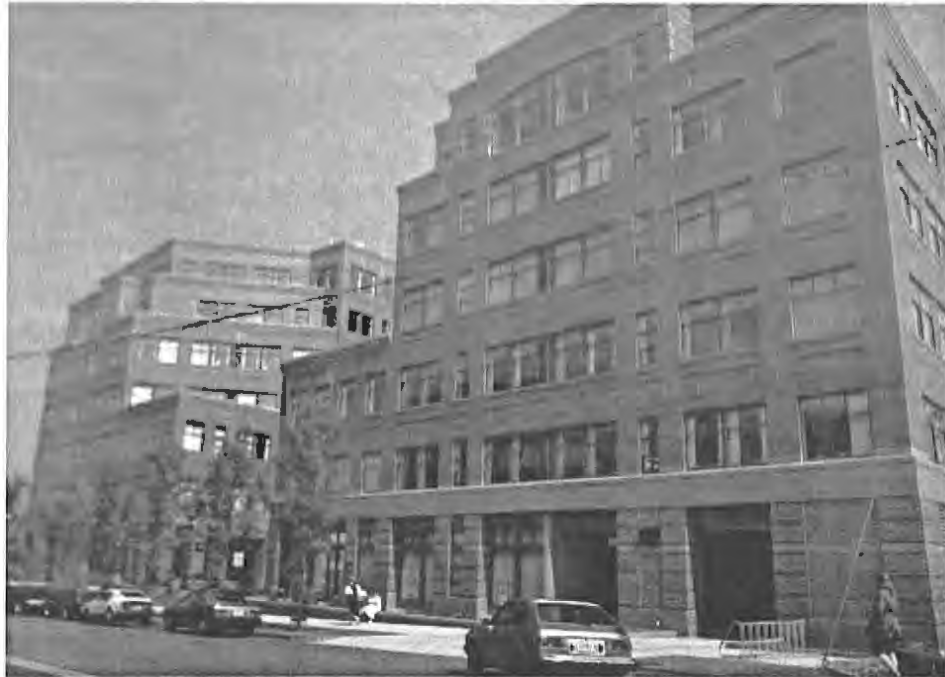
*The bulk of 100 Middle Street would have been oppressive and incompatible with nearby historic buildings on the street had it not been broken down into two towers. In addition, the multi-faceted, stepped facades and recessed courtyard help to reduce the apparent width of the building. When viewed from a distance, it appears there are two separate buildings, which are each similar in width to the significant older buildings across the street.*

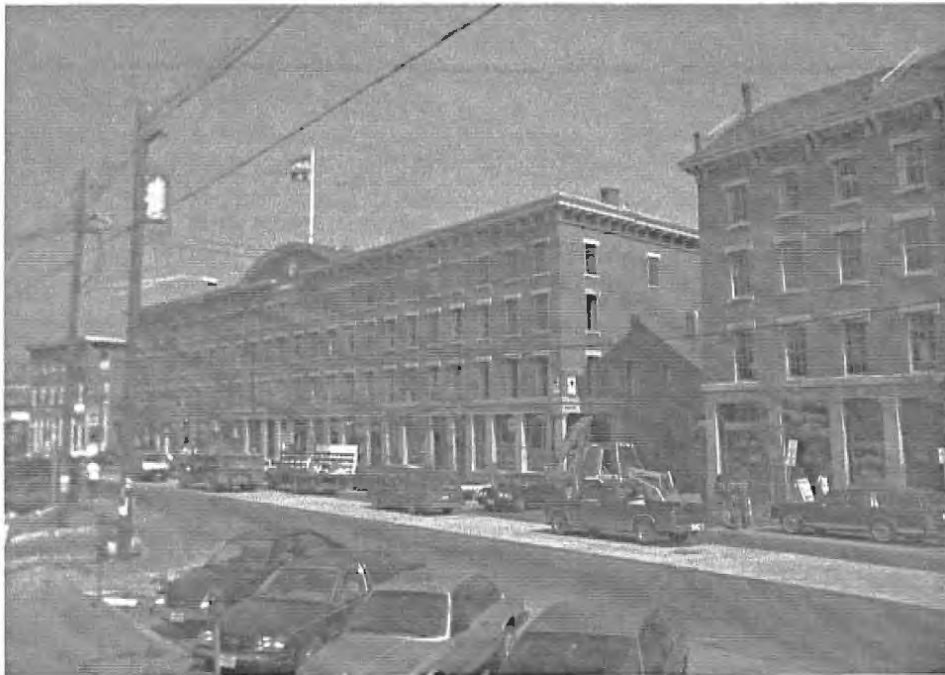
*The Thomas Block on Commercial Street is a uniquely wide building with a commanding presence and remarkable consistency on the street. At the pedestrian level, this width is broken down to a more human scale by the steady march of granite piers. Within the piers, storefront windows and doors establish another unit of width for pedestrians to relate to.*
