## Historic Preservation Board

Topic: Historic Preservation Workshop and Public Hearing 11-19-2025

- i. Preliminary Review of Proposed Updates to the City of Portland Historic Resources Design Manual; City of Portland, Applicant. The Historic Preservation Board will hold a hybrid workshop to review draft updates to the City of Portland Historic Resources Design Manual. The current Historic Resources Design Manual can be found here: <https://www.portlandmaine.gov/496/Additional-Resources>

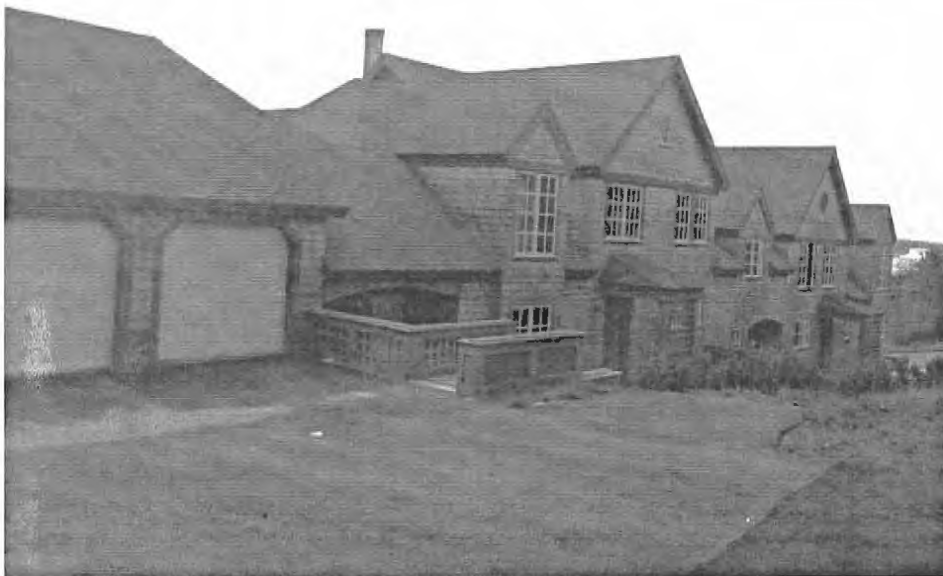
*This group of condominiums on Danforth Street, the overall width of which is considerable, is divided by roof forms and entrance canopies into units of width that fit comfortably with other residences nearby.*

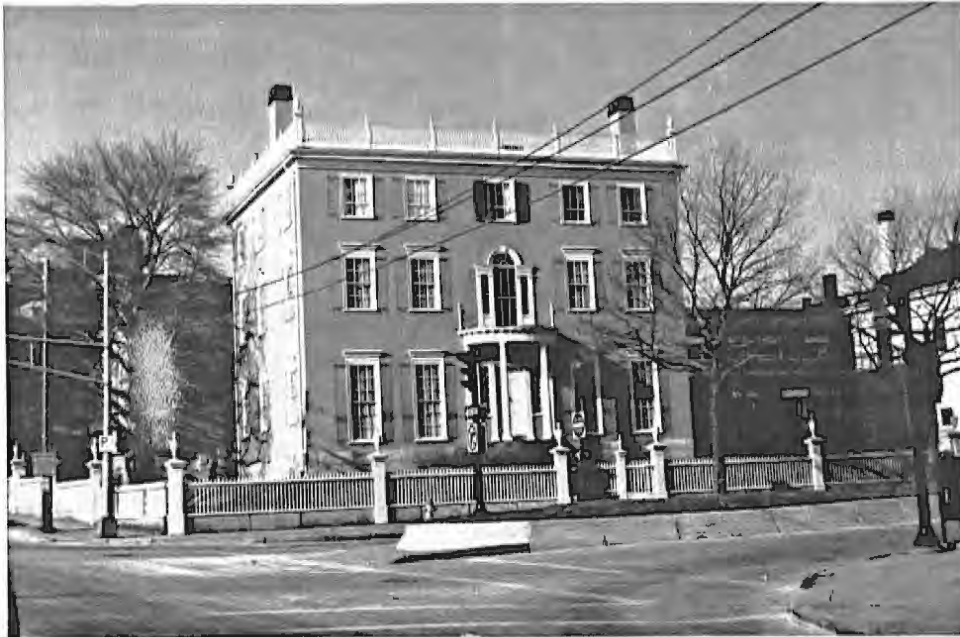
*The proportions of Federal-style houses contribute to their elegance. The ratio of width to height of the entire facade and of windows and doors within the facade of the McLellan-Swett House was based on ancient principals going back to the Romans. These proportions were standardized to a degree by the builders of the day, and can be seen in the large Federal houses along State and High Streets and on Danforth Street.*

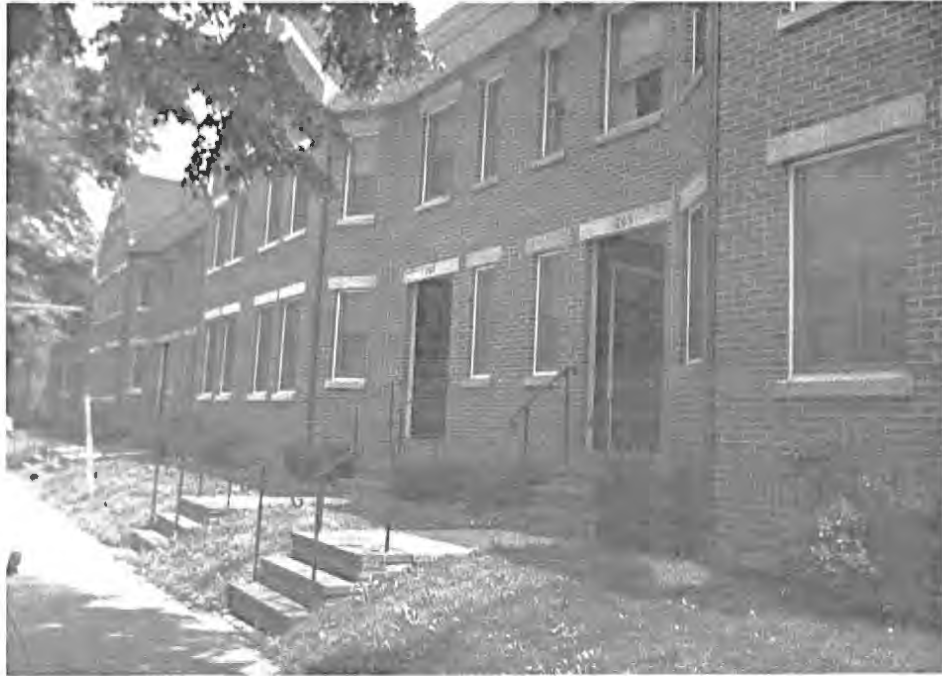
*The ratio of width to height of the projecting and recessed portions of this facade are carefully related to each other and to the width and height of neighboring houses in the West End.*

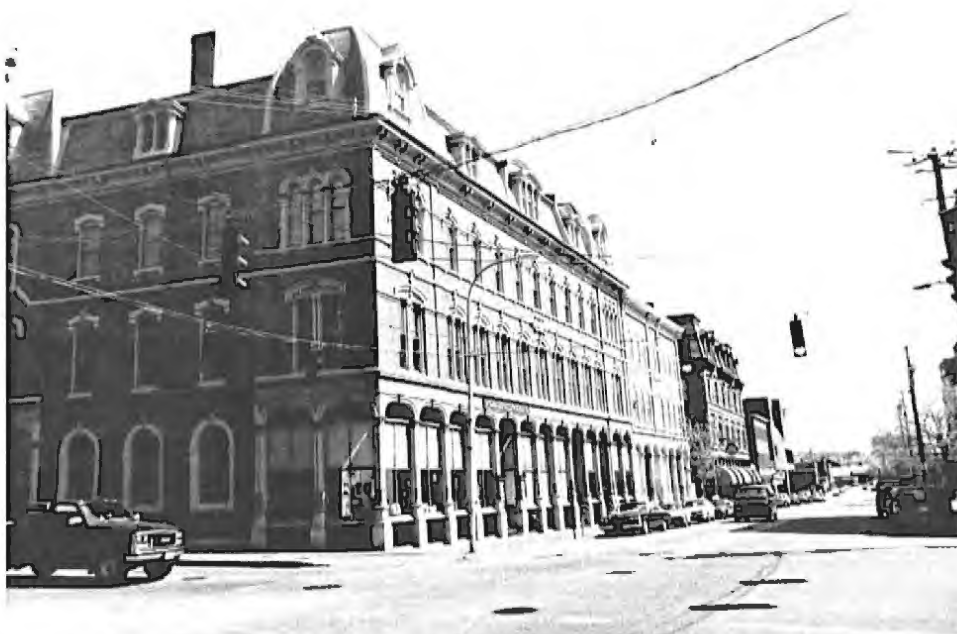
*The proportion of Victorian commercial buildings was set by many factors resulting from land use and sale patterns, limitations of building technology, etc. This view of commercial blocks on Middle Street shows a remarkable row of large three-story buildings that are very similar in scale and proportion. Such a strong pattern should be a design determinant for any new construction proposed for adjacent sites.*

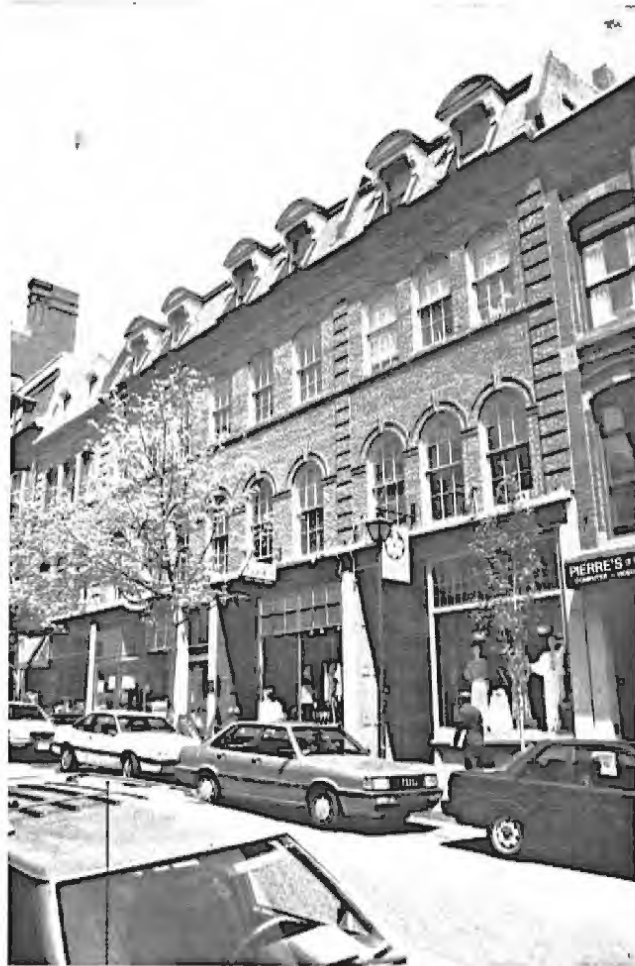
*The same is true for many smaller buildings in the Old Port. In this photograph a large commercial building is divided into typical storefront bays by storefront piers, upper story pilasters, and roof parapets to correspond with the more common single-bay structures along Exchange Street.*

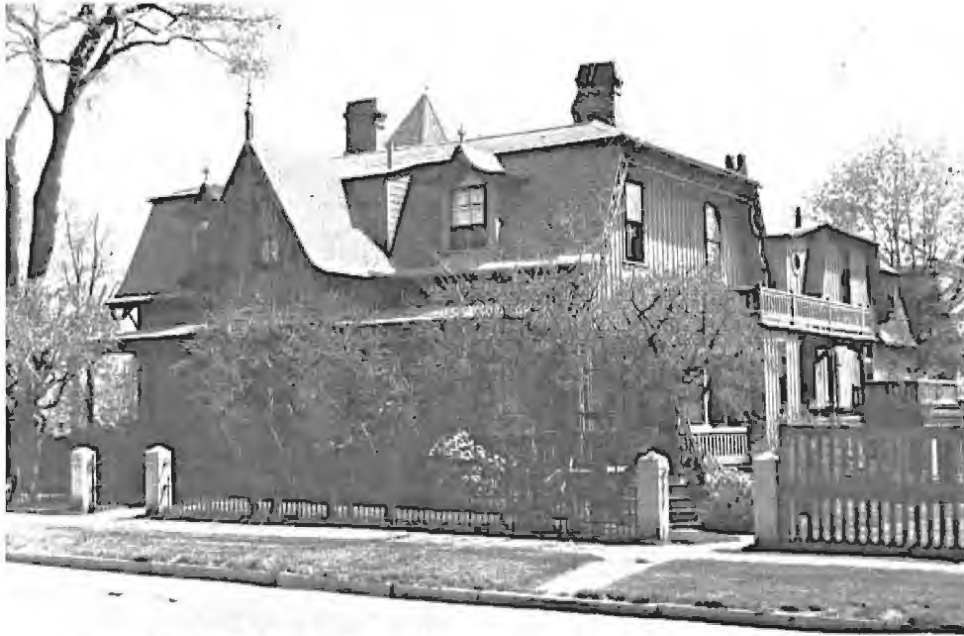
*This Western Promenade example shows how diverse roof shapes and features along Bowdoin Street can be found in an area of compatible buildings. Here the juxtaposition of an elaborate Gothic roofline with simpler, later rooflines provides a counterpoint to the similar scale and siting of all houses in the area.*

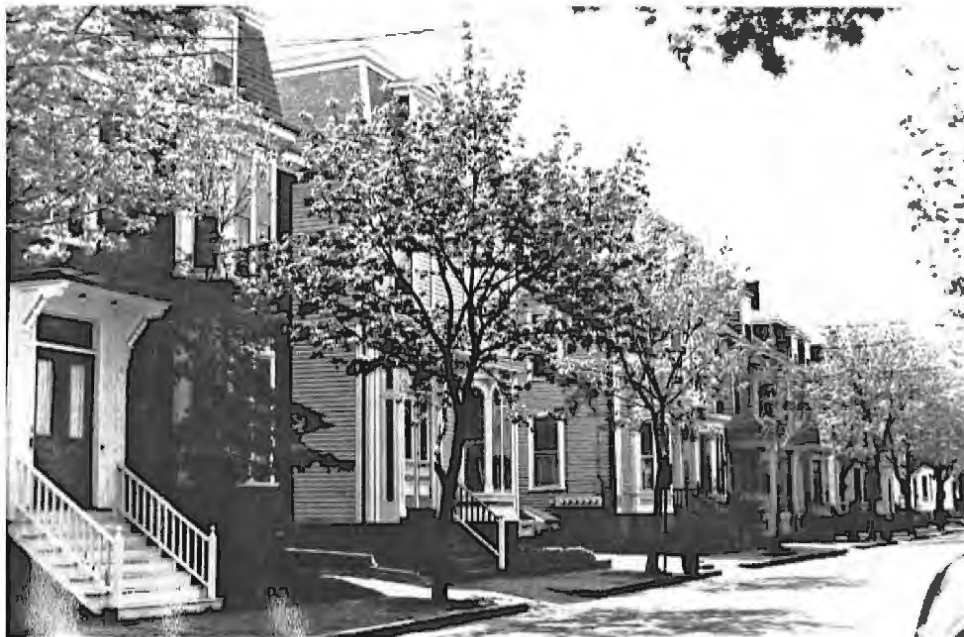
*The detached townhouses of Cushman Street represent a case where rooflines are so uniform that a new building inserted into this streetscape would be likely to have a mansard roof with the ridge perpendicular to the street. While a dramatically different roofline would not be ruled out, such a design would need to be carefully considered and justified as to its compatibility.*

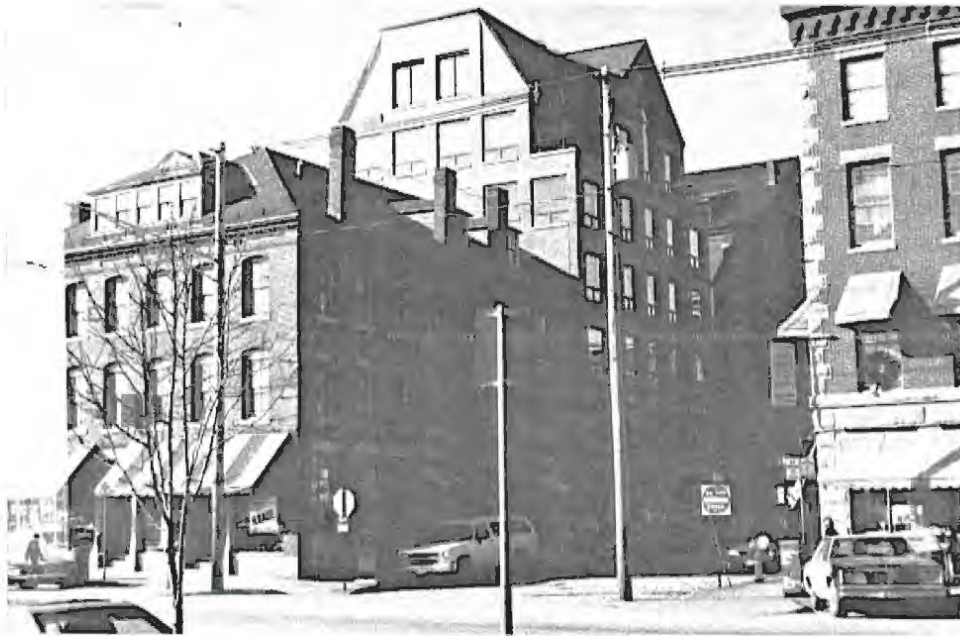
*This new commercial building in the Old Port is located on a crowded site on Moulton Street, but is perhaps most visible from Commercial Street. The multi-faceted roofline is successfully used to reduce the apparent height of the building and to harmonize with the gable, hip and gambrel roofs of its neighbors on Fore Street and Commercial Street.*

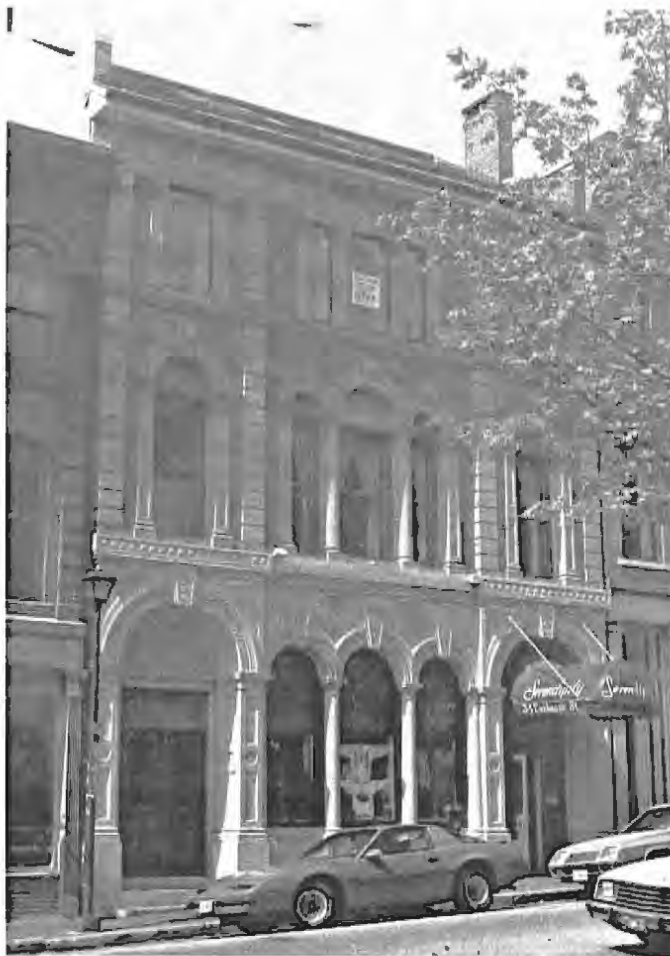
*This Old Port commercial building demonstrates the classic three-part facade composition of base, middle and top. Windows and doors are another important compositional element of commercial buildings. Storefronts and upper story windows set the pattern of a building facade. In a commercial setting, these patterns, though they can be decorated differently, are usually consistent. This building on Exchange Street has unique window and door decoration that sets it apart from its neighbors. But the window and door sizes and the rhythm they establish are similar to others in the area, and the way the windows and door are divided are likewise related to patterns found throughout the Old Port. Although upper story windows are, of necessity, different in proportion from the storefront windows and doors, the rhythm of upper and lower stories is related.*

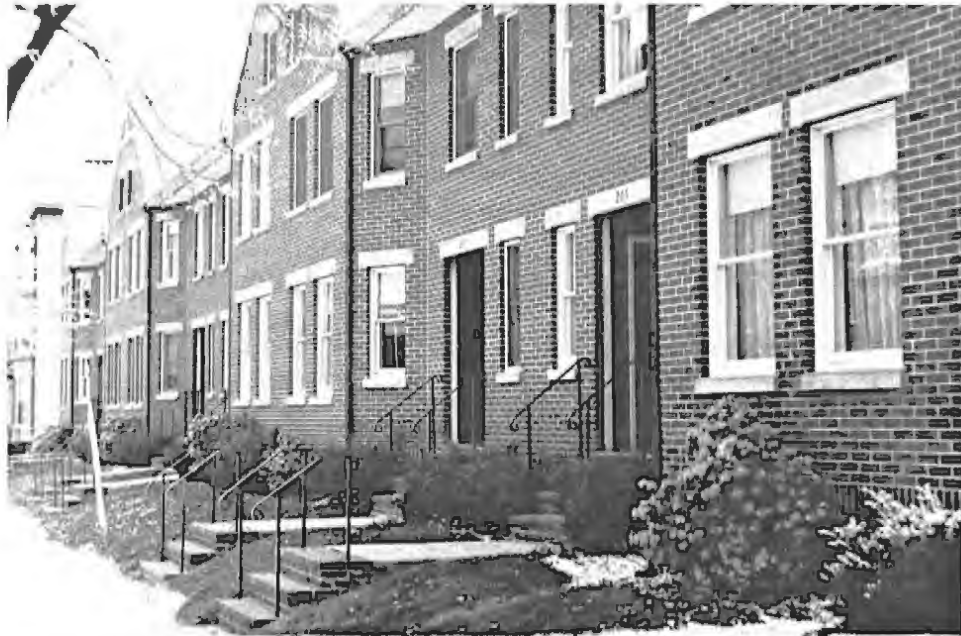
*In this condominium townhouse development on Vaughan Street, windows with stone heads and sills, together with recessed entrances, have proportions like those of neighboring historic residences. In addition, the rhythm established by the pattern of the windows and the location of the doors is in common with that of other houses in the district.*

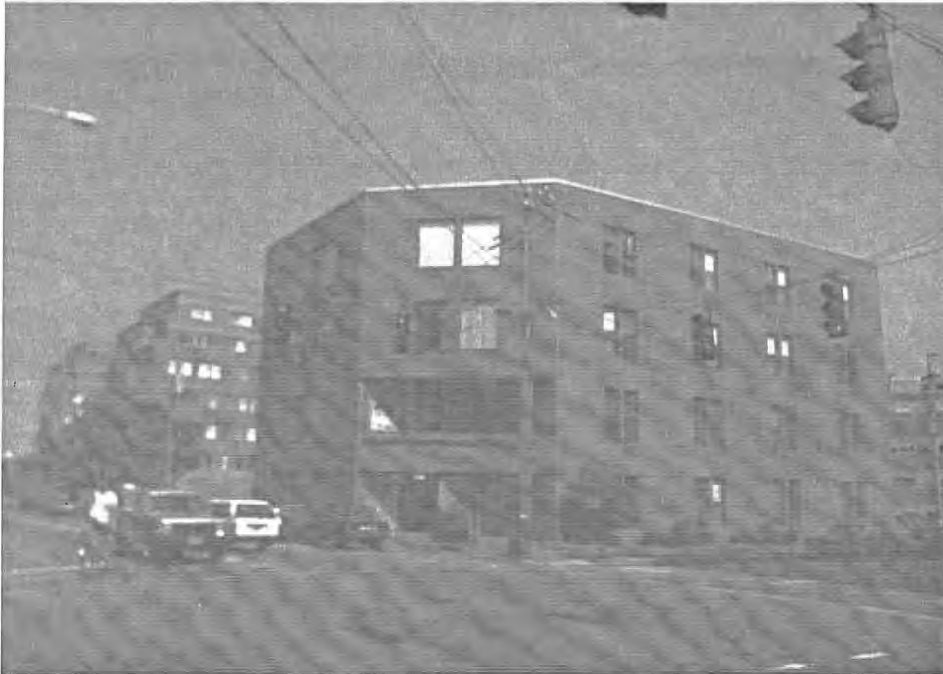
*The window and door proportion and pattern of this small commercial building at the corner of Middle and Pearl Streets, together with the recessed balcony and main entrance, are at odds with the historic buildings on the three opposite corners. The large amount of opaque wall surface and lack of glass area, especially at the ground floor, gives this building an unfriendly presence at street level that clashes with older commercial buildings in the area.*

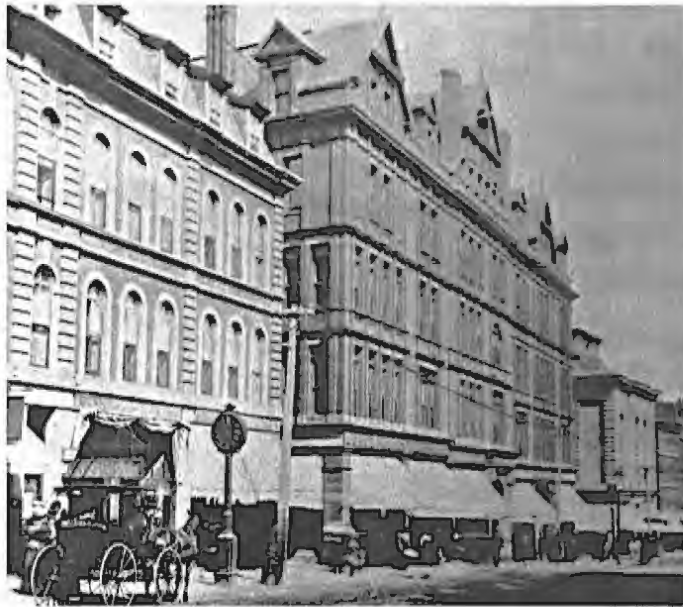
*Many commercial storefronts featured projecting awnings and recessed entries. Current code requirements dictate recessed doorways on new buildings located at the sidewalk. These awnings and recesses in this historic view along Congress Street play a major part in the composition of storefronts, and can set up a rhythm at the streetscape that is attractive in its own right. These elements play a role similar to that of porches on houses, in that they welcome the pedestrian and provide shelter from wind, rain and sun.*

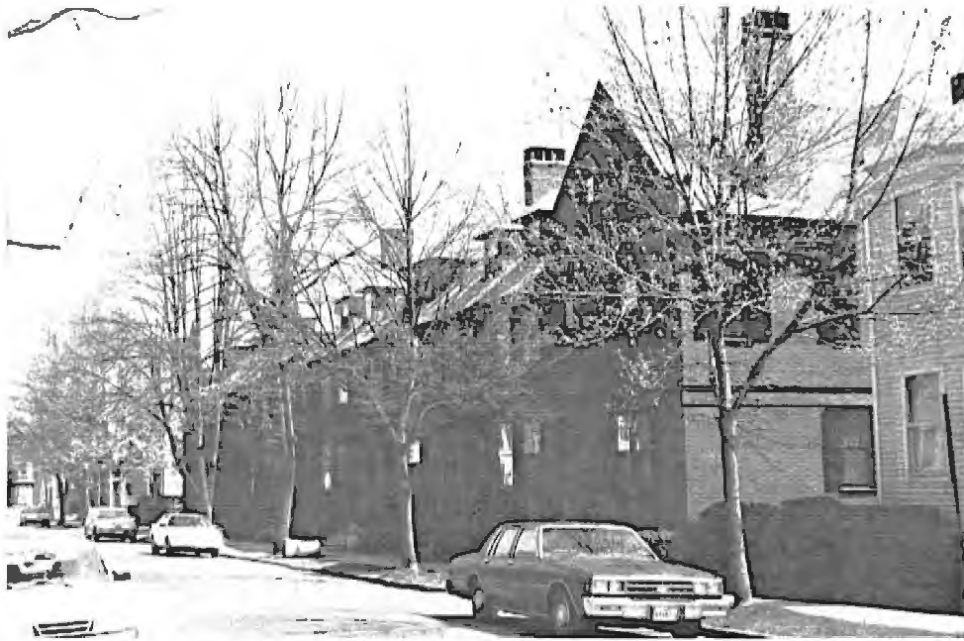
*The projecting front porches, bay windows and dormers of these Neal Street rowhouses establish a wonderful rhythm that relates the width of each house to the sidewalk and the passerby. Thus even though the houses are attached, a pattern similar to that of single-family houses is perceived.*

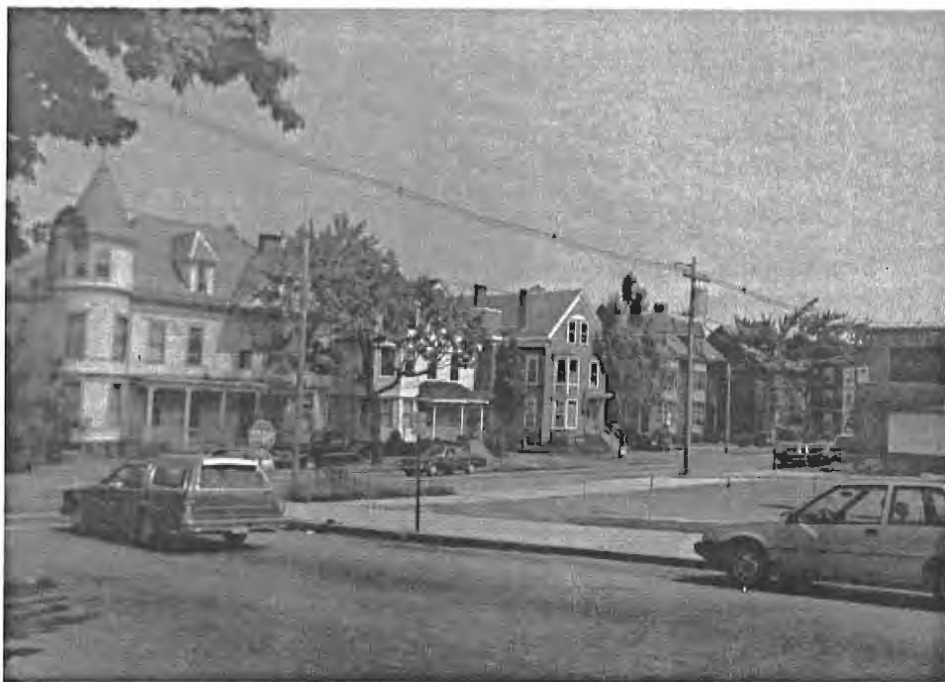
*In this photograph, detached houses on Cumberland Avenue are characterized by porches. Even though of varying sizes and degree of detail, they unify the streetscape by their presence in each facade composition and by their human scale.*

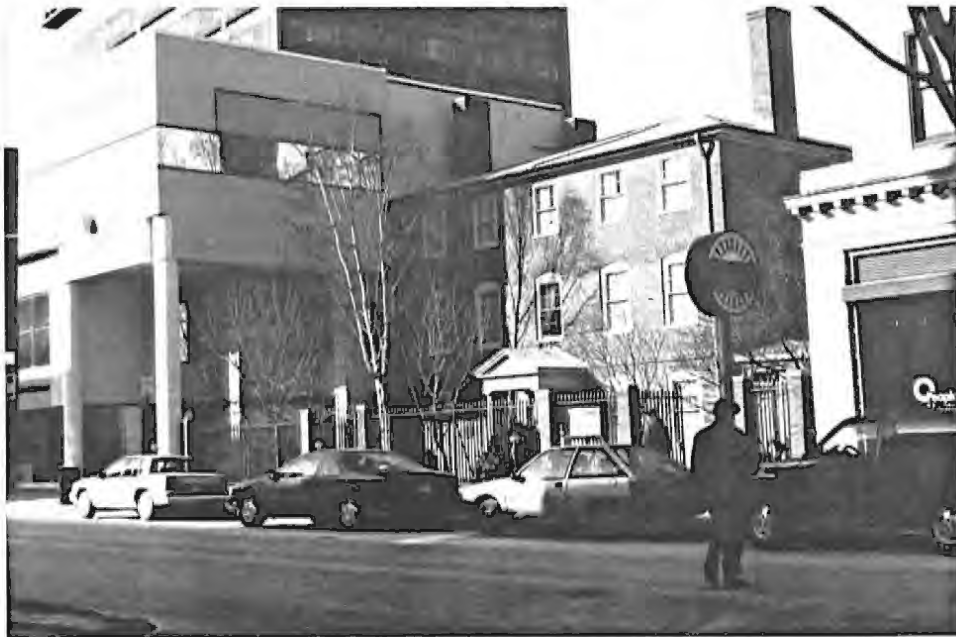
*While the use of modern building materials in historic districts is not discouraged, their compatibility with their immediate context should be carefully considered. Here, at 489 Congress Street, both the materials themselves and their coloration stand in sharp contrast to those of the Wadsworth-Longfellow House and serve to overwhelm the more restrained landmark building.*

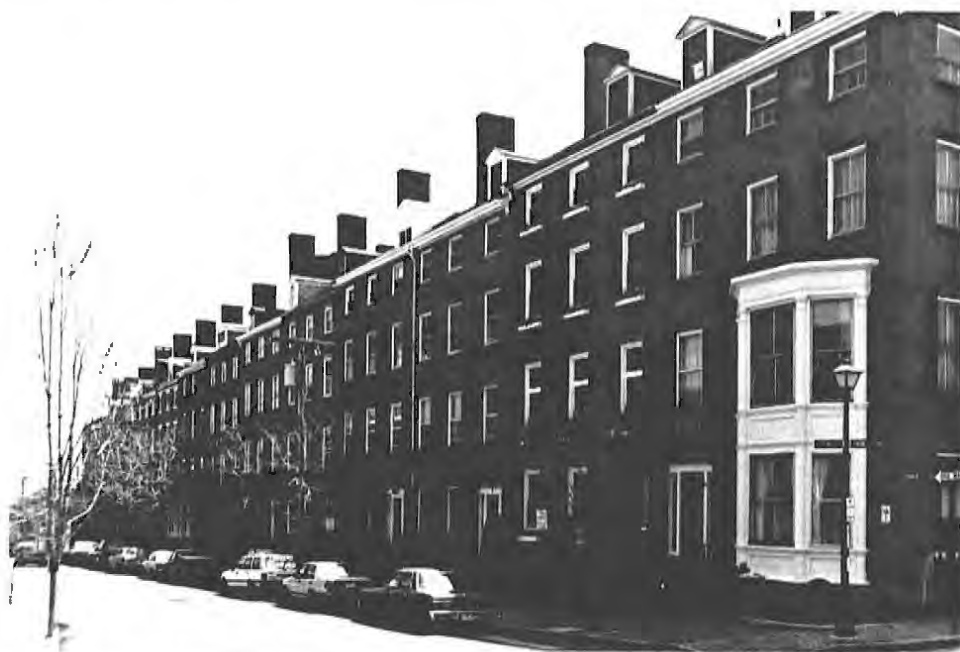
*The Park Street Row creates an attractive street wall, one that should not be broken. The continuity is emphasized by the rhythm of windows and doors, of chimneys and dormers, of porches and steps and railings. Fences and granite curbs add to the consistency of the block. This is an example of where scale, composition and relation to the street all come together to create a cohesive whole that is universe.*

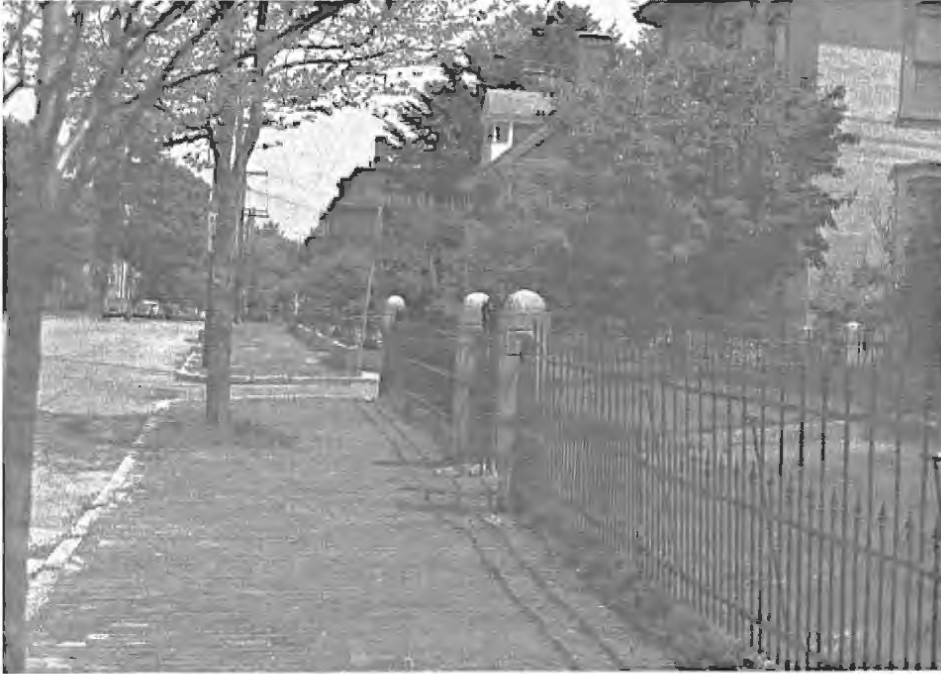
*Fences and walls create important walls of continuity, and serve to stake out important visual boundaries amidst open space. Granite curbs add an important design note. In a neighborhood where fences are commonly used at the sidewalk such as along Spring Street, an infill design can contribute to the area with a contemporary interpretation of nearby fences and curbs.*

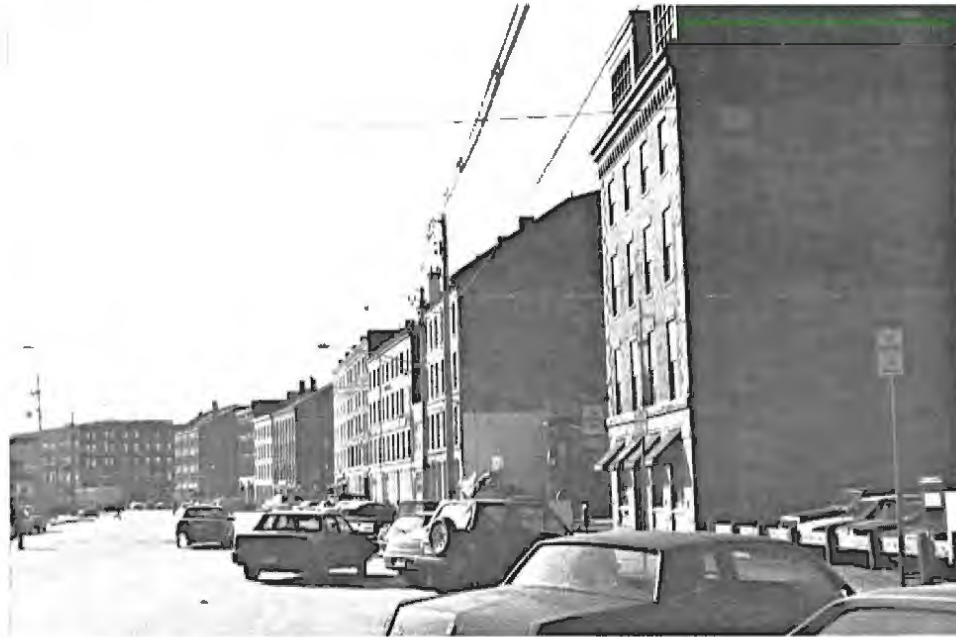
*One of Portland's finest commercial "walls" is along Commercial Street. Here, commercial buildings of remarkably consistent character form the sides of the street for a number of blocks. Buildings of various sizes are grouped together in the traditional fashion to create the solid street facade out of many parts. The result is a sense of place and enclosure that is a uniquely urban and plays a major role in the "feel" of the Old Port.*

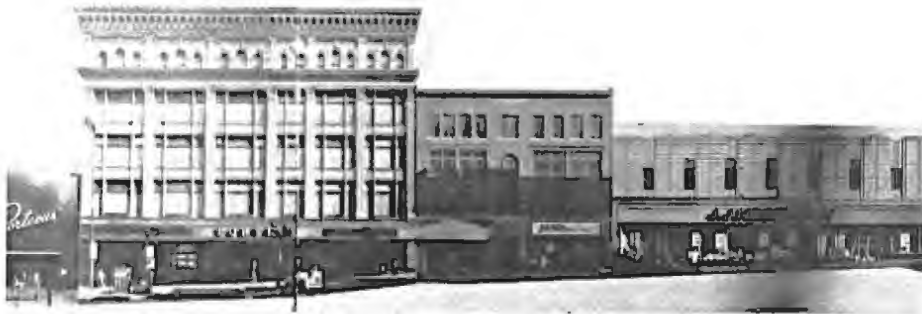
*Commercial buildings in an urban setting almost always fill all or more of their lot, extending to the property lines at the front (street) and both sides.*

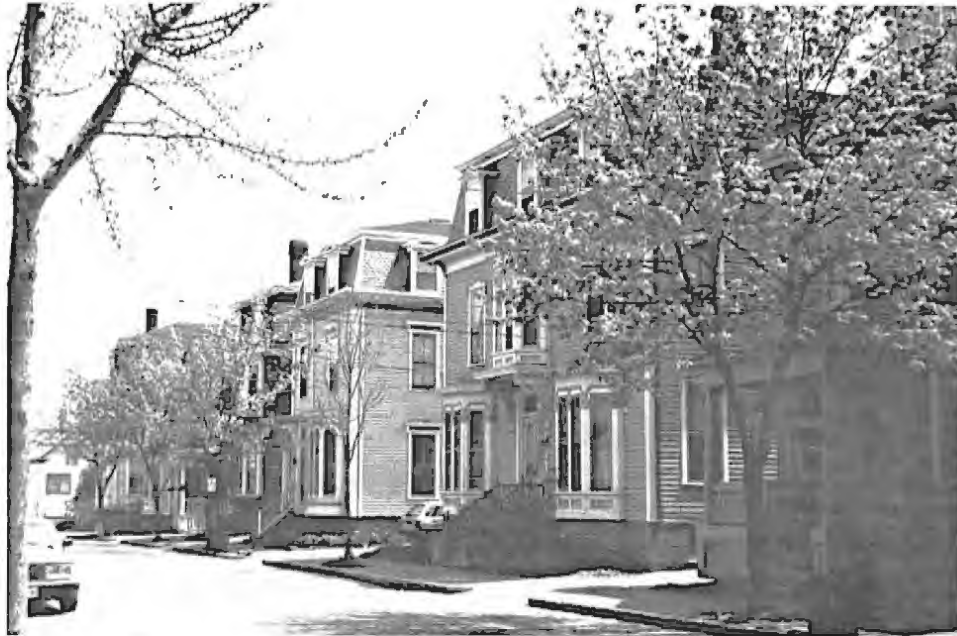
*The spacing of these detached houses on Cushman Street is consistent for the entire block. Even though the sideyards are minimal, they create a very different rhythm from that of a block of rowhouses, one that is important historically and architecturally.*

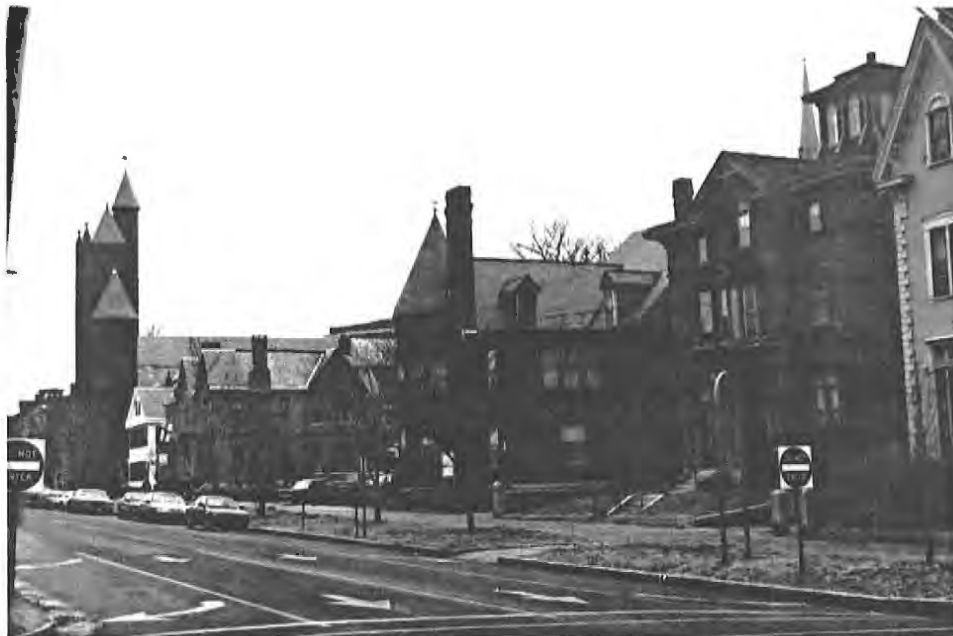
*This photograph shows larger, more distinguished houses with larger front and side yards along State Street. In this case, the residences have traditionally had more "breathing space" around them that allows all of the details of at least three sides of the houses to show. The spaciousness of these lots is a critical component of this streetscape and plays a major part in differentiating this street from Cushman Street, architecturally and historically.*

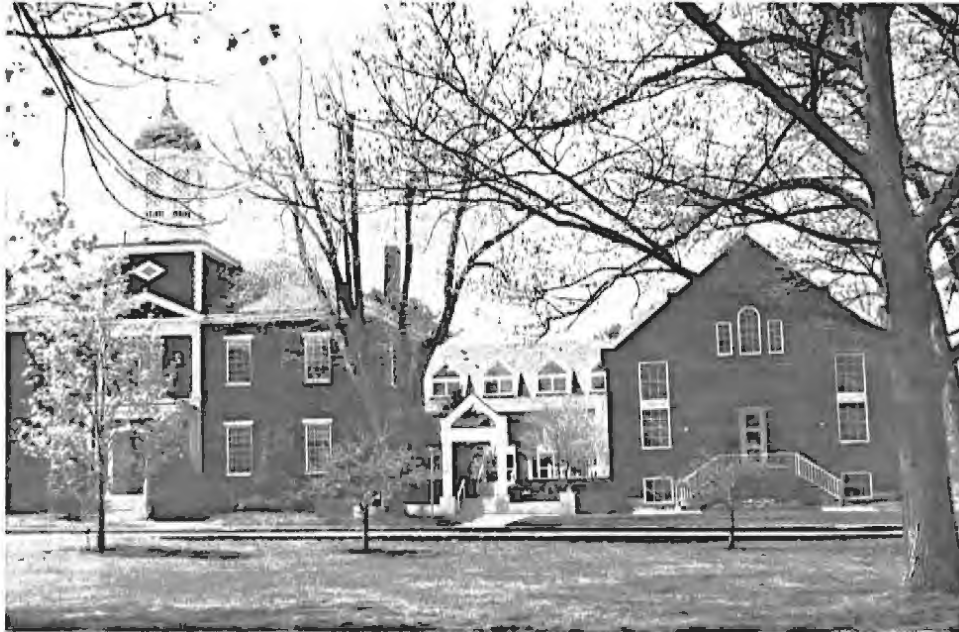
*At Westbrook College, a new building connects two historic buildings. While new construction could conceivably have been brought out to the street, in this case the contemporary structure has been recessed to allow the historic rhythm and spacing between facades at the street to continue to be the dominant characteristic of the overall composition. The two older buildings continue to be the focal points, while the new addition can have its own identity on a different plane.*

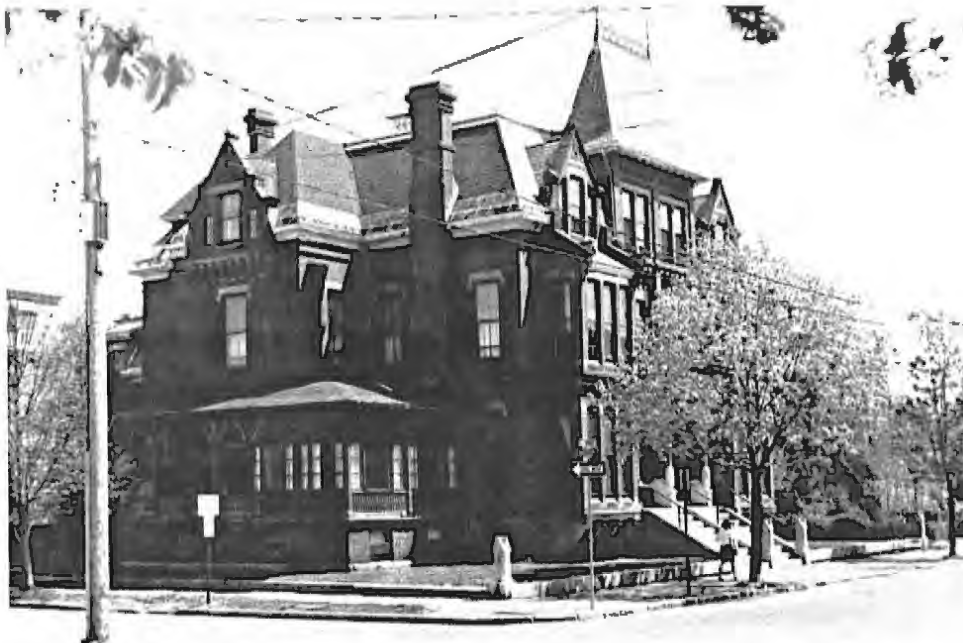
*The Francis Fassett house at 117-119 Pine Street is a dramatically vertical house. The bay windows and center tower topped with ornamental ironwork draw the eye upward from all viewing angles. This degree of vertical orientation is somewhat unusual for a free-standing house on spacious grounds. Its prominent setting at a multi-angled street intersection may have led its designer to make a monumental statement in a highly ornamental style of the day.*

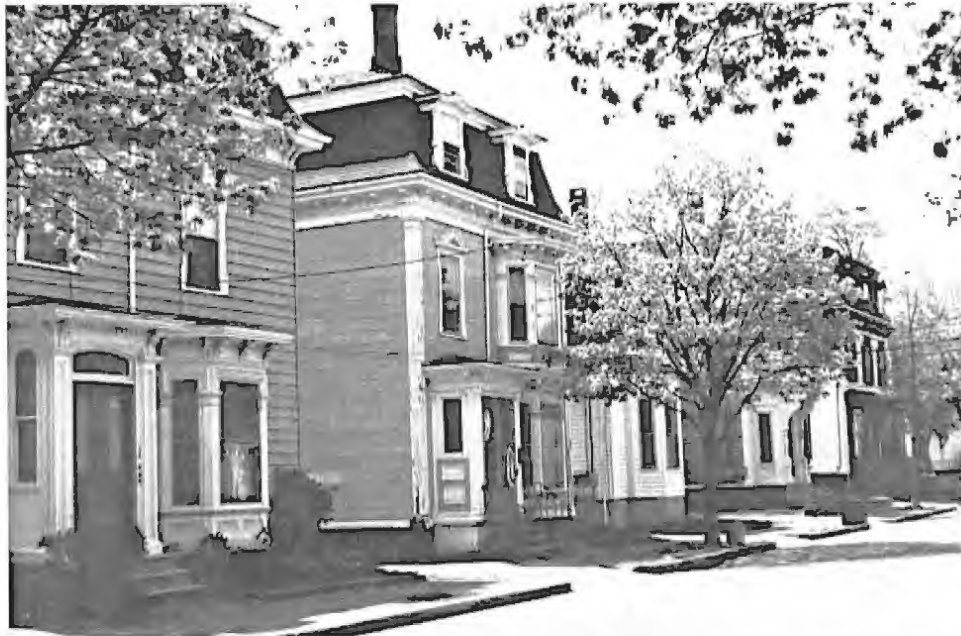
*These detached Second Empire houses on Cushman Street are likewise vertically oriented, though in a more subtle manner. The bay windows and Mansard roofs emphasize the verticality of the narrow three-story structures.*

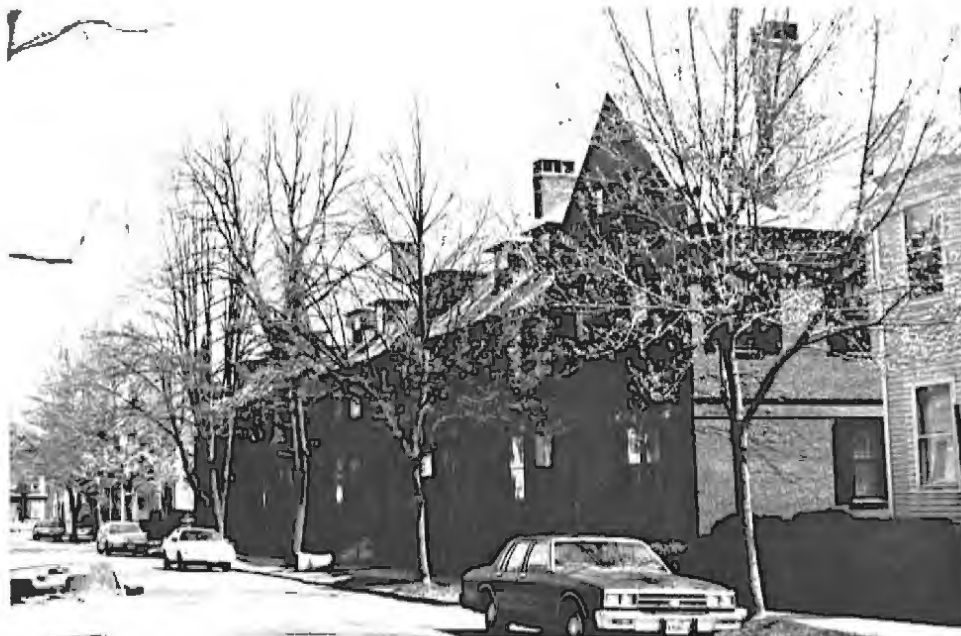
*Attached rowhouses like these on Neal Street can have both horizontal and vertical expression. In this case, the vertical line established by projecting bay windows and projecting wings at the center and both ends are counteracted by the sweeping roofline. Walking along the sidewalk in front of the building, one senses the vertical nature of individual townhouses. From across the street, however, the overall image of a single building dominates. This dichotomy could become a primary design determinant of a sensitive new design in an infill situation.*

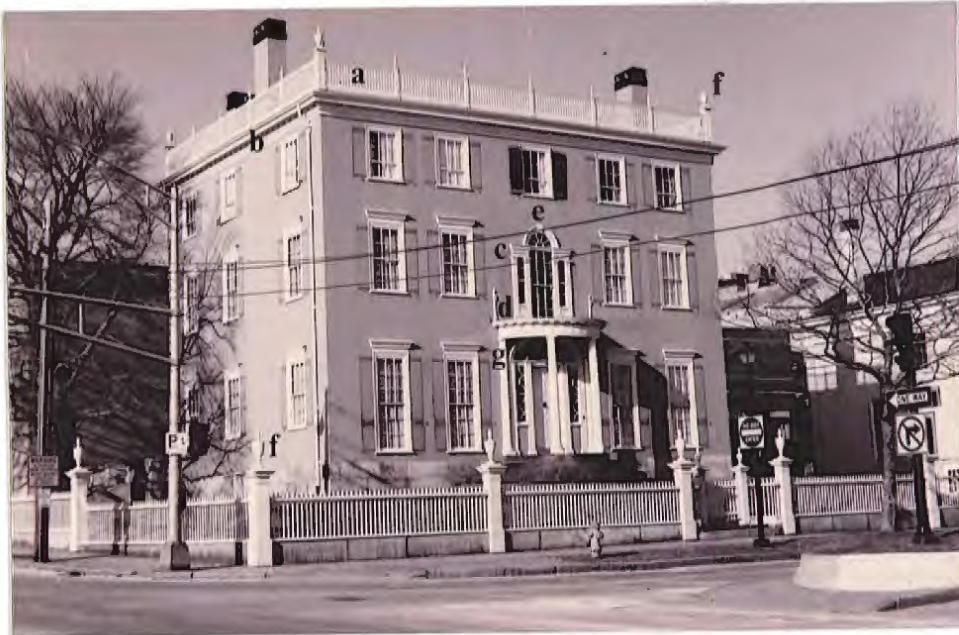
### *Federal Style*

*Hugh McLellan House, 103 Spring Street, designed and built by John Kimball, Sr. in 1800*  
a) balustrade; b) cornice; c) Palladian window; d) portico; e) keystone; f) urn; g) elliptical fanlight

The Federal Style coincides with the post Revolutionary emergence of this nation. The forms differ from colonial in proportion - the Federal is more attenuated and often delicate - and features such as Palladian

windows and balustrades are used in the "High Style" examples. The basic form, as in colonial architecture is a rectangular box with window and door openings symmetrically placed.

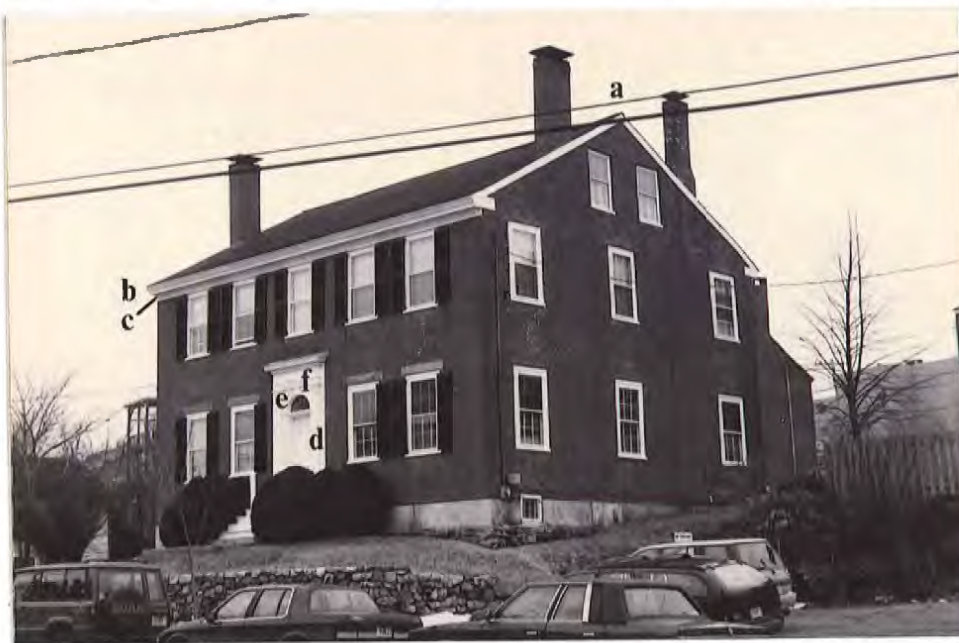
### *Federal Style*

*Daniel How House, 23 Danforth Street, built 1799*  
a) gable; b) cornice; c) entablature; d) pilasters; e) fanlight; f) keystone

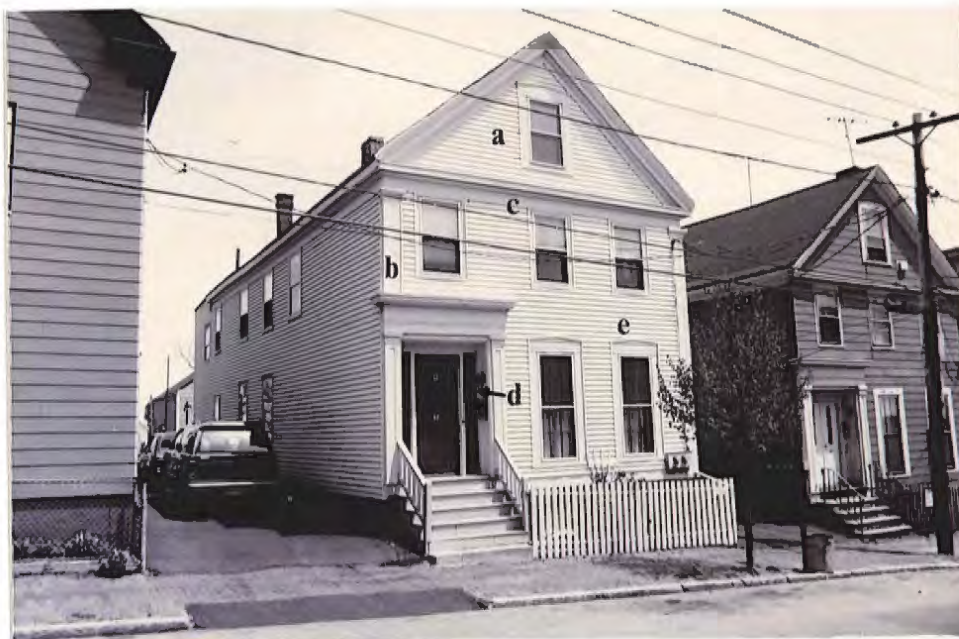
*Greek Revival Style*

*47 Brackett Street, built c. 1850  
 a) enclosed gable; b) corner pilasters; c) full entablature; d) full-length sidelights; e) pediments*

The frame vernacular Greek Revival style dwelling, at 47 Brackett Street, retains the temple aspect of the high style examples by facing the gable to the street and enclosing it to form a full pediment, supported by the corner pilasters. Other features of this style are the entranceway and the window surrounds. A full, deep entablature supported by panelled pilasters marks the recessed door while the first and attic story windows have broad flat moldings and are capped by shallow pediments. Originally all windows were glazed in a six over six configuration and the door was panelled with no light.

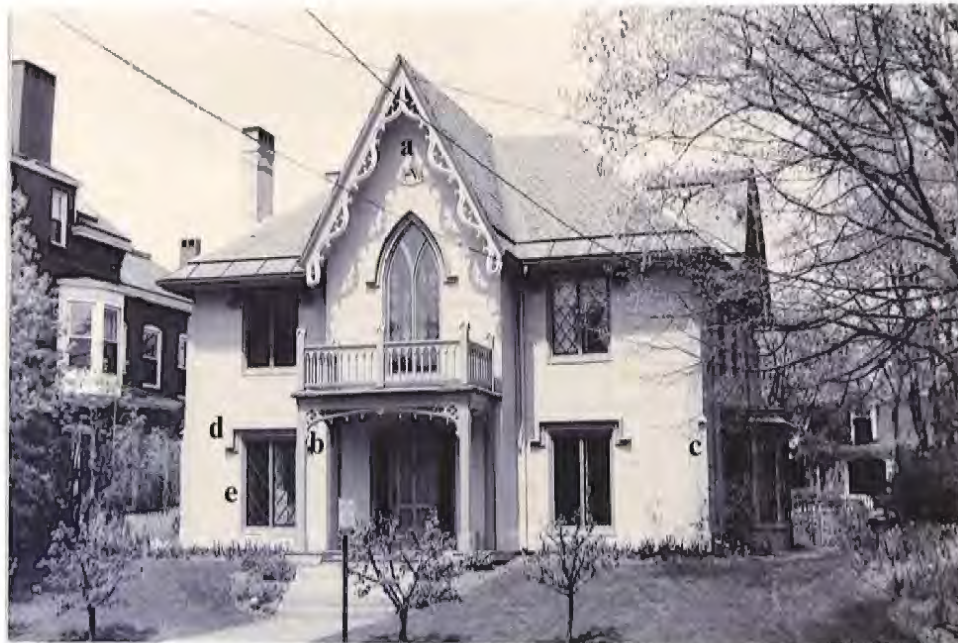
*Gothic Revival Style*  
*John J. Brown House, 387 Spring Street, built 1845, designed by Henry Rowe*  
*a) gable; b) portico; c) pier buttress; d) drip molding; e) leaded panes*

buildings. Verticality is emphasized by the corner pier buttresses, the slender portico supports and the bargeboards in the gables. Tall paired windows have romantic medieval diamond shaped leaded panes, while the central window terminates in a pointed arch outlines by a drip molding.

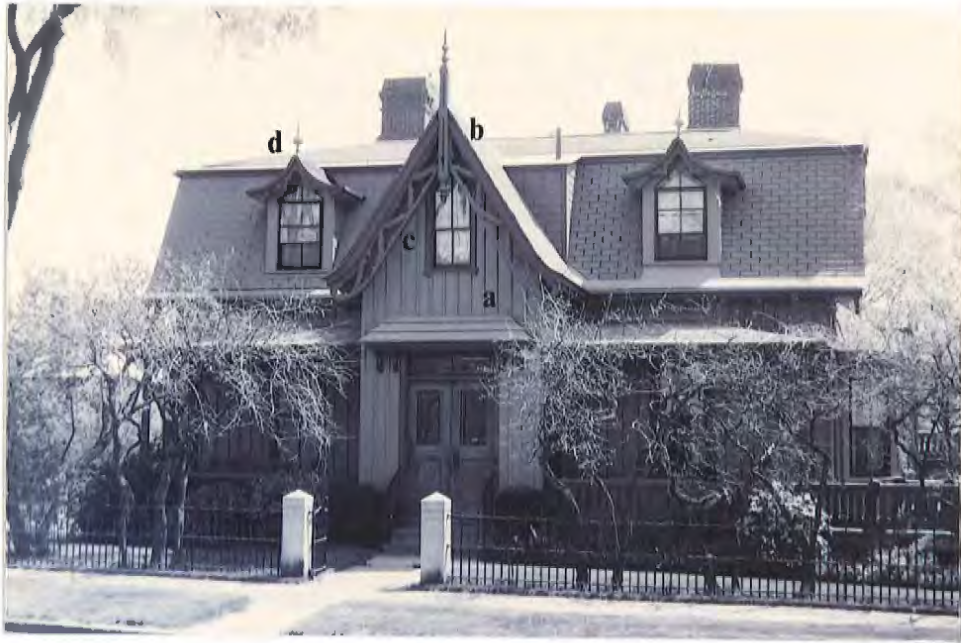
*Gothic Revival Style*  
*William Goodwin House, 75 Vaughan Street, built 1859*  
*a) board and batten; b) gable; c) bargeboards; d) finial*

This example of a Gothic Revival style, the William Goodwin House, is clad with board and batten, thus giving more emphasis to the vertical. The steep pointed gable with its decorating bargeboards and finial is characteristic as is the deceptive cottage scale of the facade. The house, in fact, extends toward the east and provides much interior space.

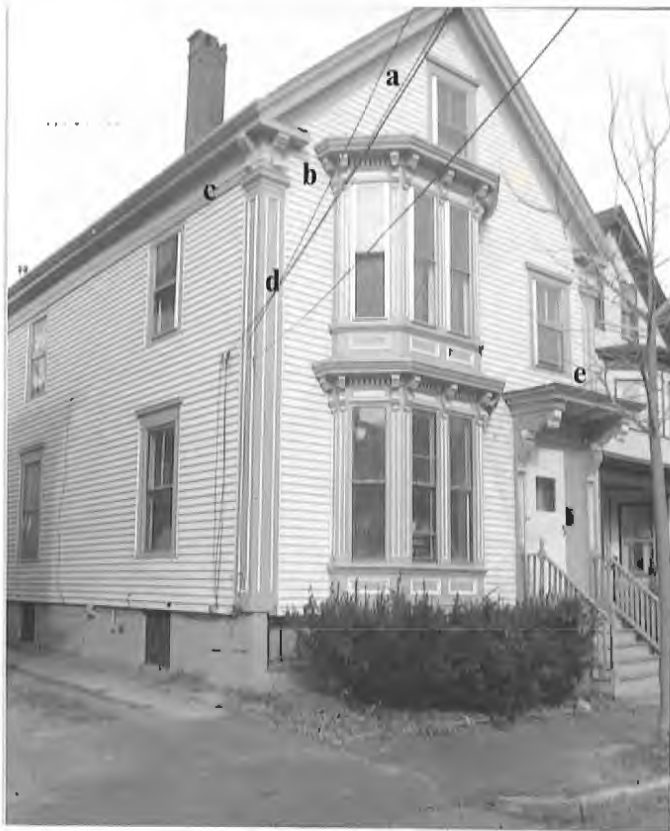
*Italianate Style*  
*Elihu Hasty House, 53 Spruce Street, built 1874*  
*a) gable; b) brackets; c) entablature; d) corner boards; e) hood*

In this typical Portland Italianate frame dwelling, the Elihu Hasty House, the gable facing the street has a rather steep pitch. Panelled corner boards (which derive from the Greek Revival), replace the quoins exhibited in the high style version. Brackets are abundant, window tops are made important with an entablature and the entrance hood is a prominent feature. Unfortunately the original double door has been replaced with a single leaf with a subsequent loss of breadth and glass.

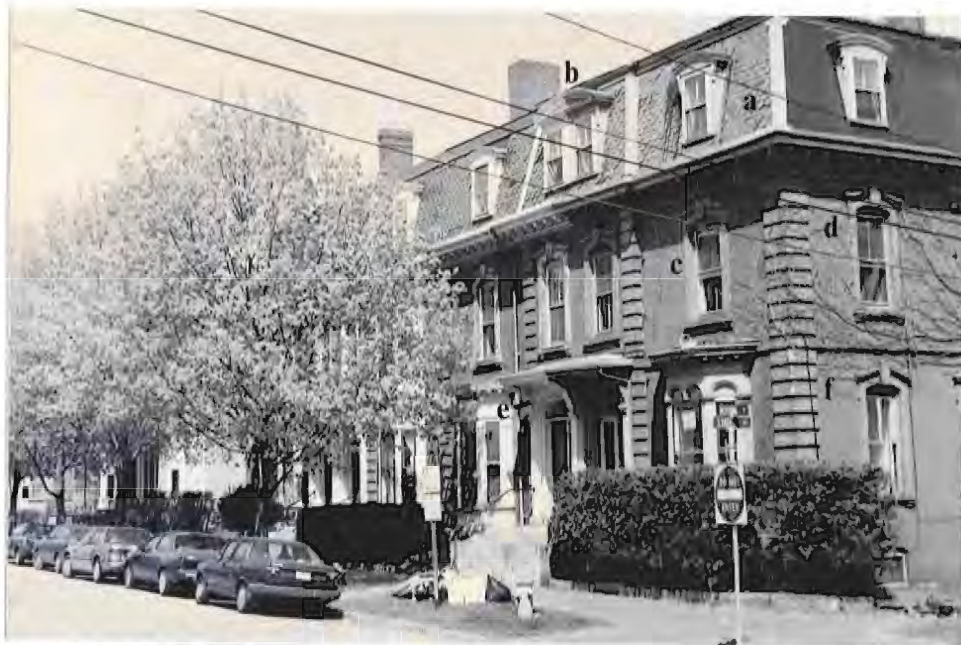
*Second Empire Style*  
*Simon H. Libby Block, 33 - 39 Deering Street, built 1866*  
*a) mansard roof; b) pediment; c) moldings; d) key stone; e) brackets; f) quoins*
