## Historic Preservation Board

Topic: Historic Preservation Workshop and Public Hearing 11-19-2025

- i. Preliminary Review of Proposed Updates to the City of Portland Historic Resources Design Manual; City of Portland, Applicant. The Historic Preservation Board will hold a hybrid workshop to review draft updates to the City of Portland Historic Resources Design Manual. The current Historic Resources Design Manual can be found here: <https://www.portlandmaine.gov/496/Additional-Resources>

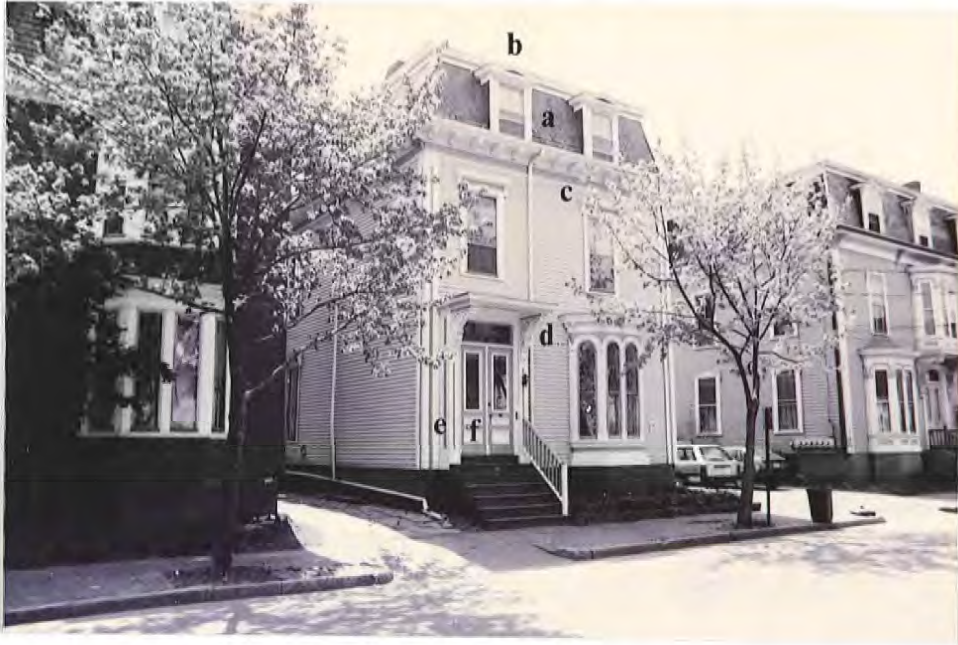
*Second Empire Style*  
*Stephen R. Small House, I, 18 Cushman Street, built 1870*  
*a) mansard roof; b) pediment; c) cornice; d) brackets; e) corner boards; f) double leaf entrance*

In the frame vernacular example, the Stephen R. Small House, the resemblance to Italianate forms is a clear reminder that these styles influenced each other. In common are the corners articulated by panelled corner boards, the strongly projecting cornice and entrance hood, both supported on brackets. Windows, too, have bracketted cornices or, on the dormers, triangular pediments. The mansard roof form, however, is the distinctive mark of the Second Empire style, and since the steep pitch is so visible, decorative patterns of slate form an important part of the design.

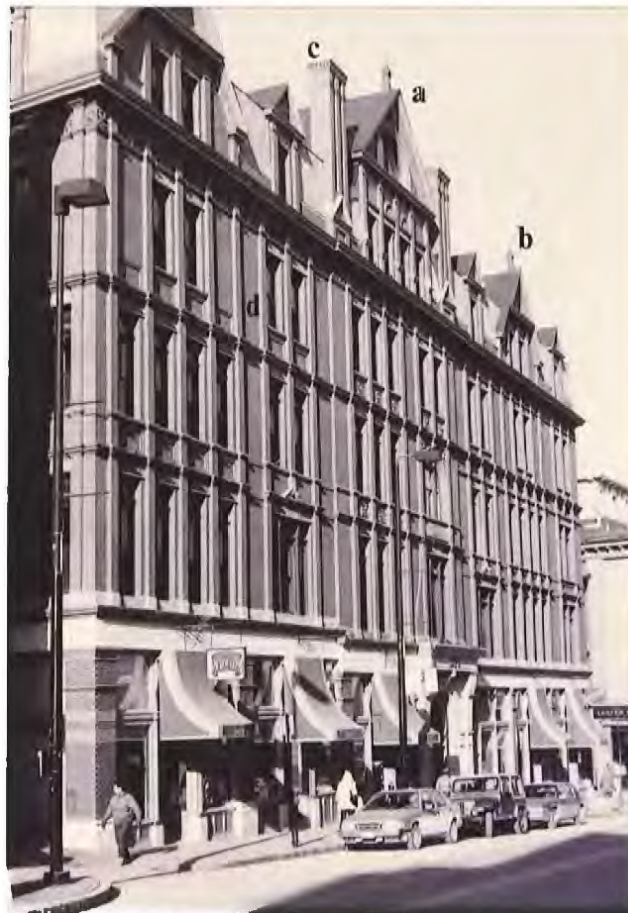
*Queen Anne Style*  
*John B. Brown Memorial Building, 1882-1883, 523-543 Congress Street, designed by Francis H. Fassett*  
*a) gable; b) finial; c) chimney stack; d) pilaster*

the several pointed gables surmounted by finials. The terra cotta panels which line up below the roofline add textural richness and the gables and chimneys create a picturesque, open skyline.

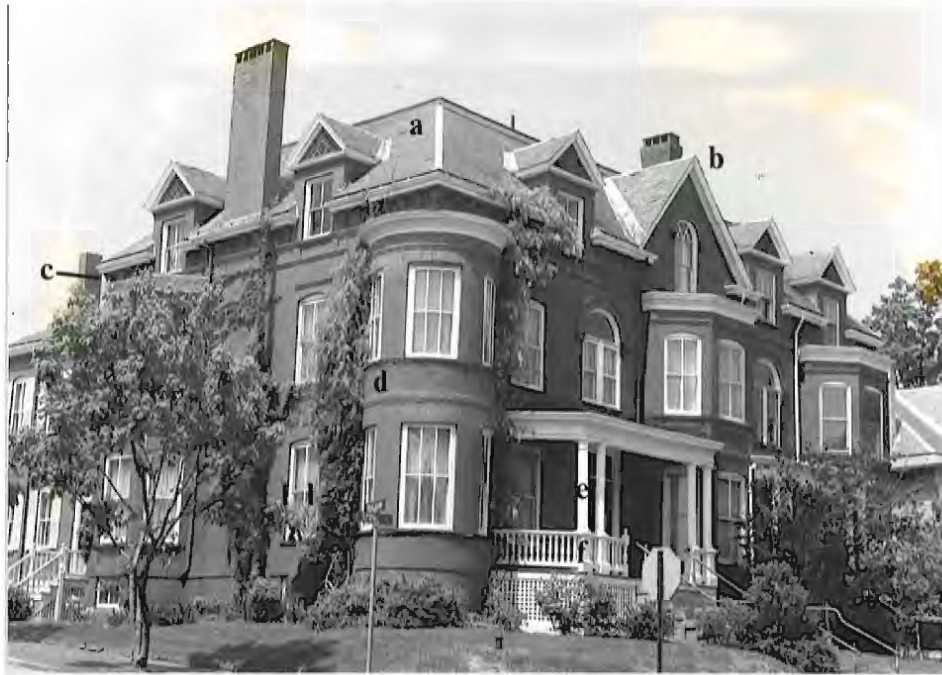
*Queen Anne Style*

*Willis A. Cates House, 398 Spring Street, built 1897*

This double house, the Willis A. Cates House, - a favorite Portland dwelling form - shares a number of characteristics with the John B. Brown building. The most obvious is its basically blocky shape which is enlivened by various projecting elements. The steep hipped roof is pierced by a gable, gabled dormers and tall chimney stacks. The walls are enlivened by a corner tower and three sided bay windows, decorative brickwork - brackets along the eaves, panels and string course. Round and elliptical topped windows and deep porches supported on slender columns add to the sculptural character of the structure.

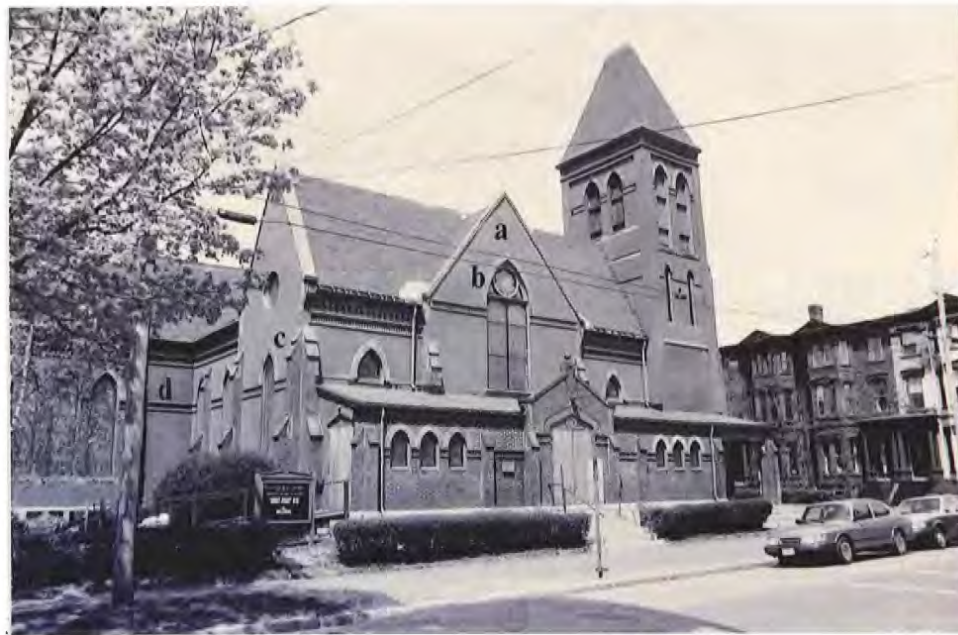
*High Victorian Gothic Style*  
*Williston Congregational Church, 32 Thomas Street, built 1877, designed by Francis Fassett*  
*a) gable; b) pointed window; c) pier buttress; d) string course*

This style, as seen in the Williston Congregational Church, was, clearly, a favorite for ecclesiastical

structures of the last quarter of the nineteenth century. The steeply pitched roof and sharply outlined gables, along with the square tower terminated in a likewise steep roof, are characteristic of this style. The use of a medieval Gothic vocabulary in pointed windows, pier buttresses, and stained glass extends the metaphor. Typical of the late nineteenth century are the stone moldings and decorative brick string courses. In point of fact these latter features, coupled with an asymmetrical plan, make this a less formal, more village-scale building.

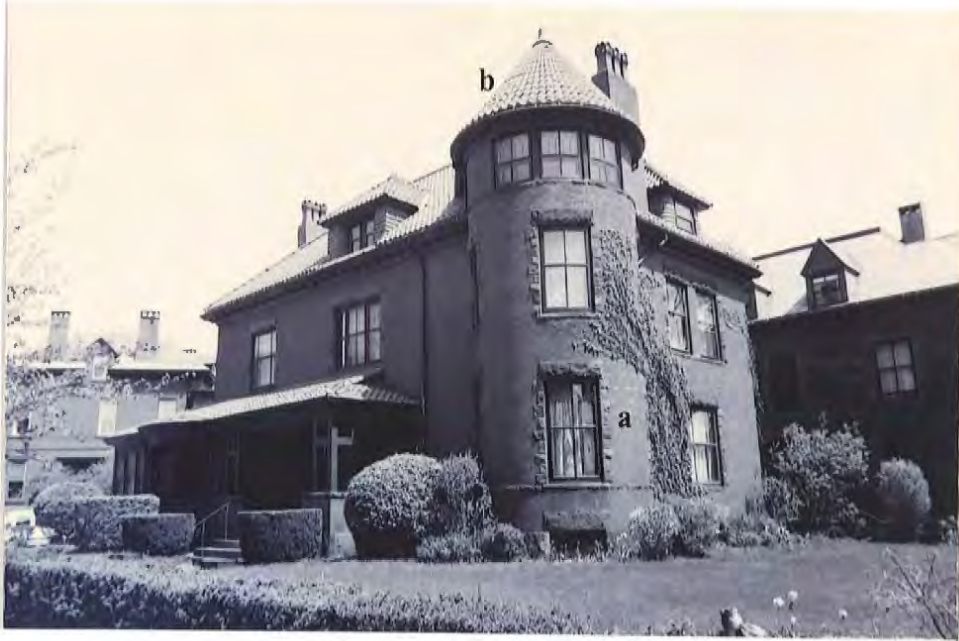
*High Victorian Gothic Style  
Harry Butler House, 1 Thomas Street, built 1892-1894, designed by John Calvin Stevens, I  
a) molding; b) conical roof*

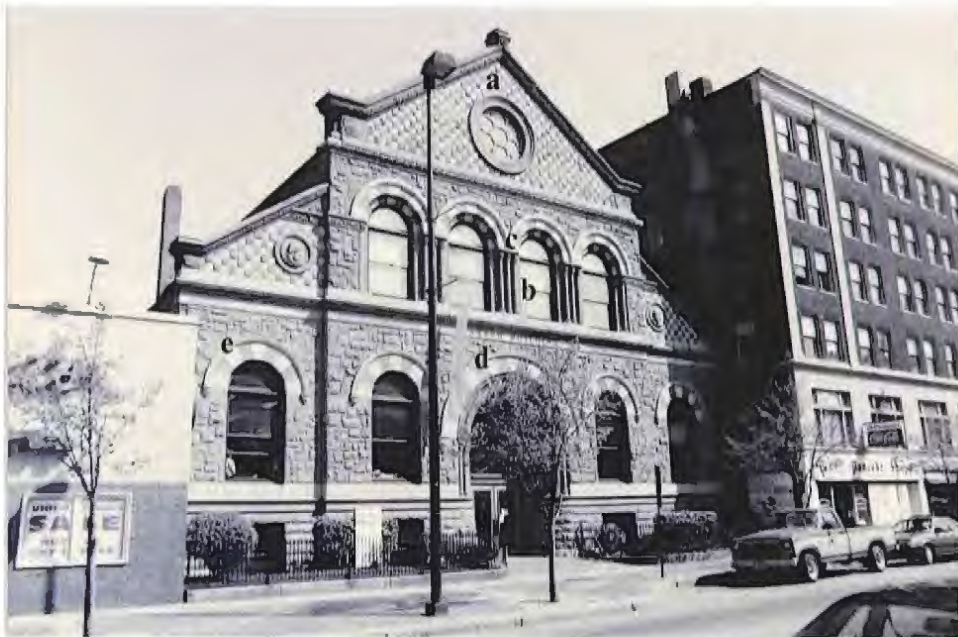
*Romanesque Revival Style*  
*Baxter Building, Congress Street, built 1888, designed by Francis H. Fassett*  
*a) gable; b) colonette; c) capitals; d) "nave"; e) "side aisles"*

The model for the Baxter Building, Portland's former Public Library is a Romanesque church facade with its indication of nave and side aisles. Deeply recessed arched openings are outlined by alternating colors of stone. The entrance adds colonettes with carved capitals leading up to a richly carved inner arch. Some stone is left rough and there are portrait panels on either side. Larger window panes became common by the last quarter of the century. Spacing of windows during this period varies, as seen here with wide spaces below and a tighter rhythm above.

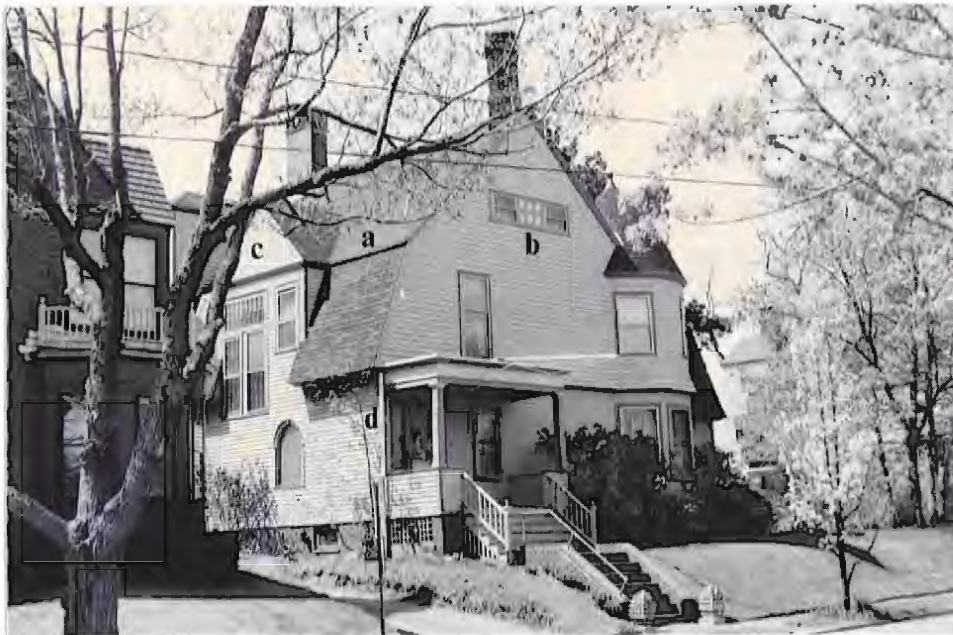
*Shingle Style*

*Montgomery S. Gibson House, 44 Bowdoin Street, built 1885-86, designed by John Calvin Stevens, I  
a) gambrel gable; b) decorative panel; c) dormer; d) overhang*

asymmetrical front gambrel gables, the low corner tower, large dormers on the flank and tall, panelled chimney stacks. The smooth shingle surface of the gambrel gable wraps itself around the tower; at the peak of the facade the shingles make a wave pattern just above the panelled window strip.

Although the house is large, the insistent horizontality of the overhang and the depth of the eaves create an informal cottage scale which is quite different from the strong verticality of the Queen Anne, Second Empire and Italianate styles.

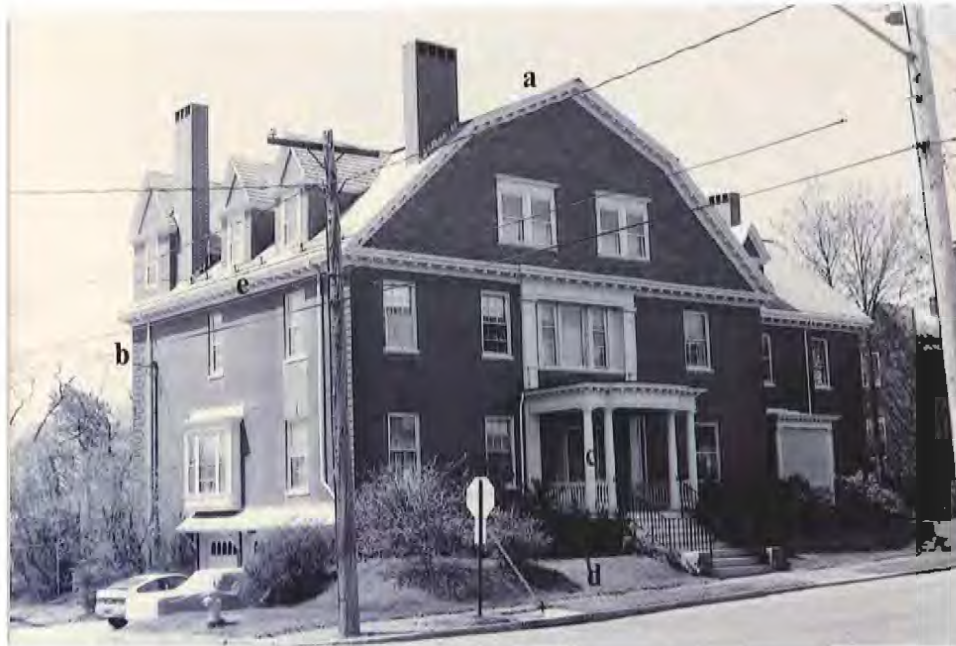
*Colonial Revival Style*  
*Franklin C. Payson House, 28 Bowdoin Street, built 1901, designed by John Calvin Stevens, I*  
*a) gambrel; b) quoins; c) column; d) balustrade; e) modillions*

elliptical fan lighted door, columns, balustrades, and roofline modillions are eighteenth century details freshly used. The depth and substantiality of the portico, the attic paired windows, and the principal entrance in the gable end are Revival traits.

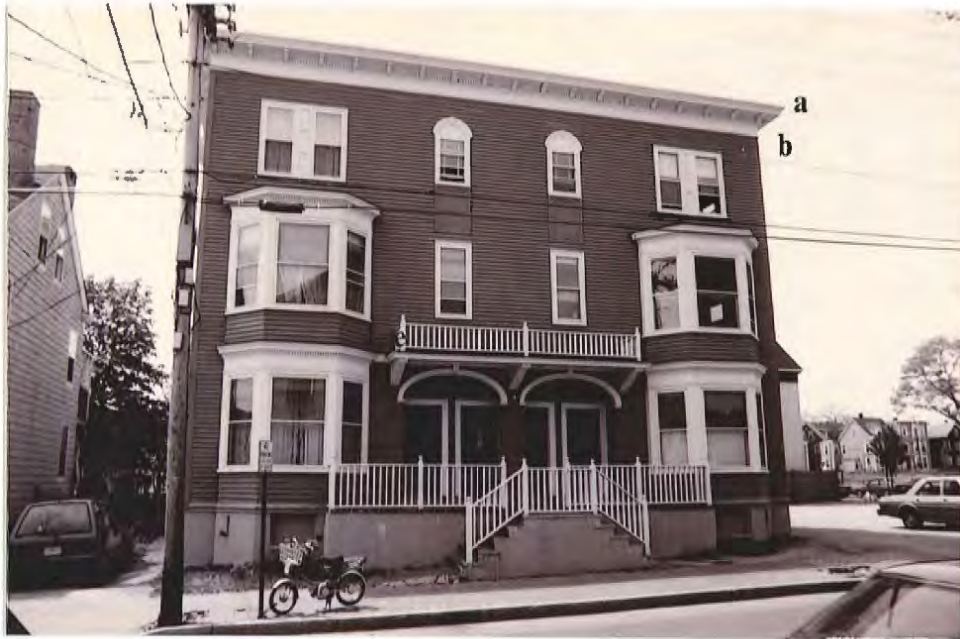
*Colonial Revival Style*  
*122-124 Brackett Street, built around 1897*  
*a) cornice; b) modillions; c) elliptical arch; d) keystone; e) balustrade*

In a vernacular structure, like 122-124 Brackett Street, the blocky shape needed for an apartment building is most evident, yet style characteristics are important for articulating the mass. Modillions under the cornice, the semi-circular "fans" on the center third floor windows, the elliptical arches with keystones over the entrances, and the balustrades identify this building as Colonial Revival.

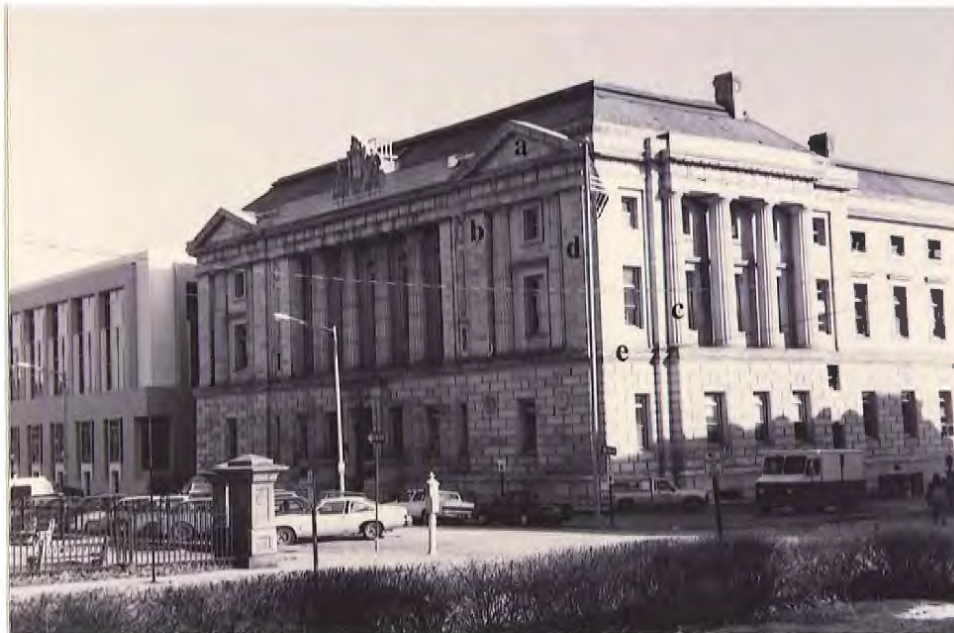
*Classical Revival Style*

*Cumberland County Courthouse, built 1906-1910, designed by George Burnham and Guy Lowell  
a) pediment; b) entablature; c) Doric columns; d) pavillions; e) horizontal molding*

The Cumberland County Courthouse appears as a more massive and compact building because the collaborating architects (Burnham of Portland, Lowell of Boston) make the first floor serve as a solid base surmounted by a horizontal projecting molding, and unify the second and third stories by monumental Doric columns. The ends of the principal facade are articulated by projecting pedimented pavillions, while the connecting colonnade stands in relief against the recessed window area. A fully developed entablature rests on the columns of the side elevation as well.

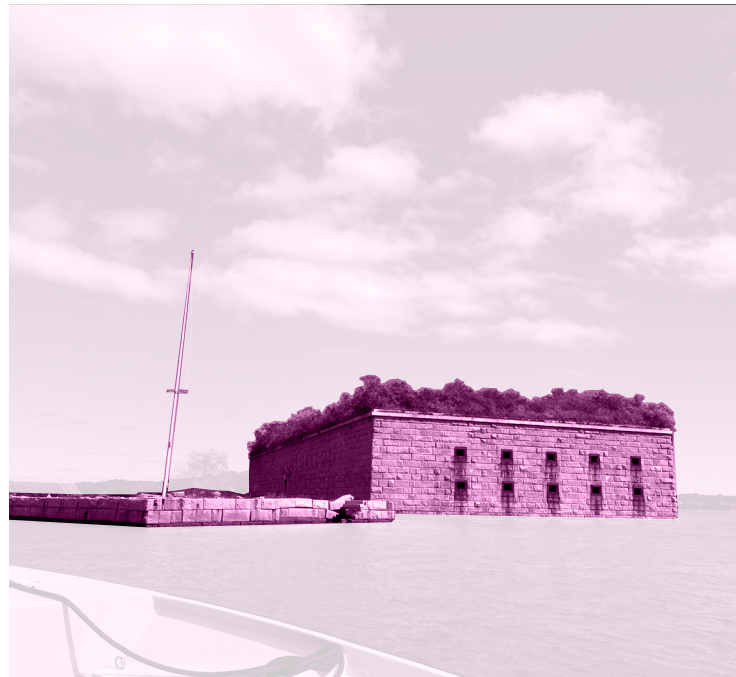
Fort Gorges, located in Casco Bay, is an obsolete and abandoned coastal fortification which was transferred from federal to City ownership in 1960. Given the limited access to the fort, and its public ownership, the building is only minimally maintained to protect it from collapse or severe deterioration while keeping it relatively safe for public access.

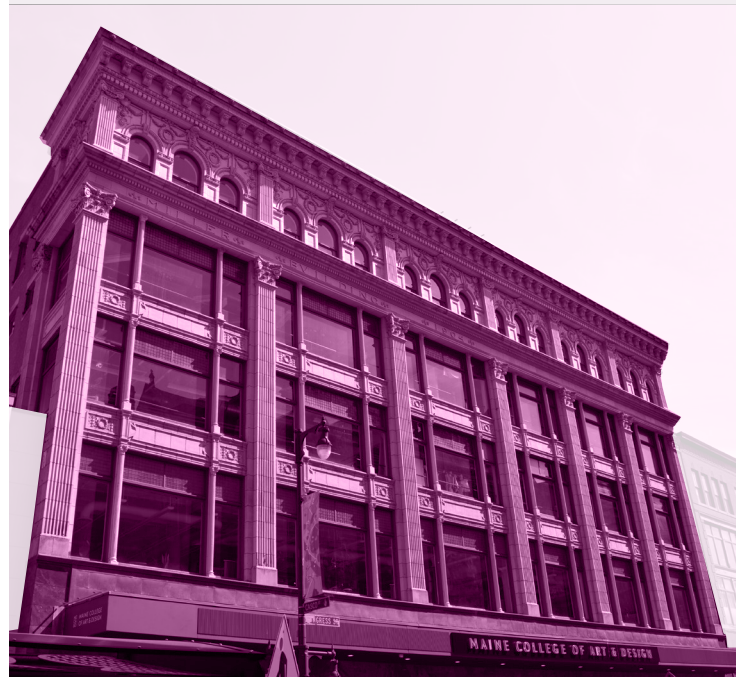
The former Porteause, Mitchell & Braun Department Store (522 Congress Street) was purpose built to house a large retail business. Beginning in 1993, the Maine College of Art & Design purchased the building and began rehabilitating it for use as classrooms, studios, and student amenities, all while retaining the building's architectural character.

Many historic buildings were designed with flexible floor plans, meaning they can readily accommodate a variety of uses. For example, the former Porteous, Mitchell & Braun Department Store (522 Congress Street) was converted from a retail to educational use with minimal exterior alterations.

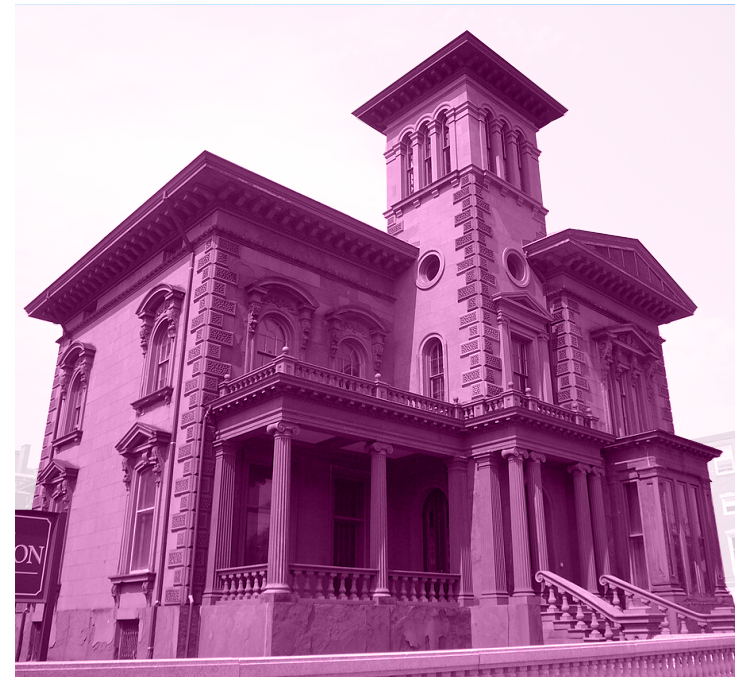
The Morse-Libby Mansion (109 Danforth Street and known as the Victoria Mansion), the property is maintained as a historic house museum. The building is open for public tours and has been undergoing work to maintain or restore the building's original mid-nineteenth century character so that the public can understand the building as a snapshot in time.

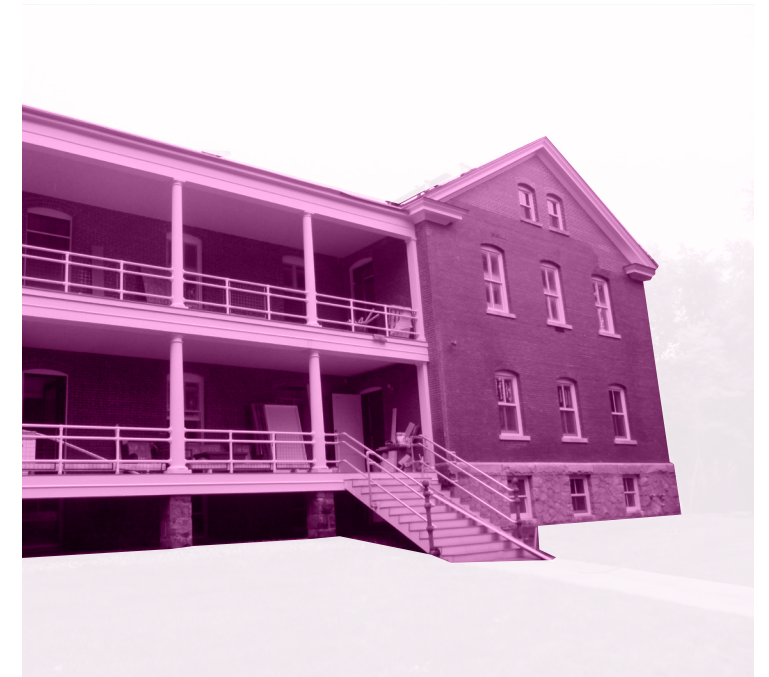
The Fort McKinley Double Barracks (22 McKinley Court, Great Diamond Island) was severely burned during renovations in 2013. After the almost total loss of the building, it was carefully reconstructed in exacting detail for use as a hotel.

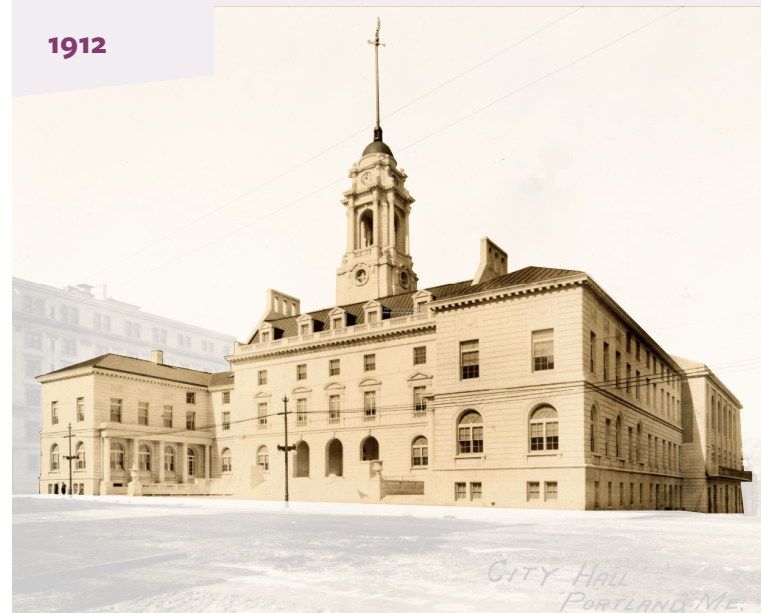
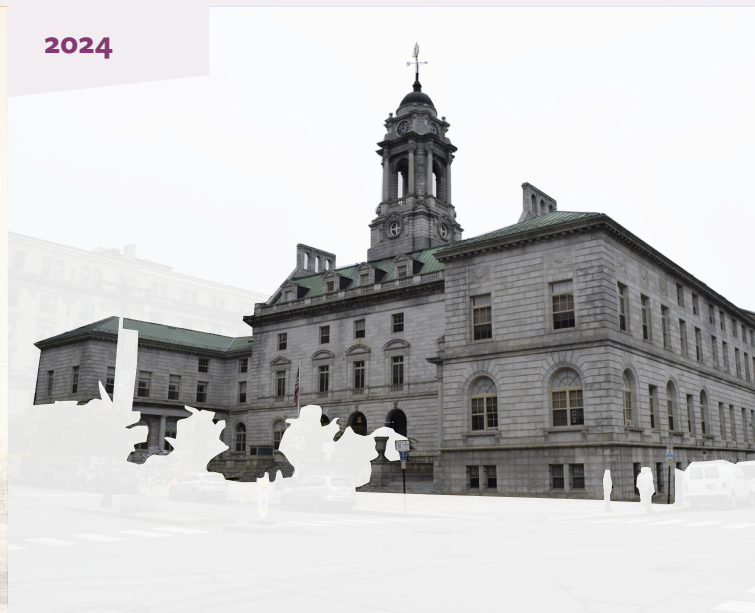
1912

Portland City Hall largely appears as it did after construction. In addition to being contributing to the Congress Street Historic District, City Hall is also a landmark due to its prominence and architectural significance.

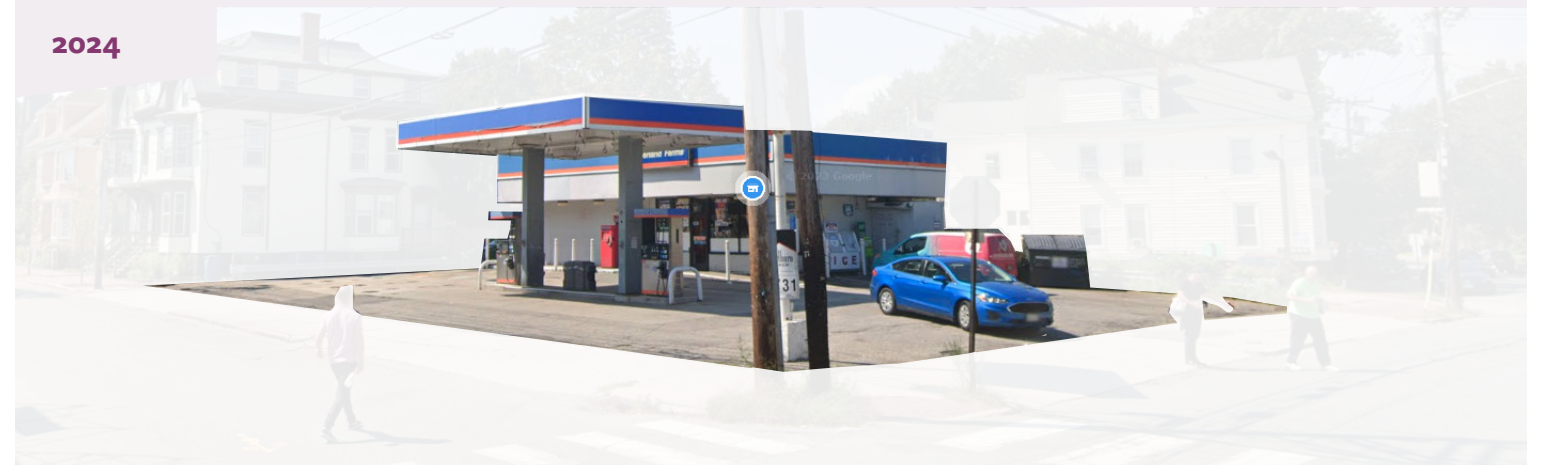
2024

This gas station was constructed sometime in the later half of the 20th century, after most of the buildings in the West End Historic District. It's date of construction makes it noncontributing.

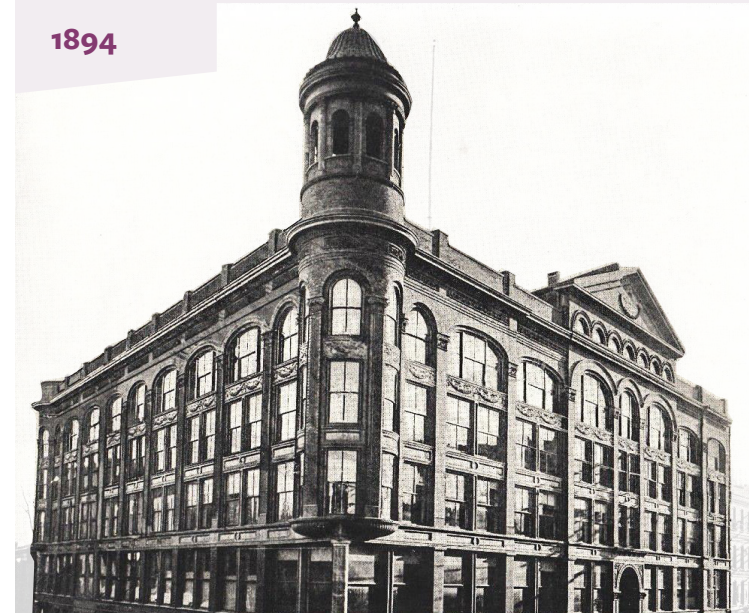
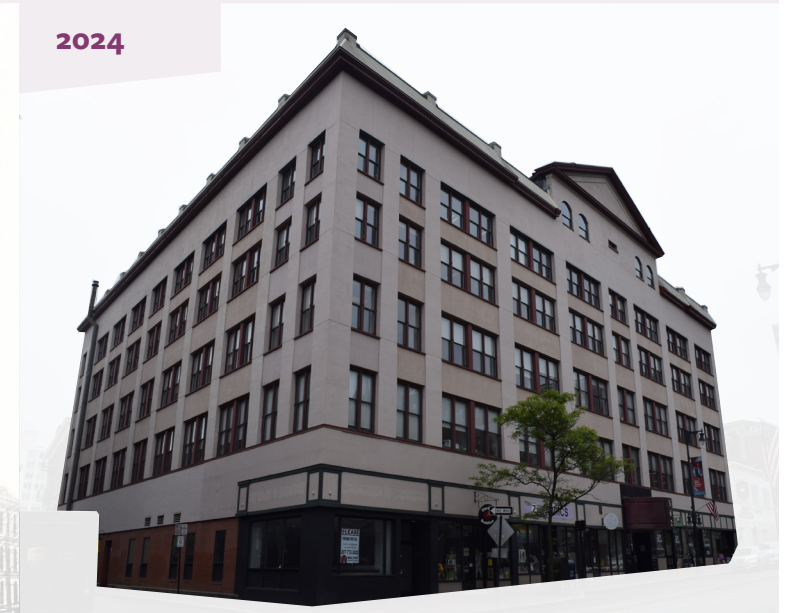
1894

The Baxter Memorial Building was heavily altered in 1954. The remodel involved removal of many decorative details, including a corner turret and reconfiguration of windows. Given the loss of so much detail and character, the building is noncontributing.

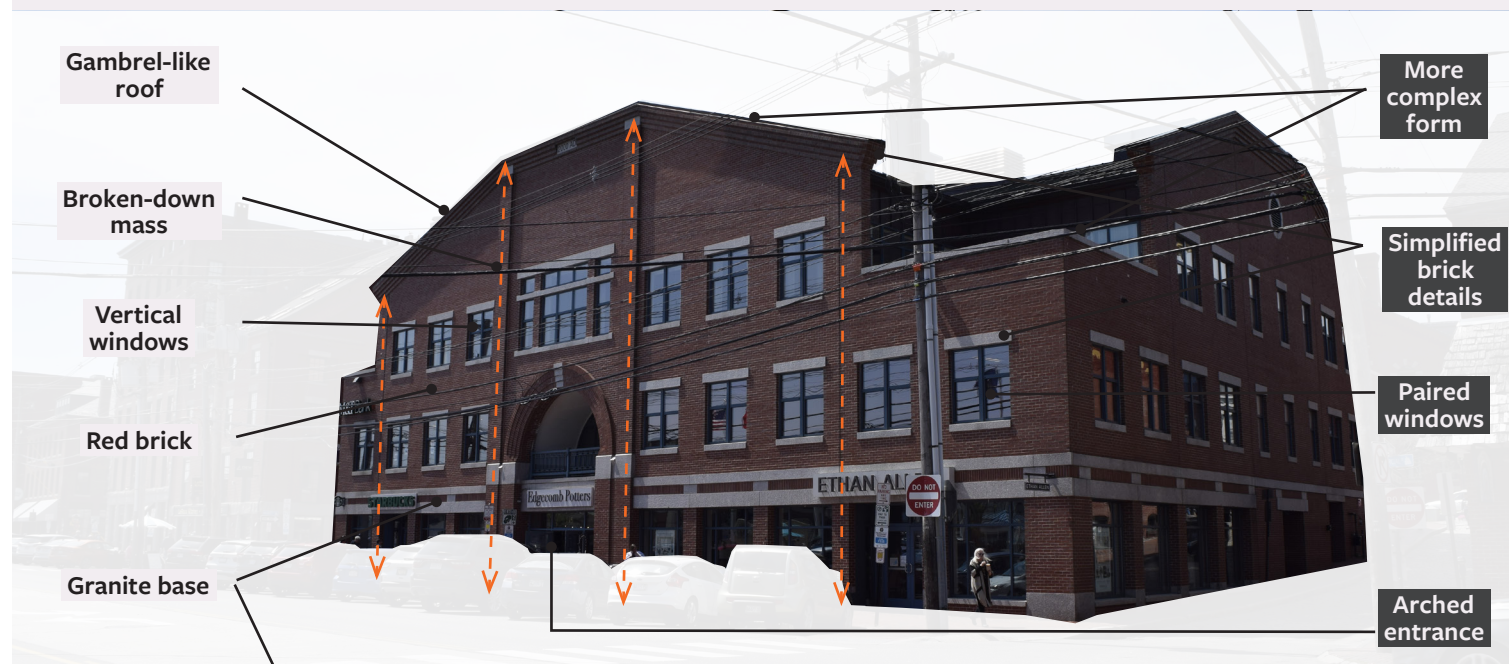
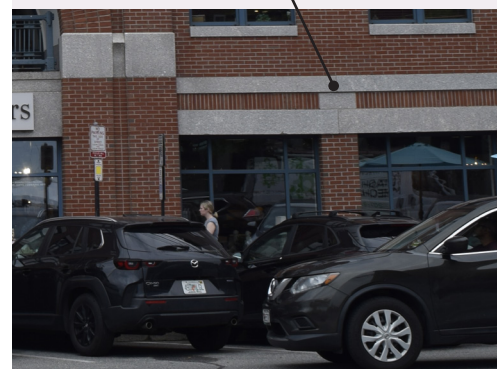
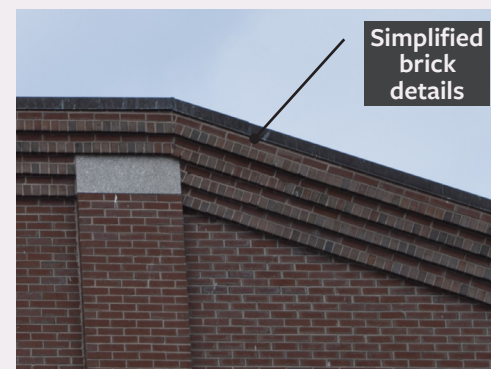
## 145 COMMERCIAL STREET (2000)

This project achieves compatibility through primary building materials of red brick and granite that strongly reference the surrounding context. A granite base, roof that references nearby gambrel roofs, and broken-down massing relate this larger building to nearby buildings. Vertically oriented windows with traditional headers and sills also relate to nearby historic buildings.

The design uses simplified details, paired windows, and an exaggerated arched entrance to help differentiate it from nearby historic buildings. Additionally, the slightly more complex form, which helps breakdown the building's scale, helps distinguish it.

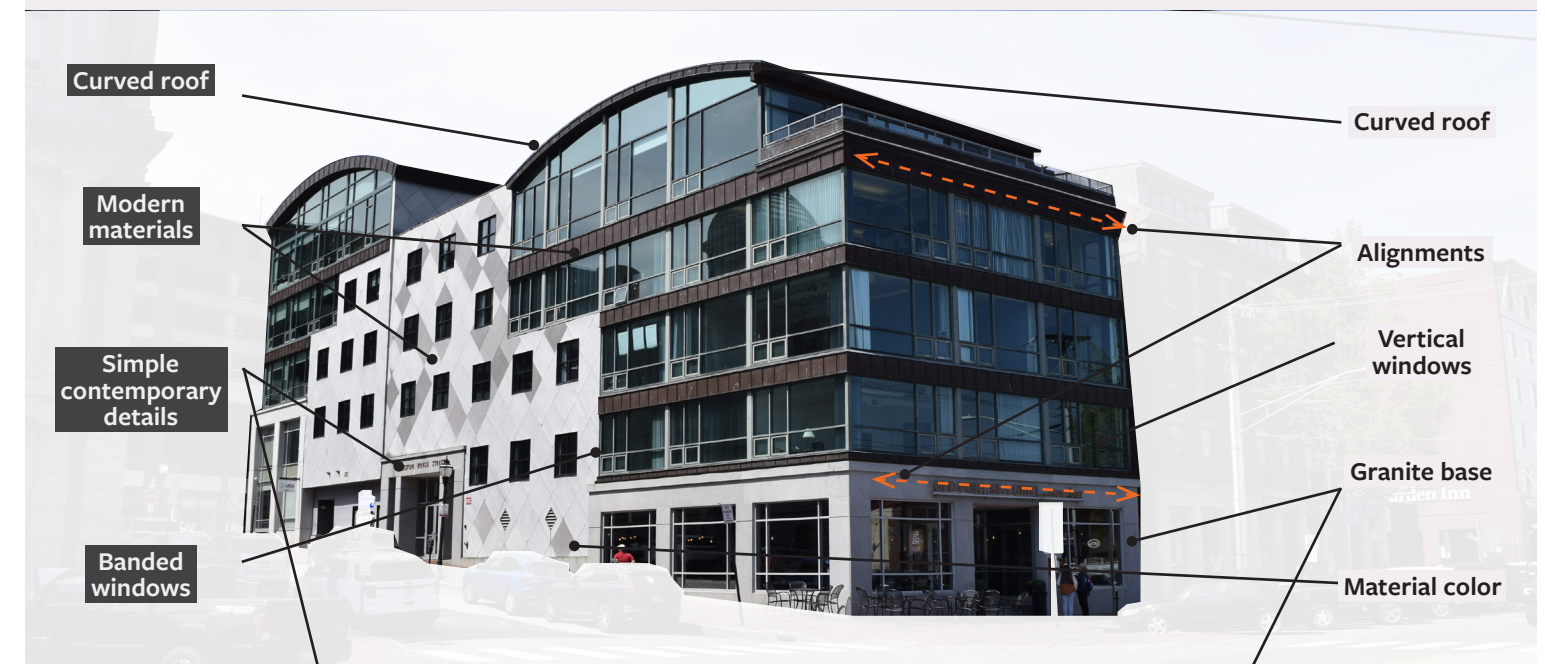
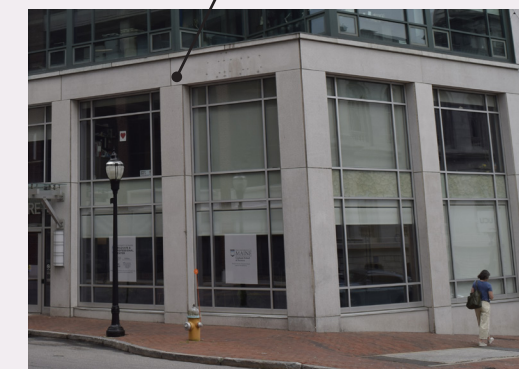
## 300 FORE/93 COMMERCIAL STREET (2007)

This project achieves compatibility through alignment of floors and cornices with adjacent buildings, a compatible width, an abstracted roof form, and the use of granite as a contextual material close to the sidewalk. While the windows are banded, they are generally broken down into vertically-oriented units. The color of the fiber-cement board paneling is also a play on the adjacent U.S. Custom House.

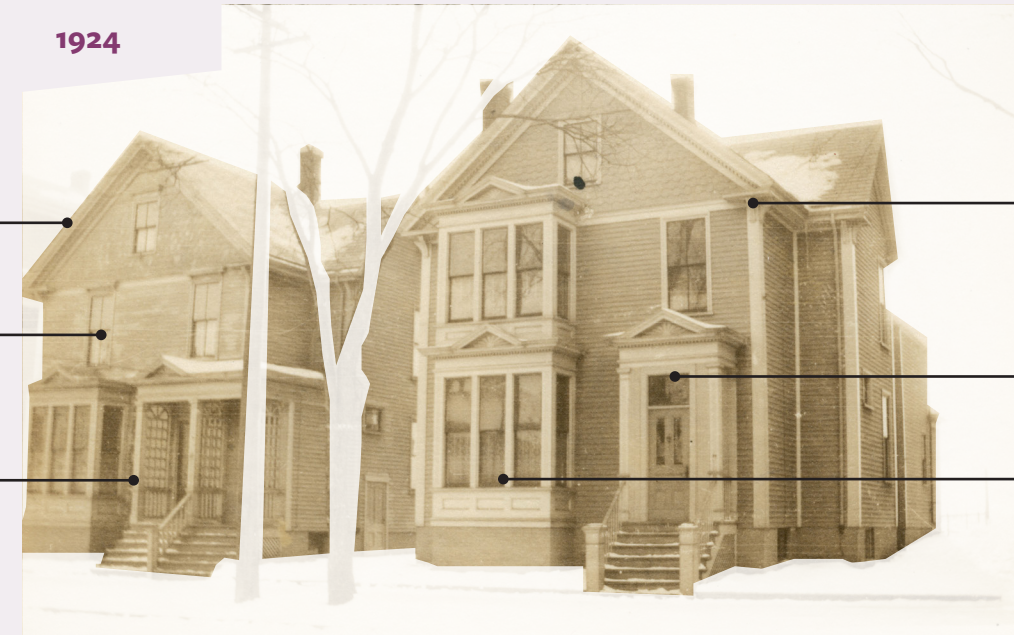
1924

34 North Street is largely intact, to its historic appearance, retaining its original trim details, front porch design, and a window configuration.

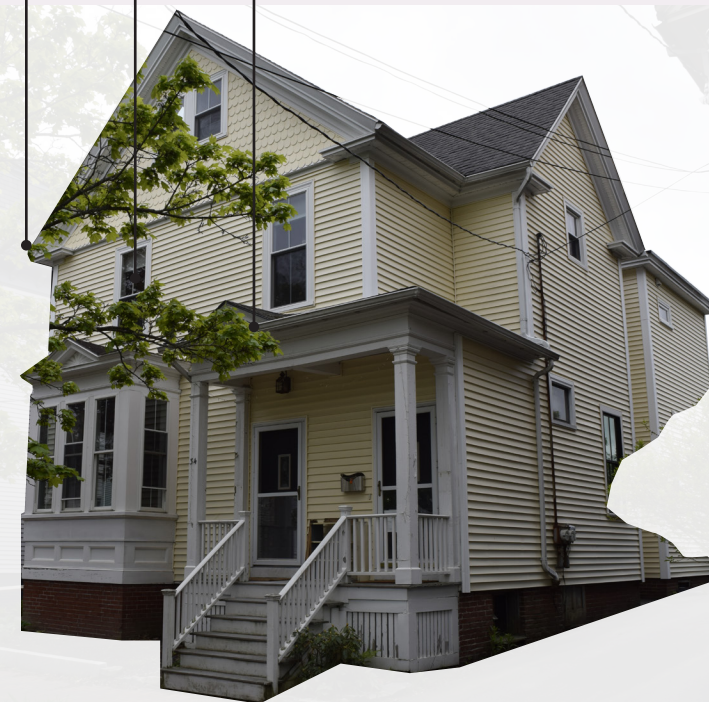
2025

36 North Street has experienced alterations to the window pattern at the first floor bay, removal of the decorative entry vestibule, and reduction in the size of a prominent second story window.

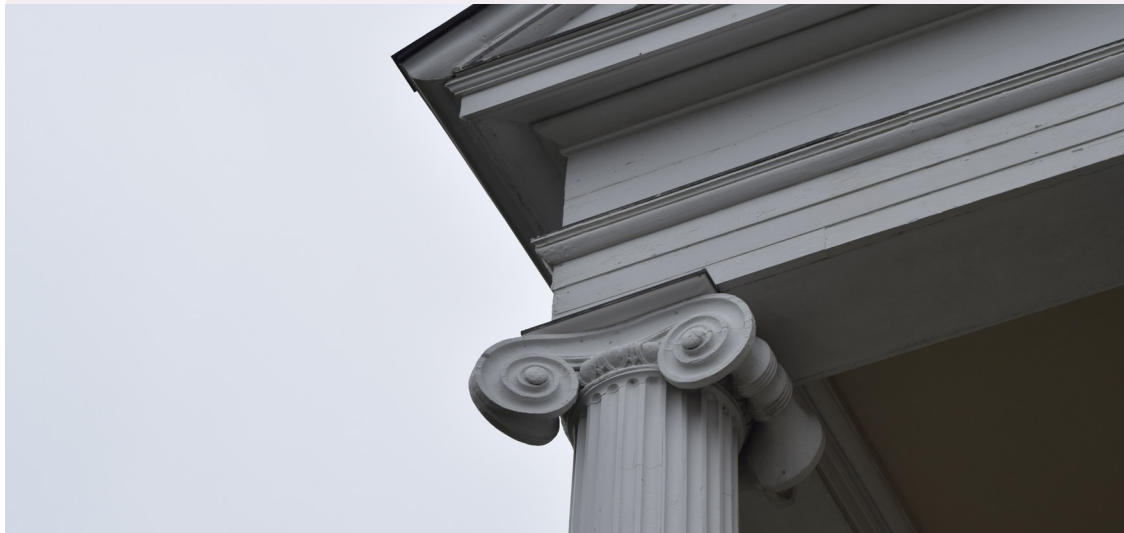
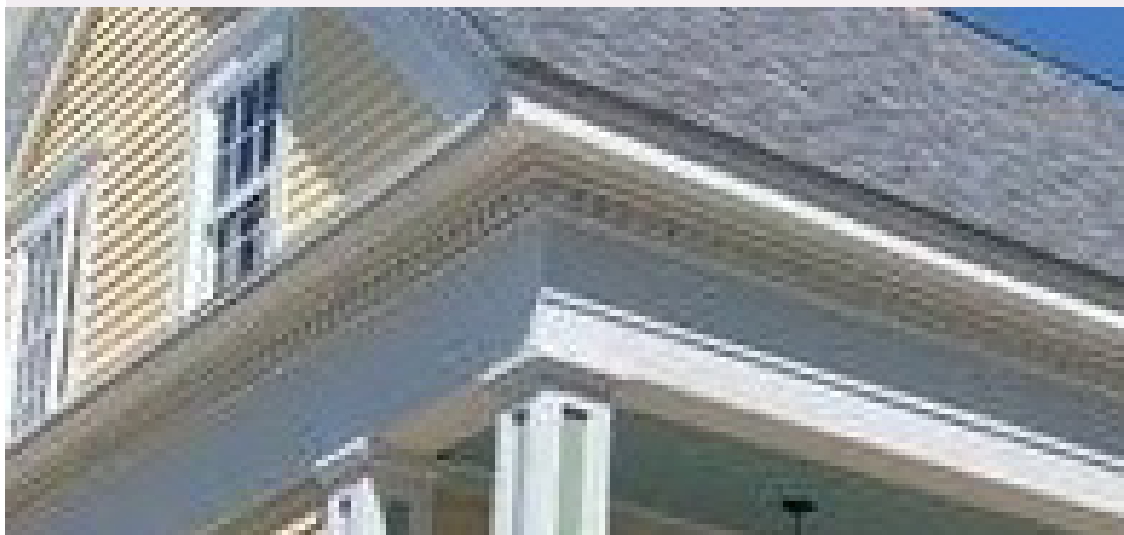
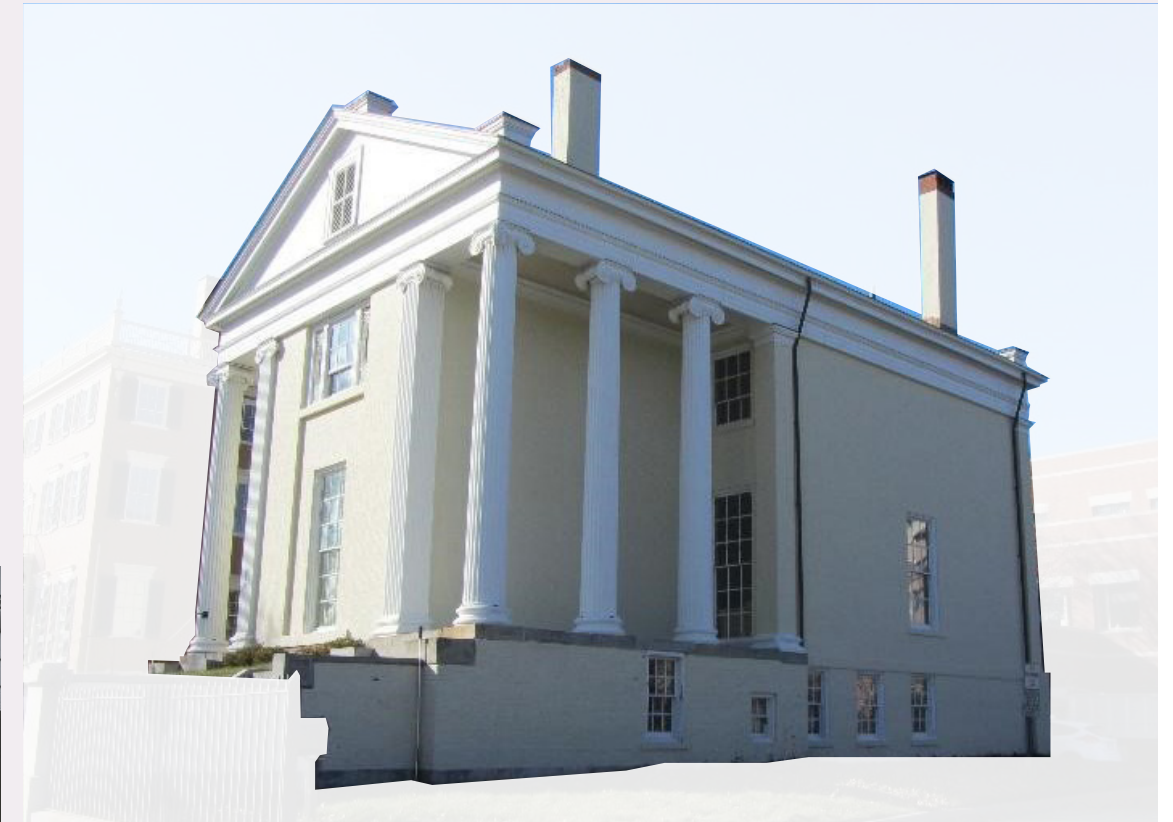
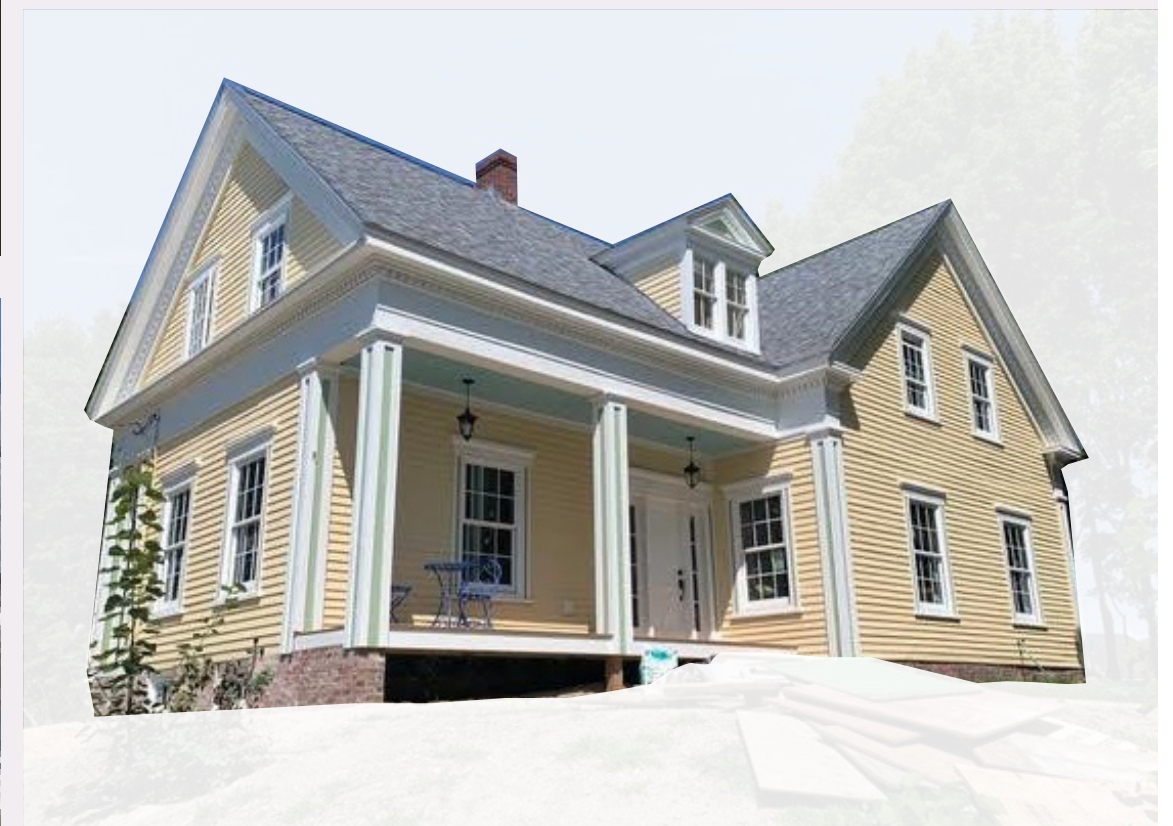
The Charles Q. Clapp House (97 Spring Street) constructed in 1832 (left), and the Margarett Emerson House (99 Capisic Street) constructed in 1848 (right) are two examples of the Greek Revival architectural style, respectively representing the high-style and the vernacular. The buildings are remarkably similar in plan and form with pronounced temple fronts supported on symmetrical inset porches. However, they are substantially different in the complexity of their details. The high-style Clapp House features intricately carved fluted ionic columns, oversized nine-over-nine windows, and beautifully carved foliate details around the central second story windows. The vernacular Emerson House features much more subdued square columns and simple classical window hoods. Each embodies the previous owners' economic class and aesthetic sensibilities. The carefully carved details of the Clapp House speak to the wealth of the owner while the more modest moldings of the Emerson House reflect more humble means. Similarly, the older Clapp House was built during the rise of Greek Revival architecture's popularity, putting the owner at the cutting edge of taste, whereas the Emerson house shows an owner keeping abreast of a well-established style. It is the different qualities of each of these houses' representation of the Greek Revival style that help to tell their unique stories.
