## Historic Preservation Board

Topic: Historic Preservation Workshop and Public Hearing 11-19-2025

- i. Preliminary Review of Proposed Updates to the City of Portland Historic Resources Design Manual; City of Portland, Applicant. The Historic Preservation Board will hold a hybrid workshop to review draft updates to the City of Portland Historic Resources Design Manual. The current Historic Resources Design Manual can be found here: <https://www.portlandmaine.gov/496/Additional-Resources>

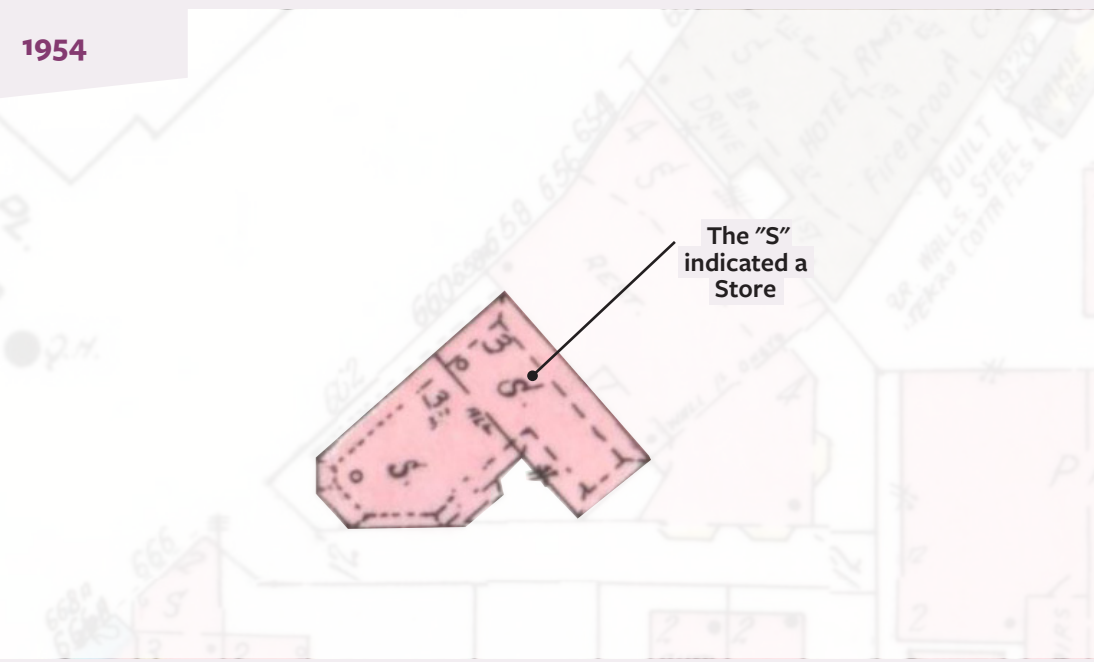
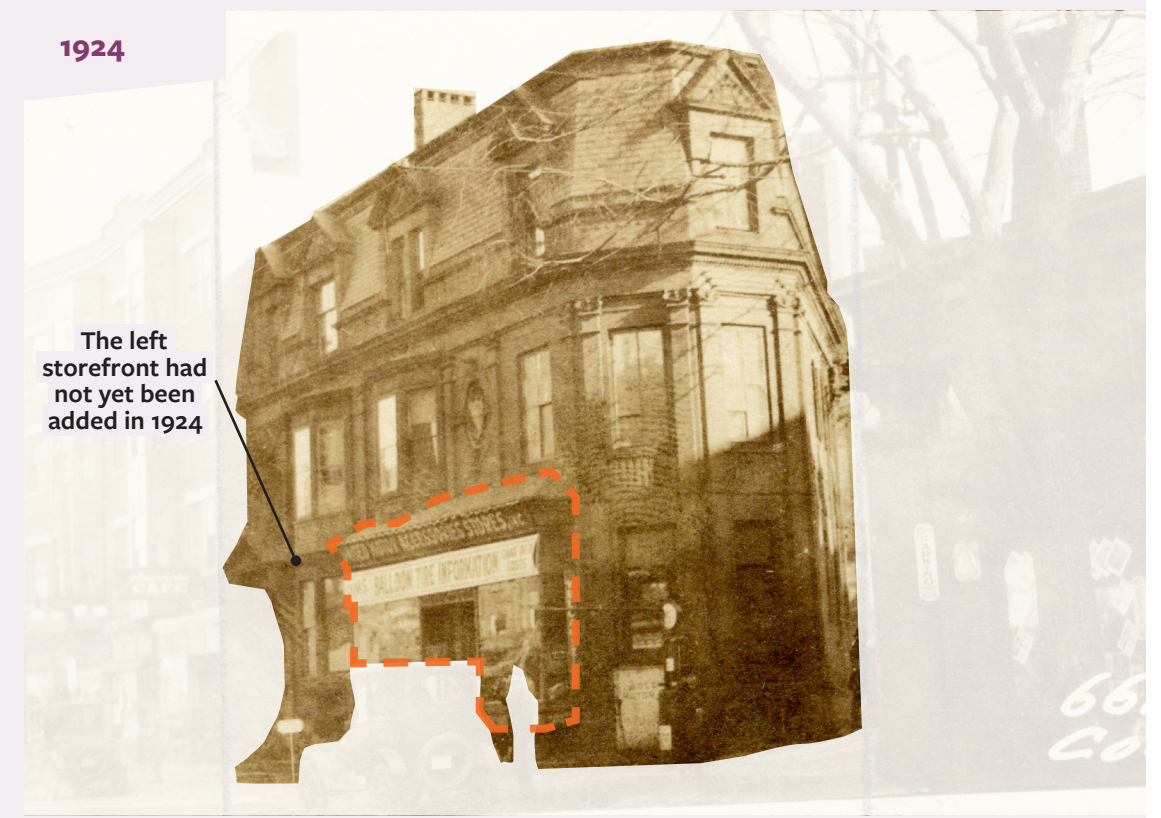
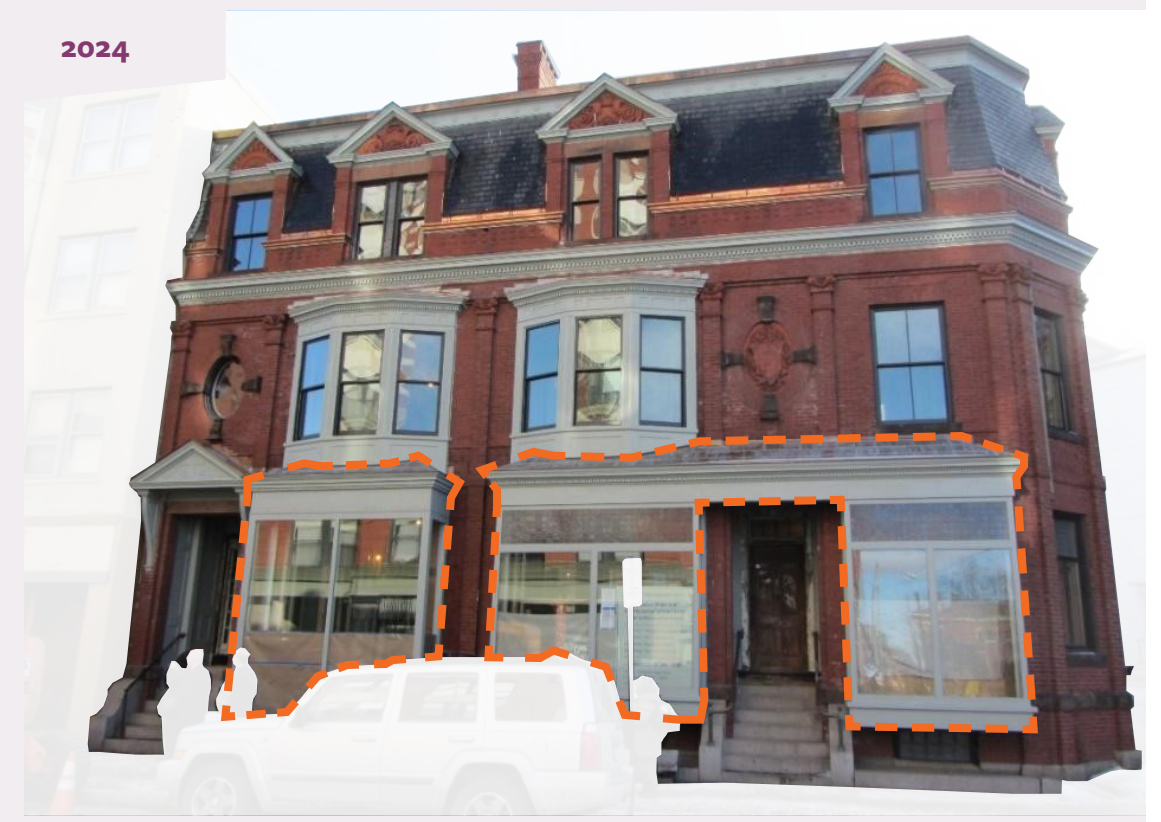
The George S. Hunt Block (1886, 660-662 Congress Street) was originally built as a pair of elaborate single-family homes. In the 1910s, storefronts were added to accommodate a commercial use at the first floor. These modifications represent the evolution of Congress Street from a primarily residential neighborhood to a commercial corridor. Although the storefronts were a major change to the structure, they were executed in high quality materials, and designed such that many of the details of the original structure are still visible and prominently displayed. No photographs of the building prior to the storefront alterations, and the building has existing in largely this form for over 100 years.

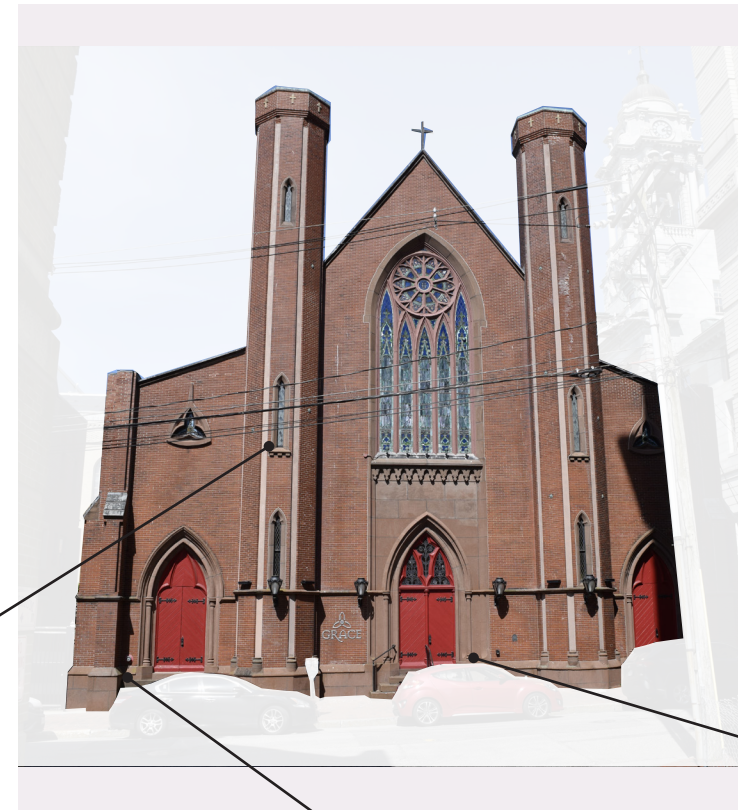
The former Chestnut Street Methodist Church (15 Chestnut Street) has a number of significant exterior features including decorative brickwork, leaded stained glass windows, and carved brownstone details.

As part of an extensive rehabilitation of the property, the condition of each element was assessed and the most appropriate treatment of repair or replacement was selected.

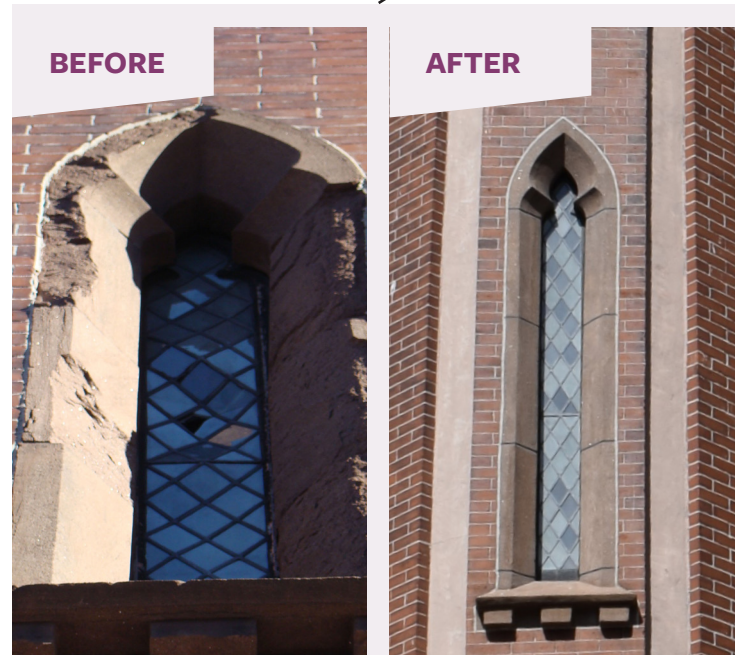
A number of the former church's leaded stained-glass windows were damaged with broken glass and failing leading. Given the distinctiveness of the windows and the amount of remaining glass, it made the most sense to repair rather than replace the windows.

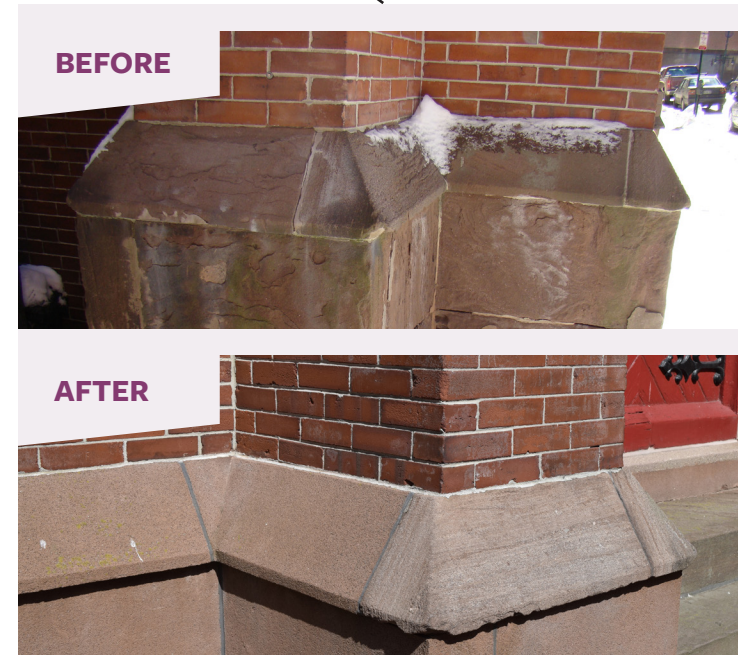
Brownstone is a very soft stone, susceptible to weathering, and the loss of details. Where deterioration was limited, an appropriately formulated patching compound or small dutchman repair was used to make the stones whole again.

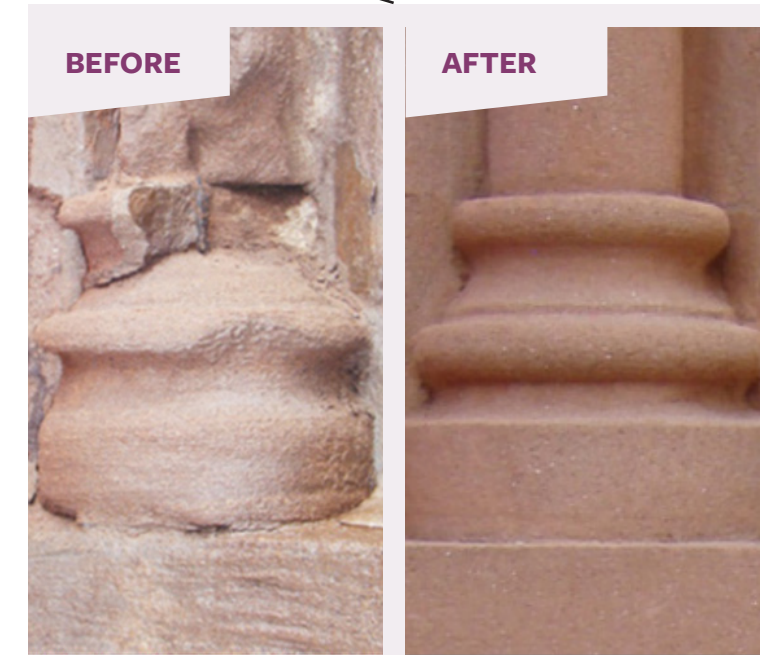
In other, particularly worn areas, the masonry was restored by creating new cast stone pieces, carefully matching the profiles, color, and texture of the original stone.

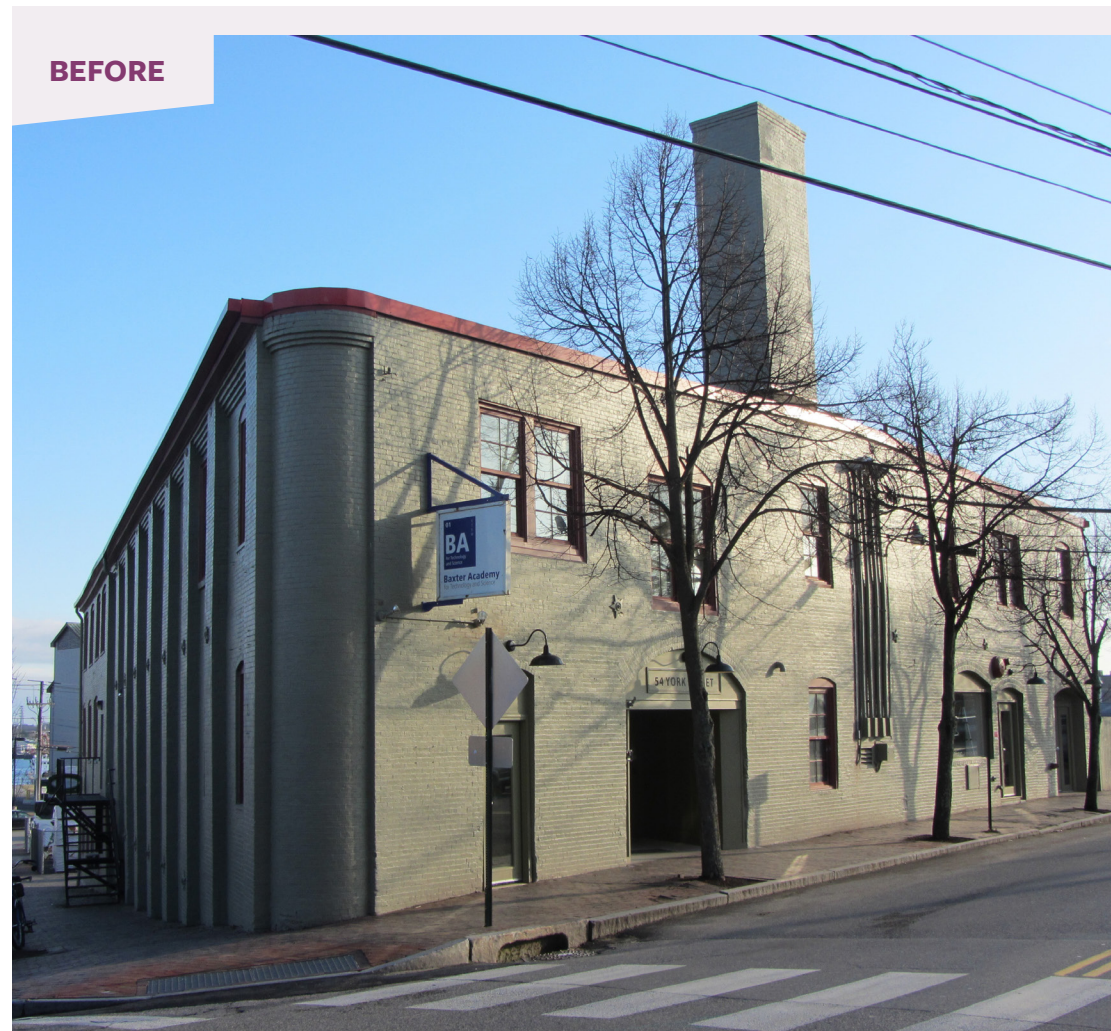
BEFORE

Painted masonry can be a challenging for property owners, especially when the paint is not formulated for use on masonry. At the former industrial building at 54 York Street, decades of inappropriate paint were negatively affecting the appearance and condition of the historic masonry. The owner decided to restore the masonry by removing paint.

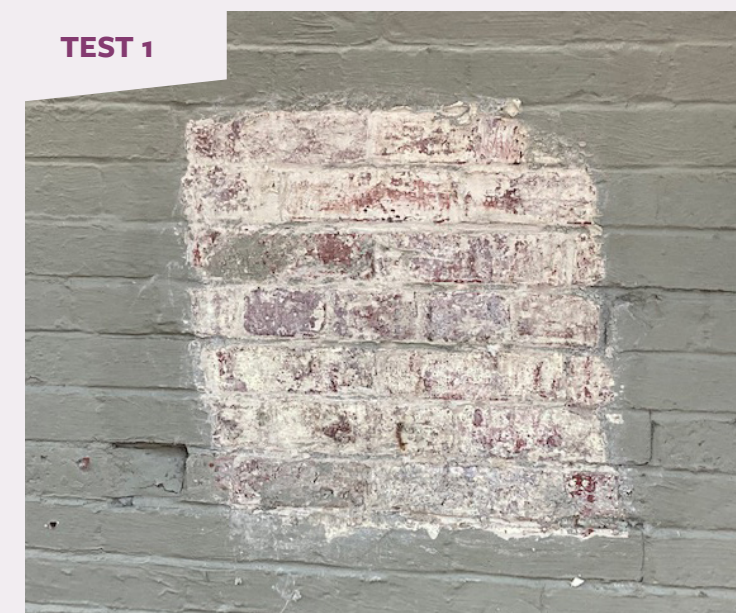
TEST 1

Different products were tested on discrete areas to ensure that the paint removal products would not damage the masonry while achieving the desired cleaning effect.

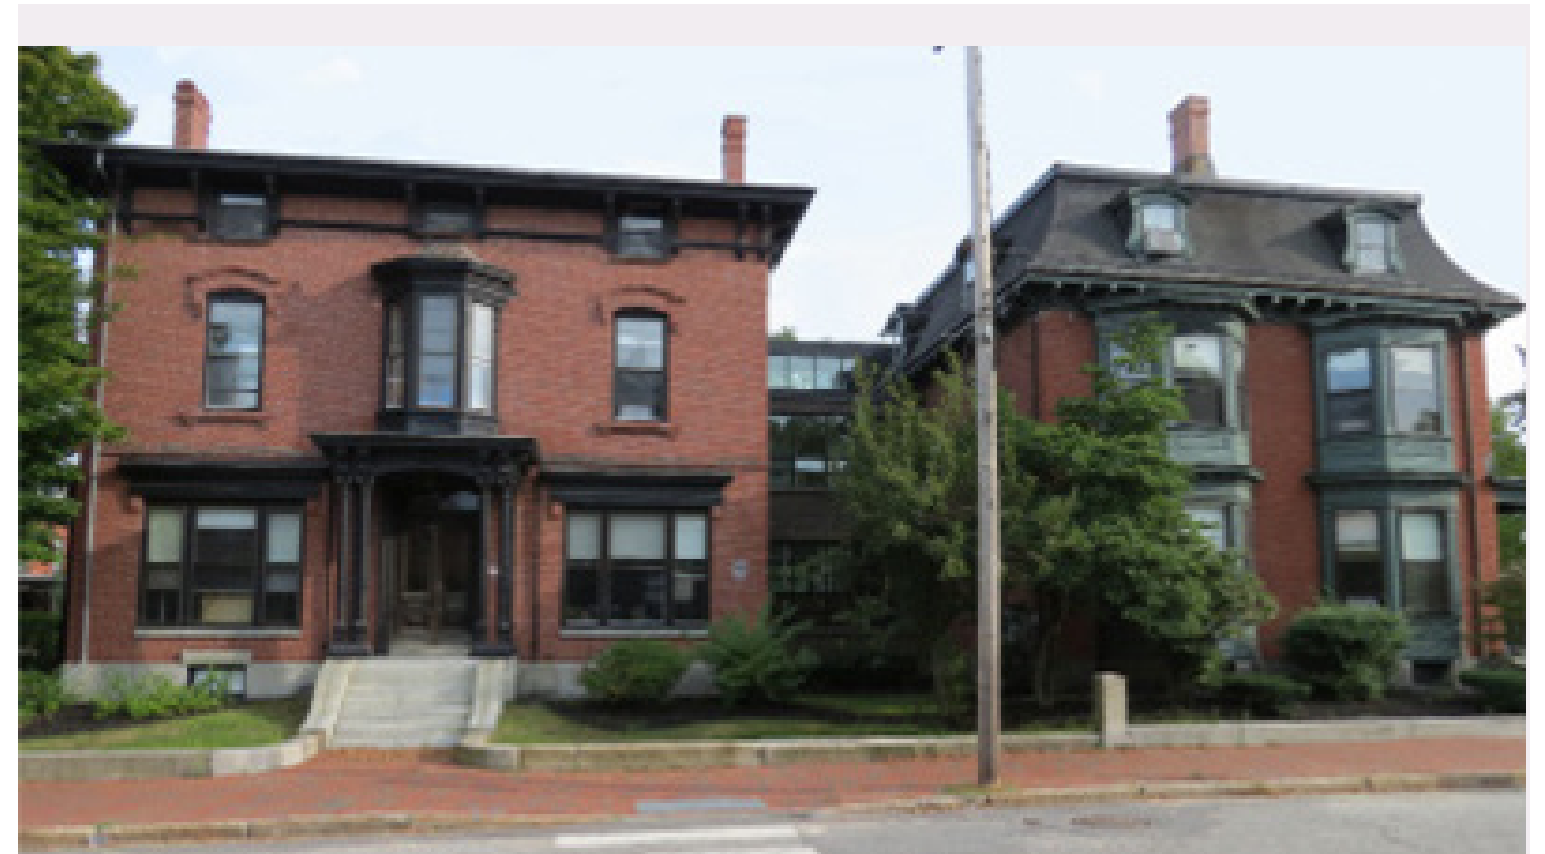
The Seth C. Deyer House (1867, 338 Spring Street, left) and the John Randall House (1860, 342 Spring Street, right) are now a part of the Waynflete School. As part of their rehabilitation to an academic use, a rear addition was constructed to connect the structures. This addition is set well back from the building facades and is recessive in design and color, allowing the two historic buildings to continue to read as separate structures. The addition also uses a higher proportion of glass and simple contemporary details to differentiate itself from the more solid and ornate historic structures.

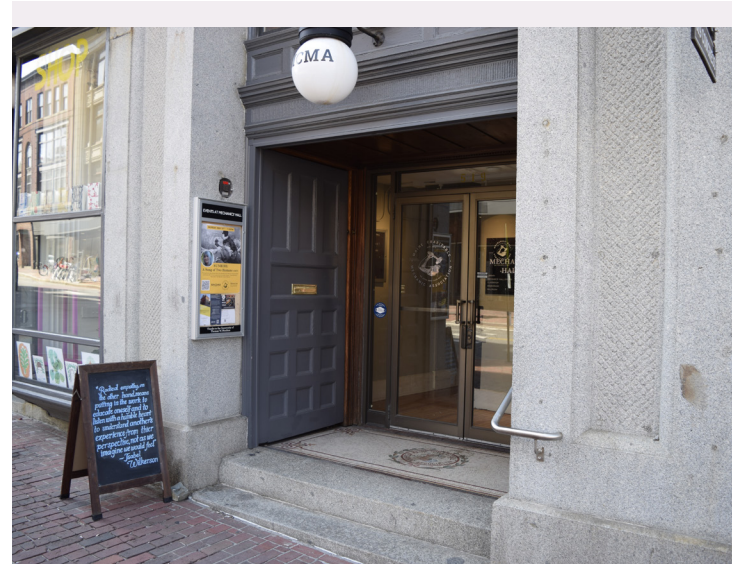
When a new air-lock entry was needed to improve the functionality of the main entrance at Mechanic's Hall (1857, 519 Congress Street), it was constructed inside the building, leaving the original wood paneled doors intact. The wood doors remain visible when open, and are pulled shut after business hours.

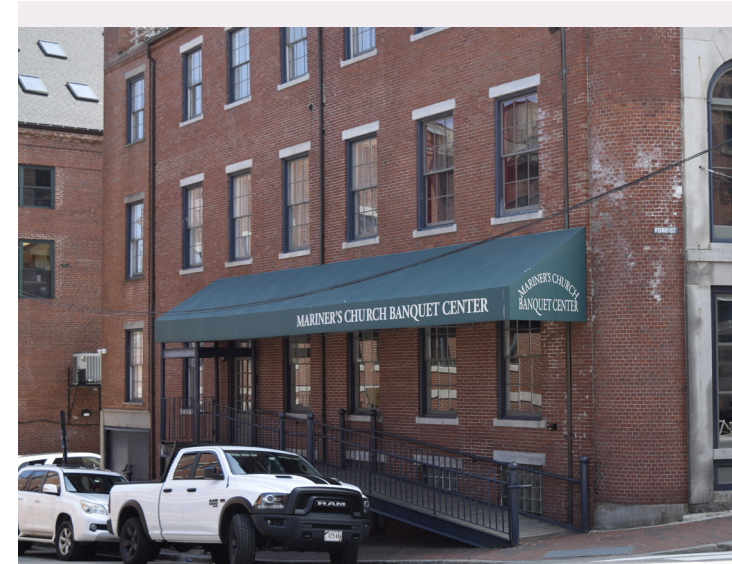
At the Mariner's Church (1828, 366 Fore Street) a new accessible means of entering the building was required. A new metal ramp was designed to be installed along the side elevation. The ramp was built with its own structure system, minimizing the points of connection to the historic structure. The ramp could easily be removed should a better accessibility solution be developed.

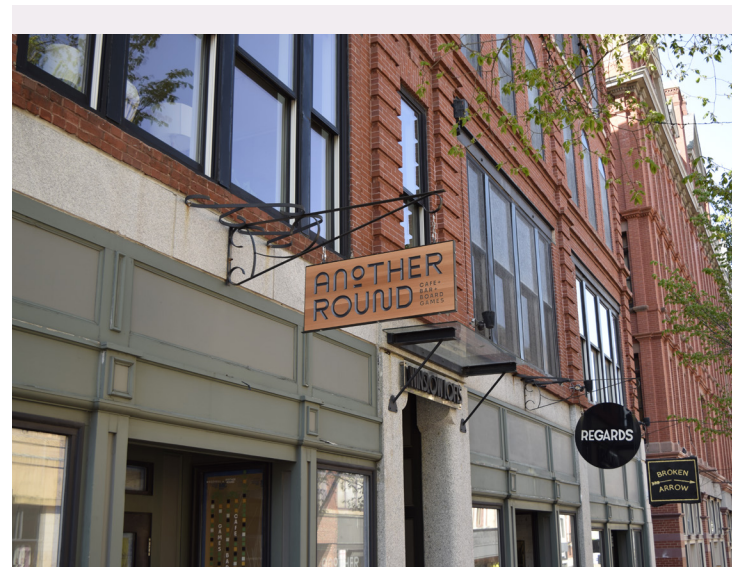
At 549 Congress Street (1880) durable brackets were installed that can hold a variety of sign types as the commercial tenants change over time. This approach minimizes damage to the historic masonry by only requiring replacement of the sign panel.

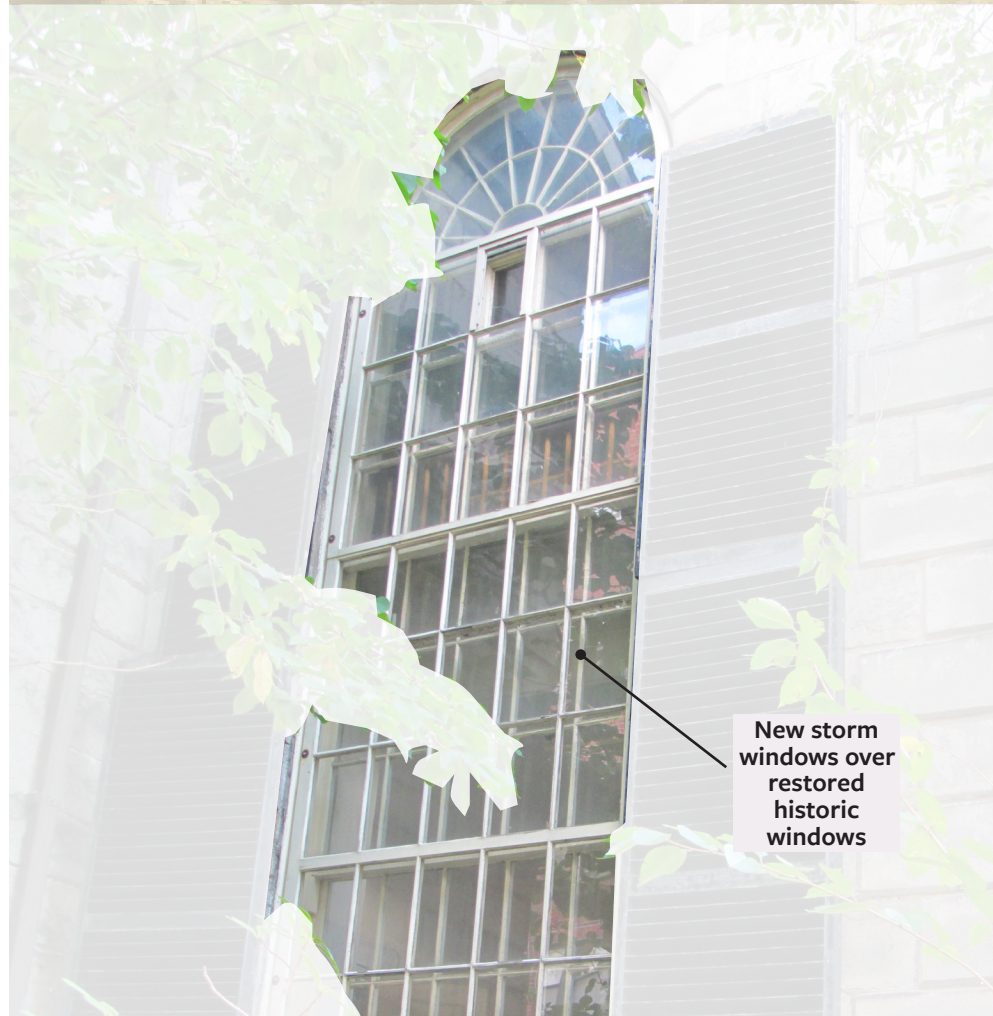
New storm windows over restored historic windows

- B** Character-defining windows have been retained.
- E** Distinctive windows have been retained.
- F** Historic windows have been repaired and protected using new storm windows.

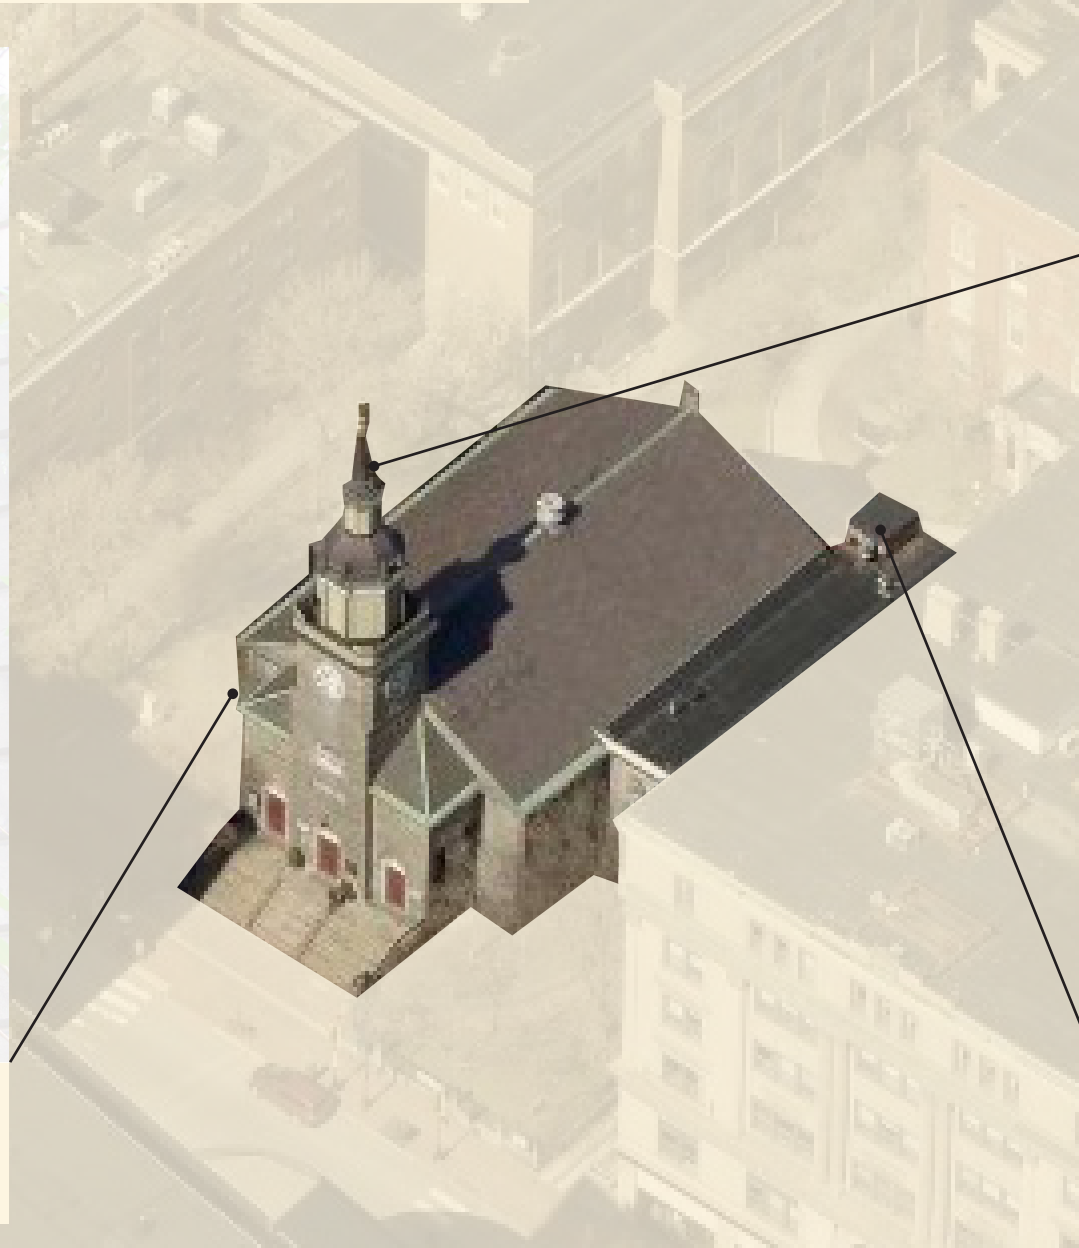
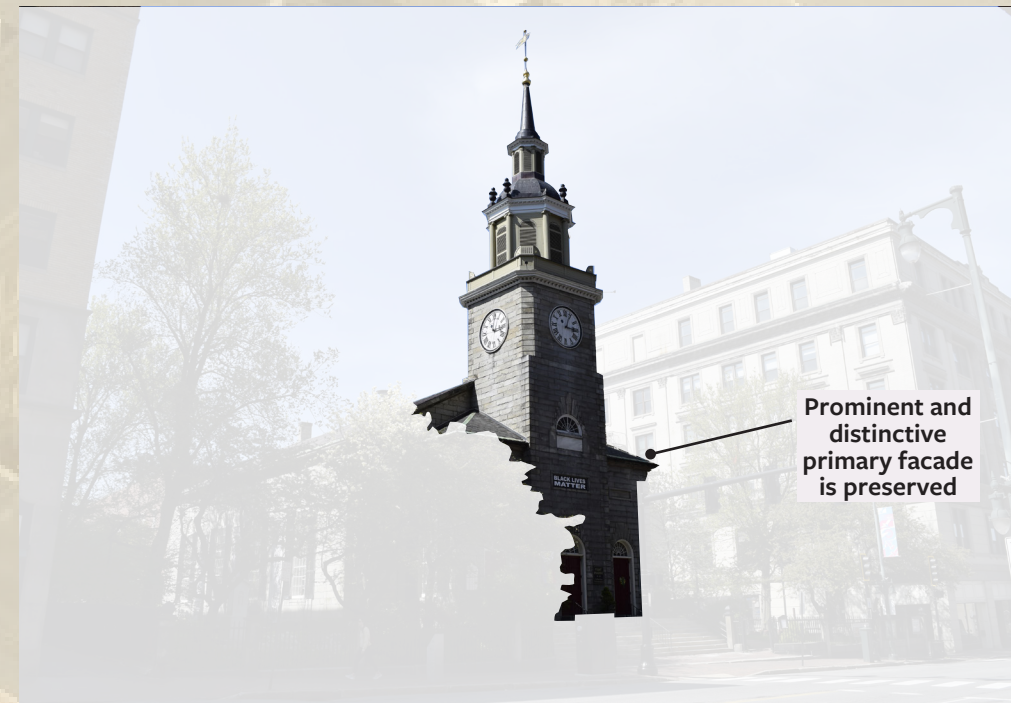
Prominent and distinctive primary facade is preserved

- E** The distinctive primary elevation of the church was preserved.
- I** Necessary additions were made at the rear to avoid destroying prominent features.

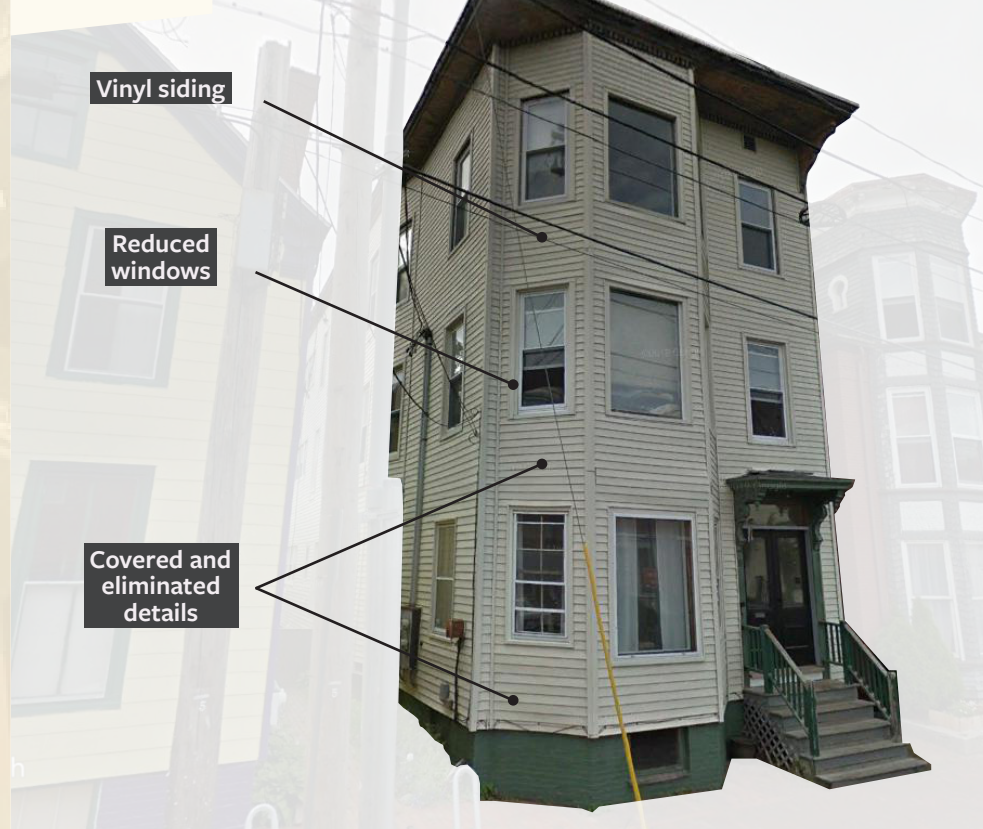
**B** The vinyl siding had covered over many historic details and several window openings were altered in size.

**F** Existing historic features were repaired rather than replaced. Missing features were recreated based on documentation.

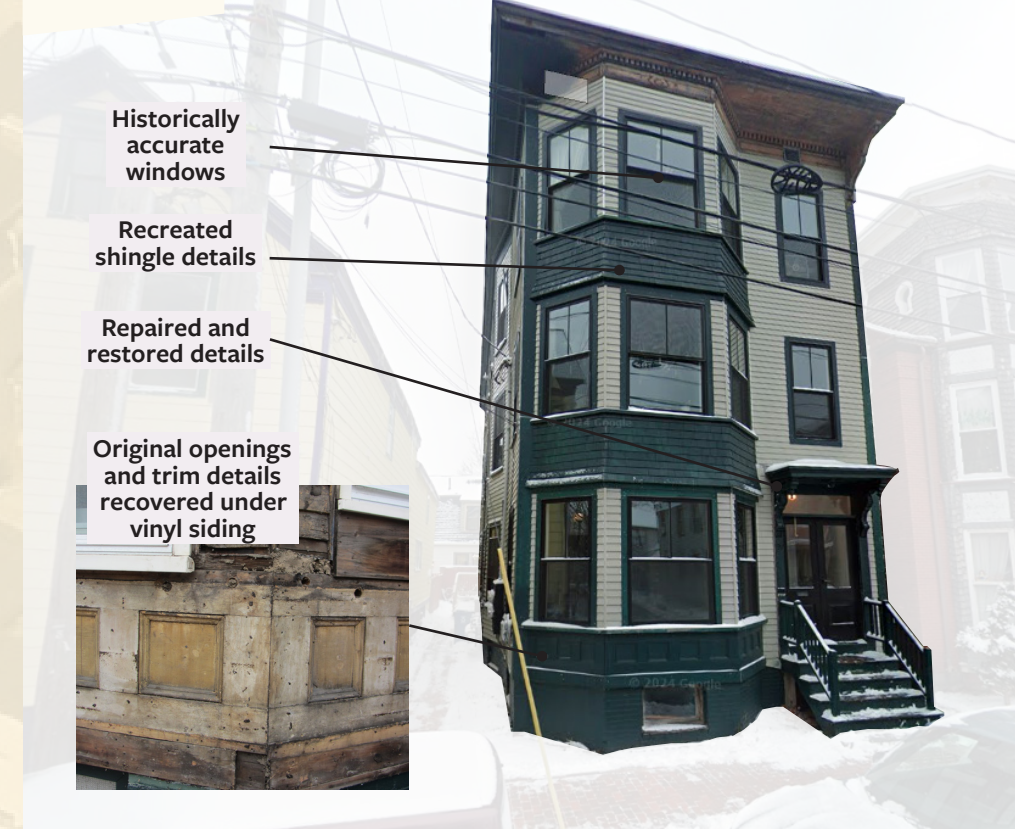
**B** Several historic features that were uncovered were retained.

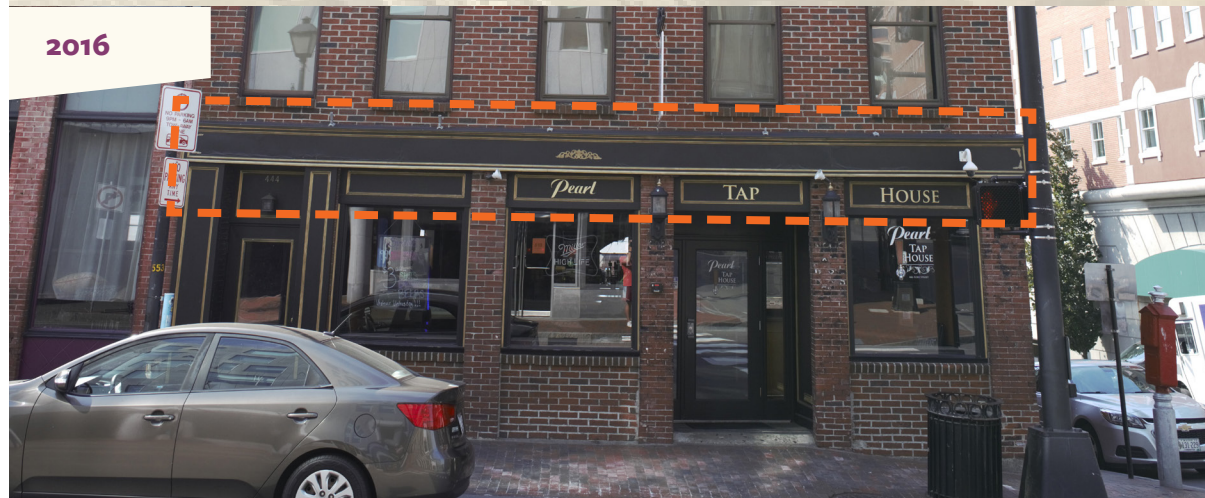
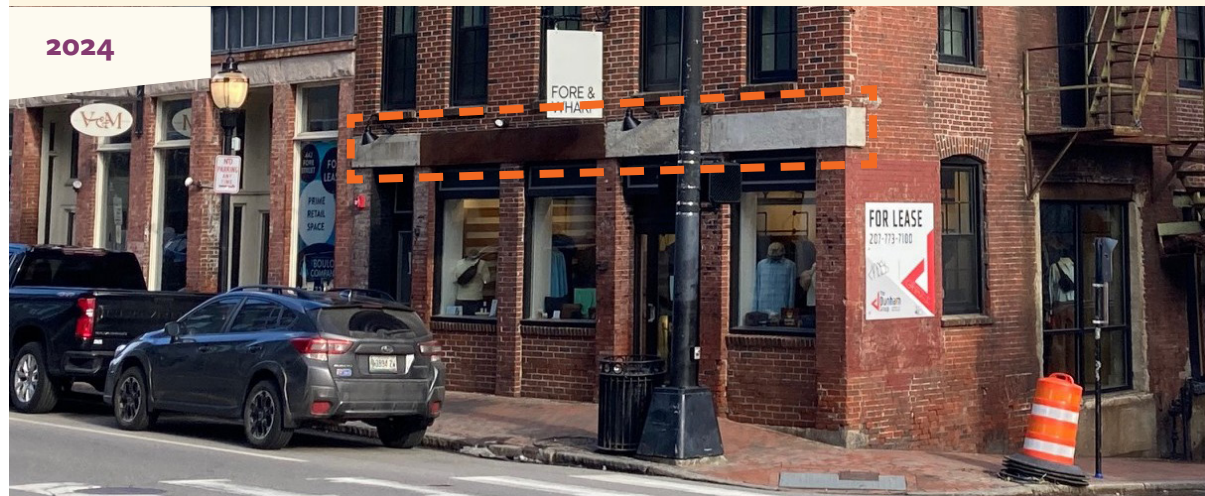
At the Rufus Dunham Block, a faux-historical sign band of painted and gilded wood was installed above the storefront. As part of an exterior rehabilitation, this non-historic feature was removed revealing a large original granite header. This historic element was left exposed, more closely matching the historic appearance of the building. Additionally, at the side of the building, where a large freight entrance had been punched through the side of the building in the mid twentieth century, simple contemporary glazing was used to fill the opening rather than a faux-historical six-over-six window. This approach makes clear that that opening is not an original feature of the building.

- B** Original granite was uncovered and retained.
- D** Faux-historical sign band and signs were removed to show original materials.

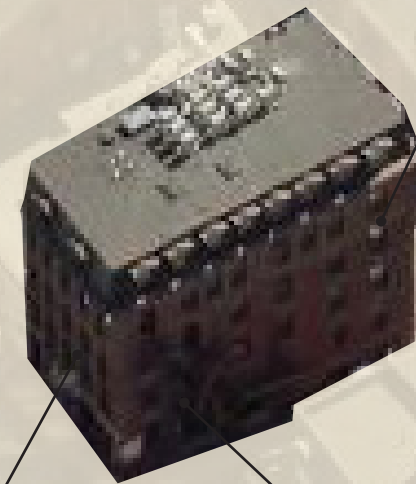
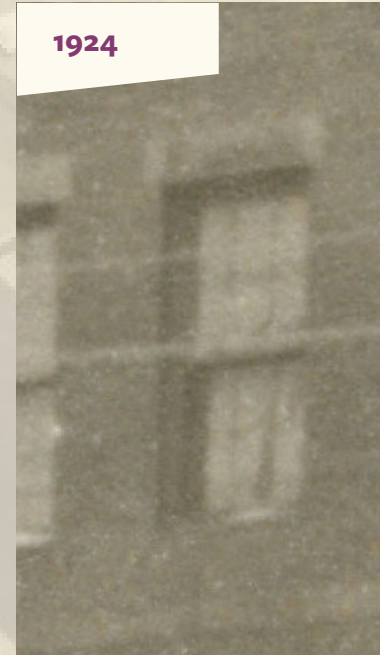
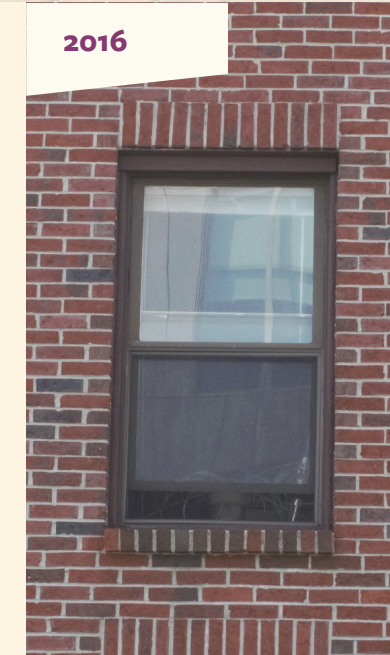
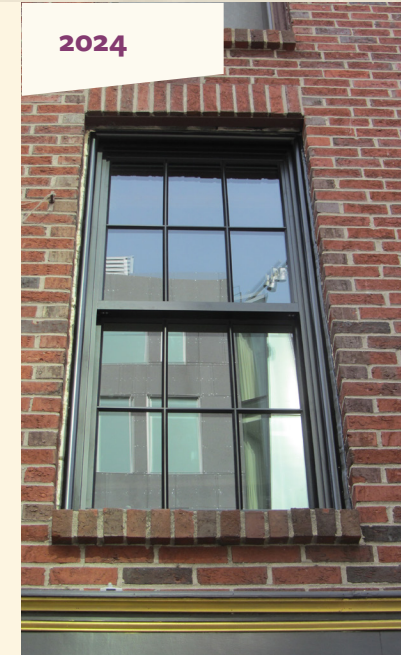
- C** Replacement windows were based on historic evidence.
- F** Replacement windows were based on historic evidence.

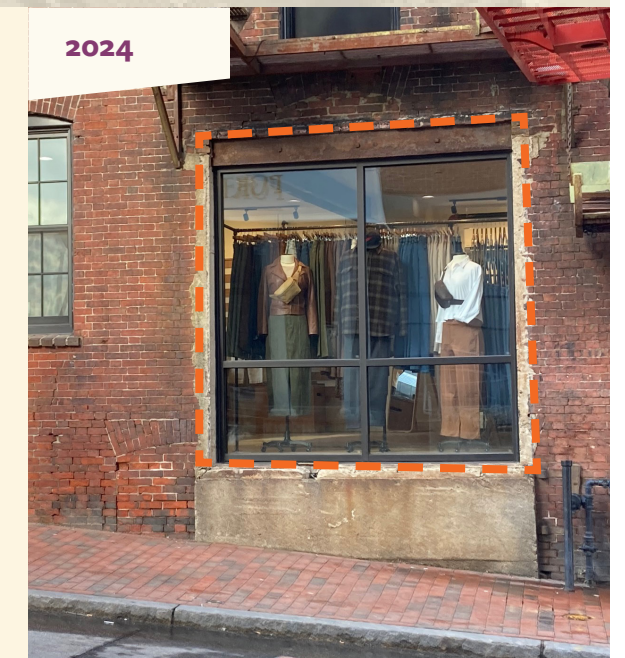
2024

- B** No existing historic features were damaged.
- I** A simple contemporary design was used for the infill.
- J** The contemporary window could easily be reversed.

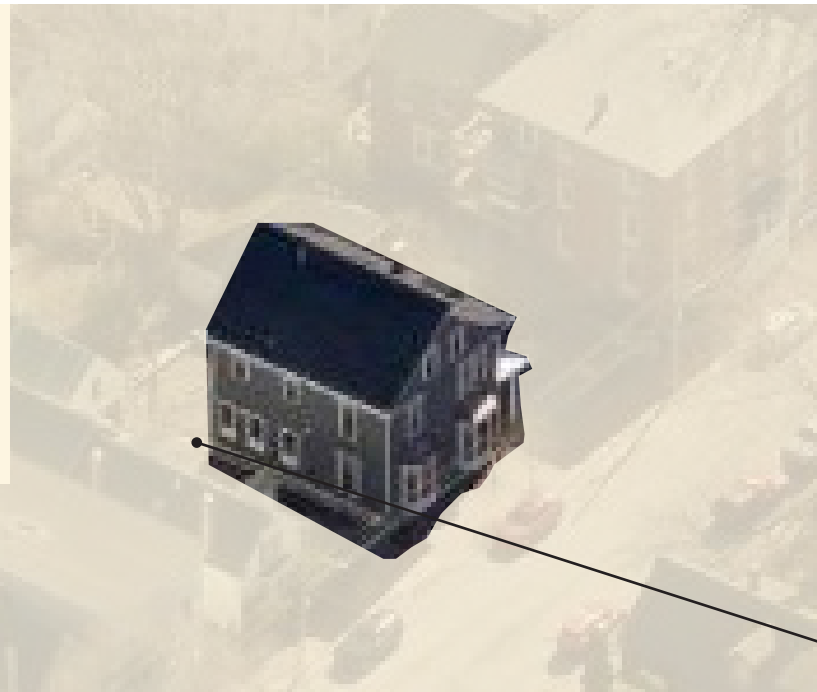
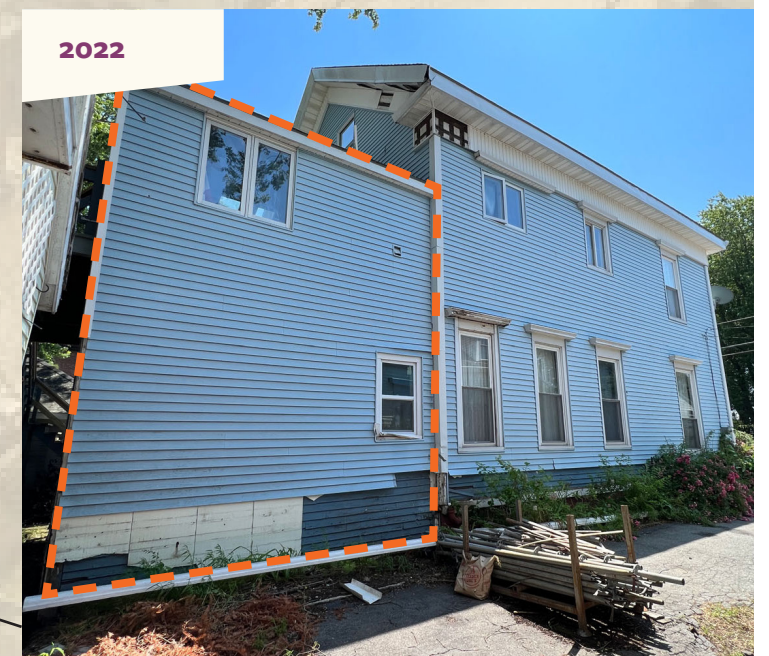
2022

**B** The rear el was found to not be historically significant due to a lack of distinctive features, altered openings, and limited visibility from the street. It was approved to be removed.

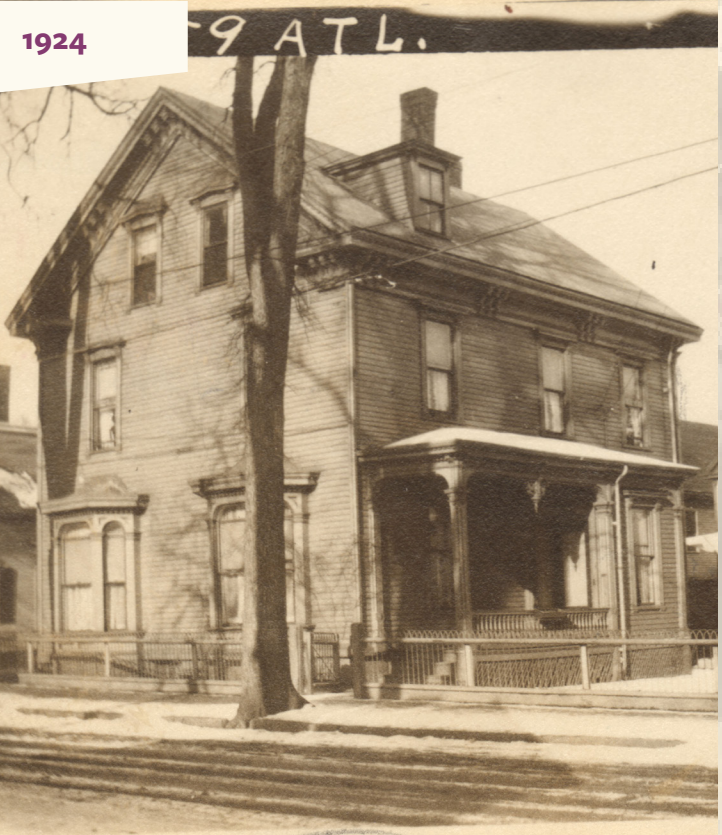
1924

**F** Historic photos and physical evidence were used to document the historic appearance of the building.

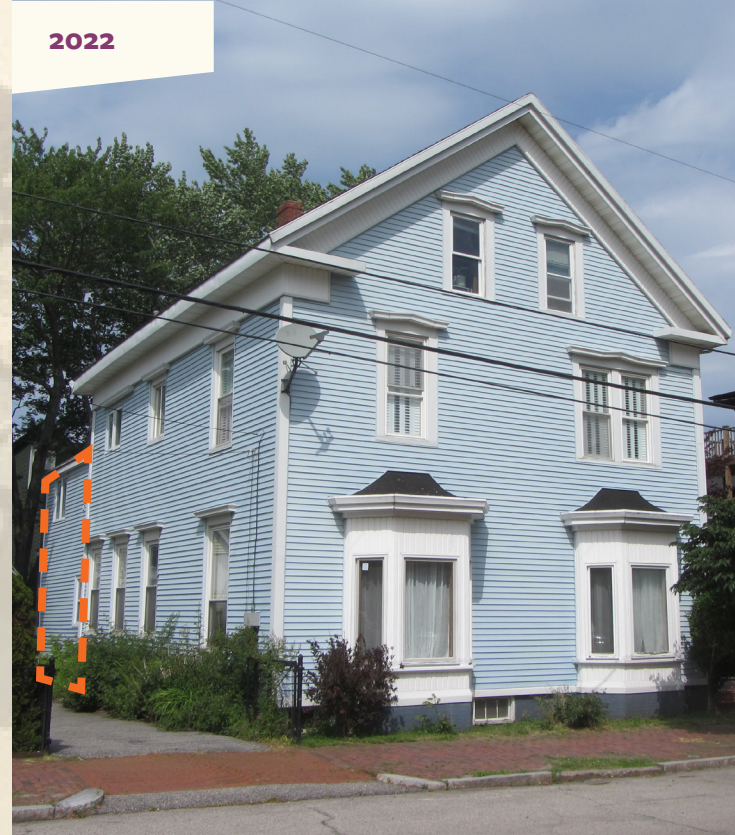
2022

**B** Vinyl siding had covered over many historic details.  
**E** The rear el was determined to not be historically significant and was approved to be removed.

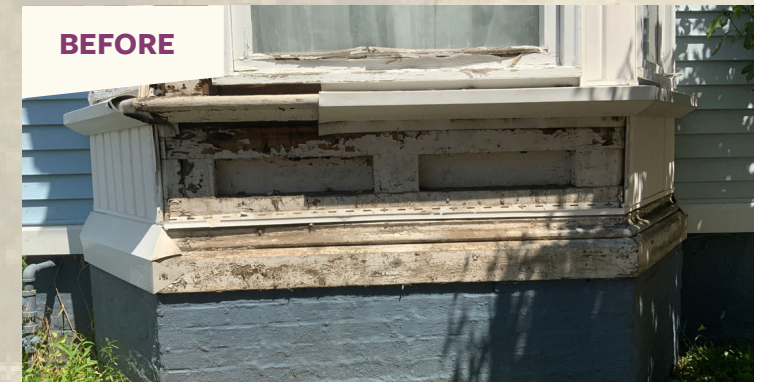
2024

**B** Several historic features that were uncovered were retained.  
**F** Existing historic features were repaired rather than replaced. Missing features were recreated based on documentation

At 59 Atlantic Street, the house had been completely clad in vinyl siding and aluminum flashing at some point before designation of the Munjoy Hill Historic District. As part of an extensive renovation, these non-historic materials were removed and the house was re-clad in fiber-cement clapboards a close visual match to the remaining historic clapboards found during removal of the vinyl siding. Additionally, removal of aluminum flashing revealed a number of original wood details including decorative corner boards, window hoods, and dentil cornices and arched windows at the front bays. These features were carefully restored as part of the project. Additionally, the applicants successfully argued to the Historic Preservation Board that a rear el, while having been present on the building for some time, lacked architectural character and historic integrity. The non-character-defining el was removed as part of an overall project.
