## Historic Preservation Board

Topic: Historic Preservation Workshop and Public Hearing 11-19-2025

- i. Preliminary Review of Proposed Updates to the City of Portland Historic Resources Design Manual; City of Portland, Applicant. The Historic Preservation Board will hold a hybrid workshop to review draft updates to the City of Portland Historic Resources Design Manual. The current Historic Resources Design Manual can be found here: <https://www.portlandmaine.gov/496/Additional-Resources>

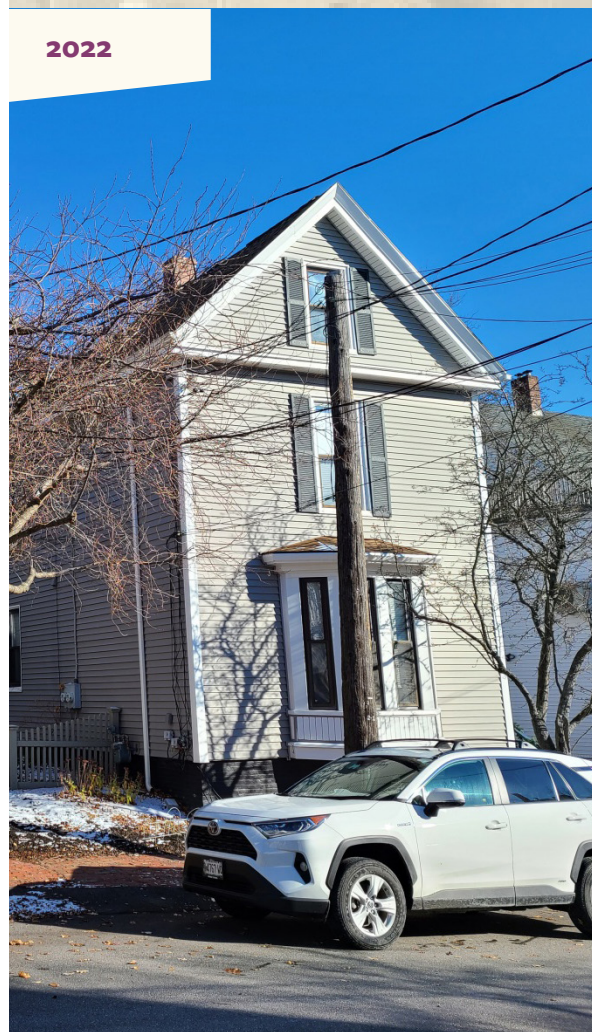
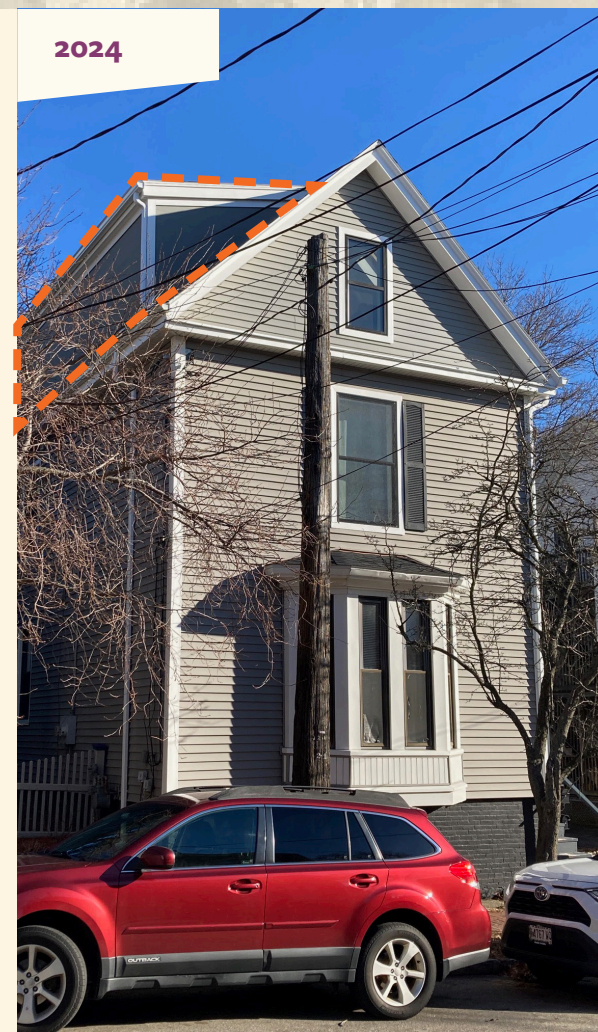
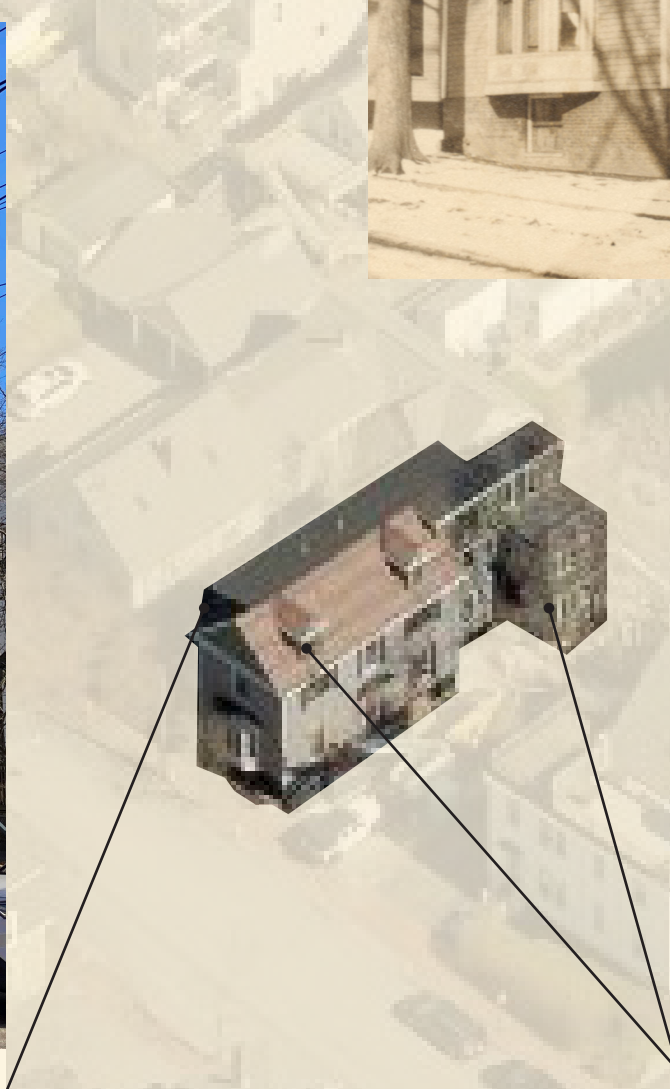
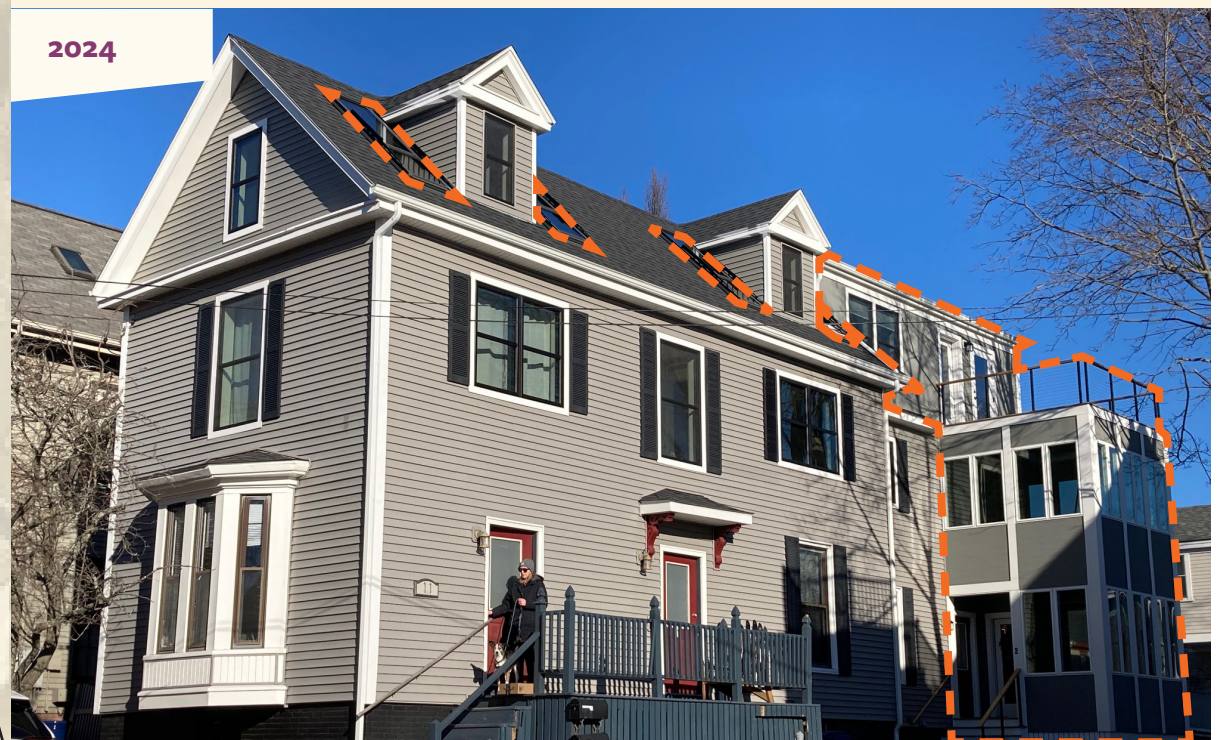
**WILLIAM H. WEEKS HOUSE**

At the William H. Weeks House, a dormer and side addition have been added to increase the occupiable floor area of the third floor. The dormer addition is setback from the street to respect the existing gable roof, while the side addition is set back from the main mass of the house. As part of the review, the pair of gabled dormers were retained as they are original to the house. In order to bring additional light, skylights were incorporated around the existing dormers.

- B** The new addition does not affect the front gable, leaving that historic feature intact.
- C** The new dormer is set back from the gable, allowing the original roof to remain legible.
- I** The dormer addition is compatible in its scale, but differentiated in its materials roof form.

- B** Original dormers and the overall form of the house were retained. Skylights do not alter the roof form.
- I** The rear additions are compatible in their placement, and differentiated through simple modern materials.
- J** The skylights and rear additions could be removed, leaving the original form of the house intact.

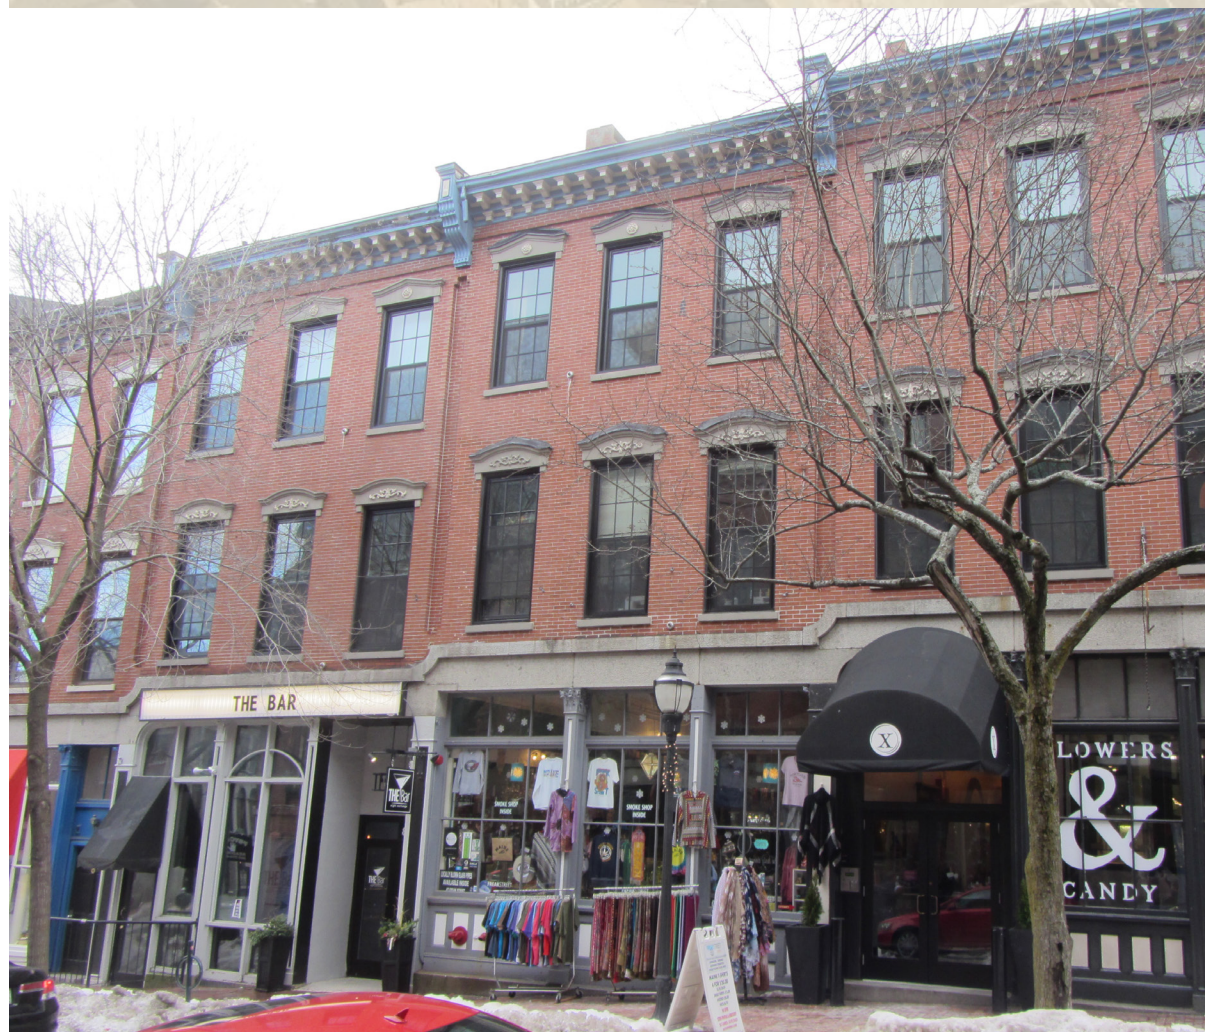
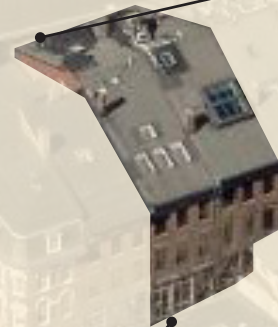
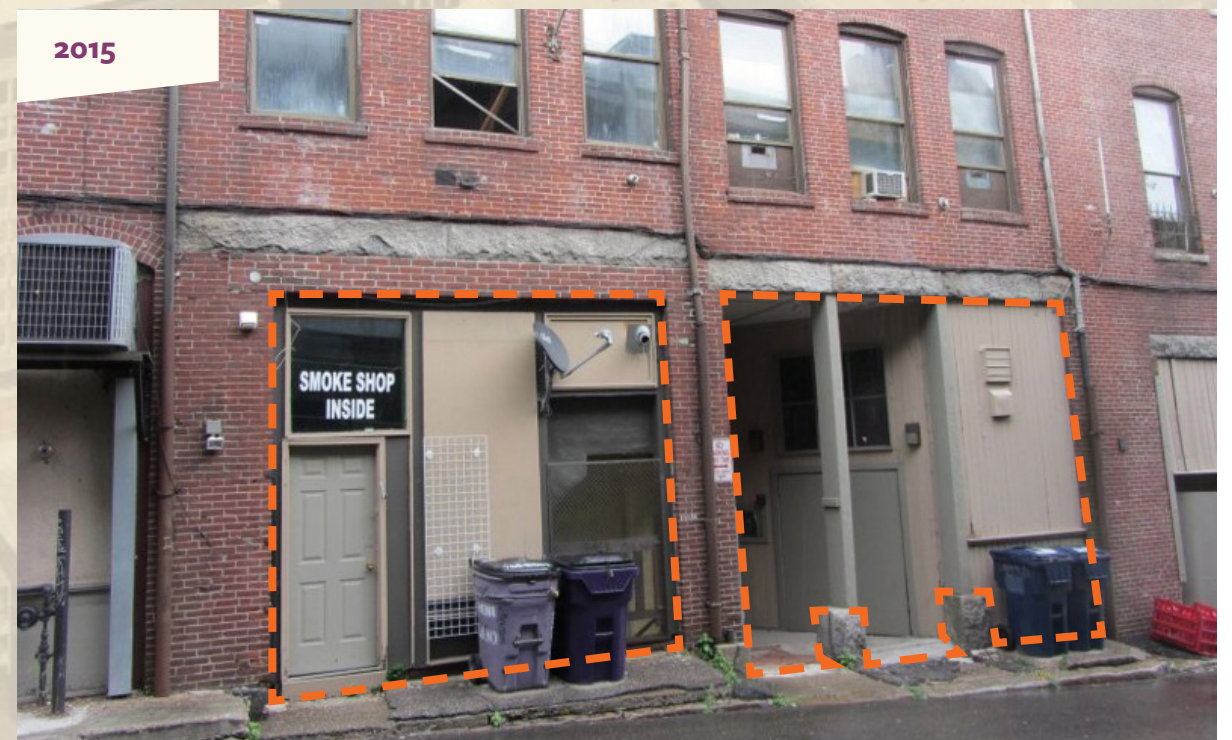
#### J. & C.J. BARBOUR BLOCK

At the Barbour Block, the first floor rear of the building, which faces onto the public alley of Fox Court had previously been heavily altered, making the area dark and unsightly. The owners wanted to improve the appearance of the rear of the building and bring more light into the commercial units. Working within the existing masonry openings, they removed a mixture of non-historic storefront, windows, and doors, replacing it all with a consistent modern storefront system. They also installed a pair of contemporary glass canopies to make the new entrances more welcoming and offer protection from rain and melting snow. The awnings were placed so as not to obscure the historic granite headers which were retained.

- B** The proposed sitework involved no changes to existing significant features.
- E** The alterations were concentrated at the rear of the building, away from the more distinctive features at the front of the building.

- B** No existing historic masonry or other features were removed or damaged.
- I** A simple contemporary design was used for the new storefront and canopies.
- J** The new storefront and awning could easily be reversed without damaging historic materials.

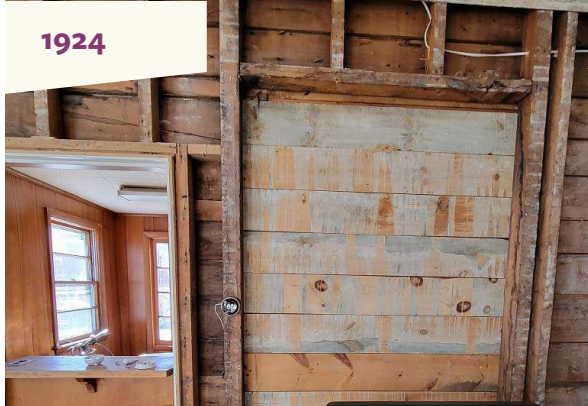
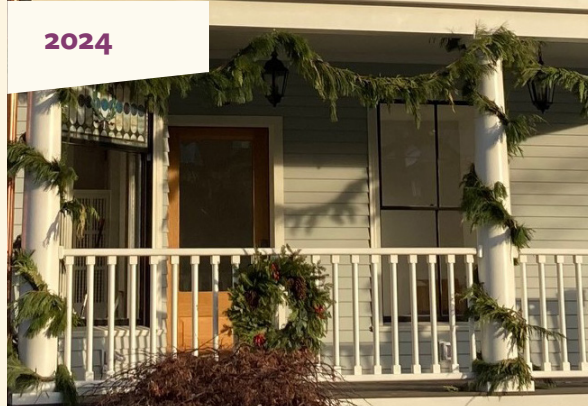
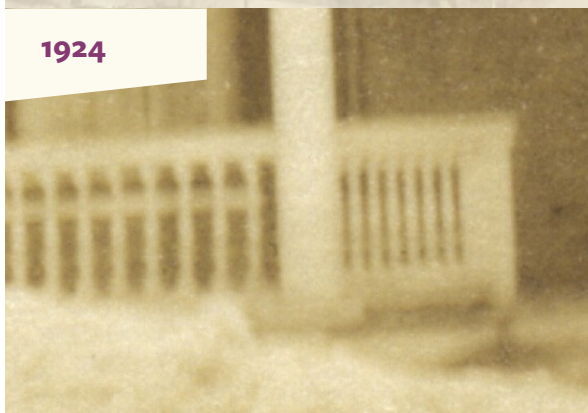
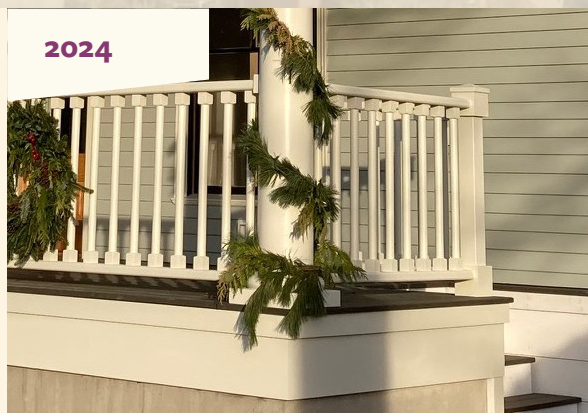
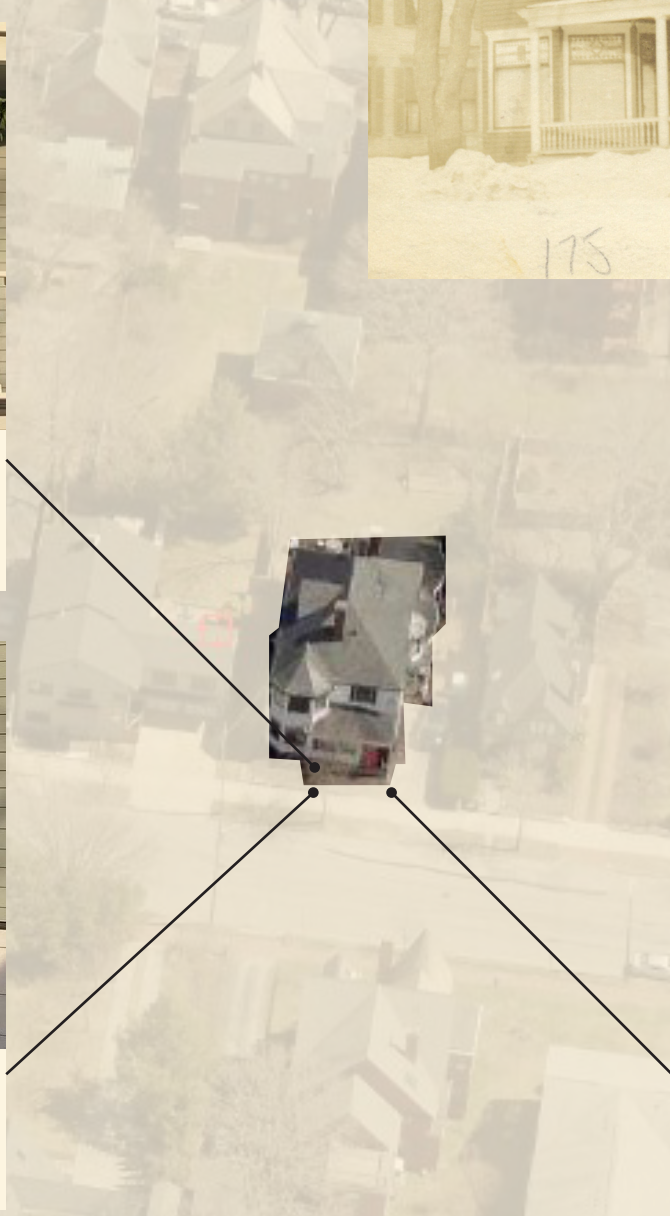
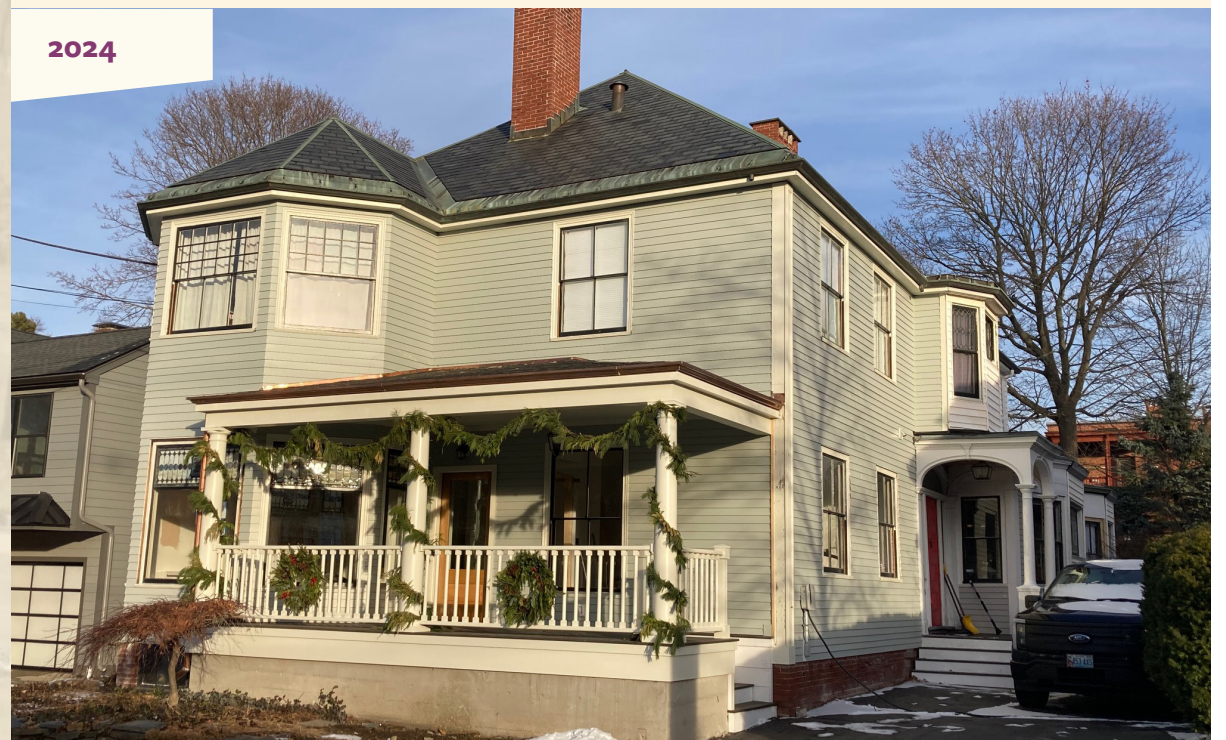
**CYRUS F. DAVIS HOUSE**

At the Cyrus F. Davis House, the front porch had been enclosed, and the entire house clad in vinyl siding sometime in the mid-twentieth century when parts of the home were converted to a doctor's office. The owners wanted to remove the non-historic porch enclosure, recreate the missing porch, reinstall a removed stained-glass window, and install a missing window and new door. Where possible, the missing features were recreated based on the historic tax photo. Where documentation was unclear, such as at the porch railing, a new simplified code-compliant railing was used. The new door to the porch uses a simple design and simplified trim to subtly distinguish itself from historic openings.

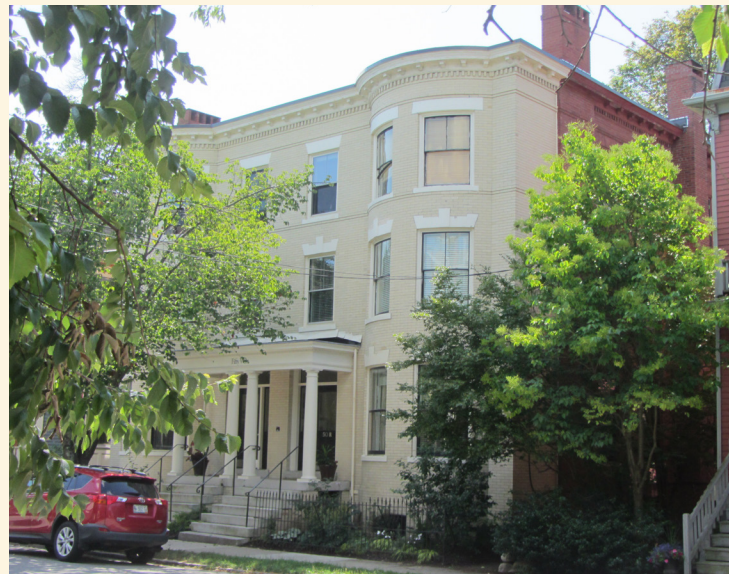
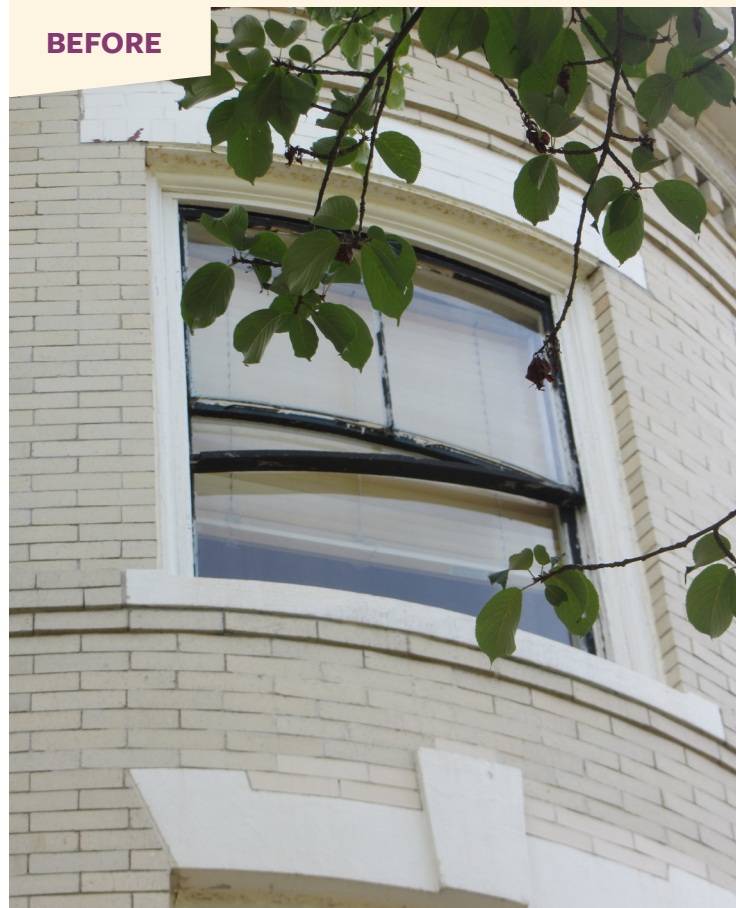
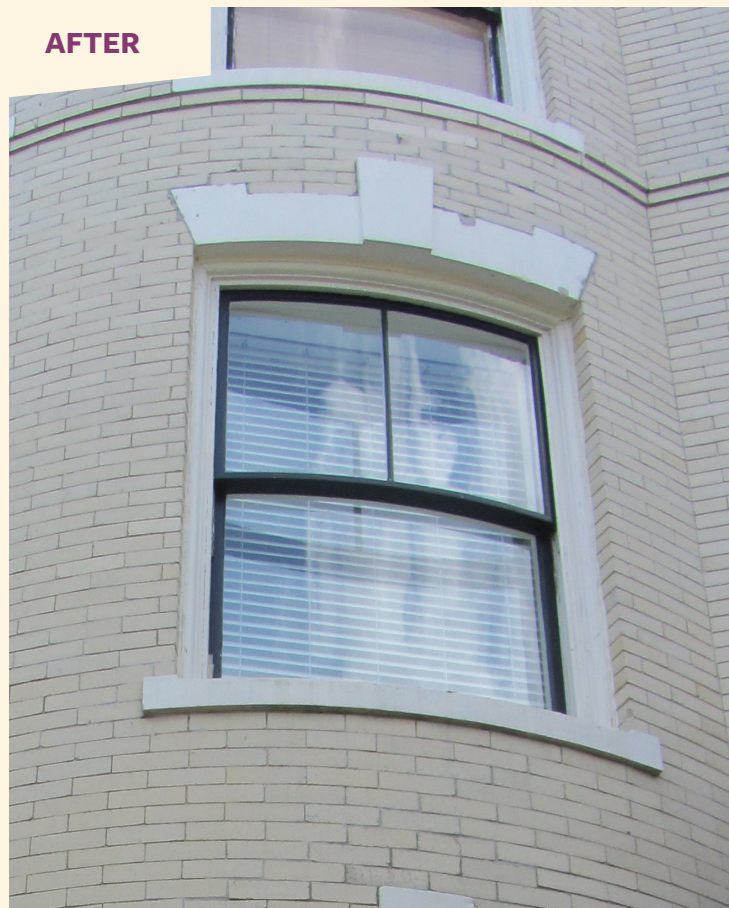
At the J. B. Brown and Sons Apartment House (50 West Street), historic curved two-over-one wood windows throughout were in relatively sound condition. They were carefully removed, restored with new glazing putty and paint, and were reinstalled along with new storm windows retaining all of the details and character of the historic windows.

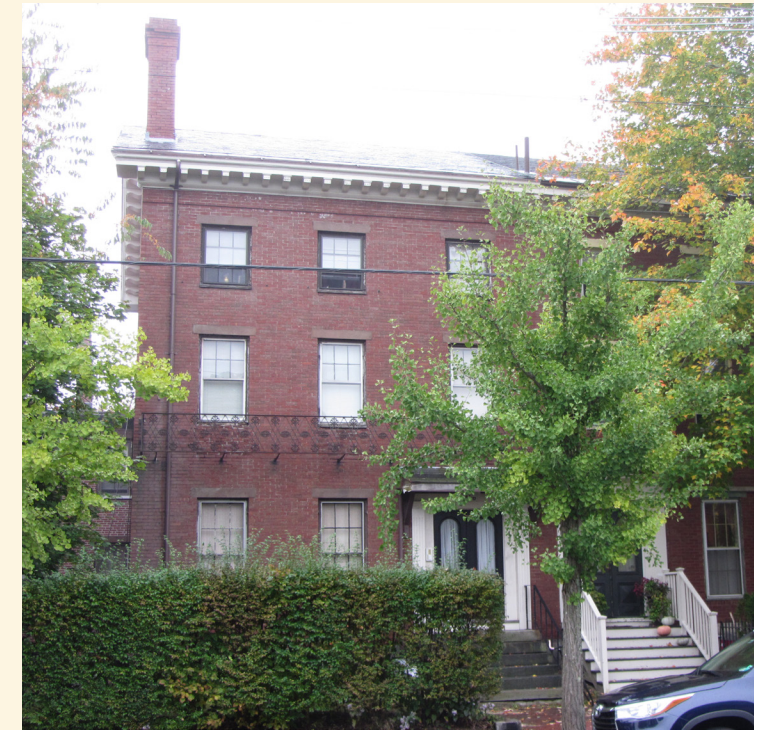
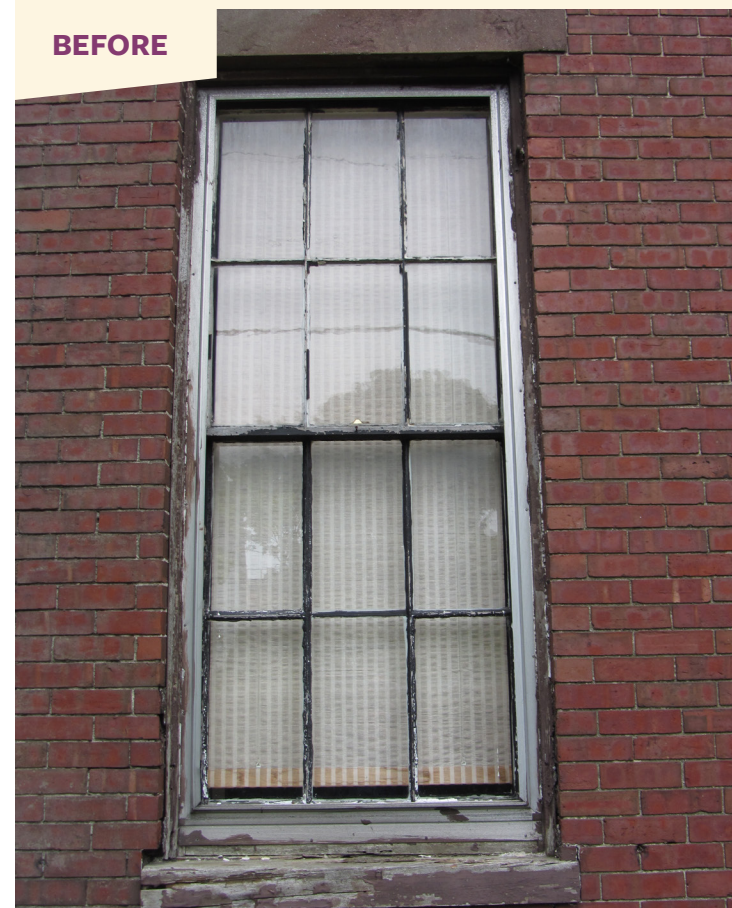
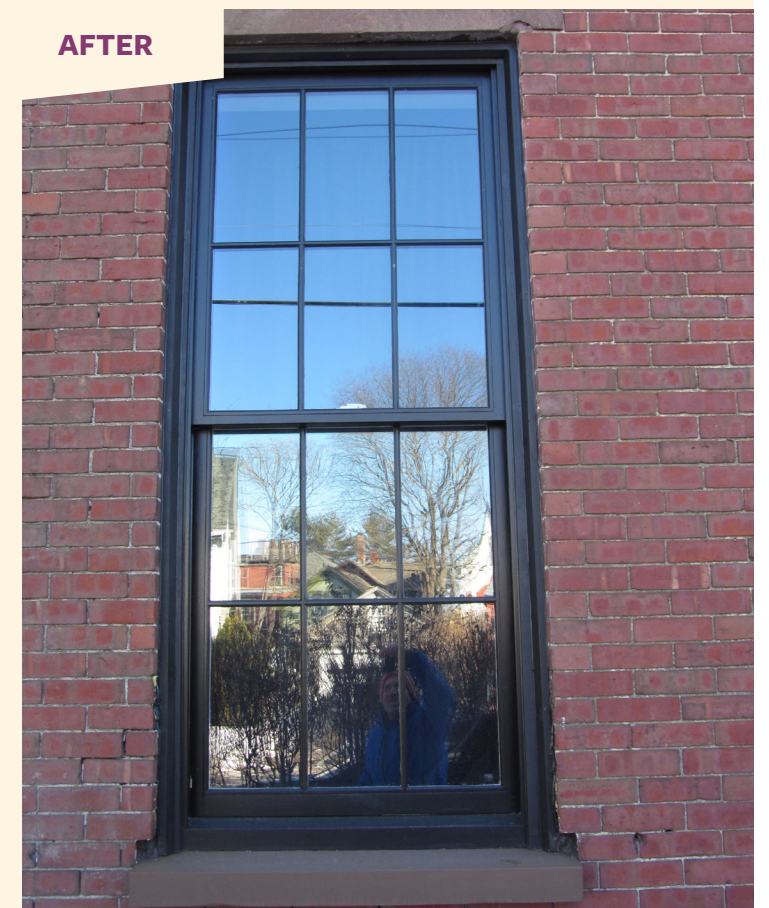
At a part of the Hamblen Double Residence (206 Danforth Street) original six-over-six double-hung windows were badly deteriorated. An appropriate fiberglass replacement window which could match the divided-lite pattern and putt-glazed profile was identified and approved as a replacement.

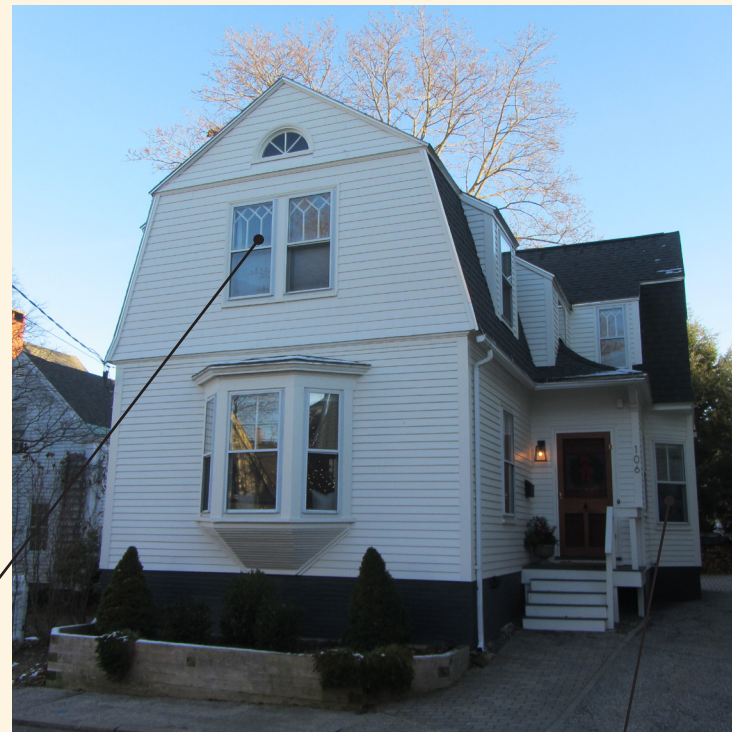
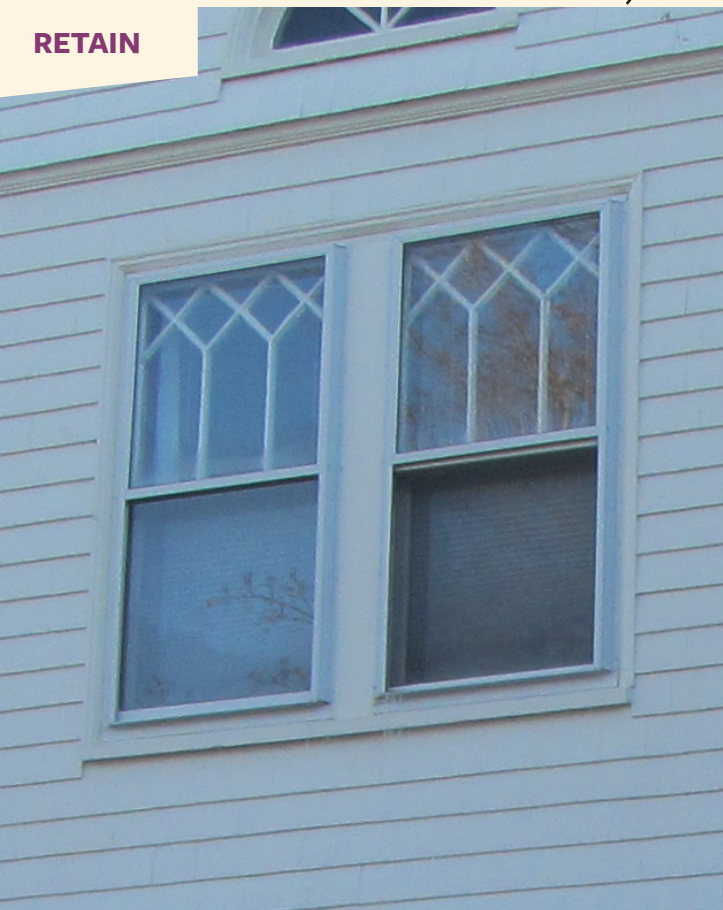
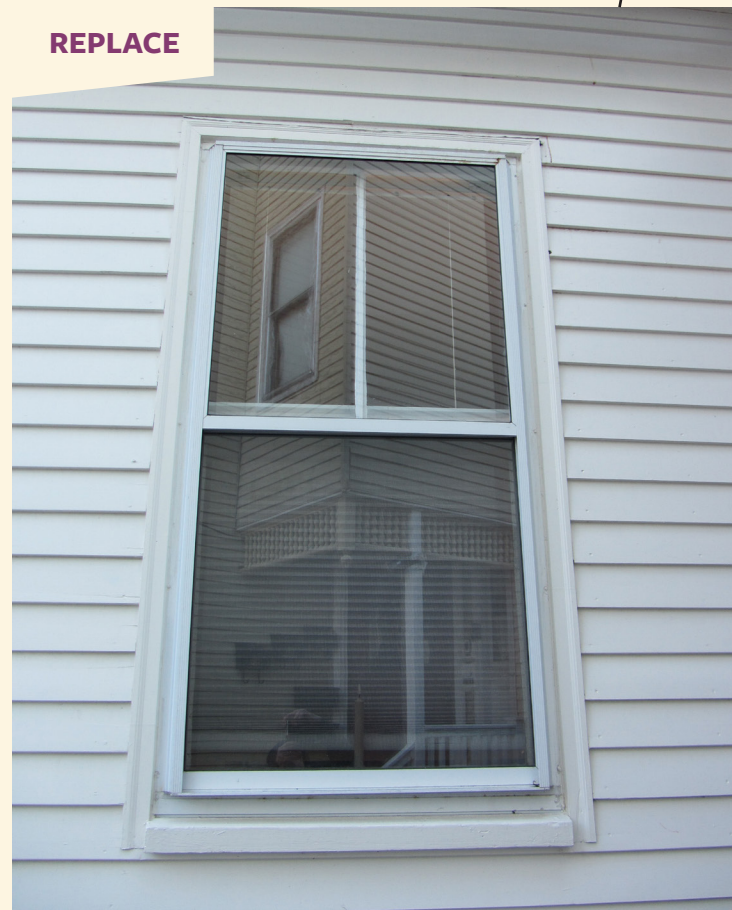
At the John S. Fogg House (106 Spruce Street), most of the fairly simple two-over-one windows could be readily matched with replacement aluminum-clad wood windows, while several had distinctive decorative diamond muntins. These were significantly more expensive to recreate in a modern window, so these windows were retained and restored.

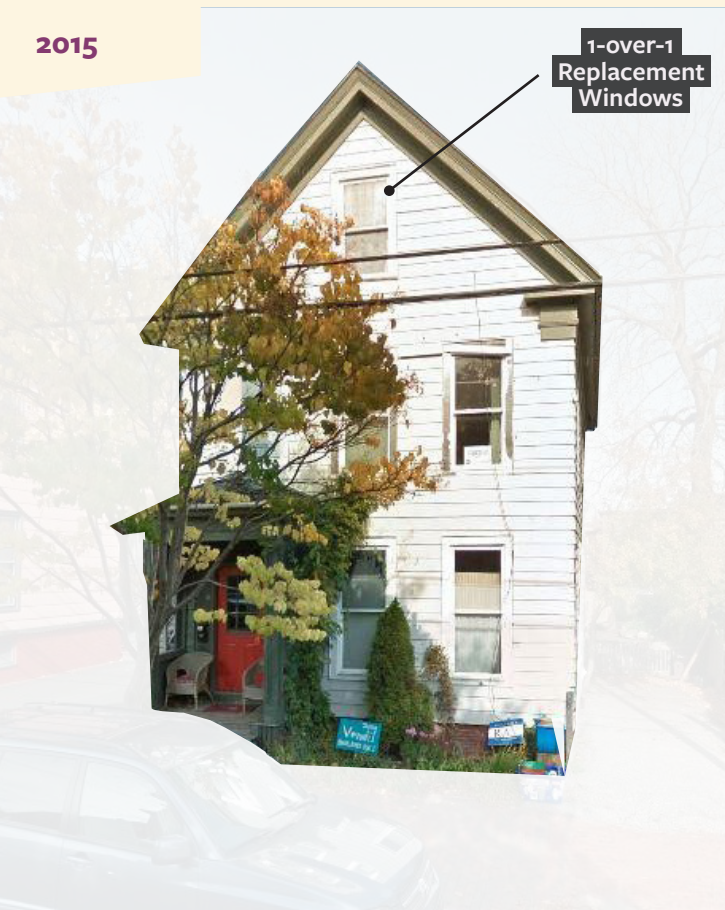
At the Richard L. Jordan House (73 Atlantic Street), all of the building's historic windows had been replaced with simplified one-over-one windows prior to the designation of the Munjoy Hill Historic District. After the replacement windows started to fail the owner wanted to bring back some of the building's historic character. While neighboring buildings have a variety of window styles, the owner reviewed the 1924 tax photo to identify two-over-two windows as the historically accurate design for the new replacement windows.

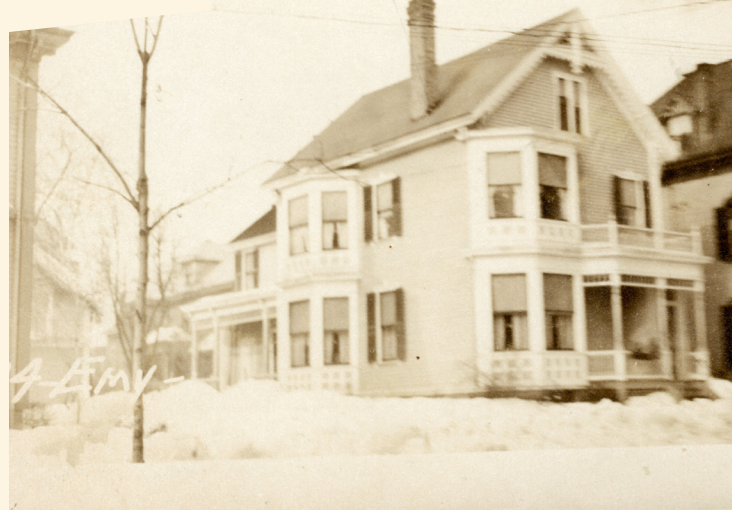
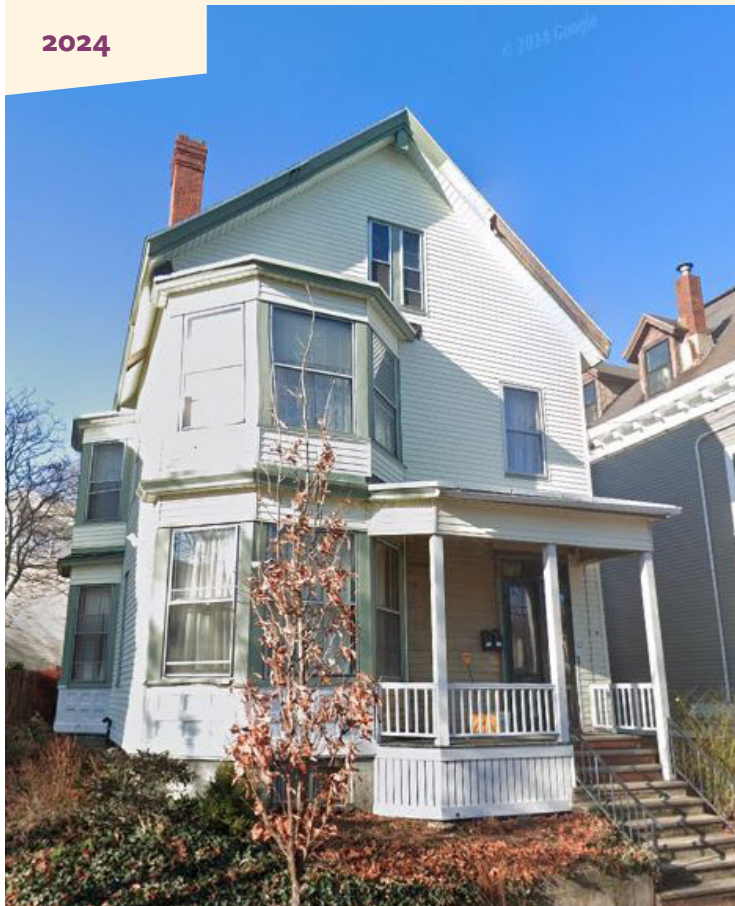
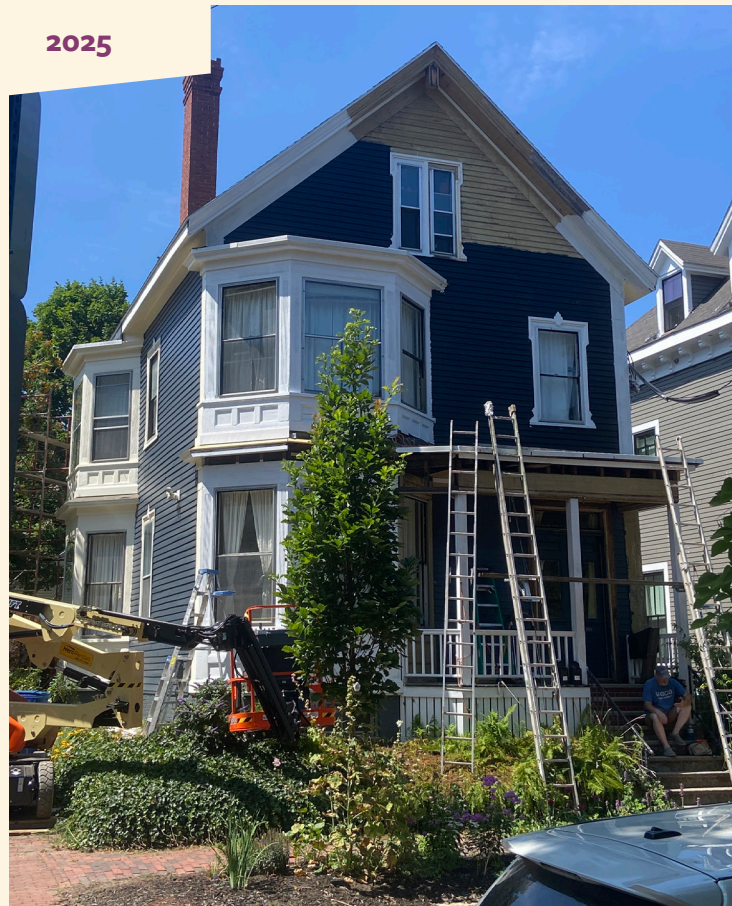
At the David H Blanchard House (114 Emery Street) original trim and details were uncovered beneath a non-historic siding. The trim was in good condition in relatively good condition and largely required prepping and painting. Where some trim and siding was deteriorated or missing, it was replaced with new wood siding or trim to match.

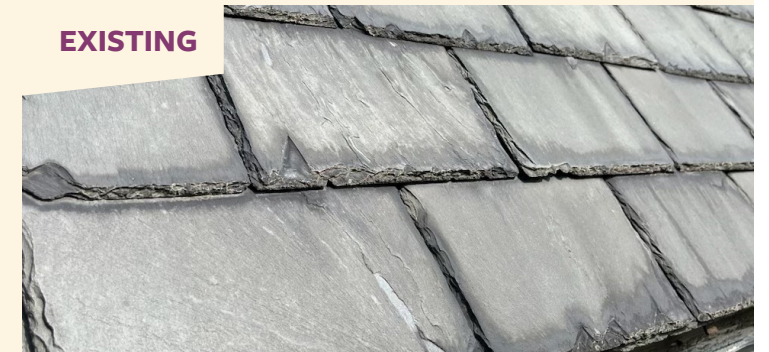
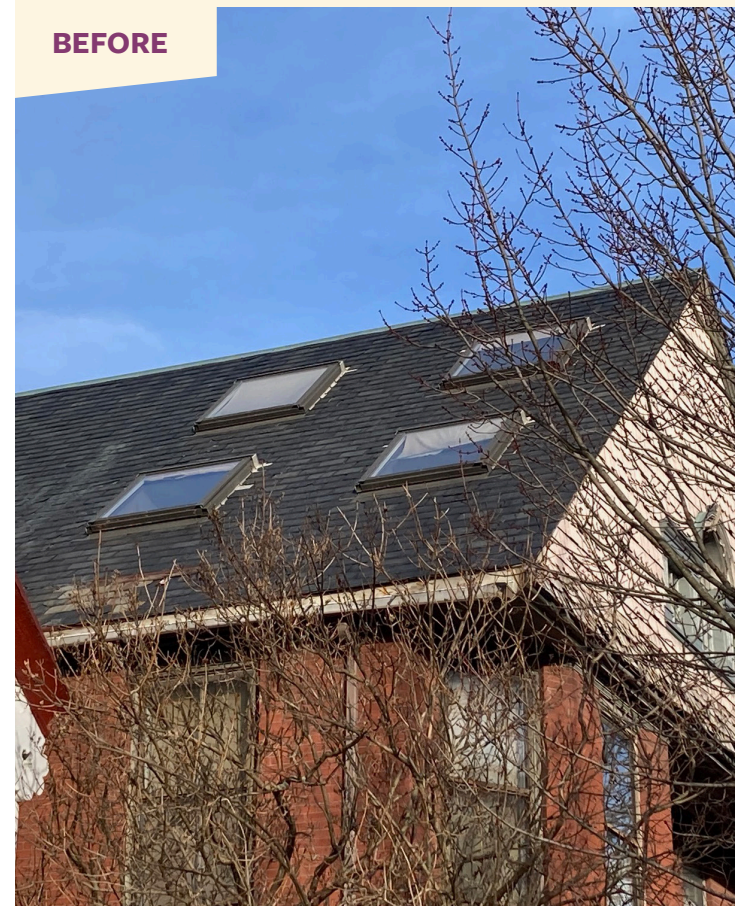
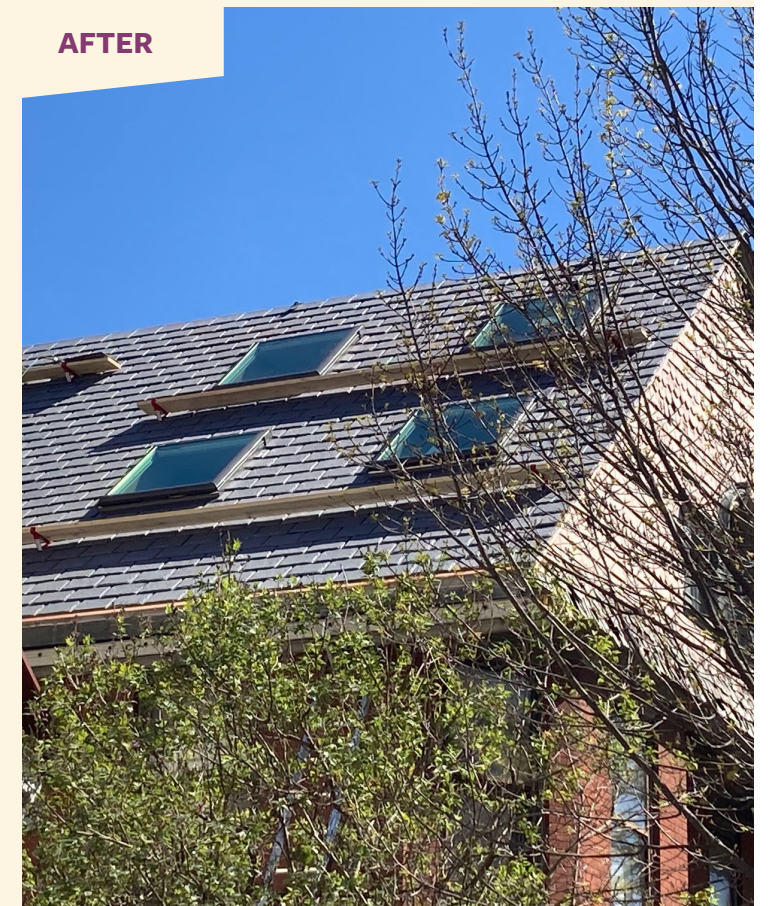
At 489 Cumberland Avenue, the property owner explored retention and repair of a historic slate roof; however, rusting fasteners and brittle old slates meant that the entire roof needed to be removed and replaced. The owner worked with the Historic Preservation Board to identify a synthetic faux-slate roofing material that was a good visual match for the historic slate.

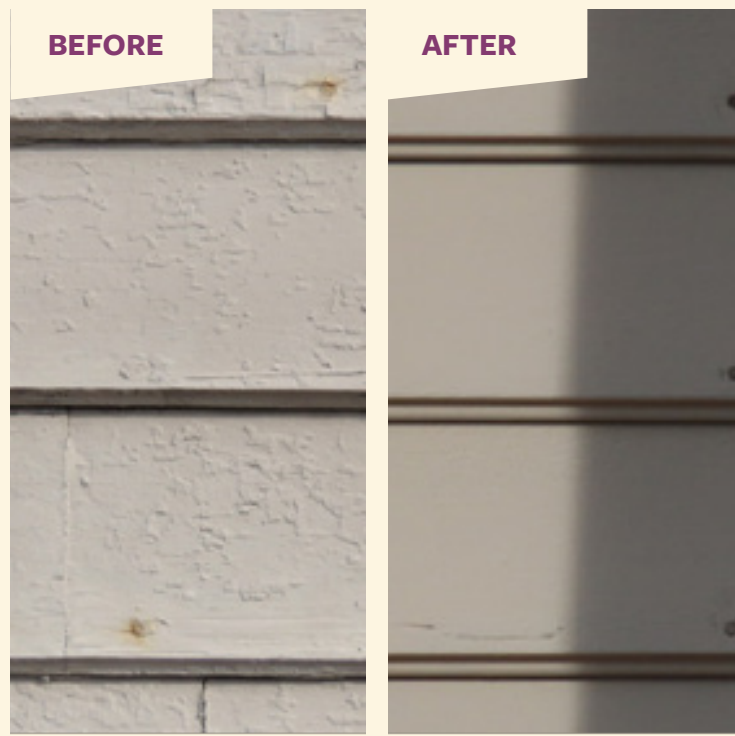
At the John and Warren Sparrow House (124-126 Winter Street), painting of historic wood clapboard siding had not been kept up, causing many of the clapboards to rot and split. It was determined that the most efficient course was to undertake a complete replacement of the siding. In this case, the historic clapboards had a distinctive curved profile along the bottom edge, which was accurately recreated on the replacements.

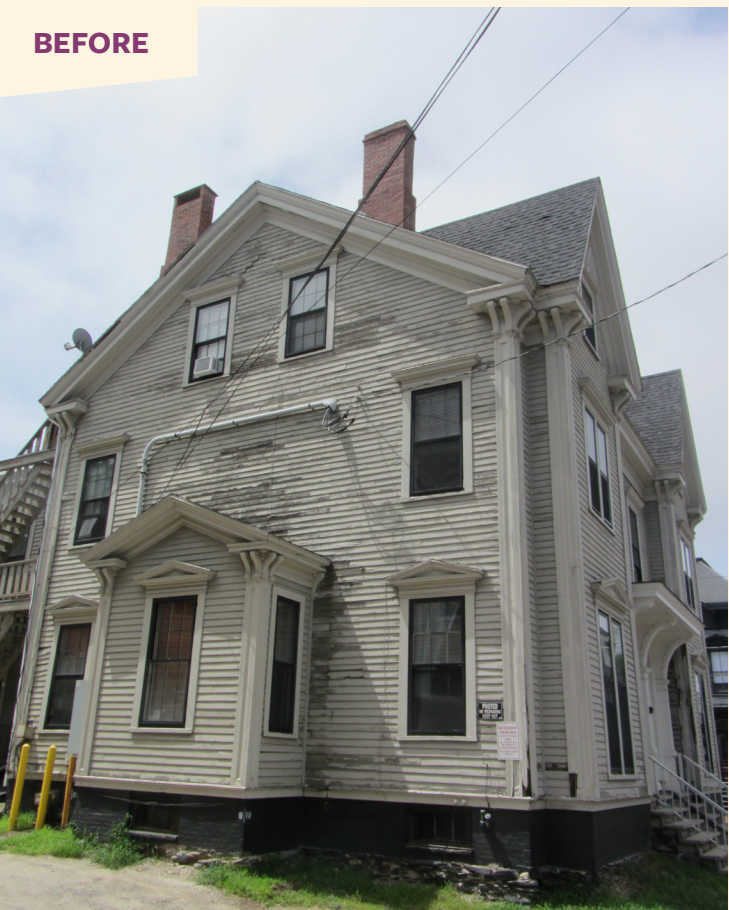
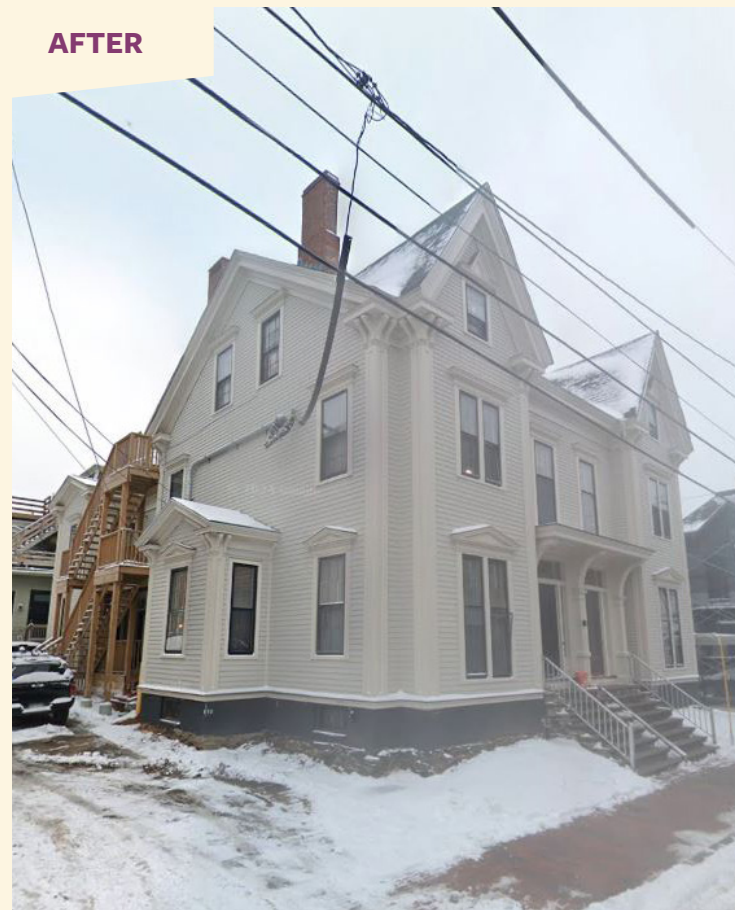
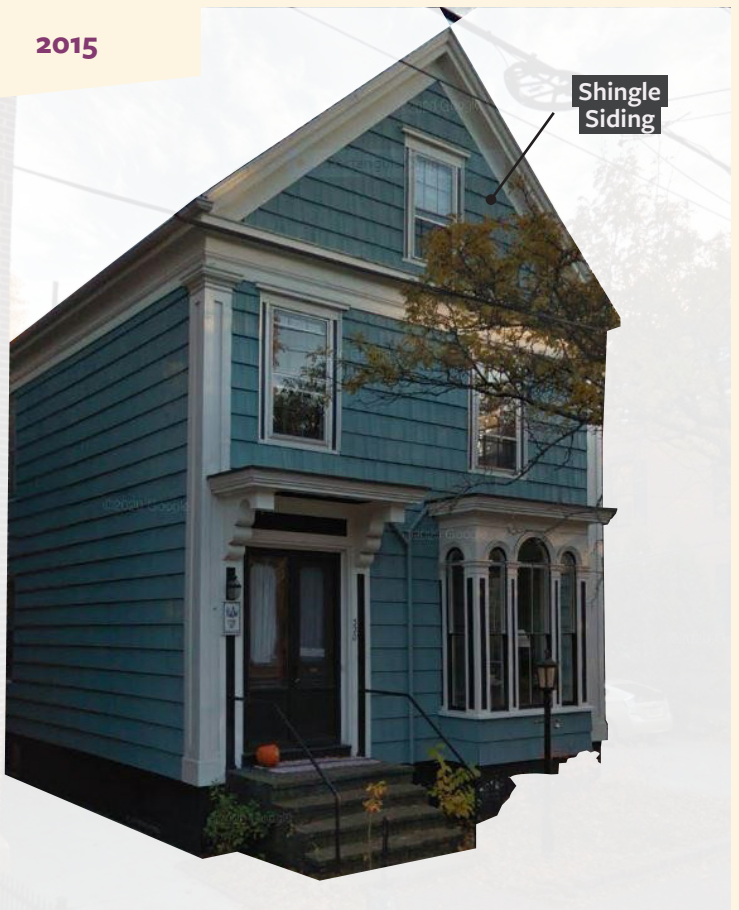
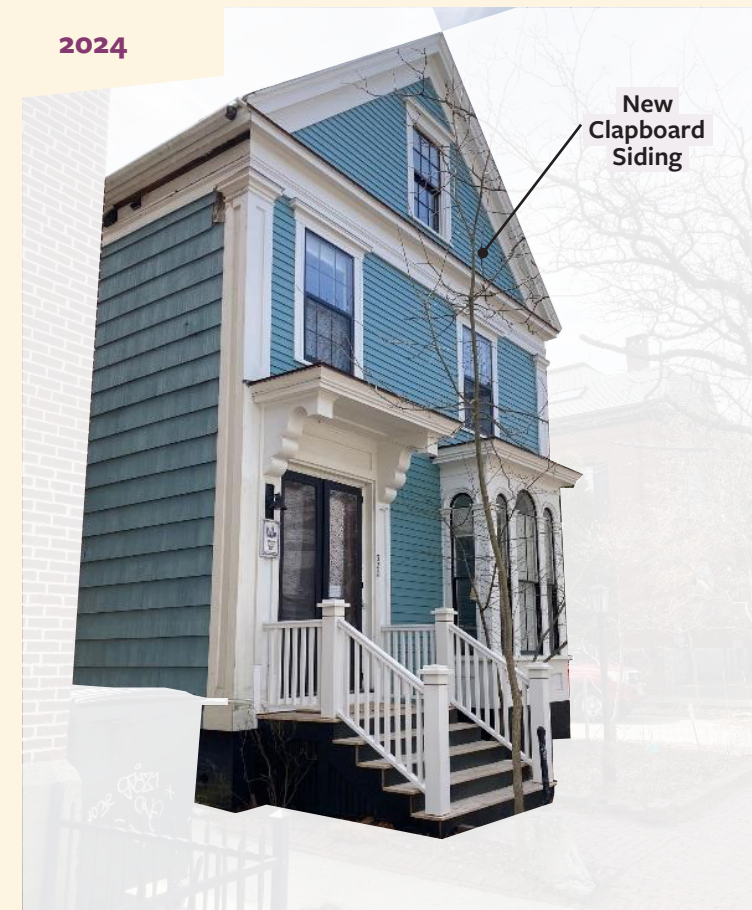
The Stephen K. Dyer House (320 Spring Street) had originally been clad in clapboards reflective of its austere Greek revival character (left). At some point, the clapboards were replaced with wide wood shingles, giving the house a more rustic appearance than was historically accurate. As part of a thorough façade rehabilitation, the shingles on the primary façade were replaced with historically accurate clapboards, restoring the structure's historic character.
