## Historic Preservation Board

Topic: Historic Preservation Workshop and Public Hearing 11-19-2025

- i. Preliminary Review of Proposed Updates to the City of Portland Historic Resources Design Manual; City of Portland, Applicant. The Historic Preservation Board will hold a hybrid workshop to review draft updates to the City of Portland Historic Resources Design Manual. The current Historic Resources Design Manual can be found here: <https://www.portlandmaine.gov/496/Additional-Resources>

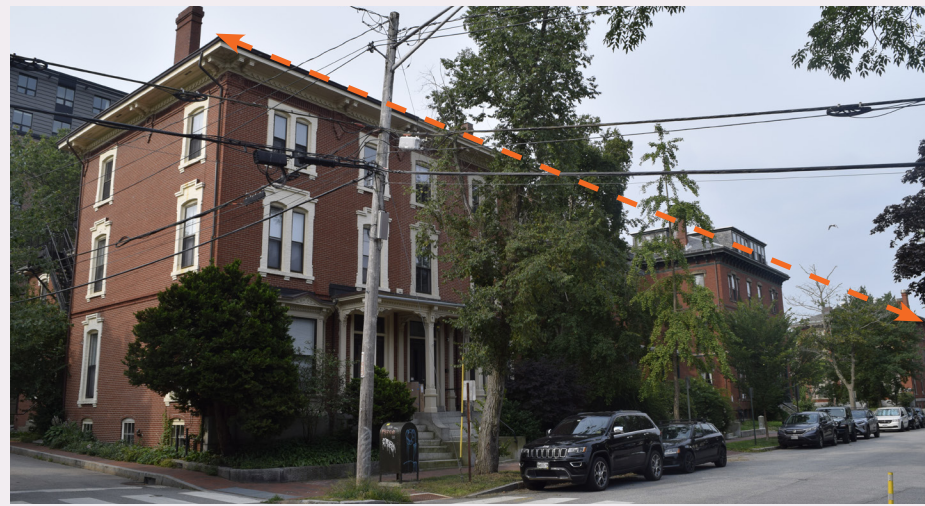
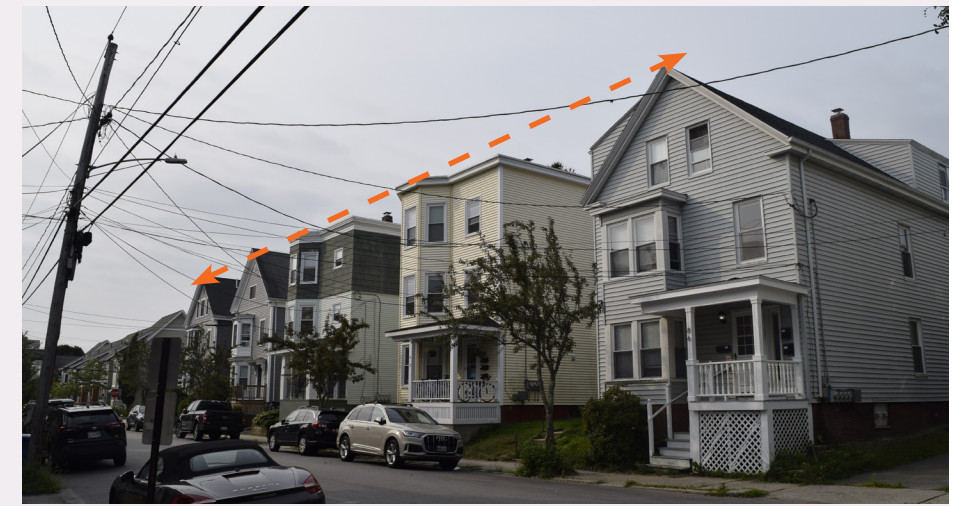
Along these sections of Deering Street (left) and Vesper Street (right) properties are very consistent in height, despite a variety of building forms.

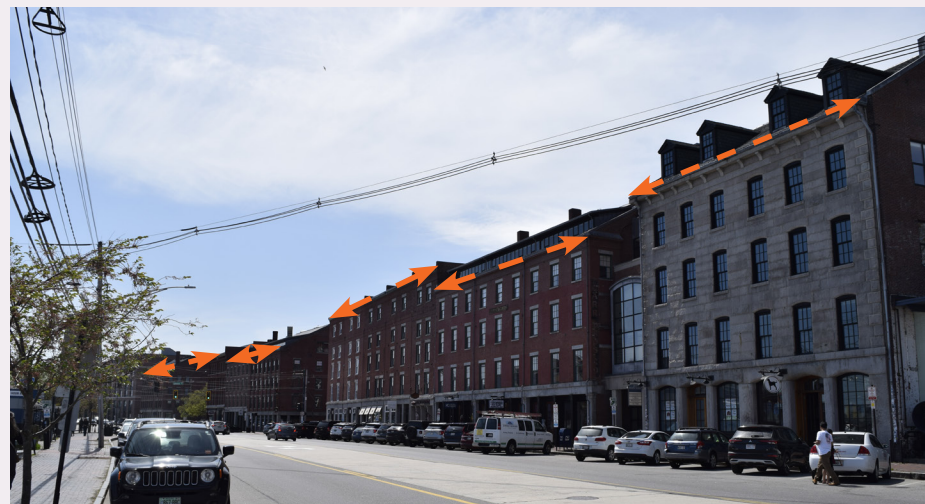
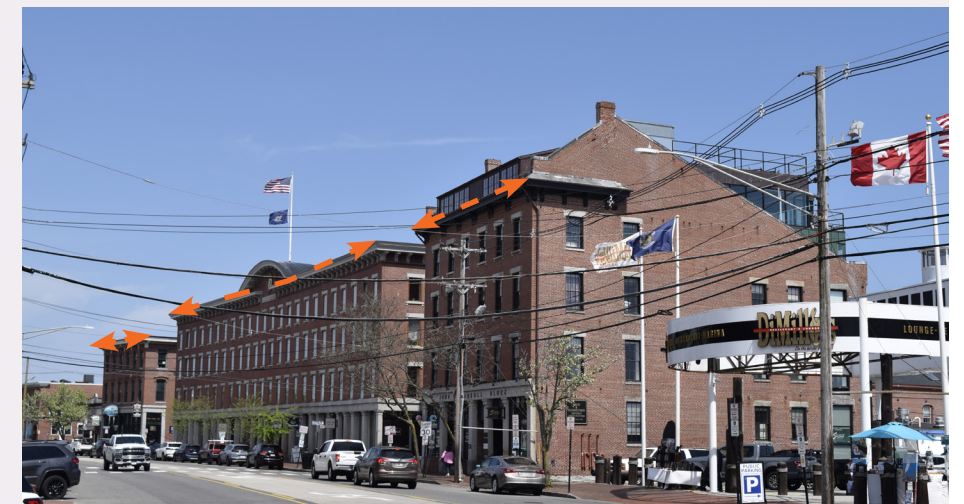
Commercial Street has a very fairly consistent height with some minor variation.

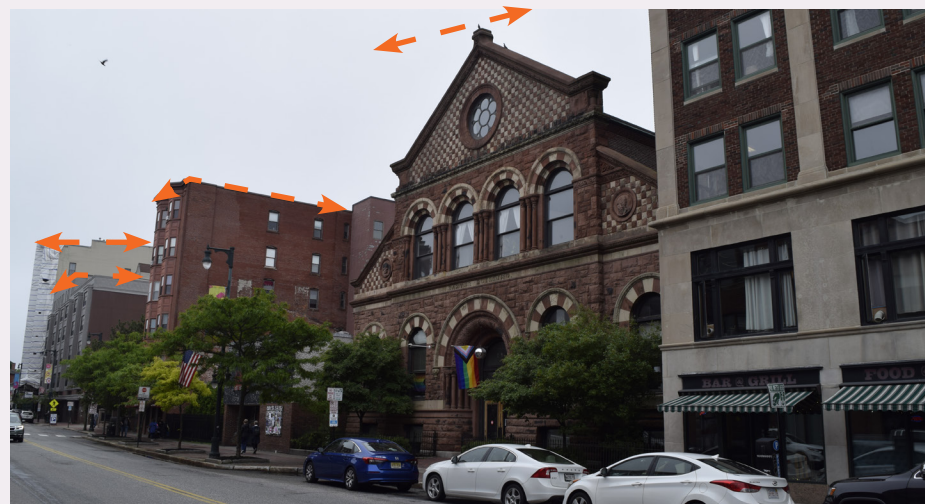
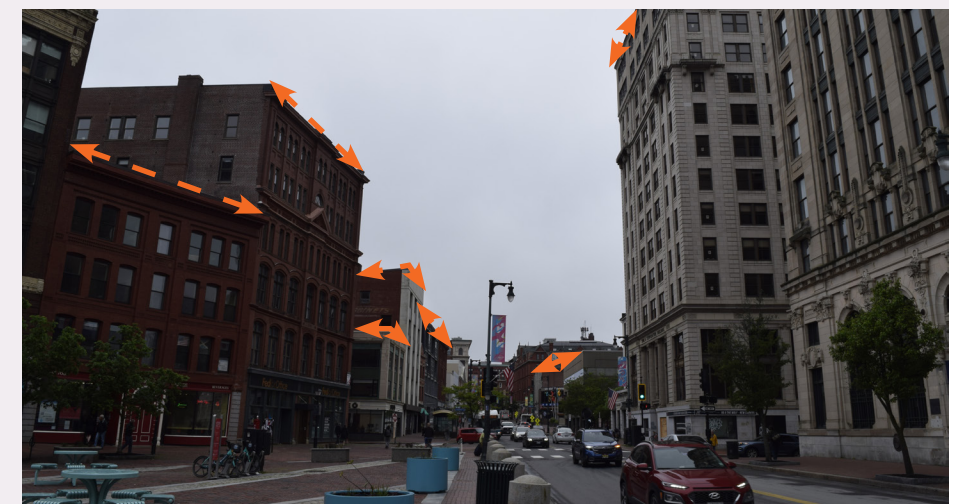
Congress street exhibits a significant variety of building heights.

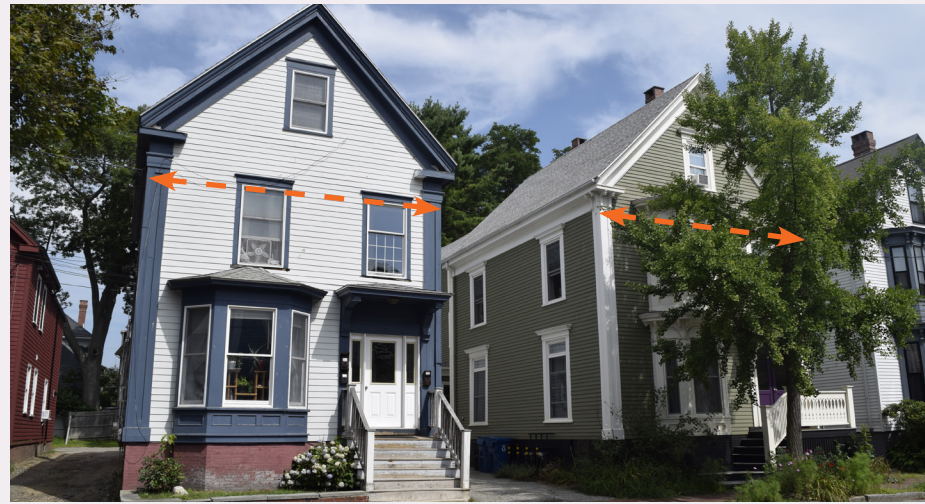
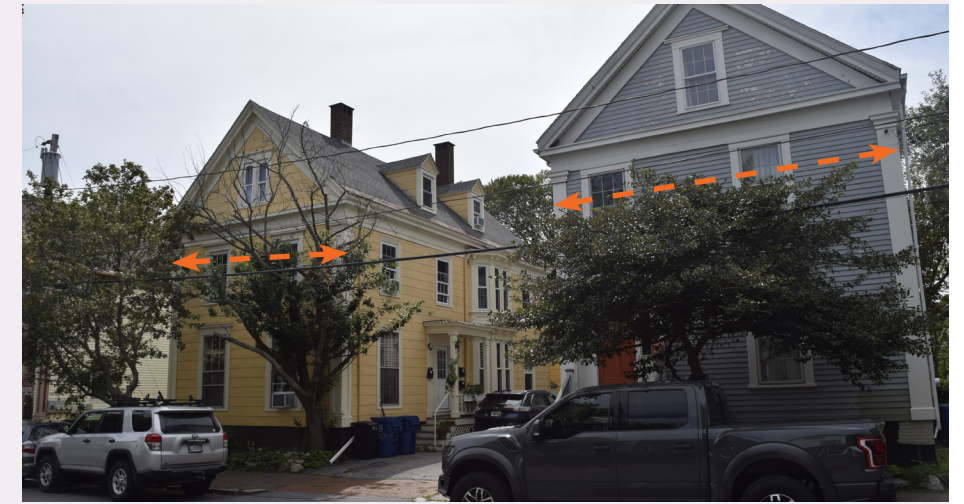
Some sections exhibit very consistent building widths.

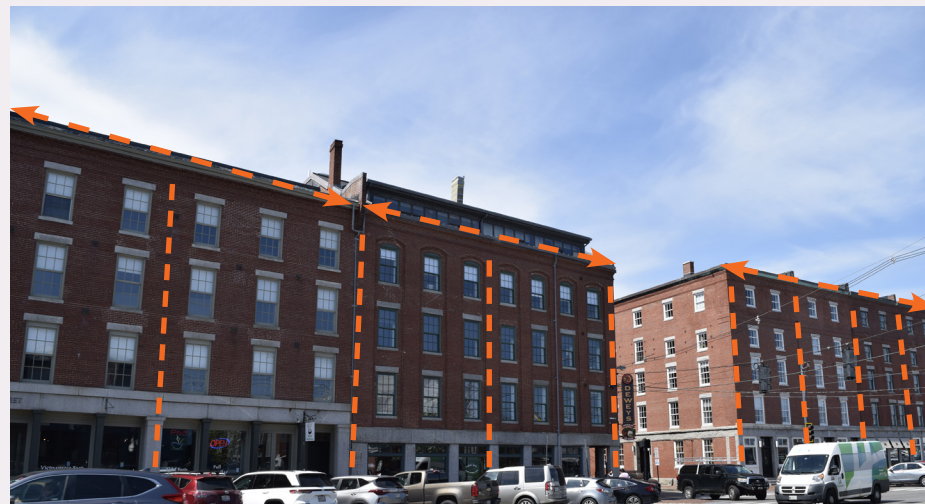
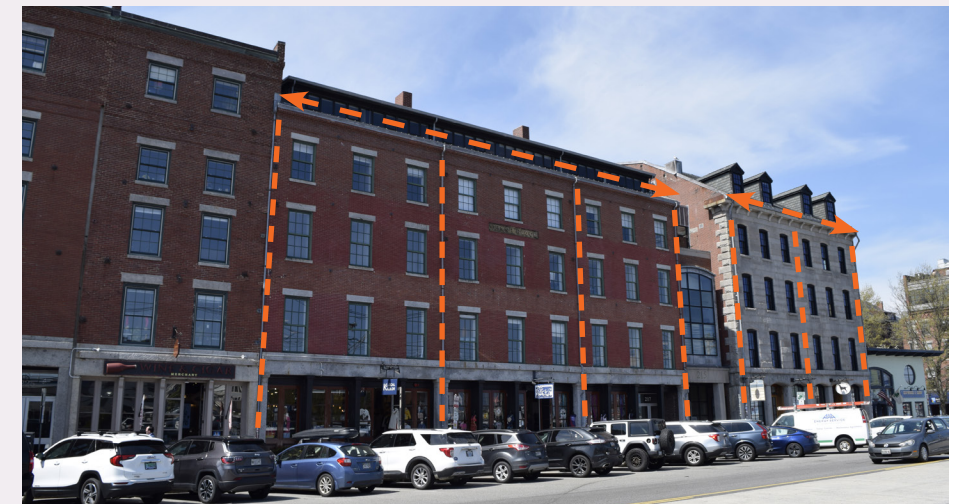
Along this stretch of commercial Street, buildings vary in width, but most buildings are broken down into a more regular rhythm.

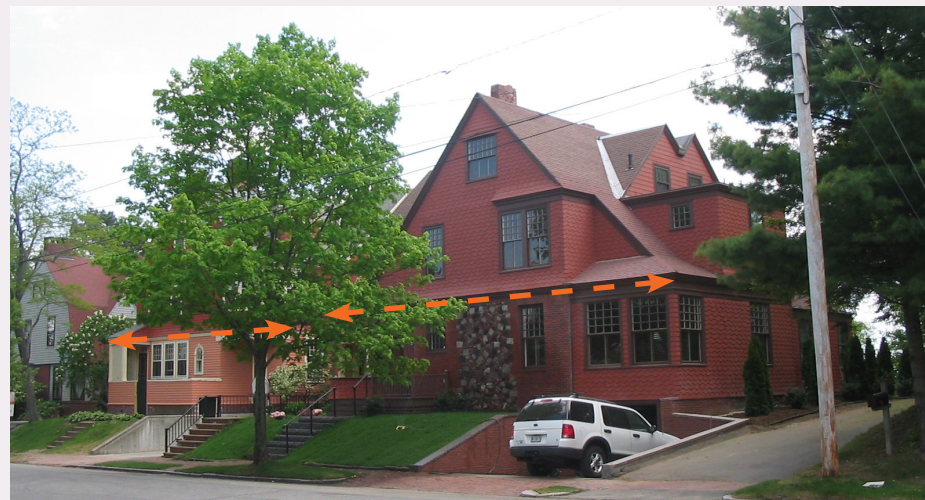
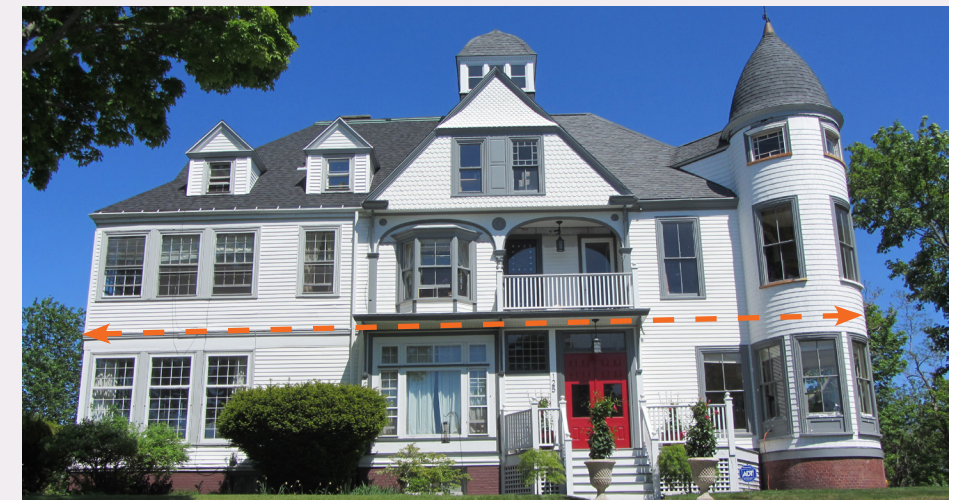
Along Bowdoin Street, properties exhibit a variety of building widths.

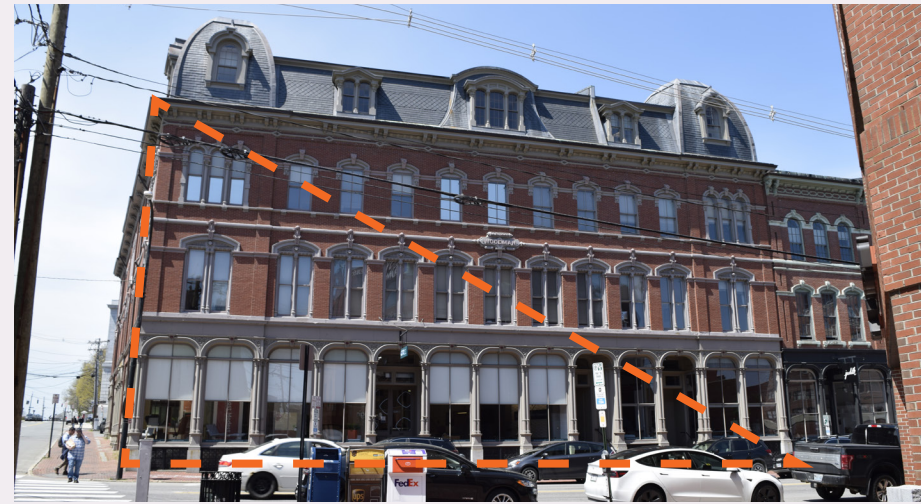
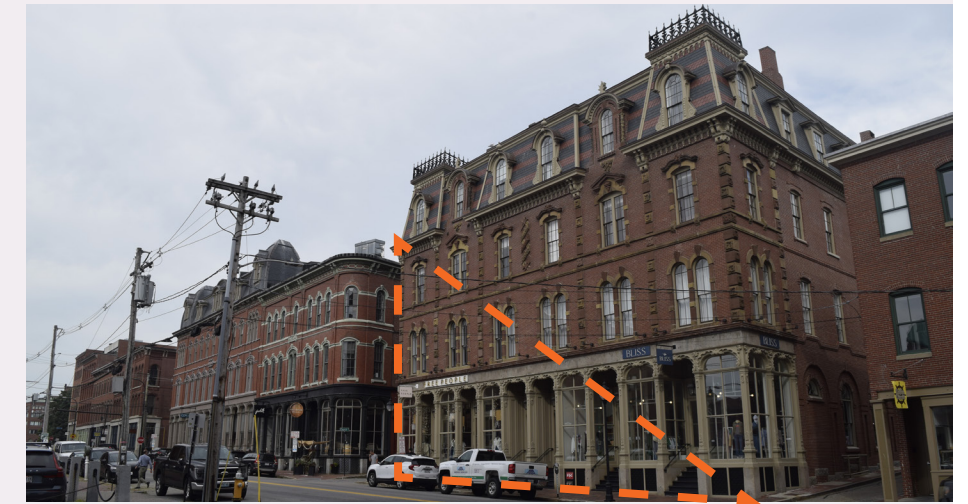
Along Middle Street, many properties exhibit consistently horizontally proportioned facades.

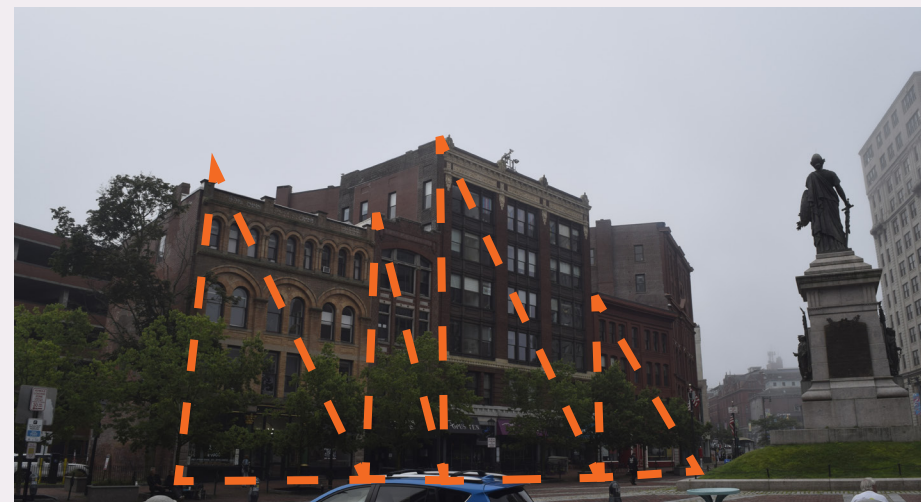
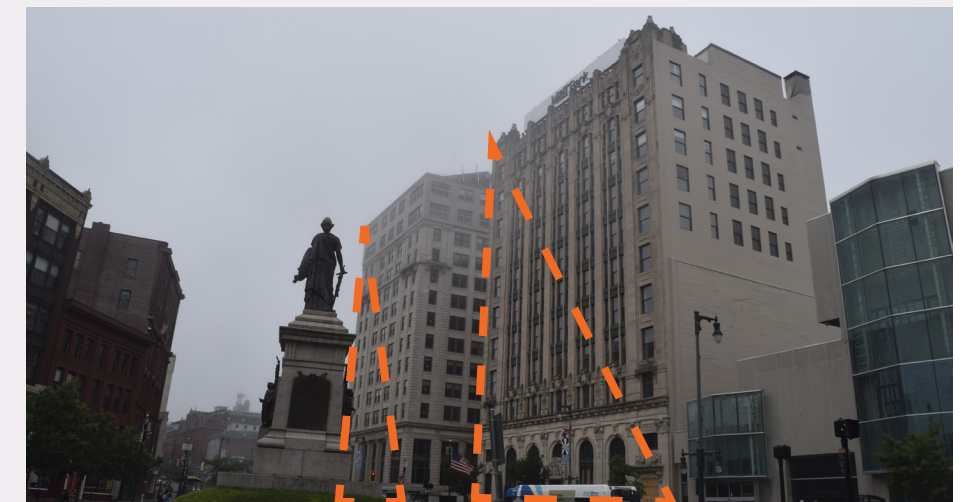
Around Monument Square properties tend to have very vertically proportioned facades.

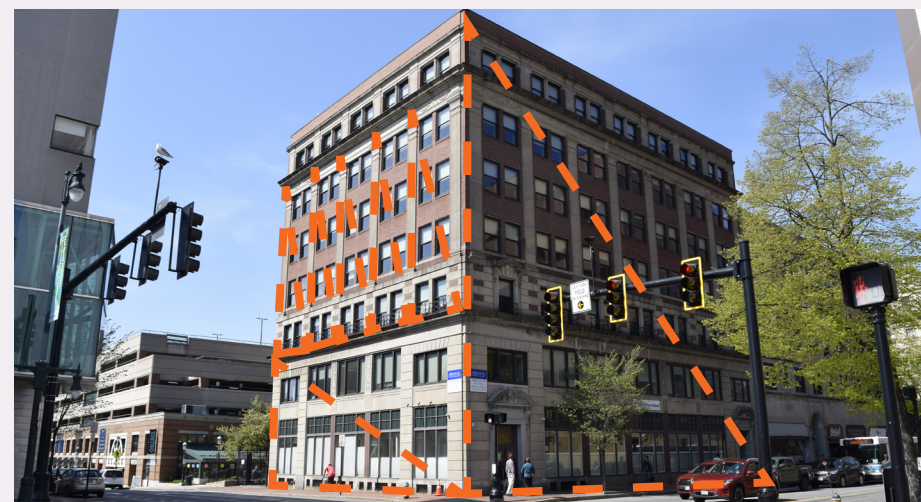
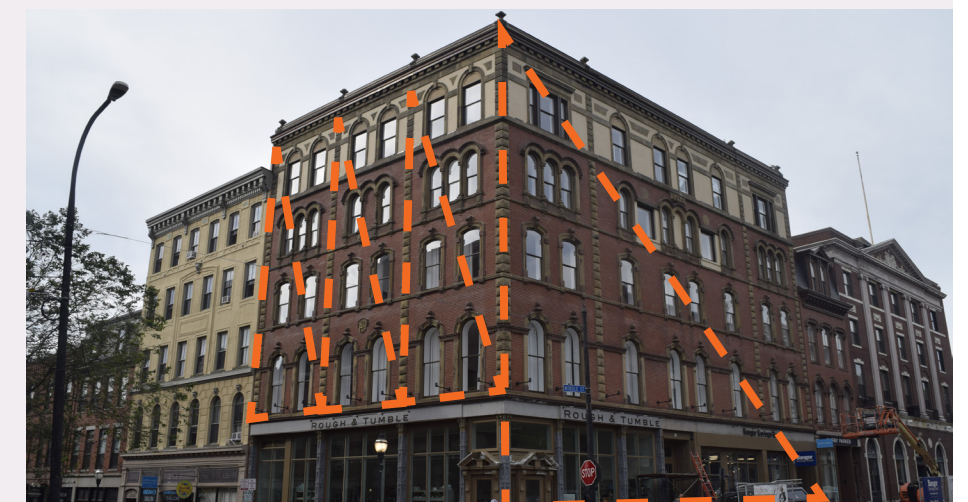
Some buildings, such as these along Congress (left) and Exchange (right) Streets exhibit a mix of proportions.

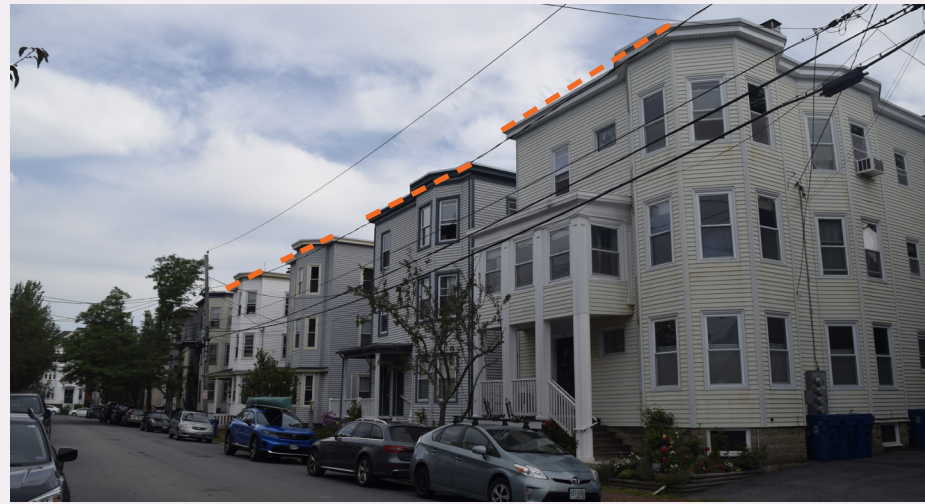
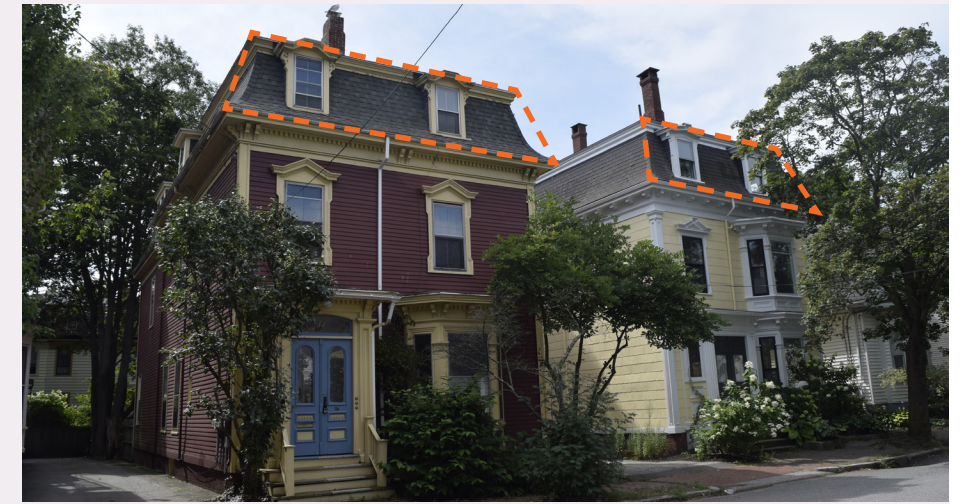
Along parts of Vesper (left) and Cushman (right) Streets, buildings use very regular roof shapes.

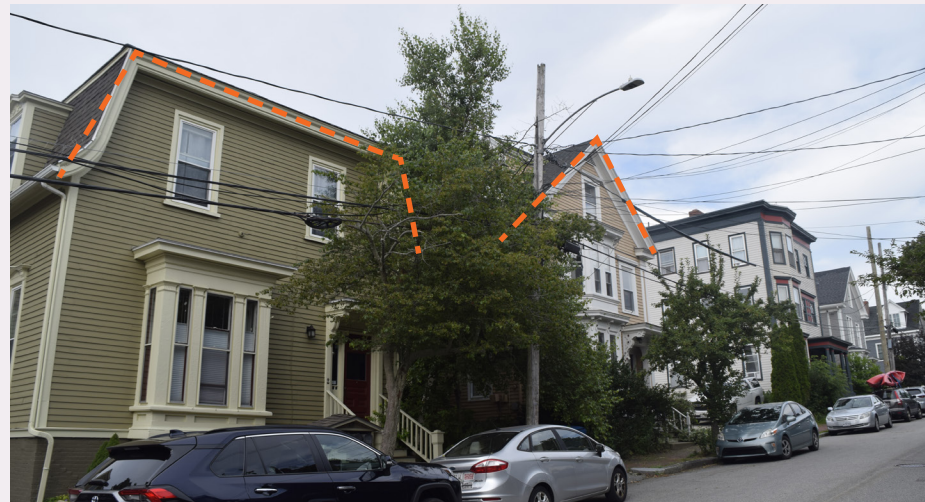
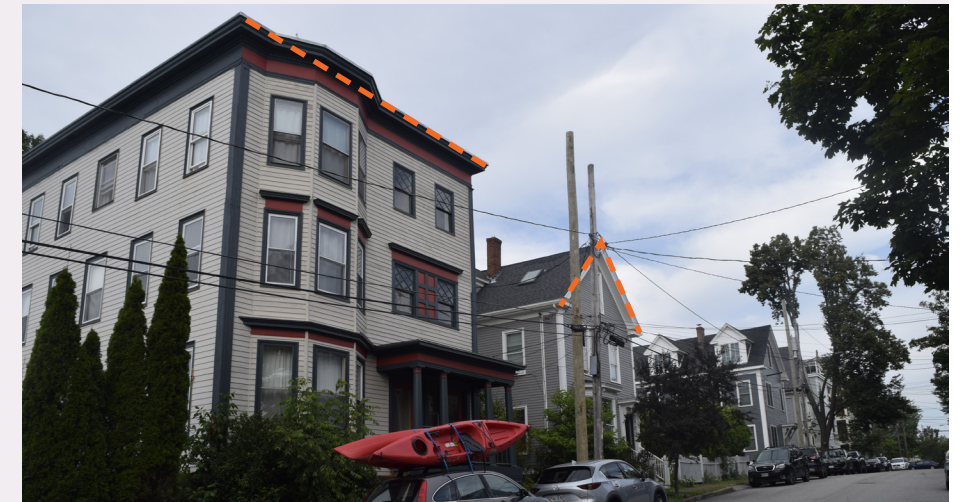
Many areas, such as along this stretch of O'Brien Street feature a wide variety of roof shapes.

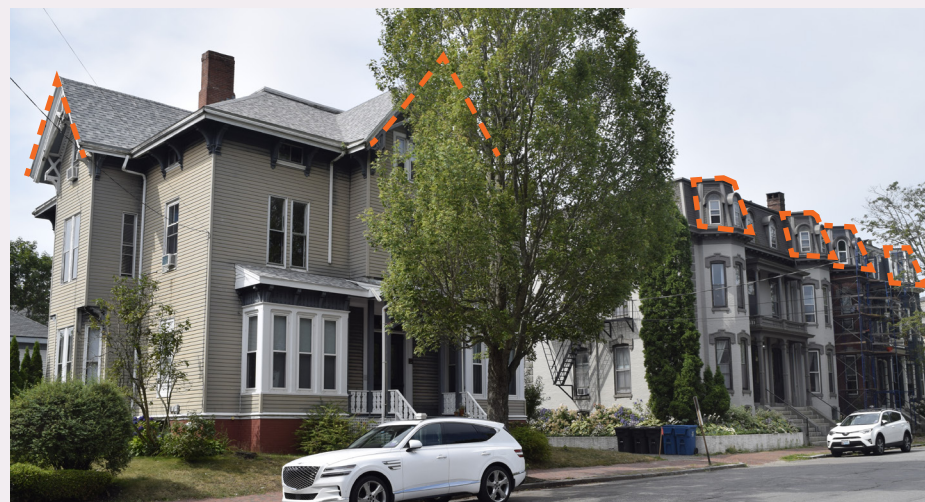
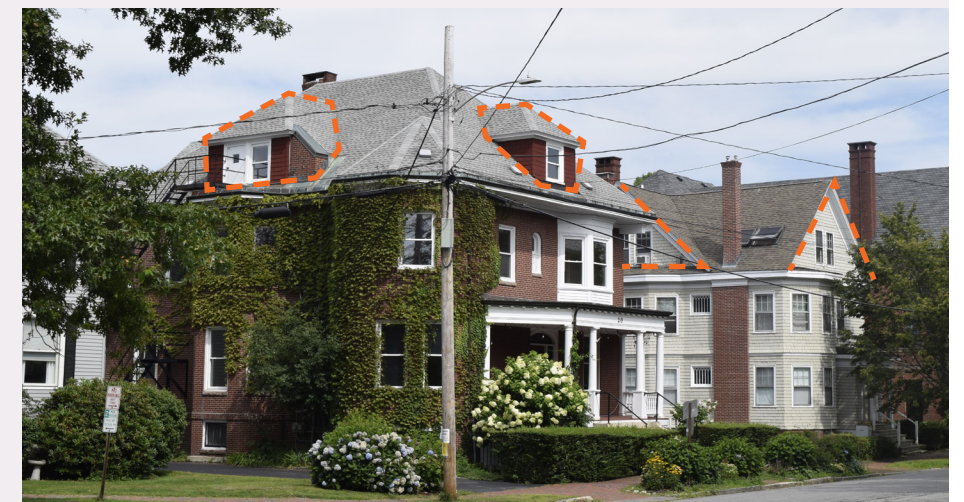
Some areas, such as these sections of Pine (left) and Thomas (right) Streets feature roof forms that are articulated by a variety of dormers and cross-gables.

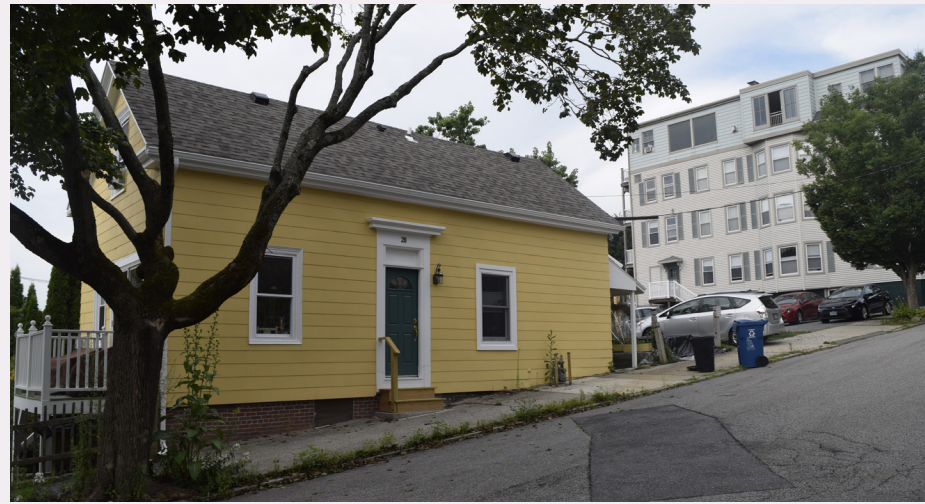
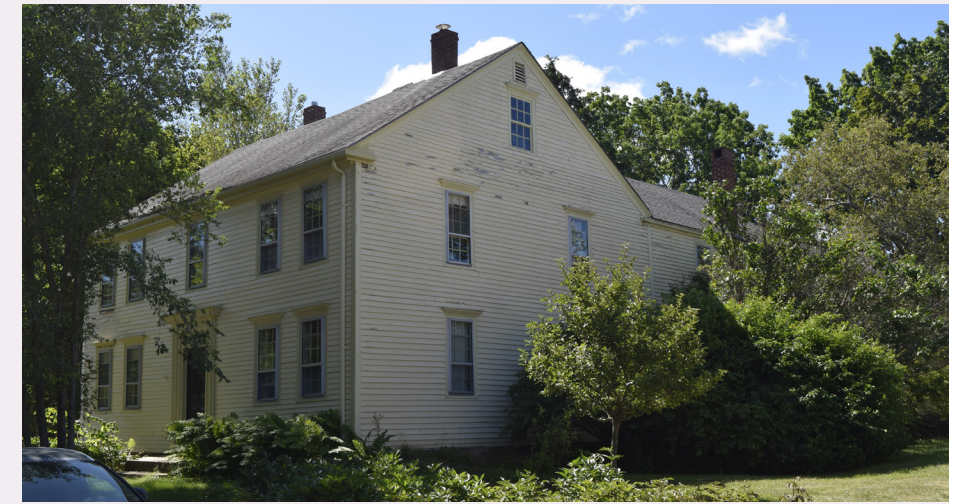
28 Waterville Street (left) and 1258 Westbrook Street (right) are of a similar form and style; however, the buildings are at very different sizes. Windows and doors are adjusted on each to be proportion to that overall scale.

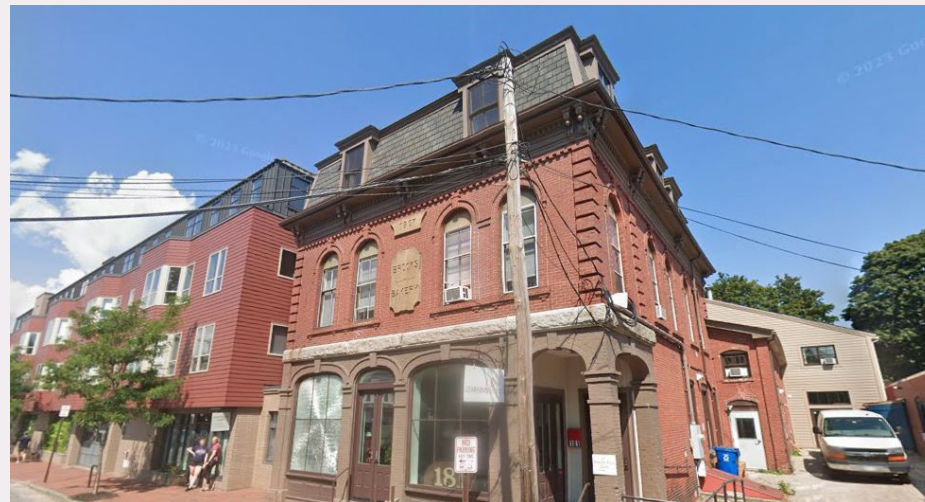
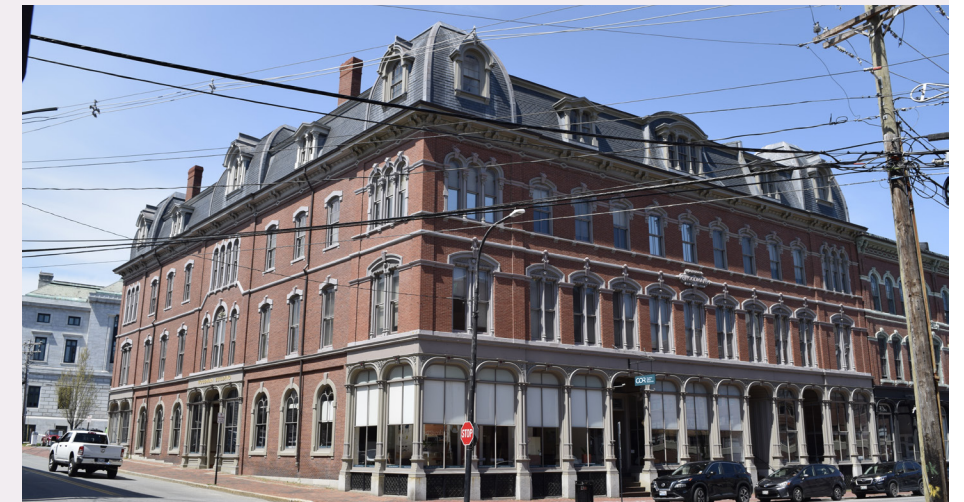
Similarly at 181 Brackett Street (left) and 141 Middle Street (right) commercial buildings of the same style were constructed at different sizes and the various features of the buildings are appropriately scaled to the overall scale.

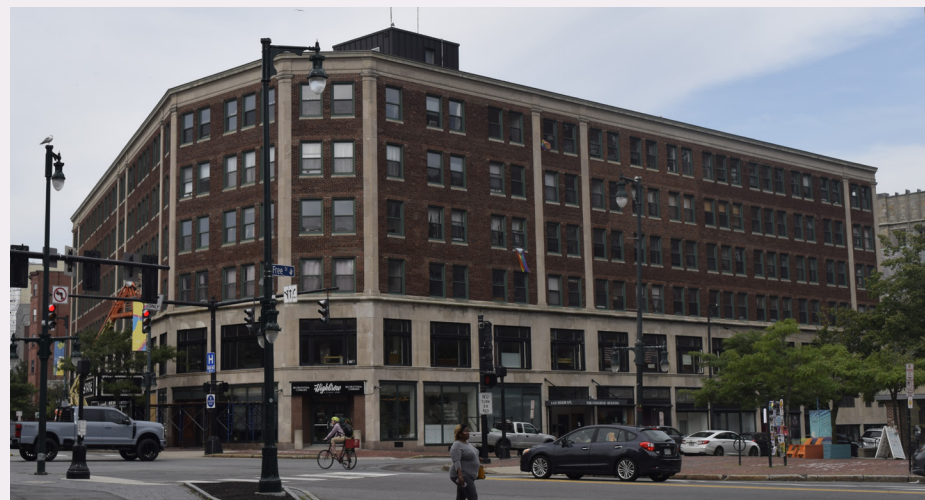
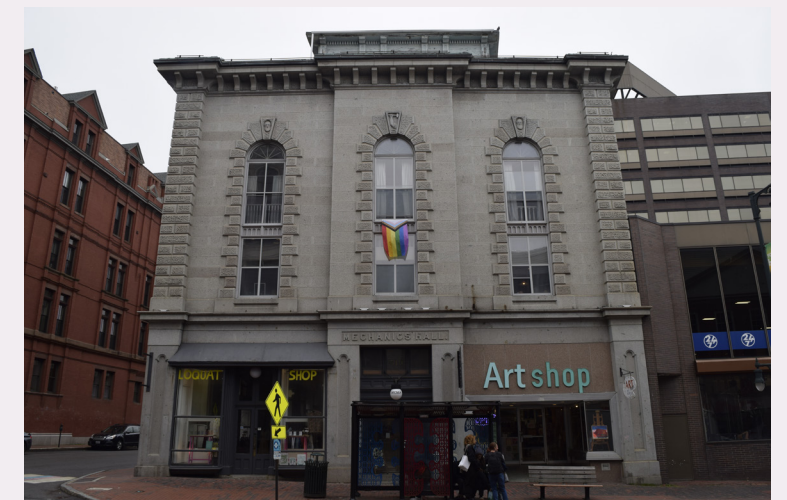
Some properties such as the State Theater (609 Congress, left) and Mechanics Hall (511 Congress, right) use oversized or "monumental" but still proportionally-scaled building elements to help make the size of these large buildings relatable.

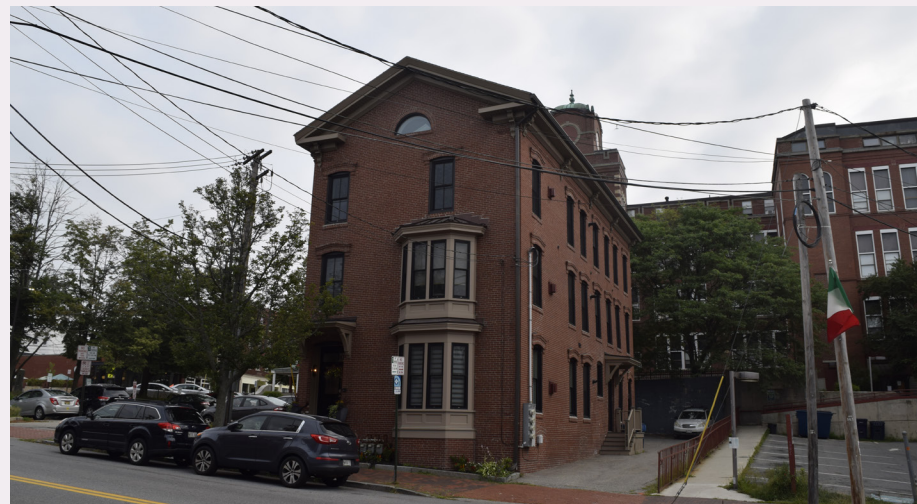
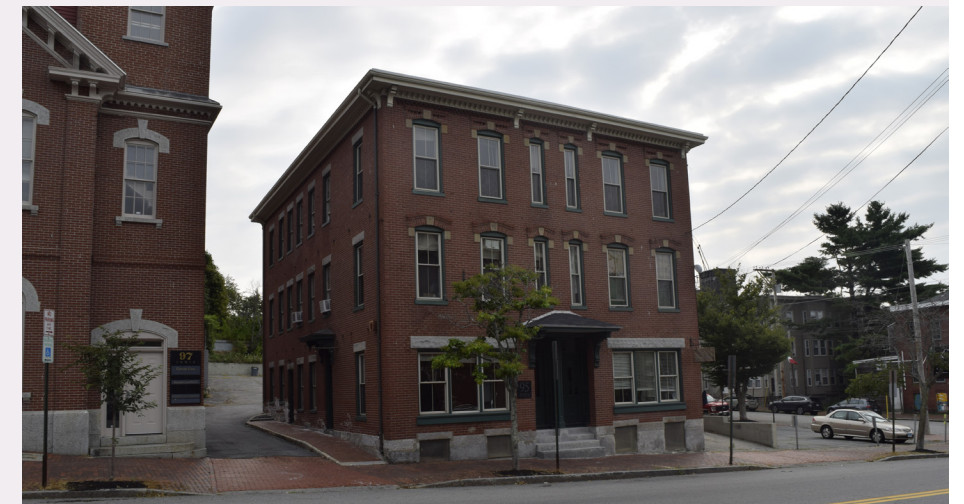
As in many historic contexts, windows along India street are primarily vertically proportioned.

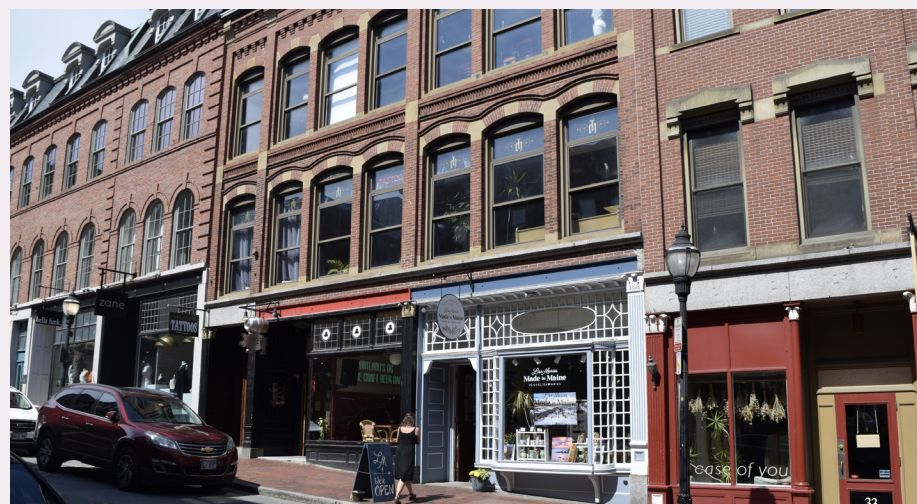
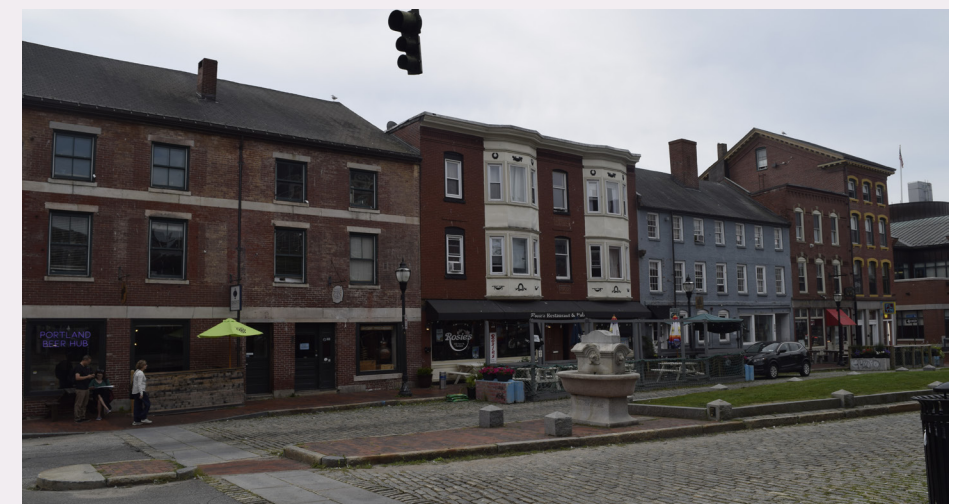
Many later commercial areas, especially office buildings, featured more horizontal windows or groupings of windows such as are found along Congress Street.

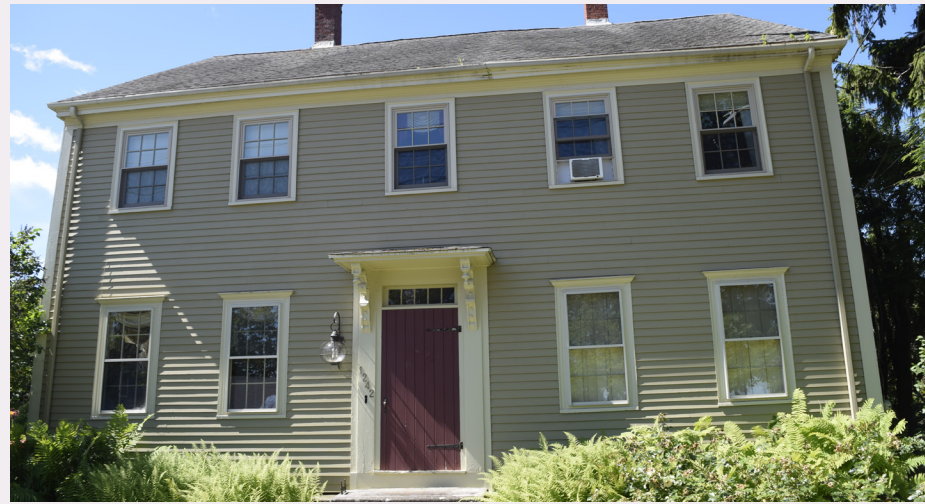
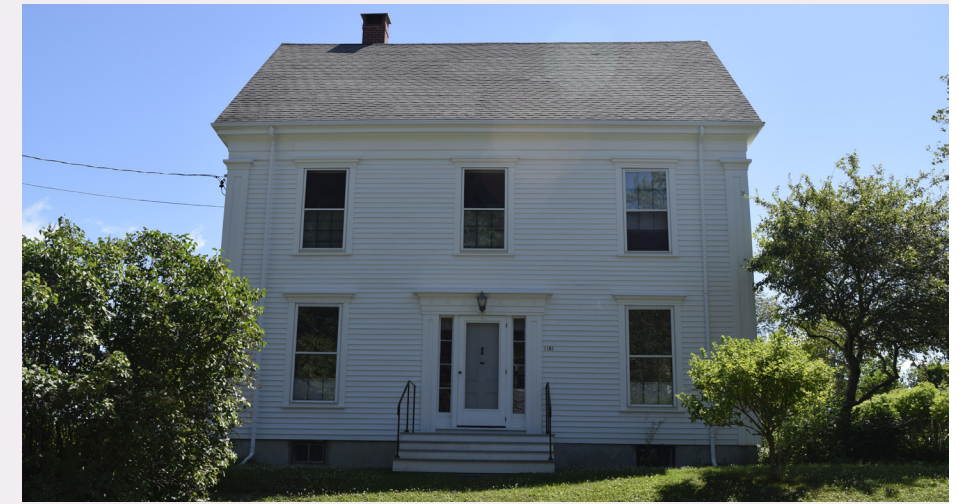
In some contexts, such as in the Stroudwater Historic District, properties are primarily solid, with relatively small windows.

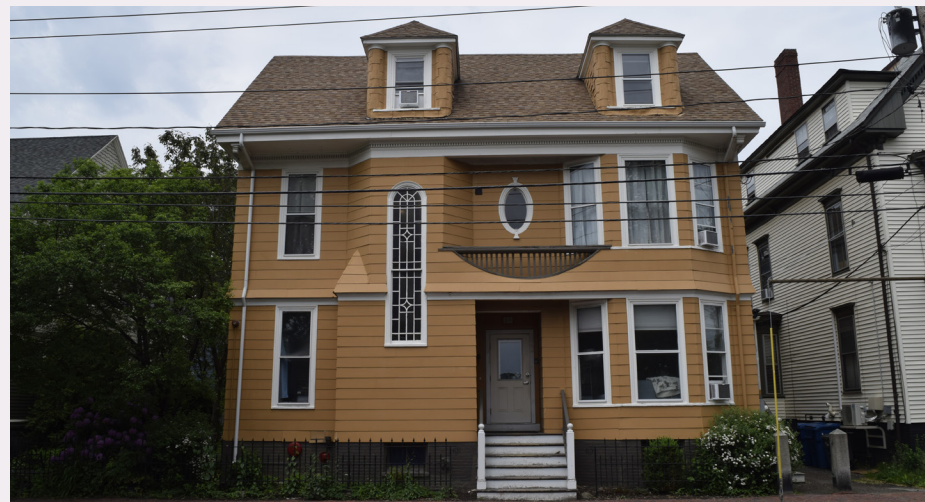
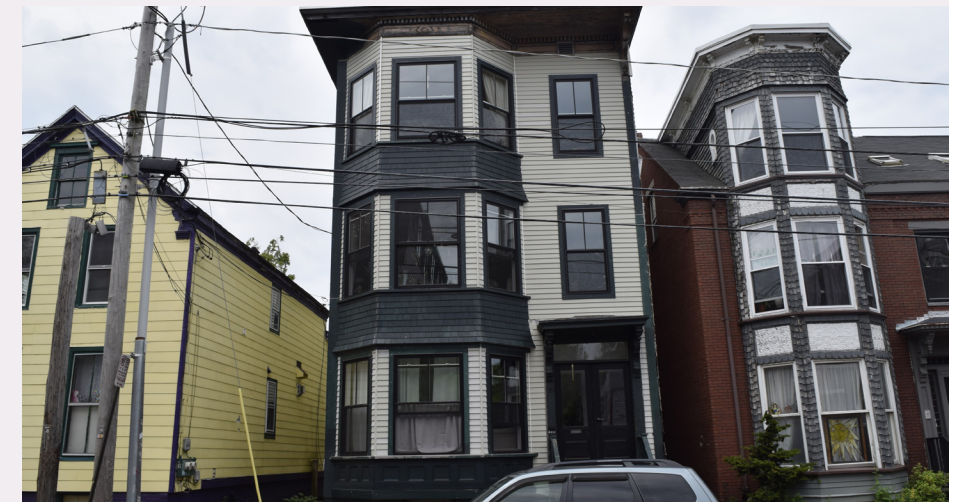
Many contexts, such as these sections of Pine Street, feature varying ratios, even on the same building. Many properties feature bay windows or other projects that feature significantly more window than solid wall.

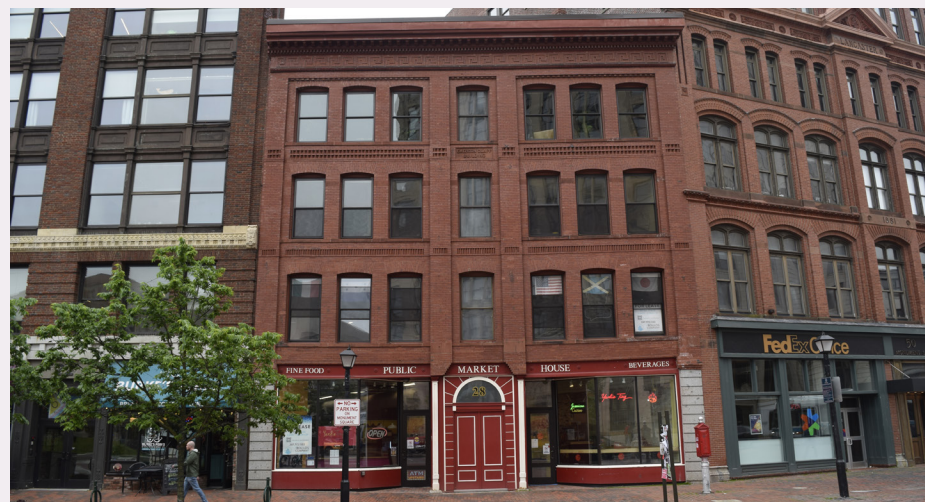
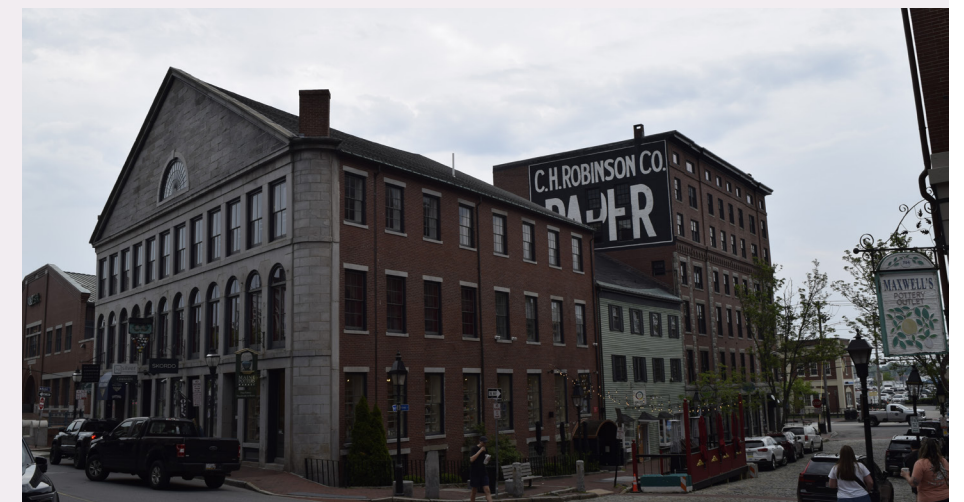
Many commercial and industrial areas feature especially high percentages of window in their facades, such as along Congress (left) and Fore Streets (right).

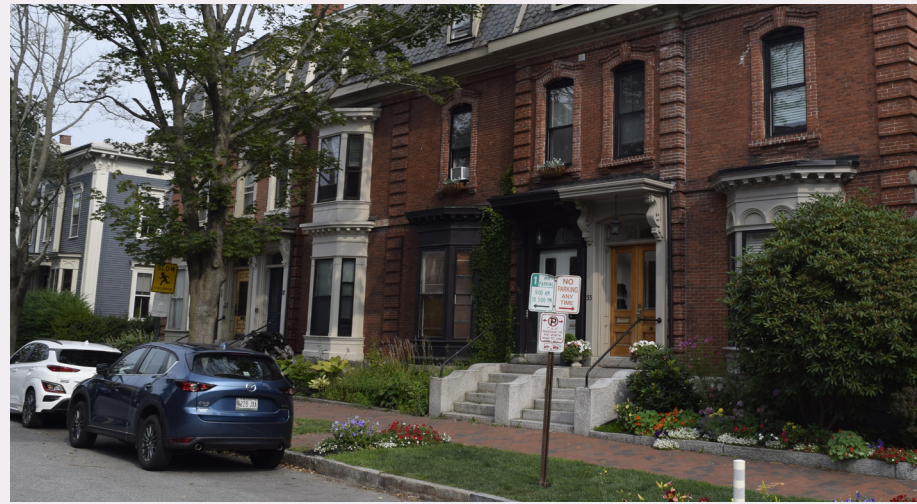
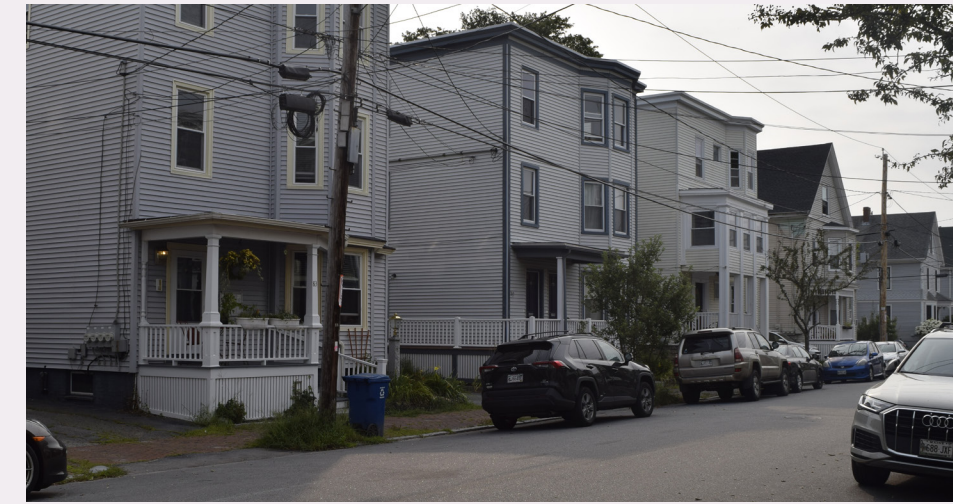
Some contexts feature a very consistent pattern of entrances with repeated elements such as entry hoods, porches, or bay windows as can be seen along Deering (left) and Vesper (right) Streets respectively.

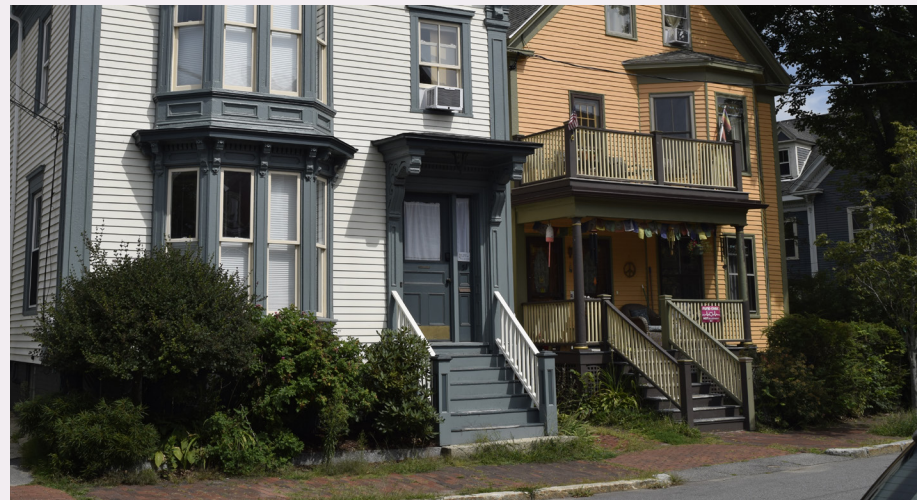
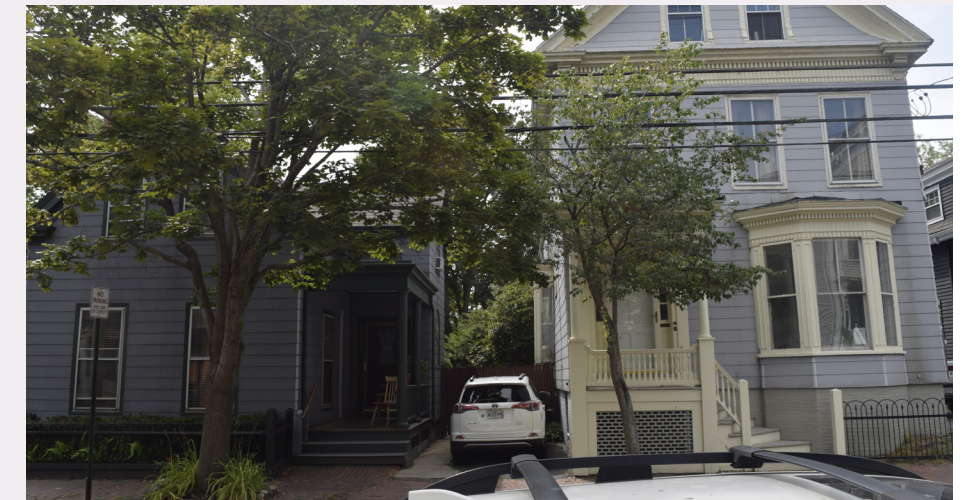
In other areas, it's typical to see a more irregular pattern of entrances and a variety of projecting and recessed features as can be found along these sections of Spruce (left) and Spring (right) streets.

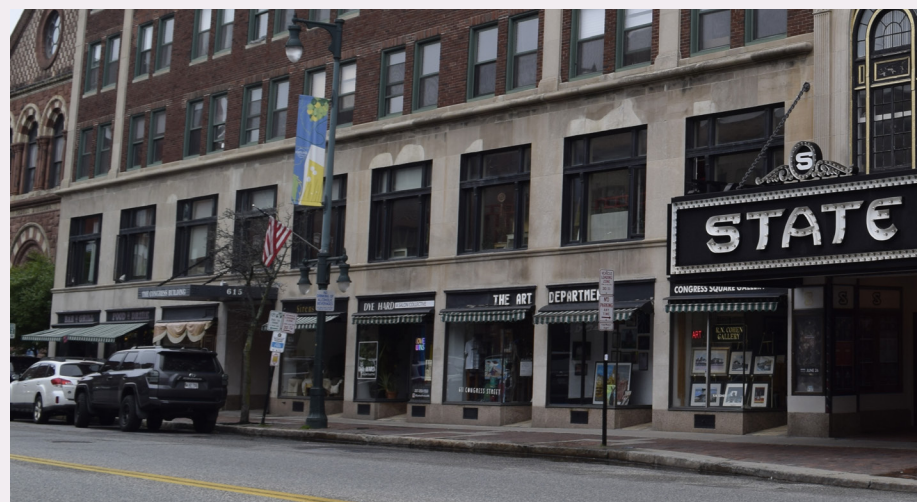
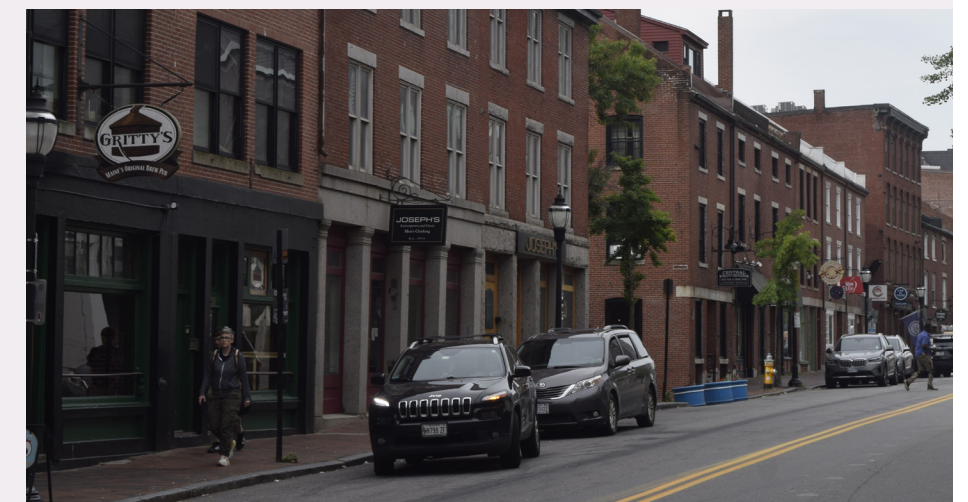
In many commercial areas, such as along Congress (left) and Fore (right) Streets, it's common to see a fairly regular rhythm of recessed storefront entrances between more articulated building entrances.
