## Historic Preservation Board

Topic: Historic Preservation Workshop and Public Hearing 11-19-2025

- i. Preliminary Review of Proposed Updates to the City of Portland Historic Resources Design Manual; City of Portland, Applicant. The Historic Preservation Board will hold a hybrid workshop to review draft updates to the City of Portland Historic Resources Design Manual. The current Historic Resources Design Manual can be found here: <https://www.portlandmaine.gov/496/Additional-Resources>

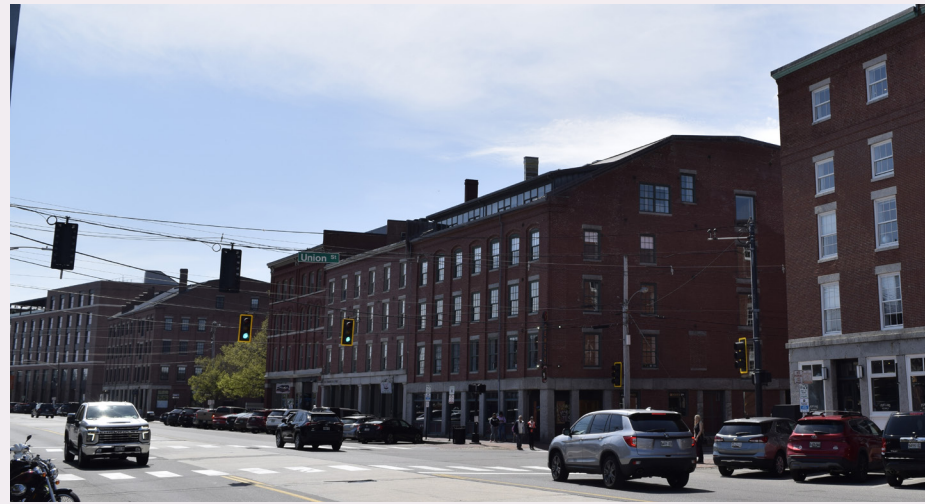
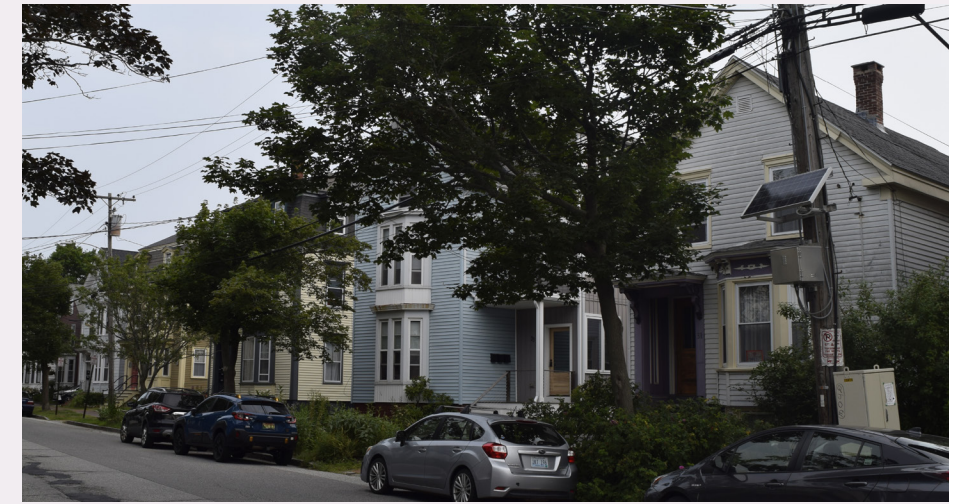
Many contexts feature predominant materials such as along Commercial Street (left) where brick and granite are the most common materials or along North Street (right) where clapboard siding is found on most buildings.

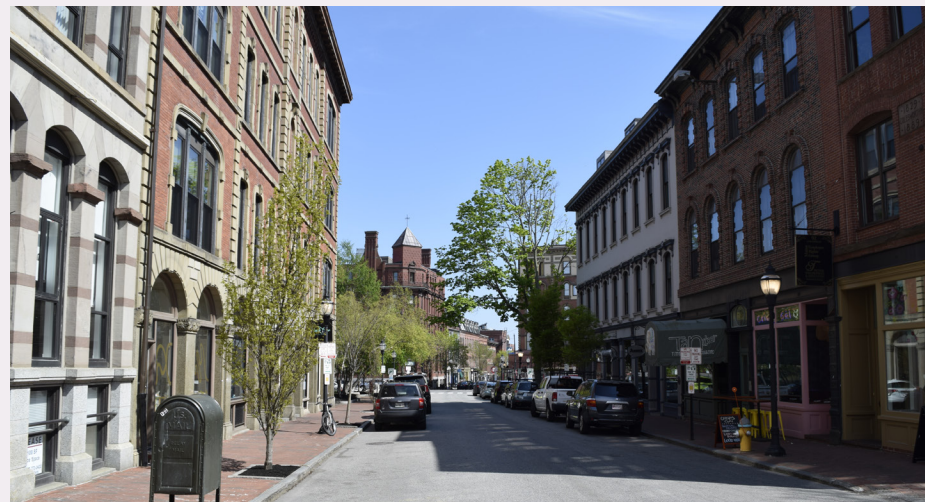
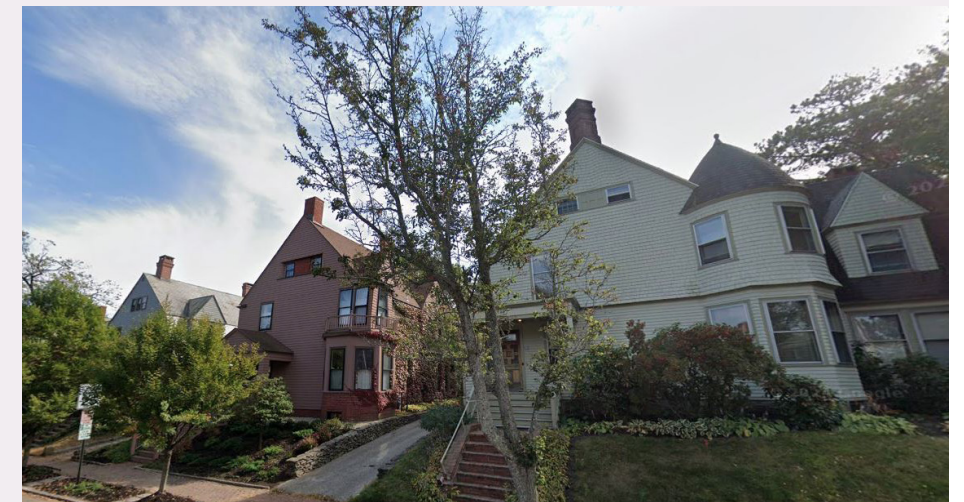
In some contexts, a category of materials such as masonry or wood might be most common, but a mix of expressions. Along Exchange Street (left) a wide variety of brick and stone are used, while along Bowdoin Street (right) a mix of shingle and clapboard wood siding are used.

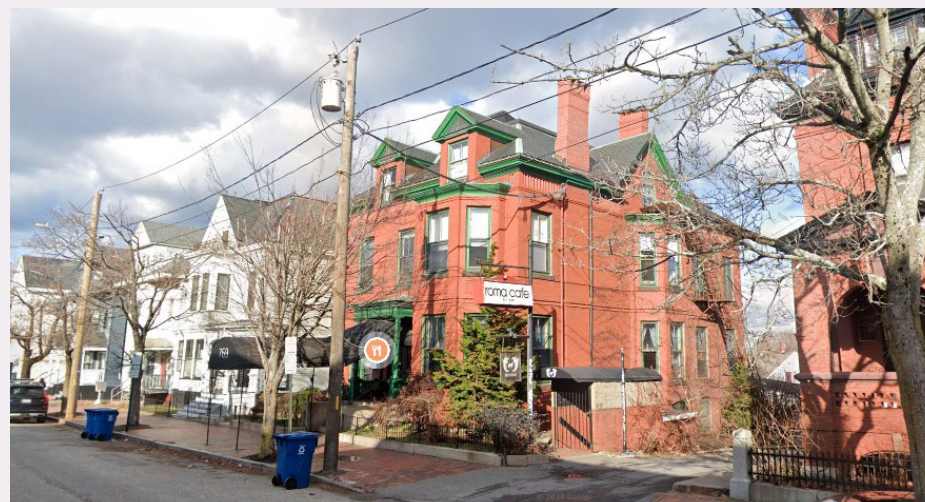
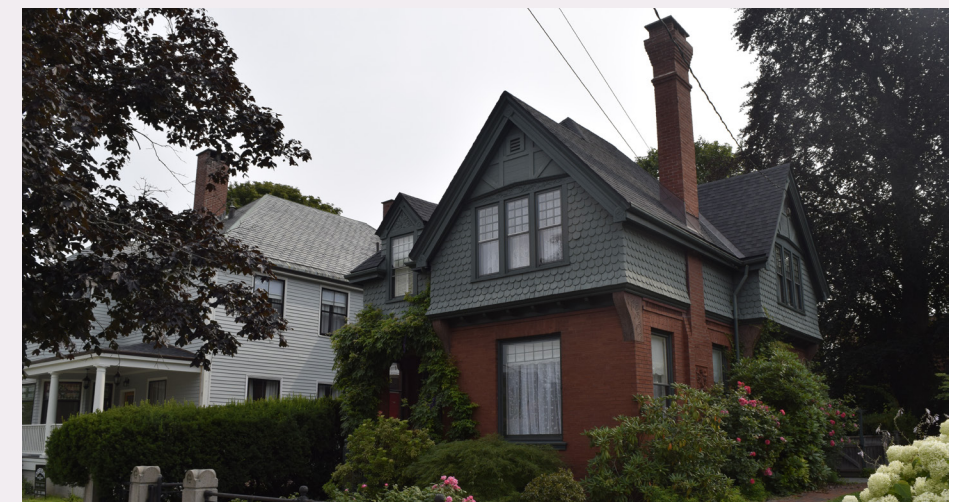
Many areas also feature a wide mix of materials such as along Congress (left) and Vaughan (right) Streets.

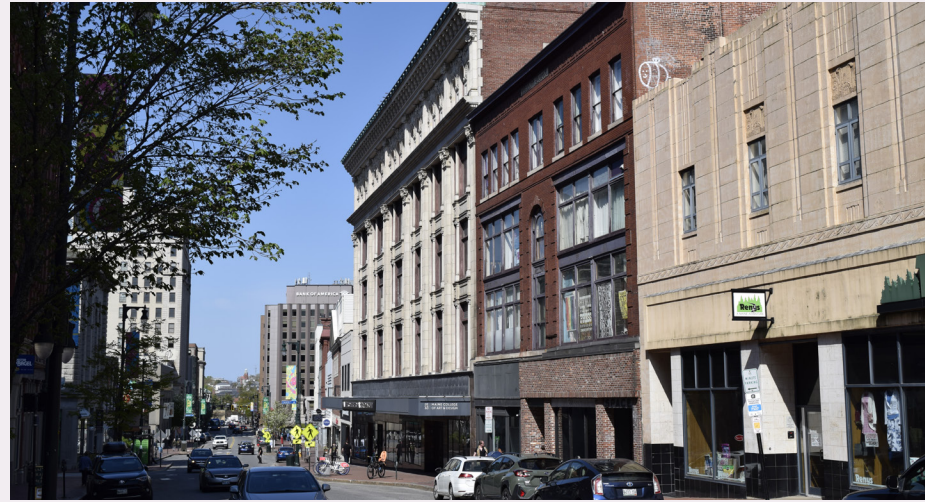
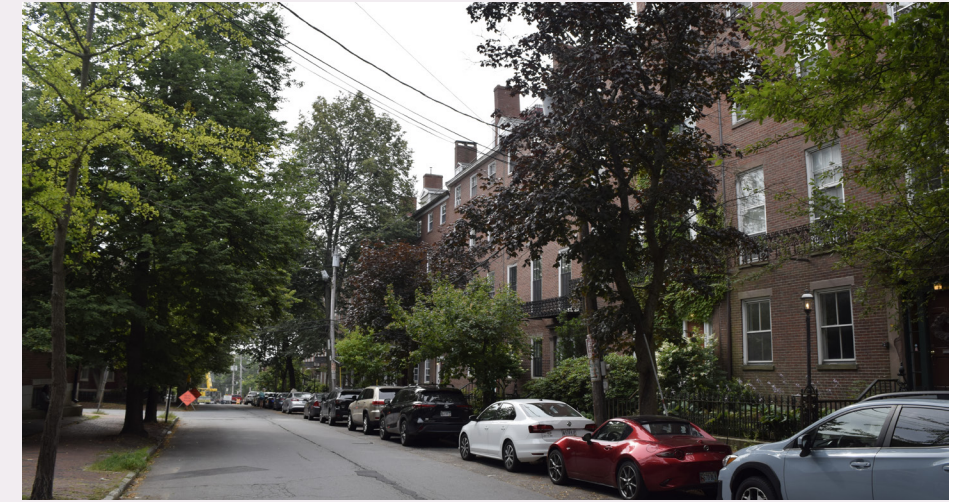
Some contexts have strongly defined walls of continuity, such as along Congress Street (left) or Park Street (right). Along Park Street, the walls are reinforced by the continuous granite curb and iron fence.

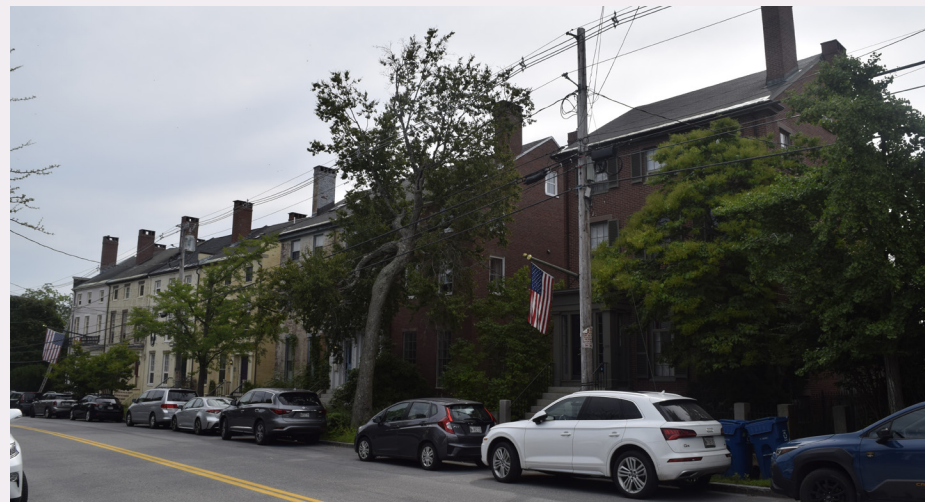
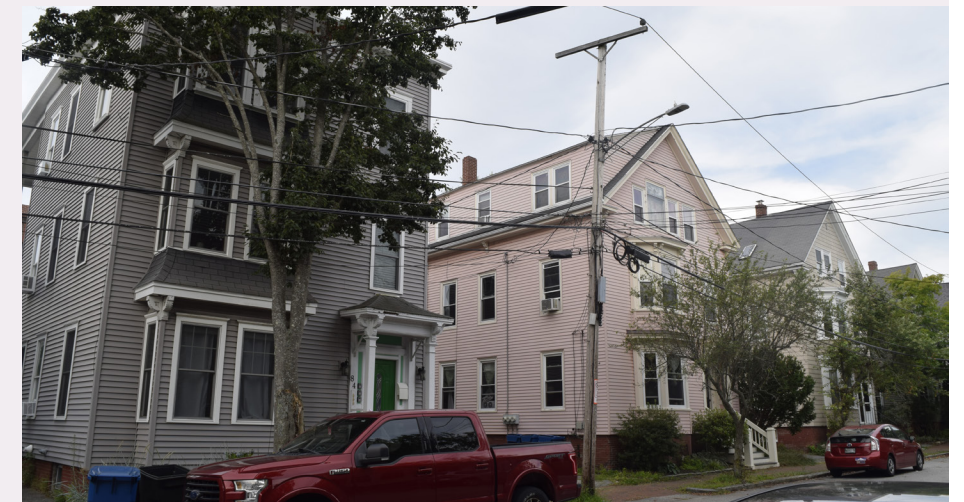
In other areas, properties have a consistent facade placement that creates a consistent wall, but this is broken up by regular gaps between buildings. This can be seen along Danforth (left) and Beckett (right) Streets.

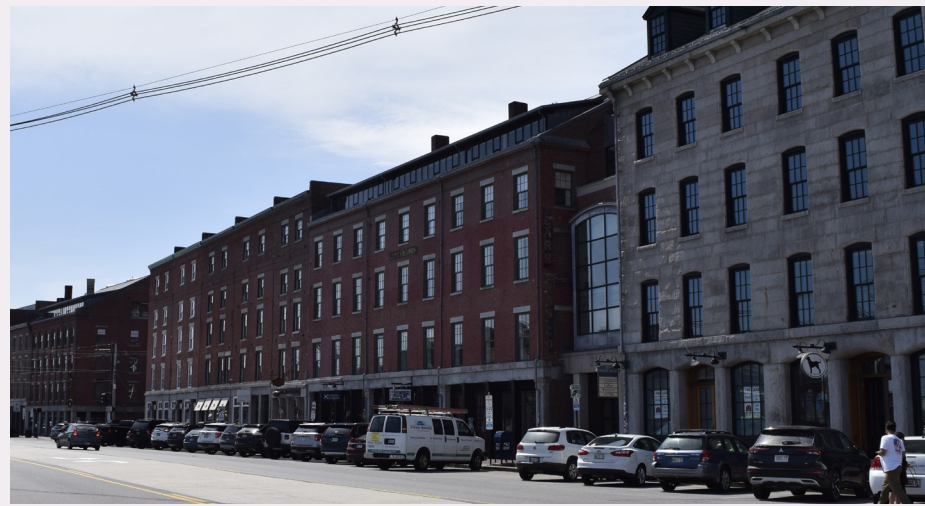
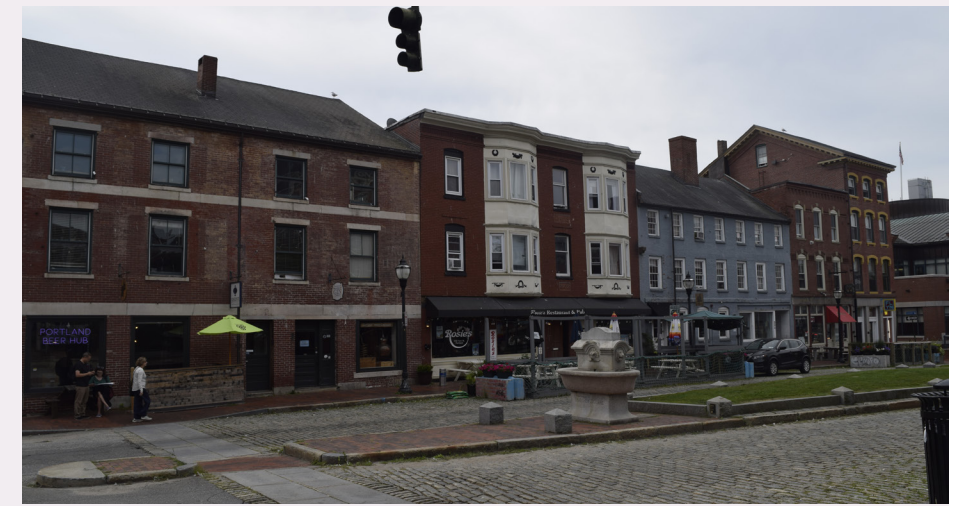
In densely developed, mix-ed use areas, such as along Commercial (left) or Fore (right) Streets, properties were developed with party walls and no space between buildings.

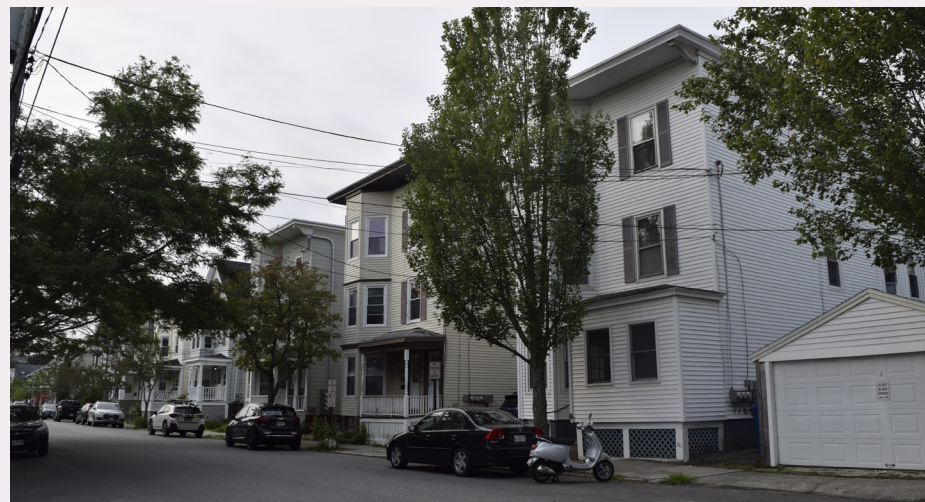
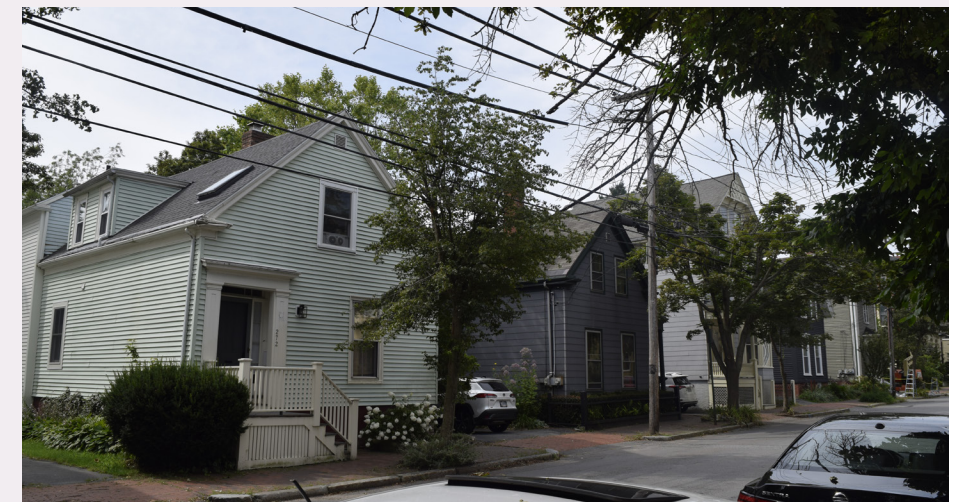
In dense residential areas, properties are often tightly, but evenly spaced such as along Vesper (left) and Spring (right) Streets.

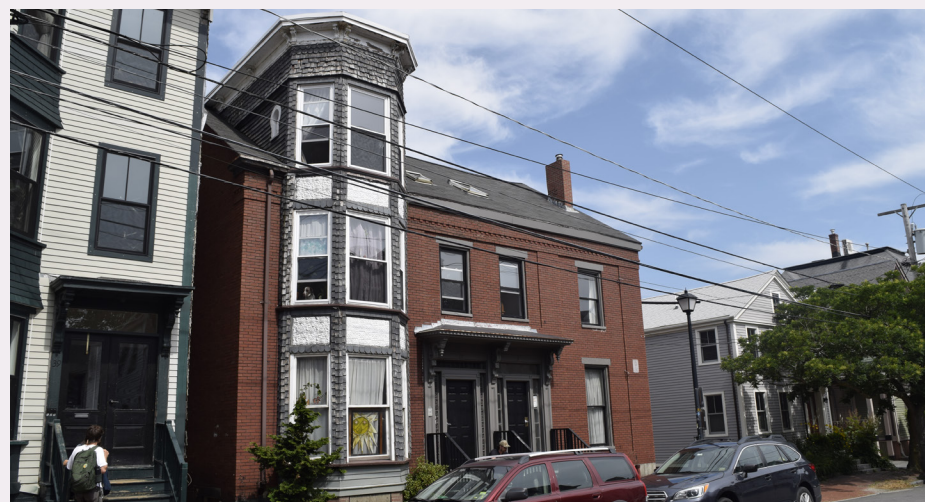
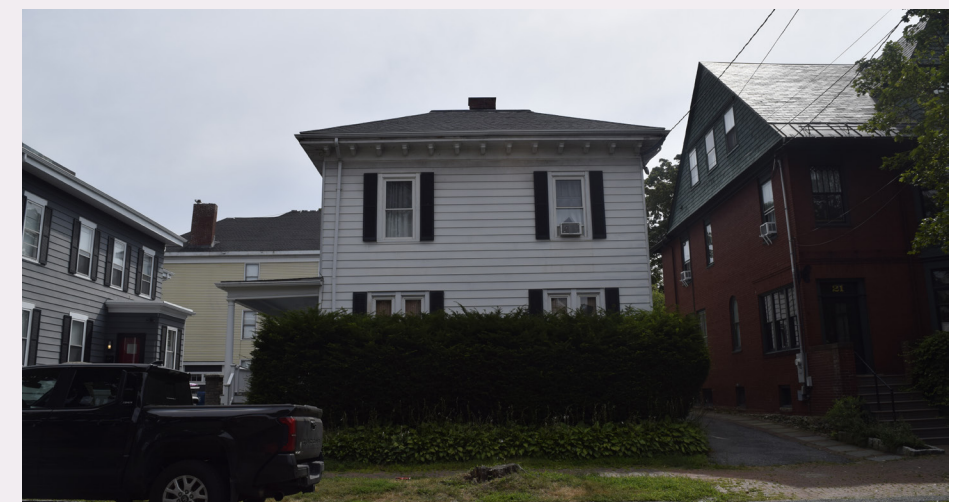
Other areas feature more irregular spacing such as along Pine (left) and Thomas (right) Streets.

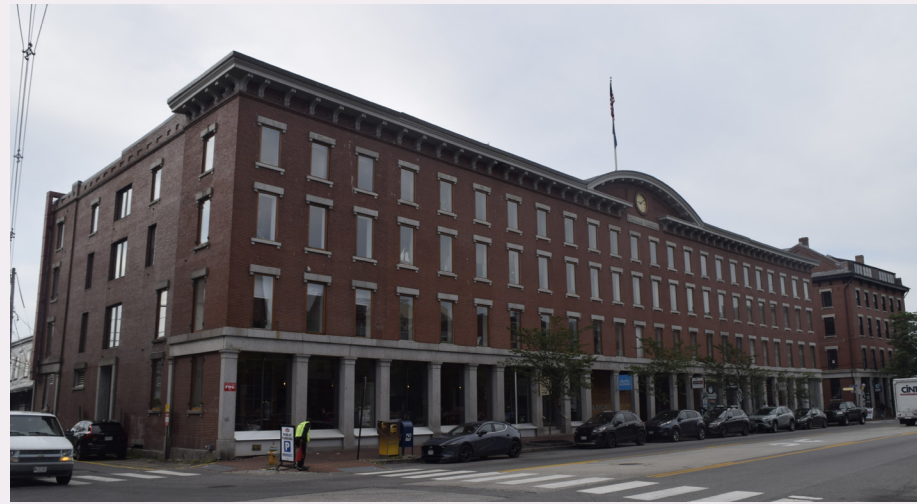
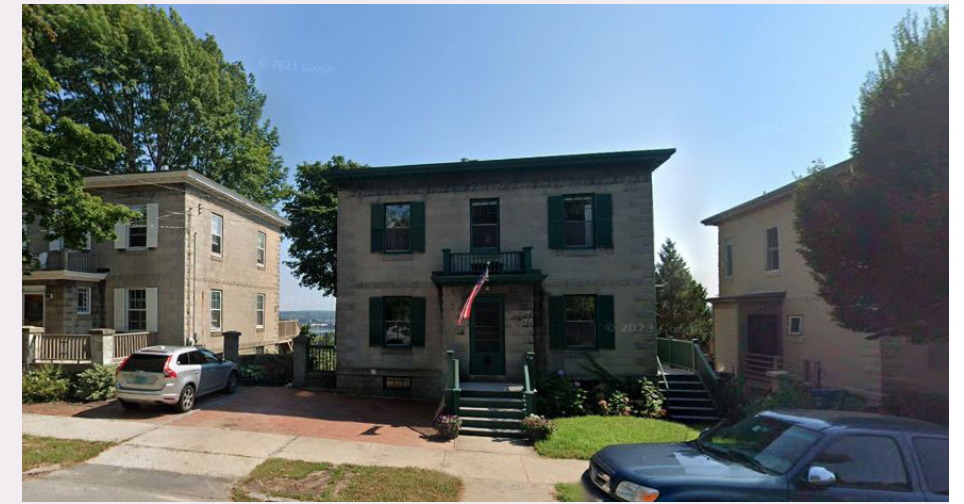
Some properties have clearly horizontal façades such as 100 Commercial Street (left) or 342-358 Danforth Street (right)

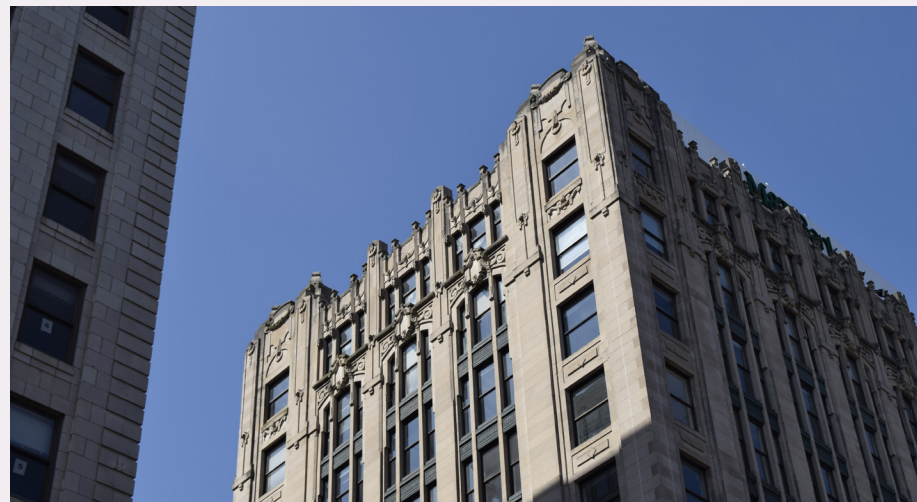
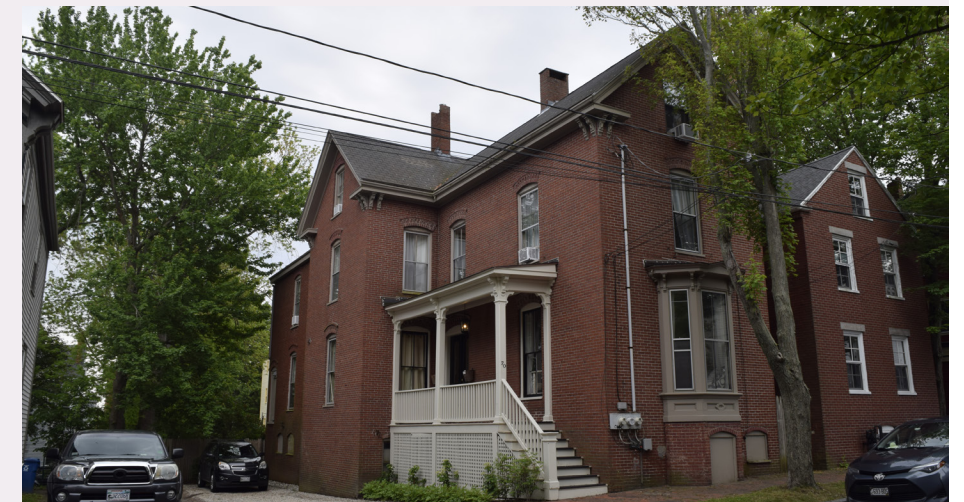
Others, such as 465 Congress Street (left) or 70 Gray Street (right) have a clearly vertical expression.

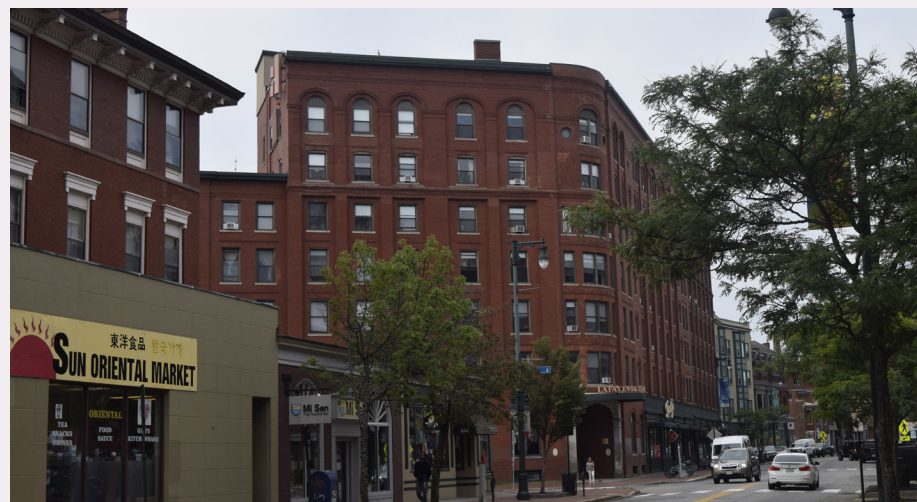
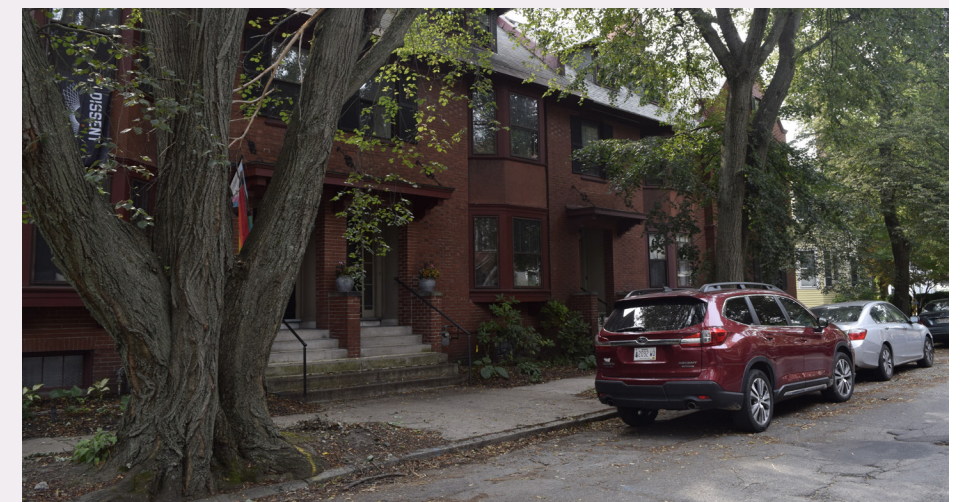
Many properties, such as 638 Congress (left) and 117-131 Neal Street (right) feature a mixture of vertical and horizontal expressions.

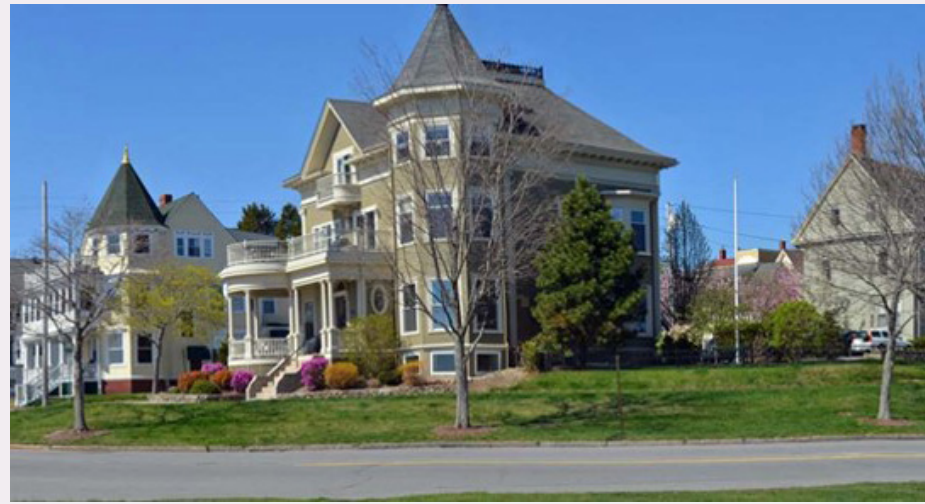
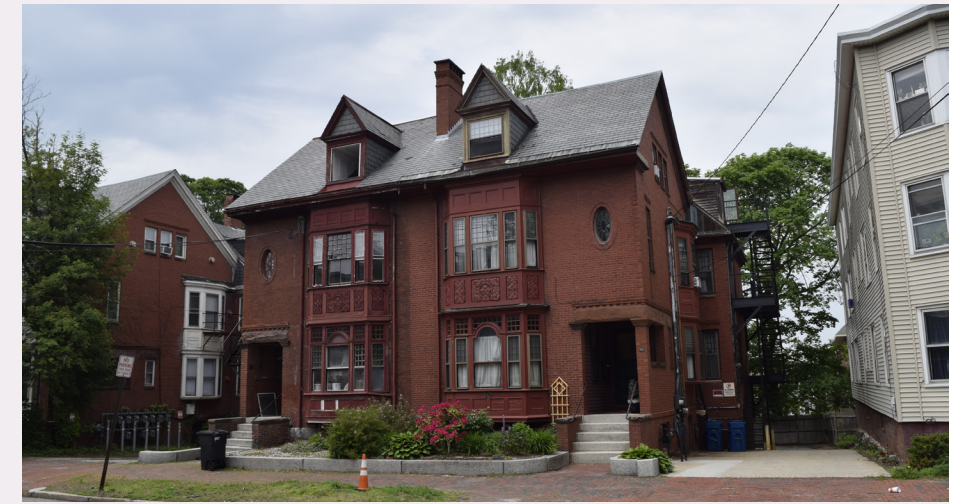
In some areas, such as along the Eastern Promenade (left) large, open lawns or yards are typical. In many residential areas, shallow landscaped front yards are common, such as along Cumberland Avenue (right).

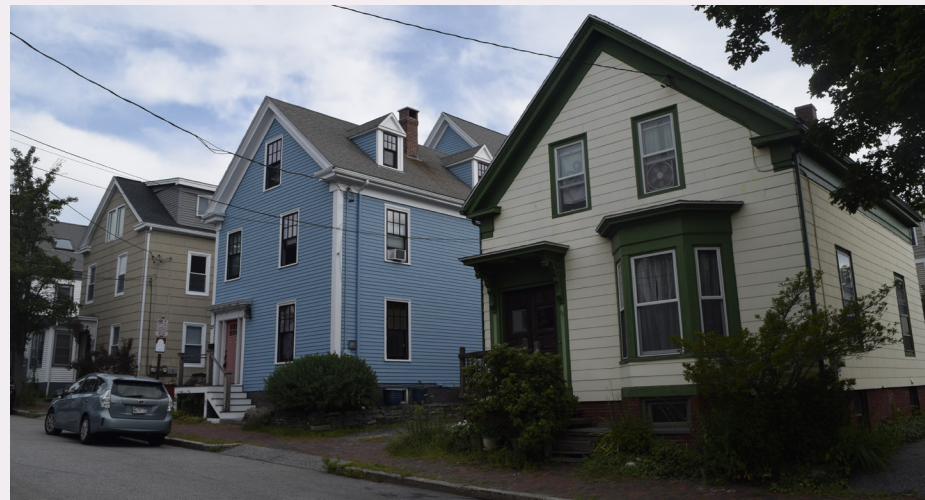
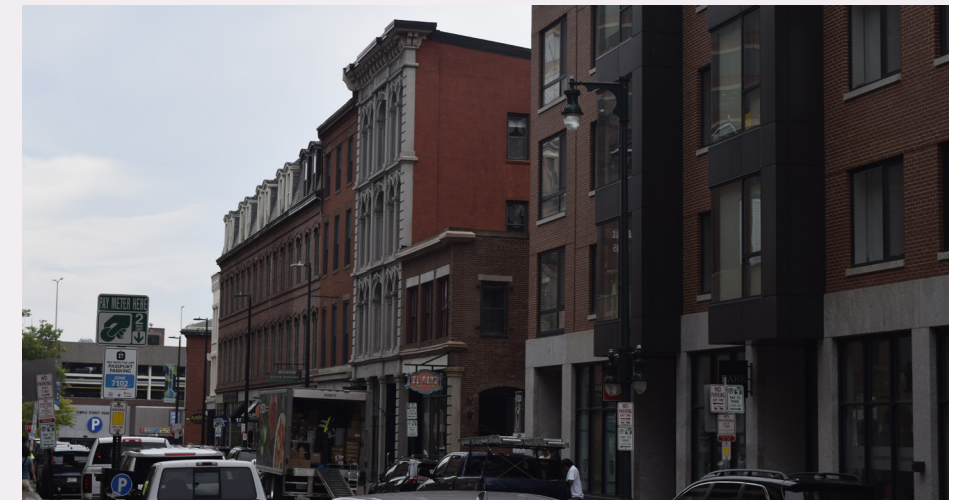
Very common in both residential and mixed-use areas are buildings built right along the sidewalk with little, or no yard, such as along O'Brien (left) or Free (right) Streets.

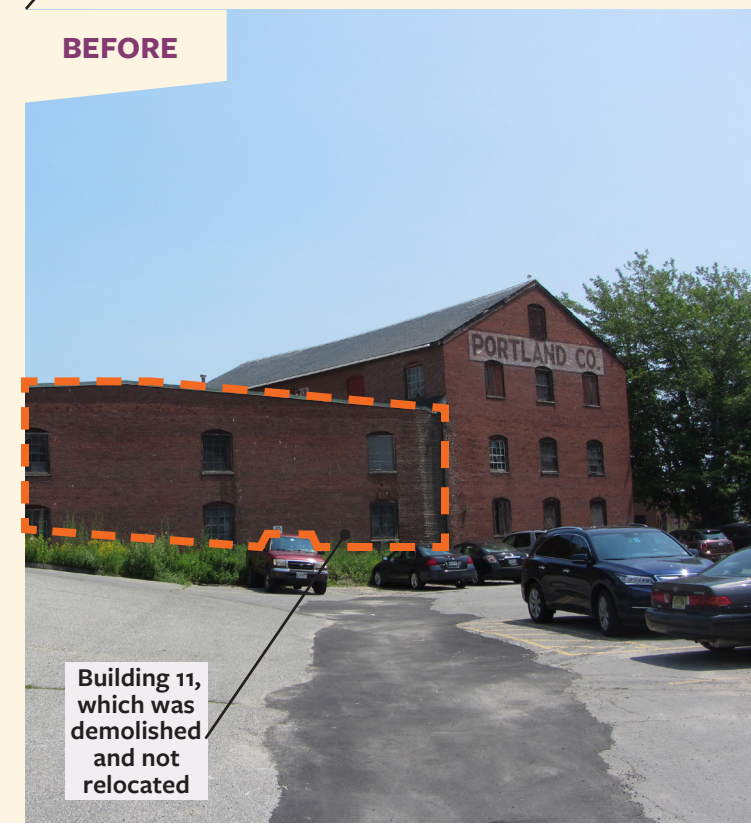
West Elevation – “Portland Co.” – Common Bond | South Elevation – facing water – “Common Bond” The bonding pattern for the West and South Elevation consist of common bond with header courses that align and repeat at every 8 courses, intermixed with Flemish Header Courses – A full documentation of the exterior will hopefully reveal a pattern to the seemingly random choice of coursing

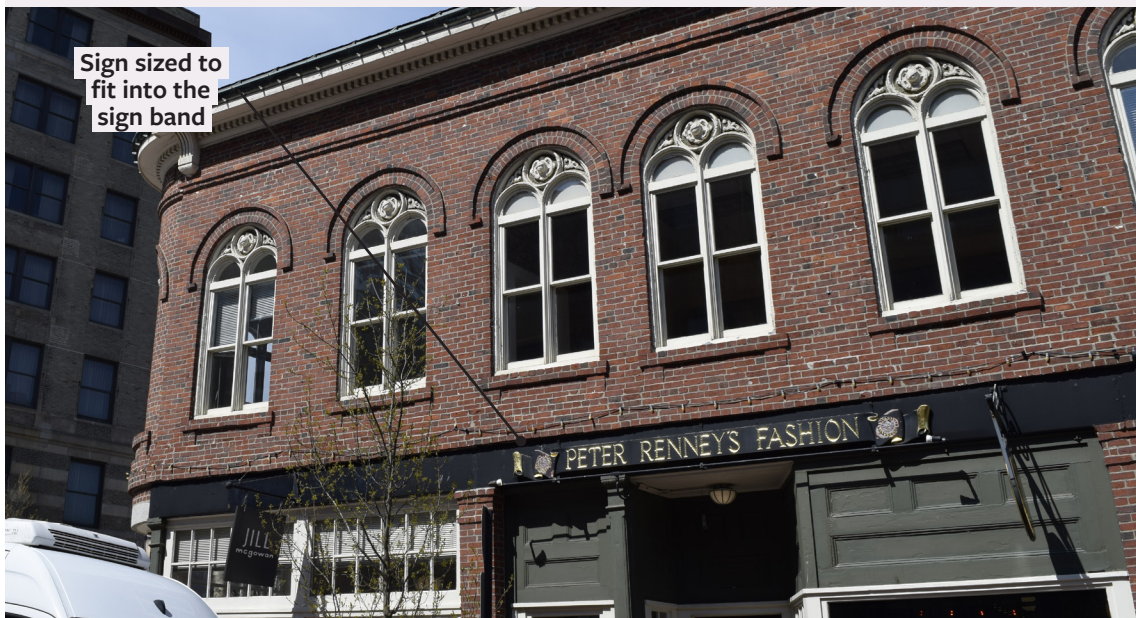
Sign sized to fit into the sign band

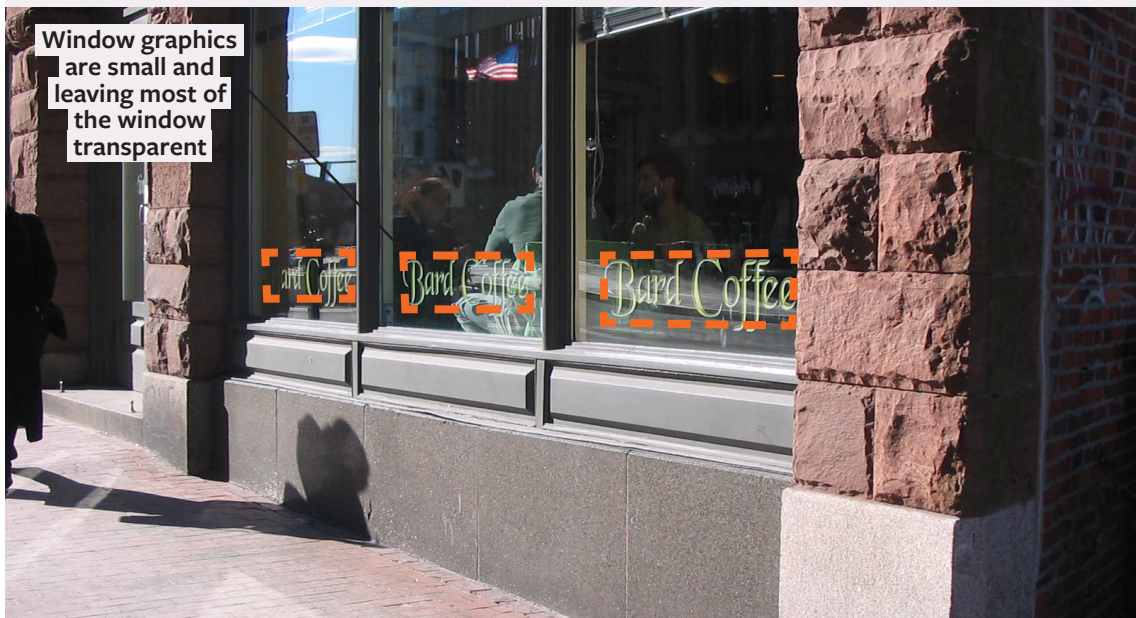
Window graphics are small and leaving most of the window transparent

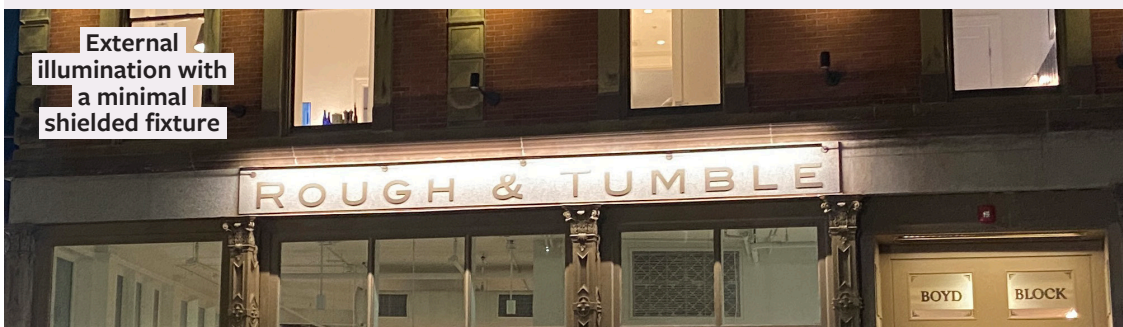
External illumination with a minimal shielded fixture

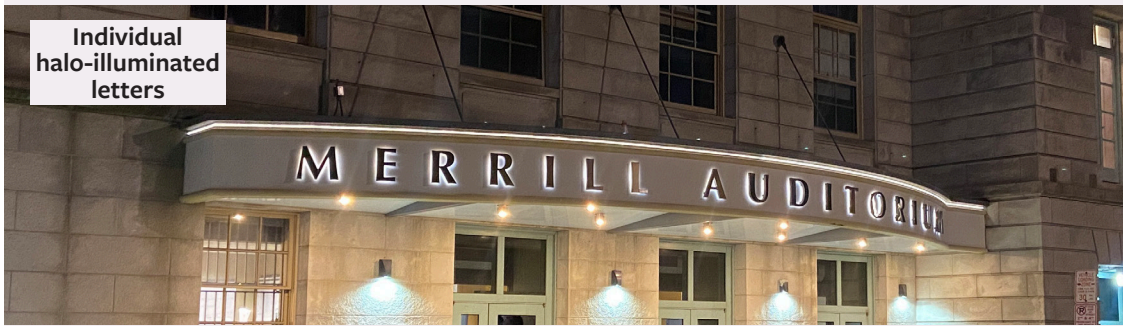
Individual halo-illuminated letters

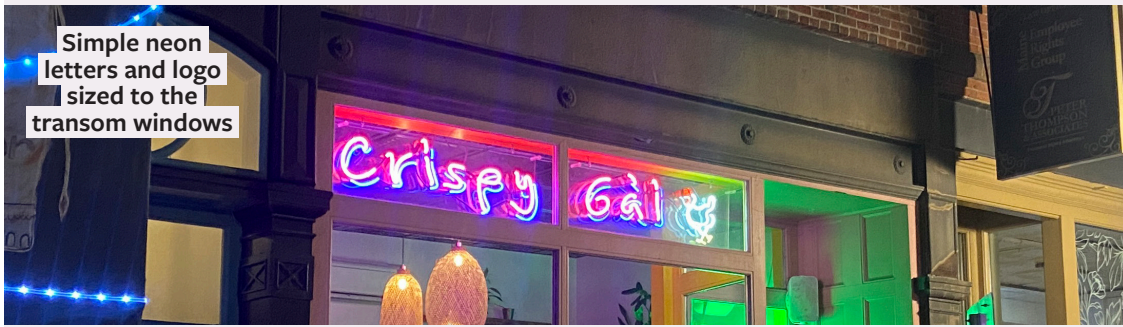
Simple neon letters and logo sized to the transom windows

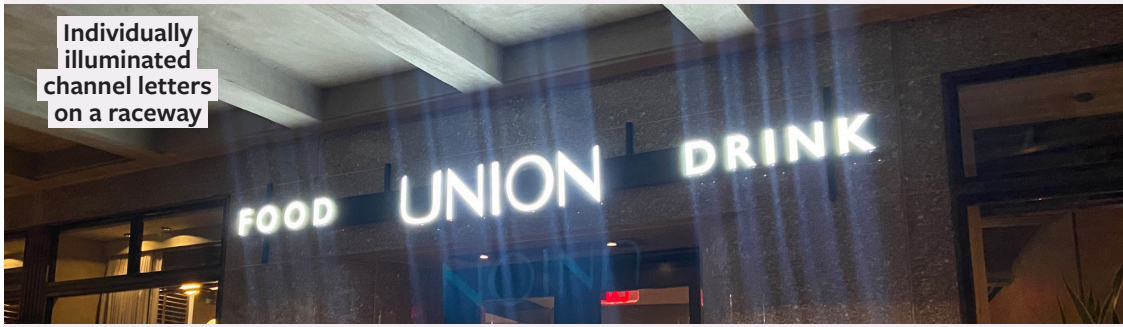
Individually illuminated channel letters on a raceway

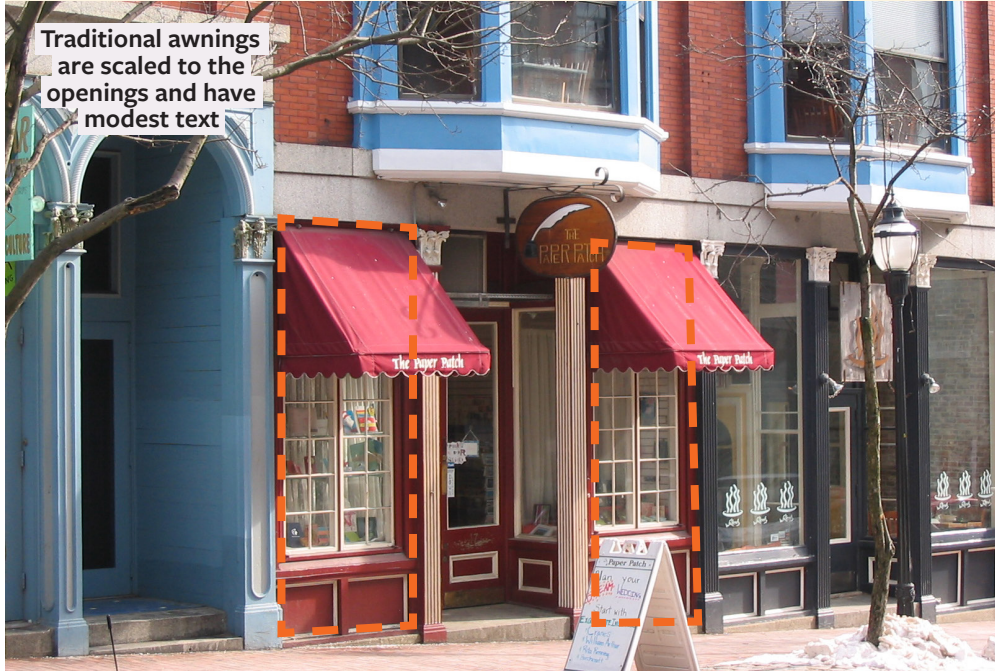
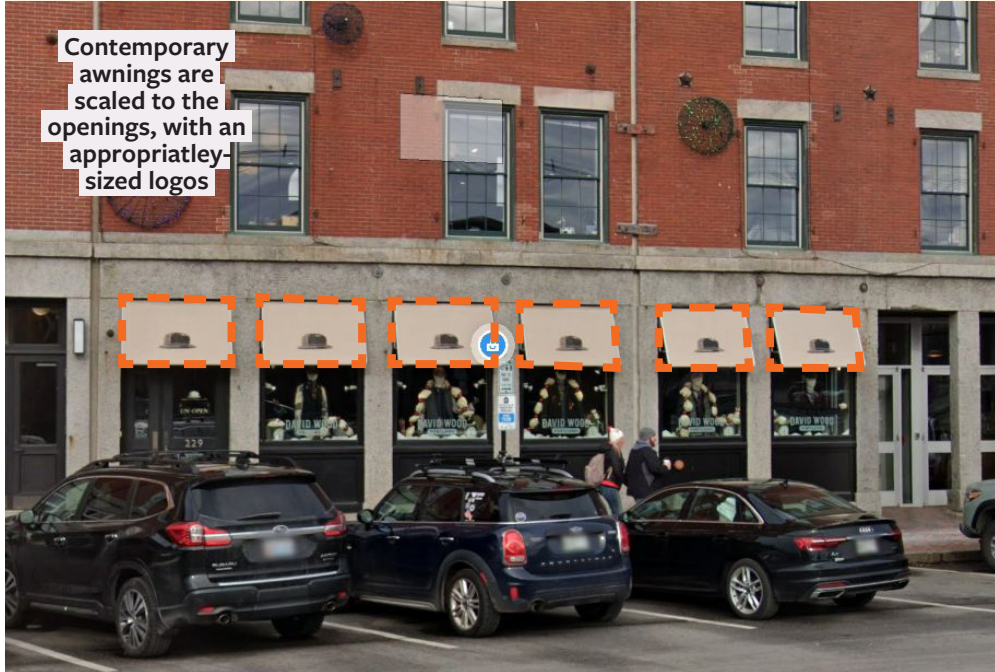
- A. The shape and size of awnings should correspond to the shape and size of the opening over which they are proposed, and should not obscure architecturally significant elements of the building, including distinctive windows.
- B. Where there are existing awnings that meet the guidelines on the building, new awnings should be designed and located to be compatible with those existing.
- C. Sign text or graphics should not constitute the entire surface area of the awning.

An example of a well-coordinated signage scheme. The awnings' traditional form (shed style with loose scalloped valance) and placement over the transom windows reinforce the historic character of the storefront.

This awning solution is a successful contemporary interpretation of the traditional shed-type awning. Instead of a loose and/or scalloped valance, the valance is taut. The graphic element on the slope of the awning, while not typically encouraged, works here because of its scale, subtlety and repetition.

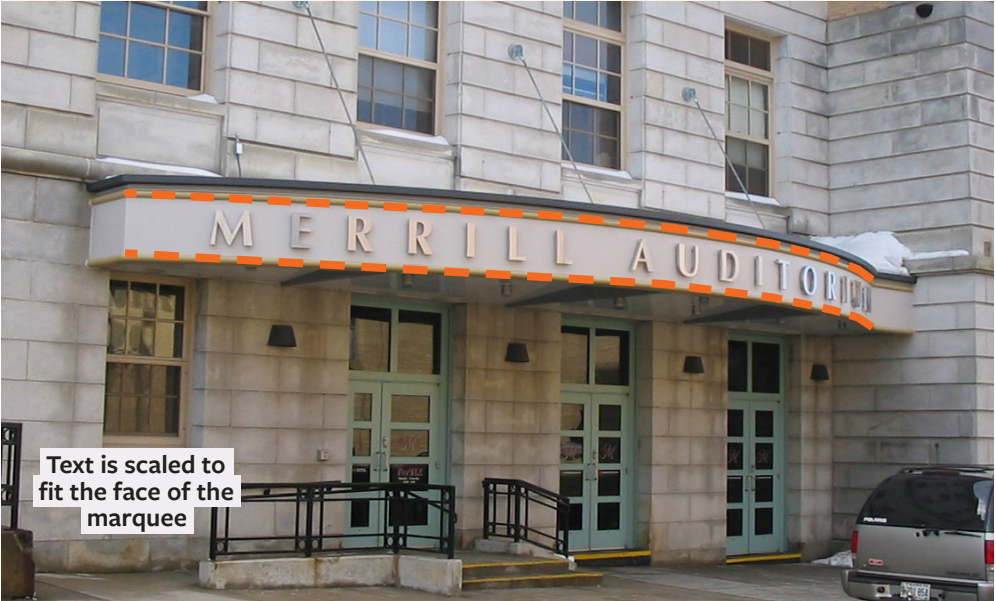
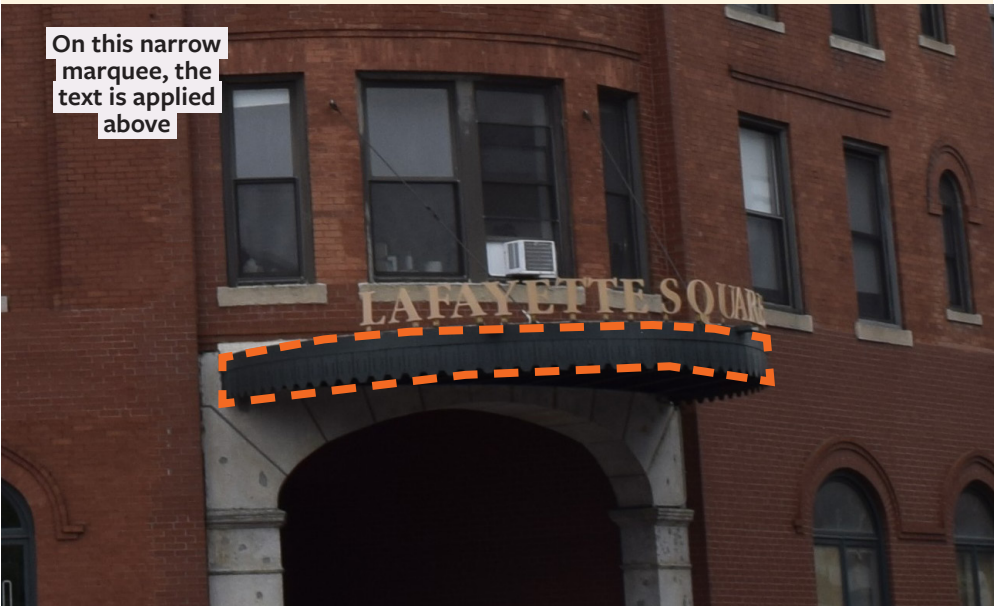
- A. The design of the sign should be compatible with the design of the canopy or marquee.
- B. Signs should be placed on the visible faces of the canopies or marquees.
- C. Where the canopy or marquee is too thin, or lacks open areas for surface mounted signs, it may be appropriate to attach signs to the underside or top of the canopy or marquee, provided it does not obstruct most views of significant elements of the building beyond.
- D. For historic canopies or marquees, the signs should not obscure or damage distinctive elements of the canopy itself.

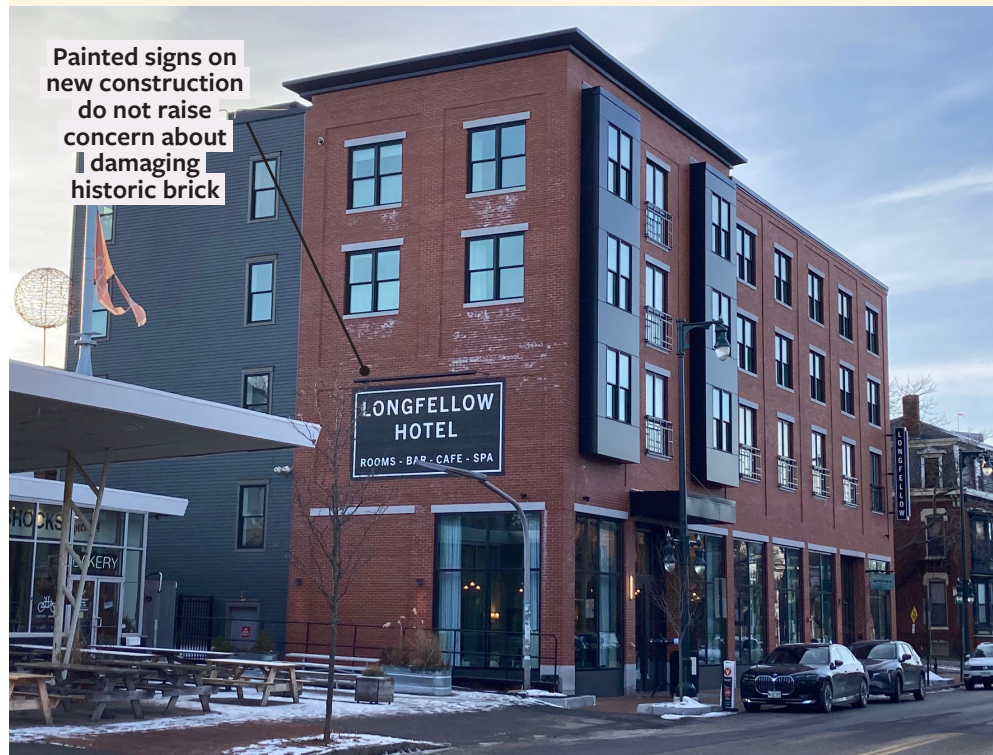
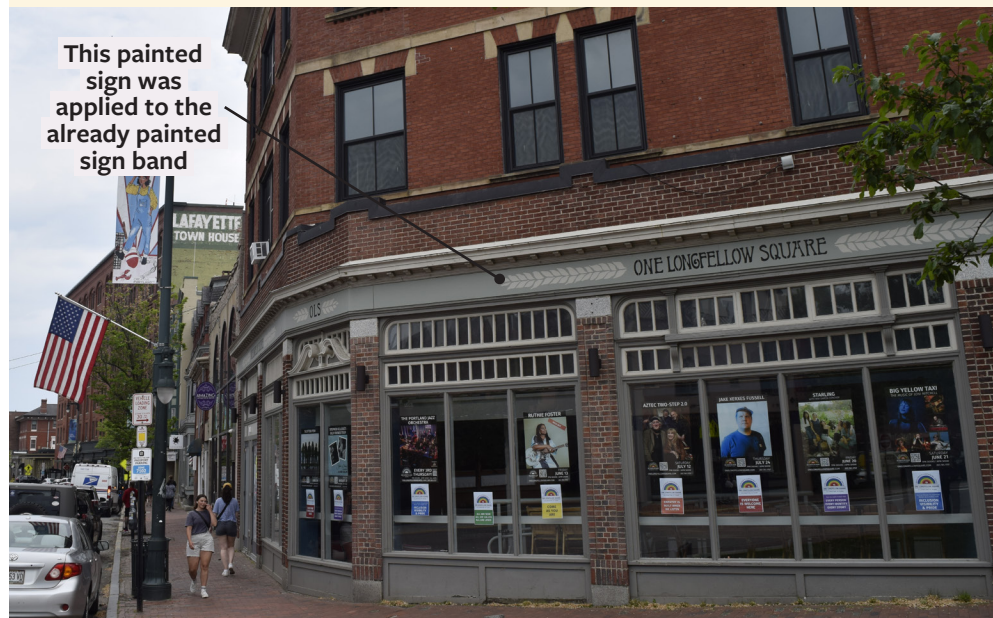
- A. Painted wall signs should be limited to already painted surfaces. Painted wall signs are generally not allowed on unpainted masonry surfaces as they are not readily reversible, and paint can cause damage to historic masonry.
- B. Paints formulated for use on masonry should be used to reduce the need for maintenance and the potential for damage to masonry.

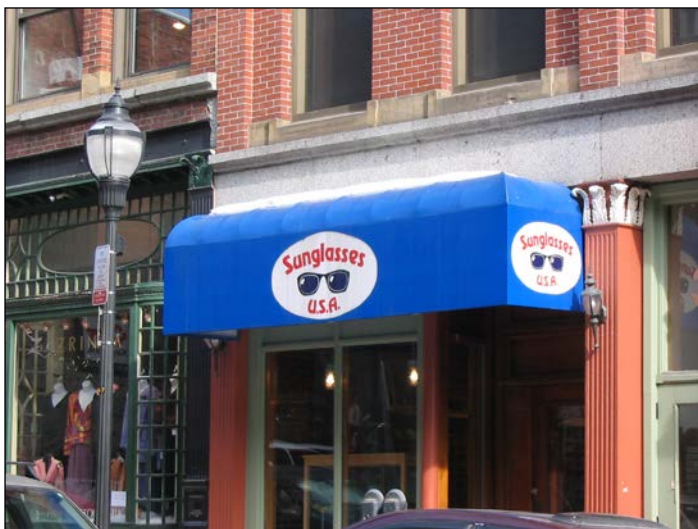
This awning solution is inappropriate for its historic setting. The combination of a non-traditional shape, shiny plastic material, and poorly integrated graphics is in conflict with the historic character of the property and streetscape.

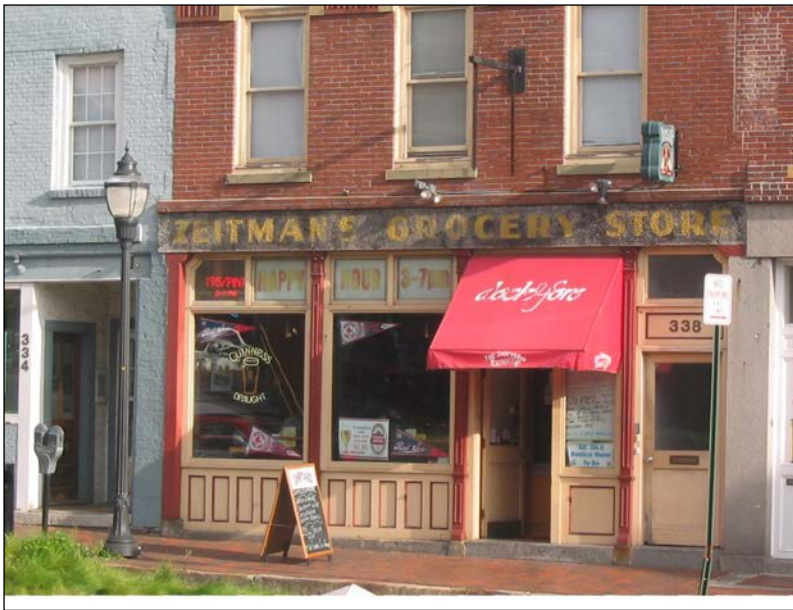
Historic signs are important reminders of Portland's commercial history and may not be removed or covered without express approval.

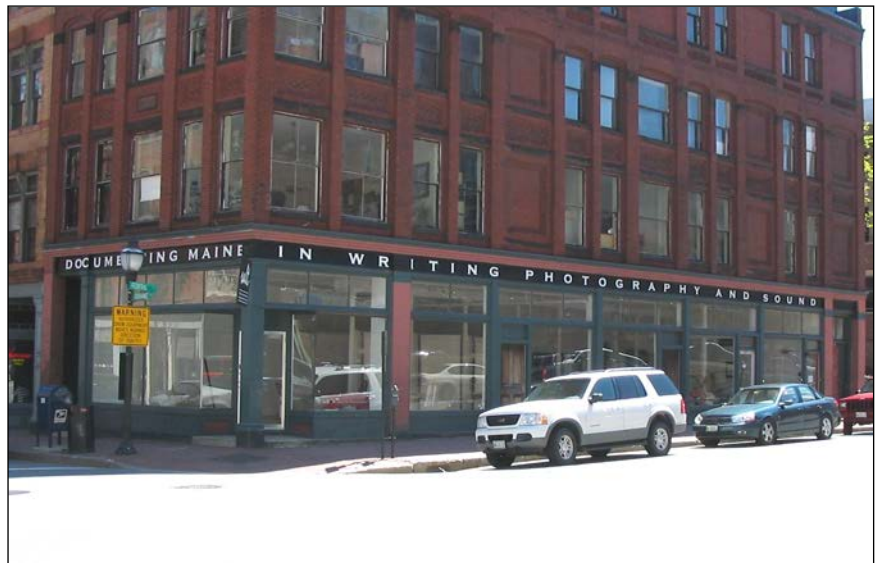
A sophisticated signage solution, reminiscent of historic signage and well-suited to the building's corner location.

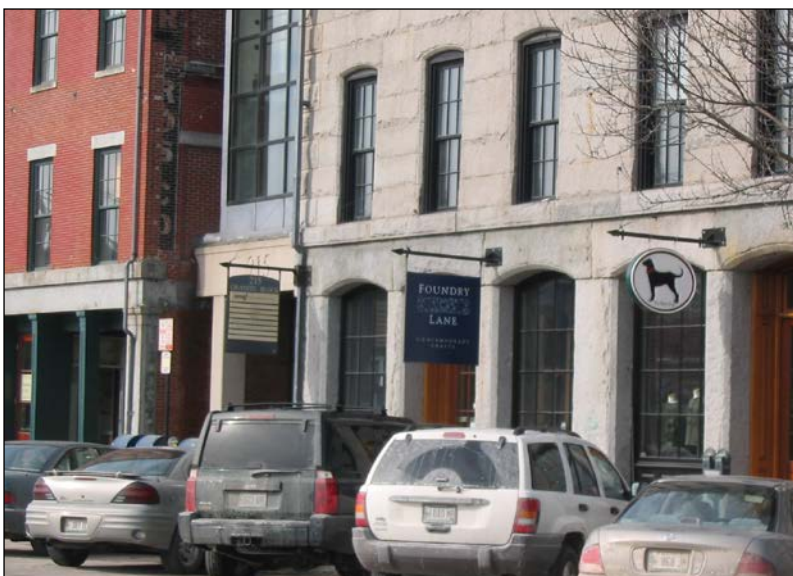
On commercial blocks with several individual storefronts, it is advisable to develop a master plan for signage that ensures a level of consistency while showcasing the individual nature of each business. Here, the same style bracket is used across the entire ground floor frontage. The signs themselves are all wood, non-lit and similarly sized.
