## Historic Preservation Board

Topic: Historic Preservation Workshop and Public Hearing 11-19-2025

- i. Preliminary Review of Proposed Updates to the City of Portland Historic Resources Design Manual; City of Portland, Applicant. The Historic Preservation Board will hold a hybrid workshop to review draft updates to the City of Portland Historic Resources Design Manual. The current Historic Resources Design Manual can be found here: <https://www.portlandmaine.gov/496/Additional-Resources>

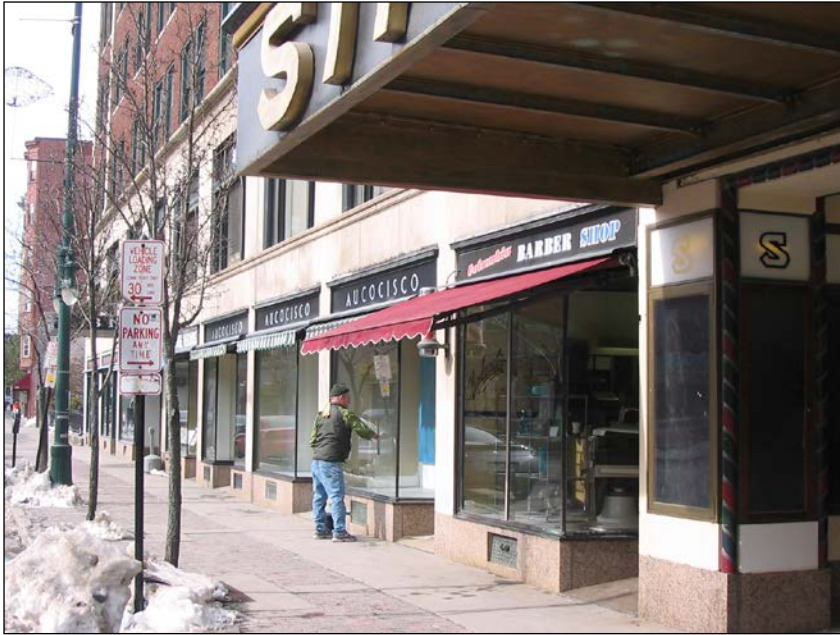
A classic example of traditional signage and retractable awnings still in use. The consistency shown here is particularly well-suited to large buildings with multiple storefront tenants.

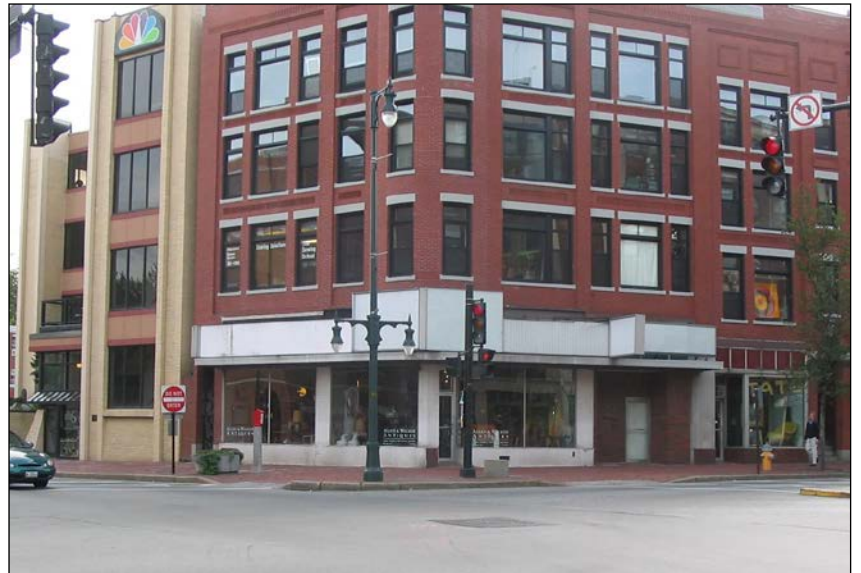
Obsolete signs should be removed entirely. Even with the graphics removed, these sign panels distract from and clutter a landmark building on a prominent corner.

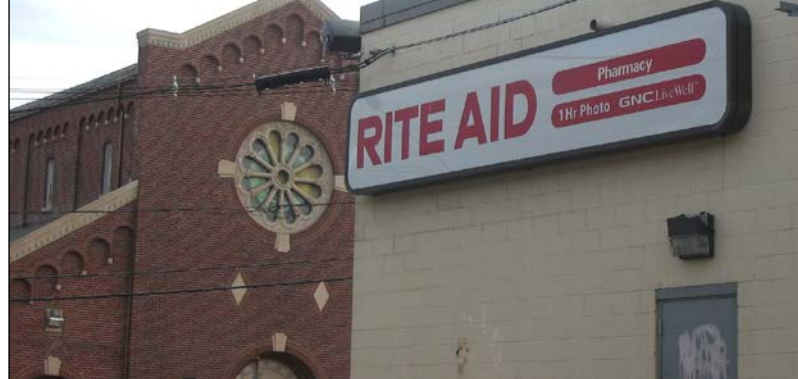
Standard internally-illuminated box-type signs are not appropriate in historic districts. This example, not in a district, illustrates the visual impact of this type of signage on its historic neighbor.

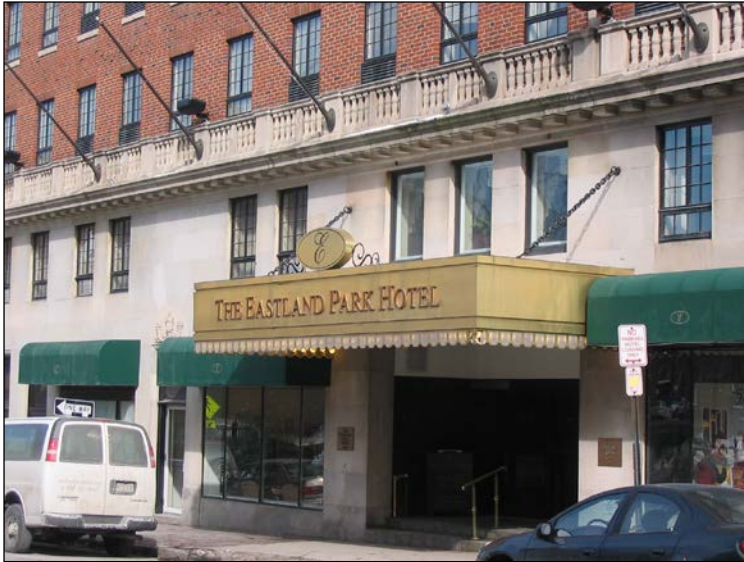
When the Eastland Park Hotel wanted to re-establish the original grandeur of its main entrance, this traditional style marquee with signage was created to evoke the era and spirit of the hotel's 1920's construction.

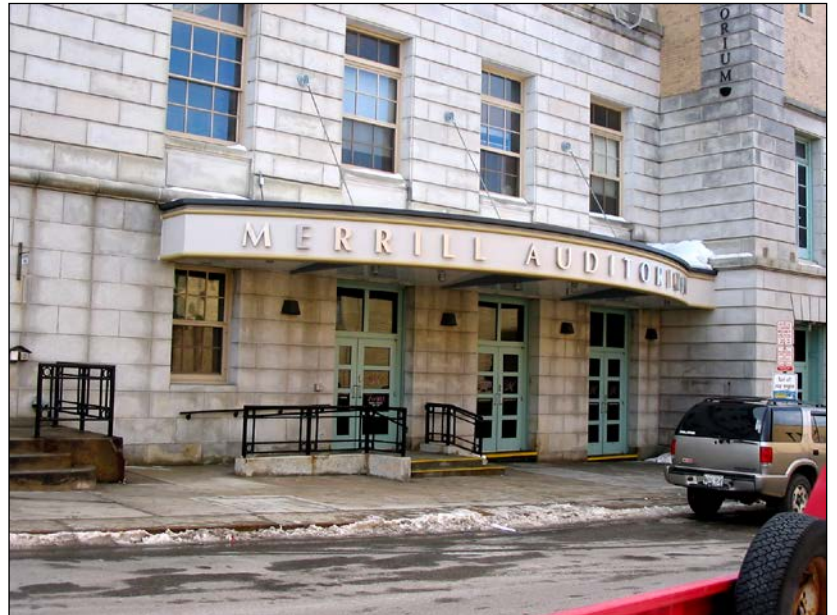
Located at the rear of City Hall, Merrill Auditorium long suffered from a lack of visibility and its "back door" entrance gave no clue as to the grandeur and elegance of the space within. This marquee, added in 2006, successfully improves visibility for the auditorium and enhances the sense of arrival, just as traditional marquees were designed to do. Although clearly contemporary in design and material, this installation is seamlessly integrated with its historic setting. The brushed aluminum letters project from the face of the sign band, giving depth and visual interest to the marquee.

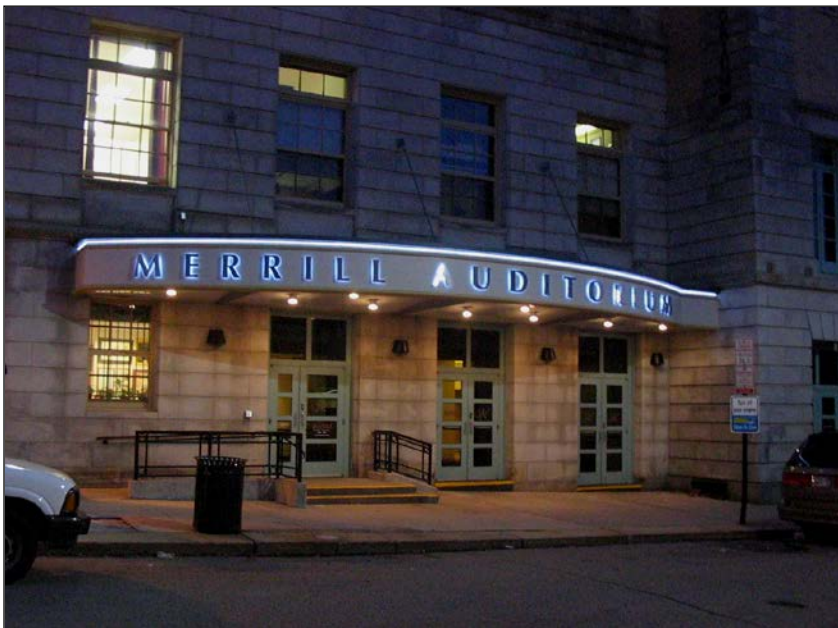
At night, the letters are halo-lit; a subtle band of neon completes the composition.

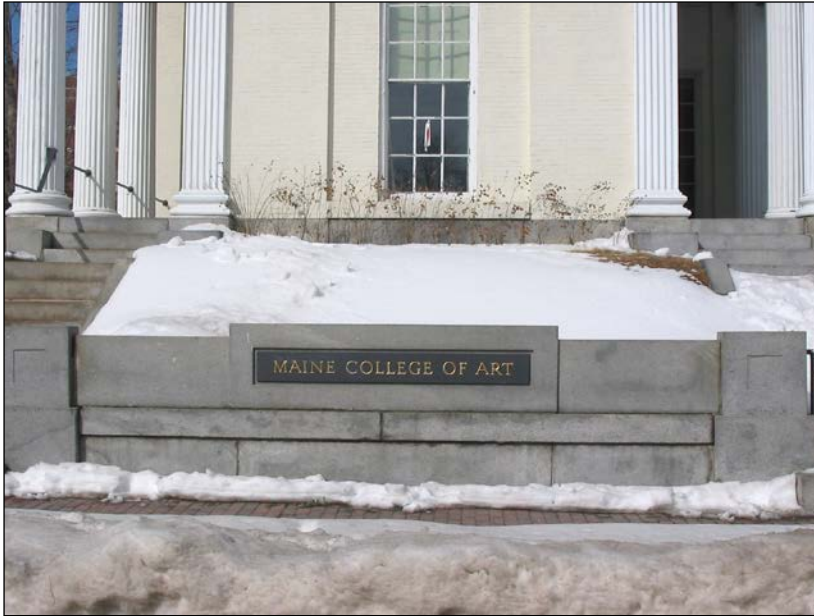
This discrete sign, incorporated within the historic granite retaining wall, serves its intended purpose without competing with the landmark building behind it. The typeface, gold-leaf lettering and slate sign panel also reinforce the dignity of its setting.

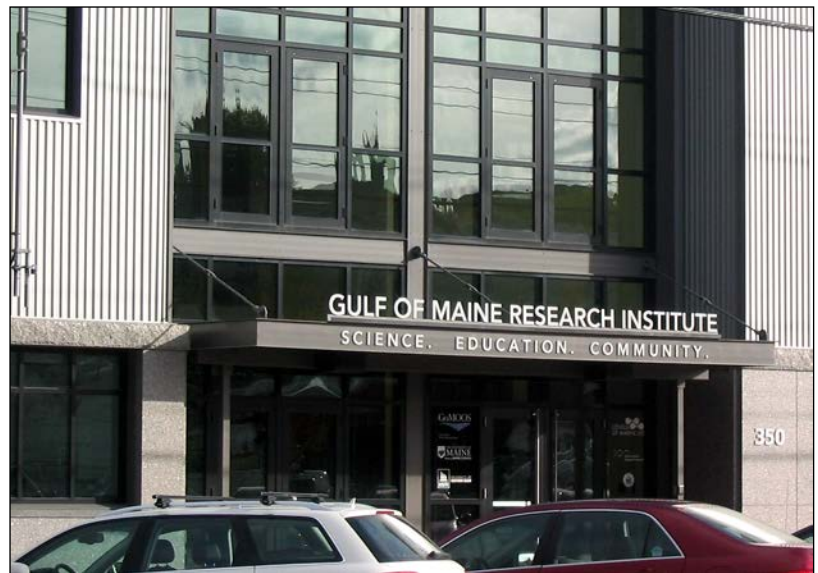
A well designed and executed sign that is both understated and highly effective for its purpose. Individual laser-cut metal letters stand atop a metal entrance canopy.

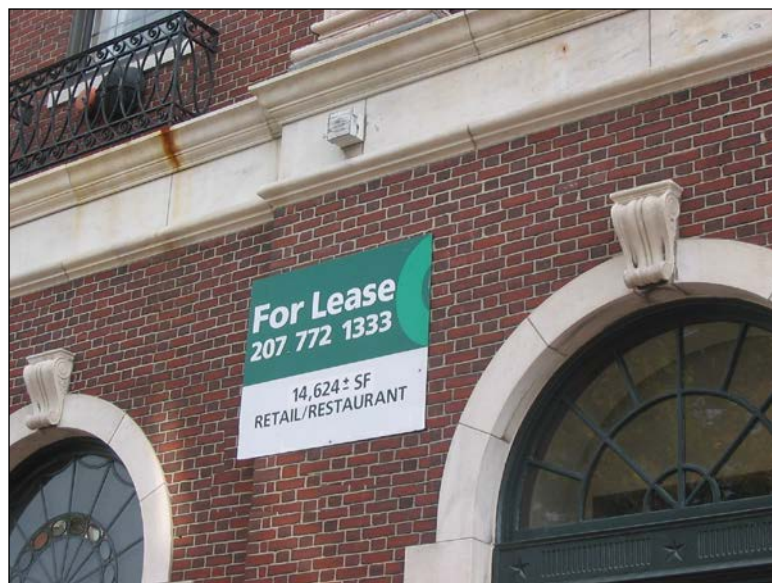
All too often, real estate signs remain in place long after the space they advertise is leased, becoming permanent fixtures that clutter the façade of a historic structure. For this reason, they should be placed in windows and removed as soon as a space is filled.

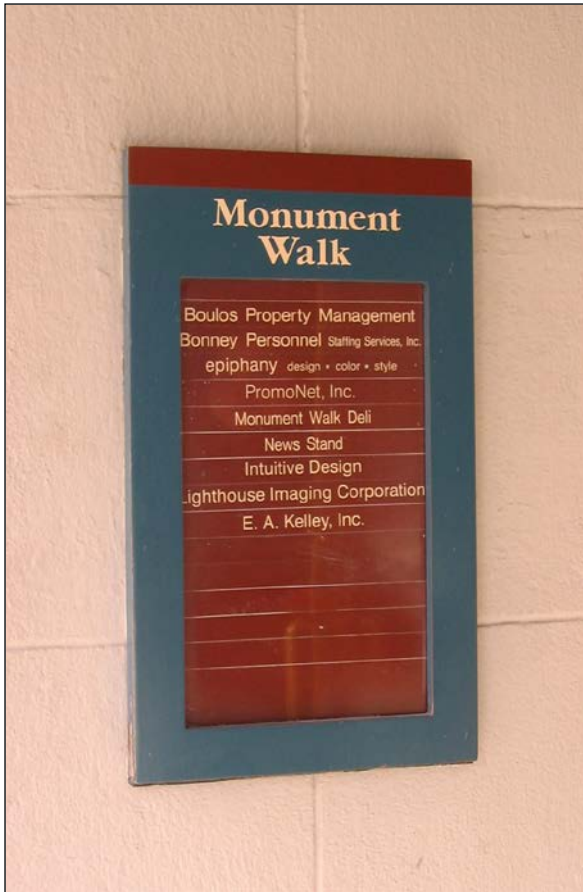
Directory signs, located near the main building entrance, are an appropriate solution for upper floor tenants. Upper floor signs for individual tenants are not encouraged.

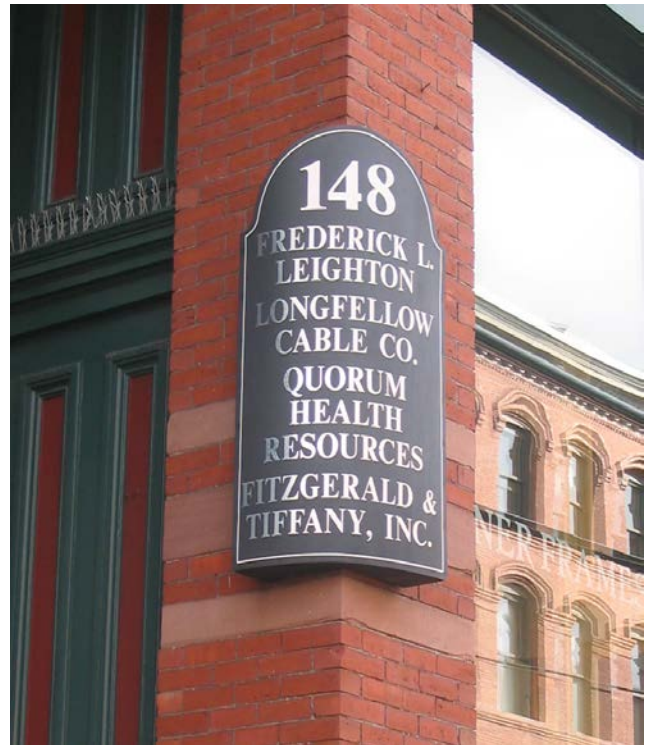
A curved metal sign mounted at a corner is a form of signage that appears in historic photos of Portland. Here it has been used as a building directory for a historic structure.

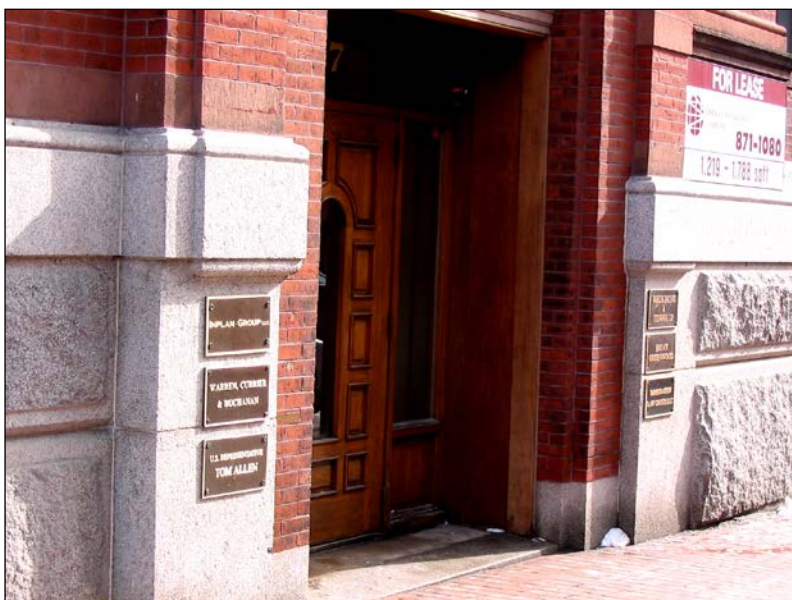
Grouped bronze plaques can be an effective form of directory signage, and is often used for professional offices. Close coordination of the individual plaques, in terms of size, style and placement, is critical.

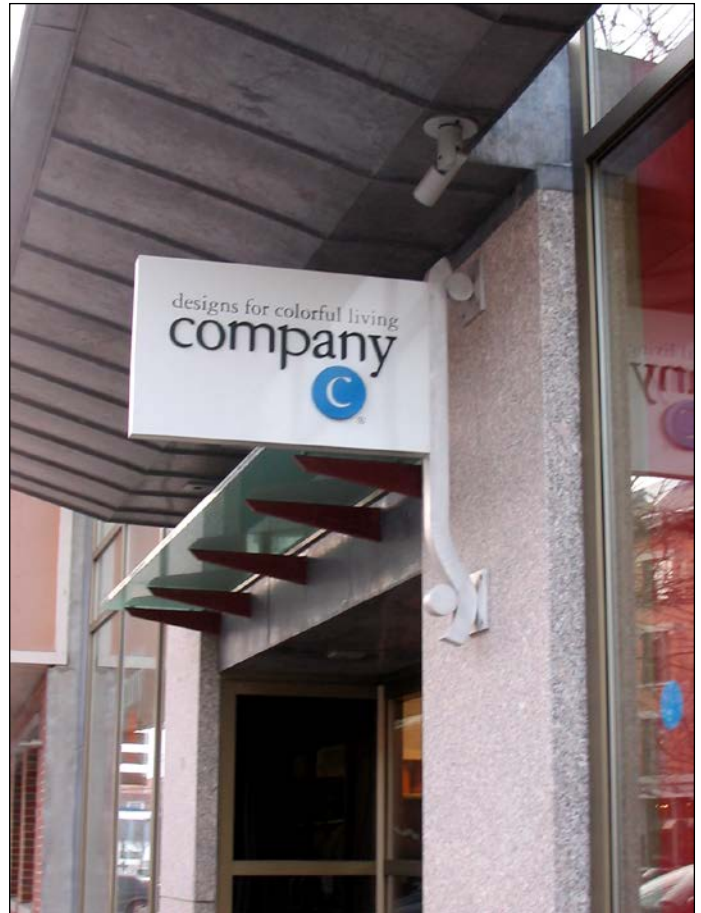
A sculptural, contemporary bracket and sign well-suited to its modern storefront. Note the subtle spotlights that do not detract from the sign or storefront.

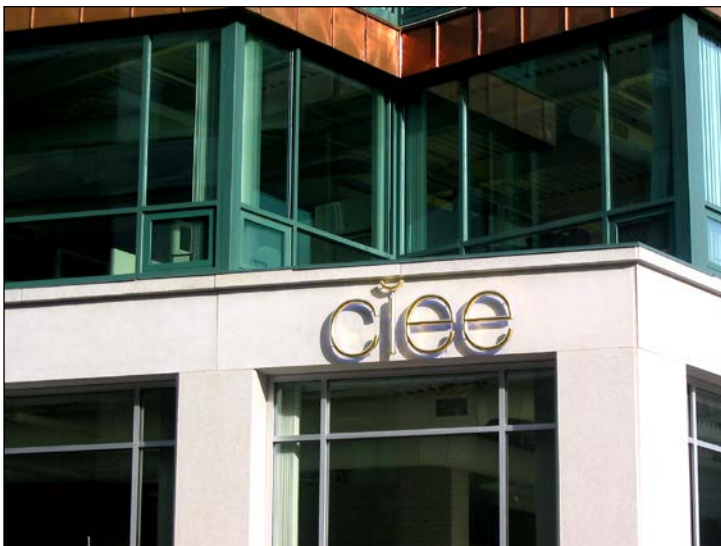
This sign, which features subtle halo backlighting, reinforces the clean, contemporary design of the building itself.

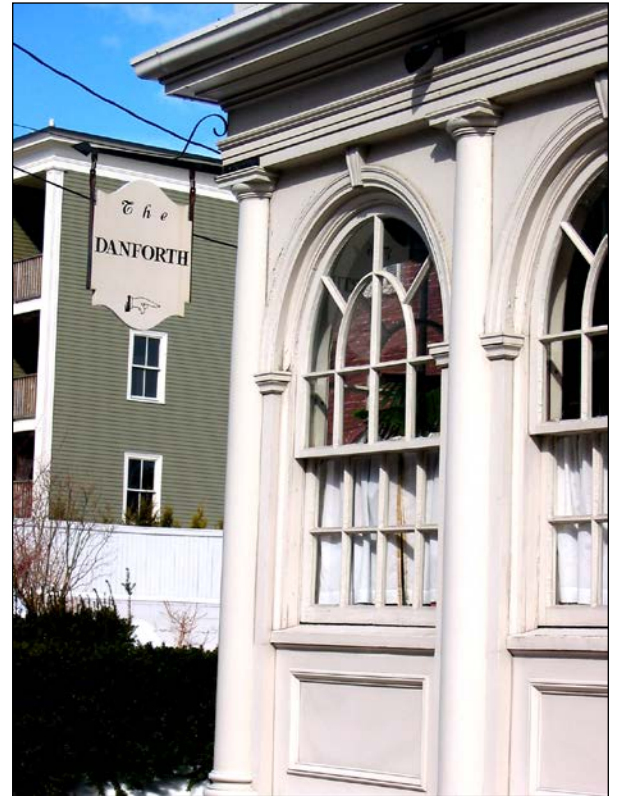
When residential buildings are converted to business use, sign solutions need to be carefully considered. In this instance, the size and placement of the sign is at odds with the residential character of the structure.

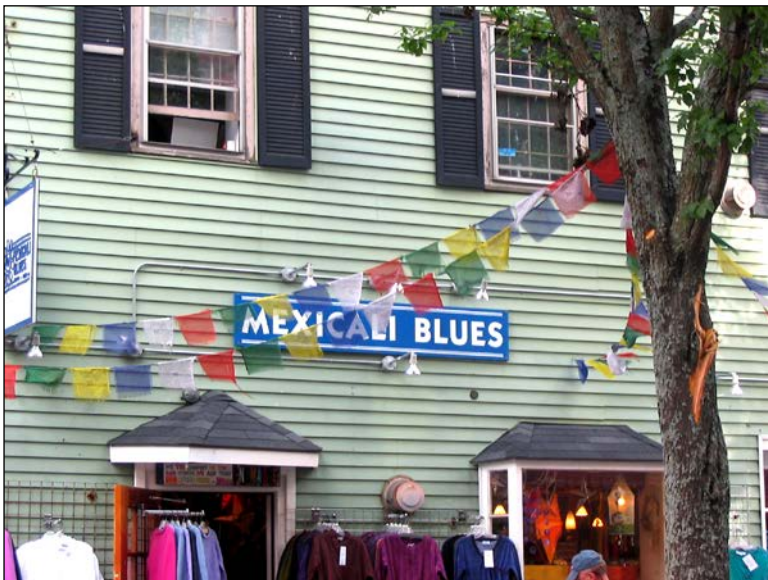
This small scale business sign, with its traditional shape and graphic style, is especially appropriate for its historic residential context.

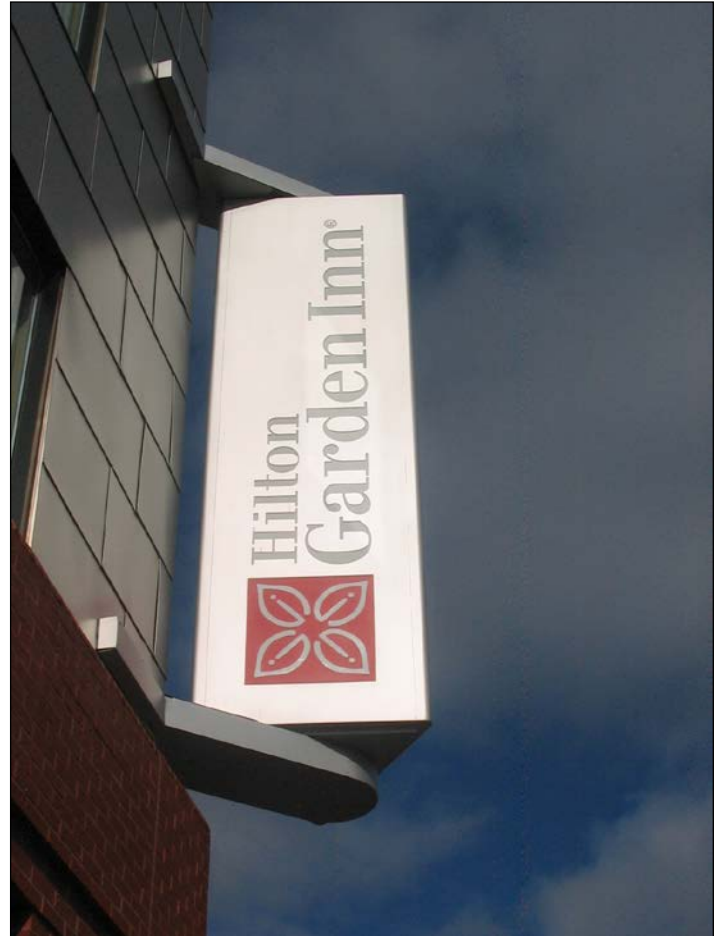
Subtle internal halo illumination, instead of a standard internally illuminated sign box with a glowing sign face, helps relate this sign to its historic district context.

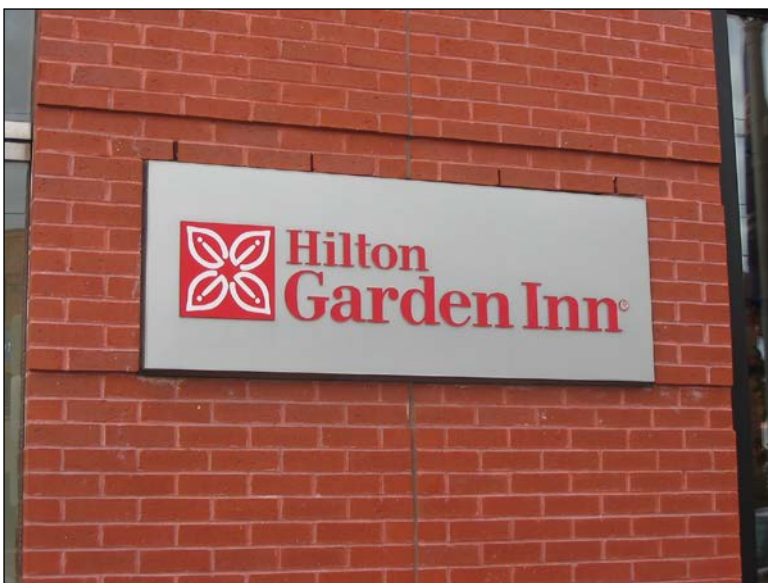
This sign illustrates how a departure from a standard corporate sign solution can effectively relate the signage to the unique character and materials of a particular building. Such an approach can help to avoid the “Anywhere, America” homogenization that standard corporate sign solutions create.

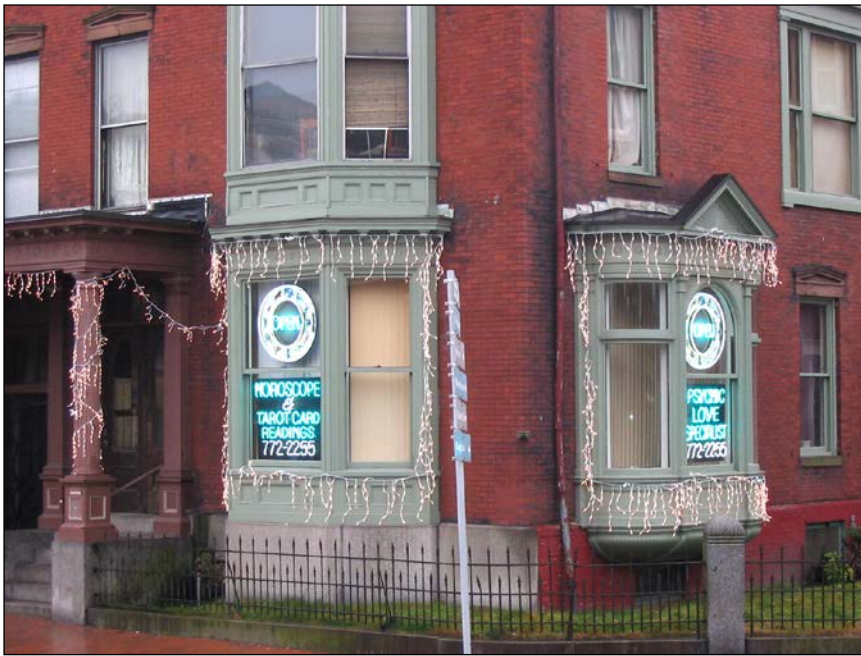
Installed without approval (and subsequently removed,) this signage overwhelmed the architectural features of this dignified building.

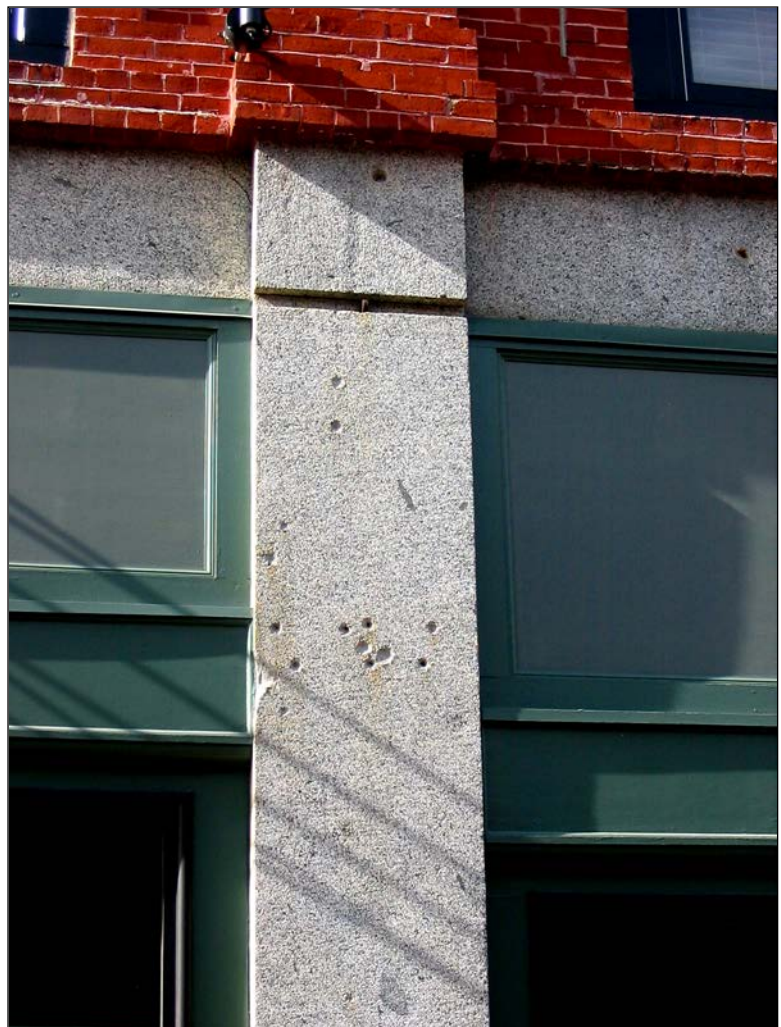
This photo illustrates what happens over time when signs brackets are mounted directly into architectural masonry. Not only does the appearance of the building suffer, but permanent damage is done to the masonry as well. Whenever possible, existing brackets or holes should be reused. Alternatively, brackets should be mounted into the mortar joints, not the masonry itself.
