# CITY OF PORTLAND, MAINE

### AGENDA

**PUBLIC HEARING  
1 COMMERCIAL STREET**

**TO:** Chair Sheridan and Members of the Historic Preservation Board  
**FROM:** Rob Wiener, Preservation Compliance Coordinator  
**DATE:** September 26, 2019  
**RE:** October 2, 2019 **PUBLIC HEARING – Final Review of  
Alterations and Dormer Additions**

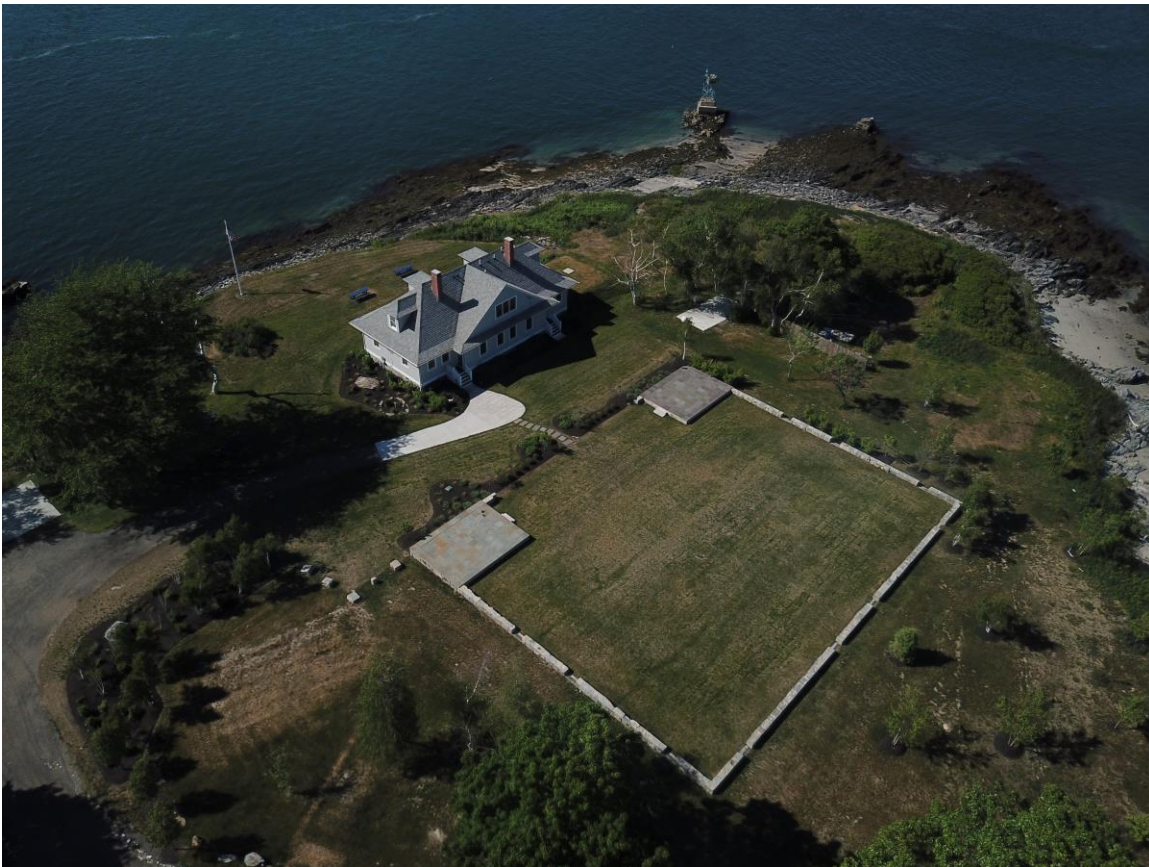
Here is a photo of the existing foundation that once supported the Detention Barracks.

Located east of the small detention barracks are the deteriorated and partial remnants of the one-story large barracks constructed in 1920. The barracks was constructed of brick laid in a six-course common bond on a poured concrete foundation. The barracks was razed in 1962.

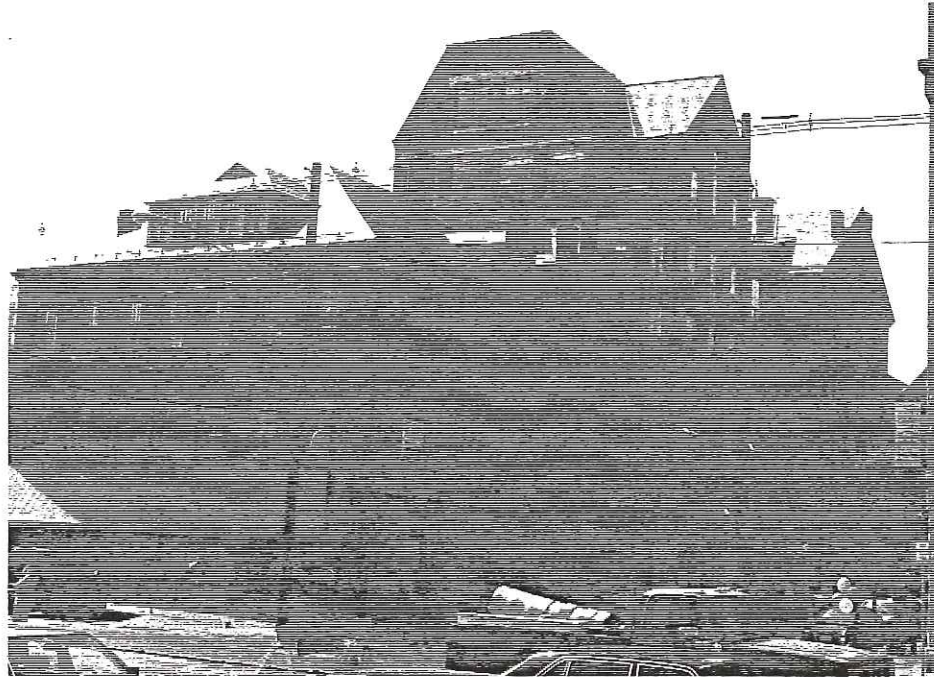
*Ten Moulton Street illustrates how the height of infill construction can serve as a bridge between the heights of surrounding structures. While the infill building is taller than its immediate neighbor on Commercial Street, it is roughly the same height as the adjacent building that fronts on Fore Street. The roof also contributes to the impression of proper scale relative to its neighbors by echoing the dormer shape of the building in the foreground and the gable shape of the building behind it. Details, such as the cut-out balconies, also help to reduce its apparent height, especially from the street.*
