# **CITY OF PORTLAND, MAINE**

## **HISTORIC PRESERVATION BOARD**

### **AGENDA**

#### **HISTORIC PRESERVATION BOARD MEETING**

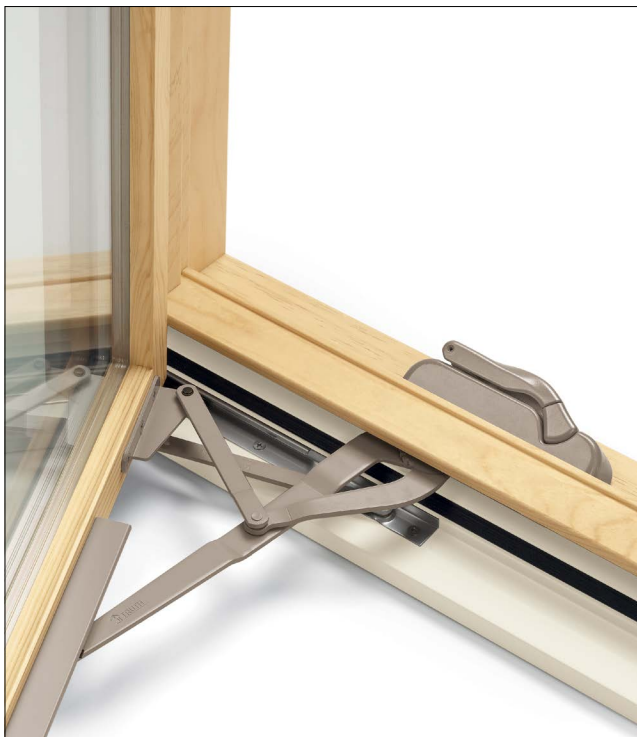
The roto-gear is the operating mechanism that crank to open and close casement and awning windows. Casement locks seal the window tightly closed. Excessive cranking when closing window does not improve the seal and may damage roto-gear.

The sash tracks should be occasionally cleaned out with a soft bristle brush. If the casement window is less than 24 1/4" (622 mm) in width, roto-gear arms and assembly may differ from those shown.

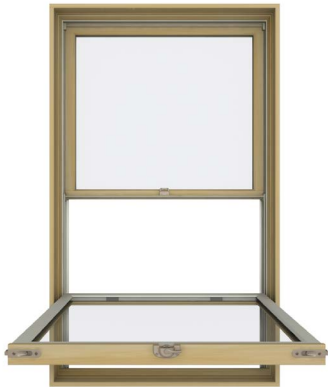
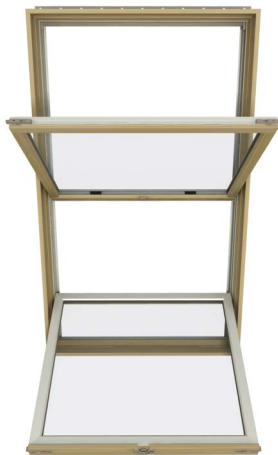
1. To tilt the bottom sash inward, unlock and raise the sash about 3" (76 mm). Grasp both tilt latches (found on the check rail), slide inward and tilt the sash toward you to a horizontal position. See illustrations below.
2. To tilt the top sash inward, lower the sash about 6" (152 mm). Grasp both tilt latches (found on the top rail), slide inward and tilt the sash toward you to a horizontal position. See illustrations below.
