# CITY OF PORTLAND, MAINE

## HISTORIC PRESERVATION BOARD

#### HISTORIC PRESERVATION BOARD MEETING

Topic: Historic Preservation Board Public Hearing and Workshop 3-16-2022

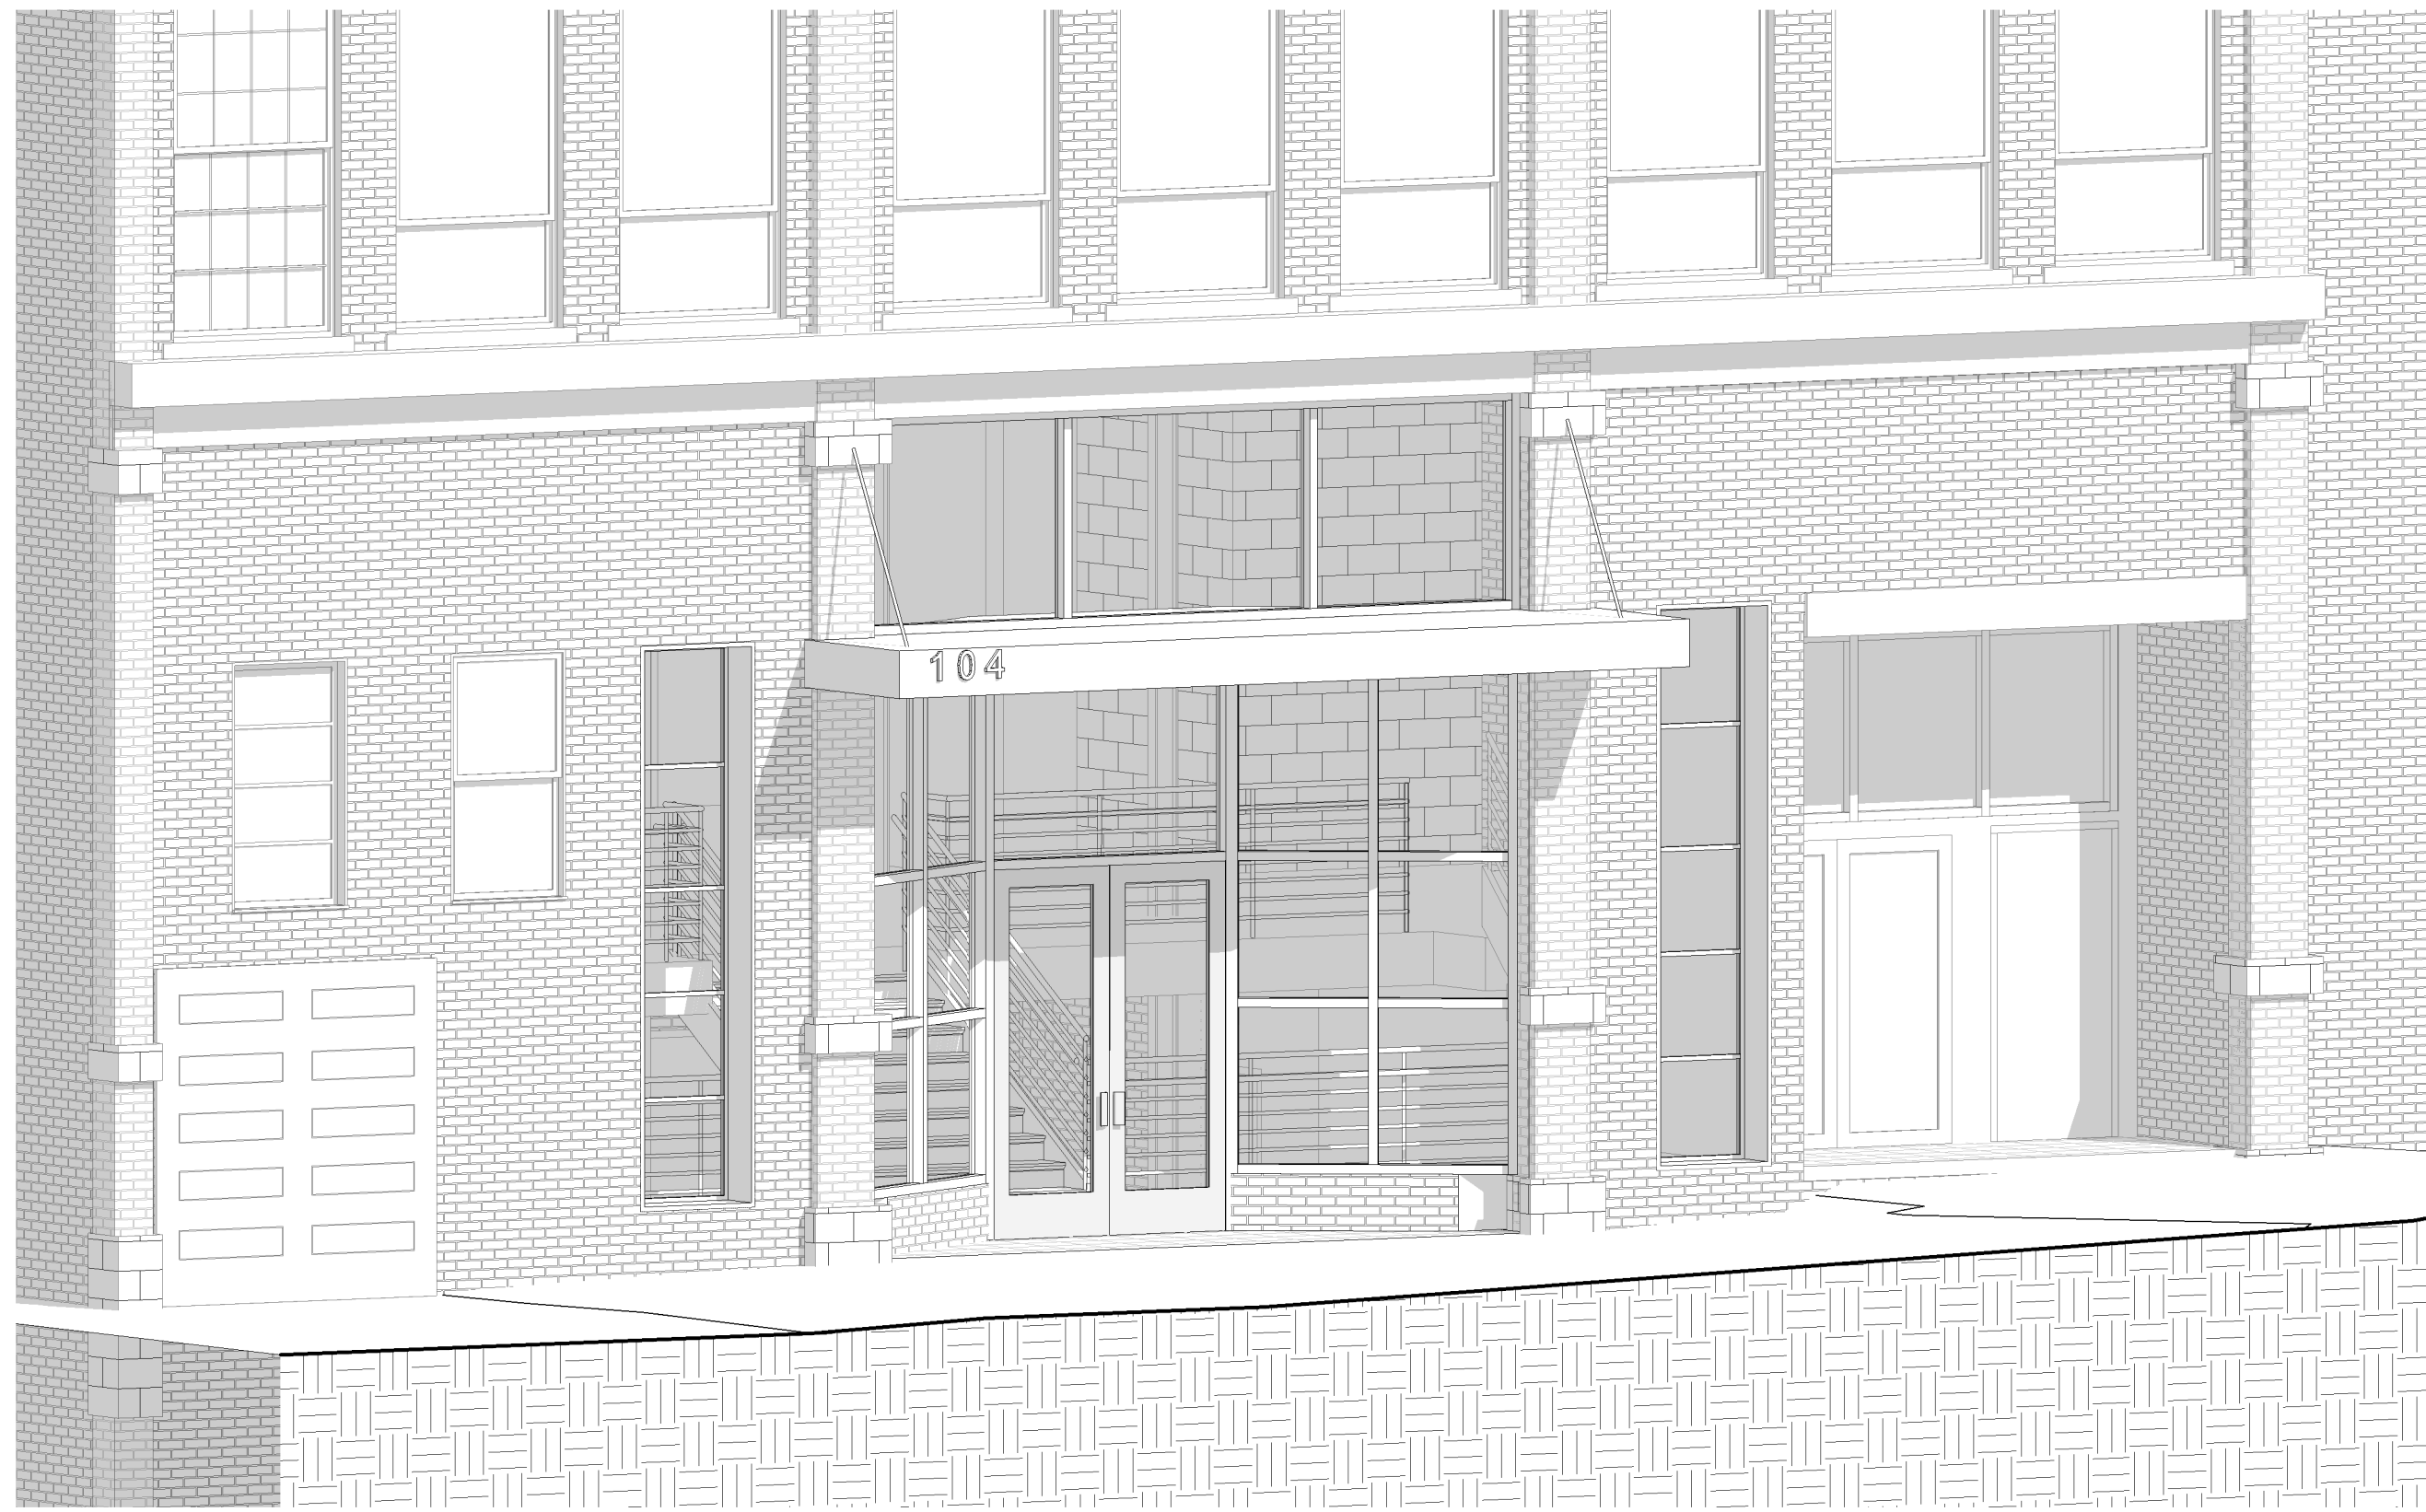
4 | PROPOSED CENTER ST. FACADE - AXONOMETRIC

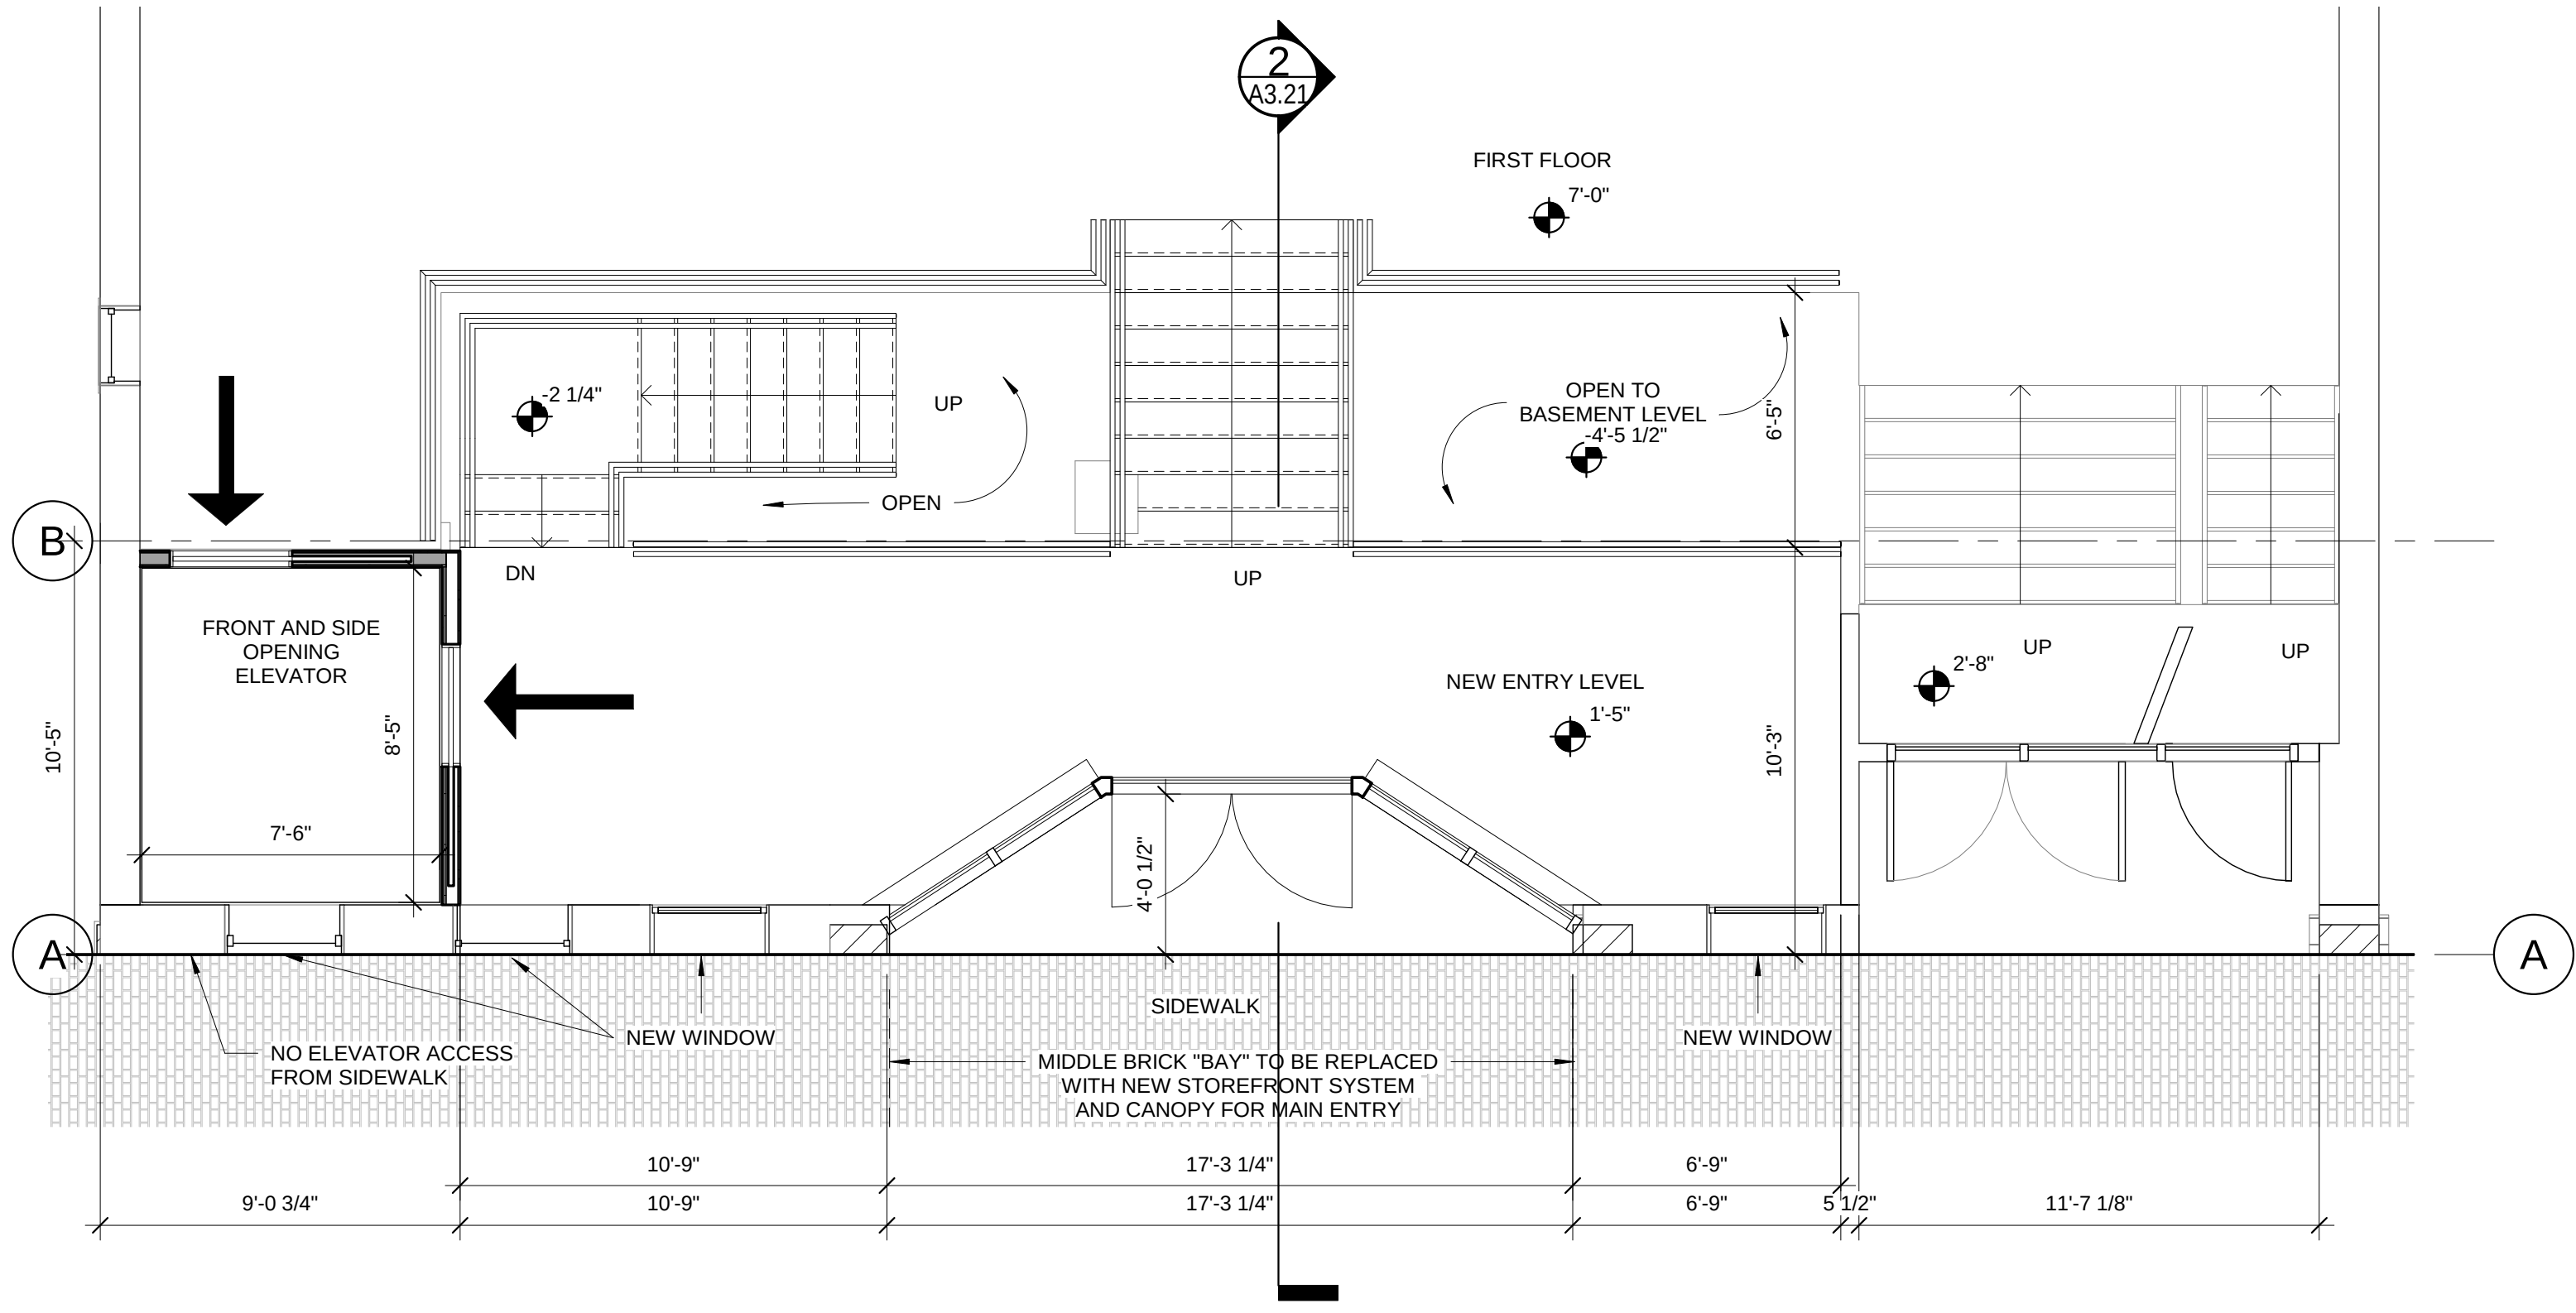
3 | ENLARGED 1ST FLOOR

1/4" = 1'-0"

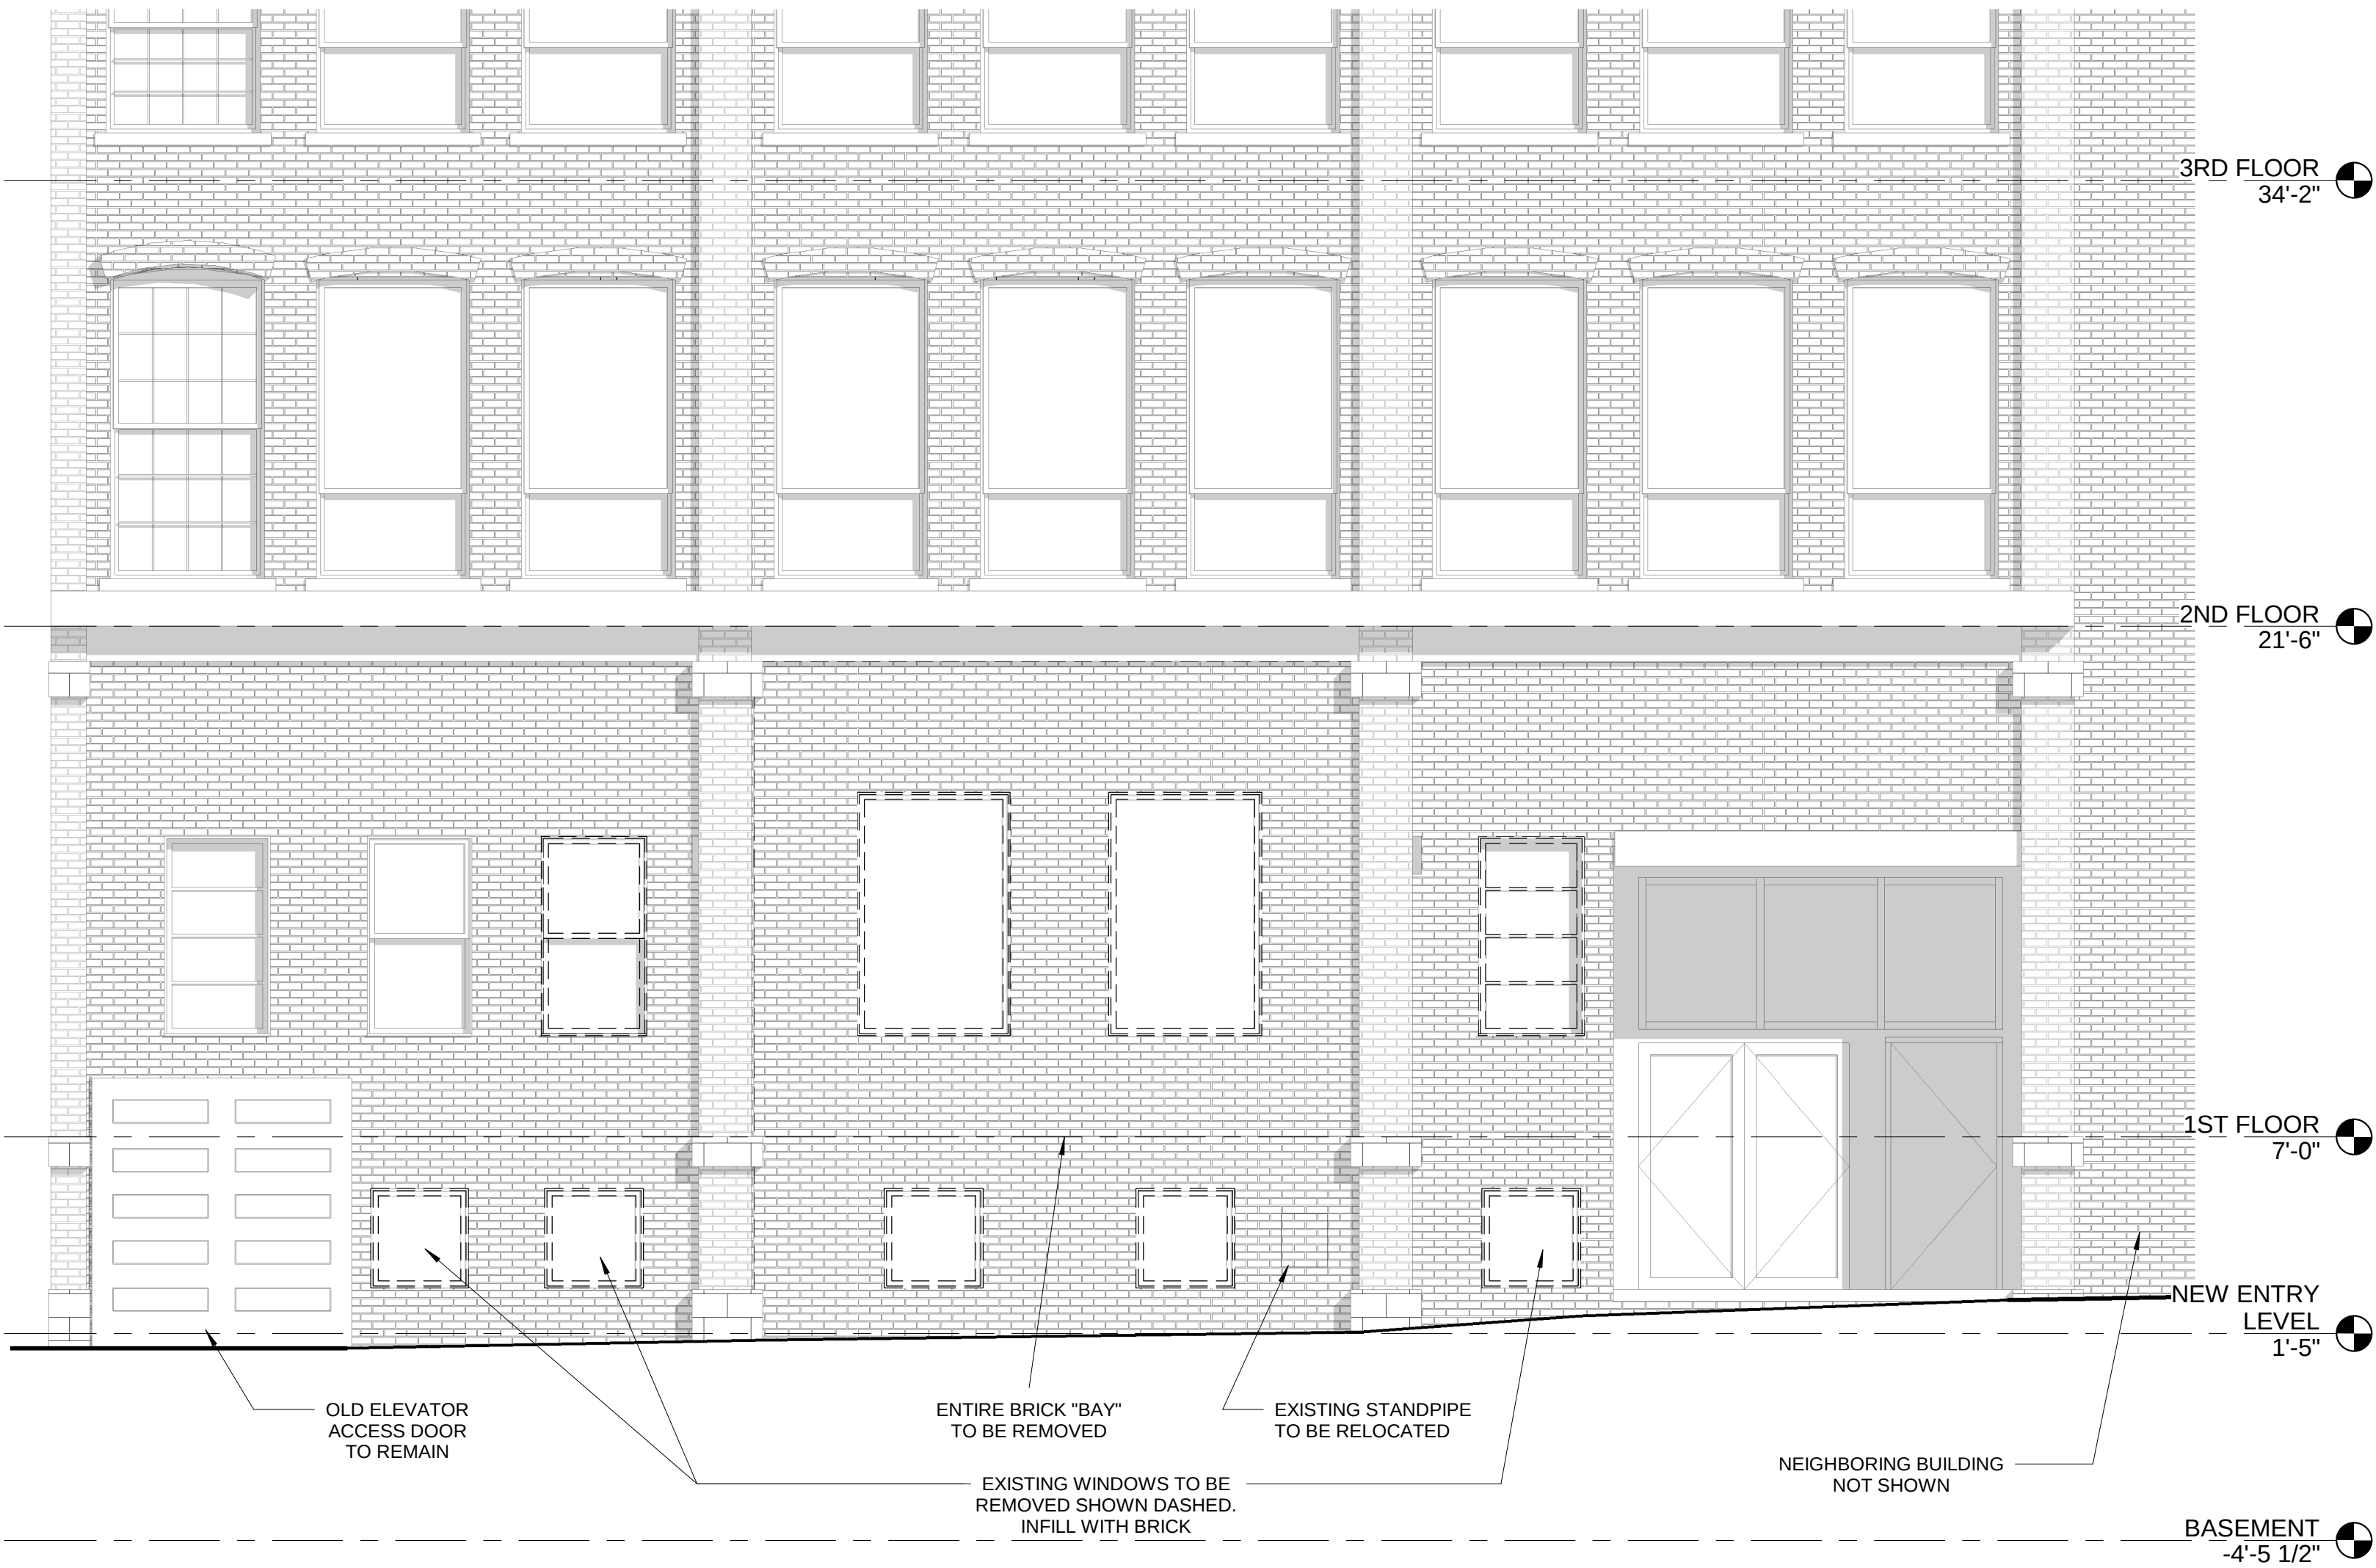
1 | CENTER ST. FACADE EXISTING / DEMO

1/4" = 1'-0"

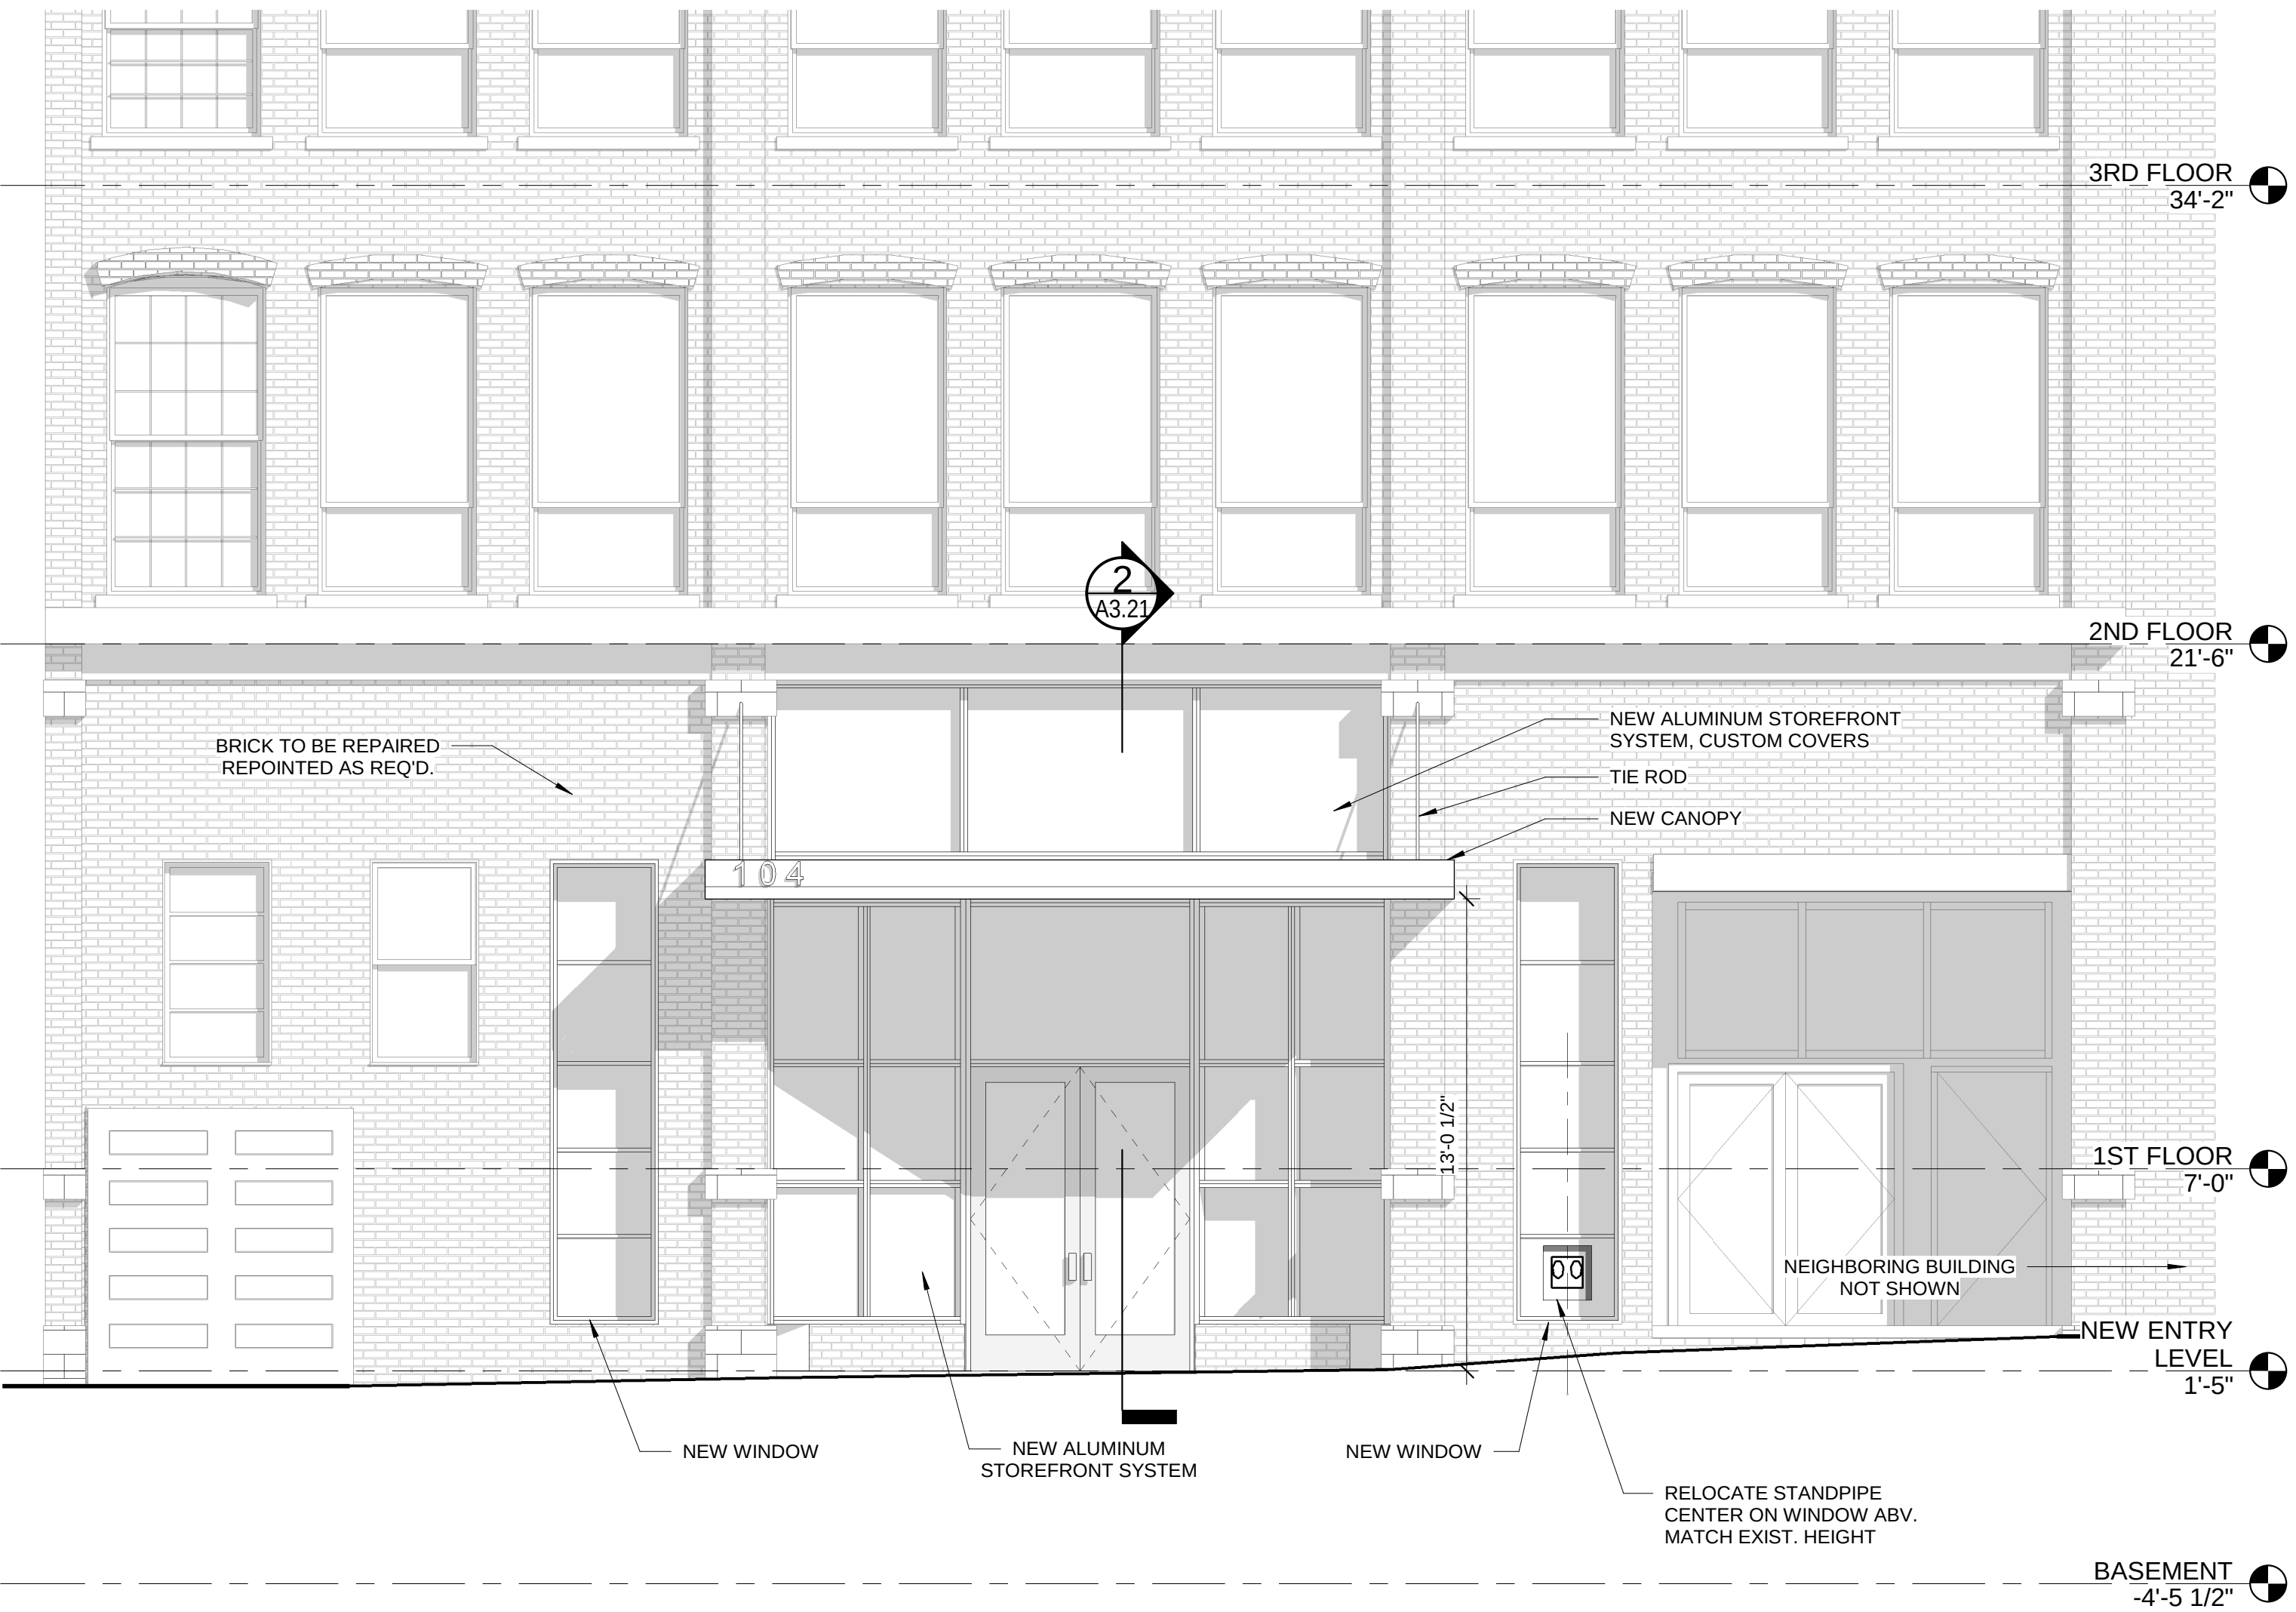
2 | PROPOSED CENTER ST. FACADE

1/4" = 1'-0"

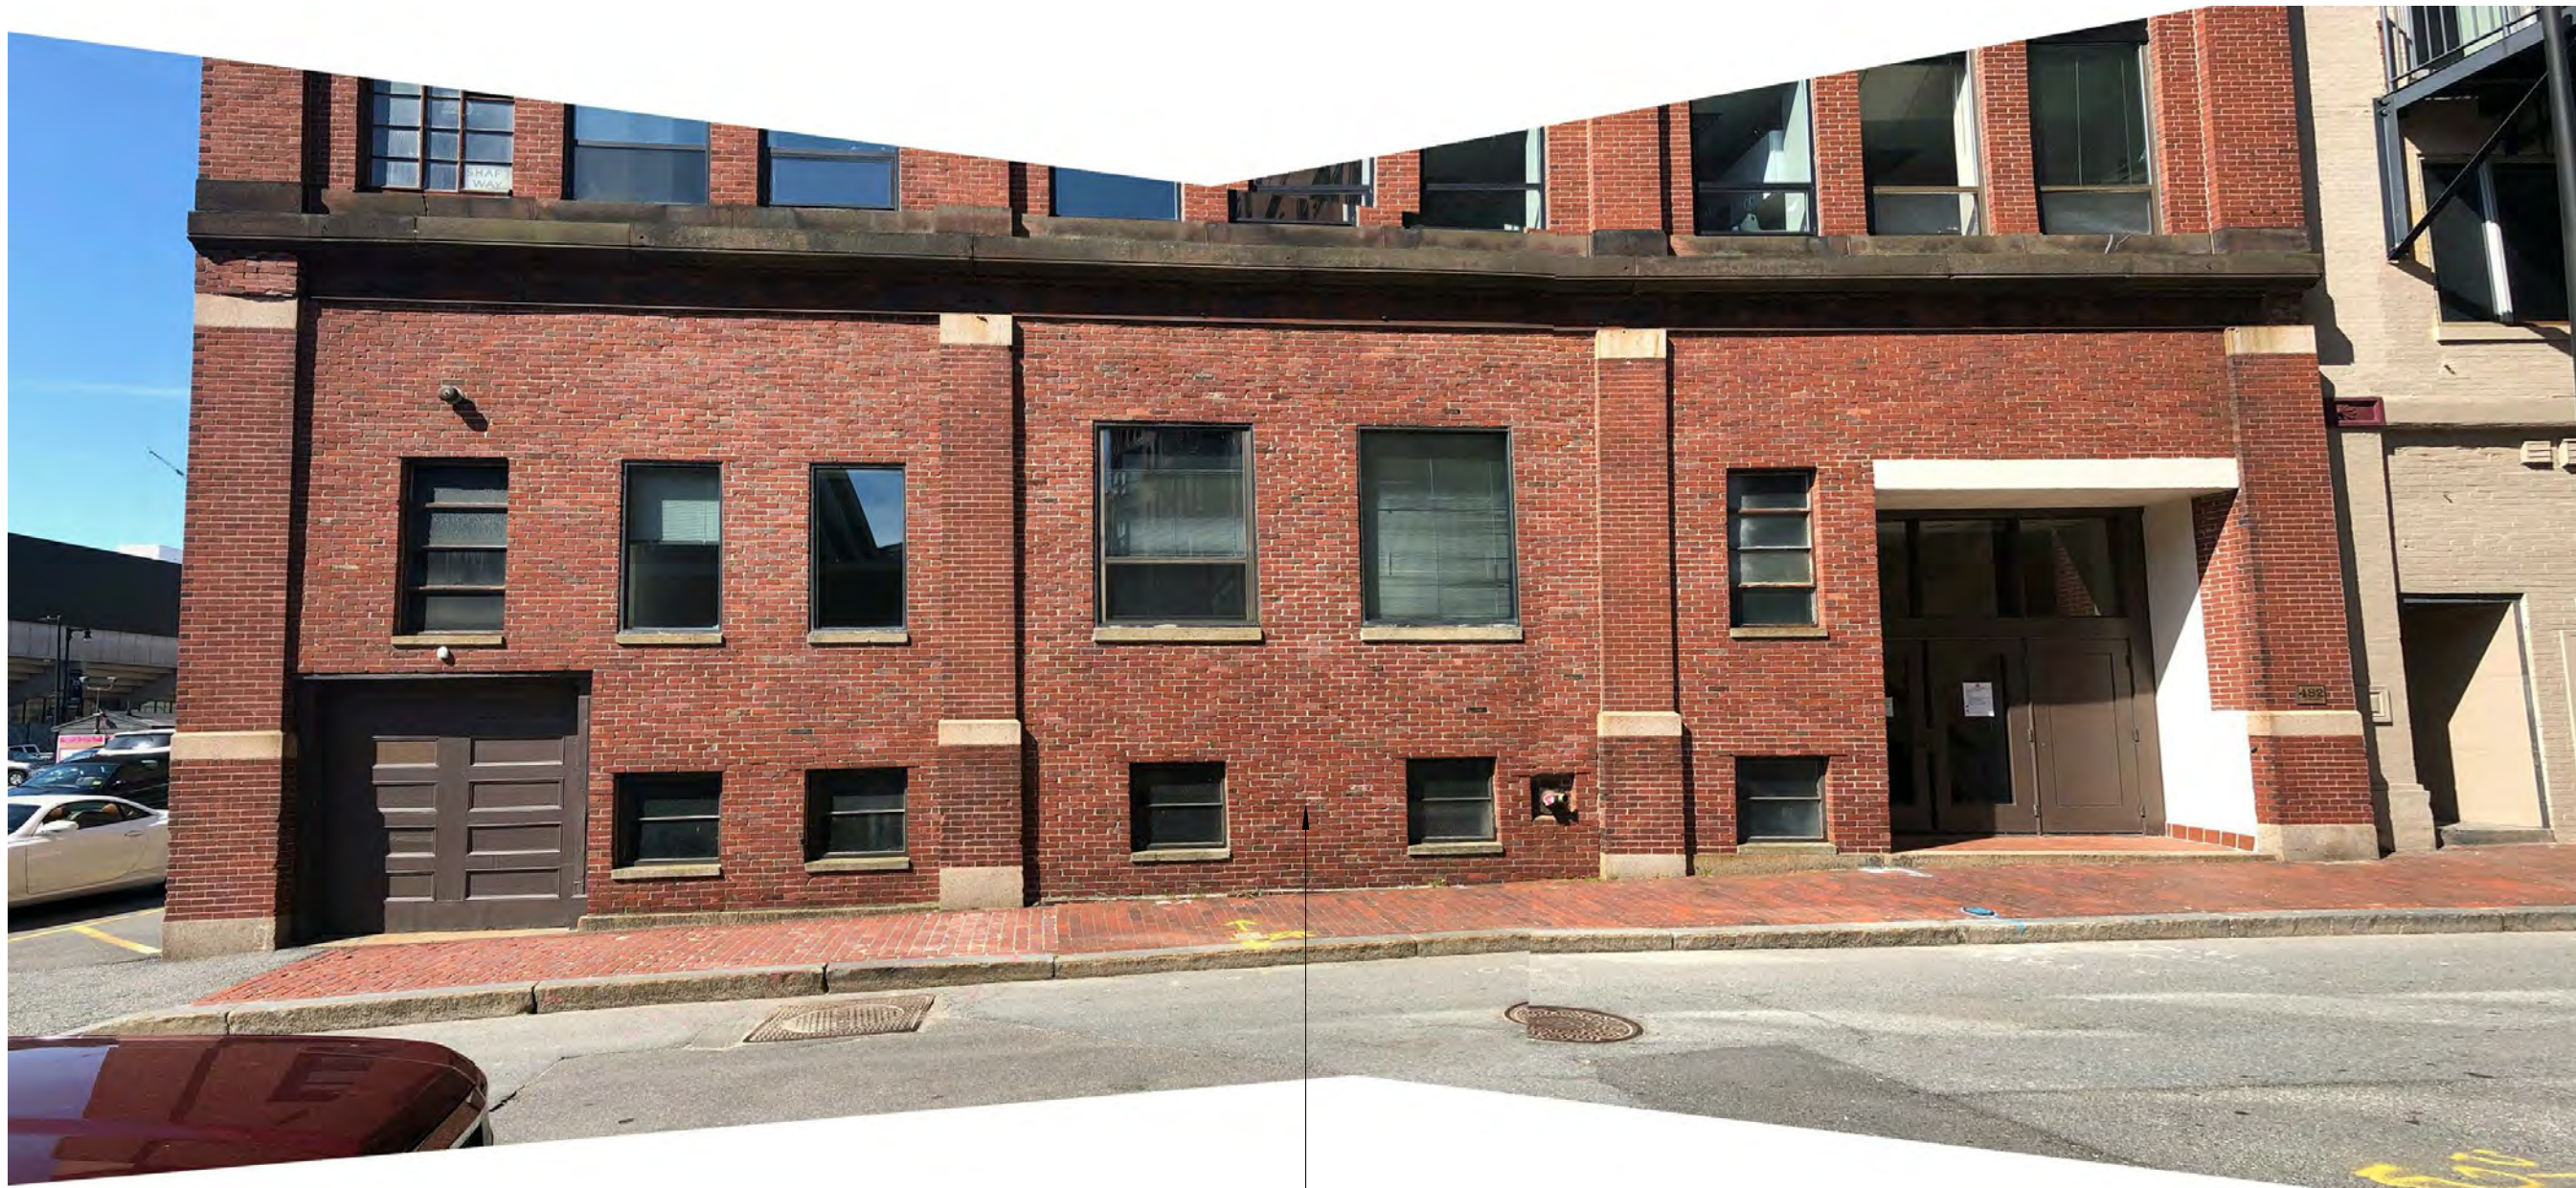
CENTER STREET  
VIEWS

MIDDLE BAY TO BE REPLACED  
W/ STOREFRONT SYSTEM

Mr. Lloyd's original concept proposing to remove the infill from the middle of the three ground-level bays and replace the entire panel with glass and metal-framed storefront was welcomed by the Board at the workshop, because of the prospect of reinvigorating a once active street face. At the time (2019) the layout of the entry doors and storefront windows was not fully developed, and Mr. Lloyd did not have access to the 1924 tax photo of the façade as he prepared for the workshop.

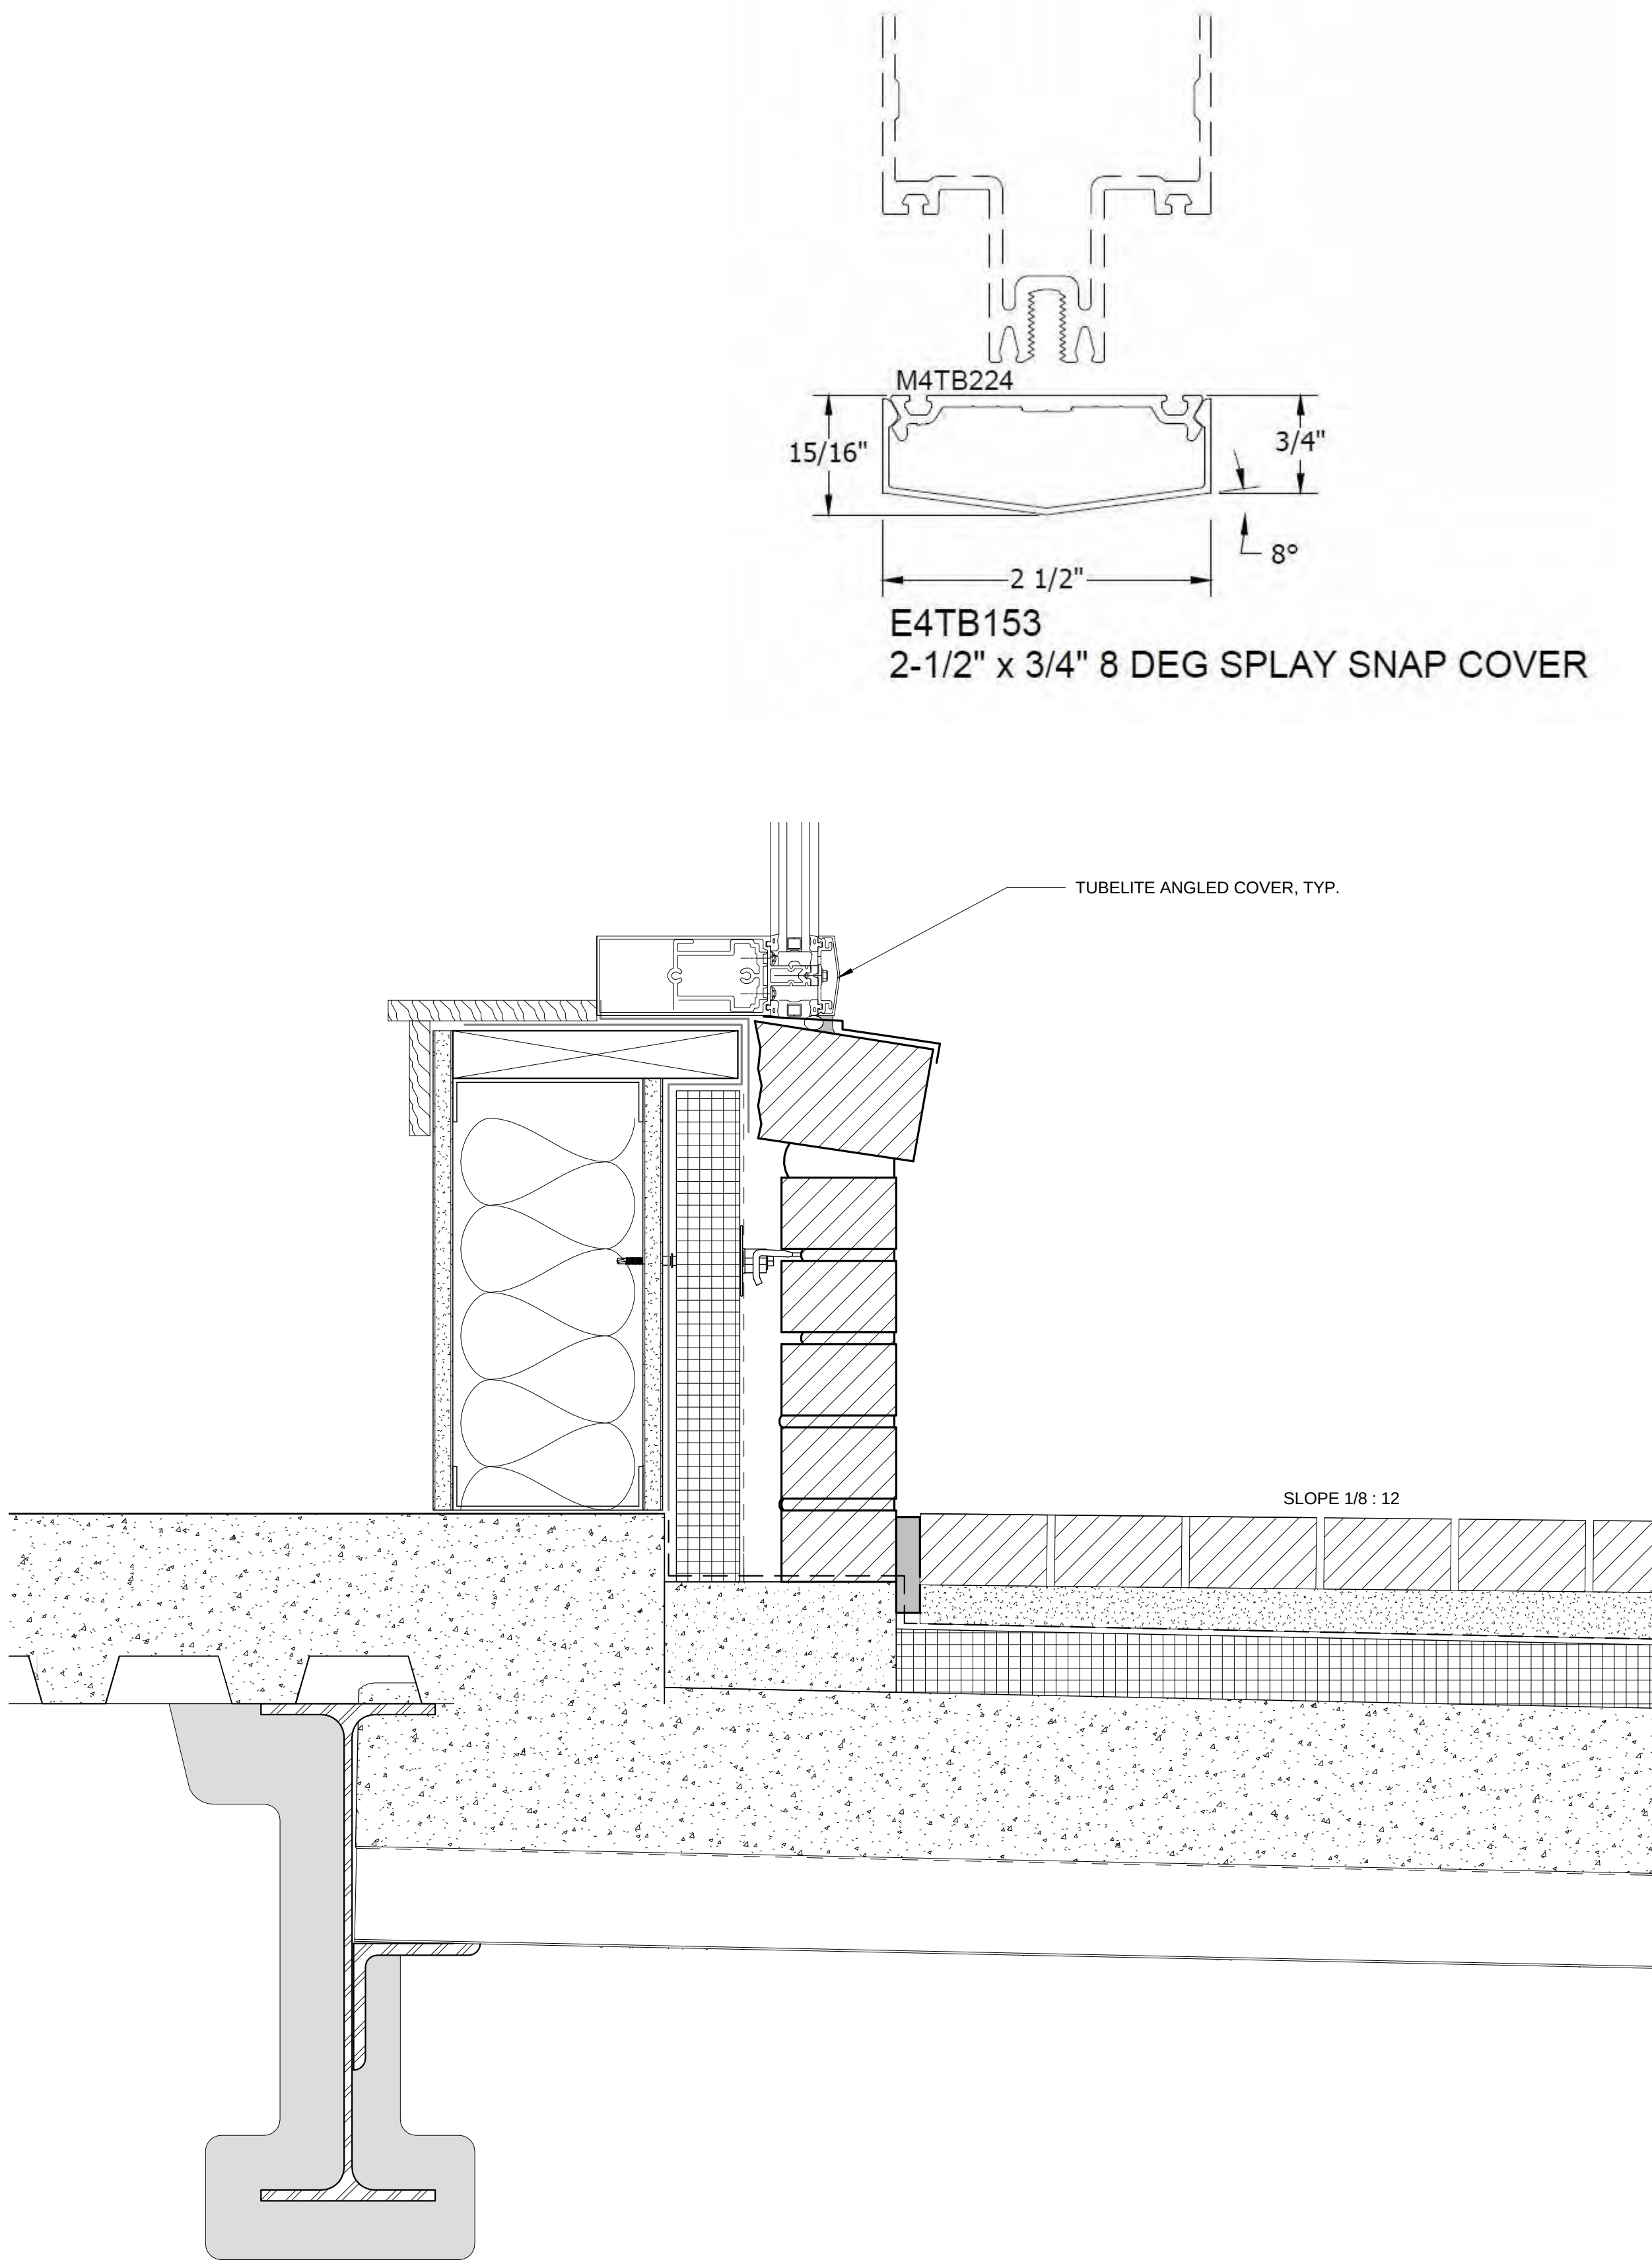
1 | BRICK BASE TRANSITION  
3" = 1'-0"
