# CITY OF PORTLAND, MAINE

## HISTORIC PRESERVATION BOARD

#### HISTORIC PRESERVATION BOARD MEETING

Topic: Historic Preservation Board Public Hearing and Workshop 3-16-2022

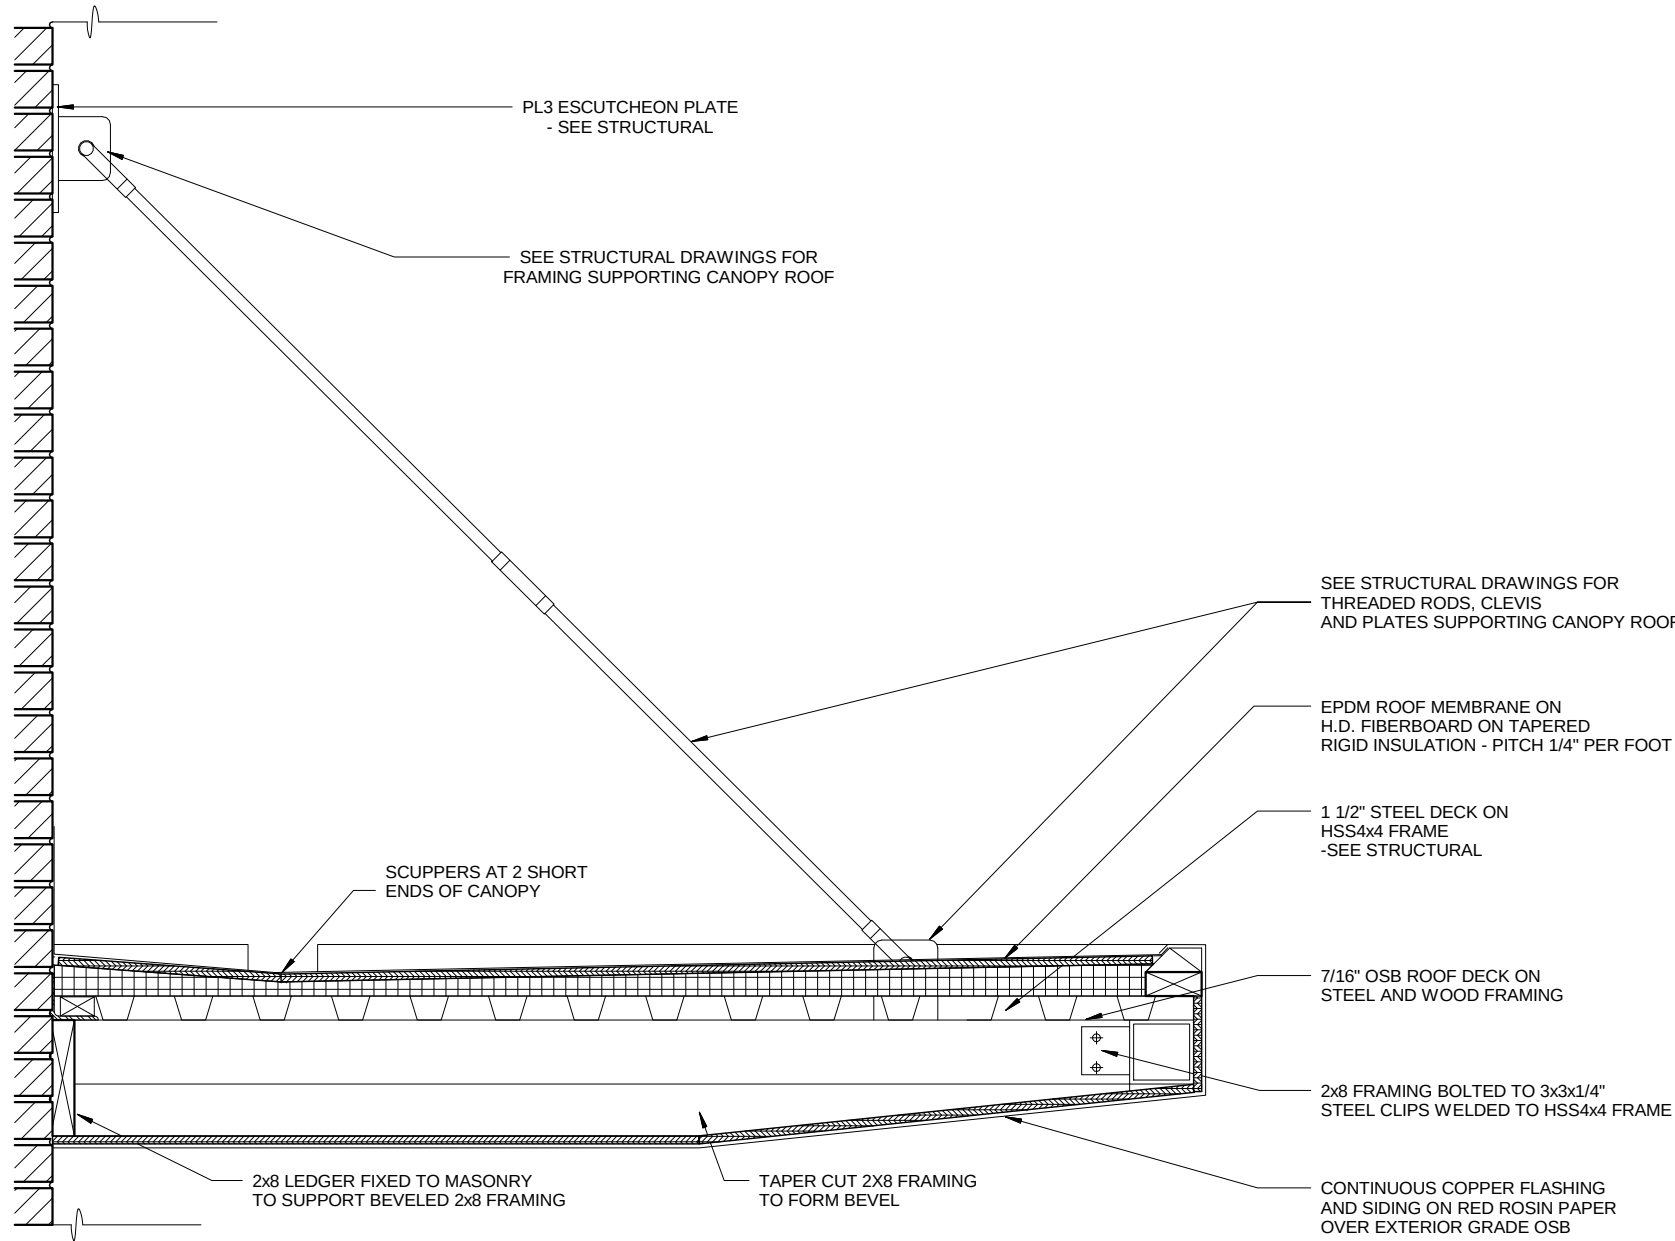
3 | ROOF DETAIL - ENTRY CANOPY  
1" = 1'-0"

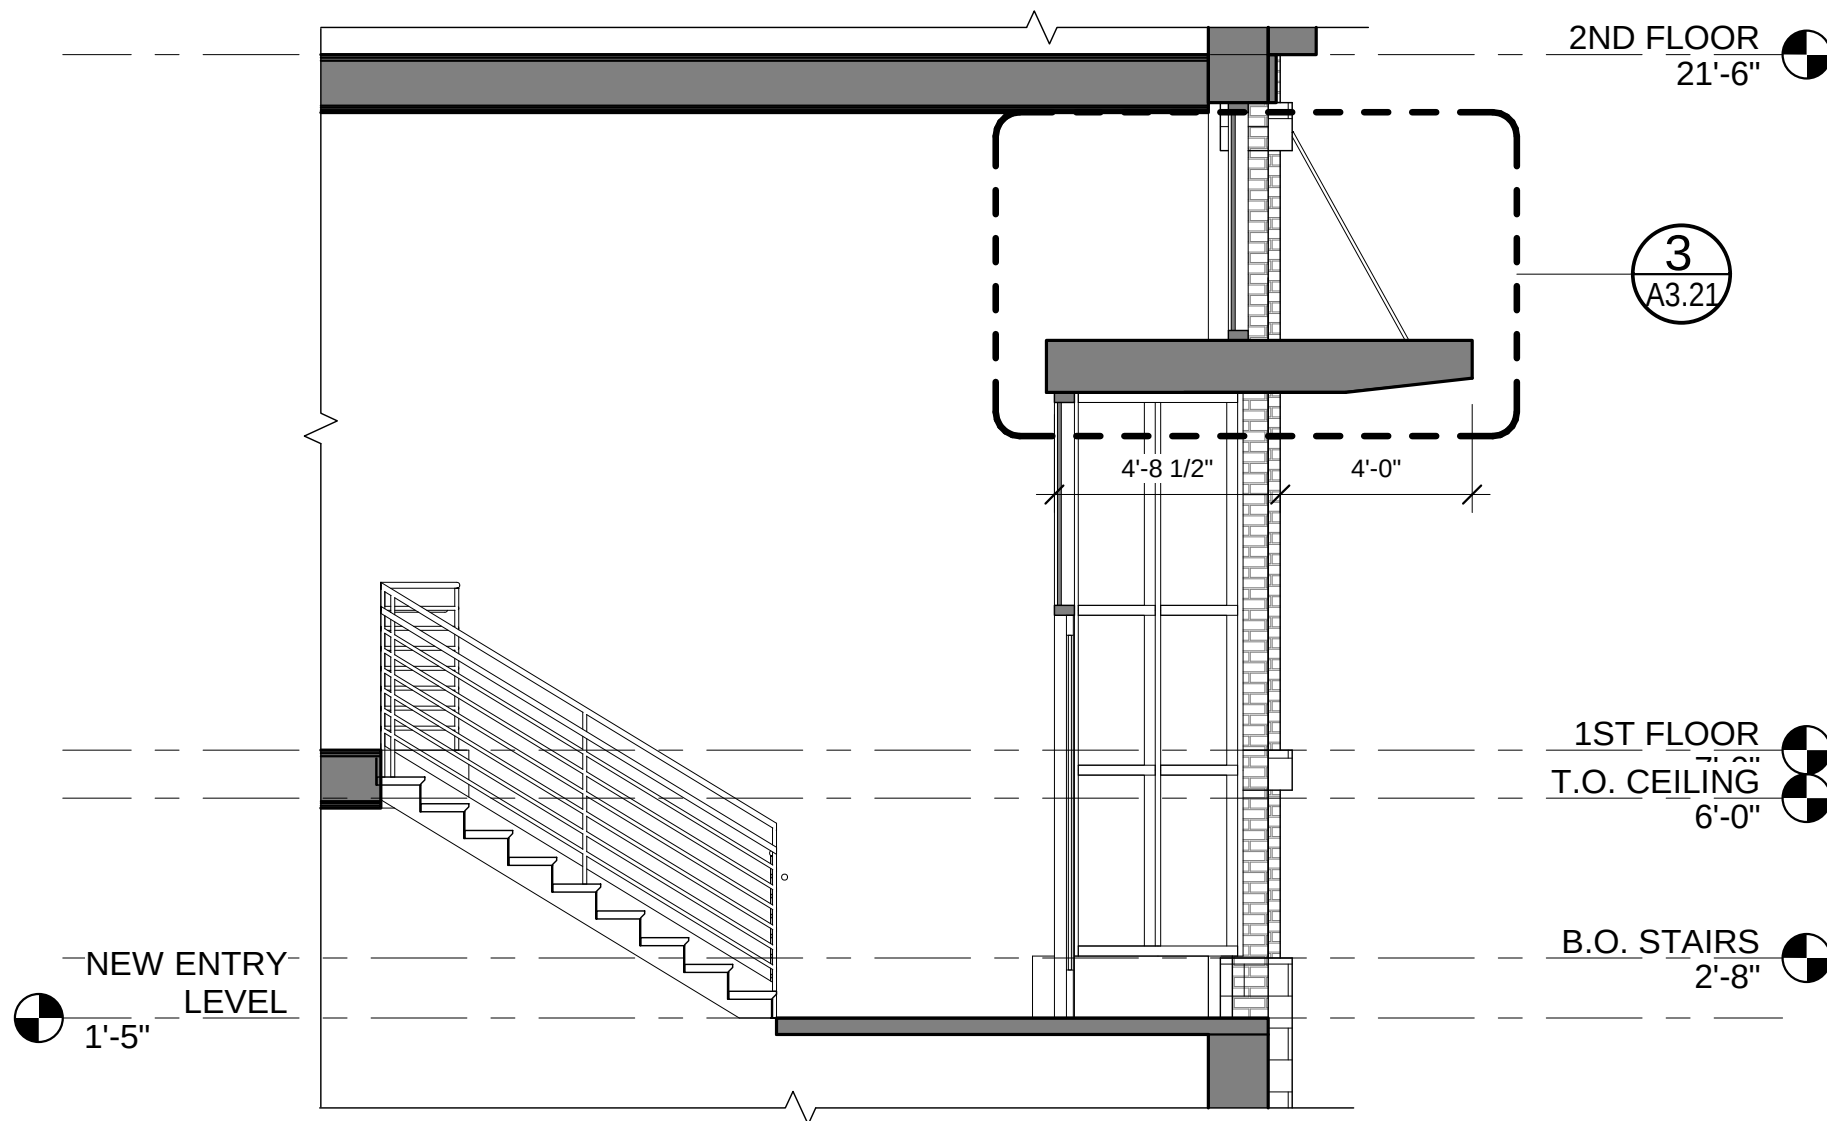
2 | STOREFRONT SECTION  
1/4" = 1'-0"

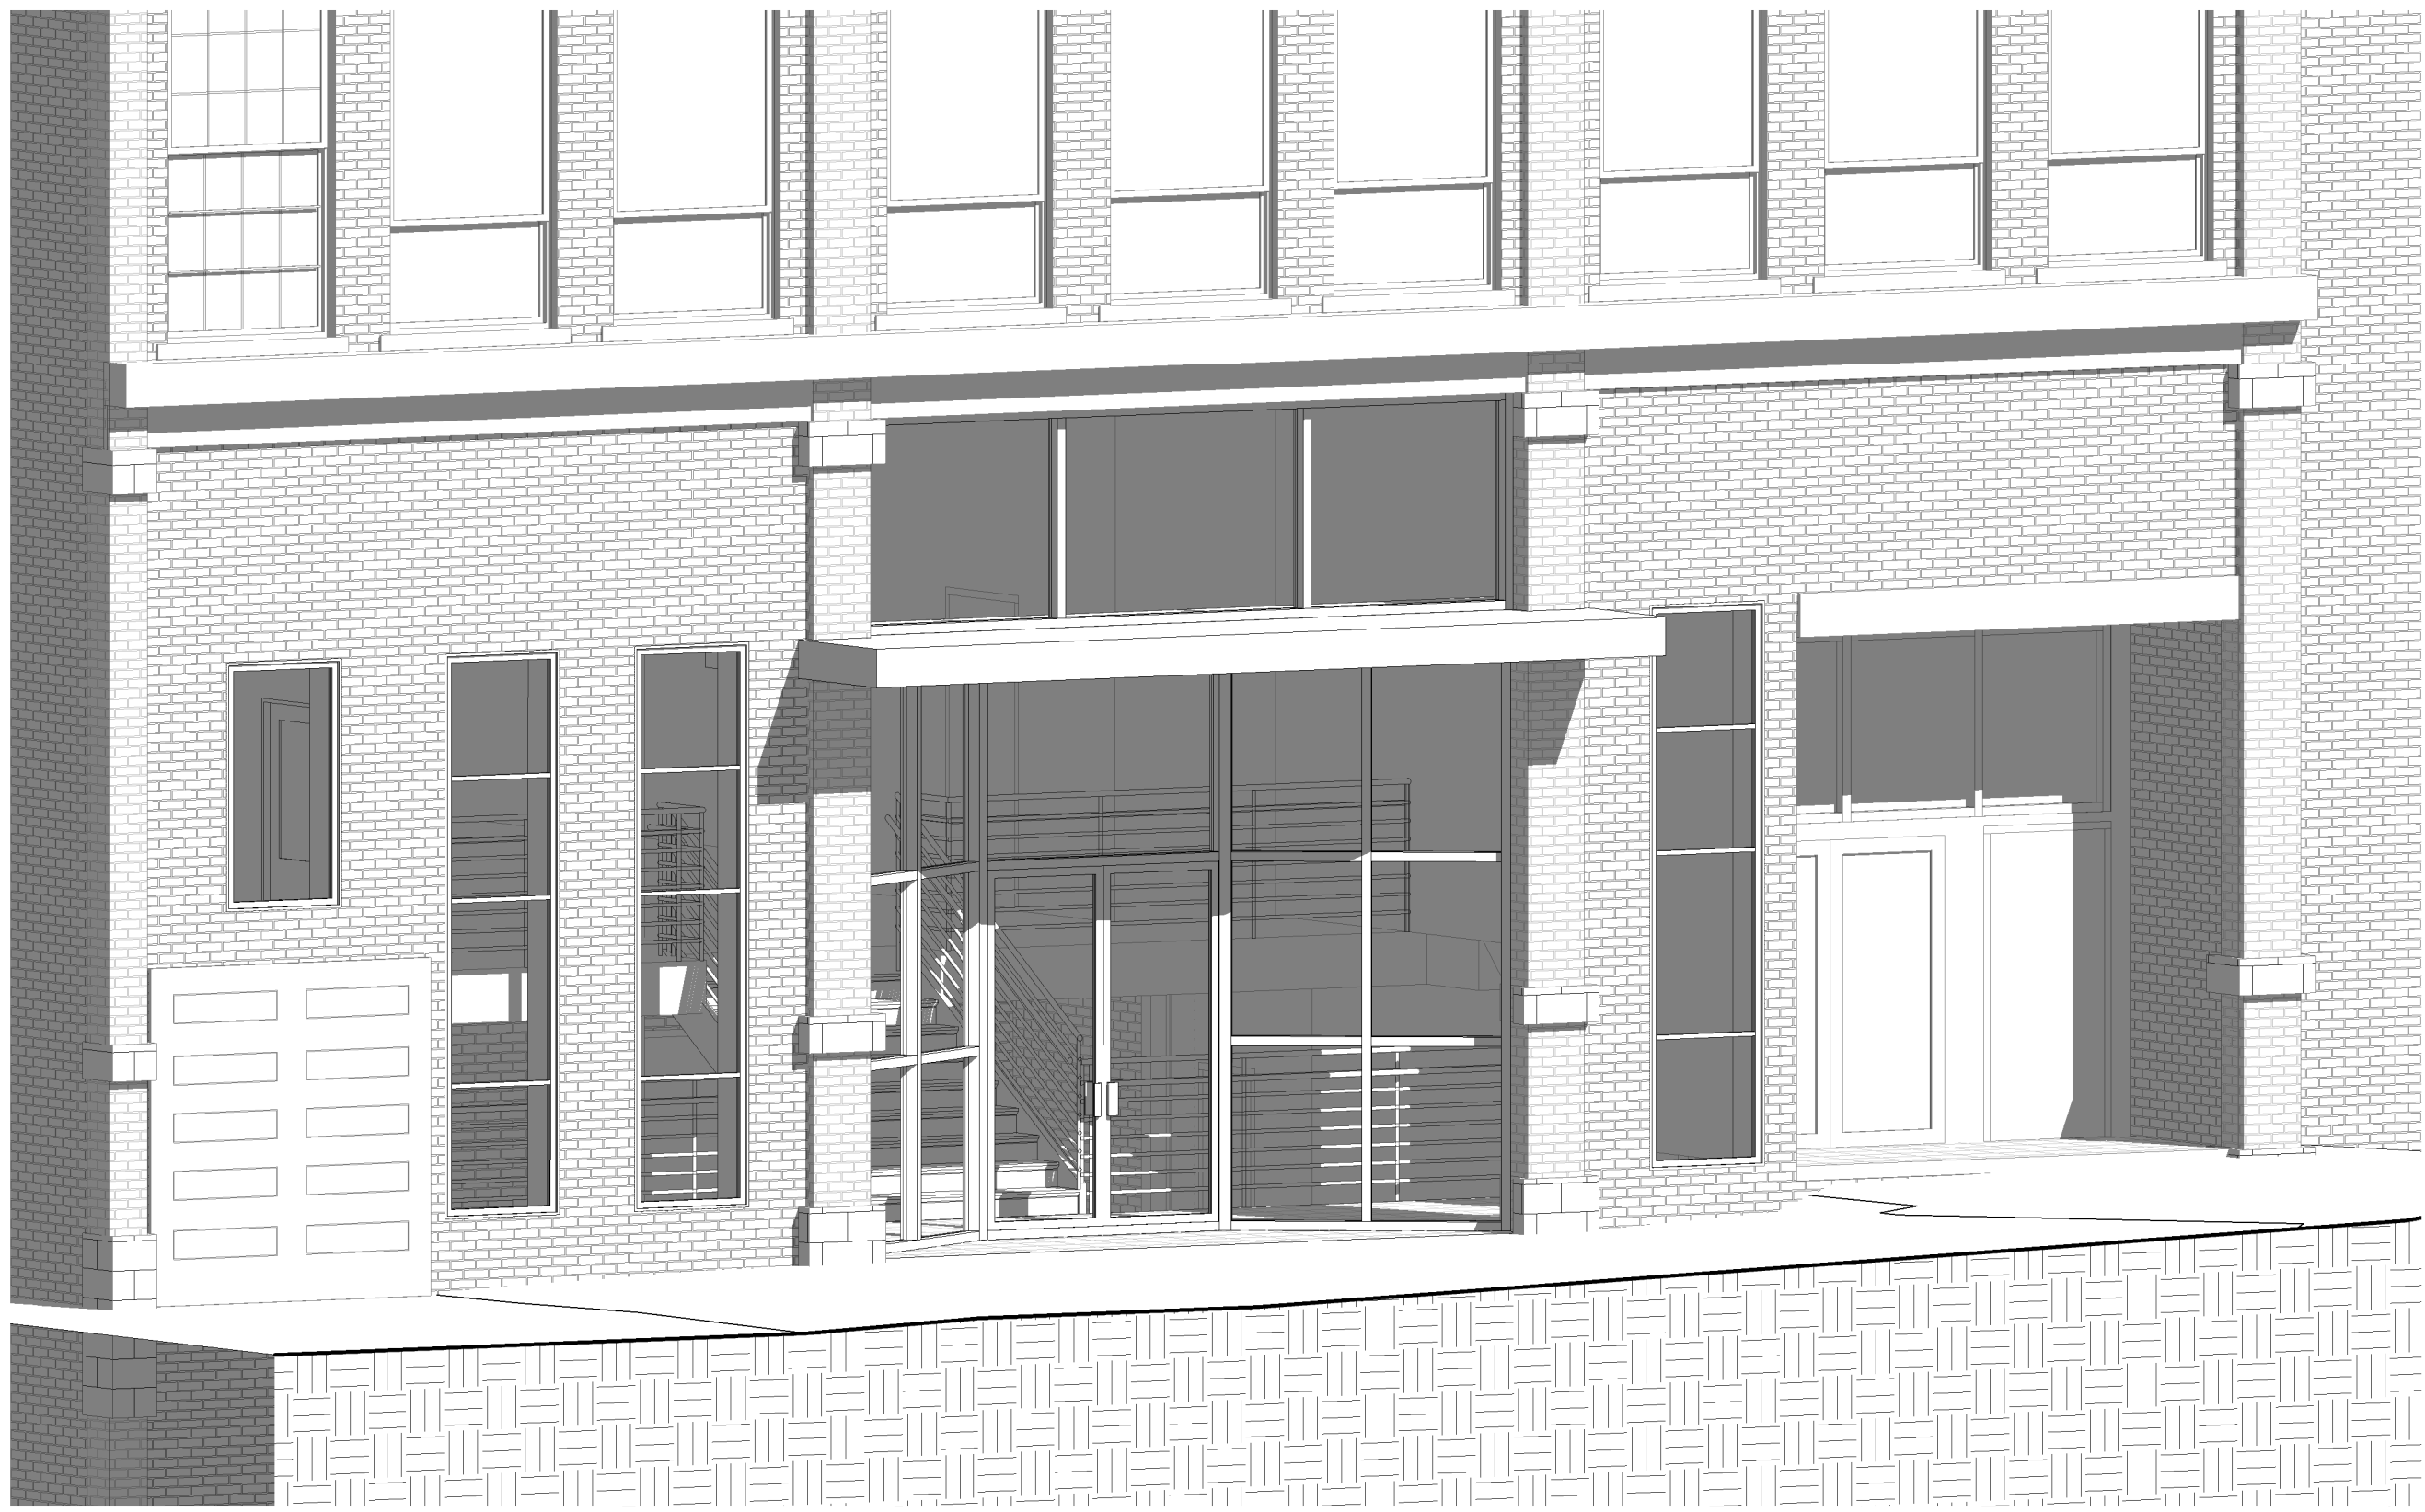
4 | PROPOSED CENTER ST. FACADE - AXONOMETRIC

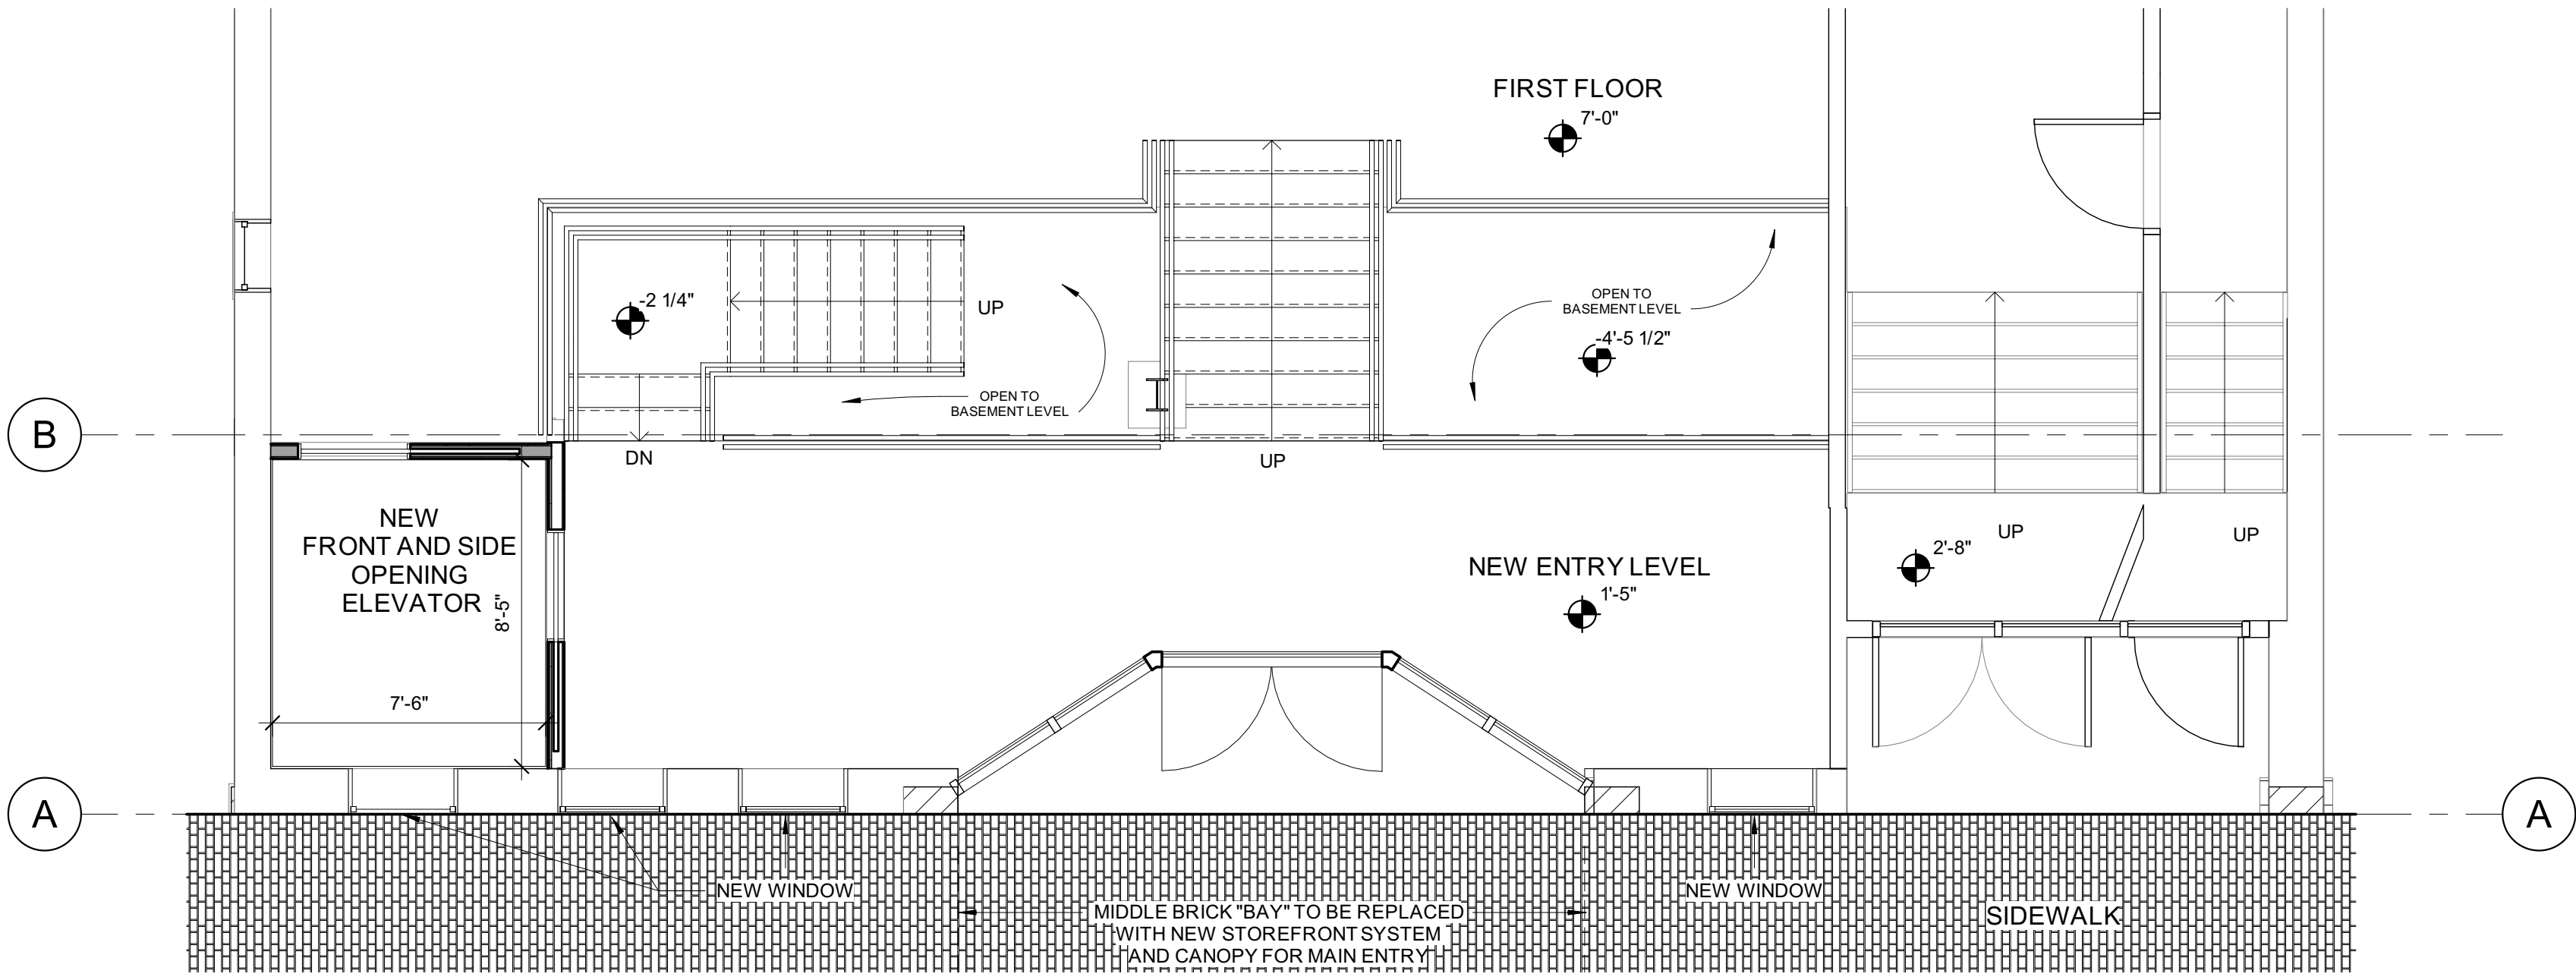
3 | PROPOSED ENTRY FLOOR PLAN  
1/4" = 1'-0"

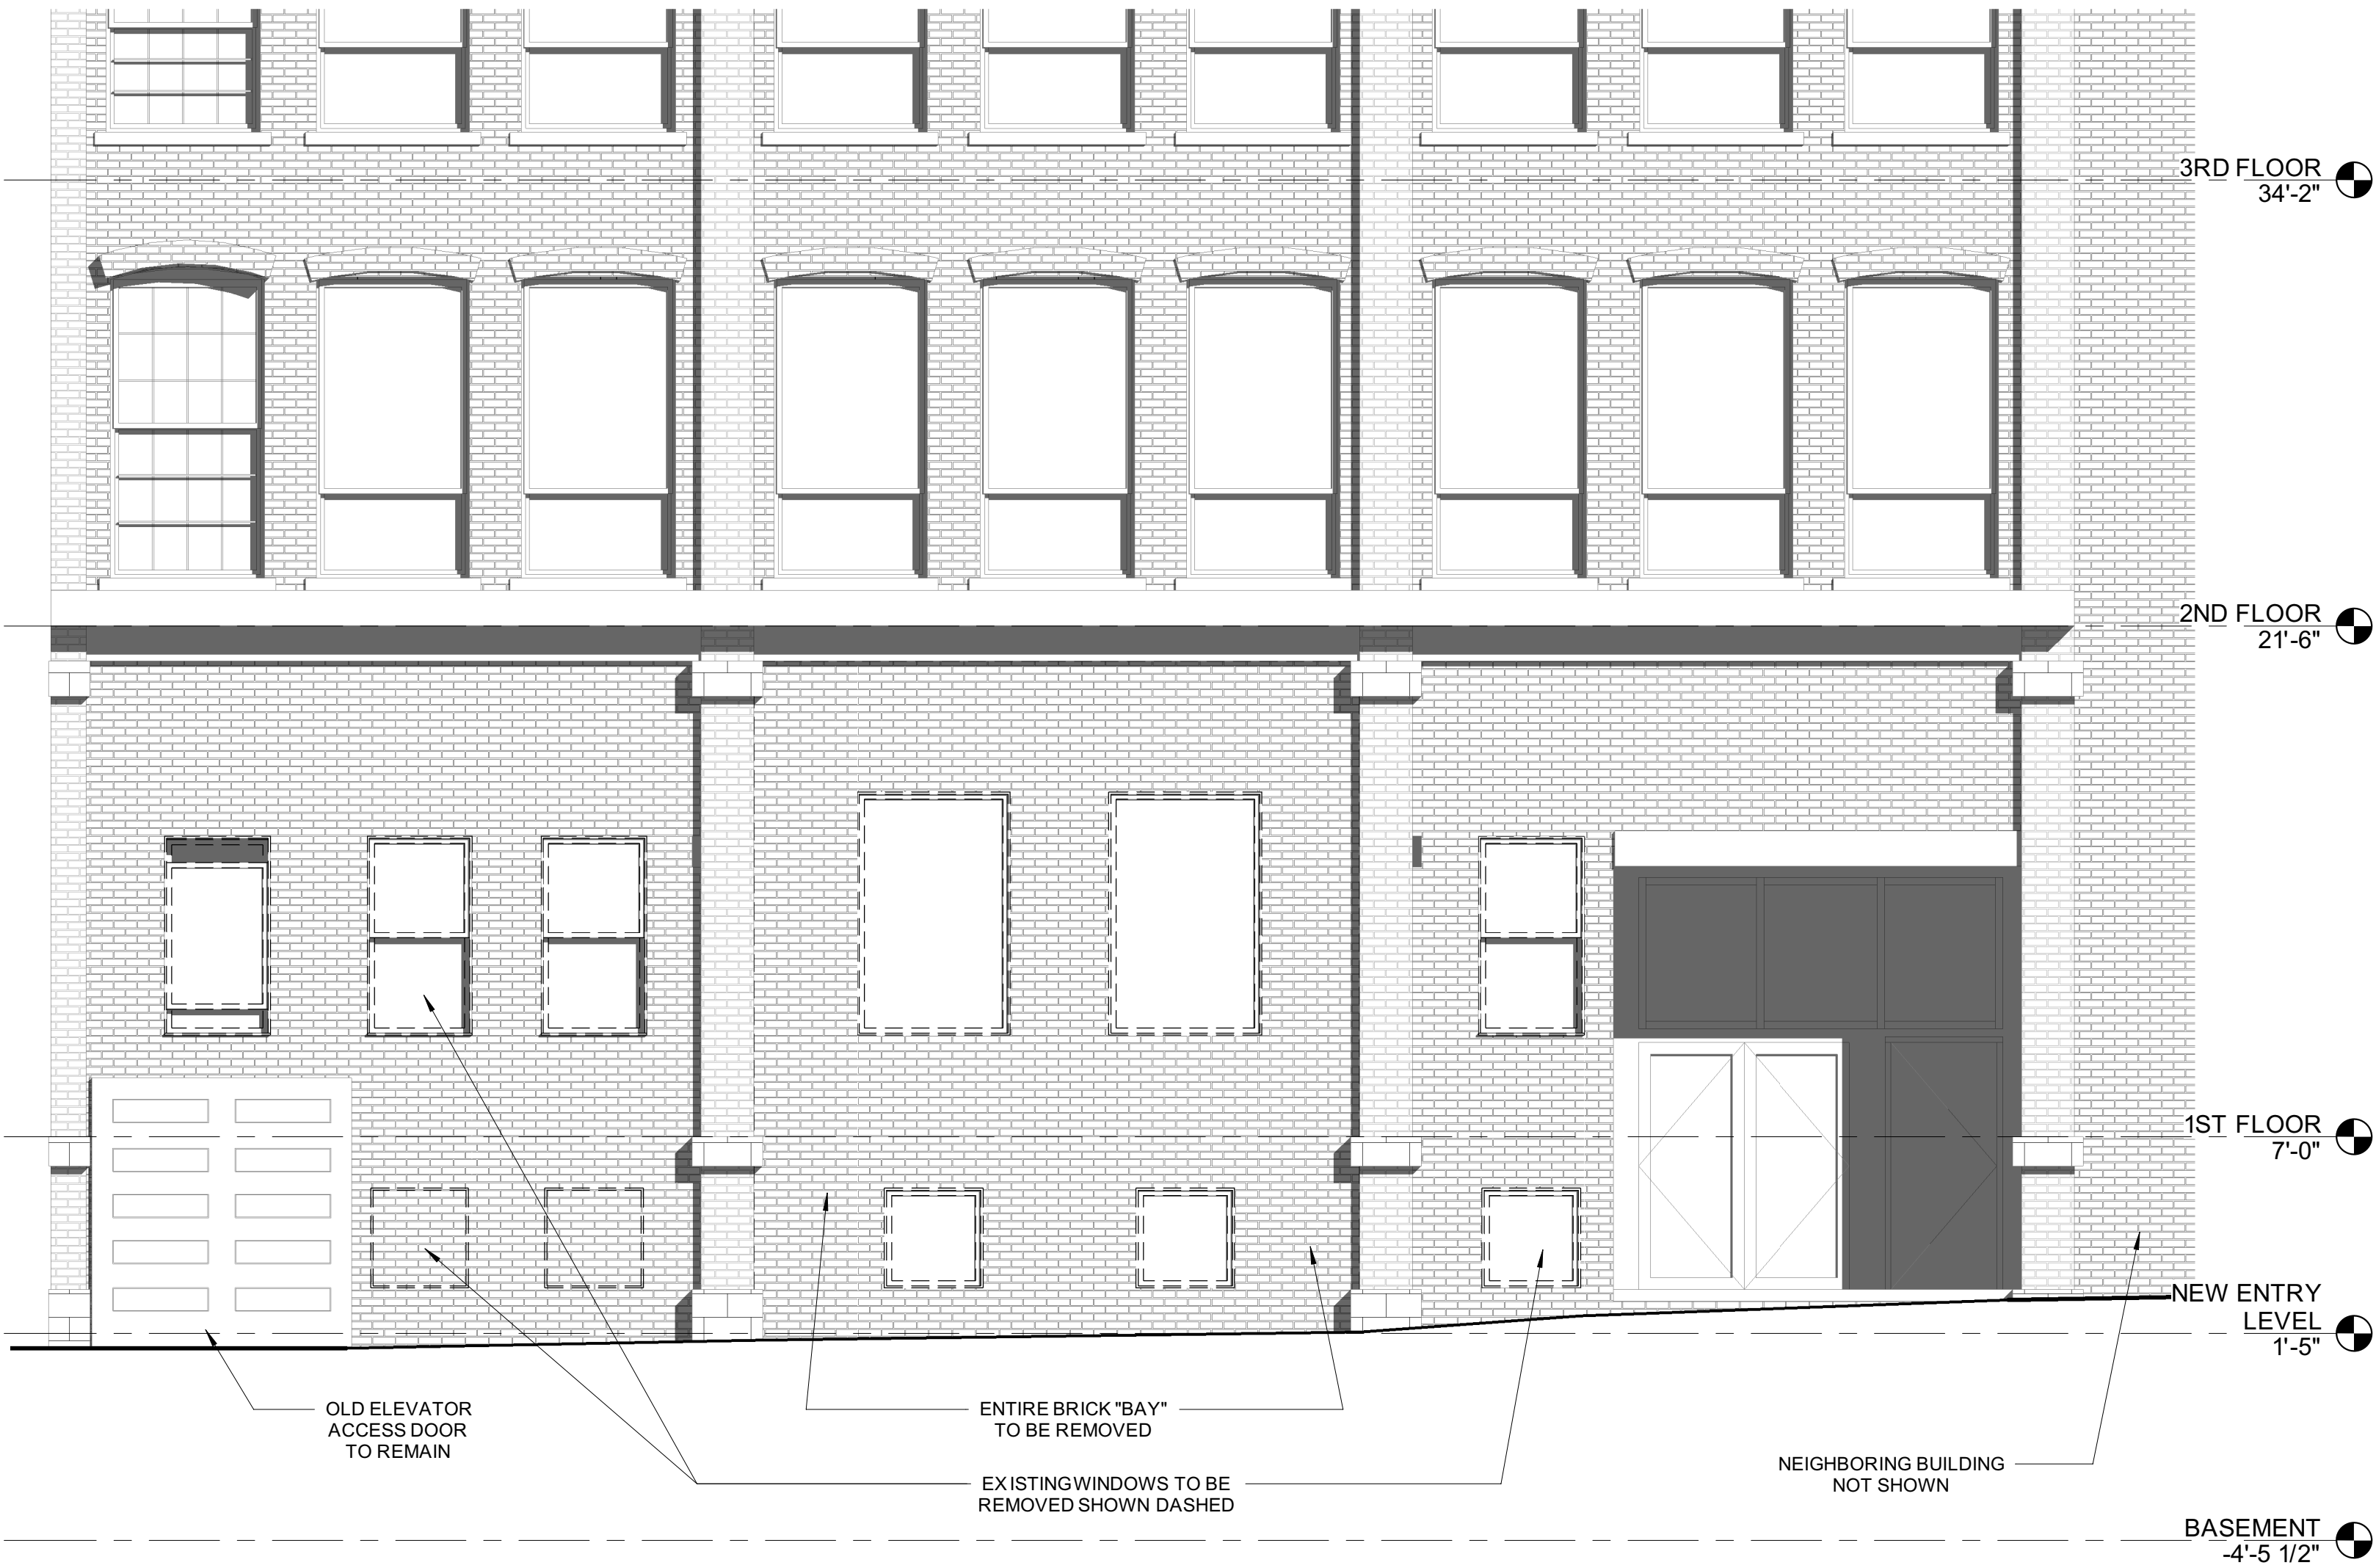
1 | CENTER ST. FACADE EXISTING / DEMO  
1/4" = 1'-0"

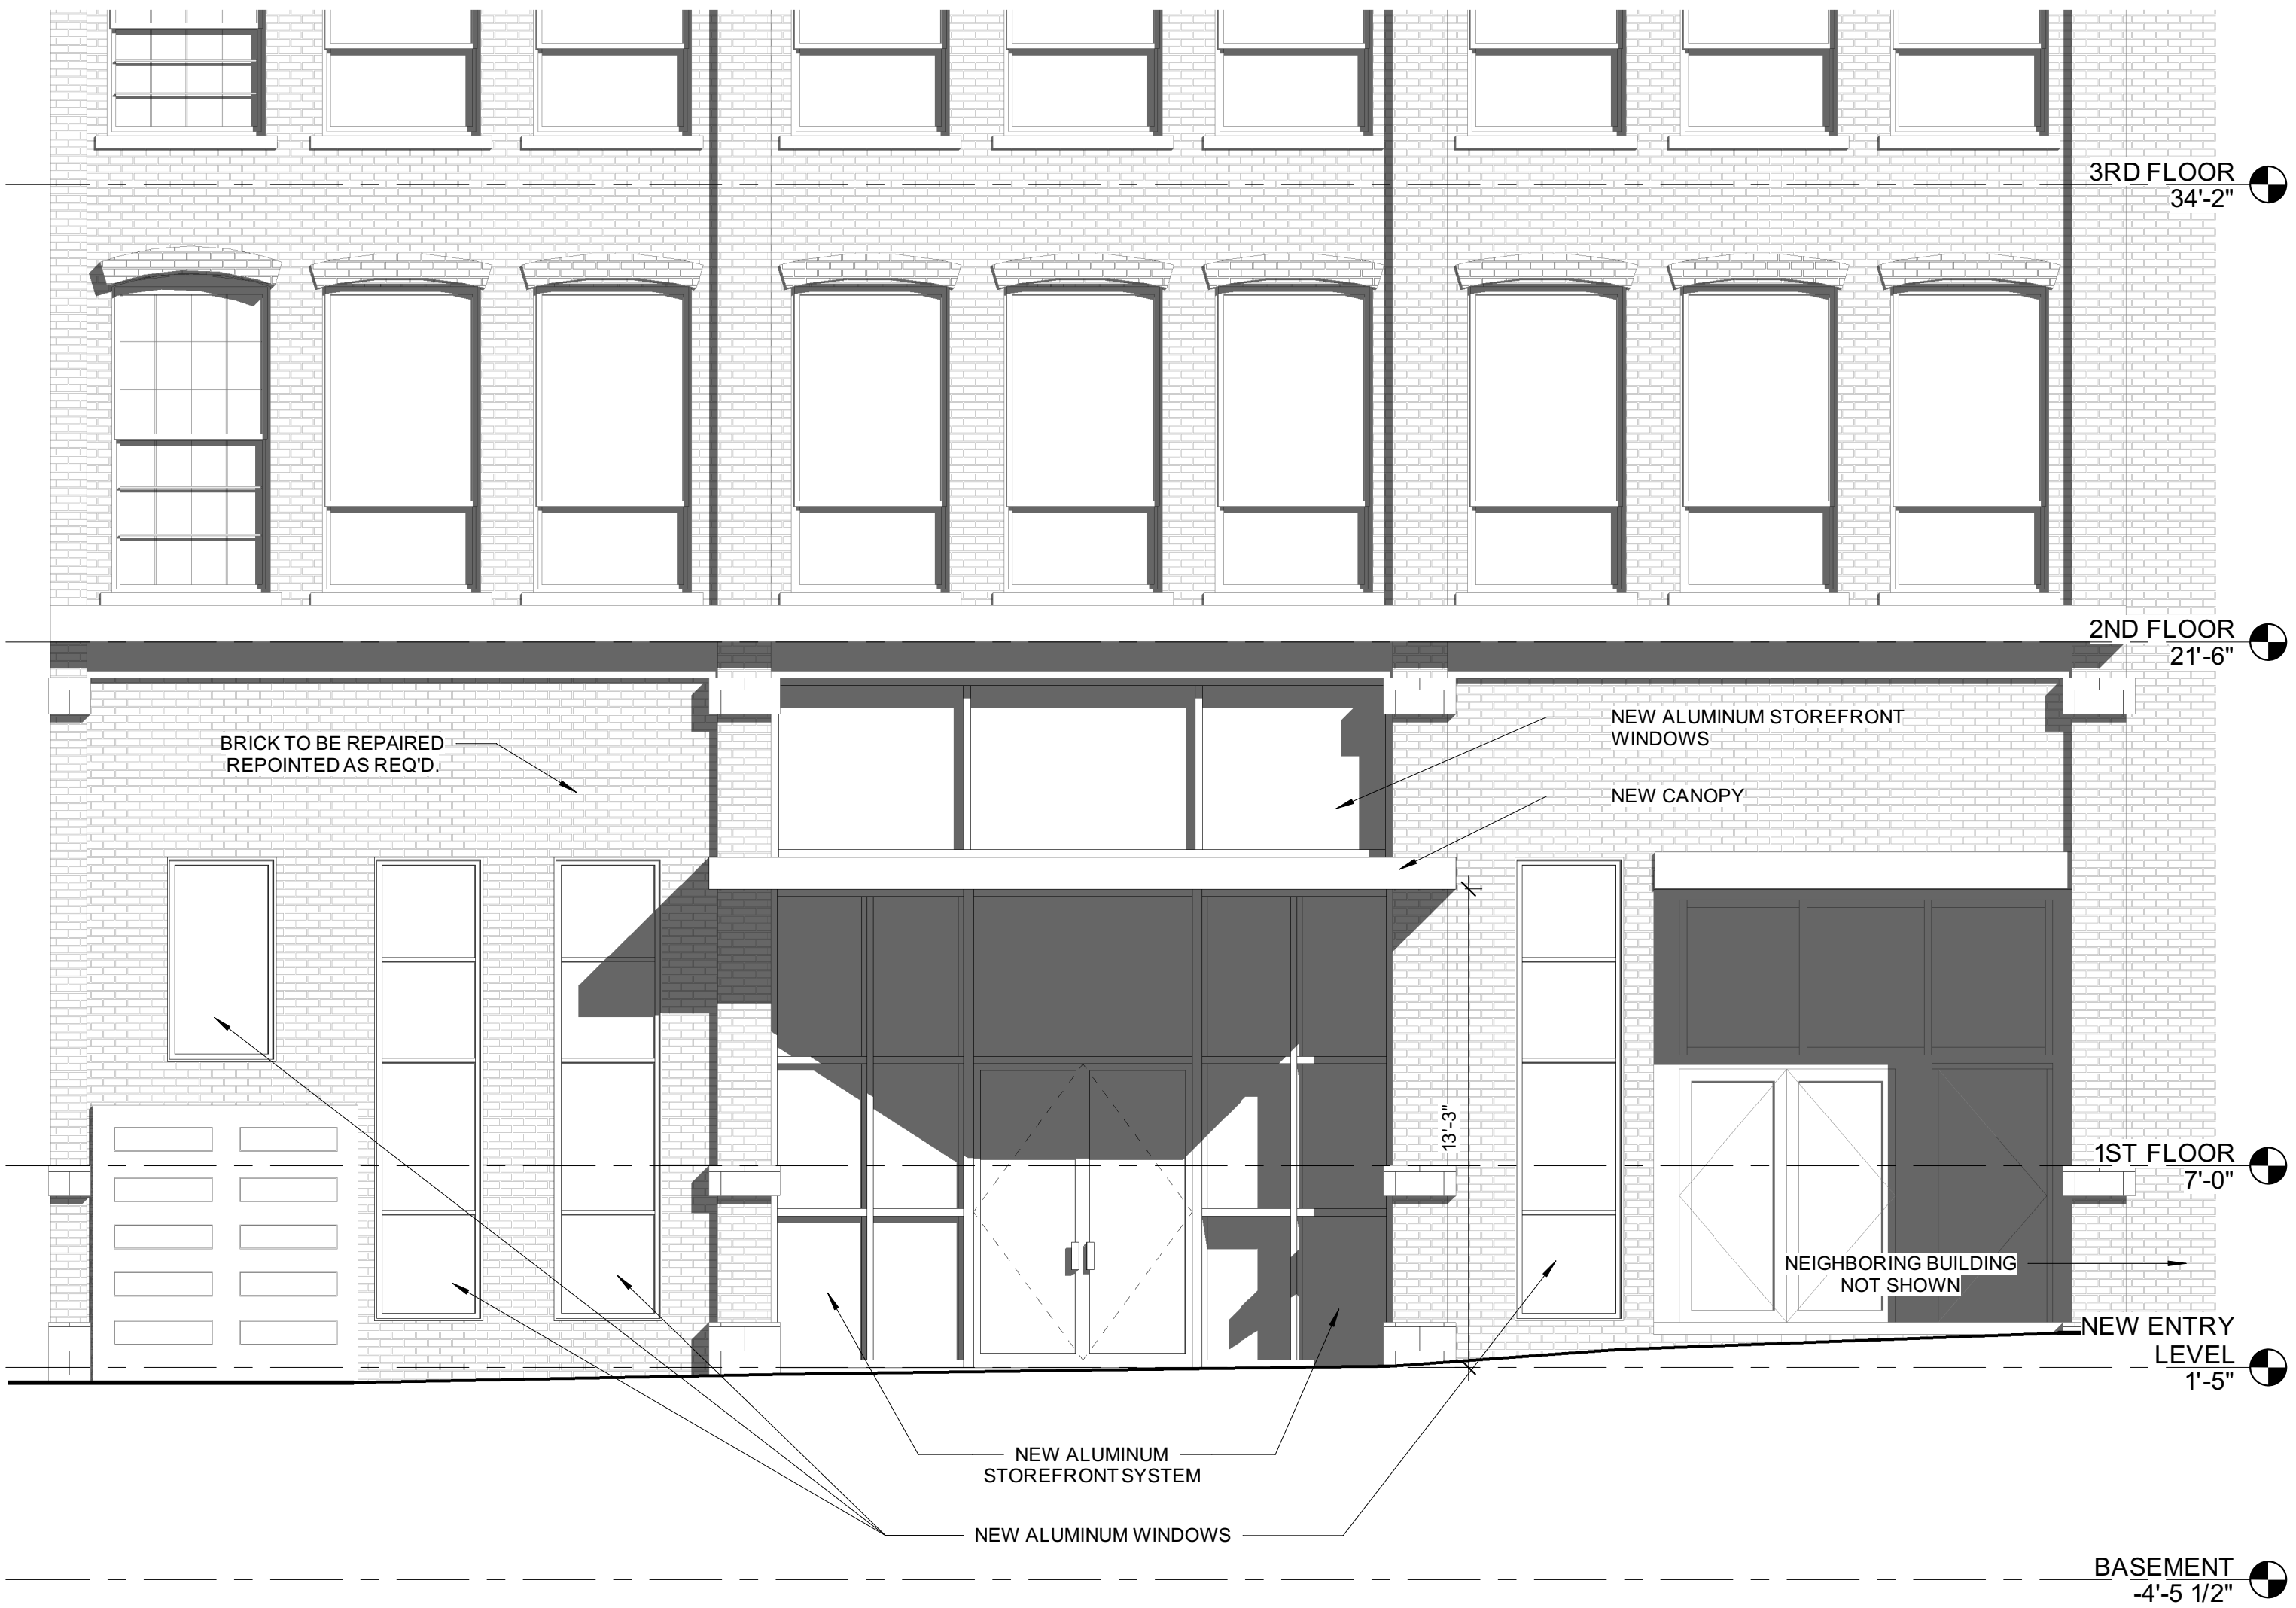
2 | PROPOSED CENTER ST. FACADE  
1/4" = 1'-0"

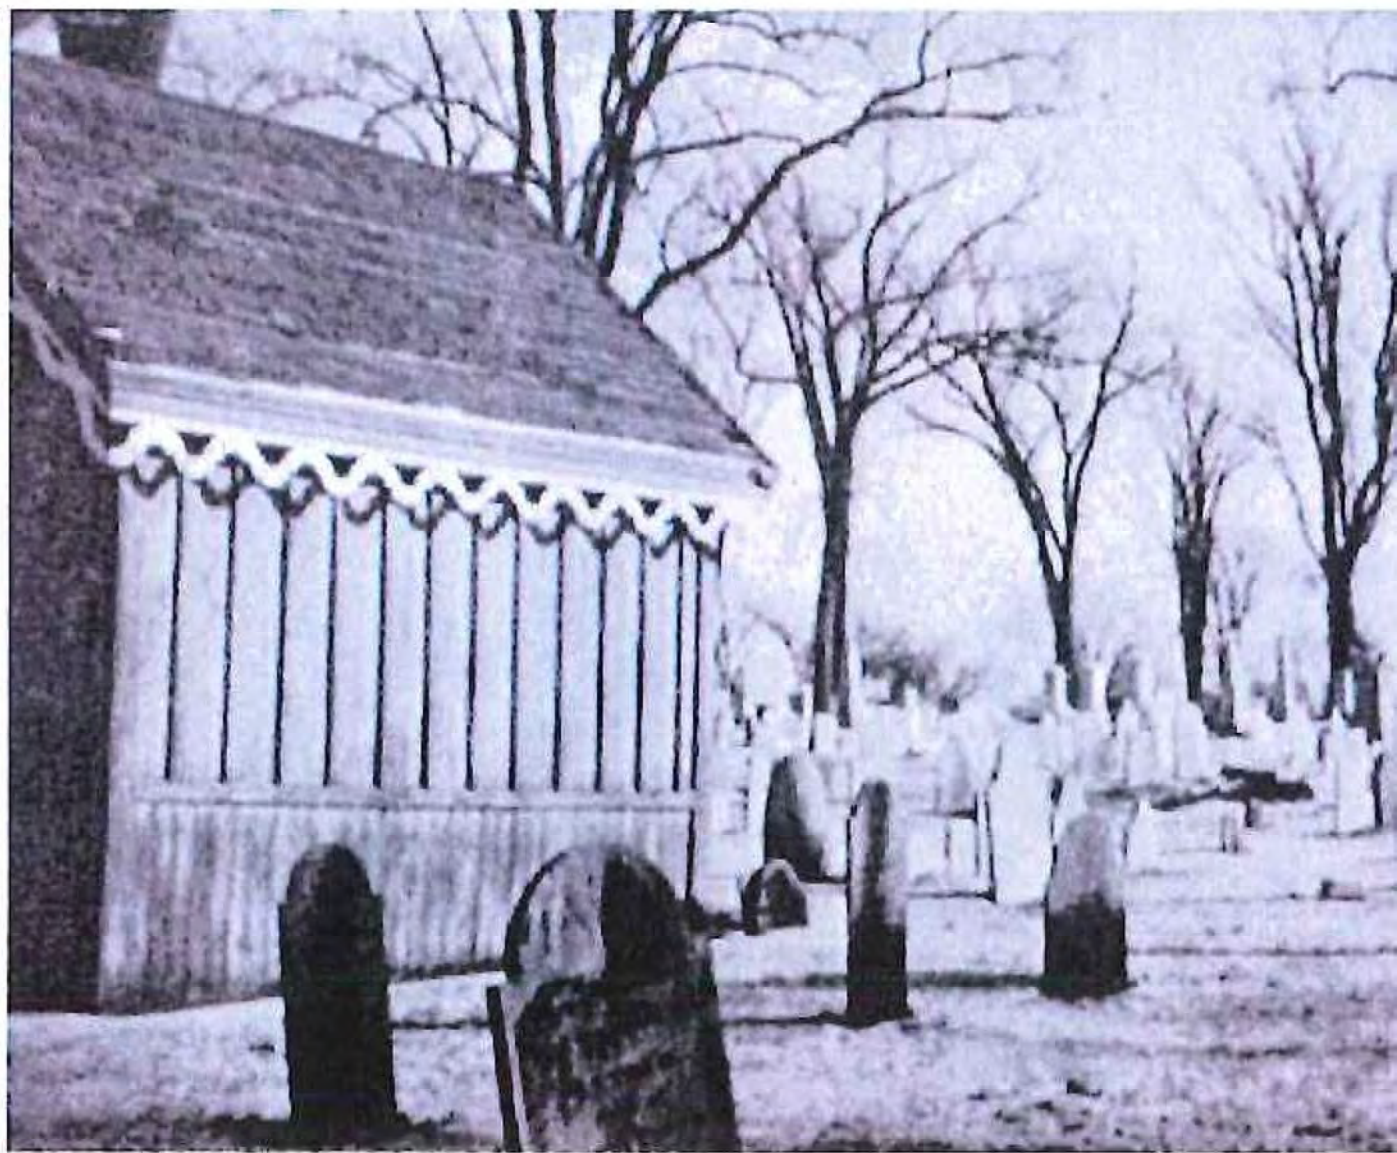
4. The tool shed, originally called the "Dead House," at Eastern Cemetery prior to the restoration work.

The EC Dead House at 12 feet nine inches (exterior) square is large enough and tall enough to store all the equipment needed to repair gravestones, as would be an 11 by 14 foot building. However, it's tight to maneuver small wagons and wheelbarrows inside the Dead House and would be harder in a building any narrower.

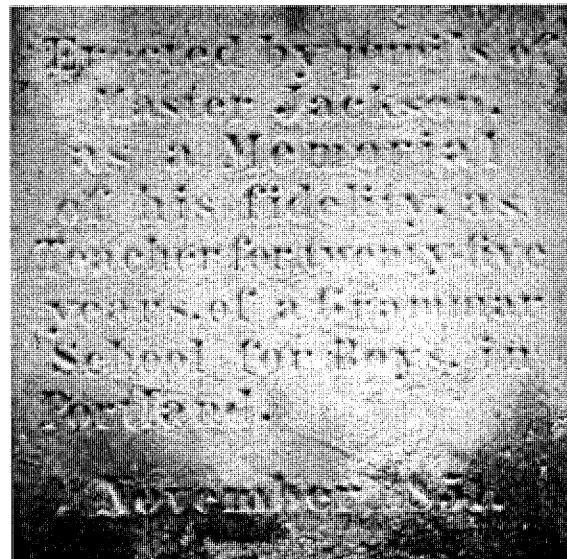
*Eroding inscription on Jackson monument*

The stones that show the most extensive deterioration and are the most at risk are the marble markers. Calcium carbonate is particularly susceptible to deterioration from acidic deposition [acid rain] and other atmospheric pollutants. About 1,000 of the marble markers [over 60% of the total markers] have eroded surfaces varying from slight to severe. Lichen, moss, mildew, fungi grow on many of the marble, sandstone and even granite markers. The markers in the best condition are the slate tablets and granite markers. While all of the slates have clear inscriptions and very little splitting or spalling, many are tilted and need to be reset to preserve their stability.

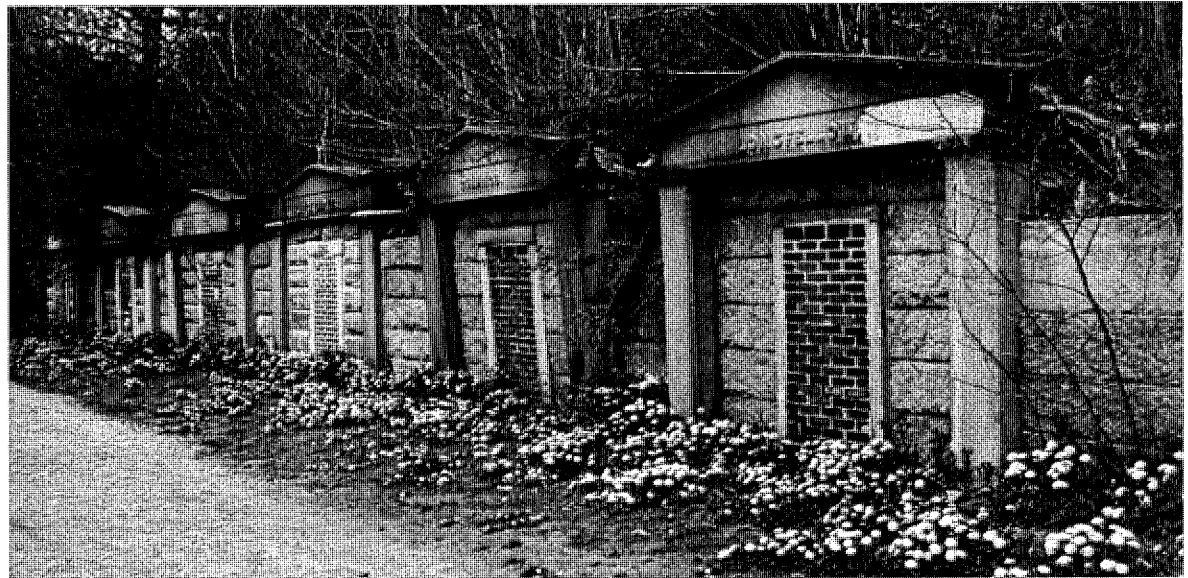
Connecting retaining wall: The top stone has shifted and should be reset.

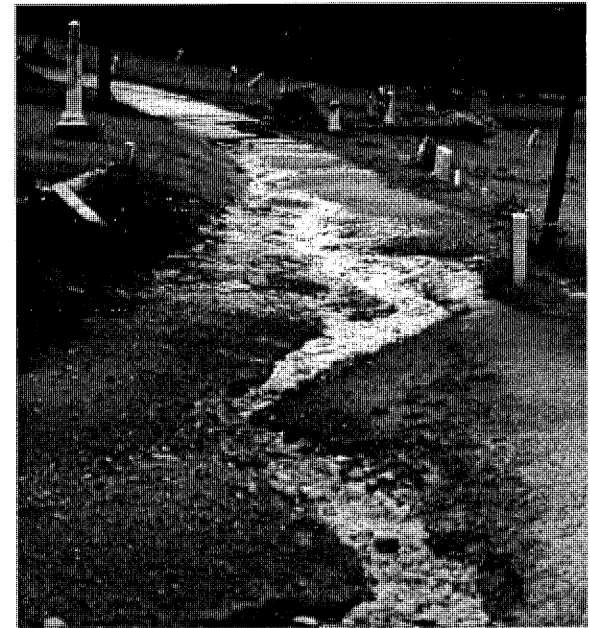
*Erosion on southwest perimeter avenue*

The Fir Avenue on the north side, from the high point near the Longfellow tomb, carries a concentrated flow toward Vaughan Street and then turns toward the central oval, Woodbine Grove, near the Daveis Memorial Gate where it runs over burial plots in an eroded area. It appears that earth fill has been added [it has a different color and texture than surrounding materials] inside the Daveis gate diverting surface drainage from following Fir Avenue adjacent to Vaughan Street. Water flows along Cypress Avenue adjacent to Woodbine Grove to the main vehicular gate and then down Fir Avenue parallel to Vaughan Street. At the southeast corner of the cemetery, water leaves the avenue and flows overland toward Western Promenade.

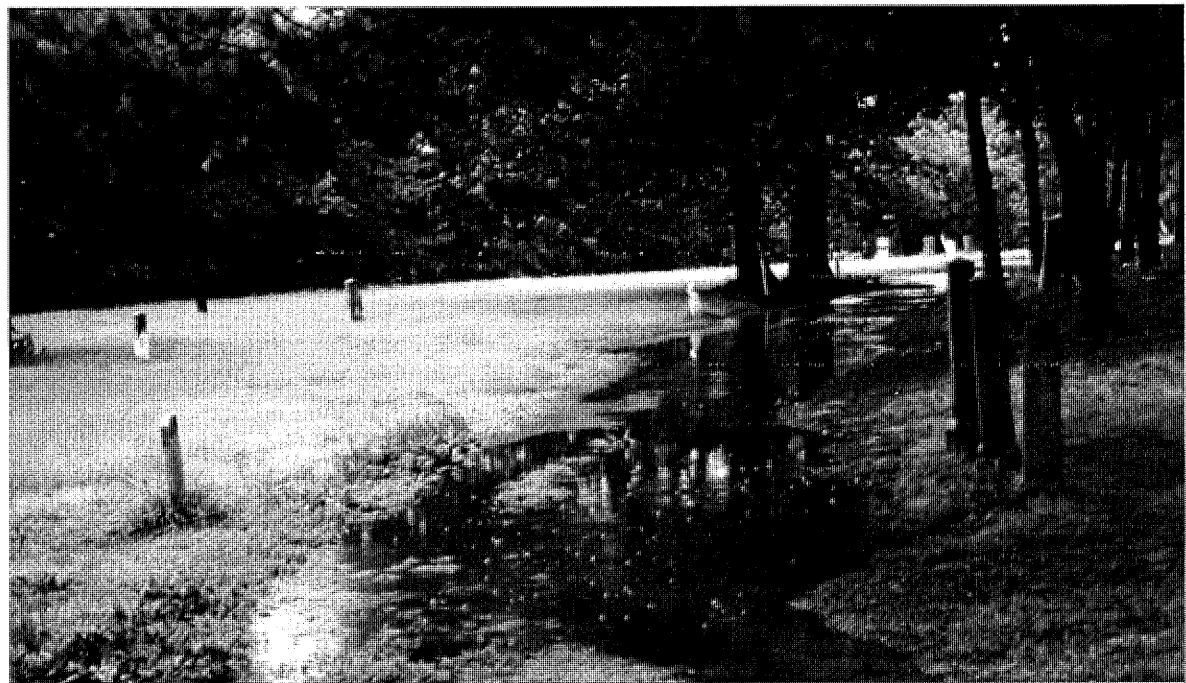
*Ponding on southeast perimeter avenue*

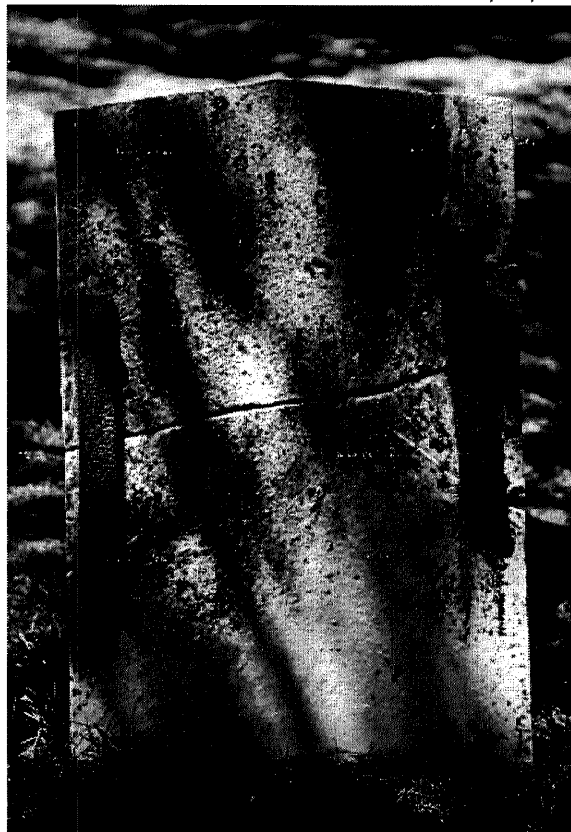
Where broken stones have been repaired with iron or bronze straps and bolts, they are extremely liable to cracking around the bolt hole. Iron straps not only stain markers, but they also rust and expand, causing the stones to fracture. Bronze straps also cause staining.

*Marble marker with iron strap repair*
