# CITY OF PORTLAND, MAINE

## HISTORIC PRESERVATION BOARD

#### HISTORIC PRESERVATION BOARD MEETING

Topic: Historic Preservation Board Public Hearing and Workshop 3-16-2022

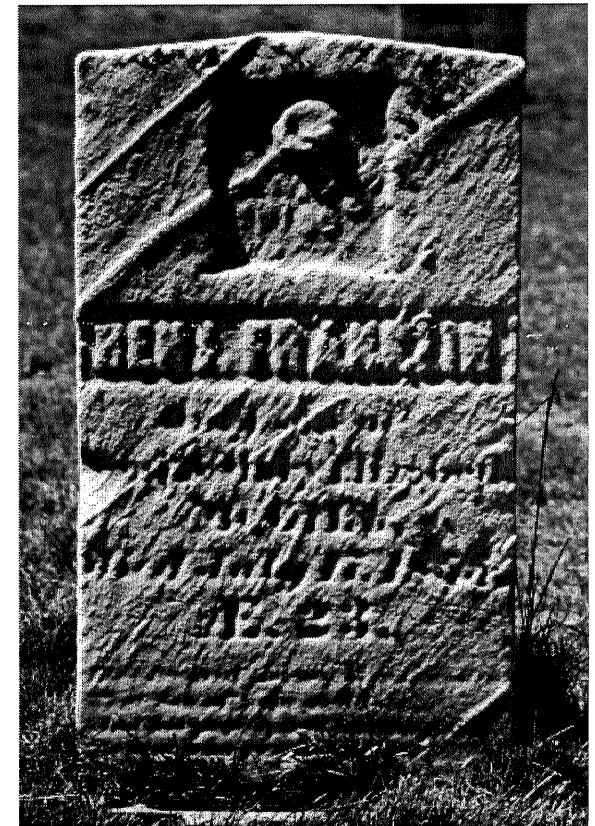
*Deteriorated marble marker*

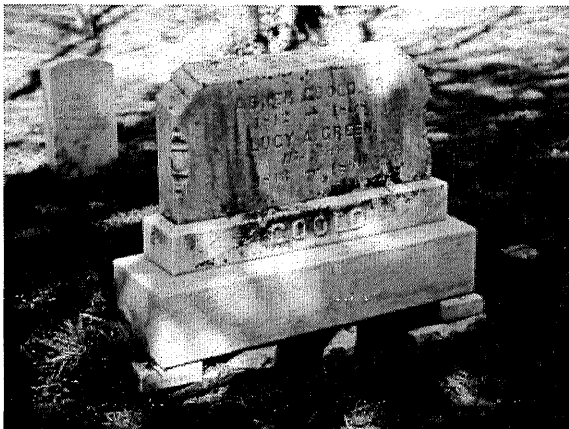
*Marble marker with exposed foundation*

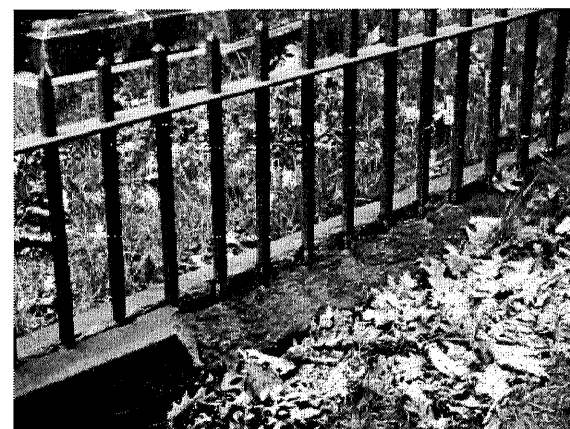
*Rust jacking damage at family plot edging*

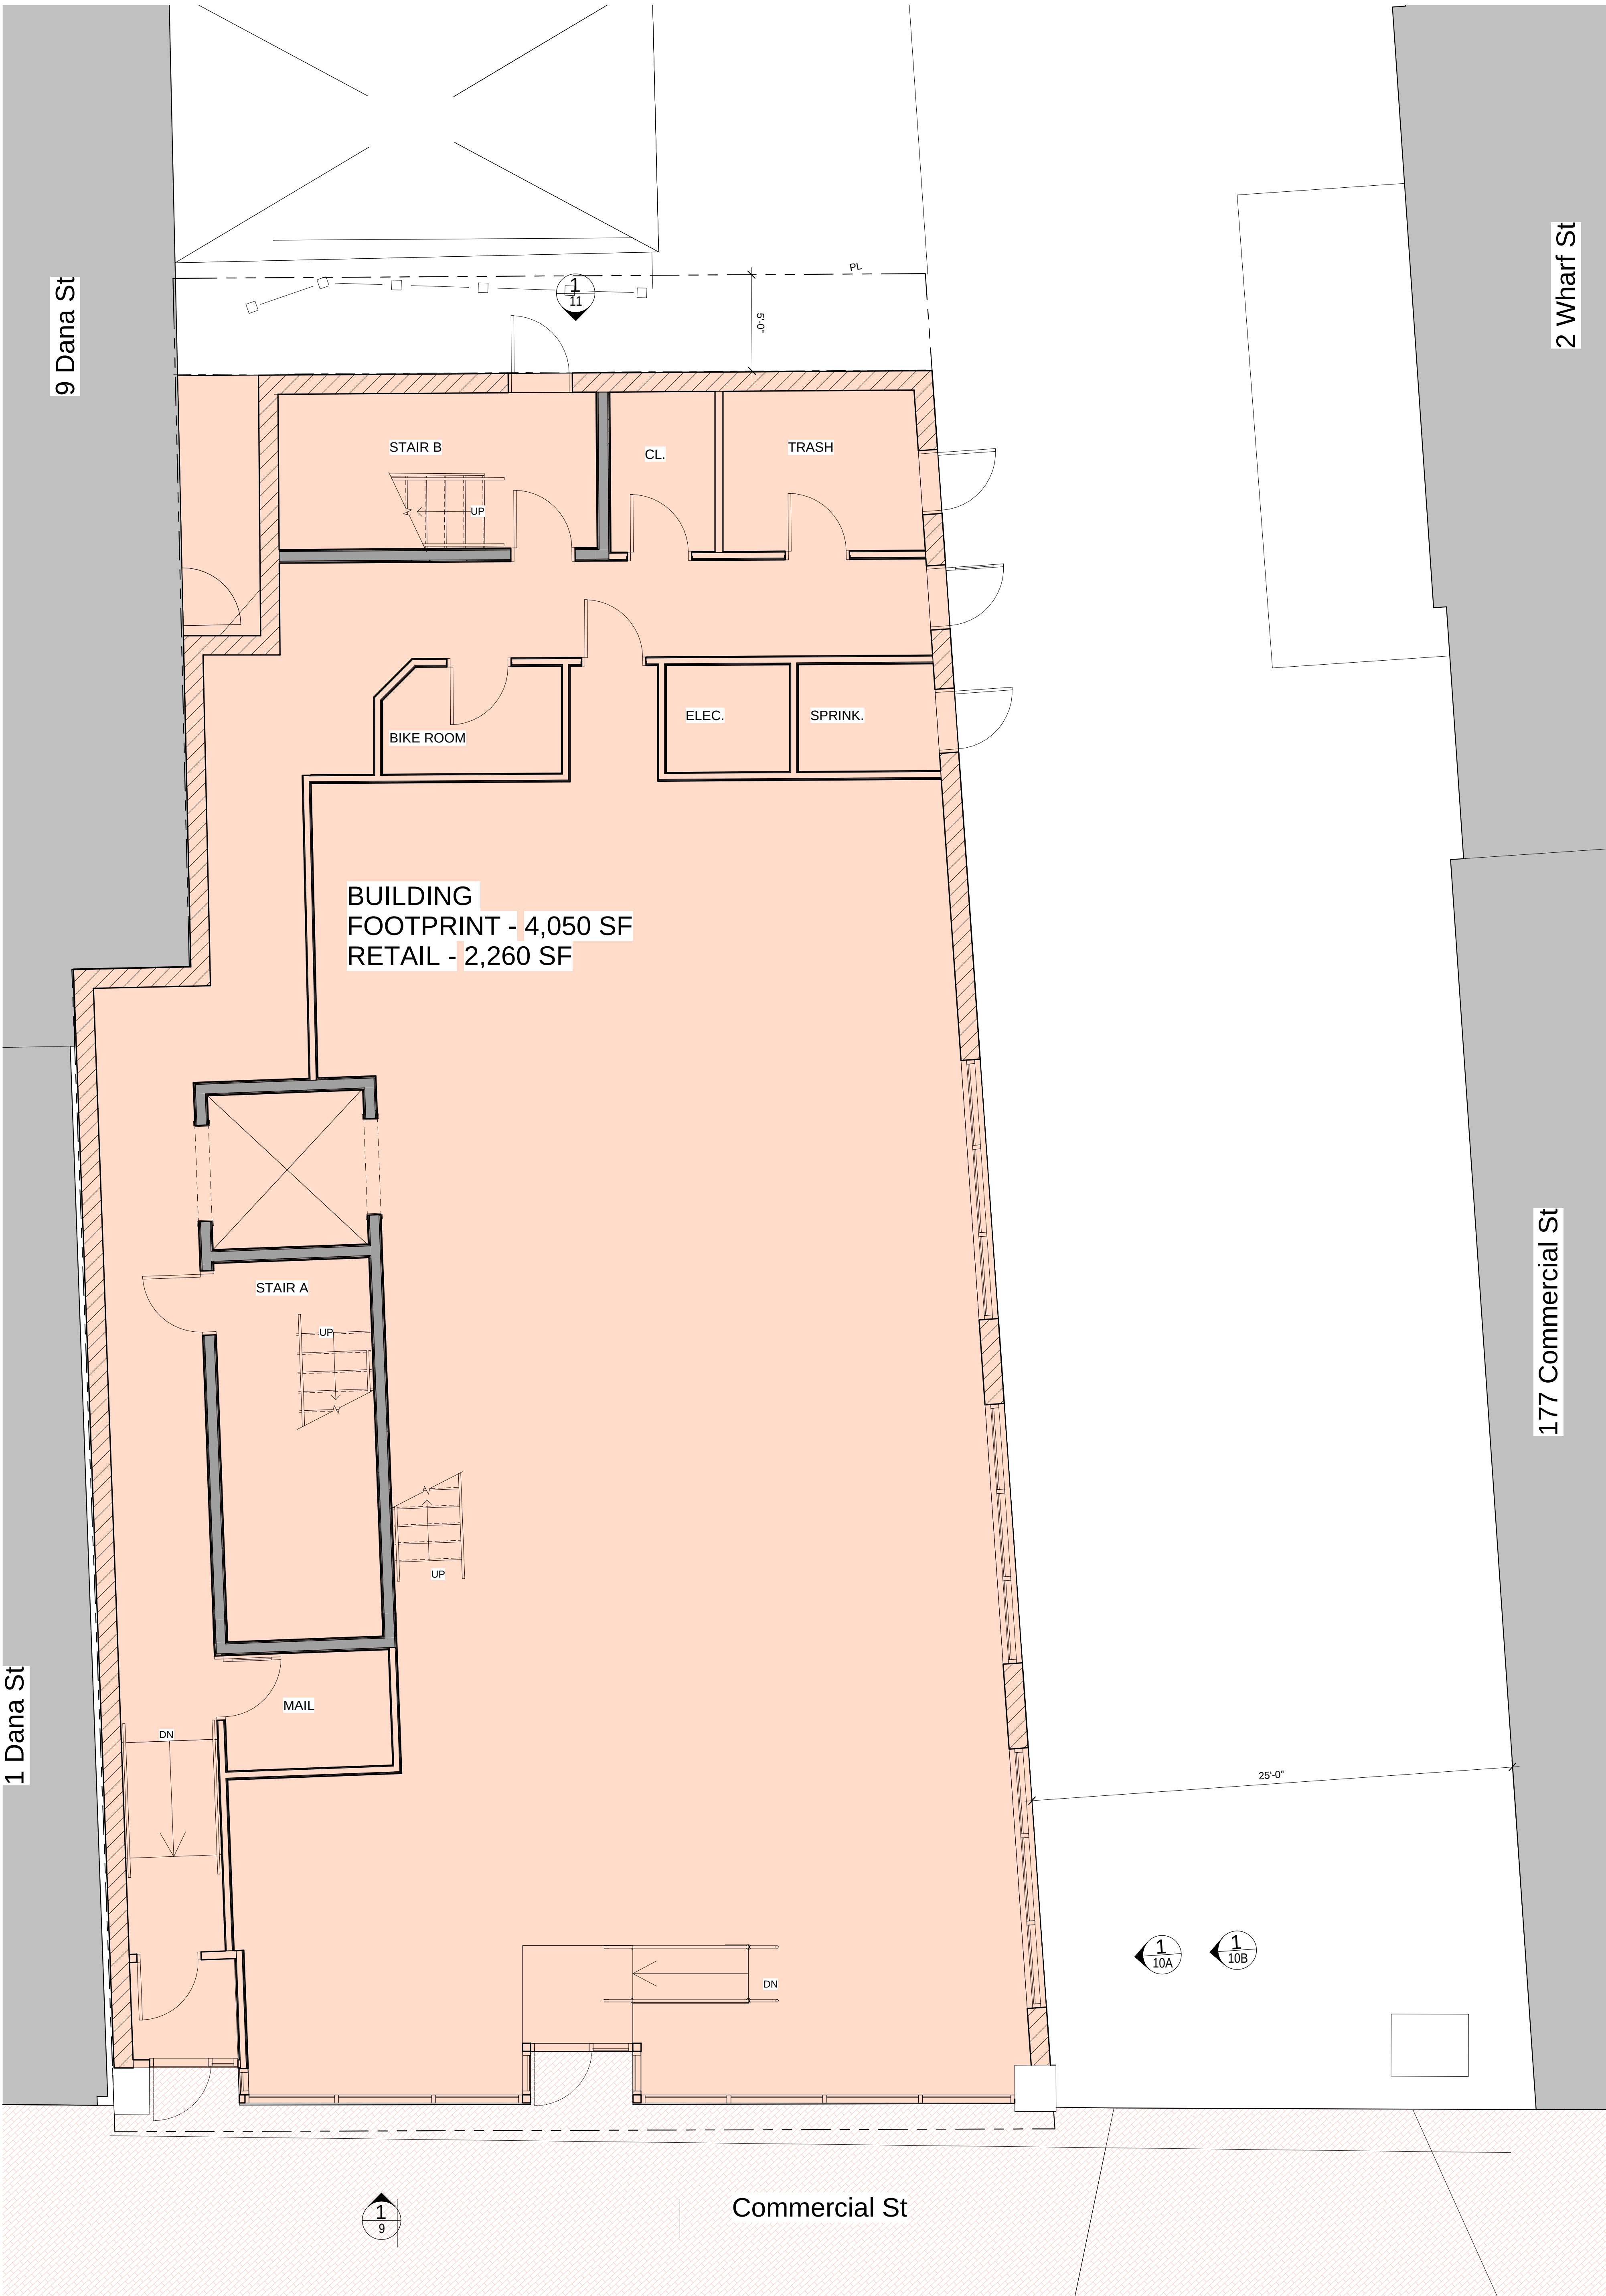
1 | 1ST FLOOR PLAN  
1/4" = 1'-0"

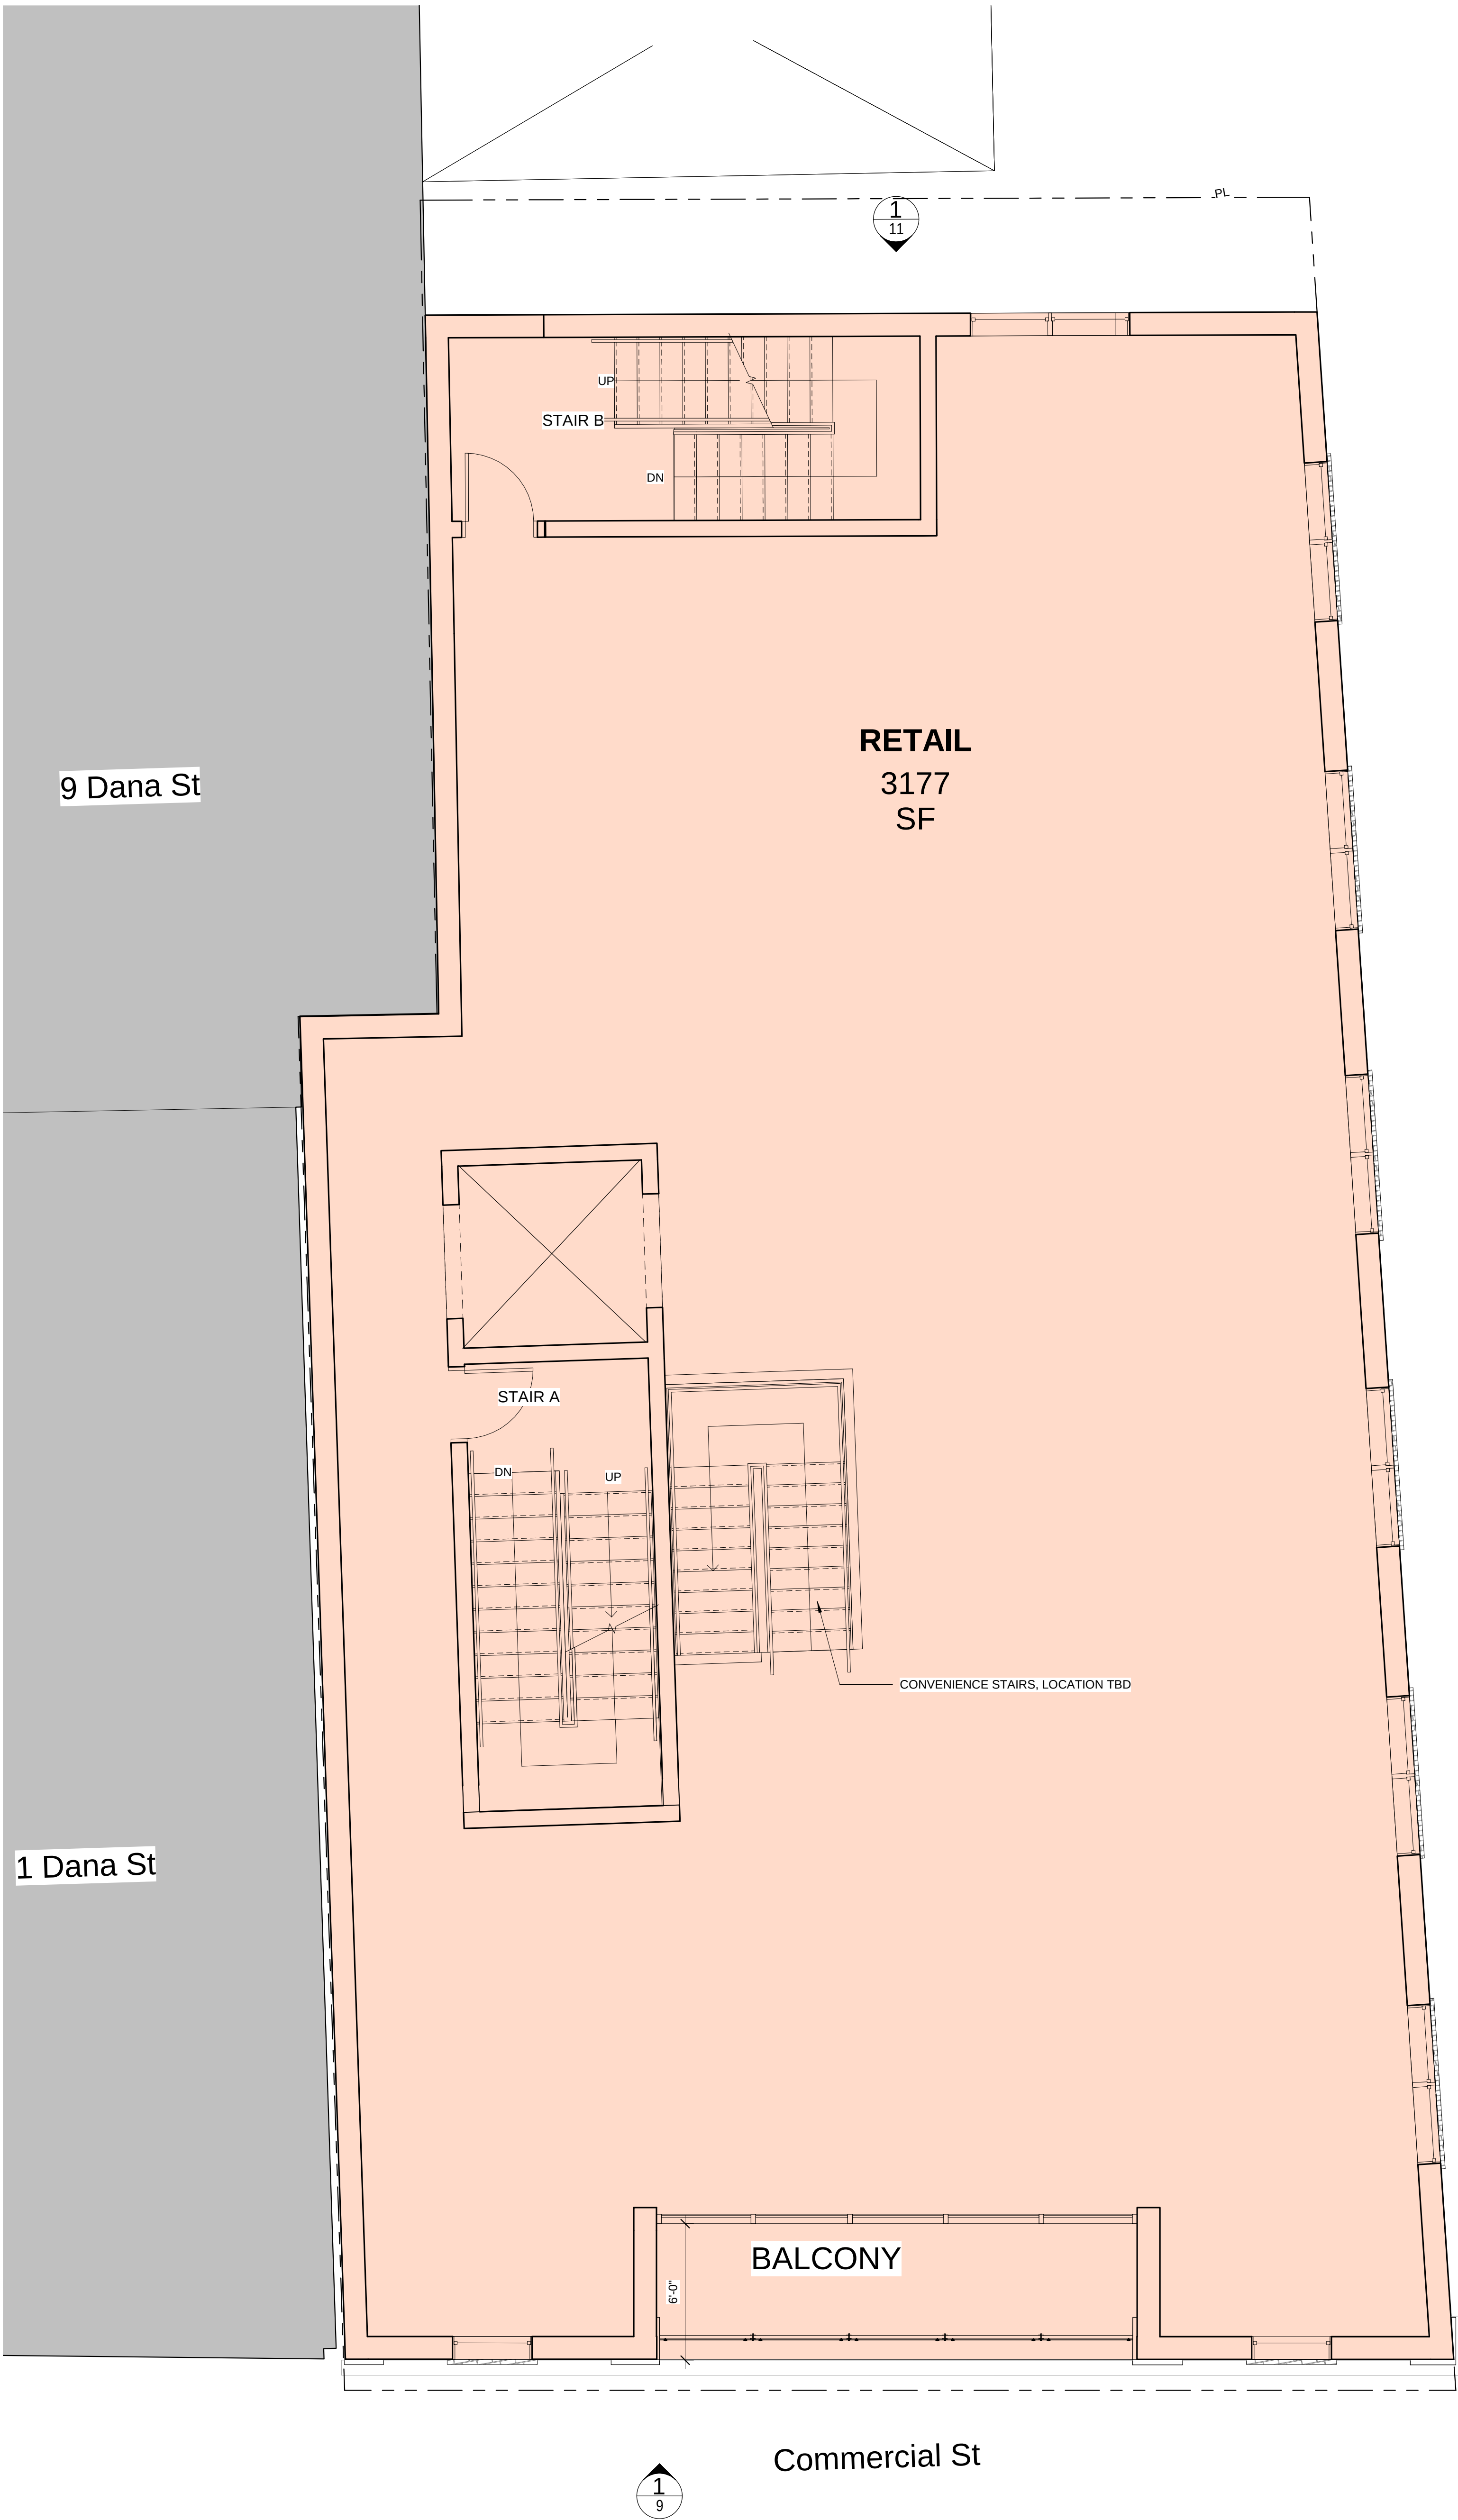
1 | 2ND FLOOR  
1/4" = 1'-0"

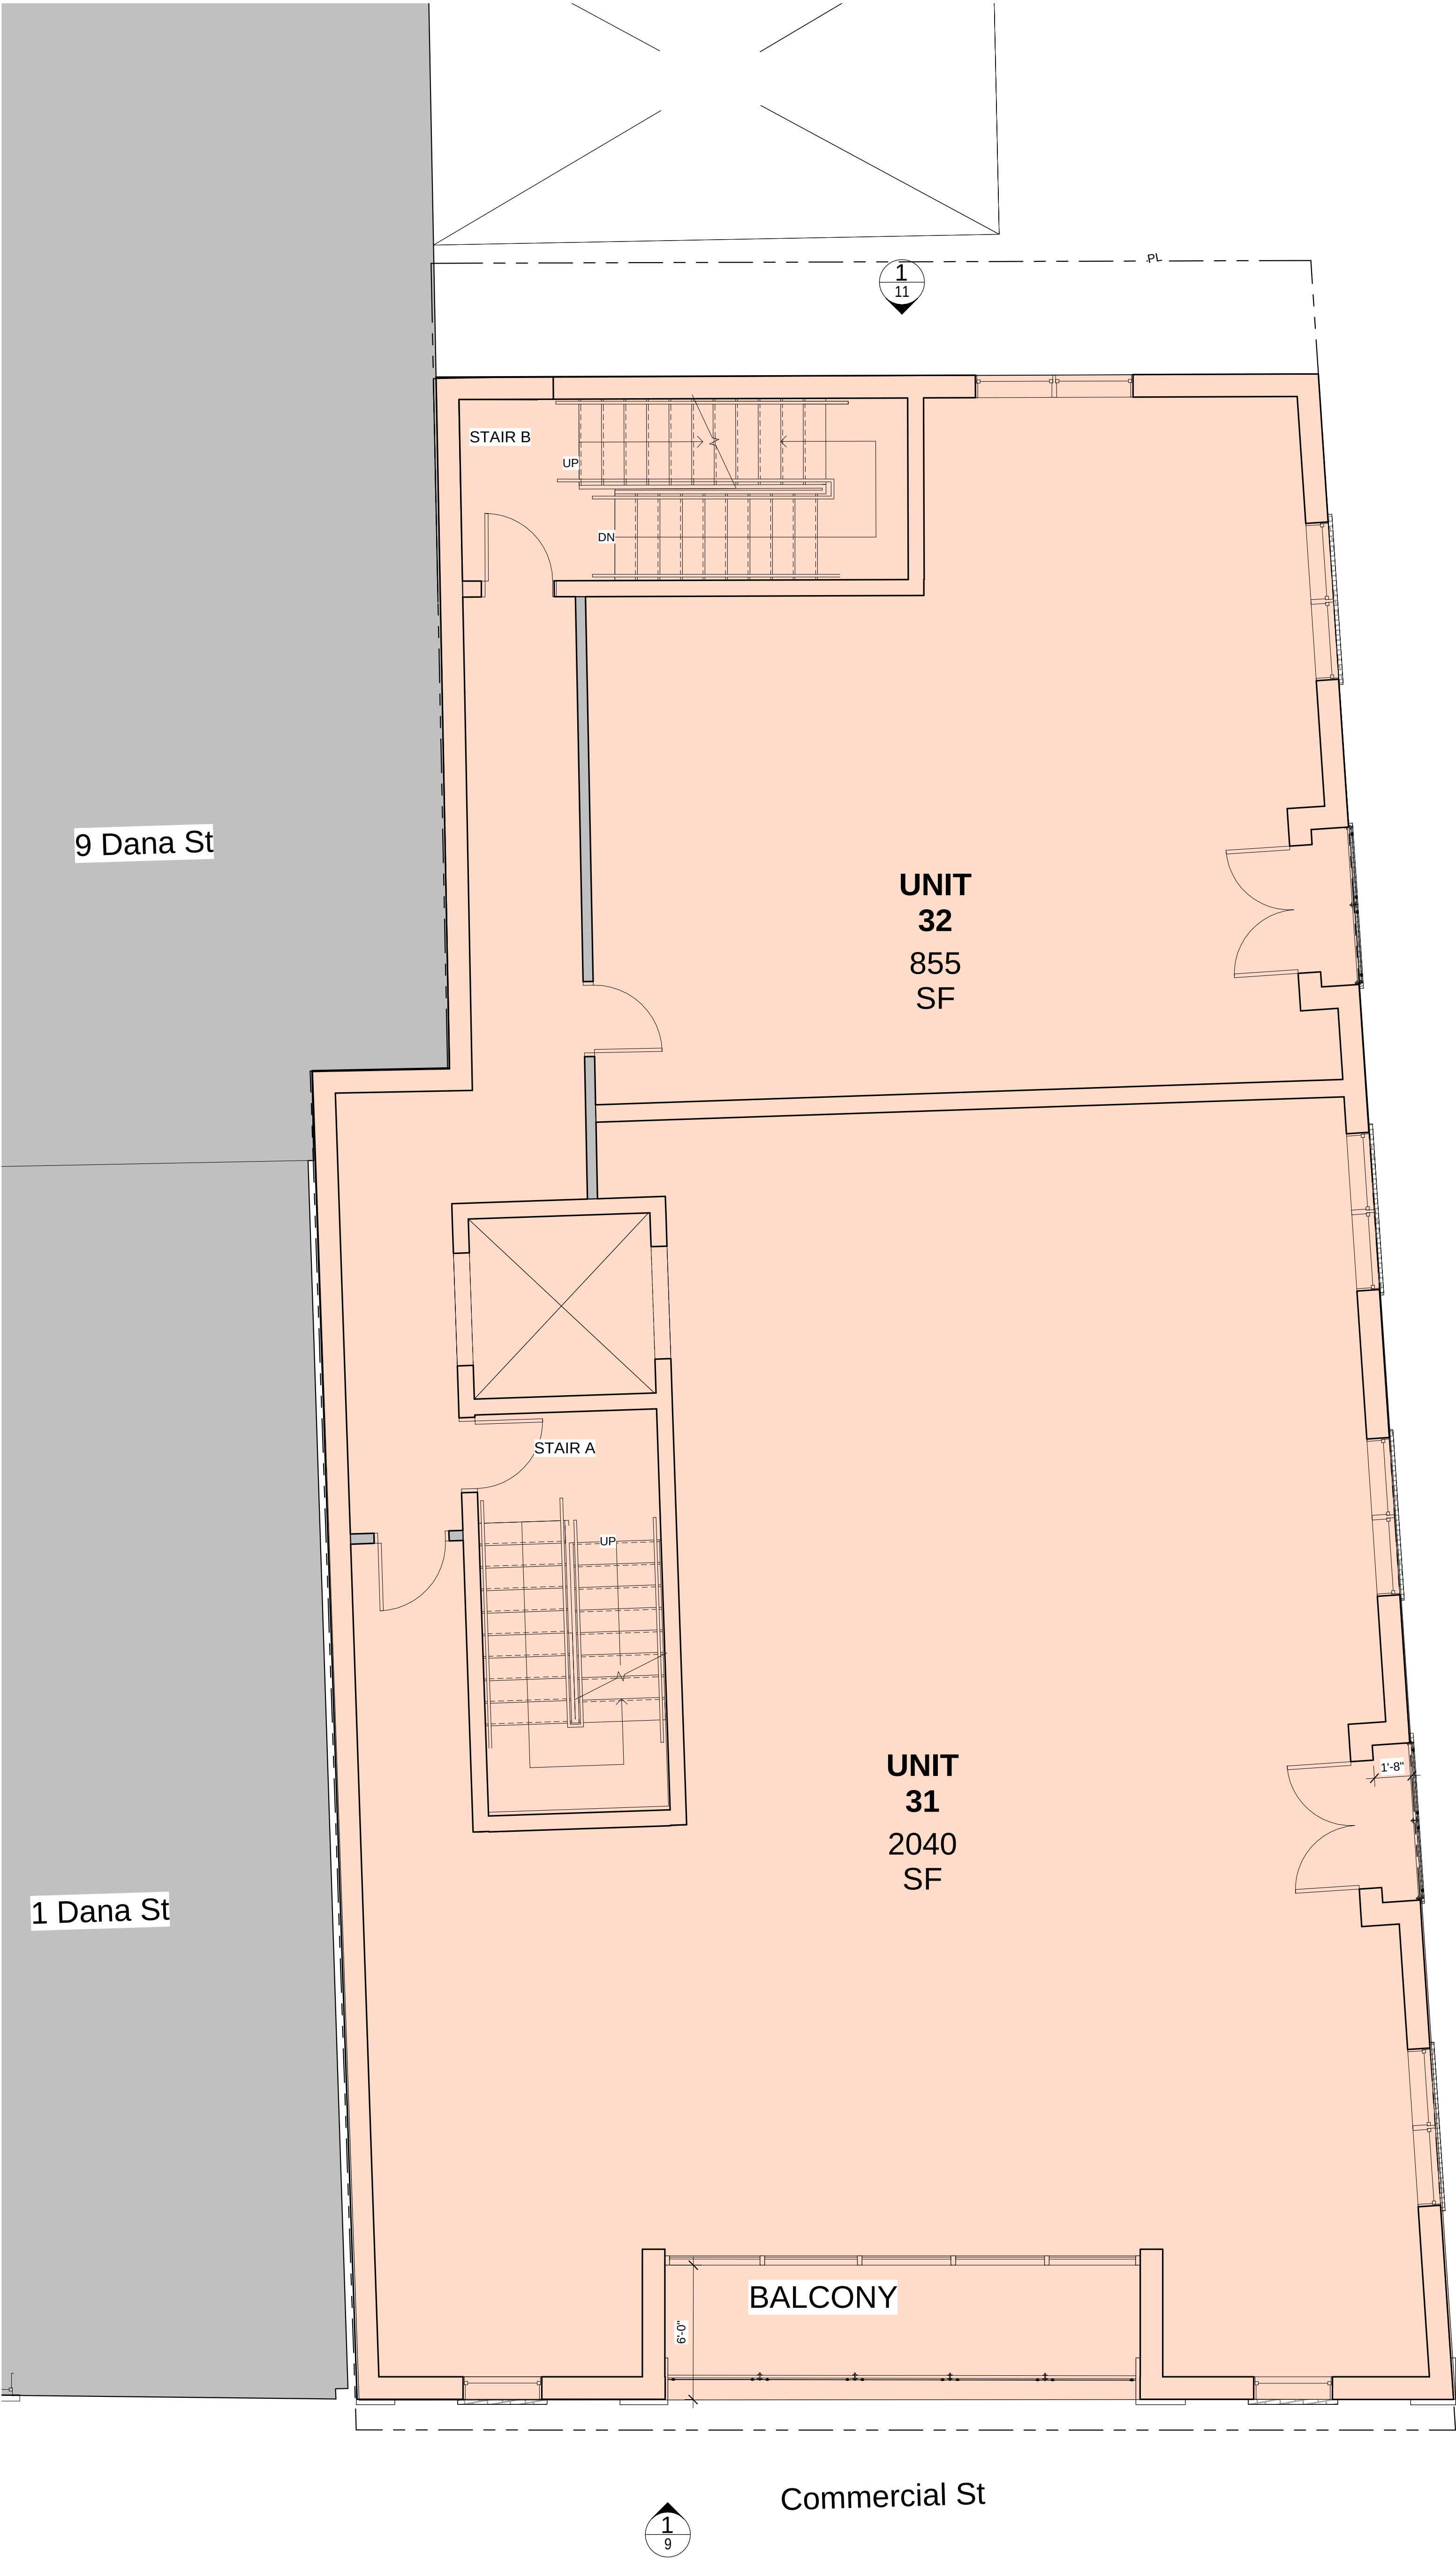
**1** | 3RD FLOOR  
1/4" = 1'-0"

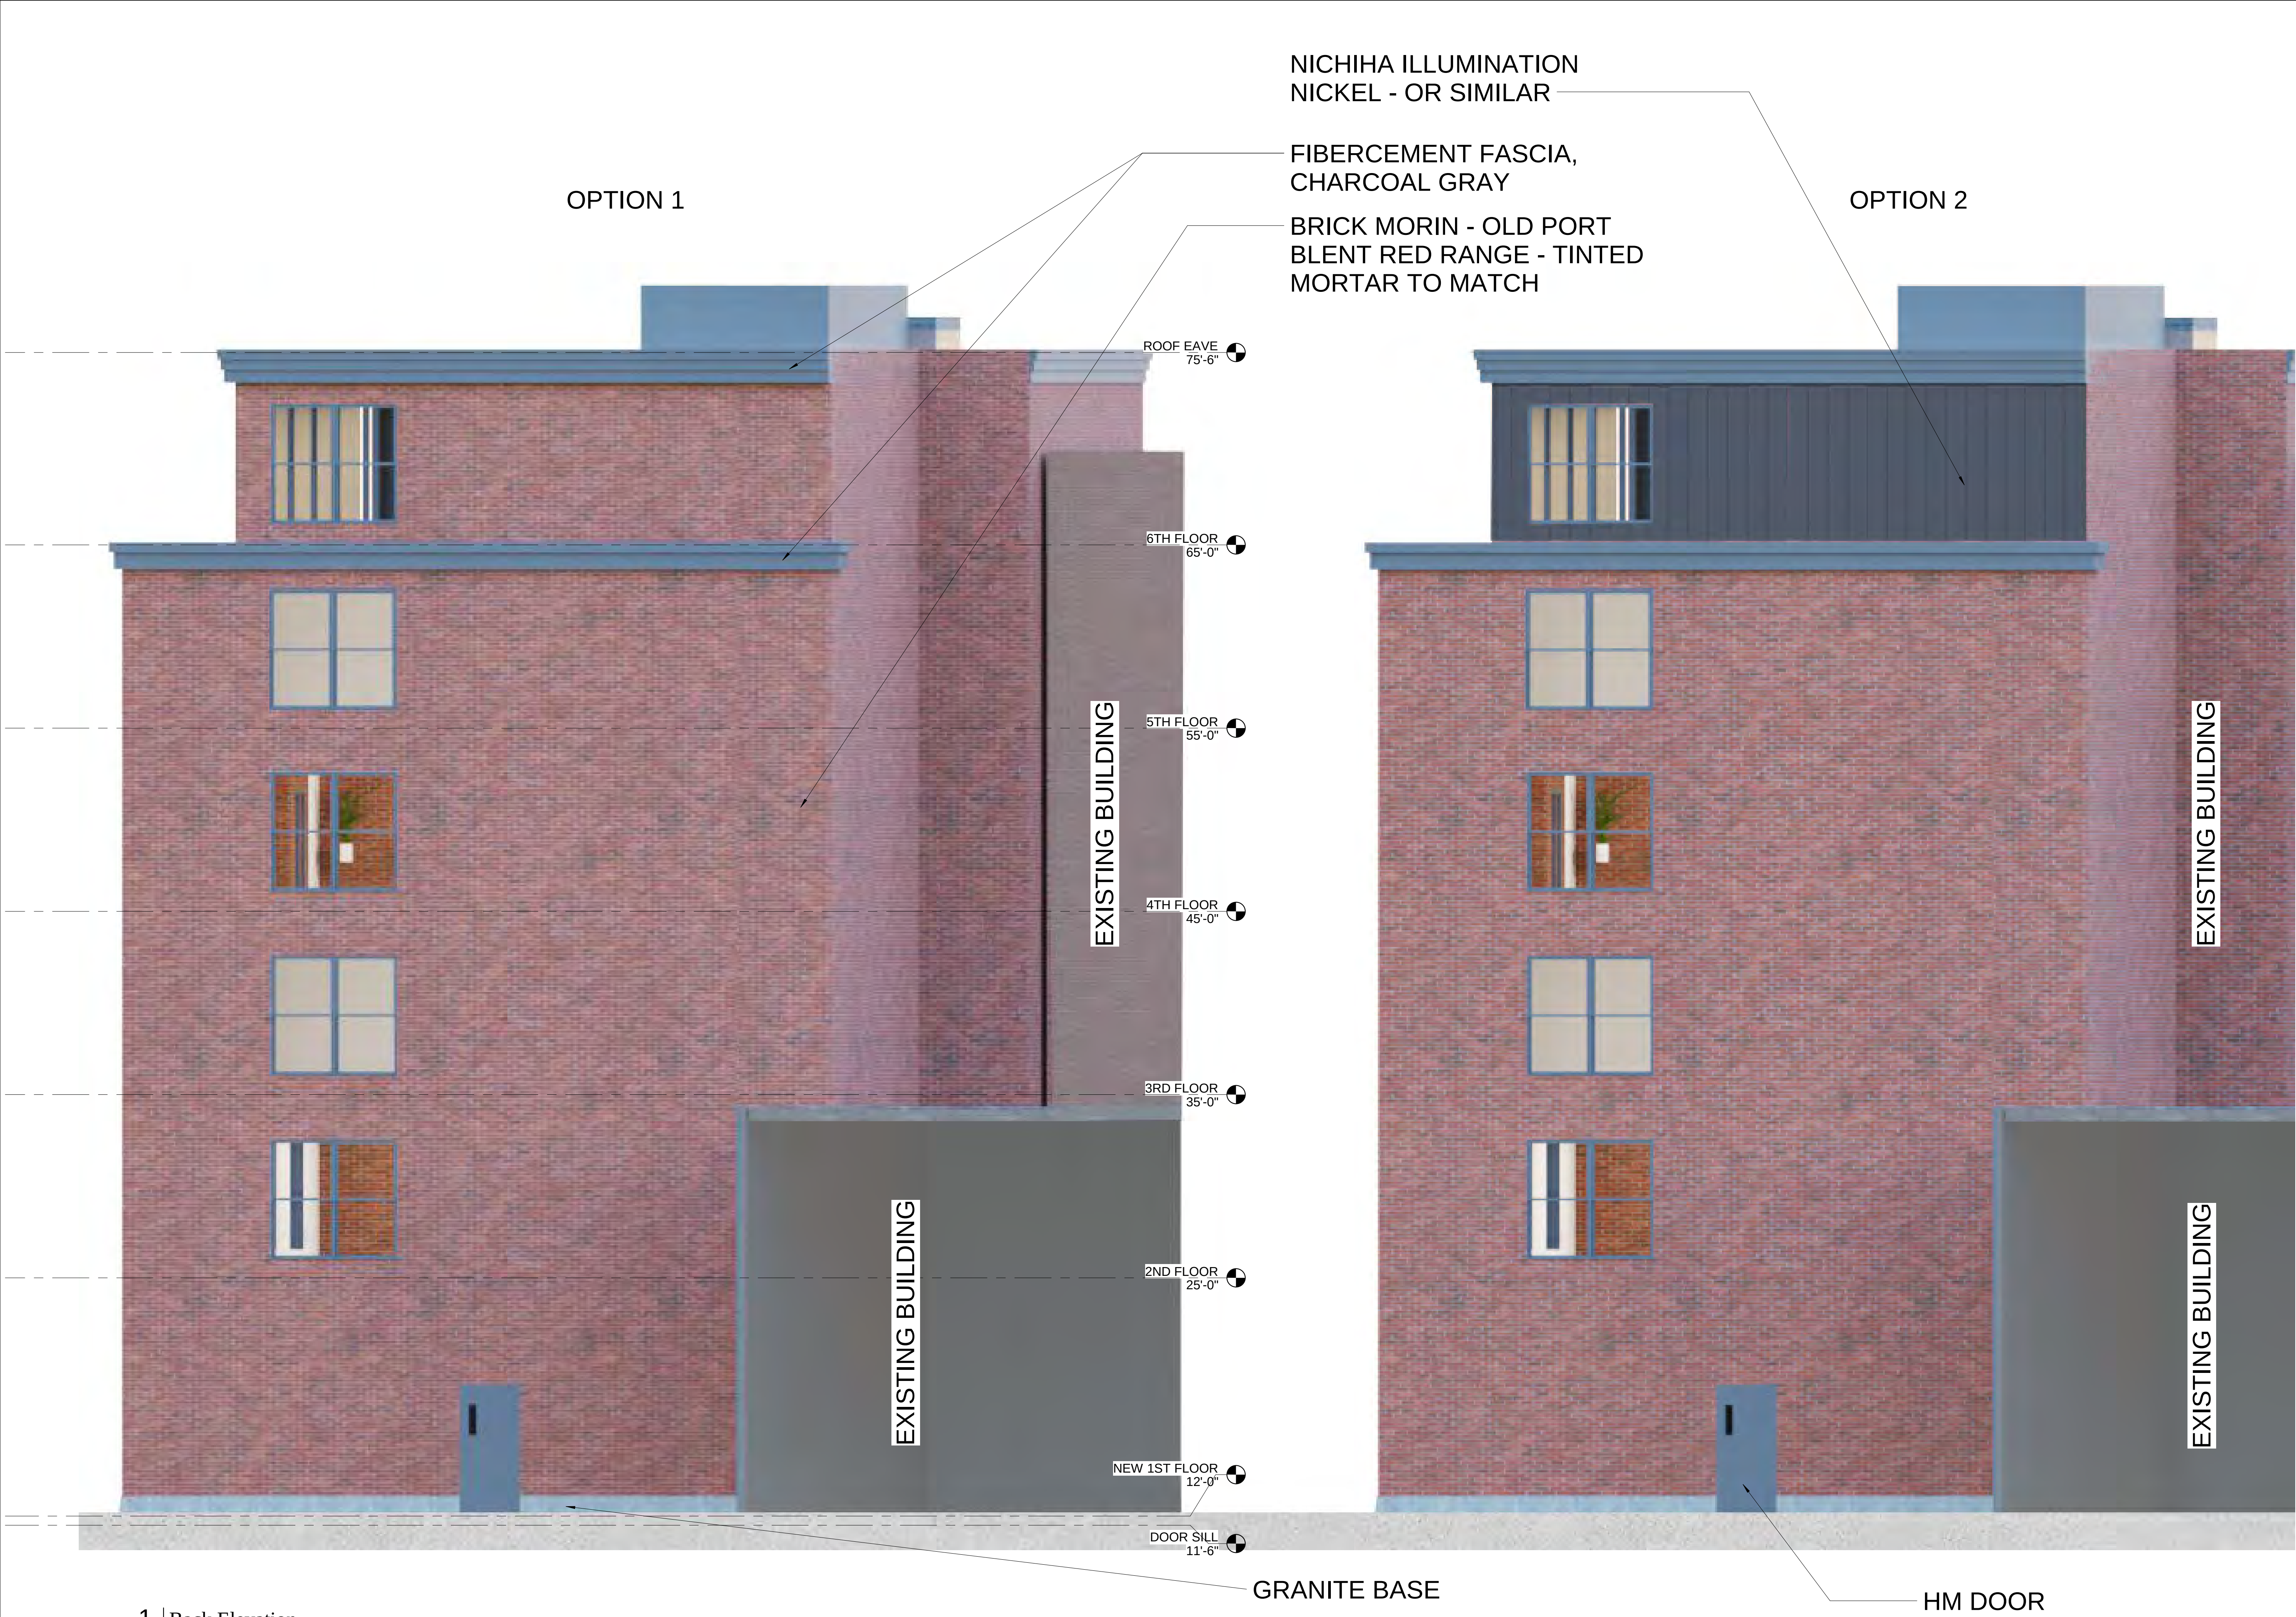
1 | Back Elevation  
1/4" = 1'-0"

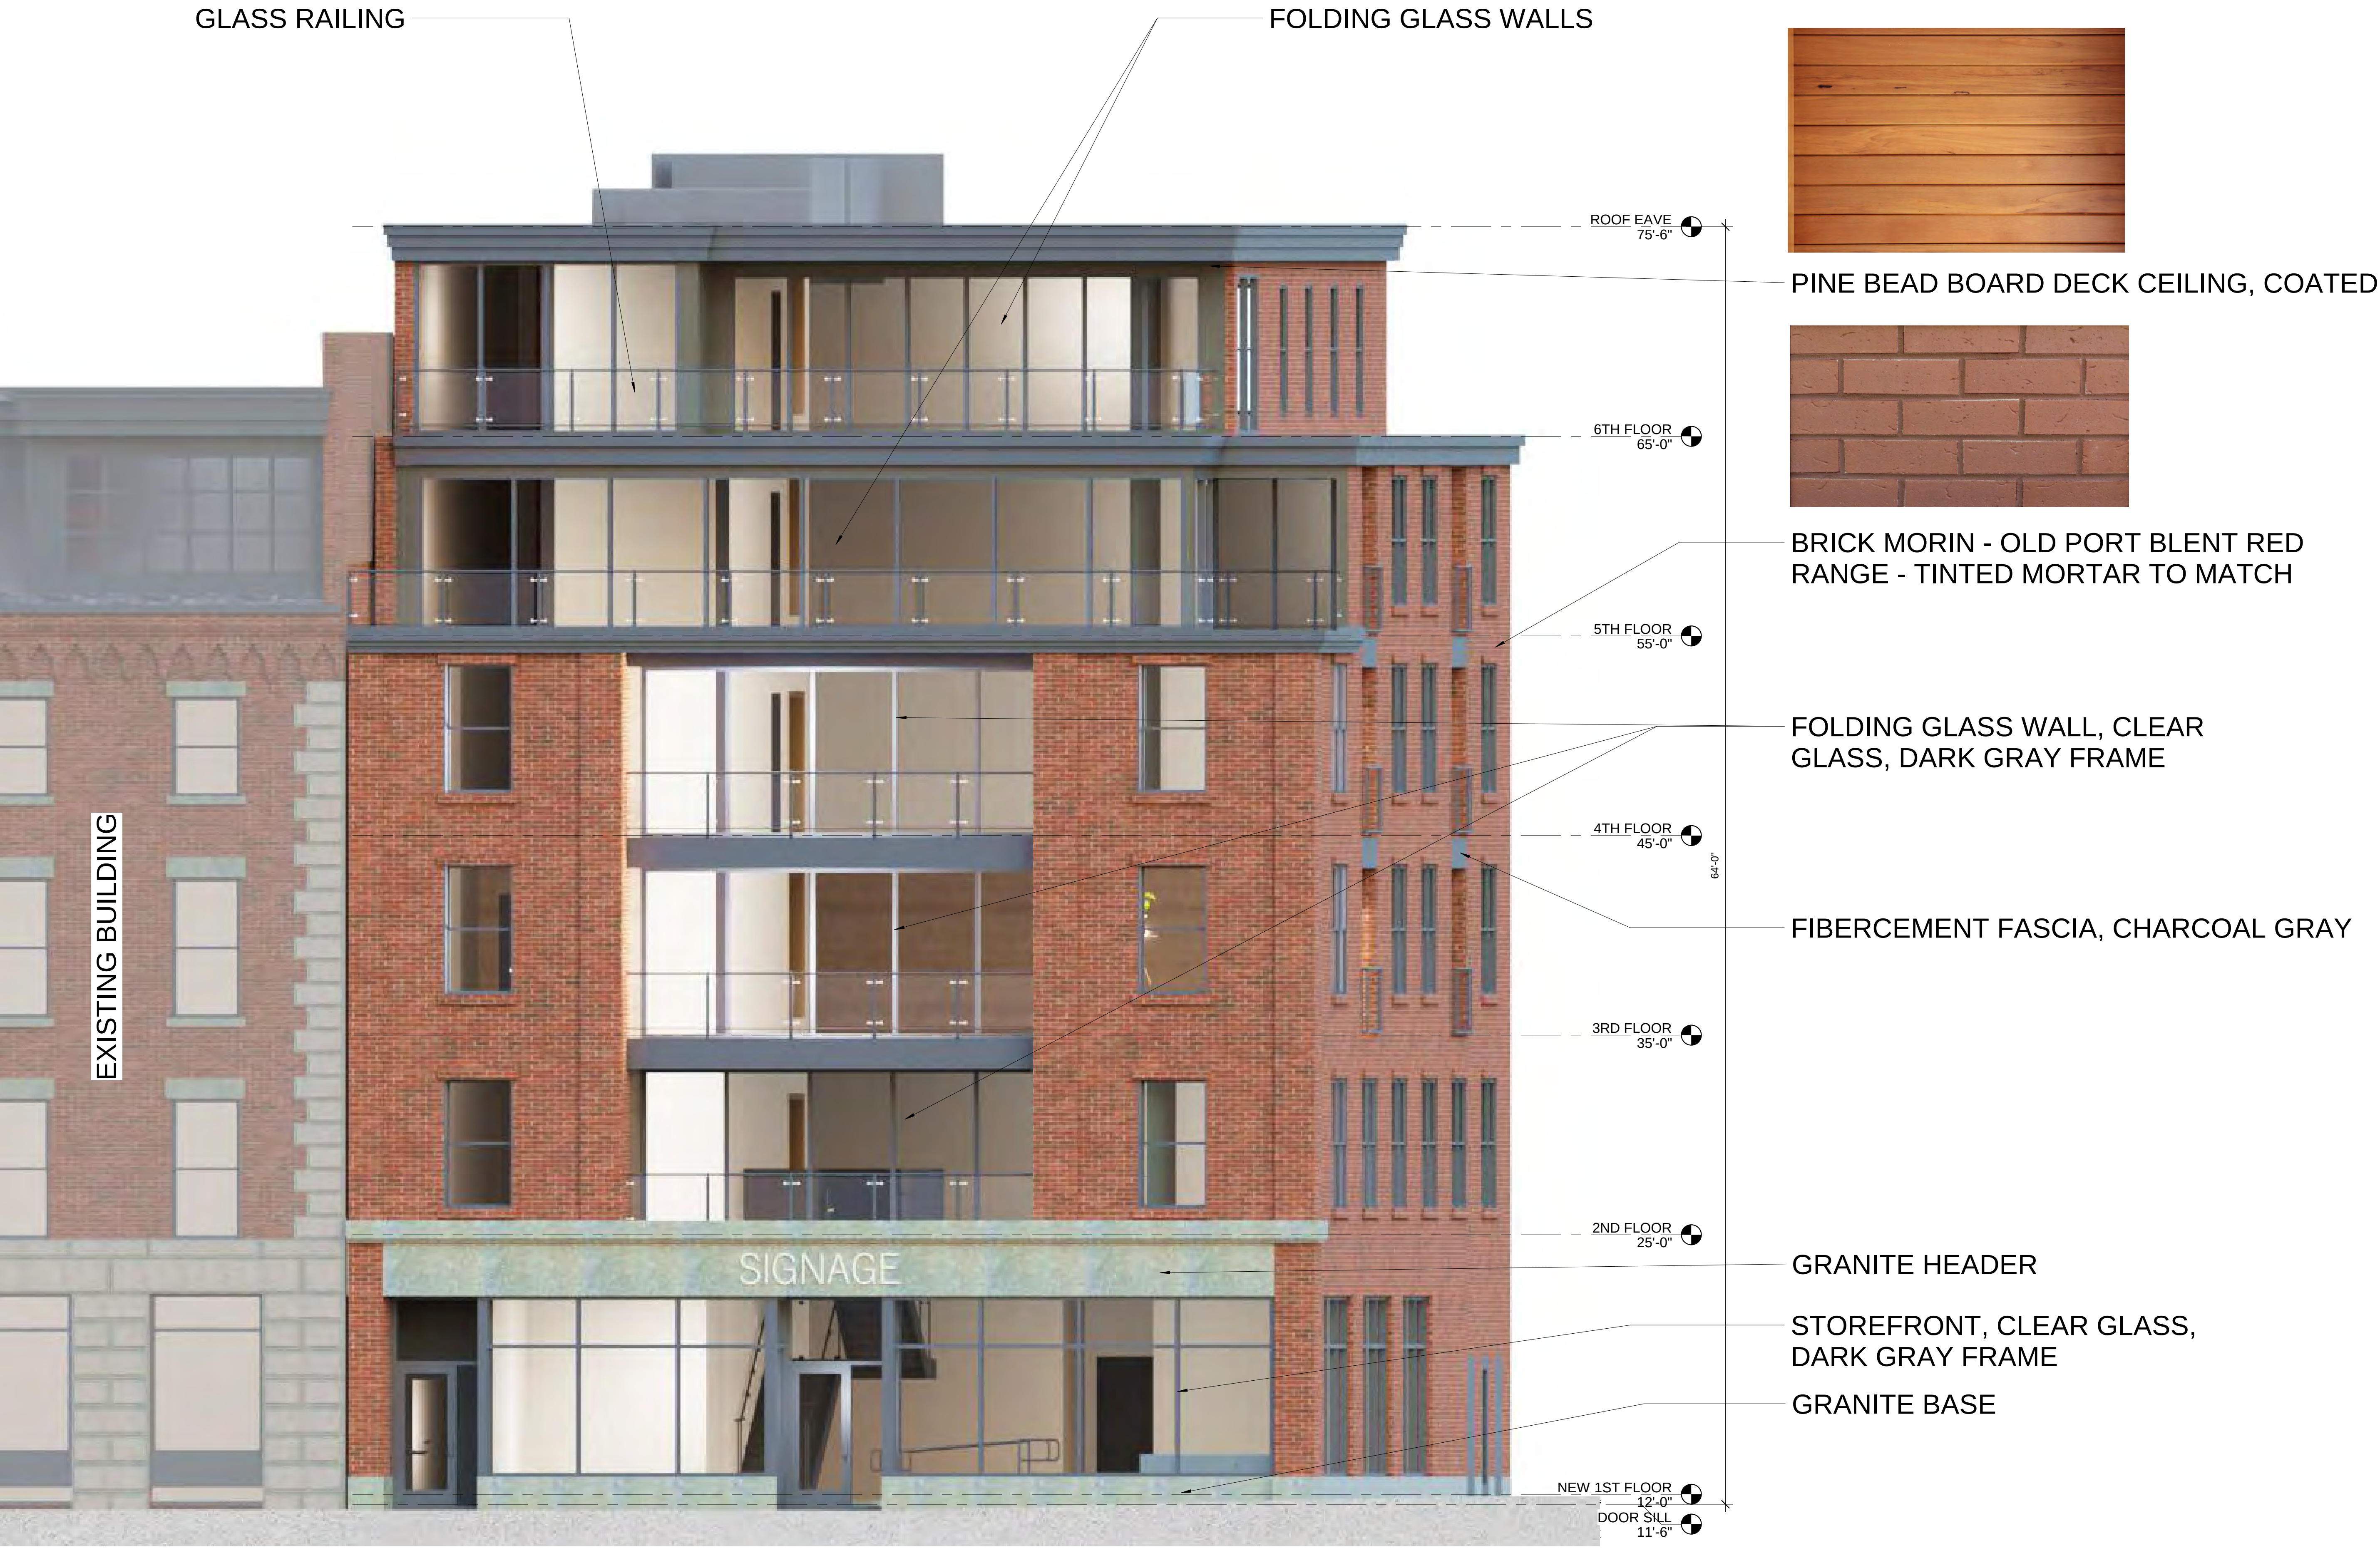
1 | Front Elevation  
1/4" = 1'-0"
