# CITY OF PORTLAND, MAINE

## HISTORIC PRESERVATION BOARD

#### HISTORIC PRESERVATION BOARD MEETING

Topic: Historic Preservation Board Public Hearing and Workshop 3-16-2022

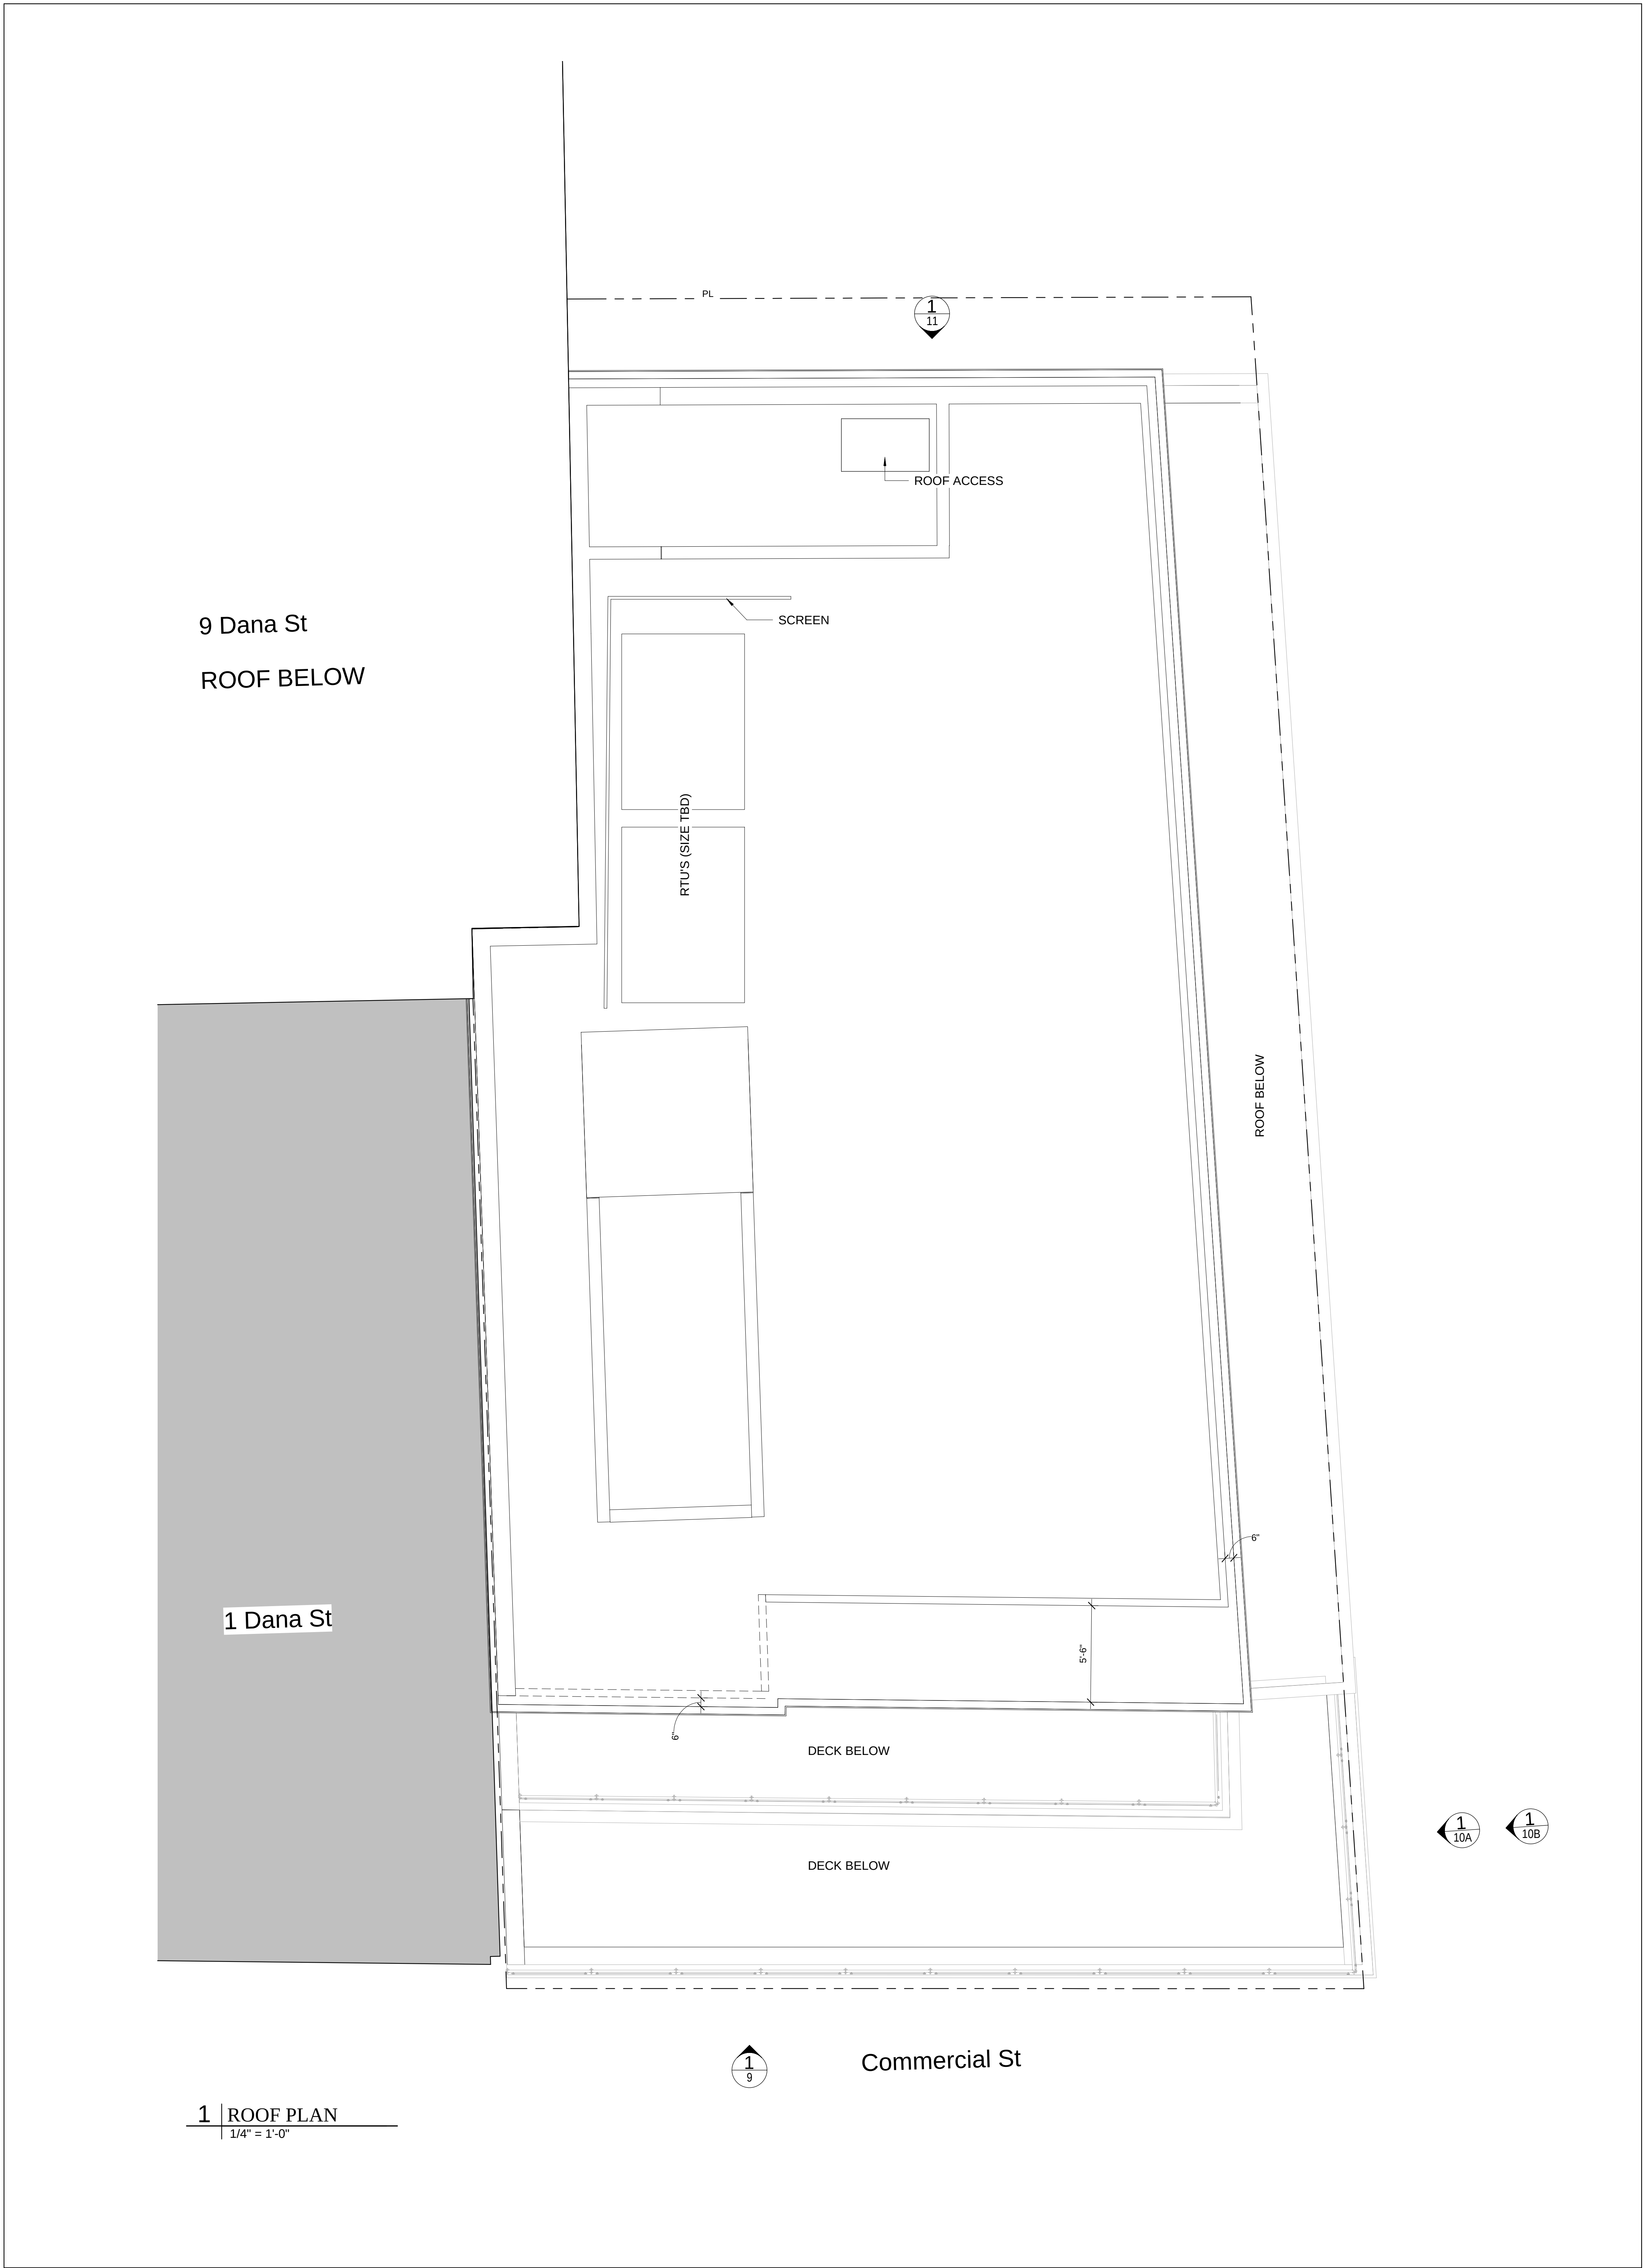
| | ROOF PLAN | | | Portland, Maine | | | | |

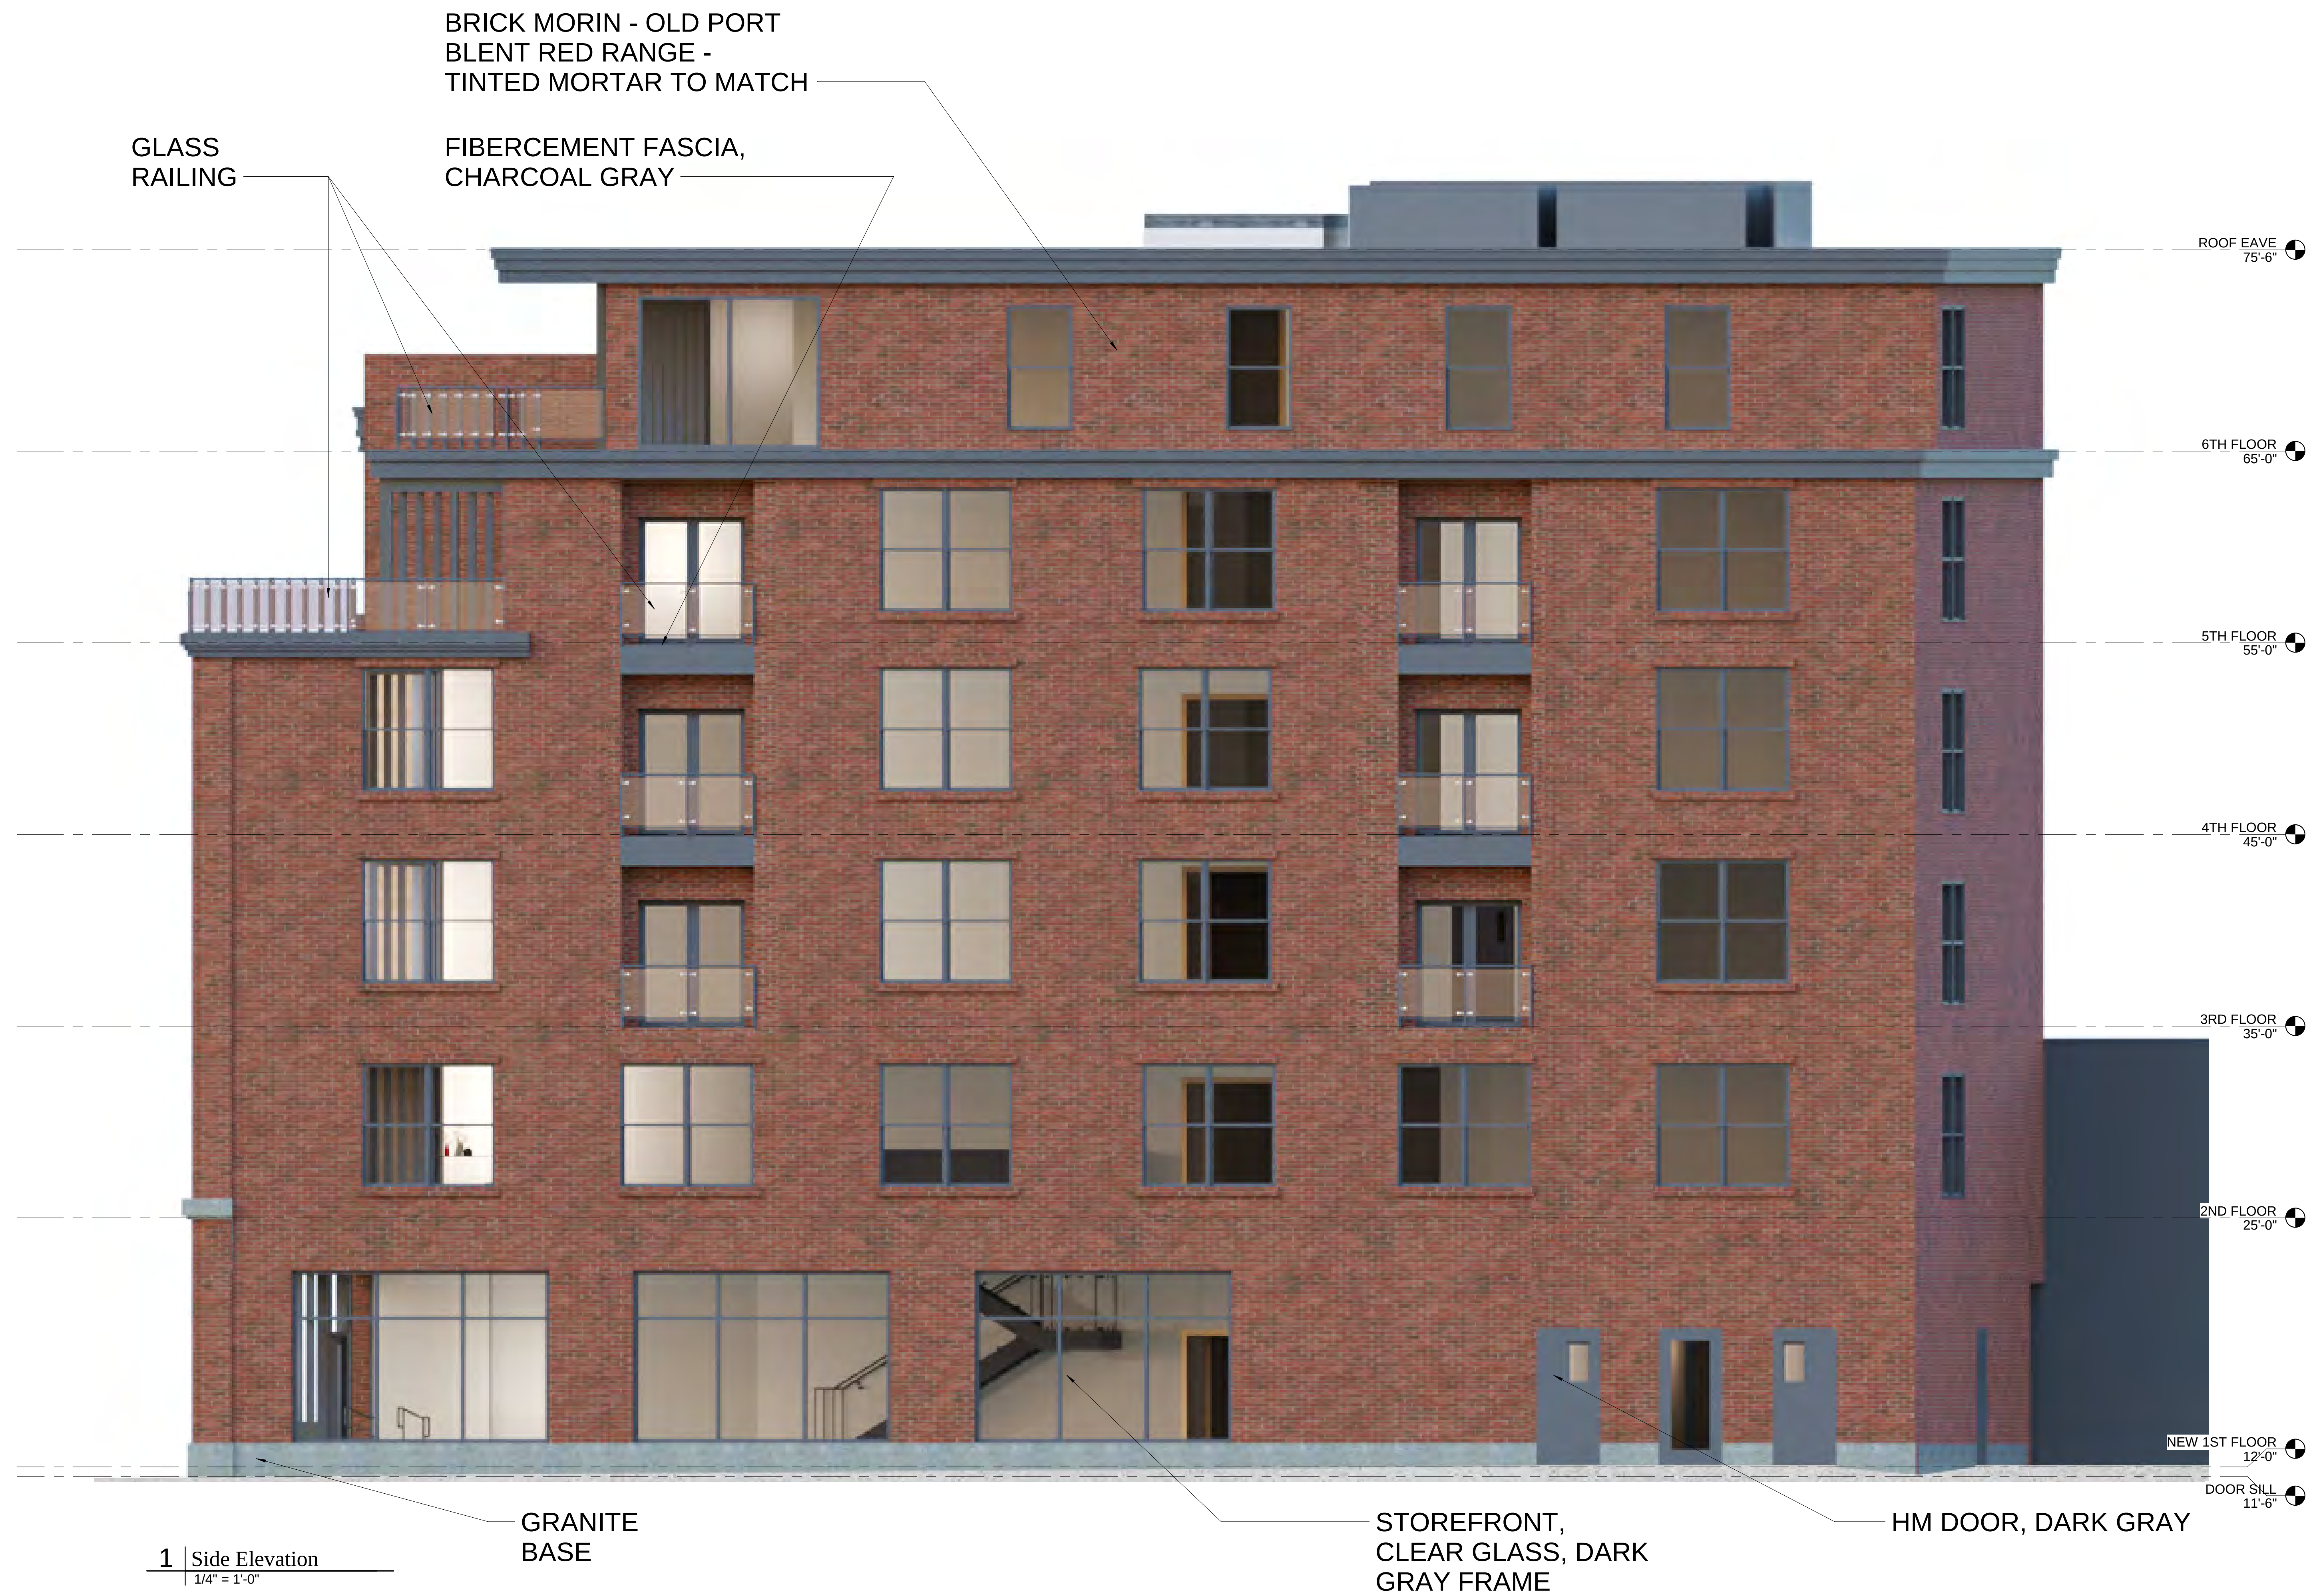
1 | Side Elevation  
1/4" = 1'-0"

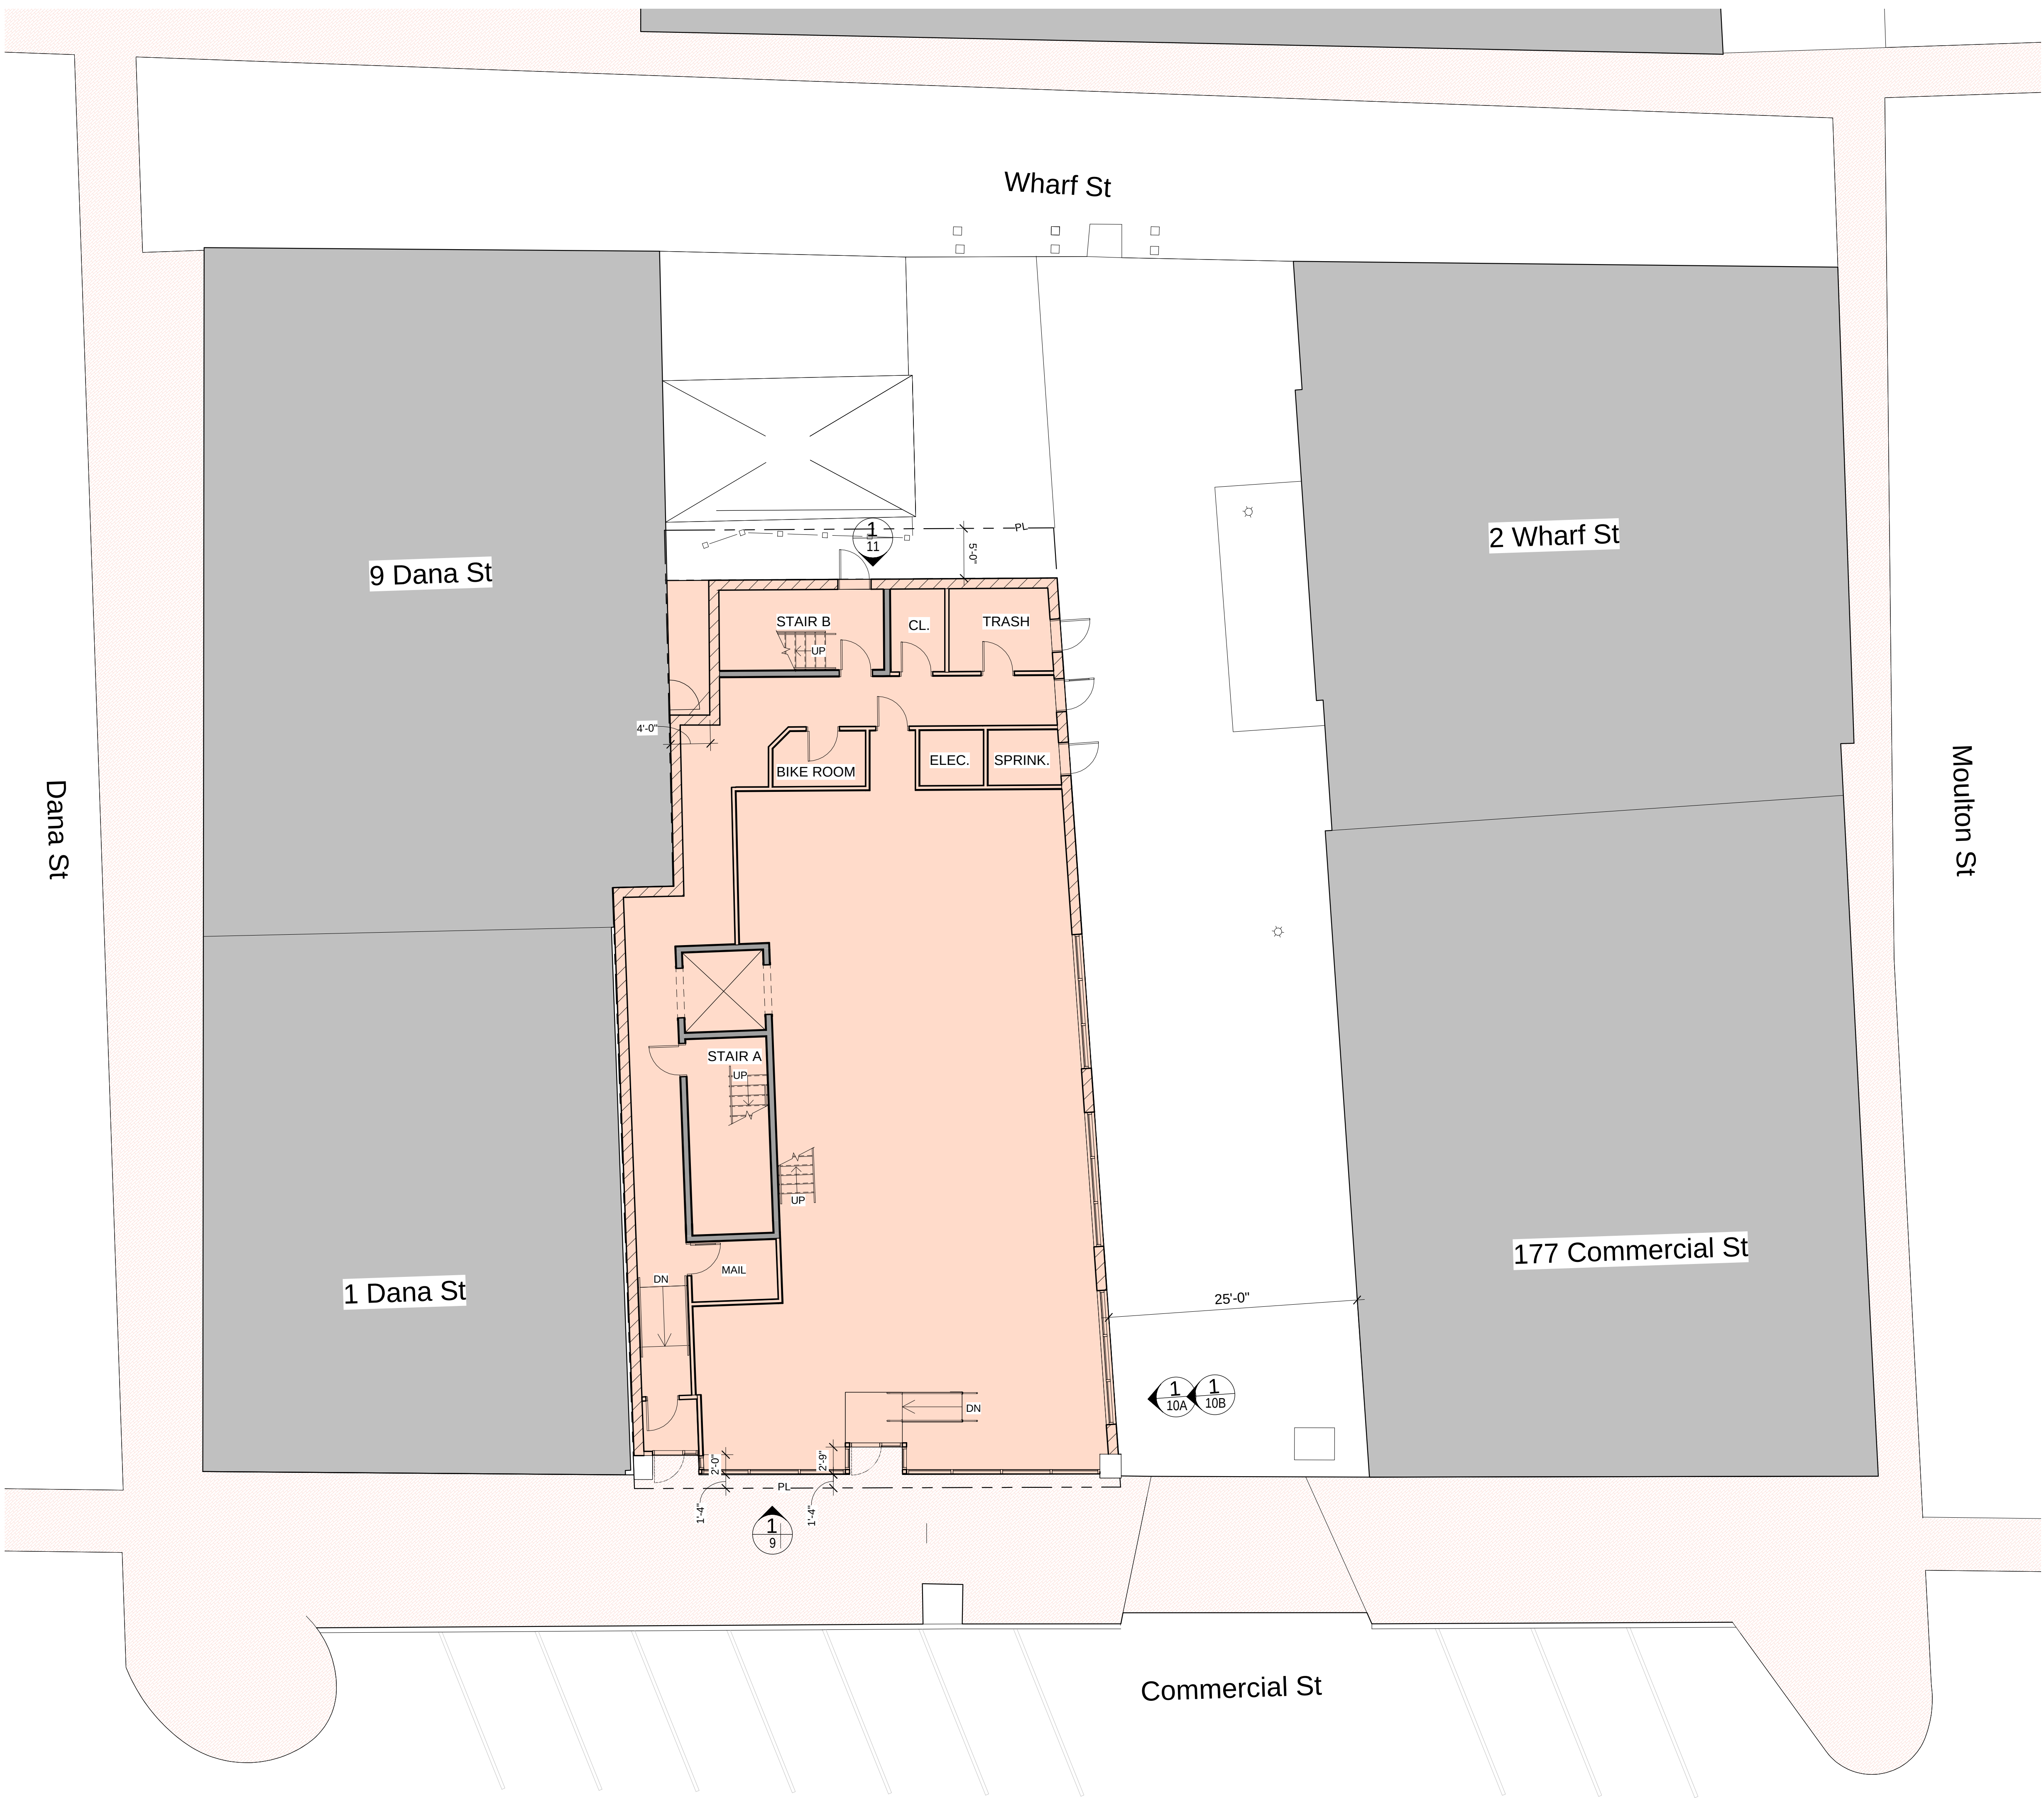
1 | SITE PLAN  
1/8" = 1'-0"
