## HISTORIC PRESERVATION BOARD

#### HISTORIC PRESERVATION BOARD MEETING

WORKSHOP  
404 CUMBERLAND AVENUE (rear addition to 55 Forest Avenue)

WORKSHOP  
63 CHADWICK STREET

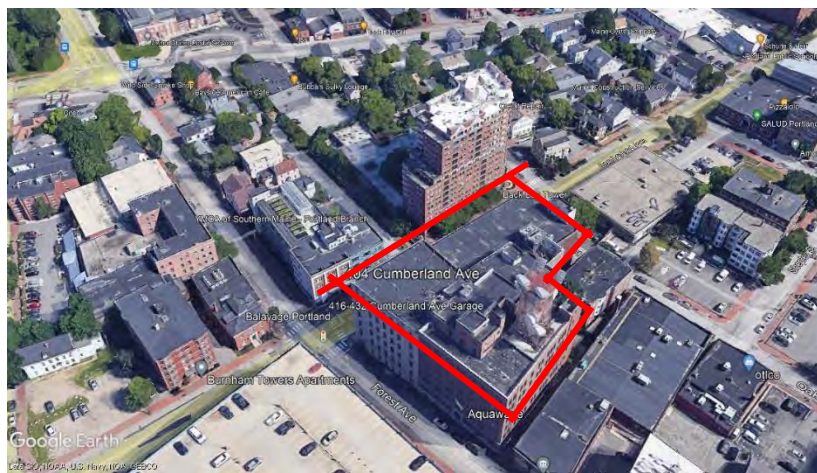
New England Telephone's complex prior to recent property subdivision

As noted above, the subject structure is part of a complex of buildings fronting on Forest Avenue, Cumberland Avenue and Oak Street that were developed by New England Telephone (later AT&T and now Consolidated Communications). The original building, located at 45 Forest Avenue, was built in 1913. In 1924, two additional floors were added as well as a four-story rear addition. A second six-story building at 55 Forest was built in 1932. This structure is a designated Landmark within the Congress Street Historic District, as it is an elegant example of Art Deco style architecture which was never common in Portland. The building is clad in limestone with carved foliate details on a polished black granite base.

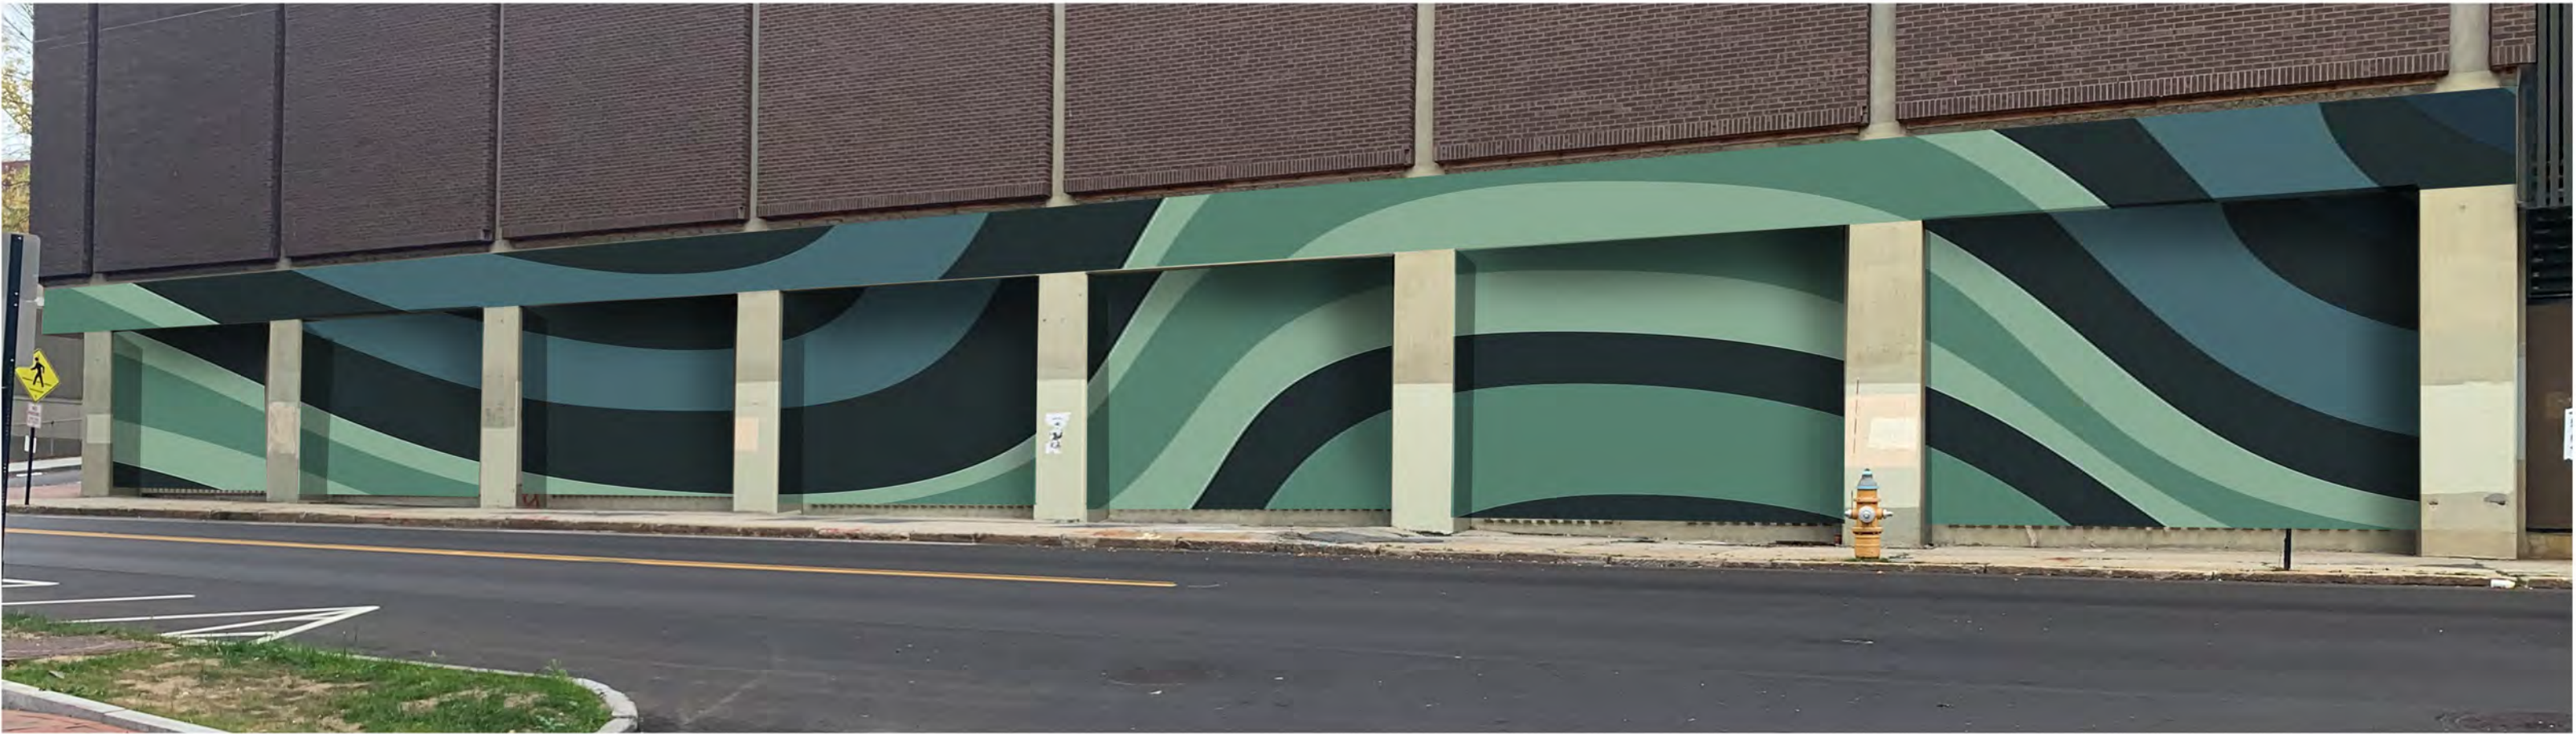
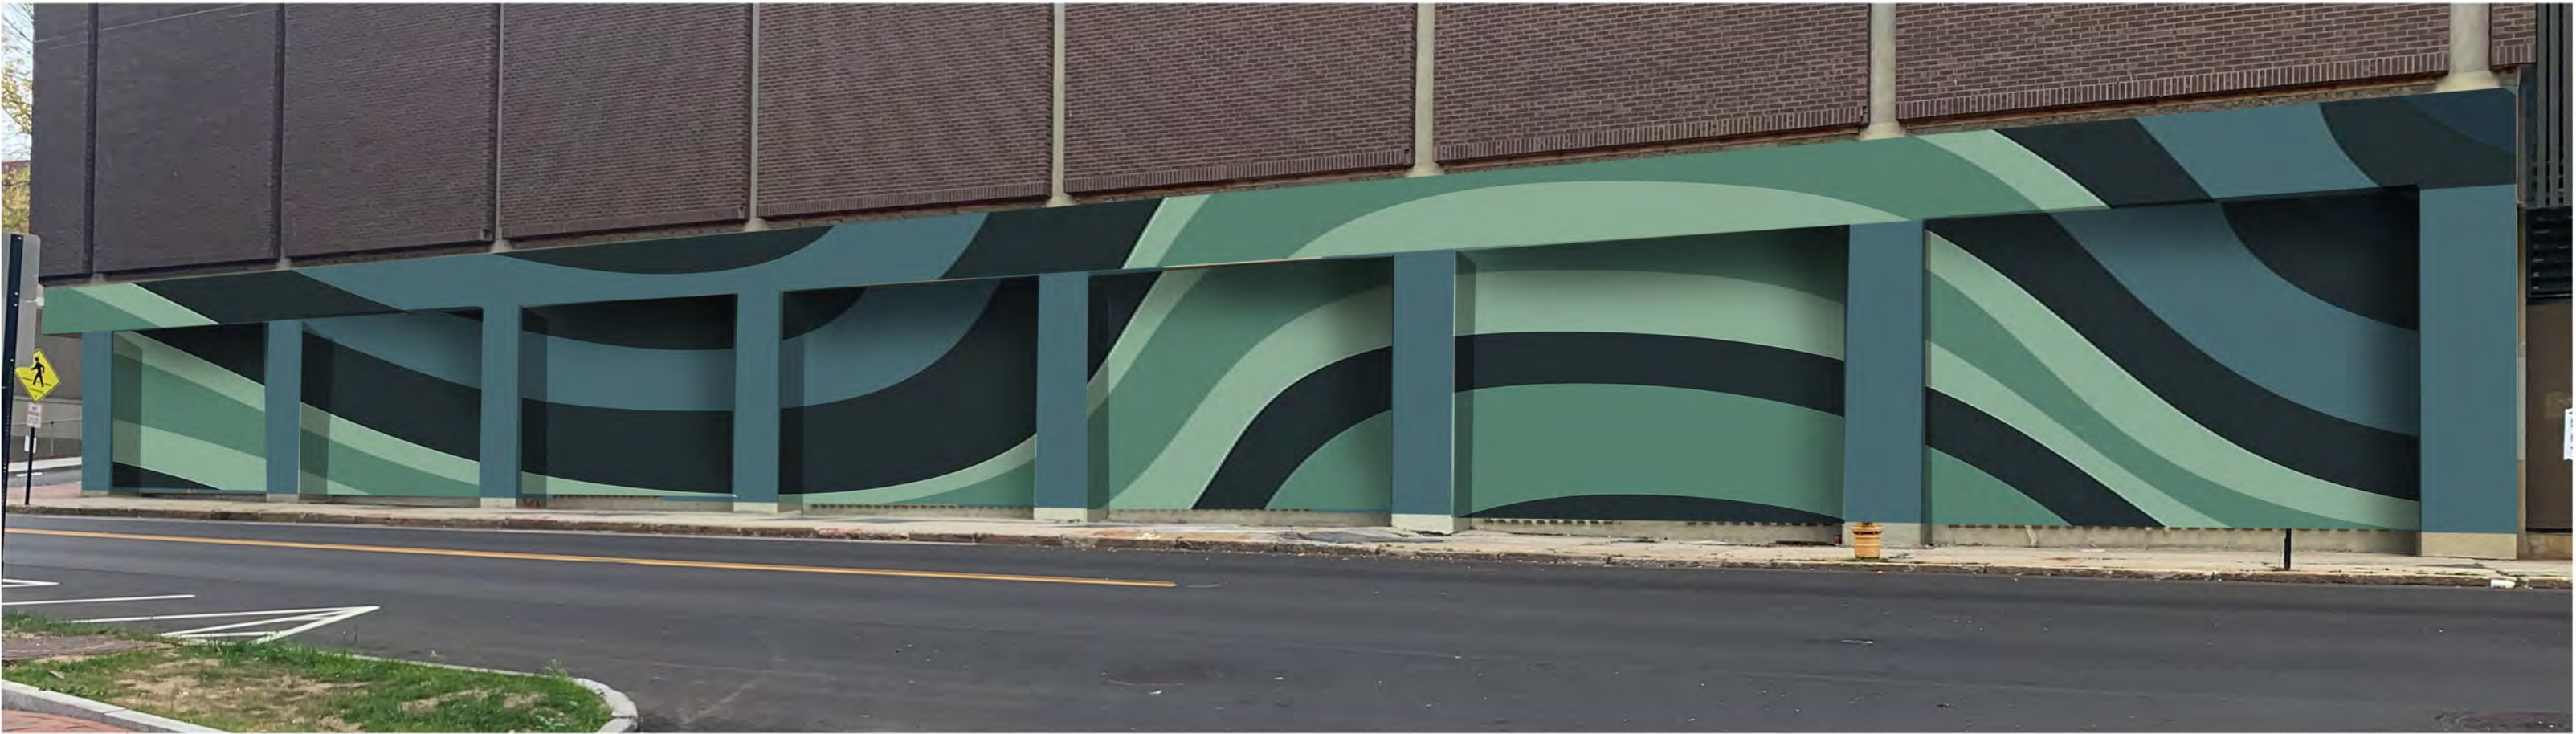
1. Rendering of mural prepared by Jared Goudette, submitted for July 6 workshop

Based on the rendering provided, the mural will extend across the entire ground floor of the 1972 addition, from the sidewalk to the top of the base's continuous lintel. (The brick panels on the upper floors project slightly beyond the face of this lintel.) The mural will begin just beyond the juncture between the Art Deco building and the addition, wrap the corner of Cumberland and Oak and extend across and beyond the wide concrete pier on Oak. As noted above, no additional details have been provided since January on installation details, preparation of the wall surface, etc, though these items were discussed to some extent at the prior meeting.
