**LEGAL ADVERTISEMENT  
HISTORIC PRESERVATION BOARD  
CITY OF PORTLAND  
Public comments are taken at all meetings.**

**PUBLIC HEARING  
PORTLAND COMPANY COMPLEX  
58 FORE STREET**

**RE:** July 15, 2015      **Public Hearing – Review and Confirmation of Draft Portland Company  
Historic District Designation Report**

# Portland Company Historic District Designation Report

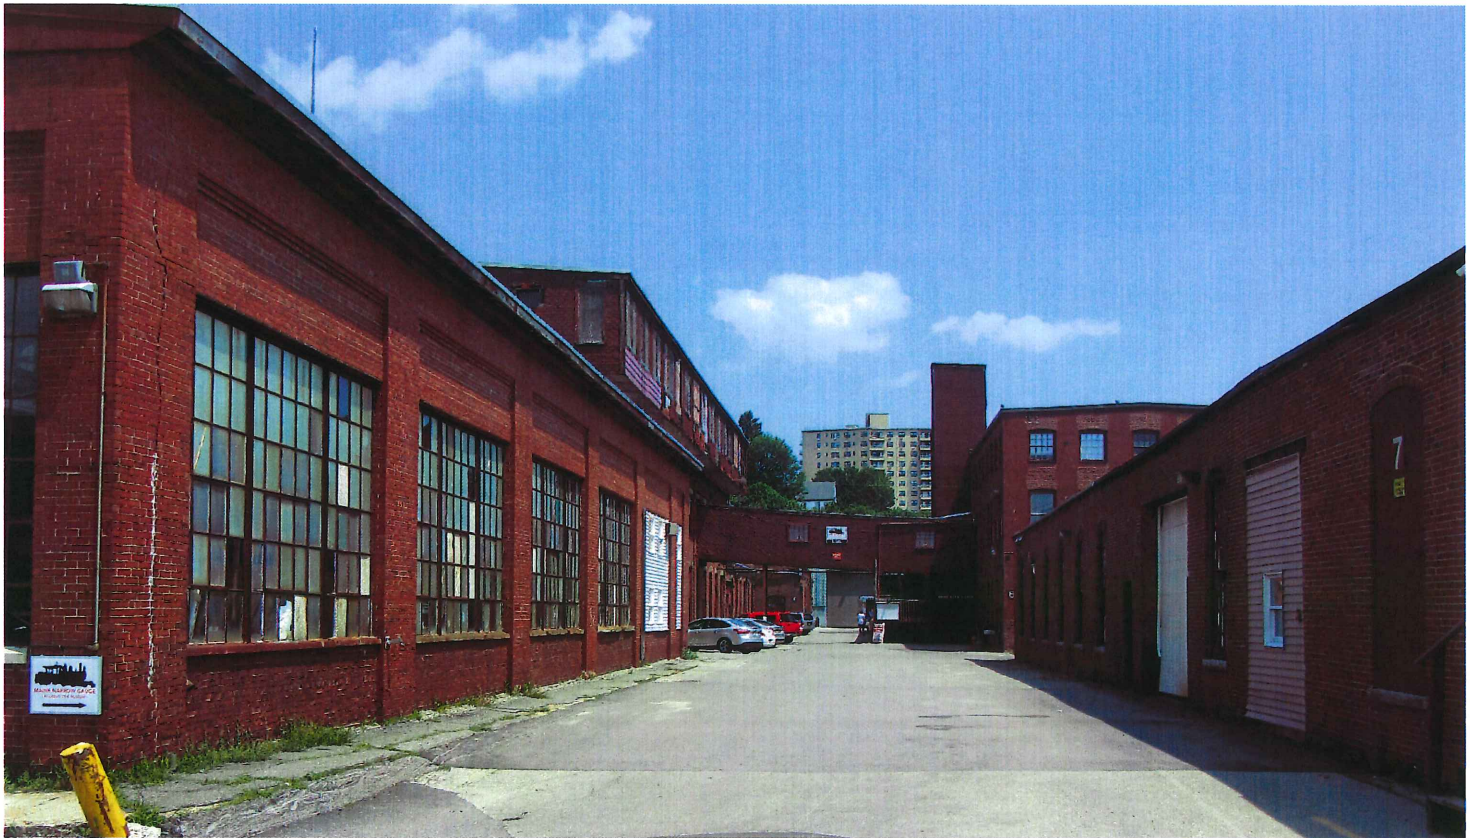
The linear alignment of the buildings east of the entrance yard creates a series of private streets or alleys. The distance between building rows allows one to observe the connected nature of the buildings and appreciate the scale of the complex.

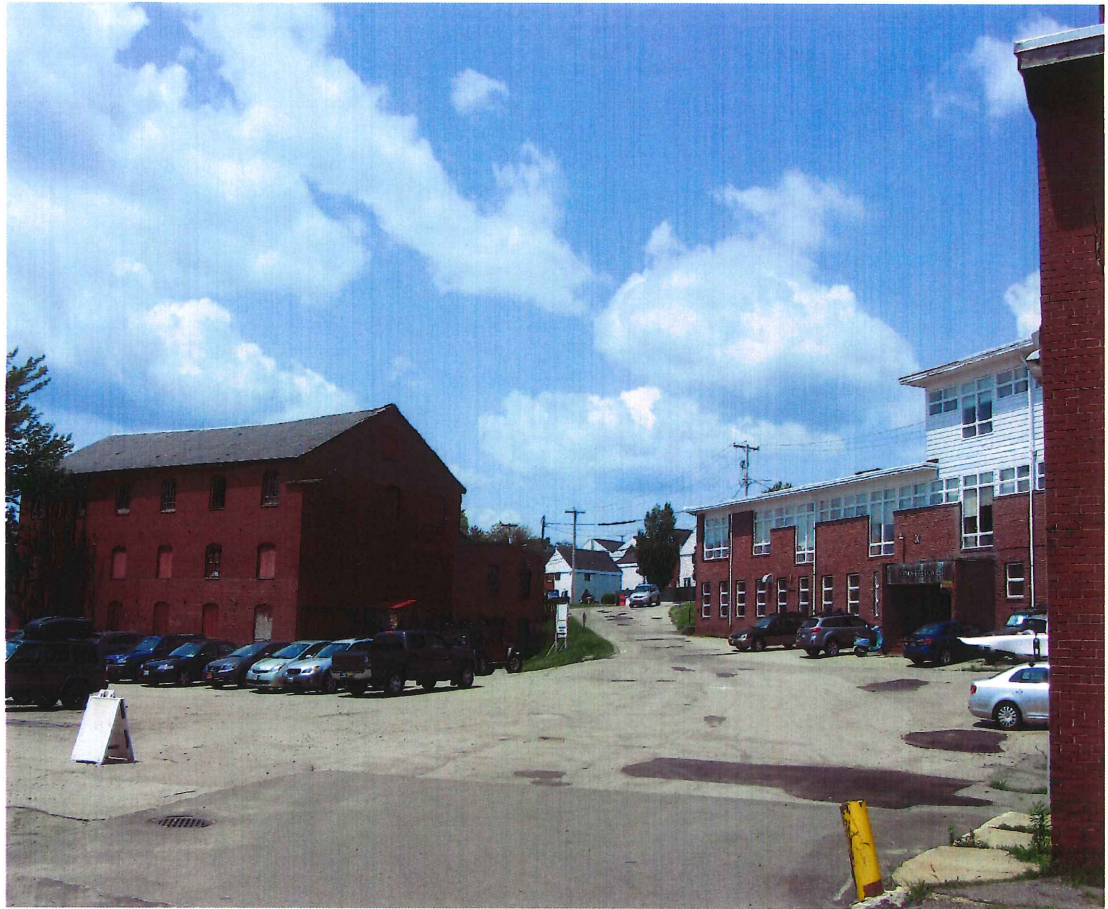
**Important site characteristics include a major entrance into the complex from Fore Street toward the west end of the district and a generous open space between Building 12 and the historic manufacturing rows. It is from this space that the original alignment of the production buildings is observed and the alleys are accessed.**

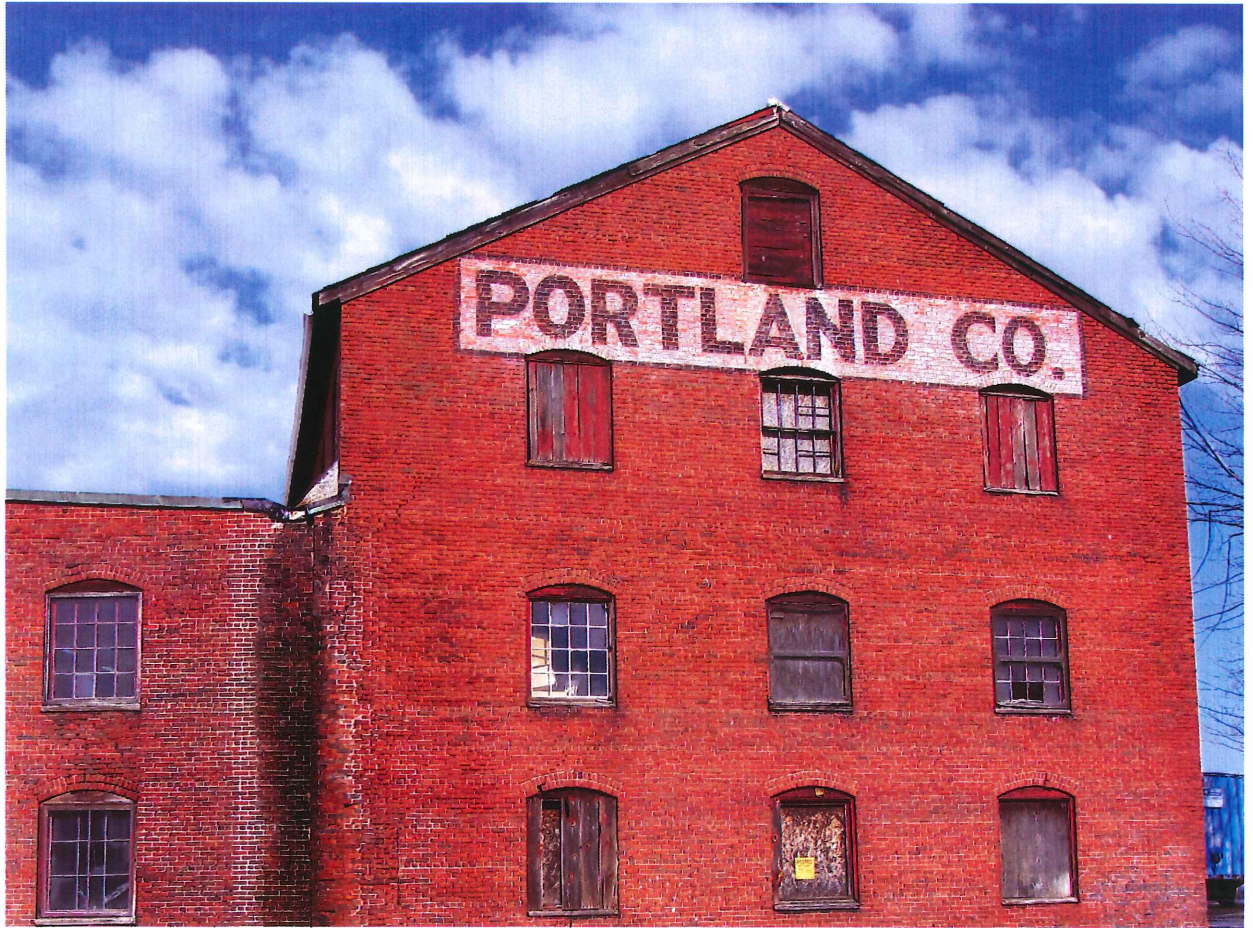
**A unifying characteristic of the industrial buildings within the Portland Company complex is their simplicity of form and repetition of detail. Most buildings are brick with granite or concrete window lintels and sills.**

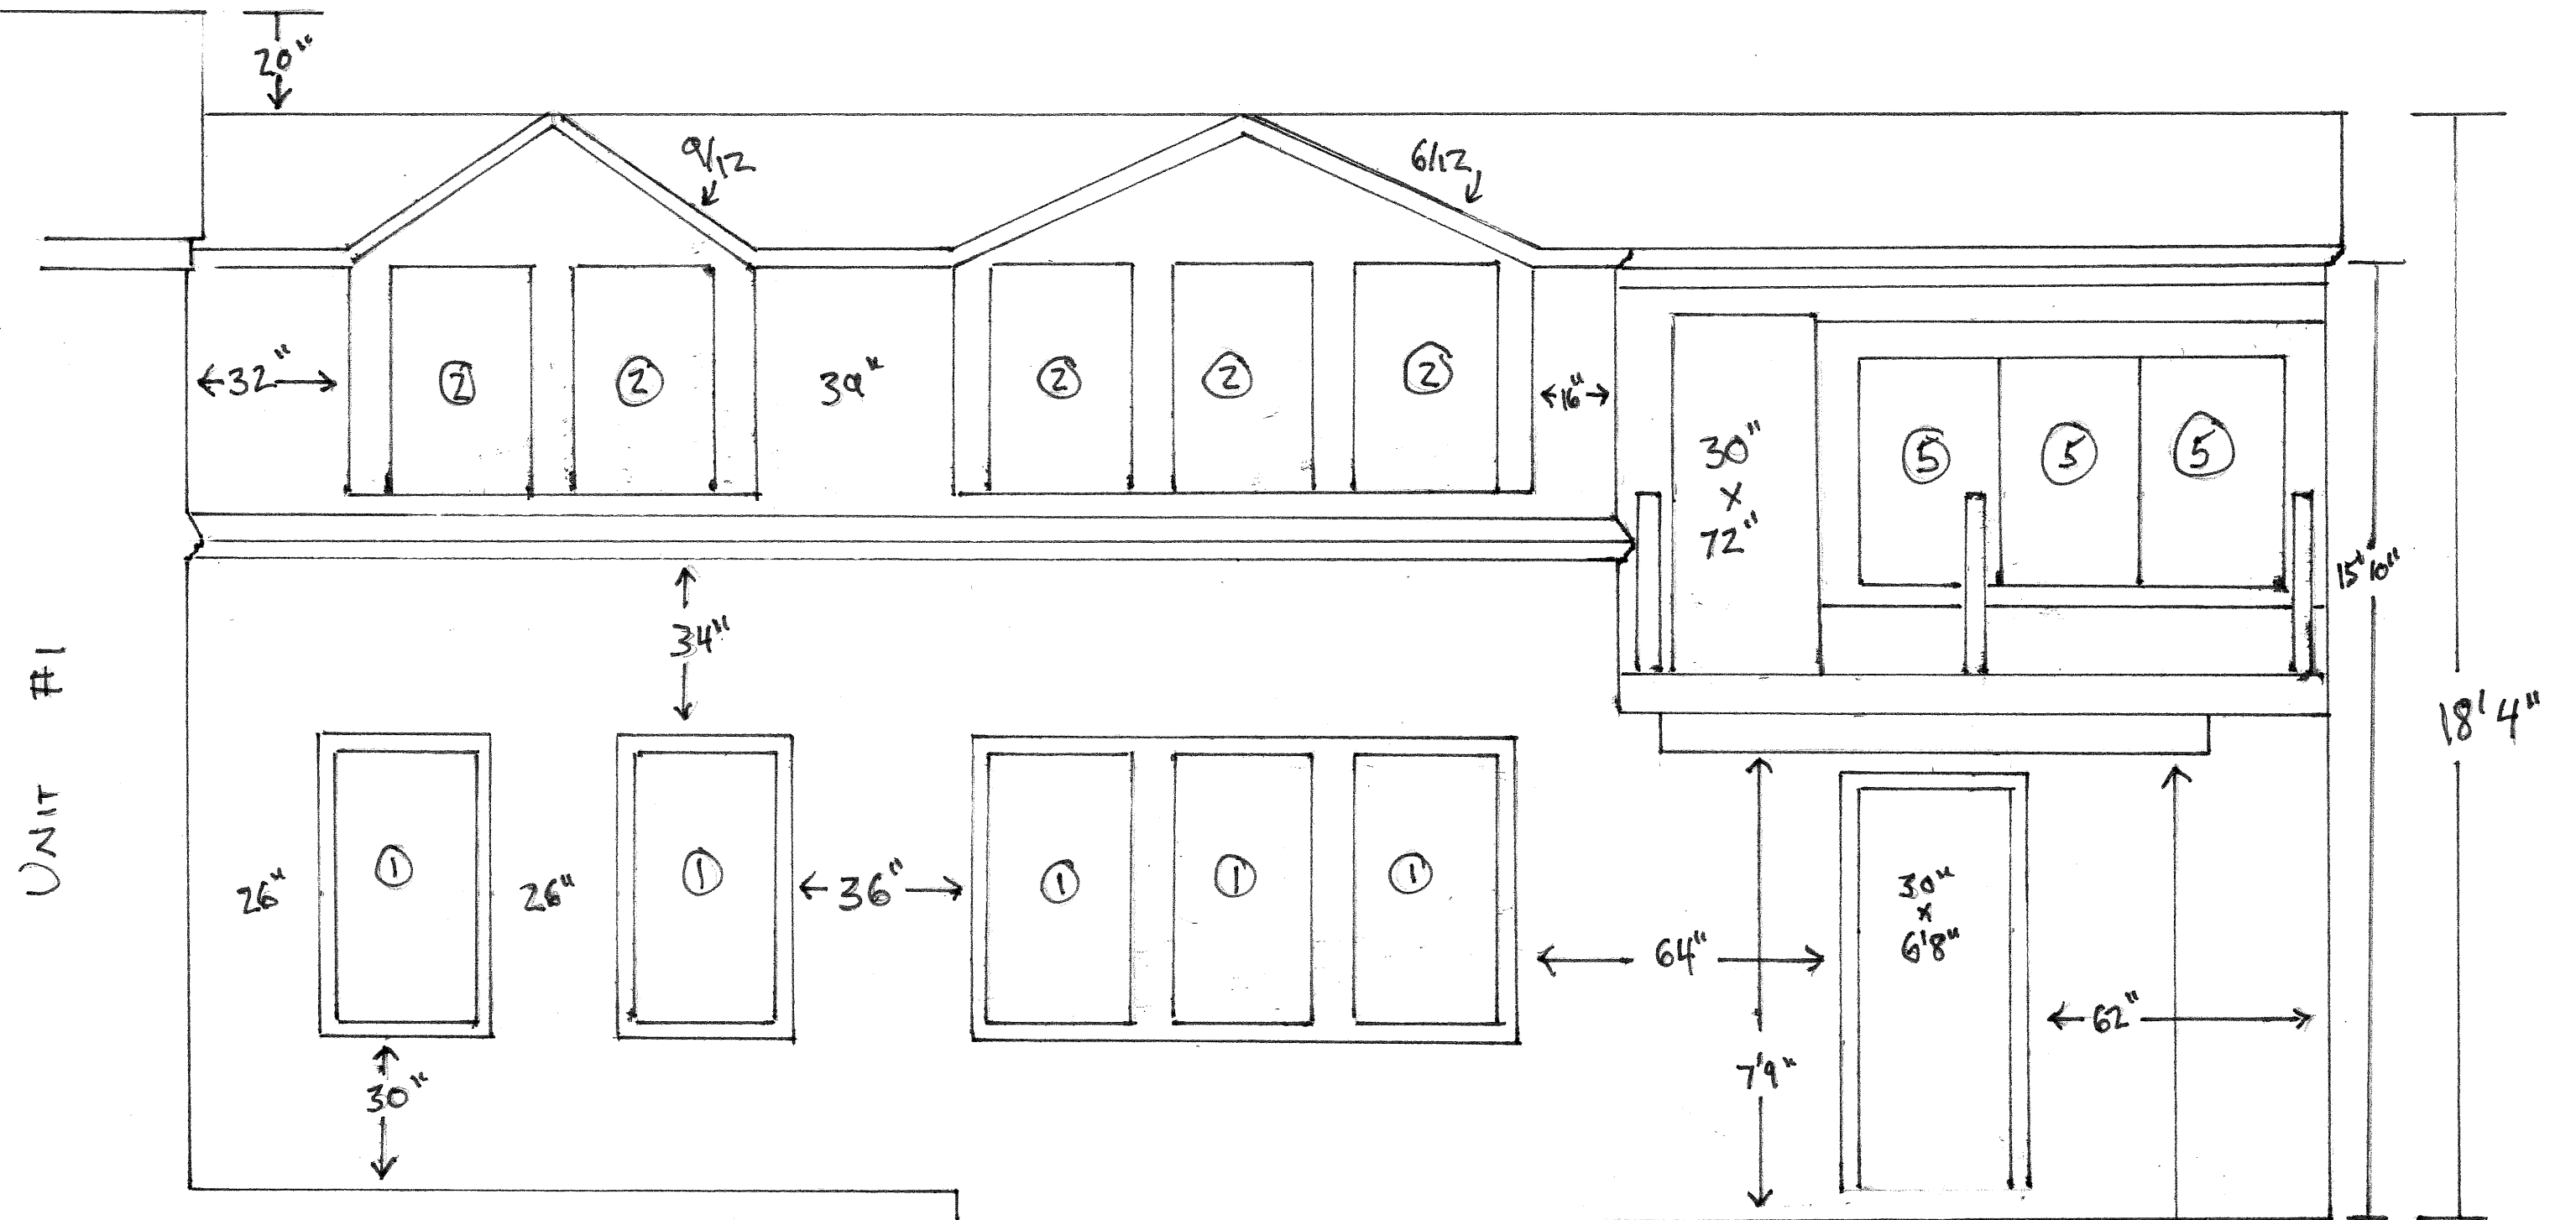
113 WINTER ST.  
EXISTING REAR (EAST) ELEVATION  
 $\frac{3}{8}" = 1'0"$

WINDOWS:  
 (1) 28x54  
 (2) 28x45  
 (5) 28x46

EXTEND RAFTERS UNDER  
 DECK FOR 2' COVERED  
 ENTRY SHED ROOF
