**CITY OF PORTLAND, MAINE**  
Standing Committee on Sustainability and Transportation  
Councilor Andrew Zarro, District 4, Chair  
Councilor Roberto Rodriguez, At-Large  
Councilor Victoria Pelletier, District 2

Agenda  
May 10, 2023  
5:00 PM  
via Zoom

To: Councilor Zarro and members of the Sustainability and Transportation Committee  
Re: Stroudwater Dam recommendation  
Date: May 5, 2023

*Stroudwater Dam (MEMA Dam #441)  
2022 Visual Dam Safety Inspection Report*

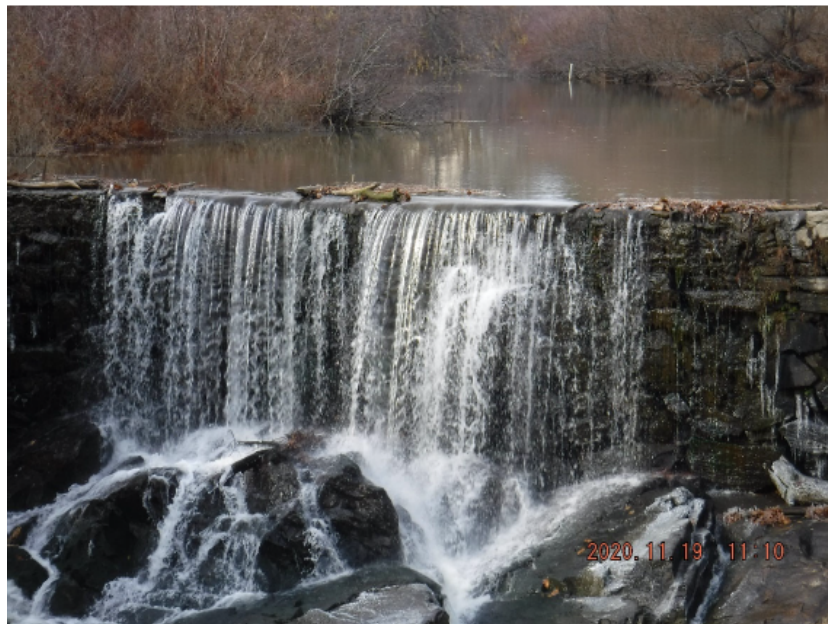
Stroudwater Dam as seen in November, 2020

Despite these interventions, Streamworks reports that the Stroudwater Dam is in poor condition. Their inspection conducted in November, 2022 identified a number of concerns including leaks, damaged masonry, vegetation growing on the structure, and unrestricted public access to the structure. They recommend a variety of actions to address these issues which are detailed in their full report that we have included in the back up material.

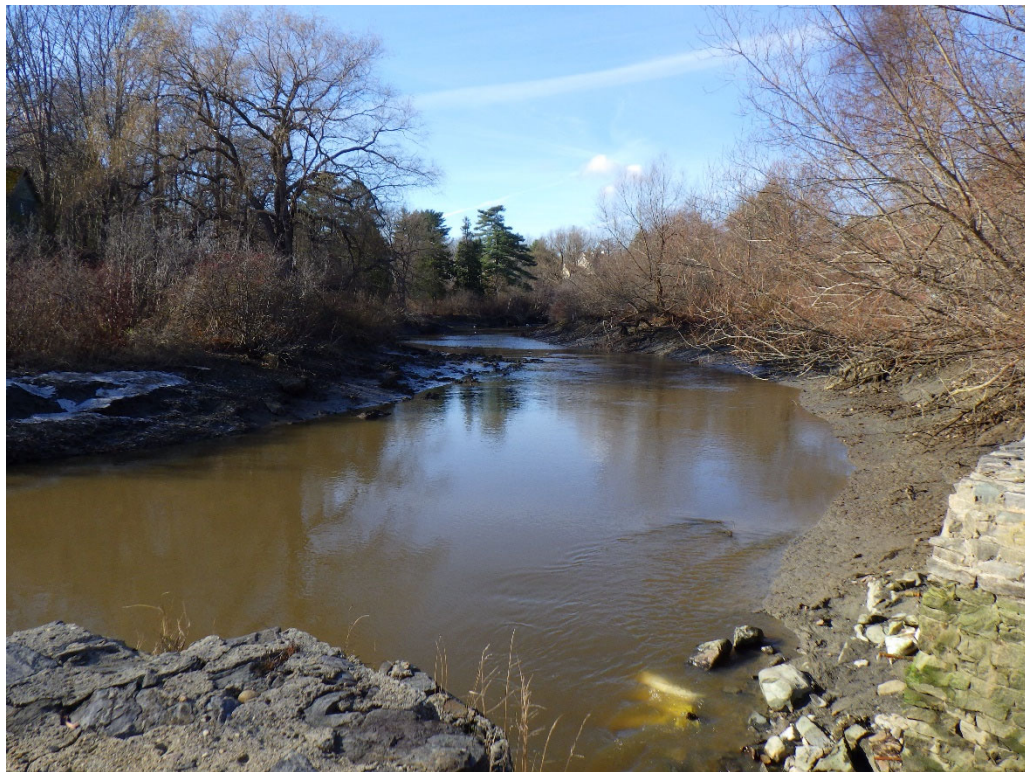
**Photo 2:** Reservoir at time of inspection (looking upstream from dam)

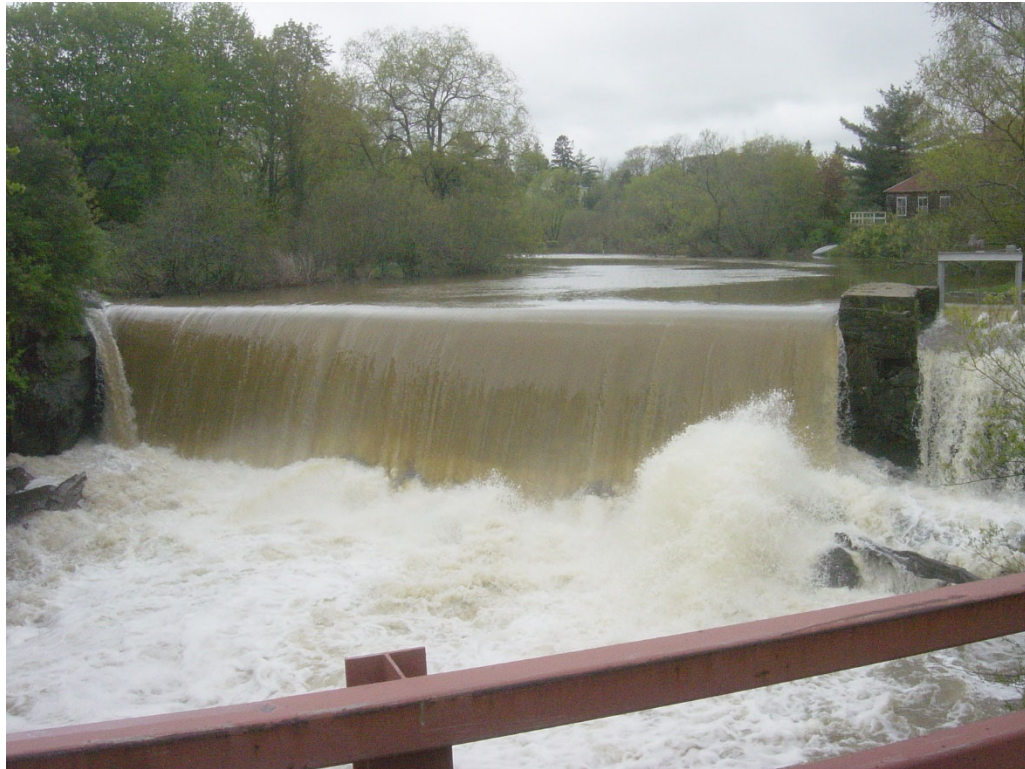
- The Soil Conservation Services’ (1975) *Flood Hazard Analysis* reported the 1-in-100 annual chance (100-year) event, which is often the minimum spillway design flood, would overtop the dam. Based on the provided cross-section, the current dam appears to have less spillway capacity than it did in 1975 (i.e., would be more prone to overtopping currently);

**[Historic] Photo 3:** Dam spillage on May 15, 2006 (Mother's Day Flood) – NOTE overflow of former steel slide gate acting as a sort of secondary spillway

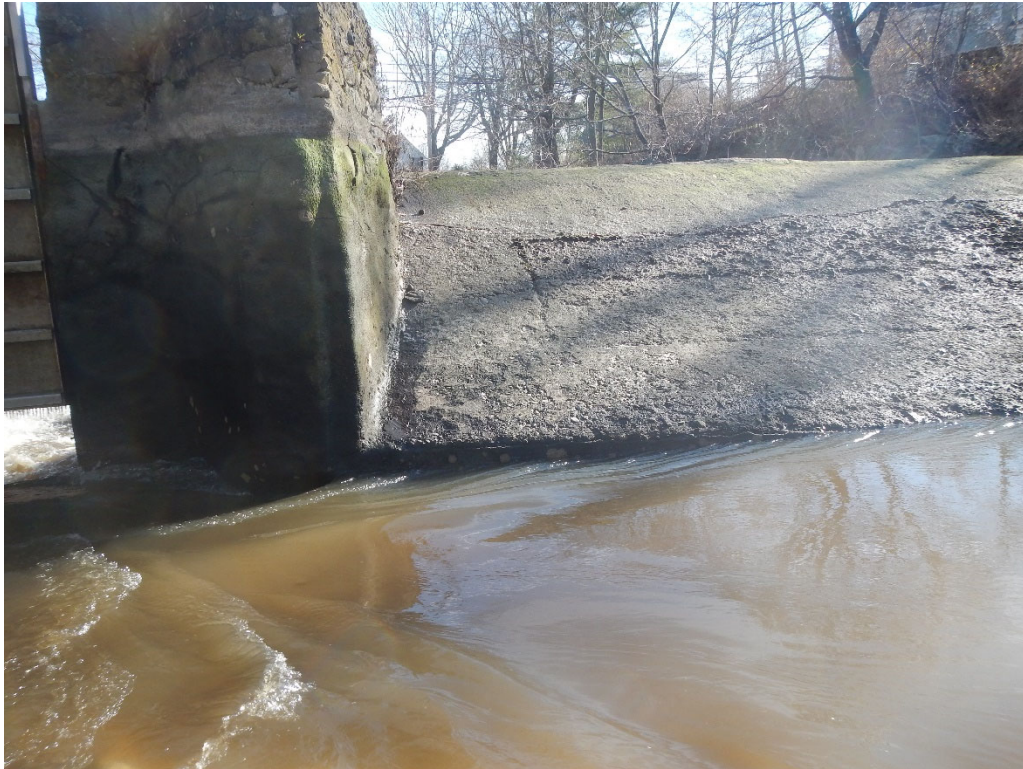
**Photo 13:** Divider pier and interface with upstream face of Primary Spillway

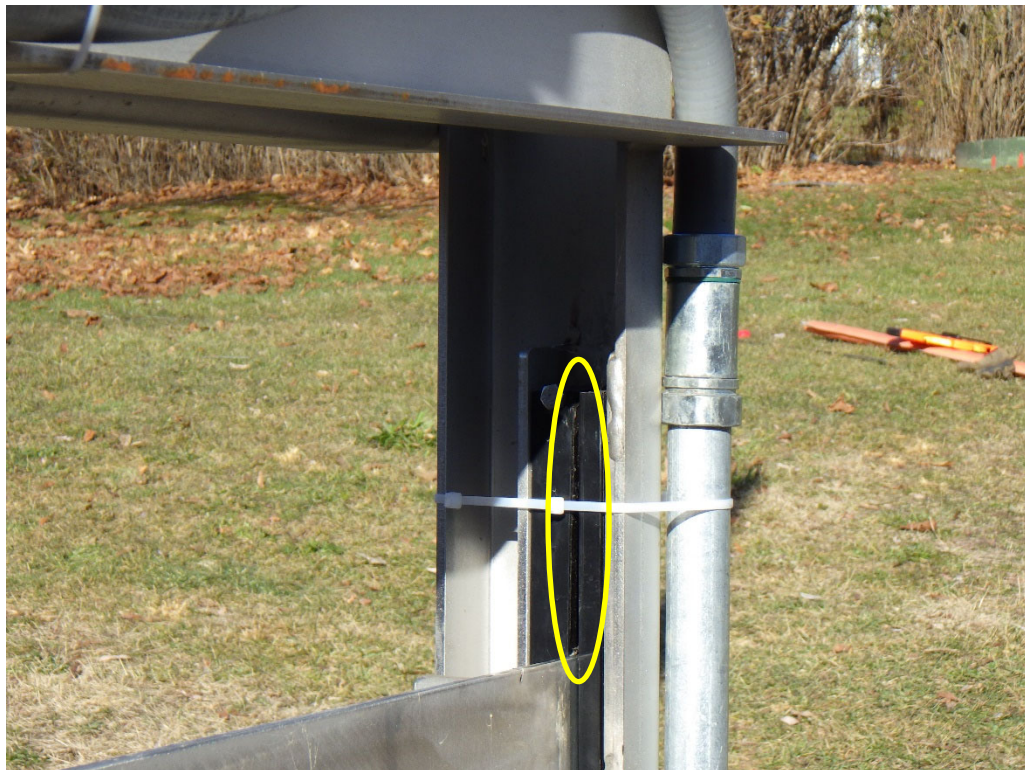
- The aluminum slide gate controlling discharge to the low-level outlet (Photo 15) operated without binding but operators have indicated that the slide gate can bind and require hand operation of the actuator. The gate leaf slot formed by two Ultra High Molecular Weight Plastic (UHMW) strips is narrow (Photo 16) and could be enlarged to provide smoother operation;

**Photo 16:** Guide strip slot clearance of Aluminum Slide Gate

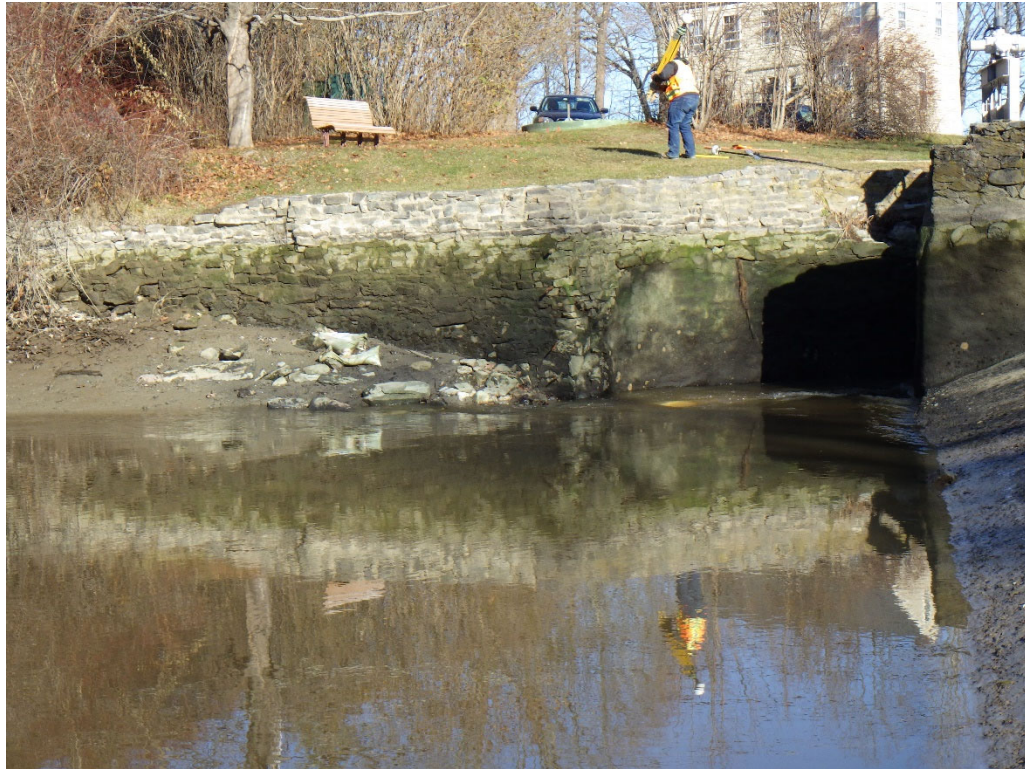
- The dam is located adjacent to a small public area with bench (Photo 17) but there are no features (fence, signage, etc.) to deter public access to the dam, the approach to the low-level outlet, or left abutment training wall;

**Photo 17:** Left abutment training wall

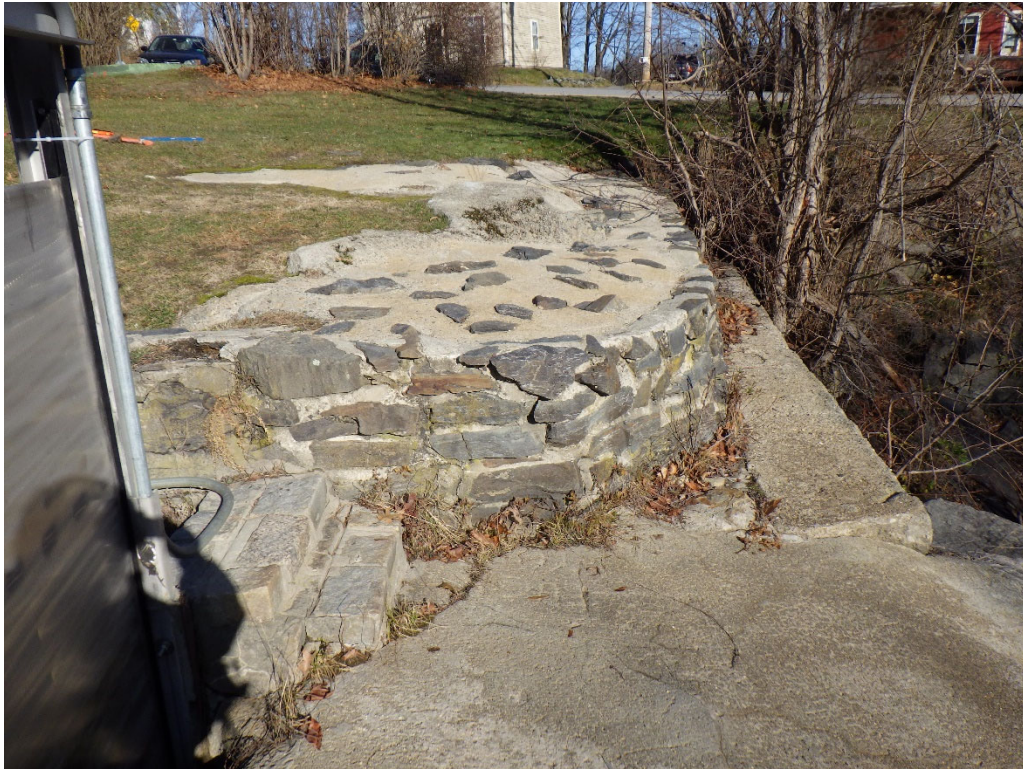
- Stone loss behind the shotcrete overlay has occurred (Photo 35) and may continue with seepage and leakage through the dam.
- The 1986 GEI report identified voids below the surface concrete fill placed atop the downstream face of the left abutment (Photo 25). The concrete fill was not significantly cracked or fractured indicating the void and associated material piping may have stabilized in this area;

**Photo 25:** Concrete fill in historic low part of dam crest (downstream edge of Left Abutment)

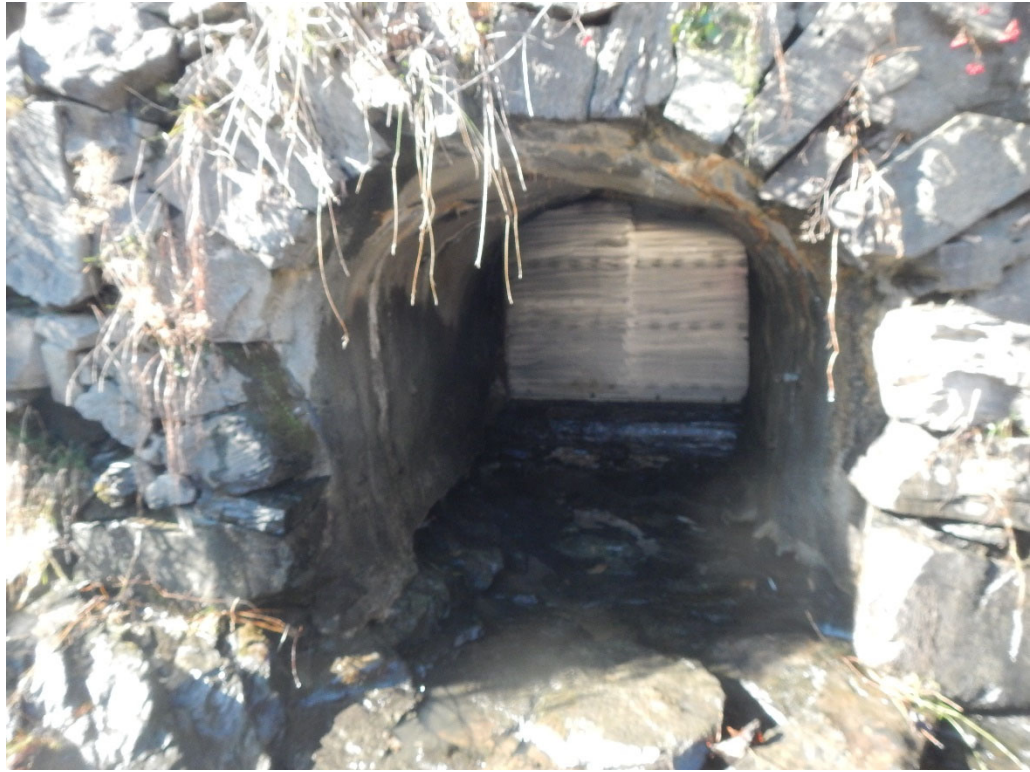
**Photo 29:** Sluiceway, following closure of Aluminum Slide Gate

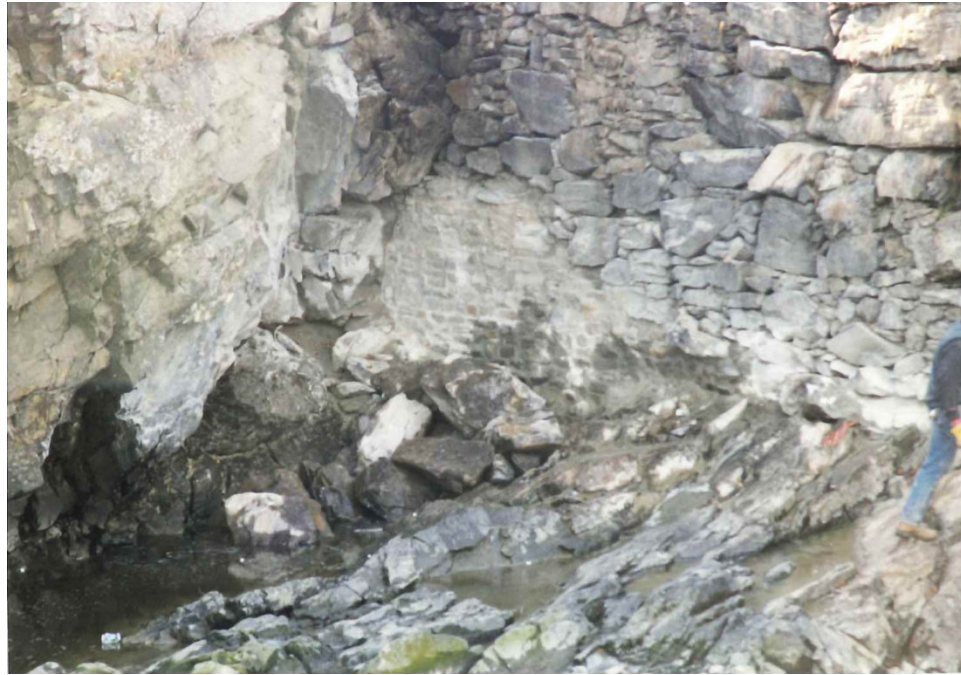
- A 60-inch wide by 30-inch high by 45-inch deep void was observed near the right toe of the downstream face of the dam, near the contact with the bedrock foundation and right bedrock abutment (Photos 43 and 47 through 49); this void was observed to be conveying leakage at the time of inspection. The void is located near the area of a 1998 repair (Photos 45 and 46) of a partial failure of the downstream face of the dam (Photo 44) and this repair may have partially failed or been undermined. This loss of material was noted in the 2012 inspection report but was partially obscured in inspection photos by high water. Untreated, the void may continue gradually expanding until a sudden, uncontrolled piping failure of the dam possibly occurs which would pose a public safety concern; and,

**[Historic] Photo 45:** 1998 repair of partial failure of downstream face at current site of void

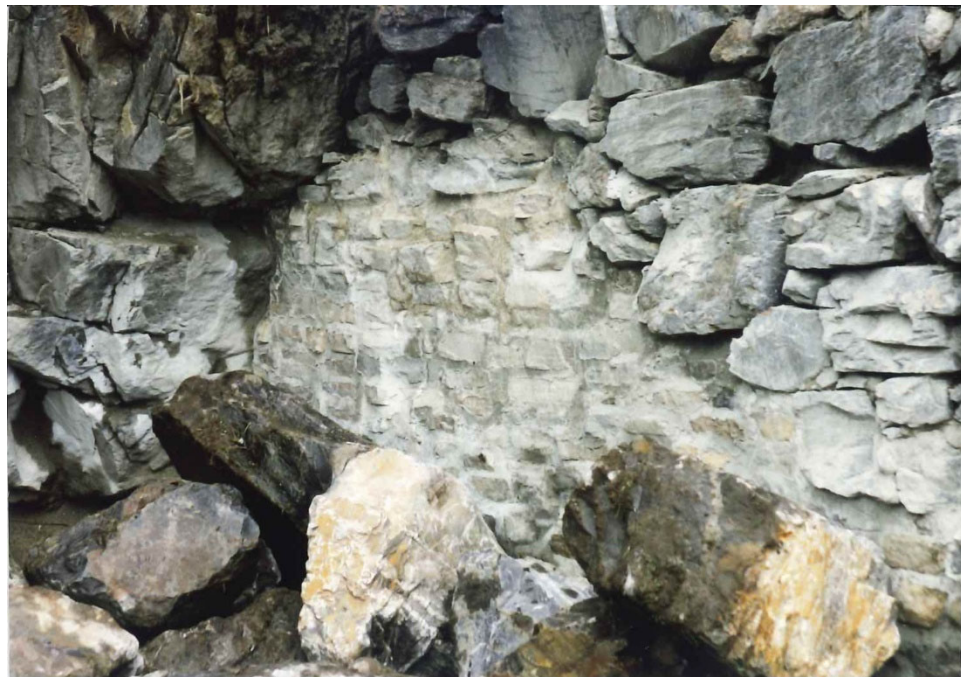
**[Historic] Photo 46:** 1998 repair of partial failure of downstream face at current site of void (detail of contact with right bedrock abutment)
