- i. Presentation on Findings of Building Condition Report; PORTLAND COMPANY COMPLEX, 58 FORE STREET; Report prepared by Resurgence Engineering and Preservation for City of Portland Planning Department.

**RE:** April 1, 2015      WORKSHOP – Presentation on Findings of Building Condition Assessment of Portland Company Complex

# PORTLAND COMPANY COMPLEX GENERAL BUILDING CONDITION REPORT

PERFORMED FOR  
CITY OF PORTLAND, MAINE PLANNING DEPARTMENT  
389 CONGRESS STREET  
PORTLAND, ME 04101

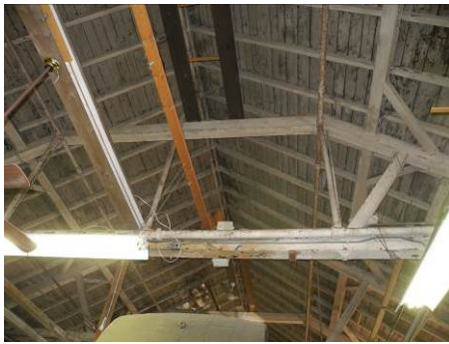
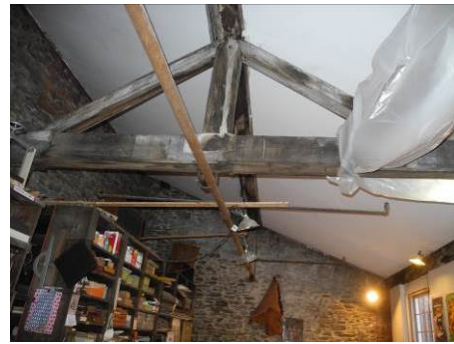
*Queen Rod Truss in Building 6B (left); King Post Truss in Building 14 (right)*

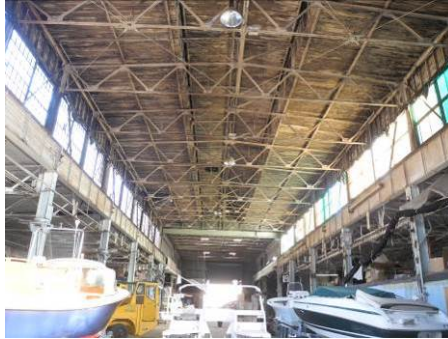
1895 Steel Mill Building Construction in Building 4 (left) and c.1904 snow loading diagram from Ketchum text. Snow loading diagram in this text is based upon latitude in degrees, and upon roof pitch.

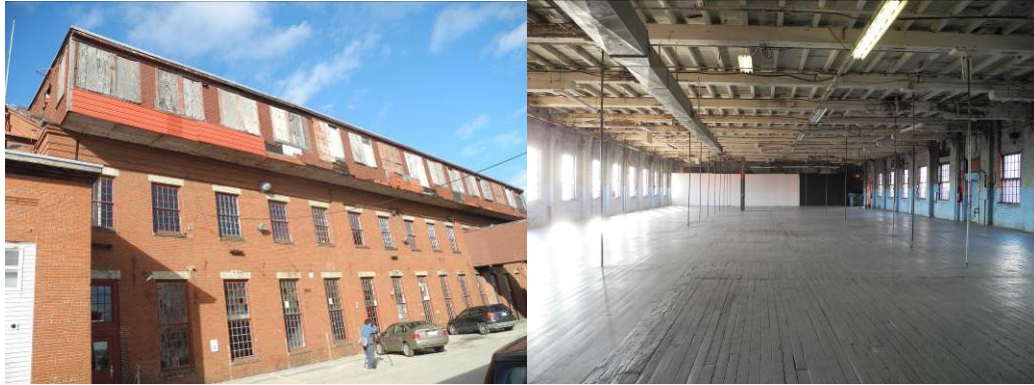
- 11,300 square foot footprint, three stories with overhanging third floor added in 1905 (above).
- Third floor overhangs for nearly the entire building length on the south side, and approximately half the building length on the north side. Cantilevered floor has little backspan.

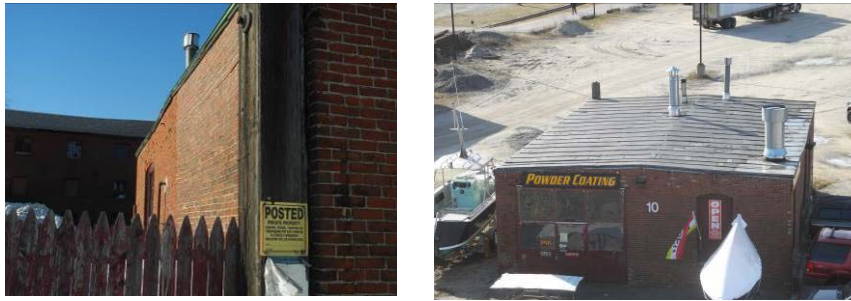
- 1,350 square foot footprint, single story (Photo #10.1);
- Unreinforced multi-wythe brick masonry perimeter bearing walls;
- Numerous infilled brick windows and enlarged door openings (Photo #10.3, #10.6, #10.8);
- west masonry wall has been partially rebuilt and is currently structurally unstable (Photo #10.3, #10.9);
- Some wood-framed window glazing on north and west walls;
- Battened membrane roof with numerous patches and ponding (Photo #10.2), indicating that the rafters have sagged significantly or rotted near the eaves.

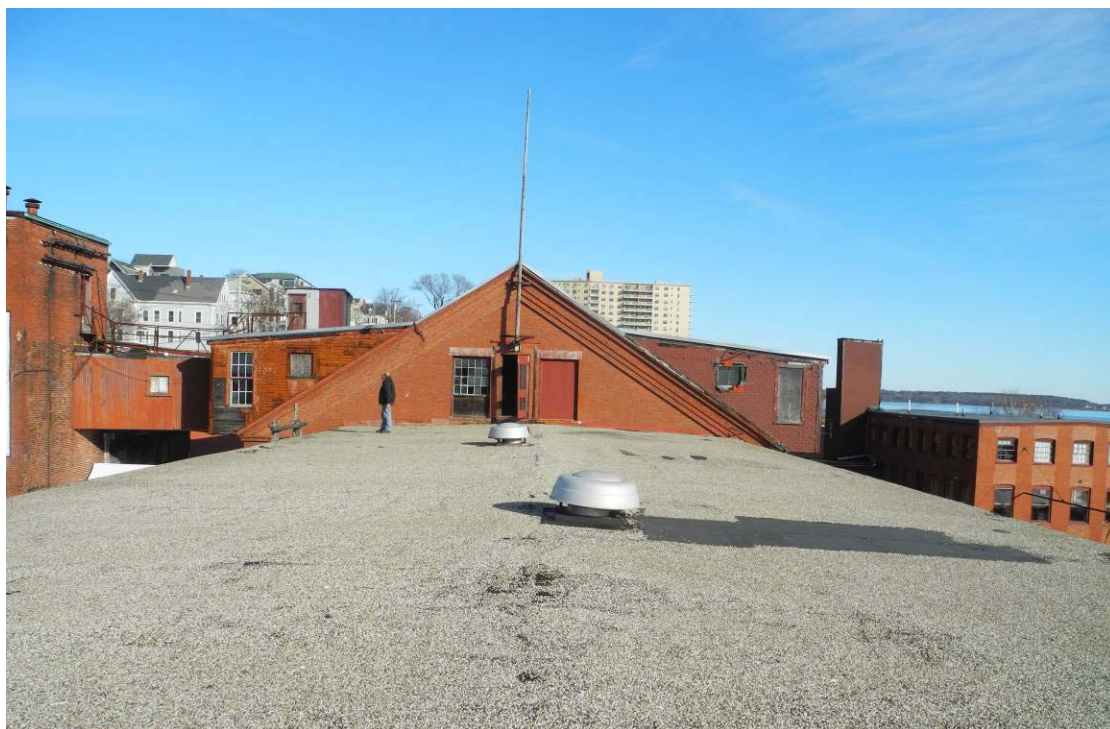
**PHOTO**  
**#1.3**  
A 30 86.jpg

Building 1: View from west end of upper roof, showing felt and gravel surface. Lower side roof levels, not visible, consist of rubber membrane on south side and possibly felt on the north side. Building 2 gable roof visible in background.

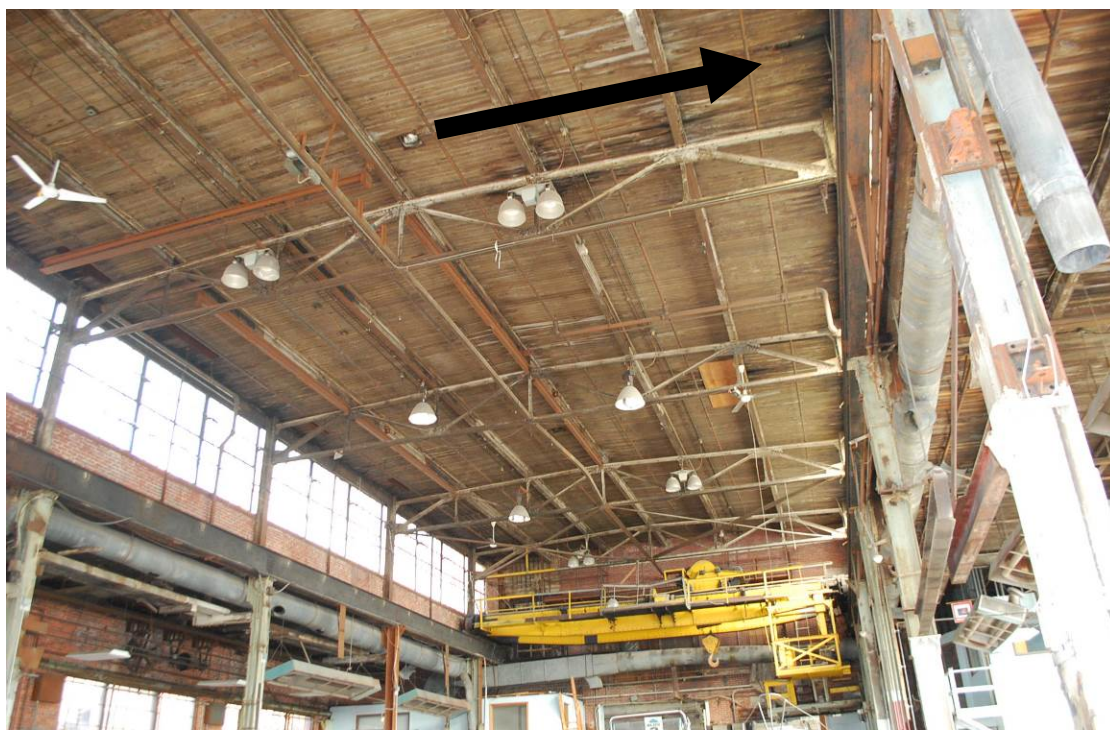
**PHOTO**  
**#1.4**  
R 17.jpg

Building 1: Interior view of upper roof framing, showing flat Warren trusses, I-beam purlins, and edge and center-bead roof decking. Note rotted decking areas (arrow) and steel-framed clerestory windows.

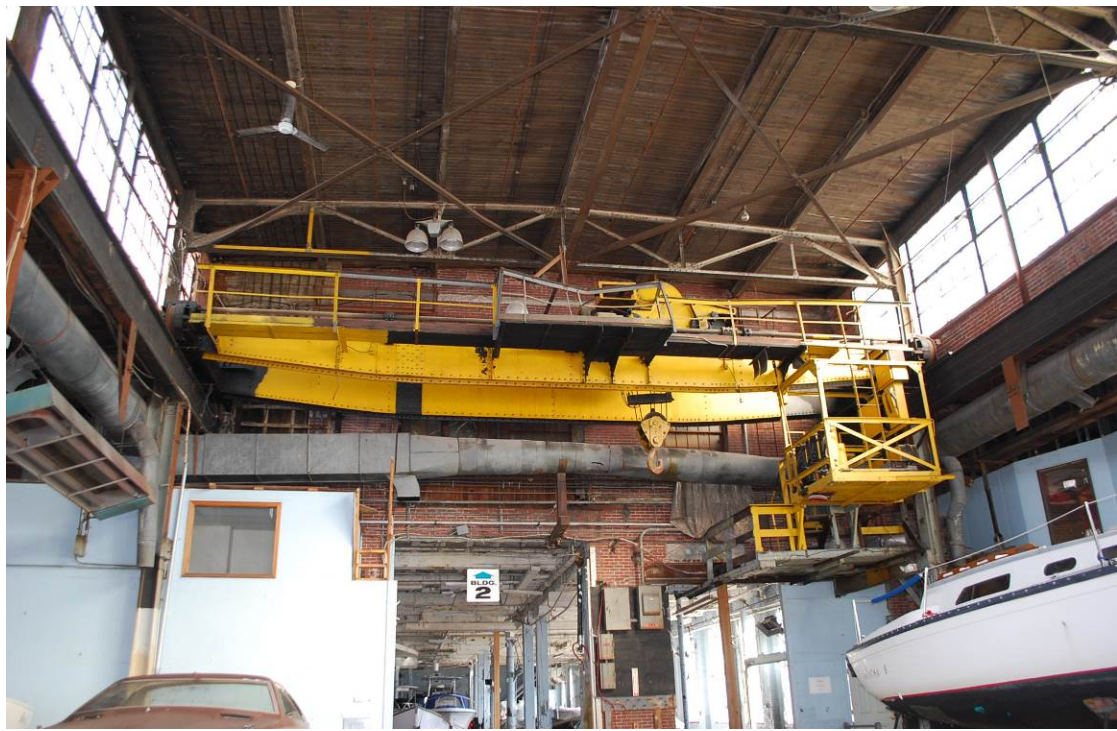
**PHOTO**  
**#1.5**  
R 37.jpg

Building 1: Existing rail crane is supported by girders spanning the length of the building. Rail cranes in mill buildings require offset framing at columns in order to support low roofs and upper roof framing. Note horizontal angle bracing at high roof.

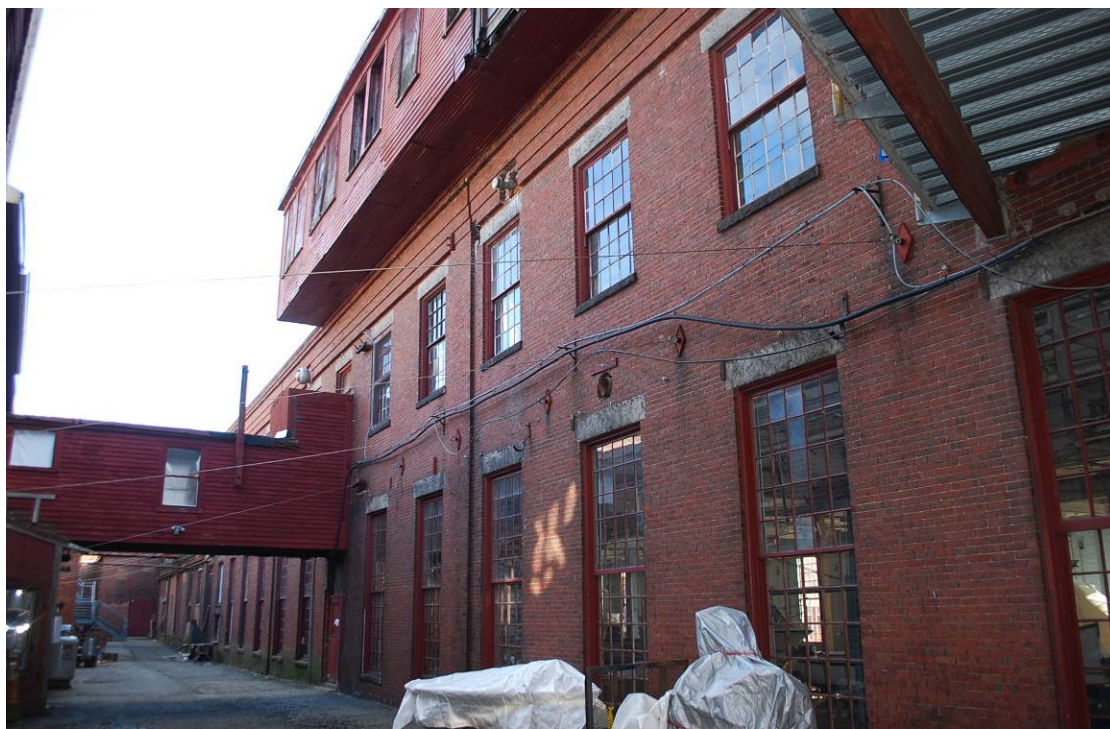
**PHOTO  
#2.1**  
R 26.jpg

Building 2: View from southeast. Note third floor (added in 1905) cantilevered over original building cornice. Walkway to Building 6 was not assessed as part of this study.

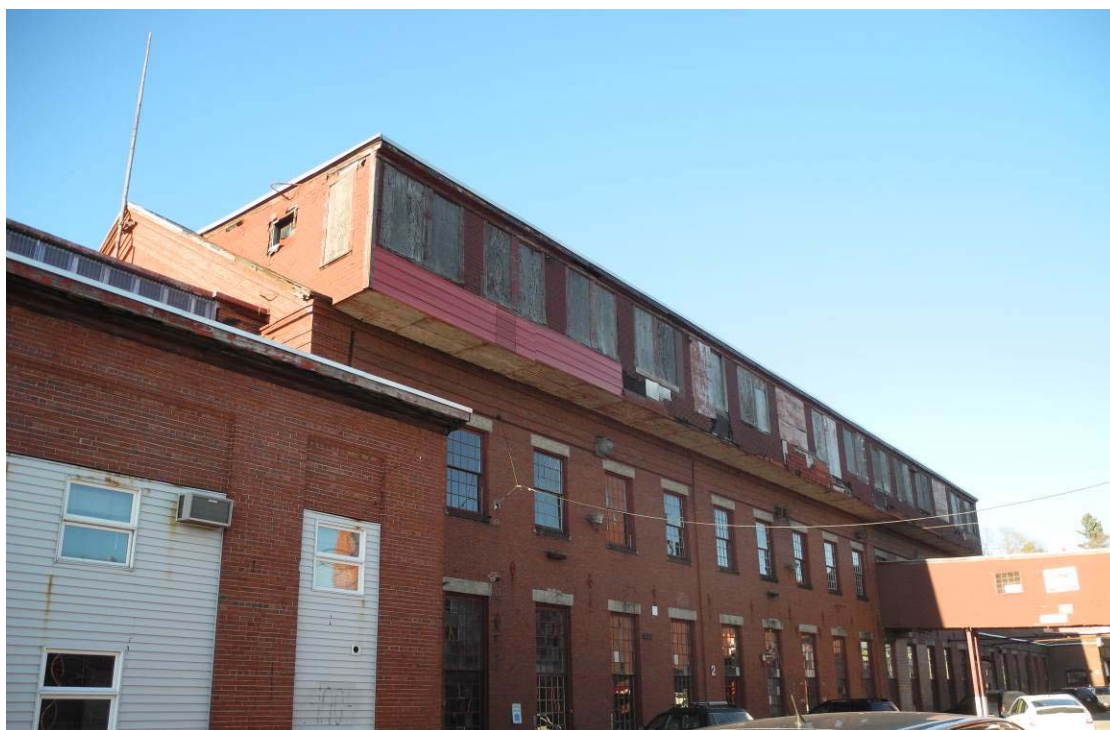
**PHOTO  
#2.2**  
A P 5.jpg

Building 2: View from southwest showing continuous third-floor shed dormer cantilevered over original roof cornice.

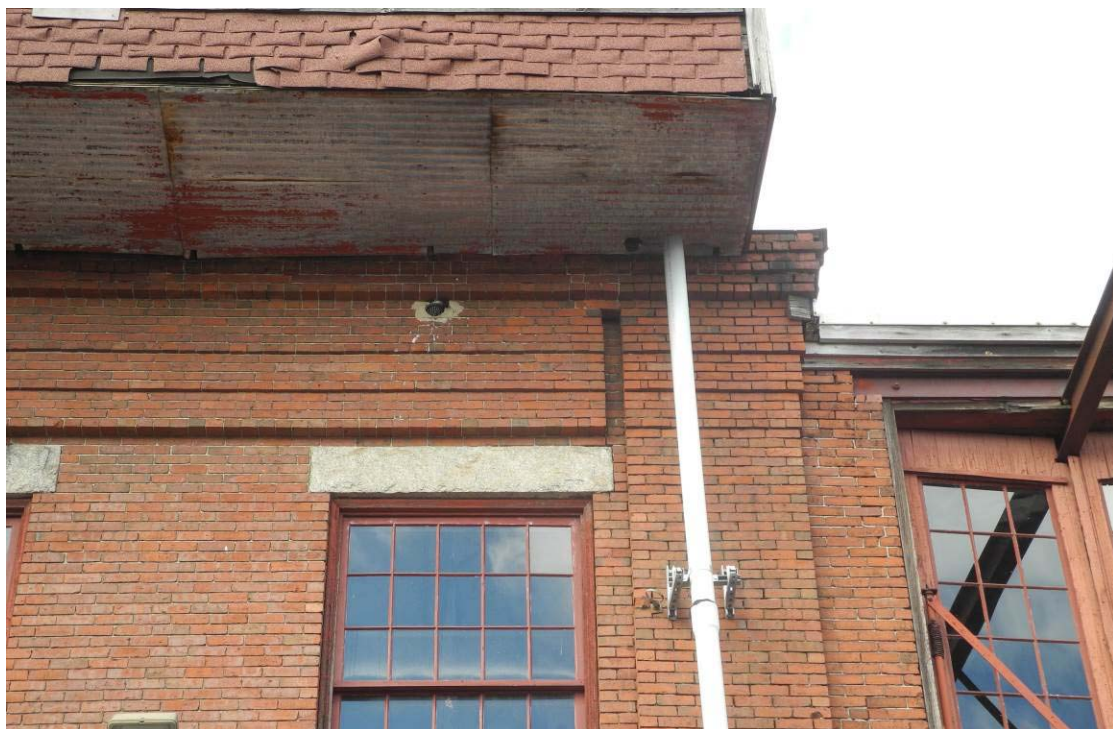
**PHOTO  
#2.3**  
A 29 14.jpg

Building 2: View of southeast corner of building, looking up at cantilevered dormer. Note relief in brick cornice above window. A downspout likely descended from that location before the addition was built.

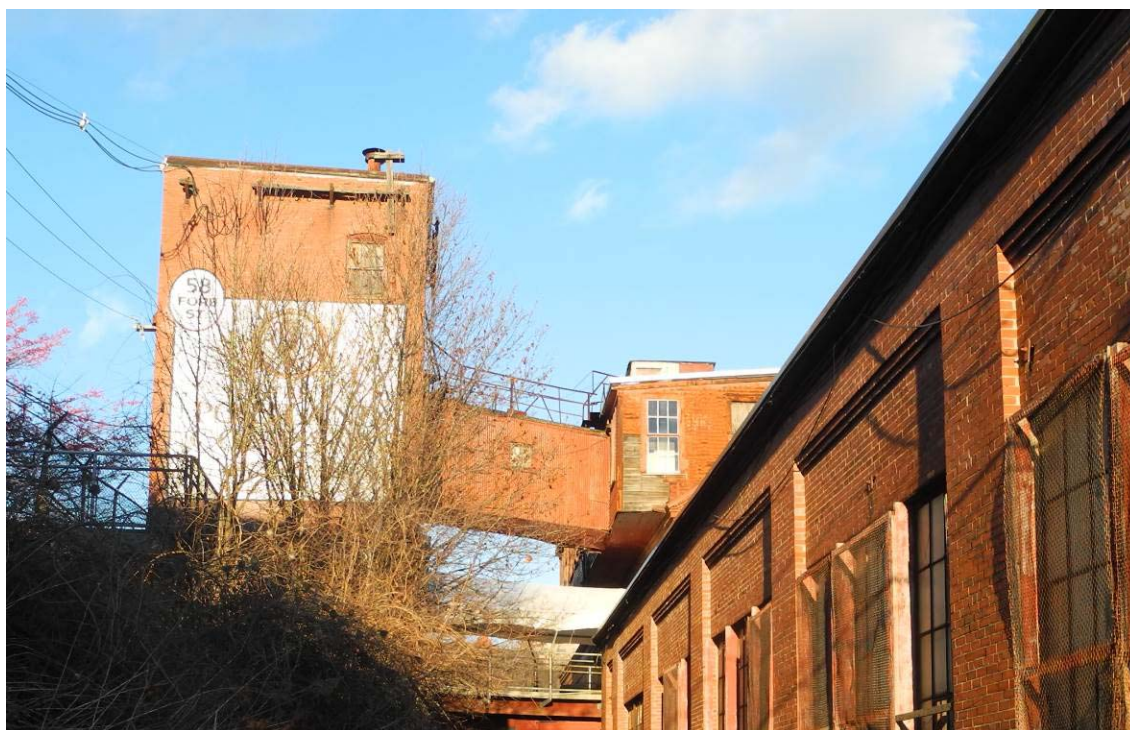
**PHOTO  
#2.4**  
A 29 107.jpg

Building 2: Walkway from third-floor drafting room to plan vault. Walkway was not assessed as part of this project.

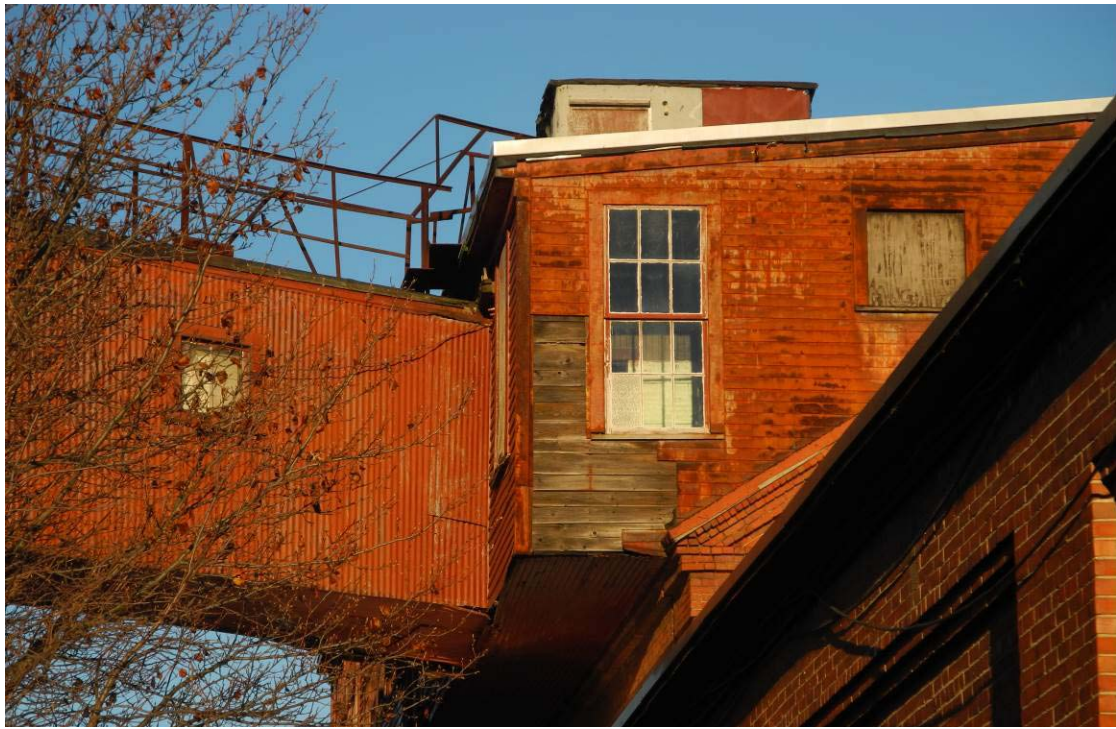
**PHOTO  
#2.5**  
ah 1 x 0.jpg

Building 2: Metal-clad walkway extending from Building 24 (vault storage) to drafting office allowed quick access to drawings in progress and drawings from archives, without exposing drawings or draftsmen to weather conditions.

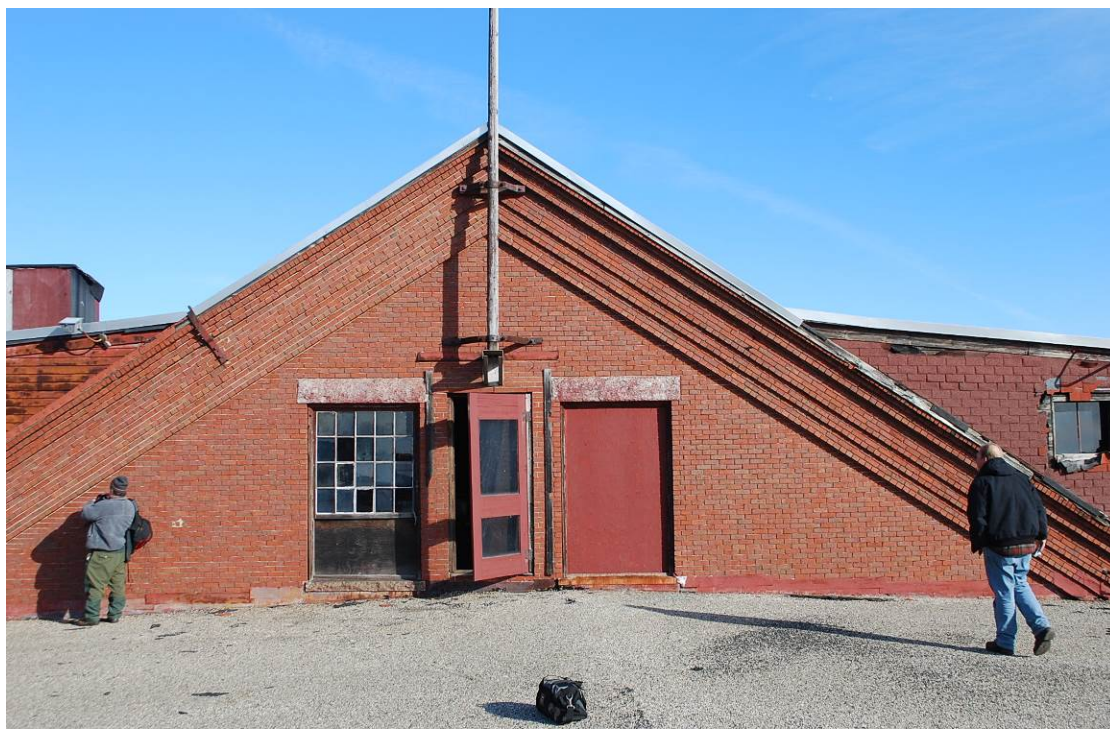
**PHOTO**  
**#2.7**  
R 179.jpg

Building 2: Gable end rake viewed from Building 1 roof. With proper safety precautions, much of the rake and gable peak can be repointed without extensive scaffolding.

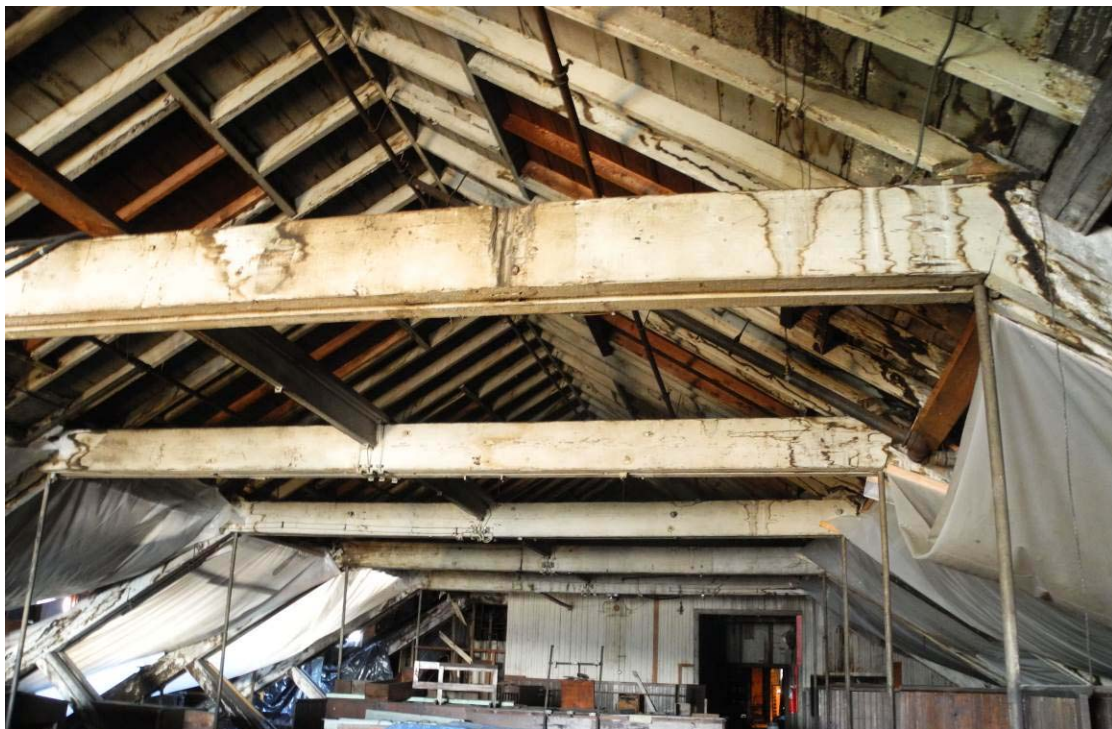
**PHOTO**  
**#2.11**  
 A 30 100.jpg

Building 2: 3<sup>rd</sup> floor drafting office viewed from west wall. Queen rod trusses support roof structure, and lower half of roof extends out as low-slope shed dormers, not visible in this photo.

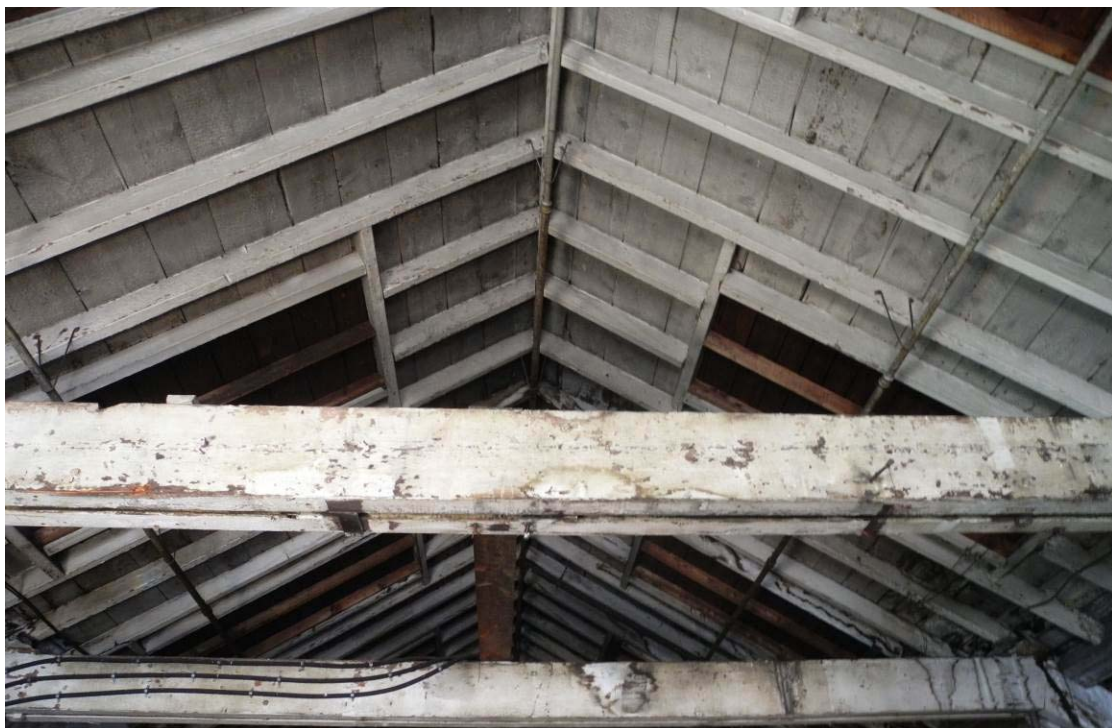
**PHOTO**  
**#2.12**  
 A 30 55.jpg

Building 2 upper roof: Note skylights previously located along roof.

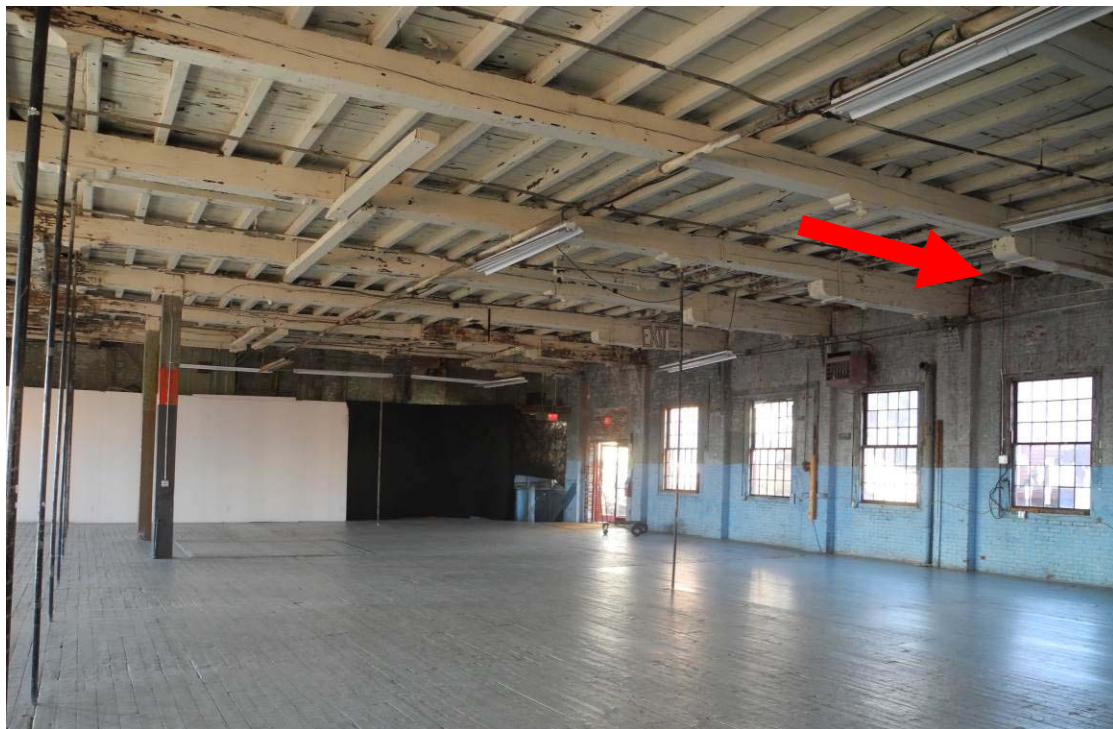
**PHOTO  
#2.13**  
A 29 58.jpg

Second floor assembly area, supported below by additional cast iron and timber posts. Iron rods were used to suspend the floor from the roof trusses. Dormer cantilever floor framing has very little backspan (arrow).

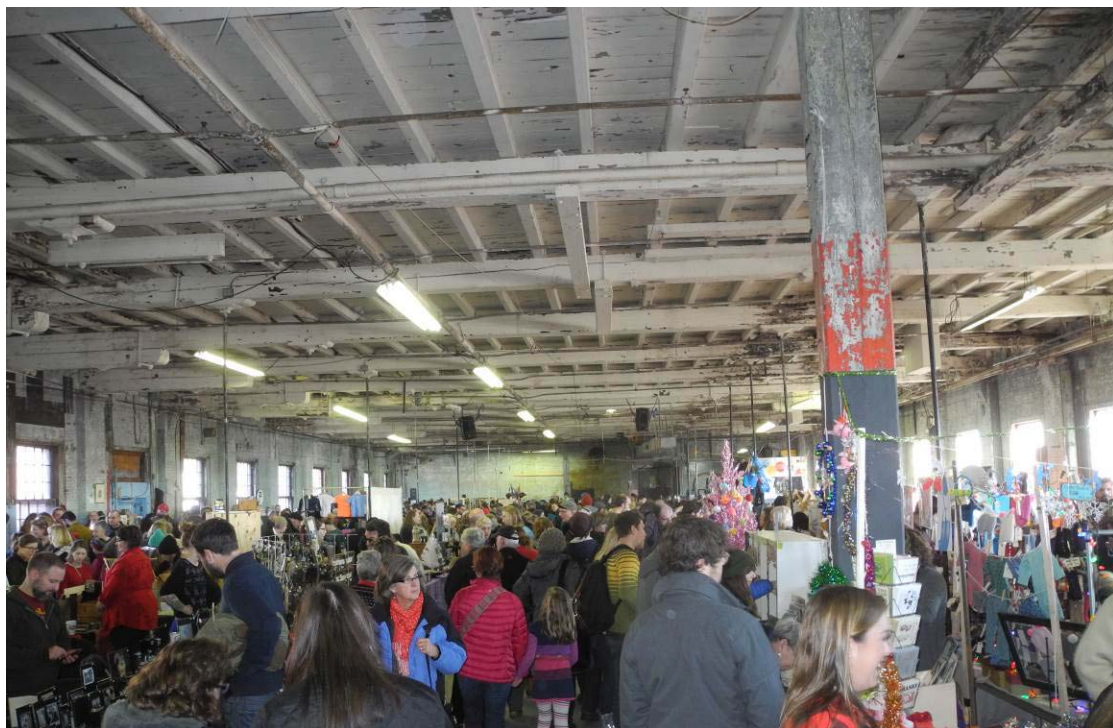
**PHOTO  
#2.14**  
A P 1.jpg

Second floor assembly area: In use as assembly facility, December 2014.

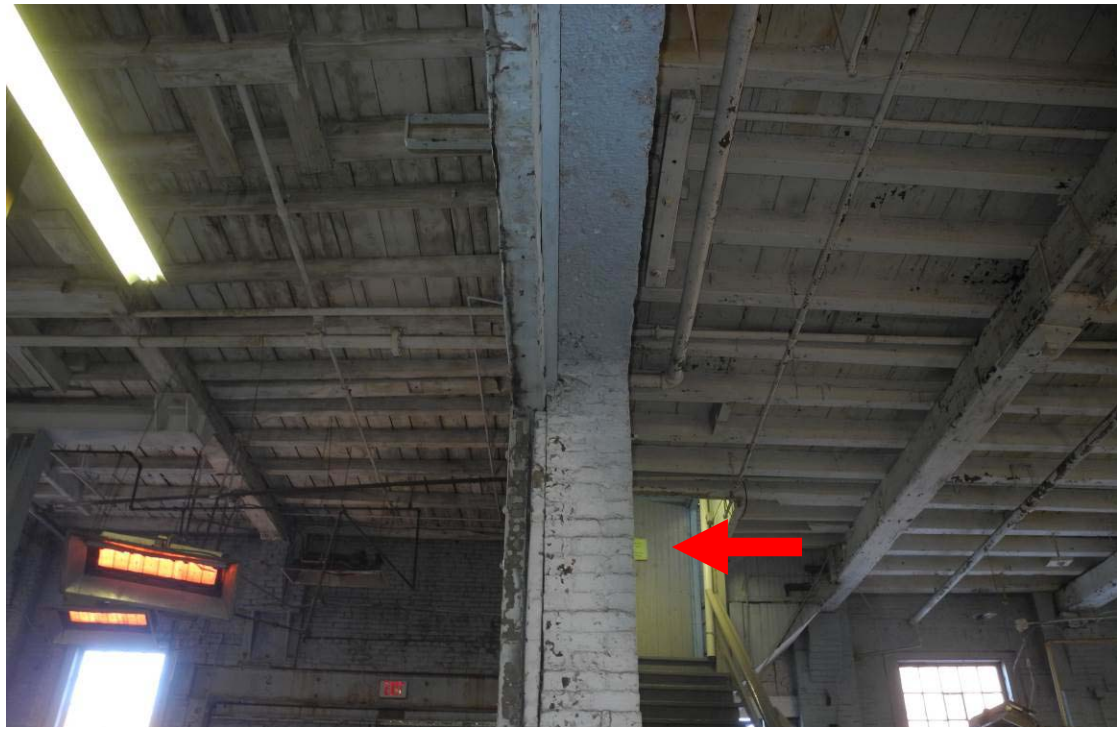
**PHOTO  
#2.15**  
A 3 23.jpg

Building 2 (right side of wall) and Building 3 (left side of wall) share a common partition that consists primarily of 12-inch (3 wythe) brick masonry. Arrow indicates point of view from stair landing shown in Photo 2.24 below.

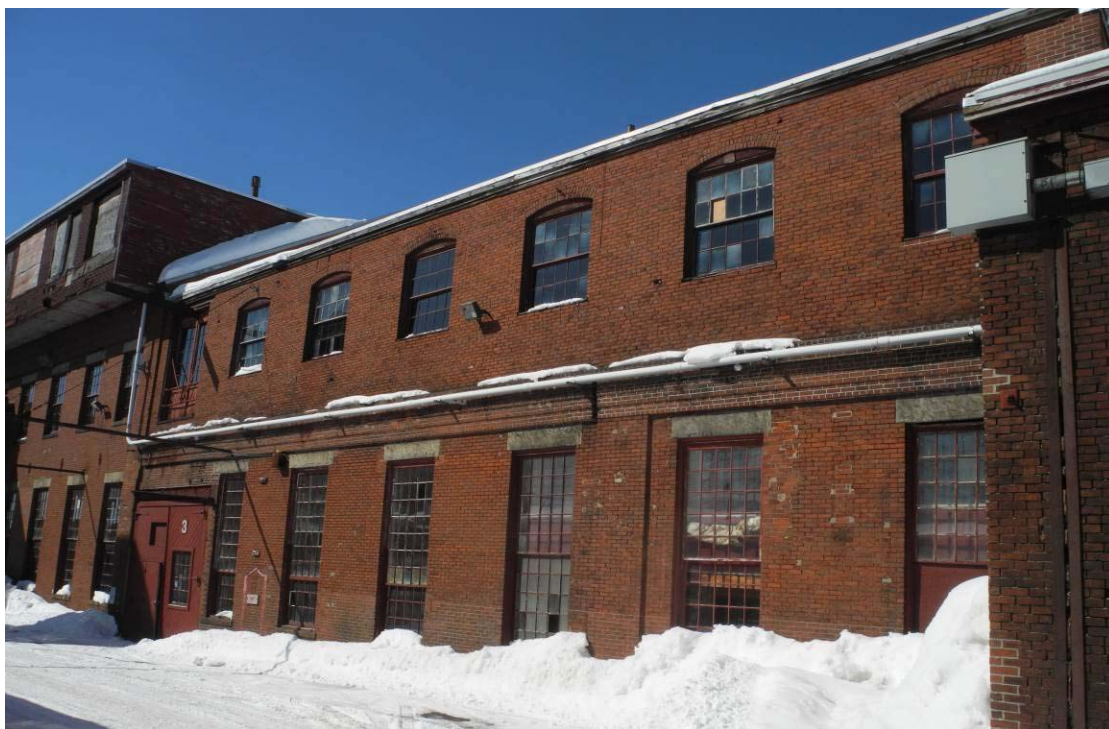
**PHOTO**  
**#3.1**  
A 2 78.jpg

Building 3: View from southeast. Second floor added sometime around 1895. Unlike level added at Building 2 (at left) second floor wall consists of loadbearing brick masonry in alignment with the first-floor masonry wall.

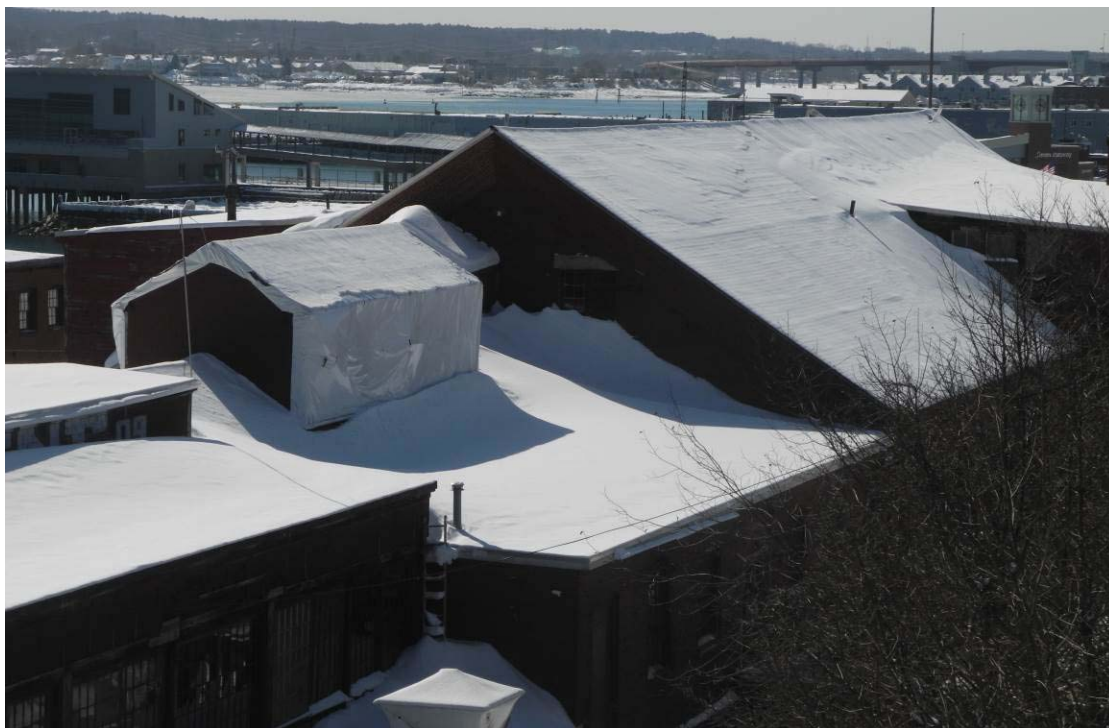
**PHOTO**  
**#3.2**  
A 2 73.jpg

Building 3: View from northeast showing original monitor roof extending above clerestory roof now covered in snow. Note drifting patterns developing around various roof intersections.

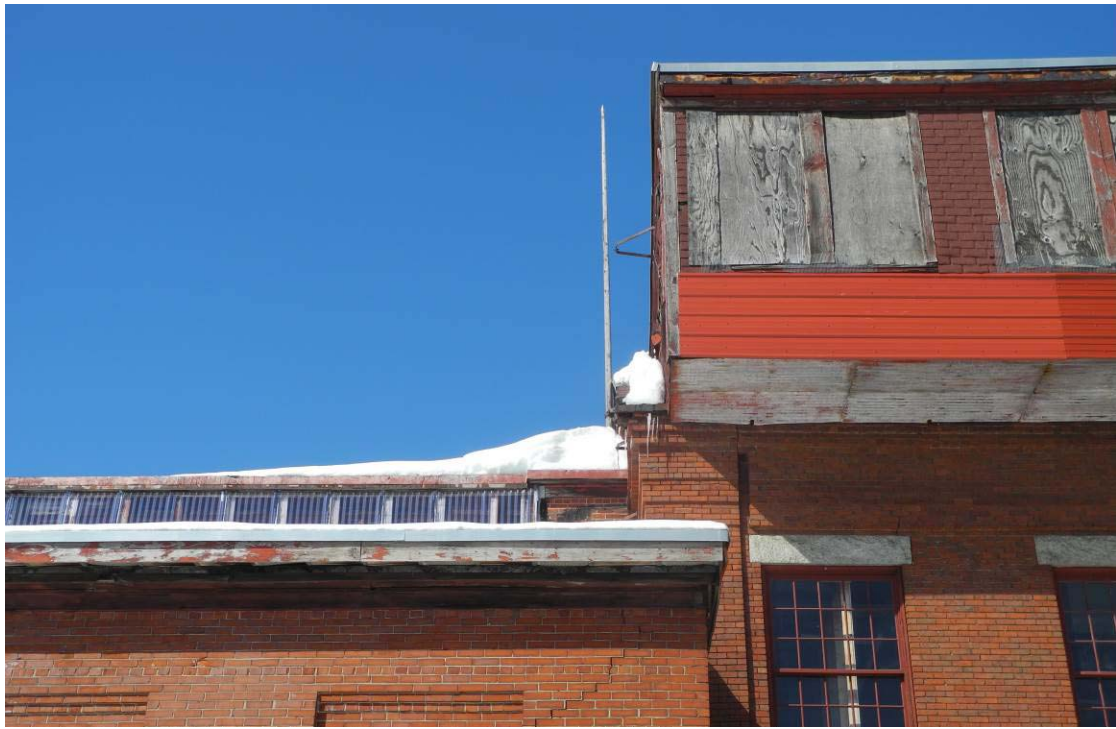
**PHOTO**  
**#3.3**  
A 2 107.jpg

Building 3: View of northwest corner of building, looking up at cantilevered dormer of Building 2 (right) and clerestory of Building 3 (left).

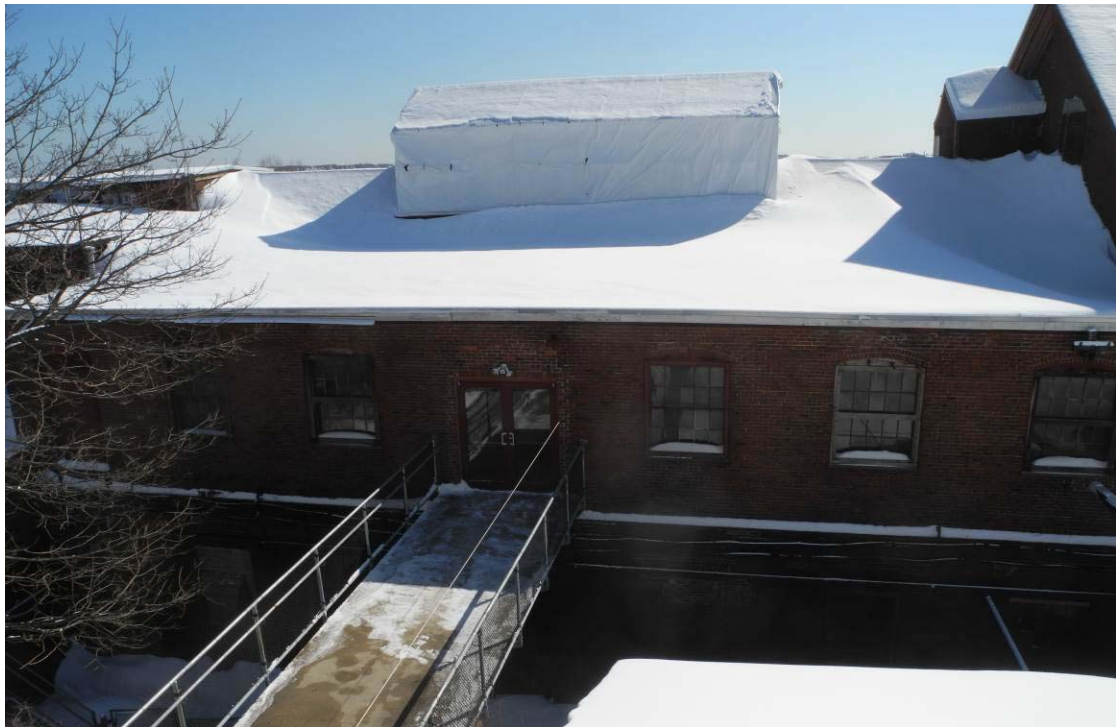
**PHOTO**  
**#3.4**  
A 2 63.jpg

Building 3: Walkway from second-floor space to stair landing leading to Fore Street. Walkway was not assessed as part of this project.

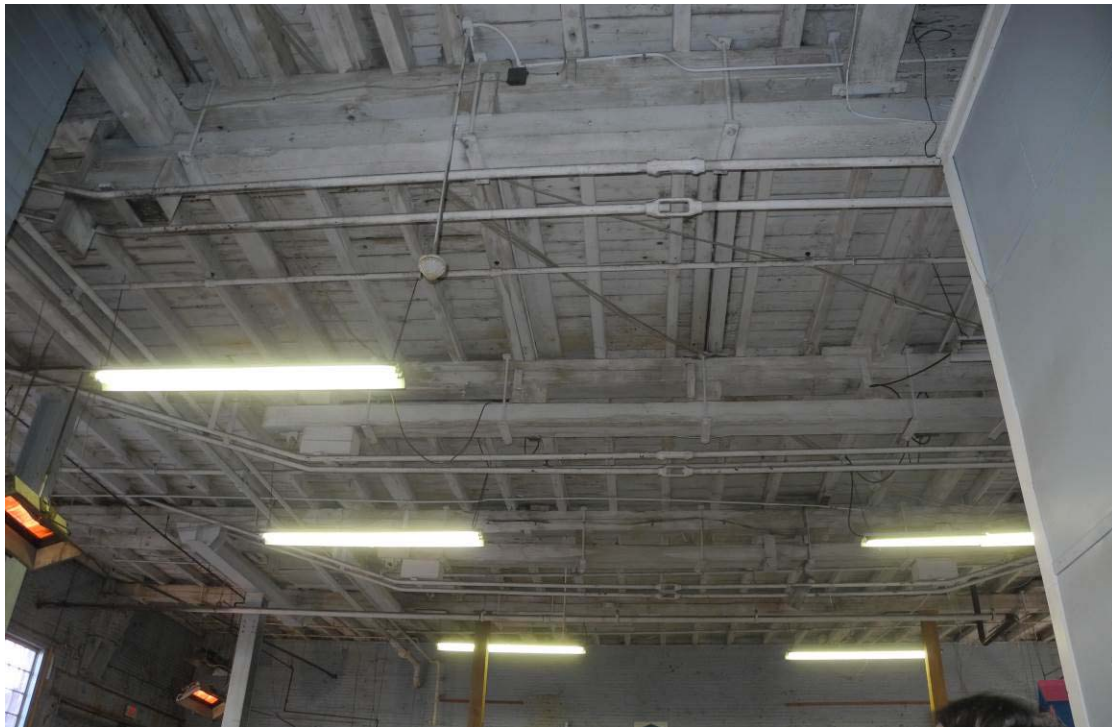
**PHOTO**  
**#3.5**  
A 3 20.jpg

Building 3: Second floor framing viewed from east. Added rods and turnbuckles create double-strut trussed beams that also serve as the bottom chord of the roof trusses.

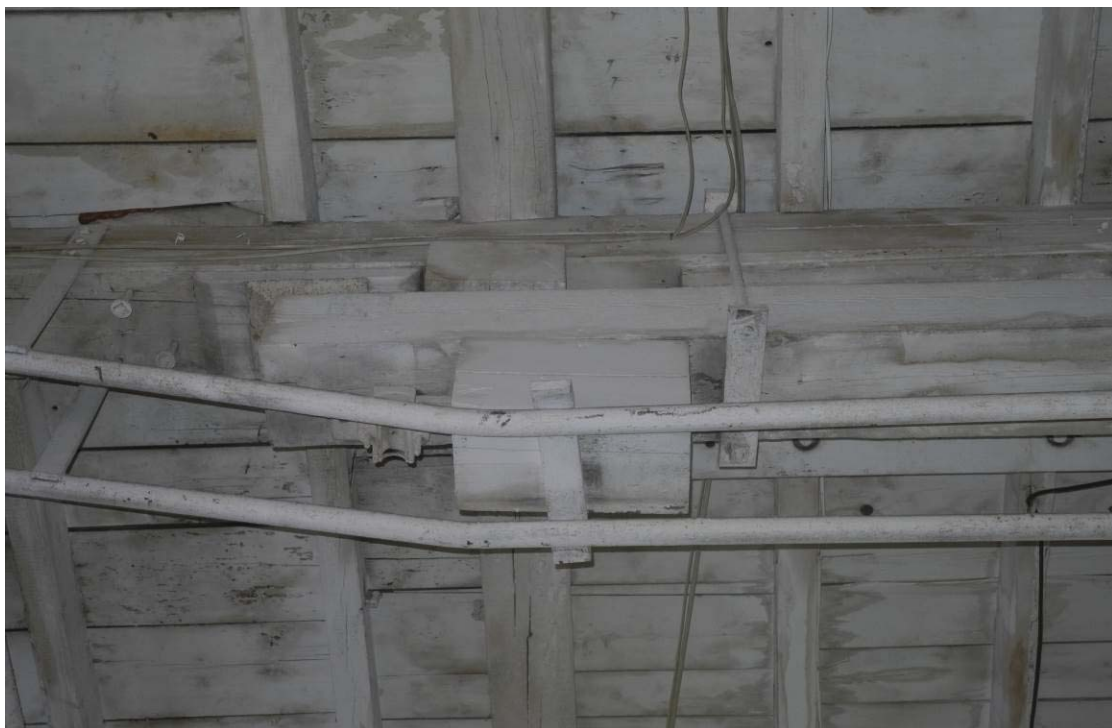
**PHOTO**  
**#3.6**  
A 3 21.jpg

Building 3: Detail looking up at reinforced bottom chord of underhung queen rod truss/trussed girder. Further inspection is necessary to better understand the load path of this framing system.

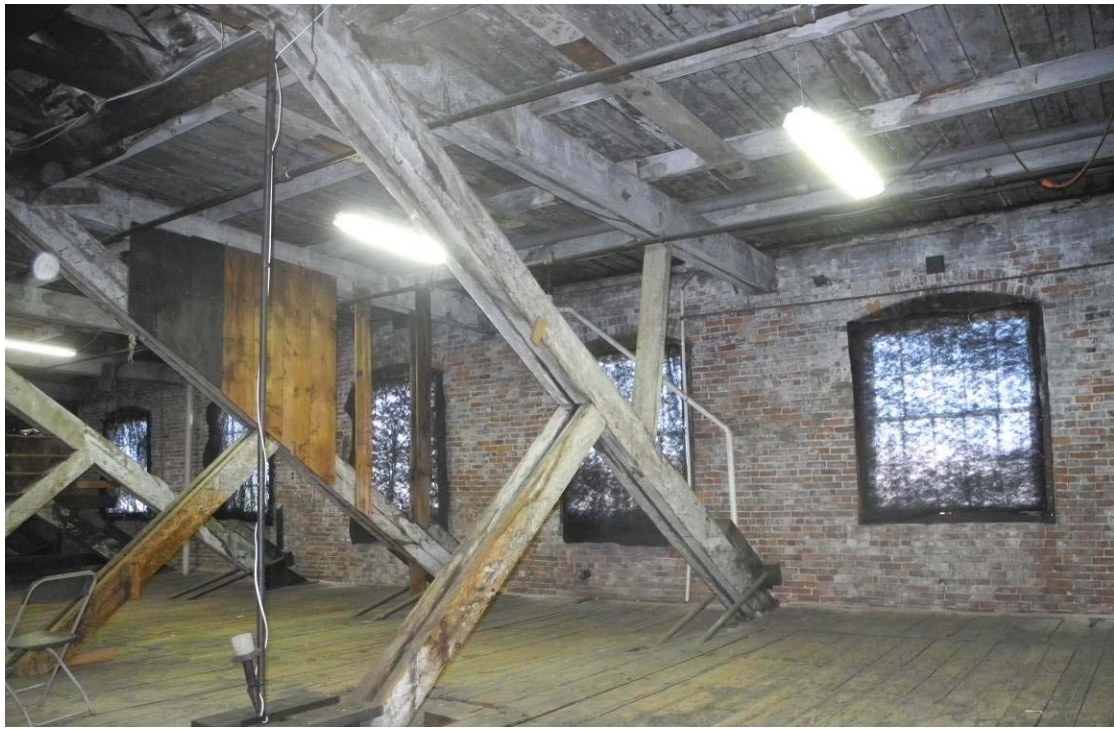
**PHOTO**  
**#3.7**  
A 3 29.jpg

Building 3: Original roof truss modified to create third-floor dormer. View taken looking toward south facing wall.

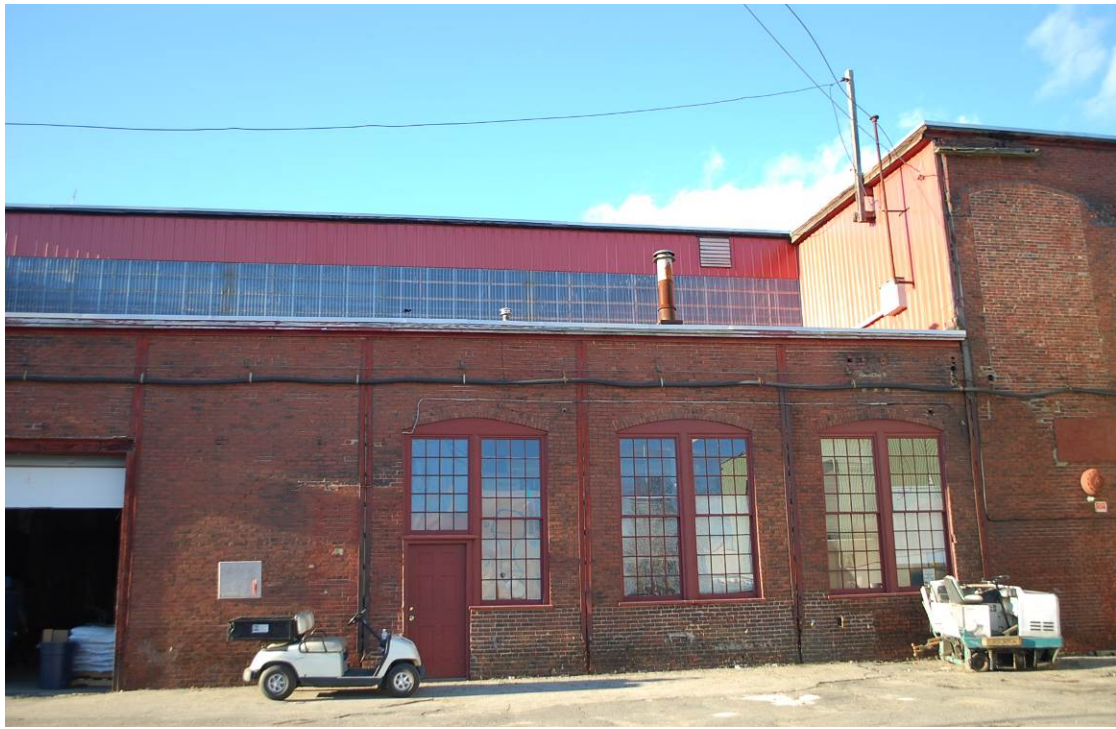
**PHOTO**  
**#4.2**  
R 65.jpg

Building 4: View looking east shows 30-light clerestory windows. As a foundry building, snow loads likely never accumulated on the roof while the foundry was operational. Since closing, snow loads can accumulate on roof.

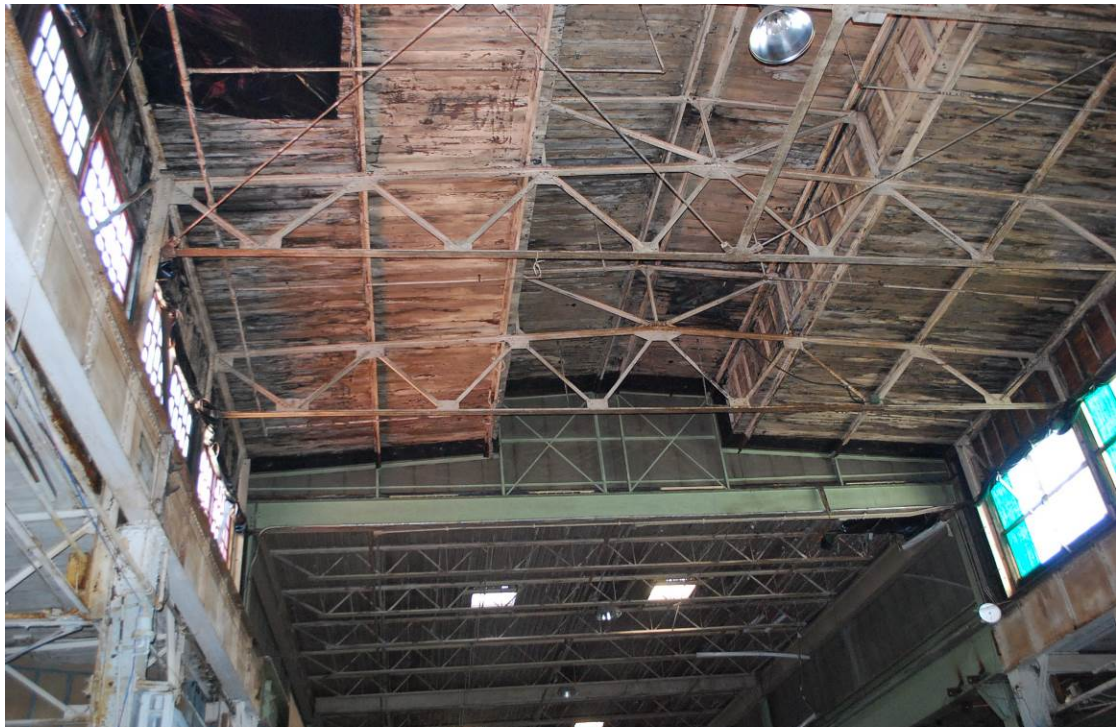
**PHOTO  
#4.3**  
R 79.jpg

Building 4: View looking north. Construction date of taller two-story structure at right is unknown but reportedly dates to original construction.

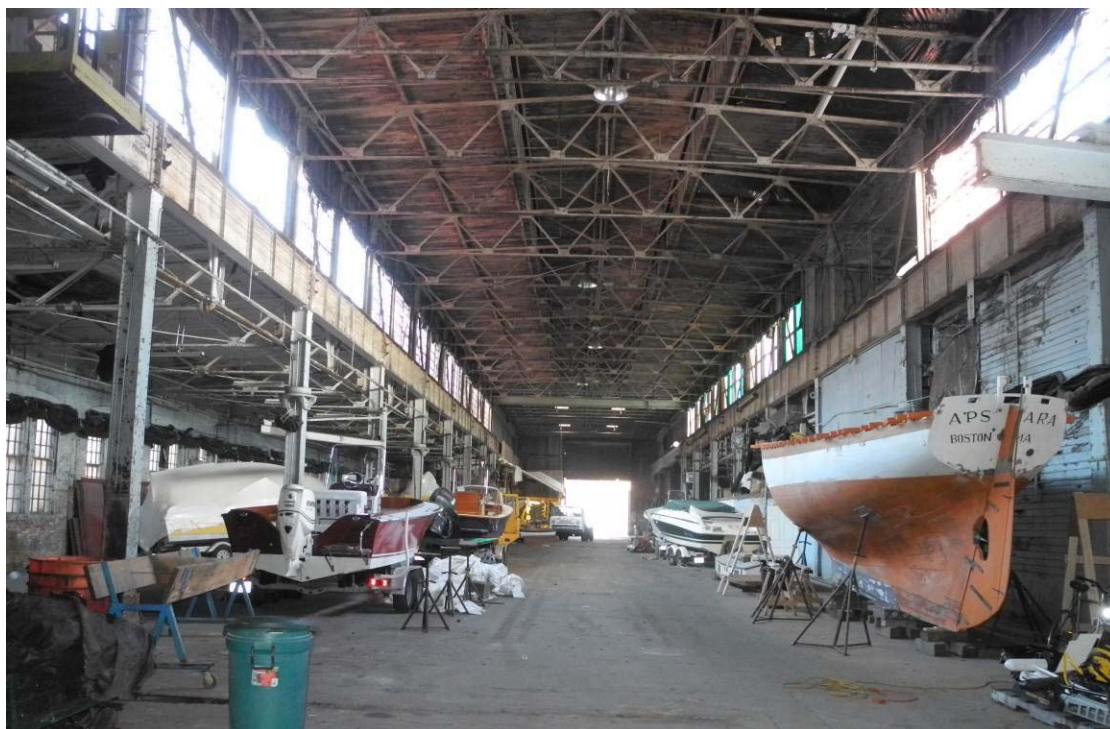
**PHOTO  
#4.4**  
R 89.jpg

Building 4: View toward east, where new roof structure of Building 5 spans across the building width with contemporary steel roof joists.
