- i. Presentation on Findings of Building Condition Report; PORTLAND COMPANY COMPLEX, 58 FORE STREET; Report prepared by Resurgence Engineering and Preservation for City of Portland Planning Department.

**RE:** April 1, 2015      WORKSHOP – Presentation on Findings of Building Condition Assessment of Portland Company Complex

# PORTLAND COMPANY COMPLEX GENERAL BUILDING CONDITION REPORT

PERFORMED FOR  
CITY OF PORTLAND, MAINE PLANNING DEPARTMENT  
389 CONGRESS STREET  
PORTLAND, ME 04101

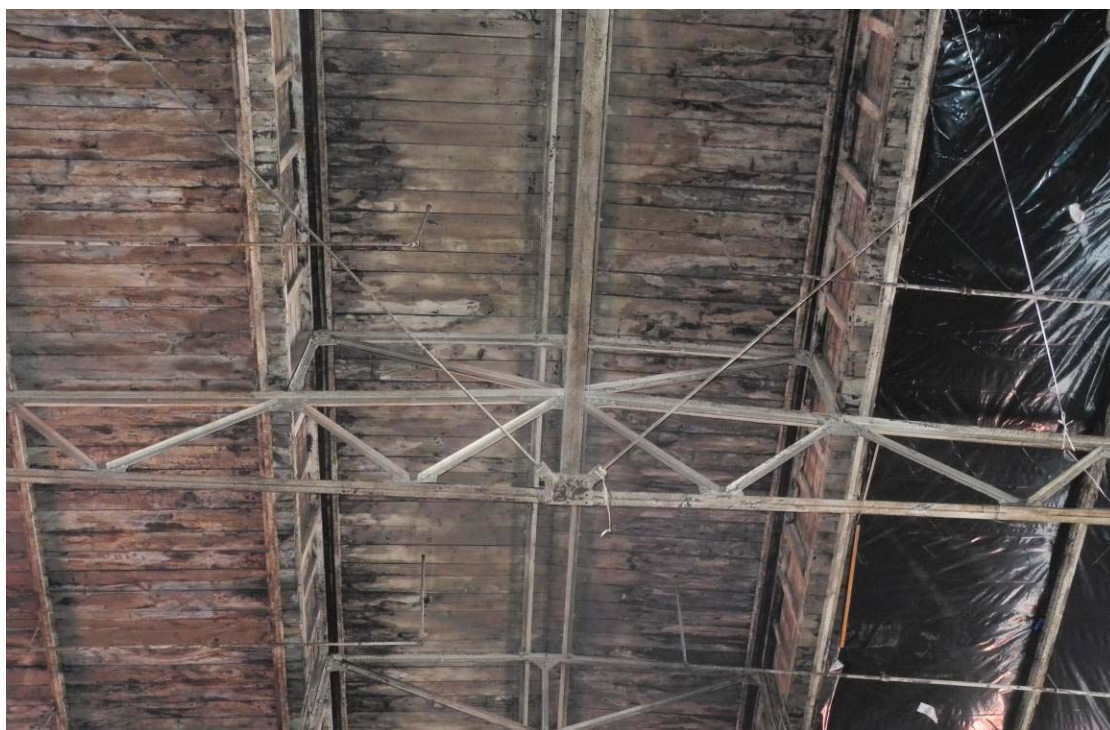
**PHOTO  
#4.5**  
A 29 63.jpg

Building 4: Expansive open space and high ceiling provides natural light, unless monitor windows are covered. East end of Building 4 ties into surrounding Building 5, eliminating the pattern of structure and light.

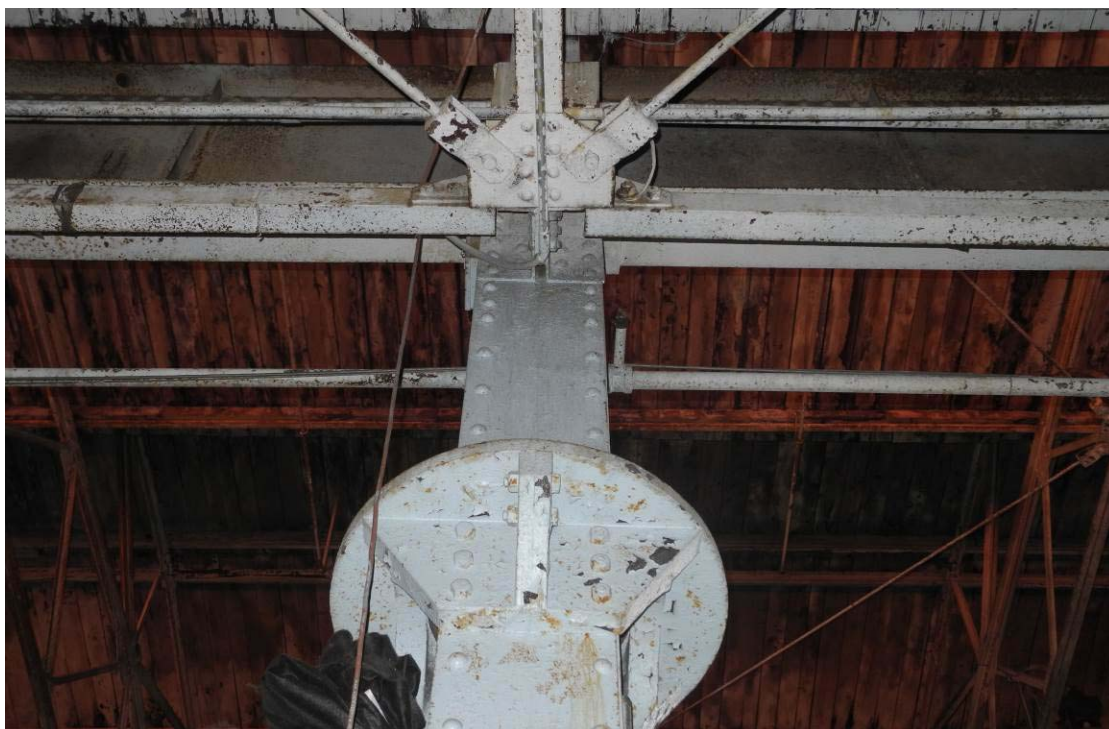
**PHOTO  
#4.6**  
A 29 64.jpg

Building 4: Monitor roof at center of photo supported by small steel truss framed onto clerestory truss.

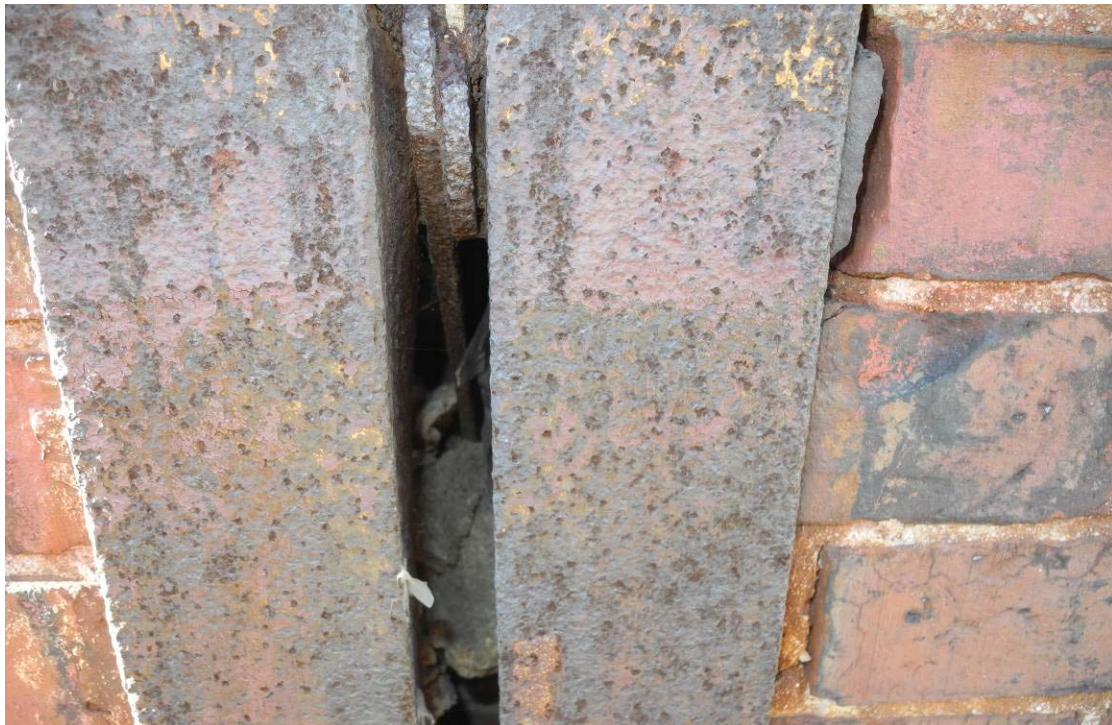
**PHOTO**  
**#4.11**  
A 29 49.jpg

Building 4: Significantly deteriorated built-up angle column. Constant exposure to a shoreline environment, along with inherent construction flaw, caused failure of these columns for several feet above the base.

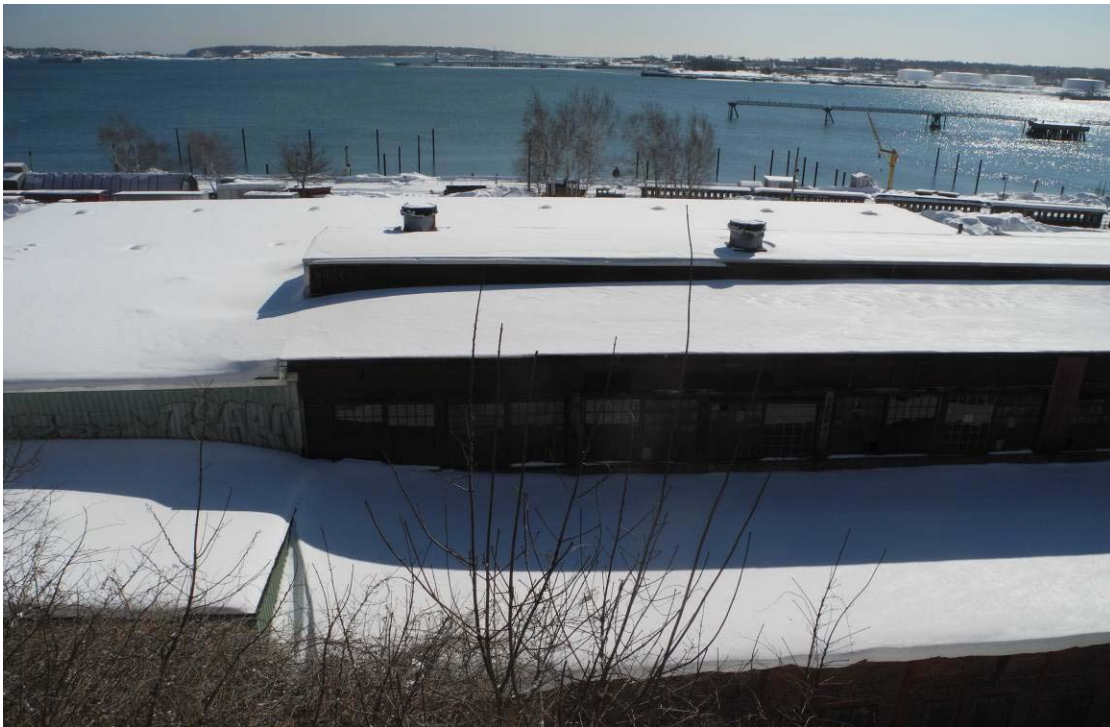
**PHOTO  
#4.14**  
A 2 70.jpg

Building 4, looking Southwest along upper roofs. Note tall clerestory roof and smaller upper monitor roof at clerestory roof ridge.

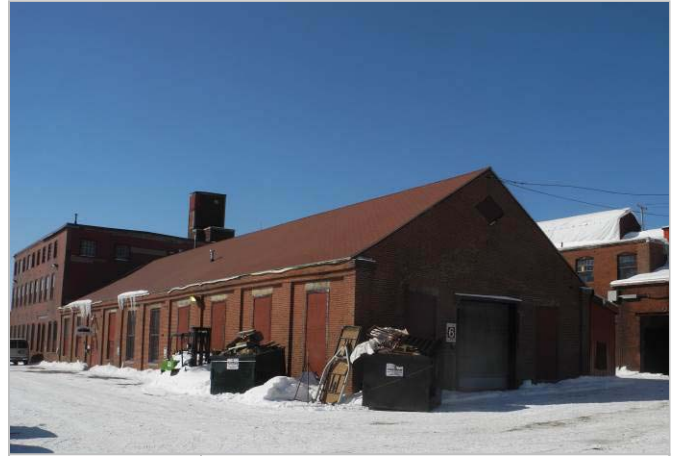
**PHOTO  
#6B.1**

Building 6B: View from southwest. Building 6A is at far left of photo. Building has relatively steep pitched roof in comparison with most buildings on site.

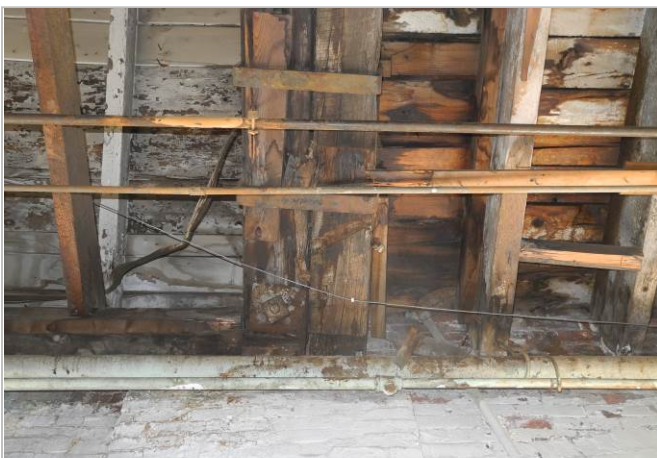
**PHOTO  
#6B.4**

Building #6B: Roof truss framing showing flush-framed rafters, purlins, and diagonal knee bracing.

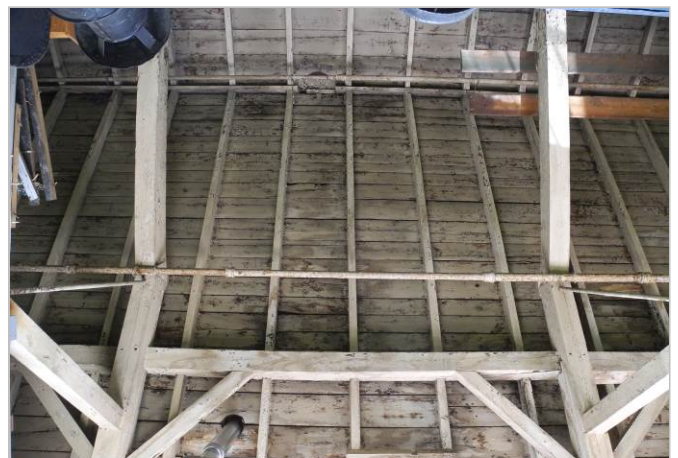
**PHOTO  
#6B.5**

Building #6B west end roof truss: Deteriorated south end of roof truss. Building #6A second floor visible at right. Provide temporary shoring beneath truss.

As stated in the BSE report, immediate safety concerns need to be addressed, whether as isolated repairs (Building 6A/6B common wall and truss) or comprehensive measures (vacancy of Building 11).

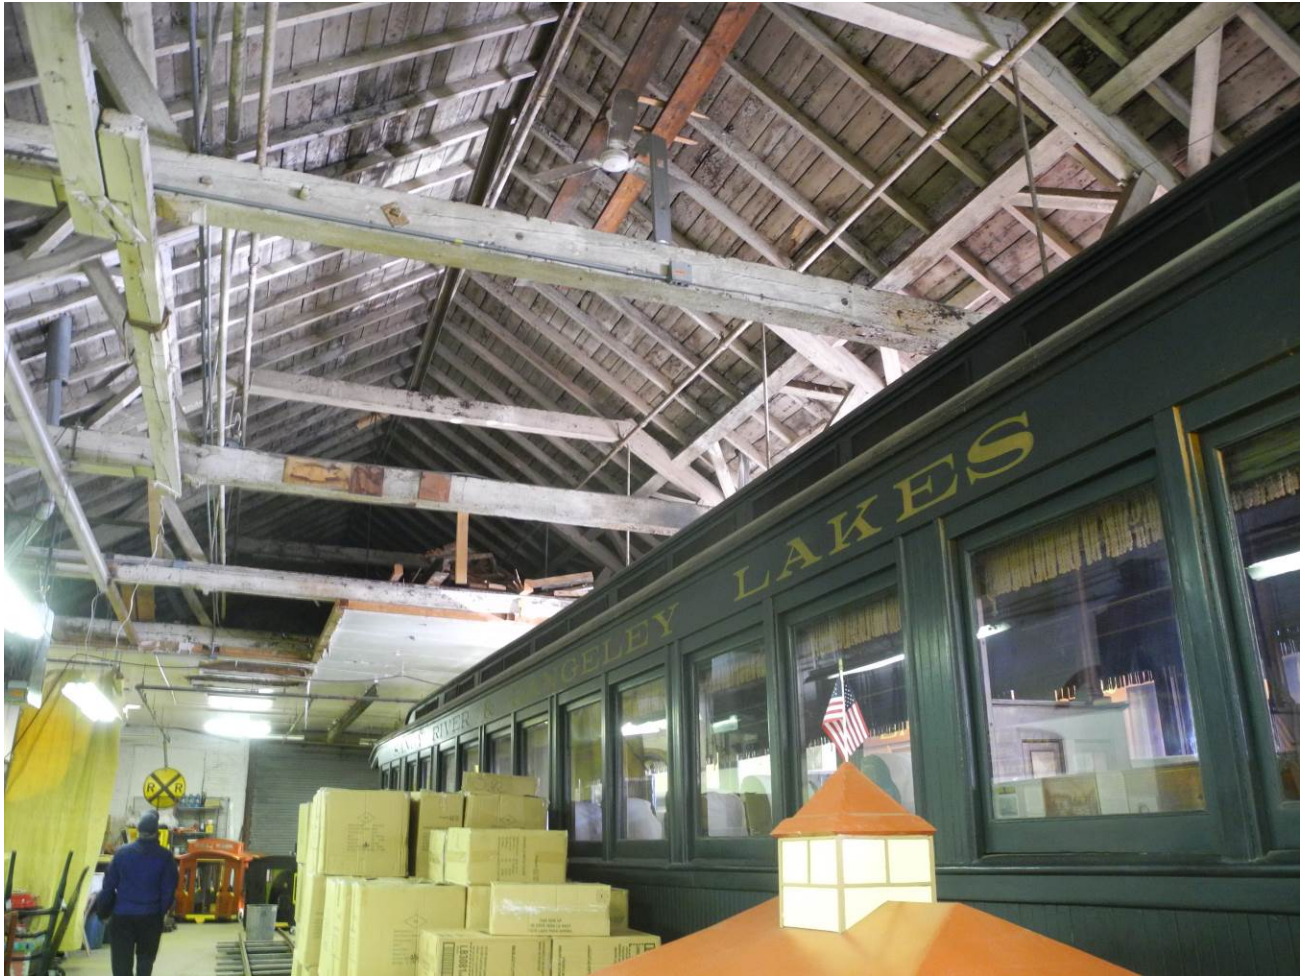
**PHOTO  
#6B.6**

Typical framing bay: Rafters extend from center purlin up to ridge. Knee braces serve to provide lateral stability in the longitudinal direction of roof.

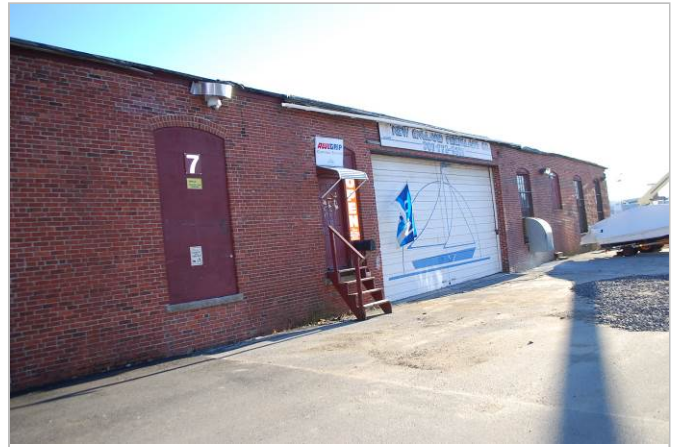
**PHOTO  
#7.1**  
R 101.jpg

Building 7: View from northwest showing large overhead door openings cut into masonry bearing wall.

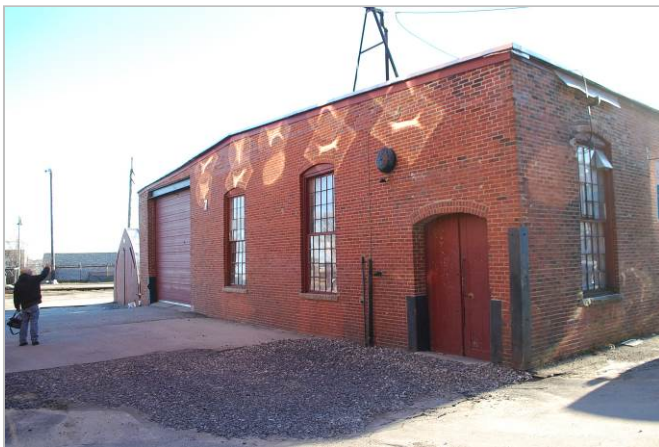
**PHOTO  
#7.2**  
R 102.jpg

Building 7: North elevation, looking west. Many changes have been made to the building facades, weakening existing walls and diminishing original fabric.

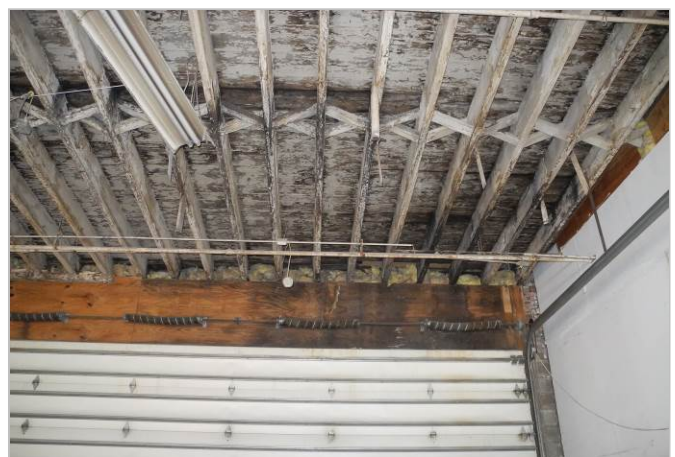
**PHOTO  
#7.5**  
A 30 15.jpg

East end unit: Conventional flat rafters with tapered shim on top provide roof pitch in this area. Rafters appear to be significantly undersized for span length.

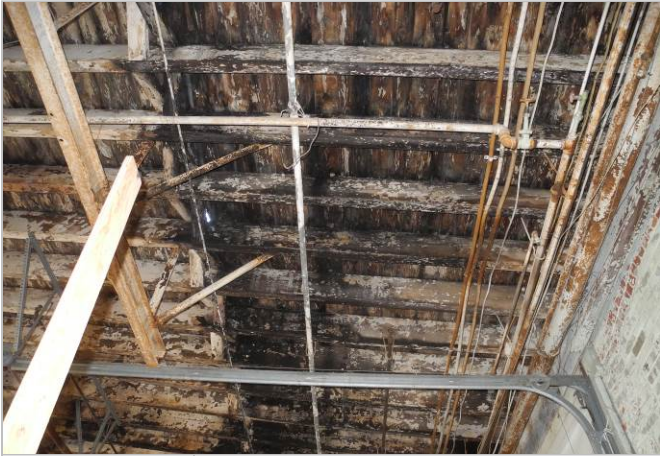
**PHOTO  
#7.6**  
A 30 20.jpg

North wall overhead door opening: Roof leaking near eaves is possibly causing wall top plate rot and infiltration into masonry above steel header.

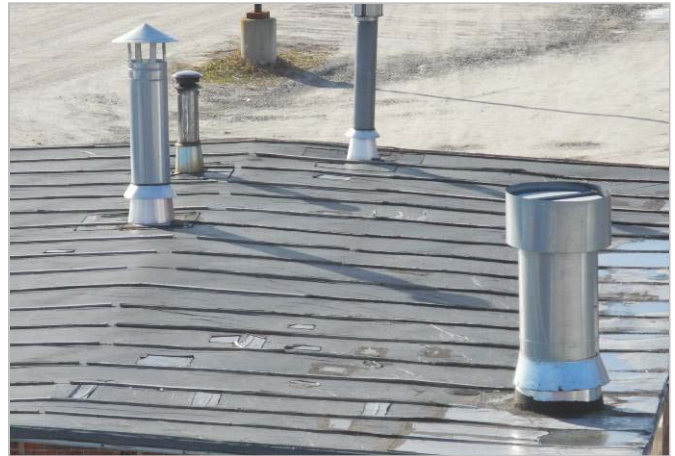
**PHOTO  
#10.1**

Building 10: View from Building 1 Roof showing Building 10 roof and East elevation. Note very low slope roof with surface partially covered by battens.

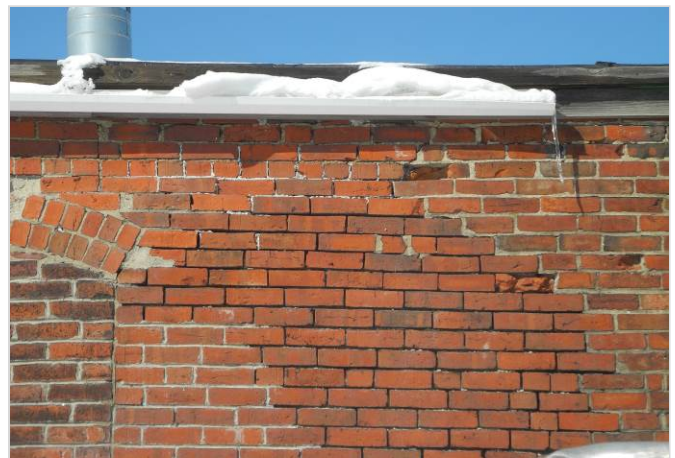
**PHOTO  
#10.3**

Building 10: West elevation wall showing unstable rebuilt south half (right) and deteriorated north section (left). Original window remains at south half.

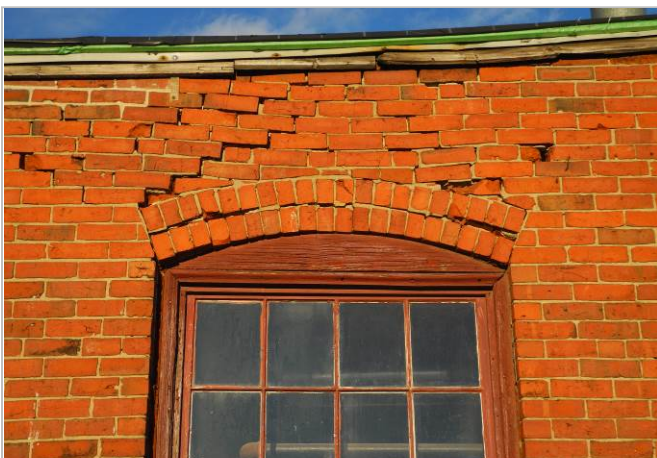
**PHOTO  
#10.4**

Building 10: Loose mortar and deteriorated masonry on South elevation near infilled window. Building likely retains few of its original windows.

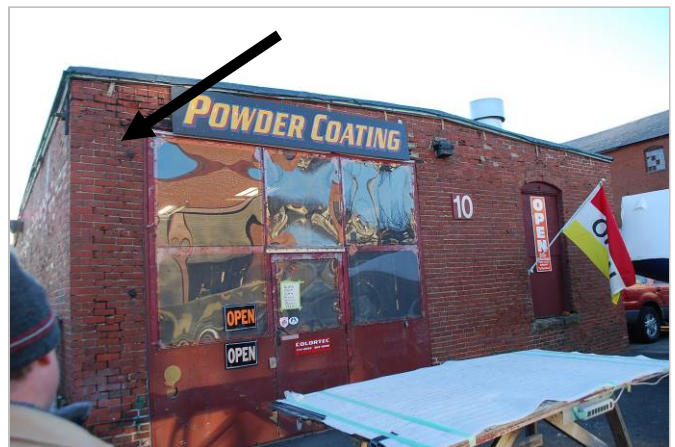
**PHOTO  
#10.5**

West elevation window: Significant bow in masonry wall and failed brick. Potential exists for significant water infiltration from driven rain.

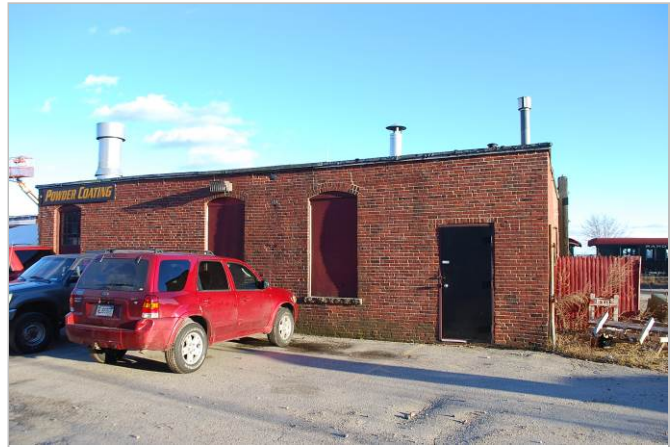
**PHOTO  
#10.7**  
R 128.jpg

Building 10 south wall: Note infilled windows with granite sills and arched headers.

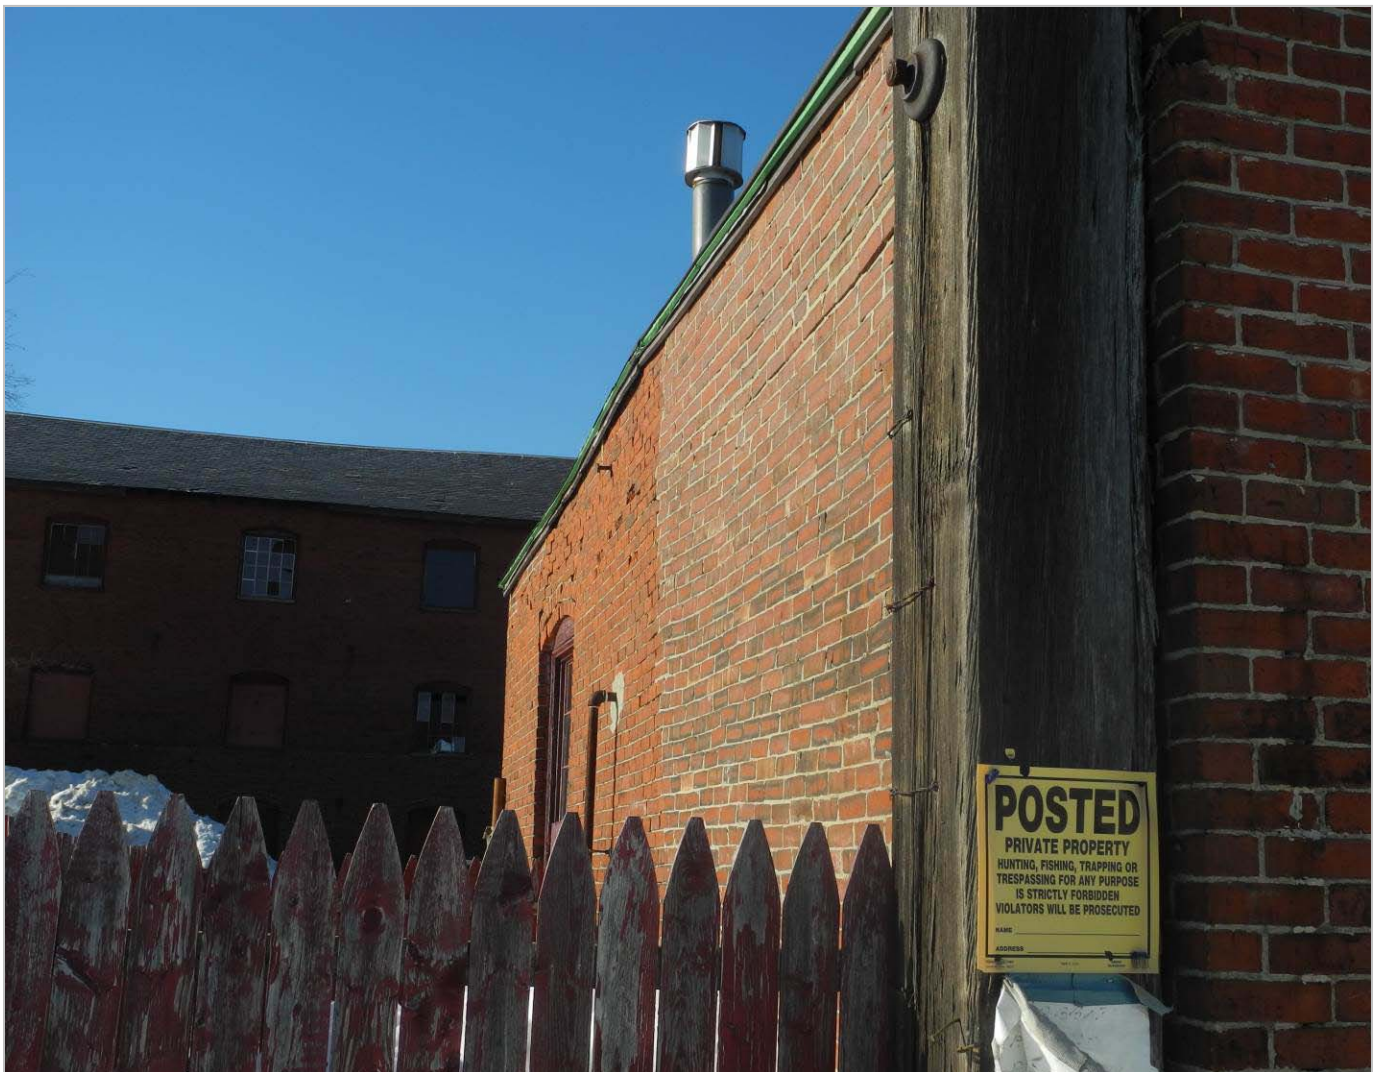
**PHOTO  
#10.8**  
R 124.jpg

Building 10 north wall: Infilled wood windows (one opening remaining) and recently-added door.

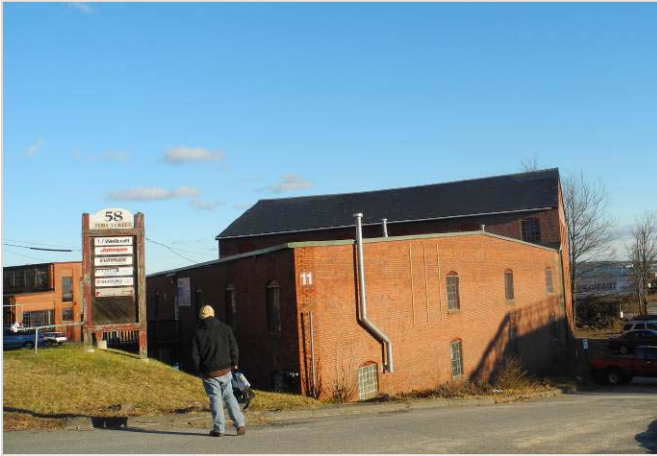
**PHOTO  
#10.9**  
A 3 5.jpg

West elevation, viewed from south: Significantly bowed masonry at south half of wall is unstable. Upper masonry at north half of wall is in poor condition (see Photo #10.5) We concur with the BSE report that the building should not be occupied.

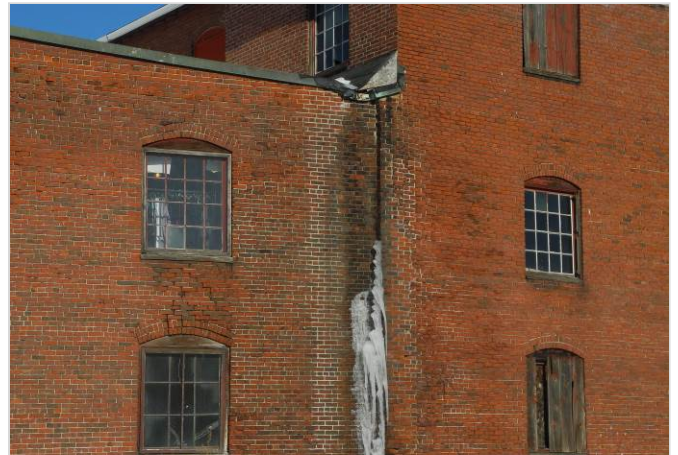
**PHOTO  
#11.3**  
A 3 81.jpg

Building 11: North elevation along driveway. Snow and water accumulations lead to infiltration, mortar erosion, lateral pressures and wall failure.

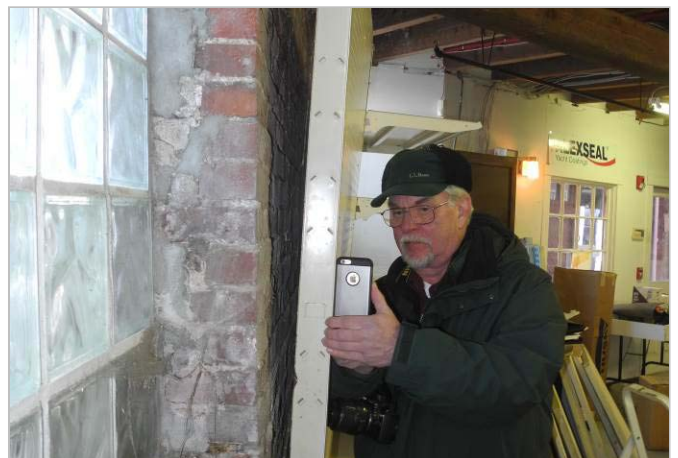
**PHOTO  
#11.5**  
A 30 30.jpg

Ground floor north wall: Significant bow in masonry wall caused by lateral earth pressure and potential local rot beneath floor.

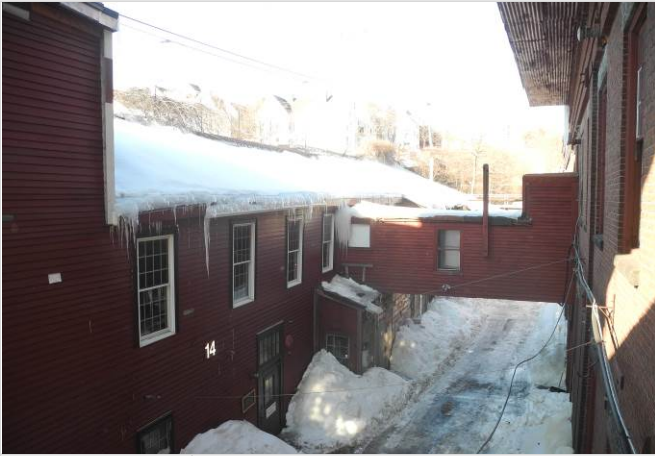
**PHOTO  
#11.10**

Roof framing: Apparent attempt to strengthen roof girder below drift area at Building 12 intersection. Ceiling conceals most framing, leaving condition unknown.

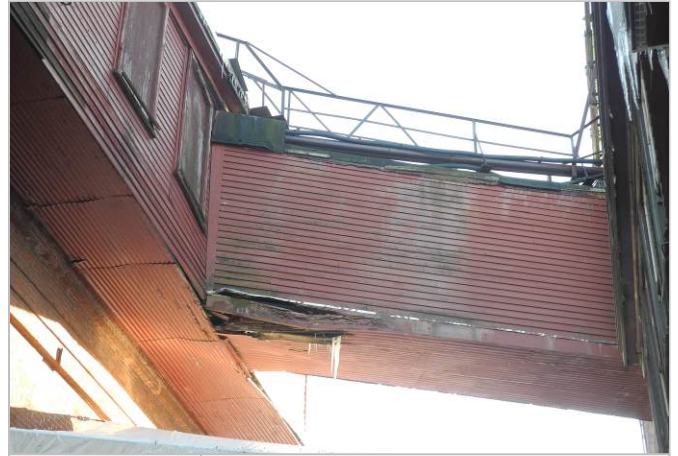
**PHOTO  
# 14.1**  
A 2 35.jpg

Building 14: View from walkway into Building 2 second floor. Fore Street runs roughly parallel to the Building 14 roofline.

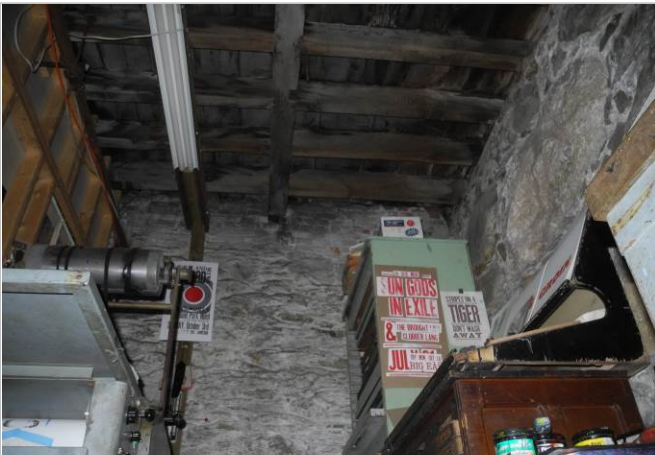
**PHOTO  
# 14.2**  
A 3 62.jpg

Building 14: East side of walkway to Building 2 third floor. Bridge connected drafting room to map room. Note rotted framing and water damage at base.

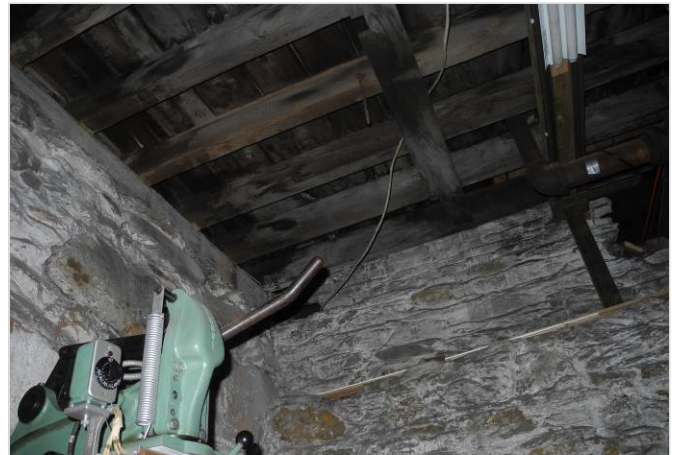
**PHOTO  
# 14.3**  
A 3 57.jpg

Building 14: First floor wall at west side of Building 14 serves as a buttress for the larger retaining wall at right.

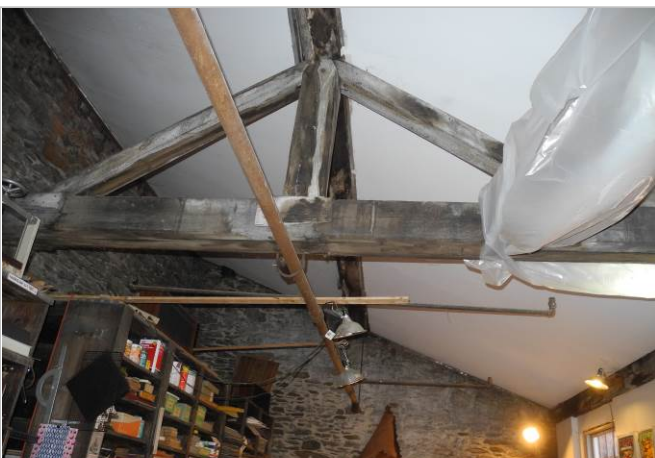
**PHOTO  
# 14.4**  
A 3 59.jpg

Building #14: East side of Building 14 wall buttress.

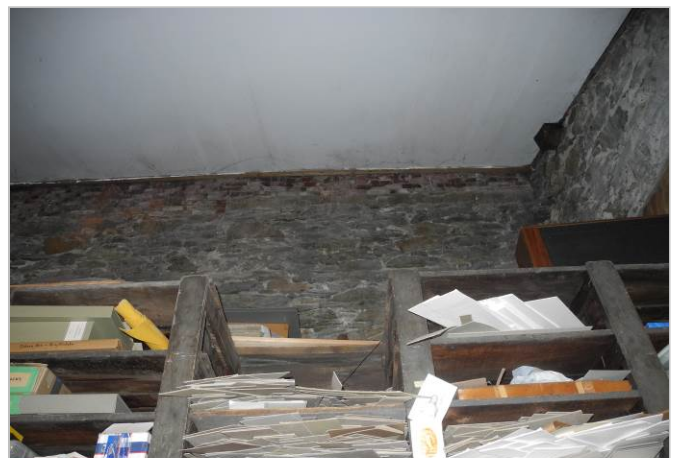
**PHOTO  
# 14.5**  
A 3 52.jpg

Building #14, second floor: Kingpost timber truss supporting pitched roof central purlin. Ceiling prohibited view of roof rafters and purlins in this room.

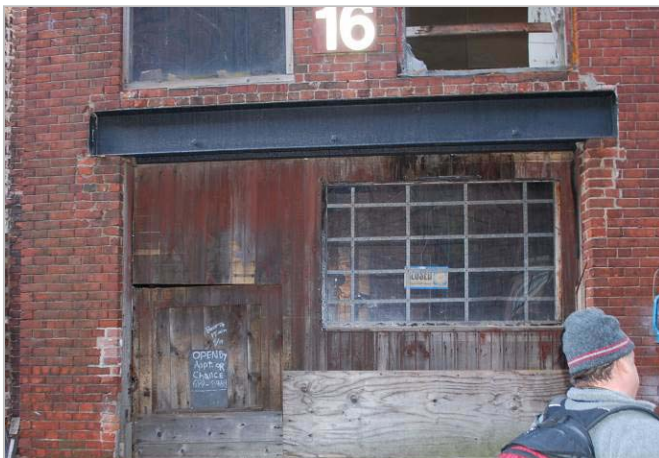
**PHOTO  
# 16.2**  
R 56.jpg

Building 15: View from southeast from alleyway. Building did not appear to be safe to enter, and we did not enter first floor.

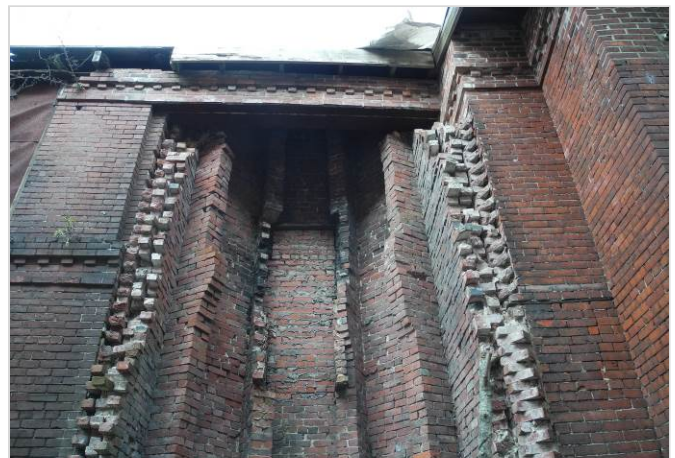
**PHOTO  
# 16.3**  
a f 93.jpg

Building 16: Enlarged opening in south elevation wall. Entire south wall requires repointing, repair, and anchoring into east wall.

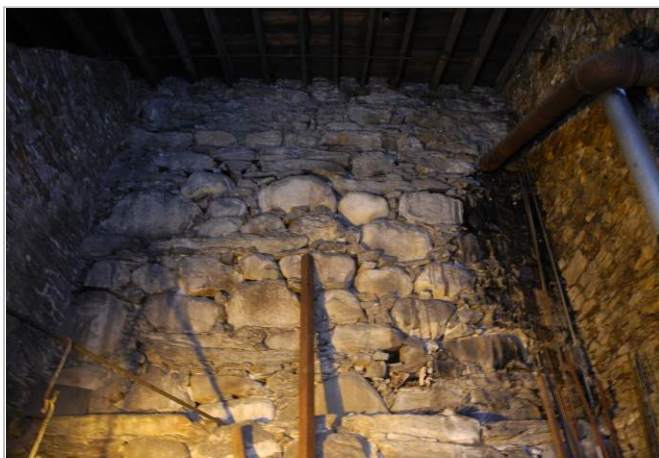
**PHOTO  
# 16.4**  
P 23.jpg

Building 15/16: Remnants of boiler house chimney stack between Buildings 15 and 16.

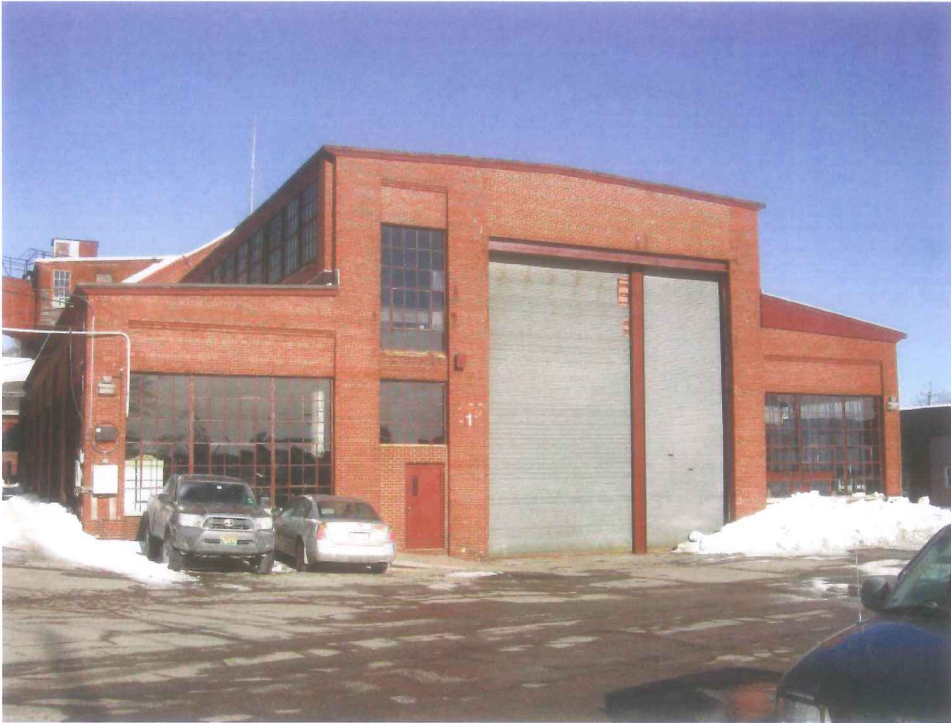
- Building 1 features a central, longitudinal clerestory high bay space with low “saddle bag” roofs to each side (Photo 1-1).
- The high bay space has bridge crane rails with dual bridge & trolley systems.

Photo 1-1: General View, Building 1

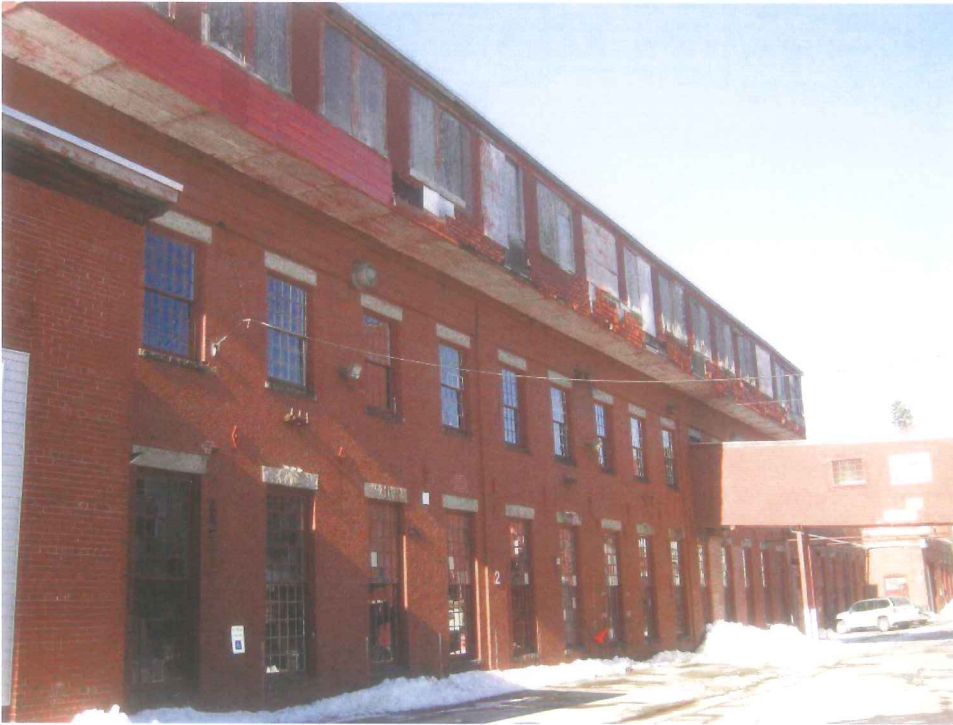
- Building 2 features open bay ground floor, second floor hung from timber trusses/loft area above (Photo 2-1). Loft area has overhanging shed roof structure that appears to be added after the original construction. Exterior brick masonry walls are load bearing.

Photo 2-1: Building 2 exterior south elevation.

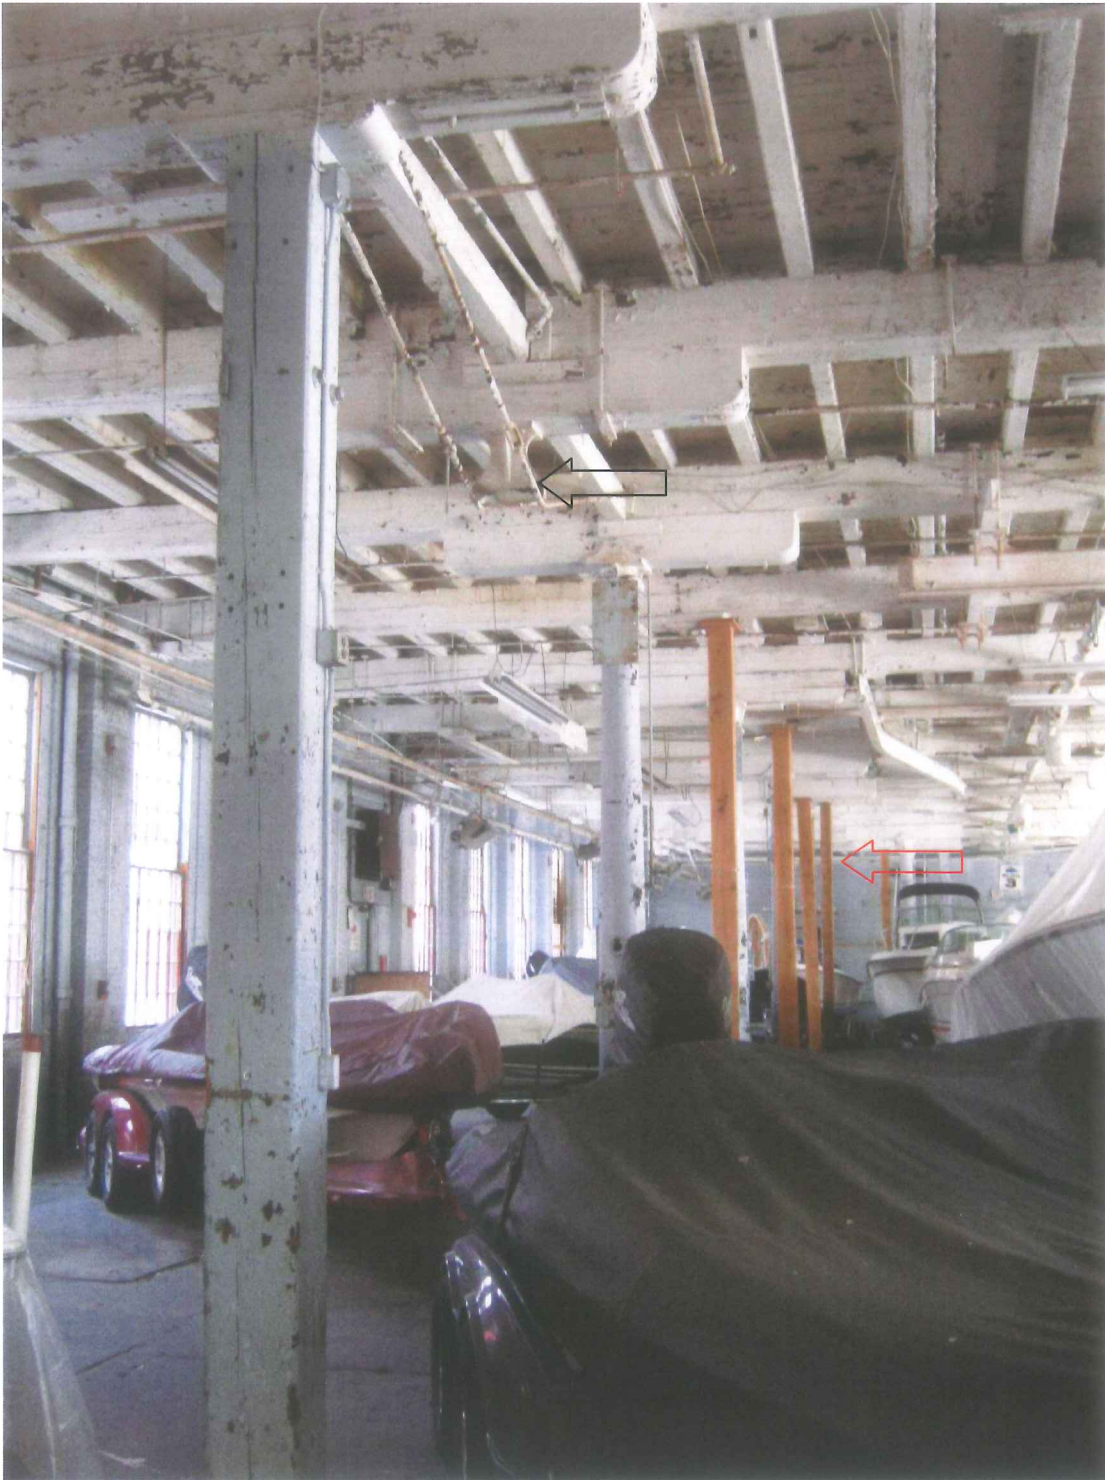
- Several timber posts have been added between the ground floor and second floor for supplemental support. Hanger rods from above were removed in several locations and it is likely these posts were provided to supplement the structure (Photo 2-2).

- Second floor and loft show evidence of significant permanent creep deflection.
- Queen and king post trusses rods, steel beams and other methodology have been utilized to supplement the second floor framing in an inconsistent manner (Photo 2-2).

Photo 2-2: Interior photo, building 2 taken from the ground floor. Note added posts, king post truss.

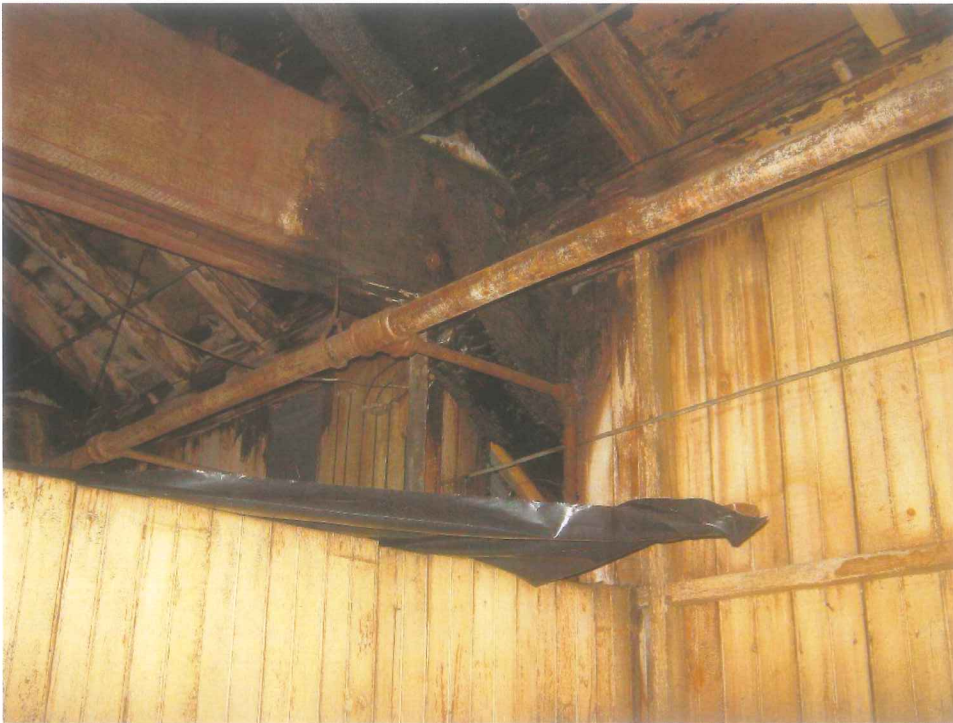
- Modified hangers were noted extending from the loft trusses to the second floor framing.
- At the roof and loft level, charring and fire damage of truss members and wood decking was noted. Several members had substantial charring damage (Photo 2-3).

Photo 2-3: Charring of truss top chord.

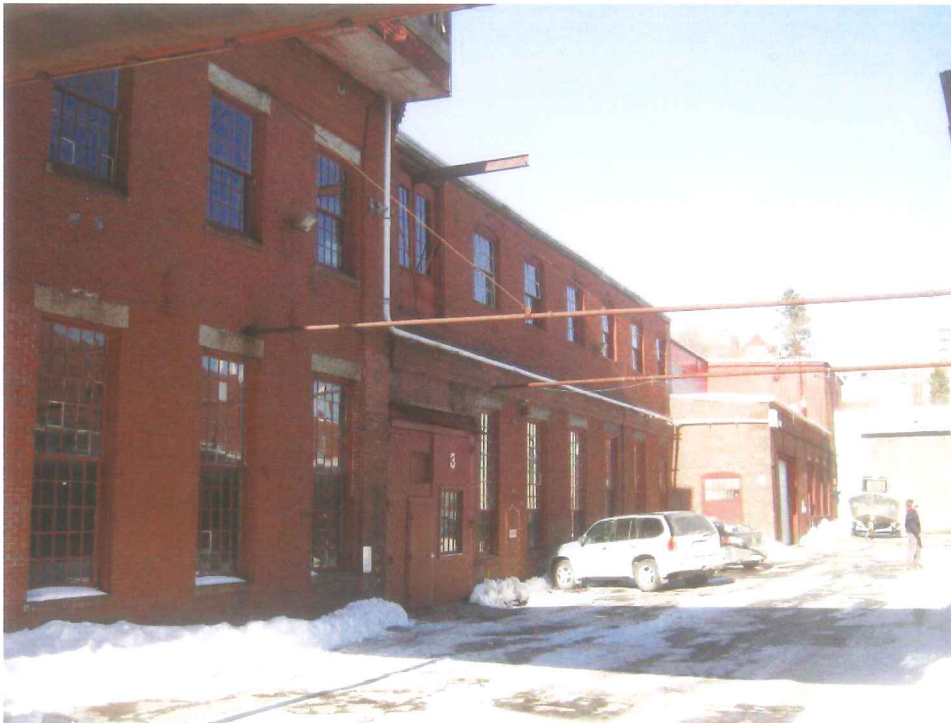
Photo 3-1: Exterior view of Building 3

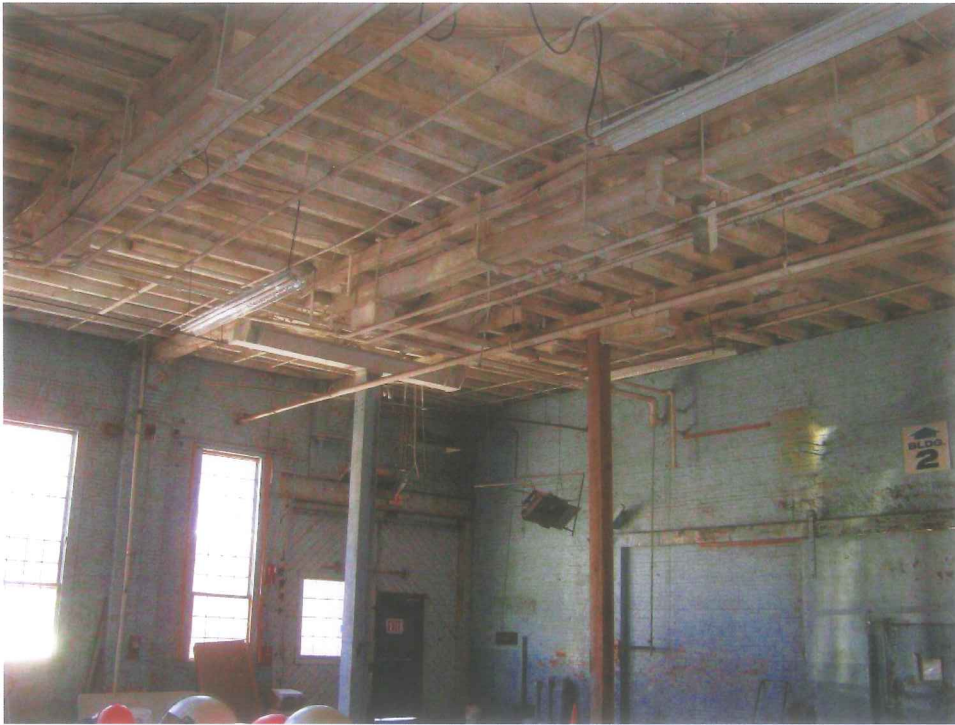
- Several timber posts have been added between the ground floor and second floor for supplemental support. Hanger rods from above were removed in some locations and it is likely these posts were provided to supplement the structure (Photo 3-2).

- Second floor show evidence of permanent creep deflection.
- A steel "T" column was added in one location presumably to eliminate an interference. Unbalanced loading on the cantilevered ends of the "T" beam may not be rationally stable (Photo 3-2).

Photo 3-2: Interior view of Building 3. Note supplemental post, "T" column, queen post trusses.

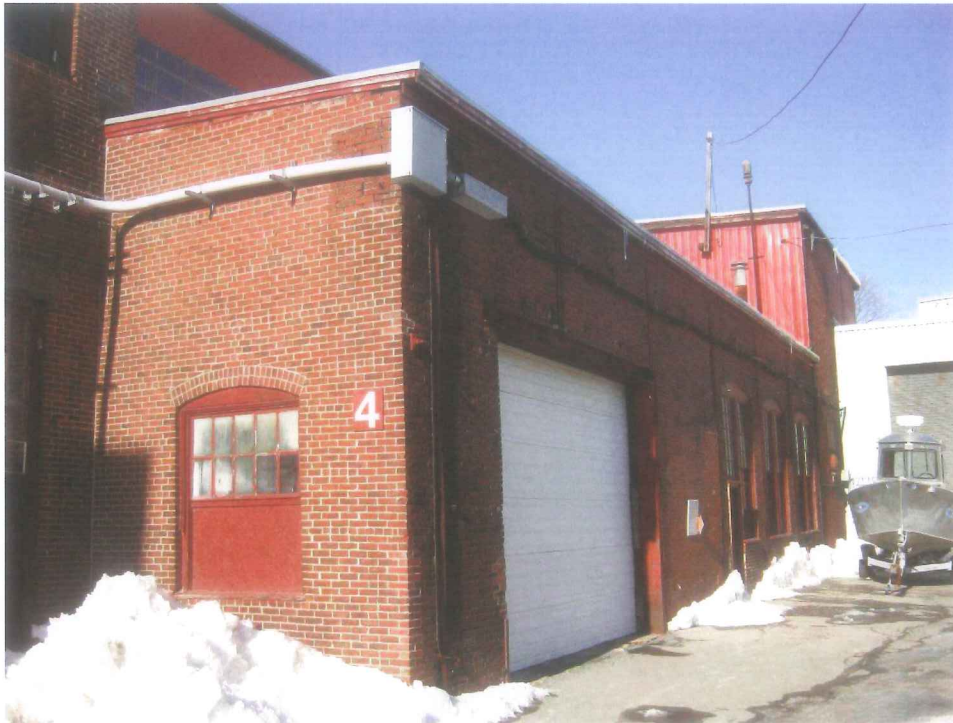
- Building 4 features a central, longitudinal double clerestory high bay space with low “saddle bag” roofs to each side [configuration similar to building 1] (Photo 4-1 & 4-2).

Photo 4-1: Exterior of Building 4. Note a majority of the south and east faces of the building are wrapped by Building 5.

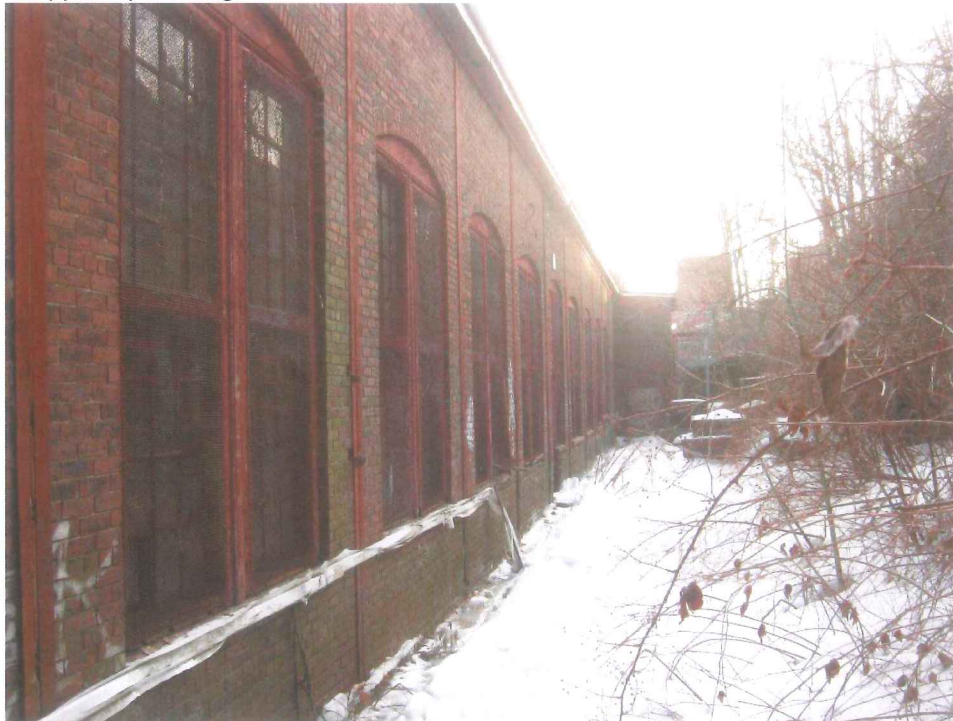
- Wood plank roof decking was rotting in several locations, particularly at eaves due to leaking roofs (Photo 4-2). In general, roof appears to have leaks throughout. Wood deck not effective diaphragm to transfer lateral loads.

Photo 4-2: Exterior of Building 4, North Side.

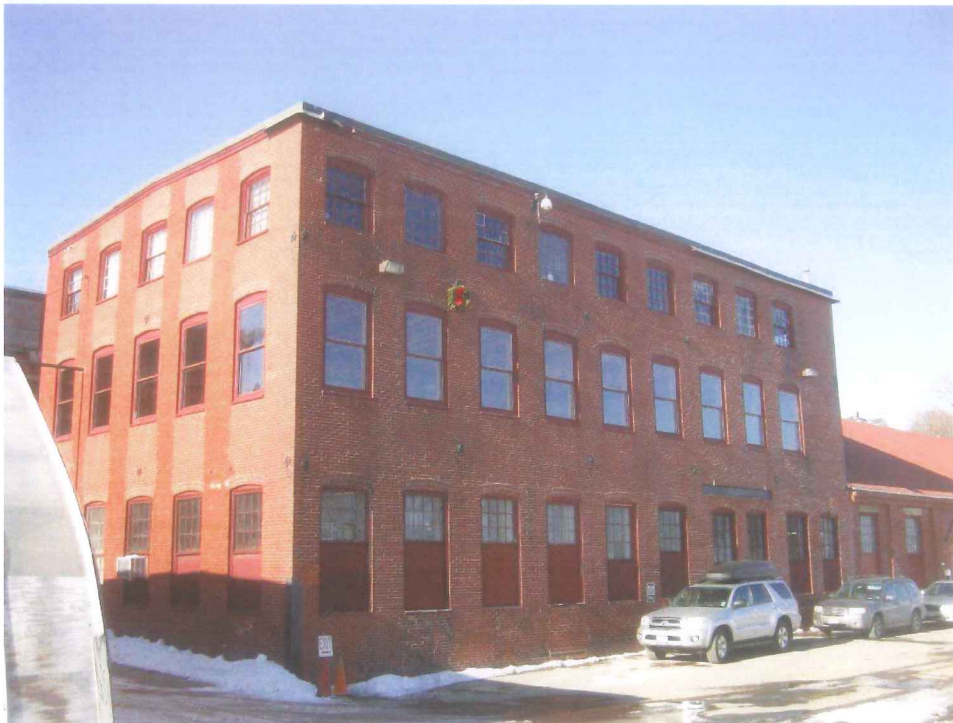
Photo 6A-1: Building 6A exterior view.
