- i. Presentation on Findings of Building Condition Report; PORTLAND COMPANY COMPLEX, 58 FORE STREET; Report prepared by Resurgence Engineering and Preservation for City of Portland Planning Department.

**RE:** April 1, 2015      WORKSHOP – Presentation on Findings of Building Condition Assessment of Portland Company Complex

# PORTLAND COMPANY COMPLEX GENERAL BUILDING CONDITION REPORT

PERFORMED FOR  
CITY OF PORTLAND, MAINE PLANNING DEPARTMENT  
389 CONGRESS STREET  
PORTLAND, ME 04101

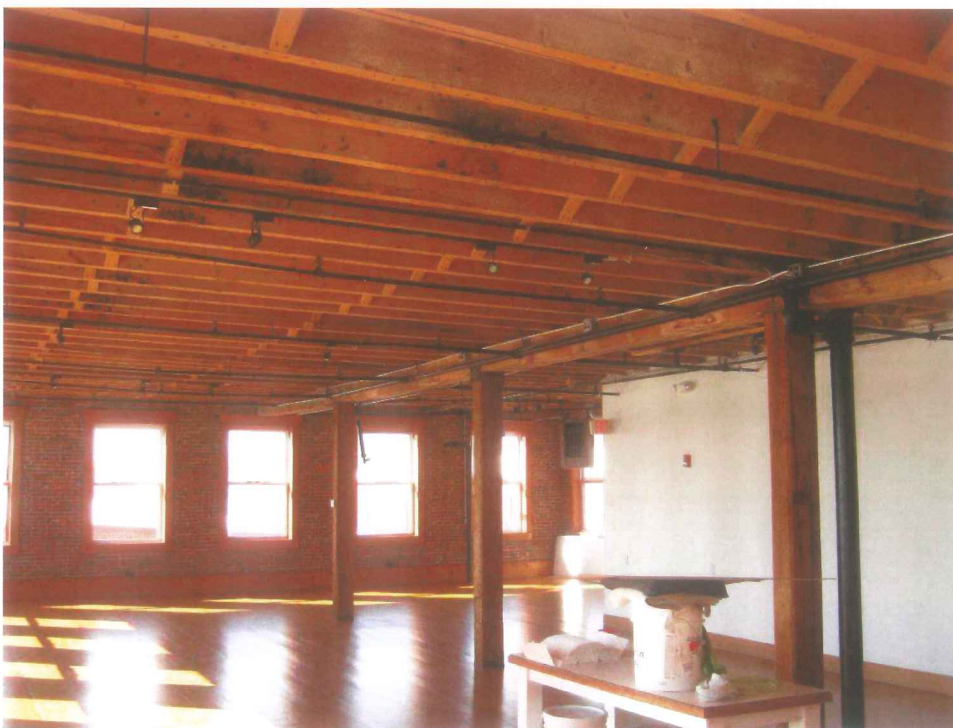
- Floors have slope to center beam bearing line. It is suspected that the center bearing line has either settled or timber column bases have deteriorated (Photo 6A-2). Timber column bases were surrounded by a concrete slab-on-grade and could not be observed.

Photo 6A-2: General view of center bearing line of Building 6A at second floor level.

- Center bearing foundations may require rework; additional investigation will be required to understand cause of column settlement.
- Lateral load resisting system will require retrofit to address stiffness discontinuity. Introduce lateral load resisting system with wall shotcrete or steel frame.
- Repair exterior masonry including repointing, rebuilding bulged areas, cleaning.
- Replace first and third floor windows.
- Replace wood elements and repaint.

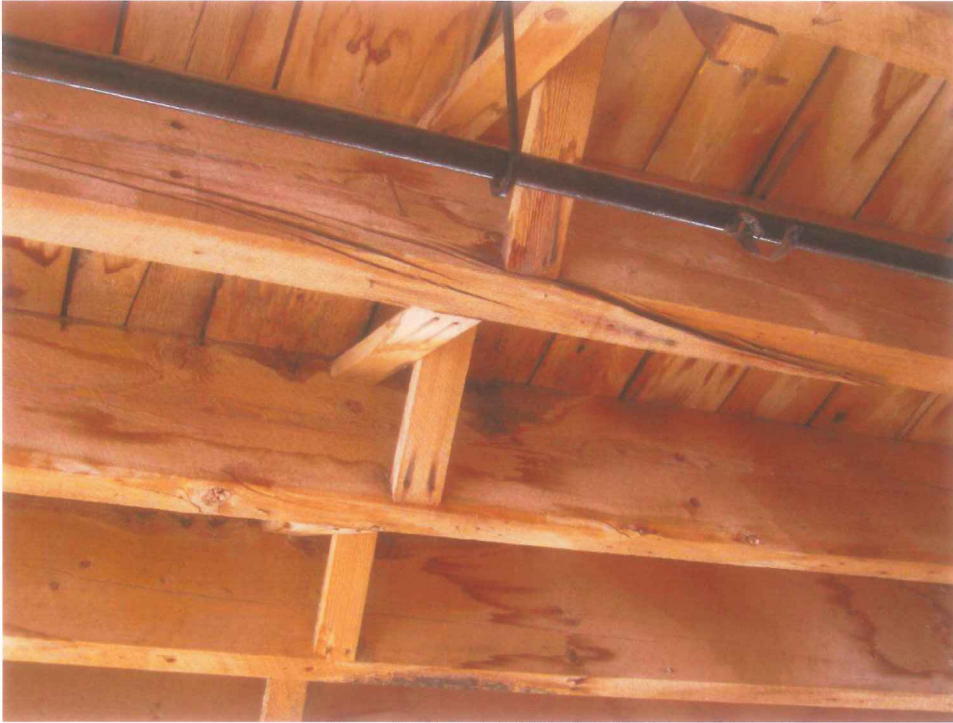
- Several floor joists have longitudinal splitting and may have been overstressed (Photo 6A-3 & 4).
- Visual evidence of prior leaking was visible at the roof level, but leaks did not appear to be active (Photo 6A-5 ).

Photo 6A-3: Floor joist splitting.

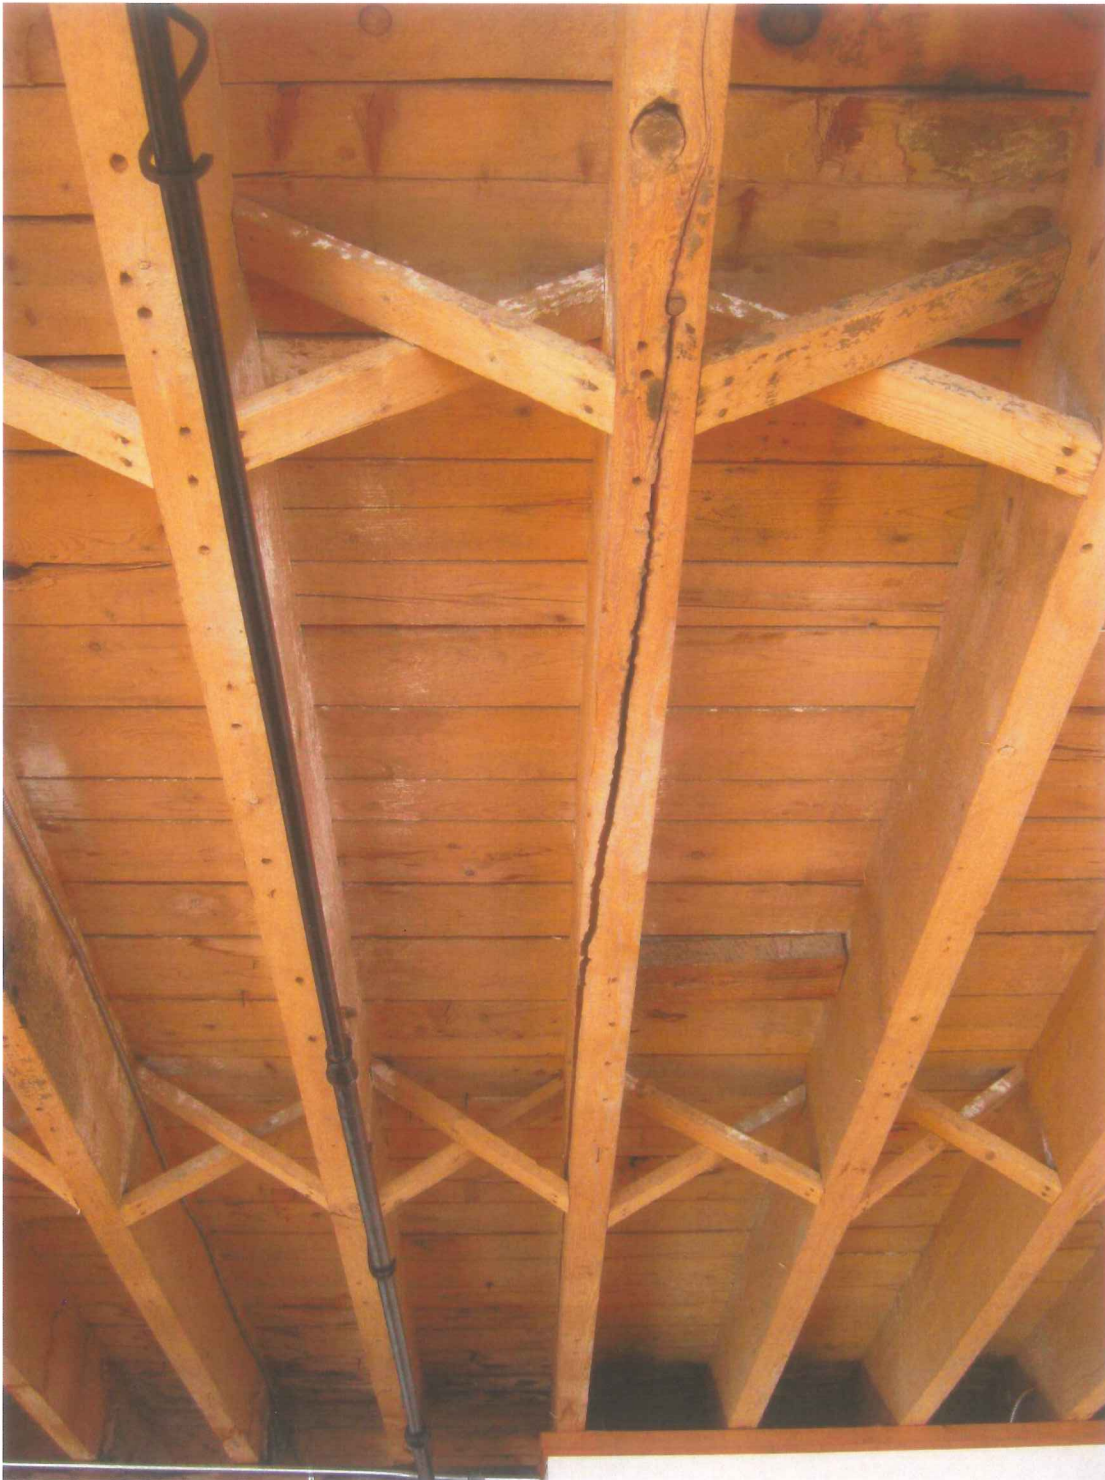
Photo 6A-4: Floor joist splitting.

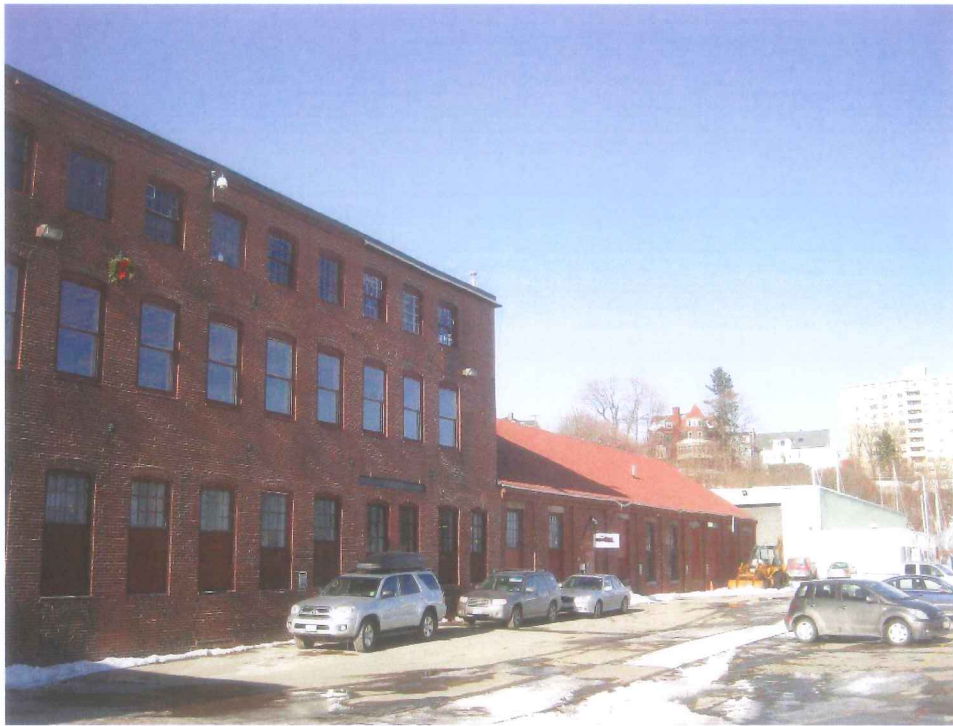
Photo 6B-1: Buildings 6A (left) and 6B (right).

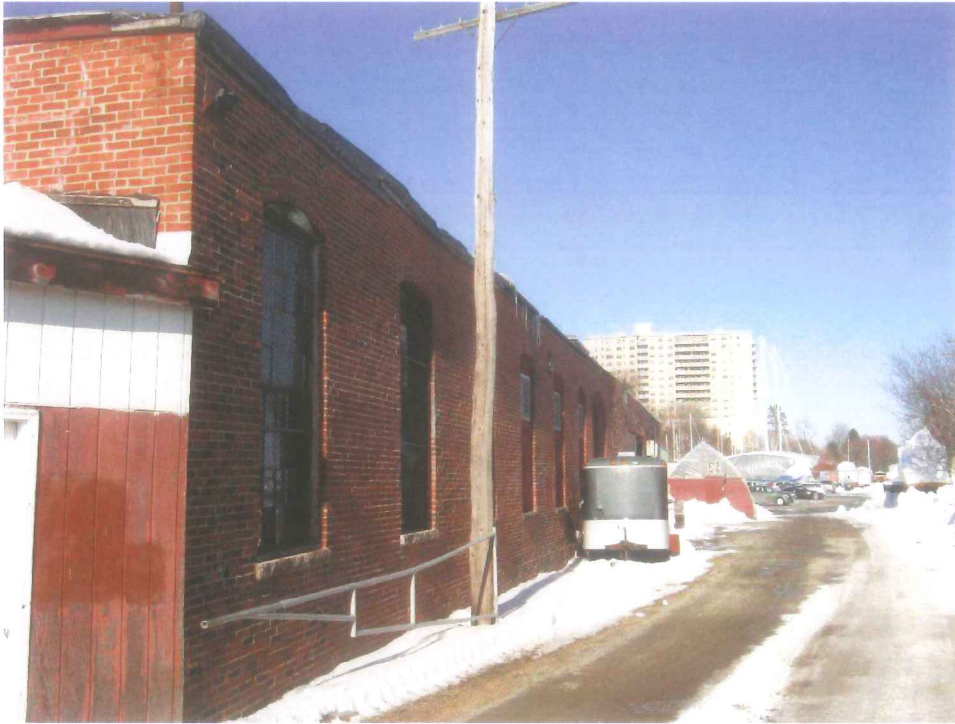
Photo 7-1: South elevation of Building 7.

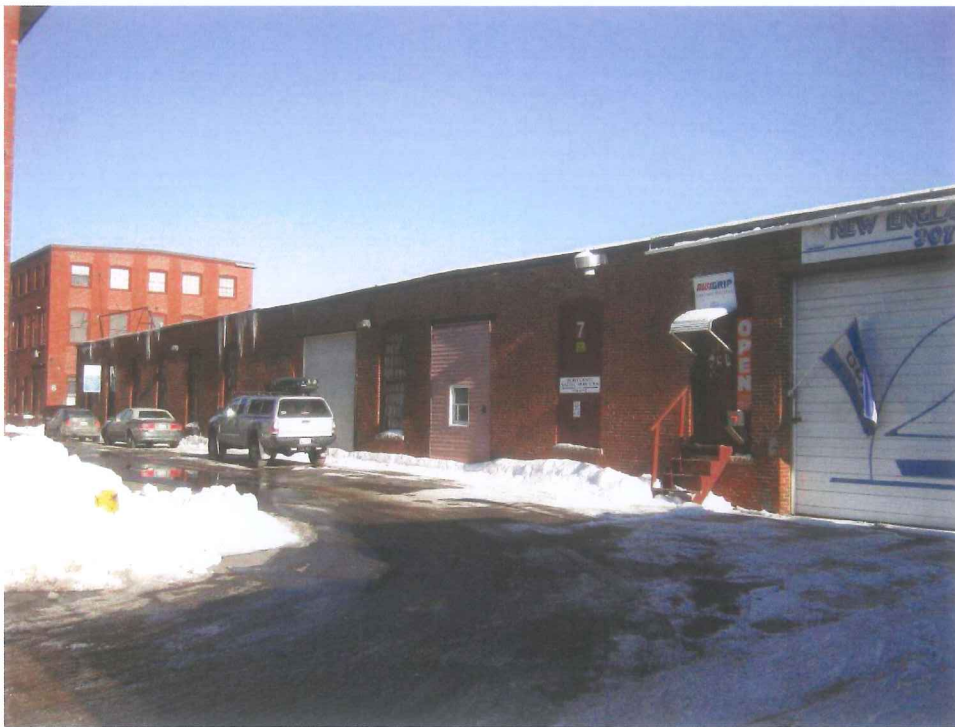
Photo 7-2: North elevation of Building 7.

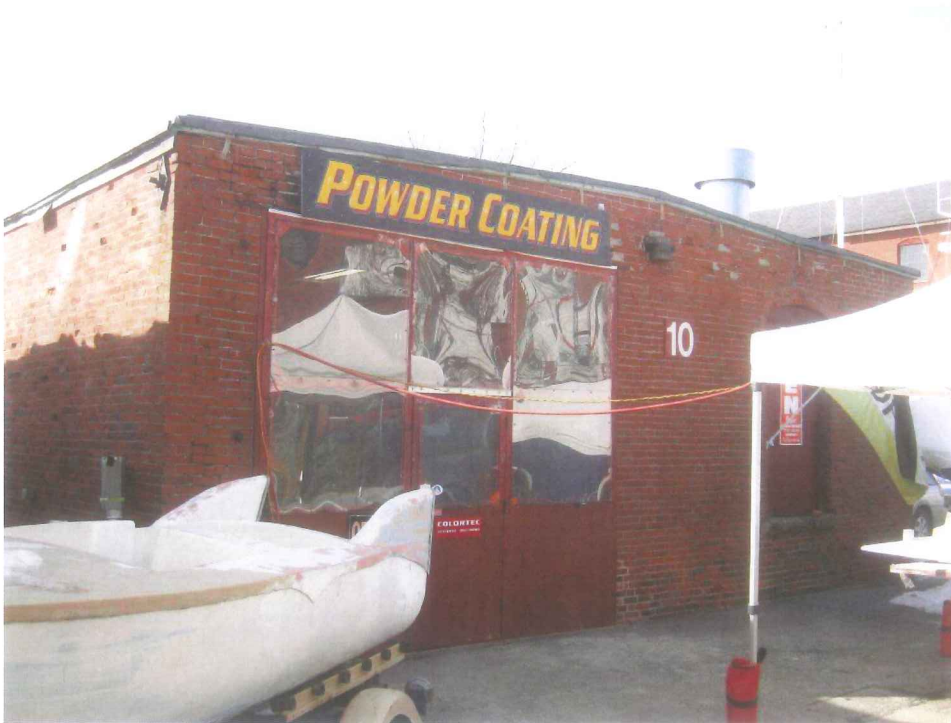
Photo 10-1: Exterior view of Building 10.

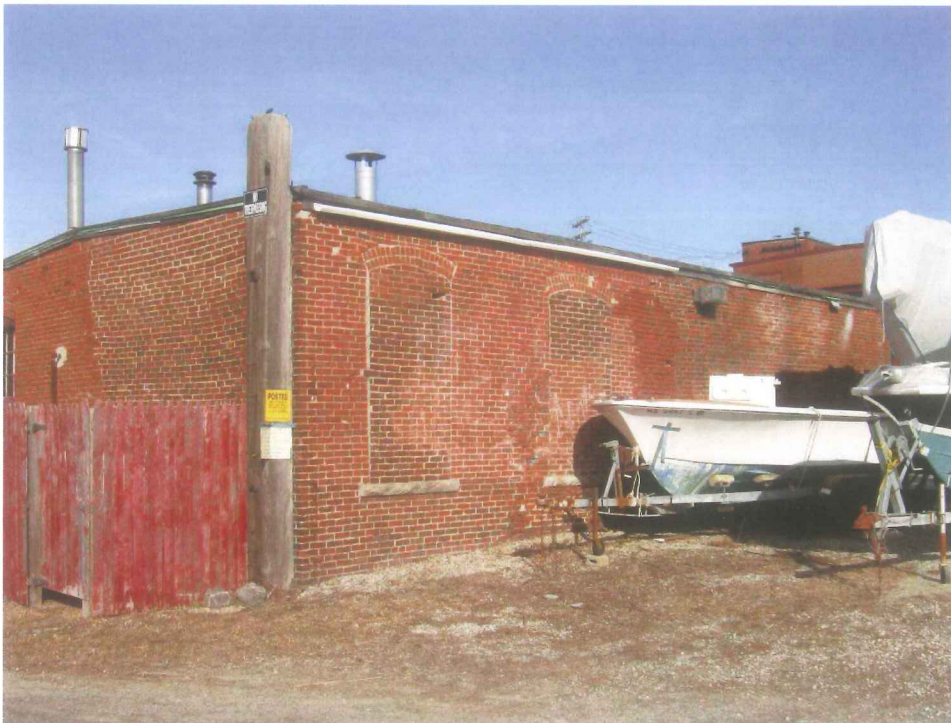
Photo 10-2: Exterior view of Building 10.

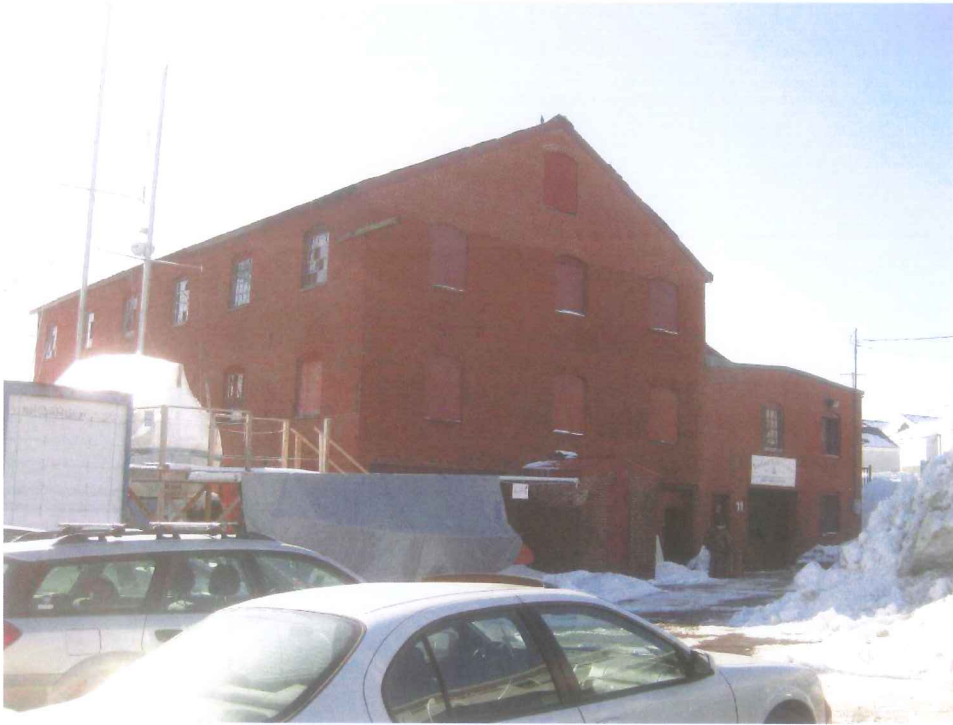
Photo 11-1: Buildings 11 (right) and 12 (left) looking at southeast corner.

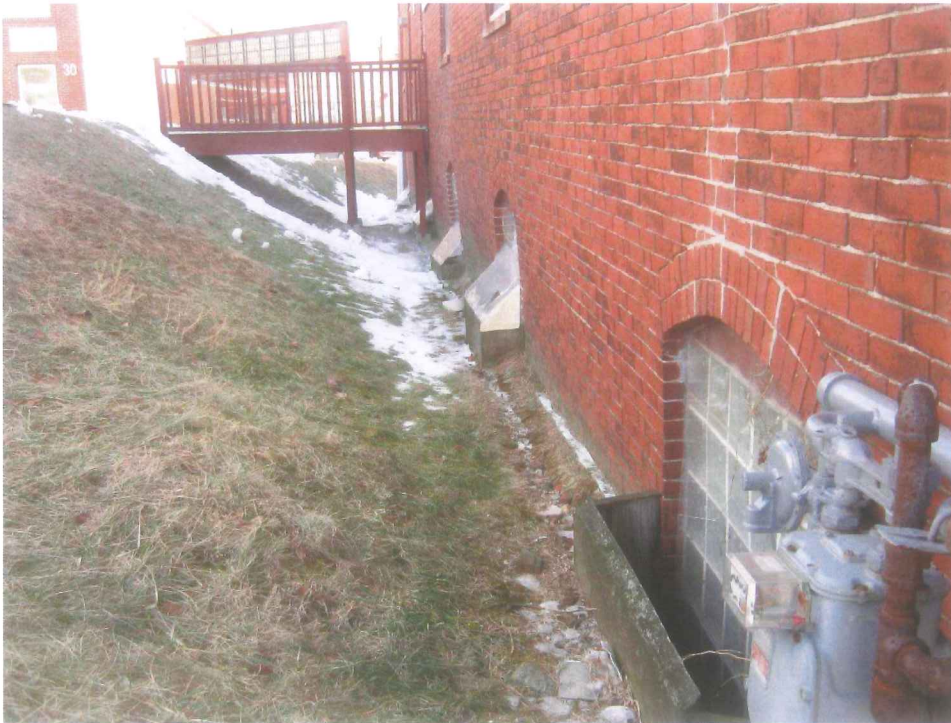
- Roof is likely not designed for sliding and drifting snow coming from adjacent Building 12 pitched roof.
- The exterior ground floor wall to north is retaining an embankment and is severely bowed inward from the window sill line up (Photo 11-3). Window wells in this area provide avenue for water entry (Photo 11-4).

Photo 11-4: Window wells and embankment at north wall.

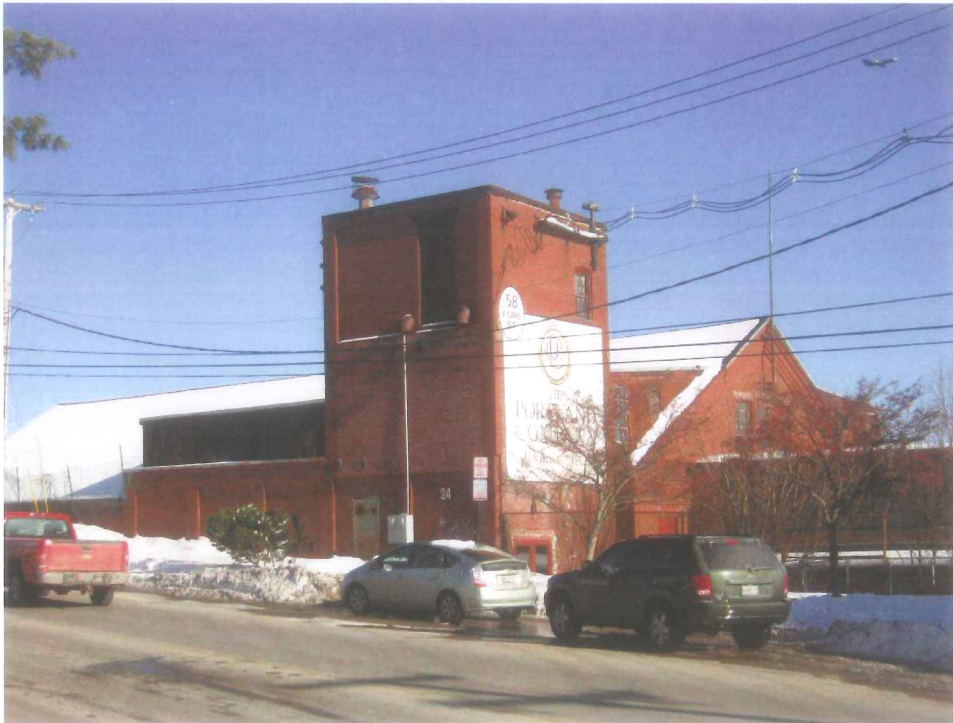
Photo 58-1: 58 Fore Street Vault/Tower structure viewed from Fore Street.

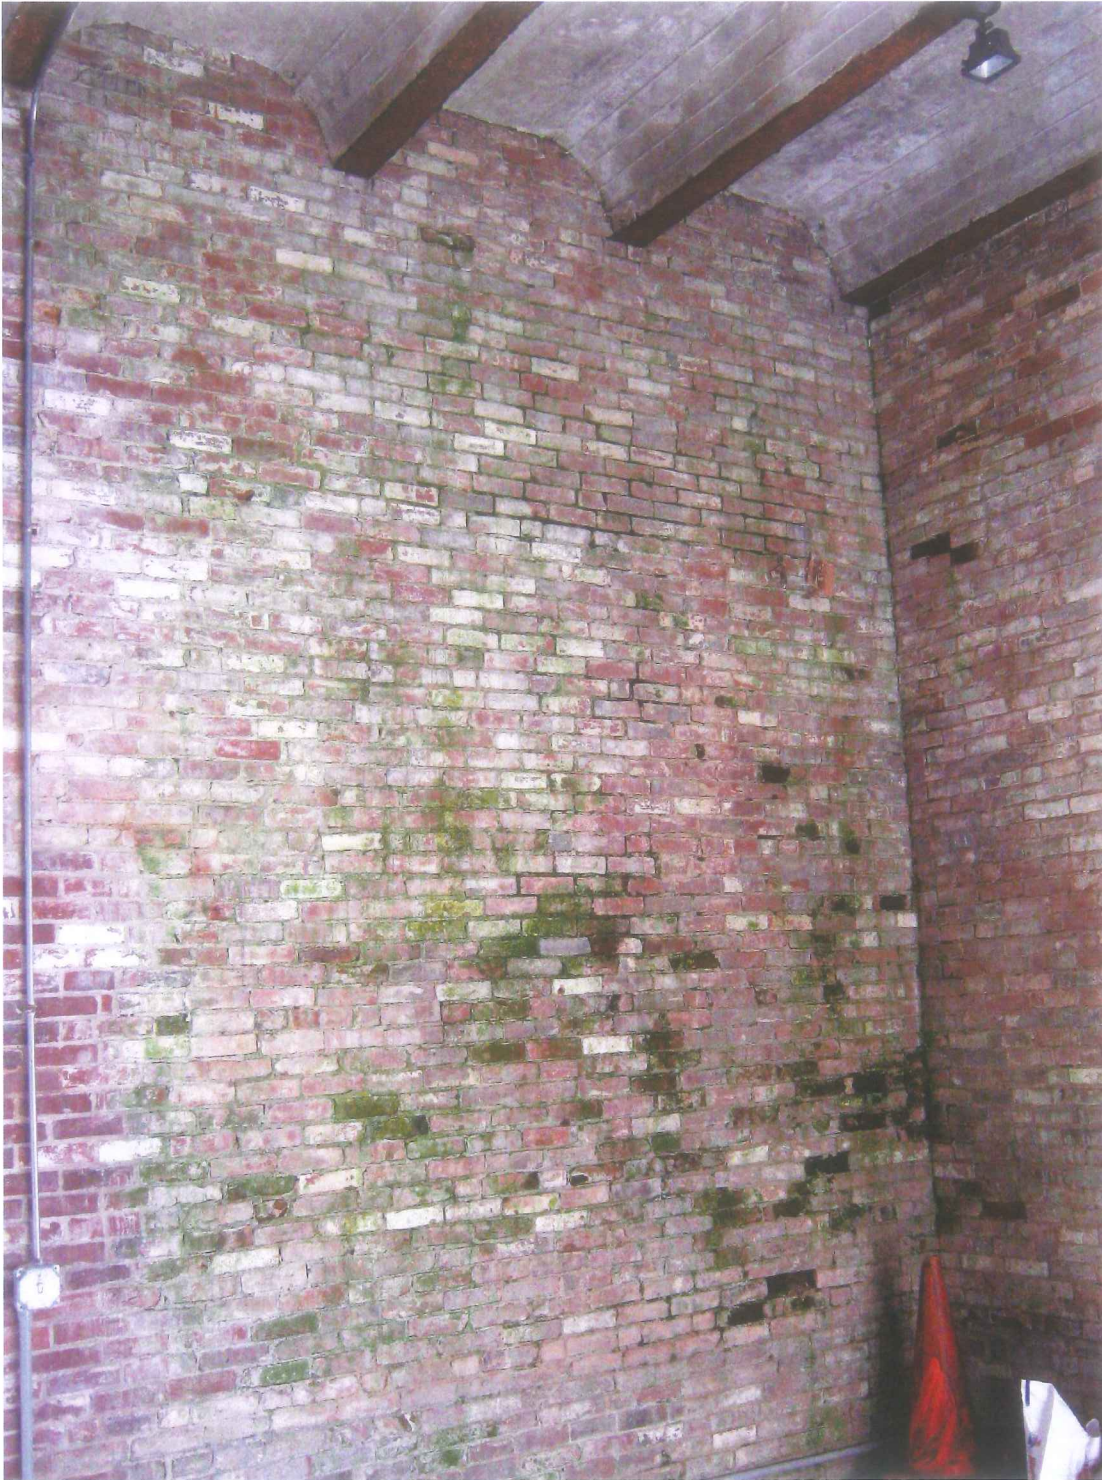
Photo 58-1: Moss growing on interior walls.

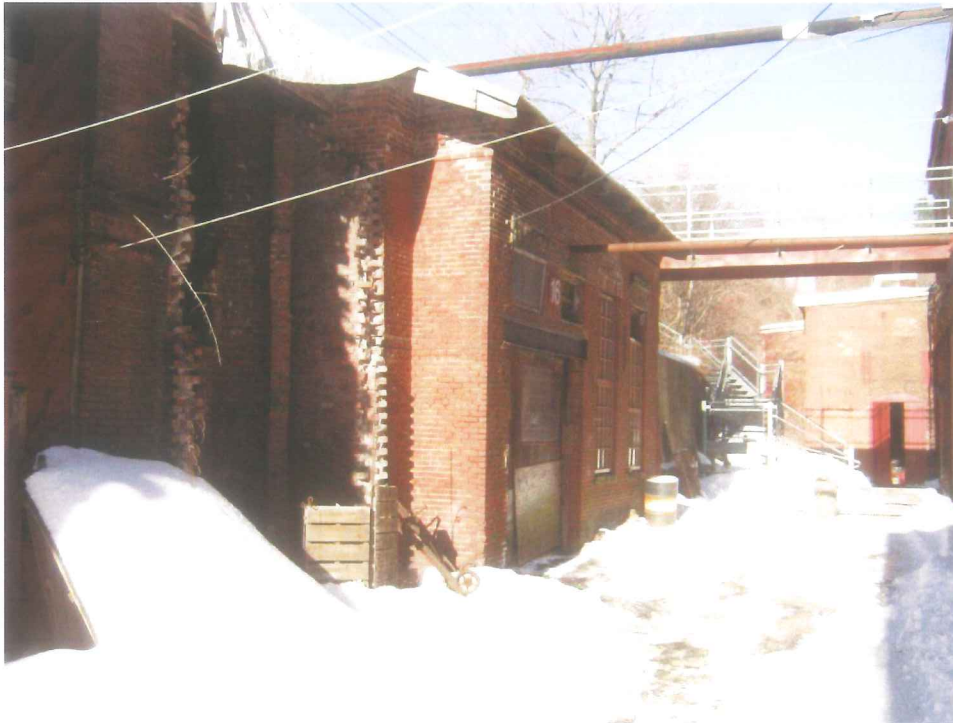
- Wood rafter framed roof, back wall and side walls are stone retaining wall for embankment, brick masonry front wall (Photo 16-1).
- Fore Street stone retaining wall at is dry stacked. It was apparent that water travels through the wall.

Photo 16-1: Exterior view of blacksmith shop/Building 16.

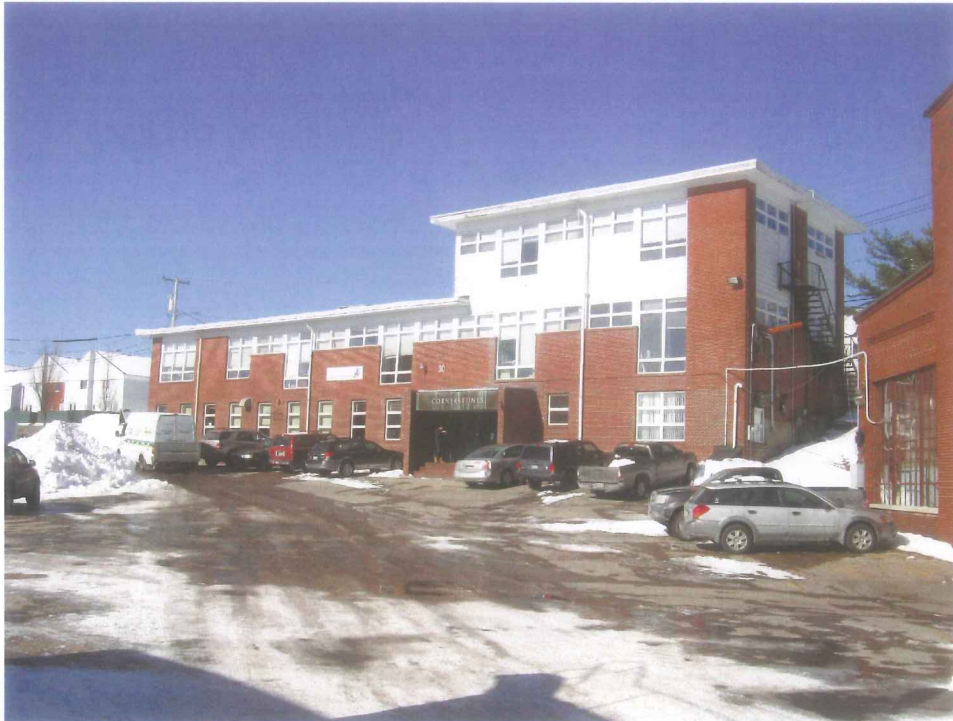
Photo 30-1: Southwest elevation of building 30.

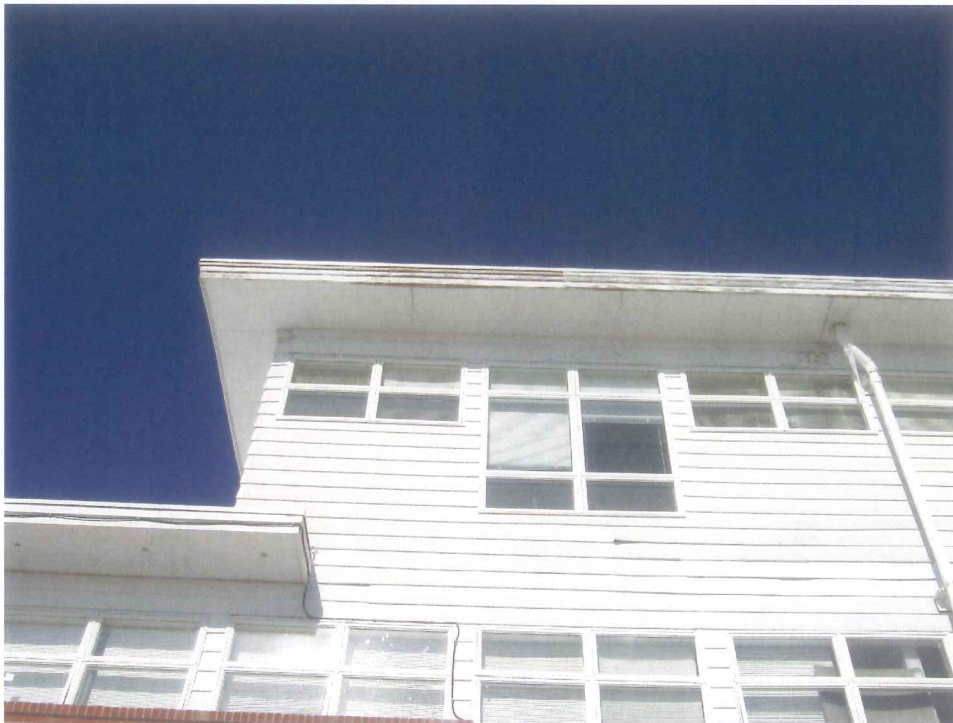
- Building 30 is a two story building with a third story roof pop up area to the east.
- Review as limited- Hard ceilings were in place at time of review and spaces were occupied.
- Peeling paint was noted particularly at the high roof eave (Photo 30-2).
- Siding was uneven and may suggest underlying issues (Photo 30-2).
- Evidence of leaking was noted in several locations on the fixed ceiling adjacent to the southwest wall (Photo 30-3).
- On the south face open joints were noted with horizontal steel protruding. The steel was corroded. Other open joints and missing bricks were noted.
- Window lintels were rusted with mortar separation from the horizontal leg.
- Building exterior sealants are past design life.
- Downspout were leaking and frozen.
- Entry step heights do not meet code requirements.

Photo 30-2: Peeling paint at roof eave, uneven siding.
