# CITY OF PORTLAND, MAINE

## HISTORIC PRESERVATION BOARD

WORKSHOP  
ONE CENTER STREET

Fathom HKS  
SCHEMATIC DESIGN  
01.16.2019

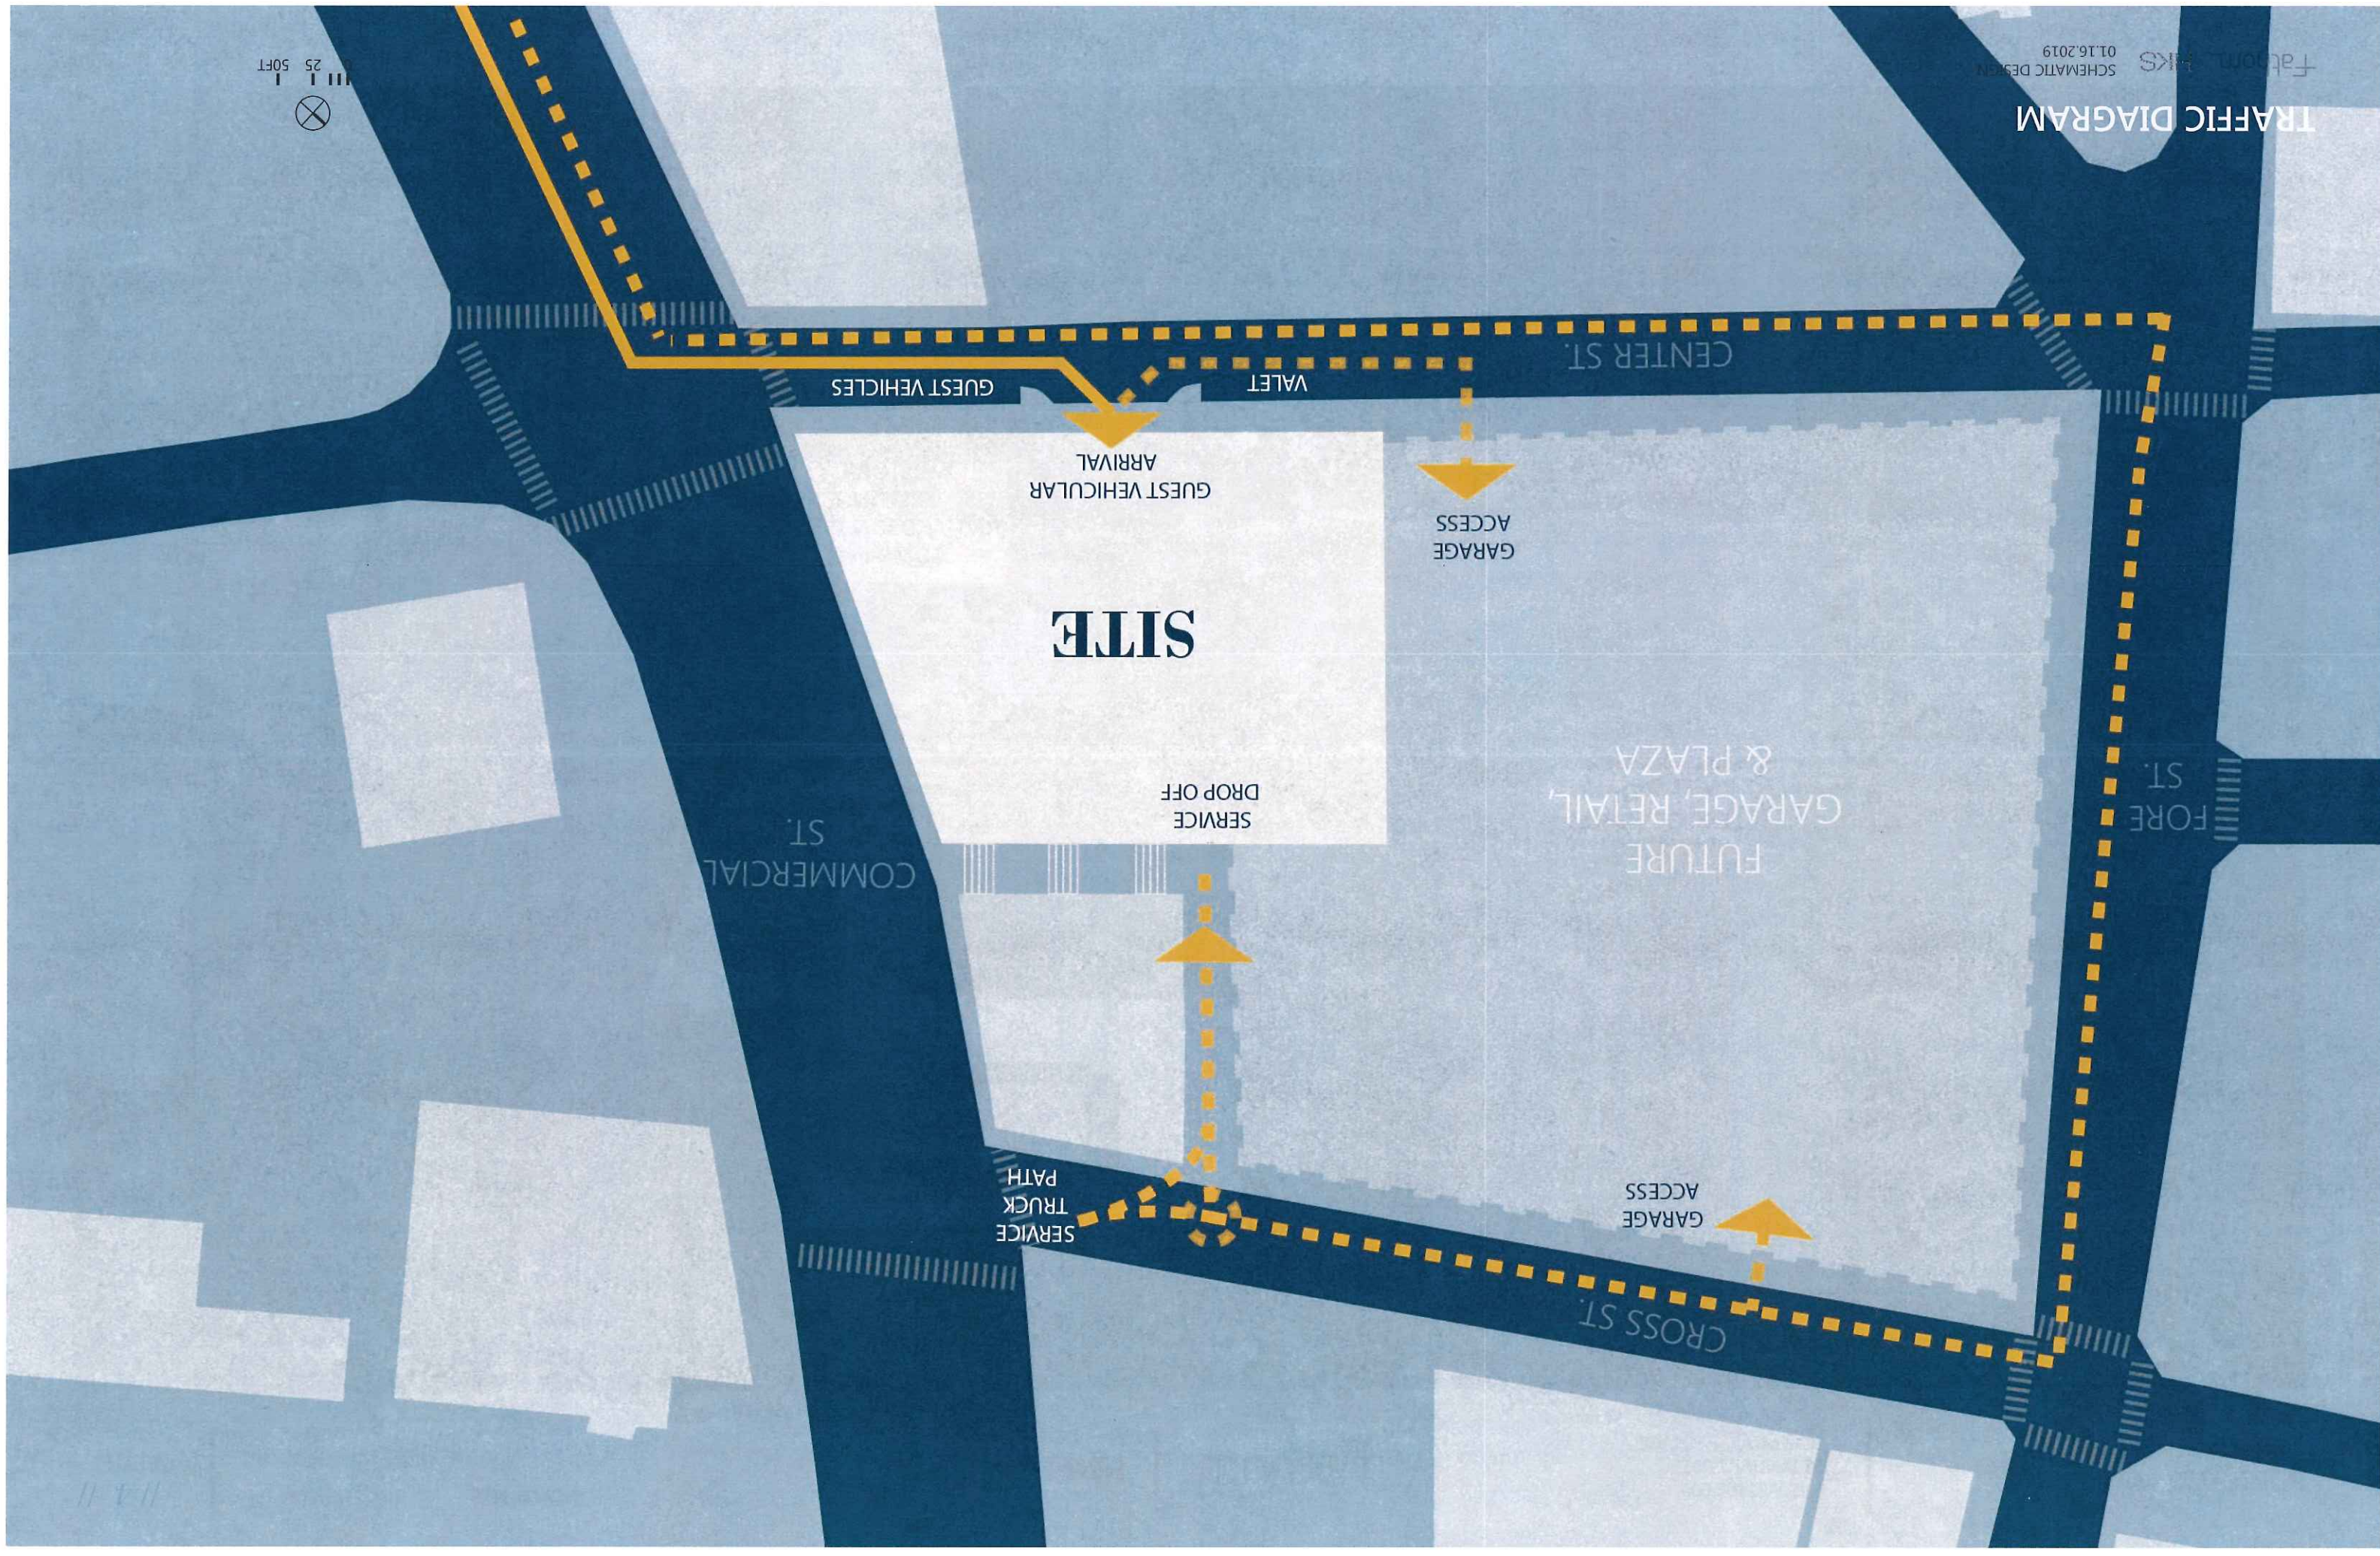
## PEDESTRIAN ACCESS DIAGRAM

LEVEL 01 - STREET LEVEL  
SCALE NTS

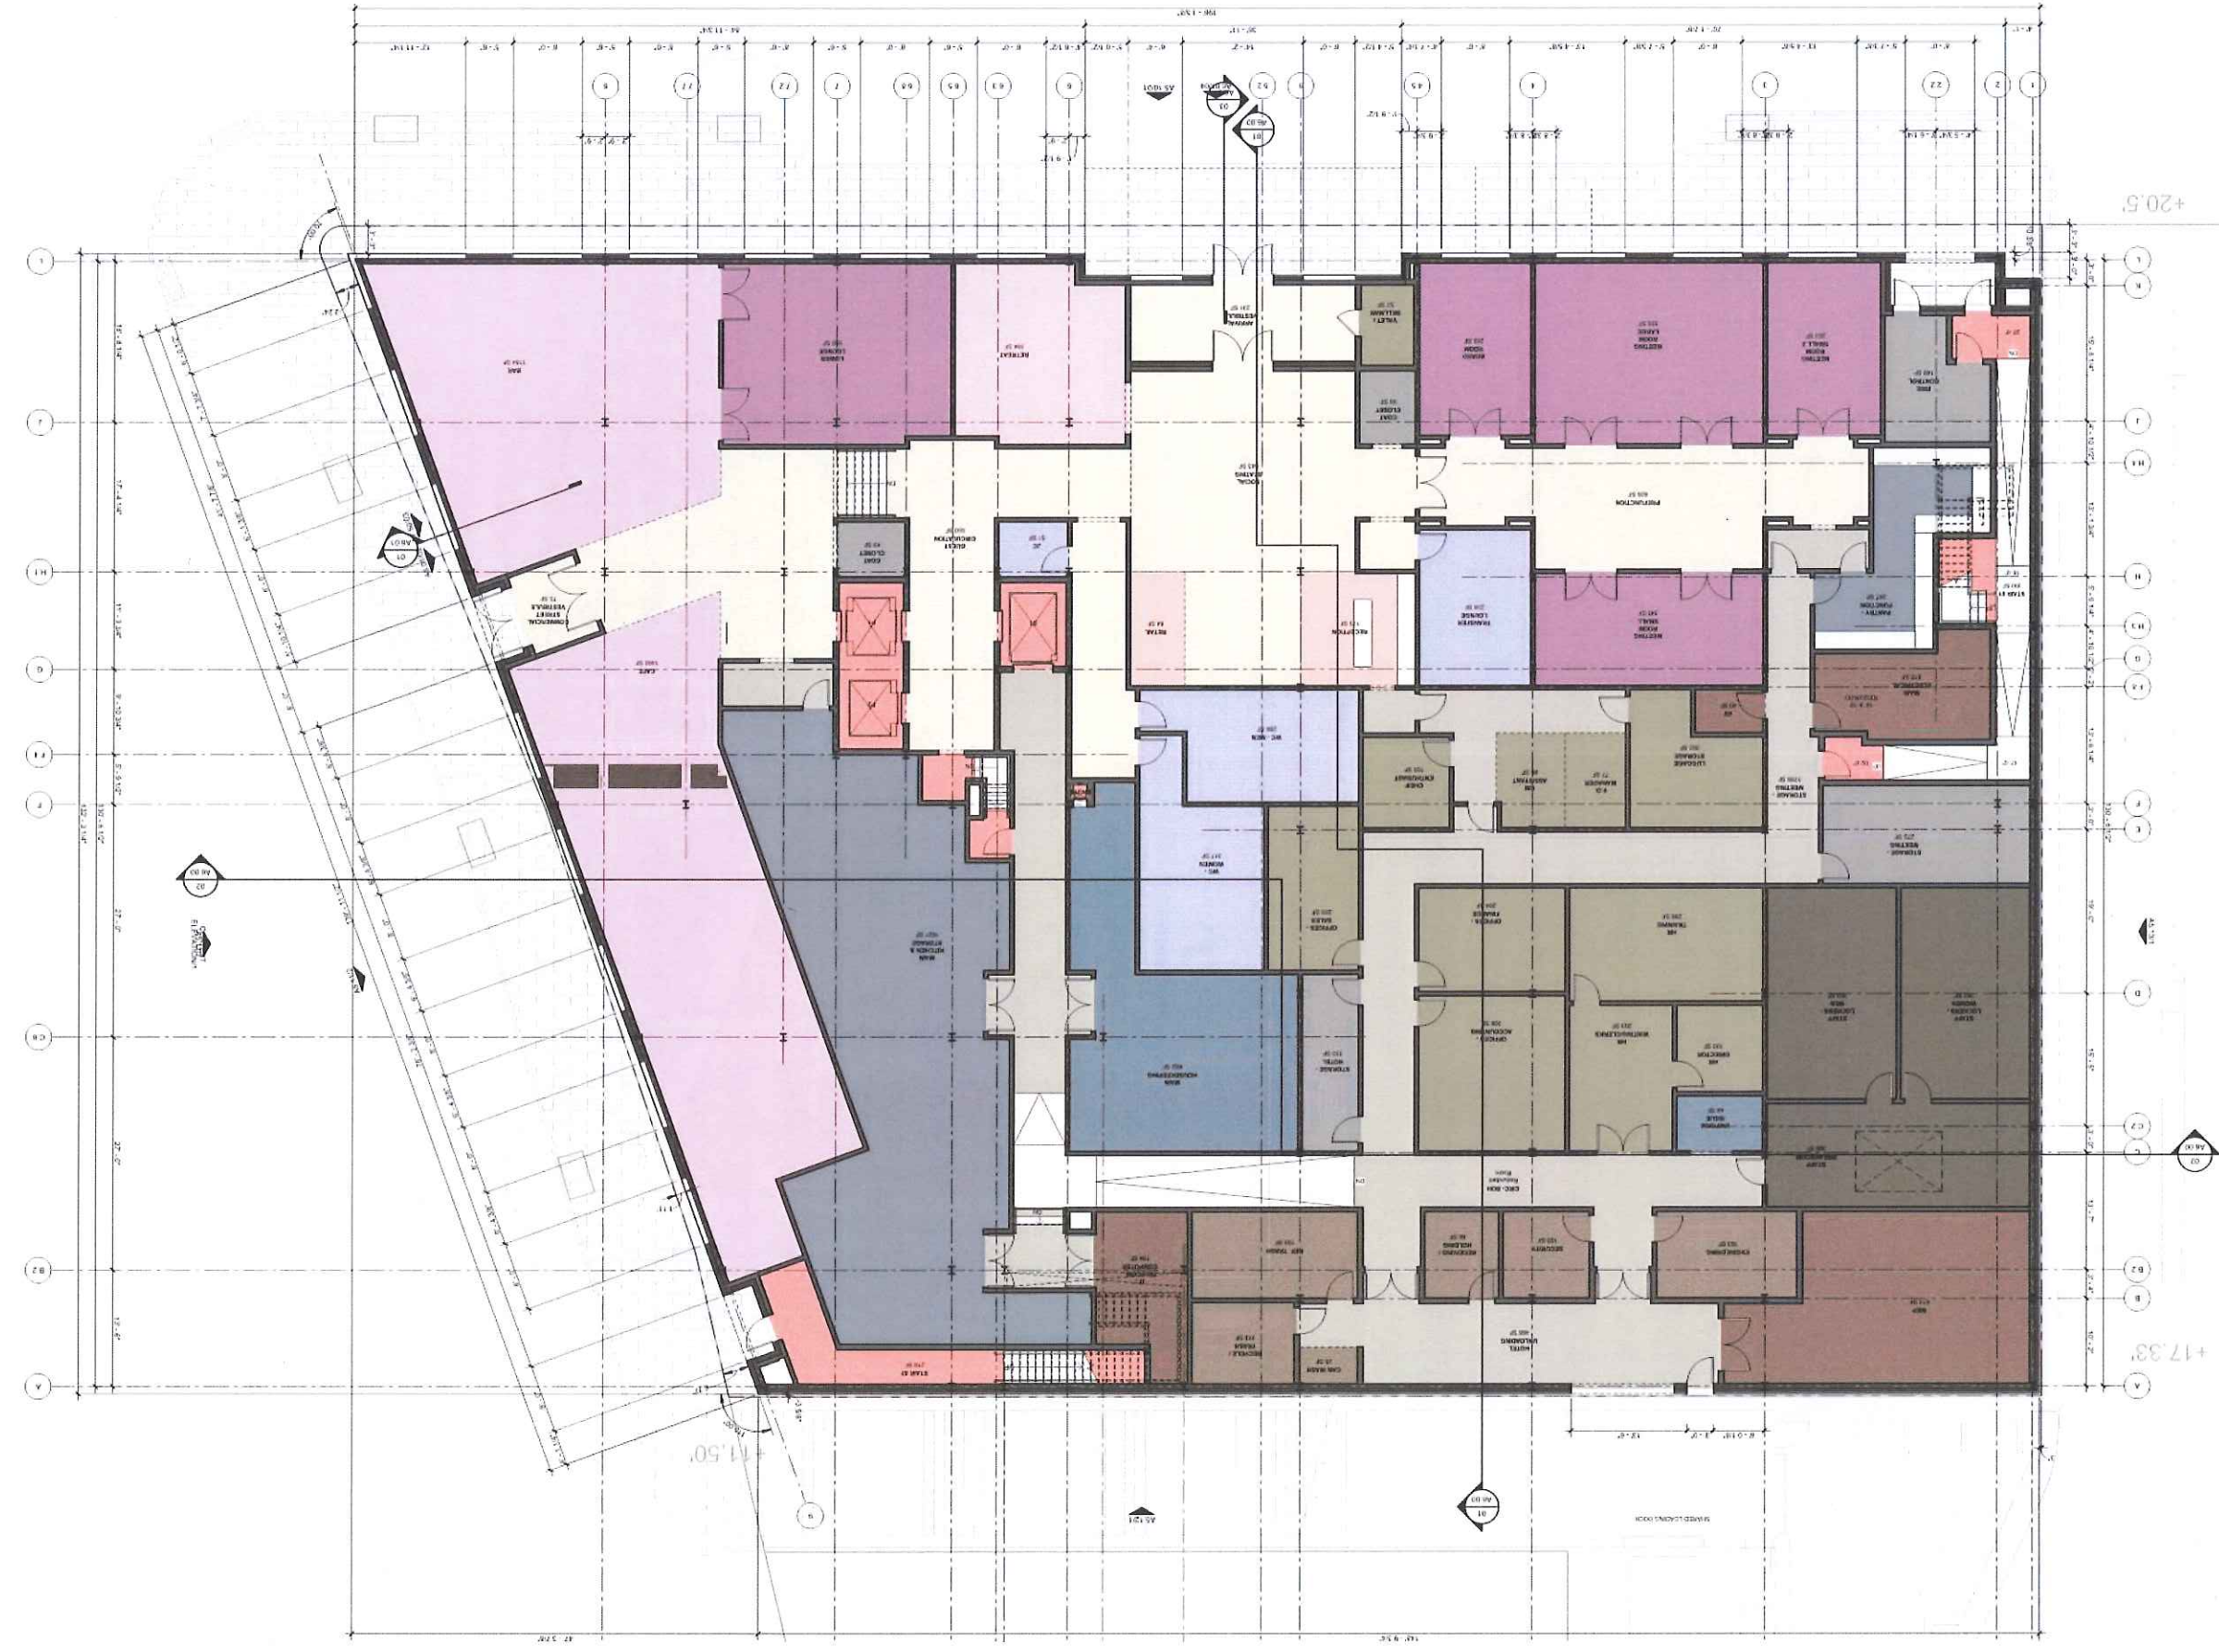
**LEVEL 02, 03, 04 & 05**  
**SCALE NTS**

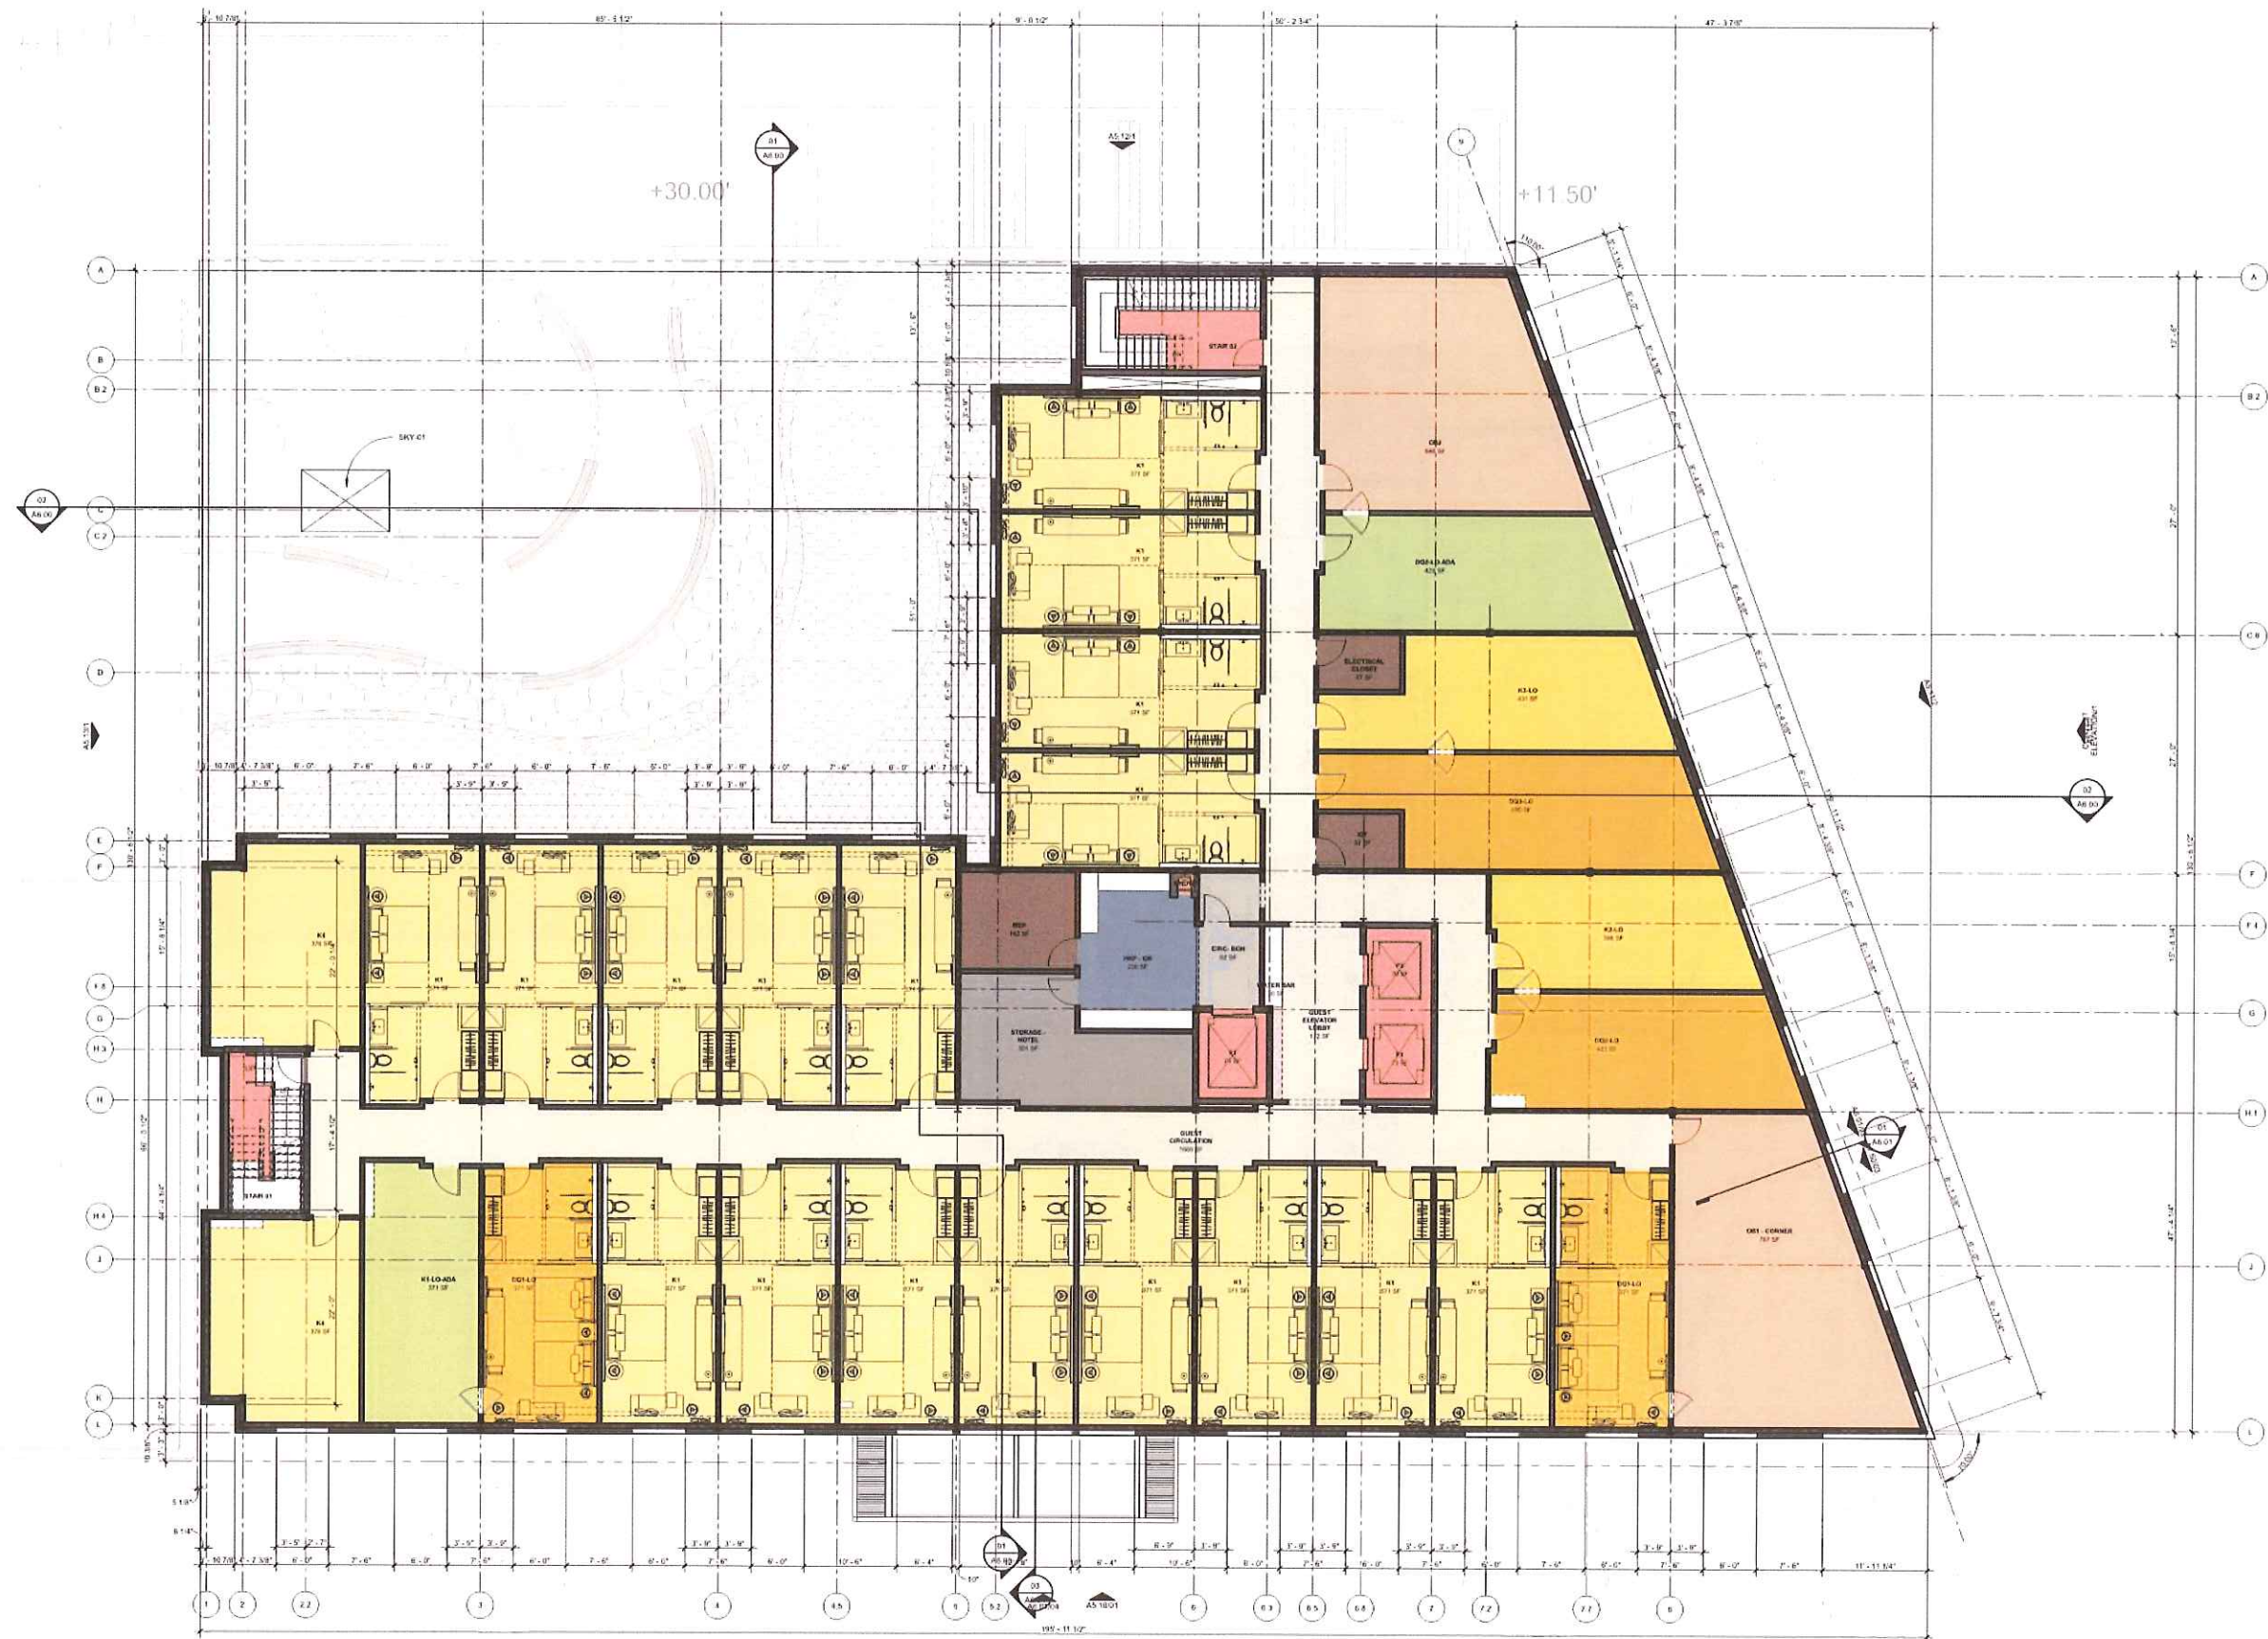
LEVEL 06 - ROOFTOP BAR & GUESTROOMS  
SCALE NTS

- It was noted that the glazed tower element at the southwest corner of the building does not correspond to the interior program proposed for the upper floors. Floor plans indicate that the corner will be occupied by hotel rooms above the main floor, rather than common areas. Based on observations of another recently-constructed hotel with a similar feature, Board members noted it was inevitable that curtains will be drawn and the transparency and clarity of design intended for this key element will be undermined. The project architects were encouraged to reconsider the treatment of this corner, given the interior program.

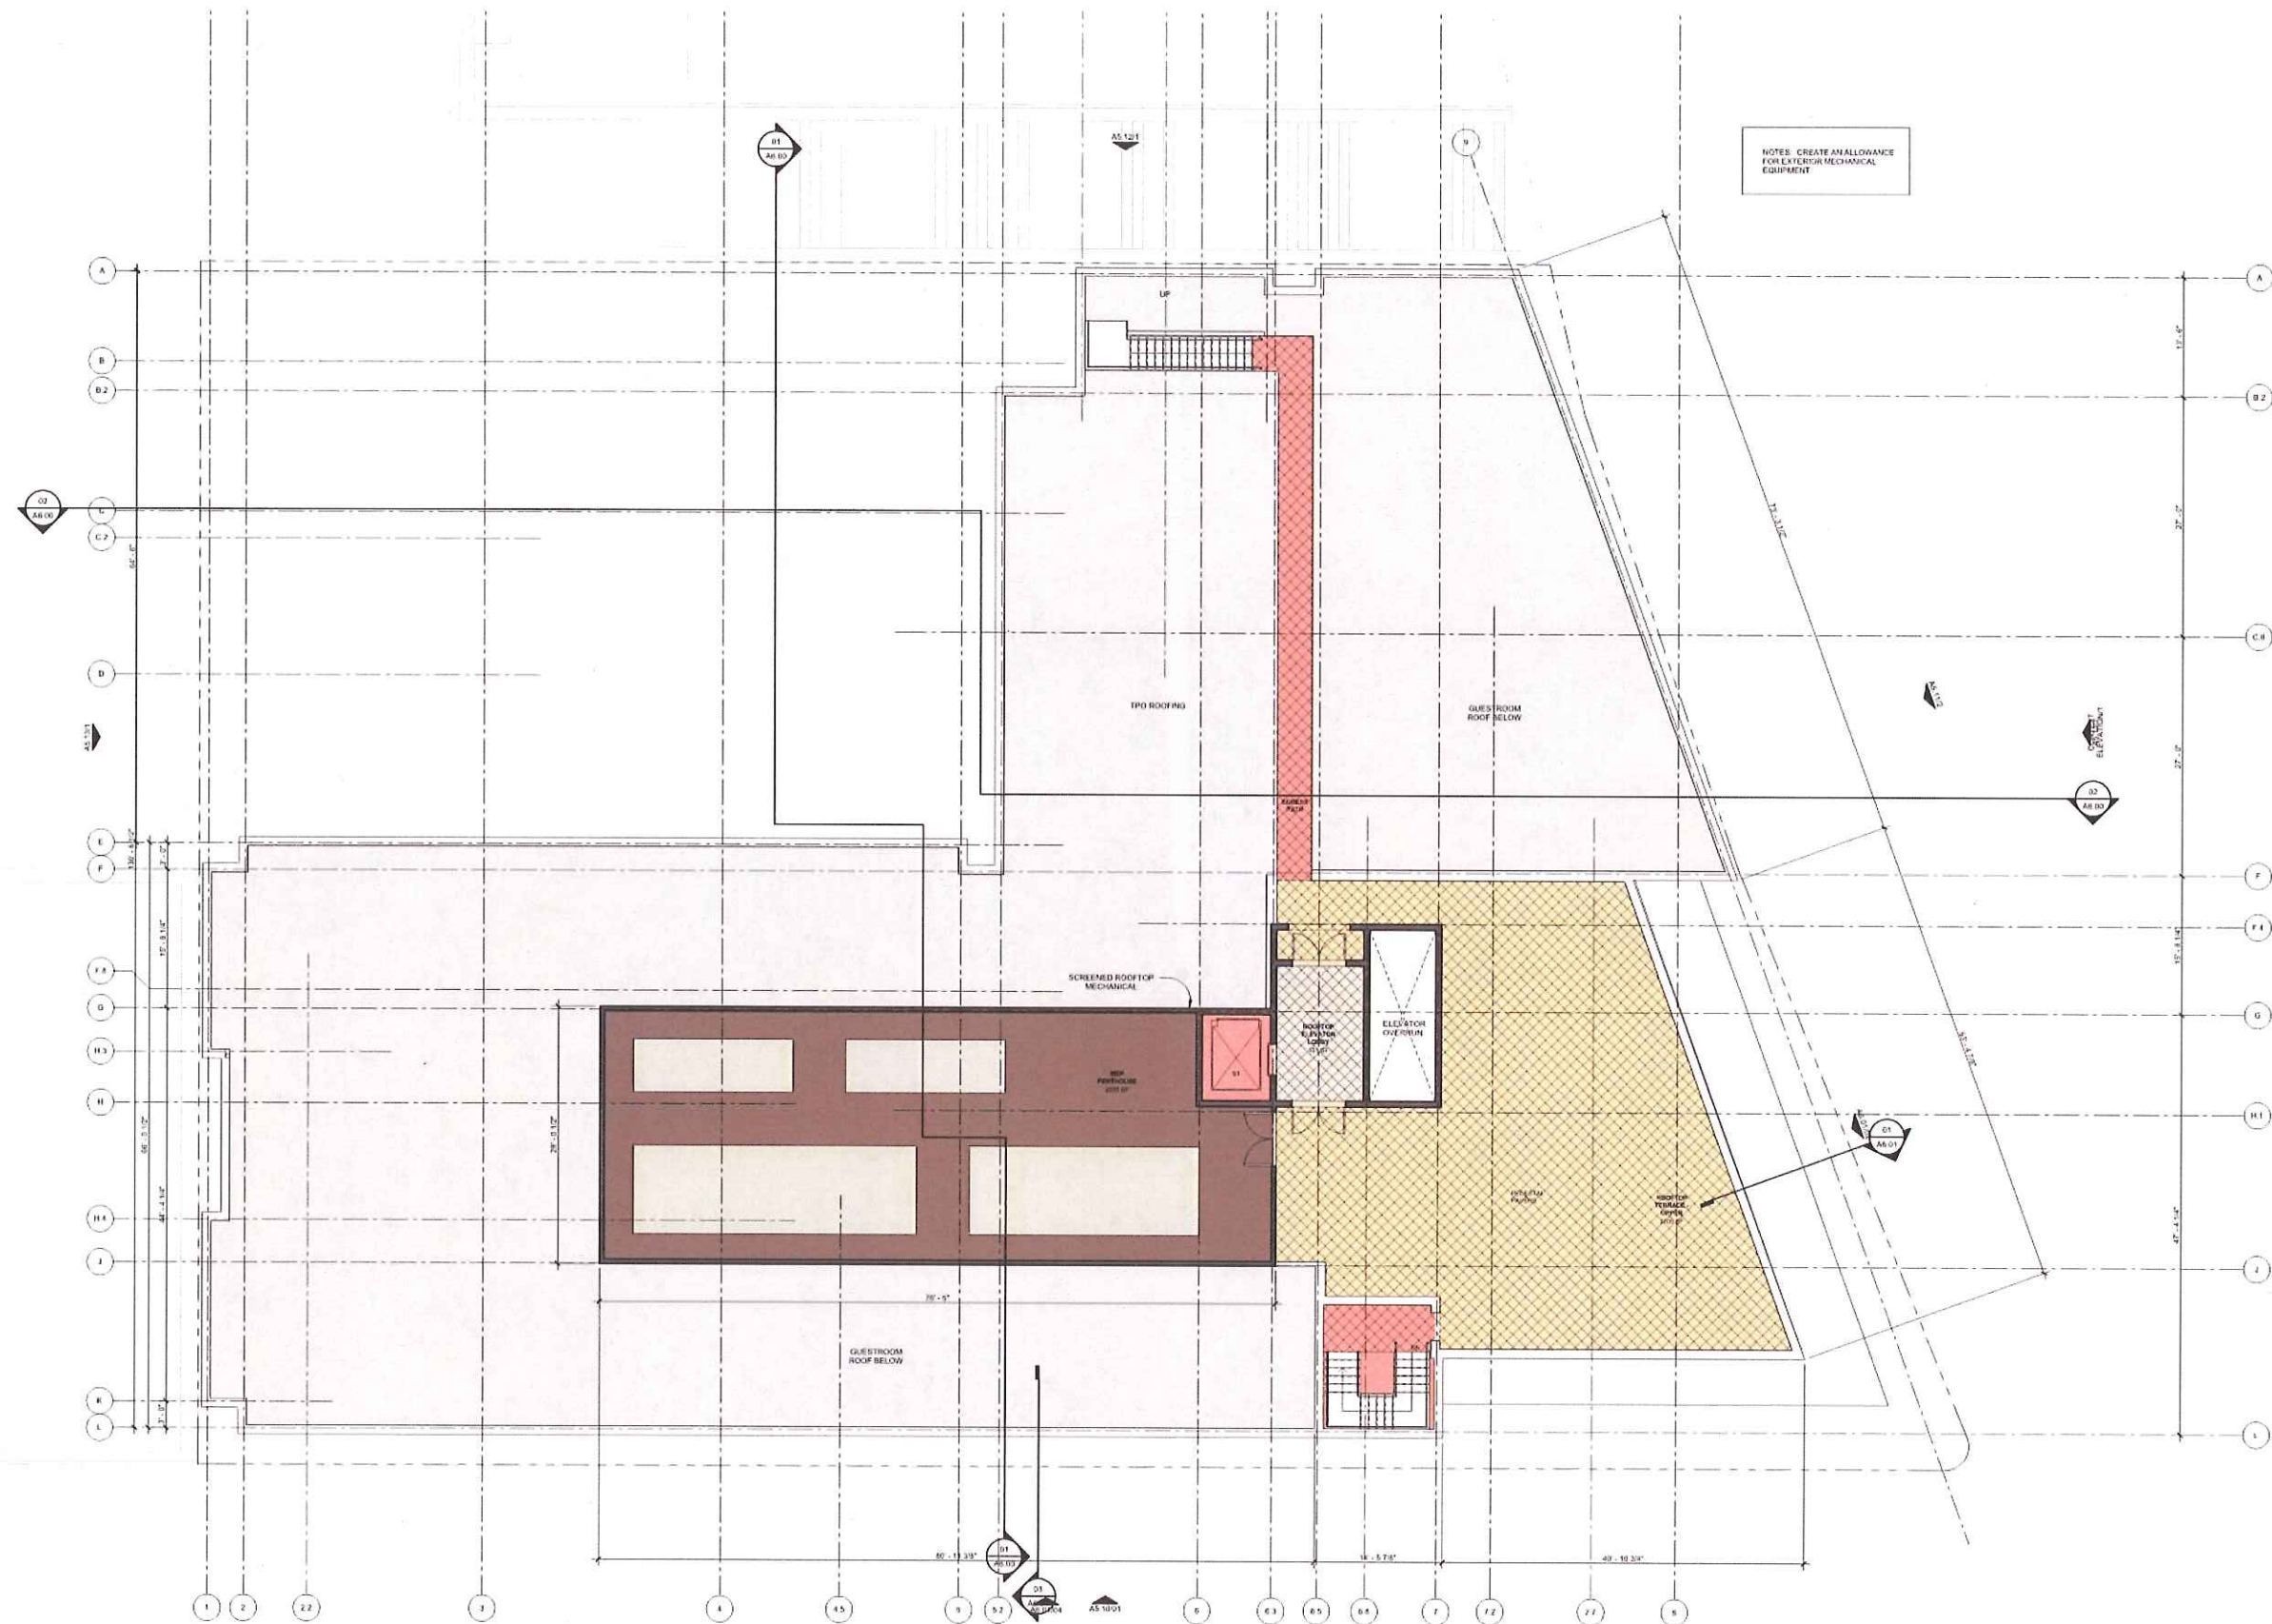
**LEVEL 07 - ROOFTOP TERRACE**  
SCALE NTS
