# CITY OF PORTLAND, MAINE

## HISTORIC PRESERVATION BOARD

WORKSHOP  
ONE CENTER STREET

Fathom HKS  
SCHEMATIC DESIGN  
01.16.2019

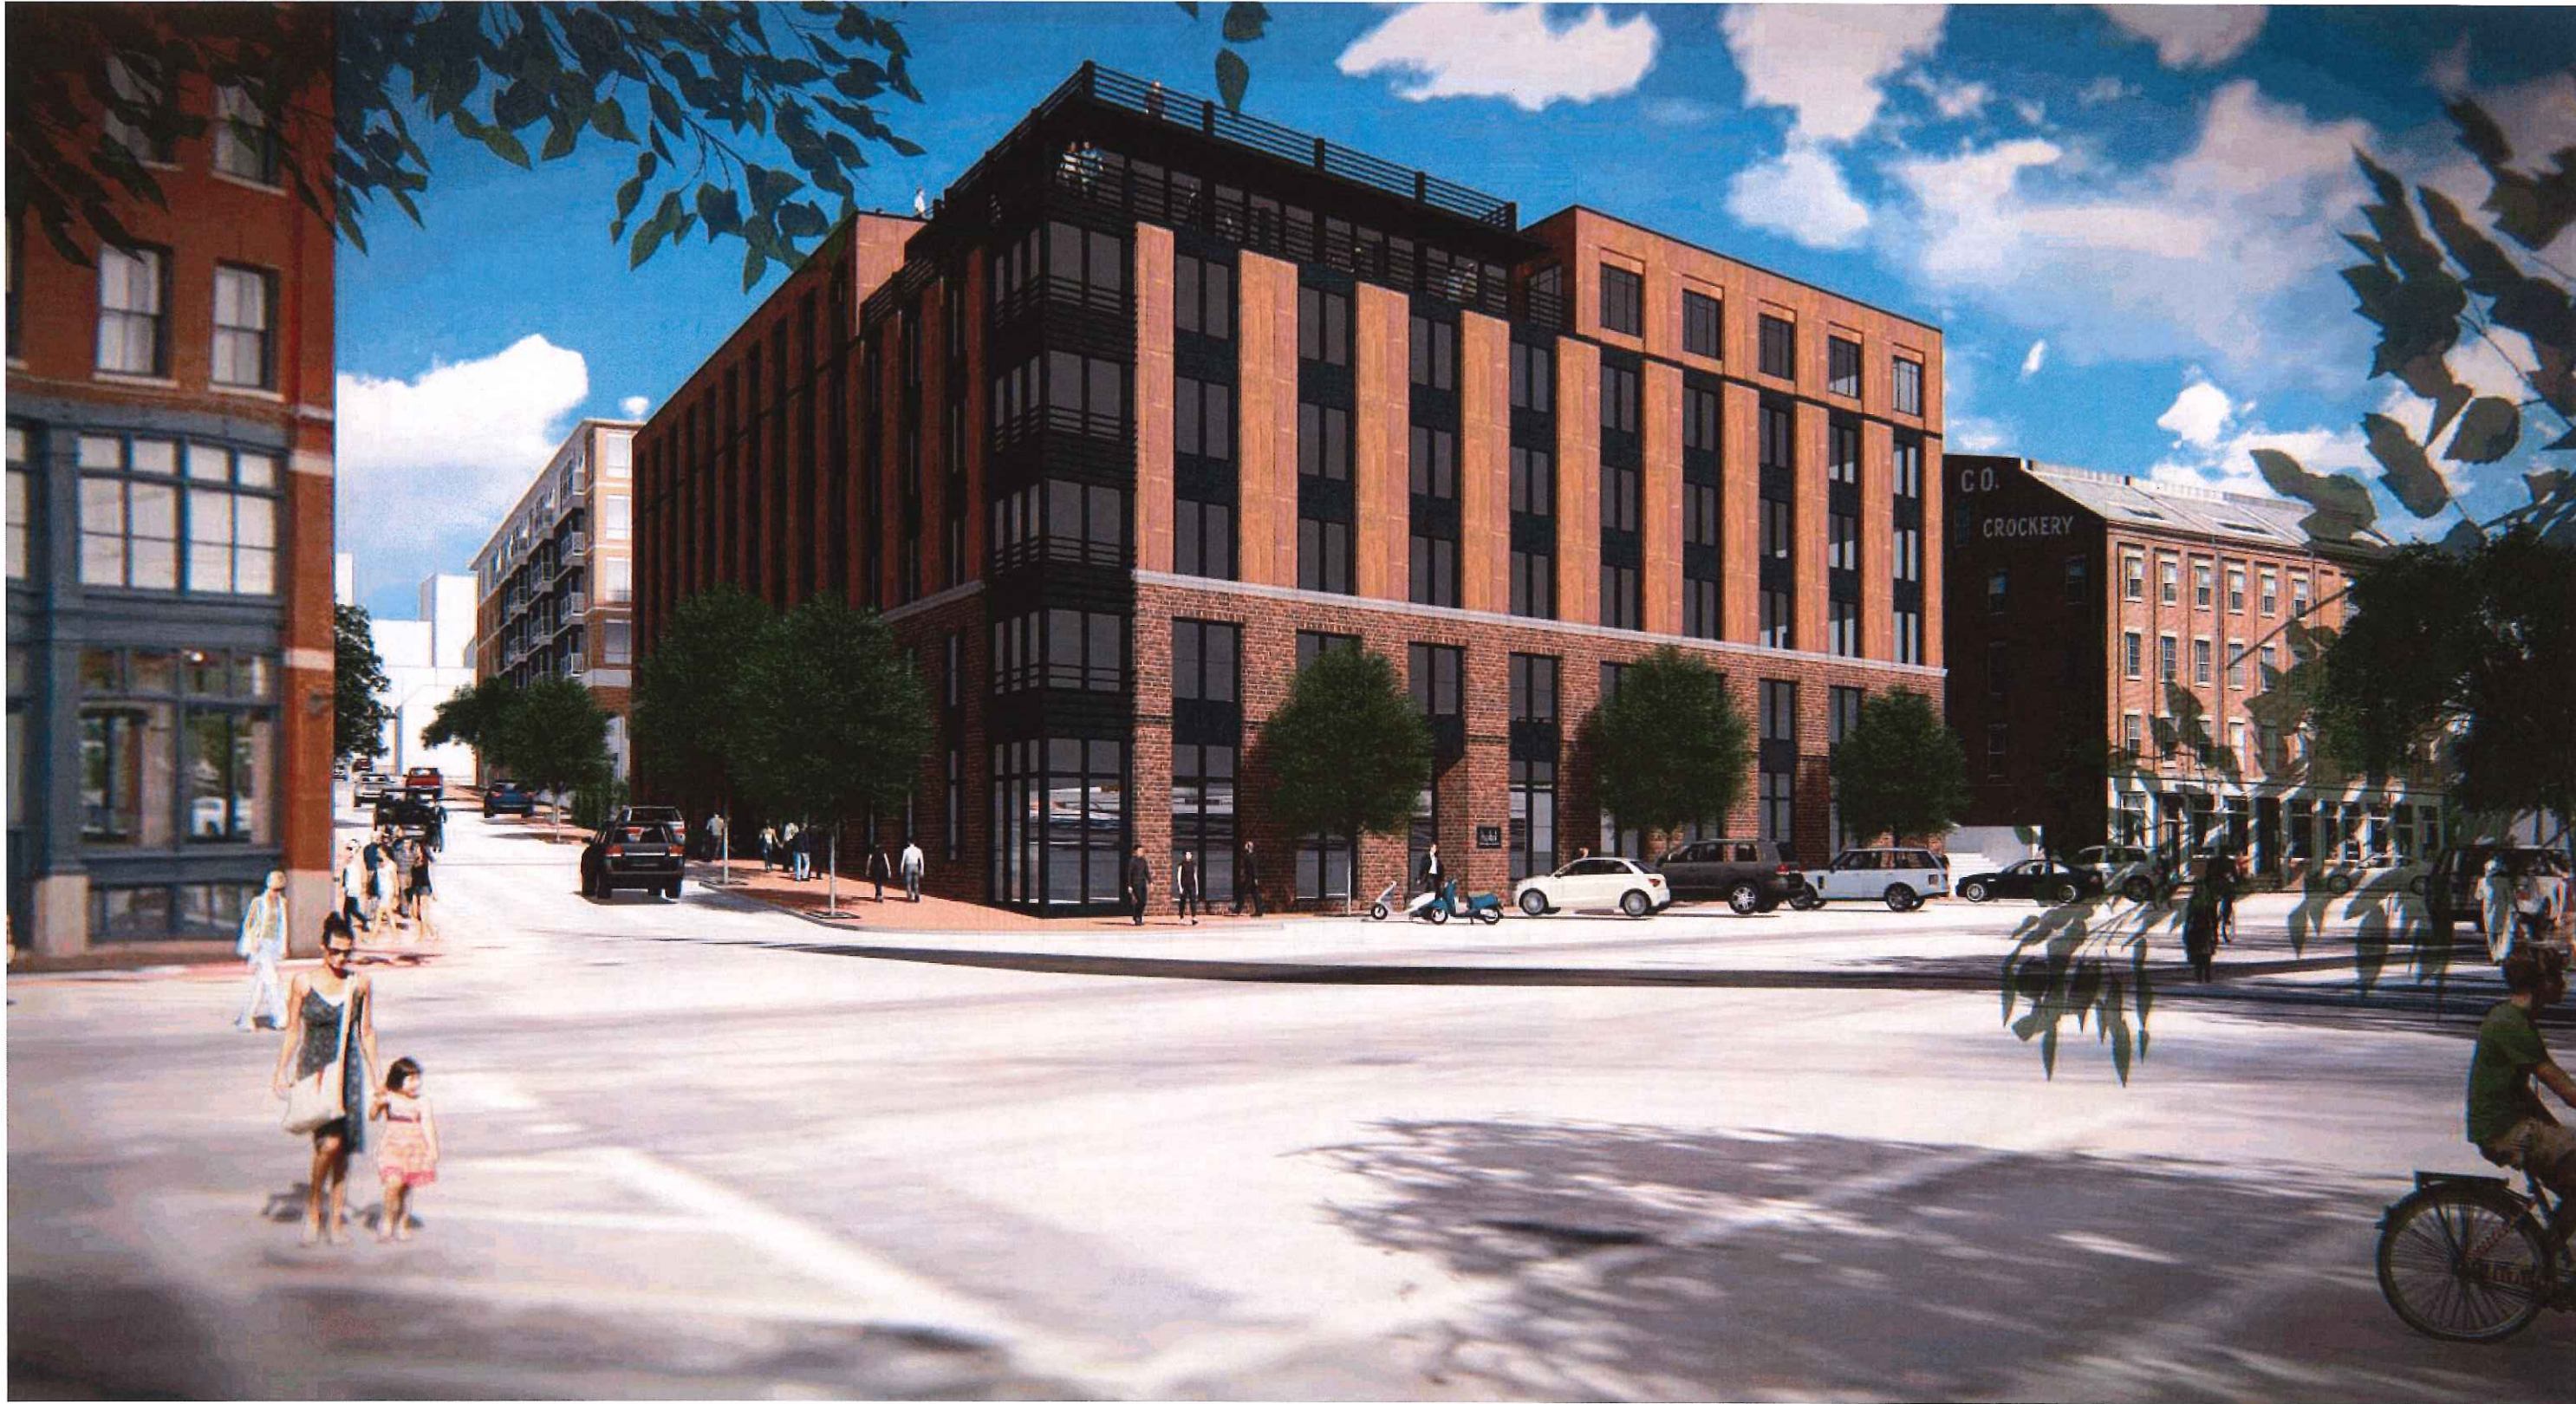
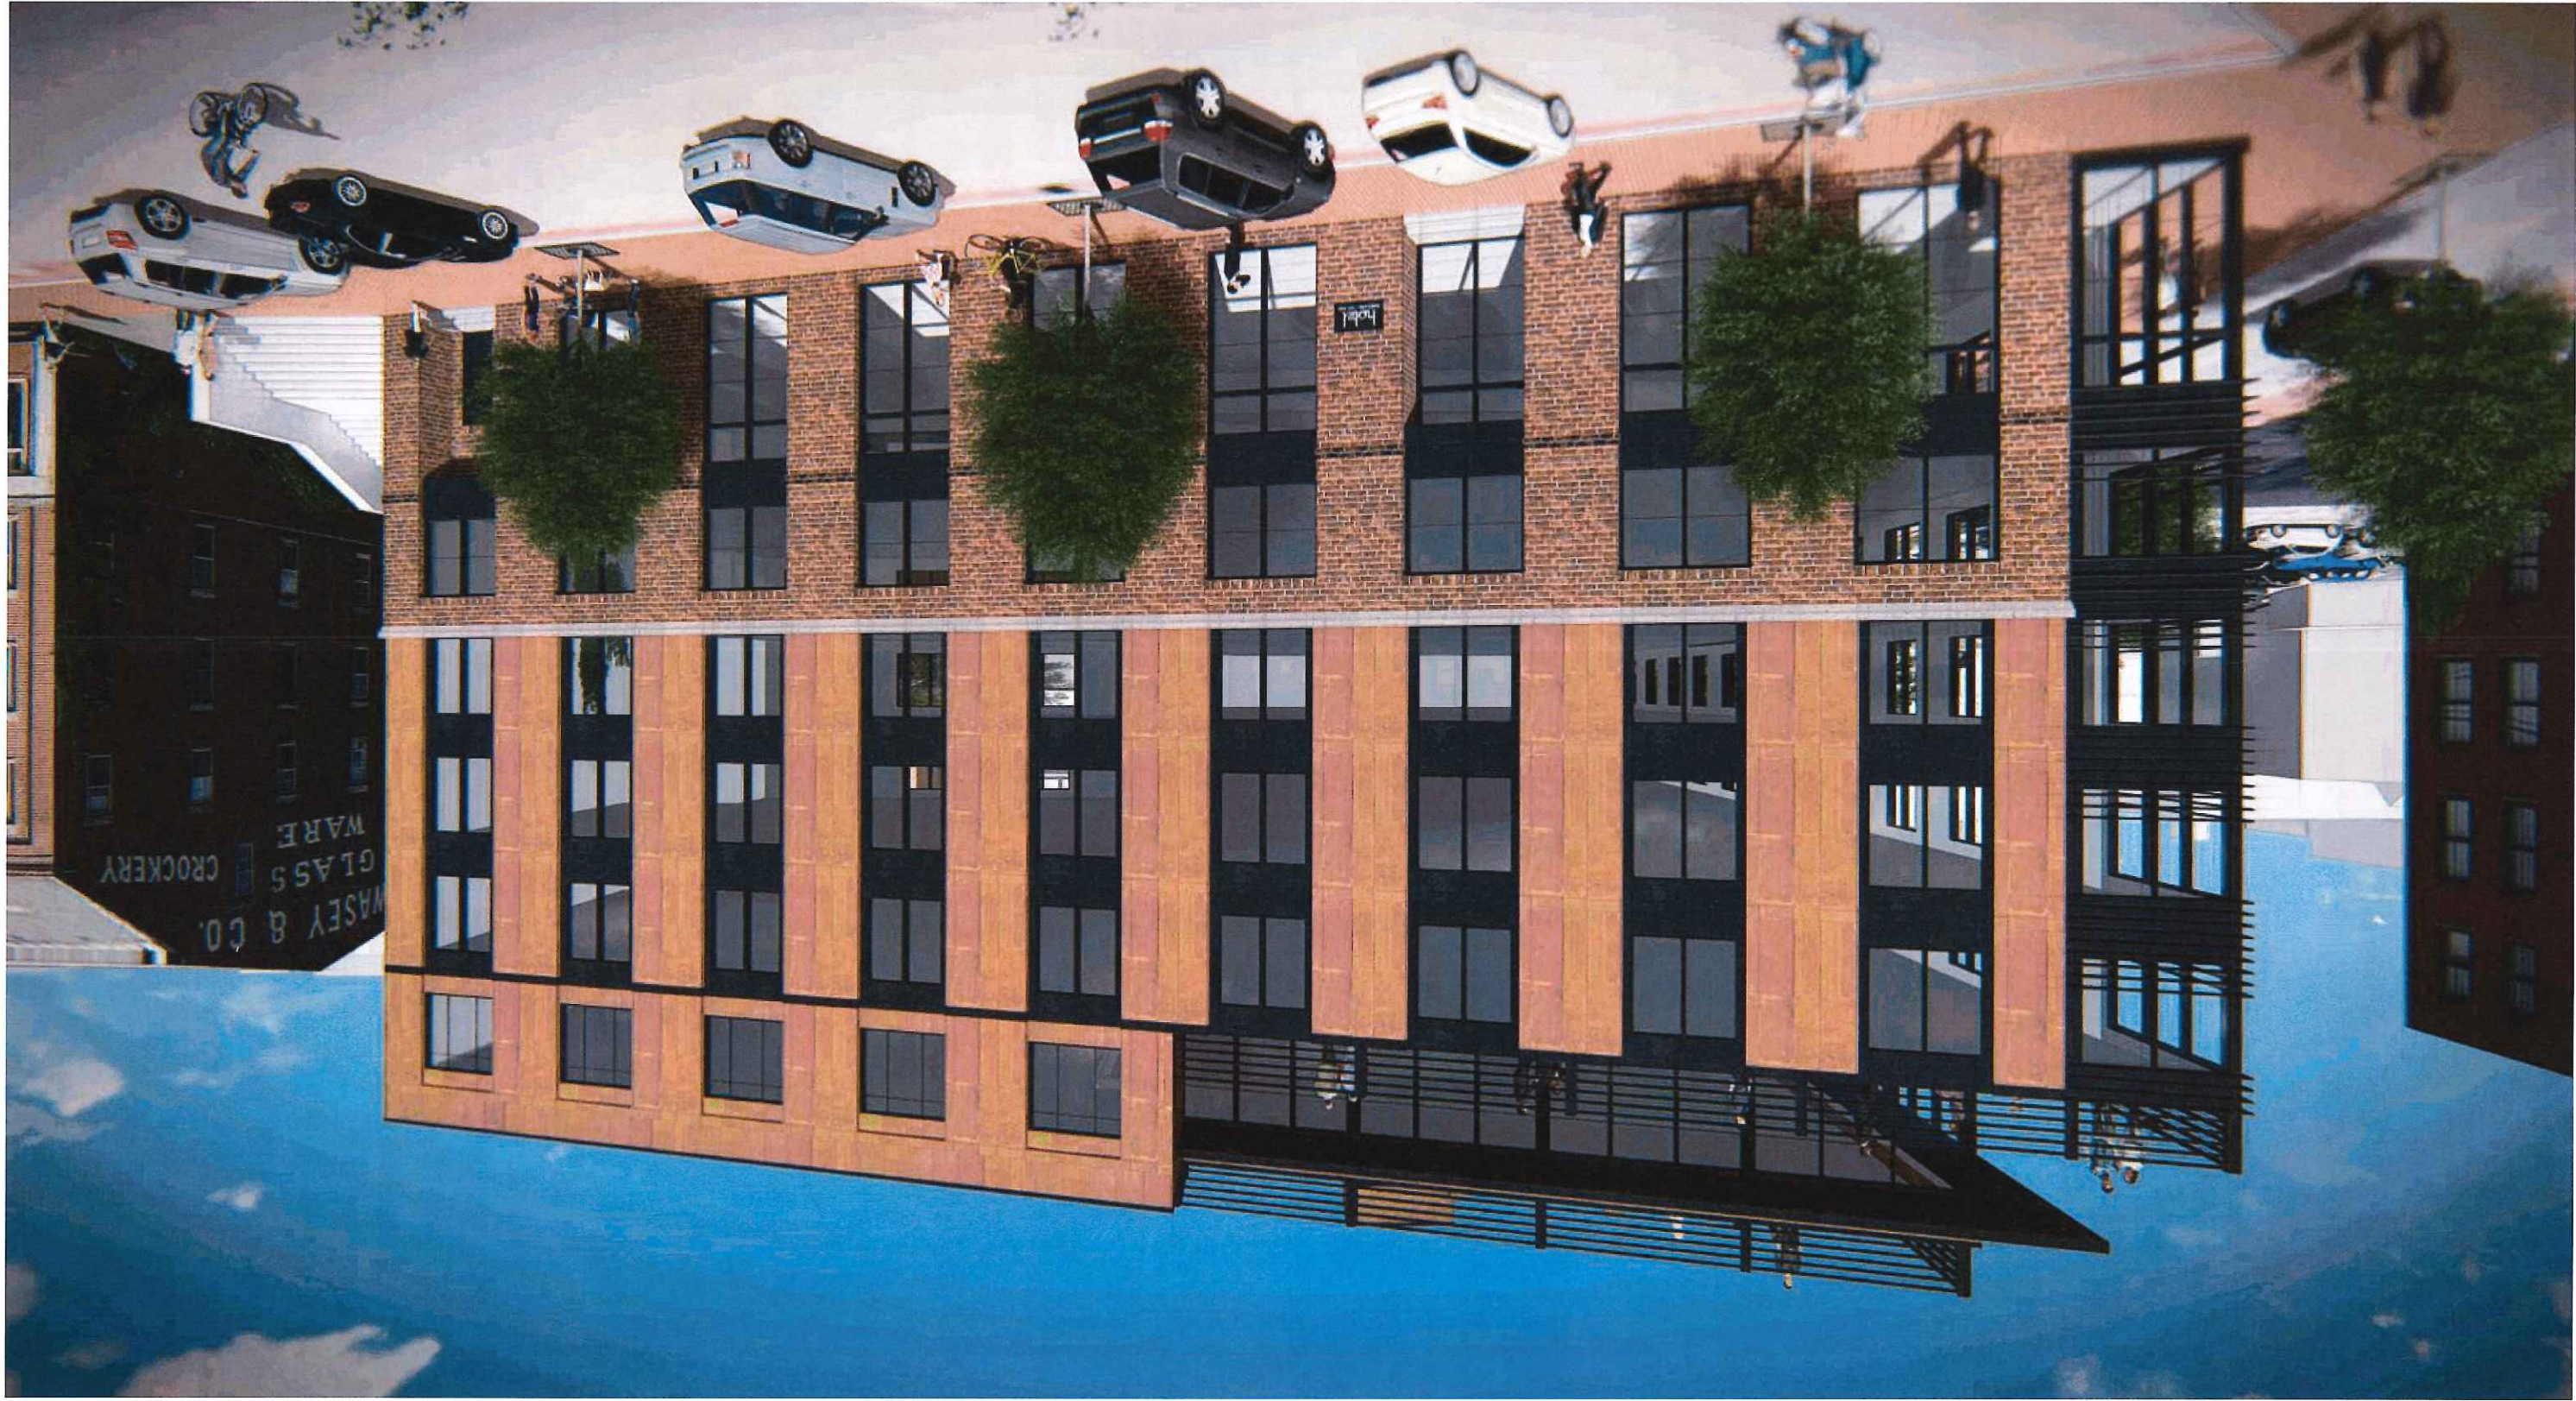
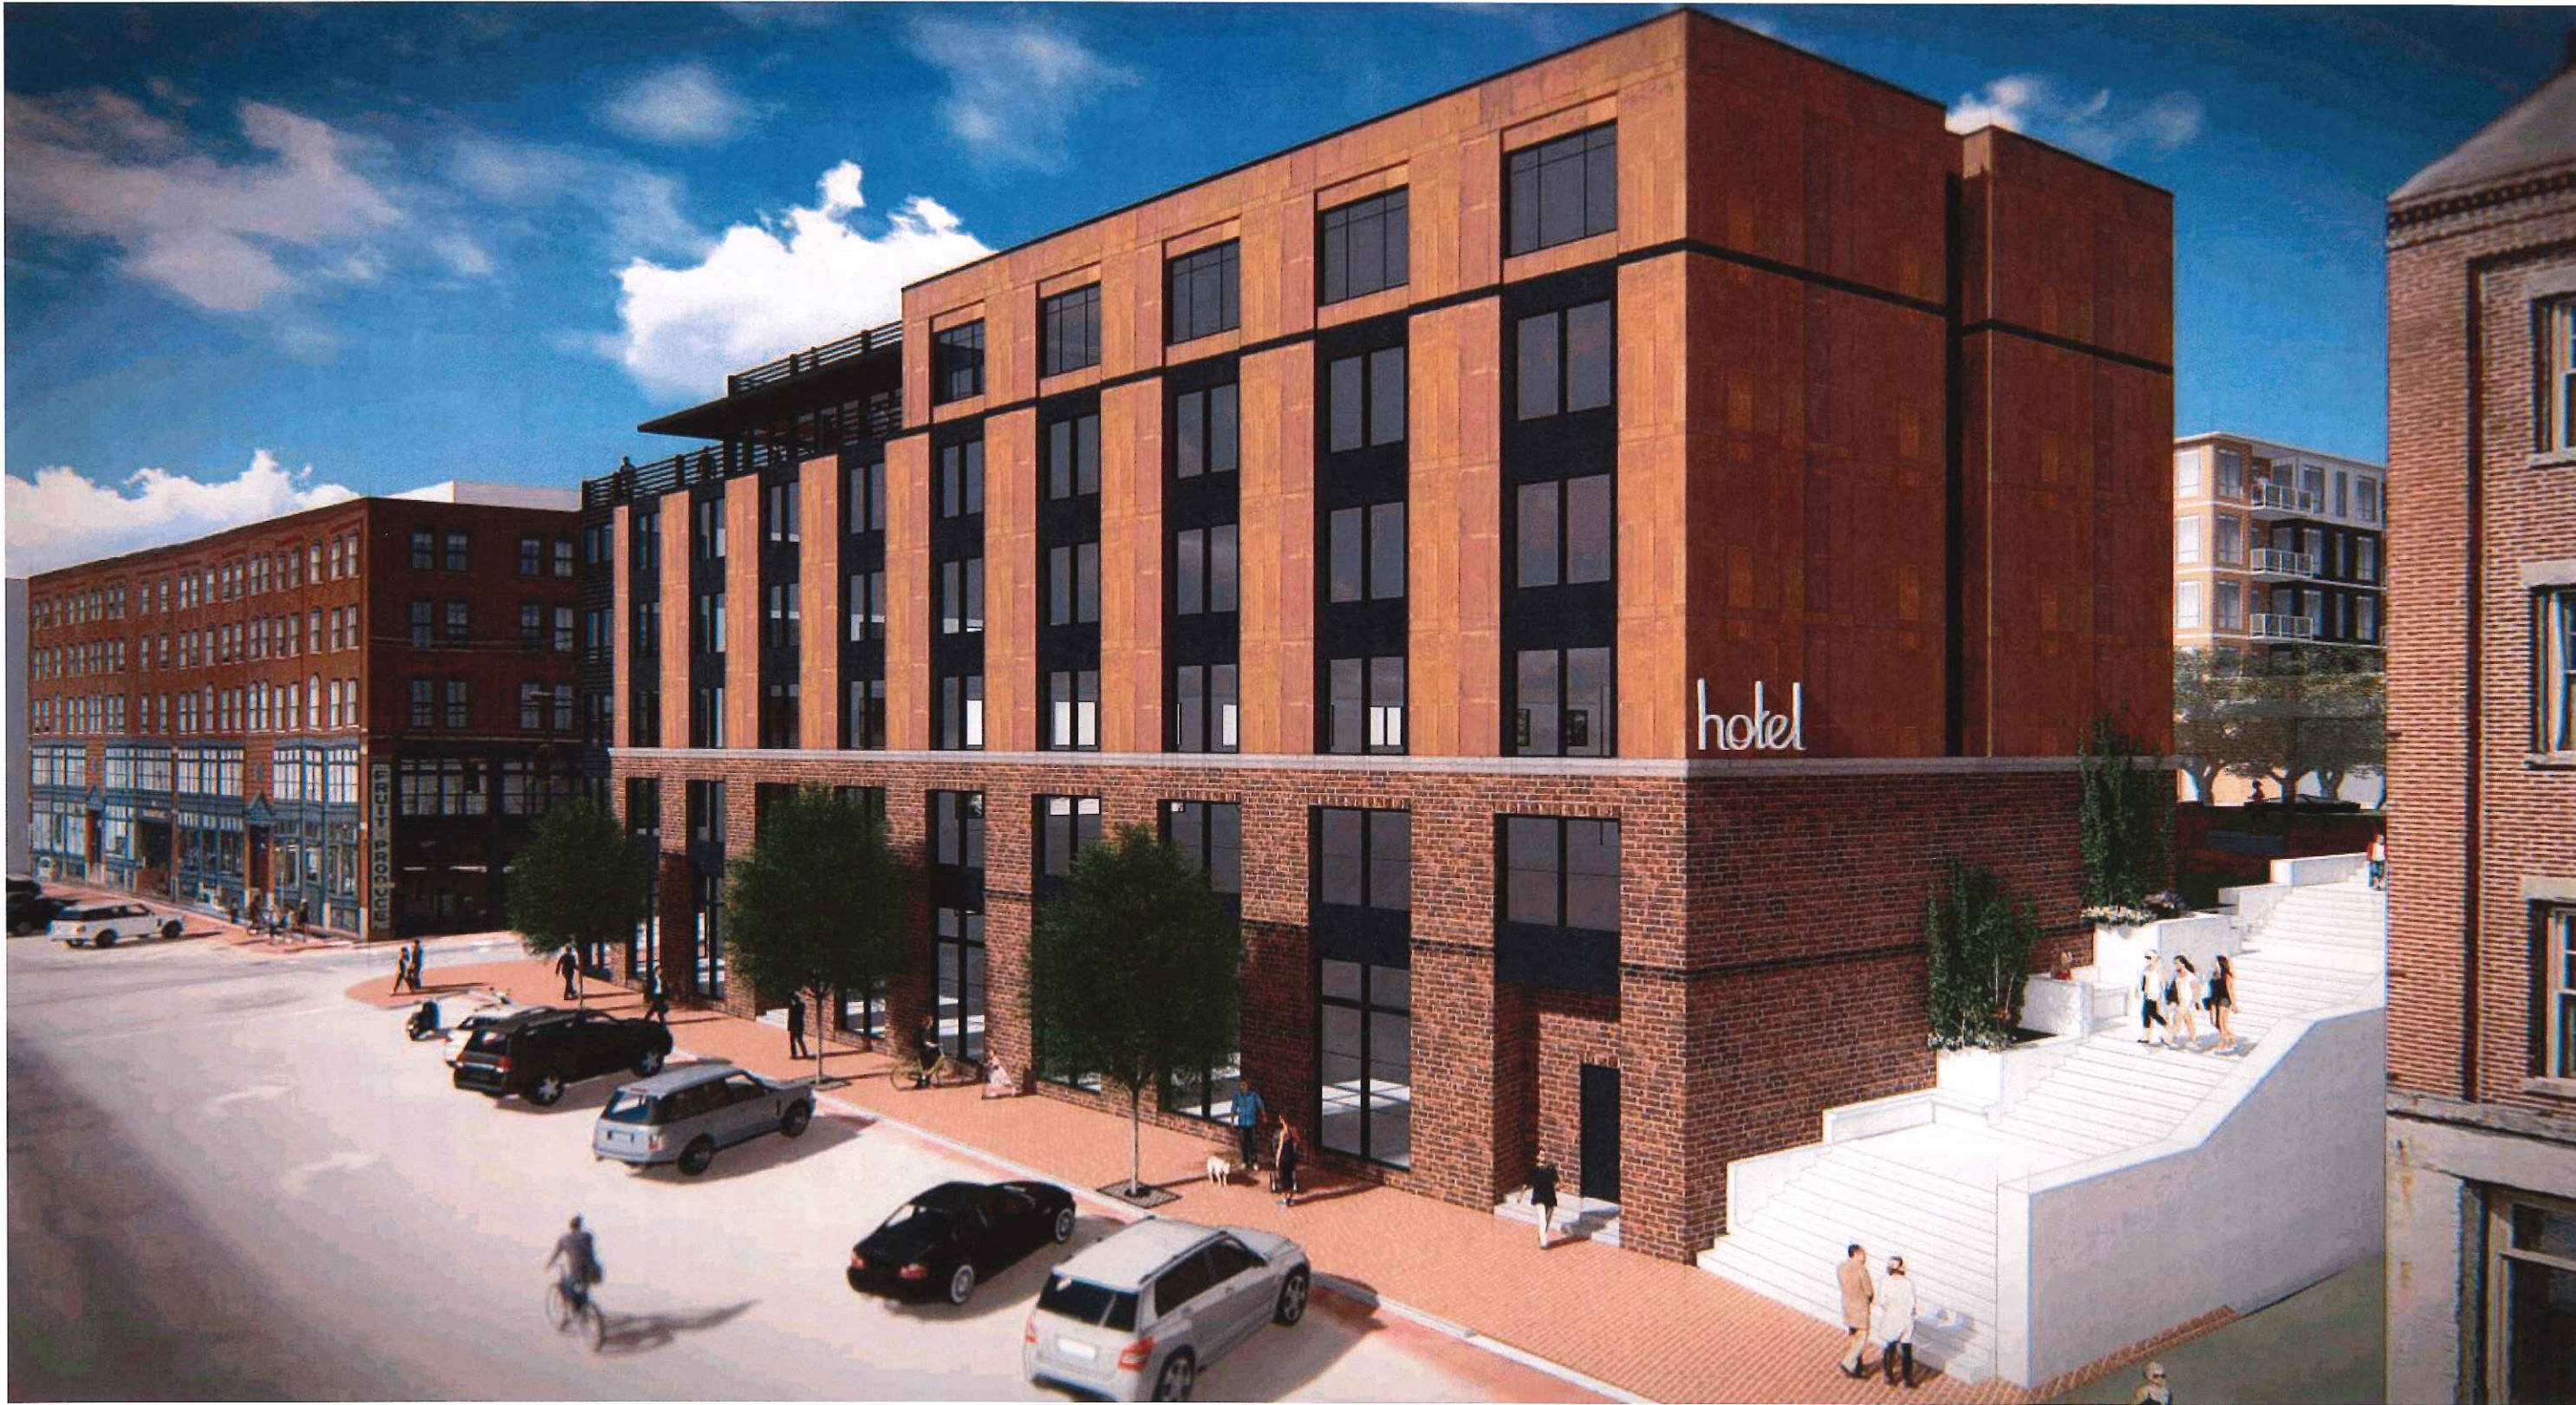
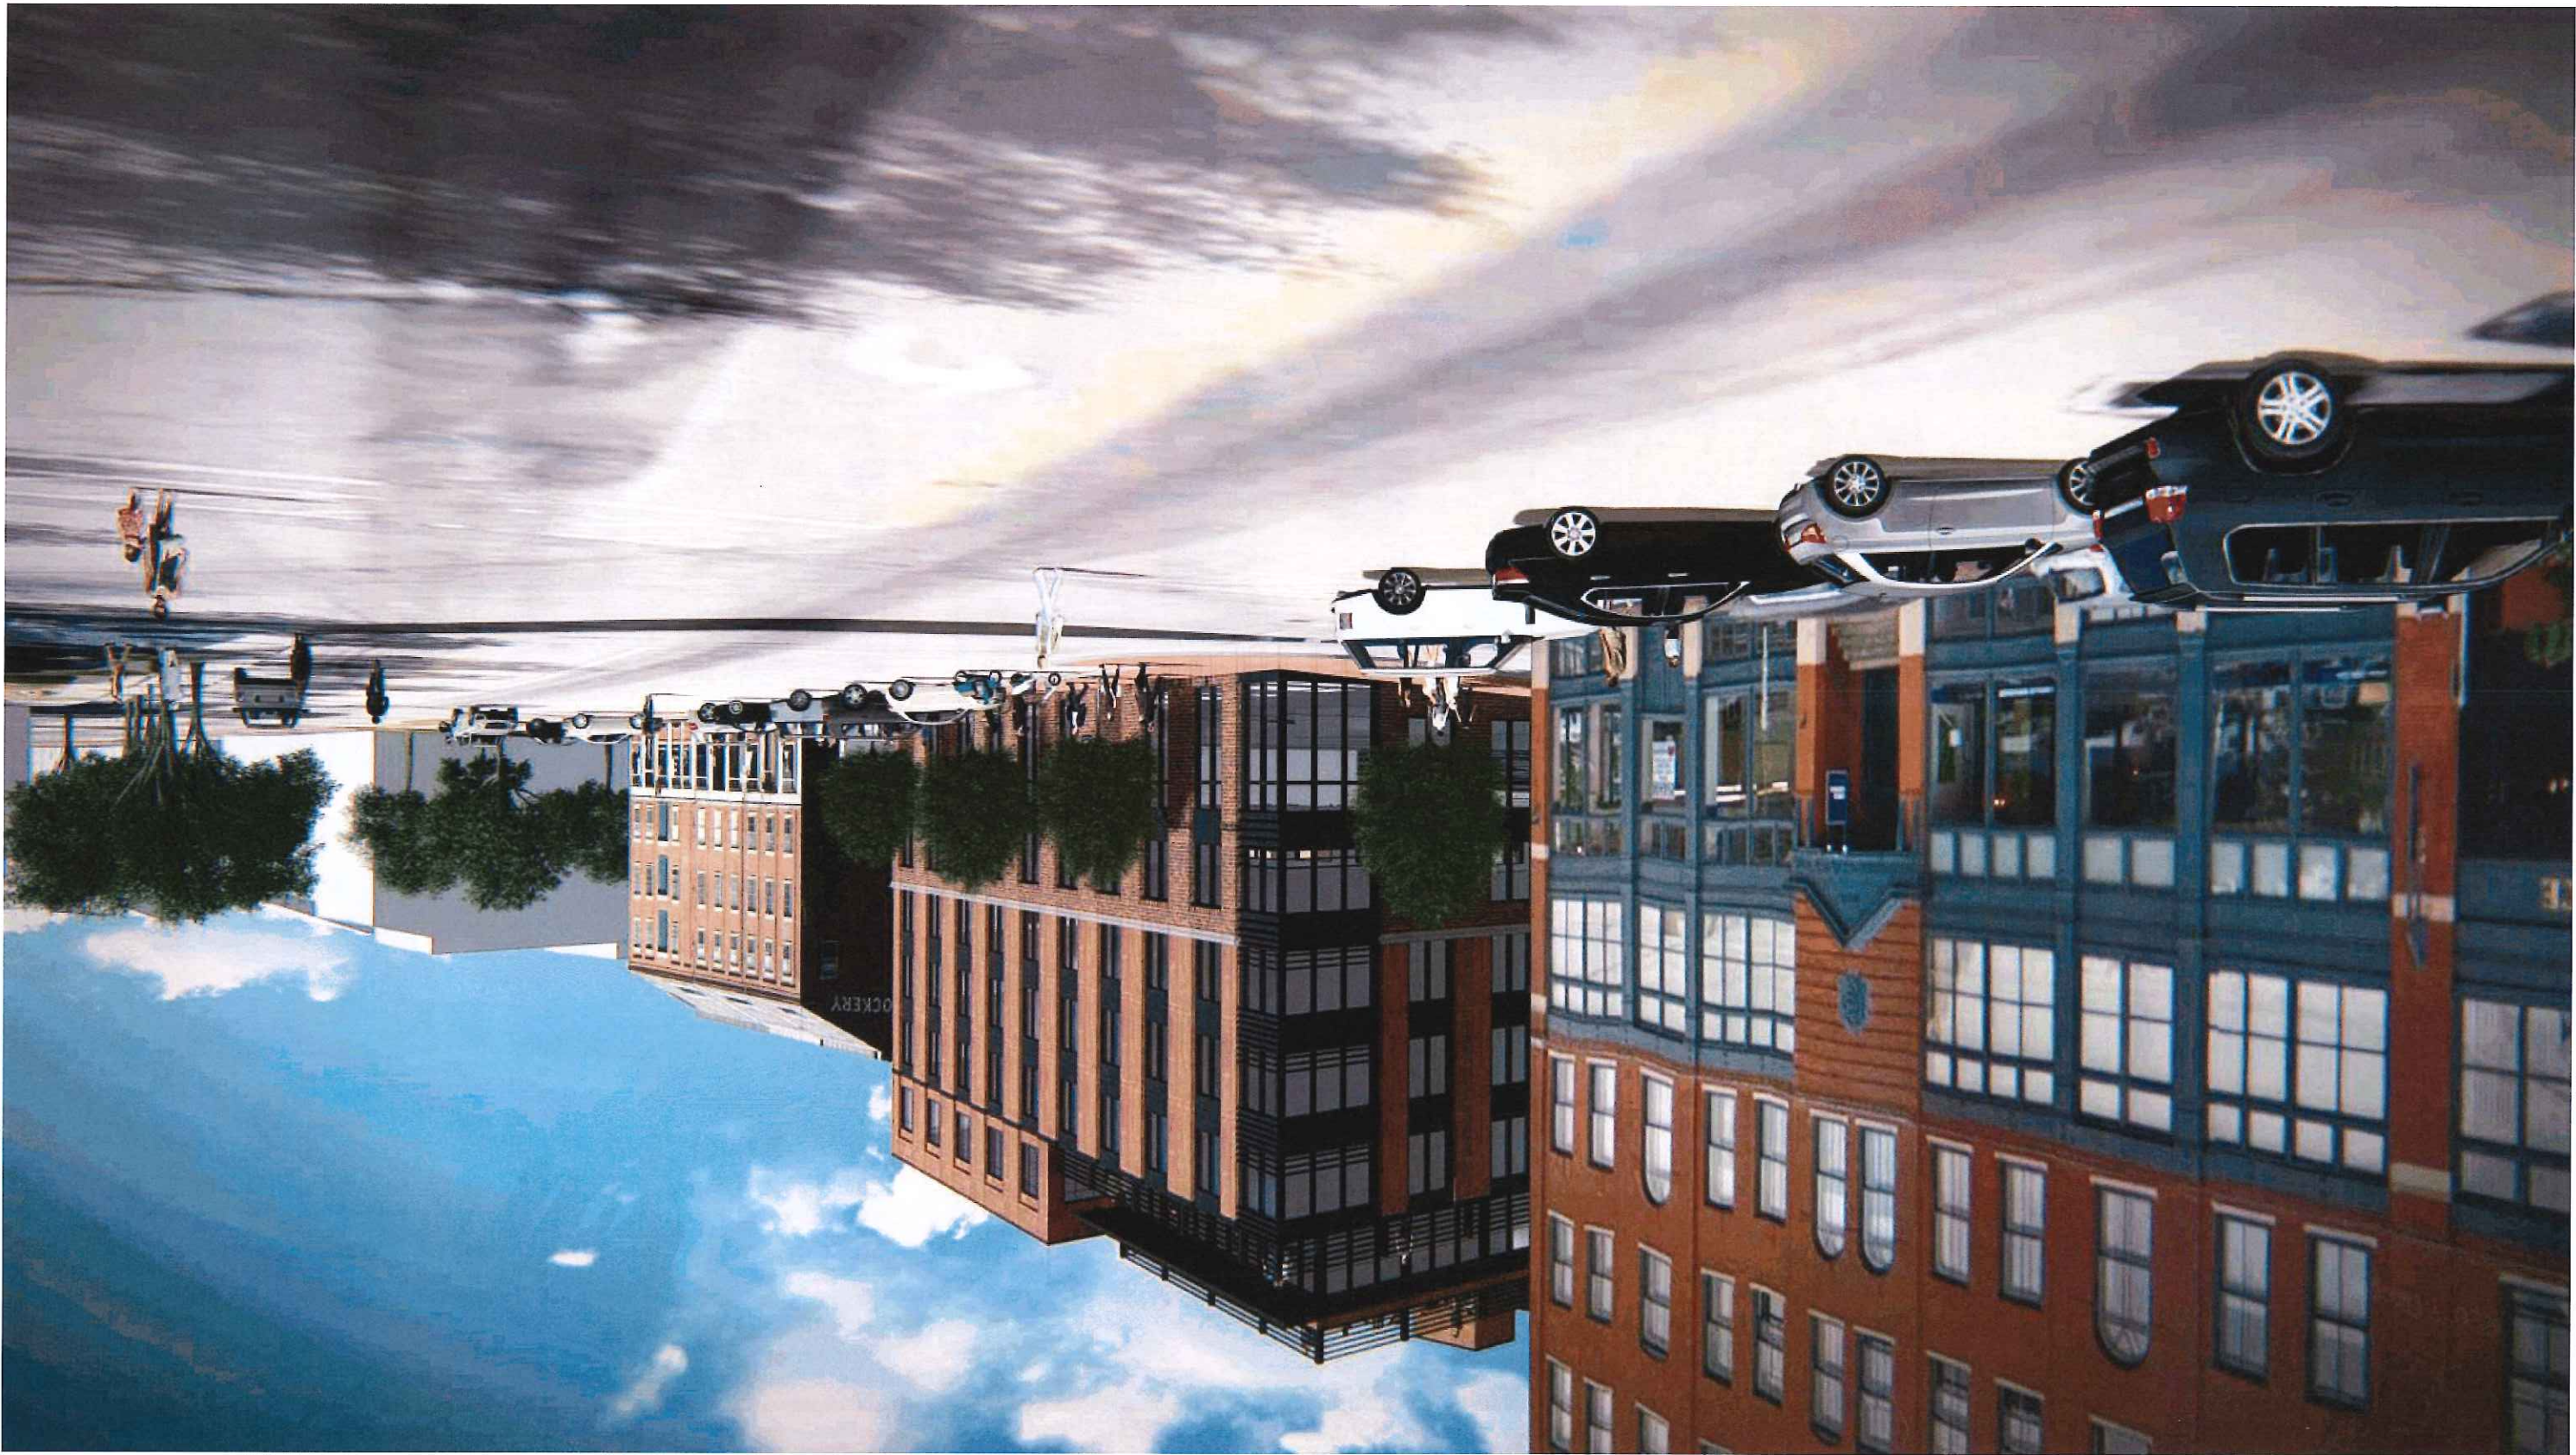
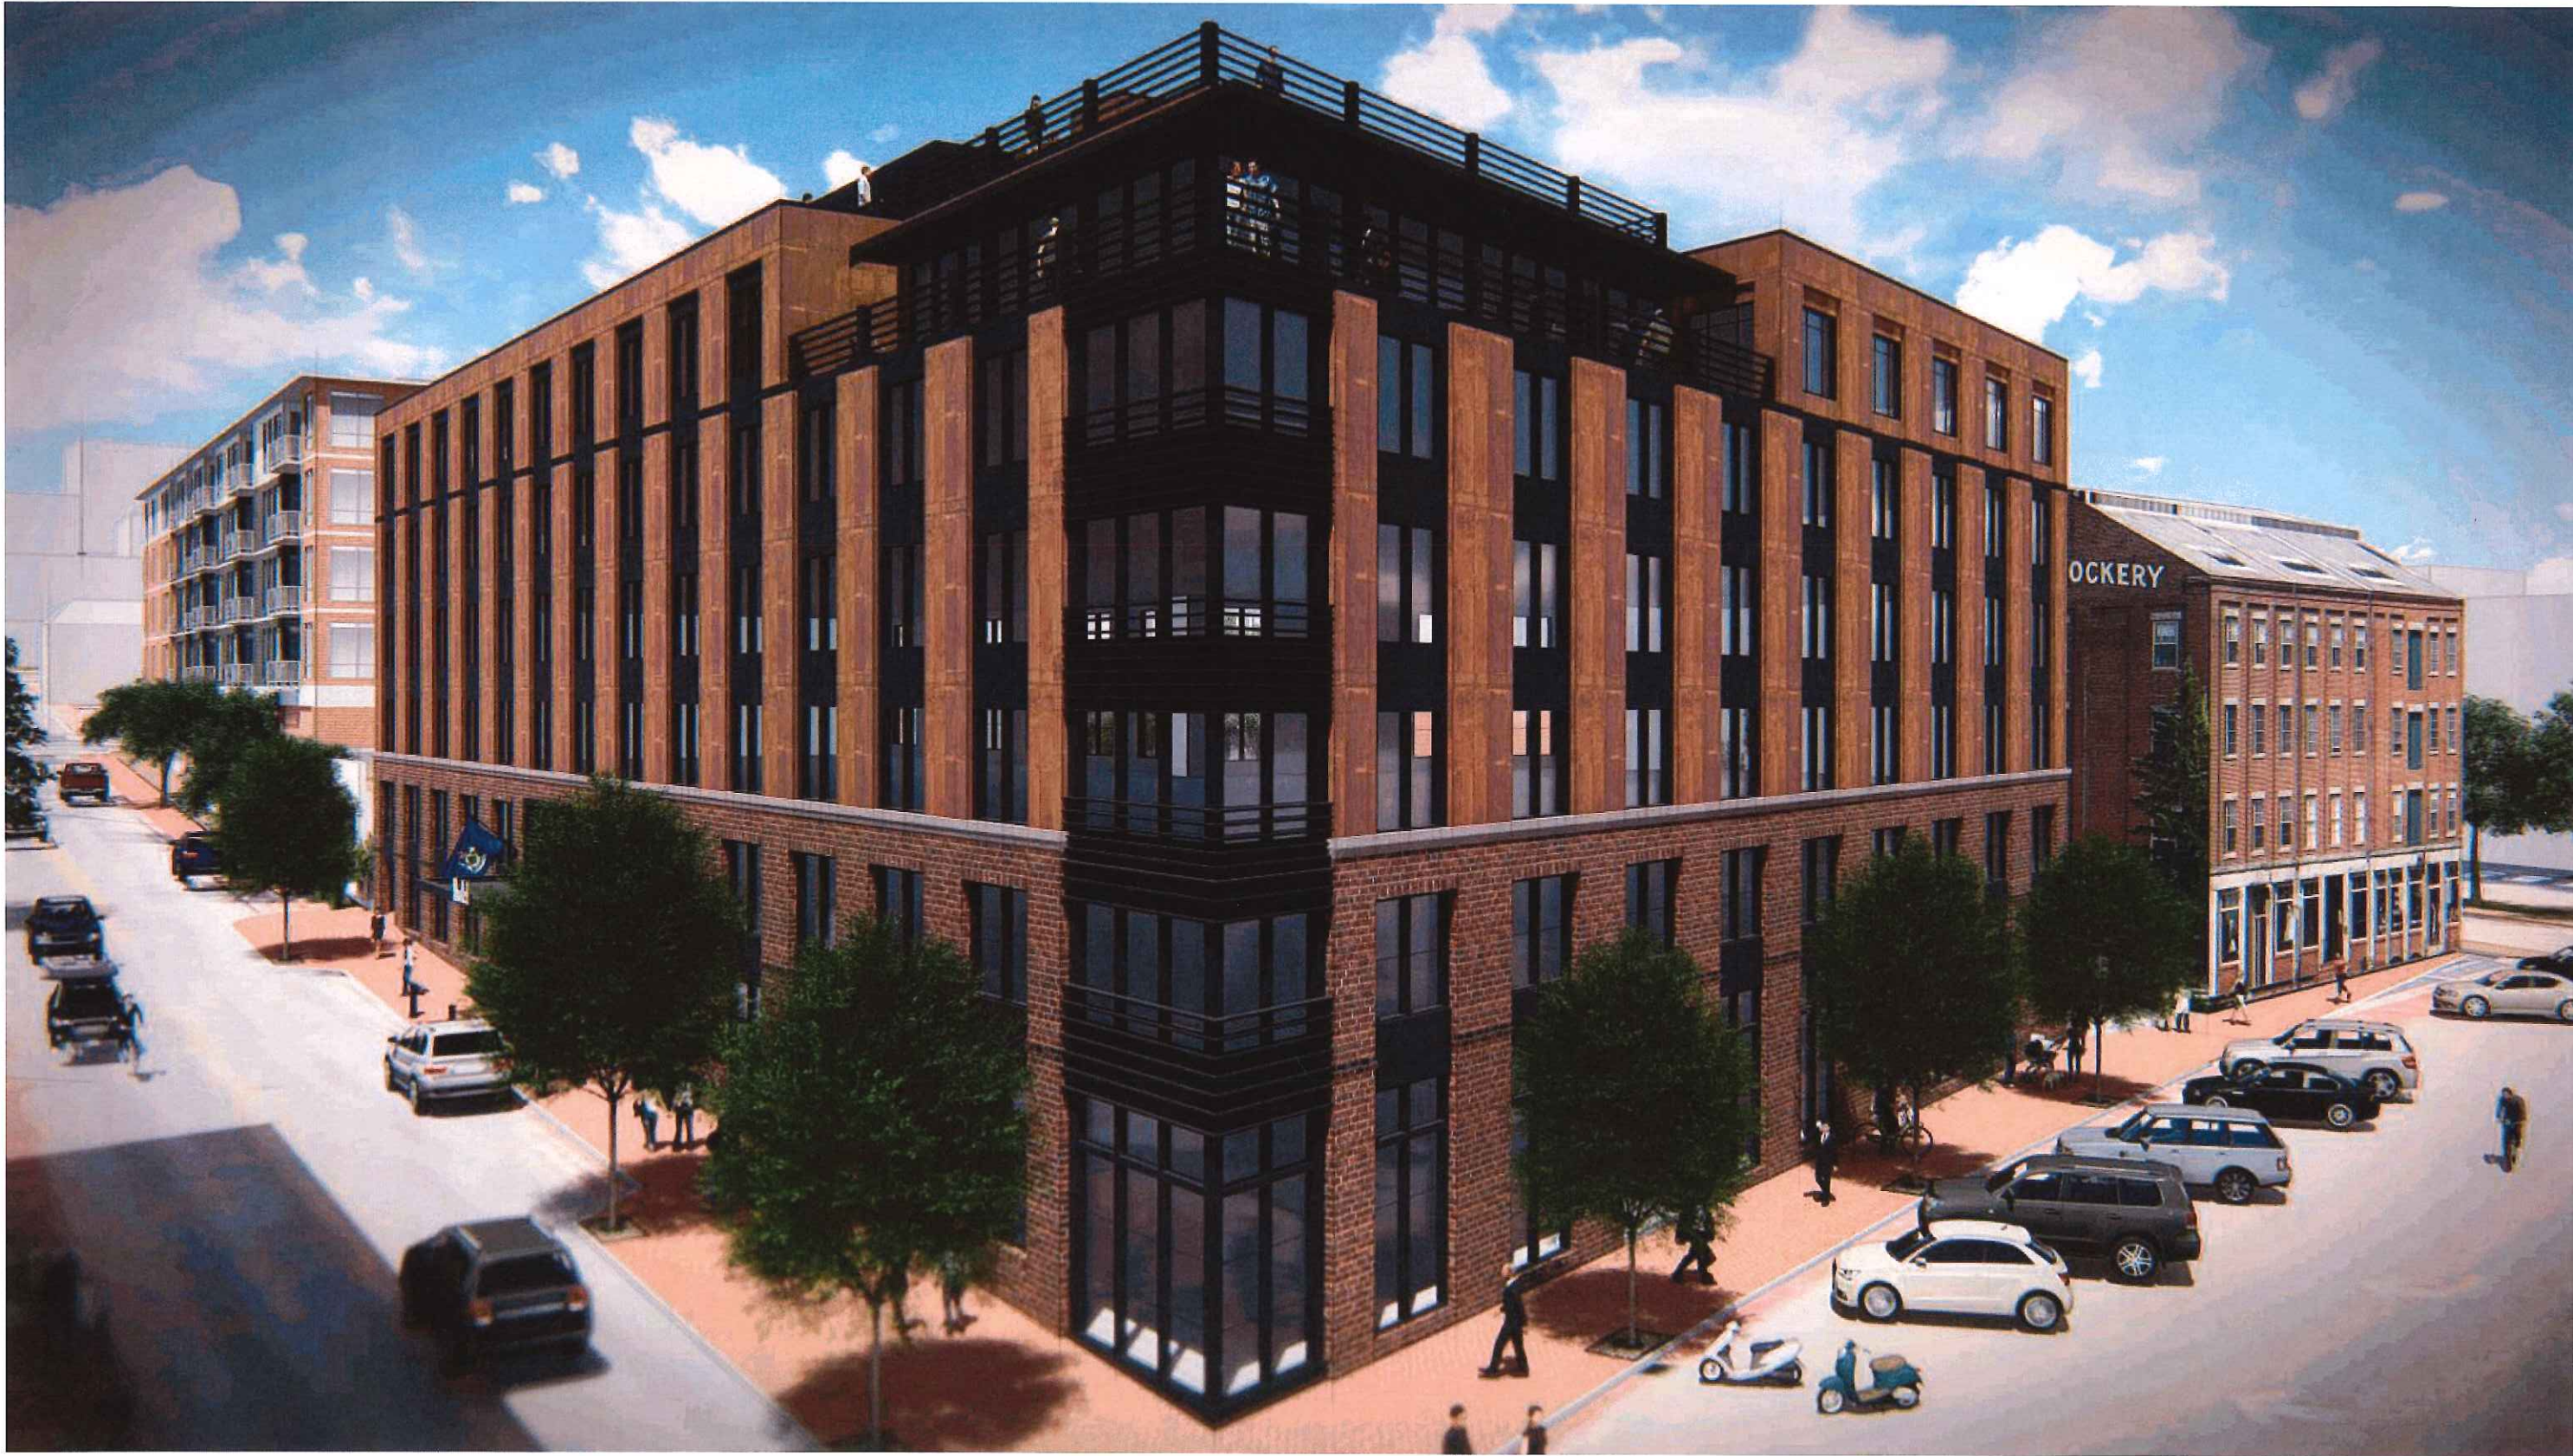
RENDERINGS + ELEVATION

COMMERCIAL STREET

**SCALE 11X17: 1' = 20'**

- Ironically, one of the key identified problems with the design appeared to have arisen from the architect's effort to pick up on key datum lines of the buildings on either side of the proposed hotel. This effort to create a design that mediated between buildings of disparate scale and base heights resulted in an unduly complicated, "split" façade that was at odds with the prevailing development pattern on Commercial Street. As several members of the Board noted, Commercial Street facades are noteworthy for their overall consistent architectural expression. Board members encouraged the project architect to eliminate some of the intermediate cornices that referenced datum lines of the abutments, adjust the material palette of the upper floors to create a simpler composition of base/middle/top and, most importantly, unify the Commercial Street façade to create a more cohesive architectural expression.

- Board members noted that the treatment proposed for the top floor contributed significantly to the Commercial Street façade's lack of cohesiveness and hybrid nature. As proposed, the eastern half of the top floor was positioned at the same plane as the lower floors, continued the same design vocabulary of the floors below and terminated in a flat roof with no projecting cornice. The western half of the top floor, which is to be occupied by a bar, was set back approximately 11 feet behind a metal railing and featured continuous glazing. A prominent projecting canopy, set at a lower height than the wall height of the eastern end, capped this recessed element.

- Board members expressed some concern about the overall size of the windows, particularly the upper floor windows. Acknowledging that windows on a new building will be larger than those on structures built in the 19<sup>th</sup> century and that the proposed window sizes were proportionate to the building itself, members of the Board nevertheless found the windows to be oversized when viewed in the context of neighboring buildings. Some adjustment in size was encouraged.

Although the enclosed proposal reflects a number of positive and responsive design revisions, staff continues to have reservations about the proposed treatment of the sixth-floor level of the building in terms of achieving compatibility with the surrounding Commercial Street context. All of the measures taken to unify the façade below this level are undermined by the sharp division in treatment at the top floor. As was noted in the previous staff report and by Board members at the first workshop, one of the most important shared characteristics of the buildings that line the inland side of Commercial Street is their simplicity of form and overall consistency of architectural expression.
