# CITY OF PORTLAND, MAINE

## HISTORIC PRESERVATION BOARD

WORKSHOP  
ONE CENTER STREET

Fathom HKS  
SCHEMATIC DESIGN  
01.16.2019

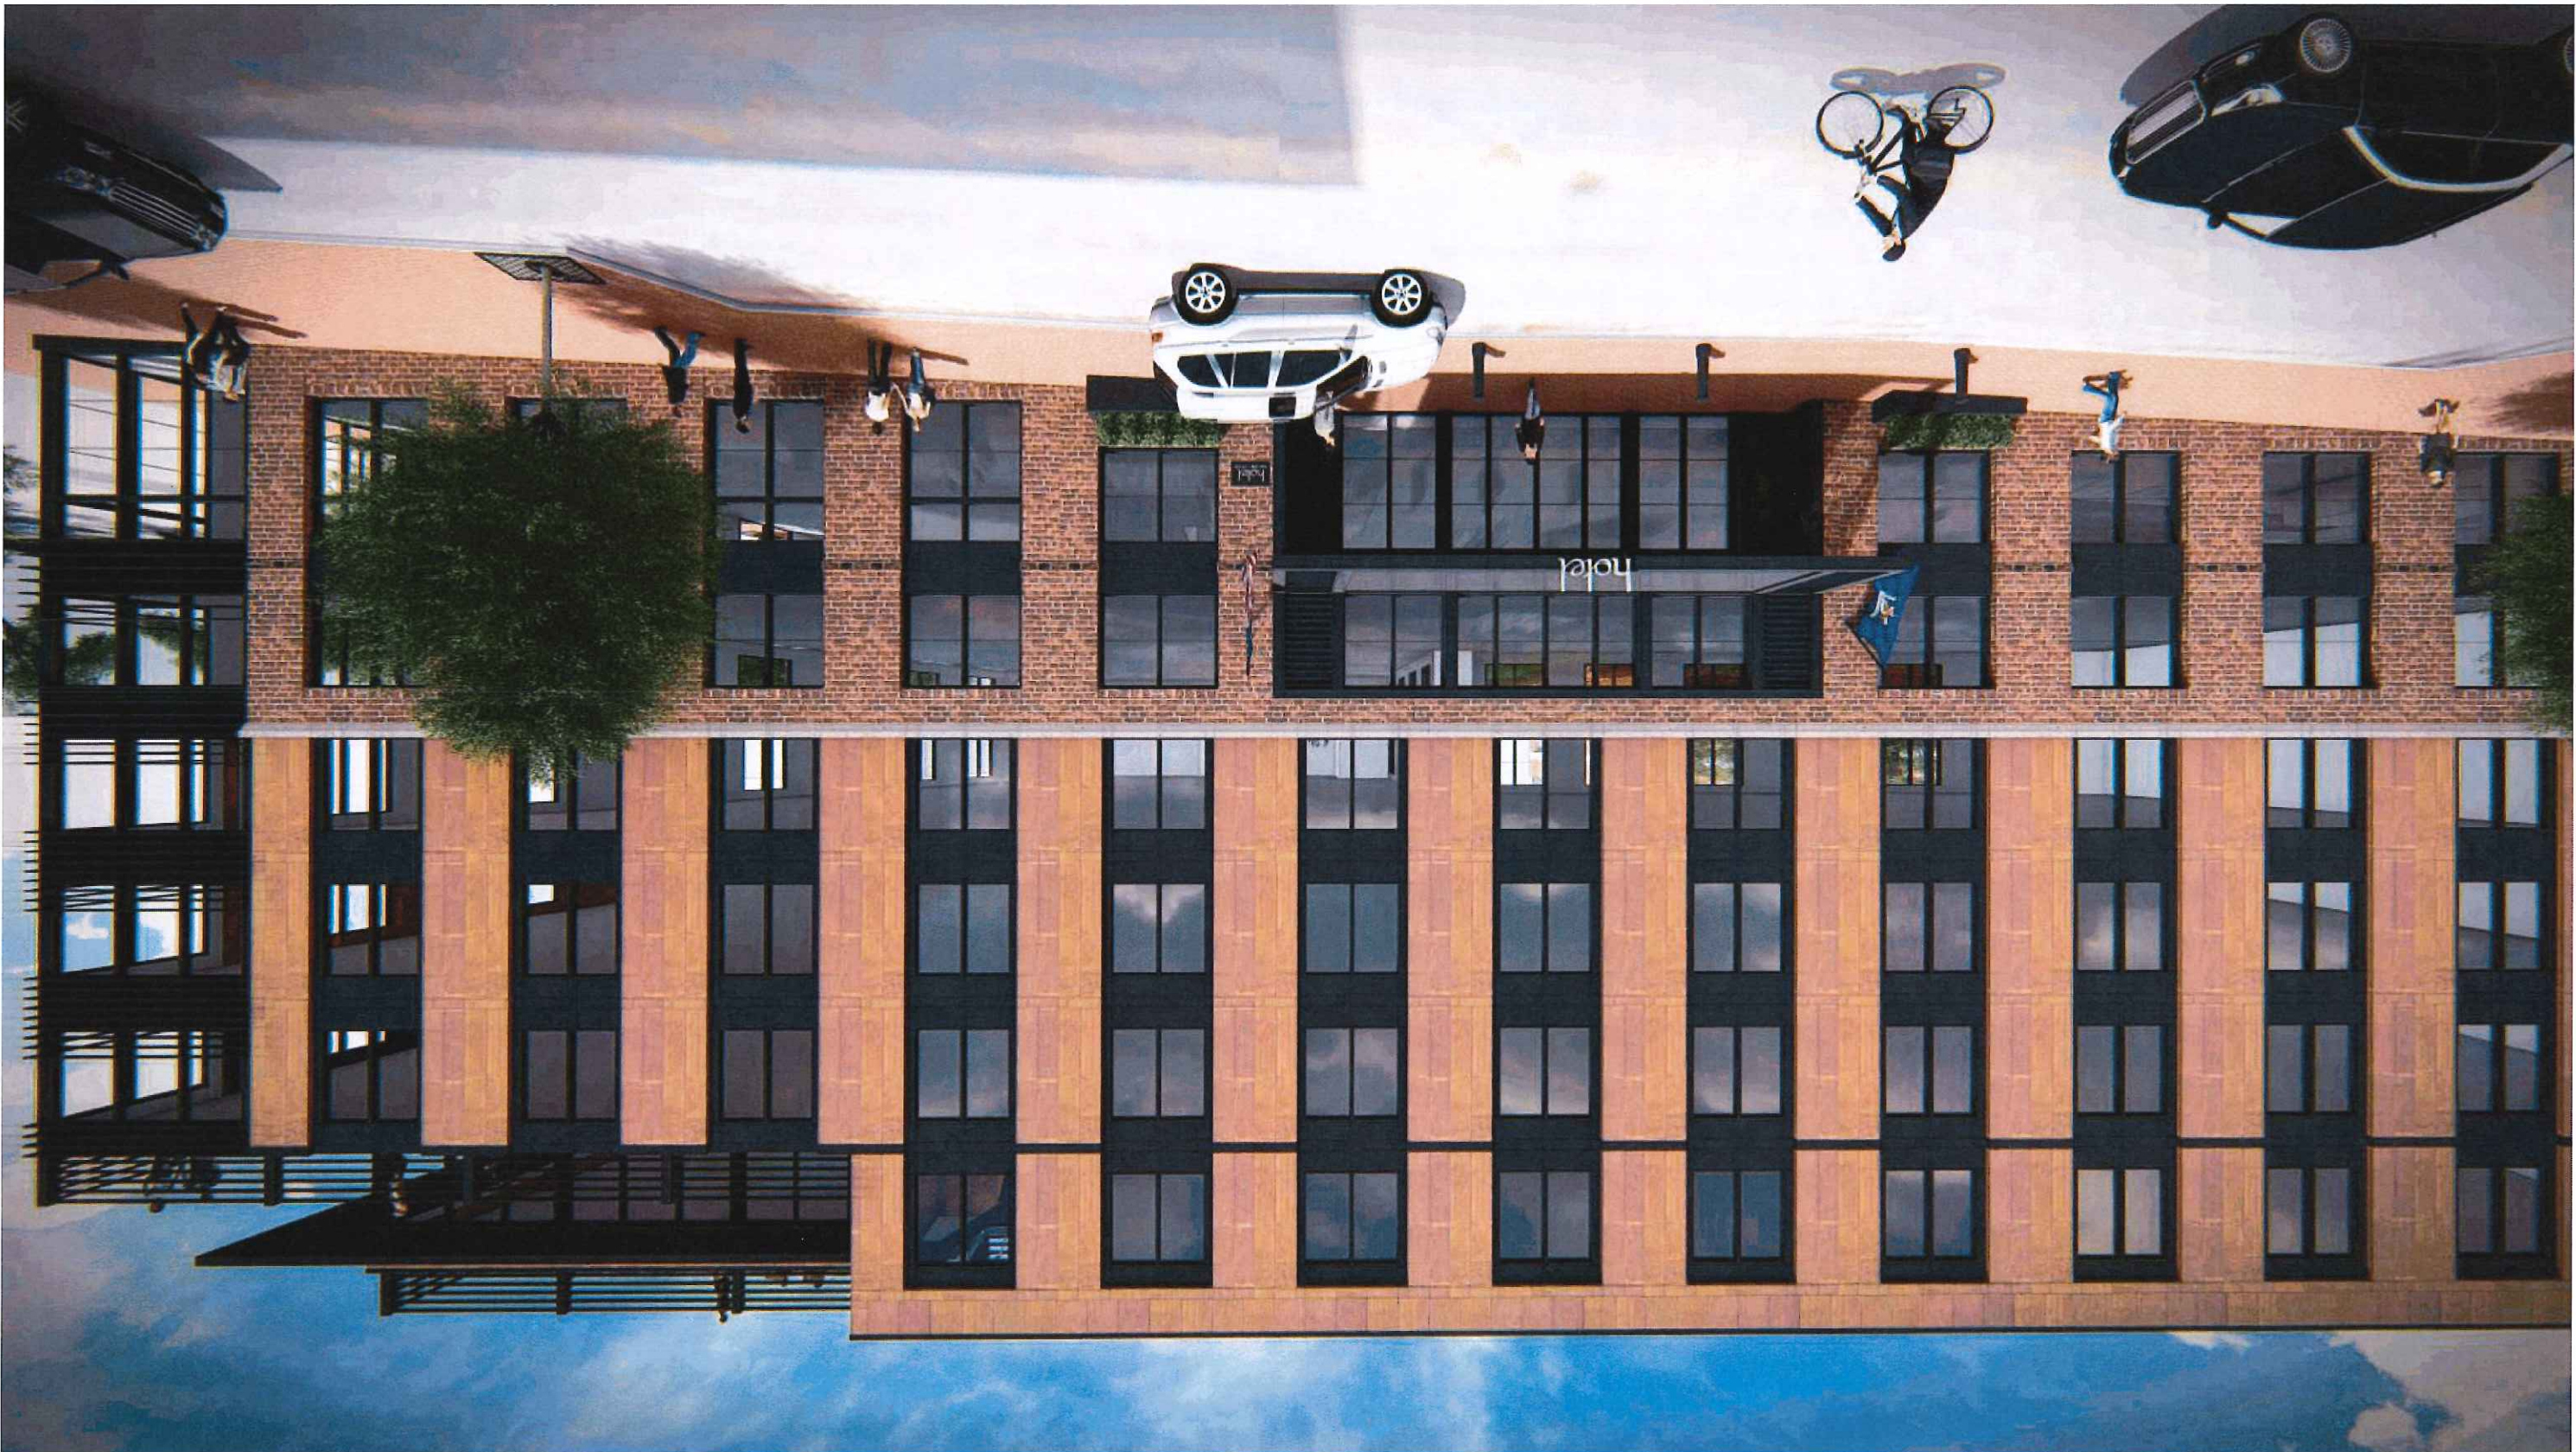
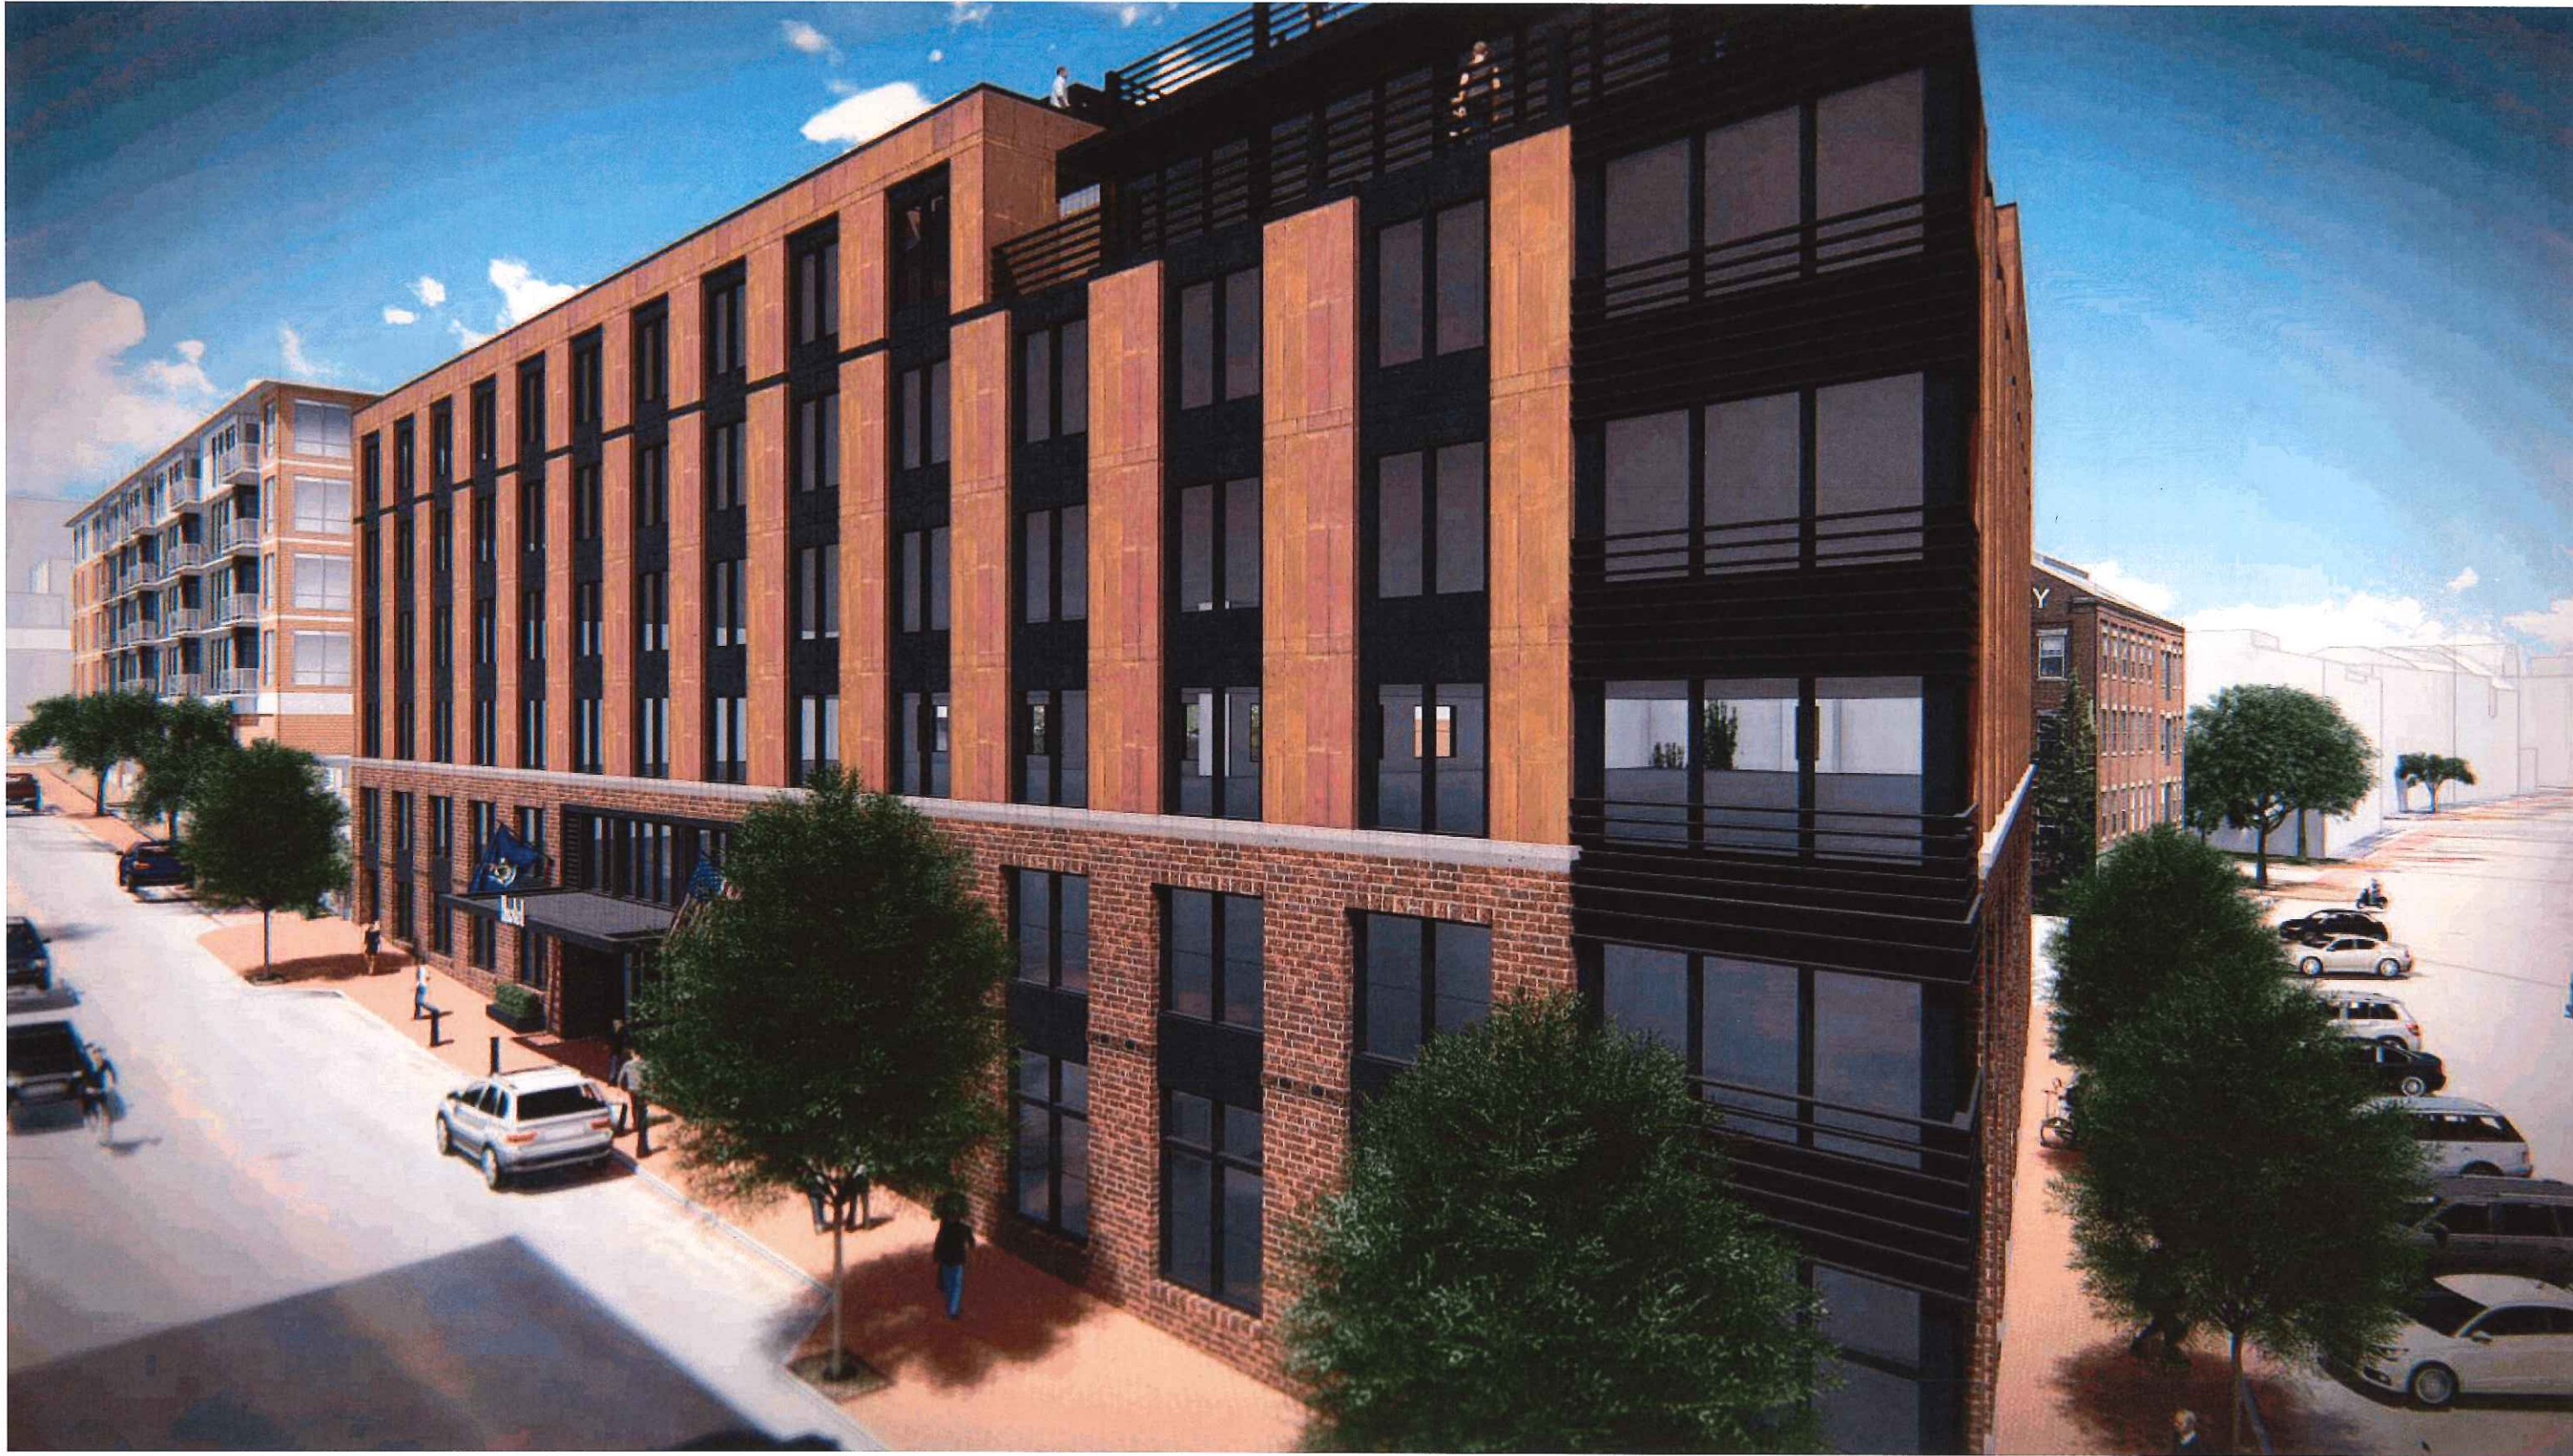
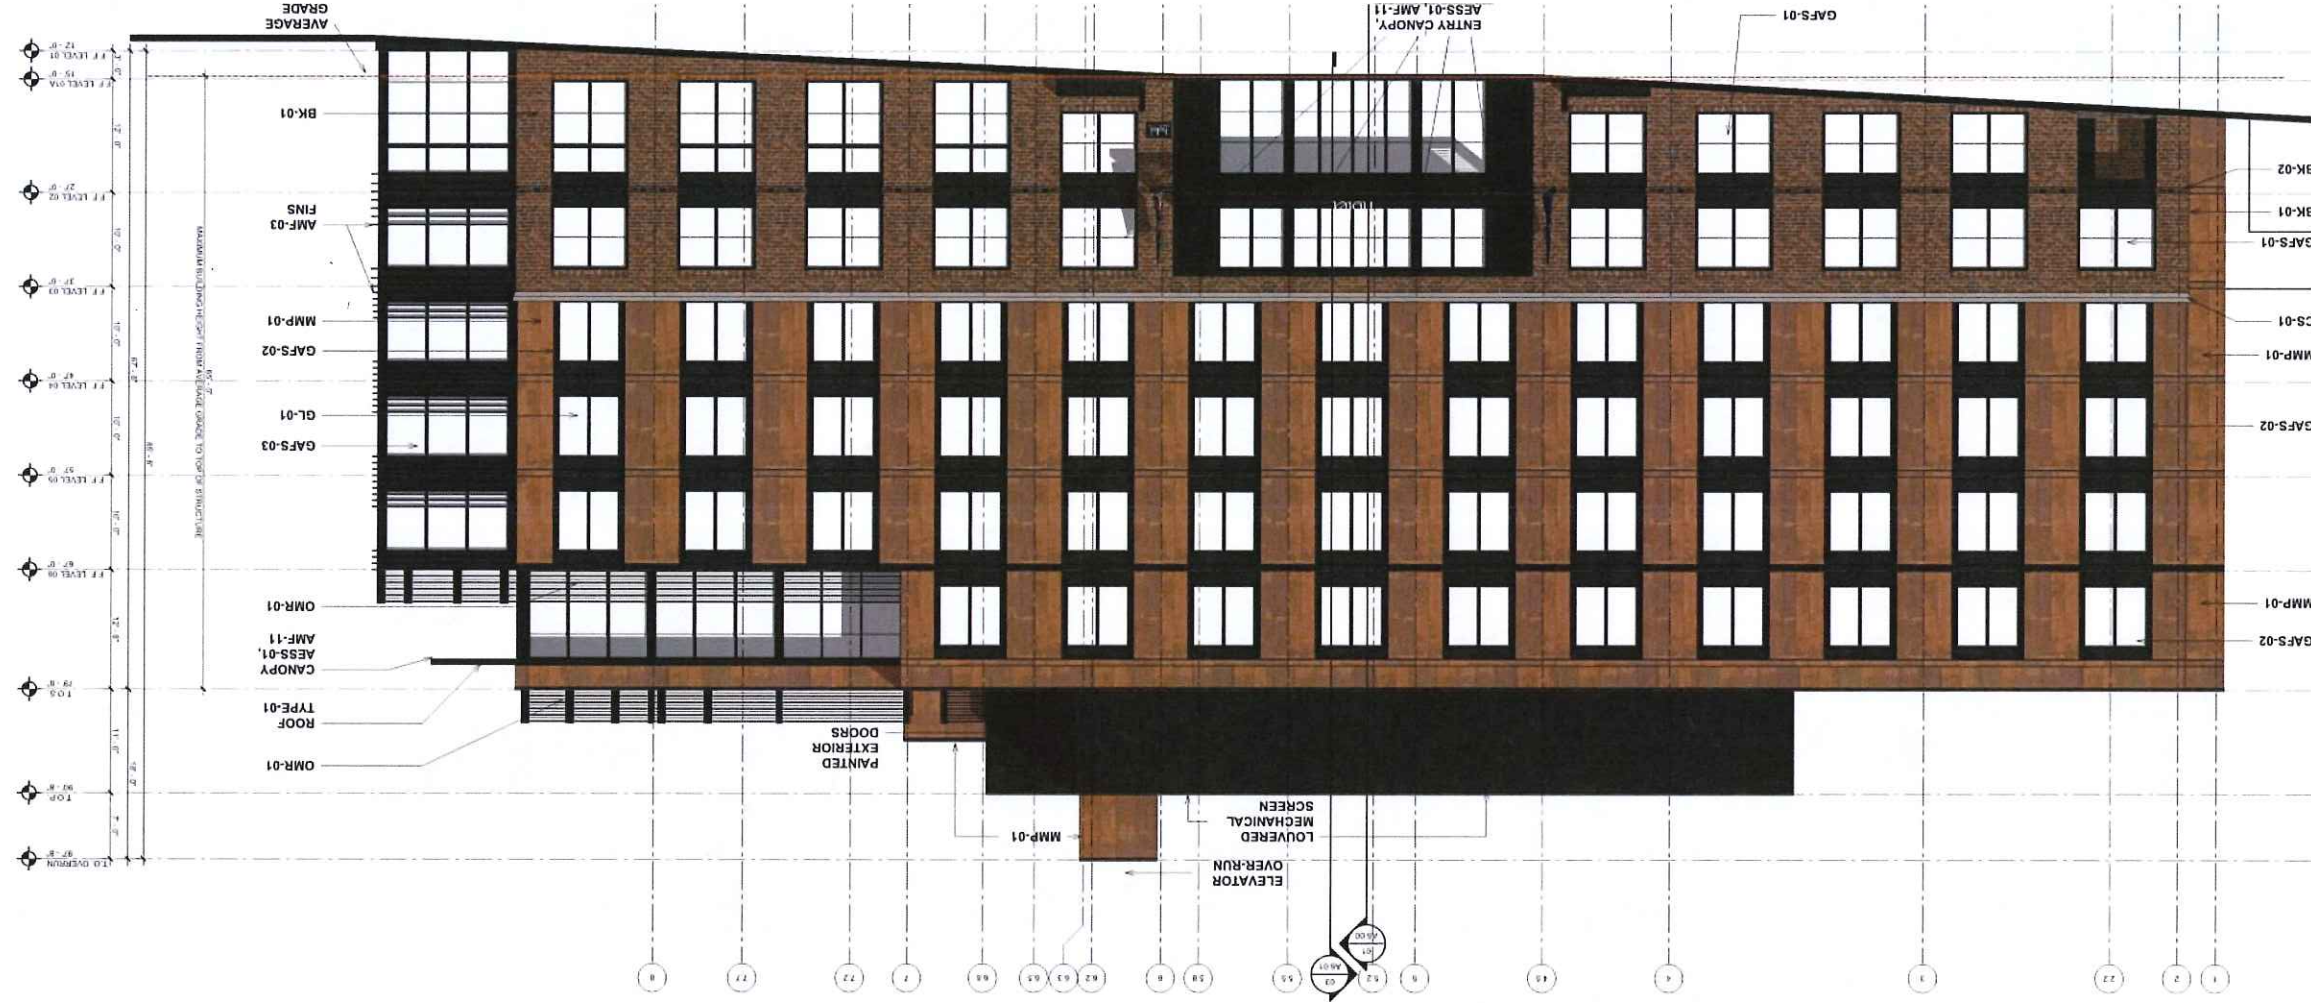
RENDERINGS + ELEVATION  
CENTER STREET

- Some members questioned the lack of windows on the east elevation of the hotel, especially near the Commercial Street corner.
- Board members recommended that the intermediate cornices on the Center Street elevation be removed as well.
