# CITY OF PORTLAND, MAINE

## HISTORIC PRESERVATION BOARD

WORKSHOP  
ONE CENTER STREET

Fathom HKS  
SCHEMATIC DESIGN  
01.16.2019

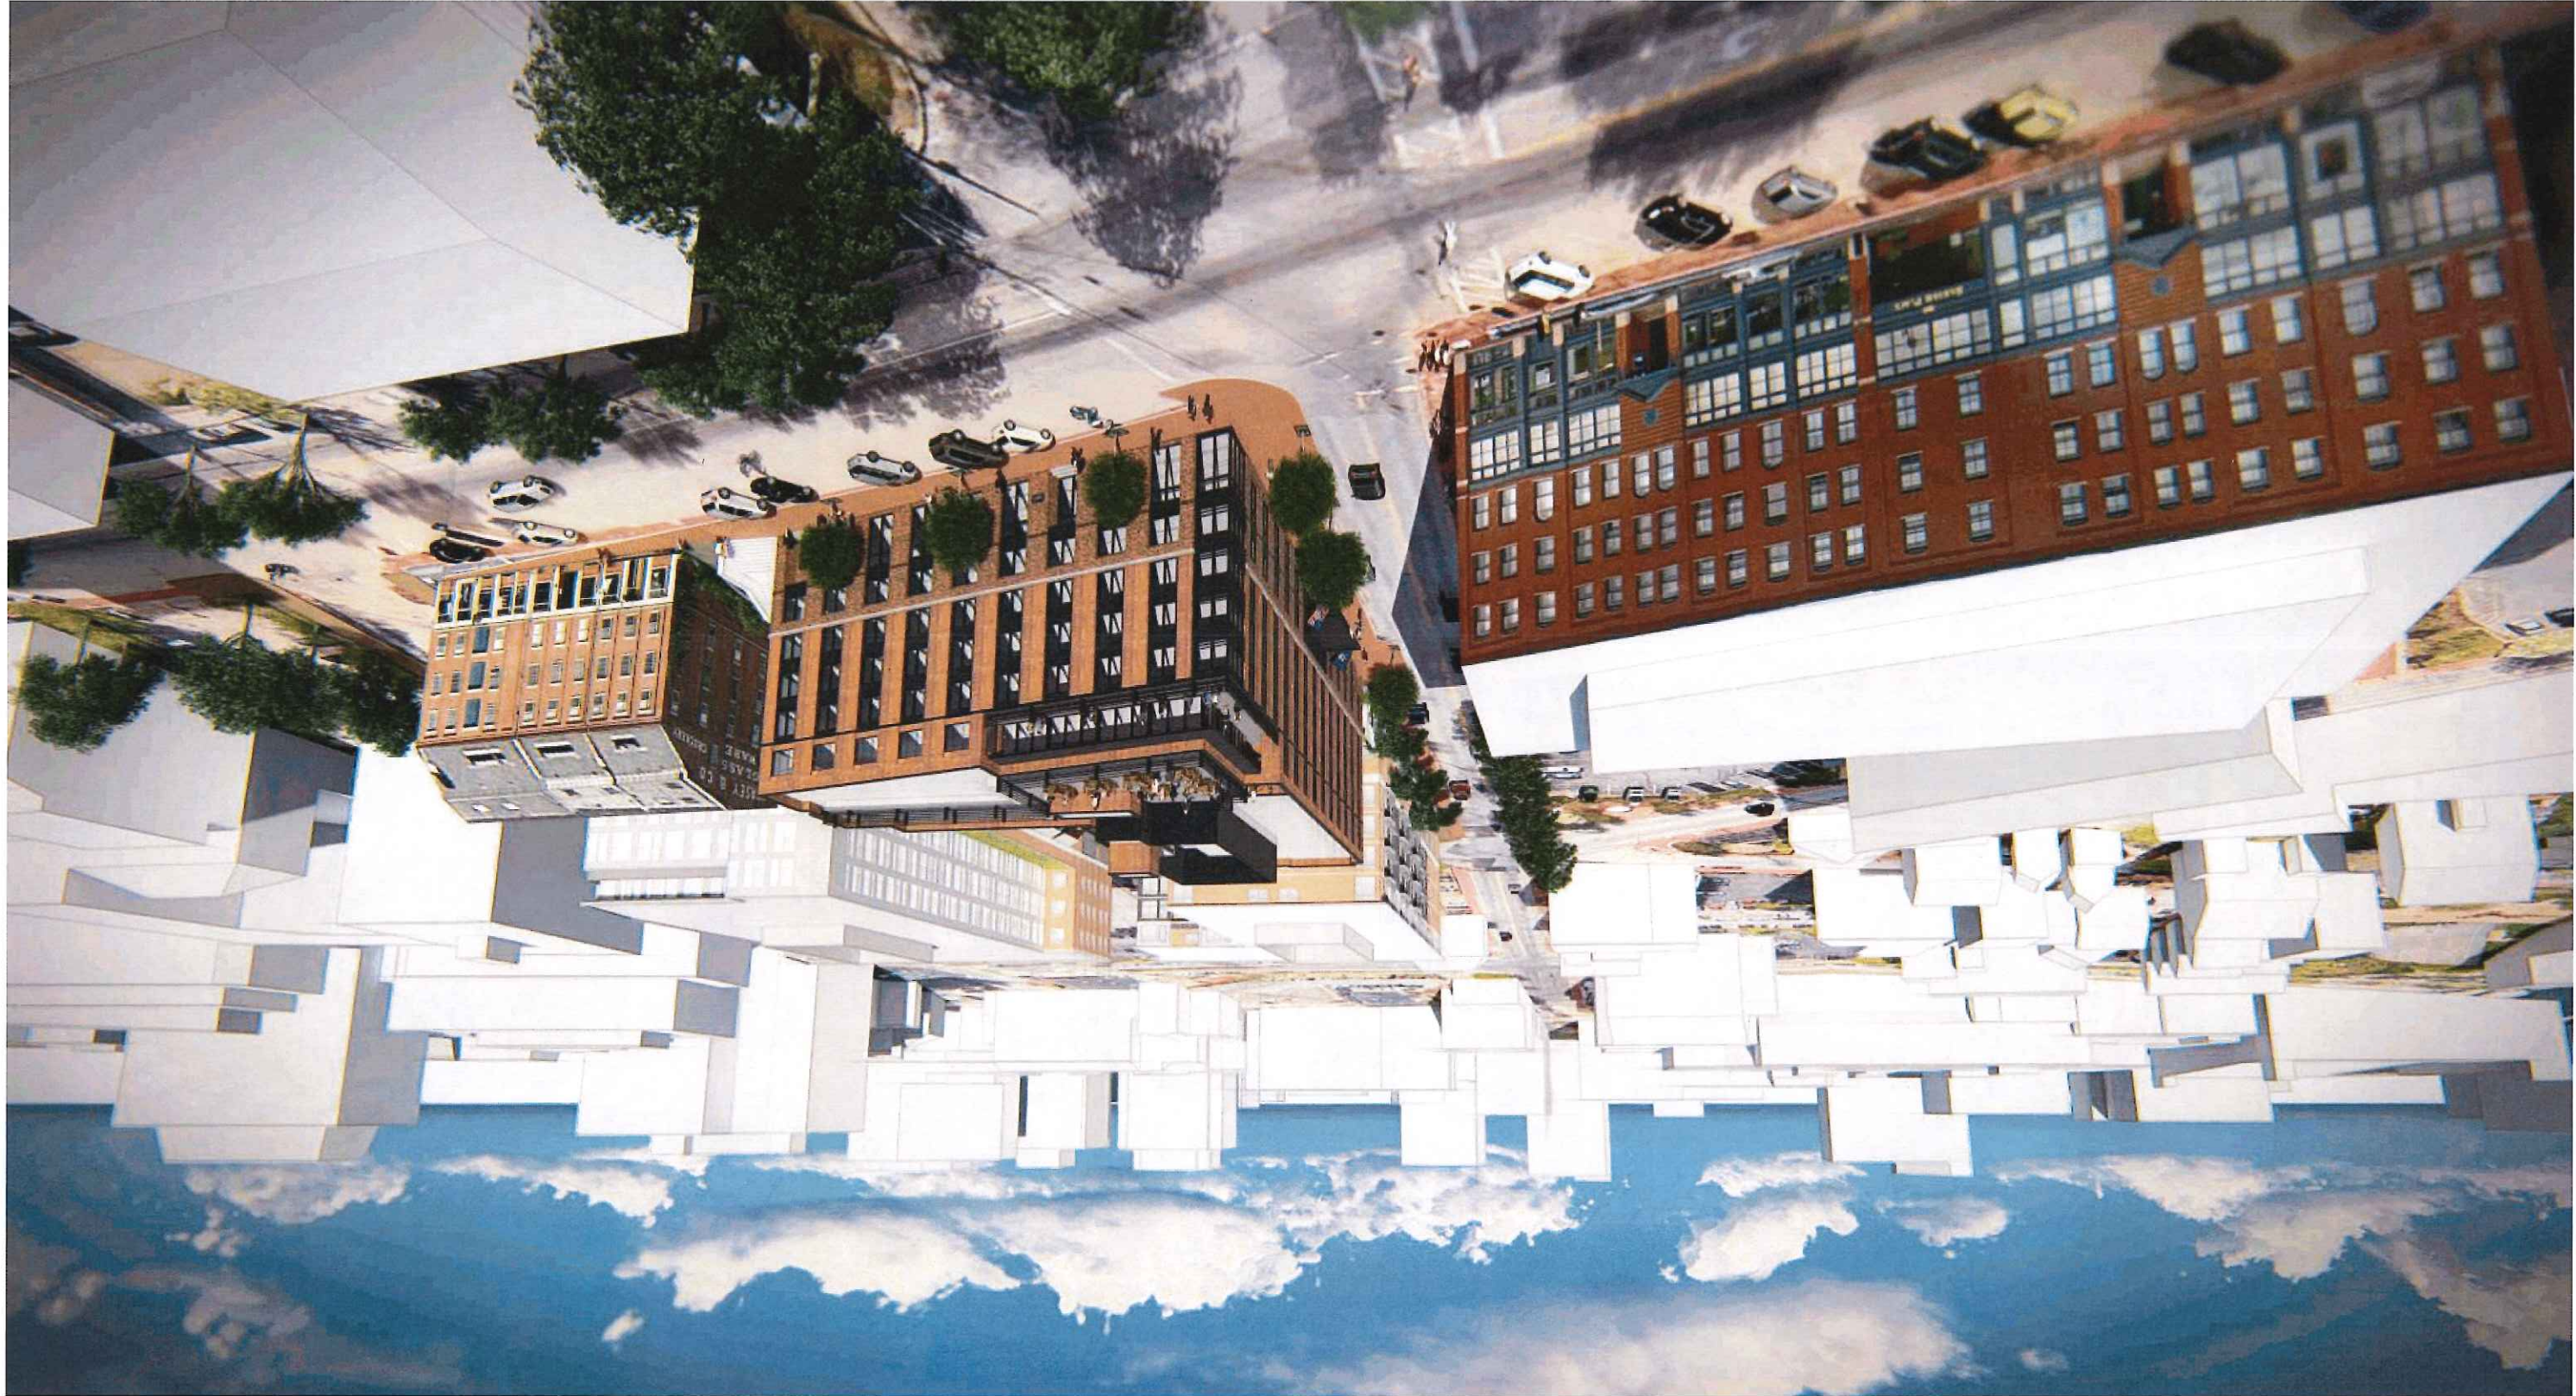
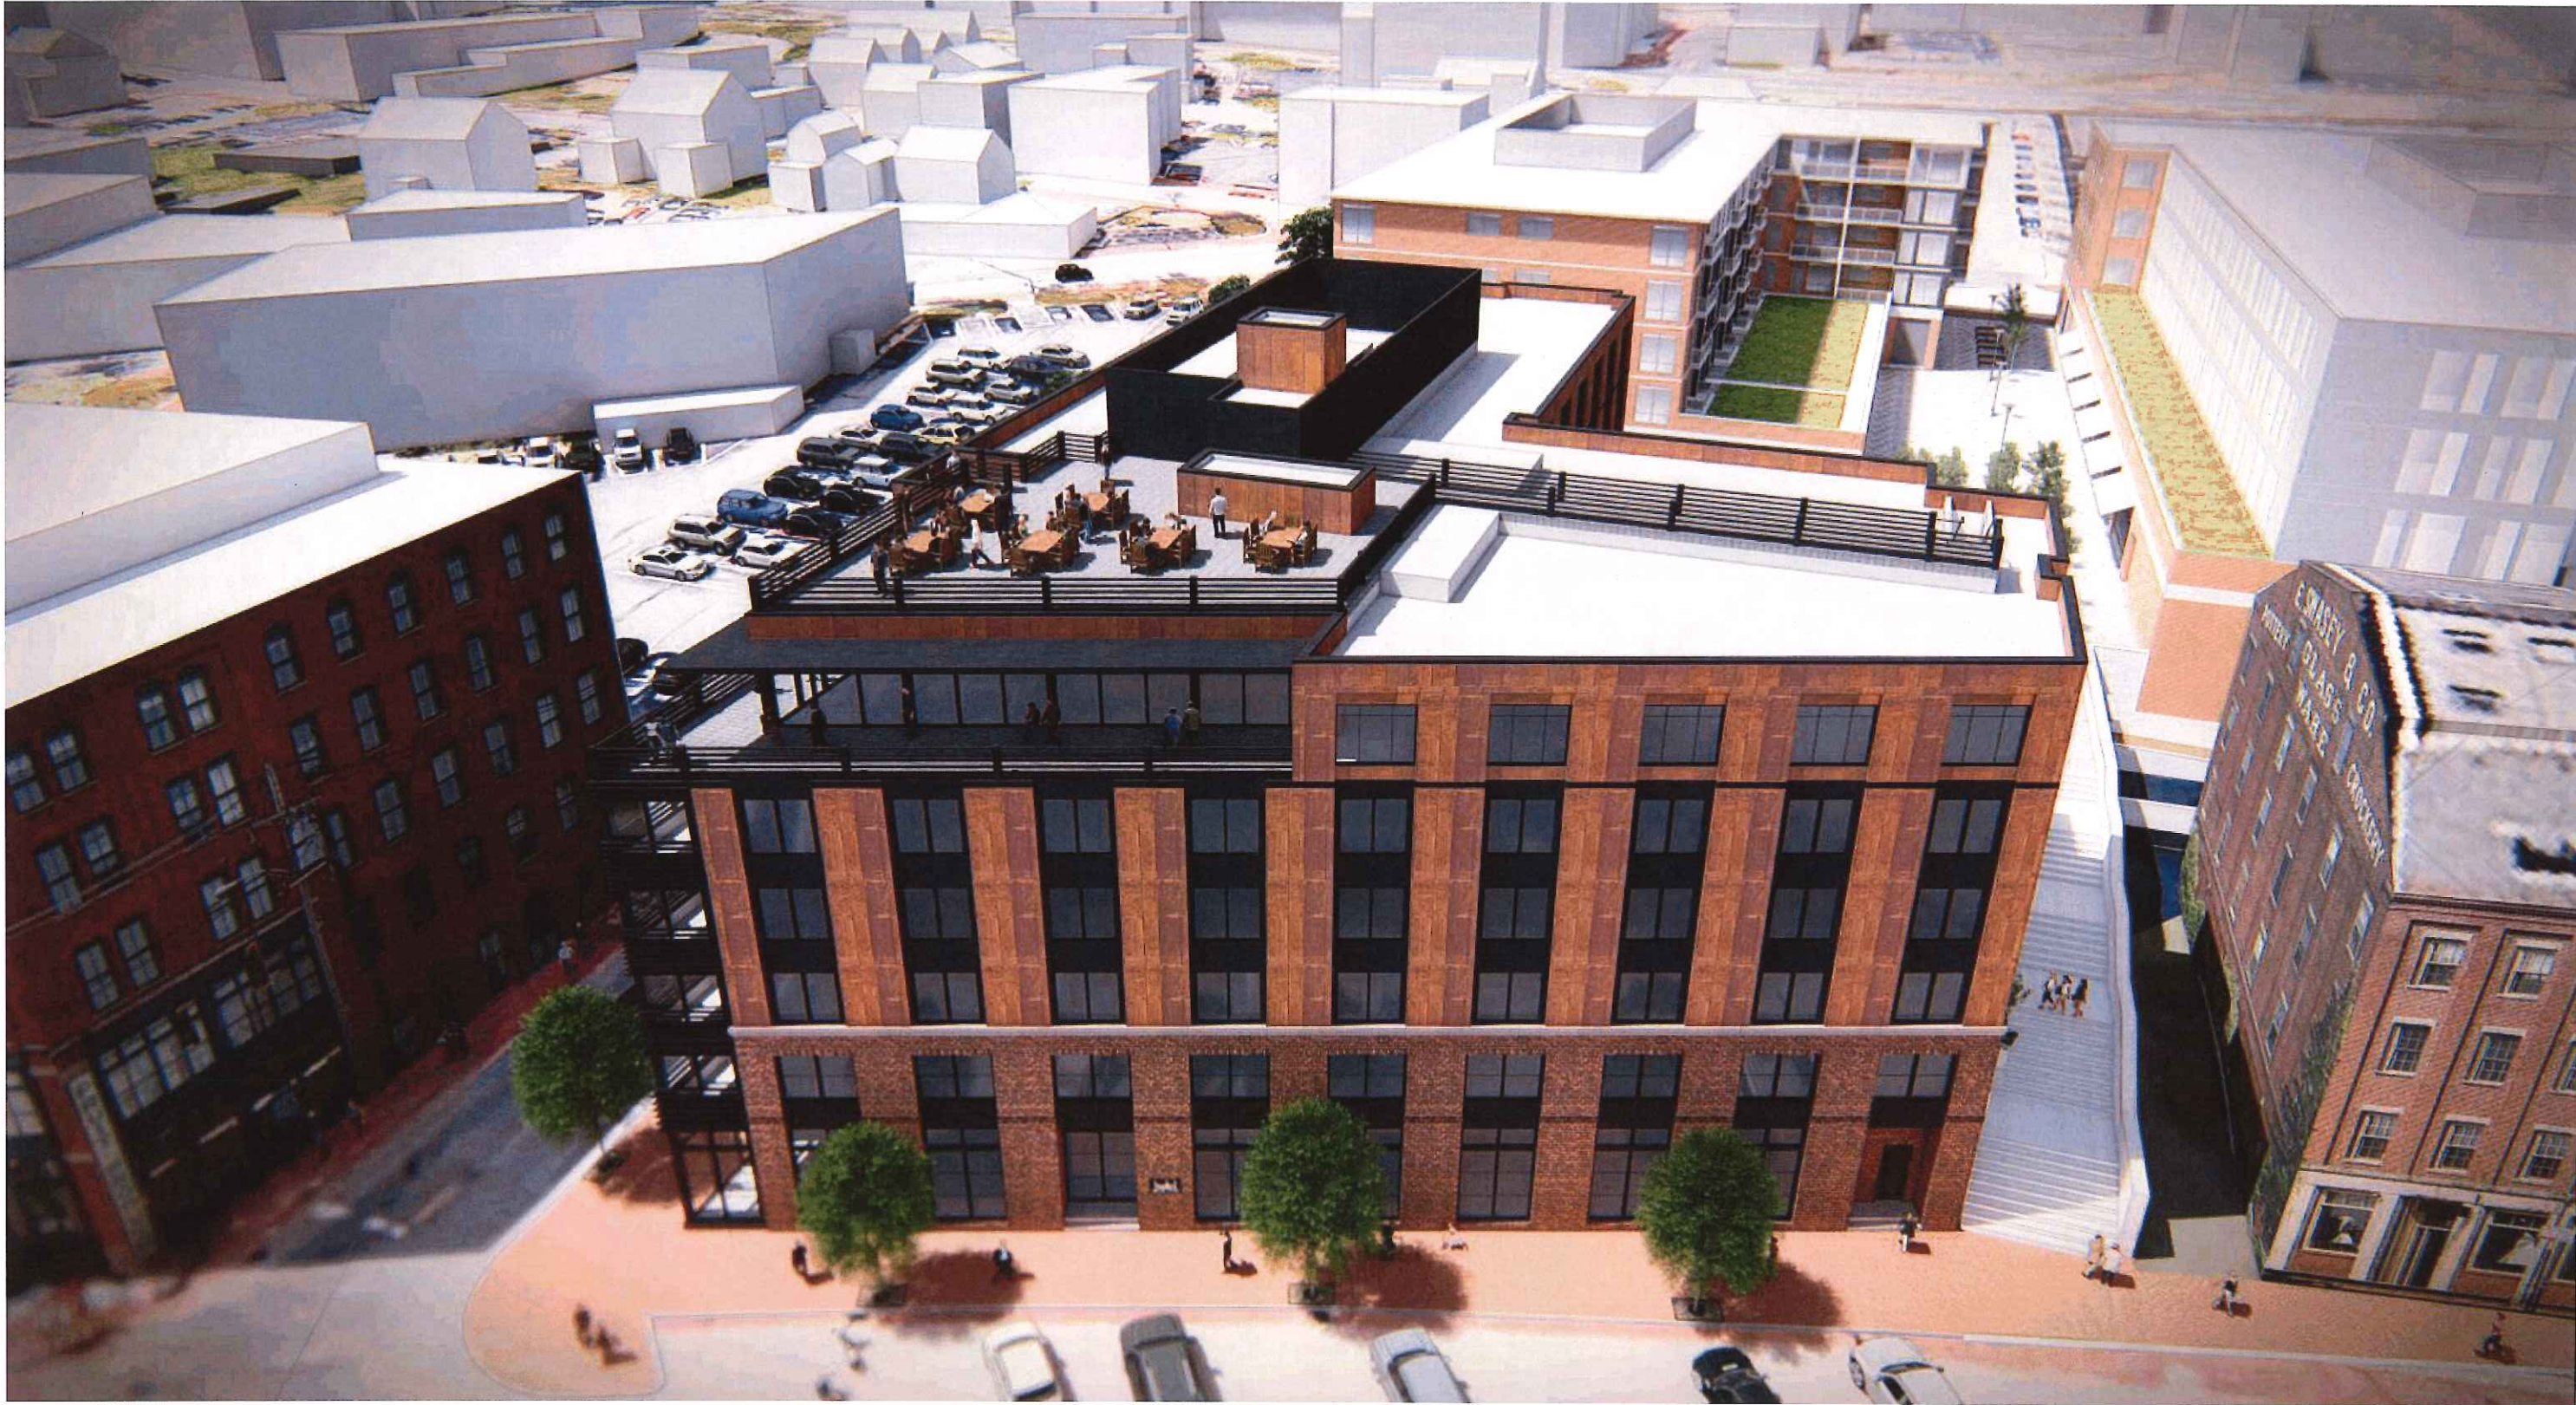
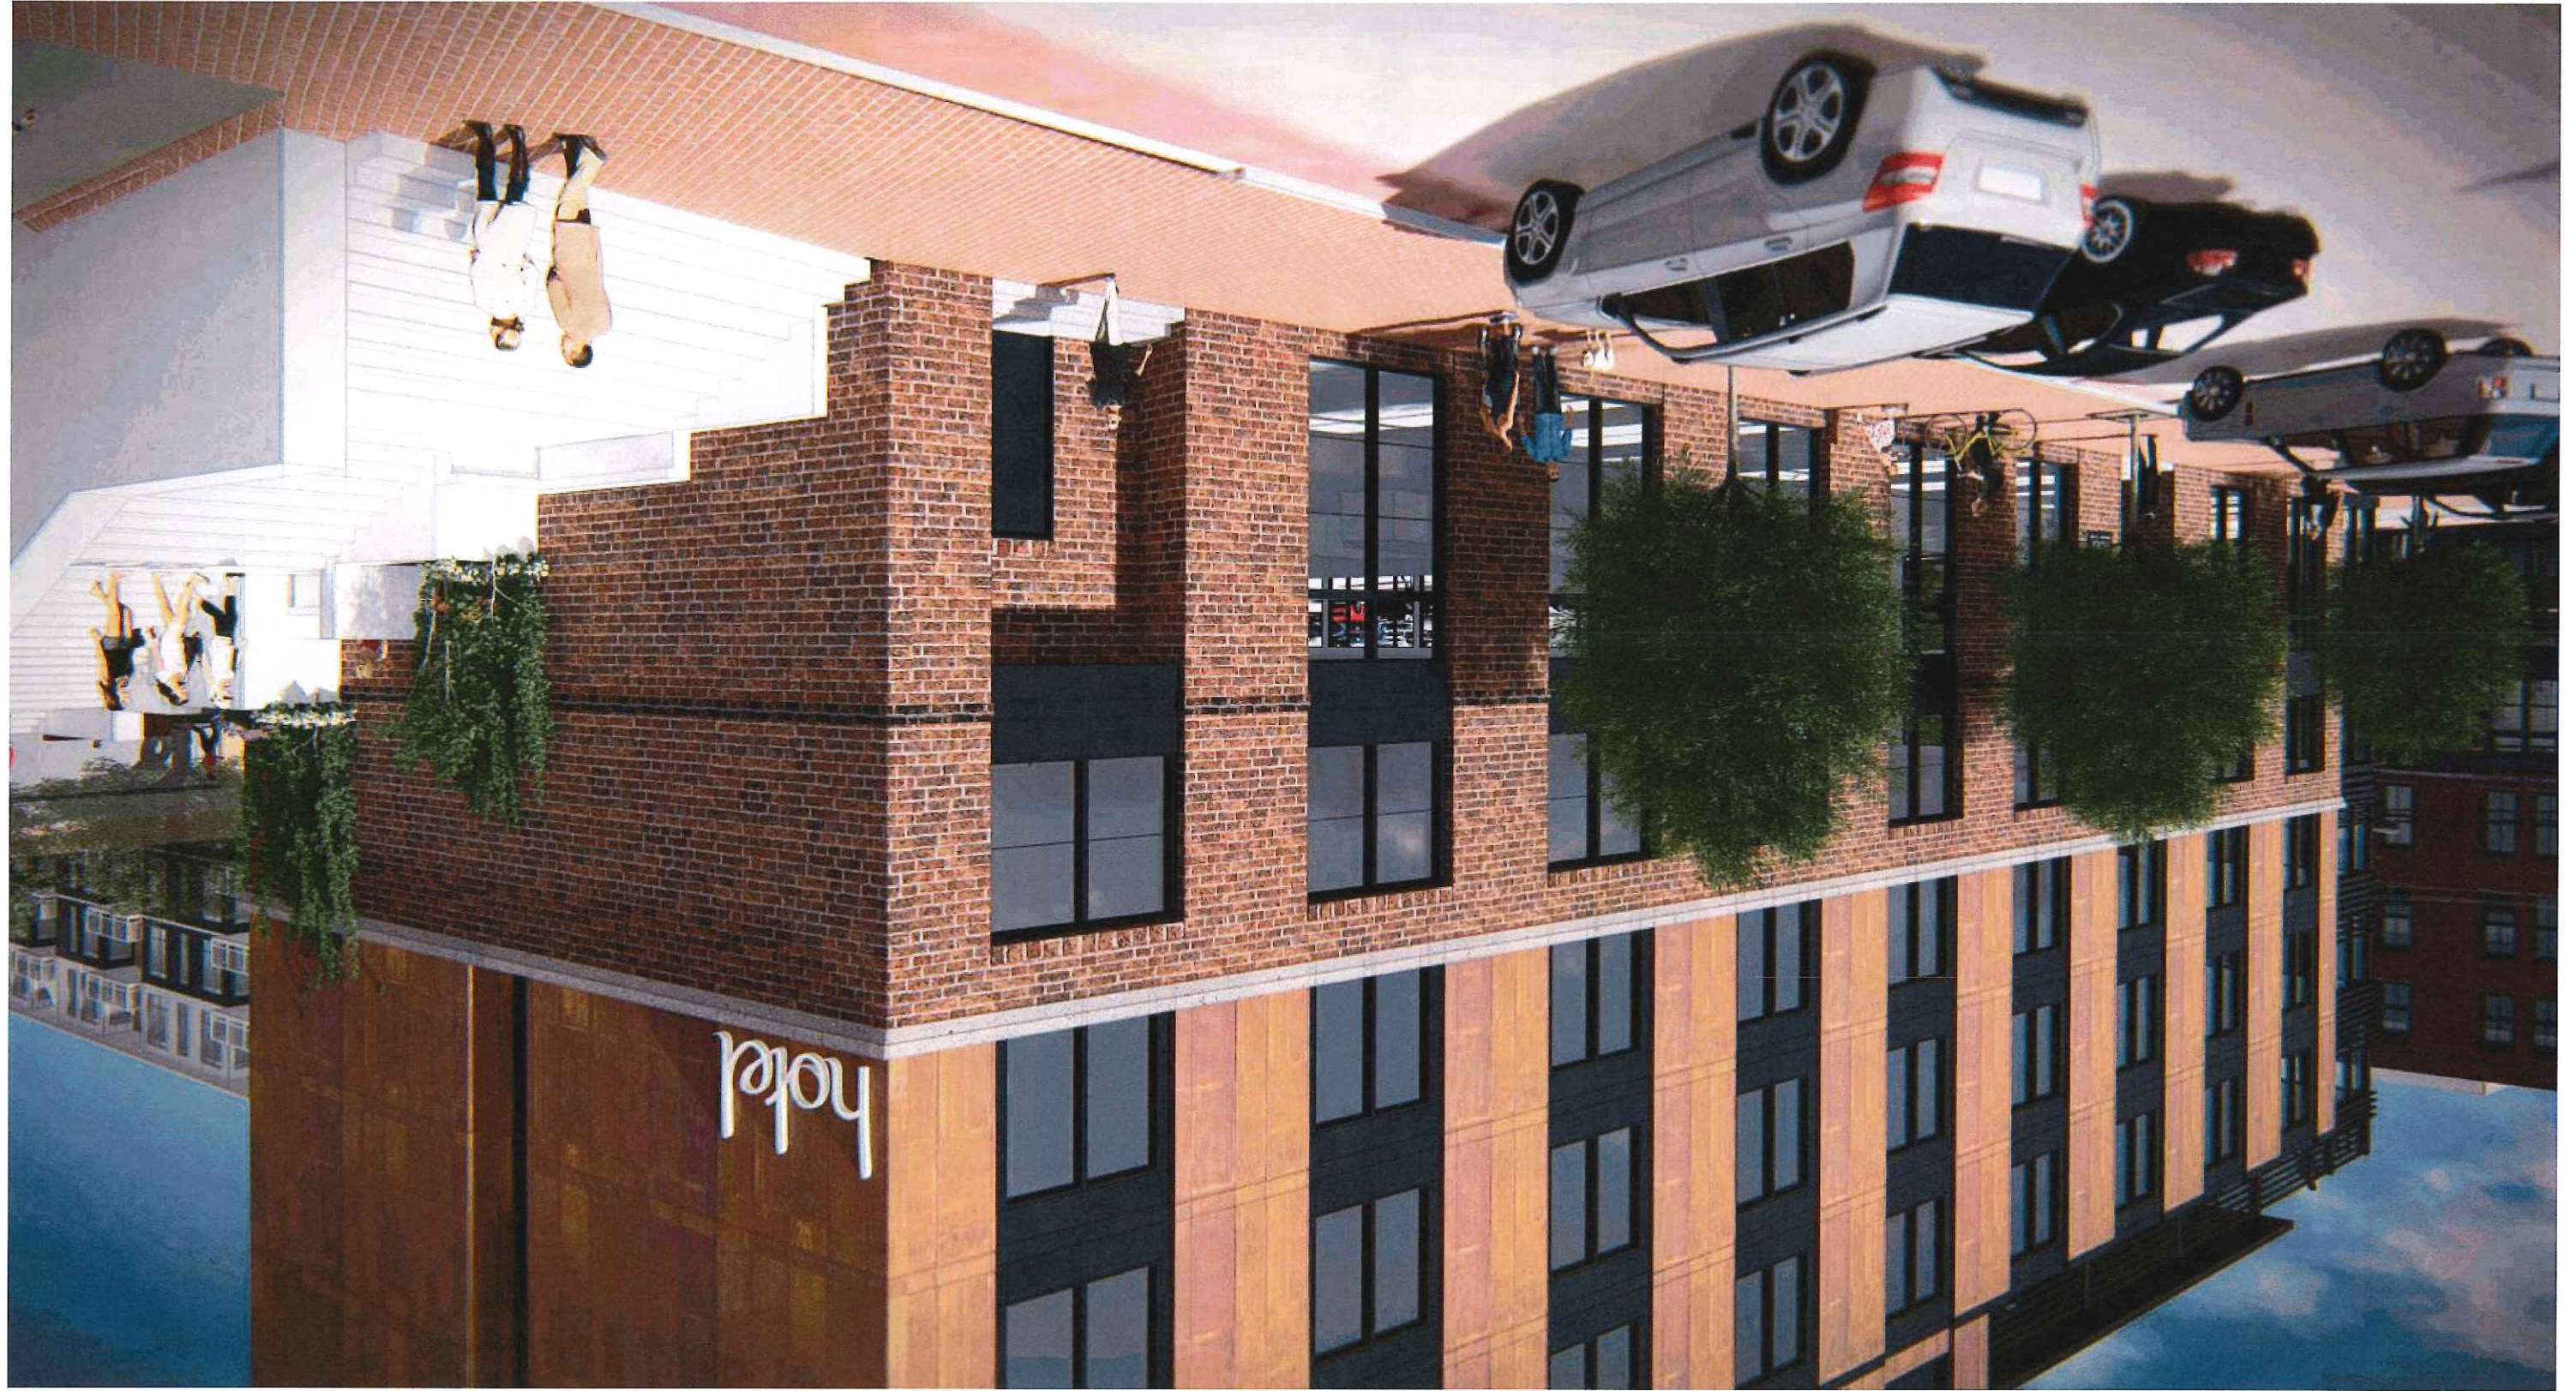
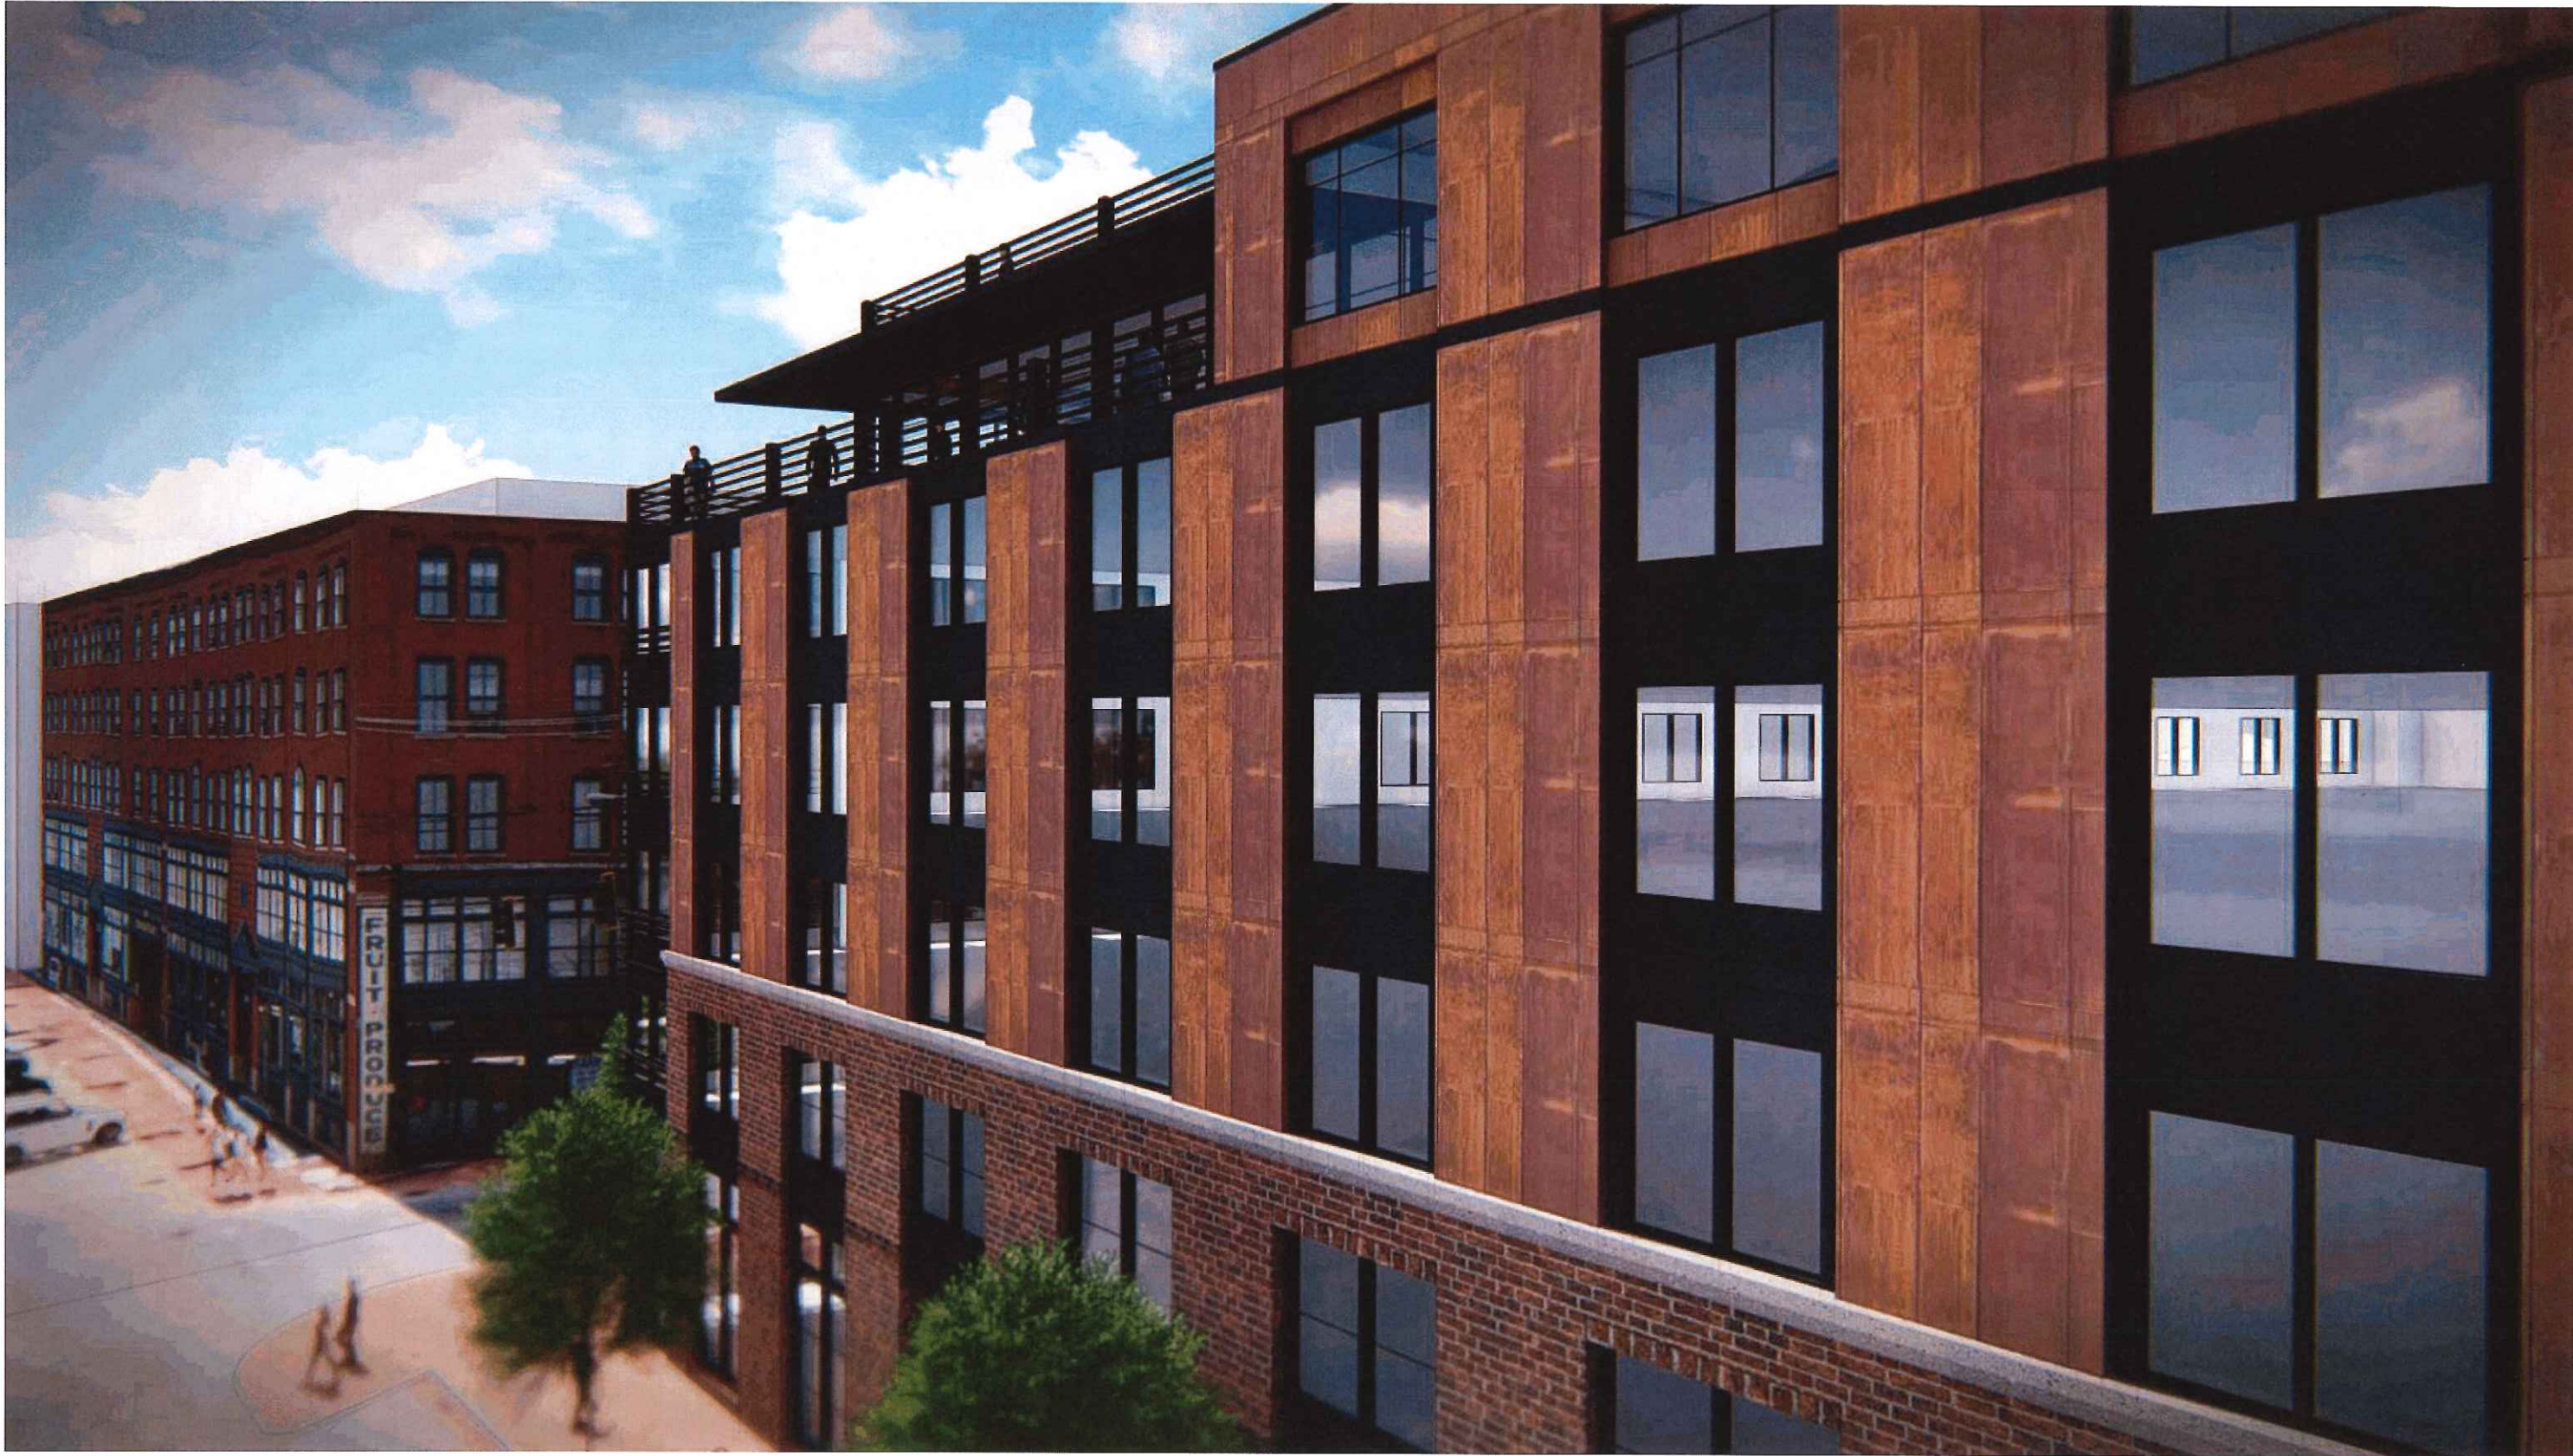
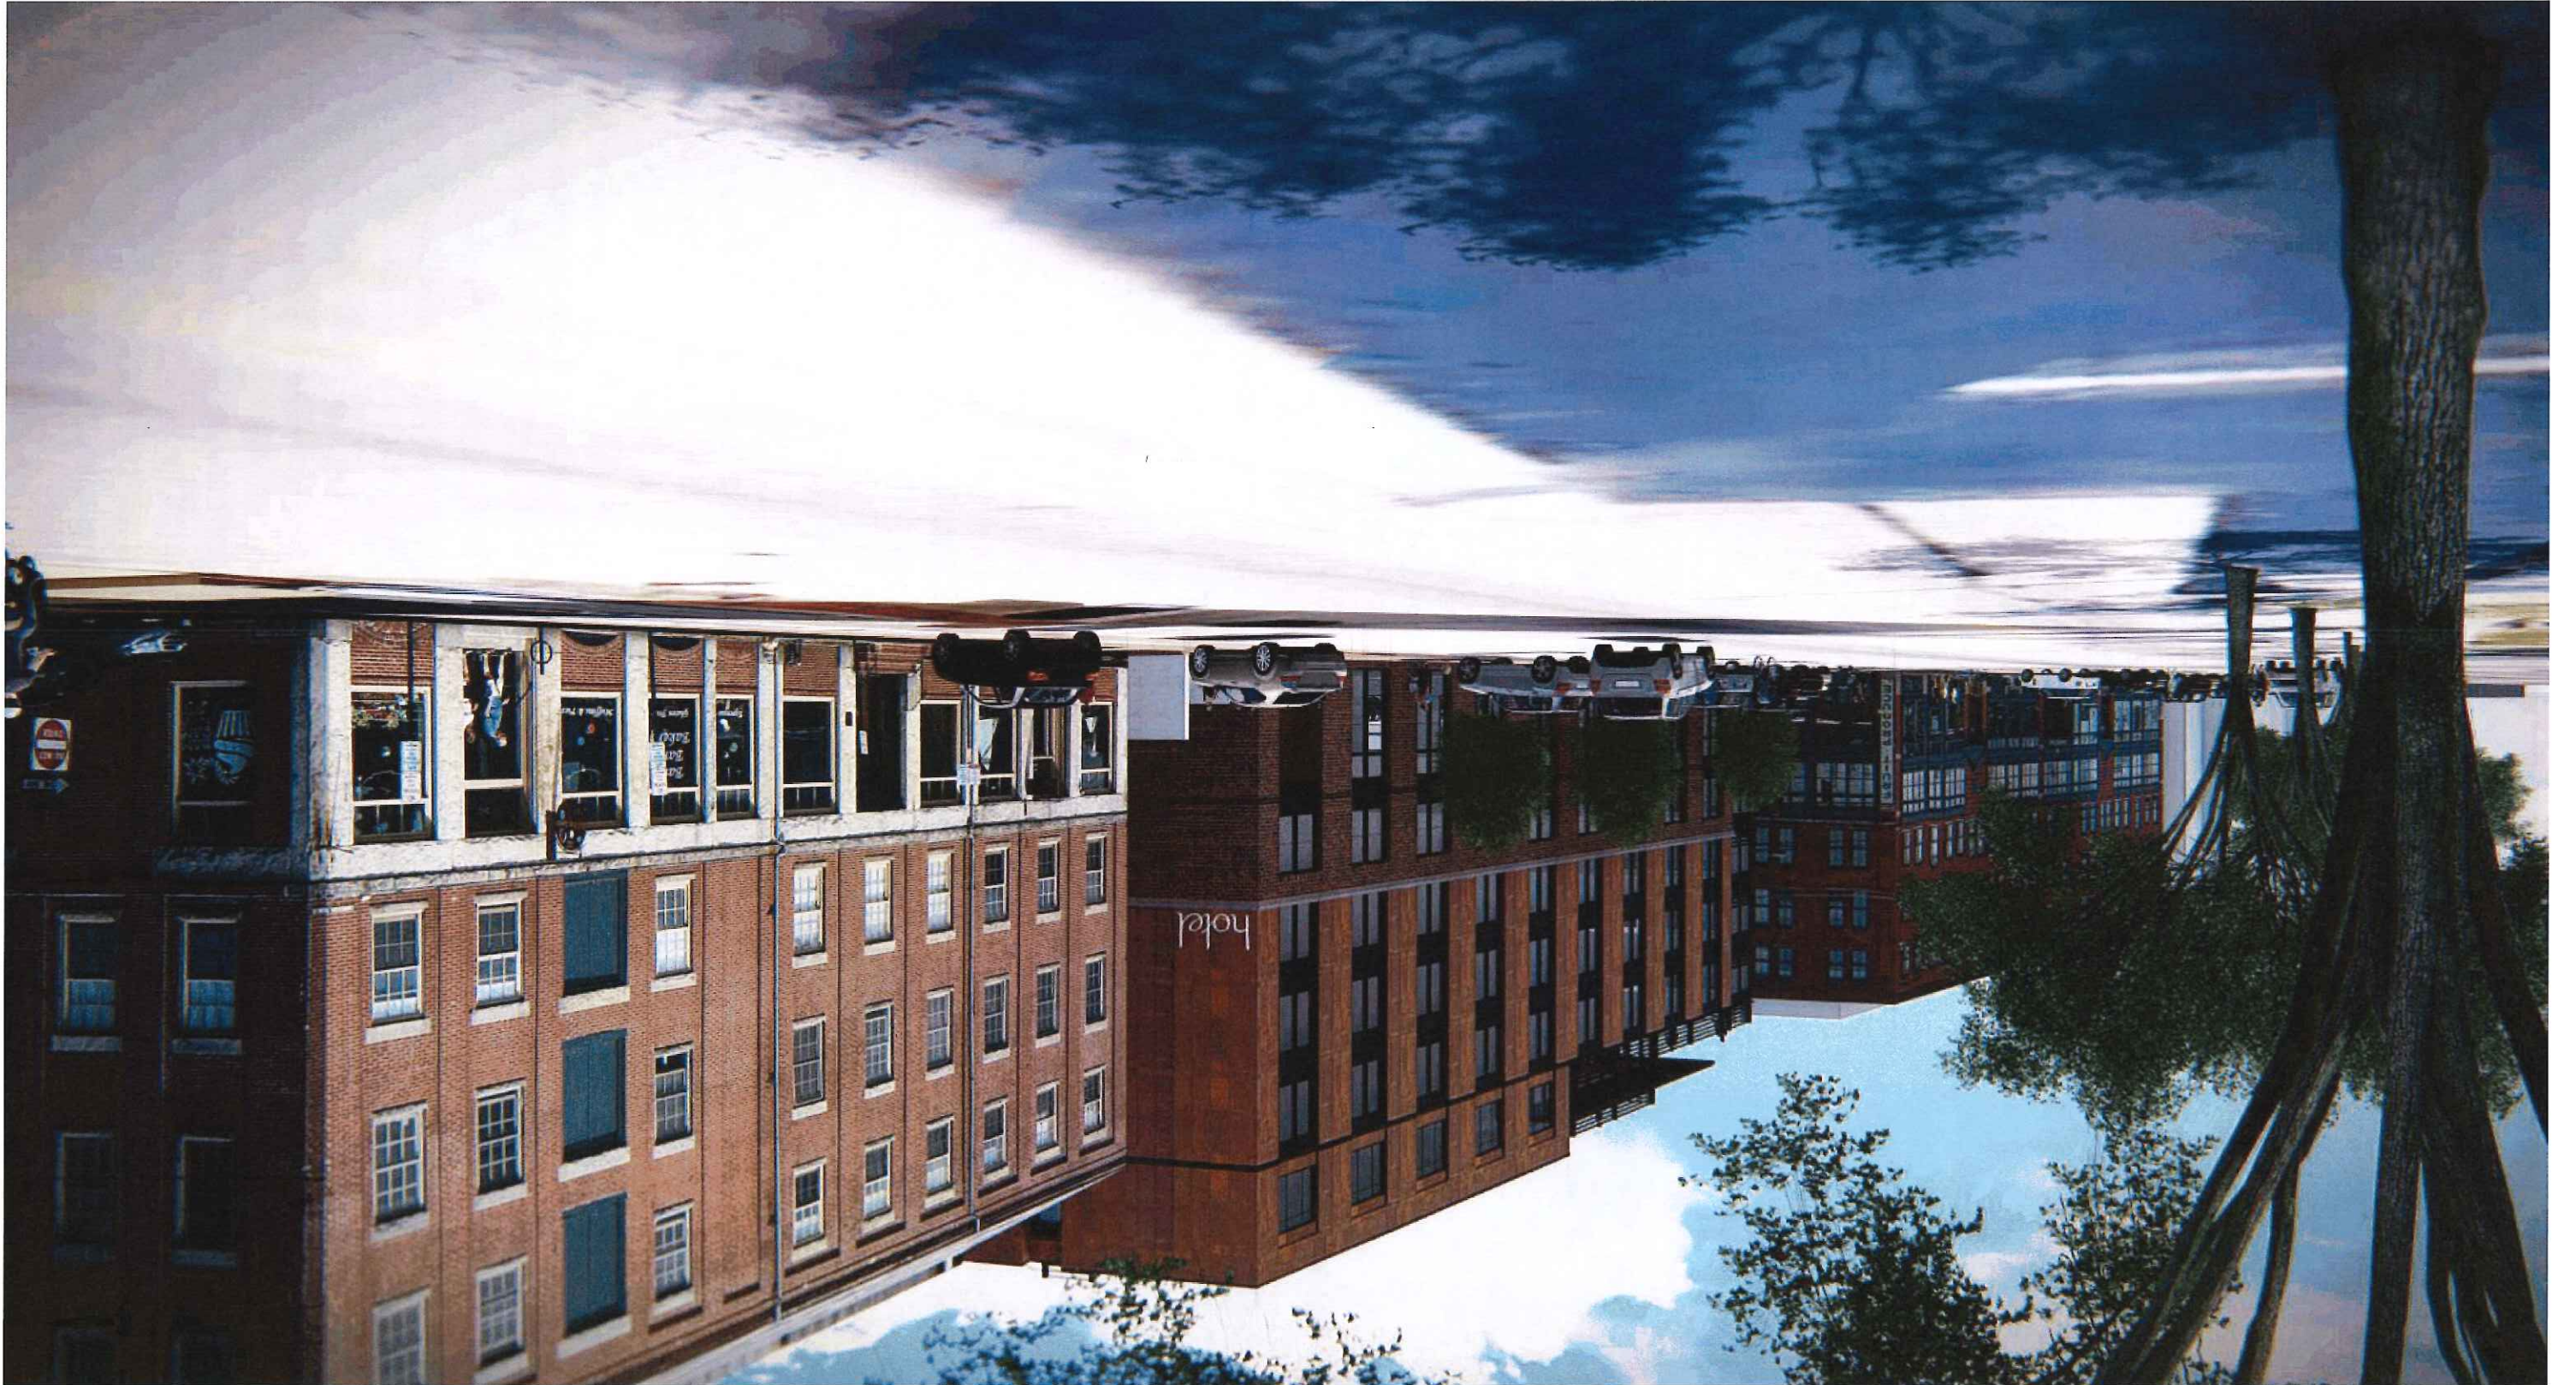
OVERALL VIEWS + DETAILS

- The detailing of the overall two-level brick openings has been adjusted. The rust-colored metal surround from Workshop 01 has been replaced with brick which returns into the window. This was to help in ease of construction and more simplified detailing keeping the brick base pure in form.

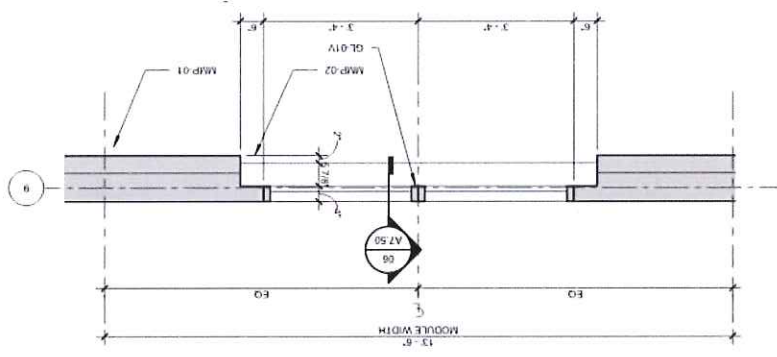
PROFILE SECTION  
& PLAN THROUGH  
METAL PANEL

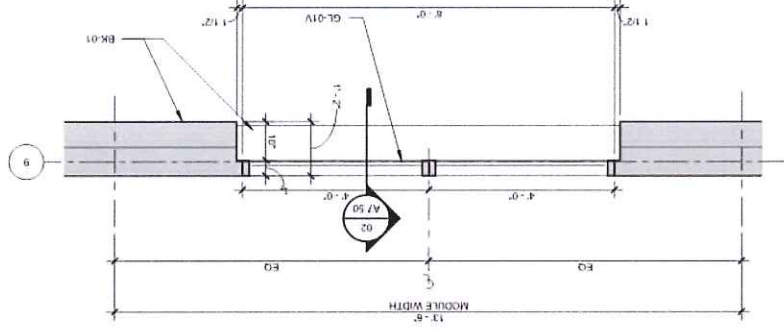
PROFILE SECTION  
& PLAN  
THROUGH BASE  
SCALE NTS

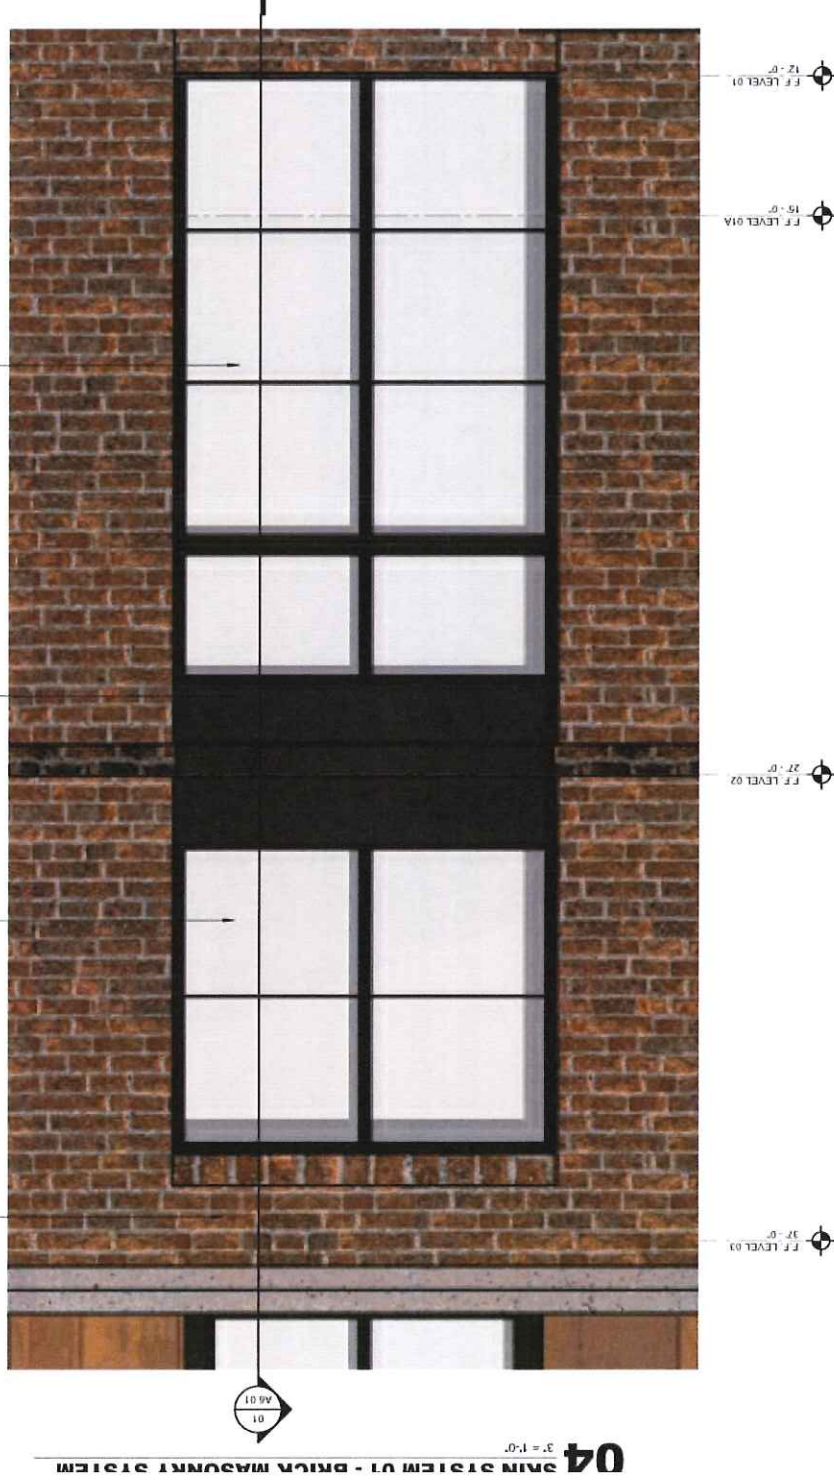
04 MAIN SYSTEM 01 - BRICK MASONRY SYSTEM

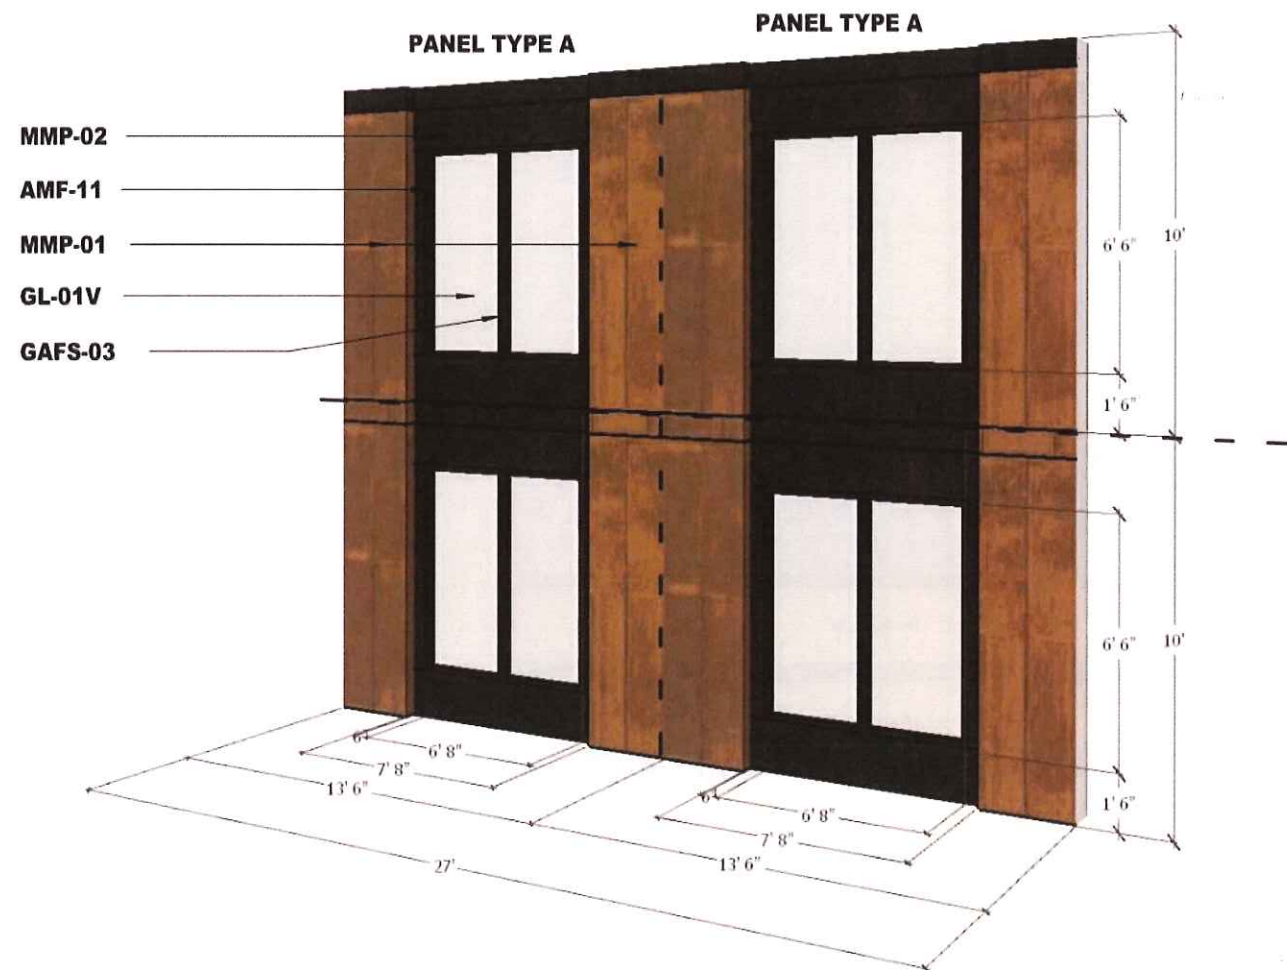
SKIN SYSTEM 02  
MODULAR METAL PANEL

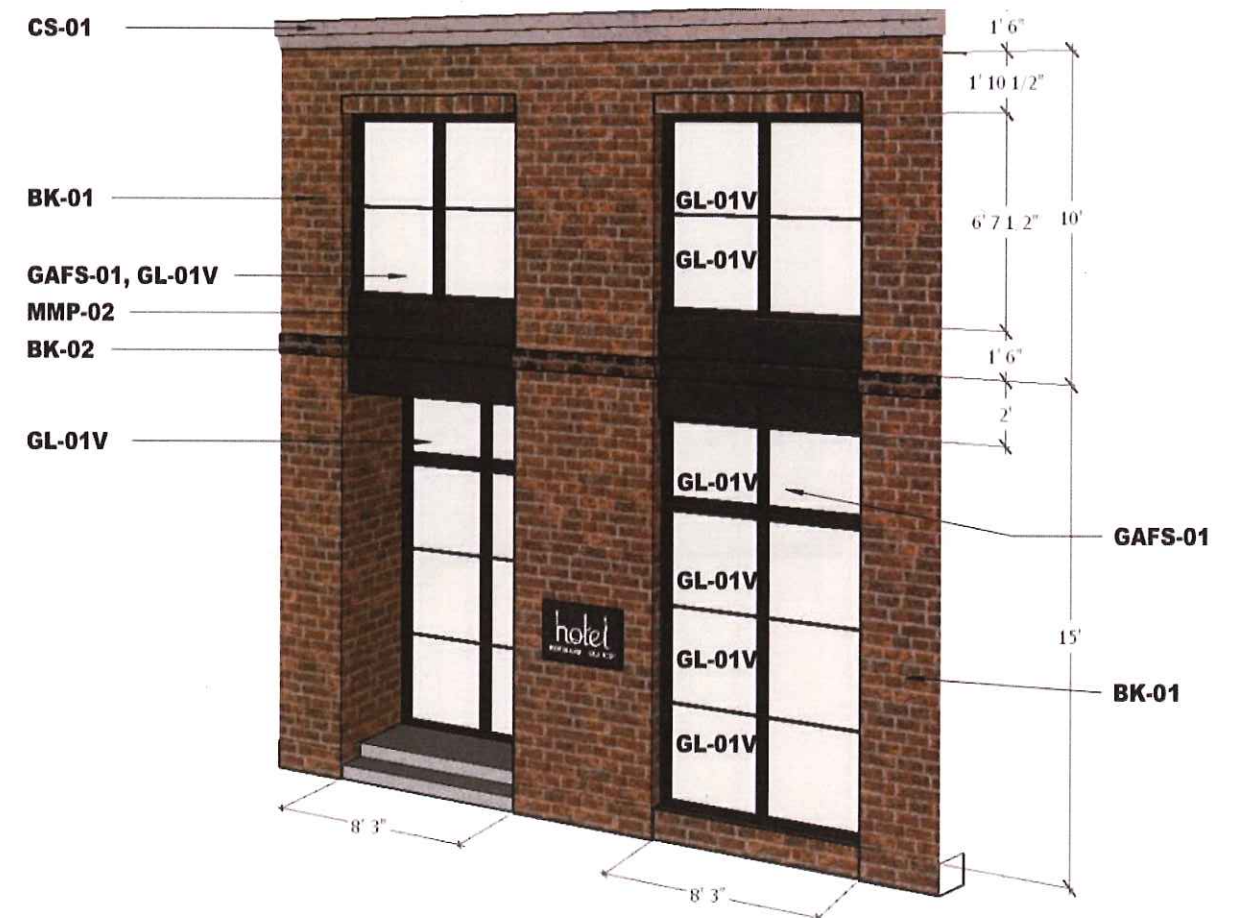
SKIN SYSTEM 01  
BRICK MASONRY

BUILDING SECTION 01  
SCALE 1/16"=1'-0"
