# CITY OF PORTLAND, MAINE

## HISTORIC PRESERVATION BOARD

WORKSHOP  
ONE CENTER STREET

Fathom HKS  
SCHEMATIC DESIGN  
01.16.2019

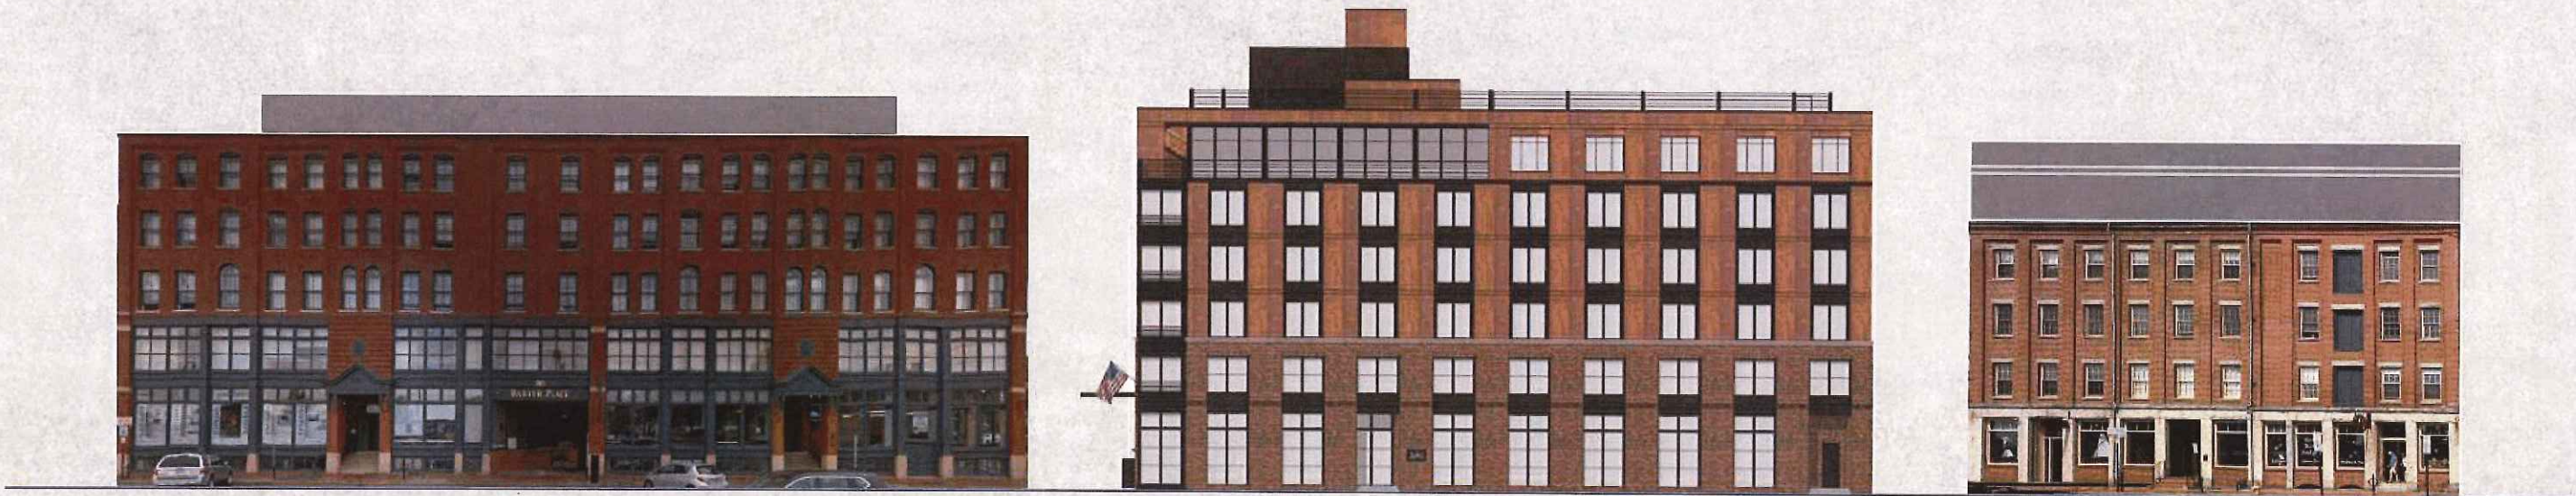
HISTORIC CONTEXT - PALETTE

BAXTER DAVIS BLOCK

CENTER STREET  
BOUTIQUE HOTEL

RICHARDSON WHARF  
COMPANY

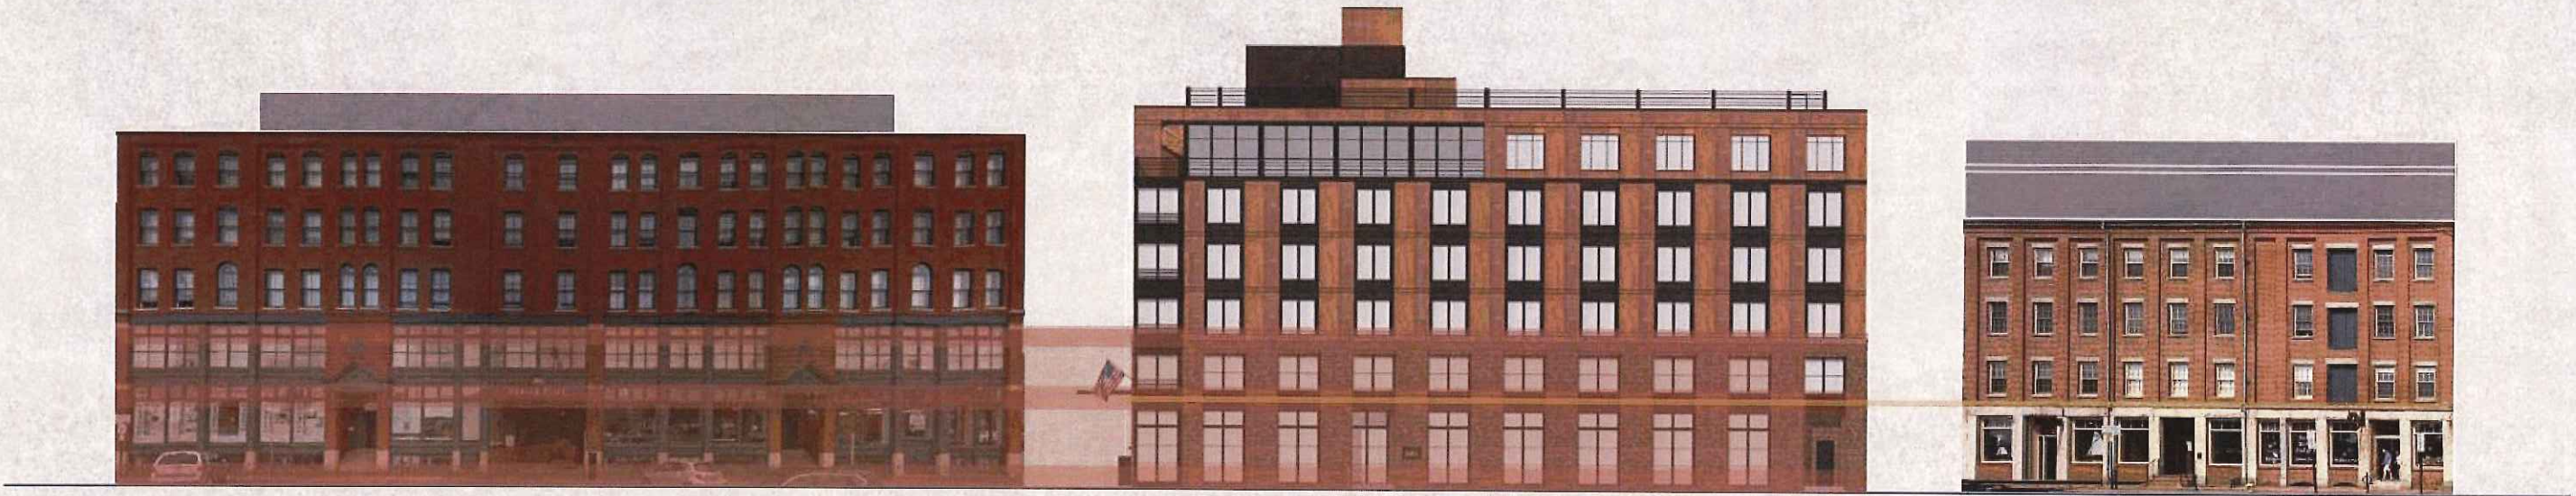
HISTORIC CONTEXT - ADJACENT BUILDING RELATIONSHIPS

BAXTER DAVIS BLOCK

CENTER STREET  
BOUTIQUE HOTEL

RICHARDSON WHARF  
COMPANY

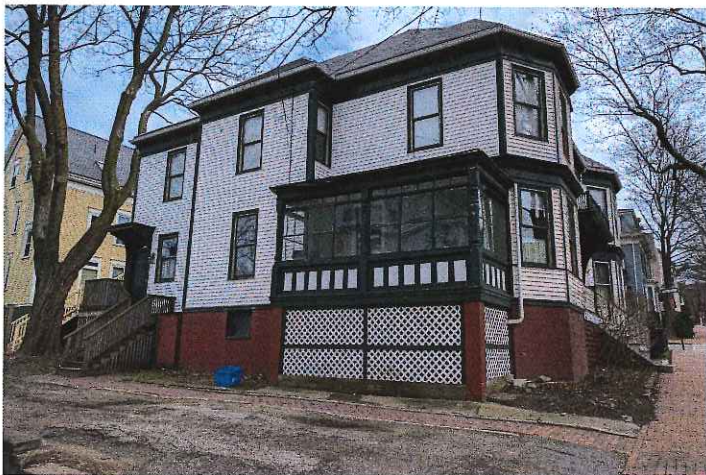
PHOTO OF THE EXISTING BUILDING

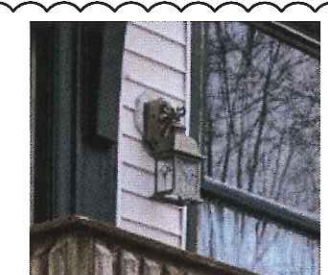
PHOTO OF THE EXISTING LIGHT FIXTURE

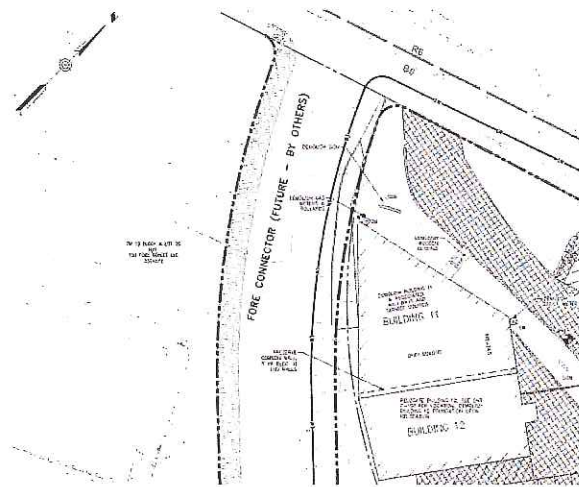
**Existing Building #12 and #11 on the current site**

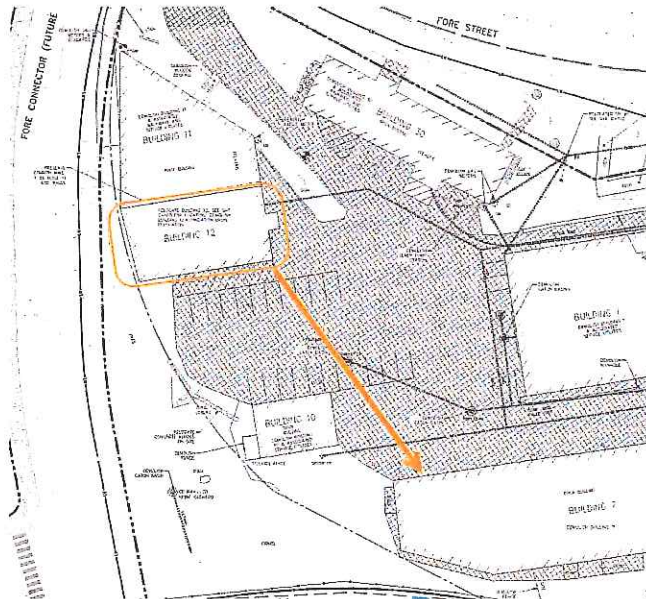
**Building #12 will be relocated approximately 200 feet East of its current location**

1. Building #12 will be relocated approximately 200 feet East of its current location

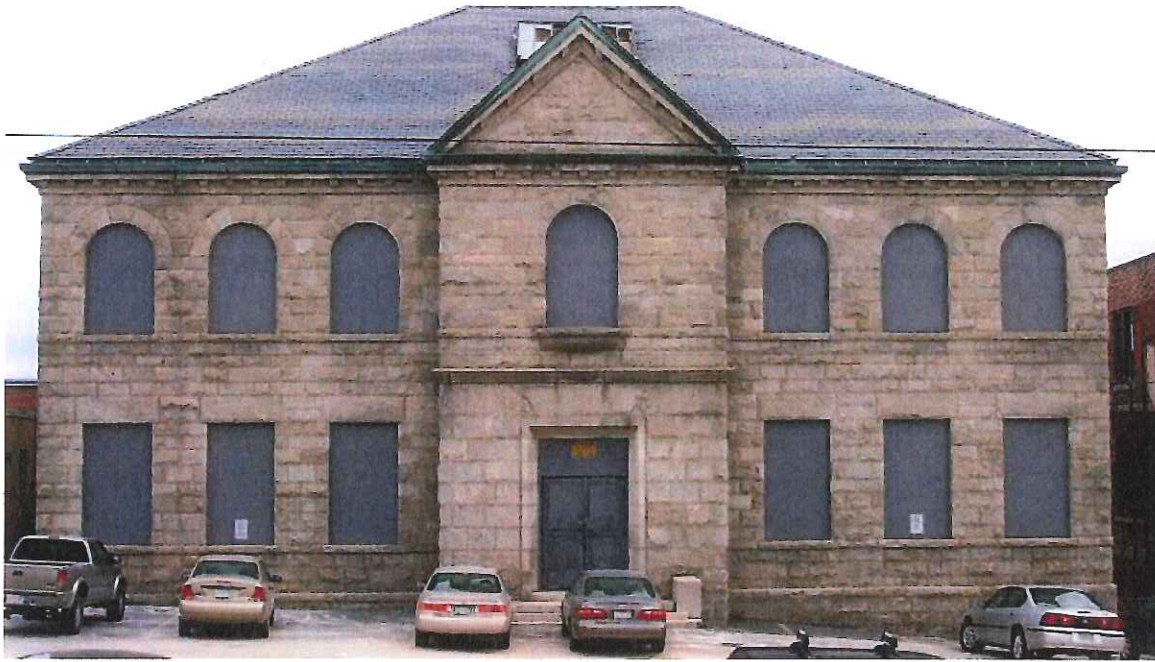
**Granite Building Prior to Relocation – Suffered significant Fire in 1985 and Boarded Up**

**Example #1: The Granite Building Relocation – Consigli Home Office, Milford, Mass**  
Consigli Disassembled, Relocated and Reconstructed the “Granite Building” in Milford Massachusetts. The existing school was converted to the Consigli home office in its new location at 72 Sumner Street in Milford Massachusetts.

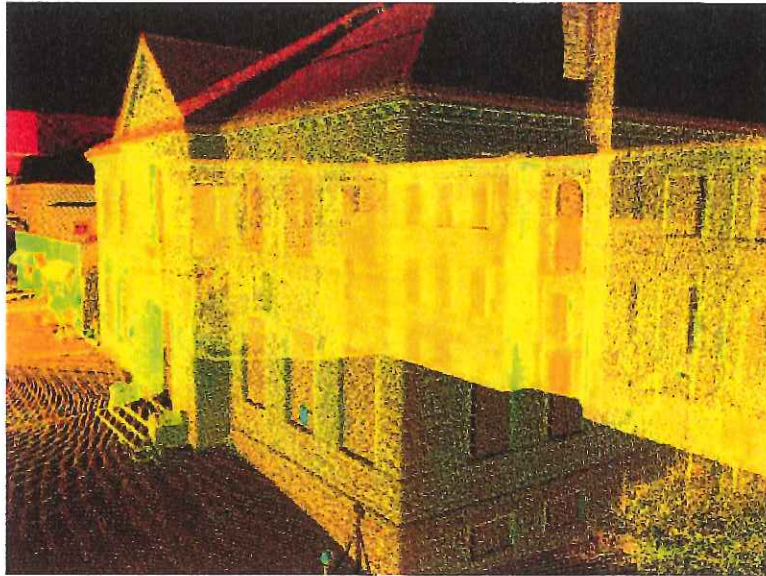
Documentation of Existing Conditions Utilizing Laser Scanning Technology

- Laser Surveying
- Numbering
- Cataloging
- 3D Computer Modeling
- Field Measuring

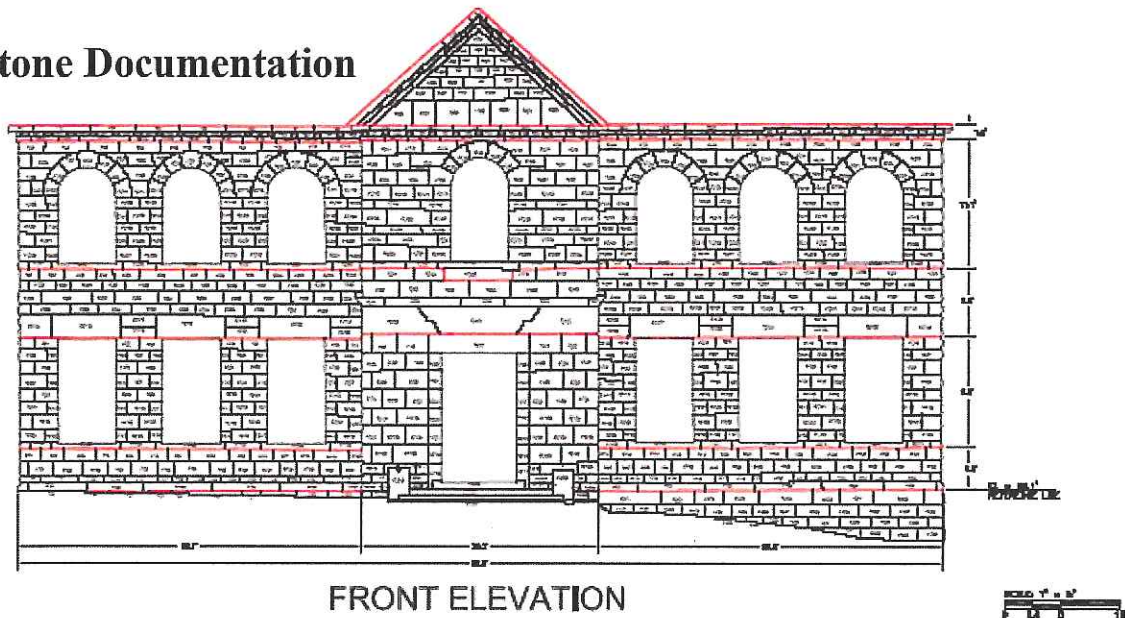
Granite Building Documentation of Existing Conditions prior to Disassembly – 2 Dimensional Shop Drawings were created from the 3D Laser Scan

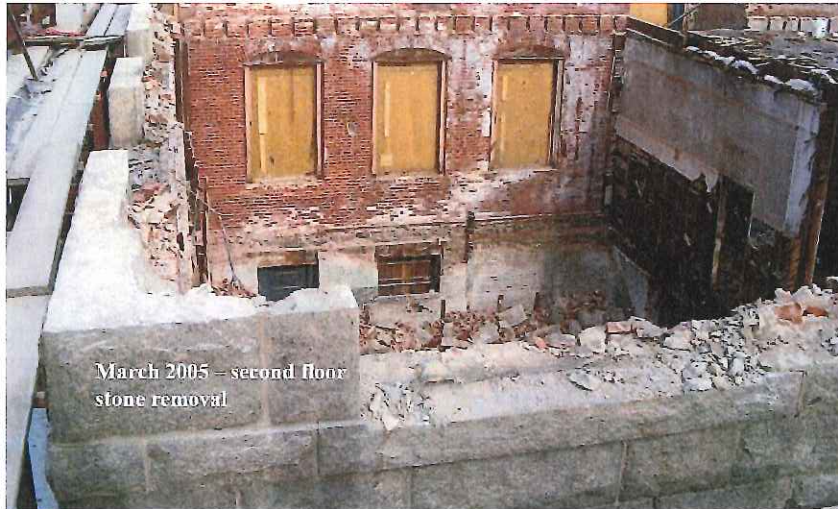
March 2005 – second floor  
stone removal

**Progress of Stone Veneer Disassembly**

- 2,500 Pieces of Granite Removed and Salvaged

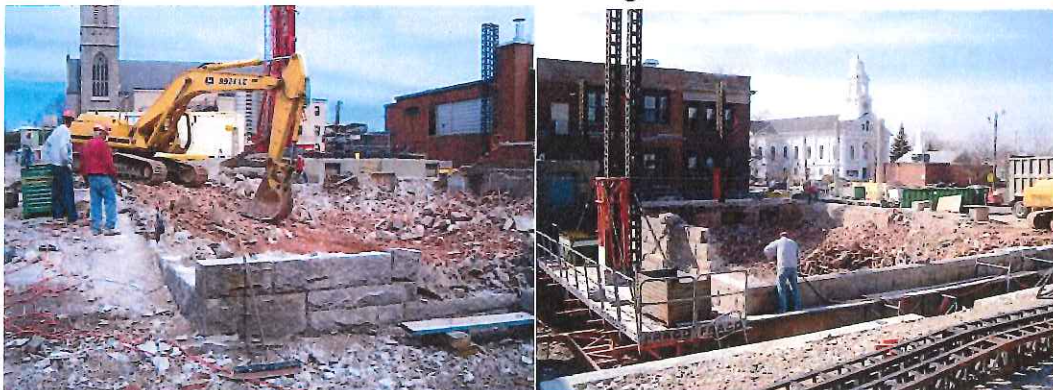
**Salvaging Stone Veneer – Demolishing Backup wall Masonry**

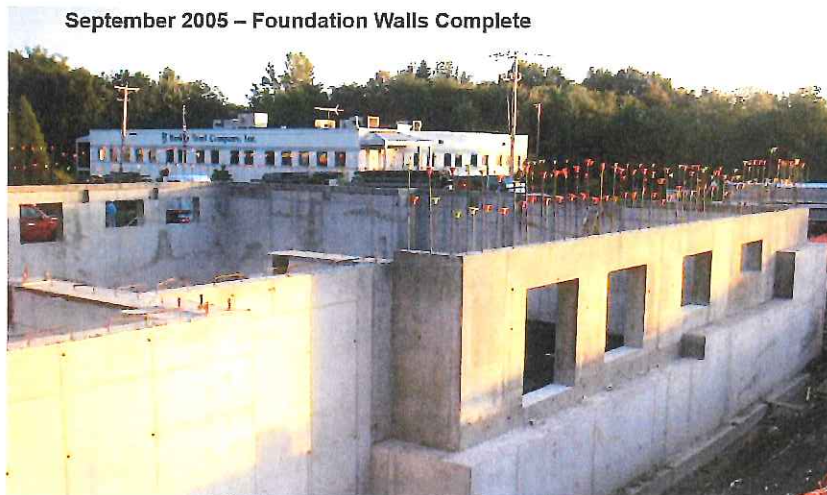
September 2005 – Foundation Walls Complete

**New Concrete Foundation Walls**

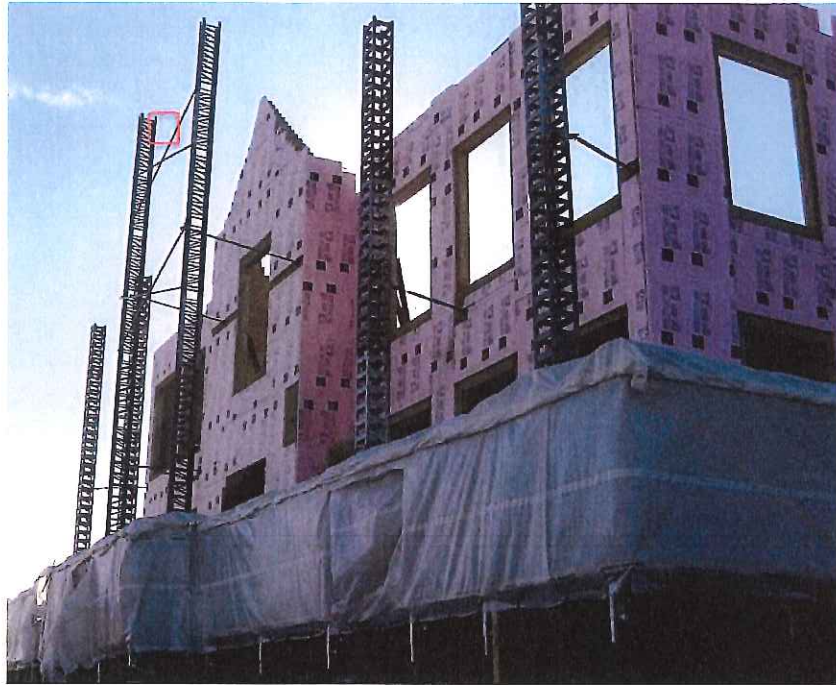
**Insulated Veneer Wall Construction Meeting Current Building and Energy Code**

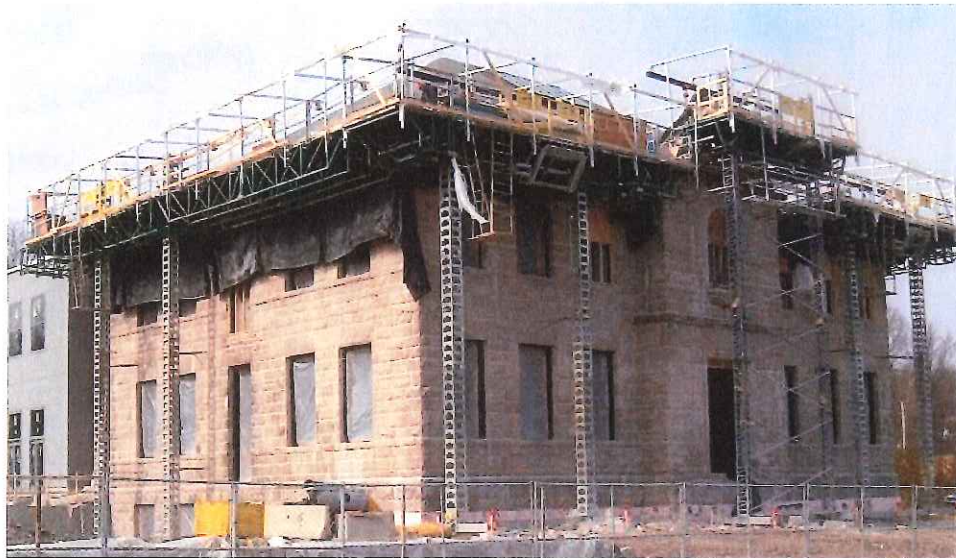
**Completed Veneer Reconstruction**

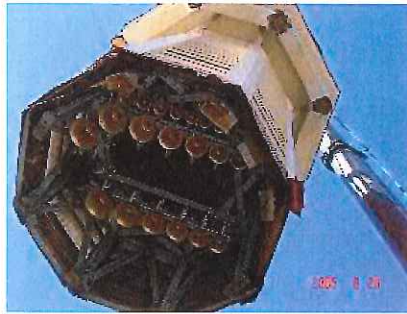
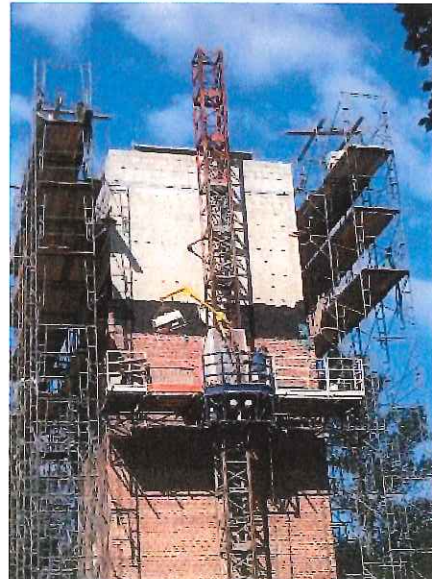
**During Rebuild**

Consigli documented existing conditions of the Fuller Memorial Bell tower located at Phillips Academy in Andover, Massachusetts. Due to the excessive deterioration of the exterior wythe of the existing building, a reconstruction was chosen in order to provide for a long term solution to the reconstruction of the building.

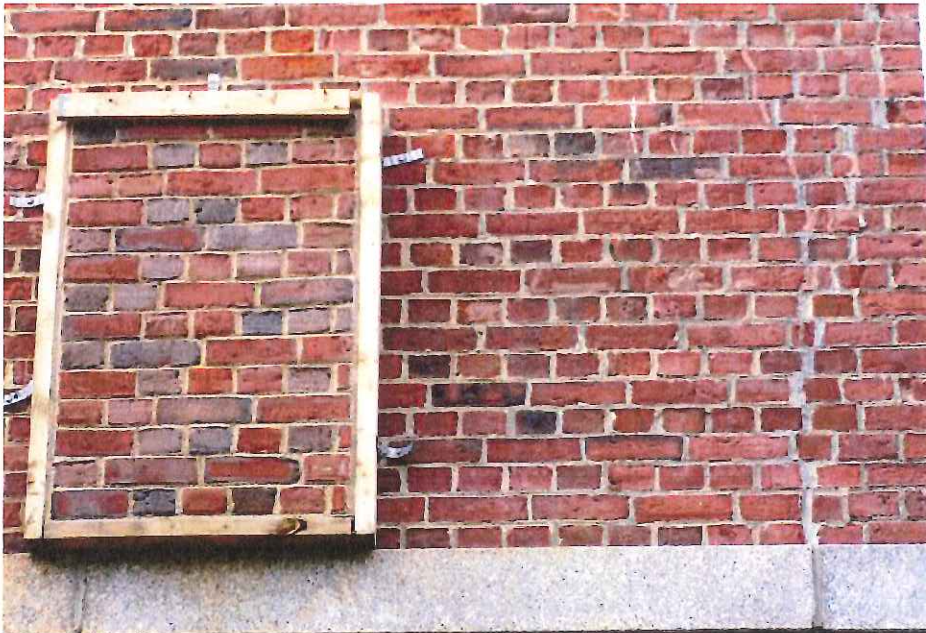
Mockup of replacement brick (within wood framed panel) at Phillips Academy Memorial Bell Tower where the exterior veneer had failed and needed replication. The approved mockup within the wood frame was removed and saved for generation for the preconstruction mockup of the new wall construction and to provide a standard for quality control of the reconstruction.

Mockups were utilized to document the proposed mortar, bonding pattern and replacement brick for the reconstruction.

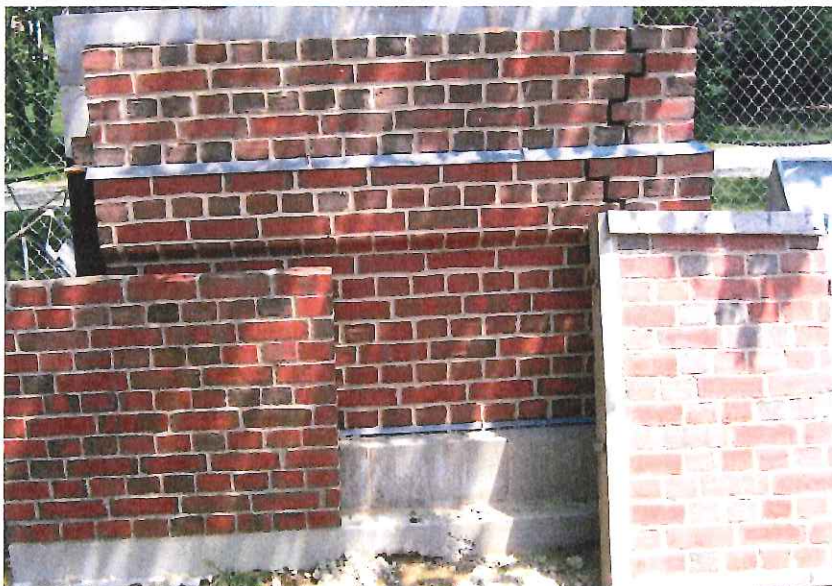
New Veneer mockup with approved mockup panel

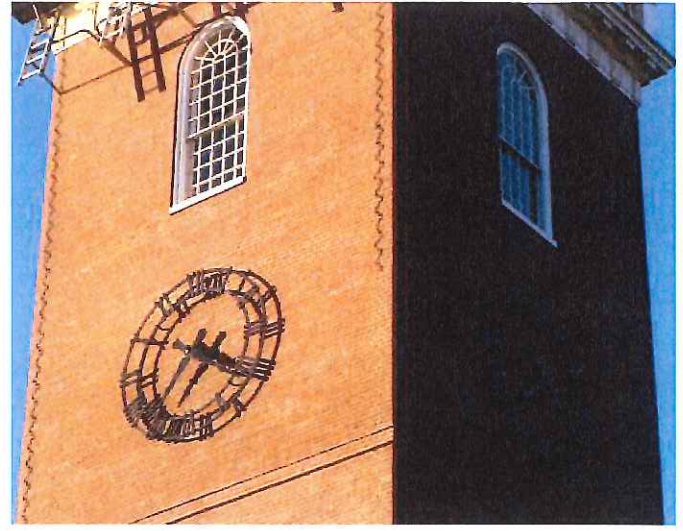
#### **Reconstructed Veneer Tower**

Modern construction was utilized for the reconstruction which included the introduction of an insulated / flashed rain screen brick veneer with control joints that were sealed and “sanded”. The new construction in the image on the right shows the introduced “zipper control joint” at the building corners. Note the lower section of the control joint on the right has been filled with sealant and a “sanded” finish applied by broadcasting sand utilized in the mortar mix in the wet sealant joint.

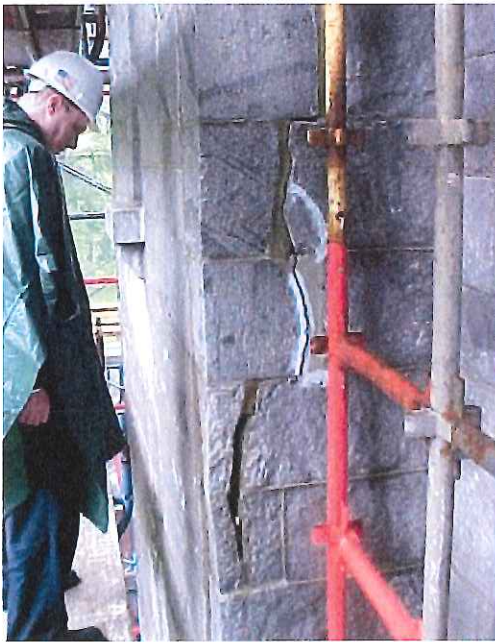
Existing Cracked Masonry Façade

Consigli documented existing conditions of the Bowdoin College Chapel Bell Towers and reconstructed the veneer stone. The Belfry level floor was cast as a new concrete floor structure and precast concrete backup panels were utilized as backup walls for the upper sections of the tower in order to provide a stable backup wall system for the spire reconstruction. The reconstruction of the towers was chosen due to the failure of the masonry veneer of the existing building.

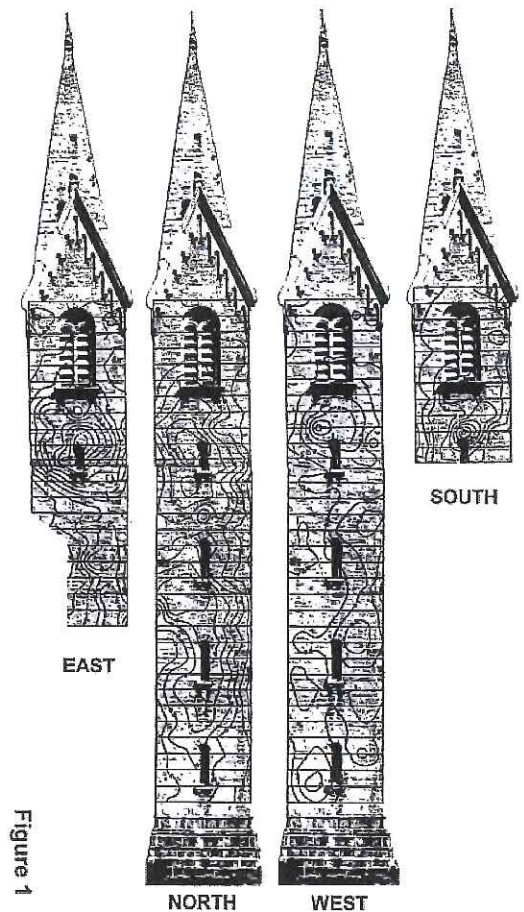
Figure 1

Contour Map of out of plane displacement of masonry

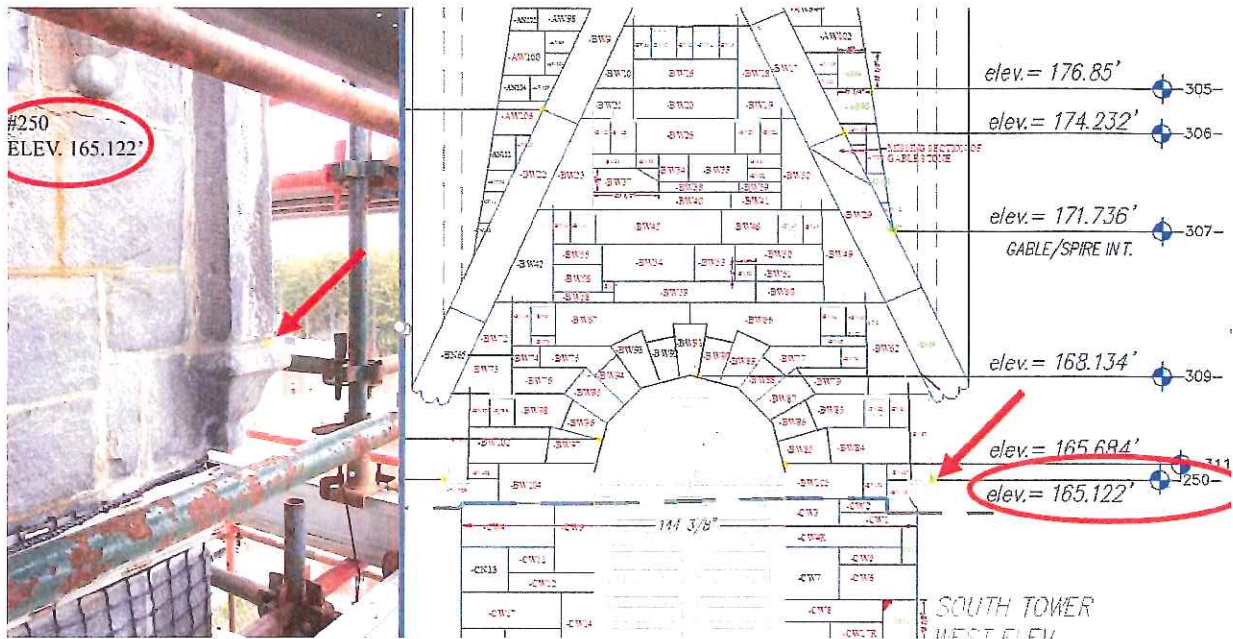
Shop drawing preparation and mockup execution prior to reconstruction  
Note the documentation of coursing levels and datum elevations

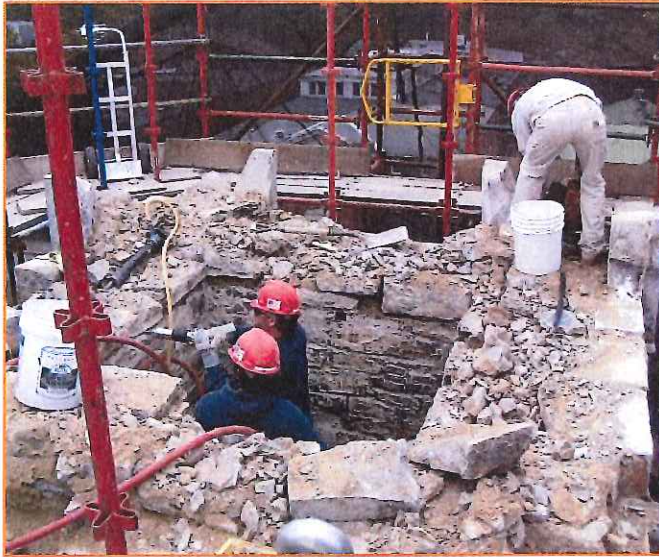
Preconstruction Mockups for Quality Control of coursing

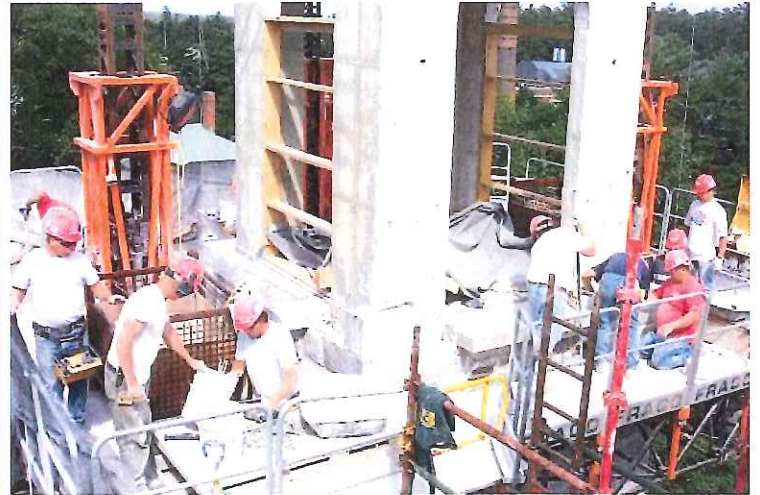
Disassembly of Veneer and Backup Wall

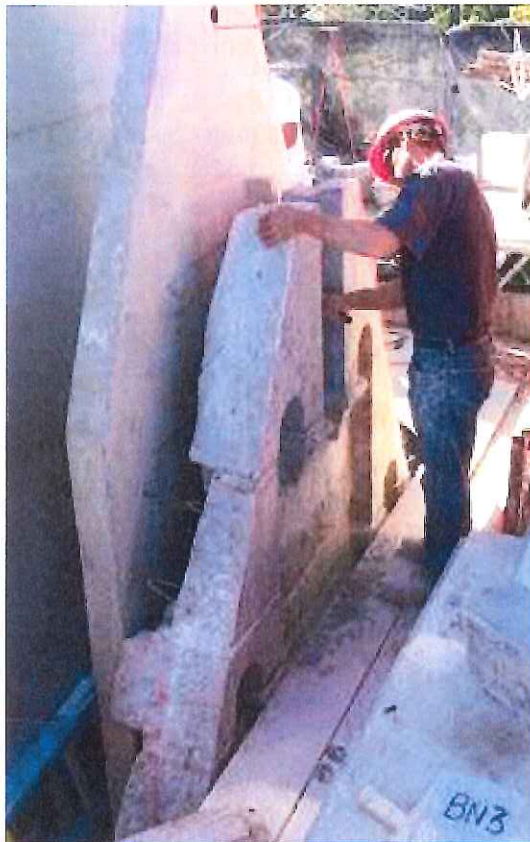
Reconstruction of Backup Wall – using Precast

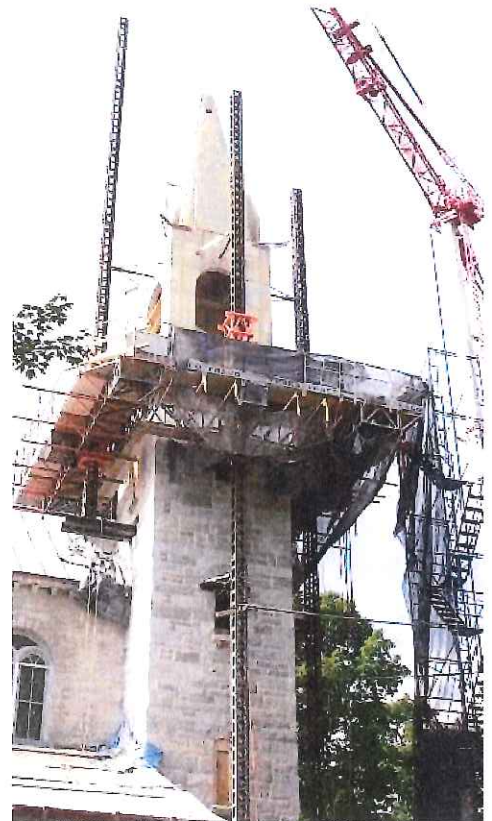
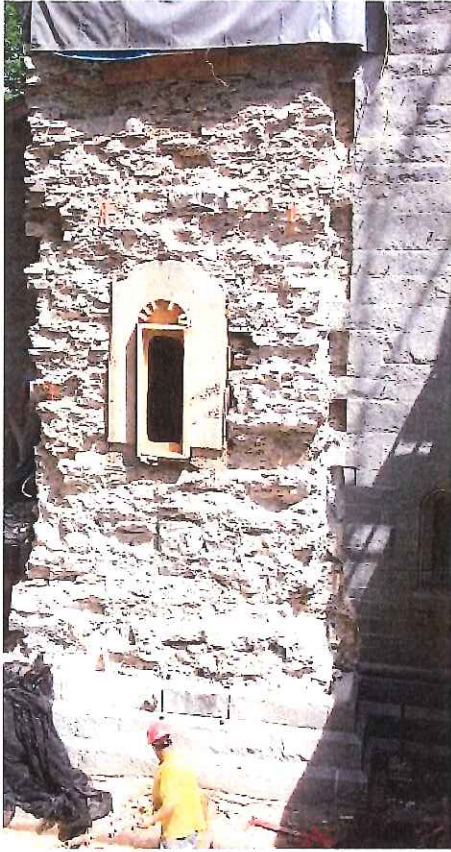
Veneer Reconstruction At Spires  
Bell Towers - Complete Disassembly and Backup Reconstruction

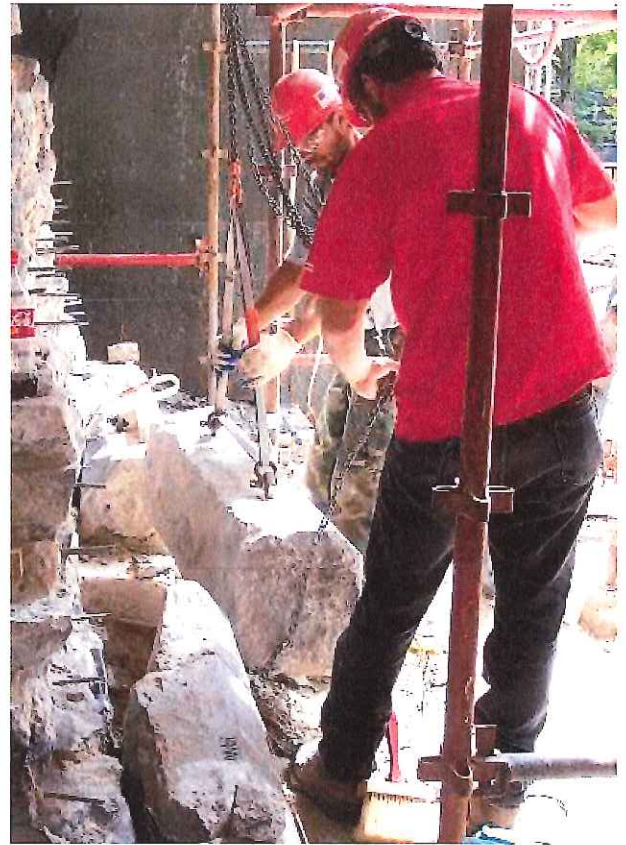
Disassembly of Lower Tower – Veneer Only

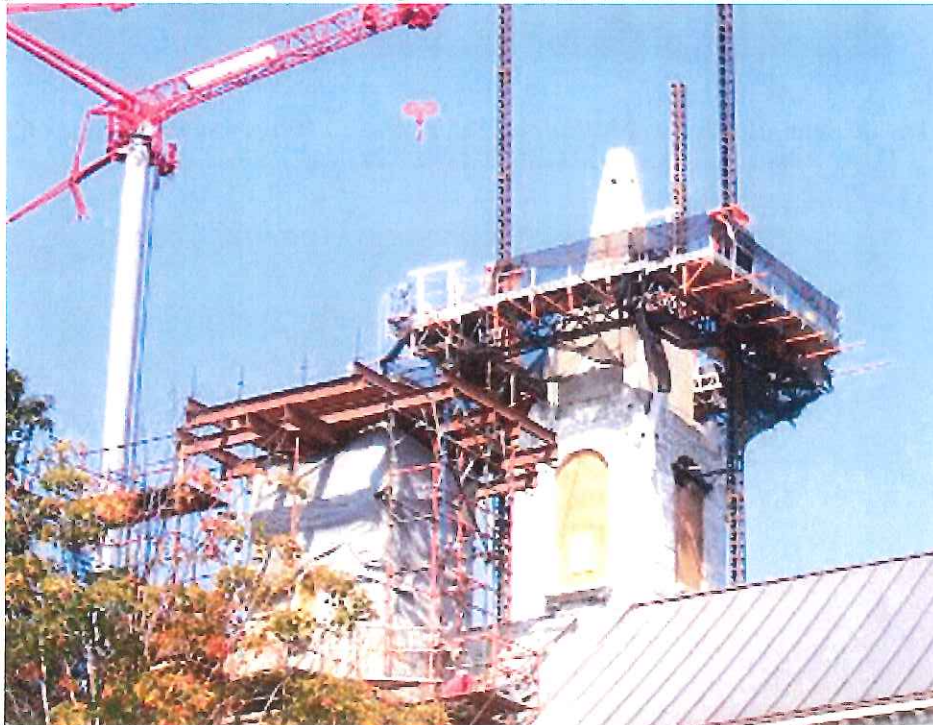
Reconstructed Veneer at Lower Towers

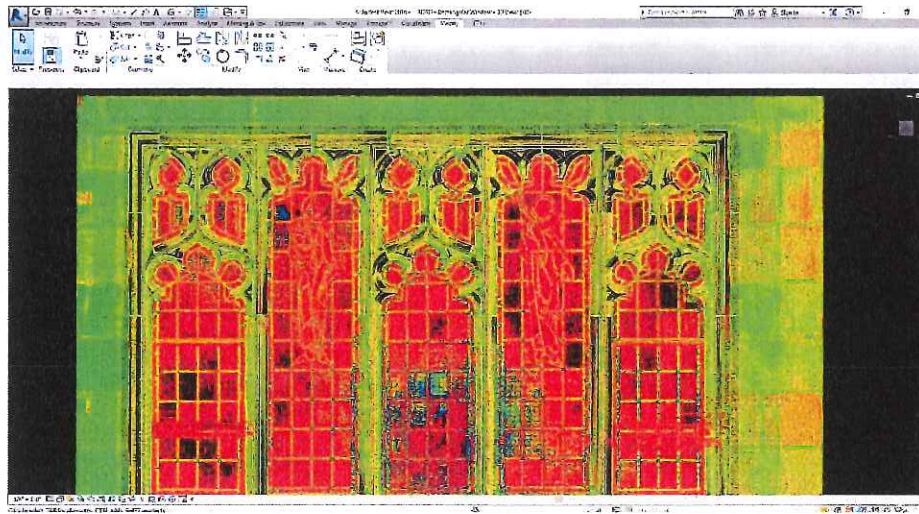
Images of the 3D models are below.

#### Laser Scan of Masonry Windows Surrounds – Bates College Gomes Chapel

Consigli is utilizing laser scanning to replicate the Cast Stone traceries of the Bates College Gomes Chapel stained glass window surrounds. The cast stone has deteriorated beyond its repair and has been specified to be replaced. Consigli has used laser scanning to document the geometry of the masonry surrounds. We have generated 3D models of the cast stone, and are using Computer Numerical Controlled (CNC) cutting of foam to develop exact shapes for the replacement cast stone elements.

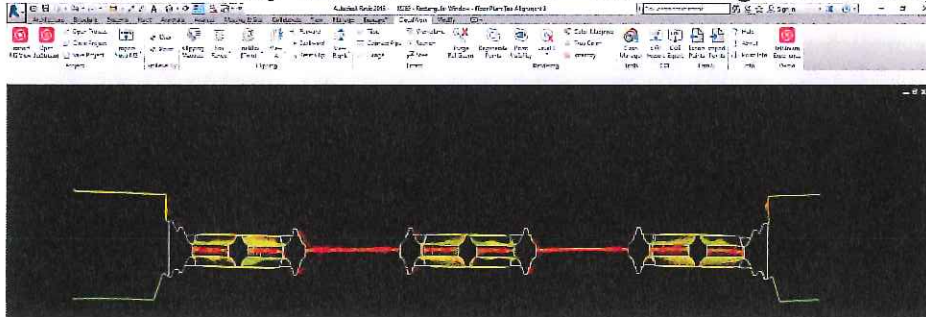
Cross Section of model information from Laser Scan

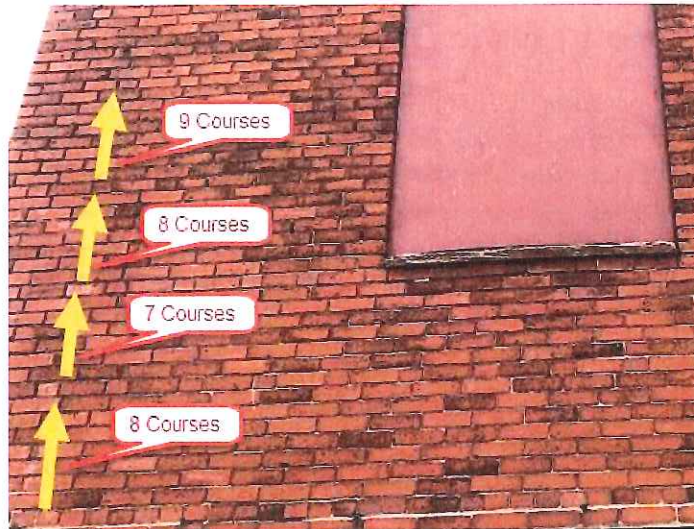
See below for coursing photo

East Elevation Facing Historic Core – Brick is laid up in a “Common Bond with Flemish Headers”. (comprised of alternating stretchers and headers). The header brick courses occur every 8 courses (except the course below the 2<sup>nd</sup> floor window where a header course was laid at the seventh course below the window). The next header course was laid 8 courses up and then 9 courses to restart the module of each 8 courses....

Through the documentation process, we will document the façade with high resolution photographs, recording all existing conditions and we will note any architectural anomalies. Additional written documentation of existing conditions will be completed in order to document those architectural conditions that will be incorporated in the final construction. In our preliminary review, we have already identified differences in the brick coursing / bonding patterns in two of the elevations of the building.

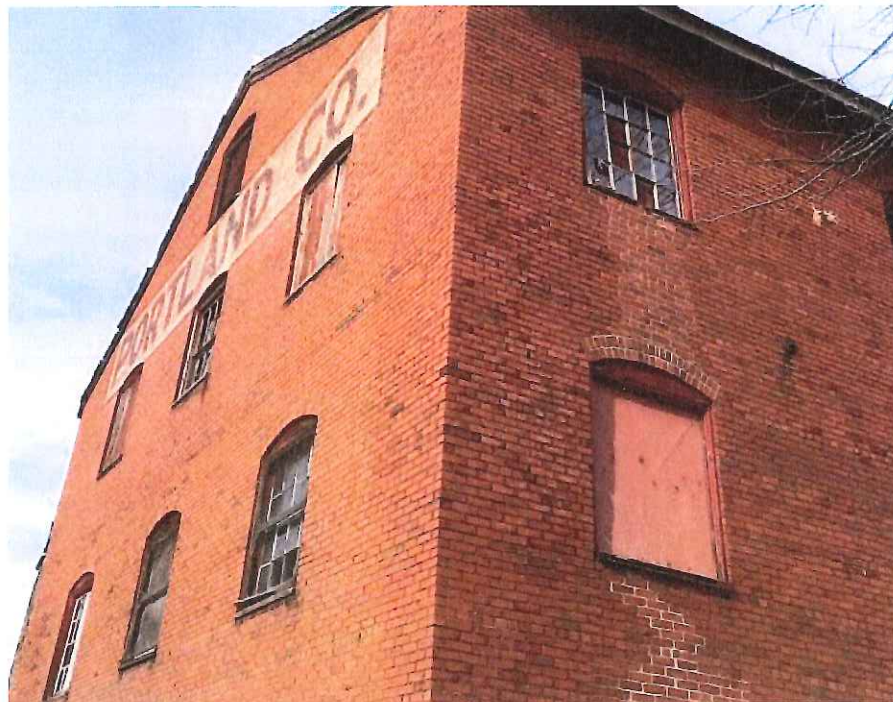
| West Elevation – “Portland Co.” – Common Bond | South Elevation – facing water – “Common Bond” |

The bonding pattern for the West and South Elevation consist of common bond with header courses that align and repeat at every 8 courses, intermixed with Flemish Header Courses – A full documentation of the exterior will hopefully reveal a pattern to the seemingly random choice of coursing

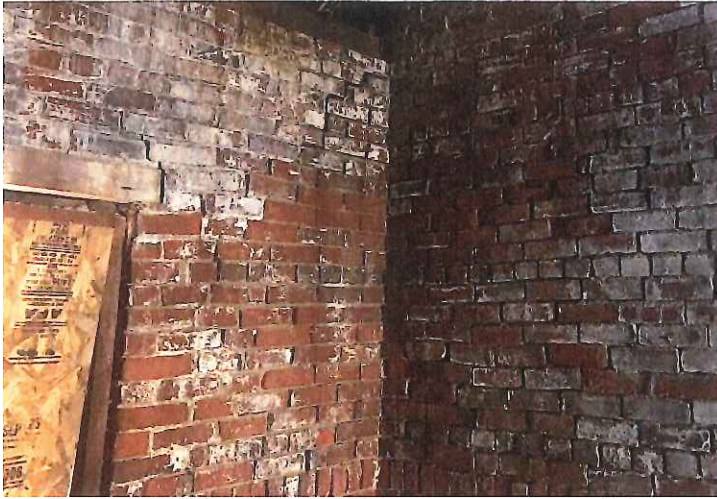
Separating Building #12 Wall from Common wall between 12 and 11

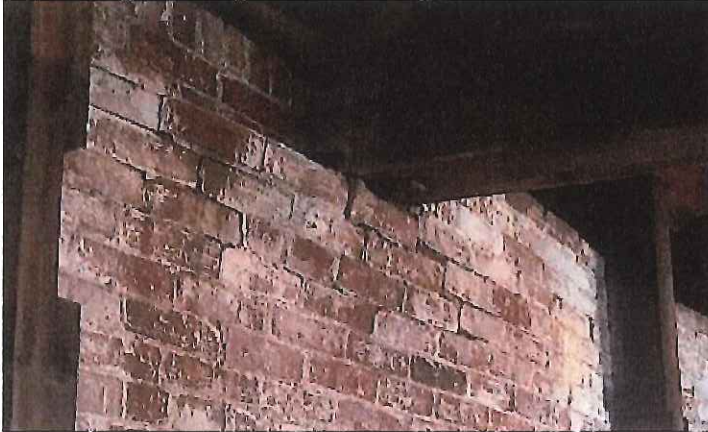
Failed Inner Wythe at Timber Connection

3. Post up / shore the underside of all timber to masonry wall connections at exterior walls where the bearing conditions of 2<sup>nd</sup> floor framing has failed and pulled the inner wythe of Building #12 walls out of plane.

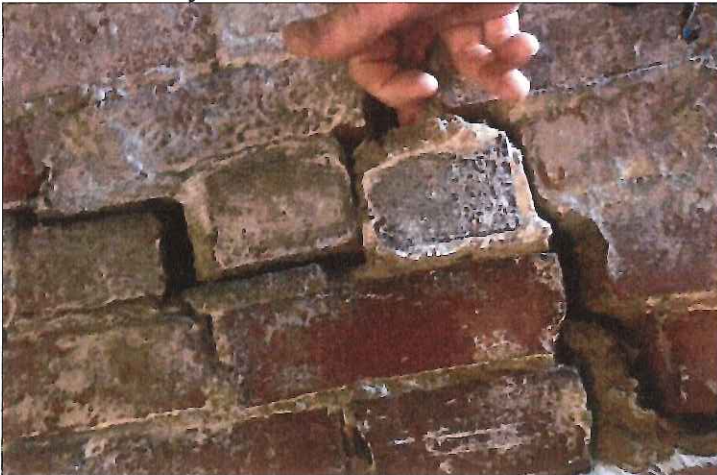
Existing Masonry Crack and sand from within masonry core

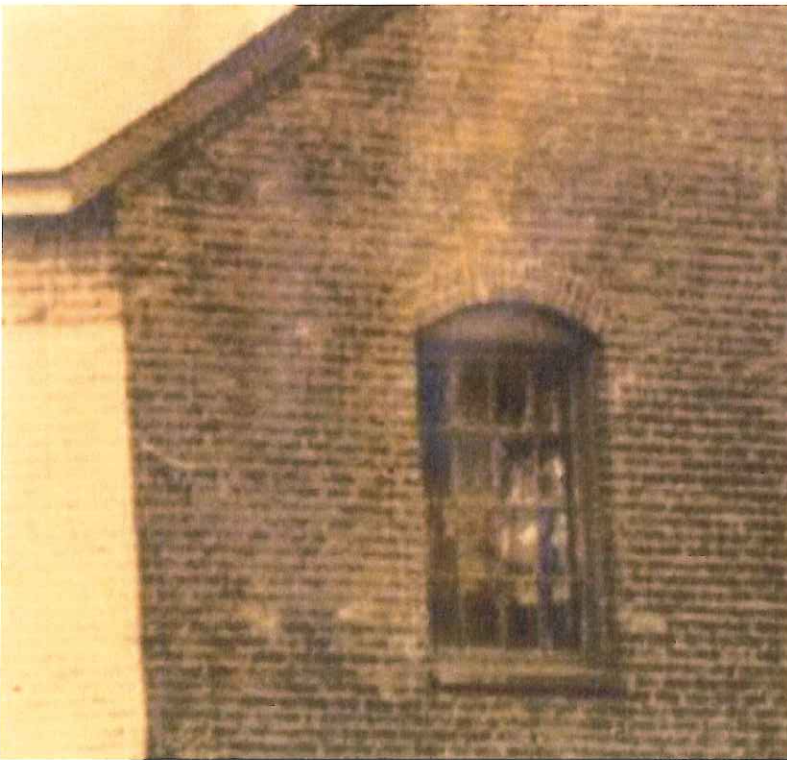
Building #12 – Roof Edge and Window Construction - Excerpted from source image above

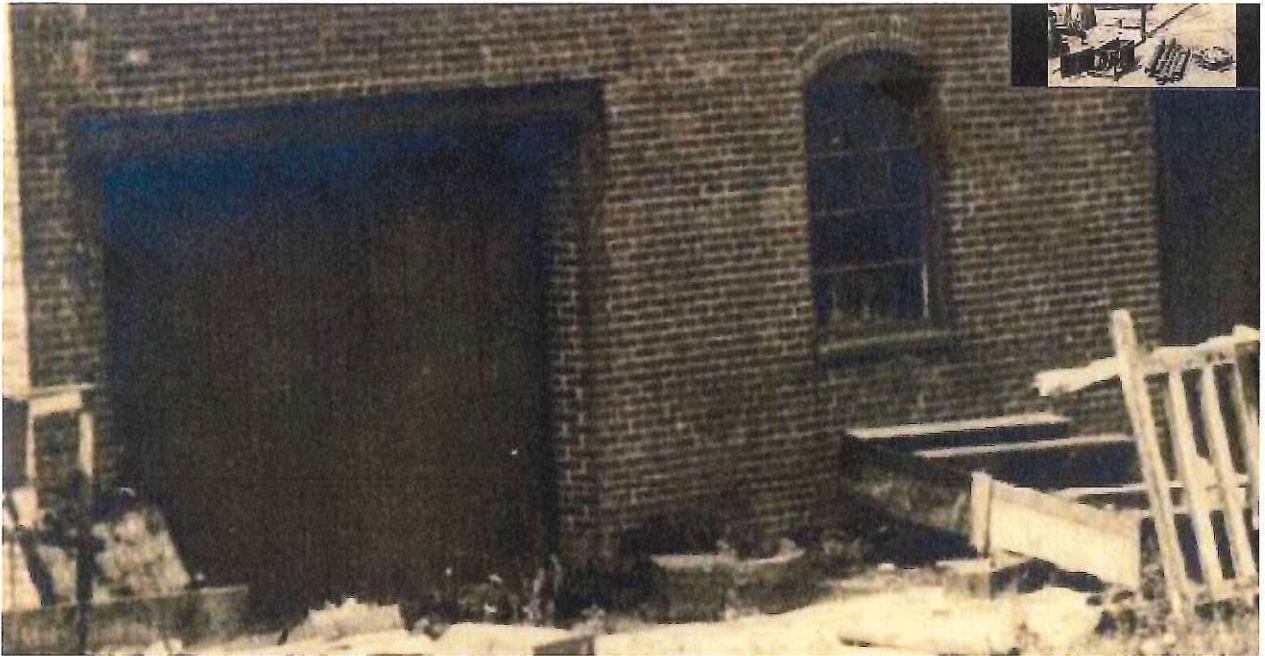
Building #12 – “Garage Door” and Existing Window at Grade - Excerpted from source image above

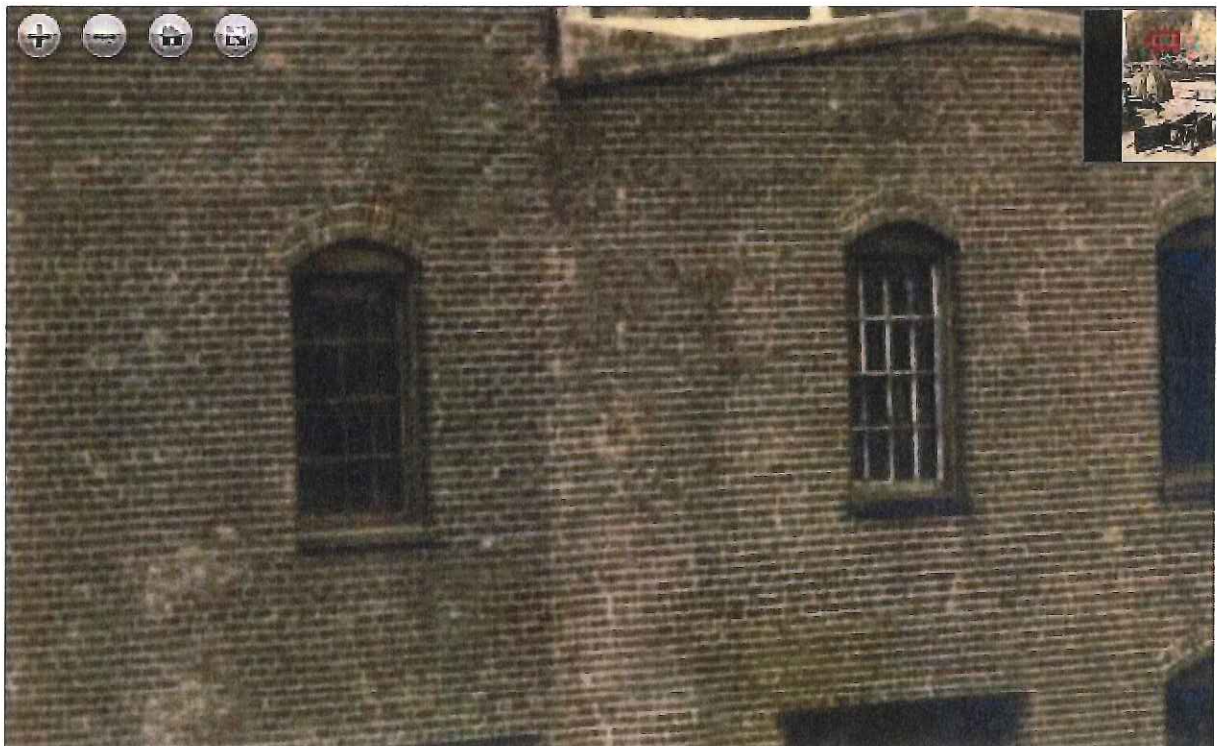
Building #12 – Interface with Building #11 - Excerpted from source image above

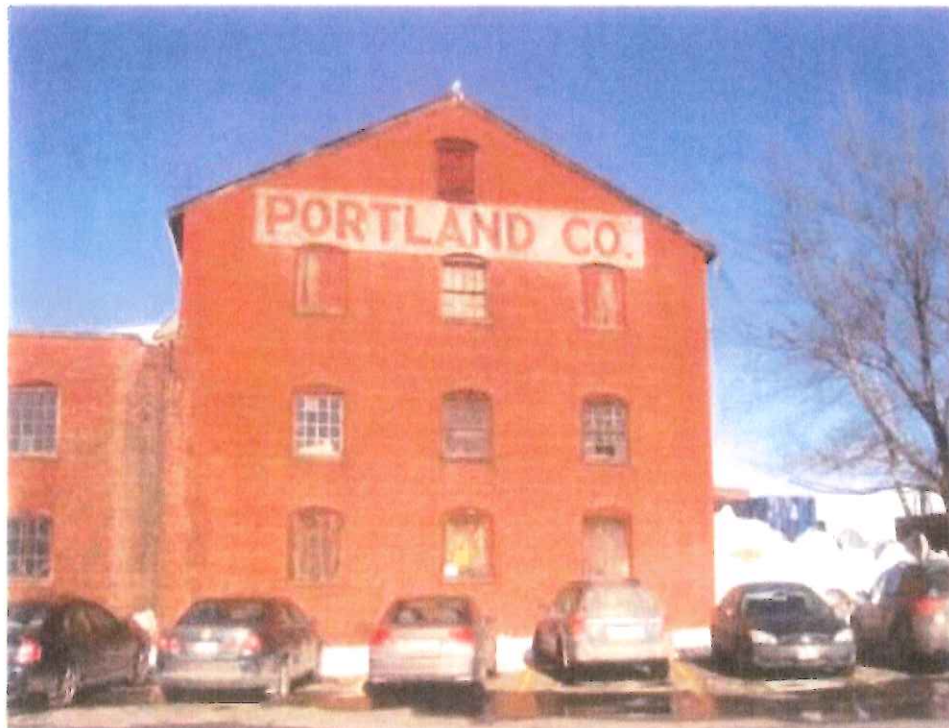
Photo 12-1: West elevation of building 12. Note windows with missing and broken panes, base

- Evidence of previous shed roof removal. Bulging and slip plane from flashing left place.
- Entry shed masonry in poor condition.
- Open joints noted in west gable (east gable appears to have been repointed).
- Wooden lintels noted at interior rotting and sagging.
- Wooden window and sills in poor condition with broken and missing panes, rotting wood (Photo 12-1, 2 & 5).

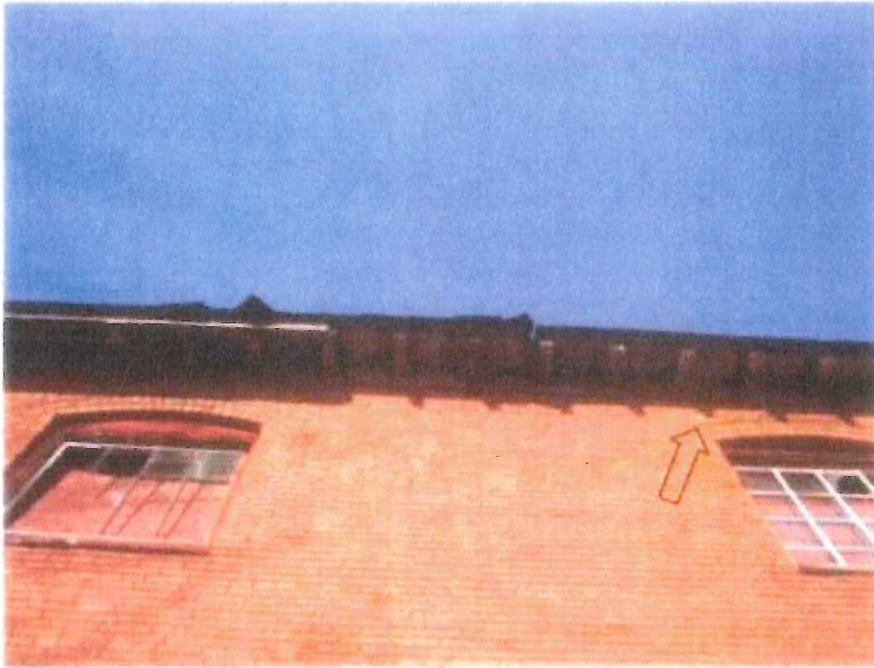
Photo 12-2: Eave with loose slates, missing eave trim, masonry cracking and broken windows.

- Building 12 story is a three story building with gable roof and mezzanine space in gable.
- Slate roof materials are loose and missing in many locations, particularly at corners. North half of gable drains onto the roof of Building 11. Wood roof eave trim rotten loose or missing in several locations (Photo 12-2). Some rafter tails appear rotten in some locations. Daylight visible through roof on the east side and rotten sheathing noted in many locations. Roof rafter framing appeared undersized.
