# CITY OF PORTLAND, MAINE

## HISTORIC PRESERVATION BOARD

WORKSHOP  
ONE CENTER STREET

Fathom HKS  
SCHEMATIC DESIGN  
01.16.2019

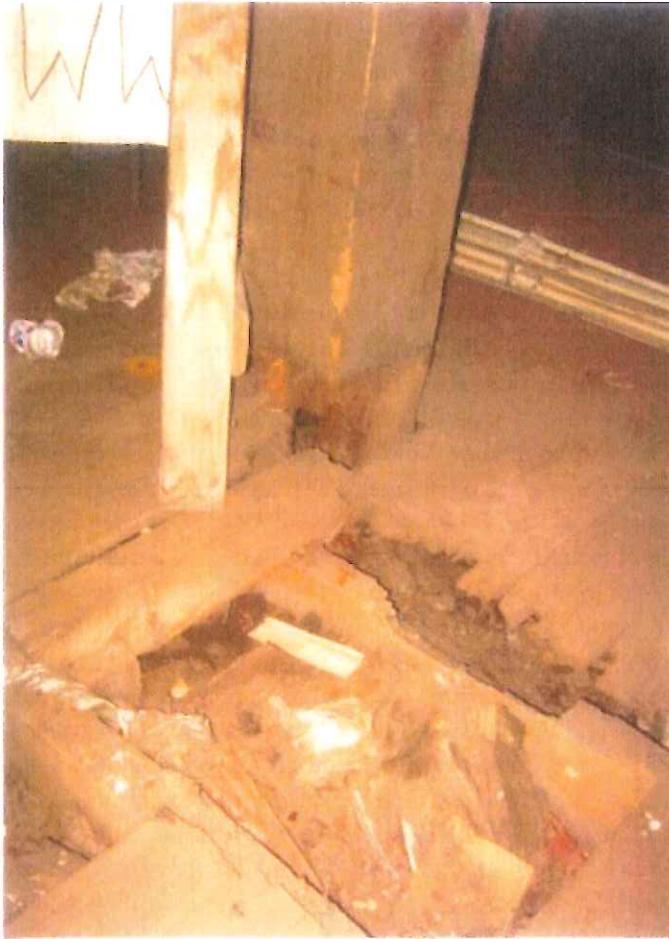
Photo 12-4: Rotting column bottom, floor joists and sills at ground floor.

- Roof has sag along the longitudinal axis.
- Third floor deck and joists rotten in areas below leaking roofs.
- The ground floor dips to the center. Wood sills bearing on grade and columns bearing on grade were observed to be rotten. In one location the post supporting from the structure above was actually hanging from the floor beam due to the deterioration of the column base (Photo 12-4).

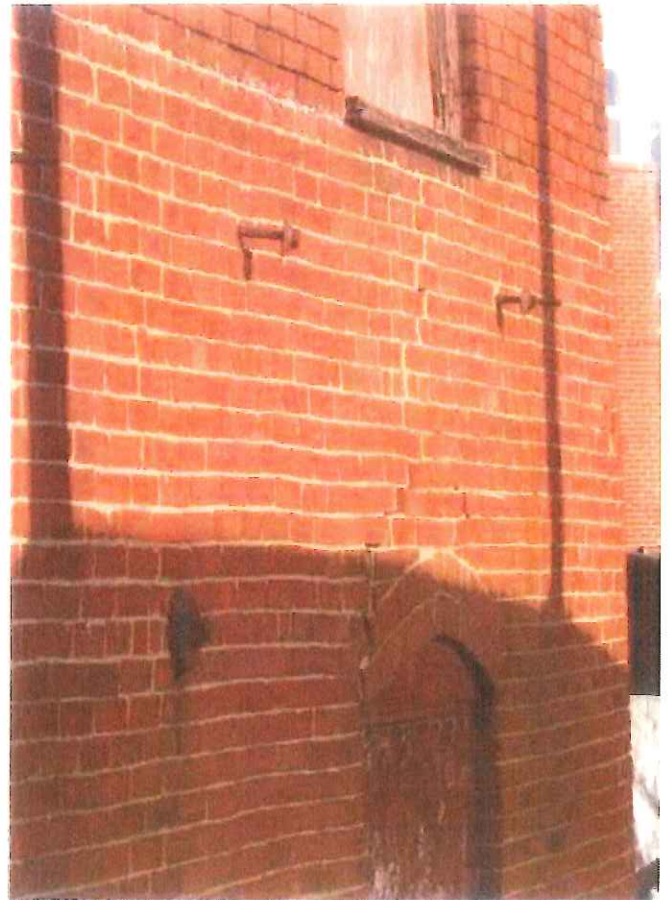
Photo 12-5: Diagonal masonry cracking over window opening, open joints, rotting window sill.

- Arching & diagonal cracks over windows that extend through the entire width of the masonry (Photo 12-5).
  - Open joints in many locations.
  - Bulging in some locations.

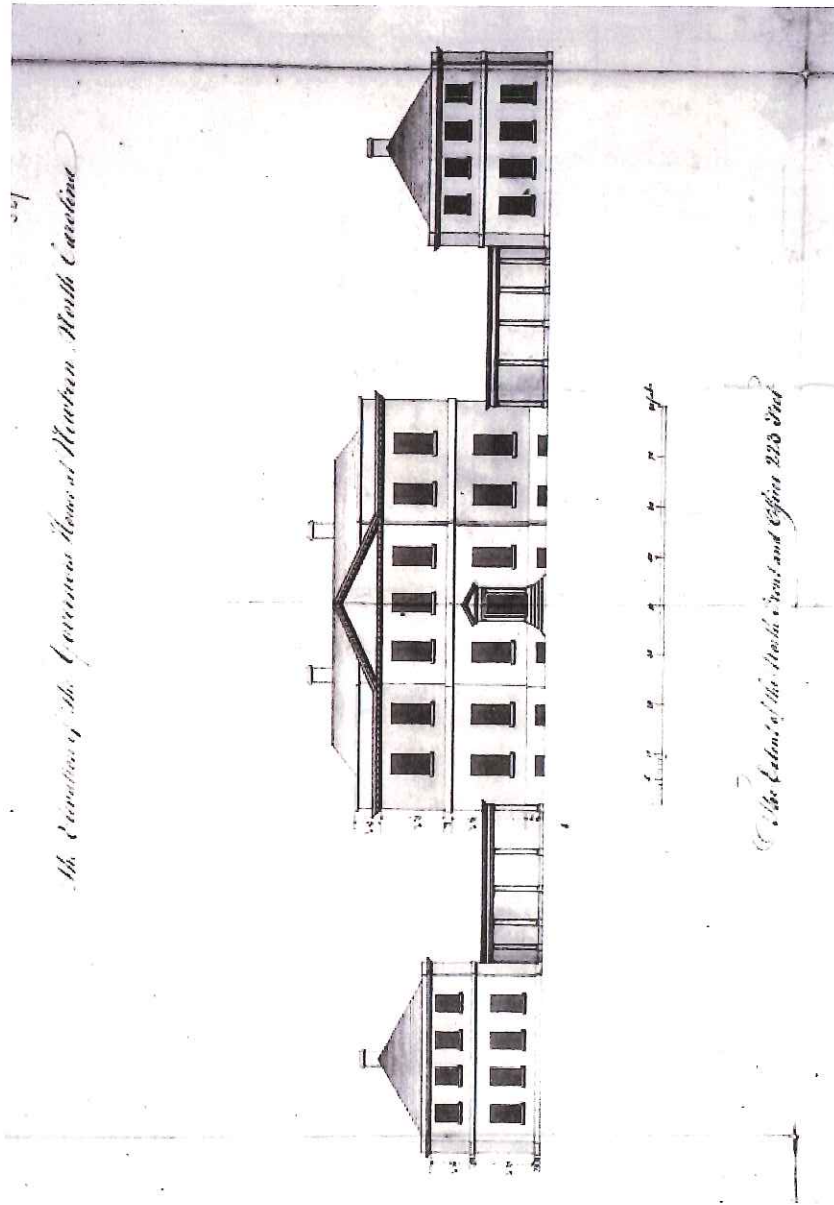
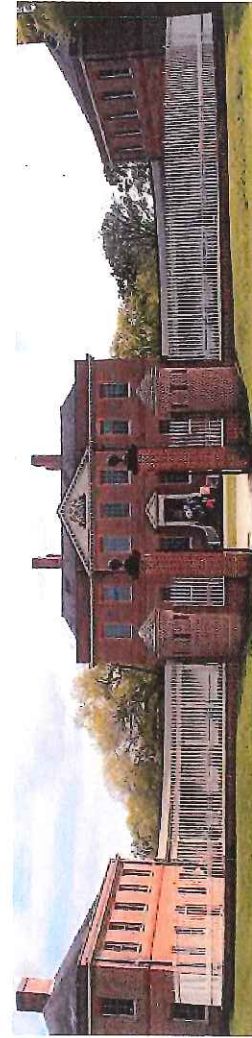
[1 a-b] Tyrone Palace, New Bern, NC, was designed by John Hawks in 1767 for Governor William Tyrone. It was completed in 1770, but destroyed by fire in 1798. The palace was reconstructed in 1959 based on the original plans, and on its original foundation, which was found 5 feet below the street, with the help of the 1767 drawing. Photo: Courtesy Tyrone Palace, New Bern, NC. Drawing: Courtesy of the State Archives of North Carolina.

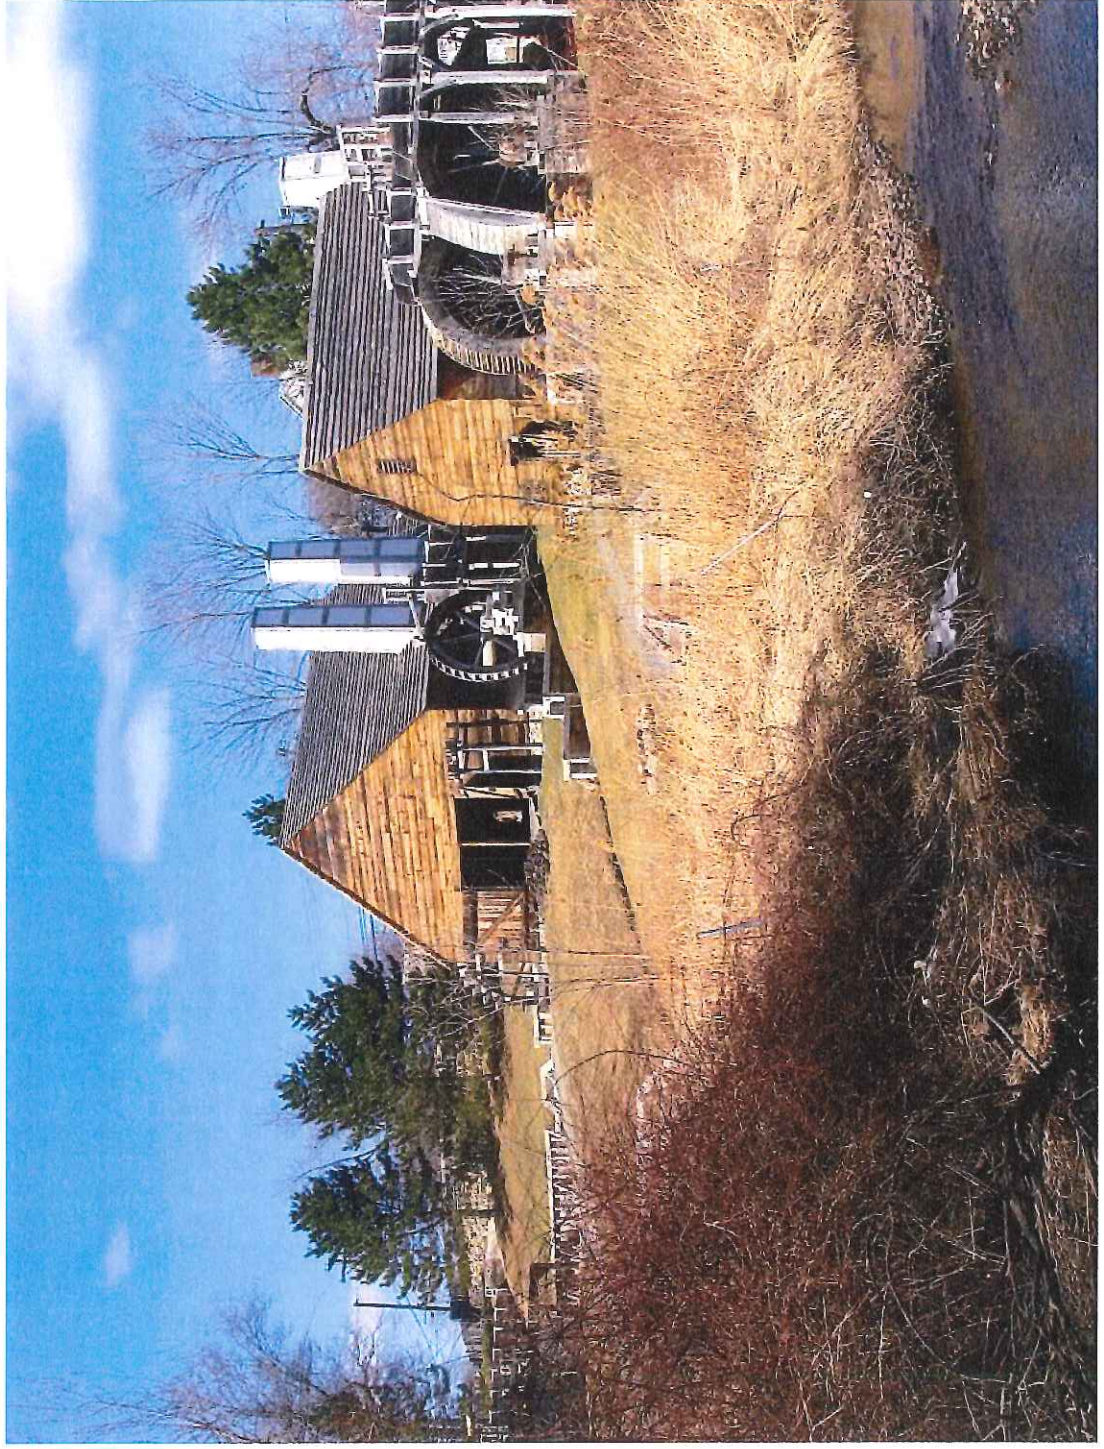
[2] The Saugus Iron Works, Saugus, MA, a National Historic Site, was active from 1646 to about 1670 and was the first integrated iron works in North America. The forge and mill (shown here) are part of the site which was reconstructed based on archeological research and historic documents and opened in 1954. Photo: Daderot at the English language Wikipedia.

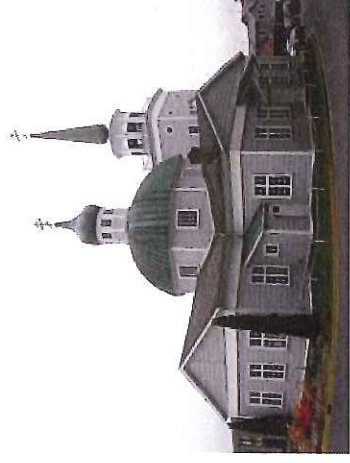
[3] The Cathedral of Saint Michael the Archangel, built in the early 1840s in Sitka, AK, was devastated by fire in 1966. It was reconstructed using measured drawings done in 1961 by the Historic American Buildings Survey (HABS). While the original cathedral was built of logs covered on the exterior with wood siding, its replacement is a fire-resistant structure with concrete and steel walls that replicates the historic building's appearance. Photo: Barek at Wikimedia Commons.

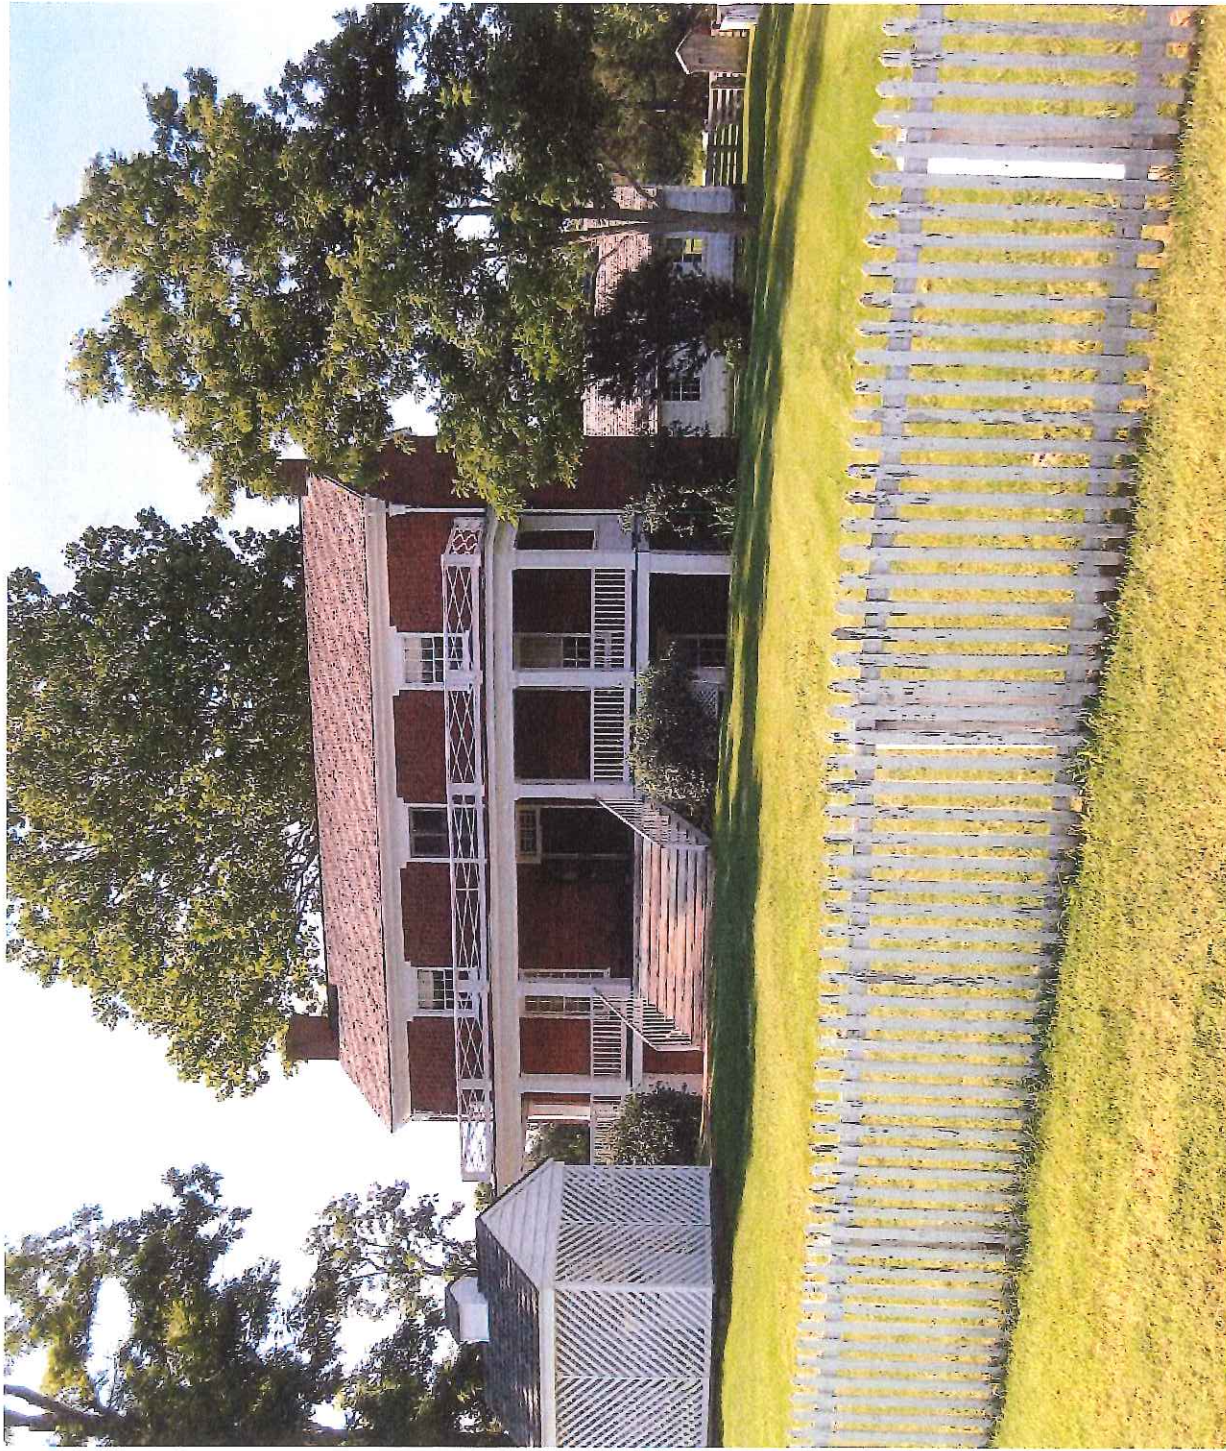
[4] The McLean House, where Robert E. Lee surrendered to Ulysses S. Grant, is located on the site of the battlefield—now part of Appomattox Courthouse National Historical Monument (VA). Several years after the end of the Civil War, measured drawings were made of the house before it was dismantled to be moved to Washington, DC, where it was to be reconstructed as a tourist attraction. This scheme never came to fruition, and the dismantled pieces gradually disappeared. The house was accurately reconstructed in 1949 on the original site based on the measured drawings.

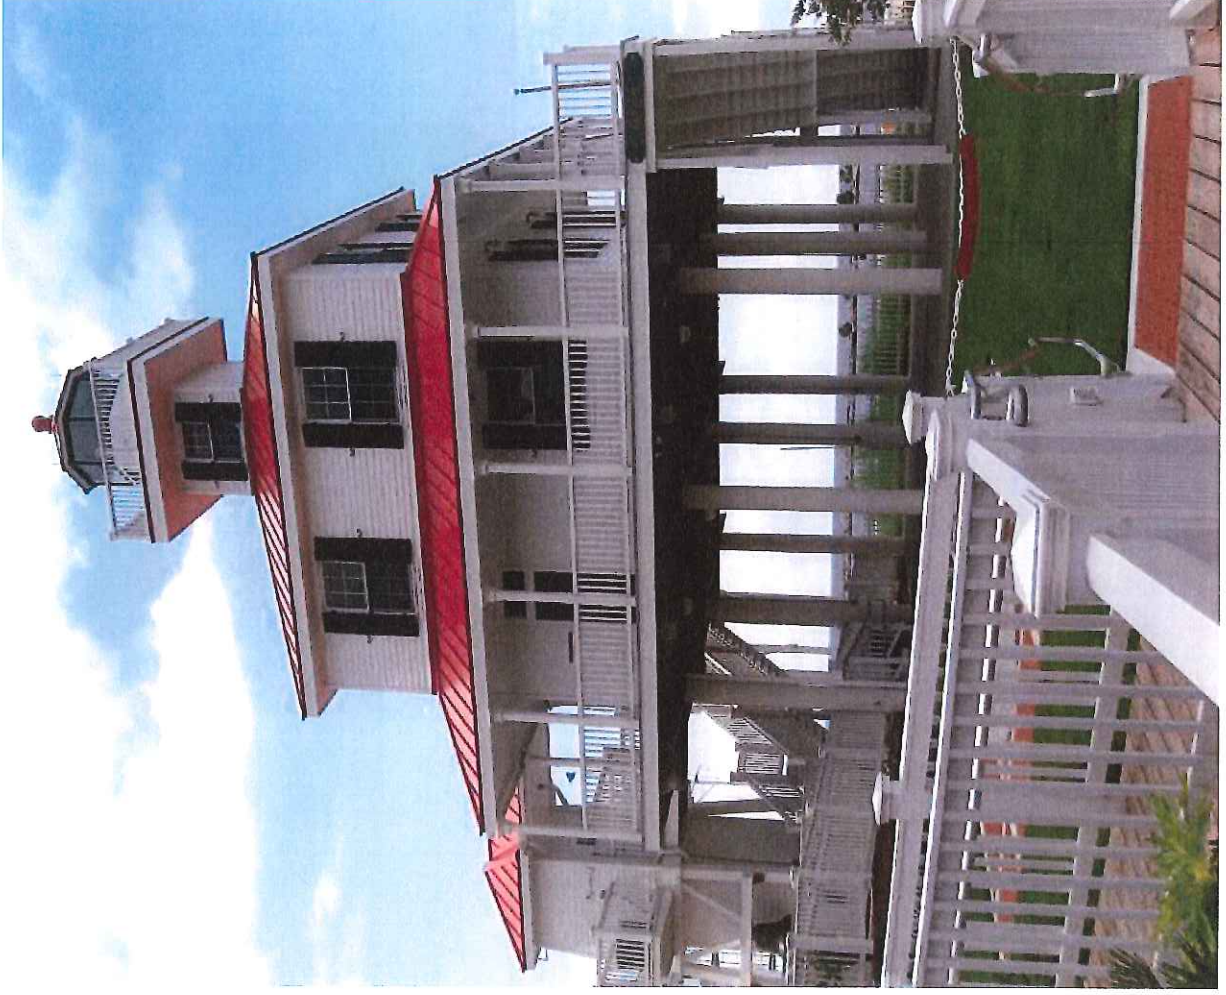
[6] This lighthouse on Lake Ponchartrain in New Orleans was reconstructed after the historic 1890 lighthouse was destroyed by Hurricane Katrina.

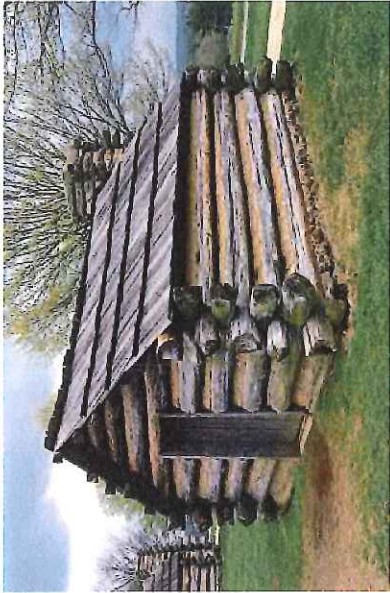
[7] The Muhlenberg Brigade Huts are reconstructions of nine log huts erected in 1777 at Valley Forge during the Revolutionary War. They have been reconstructed on the historic road with logs cut with modern power tools and finished with cement, unlike the original logs which were hand hewn and finished with traditional chinking. Photo: Rdsmith4 at Wikimedia Commons.

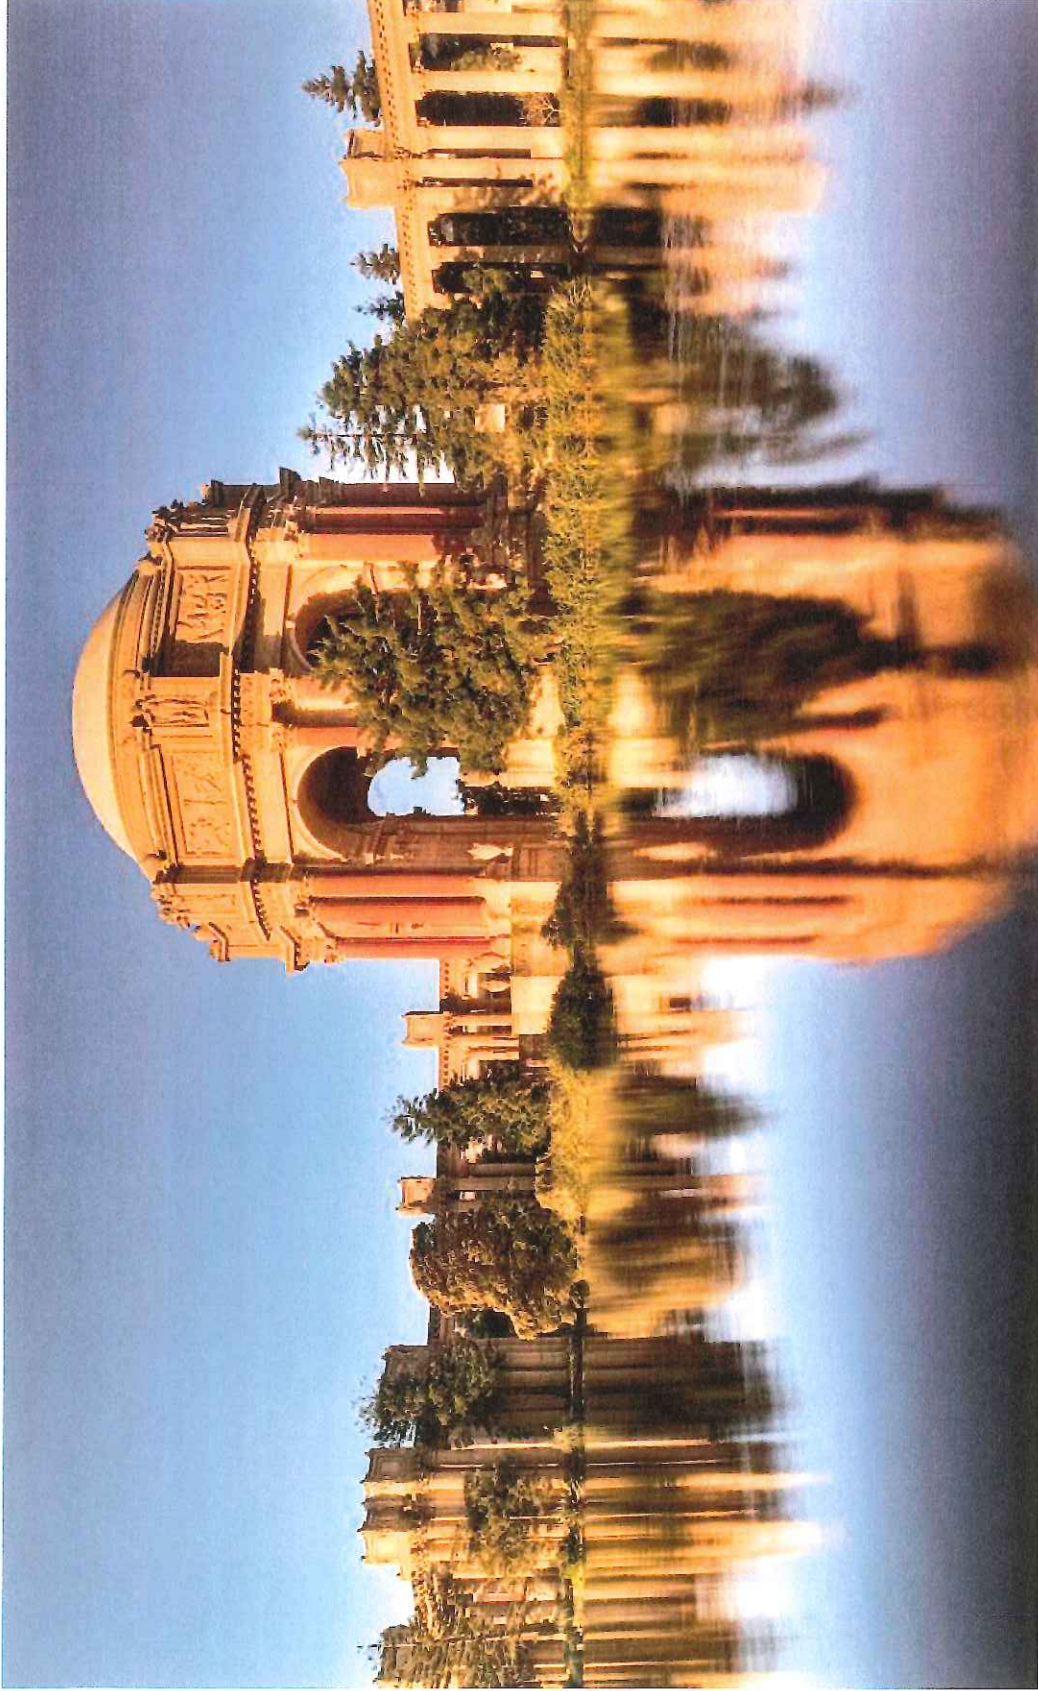
[8] The Palace of Fine Arts was designed by Bernard Maybeck and built for the 1915 Panama-Pacific Exposition in San Francisco. The pavilion was intended to be temporary and, although it had a steel structure, the exterior was finished only with stucco, an impermanent material composed of plaster and fiber. The building was not torn down after the exposition, and it eventually fell into ruin. In 1964, all but the steel structure was demolished, and the building was reconstructed with lightweight poured-in-place concrete. *Photo: Kevin Cole at Wikimedia Commons.*
