3. High And York Streets

**LEGAL ADVERTISEMENT  
HISTORIC PRESERVATION BOARD  
CITY OF PORTLAND  
Public comments are taken at all meetings.**

**York Street Apartments**  
Portland, Maine

**Introduction**

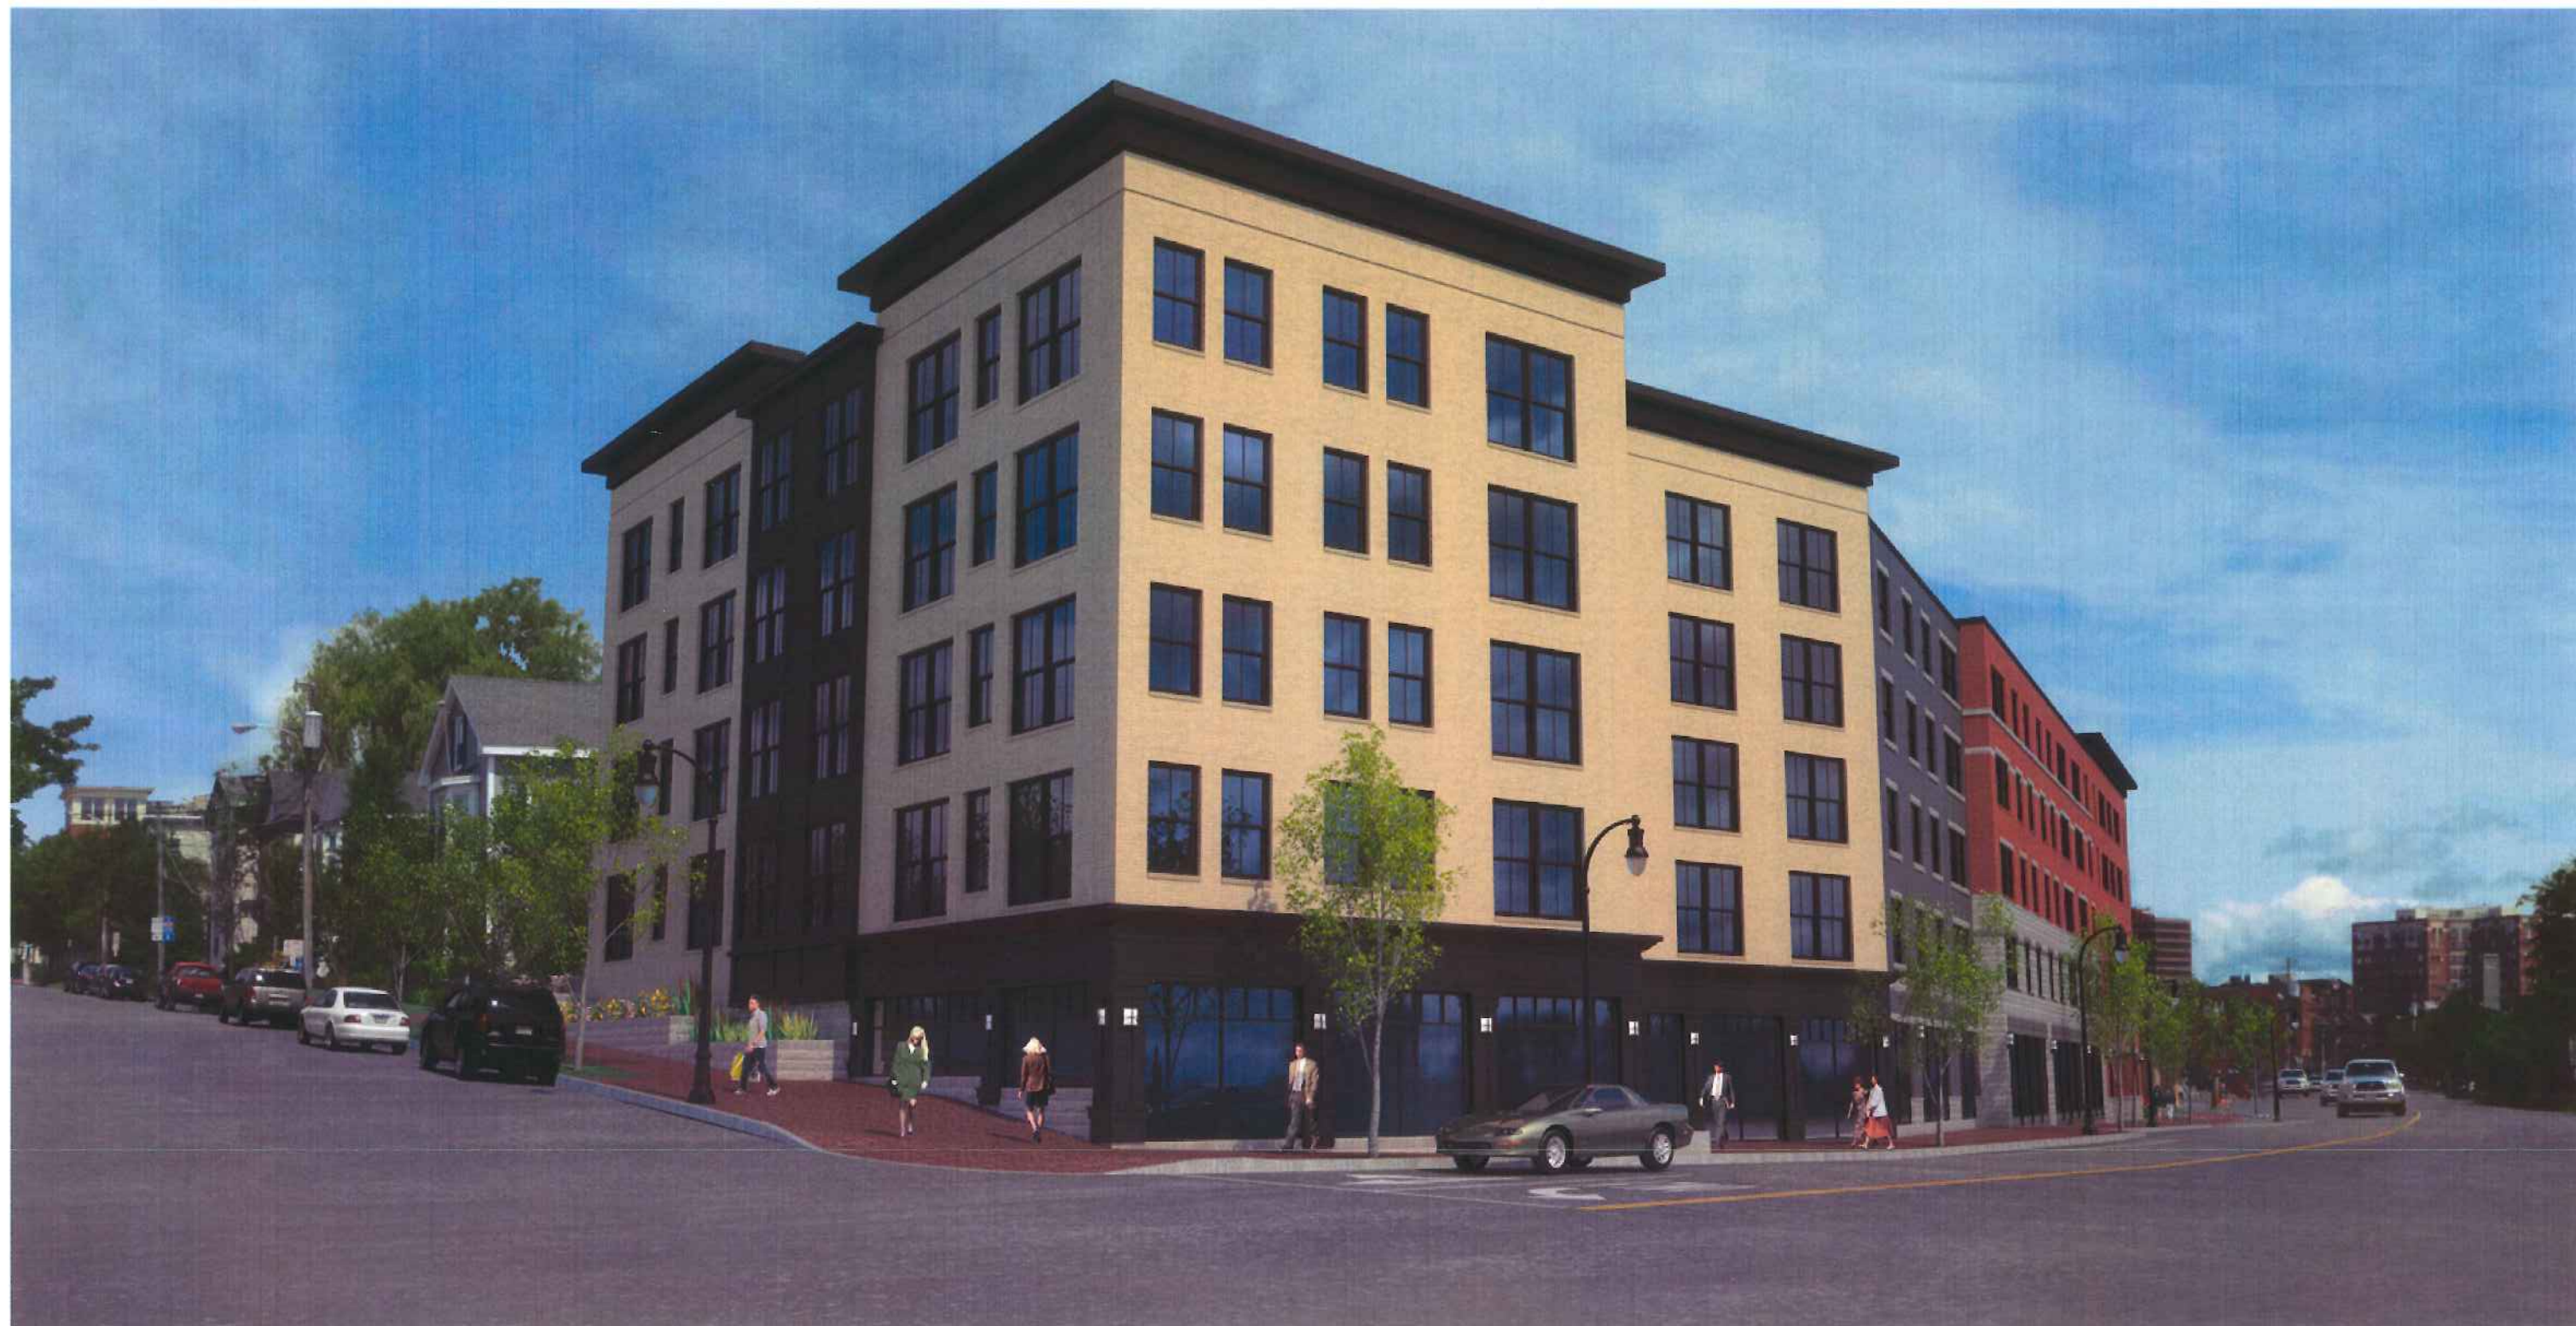
PERSPECTIVE VIEW AT THE CORNER OF YORK AND HIGH STREET

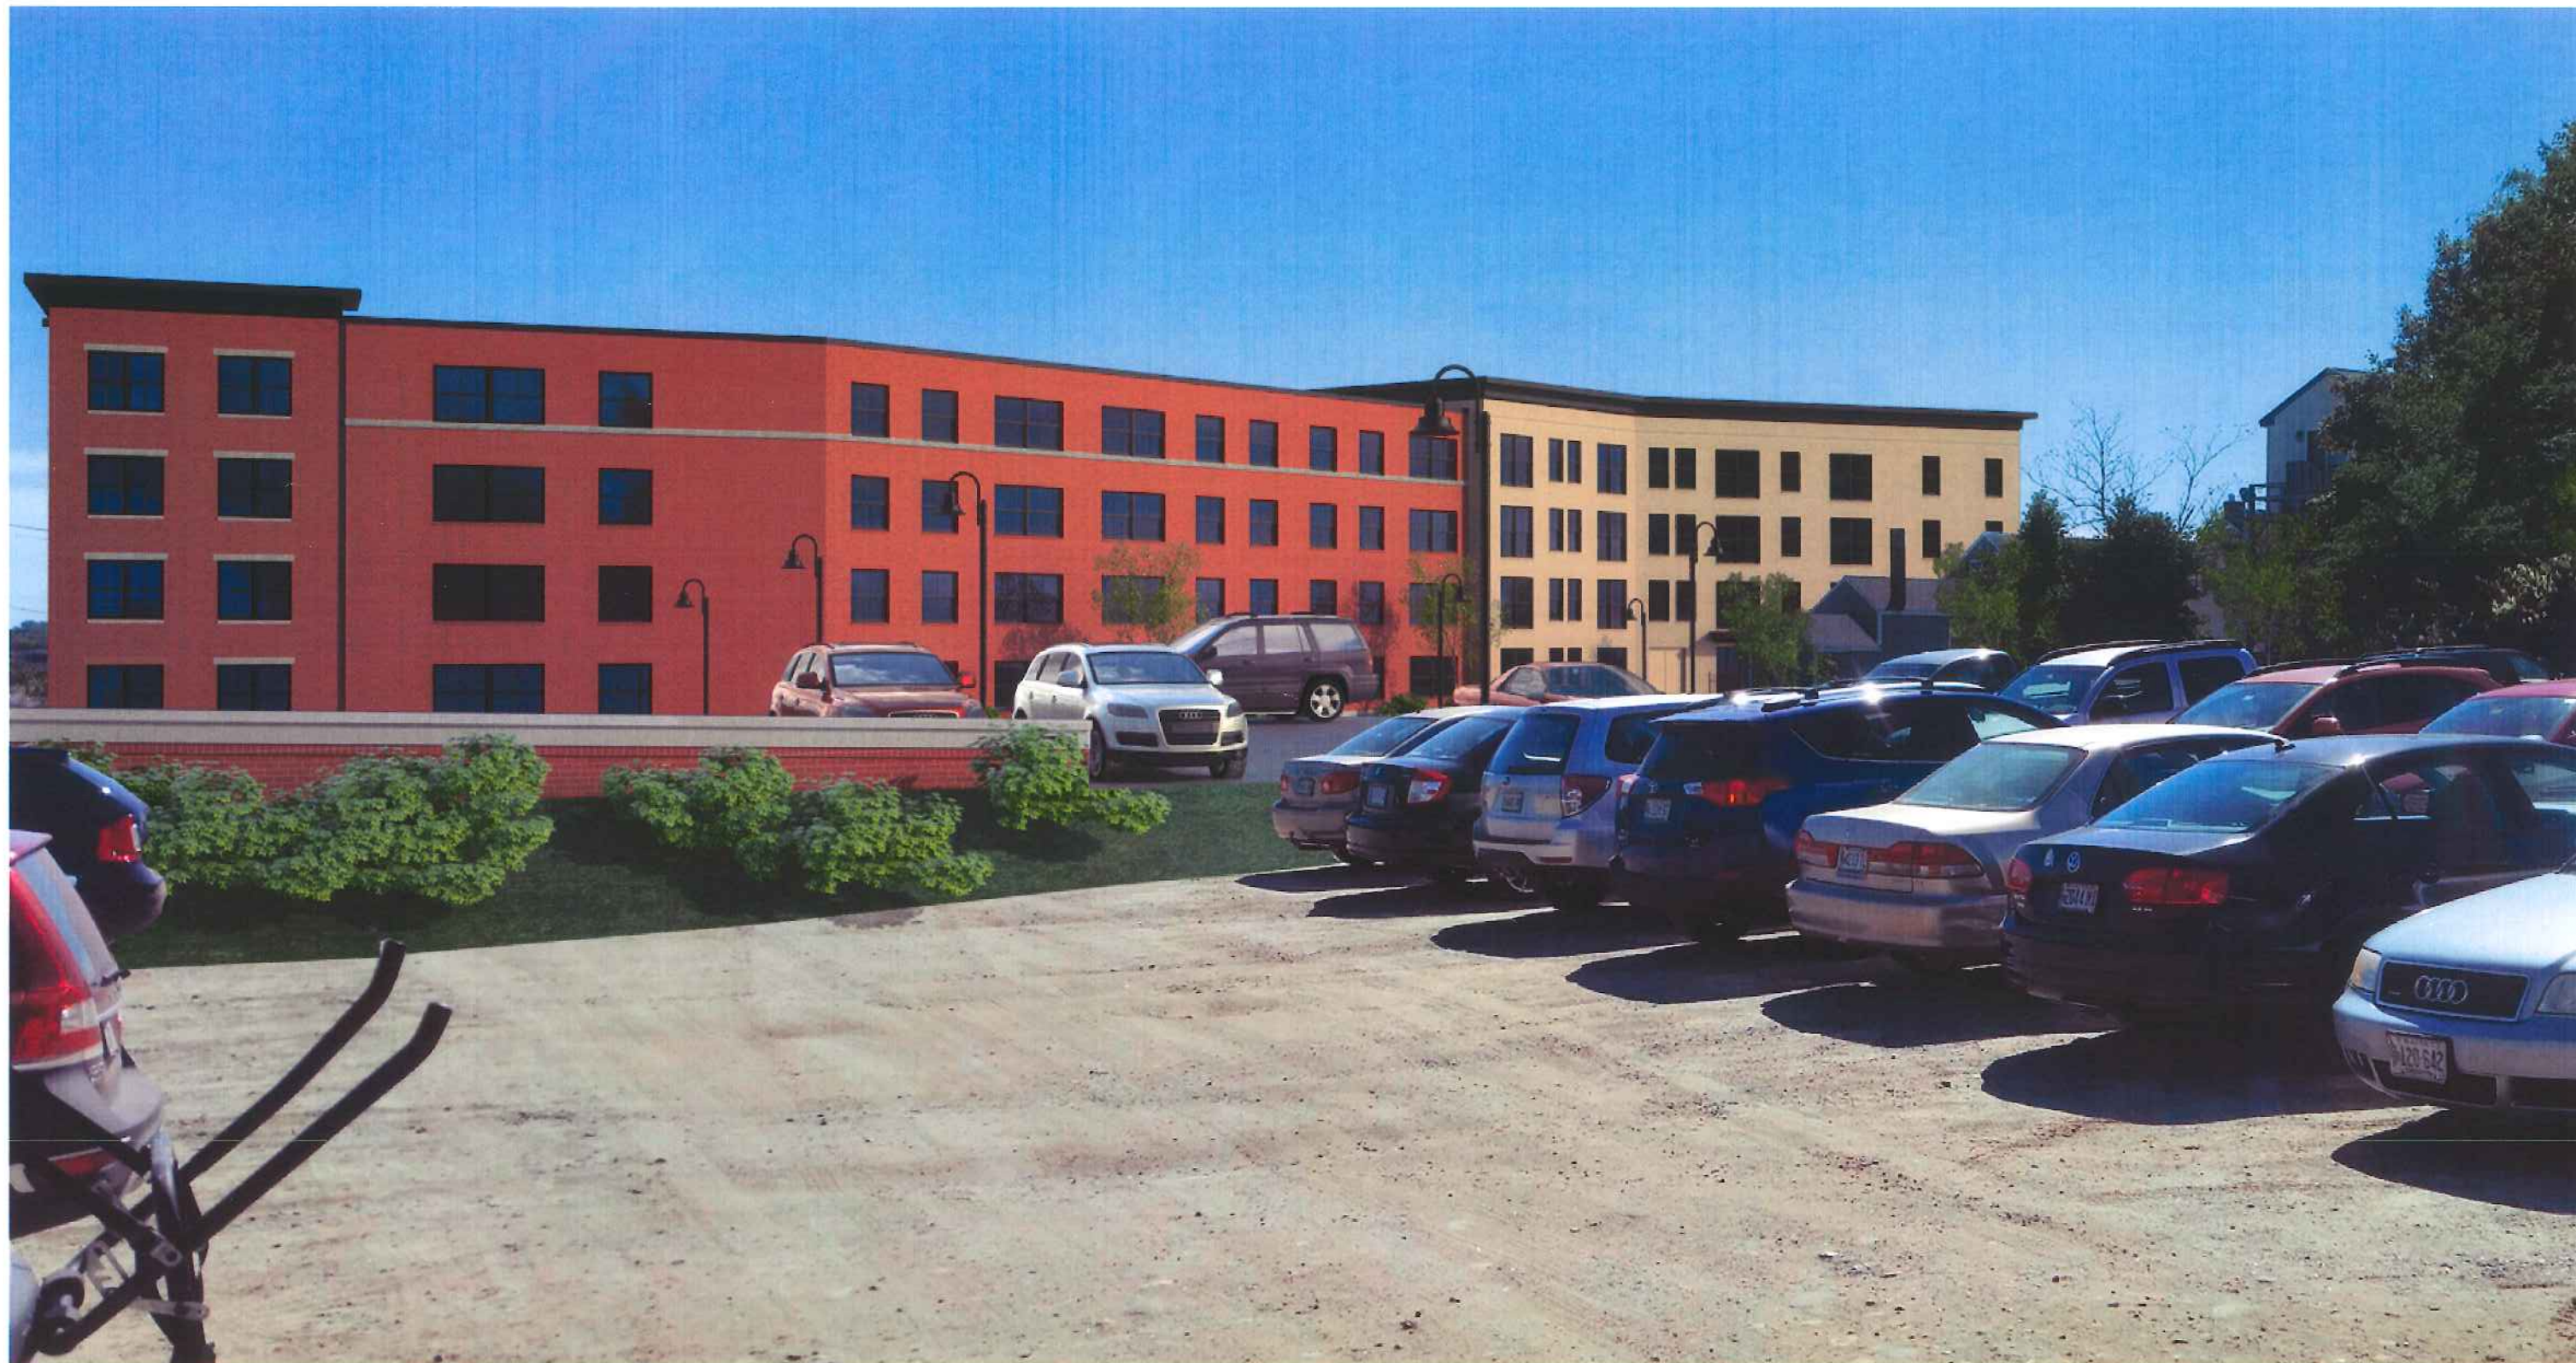
PERSPECTIVE VIEW FROM DANFORTH STREET

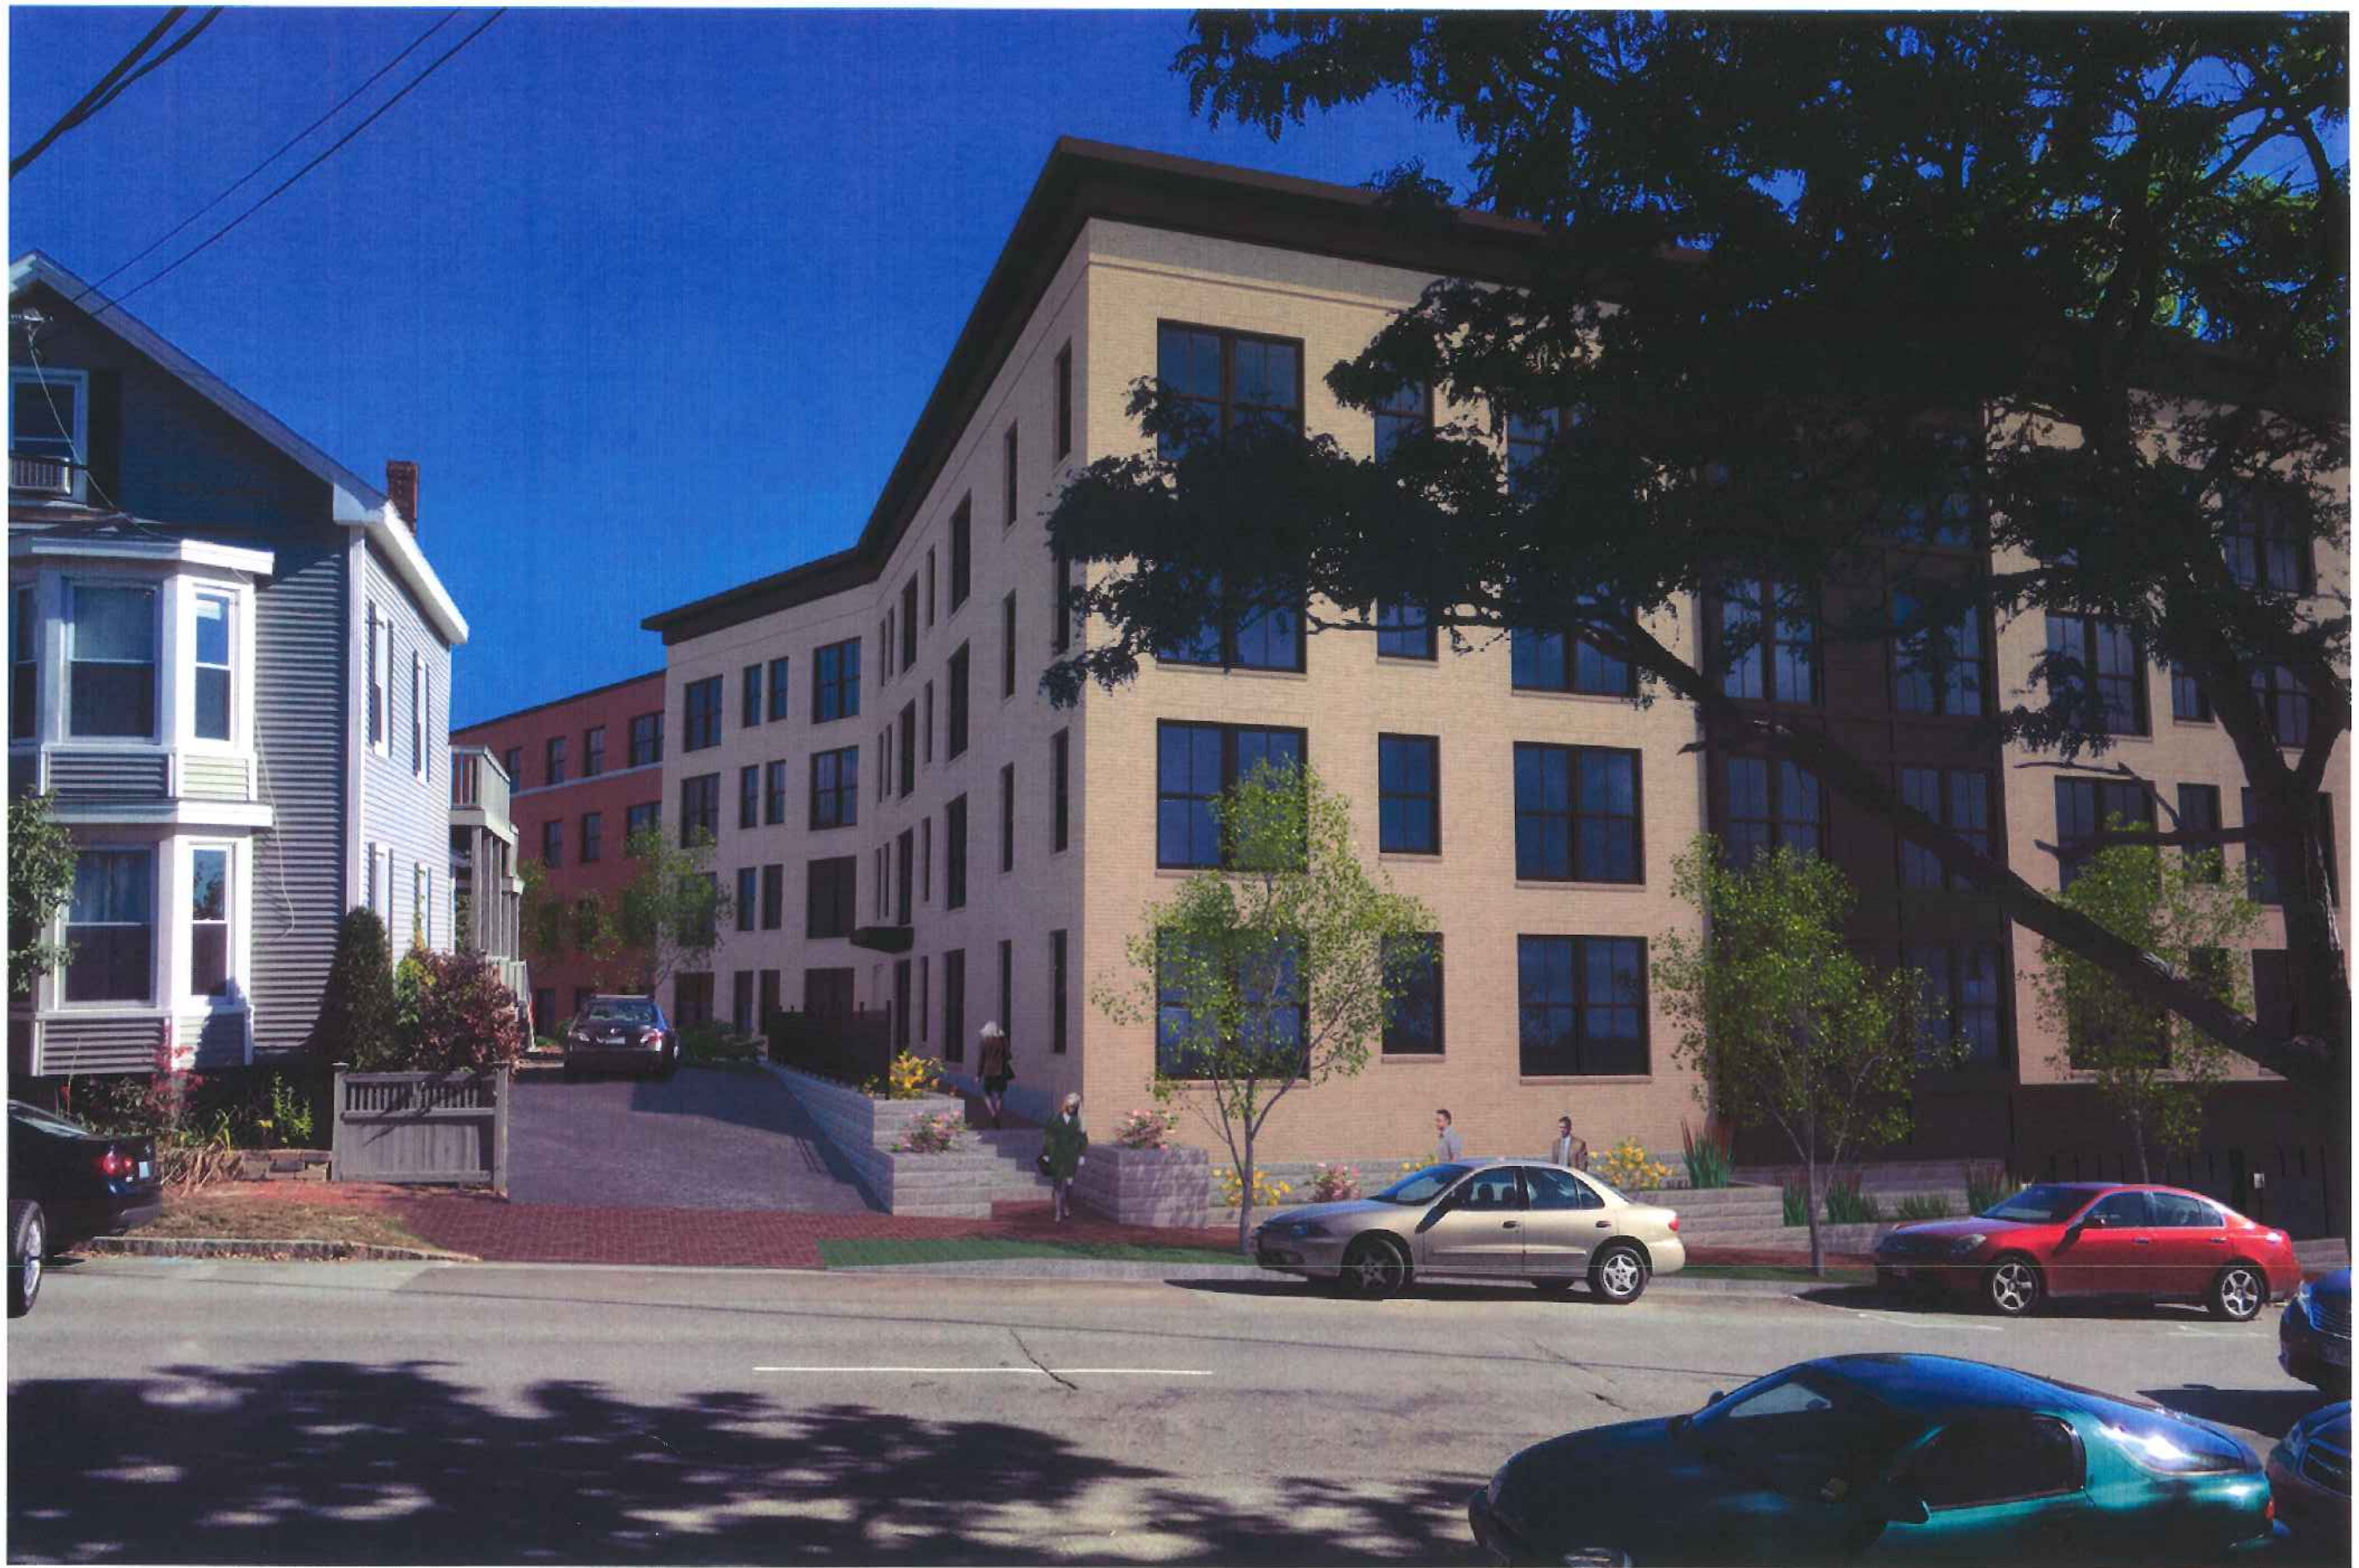
PERSPECTIVE VIEW FROM HIGH STREET

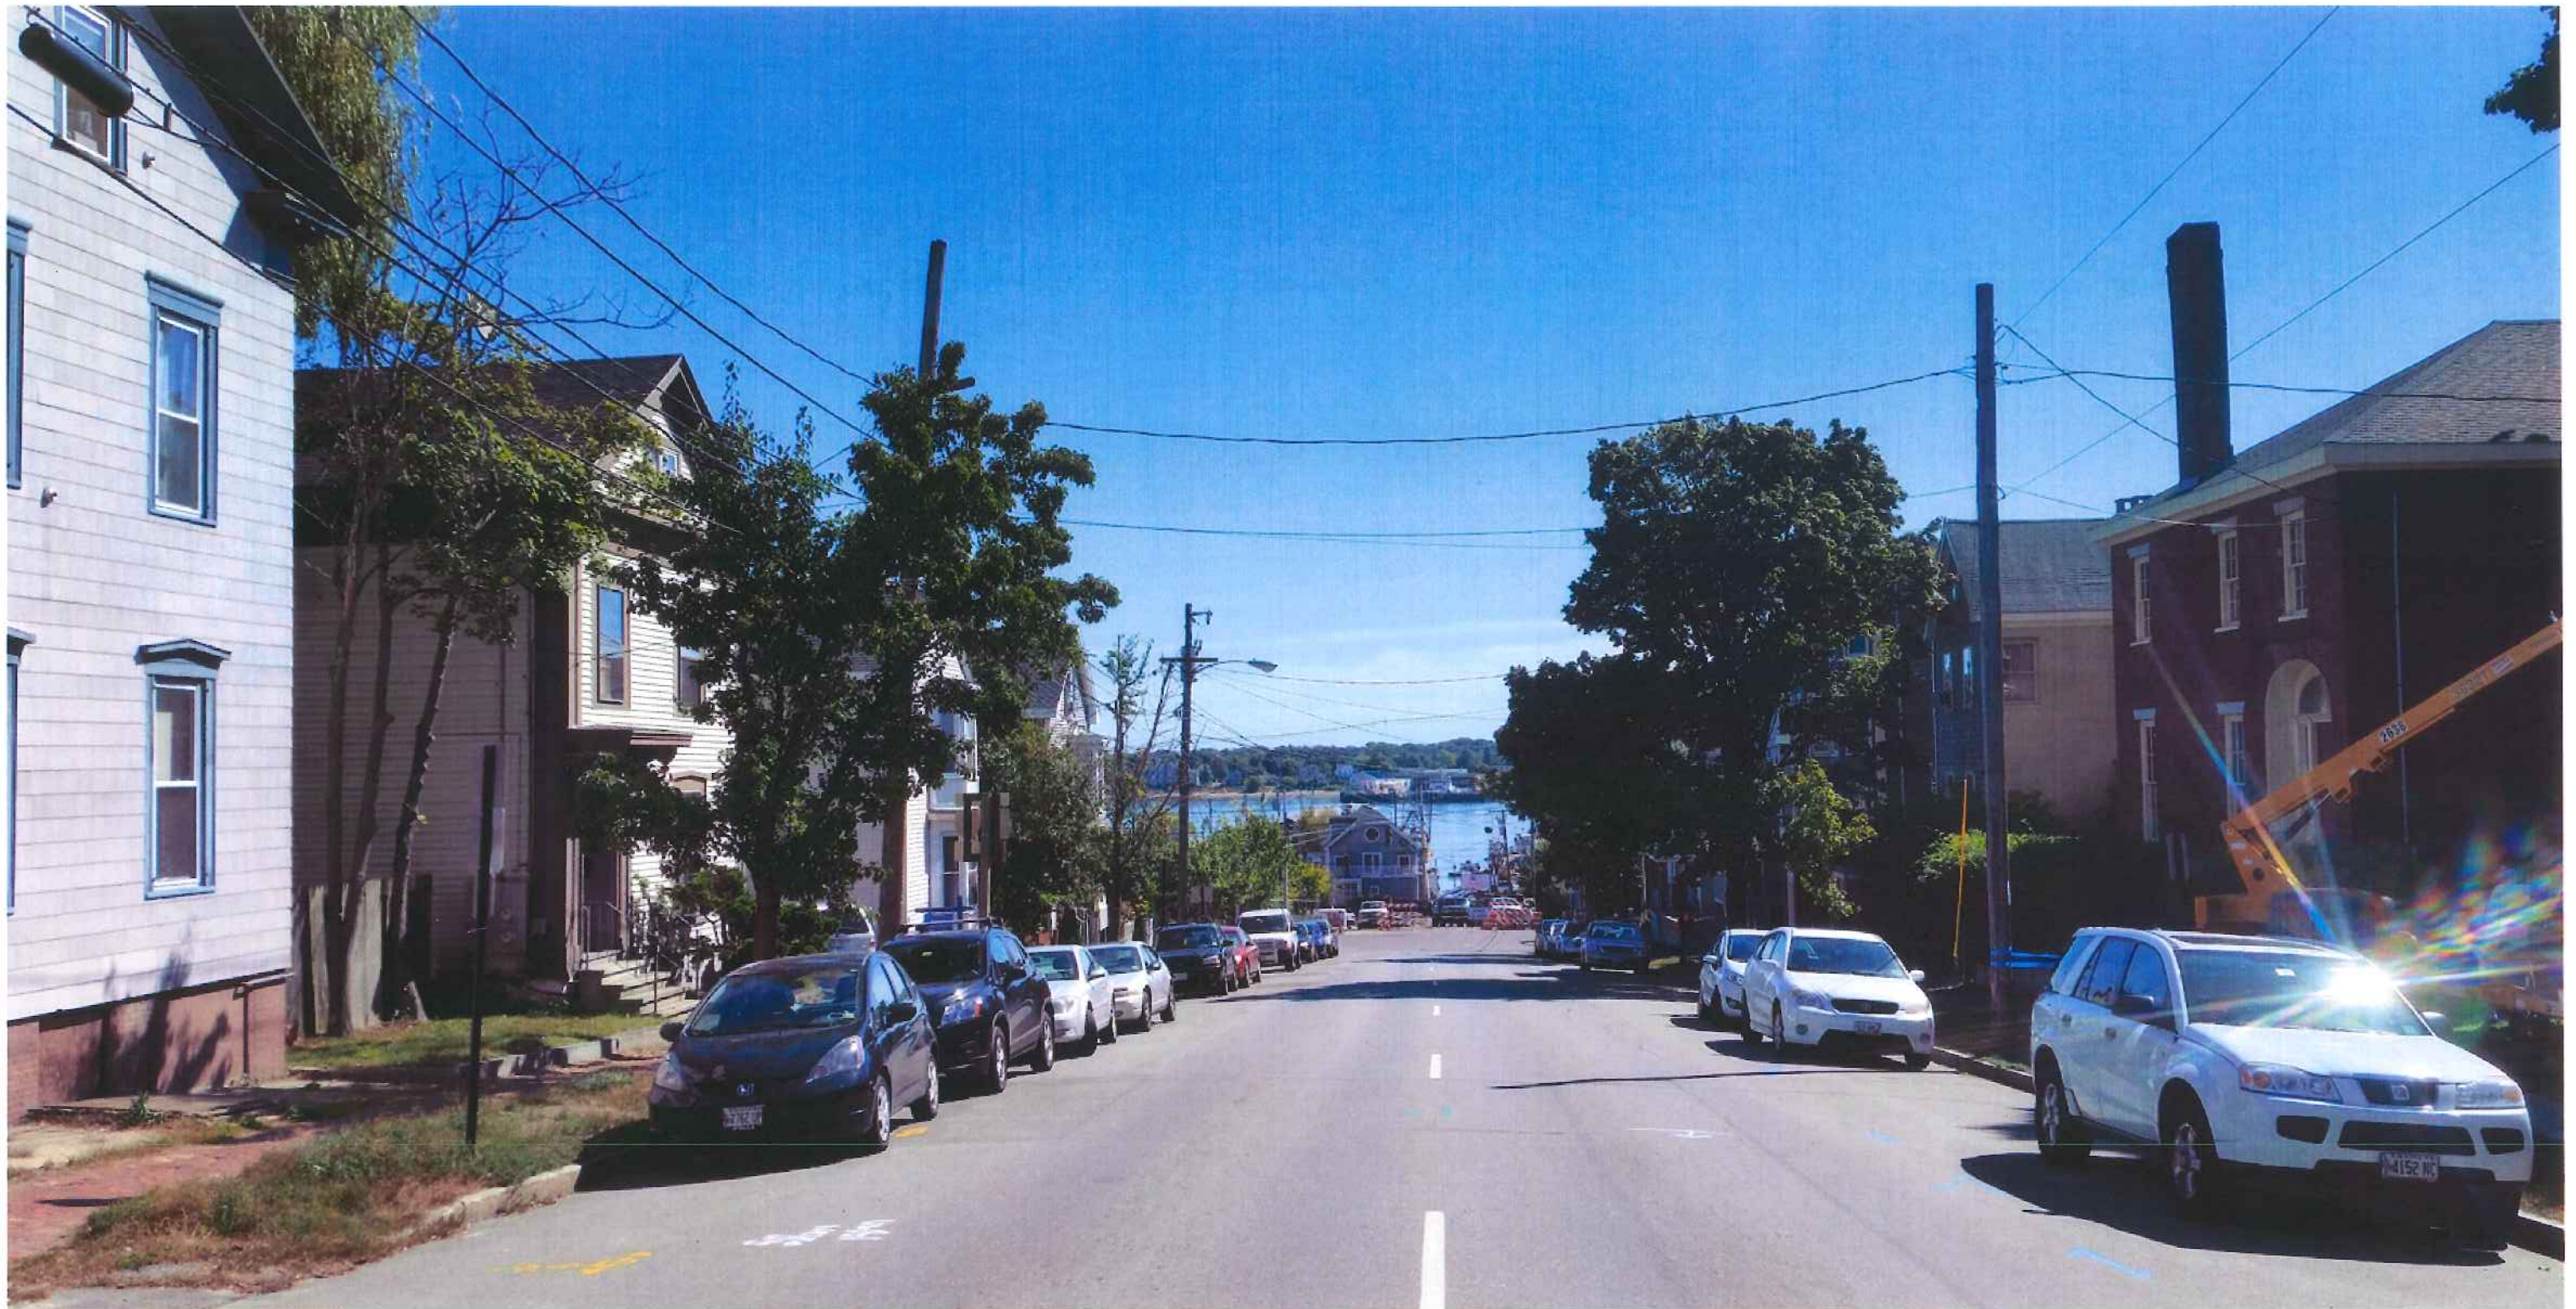
PRESENT HIGH STREET VIEW CORRIDOR

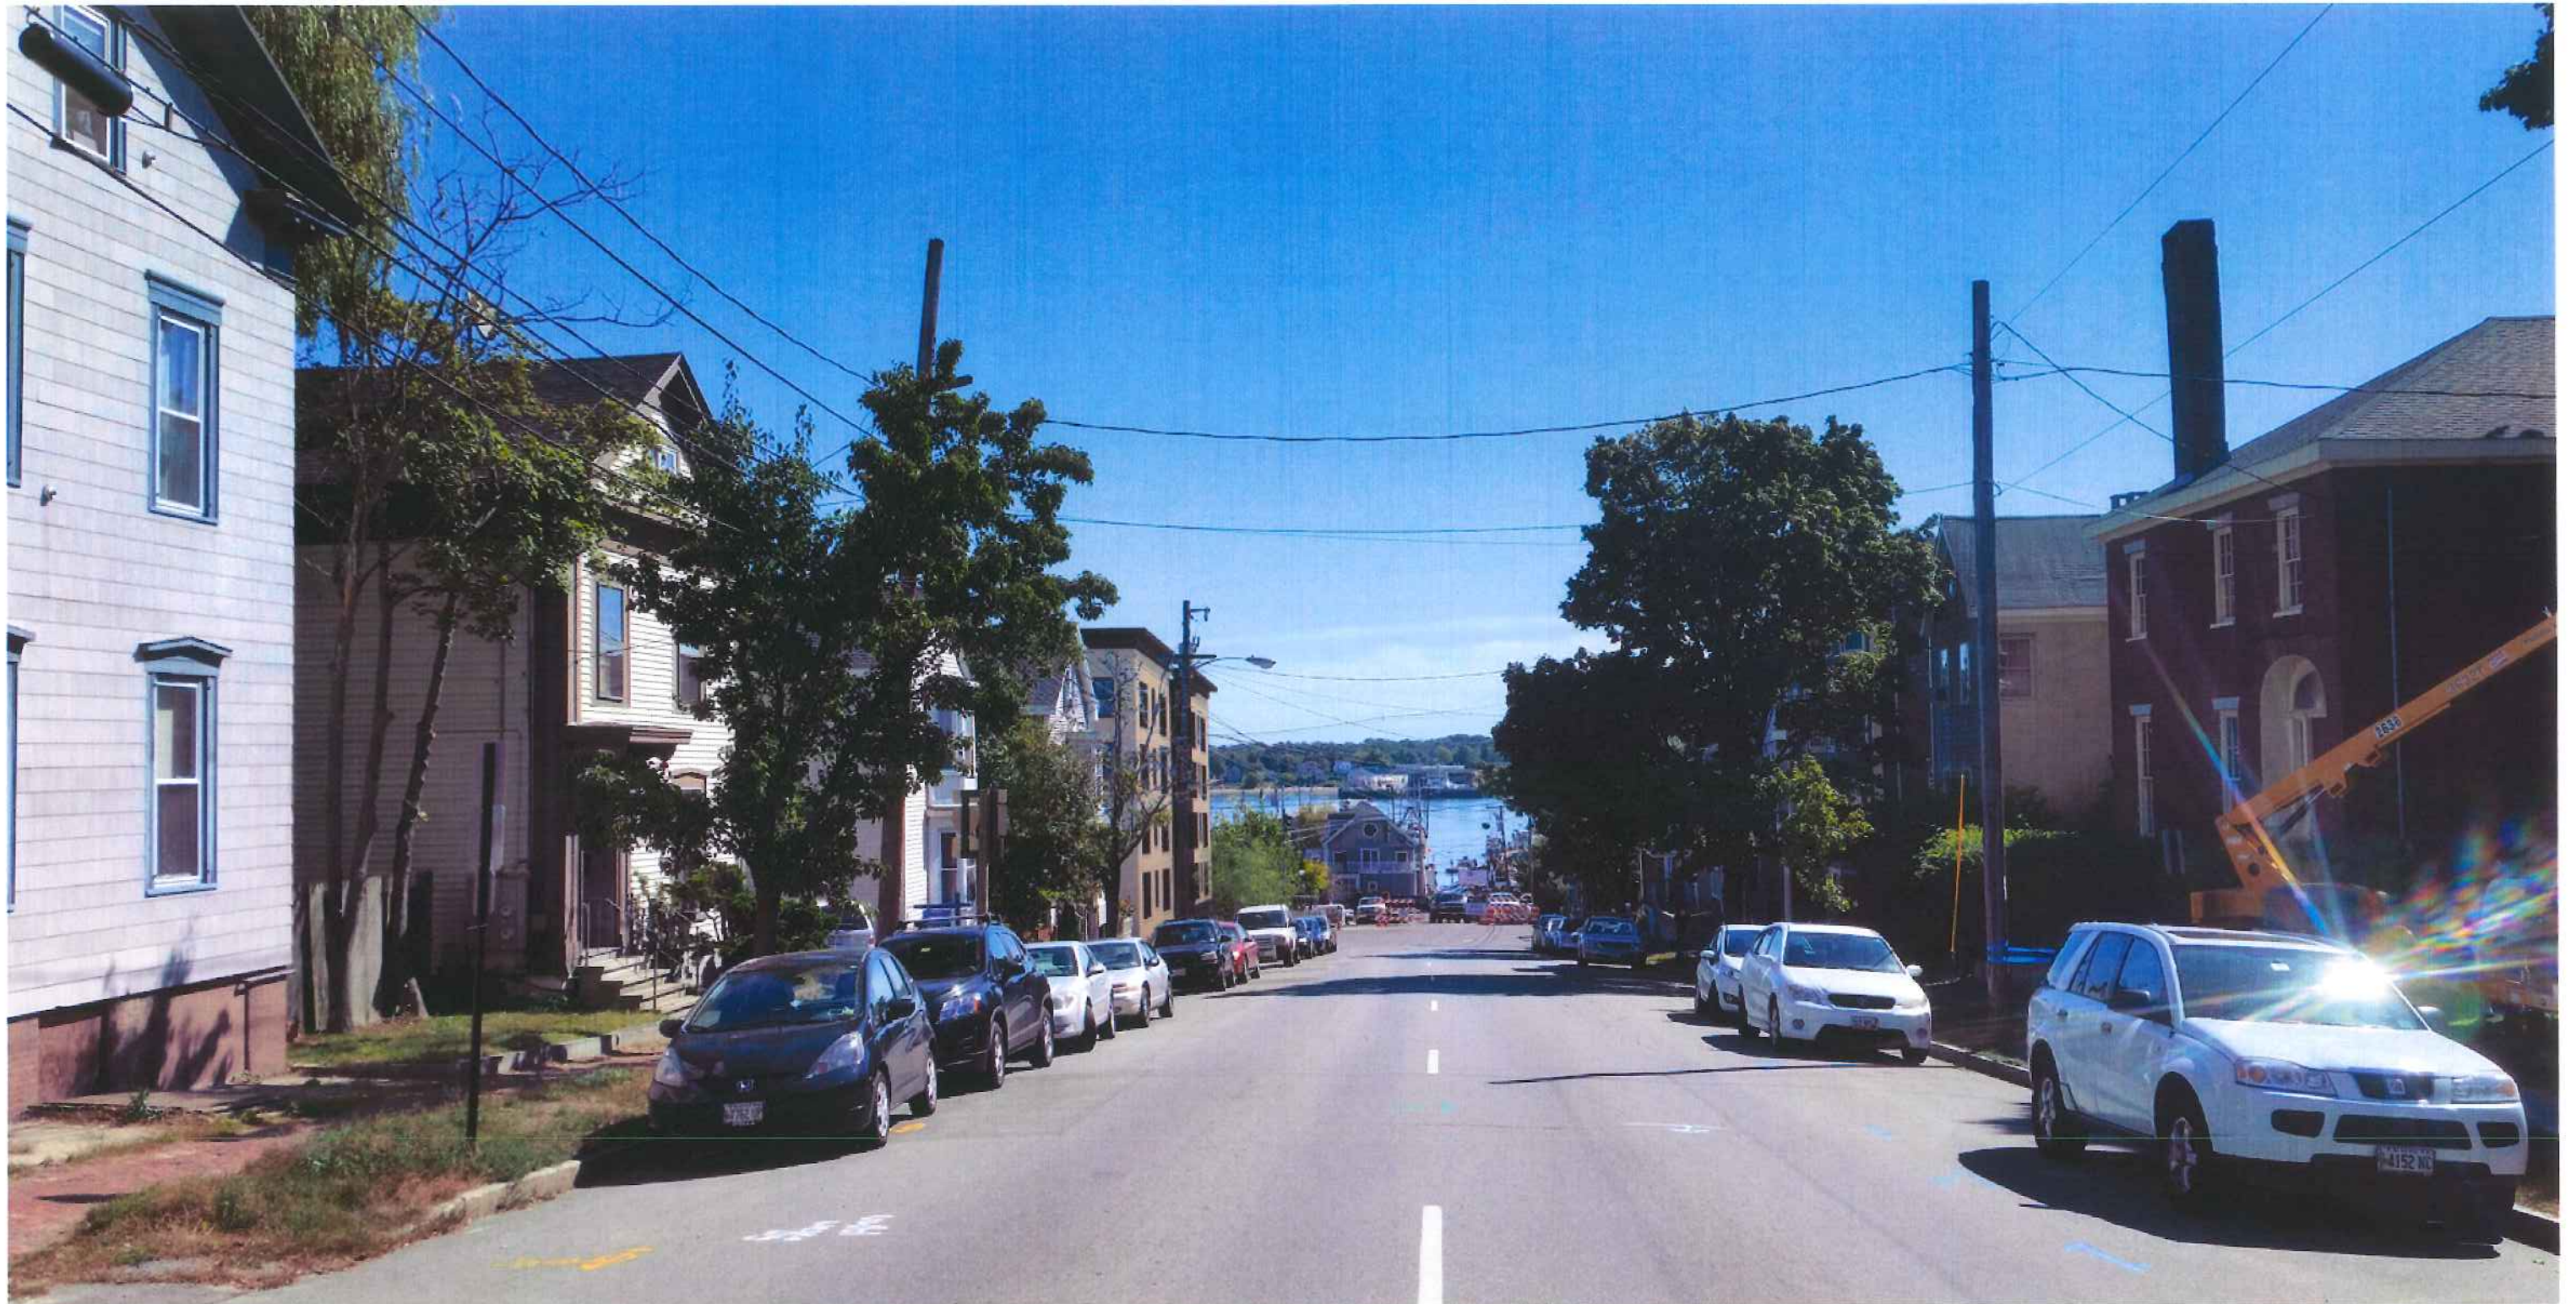
FUTURE HIGH STREET VIEW CORRIDOR

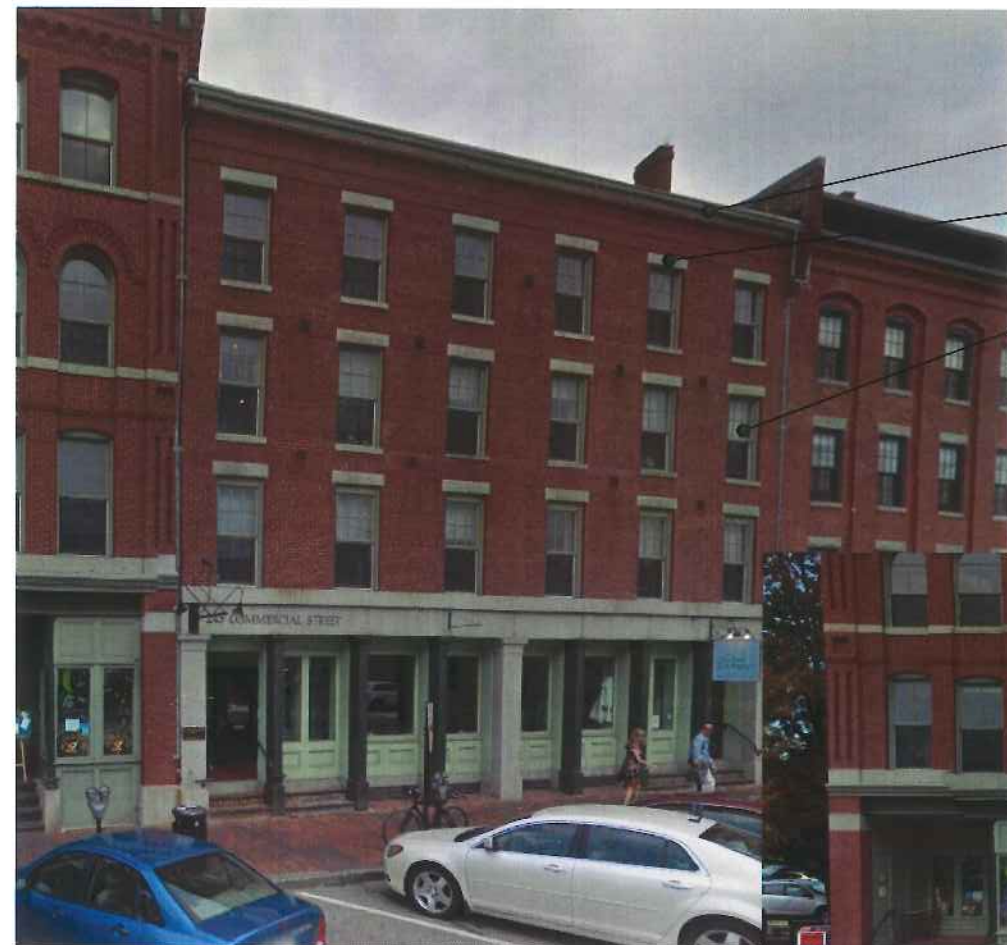
245 Commercial Street

Notable Elements:

vertically proportioned openings

granite base

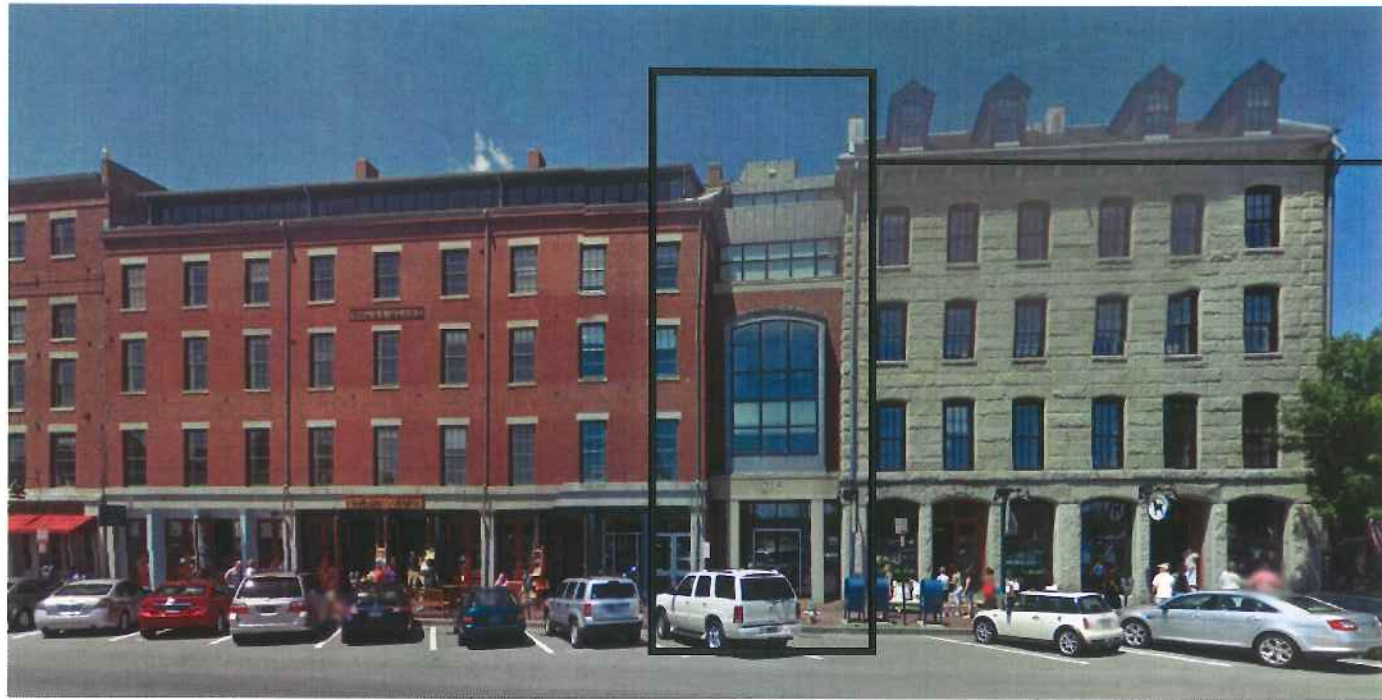
215 Commercial Street

Notable Elements:

facade creates a link / transition between two strongly developed fenestrations. The "link" recedes to the background allowing the adjacent buildings to be prominent

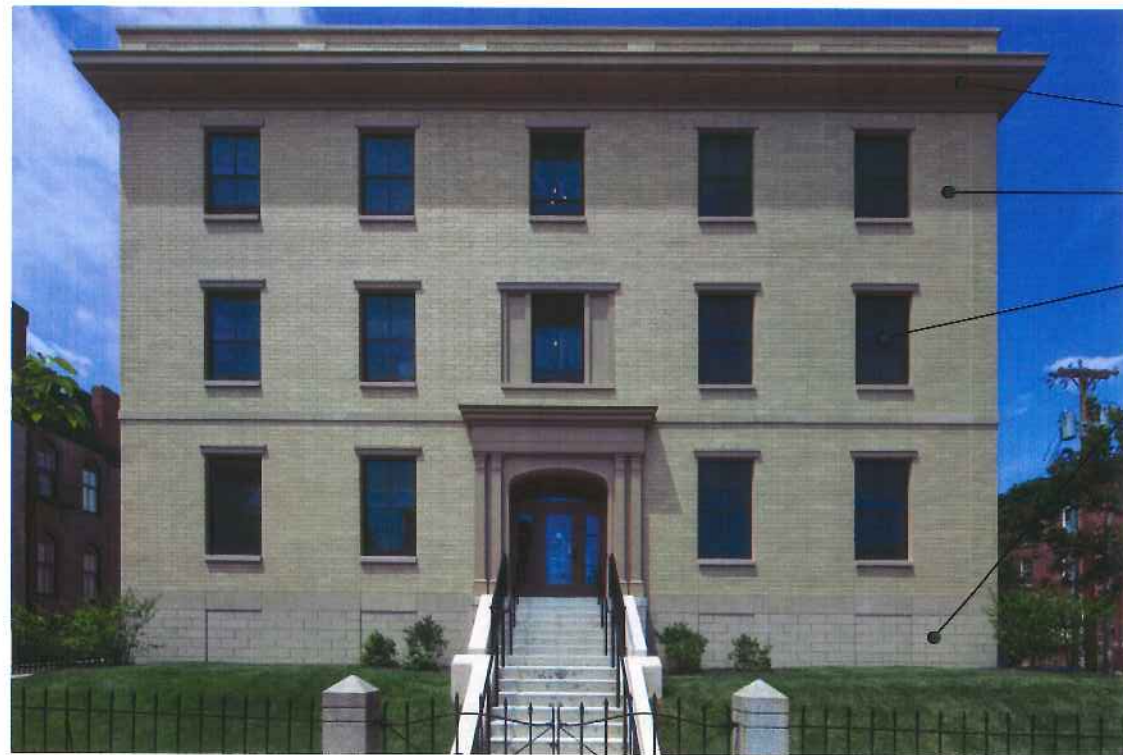
68 High Street

Notable Elements:

vertically proportioned openings

varied base

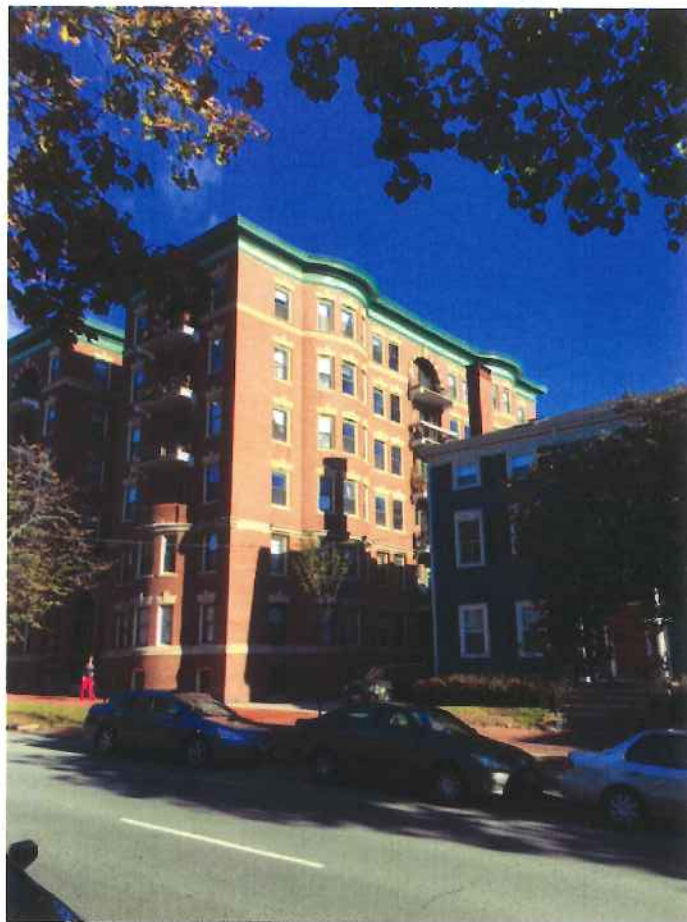
State Street

#### Notable Elements:

overall building height varies but  
scale and proportion remain  
similar to surrounding context.

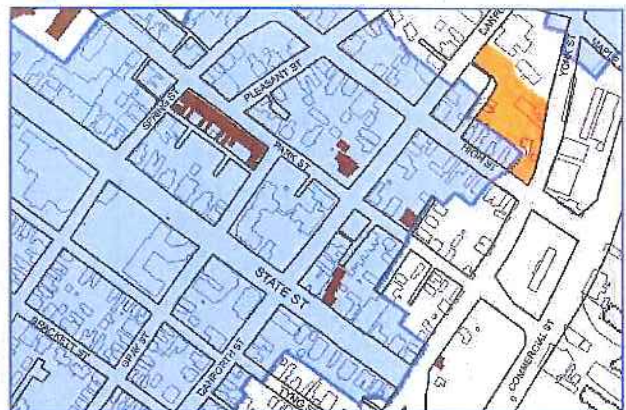
As the detail from the West End Historic District map shows, the district extends all the way to York Street in the vicinity of State Street. East of State Street, however, the district stops short of York Street. This is due to the fact that many of the buildings on or approaching York Street have been significantly altered over time and have lost much of their architectural integrity. While the buildings directly across High Street from the proposed development are

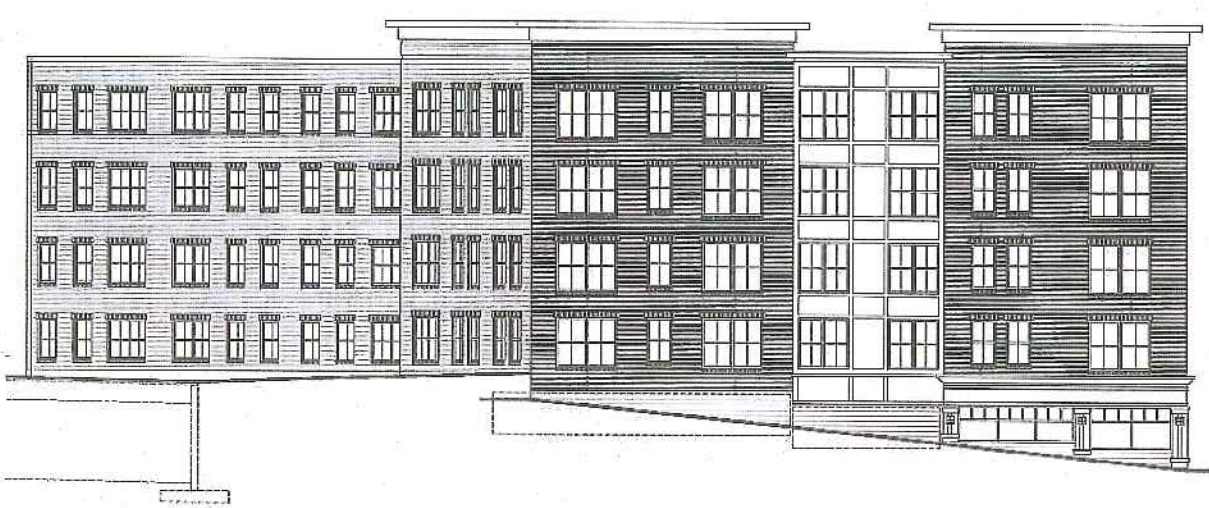
3 HIGH STREET EXTERIOR ELEVATION  
3/32" = 1'-0"

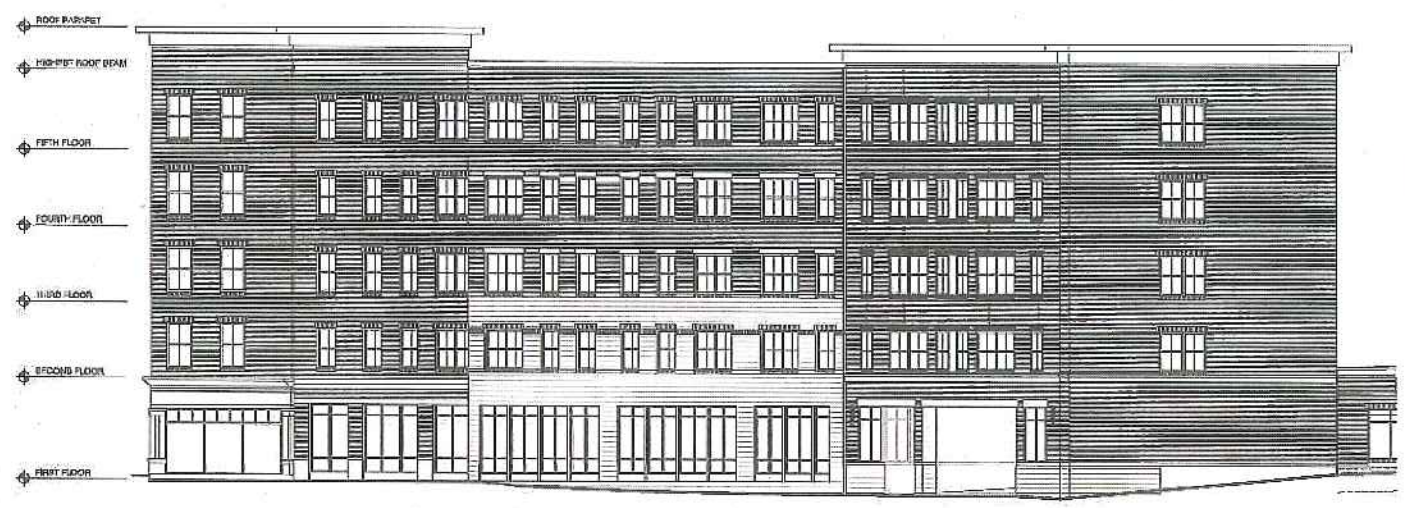
2 SIDE YORK STREET EXTERIOR ELEVATION  
3/32" = 1'-0"
