3. High And York Streets

**LEGAL ADVERTISEMENT  
HISTORIC PRESERVATION BOARD  
CITY OF PORTLAND  
Public comments are taken at all meetings.**

**York Street Apartments**  
Portland, Maine

**Introduction**

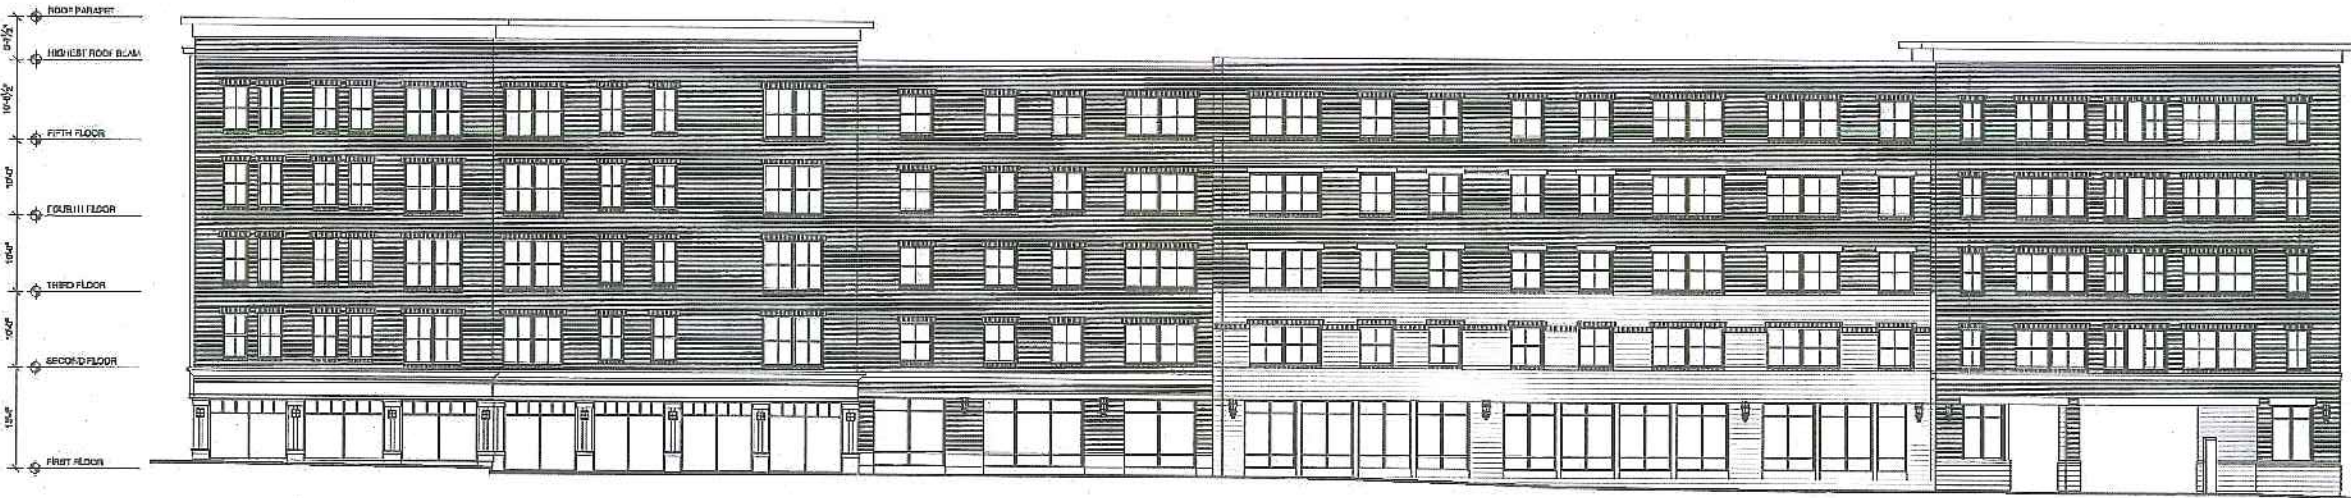
1 YORK STREET EXTERIOR ELEVATION  
3/32" = 1'-0"

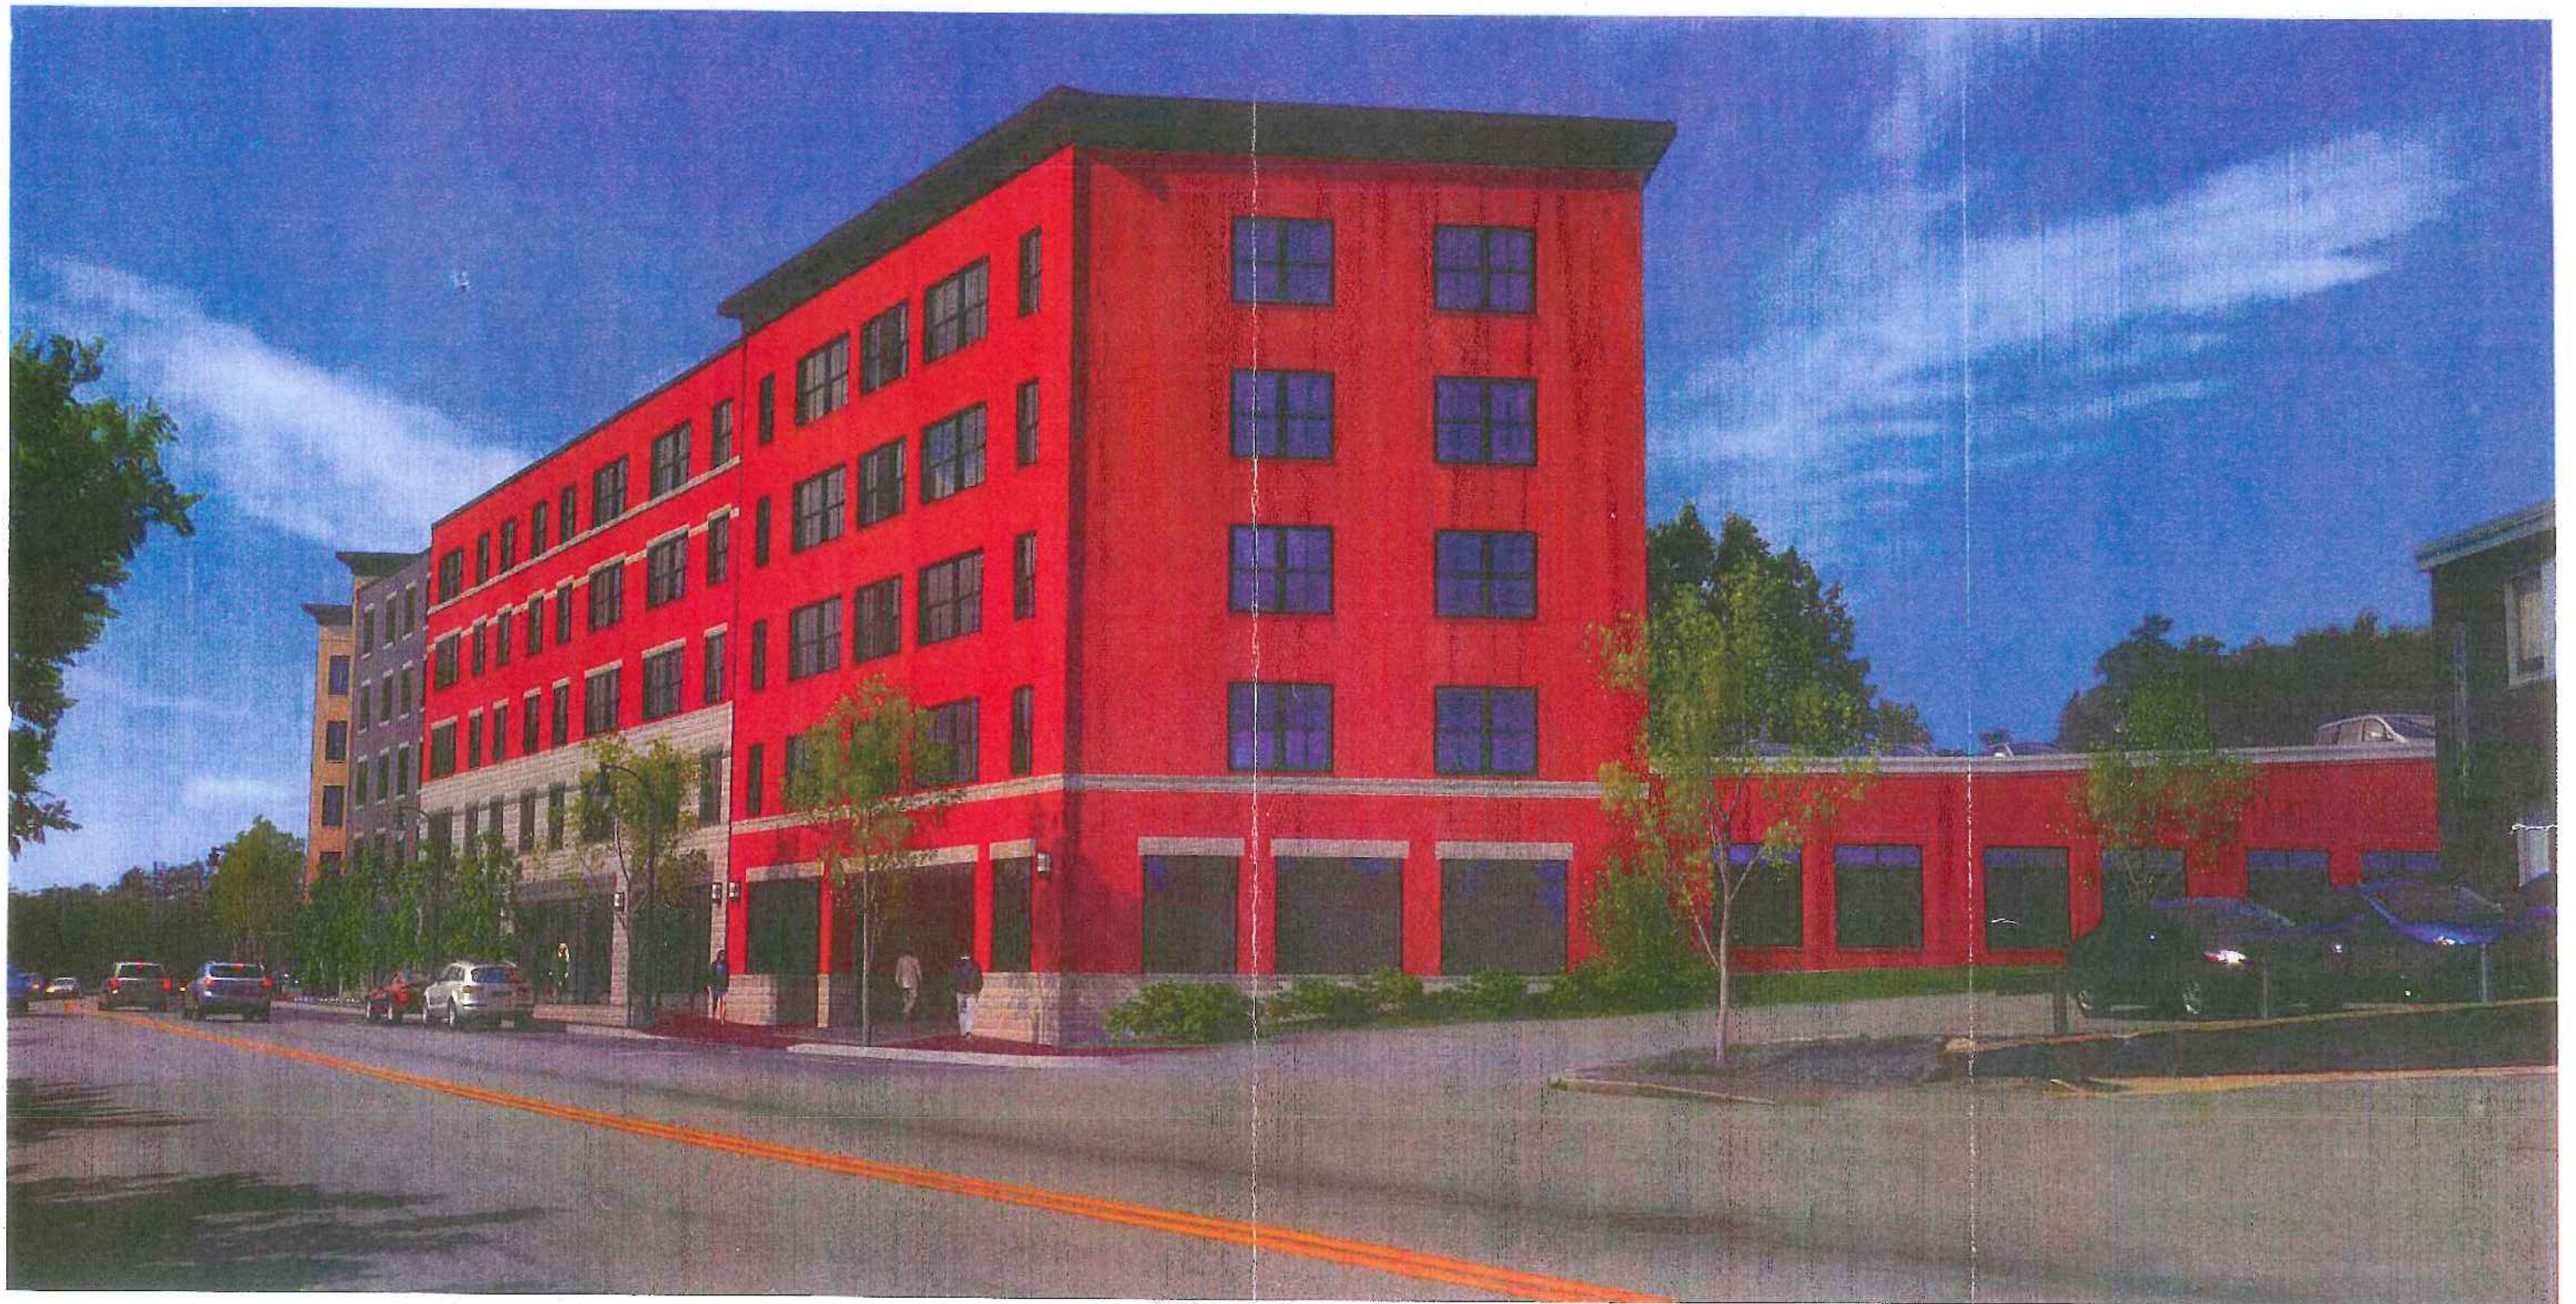
Perspective View from York Street

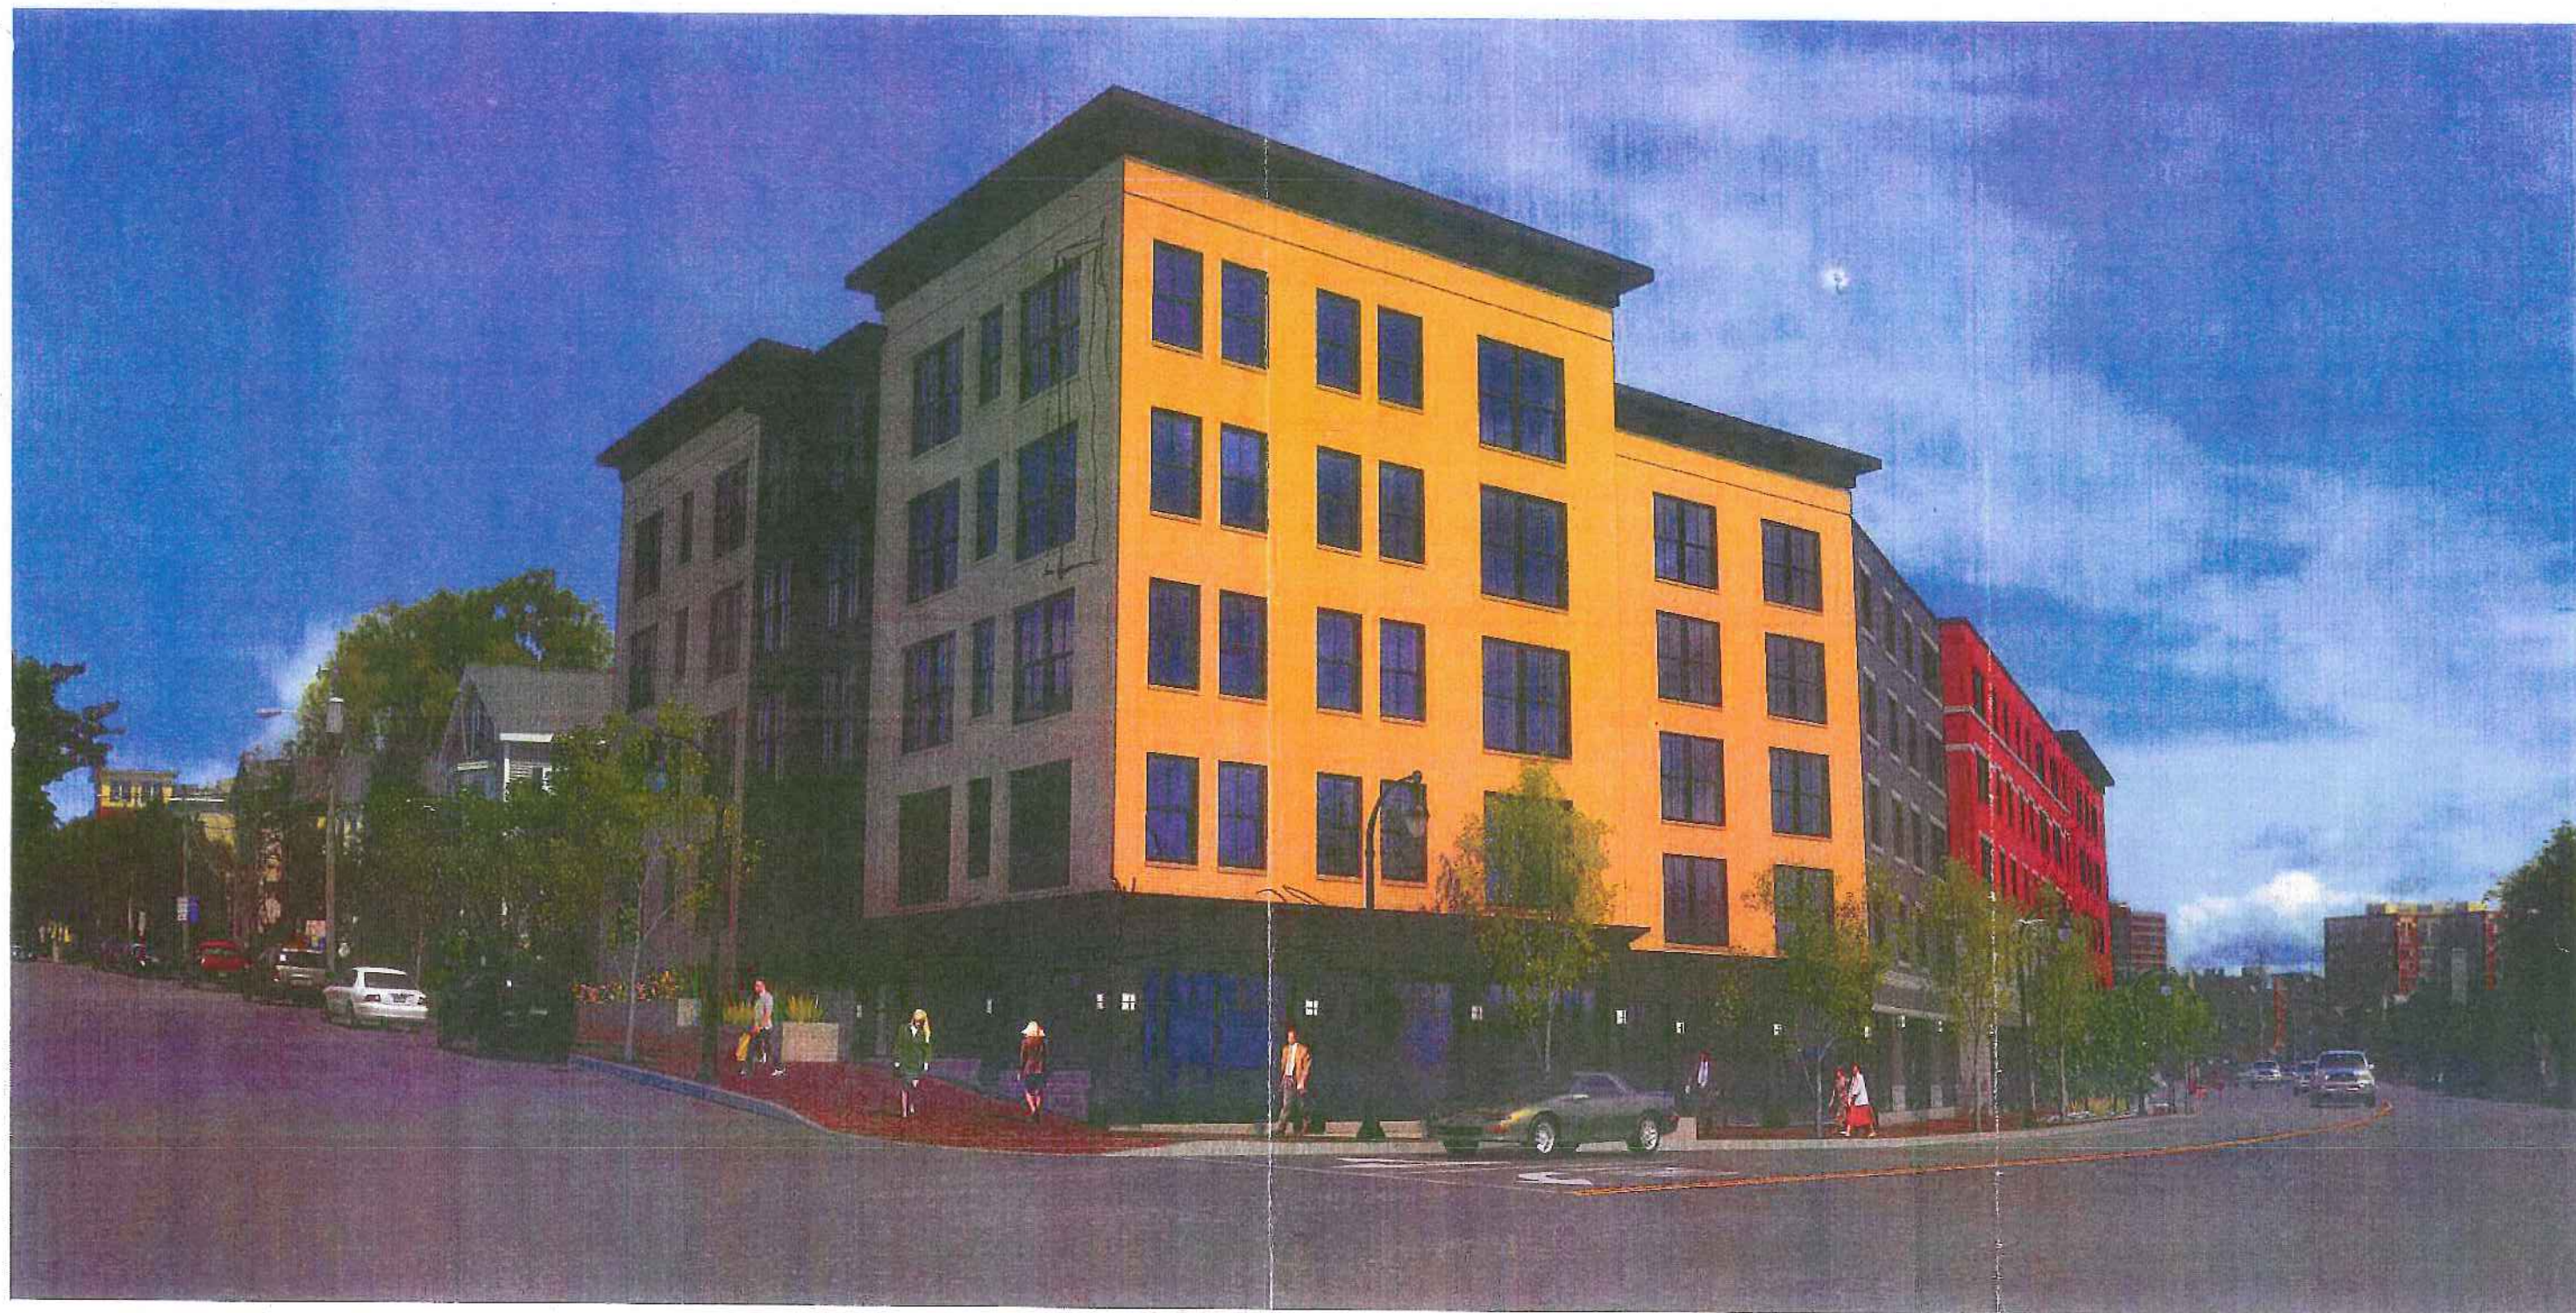
Perspective View from the corner of York Street and High Street

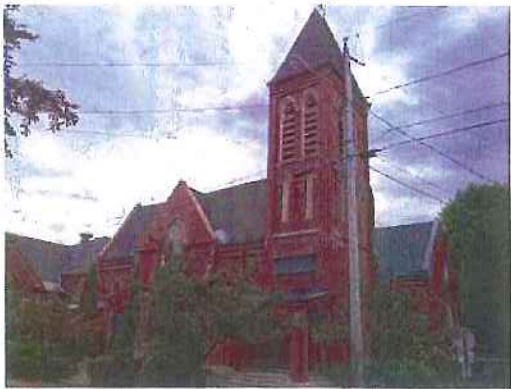
East facade facing Thomas Street - featuring the main entrances to the Church and the Bell Tower

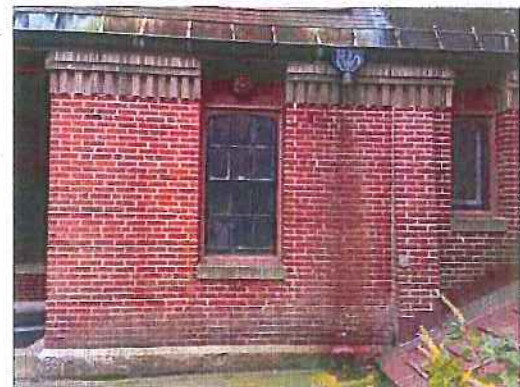
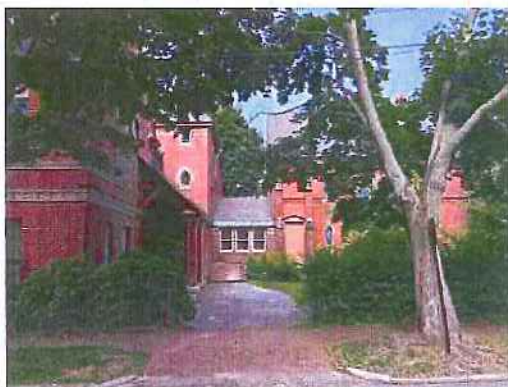
East facade of 'Connector' piece facing Thomas Street

As noted above, the small building connector that adjoins the parish house and the chapel portion of the church was constructed sometime after the two structures were built. It was built originally as an open breezeway, but was enclosed sometime later. Architecturally, it is not of the same caliber as the buildings it adjoins. Plans call for replacing this structure with a fully glazed entry portico with a flat roof. A new glass guardrail is proposed at the edge of the raised brick landing that accesses this entry portico. On the back side of the portico, away from the street, another brick landing and stairs are proposed. These lead to a service area at the rear.

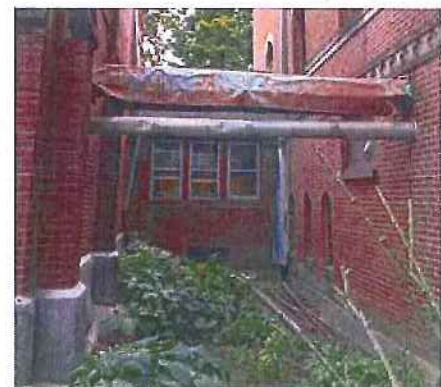
West facade of 'Connector' piece facing parking

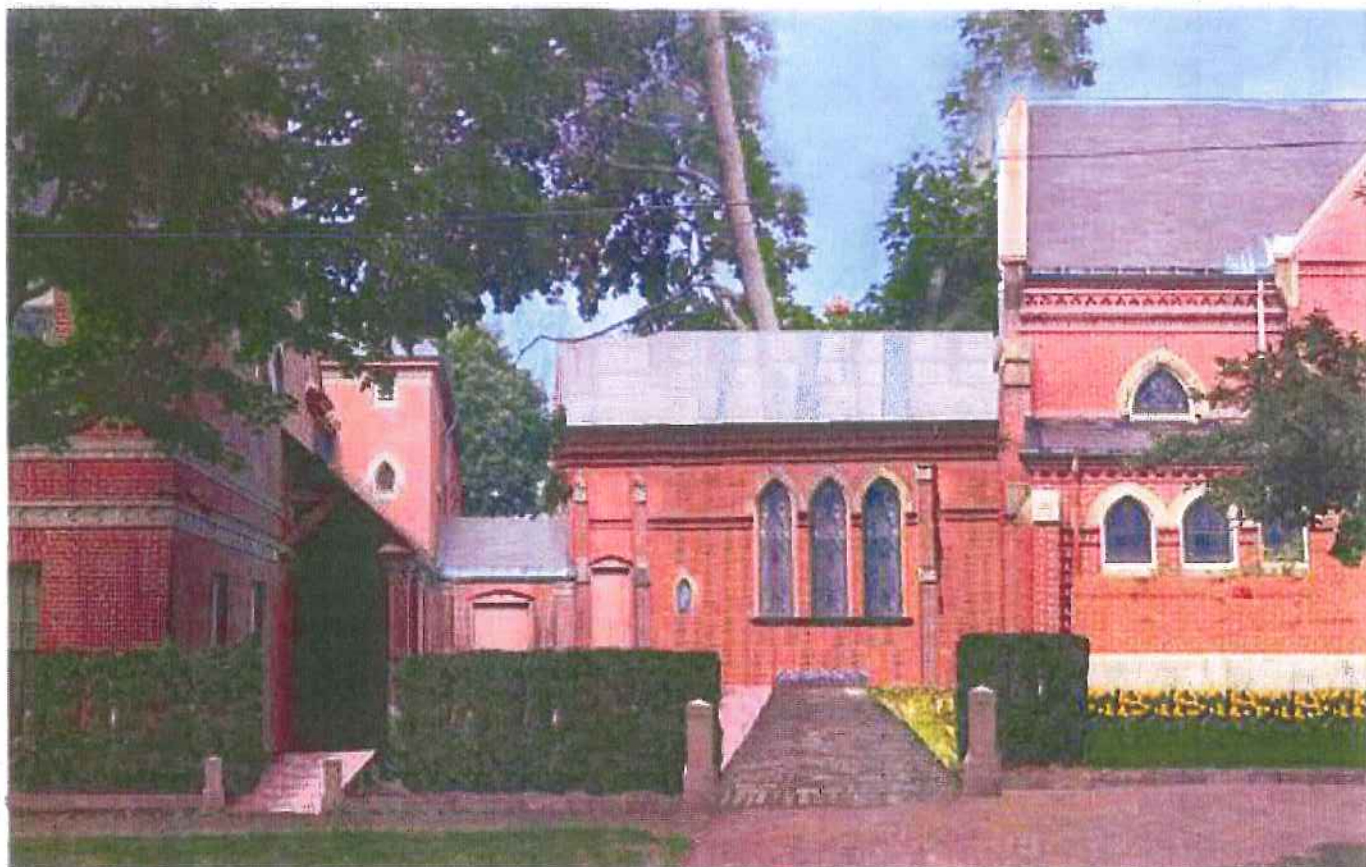
The four parking spaces will be accessed from Thomas Street via a new curb cut that centers on the three magnificent stained glass windows in the Church. This will increase visibility of these windows for the public and insure maximum light penetration for the stained glass. Granite Belgium block pavers will line the access road and granite piers will mark the opening from the street. A granite planter sits at the base of the windows, at the end of the access road, to soften this view. This planter is to be filled with annuals each summer. A brick walk separates the parking stalls from the access road and leads occupants to the Residential entrance stairs. A low perennial border lines the south facing edge of the Courtyard, filled with long-flowering Stella DeOro Daylily and Obedient plant. Icicle Veronica will be planted between the Daylily and Obedient plant to insure constant white blooms throughout the summer months. Finally, a solid hedgerow of evergreen Hicks Yew will fill the planting strip between the parking stalls and Thomas Street sidewalk, blocking views of the automobile, yet still allowing views from the street to the historic architecture. A photo mock-up of the view from Thomas Street, copied on the next page, illustrates the Courtyard design concept of creating a full public view of the historic windows while blocking views of parked cars.

Above: A photo simulation of the proposed design for the Courtyard, as seen from Thomas Street. Cars are parked behind the hedge of Hicks Yew, separated from the Belgium Block paver entry drive by a brick sidewalk.

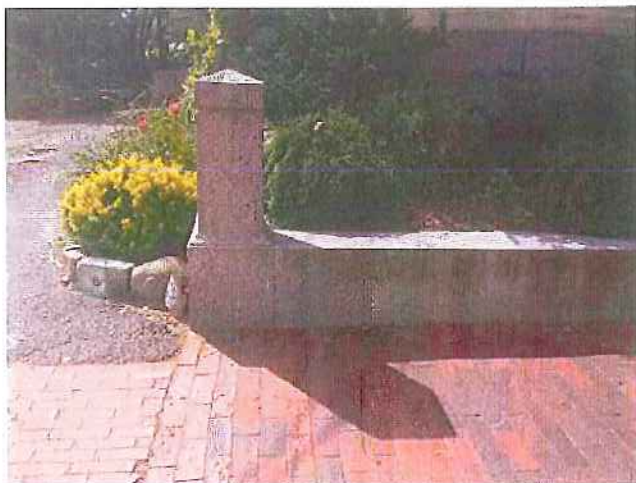
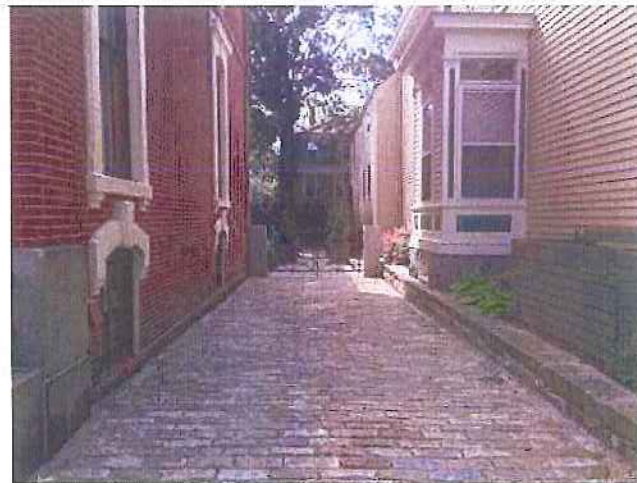
Images taken in Portland's Western Promenade showing examples of typical landscape materials proposed for the Courtyard, such as low granite curbing, brick sidewalks, granite piers, Belgium block paving, and simple landscape plantings.

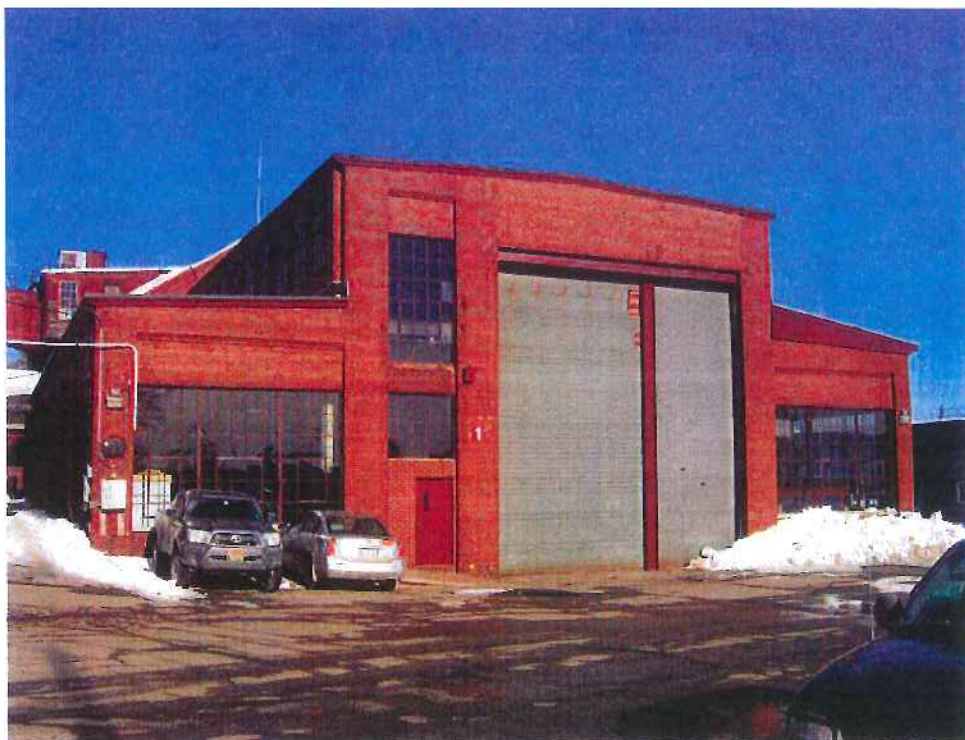
Photo 1-1: General View, Building 1

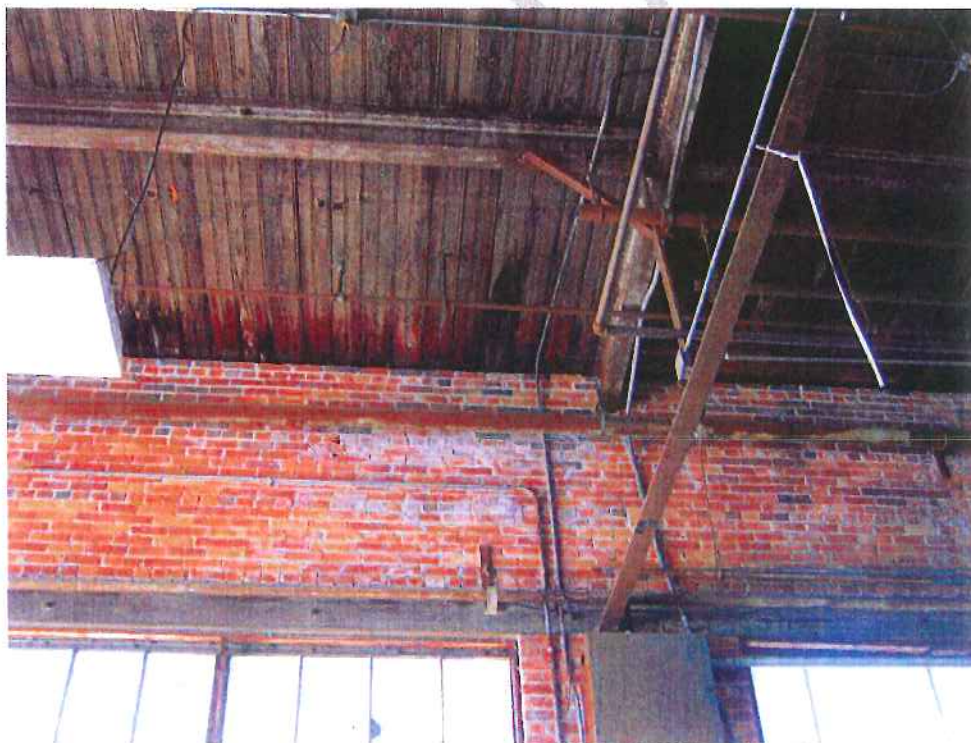
Photo 1-2: Wood deck condition at eave.

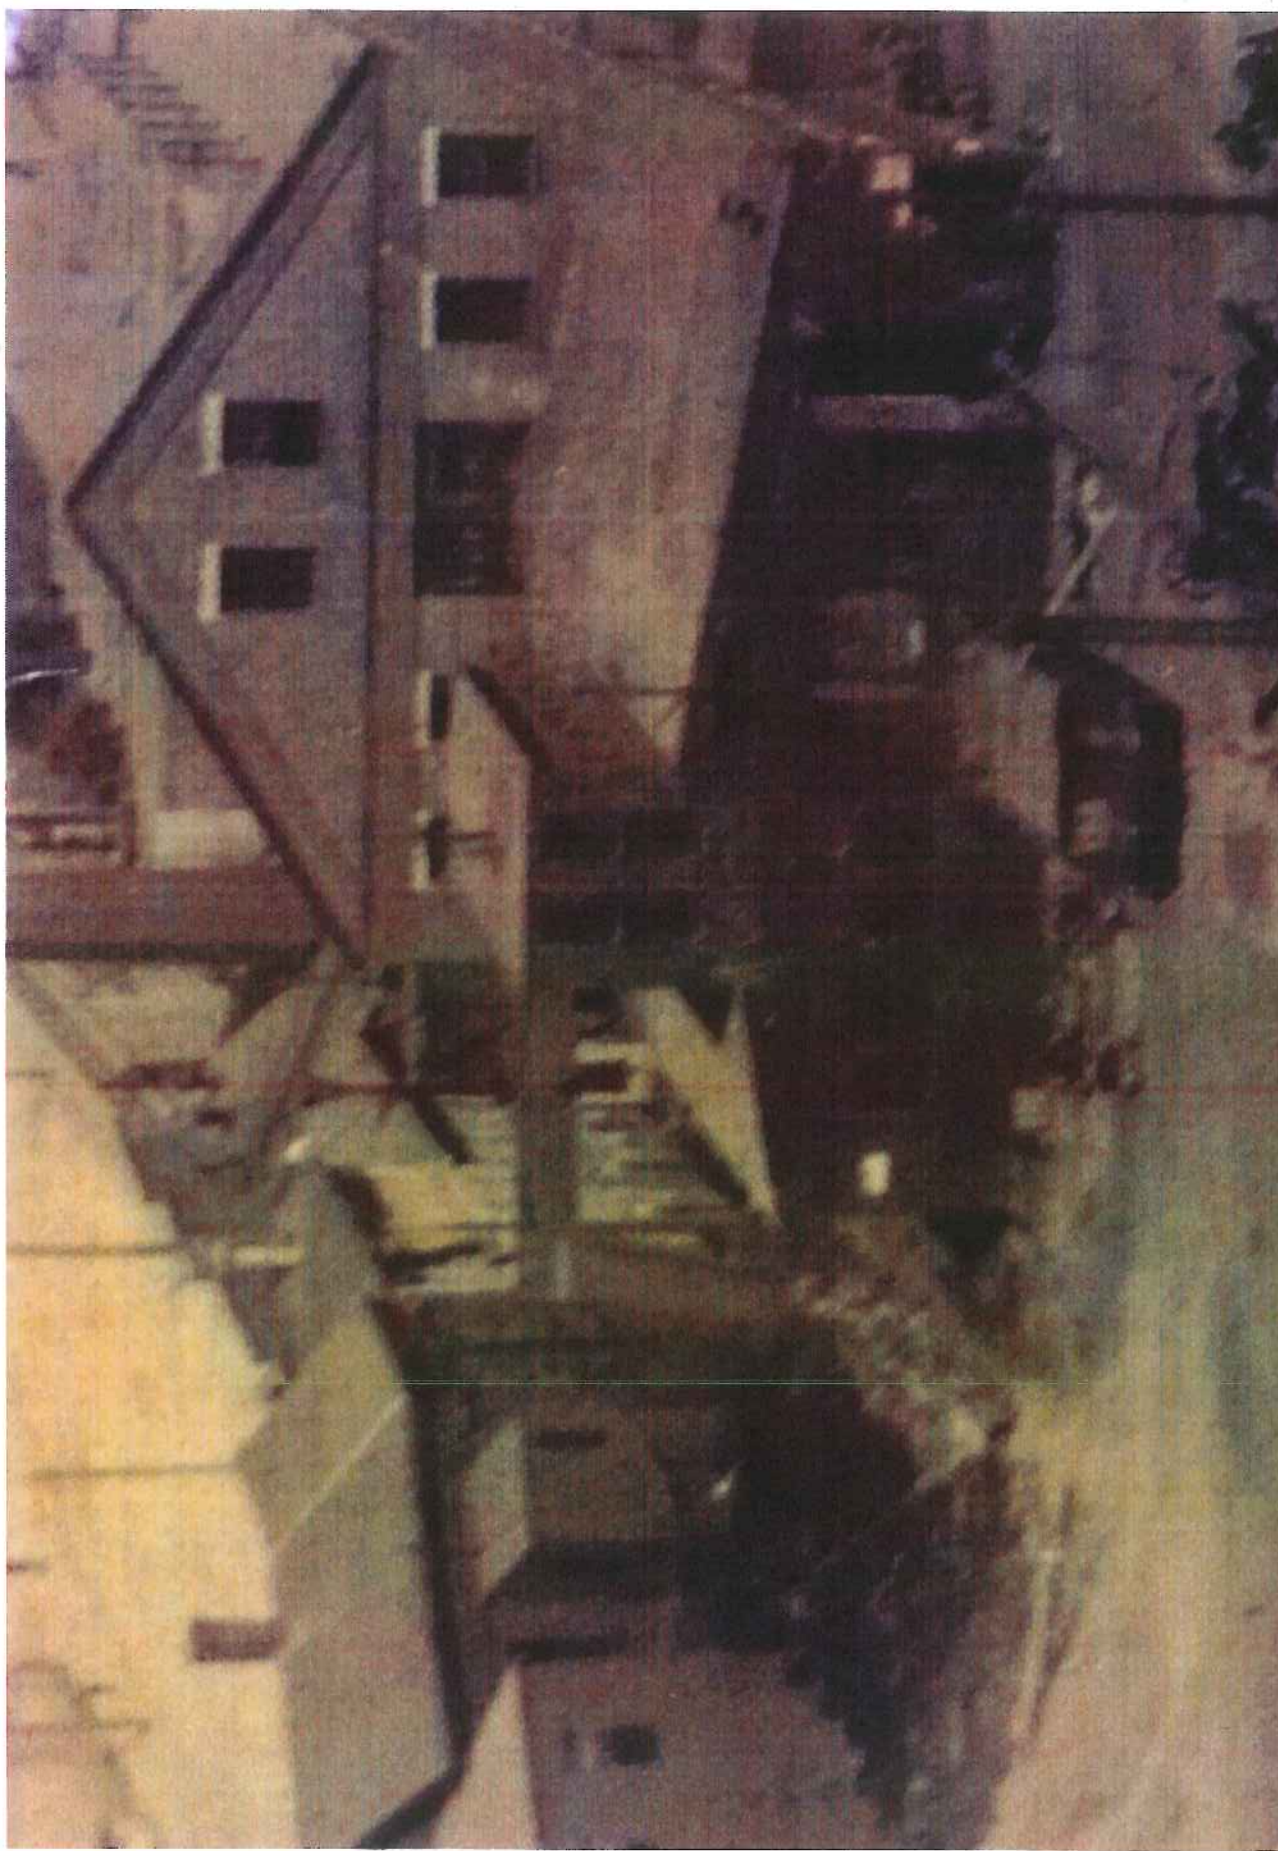
PHOTO C: Second version of Building 1 with roofline change and addition of monitor (photo circa 1896)

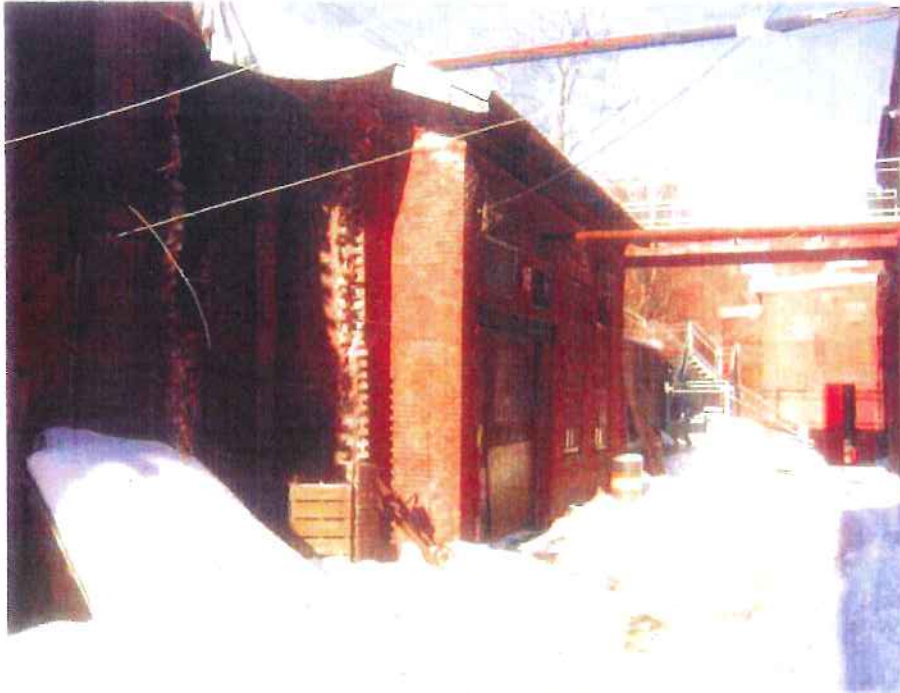
Photo 16-1: Exterior view of blacksmith shop/Building 16.

- Wood rafter framed roof, back wall and side walls are stone retaining wall for embankment, brick masonry front wall (Photo 16-1).
- Fore Street stone retaining wall at is dry stacked. It was apparent that water travels through the wall.

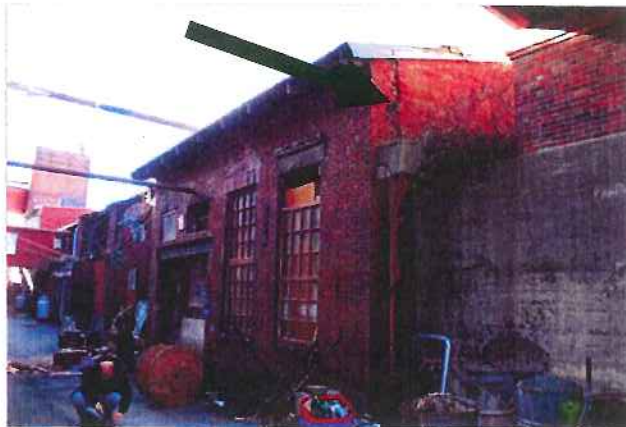
**PHOTO  
#16.1**  
R 57.jpg

Building 16: View from southeast from alleyway. Note masonry wall return cracks on east elevation (arrow).

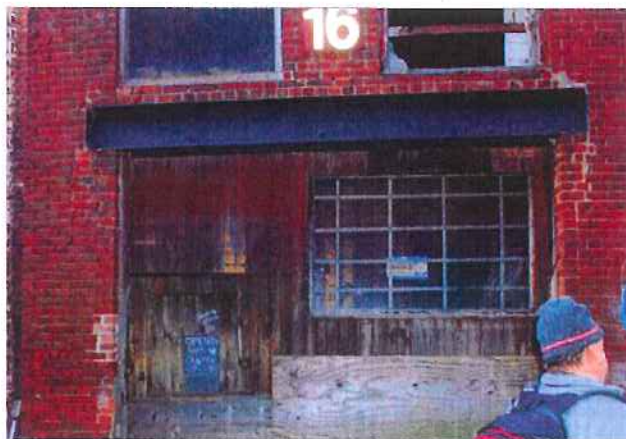
**PHOTO  
#16.3**  
a f 93.jpg

Building 16: Enlarged opening in south elevation wall. Entire south wall requires repointing, repair, and anchoring into east wall.

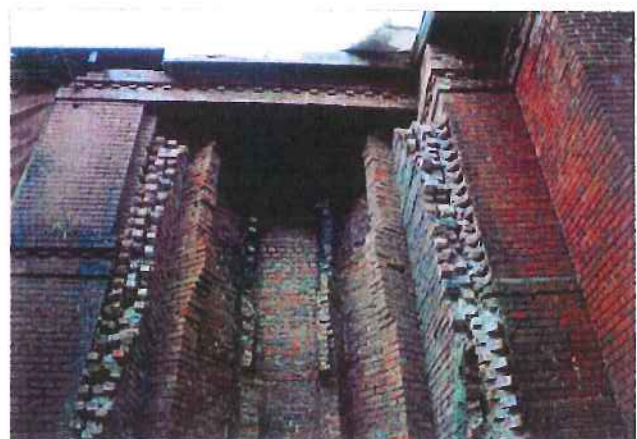
**PHOTO  
#16.4**  
P 23.jpg

Building 15/16: Remnants of boiler house chimney stack between Buildings 15 and 16.

- The wooden and brick masonry walls of both buildings are in poor condition.
- The chimney base bricks should be checked and stabilized in place.
- Timber and lumber roof framing at Building 16 is undersized for contemporary snow loads.

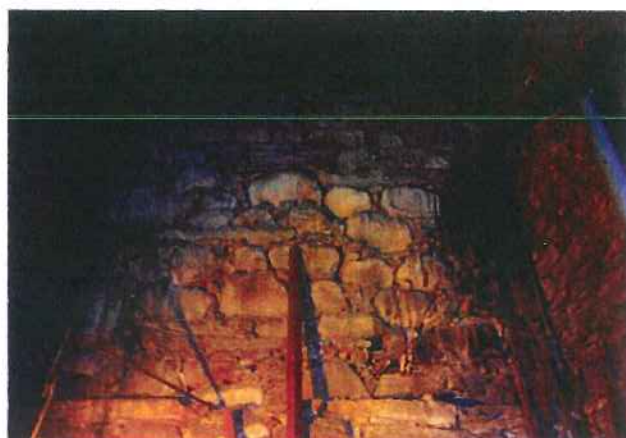
**PHOTO  
#16.5**  
P 25.jpg

Building 16: North wall doubles as Fore Street retaining wall. Sloped roof rafters bear onto top of wall. Need to check condition of top plate above this wall.

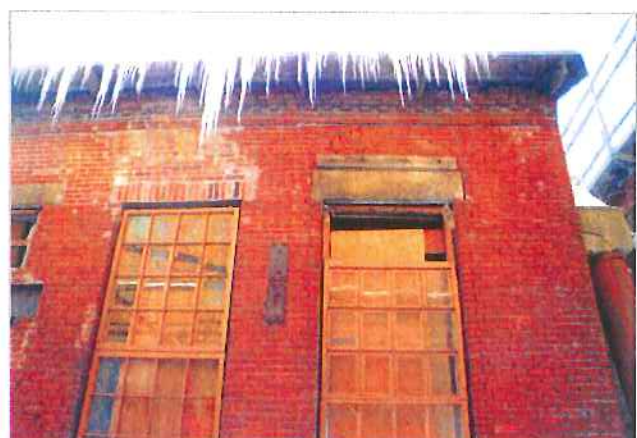
**PHOTO  
#16.6**  
A 29 35.jpg

Building 16 south wall (detail): Masonry has simple details and small cornices at the top. Window header at left has been replaced with brick soldier course and steel lintel.

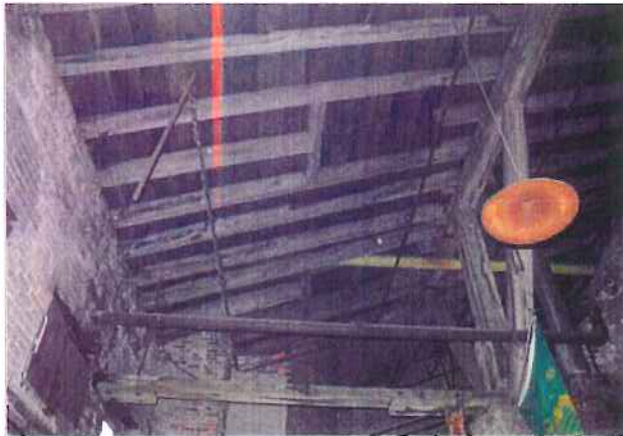
**PHOTO  
#16.7**  
A 29 36.jpg

Building 16 roof framing, south wall: Roof previously had skylights or vents on south side of roof. Note center line of bearing at braced column. Framing likely undersized.

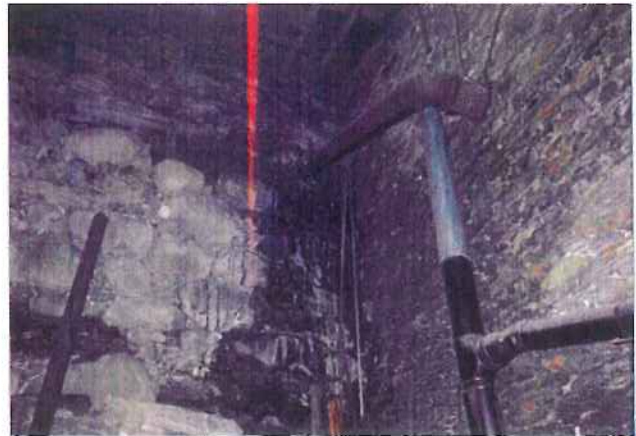
**PHOTO  
#16.8**  
A 29 37.jpg

North and east walls: Barrels beneath multiple active roof leaks.

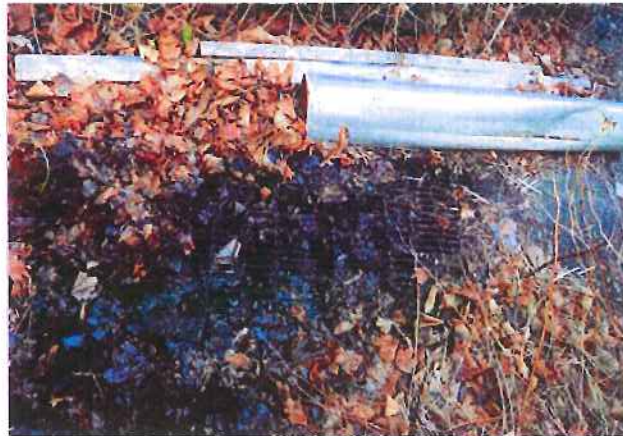
**PHOTO  
#16.9**  
A 29 42.jpg

Catch basin grate, east of Building 16: Grate covered by leaves and debris, and basin itself appears to be clogged.

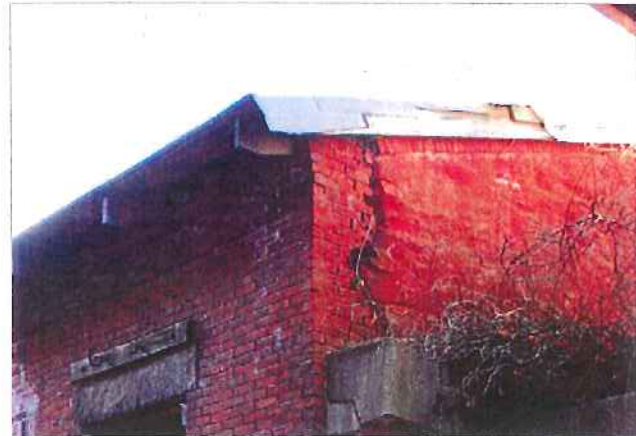
**PHOTO  
#16.10**  
A 30 42.jpg

Building 15 southeast wall corner: Masonry repair is required to create weatherproof and structurally sound transition from brick to stone wall.

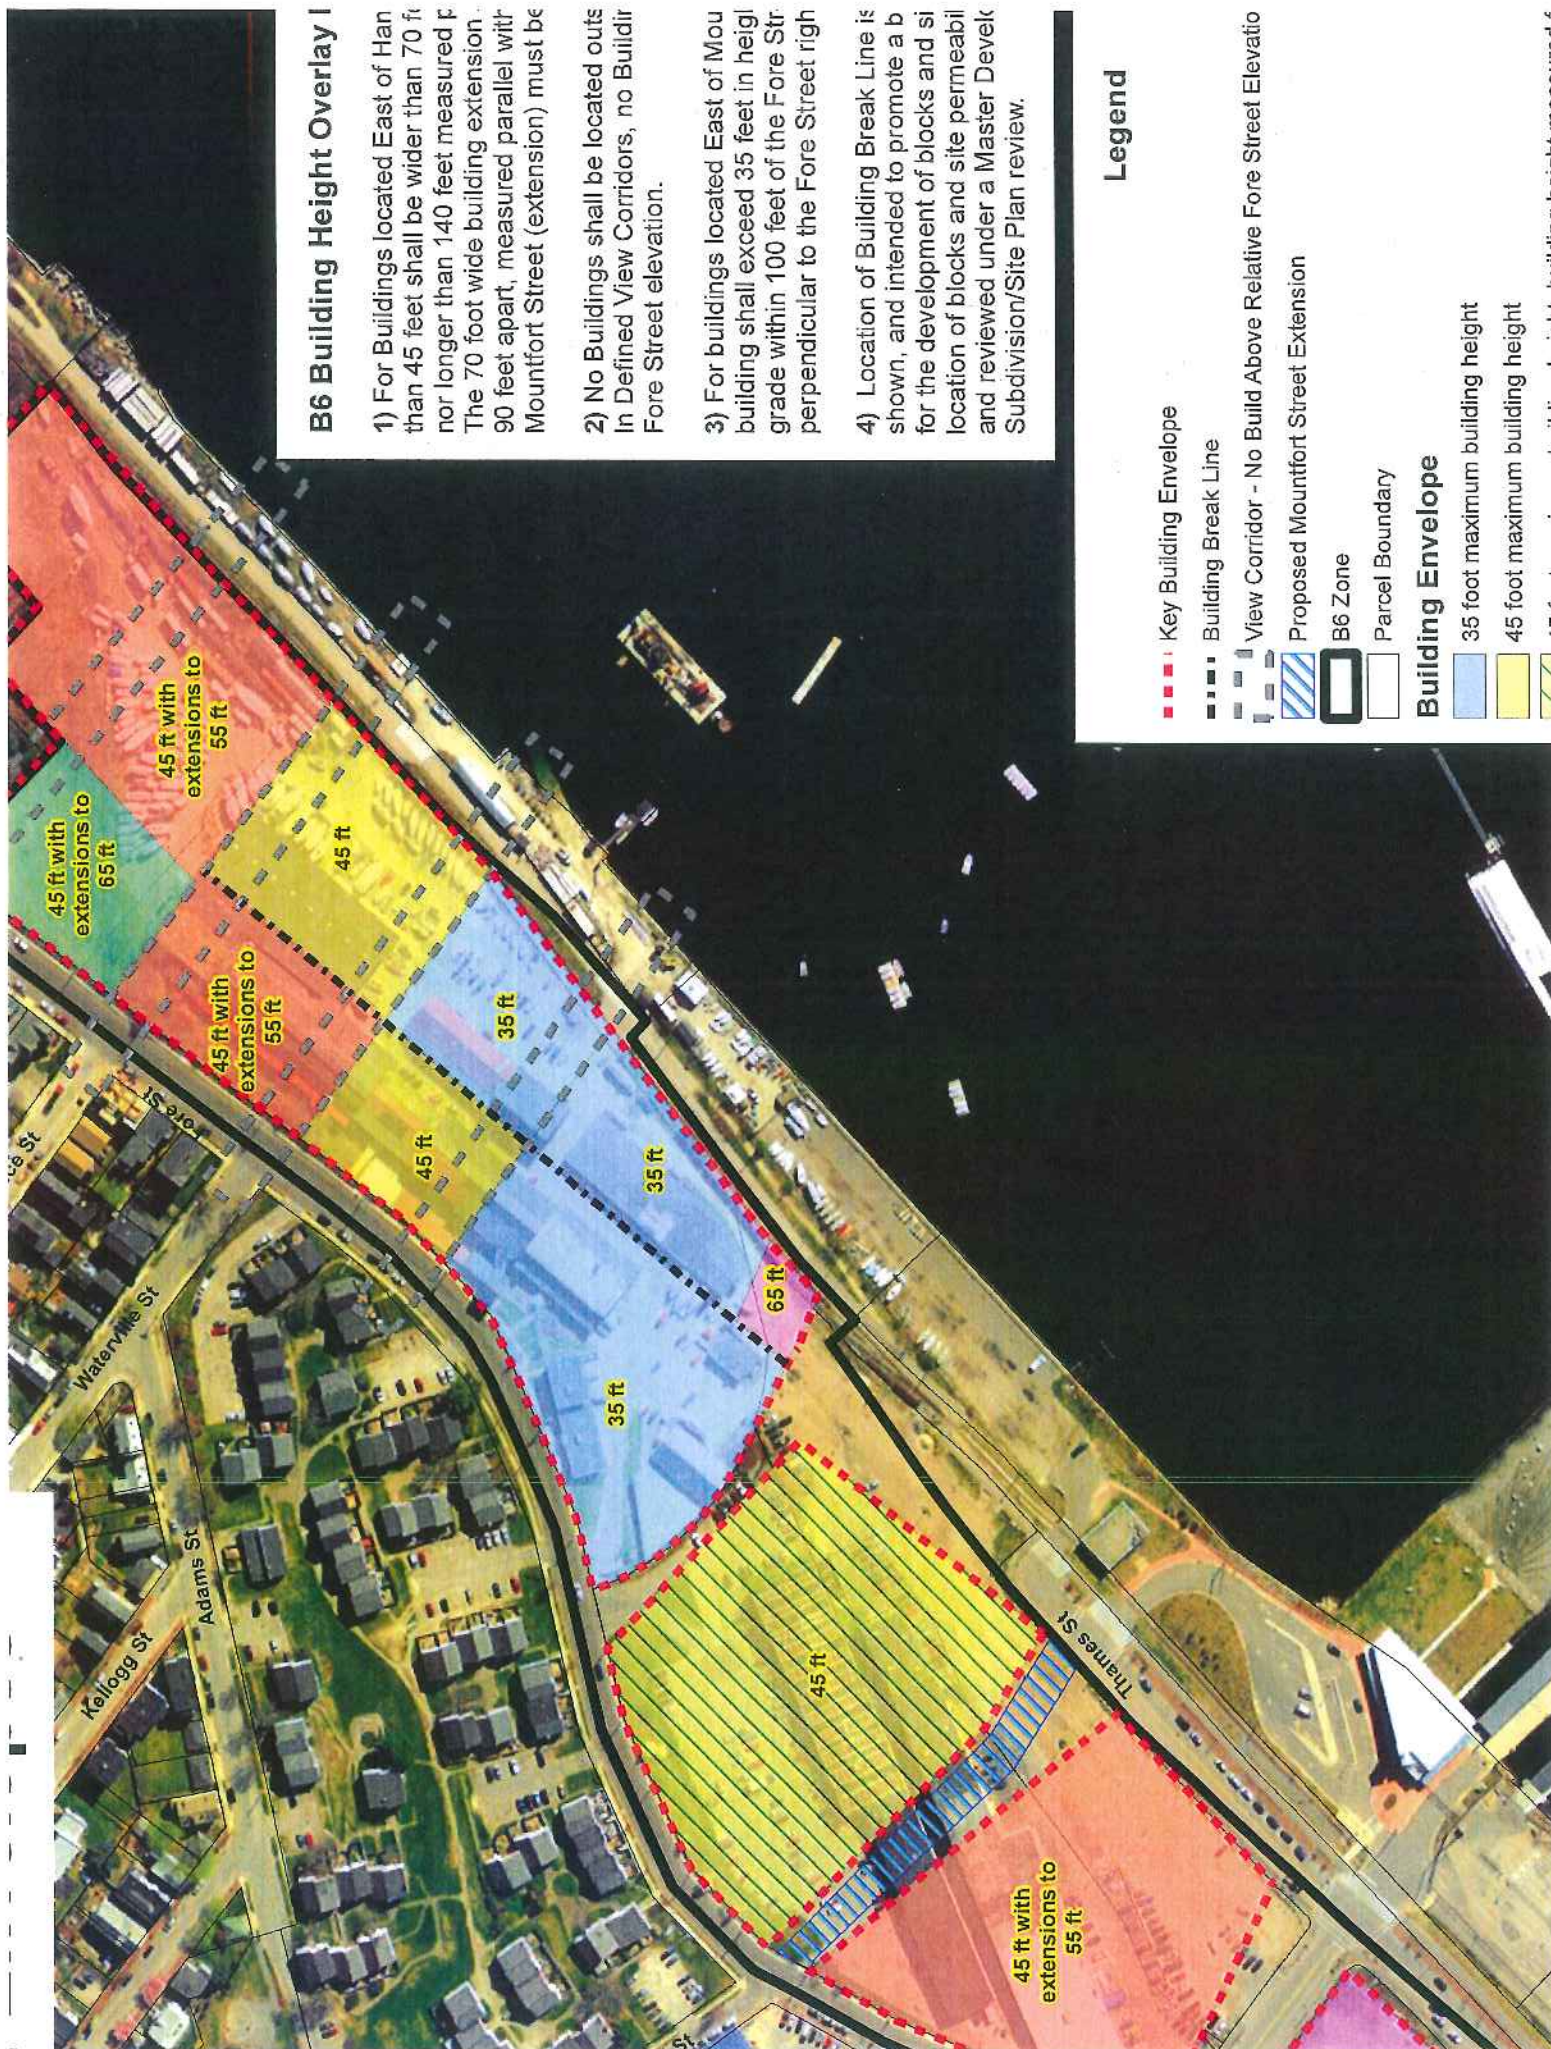
### B6 Building Height Overlay I

- 1) For Buildings located East of Han than 45 feet shall be wider than 70 ft nor longer than 140 feet measured p The 70 foot wide building extension 90 feet apart, measured parallel with Mountfort Street (extension) must be
- 2) No Buildings shall be located outs In Defined View Corridors, no Buildir Fore Street elevation.
- 3) For buildings located East of Mou building shall exceed 35 feet in heigl grade within 100 feet of the Fore Str perpendicular to the Fore Street righ
- 4) Location of Building Break Line is shown, and intended to promote a b for the development of blocks and si location of blocks and site permeabil and reviewed under a Master Devekl Subdivision/Site Plan review.
