3. High And York Streets

**LEGAL ADVERTISEMENT  
HISTORIC PRESERVATION BOARD  
CITY OF PORTLAND  
Public comments are taken at all meetings.**

**York Street Apartments**  
Portland, Maine

**Introduction**

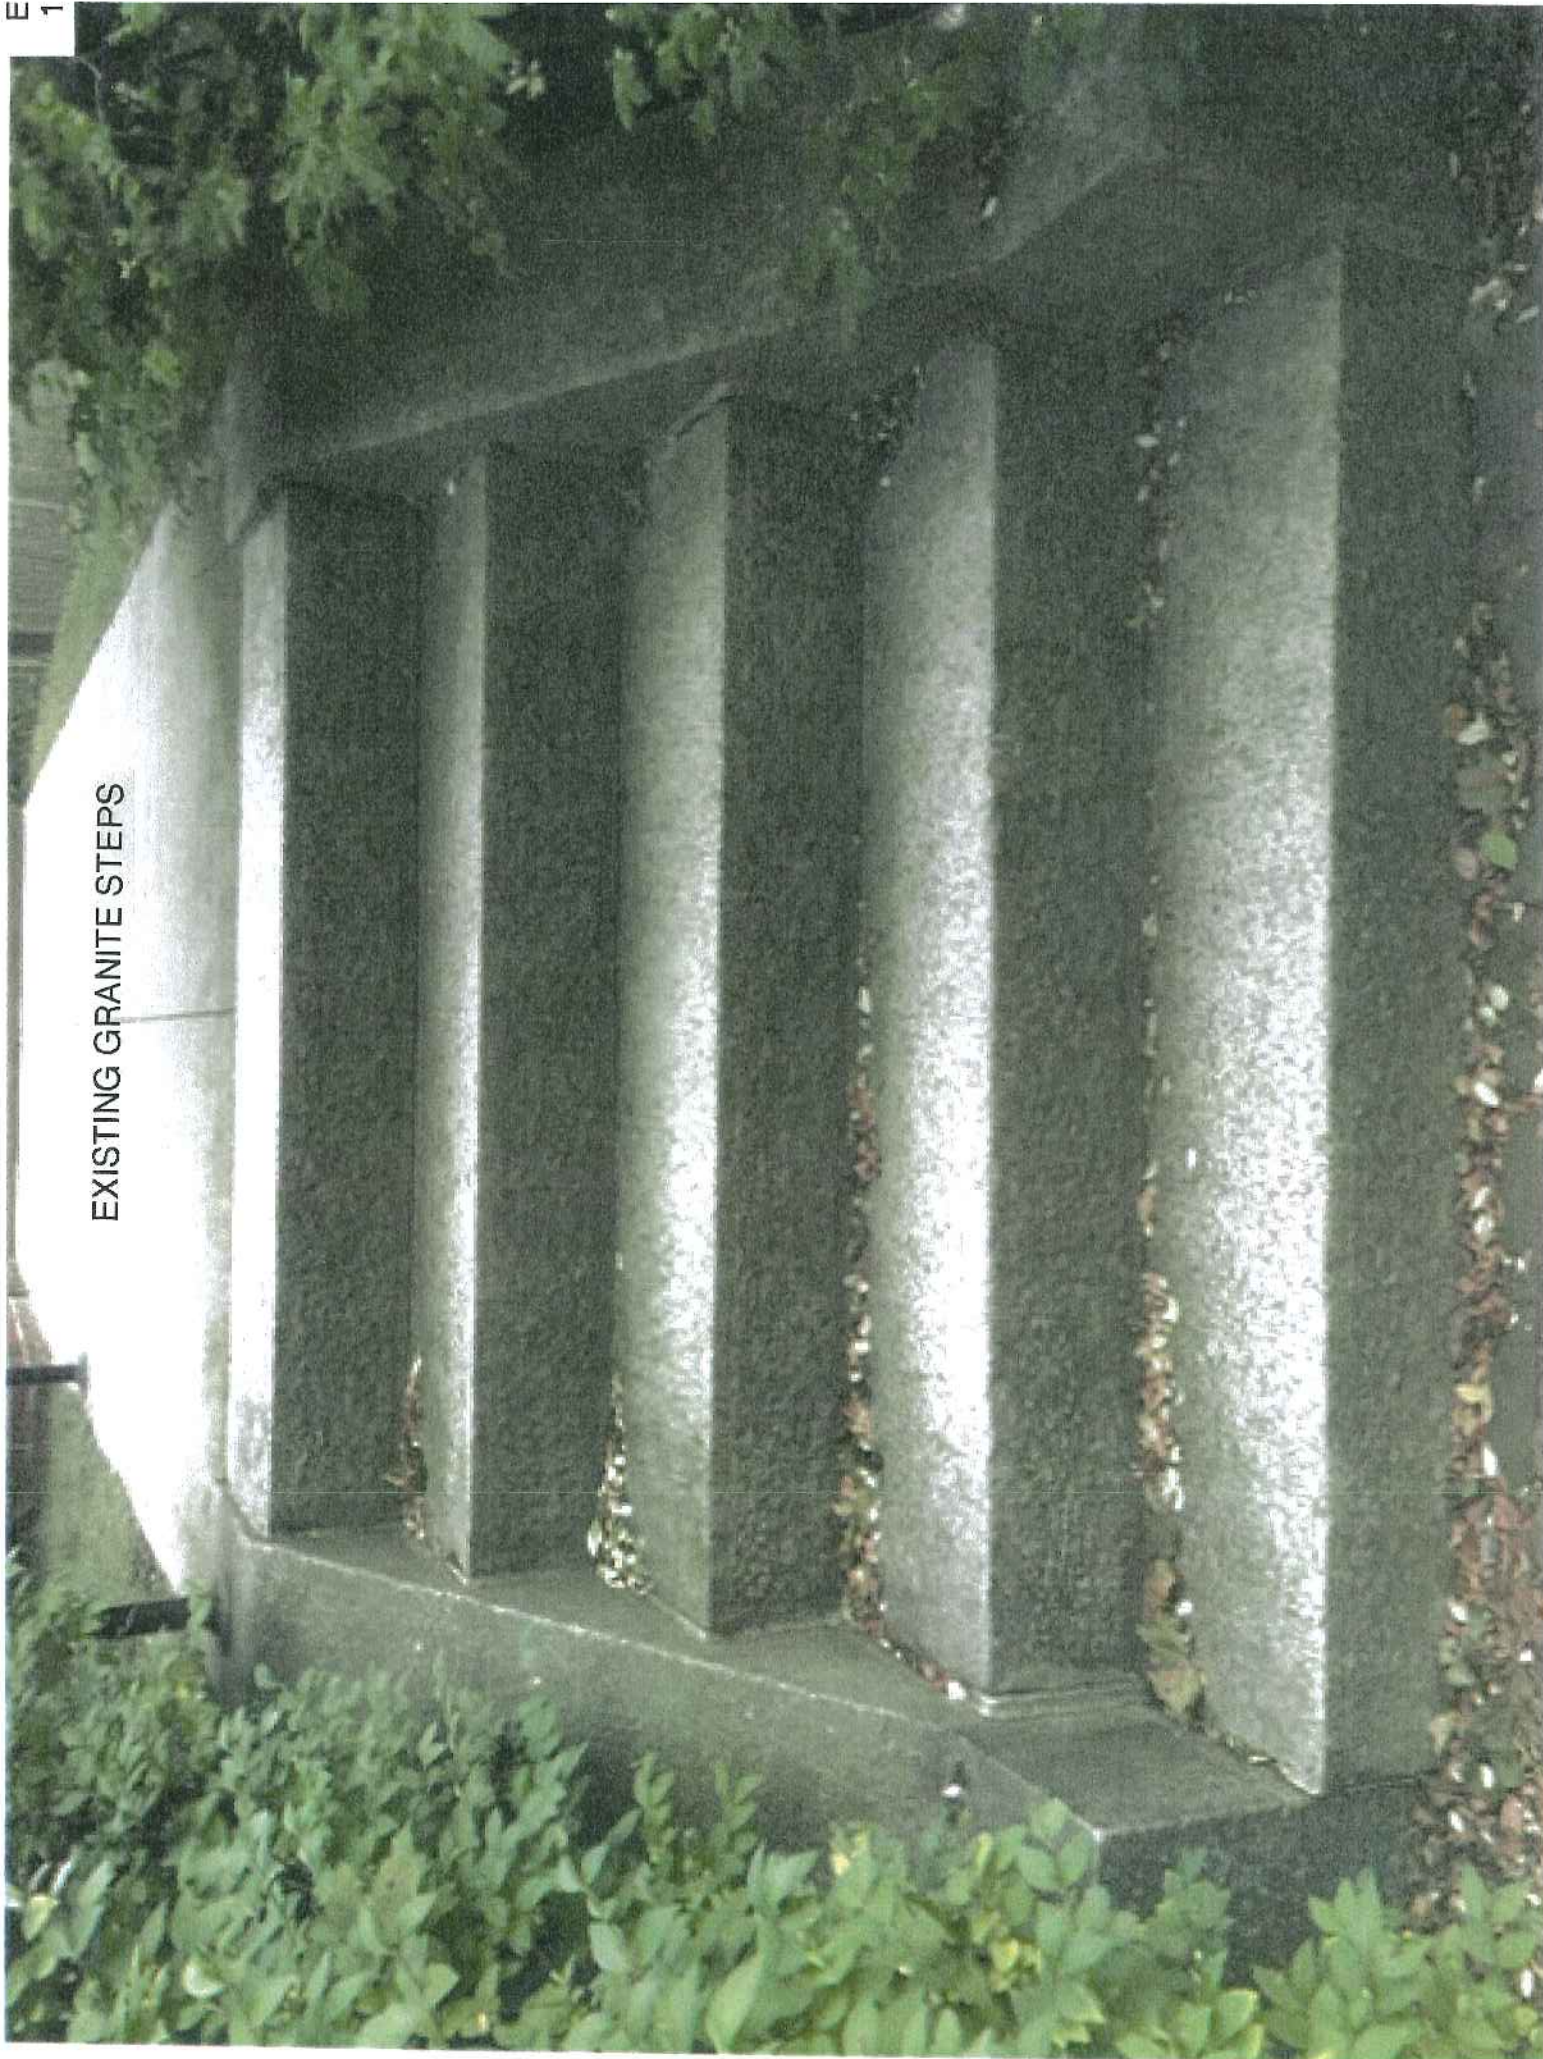
# ISOMETRIC VIEW

EXISTING GRANITE STEPS

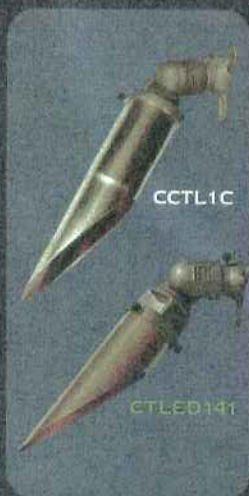
### Copper Tree Light (CCTL1C, CTLED141)

- Heavy-gauge extra-long copper shroud for maximum light control
- Shroud can be rotated 360°
- Fast-mount solid bronze canopy base
- Pre-wired with 35 ft. #16-2 No-Ox® marine grade wire
- 10.25" tall x 2.25" wide
- Uses MR-16 lamp (not included)

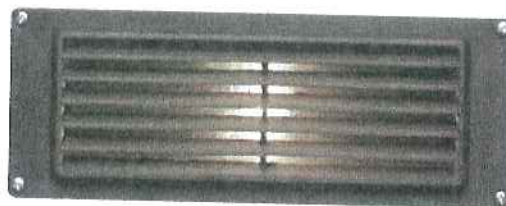
STEP LIGHTING RECESSED IN  
RISERS OF STEPS FOR NIGHT ILLUMINATION

DOWN LIGHTING IN TREES  
FOR WALKWAY ILLUMINATION
