**PORTLAND FISH PIER AUTHORITY  
BOARD OF DIRECTORS  
July 16, 2026, 3:00 PM**

SPECIAL PORTLAND FISH PIER AUTHORITY  
BOARD OF DIRECTORS SPECIAL MEETING  
June 11, 2026, 3:30 PM

The City of Portland retained Simpson Gumpertz & Heger (SGH) to review the findings and recommendations of a recent inspection of the Service Piers at the Portland Fish Pier complex in Portland, ME, that was completed by TEC Associates, and to provide a report on our findings and recommendations. The primary objective of this assignment is to offer a second opinion on the need for the operational restrictions recommended in that inspection report.

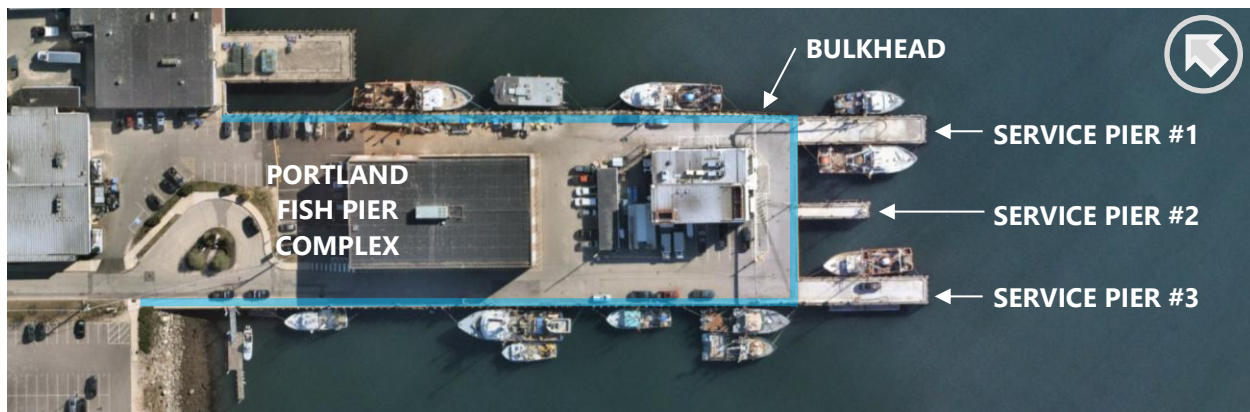
**Figure 1 – Portland Fish Pier Aerial Photo (Nearmap)**

The Portland Fish Pier complex is a City-owned waterfront facility located at 1 Portland Fish Pier on Commercial Street in Portland, Maine (Figure 1). Existing marine structures at the site include the tied-back steel sheet pile bulkhead and the fixed Service Piers #1, 2, and 3.

The Service Piers are used to load vehicles and vessels with fuel and ice, and to unload commercial fishing vessels. The north slip at Service Pier #1 is the only location that can readily accommodate fueling large vessels because of the available slip length and a high-flow fuel line.
